**Flood Control Project Maintenance
Levee Inspections**

Fall 2016 Levee Maintenance Deficiency Summary Report

**Flood Control Project Maintenance
Levee Inspections**
LMA District Cover Sheet
Fall 2016 Levee Inspection Results

Reclamation District No. 0556 Upper Andrus

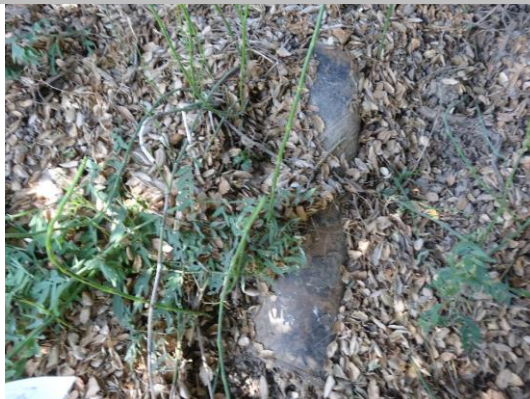
Photo 1 of 2 : UCIP_FA_2016_45683_74200.jpg

LM Start	1.17	Rating **	M	Issue No.	391 (cont)
LM End	1.17	Issue Type +	En	Location *	LS

LS view of pipe appearing abandoned in place.

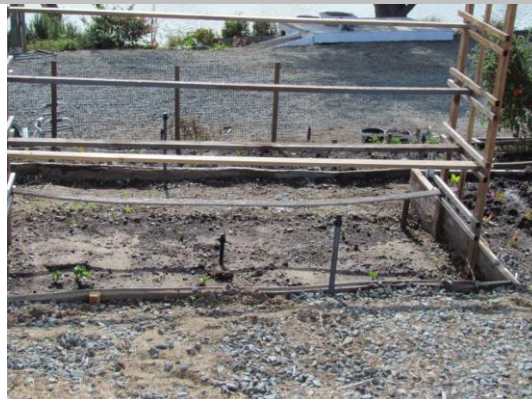
Photo 1 of 2 : FA_2016_RD0556_18_70_20160919_00010.jpg

Landowner has dug into waterward slope and placed planterboxes.

LM Start	3.94	Rating **	U	Issue No.	70
LM End	4.01	Issue Type +	En	Location *	WS
Category	Earthen Levee			GPS Latitude/Longitude	
				Start	End
Item	Encroachments			38.201515 °	38.201105 °
				-121.542573 °	-121.543720 °
DWR ID	DWR_RD0556_01_f_2014_70				
Comment Code					
CR : Crops					
Inspector Comment					
Remove the unauthorized planter boxes repack earth materials back on slope.

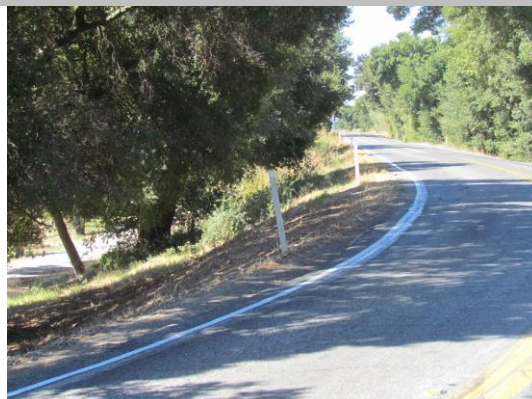
Photo 1 of 1 : FA_2016_RD0556_19_29_20161031_00052.jpg

RD 556 Unit 2 looking downstream landside levee mile 0.00-1.35.

LM Start	0.00	Rating **	U	Issue No.	29
LM End	1.35	Issue Type +	Ma	Location *	LS
Category	Earthen Levee			GPS Latitude/Longitude	
				Start	End
Item	Vegetation			38.200550 °	38.239821 °
				-121.544190 °	-121.542440 °
DWR ID	DWR_RD0556_02_f_2016_29				
Comment Code					
V1 : Control annual grass and weeds on the levee slopes and easements.					
Inspector Comment					
Control the wild vegetation and wild tree growth from the landside slope and shoulder heading downstream

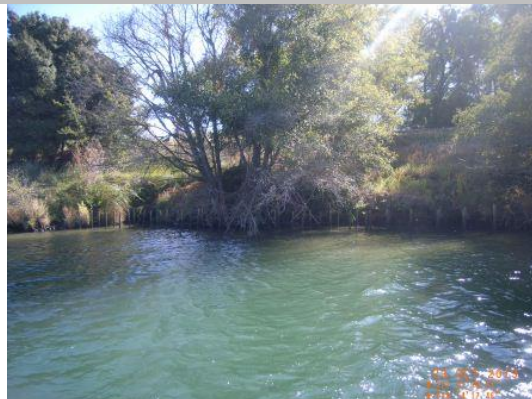
Photo 1 of 1 : FA_2016_RD0556_19_12_20160919_00010.jpg

LM Start	0.31	Rating **	M	Issue No.	12
LM End	0.60	Issue Type +	Ma	Location *	WS
Category	Supplemental			GPS Latitude/Longitude	
				Start	End
Item	2015 USACE Erosion Survey, DRAFT			38.238784 °	38.237862 °
				-121.523932 °	-121.529188 °
DWR ID	DWR_RD0556_02_f_2016_12				
Comment Code					
Inspector Comment					
2002 - Two rocked sections (150 ft long) at the downstream end.					
2005 - Lots of old brush boxes, some with established vegetation in the area behind the boxes. 2006 - Some small spots fixed with stone.					
2009 - Minimal new erosion, rock in the middle of the reach may be new. 2011 - Minor new erosion at the toe. 2013 - Minor new erosion.					
2015: Site is currently under construction. [2015 Site ID: SAC_26-0_L]

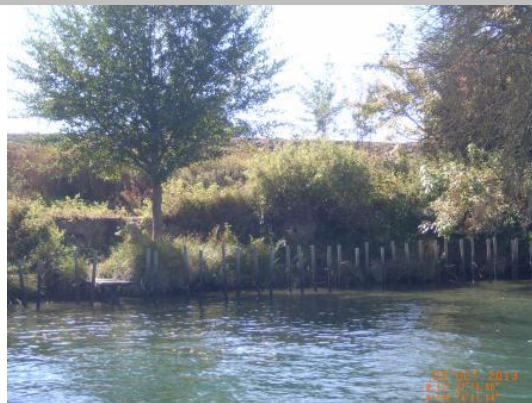
Photo 1 of 1 : FA_2016_RD0556_19_2_20160919_00002.jpg

LM Start	1.03	Rating **	M	Issue No.	2
LM End	1.15	Issue Type +	Ma	Location *	WS
Category	Supplemental			GPS Latitude/Longitude	
				Start	End
Item	2015 USACE Erosion Survey, DRAFT			38.238772 °	38.239265 °
				-121.536788 °	-121.538845 °
DWR ID	DWR_RD0556_02_f_2016_2				
Comment Code					
Inspector Comment					
1997 - Rock is in poor condition and has failed in many places. Scallops in berm with remnants of old rock in the toe area. 2005 - Brush boxes present. 2013 - Site extended upstream approximately 300 ft to include new erosion pockets. 2015: Minor new erosion at toe. [2015 Site ID: SAC_25-2_L]

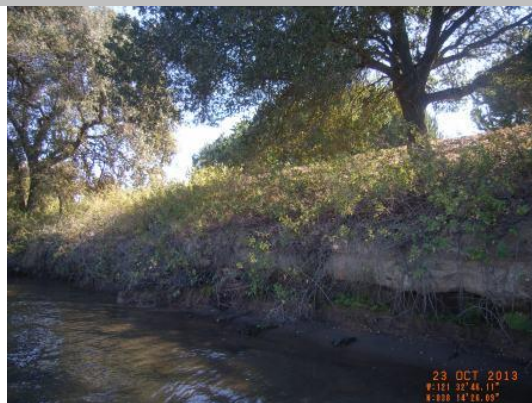
Photo 1 of 1 : FA_2016_RD0556_19_5_20160919_00005.jpg

LM Start	1.45	Rating **	M	Issue No.	5
LM End	1.59	Issue Type +	Ma	Location *	WS
Category	Supplemental			GPS Latitude/Longitude	
				Start	End
Item	2015 USACE Erosion Survey, DRAFT			38.240401 °	38.240772 °
				-121.544106 °	-121.546791 °
DWR ID	DWR_RD0556_02_f_2016_5				
Comment Code					
Inspector Comment					
1997 - Slow erosion of the berm at the waterline; bench below water. 2005 - Brush boxes present. 2010 - Minor new erosion. 2013 - There is little to no berm remaining at downstream end of this site. 2015: No observed changes. [2015 Site ID: SAC_24-8_L]

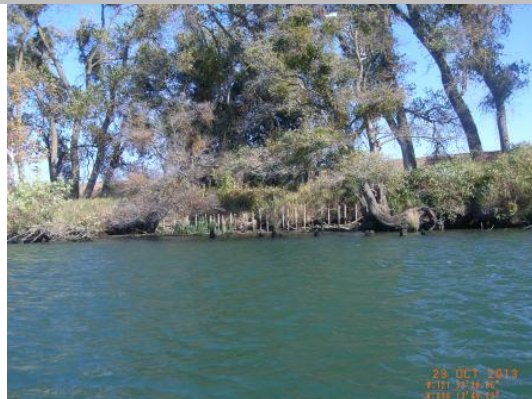
Photo 1 of 1 : FA_2016_RD0556_19_11_20160919_00009.jpg

LM Start	2.93	Rating **	M	Issue No.	11
LM End	3.04	Issue Type +	Ma	Location *	WS
Category	Supplemental			GPS Latitude/Longitude	
				Start	End
Item	2015 USACE Erosion Survey, DRAFT			38.228202 °	38.226601 °
				-121.555502 °	-121.555605 °
DWR ID	DWR_RD0556_02_f_2016_11				
Comment Code					
Inspector Comment					
1997 - Few scallops in berm, some getting close to levee toe. 2005 - Brush boxes present. 2012 - More erosion of the toe since last year. 2015: No observed changes. [2015 Site ID: SAC_23-3_L]

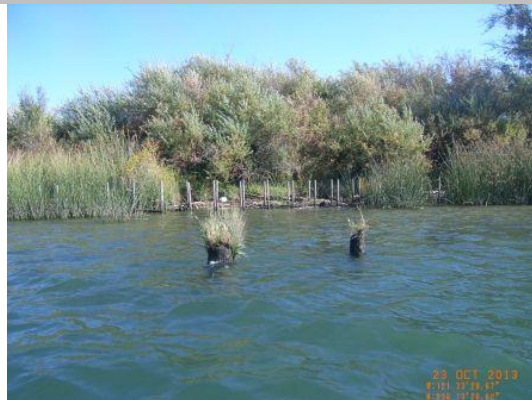
Photo 1 of 1 : FA_2016_RD0556_19_10_20160919_00008.jpg

LM Start	3.17	Rating **	M	Issue No.	10
LM End	3.28	Issue Type +	Ma	Location *	WS
Category	Supplemental			GPS Latitude/Longitude	
				Start	End
Item	2015 USACE Erosion Survey, DRAFT			38.224850 °	38.223233 °
				-121.555641 °	-121.555687 °
DWR ID	DWR_RD0556_02_f_2016_10				
Comment Code					
Inspector Comment					
2000 - Recently fallen cottonwood at the downstream end. 2005 - Empty brush boxes. 2011 - A few trees have fallen since last year. 2012 - Potential new tree popout since last year. 2013 - New erosion at downstream end of site and a recent tree pop-out observed. 2015: No observed changes. [2015 Site ID: SAC_23-2_L]

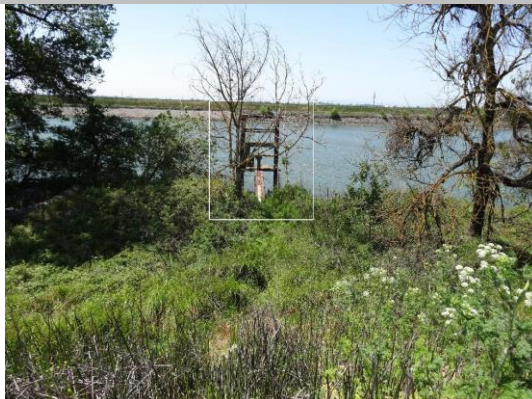
Photo 1 of 2 : UCIP_FA_2016_12527_20297.jpg

LM Start	3.51	Rating **	M	Issue No.	90 (cont)
LM End	3.51	Issue Type +	En	Location *	WS

WS- pump, pipe, and walkway on steel structure in the stream.

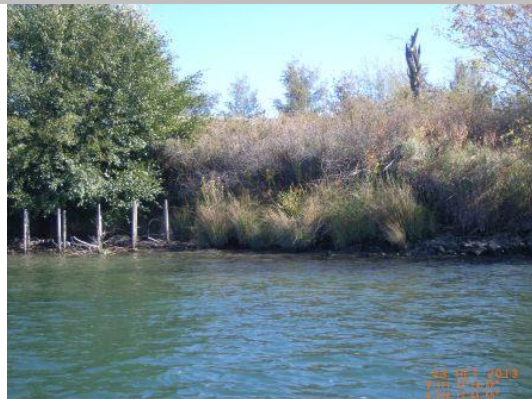
Photo 1 of 1 : FA_2016_RD0556_19_8_20160919_00007.jpg

LM Start	3.58	Rating **	M	Issue No.	8
LM End	3.64	Issue Type +	Ma	Location *	WS
Category	Supplemental			GPS Latitude/Longitude	
				Start	End
Item	2015 USACE Erosion Survey, DRAFT			38.218951 °	38.218104 °
				-121.556689 °	-121.556819 °
DWR ID	DWR_RD0556_02_f_2016_8				
Comment Code					
Inspector Comment					
1997 - Scallops into berm and very close to levee toe. 2005 - Brush boxes present. 2011 - New toe scour and freshly fallen tree. 2012 - New tree popout has taken significant portion of soil out of the levee. 2015: No observed changes. [2015 Site ID: SAC_22-7_L]

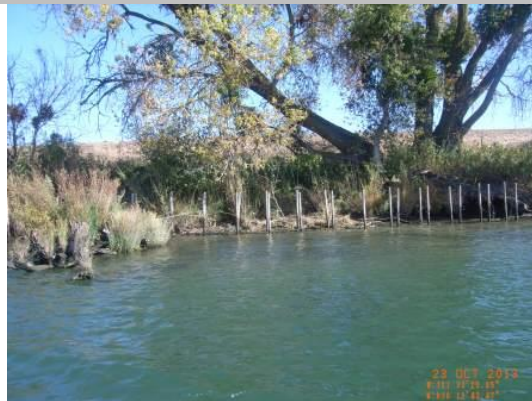
Photo 1 of 1 : FA_2016_RD0556_19_4_20160919_00004.jpg

LM Start	3.95	Rating **	M	Issue No.	4
LM End	4.12	Issue Type +	Ma	Location *	WS
Category	Supplemental			GPS Latitude/Longitude	
				Start	End
Item	2015 USACE Erosion Survey, DRAFT			38.213581 °	38.211112 °
				-121.557197 °	-121.557042 °
DWR ID	DWR_RD0556_02_f_2016_4				
Comment Code					
Inspector Comment					
2002 - Spot rock along berm, but not in the erosion pockets. 2005 - Some new minor stone revetment at the upstream end. Brush boxes present. 2006 - Currently installing new brush in downstream brush boxes. 2007 - Rock in middle portion for about 150 ft. 2010 - Some attempt at repairs but still has pockets of erosion. 2012 - More erosion along the toe. 2015: No observed changes. [2015 Site ID: SAC_22-5_L]

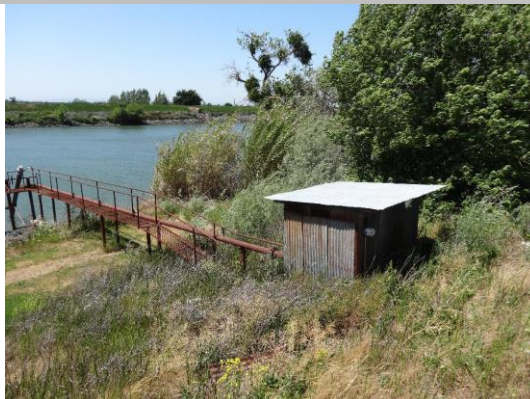
Photo 1 of 2 : UCIP_FA_2016_12543_20302.jpg

LM Start	3.99	Rating **	M	Issue No.	91 (cont)
LM End	3.99	Issue Type +	En	Location *	WS

WS- pipe and pump on steel pile structure. Steel walkway from pump house to the pump on steel structure.

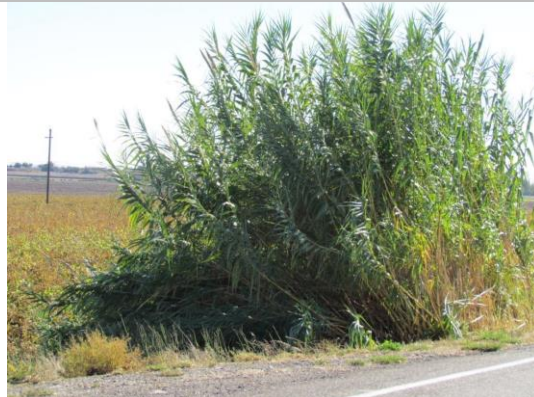
Photo 1 of 1 : FA_2016_RD0556_19_86_20160919_00013.jpg

Landside levee shoulder levee mile 3.99 RD 556 Unit 2.

LM Start	3.99	Rating **	U	Issue No.	86
LM End	3.99	Issue Type +	Ma	Location *	LS
Category	Earthen Levee			GPS Latitude/Longitude	
				Start	End
Item	Vegetation			38.212918 °	38.212918 °
				-121.556848 °	-121.556848 °
DWR ID	DWR_RD0556_02_f_2015_86				
Comment Code					
V2 : Remove the wild growth other than native grasses from the levee slopes.					
Inspector Comment					
Remove the patch of bamboo from the landside shoulder.

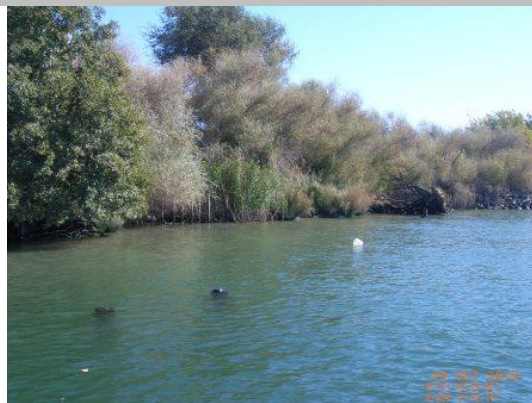
Photo 1 of 1 : FA_2016_RD0556_19_7_20160919_00006.jpg

LM Start	4.45	Rating **	M	Issue No.	7
LM End	4.49	Issue Type +	Ma	Location *	WS
Category	Supplemental			GPS Latitude/Longitude	
				Start	End
Item	2015 USACE Erosion Survey, DRAFT			38.206377 °	38.205729 °
				-121.557184 °	-121.557108 °
DWR ID	DWR_RD0556_02_f_2016_7				
Comment Code					
Inspector Comment					
2013 - Erosion pockets encroaching on levee foundation. 2015: No observed changes. [2015 Site ID: SAC_21-9_L]

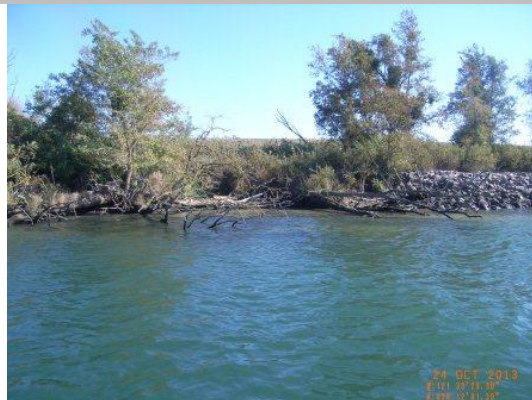
Photo 1 of 1 : FA_2016_RD0556_19_3_20160919_00003.jpg

LM Start	4.77	Rating **	M	Issue No.	3
LM End	4.88	Issue Type +	Ma	Location *	WS
Category	Supplemental			GPS Latitude/Longitude	
				Start	End
Item	2015 USACE Erosion Survey, DRAFT			38.201687 °	38.200225 °
				-121.557305 °	-121.557749 °
DWR ID	DWR_RD0556_02_f_2016_3				
Comment Code					
Inspector Comment					
1999 - Downstream 140 ft repaired with rock. 2010 - Lots of woody debris, but no changes to site. 2015: Site extended upstream due to erosion pockets. [2015 Site ID: SAC_21-5_L]
