**Flood Control Project Maintenance  
Levee Inspections**

**Fall 2017 Levee Maintenance Deficiency Summary Report**

**Sacramento River Basin**

**Reclamation District No. 0556 Upper Andrus**

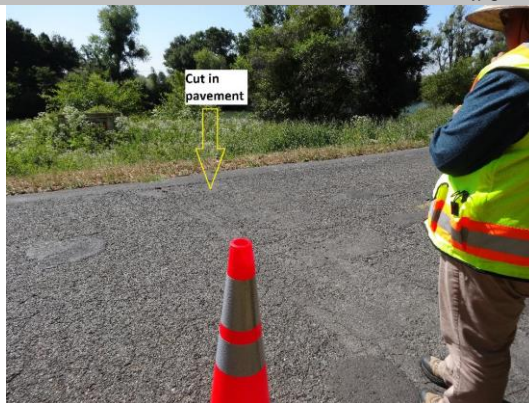
Photo 2 of 3 : UCIP\_FA\_2017\_45564\_74146.jpg

LM Start	<b>0.44</b>	Rating **	M	Issue No.	<b>387 (cont)</b>
LM End	<b>0.44</b>	Issue Type +	En	Location *

View of WS; cut in pavement in alignment with arrow and Olivia indicating location of crossing trench.

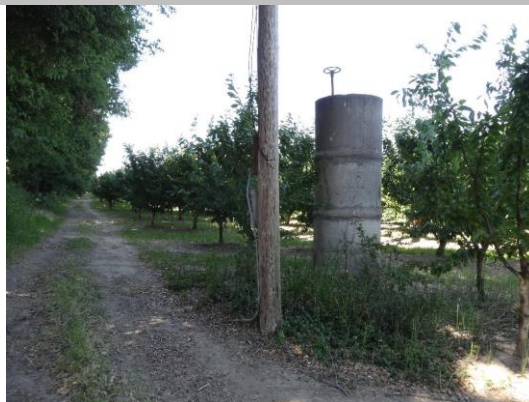
Photo 3 of 3 : UCIP\_FA\_2017\_45664\_74192.jpg

LM Start	0.54	Rating **	M	Issue No.	389 (cont)
LM End	0.54	Issue Type +	En	Location *	
Category	Supplemental			GPS Latitude/Longitude	
				Start	End
Item	DWR UCIP Field Study			38.232354 °	38.232354 °
				-121.521727 °	-121.521727 °
DWR ID					
Comment Code					
Inspector Comment					
FS_ID:45664 DS_ID:20826 EP_NO: 5548A Repair Type: Non-Urgent Crossing Status: Found UCIP Comments: Dense vegetation prevented inspection of WS slope. FIELD_STRUCT_DESC: 14-inch pipe through levee 5.0 feet below the crown. Pole with panel and standpipe on landward toe (5548A- Kay Dix Ranch 1986). FS Date: 5/27/2015

Standpipe and service pole visible off LS toe.

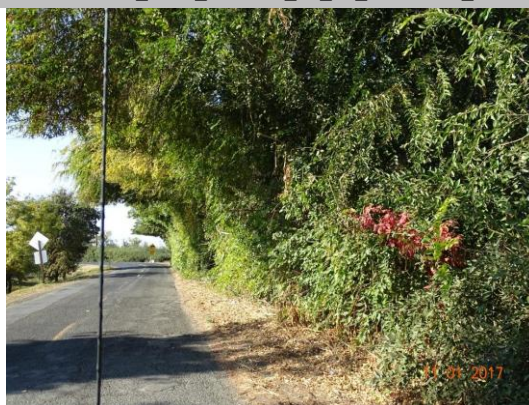
Photo 1 of 1 : FA\_2017\_RD0556\_18\_24\_20171117\_00060.jpg

LM Start	0.87	Rating **	U	Issue No.	24
LM End	0.92	Issue Type +	En	Location *	LS
Category	Earthen Levee			GPS Latitude/Longitude	
				Start	End
Item	Vegetation			38.228820 °	38.228480 °
				-121.525853 °	-121.526470 °
DWR ID	DWR_RD0556_01_f_2017_24				
Comment Code					
V6 : Landscaping					
Inspector Comment

Trim/thin landscaping to allow inspection and access to levee slope and toe.

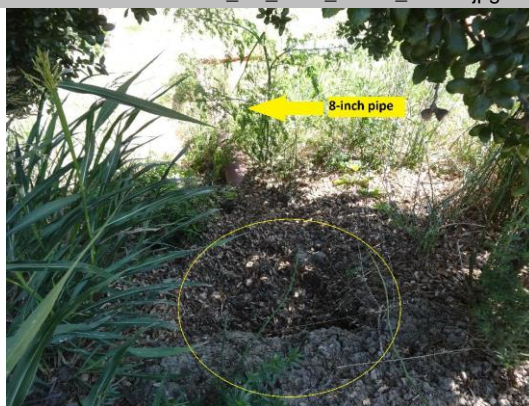
Photo 1 of 3 : UCIP\_FA\_2017\_46799\_74739.jpg

LM Start	1.17	Rating **	M	Issue No.	390
LM End	1.17	Issue Type +	En	Location *	
Category	Supplemental			GPS Latitude/Longitude	
				Start	End
Item	DWR UCIP Field Study			38.227534 °	38.227534 °
				-121.529396 °	-121.529396 °
DWR ID					
Comment Code					
Inspector Comment					
FS_ID:46799 DS_ID:25106 EP_NO: N/A Repair Type: Non-Urgent Crossing Status: Found UCIP Comments: Possible erosion above pipe on LS needs attention. FIELD_STRUCT_DESC: 8-inch steel irrigation pipe unknown feet below crown visible on LS 6 ft away from 10-inch pipe. Post likely for protection of vent located off the crown on shoulder. Electric pole next to pipe on LS. FS Date: 5/27/2015

LS view: 8-inch pipe off LS slope with possible erosion above pipe (circled).

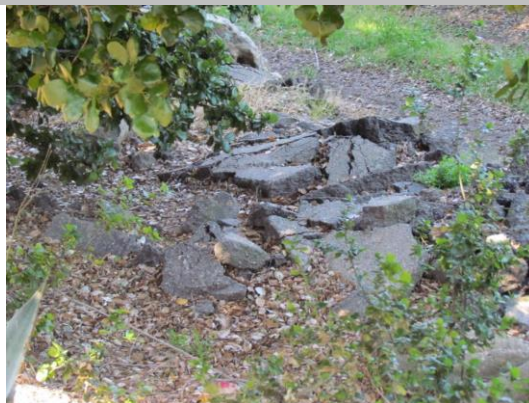
Photo 2 of 3 : FA\_2017\_RD0556\_18\_27\_20171002\_00006.jpg

LM Start	<b>1.34</b>	Rating **	U	Issue No.	<b>27 (cont)</b>
LM End	<b>1.37</b>	Issue Type +	En	Location *	LS

RD 556 Unit 1 levee mile 1.34-1.37 continuation of material on the toe.

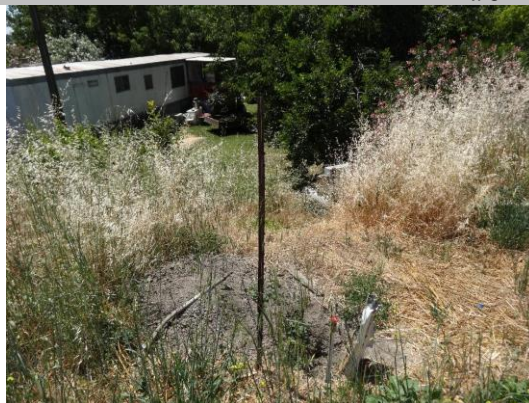
Photo 1 of 3 : UCIP\_FA\_2017\_45803\_74285.jpg

LM Start	<b>2.44</b>	Rating **	U	Issue No.	<b>397 (cont)</b>
LM End	<b>2.44</b>	Issue Type +	En	Location *

Pipe, pump @LS toe. 2'x2' hole off shoulder. Spigot in hole possibly for irrigation. House and service pole in background.

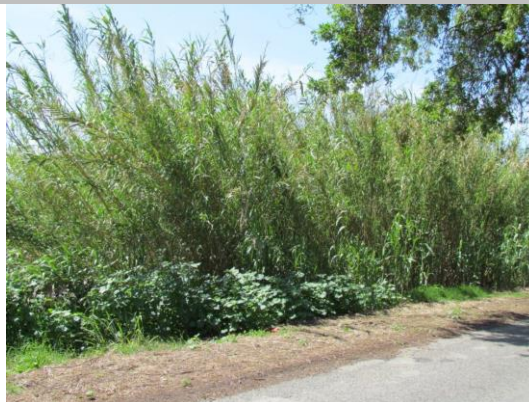
Photo 1 of 1 : FA\_2017\_RD0556\_18\_35\_20171002\_00012.jpg

LM Start	3.12	Rating **	U	Issue No.	35
LM End	3.14	Issue Type +	Ma	Location *	WS
Category	Earthen Levee			GPS Latitude/Longitude	
				Start	End
Item	Vegetation			38.211103 °	38.210970 °
				-121.537993 °	-121.538370 °
DWR ID	DWR_RD0556_01_s_2017_35				
Comment Code					
V2 : Remove the wild growth other than native grasses from the levee slopes.					
Inspector Comment					
Remove the unwanted wild growth from the waterside slope.

RD 556 Unit 1 levee mile 3.12-3.14 waterside shoulder and slope.

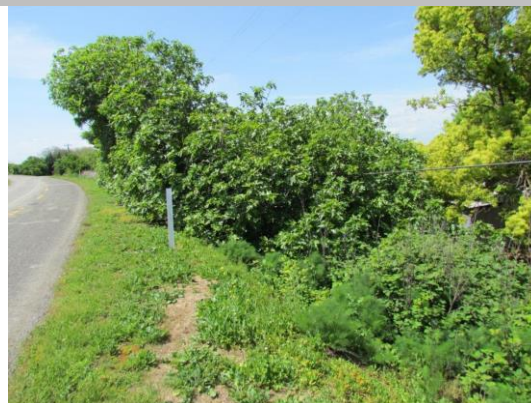
Photo 1 of 1 : FA\_2017\_RD0556\_18\_38\_20171002\_00016.jpg

LM Start	3.25	Rating **	U	Issue No.	38
LM End	3.29	Issue Type +	Ma	Location *	LS
Category	Earthen Levee			GPS Latitude/Longitude	
				Start	End
Item	Vegetation			38.210250 °	38.209842 °
				-121.540207 °	-121.540658 °
DWR ID	DWR_RD0556_01_s_2017_38				
Comment Code					
V7 : Trees / Woody Vegetation					
Inspector Comment					
Remove the wild tree growth and vegetation from the landside levee slope and toe so the ground can be seen.

556 Unit 1 levee mile 3.25-3.29 woody tree growth and vegetation blocking the view of the levee slope and toe.

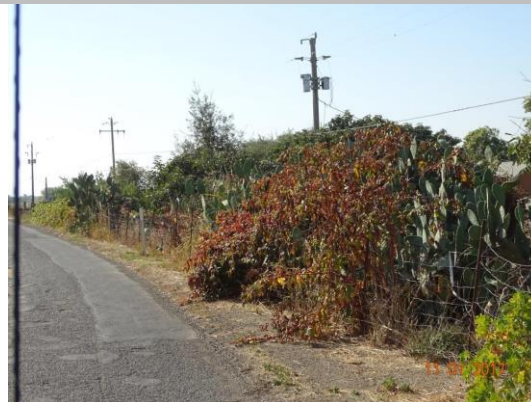
Photo 1 of 1 : FA\_2017\_RD0556\_18\_29\_20171117\_00066.jpg

LM Start	3.38	Rating **	U	Issue No.	29
LM End	3.38	Issue Type +	En	Location *	LS
Category	Earthen Levee			GPS Latitude/Longitude	
				Start	End
Item	Vegetation			38.208755 °	38.208755 °
				-121.541395 °	-121.541395 °
DWR ID	DWR_RD0556_01_f_2017_29				
Comment Code					
V6 : Landscaping					
Inspector Comment

Large cactus growing on shoulder and slope should be removed to allow inspection and access.

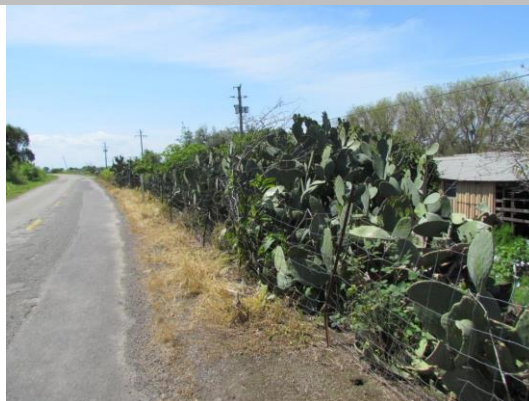
Photo 1 of 1 : FA\_2017\_RD0556\_18\_41\_20171002\_00017.jpg

LM Start	3.42	Rating **	M	Issue No.	41
LM End	3.93	Issue Type +	Ma	Location *	LS
Category	Earthen Levee			GPS Latitude/Longitude	
				Start	End
Item	Vegetation			38.208113 °	38.201603 °
				-121.541582 °	-121.542352 °
DWR ID	DWR_RD0556_01_s_2017_41				
Comment Code					
V2 : Remove the wild growth other than native grasses from the levee slopes.					
Inspector Comment					
Remove the wild growth other than annual grasses from the levee slope.

556 Unit 1 levee mile 3.42-5.47 landside shoulder and slope.

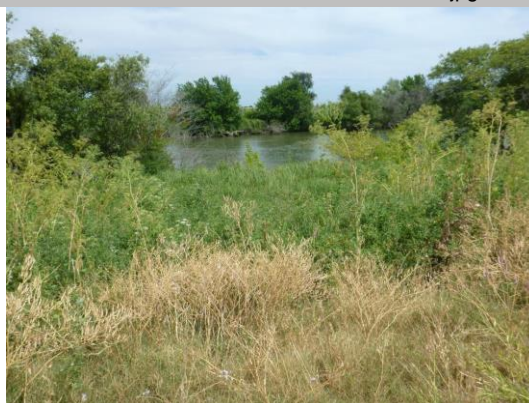
Photo 1 of 2 : LEVAL\_FA\_2017\_67\_701.jpg

LM Start	3.43	Rating **	A/W	Issue No.	23
LM End	3.75	Issue Type +	Ma	Location *	
Category	Supplemental			GPS Latitude/Longitude	
				Start	End
Item	2017 Storm Damage			38.208070 °	38.203400 °
				-121.541700 °	-121.540990 °
DWR ID	DWR_RD0556_01_f_2017_23				
Comment Code					
Inspector Comment					
Levee Evaluation Comments					
Description:					
Site ID No:67					
Site Designation:USACE_CESPK_UPA1_2011_p_0143					
Repair Type: Stability					
Rating:Area of Concern					
Field Date:2/7/2017					
Notes: inactive ditch on landside toe, slope covered in heavy vegetation, minor landside lower slope sloughing observed,

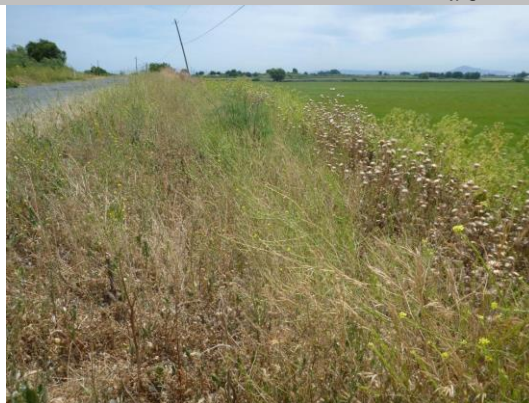
Photo 2 of 2 : LEVAL\_FA\_2017\_67\_702.jpg

LM Start	3.43	Rating **	A/W	Issue No.	23 (cont)
LM End	3.75	Issue Type +	Ma	Location *	
Category	Supplemental			GPS Latitude/Longitude	
				Start	End
Item	2017 Storm Damage			38.208070 °	38.203400 °
				-121.541700 °	-121.540990 °
DWR ID	DWR_RD0556_01_f_2017_23				
Comment Code					
Inspector Comment					
Levee Evaluation Comments					
Description:					
Site ID No:67					
Site Designation:USACE_CESPK_UPA1_2011_p_0143					
Repair Type: Stability					
Rating:Area of Concern					
Field Date:2/7/2017					
Notes: inactive ditch on landside toe, slope covered in heavy vegetation, minor landside lower slope sloughing observed,

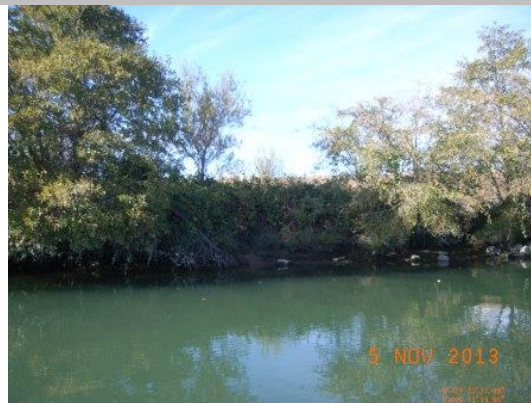
Photo 1 of 1 : FA\_2017\_RD0556\_18\_1\_20171002\_00001.jpg

LM Start	5.12	Rating **	M	Issue No.	1
LM End	5.27	Issue Type +	Ma	Location *	WS
Category	Supplemental			GPS Latitude/Longitude	
				Start	End
Item	2015 USACE Erosion Survey, DRAFT			38.189775 °	38.188121 °
				-121.557729 °	-121.559413 °
DWR ID	DWR_RD0556_01_f_2016_1				
Comment Code					
Inspector Comment					
1997 - Toe damaged rock. 1999 - One pocket filled with gravel. 2000 - Eroding beach with some biotech rolls and stakes; some gravel on slope. 2001 - Staked, low fascine walls at bankline. 2005 - Stone revetment in between pockets. 2006 - New rock on upper slope behind brush boxes at the upstream end, Stone is sliding off the hard toe. 2015: Last observed in 2013. [2015 Site ID: GEO_7-0_R]

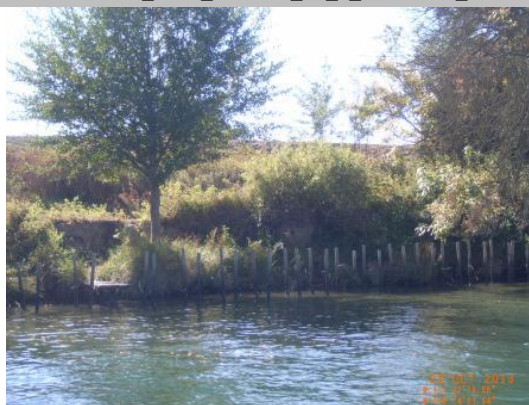
Photo 1 of 1 : FA\_2017\_RD0556\_19\_2\_20171002\_00002.jpg

LM Start	1.03	Rating **	M	Issue No.	2
LM End	1.15	Issue Type +	Ma	Location *	WS
Category	Supplemental			GPS Latitude/Longitude	
				Start	End
Item	2015 USACE Erosion Survey, DRAFT			38.238772 °	38.239265 °
				-121.536788 °	-121.538845 °
DWR ID	DWR_RD0556_02_f_2016_2				
Comment Code					
Inspector Comment					
1997 - Rock is in poor condition and has failed in many places. Scallops in berm with remnants of old rock in the toe area. 2005 - Brush boxes present. 2013 - Site extended upstream approximately 300 ft to include new erosion pockets. 2015: Minor new erosion at toe. [2015 Site ID: SAC_25-2_L]

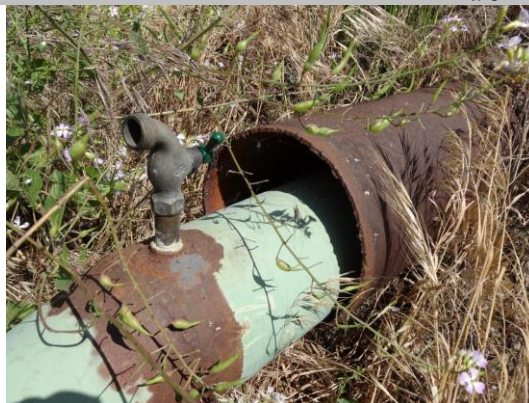
Photo 2 of 3 : UCIP\_FA\_2017\_12573\_20380.jpg

LM Start	1.22	Rating **	M	Issue No.	84 (cont)
LM End	1.22	Issue Type +	En	Location *

LS- 6-inch steel pipe sleeved through 10-inch steel pipe. 6" pipe is attached with air release valve.

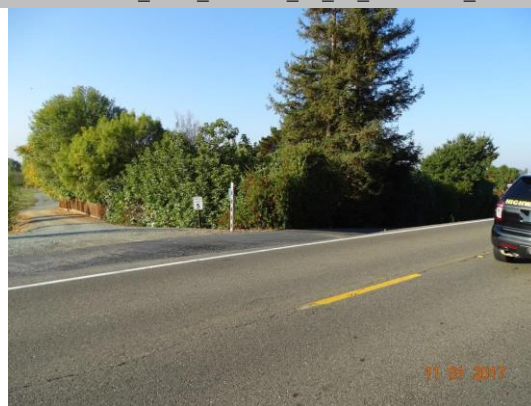
Photo 1 of 1 : FA\_2017\_RD0556\_19\_28\_20171117\_00054.jpg

LM Start	1.31	Rating **	U	Issue No.	28
LM End	1.31	Issue Type +	En	Location *	LS
Category	Earthen Levee			GPS Latitude/Longitude	
				Start	End
Item	Vegetation			38.239677 °	38.239677 °
				-121.541715 °	-121.541715 °
DWR ID	DWR_RD0556_02_f_2017_28				
Comment Code					
V6 : Landscaping					
Inspector Comment

Trim/thin oleanders.

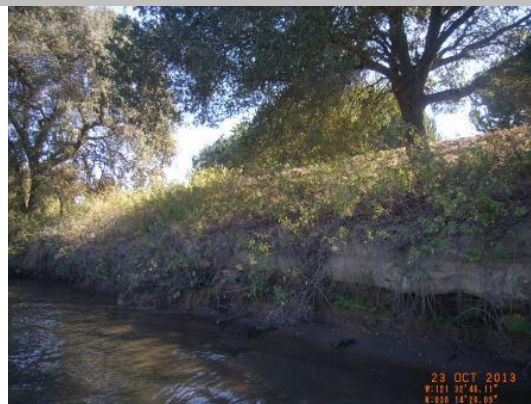
Photo 1 of 1 : FA\_2017\_RD0556\_19\_5\_20171002\_00005.jpg

LM Start	1.45	Rating **	M	Issue No.	5
LM End	1.59	Issue Type +	Ma	Location *	WS
Category	Supplemental			GPS Latitude/Longitude	
				Start	End
Item	2015 USACE Erosion Survey, DRAFT			38.240401 °	38.240772 °
				-121.544106 °	-121.546791 °
DWR ID	DWR_RD0556_02_f_2016_5				
Comment Code					
Inspector Comment					
1997 - Slow erosion of the berm at the waterline; bench below water. 2005 - Brush boxes present. 2010 - Minor new erosion. 2013 - There is little to no berm remaining at downstream end of this site. 2015: No observed changes. [2015 Site ID: SAC_24-8_L]

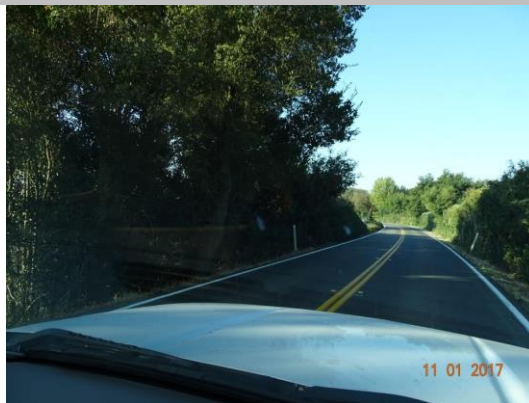
Photo 1 of 1 : FA\_2017\_RD0556\_19\_30\_20171117\_00056.jpg

LM Start	1.83	Rating **	U	Issue No.	30
LM End	1.83	Issue Type +	En	Location *	LS
Category	Earthen Levee			GPS Latitude/Longitude	
				Start	End
Item	Vegetation			38.240955 °	38.240955 °
				-121.551233 °	-121.551233 °
DWR ID	DWR_RD0556_02_f_2017_30				
Comment Code					
V6 : Landscaping					
Inspector Comment

Trim/thin oleanders on landside slope.

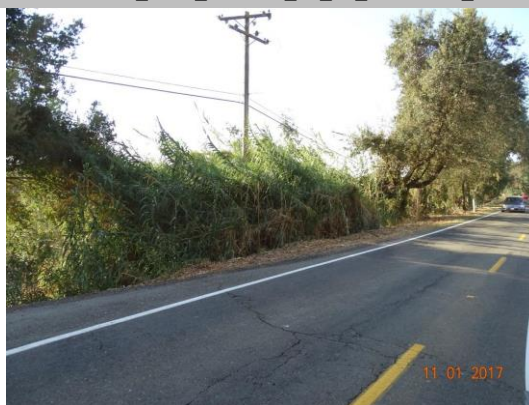
Photo 1 of 1 : FA\_2017\_RD0556\_19\_32\_20171117\_00057.jpg

LM Start	2.06	Rating **	U	Issue No.	32
LM End	2.06	Issue Type +	Ma	Location *	LS
Category	Earthen Levee			GPS Latitude/Longitude	
				Start	End
Item	Vegetation			38.239470 °	38.239470 °
				-121.554845 °	-121.554845 °
DWR ID	DWR_RD0556_02_f_2017_32				
Comment Code					
V2 : Remove the wild growth other than native grasses from the levee slopes.					
Inspector Comment

Arundo growth should be removed to allow inspection and access to landside slope and toe.

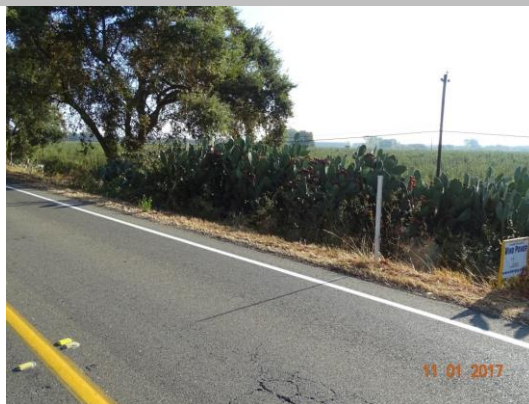
Photo 1 of 1 : FA\_2017\_RD0556\_19\_33\_20171117\_00058.jpg

LM Start	2.22	Rating **	U	Issue No.	33
LM End	2.22	Issue Type +	En	Location *	LS
Category	Earthen Levee			GPS Latitude/Longitude	
				Start	End
Item	Vegetation			38.237883 °	38.237883 °
				-121.556958 °	-121.556958 °
DWR ID	DWR_RD0556_02_f_2017_33				
Comment Code					
V6 : Landscaping					
Inspector Comment

Large growth of prickly pear cactus should be removed to allow inspection and access.

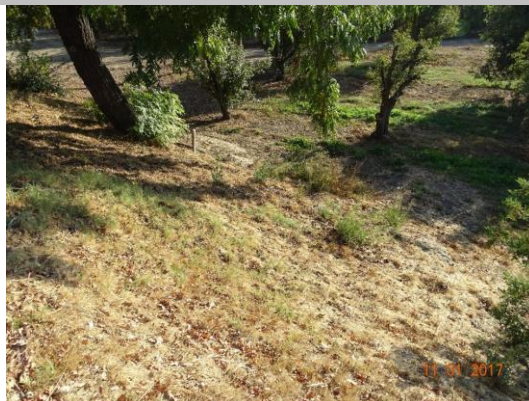
Photo 1 of 1 : FA\_2017\_RD0556\_19\_34\_20171117\_00059.jpg

LM Start	2.27	Rating **	M	Issue No.	34
LM End	2.27	Issue Type +	Ma	Location *	LS
Category	Earthen Levee			GPS Latitude/Longitude	
				Start	End
Item	Animal Control			38.237248 °	38.237248 °
				-121.557632 °	-121.557632 °
DWR ID	DWR_RD0556_02_f_2017_34				
Comment Code					
A1 : Exterminate rodents and backfill and compact or grout burrows.					
Inspector Comment

Rodent burrows observed near the base of large nut tree on landside slope. Exterminate rodents and backfill burrows.

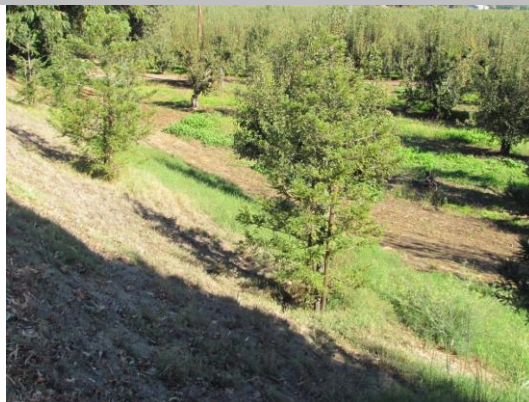
Photo 1 of 1 : FA\_2017\_RD0556\_19\_1\_20171002\_00001.jpg

LM Start	2.28	Rating **	U	Issue No.	1
LM End	2.28	Issue Type +	En	Location *	LS
Category	Earthen Levee			GPS Latitude/Longitude	
				Start	End
Item	Vegetation			38.237156 °	38.237156 °
				-121.557640 °	-121.557640 °
DWR ID	DWR_RD0556_02_f_2015_1				
Comment Code					
V6 : Landscaping					
Inspector Comment					
These unauthorized planted redwoods have been reported in the past inspections, the District needs to have the owner remove them from the levee slope.

RD 556 Unit 2 Levee mile 2.28 unauthorized planting of redwood trees planted on the slope.

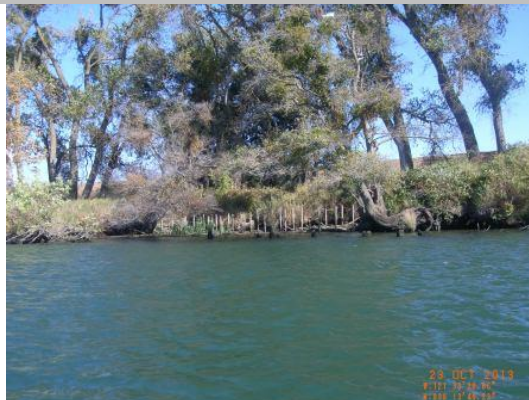
Photo 1 of 1 : FA\_2017\_RD0556\_19\_11\_20171002\_00009.jpg

LM Start	2.93	Rating **	A/W	Issue No.	11
LM End	3.04	Issue Type +	Ma	Location *	WS
Category	Supplemental			GPS Latitude/Longitude	
				Start	End
Item	2015 USACE Erosion Survey, DRAFT			38.228202 °	38.226601 °
				-121.555502 °	-121.555605 °
DWR ID	DWR_RD0556_02_f_2016_11				
Comment Code					
Inspector Comment					
1997 - Few scallops in berm, some getting close to levee toe. 2005 - Brush boxes present. 2012 - More erosion of the toe since last year. 2015: No observed changes. [2015 Site ID: SAC_23-3_L]

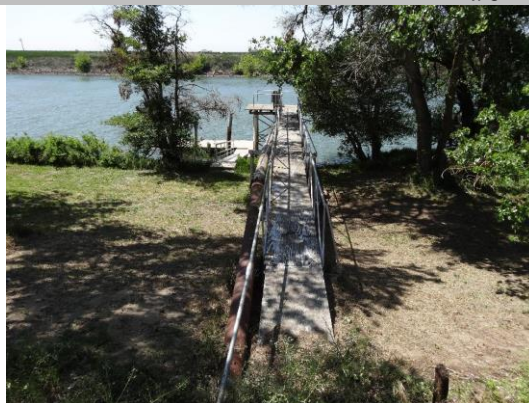
Photo 1 of 3 : UCIP\_FA\_2017\_12525\_20290.jpg

LM Start	3.07	Rating **	M	Issue No.	87
LM End	3.07	Issue Type +	En	Location *	
Category	Supplemental			GPS Latitude/Longitude	
				Start	End
Item	DWR UCIP Field Study			38.226225 °	38.226225 °
				-121.555236 °	-121.555236 °
DWR ID					
Comment Code					
Inspector Comment					
FS_ID:12525					
DS_ID:20862					
EP_NO: N/A					
Repair Type: Non-Urgent					
Crossing Status: Found					
UCIP Comments: - 9-inch steel pipe sleeved through 12-inch pipe.- needs to seal gap between two pipes.					
FIELD_STRUCT_DESC: A 9-inch steel pipe sleeved through 12-inch steel irrigation pipe through levee, 6.0 feet below crown. Pump on pile structure in stream. Steel walkway to pump, wood steps on waterward slope. Concrete spillbox with 2- 8 inch openings. (ABO #11193-Reid.). O&M Manual Sac 103, June 1954.					
FS Date: 4/25/2013

WS- walkway, pump, and pipe on steel pile structure in the river.

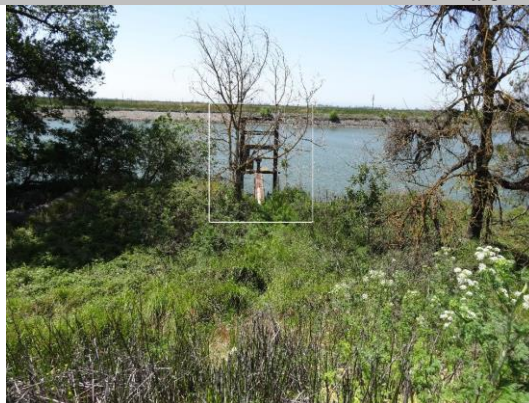
Photo 1 of 3 : UCIP\_FA\_2017\_12527\_20297.jpg

LM Start	3.51	Rating **	M	Issue No.	88
LM End	3.51	Issue Type +	En	Location *	
Category	Supplemental			GPS Latitude/Longitude	
				Start	End
Item	DWR UCIP Field Study			38.219851 °	38.219851 °
				-121.556129 °	-121.556129 °
DWR ID					
Comment Code					
Inspector Comment					
FS_ID:12527					
DS_ID:20863					
EP_NO: 11181					
Repair Type: Non-Urgent					
Crossing Status: Found					
UCIP Comments: - needs to fix siphon breaker					
FIELD_STRUCT_DESC: A 10-inch steel irrigation pipe through levee, 4.8 feet below crown. Steel walkway to pump on pile structure in stream. Siphon breaker on waterside and service pole on landward slope. A concrete spillbox with 2-15 inch openings on landside. (ABO # 11181- Collins.). O&M Manual Sac 103, June 1954.					
FS Date: 4/25/2013

WS- pump, pipe, and walkway on steel structure in the stream.

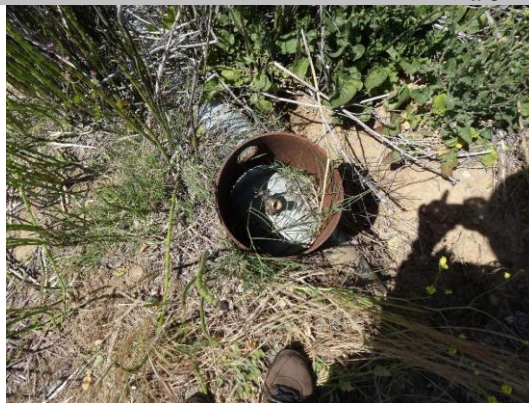
Photo 3 of 3 : UCIP\_FA\_2017\_12527\_20295.jpg

LM Start	3.51	Rating **	M	Issue No.	88 (cont)	
LM End	3.51	Issue Type +	En	Location *		
Category	Supplemental			GPS Latitude/Longitude		
				Start	End	
Item	DWR UCIP Field Study			38.219851 °	38.219851 °	
				-121.556129 °	-121.556129 °	
DWR ID						
Comment Code						
Inspector Comment						
FS_ID:12527						
DS_ID:20863						
EP_NO: 11181						
Repair Type: Non-Urgent						
Crossing Status: Found						
UCIP Comments: - needs to fix siphon breaker						
FIELD_STRUCT_DESC: A 10-inch steel irrigation pipe through levee,						
4.8 feet below crown. Steel walkway to pump on pile structure in						
stream. Siphon breaker on waterside and service pole on landward						
slope. A concrete spillbox with 2-15 inch openings on landside. (ABO #						
11181- Collins.). O&M Manual Sac 103, June 1954.						
FS Date: 4/25/2013

WS- siphon breaker on levee slope.

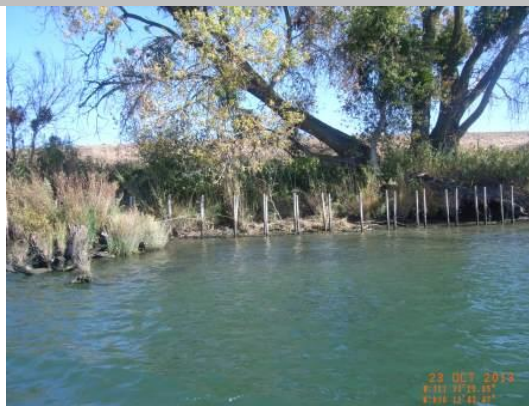
Photo 1 of 1 : FA\_2017\_RD0556\_19\_4\_20171002\_00004.jpg

LM Start	3.95	Rating **	M	Issue No.	4
LM End	4.12	Issue Type +	Ma	Location *	WS
Category	Supplemental			GPS Latitude/Longitude	
				Start	End
Item	2015 USACE Erosion Survey, DRAFT			38.213581 °	38.211112 °
				-121.557197 °	-121.557042 °
DWR ID	DWR_RD0556_02_f_2016_4				
Comment Code					
Inspector Comment					
2002 - Spot rock along berm, but not in the erosion pockets. 2005 - Some new minor stone revetment at the upstream end. Brush boxes present. 2006 - Currently installing new brush in downstream brush boxes. 2007 - Rock in middle portion for about 150 ft. 2010 - Some attempt at repairs but still has pockets of erosion. 2012 - More erosion along the toe. 2015: No observed changes. [2015 Site ID: SAC_22-5_L]

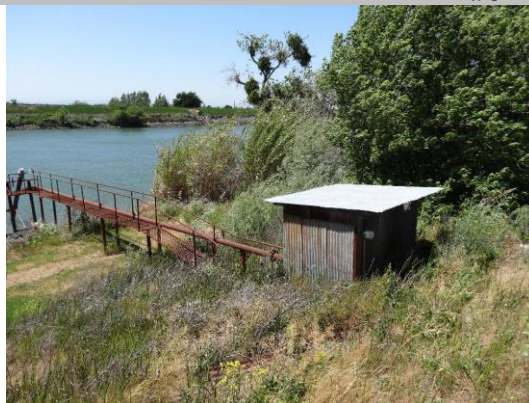
Photo 1 of 3 : UCIP\_FA\_2017\_12543\_20302.jpg

LM Start	3.99	Rating **	M	Issue No.	89	
LM End	3.99	Issue Type +	En	Location *		
Category	Supplemental			GPS Latitude/Longitude		
				Start		End
Item	DWR UCIP Field Study			38.213031 °		38.213031 °
				-121.556800 °		-121.556800 °
DWR ID						
Comment Code						
Inspector Comment						
FS_ID:12543 DS_ID:20864 EP_NO: 11197 Repair Type: Non-Urgent Crossing Status: Found UCIP Comments: Electric control panel in pump house.Needs cleaning of CMP riser on landside. FIELD_STRUCT_DESC: A 6-inch steel irrigation pipe through levee 6.5 feet below crown. Slanted pump on steel pile structure in the stream, walkway to the pump, and gate valve in pump house on waterward slope. Siphon breaker and service poles on landward slope. Concrete standpipe on landside. (ABO #11197- Souza.). O&M Manual Sac 103, June 1954. FS Date: 4/25/2013

WS- pipe and pump on steel pile structure. Steel walkway from pump house to the pump on steel structure.

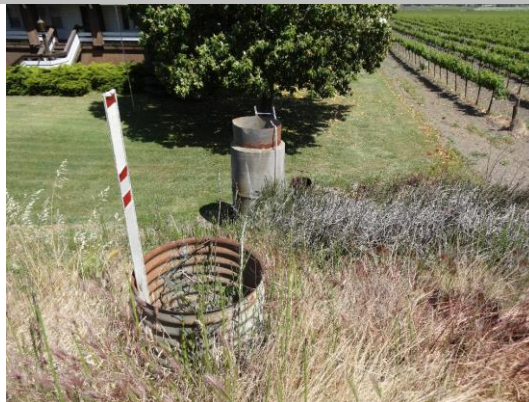
Photo 2 of 3 : UCIP\_FA\_2017\_12543\_20301.jpg

LS- siphon breaker in CMP riser and concrete standpipe behind CMP riser.

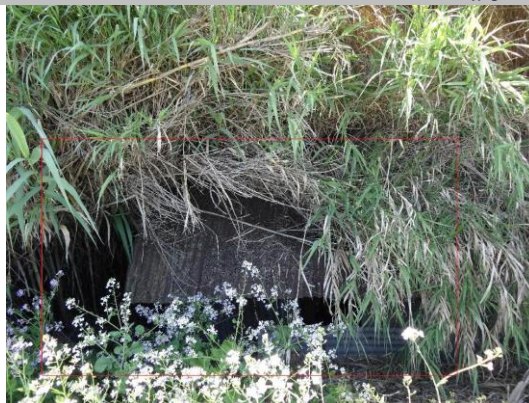
Photo 2 of 3 : UCIP\_FA\_2017\_12545\_20309.jpg

LM Start	4.26	Rating **	M	Issue No.	90 (cont)	
LM End	4.26	Issue Type +	En	Location *		
Category	Supplemental			GPS Latitude/Longitude		
				Start	End	
Item	DWR UCIP Field Study			38.209117 °	38.209117 °	
				-121.556803 °	-121.556803 °	
DWR ID						
Comment Code						
Inspector Comment						
FS_ID:12545 DS_ID:20865 EP_NO: 11194 Repair Type: Non-Urgent Crossing Status: Found UCIP Comments: - CMP riser found abandoned on LS slope. Due to dense vegetation siphon breaker could not be found.- Dense vegetation on both sides of the levee.- Oil leaks from pump set. FIELD_STRUCT_DESC: A 8-inch pipe through levee, 6.7 feet below crown. Pump and gate valve in pump house on waterward slope. Siphon breaker on landward slope. (ABO #11194- Robinson.). O&M Manual Sac 103, June 1954. FS Date: 4/25/2013

WS- pump house inside the dense vegetation.

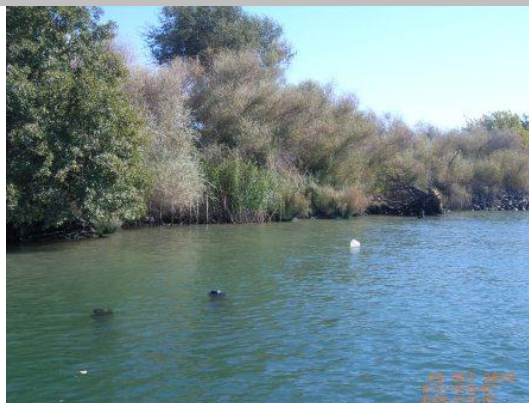
Photo 1 of 1 : FA\_2017\_RD0556\_19\_7\_20171002\_00006.jpg

LM Start	4.45	Rating **	M	Issue No.	7
LM End	4.49	Issue Type +	Ma	Location *	WS
Category	Supplemental			GPS Latitude/Longitude	
				Start	End
Item	2015 USACE Erosion Survey, DRAFT			38.206377 °	38.205729 °
				-121.557184 °	-121.557108 °
DWR ID	DWR_RD0556_02_f_2016_7				
Comment Code					
Inspector Comment					
2013 - Erosion pockets encroaching on levee foundation. 2015: No observed changes. [2015 Site ID: SAC_21-9_L]

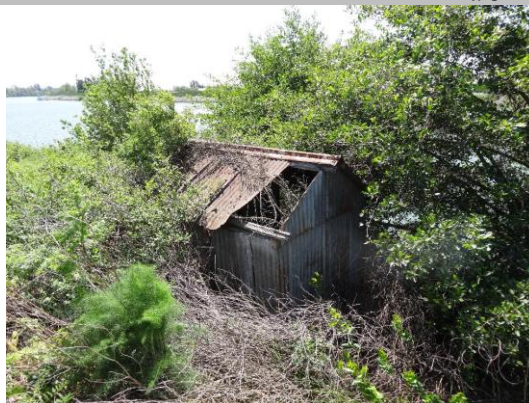
Photo 1 of 3 : UCIP\_FA\_2017\_12546\_20314.jpg

LM Start	4.54	Rating **	M	Issue No.	91
LM End	4.54	Issue Type +	En	Location *	
Category	Supplemental			GPS Latitude/Longitude	
				Start	End
Item	DWR UCIP Field Study			38.204974 °	38.204974 °
				-121.556789 °	-121.556789 °
DWR ID					
Comment Code					
Inspector Comment					
FS_ID:12546 DS_ID:20866 EP_NO: 11940 Repair Type: Non-Urgent Crossing Status: Found UCIP Comments: - Abandoned crossing.- Siphon breaker on LS not found due to dense vegetation, - An abandoned CMP riser and service pole found on LS.- It may need to be properly abandoned. FIELD_STRUCT_DESC: Abandoned 6-inch pipe through levee, 6.7 feet below crown. Pump and gate valve in pump house on waterward slope. Siphon breaker and service pole on landward slope. (ABO # 11940-Robinson.). O&M Manual Sac 103, June 1954. FS Date: 4/25/2013

WS- abandoned pump house on levee slope. Dense vegetation on levee slope.

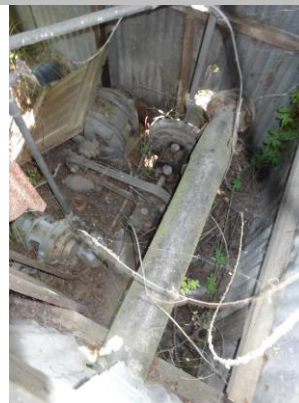
Photo 3 of 3 : UCIP\_FA\_2017\_12546\_20315.jpg

LM Start	4.54	Rating **	M	Issue No.	91 (cont)	
LM End	4.54	Issue Type +	En	Location *		
Category	Supplemental			GPS Latitude/Longitude		
				Start	End	
Item	DWR UCIP Field Study			38.204974 °	38.204974 °	
				-121.556789 °	-121.556789 °	
DWR ID						
Comment Code						
Inspector Comment						
FS_ID:12546 DS_ID:20866 EP_NO: 11940 Repair Type: Non-Urgent Crossing Status: Found UCIP Comments: - Abandoned crossing.- Siphon breaker on LS not found due to dense vegetation, - An abandoned CMP riser and service pole found on LS.- It may need to be properly abandoned. FIELD_STRUCT_DESC: Abandoned 6-inch pipe through levee, 6.7 feet below crown. Pump and gate valve in pump house on waterward slope. Siphon breaker and service pole on landward slope. (ABO # 11940-Robinson.). O&M Manual Sac 103, June 1954. FS Date: 4/25/2013

WS- abandoned gate valve, pump, and pipe in pump house

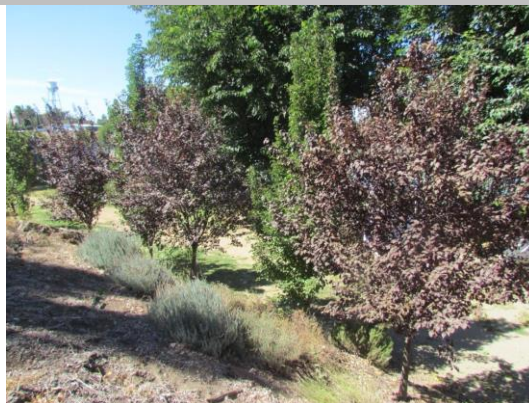
Photo 1 of 2 : FA\_2017\_RD0556\_19\_27\_20171002\_00011.jpg

RD 556 Unit 2 levee mile 2.16-2.19 waterside toe of slope.

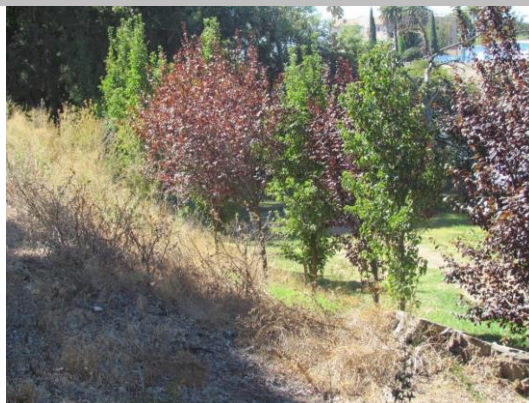
Photo 2 of 2 : FA\_2017\_RD0556\_19\_27\_20171002\_00012.jpg

RD 556 Unit 2 levee mile 2.16-2.19 waterside toe looking downstream.

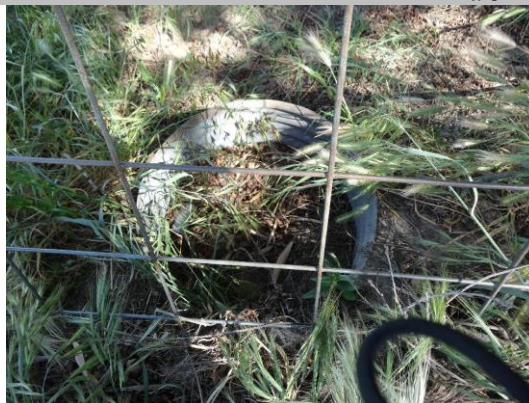
Photo 1 of 3 : UCIP\_FA\_2017\_12547\_20320.jpg

LM Start	4.73	Rating **	M	Issue No.	92
LM End	4.73	Issue Type +	En	Location *	
Category	Supplemental			GPS Latitude/Longitude	
				Start	End
Item	DWR UCIP Field Study			38.202301 °	38.202301 °
				-121.556952 °	-121.556952 °
DWR ID					
Comment Code					
Inspector Comment					
FS_ID:12547 DS_ID:20867 EP_NO: 11199 Repair Type: Non-Urgent Crossing Status: Indicator Found UCIP Comments: - pump, gate valve and pumphouse not found on waterward slope.- an abandoned electric control panel found on WS.- may need to be properly abandoned. FIELD_STRUCT_DESC: A 6-inch steel irrigation pipe through levee, 6.5 feet below crown. Siphon and concrete spill box with 2- 8 inch openings. (ABO #11199- Tokoyoshi.). O&M Manual Sac 103, June 1954. FS Date: 4/25/2013

LS- obstructed siphon breaker in CMP riser on levee slope.

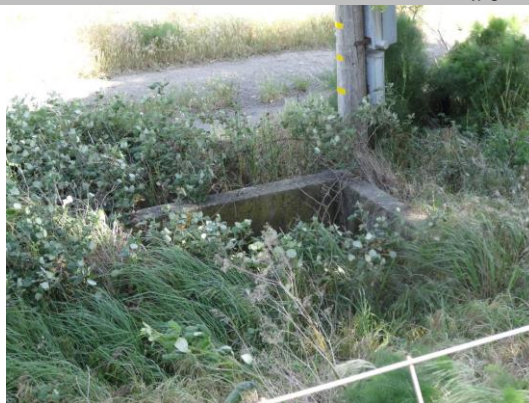
Photo 3 of 3 : UCIP\_FA\_2017\_12547\_20318.jpg

LM Start	4.73	Rating **	M	Issue No.	92 (cont)	
LM End	4.73	Issue Type +	En	Location *		
Category	Supplemental			GPS Latitude/Longitude		
				Start	End	
Item	DWR UCIP Field Study			38.202301 °	38.202301 °	
				-121.556952 °	-121.556952 °	
DWR ID						
Comment Code						
Inspector Comment						
FS_ID:12547 DS_ID:20867 EP_NO: 11199 Repair Type: Non-Urgent Crossing Status: Indicator Found UCIP Comments: - pump, gate valve and pumphouse not found on waterward slope.- an abandoned electric control panel found on WS.- may need to be properly abandoned. FIELD_STRUCT_DESC: A 6-inch steel irrigation pipe through levee, 6.5 feet below crown. Siphon and concrete spill box with 2- 8 inch openings. (ABO #11199- Tokoyoshi.). O&M Manual Sac 103, June 1954. FS Date: 4/25/2013

LS- power pole and a concrete distribution box near levee toe.

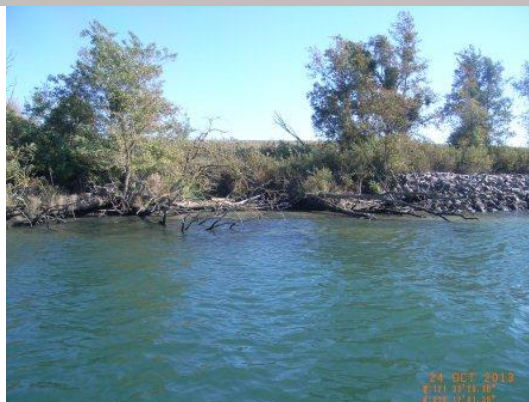
Photo 1 of 1 : FA\_2017\_RD0556\_19\_3\_20171002\_00003.jpg

LM Start	4.77	Rating **	A/W	Issue No.	3
LM End	4.88	Issue Type +	Ma	Location *	WS
Category	Supplemental			GPS Latitude/Longitude	
				Start	End
Item	2015 USACE Erosion Survey, DRAFT			38.201687 °	38.200225 °
				-121.557305 °	-121.557749 °
DWR ID	DWR_RD0556_02_f_2016_3				
Comment Code					
Inspector Comment					
1999 - Downstream 140 ft repaired with rock. 2010 - Lots of woody debris, but no changes to site. 2015: Site extended upstream due to erosion pockets. [2015 Site ID: SAC_21-5_L]

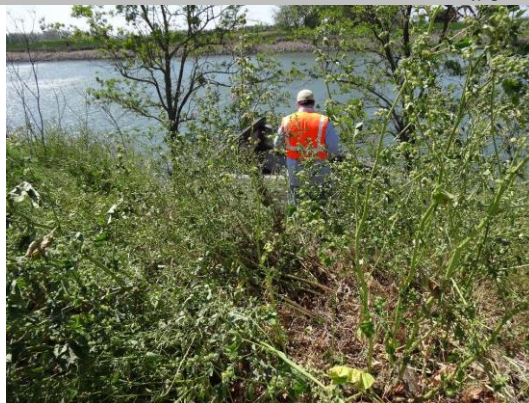
Photo 1 of 3 : UCIP\_FA\_2017\_12564\_20347.jpg

LM Start	4.95	Rating **	M	Issue No.	93	
LM End	4.95	Issue Type +	En	Location *		
Category	Supplemental			GPS Latitude/Longitude		
				Start	End	
Item	DWR UCIP Field Study			38.199133 °	38.199133 °	
				-121.557939 °	-121.557939 °	
DWR ID						
Comment Code						
Inspector Comment						
FS_ID:12564 DS_ID:20868 EP_NO: 11191 Repair Type: Non-Urgent Crossing Status: Found UCIP Comments: - needs to fix CMP riser. FIELD_STRUCT_DESC: A 8-inch pipe through levee, 5.7 feet below crown. Pump on waterward slope, gate valve on berm. Siphon breaker and service pole on landward slope. (ABO #11191-Pacific Fruit Exchange.) FS Date: 4/25/2013

WS- pump house on levee slope.

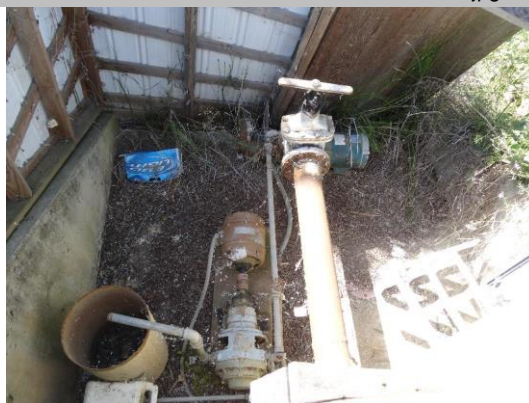
Photo 2 of 3 : UCIP\_FA\_2017\_12564\_20346.jpg

WS- pump, pipe and gate valve in pump house.

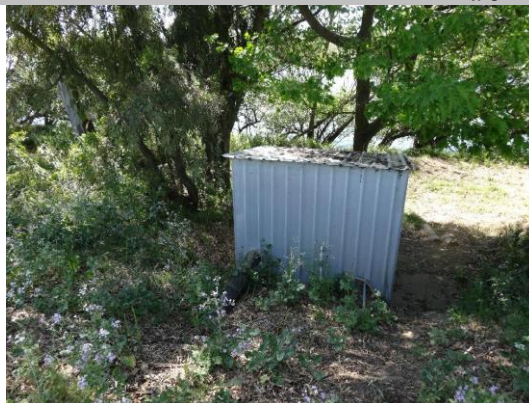
Photo 1 of 3 : UCIP\_FA\_2017\_12570\_20364.jpg

LM Start	5.21	Rating **	U	Issue No.	94
LM End	5.21	Issue Type +	En	Location *	
Category	Supplemental			GPS Latitude/Longitude	
				Start	End
Item	DWR UCIP Field Study			38.195755 °	38.195755 °
				-121.560078 °	-121.560078 °
DWR ID					
Comment Code					
Inspector Comment					
FS_ID:12570 DS_ID:20869 EP_NO: 11185 Repair Type: Urgent Crossing Status: Found UCIP Comments: Large pit and erosion on WS levee berm. FIELD_STRUCT_DESC: A 8-inch pipe through levee, 5.7 feet below crown. Pump and gate valve in pump house on waterward slope. Siphon breaker, concrete box, and service pole on landward slope. (ABO # 11185- Langhart.) FS Date: 4/25/2013

WS- pump house on levee slope

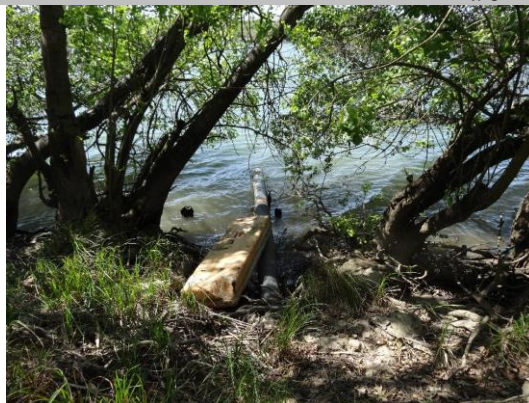
Photo 3 of 3 : UCIP\_FA\_2017\_12570\_20367.jpg

LM Start	5.21	Rating **	U	Issue No.	94 (cont)	
LM End	5.21	Issue Type +	En	Location *		
Category	Supplemental			GPS Latitude/Longitude		
				Start	End	
Item	DWR UCIP Field Study			38.195755 °	38.195755 °	
				-121.560078 °	-121.560078 °	
DWR ID						
Comment Code						
Inspector Comment						
FS_ID:12570						
DS_ID:20869						
EP_NO: 11185						
Repair Type: Urgent						
Crossing Status: Found						
UCIP Comments: Large pit and erosion on WS levee berm.						
FIELD_STRUCT_DESC: A 8-inch pipe through levee, 5.7 feet below crown. Pump and gate valve in pump house on waterward slope.						
Siphon breaker, concrete box, and service pole on landward slope.						
(ABO # 11185- Langhart.)						
FS Date: 4/25/2013

WS- intake pipe in the stream.

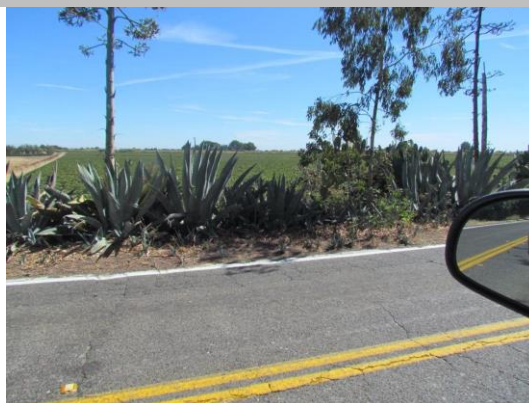
Photo 1 of 1 : FA\_2017\_RD0556\_19\_31\_20171002\_00013.jpg

LM Start	5.40	Rating **	M	Issue No.	31
LM End	5.44	Issue Type +	En	Location *	LS
Category	Earthen Levee			GPS Latitude/Longitude	
				Start	End
Item	Vegetation			38.193760 °	38.193445 °
				-121.562458 °	-121.562895 °
DWR ID	DWR_RD0556_02_s_2012_31				
Comment Code					
V6 : Landscaping					
Inspector Comment					
Control the wild growth within the landscaping. This choice of plant has taken over the levee slope and shoulder making it imposible to view the slope and ground.

RD 556 Unit 2 levee mile 5.40-5.44 landside levee shoulder and slope looking downstream.
