**Flood Control Project Maintenance
Levee Inspections**

Fall 2018 Levee Maintenance Deficiency Summary Report

Sacramento River Basin

Reclamation District No. 0556 Upper Andrus

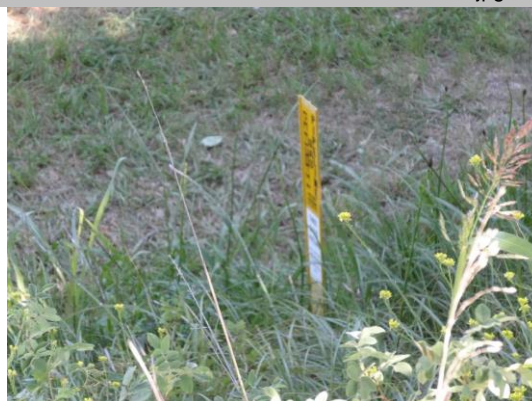
Photo 1 of 3 : UCIP_FA_2018_45564_74151.jpg

Gasline marker present on LS.

Comment Code						
Inspector Comment						
FS_ID:45564 DS_ID:20820 EP_NO: 3448 Repair Type: Non-Urgent Crossing Status: Indicator Found UCIP Comments: Dense vegetation inhibited visibility of gasline marker on WS. Need to contact owner to determine status of crossing. FIELD_STRUCT_DESC: 4.5-inch steel natural gas pipeline through the levee, 4 feet below the crown. Location marker on the waterside (WS) shoulder. Cut in pavement visible at the crossing. Gas line marker on the landside (LS) and on the opposite bank at Reclamation District No. 263 (RD0263). Pipe not located in February 1991. (Plans for construction of a 4.5-inch gas line across Georgiana Slough from Andrus Island to Tyler Island authorized under Permit No. 3448, 1960 - Pacific Gas and Electric Company [PG&E]). [Additional Reference(s): DWR Levee Log]. FS Date: 5/27/2015

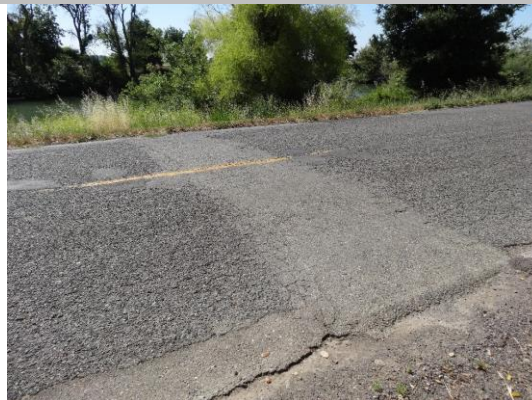
Photo 2 of 3 : UCIP_FA_2018_45663_74181.jpg

Comment Code						
Inspector Comment						
FS_ID:45663 DS_ID:20821 EP_NO: 5548 Repair Type: Non-Urgent Crossing Status: Found UCIP Comments: Dense vegetation prevents inspection of WS slope. FIELD_STRUCT_DESC: 12-inch steel irrigation discharge pipe through the levee, 5 feet below the crown. 1.25-inch electrical conduit through the levee at the same location. Pump on the waterside (WS). Concrete steps on the landside (LS) slope. Cuts in pavement visible at the crossing. (Plans to install a pump with a 12-inch discharge pipe and one electrical conduit through the levee authorized under Permit No. 5548, 1966 - George K. Adams). [Additional Reference(s): DWR Levee Log]. FS Date: 5/13/2015

View of WS with cuts visible on pavement.

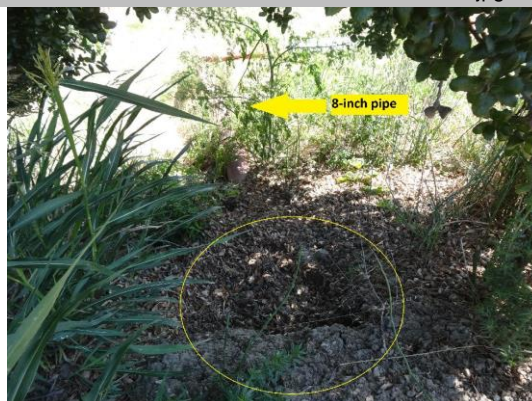
Photo 1 of 3 : UCIP_FA_2018_46799_74739.jpg

FS_ID:46799
DS_ID:25106
EP_NO: N/A
Repair Type: Non-Urgent
Crossing Status: Found
UCIP Comments: Possible erosion above pipe on LS needs attention.
FIELD_STRUCT_DESC: 8-inch steel irrigation pipe through the levee, at an unknown depth. Visible on the landside (LS), 6 feet away from the 10-inch pipe at HLM 1.17. Post likely for protection of vent located on the shoulder. Power pole next to pipe on the LS. This crossing was field discovered.
FS Date: 5/27/2015

LS view: 8-inch pipe off LS slope with possible erosion above pipe (circled).

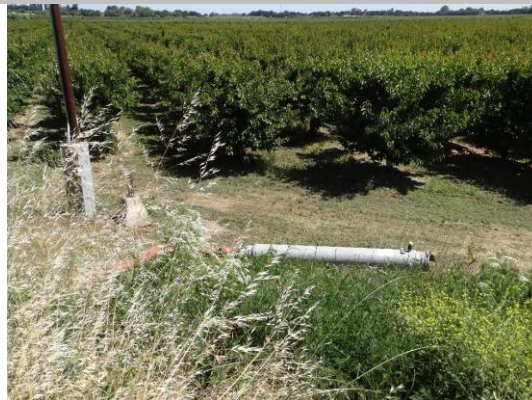
Photo 3 of 3 : UCIP_FA_2018_46799_74741.jpg

Electric pole next to pipe on LS.

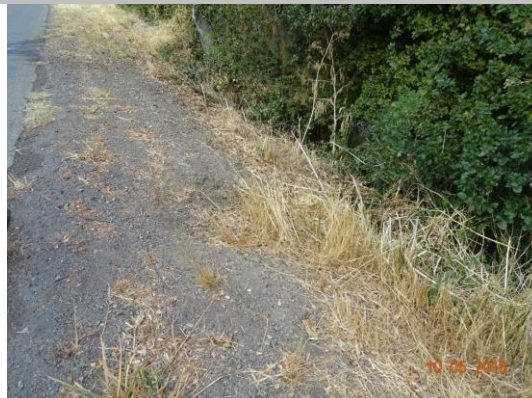
Photo 1 of 1 : FA_2018_RD0556_18_22_20181009_00068.jpg

LM Start	1.50	Rating **	M	Issue No.	22
LM End	1.50	Issue Type +	Ma	Location *	LS
Category	Earthen Levee			GPS Latitude/Longitude	
				Start	End
Item	Erosion / Bank Caving			38.225840 °	38.225840 °
				-121.534157 °	-121.534150 °
DWR ID	DWR_RD0556_01_s_2012_22				
Comment Code					
E1 : Note and monitor erosion site.					
Inspector Comment					
Dip at the top of the land side slope that is greater than 3".

View of dip at the top of the land side slope (October 2018).

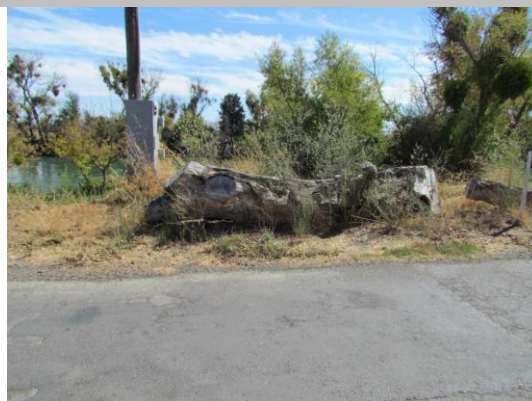
Photo 1 of 1 : FA_2018_RD0556_18_9_20180925_00001.jpg

LM Start	1.55	Rating **	A/W	Issue No.	9
LM End	1.57	Issue Type +	En	Location *	WS
Category	Earthen Levee			GPS Latitude/Longitude	
				Start	End
Item	Encroachments			38.225191 °	38.224976 °
				-121.534799 °	-121.535043 °
DWR ID	DWR_RD0556_01_s_2012_9				
Comment Code					
TR : Tree or limb					
Inspector Comment					
These cut up tree sections remain on the waterward slope to prevent parking in the area.

Cut tree sections on the waterside levee shoulder remain to prevent parking.

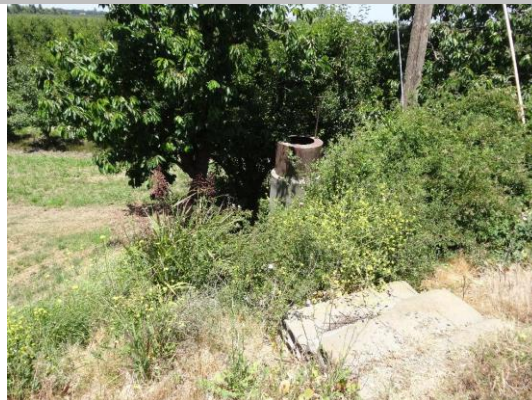
Photo 1 of 3 : UCIP_FA_2018_45743_74240.jpg

Comment Code					
Inspector Comment					
FS_ID:45743 DS_ID:20827 EP_NO: 11169 Repair Type: Non-Urgent Crossing Status: Found UCIP Comments: Dense vegetation on LS and WS limited accessibility. FIELD_STRUCT_DESC: 8-inch steel irrigation discharge pipe through the levee, 3.5 feet below the crown. 1-inch air valve. Pump and gate valve on the waterside (WS) berm. 2-inch electrical conduit through the levee. 36-inch concrete standpipe and concrete block step on the landside (LS) slope. (Retention of a 10-inch pipe through the levee, 3.5 feet below the crown, and a pump and a gate valve on the WS berm authorized under Automatic Board Order (ABO) issued as Permit No. 11169, 1975 - Darrell T. and B. M. Mealer). [Additional Reference(s): DWR Levee Log, 10-inch pipe referenced. USACE Sacramento O&M Manual 103, June 1954, (Station ""R"" 528+02.1), 10-inch pipe referenced, invert elevation 16.6 feet]. FS Date: 5/27/2015

Concrete standpipe and steps off LS toe.

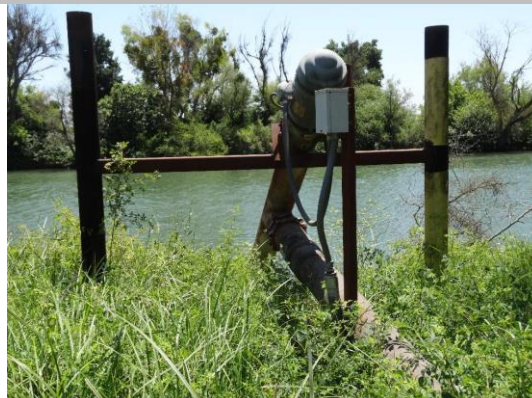
Photo 3 of 3 : UCIP_FA_2018_45743_74242.jpg

Comment Code						
Inspector Comment						
FS_ID:45743 DS_ID:20827 EP_NO: 11169 Repair Type: Non-Urgent Crossing Status: Found UCIP Comments: Dense vegetation on LS and WS limited accessibility. FIELD_STRUCT_DESC: 8-inch steel irrigation discharge pipe through the levee, 3.5 feet below the crown. 1-inch air valve. Pump and gate valve on the waterside (WS) berm. 2-inch electrical conduit through the levee. 36-inch concrete standpipe and concrete block step on the landside (LS) slope. (Retention of a 10-inch pipe through the levee, 3.5 feet below the crown, and a pump and a gate valve on the WS berm authorized under Automatic Board Order (ABO) issued as Permit No. 11169, 1975 - Darrell T. and B. M. Mealer). [Additional Reference(s): DWR Levee Log, 10-inch pipe referenced. USACE Sacramento O&M Manual 103, June 1954, (Station ""R"" 528+02.1), 10-inch pipe referenced, invert elevation 16.6 feet]. FS Date: 5/27/2015

Slant pump and pipe with 2" electrical conduit into WS slope.

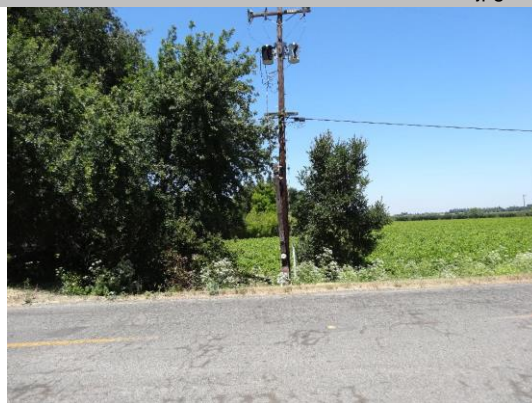
Photo 1 of 3 : UCIP_FA_2018_45764_74260.jpg

LS view: service pole on LW slope. Standpipe not visible in photo.

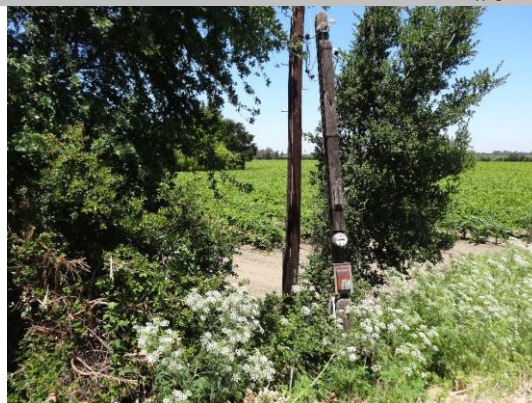
Photo 2 of 3 : UCIP_FA_2018_45764_74261.jpg

Pole on LS slope with electric box and 2-inch conduit.

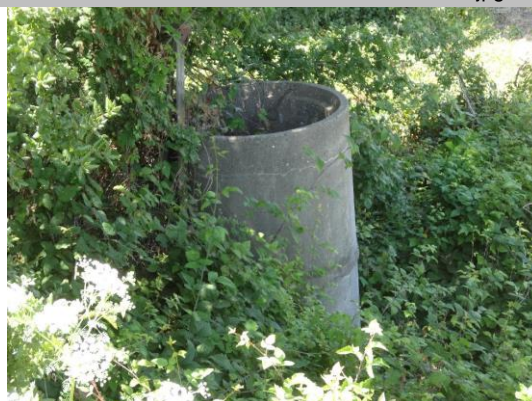
Photo 3 of 3 : UCIP_FA_2018_45764_74262.jpg

Comment Code						
Inspector Comment						
FS_ID:45764 DS_ID:20829 EP_NO: 11178 Repair Type: Non-Urgent Crossing Status: Found UCIP Comments: Dense vegetation on WS and LS. Some oil leakage inside pumphouse. FIELD_STRUCT_DESC: 8-inch steel irrigation discharge pipe through the levee, 3.7 feet below the crown. 2-inch electrical conduit through the levee, next to the 8-inch discharge pipe. 1-inch air valve and pump on the waterside (WS) berm. Service pole on the landside (LS) slope. Tin and wood pump house on the WS berm. 12-foot by 3-foot concrete standpipe on the LS. (Retention of an 8-inch pipe through the levee, 3.7 feet below the crown, a pump on the WS berm, and a service pole on the LS slope authorized under Automatic Board Order (ABO) issued as Permit No. 11178, 1975 - Allena D. Swett). [Additional Reference(s): DWR Levee Log. USACE Sacramento O&M Manual 103, June 1954, (Station ""R"" 511+00), invert elevation 16.4 feet]. FS Date: 5/27/2015

Standpipe on LS next to service pole.

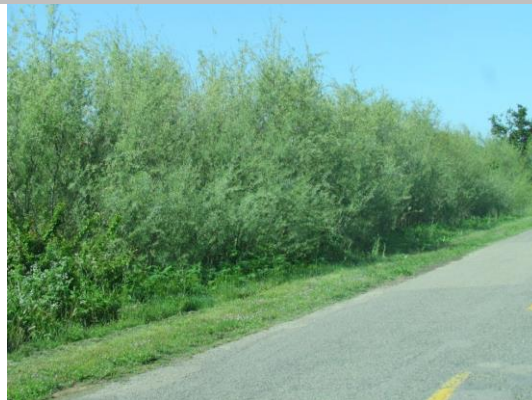
Photo 1 of 1 : FA_2018_RD0556_18_74_20180925_00031.jpg

LM Start	2.05	Rating **	U	Issue No.	74
LM End	2.29	Issue Type +	Ma	Location *	WS
Category	Earthen Levee			GPS Latitude/Longitude	
				Start	End
Item	Vegetation			38.223418 °	38.220317 °
				-121.543528 °	-121.544172 °
DWR ID	DWR_RD0556_01_f_2018_74				
Comment Code					
V2 : Remove the wild growth other than native grasses from the levee slopes.					
Inspector Comment					
Remove vegetation 20' from the crown.

RD 556 Unit 1 waterside levee mile 1.74-2.29.

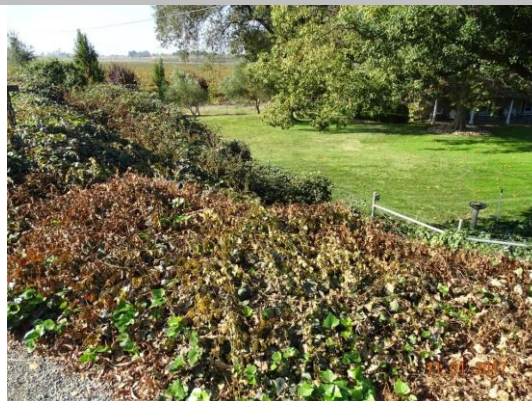
Photo 1 of 1 : FA_2018_RD0556_18_25_20180925_00007.jpg

LM Start	2.09	Rating **	U	Issue No.	25
LM End	2.11	Issue Type +	En	Location *	LS
Category	Earthen Levee			GPS Latitude/Longitude	
				Start	End
Item	Encroachments			38.223087°	38.222850°
				-121.544140°	-121.544330°
DWR ID	DWR_RD0556_01_f_2017_25				
Comment Code					
FE : Fence					
Inspector Comment

Unpermitted fence covered in berry vines along landside levee toe should be moved back 10 feet to allow access.

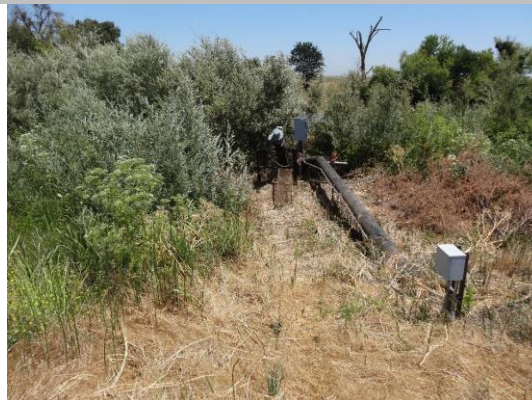
Photo 1 of 3 : UCIP_FA_2018_45786_74280.jpg

WS view: Slant pump, 12-inch and 1-inch pipe through levee.

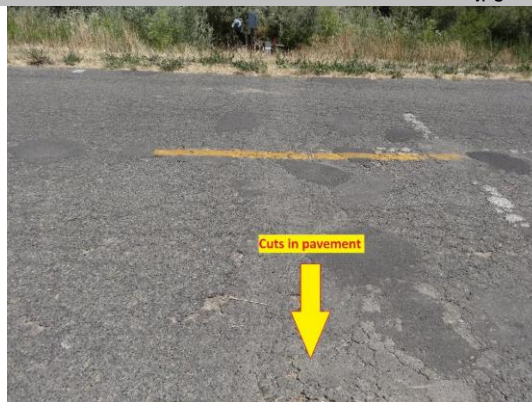
Photo 2 of 3 : UCIP_FA_2018_45786_74281.jpg

View toward WS with cuts in pavement in alignment with pipe on WS

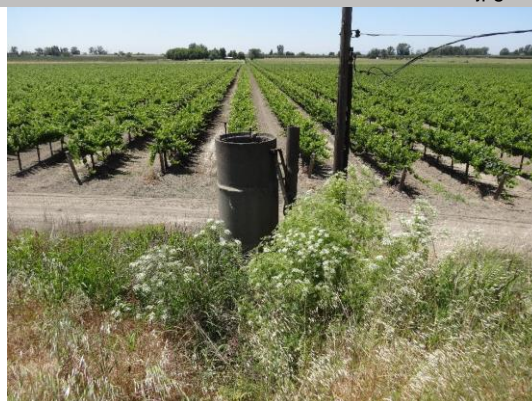
Photo 3 of 3 : UCIP_FA_2018_45786_74282.jpg

Comment Code						
Inspector Comment						
FS_ID:45786 DS_ID:20830 EP_NO: 2392 Repair Type: Non-Urgent Crossing Status: Found UCIP Comments: Hole and exposed depression adjacent to pipe at LS. Dense vegetation on WS and LS limited visibility. FIELD_STRUCT_DESC: 12-inch steel irrigation discharge pipe through the levee, 3 feet below the crown. Slant pump on the waterside (WS) bank. 1-inch electrical conduit through the levee, beside the 12-inch pipe, visible on the WS. Service pole and two standpipes at the landside (LS) toe. One of the two standpipes is 6 inches. (Plans for the installation of a pumping plant and a steel pipe through the levee authorized under Permit No. 2392, 1956 - Loyal D. Mealer). [Additional Reference(s): DWR Levee Log]. FS Date: 5/27/2015

LS: 2 standpipes and service pole.

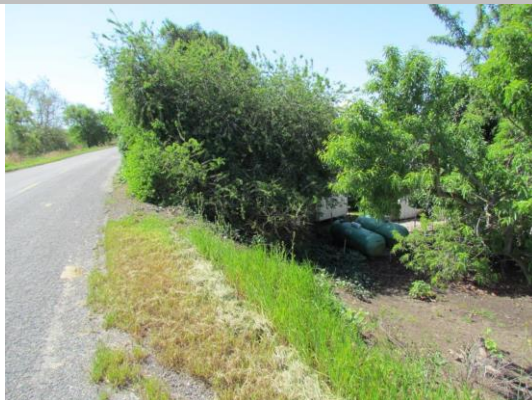
Photo 1 of 2 : FA_2018_RD0556_18_31_20180925_00015.jpg

LM Start	2.38	Rating **	U	Issue No.	31
LM End	2.43	Issue Type +	En	Location *	LS
Category	Earthen Levee			GPS Latitude/Longitude	
				Start	End
Item	Vegetation			38.219037 °	38.218342 °
				-121.543847 °	-121.543842 °
DWR ID	DWR_RD0556_01_s_2017_31				
Comment Code					
V6 : Landscaping					
Inspector Comment

Looking downstream from the landside shoulder woody tree growth blocking the slope and shoulder.

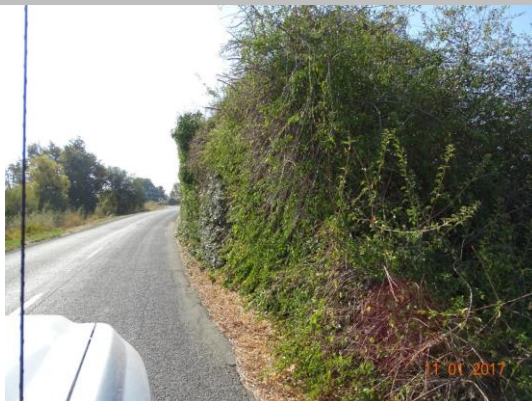
Photo 2 of 2 : FA_2018_RD0556_18_31_20180925_00016.jpg

LM Start	2.38	Rating **	U	Issue No.	31 (cont)
LM End	2.43	Issue Type +	En	Location *	LS

Trim and thin trees to allow visibility of the slope and ground.

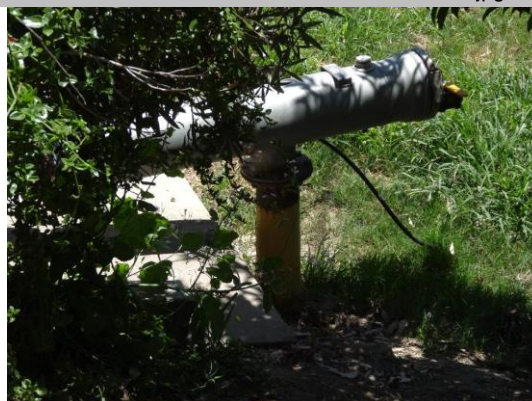
Photo 1 of 3 : UCIP_FA_2018_52734_74287.jpg

Closeup of 8-inch and 1.5-inch pipes and platform off LS toe.

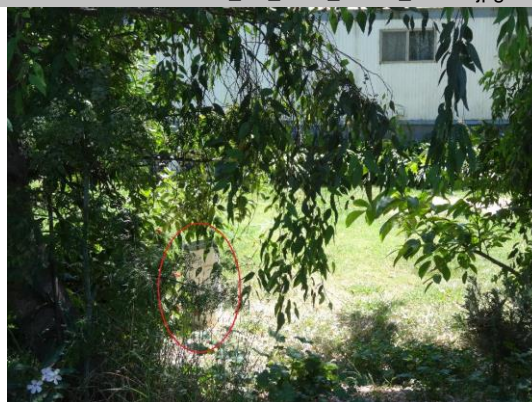
Photo 2 of 3 : UCIP_FA_2018_52734_74288.jpg

Concrete standpipe off LS toe.

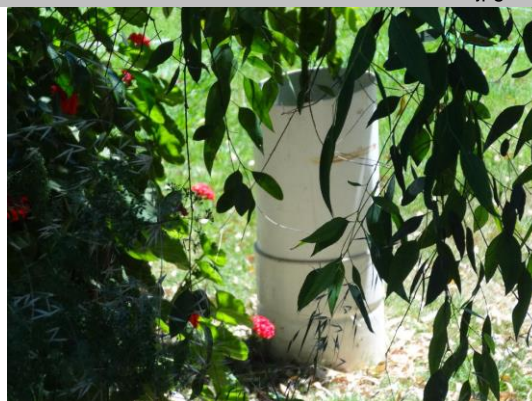
Photo 3 of 3 : UCIP_FA_2018_52734_74289.jpg

Comment Code						
Inspector Comment						
FS_ID:52734 DS_ID:20831 EP_NO: 11169 Repair Type: Non-Urgent Crossing Status: Found UCIP Comments: 07/12/2018 Hole near air vent on LS slope is still present but haven't increased in size. Pipe was running at the time of site visit, no leaks detected. Downgraded to "Non-Urgent" due to absence of levee threat. (O.Yakimov-DWR UCIP)05/27/2015 2'x2' hole on levee off LS shoulder. FIELD_STRUCT_DESC: 8-inch steel irrigation discharge pipe through the levee, 3.7 feet below the crown. 1-inch air valve. Pump and switch panel on the waterside (WS) berm. Service pole on the landside (LS). 9-foot by 3-foot concrete standpipe on the LS. 3 cables encased in a 1.5-inch steel conduit through the levee and on the WS, alongside the 8-inch pipe, disconnected on the WS. (Retention of an 8-inch pipe through the levee, 3.7 feet below the crown, a pump and a switch panel on the WS berm, and a service pole on the LS authorized under Automatic Board Order (ABO) issued as Permit No. 11169, 1975 - Darrell T. and B. M. Mealer). [Additional Reference(s): DWR Levee Log. USACE Sacramento O&M Manual 103, June 1954, (Station ""R"" 482+49.3), invert elevation 16 feet]. FS Date: 7/12/2018 1:51:13 PM

Closeup of concrete standpipe off LS toe.

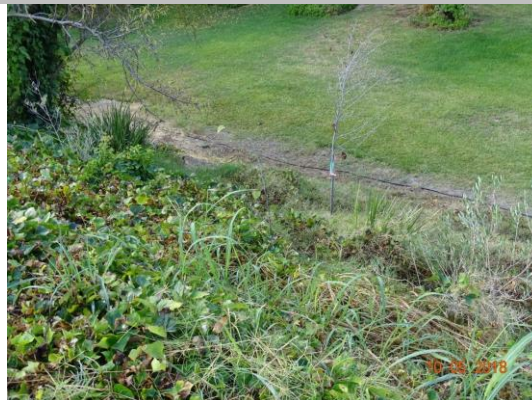
Photo 1 of 1 : FA_2018_RD0556_18_26_20181009_00069.jpg

LM Start	2.54	Rating **	M	Issue No.	26
LM End	2.54	Issue Type +	En	Location *	LS
Category	Earthen Levee			GPS Latitude/Longitude	
				Start	End
Item	Encroachments			38.216850 °	38.216850 °
				-121.543302 °	-121.543302 °
DWR ID	DWR_RD0556_01_f_2018_26				
Comment Code					
TR : Tree or limb					
Inspector Comment					
Remove new trees from levee slope.

Newly planted tree on the land side slope (October 2018).

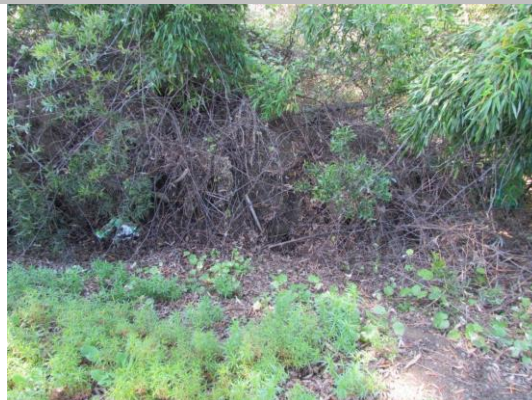
Photo 2 of 2 : FA_2018_RD0556_18_33_20180925_00018.jpg

LM Start	2.72	Rating **	U	Issue No.	33 (cont)	
LM End	2.72	Issue Type +	Ma	Location *	LS	
Category	Earthen Levee			GPS Latitude/Longitude		
				Start		End
Item	Slope Stability			38.215107°		38.215107°
				-121.540677°		-121.540677°
DWR ID	DWR_RD0556_01_s_2017_33					
Comment Code						
S1 : Repair slope instability.						
Inspector Comment						
Fallen tree on landside. Remove the fallen tree and repair the levee damage.

RD 349 Unut 1 levee mile 2.72 the root ball of the fallen tree on slope landward.

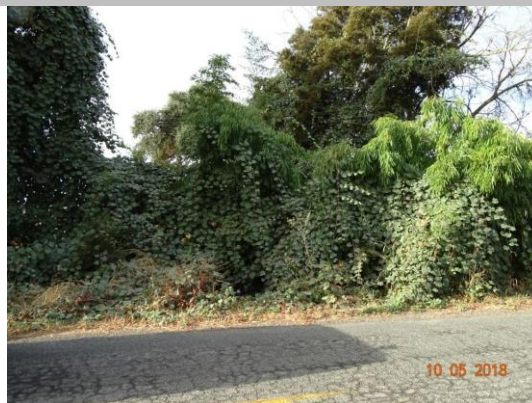
Photo 1 of 1 : FA_2018_RD0556_18_48_20181009_00070.jpg

LM Start	2.73	Rating **	U	Issue No.	48
LM End	2.73	Issue Type +	Ma	Location *	LS
Category	Earthen Levee			GPS Latitude/Longitude	
				Start	End
Item	Vegetation			38.215025 °	38.215025 °
				-121.540623 °	-121.540623 °
DWR ID	DWR_RD0556_01_f_2018_48				
Comment Code					
V2 : Remove the wild growth other than native grasses from the levee slopes.					
Inspector Comment					
Remove wild grapes

View of thick vegetation on the land side slope (October 2018).

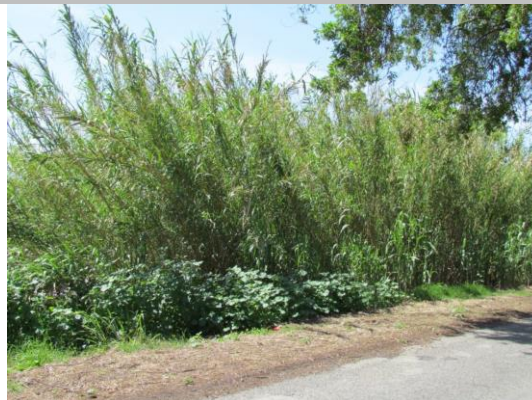
Photo 1 of 1 : FA_2018_RD0556_18_35_20180925_00020.jpg

LM Start	3.12	Rating **	U	Issue No.	35
LM End	3.14	Issue Type +	Ma	Location *	WS
Category	Earthen Levee			GPS Latitude/Longitude	
				Start	End
Item	Vegetation			38.211103°	38.210970°
				-121.537993°	-121.538370°
DWR ID	DWR_RD0556_01_s_2017_35				
Comment Code					
V2 : Remove the wild growth other than native grasses from the levee slopes.					
Inspector Comment					
Remove the arundo.

RD 556 Unit 1 levee mile 3.12-3.14 waterside shoulder and slope.

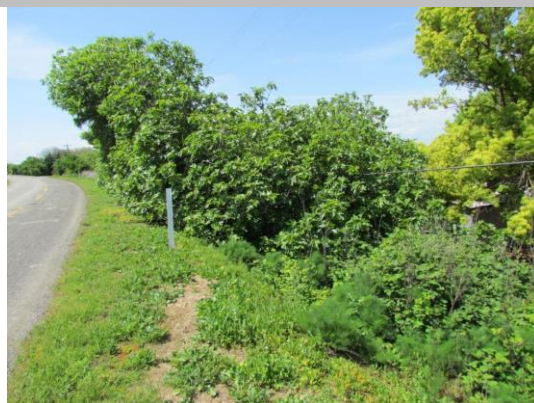
Photo 1 of 1 : FA_2018_RD0556_18_38_20180925_00021.jpg

LM Start	3.25	Rating **	U	Issue No.	38
LM End	3.29	Issue Type +	Ma	Location *	LS
Category	Earthen Levee			GPS Latitude/Longitude	
				Start	End
Item	Vegetation			38.210250 °	38.209842 °
				-121.540207 °	-121.540658 °
DWR ID	DWR_RD0556_01_s_2017_38				
Comment Code					
V7 : Trees / Woody Vegetation					
Inspector Comment					
Remove the wild tree growth and vegetation from the landside levee slope and toe so the ground can be seen.

556 Unit 1 levee mile 3.25-3.29 woody tree growth and vegetation blocking the view of the levee slope and toe.

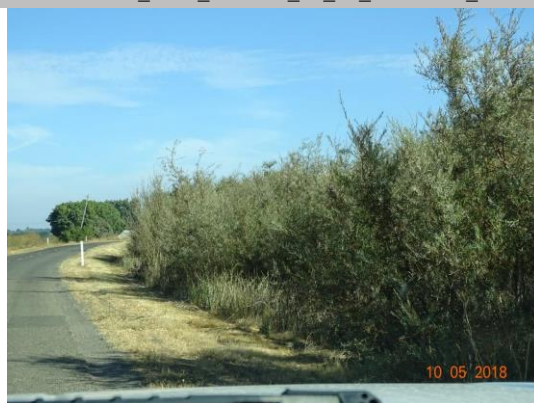
Photo 1 of 1 : FA_2018_RD0556_18_61_20181009_00071.jpg

LM Start	3.31	Rating **	U	Issue No.	61
LM End	3.84	Issue Type +	Ma	Location *	WS
Category	Earthen Levee			GPS Latitude/Longitude	
				Start	End
Item	Vegetation			38.209553 °	38.202133 °
				-121.540752 °	-121.540957 °
DWR ID	DWR_RD0556_01_f_2018_61				
Comment Code					
V2 : Remove the wild growth other than native grasses from the levee slopes.					
Inspector Comment					
Remove vegetation 20' from crown

View looking upstream on the water side slope (October 2018).

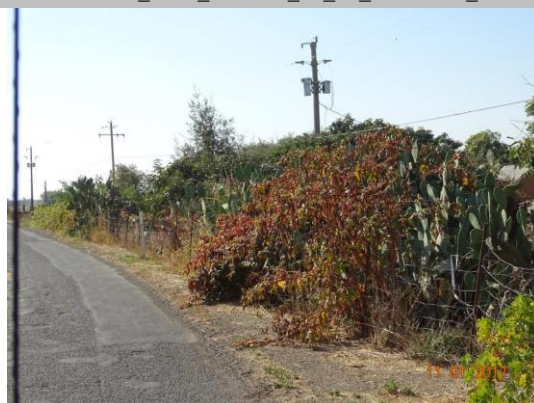
Photo 1 of 1 : FA_2018_RD0556_18_29_20180925_00013.jpg

LM Start	3.38	Rating **	U	Issue No.	29
LM End	3.42	Issue Type +	En	Location *	LS
Category	Earthen Levee			GPS Latitude/Longitude	
				Start	End
Item	Vegetation			38.208755 °	38.208191 °
				-121.541395 °	-121.541578 °
DWR ID	DWR_RD0556_01_f_2017_29				
Comment Code					
V6 : Landscaping					
Inspector Comment

Large cactus growing on shoulder and slope should be removed to allow inspection and access.

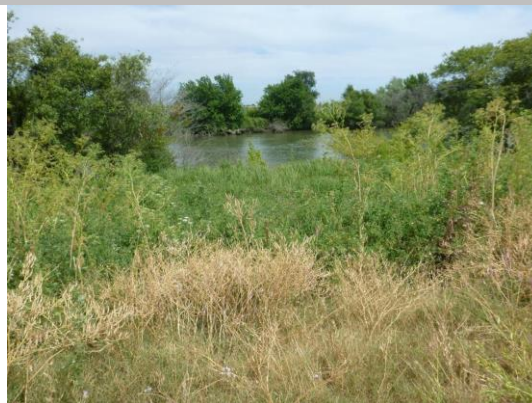
Photo 1 of 2 : FA_2018_RD0556_18_23_20180925_00004.jpg

LM Start	3.43	Rating **	A/W	Issue No.	23
LM End	3.75	Issue Type +	Ma	Location *	
Category	Supplemental			GPS Latitude/Longitude	
				Start	End
Item	2017 Storm Damage			38.208070 °	38.203400 °
				-121.541700 °	-121.540990 °
DWR ID	DWR_RD0556_01_f_2017_23				
Comment Code					
Inspector Comment					
Levee Evaluation Comments					
Description:					
Site ID No:67					
Site Designation:USACE_CESPK_UPA1_2011_p_0143					
Repair Type: Stability					
Rating:Area of Concern					
Field Date:2/7/2017					
Notes: inactive ditch on landside toe, slope covered in heavy vegetation, minor landside lower slope sloughing observed,

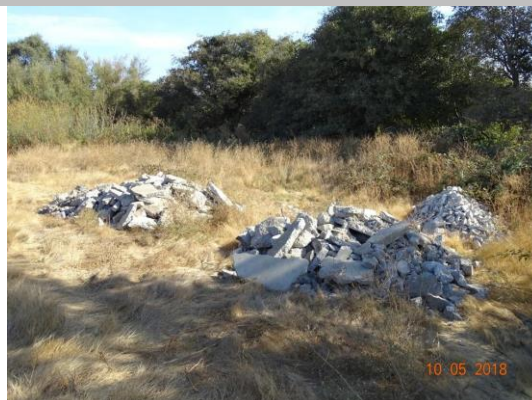
Photo 1 of 1 : FA_2018_RD0556_18_62_20181009_00072.jpg

LM Start	3.46	Rating **	U	Issue No.	62
LM End	3.46	Issue Type +	En	Location *	WS
Category	Earthen Levee			GPS Latitude/Longitude	
				Start	End
Item	Encroachments			38.207592°	38.207592°
				-121.541668°	-121.541668°
DWR ID	DWR_RD0556_01_f_2018_62				
Comment Code					
DE : Debris					
Inspector Comment					
Remove concrete piles.

Concrete debris on the water side (October 2018).

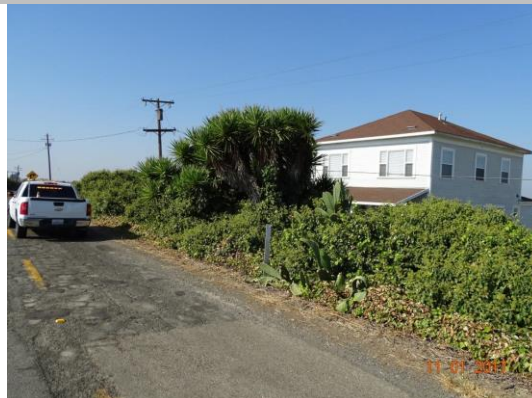
Photo 1 of 1 : FA_2018_RD0556_18_30_20180925_00014.jpg

LM Start	3.91	Rating **	U	Issue No.	30
LM End	3.91	Issue Type +	En	Location *	LS
Category	Earthen Levee			GPS Latitude/Longitude	
				Start	End
Item	Vegetation			38.201672°	38.201672°
				-121.542133°	-121.542133°
DWR ID	DWR_RD0556_01_f_2017_30				
Comment Code					
V6 : Landscaping					
Inspector Comment

Trim/thin landscaping to allow inspection and access to levee slope and toe.

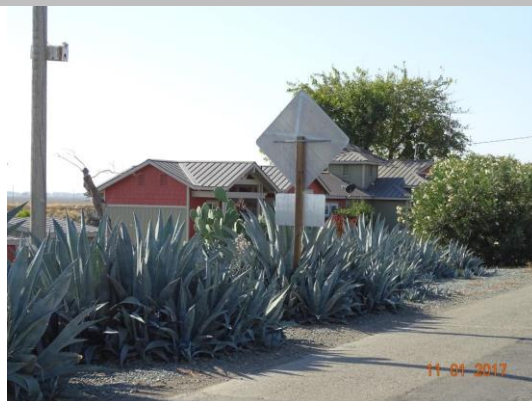
Photo 1 of 1 : FA_2018_RD0556_18_34_20180925_00019.jpg

LM Start	3.93	Rating **	U	Issue No.	34
LM End	3.98	Issue Type +	En	Location *	WS
Category	Earthen Levee			GPS Latitude/Longitude	
				Start	End
Item	Vegetation			38.201603 °	38.201273 °
				-121.542352 °	-121.543328 °
DWR ID	DWR_RD0556_01_f_2017_34				
Comment Code					
V6 : Landscaping					
Inspector Comment

Remove large cactus from waterside shoulder to allow inspection and access.

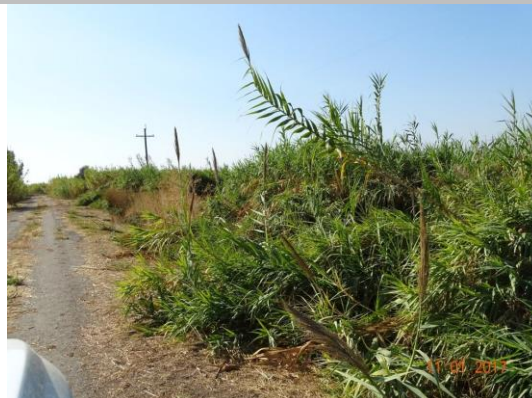
Photo 1 of 1 : FA_2018_RD0556_18_39_20180925_00022.jpg

LM Start	3.98	Rating **	U	Issue No.	39
LM End	5.48	Issue Type +	Ma	Location *	LS
Category	Earthen Levee			GPS Latitude/Longitude	
				Start	End
Item	Vegetation			38.201273 °	38.186464 °
				-121.543328 °	-121.562550 °
DWR ID	DWR_RD0556_01_f_2017_39				
Comment Code					
V2 : Remove the wild growth other than native grasses from the levee slopes.					
Inspector Comment					
Remove wild growth and arundo from landside slope and toe.

Control dense growth of wild vegetation, berry vines and arundo on landside to allow inspection and access.

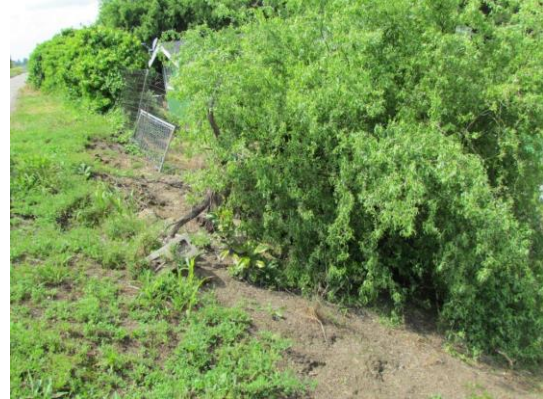
Photo 2 of 2 : FA_2018_RD0556_18_44_20180925_00025.jpg

LM Start	5.46	Rating **	U	Issue No.	44 (cont)	
LM End	5.46	Issue Type +	En	Location *	LS	
Category	Earthen Levee			GPS Latitude/Longitude		
				Start	End	
Item	Encroachments			38.186593 °	38.186593 °	
				-121.562217 °	-121.562217 °	
DWR ID	DWR_RD0556_01_s _ 2017_44					
Comment Code						
TR : Tree or limb						
Inspector Comment						
Remove the fallen tree from the landside slope and repair the damage to the slope.

view from upstream.

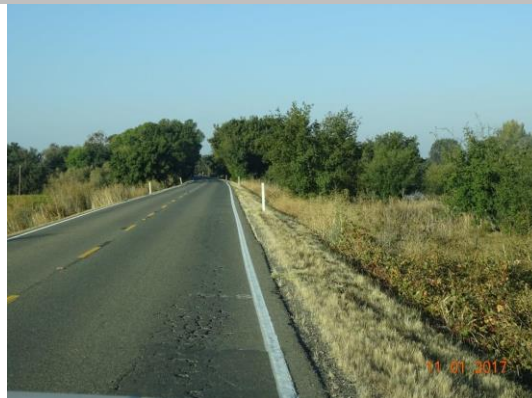
Photo 4 of 4 : FA_2018_RD0556_19_82_20180925_00023.jpg

LM Start	0.00	Rating **	M	Issue No.	82 (cont)	
LM End	1.84	Issue Type +	Ma	Location *	WS	
Category	Earthen Levee			GPS Latitude/Longitude		
				Start		End
Item	Vegetation			38.200550 °		38.241038 °
				-121.544190 °		-121.551365 °
DWR ID	DWR_RD0556_02_s_2013_82					
Comment Code						
V2 : Remove the wild growth other than native grasses from the levee slopes.						
Inspector Comment						
Remove vegetation 20' from water side shoulder.

Waterside levee slope and shoulder have been mowed to 20' from

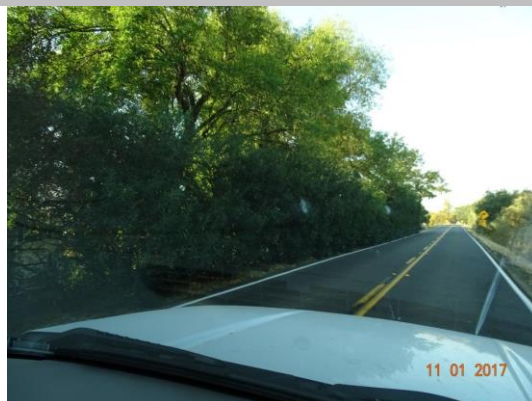
Photo 1 of 1 : FA_2018_RD0556_19_25_20180925_00002.jpg

LM Start	0.55	Rating **	M	Issue No.	25
LM End	0.55	Issue Type +	En	Location *	LS
Category	Earthen Levee			GPS Latitude/Longitude	
				Start	End
Item	Vegetation			38.237810°	38.237810°
				-121.528182°	-121.528182°
DWR ID	DWR_RD0556_02_f_2017_25				
Comment Code					
V6 : Landscaping					
Inspector Comment

Trim/thin oleanders.

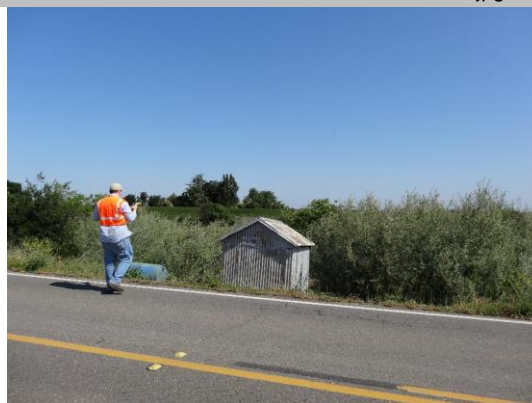
Photo 1 of 3 : UCIP_FA_2018_12512_20245.jpg

Comment Code					
Inspector Comment					
FS_ID:12512 DS_ID:20851 EP_NO: 11186 Repair Type: Non-Urgent Crossing Status: Found UCIP Comments: - a concrete box on LS- water is leaking from priming plastic tank and causing surface erosion on levee slope. FIELD_STRUCT_DESC: 4-inch steel irrigation discharge pipe through the levee, 4.3 feet below the crown. Pump and gate valve in a pump house on the waterside (WS) berm. Siphon breaker and service pole on the landside (LS) slope. Concrete spill box with three 8-inch openings. (Retention of a 4-inch pipe through the levee, 4.3 feet below the crown, a pump in a pump house on the WS berm, and a siphon breaker and a service pole on the LS slope authorized under Automatic Board Order (ABO) issued as Permit No. 11186, 1975 - Margaret M. Marks). [Additional Reference(s): DWR Levee Log. USACE Sacramento O&M Manual 103, June 1954, (Station ""J"" 192+00), 6-inch pipe referenced, invert elevation 18.8 feet]. FS Date: 4/25/2013

WS- pump house on levee berm

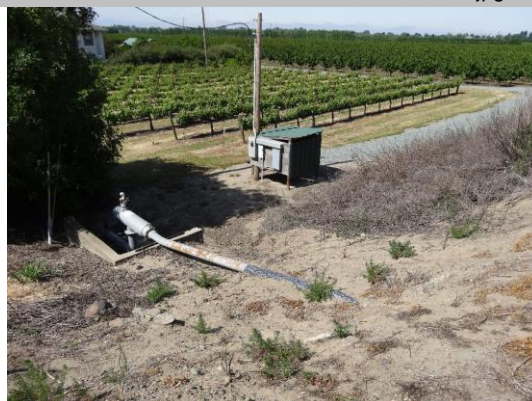
Photo 2 of 3 : UCIP_FA_2018_12512_20244.jpg

Comment Code						
Inspector Comment						
FS_ID:12512 DS_ID:20851 EP_NO: 11186 Repair Type: Non-Urgent Crossing Status: Found UCIP Comments: - a concrete box on LS- water is leaking from priming plastic tank and causing surface erosion on levee slope. FIELD_STRUCT_DESC: 4-inch steel irrigation discharge pipe through the levee, 4.3 feet below the crown. Pump and gate valve in a pump house on the waterside (WS) berm. Siphon breaker and service pole on the landside (LS) slope. Concrete spill box with three 8-inch openings. (Retention of a 4-inch pipe through the levee, 4.3 feet below the crown, a pump in a pump house on the WS berm, and a siphon breaker and a service pole on the LS slope authorized under Automatic Board Order (ABO) issued as Permit No. 11186, 1975 - Margaret M. Marks). [Additional Reference(s): DWR Levee Log. USACE Sacramento O&M Manual 103, June 1954, (Station ""J"" 192+00), 6-inch pipe referenced, invert elevation 18.8 feet]. FS Date: 4/25/2013

LS- steel pipe on a concrete box

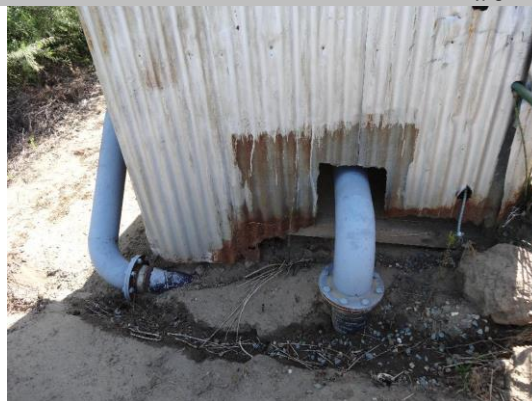
Photo 3 of 3 : UCIP_FA_2018_12512_20243.jpg

WS- pipe daylight from the pump house.

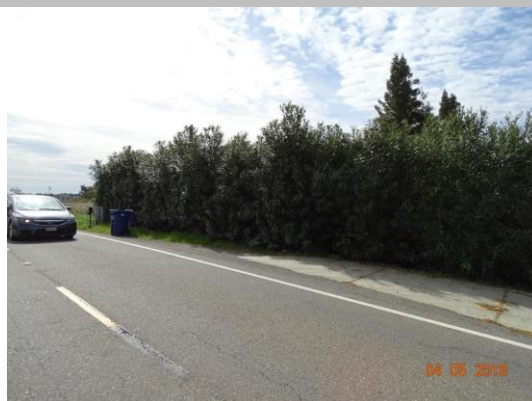
Photo 1 of 1 : FA_2018_RD0556_19_26_20180925_00003.jpg

LM Start	1.14	Rating **	U	Issue No.	26
LM End	1.14	Issue Type +	En	Location *	LS
Category	Earthen Levee			GPS Latitude/Longitude	
				Start	End
Item	Vegetation			38.239005°	38.239005°
				-121.538772°	-121.538772°
DWR ID	DWR_RD0556_02_f_2017_26				
Comment Code					
V6 : Landscaping					
Inspector Comment					
Trim/thin oleanders.

Manage oleanders to allow inspection and access.

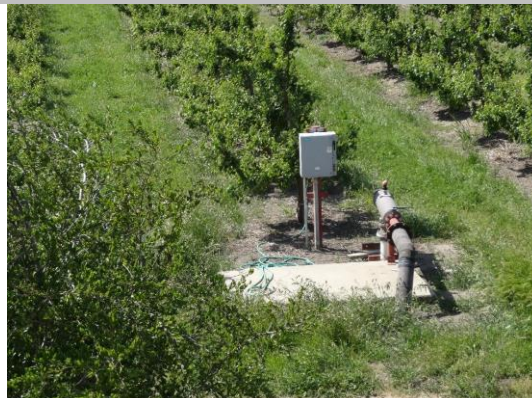
Photo 1 of 3 : UCIP_FA_2018_12573_20381.jpg

Comment Code					
Inspector Comment					
FS_ID:12573 DS_ID:20852 EP_NO: 11187 Repair Type: Non-Urgent Crossing Status: Found UCIP Comments: - gap between 6-inch pipe and 10-inch pipe needs to be sealed. FIELD_STRUCT_DESC: 6-inch steel irrigation discharge pipe sleeved through a 10-inch steel pipe through the levee, 4.8 feet below the crown. Pump on the riverbank. (Retention of a 10-inch pipe through the levee, 4.8 feet below the crown, a flap gate on the waterside (WS) end, landside (LS) end open, used to sleeve portable irrigation pipe, authorized under Automatic Board Order (ABO) issued as Permit No. 11187, 1975 - Ernest and Alvine Machado). [Additional Reference(s): DWR Levee Log]. FS Date: 4/25/2013

LS- 6-inch steel pipe on orchard.

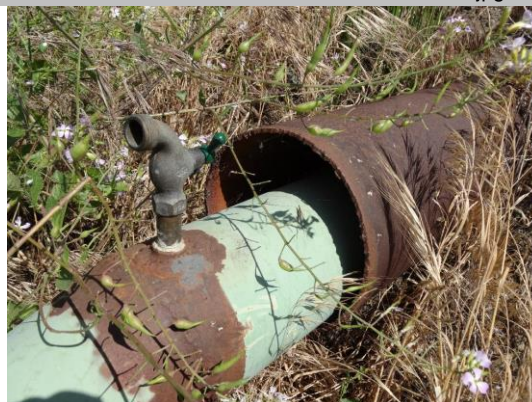
Photo 2 of 3 : UCIP_FA_2018_12573_20380.jpg

LS- 6-inch steel pipe sleeved through 10-inch steel pipe. 6" pipe is attached with air release valve.

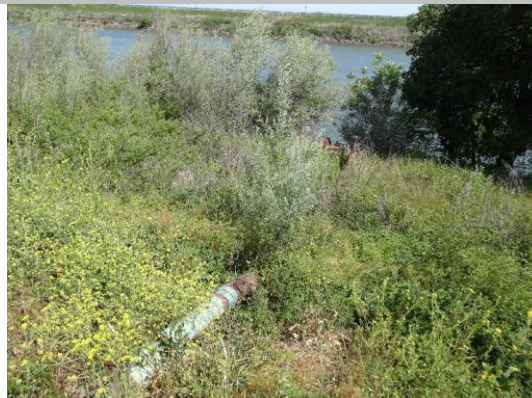
Photo 3 of 3 : UCIP_FA_2018_12573_20383.jpg

Comment Code						
Inspector Comment						
FS_ID:12573						
DS_ID:20852						
EP_NO: 11187						
Repair Type: Non-Urgent						
Crossing Status: Found						
UCIP Comments: - gap between 6-inch pipe and 10-inch pipe needs to be sealed.						
FIELD_STRUCT_DESC: 6-inch steel irrigation discharge pipe sleeved through a 10-inch steel pipe through the levee, 4.8 feet below the crown. Pump on the riverbank. (Retention of a 10-inch pipe through the levee, 4.8 feet below the crown, a flap gate on the waterside (WS) end, landside (LS) end open, used to sleeve portable irrigation pipe, authorized under Automatic Board Order (ABO) issued as Permit No. 11187, 1975 - Ernest and Alvine Machado). [Additional Reference(s): DWR Levee Log].						
FS Date: 4/25/2013

WS- 6-inch steel pipe on levee slope

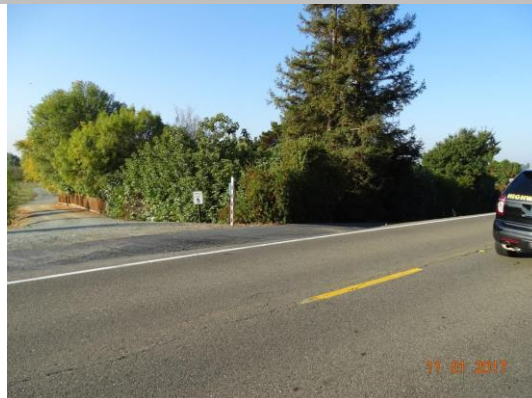
Photo 1 of 1 : FA_2018_RD0556_19_28_20180925_00004.jpg

LM Start	1.31	Rating **	U	Issue No.	28
LM End	1.31	Issue Type +	En	Location *	LS
Category	Earthen Levee			GPS Latitude/Longitude	
				Start	End
Item	Vegetation			38.239677 °	38.239677 °
				-121.541715 °	-121.541716 °
DWR ID	DWR_RD0556_02_f_2017_28				
Comment Code					
V6 : Landscaping					
Inspector Comment

Trim/thin oleanders.

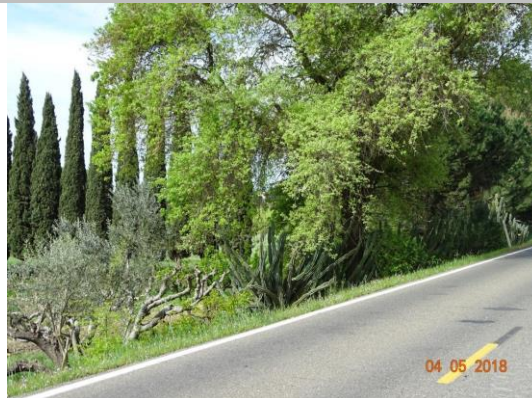
Photo 1 of 1 : FA_2018_RD0556_19_41_20180925_00014.jpg

LM Start	1.48	Rating **	U	Issue No.	41
LM End	1.48	Issue Type +	En	Location *	LS
Category	Earthen Levee			GPS Latitude/Longitude	
				Start	End
Item	Vegetation			38.240212°	38.240212°
				-121.544719°	-121.544719°
DWR ID	DWR_RD0556_02_s_2018_41				
Comment Code					
V6 : Landscaping					
Inspector Comment					
Remove cactus and thin other landscaping.

Cactus should be removed and other landscaping managed to allow access and inspection.

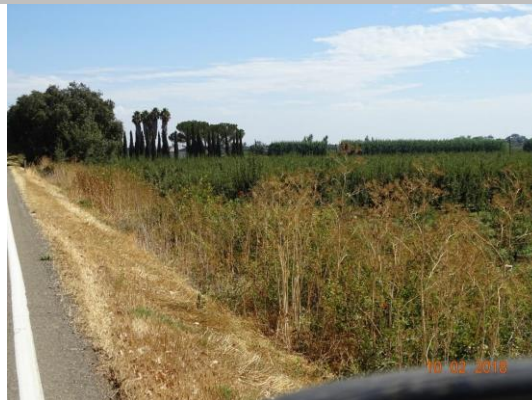
Photo 1 of 1 : FA_2018_RD0556_19_88_20181003_00076.jpg

LM Start	1.50	Rating **	M	Issue No.	88
LM End	1.68	Issue Type +	Ma	Location *	LS
Category	Earthen Levee			GPS Latitude/Longitude	
				Start	End
Item	Vegetation			38.240255 °	38.240832 °
				-121.545255 °	-121.548440 °
DWR ID	DWR_RD0556_02_f_2018_88				
Comment Code					
V1 : Control annual grass and weeds on the levee slopes and easements.					
Inspector Comment					
Remove vegetation from land side slope.

View looking downstream at vegetation on the land side slope (October 2018).

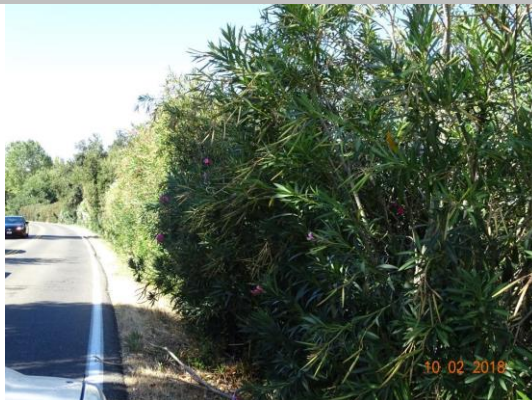
Photo 1 of 1 : FA_2018_RD0556_19_70_20181003_00063.jpg

LM Start	1.82	Rating **	U	Issue No.	70
LM End	1.92	Issue Type +	En	Location *	WS
Category	Earthen Levee			GPS Latitude/Longitude	
				Start	End
Item	Vegetation			38.241010 °	38.240618 °
				-121.551033 °	-121.552747 °
DWR ID	DWR_RD0556_02_f_2018_70				
Comment Code					
V6 : Landscaping					
Inspector Comment					
Thin oleanders to allow view down the levee slope.

View looking downstream at oleanders (October 2018).

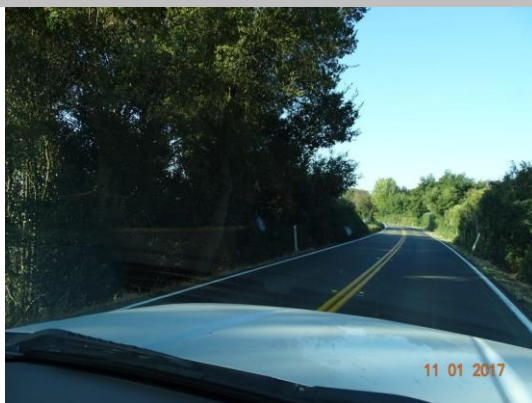
Photo 1 of 1 : FA_2018_RD0556_19_30_20180925_00006.jpg

LM Start	1.83	Rating **	U	Issue No.	30
LM End	1.99	Issue Type +	En	Location *	LS
Category	Earthen Levee			GPS Latitude/Longitude	
				Start	End
Item	Vegetation			38.240955 °	38.240024 °
				-121.551233 °	-121.553860 °
DWR ID	DWR_RD0556_02_f_2017_30				
Comment Code					
V6 : Landscaping					
Inspector Comment					
Remove/thin various landscaping including trees, bushes and large cactus.

Trim/thin oleanders on landside slope.

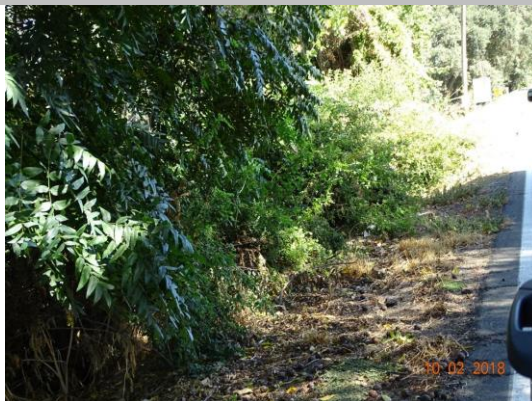
Photo 1 of 1 : FA_2018_RD0556_19_71_20181003_00064.jpg

LM Start	2.02	Rating **	M	Issue No.	71
LM End	2.78	Issue Type +	Ma	Location *	WS
Category	Earthen Levee			GPS Latitude/Longitude	
				Start	End
Item	Vegetation			38.239768 °	38.230350 °
				-121.554258 °	-121.555772 °
DWR ID	DWR_RD0556_02_f_2018_71				
Comment Code					
V2 : Remove the wild growth other than native grasses from the levee slopes.					
Inspector Comment					
Remove vegetation 20' from water side slope.

View looking upstream at vegetation on water side slope (October 2018).

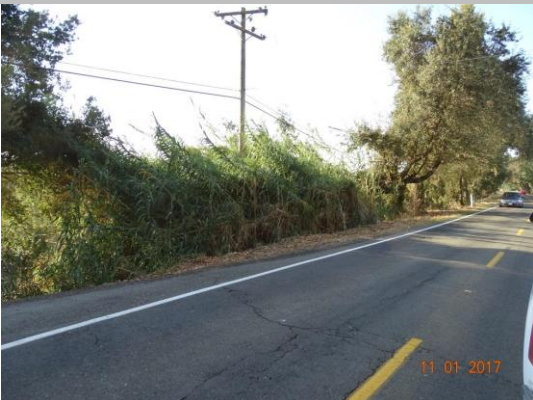
Photo 1 of 1 : FA_2018_RD0556_19_32_20180925_00008.jpg

Arundo growth should be removed to allow inspection and access to landside slope and toe.

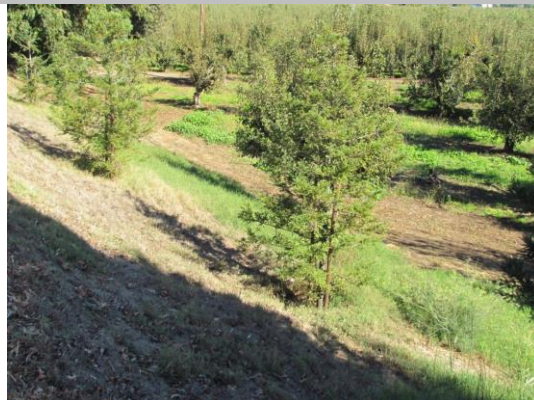
Photo 1 of 1 : FA_2018_RD0556_19_1_20180925_00001.jpg

LM Start	2.28	Rating **	U	Issue No.	1
LM End	2.28	Issue Type +	En	Location *	LS
Category	Earthen Levee			GPS Latitude/Longitude	
				Start	End
Item	Vegetation			38.237156 °	38.237156 °
				-121.557640 °	-121.557640 °
DWR ID	DWR_RD0556_02_f_2015_1				
Comment Code					
V6 : Landscaping					
Inspector Comment					
These unauthorized planted redwoods have been reported in the past inspections, the District needs to have the owner remove them from the levee slope.

RD 556 Unit 2 Levee mile 2.28 unauthorized planting of redwood trees planted on the slope.

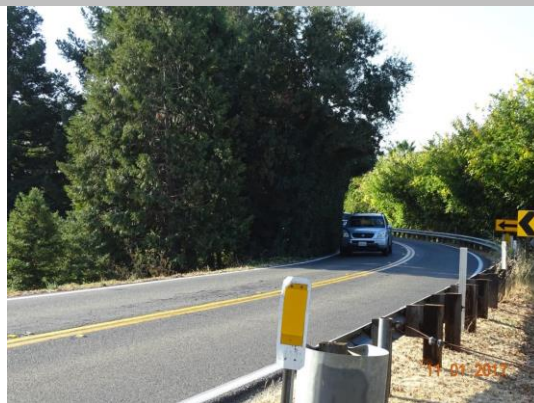
Photo 1 of 1 : FA_2018_RD0556_19_35_20180925_00011.jpg

LM Start	2.29	Rating **	U	Issue No.	35
LM End	2.29	Issue Type +	En	Location *	LS
Category	Earthen Levee			GPS Latitude/Longitude	
				Start	End
Item	Vegetation			38.237060 °	38.237060 °
				-121.557782 °	-121.557782 °
DWR ID	DWR_RD0556_02_f_2017_35				
Comment Code					
V6 : Landscaping					
Inspector Comment

Trim/thin oleanders to allow inspection and access to landside slope and toe.

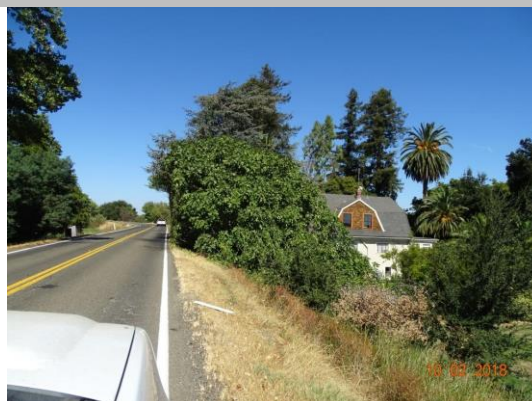
Photo 1 of 1 : FA_2018_RD0556_19_46_20181003_00074.jpg

LM Start	2.35	Rating **	M	Issue No.	46
LM End	2.87	Issue Type +	En	Location *	LS
Category	Earthen Levee			GPS Latitude/Longitude	
				Start	End
Item	Vegetation			38.236257°	38.229109°
				-121.557980°	-121.555356°
DWR ID	DWR_RD0556_02_f_2018_46				
Comment Code					
V6 : Landscaping					
Inspector Comment

View looking upstream at beginning of landscaping on land side (October 2018).

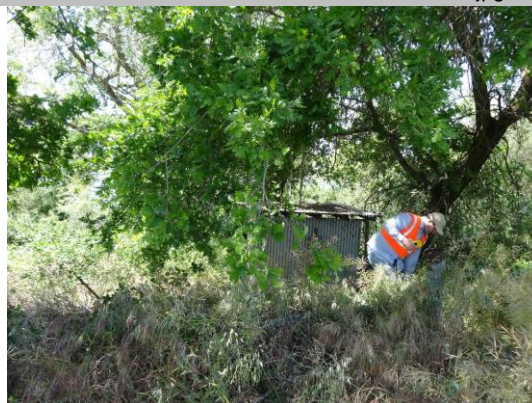
Photo 1 of 3 : UCIP_FA_2018_12574_20388.jpg

Comment Code						
Inspector Comment						
FS_ID:12574 DS_ID:20859 EP_NO: 11181 Repair Type: Non-Urgent Crossing Status: Found UCIP Comments: - Needs to clean CMP riser for proper functioning of siphon breaker. FIELD_STRUCT_DESC: 10-inch steel irrigation discharge pipe through the levee, 5.8 feet below the crown. Pump and gate valve in a pump house on the waterside (WS) slope. Siphon breaker and service pole on the landside (LS) slope. (Retention of a 10-inch pipe through the levee, 5.8 feet below the crown, a pump and a gate valve in a pump house on the WS slope, and a siphon breaker and a service pole on the LS slope authorized under Automatic Board Order (ABO) issued as Permit No. 11181, 1975 - Robert E. and G. P. Collins). [Additional Reference(s): DWR Levee Log. USACE Sacramento O&M Manual 103, June 1954, (Station ""J"" 115+25), invert elevation 18.5 feet]. FS Date: 4/25/2013

WS- pump house on levee berm

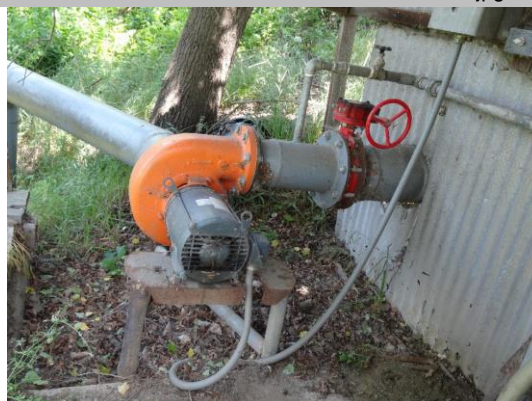
Photo 2 of 3 : UCIP_FA_2018_12574_20387.jpg

Comment Code						
Inspector Comment						
FS_ID:12574 DS_ID:20859 EP_NO: 11181 Repair Type: Non-Urgent Crossing Status: Found UCIP Comments: - Needs to clean CMP riser for proper functioning of siphon breaker. FIELD_STRUCT_DESC: 10-inch steel irrigation discharge pipe through the levee, 5.8 feet below the crown. Pump and gate valve in a pump house on the waterside (WS) slope. Siphon breaker and service pole on the landside (LS) slope. (Retention of a 10-inch pipe through the levee, 5.8 feet below the crown, a pump and a gate valve in a pump house on the WS slope, and a siphon breaker and a service pole on the LS slope authorized under Automatic Board Order (ABO) issued as Permit No. 11181, 1975 - Robert E. and G. P. Collins). [Additional Reference(s): DWR Levee Log. USACE Sacramento O&M Manual 103, June 1954, (Station ""J"" 115+25), invert elevation 18.5 feet]. FS Date: 4/25/2013

WS- pump, and gate valve in pump house.

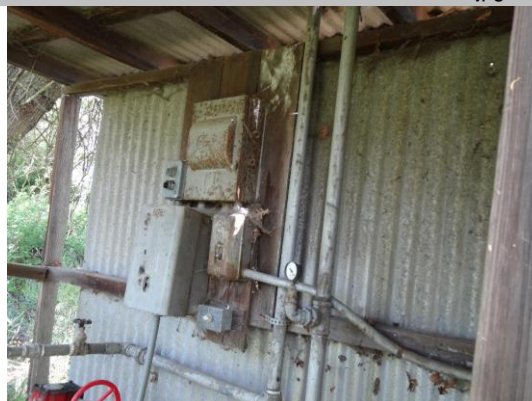
Photo 3 of 3 : UCIP_FA_2018_12574_20386.jpg

WS- power control panel and electric conduit in pump house.

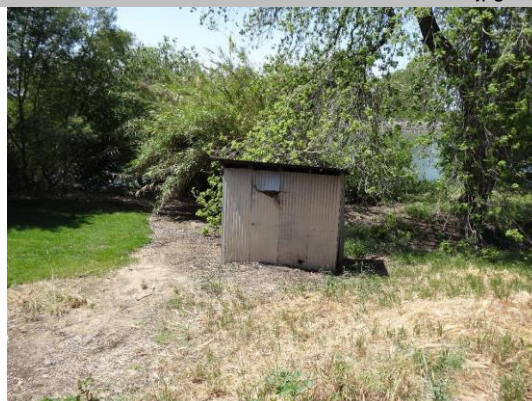
Photo 1 of 3 : UCIP_FA_2018_41713_20284.jpg

Comment Code						
Inspector Comment						
FS_ID:41713						
DS_ID:20849						
EP_NO: 11181						
Repair Type: Non-Urgent						
Crossing Status: Found						
UCIP Comments: - Needs to clean siphon breaker CMP riser.						
FIELD_STRUCT_DESC: 6-inch irrigation discharge pipe of an unknown material through the levee, 6 feet below the crown. Pressure tank in a pump house on the waterside (WS) berm. Service pole, siphon breaker, and distribution box on the landside (LS) slope. (Retention of a 6-inch pipe through the levee, 6 feet below the crown; a pump, a gate valve, and a pressure tank on the WS berm; and a service pole on the LS slope authorized under Automatic Board Order (ABO) issued as Permit No. 11181, 1975 - Robert E. and G. P. Collins). [Additional Reference(s): DWR Levee Log].						
FS Date: 4/25/2013

WS- pump house on levee berm.

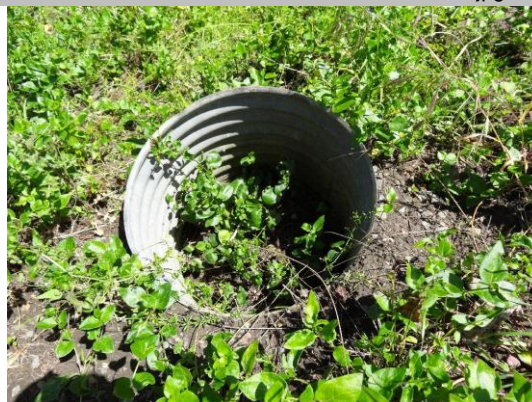
Photo 2 of 3 : UCIP_FA_2018_41713_20283.jpg

LS- siphon breaker in CMP riser on levee slope.

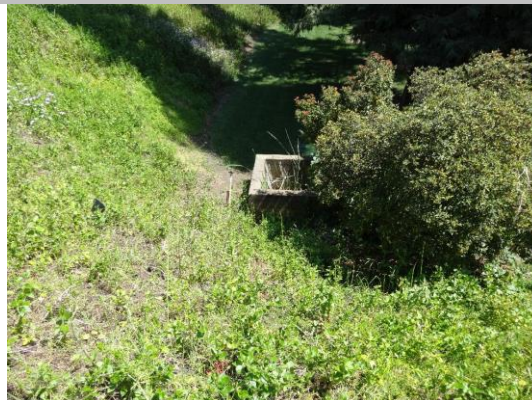
Photo 3 of 3 : UCIP_FA_2018_41713_20282.jpg

Comment Code						
Inspector Comment						
FS_ID:41713 DS_ID:20849 EP_NO: 11181 Repair Type: Non-Urgent Crossing Status: Found UCIP Comments: - Needs to clean siphon breaker CMP riser. FIELD_STRUCT_DESC: 6-inch irrigation discharge pipe of an unknown material through the levee, 6 feet below the crown. Pressure tank in a pump house on the waterside (WS) berm. Service pole, siphon breaker, and distribution box on the landside (LS) slope. (Retention of a 6-inch pipe through the levee, 6 feet below the crown; a pump, a gate valve, and a pressure tank on the WS berm; and a service pole on the LS slope authorized under Automatic Board Order (ABO) issued as Permit No. 11181, 1975 - Robert E. and G. P. Collins). [Additional Reference(s): DWR Levee Log]. FS Date: 4/25/2013

LS- concrete distribution box near toe of the levee

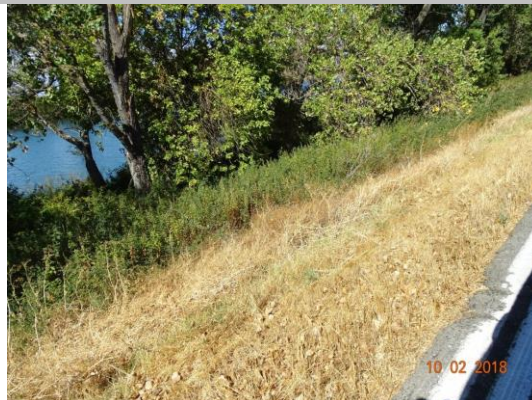
Photo 1 of 1 : FA_2018_RD0556_19_76_20181003_00065.jpg

LM Start	2.90	Rating **	M	Issue No.	76
LM End	5.71	Issue Type +	Ma	Location *	WS
Category	Earthen Levee			GPS Latitude/Longitude	
				Start	End
Item	Vegetation			38.228683 °	38.191822 °
				-121.555352 °	-121.567455 °
DWR ID	DWR_RD0556_02_f_2018_76				
Comment Code					
V2 : Remove the wild growth other than native grasses from the levee slopes.					
Inspector Comment					
Remove vegetation 20' from water side slope and patches of arundo.

View looking upstream at vegetation on the water side slope (October 2018).

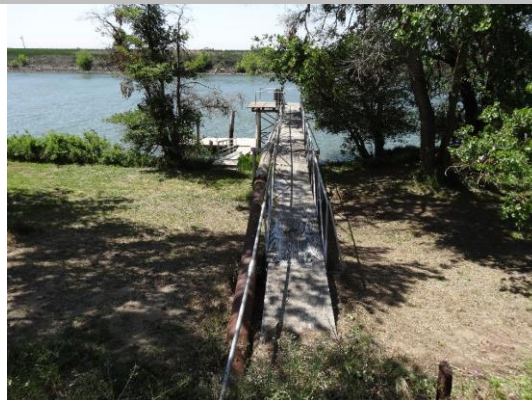
Photo 1 of 3 : UCIP_FA_2018_12525_20290.jpg

Comment Code						
Inspector Comment						
FS_ID:12525 DS_ID:20862 EP_NO: N/A Repair Type: Non-Urgent Crossing Status: Found UCIP Comments: - 9-inch steel pipe sleeved through 12-inch pipe.- needs to seal gap between two pipes. FIELD_STRUCT_DESC: 9-inch steel pipe sleeved through a 12-inch steel irrigation discharge pipe through the levee, 6 feet below the crown. Pump on a pile structure in the river. Steel walkway to the pump and wood steps on the waterside (WS) slope. Concrete spill box with two 8- inch openings. (Retention of a 12-inch pipe through the levee, 6 feet below the crown, a pump on a pile structure in the river, a steel walkway to the pump, and wood steps on the WS slope authorized under Automatic Board Order (ABO) issued as Permit No. 11193, 1975 - Gertrude M. Reid). [Additional Reference(s): DWR Levee Log. USACE Sacramento O&M Manual 103, June 1954, (Station ""J"" 80+79), invert elevation 18.3 feet]. FS Date: 4/25/2013

WS- walkway, pump, and pipe on steel pile structure in the river.
