**Flood Control Project Maintenance
Levee Inspections**

Fall 2018 Levee Maintenance Deficiency Summary Report

Sacramento River Basin

Reclamation District No. 0556 Upper Andrus

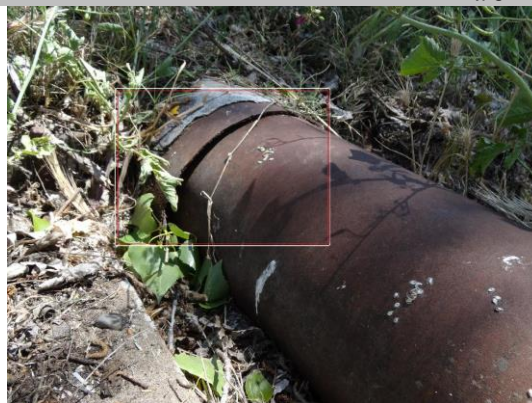
Photo 2 of 3 : UCIP_FA_2018_12525_20289.jpg

WS- 9-inch pipe sleeved through 10 inch steel pipe.

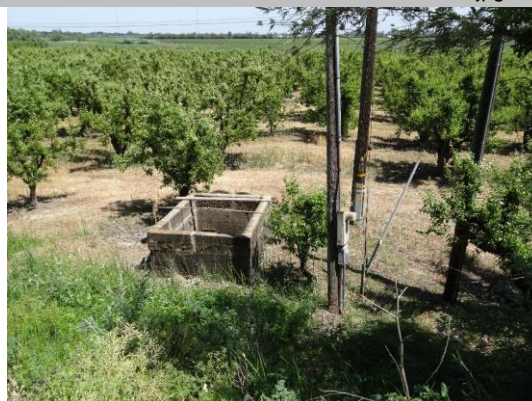
Photo 3 of 3 : UCIP_FA_2018_12525_20288.jpg

Comment Code						
Inspector Comment						
FS_ID:12525 DS_ID:20862 EP_NO: N/A Repair Type: Non-Urgent Crossing Status: Found UCIP Comments: - 9-inch steel pipe sleeved through 12-inch pipe.- needs to seal gap between two pipes. FIELD_STRUCT_DESC: 9-inch steel pipe sleeved through a 12-inch steel irrigation discharge pipe through the levee, 6 feet below the crown. Pump on a pile structure in the river. Steel walkway to the pump and wood steps on the waterside (WS) slope. Concrete spill box with two 8-inch openings. (Retention of a 12-inch pipe through the levee, 6 feet below the crown, a pump on a pile structure in the river, a steel walkway to the pump, and wood steps on the WS slope authorized under Automatic Board Order (ABO) issued as Permit No. 11193, 1975 - Gertrude M. Reid). [Additional Reference(s): DWR Levee Log. USACE Sacramento O&M Manual 103, June 1954, (Station ""J"" 80+79), invert elevation 18.3 feet]. FS Date: 4/25/2013

LS- a concrete spill box on landside of the levee.

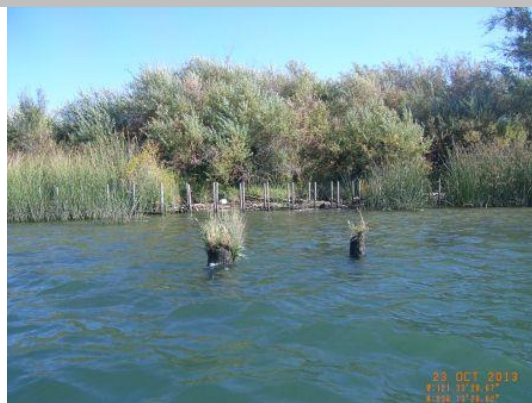
Photo 1 of 1 : FA_2018_RD0556_19_17_20181023_00079.jpg

LM Start	3.17	Rating **	M	Issue No.	17
LM End	3.28	Issue Type +	Ma	Location *	WS
Category	Supplemental			GPS Latitude/Longitude	
				Start	End
Item	2017 USACE Erosion Survey, DRAFT			38.224850 °	38.223233 °
				-121.555641 °	-121.555687 °
DWR ID	DWR_RD0556_02_f_2018_17				
Comment Code					
Inspector Comment					
2017 Site ID: SAC 23.2 L Status: Eroding 2017 Field Notes: New erosion along lower bank. Site History: 2000 - Recently fallen cottonwood at the downstream end. 2005 - Empty brush boxes. 2011 - A few trees have fallen since last year. 2012 - Potential new tree popout since last year. 2013 - New erosion at downstream end of site and a recent tree pop-out observed. 2016 - New erosion at the toe.

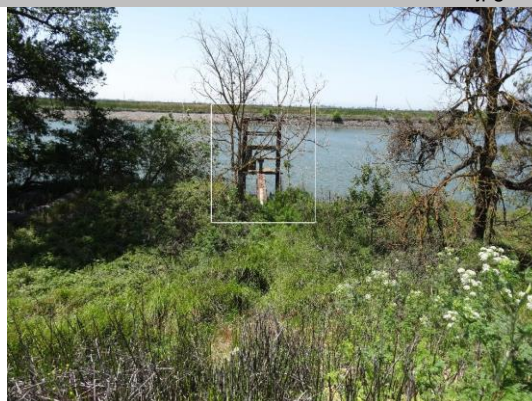
Photo 1 of 3 : UCIP_FA_2018_12527_20297.jpg

Comment Code					
Inspector Comment					
FS_ID:12527 DS_ID:20863 EP_NO: 11181 Repair Type: Non-Urgent Crossing Status: Found UCIP Comments: - needs to fix siphon breaker FIELD_STRUCT_DESC: 10-inch steel irrigation discharge pipe through the levee, 4.8 feet below the crown. Steel walkway to the pump on a pile structure in the river. Siphon breaker on the waterside (WS). Service pole on the landside (LS) slope. Concrete spill box with two 15-inch openings on the LS. (Retention of a 10-inch pipe through the levee, 4.8 feet below the crown, a steel walkway to the pump on a pile structure in the river, and a siphon breaker and a service pole on the LS slope authorized under Automatic Board Order (ABO) issued as Permit No. 11181, 1975 - Robert E. and G. P. Collins). [Additional Reference(s): DWR Levee Log. USACE Sacramento O&M Manual 103, June 1954, (Station ""J"" 58+00), invert elevation 18.2 feet]. FS Date: 4/25/2013

WS- pump, pipe, and walkway on steel structure in the stream.

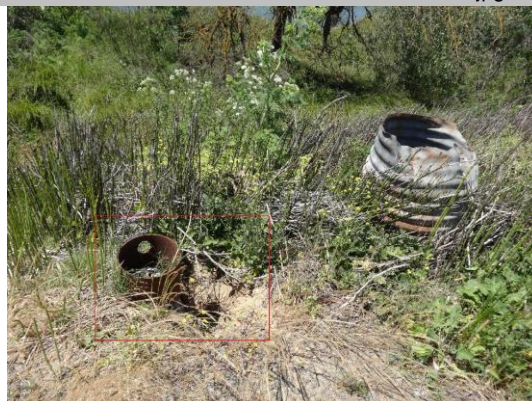
Photo 2 of 3 : UCIP_FA_2018_12527_20296.jpg

WS- siphon breaker and abandoned CMP riser lying adjacent to it.

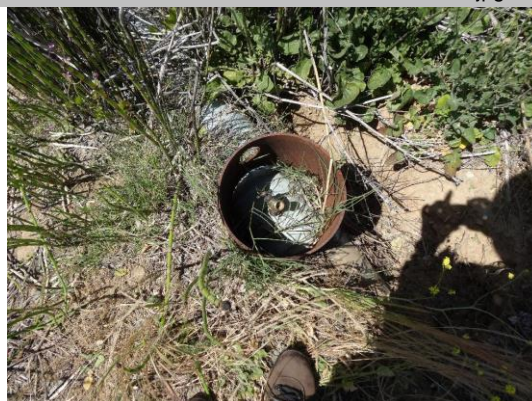
Photo 3 of 3 : UCIP_FA_2018_12527_20295.jpg

Comment Code						
Inspector Comment						
FS_ID:12527 DS_ID:20863 EP_NO: 11181 Repair Type: Non-Urgent Crossing Status: Found UCIP Comments: - needs to fix siphon breaker FIELD_STRUCT_DESC: 10-inch steel irrigation discharge pipe through the levee, 4.8 feet below the crown. Steel walkway to the pump on a pile structure in the river. Siphon breaker on the waterside (WS). Service pole on the landside (LS) slope. Concrete spill box with two 15-inch openings on the LS. (Retention of a 10-inch pipe through the levee, 4.8 feet below the crown, a steel walkway to the pump on a pile structure in the river, and a siphon breaker and a service pole on the LS slope authorized under Automatic Board Order (ABO) issued as Permit No. 11181, 1975 - Robert E. and G. P. Collins). [Additional Reference(s): DWR Levee Log. USACE Sacramento O&M Manual 103, June 1954, (Station ""J"" 58+00), invert elevation 18.2 feet]. FS Date: 4/25/2013

WS- siphon breaker on levee slope.

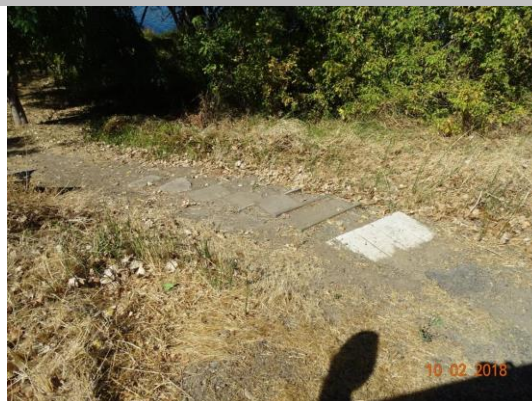
Photo 1 of 1 : FA_2018_RD0556_19_78_20181003_00067.jpg

LM Start	3.54	Rating **	M	Issue No.	78
LM End	3.54	Issue Type +	En	Location *	WS
Category	Earthen Levee			GPS Latitude/Longitude	
				Start	End
Item	Encroachments			38.219407 °	38.219407 °
				-121.556280 °	-121.556280 °
DWR ID	DWR_RD0556_02_f_2018_78				
Comment Code					
ST : Stairway					
Inspector Comment					
Stairs encroaching into slope do not have a permit.

View of stairs on water side slope (October 2018).

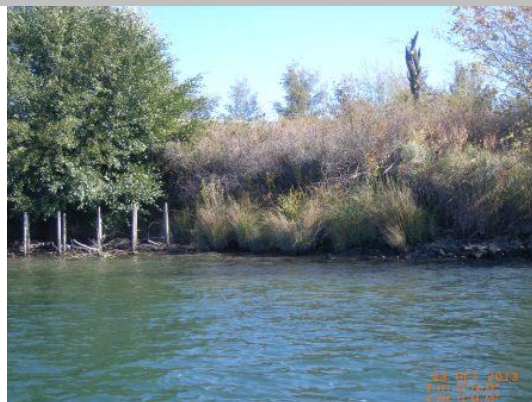
Photo 1 of 1 : FA_2018_RD0556_19_16_20181023_00078.jpg

LM Start	3.58	Rating **	M	Issue No.	16
LM End	3.64	Issue Type +	Ma	Location *	WS
Category	Supplemental			GPS Latitude/Longitude	
				Start	End
Item	2017 USACE Erosion Survey, DRAFT			38.218951 °	38.218104 °
				-121.556689 °	-121.556819 °
DWR ID	DWR_RD0556_02_f_2018_16				
Comment Code					
Inspector Comment					
2017 Site ID: SAC 22.7 L					
Status: Eroding					
2017 Field Notes: Minor new erosion at toe.					
Site History: 1997 - Scallops into berm and very close to levee toe.					
2005 - Brush boxes present. 2011 - New toe scour and freshly fallen tree. 2012 - New tree popout has taken significant portion of soil out of the levee.

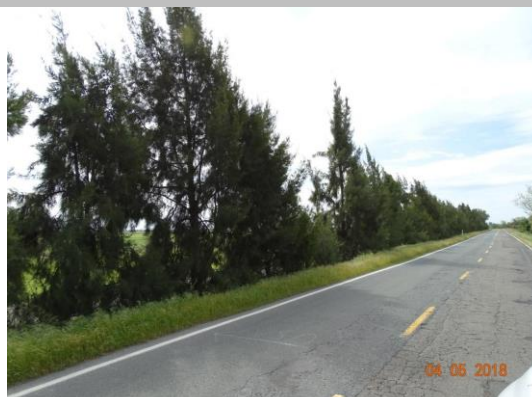
Photo 1 of 1 : FA_2018_RD0556_19_49_20180925_00015.jpg

LM Start	3.58	Rating **	U	Issue No.	49
LM End	3.74	Issue Type +	En	Location *	LS
Category	Earthen Levee			GPS Latitude/Longitude	
				Start	End
Item	Vegetation			38.218889 °	38.216543 °
				-121.556388 °	-121.556777 °
DWR ID	DWR_RD0556_02_s_2018_49				
Comment Code					
V6 : Landscaping					
Inspector Comment					
Row of evergreen trees blocks inspection and access. Should be trimmed to 5' above levee.

Row of landscaping trees blocks inspection and access.

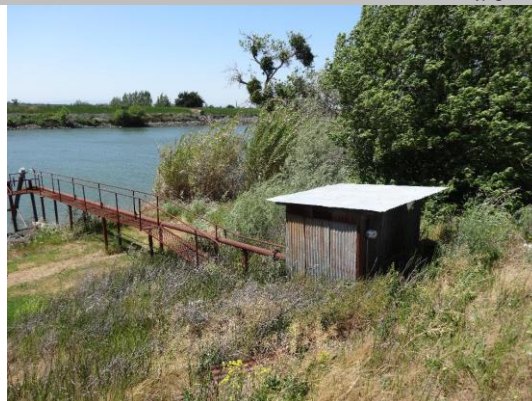
Photo 1 of 3 : UCIP_FA_2018_12543_20302.jpg

Comment Code					
Inspector Comment					
FS_ID:12543 DS_ID:20864 EP_NO: 11197 Repair Type: Non-Urgent Crossing Status: Found UCIP Comments: Electric control panel in pump house.Needs cleaning of CMP riser on landside. FIELD_STRUCT_DESC: 6-inch steel irrigation discharge pipe through the levee, 6.5 feet below the crown. Slant pump on a steel pile structure in the river. Walkway to the pump. Gate valve in a pump house on the waterside (WS) slope. Siphon breaker and service poles on the landside (LS) slope. Concrete standpipe on the LS. (Retention of a 6-inch pipe through the levee, 6.5 feet below the crown, a pump and a gate valve in a pump house on the WS slope, and a siphon breaker and a service pole on the LS slope authorized under Automatic Board Order (ABO) issued as Permit No. 11197, 1975 - Richard T. and Mary B. Souza). [Additional Reference(s): DWR Levee Log. USACE Sacramento O&M Manual 103, June 1954, (Station ""J"" 32+40), invert elevation 18.1 feet]. FS Date: 4/25/2013

WS- pipe and pump on steel pile structure. Steel walkway from pump house to the pump on steel structure.

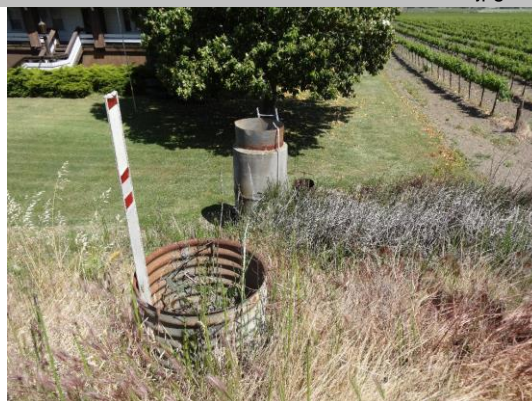
Photo 2 of 3 : UCIP_FA_2018_12543_20301.jpg

Comment Code						
Inspector Comment						
FS_ID:12543						
DS_ID:20864						
EP_NO: 11197						
Repair Type: Non-Urgent						
Crossing Status: Found						
UCIP Comments: Electric control panel in pump house.Needs cleaning of CMP riser on landside.						
FIELD_STRUCT_DESC: 6-inch steel irrigation discharge pipe through the levee, 6.5 feet below the crown. Slant pump on a steel pile structure in the river. Walkway to the pump. Gate valve in a pump house on the waterside (WS) slope. Siphon breaker and service poles on the landside (LS) slope. Concrete standpipe on the LS. (Retention of a 6-inch pipe through the levee, 6.5 feet below the crown, a pump and a gate valve in a pump house on the WS slope, and a siphon breaker and a service pole on the LS slope authorized under Automatic Board Order (ABO) issued as Permit No. 11197, 1975 - Richard T. and Mary B. Souza). [Additional Reference(s): DWR Levee Log. USACE Sacramento O&M Manual 103, June 1954, (Station ""J"" 32+40), invert elevation 18.1 feet].

LS- siphon breaker in CMP riser and concrete standpipe behind CMP riser.

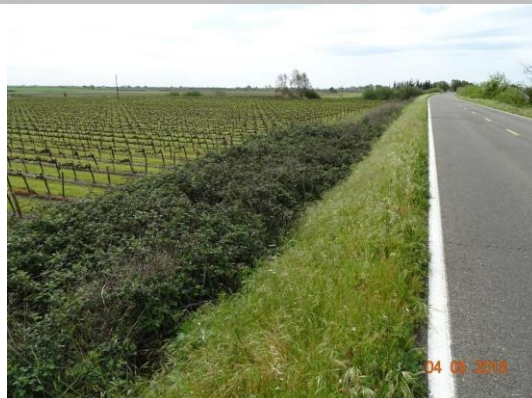
Photo 1 of 1 : FA_2018_RD0556_19_52_20180925_00016.jpg

LM Start	4.01	Rating **	U	Issue No.	52
LM End	4.38	Issue Type +	Ma	Location *	LS
Category	Earthen Levee			GPS Latitude/Longitude	
				Start	End
Item	Vegetation			38.212662 °	38.207293 °
				-121.556808 °	-121.556837 °
DWR ID	DWR_RD0556_02_s_2018_52				
Comment Code					
V2 : Remove the wild growth other than native grasses from the levee slopes.					
Inspector Comment					
Remove berry vines to allow inspection and access.

Berry vines on landside should be removed to allow inspection and access.

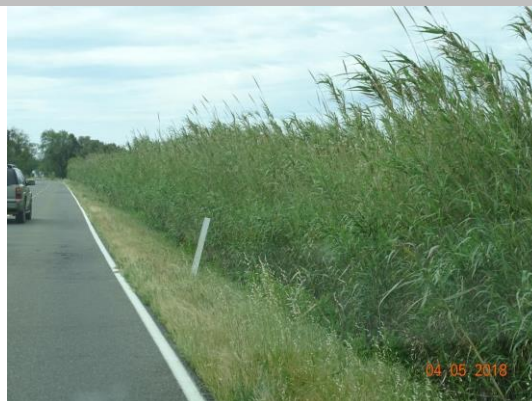
Photo 1 of 1 : FA_2018_RD0556_19_53_20180925_00017.jpg

LM Start	4.15	Rating **	U	Issue No.	53
LM End	4.33	Issue Type +	Ma	Location *	WS
Category	Earthen Levee			GPS Latitude/Longitude	
				Start	End
Item	Vegetation			38.210682 °	38.208001 °
				-121.556779 °	-121.556839 °
DWR ID	DWR_RD0556_02_s_2018_53				
Comment Code					
V2 : Remove the wild growth other than native grasses from the levee slopes.					
Inspector Comment					
Remove arundo.

Waterside arundo should be removed.

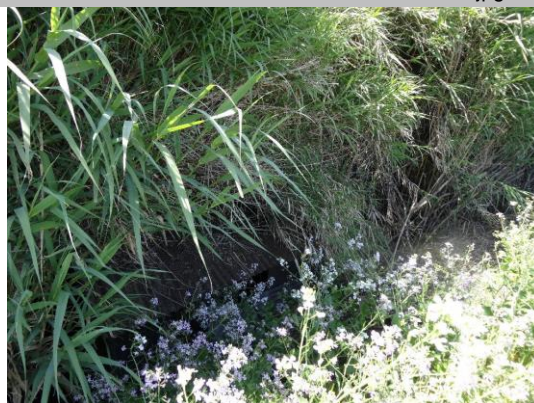
Photo 1 of 3 : UCIP_FA_2018_12545_20310.jpg

Comment Code					
Inspector Comment					
FS_ID:12545 DS_ID:20865 EP_NO: 11194 Repair Type: Non-Urgent Crossing Status: Found UCIP Comments: - CMP riser found abandoned on LS slope. Due to dense vegetation siphon breaker could not be found.- Dense vegetation on both sides of the levee.- Oil leaks from pump set. FIELD_STRUCT_DESC: 8-inch steel irrigation discharge pipe through the levee, 6.7 feet below the crown. Pump and gate valve in a pump house on the waterside (WS) slope. Siphon breaker on the landside (LS) slope. (Retention of an 8-inch pipe through the levee, 6.7 feet below the crown, a pump and a gate valve in a pump house on the WS slope, and a siphon breaker on the LS slope authorized under Automatic Board Order (ABO) issued as Permit No. 11194, 1975 - Gerald E. and William M. Robinson, et al.). [Additional Reference(s): DWR Levee Log. USACE Sacramento O&M Manual 103, June 1954, (Station ""J"" 18+20), invert elevation 18 feet]. FS Date: 4/25/2013

WS- pump house not visible due to the dense vegetation.

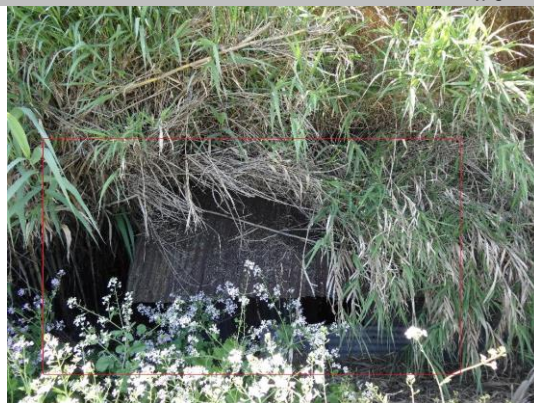
Photo 2 of 3 : UCIP_FA_2018_12545_20309.jpg

WS- pump house inside the dense vegetation.

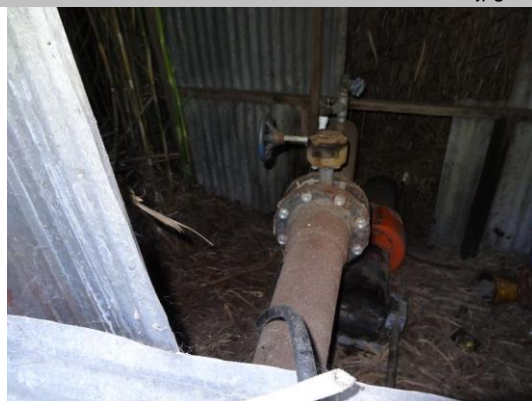
Photo 3 of 3 : UCIP_FA_2018_12545_20308.jpg

Comment Code						
Inspector Comment						
FS_ID:12545 DS_ID:20865 EP_NO: 11194 Repair Type: Non-Urgent Crossing Status: Found UCIP Comments: - CMP riser found abandoned on LS slope. Due to dense vegetation siphon breaker could not be found.- Dense vegetation on both sides of the levee.- Oil leaks from pump set. FIELD_STRUCT_DESC: 8-inch steel irrigation discharge pipe through the levee, 6.7 feet below the crown. Pump and gate valve in a pump house on the waterside (WS) slope. Siphon breaker on the landside (LS) slope. (Retention of an 8-inch pipe through the levee, 6.7 feet below the crown, a pump and a gate valve in a pump house on the WS slope, and a siphon breaker on the LS slope authorized under Automatic Board Order (ABO) issued as Permit No. 11194, 1975 - Gerald E. and William M. Robinson, et al.). [Additional Reference(s): DWR Levee Log. USACE Sacramento O&M Manual 103, June 1954, (Station ""J"" 18+20), invert elevation 18 feet]. FS Date: 4/25/2013

WS- pump, gate valve and pipe in pump house.

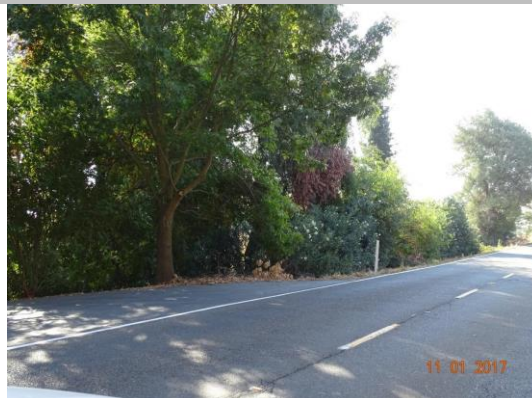
Photo 1 of 1 : FA_2018_RD0556_19_36_20180925_00012.jpg

LM Start	4.41	Rating **	M	Issue No.	36
LM End	4.41	Issue Type +	En	Location *	LS
Category	Earthen Levee			GPS Latitude/Longitude	
				Start	End
Item	Vegetation			38.206915 °	38.206915 °
				-121.556818 °	-121.556818 °
DWR ID	DWR_RD0556_02_f_2017_36				
Comment Code					
V6 : Landscaping					
Inspector Comment

Oleanders, trees and other landscaping should be trimmed to allow inspection and access to landside slope and toe.

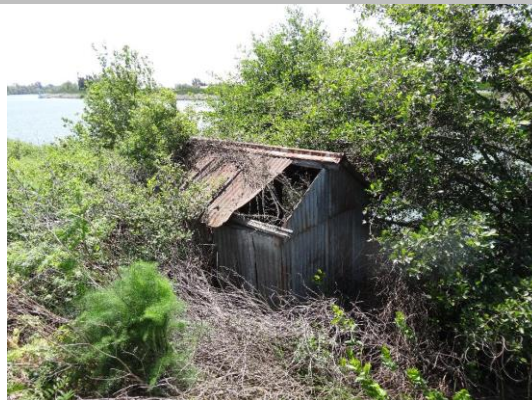
Photo 1 of 3 : UCIP_FA_2018_12546_20314.jpg

Comment Code					
Inspector Comment					
FS_ID:12546 DS_ID:20866 EP_NO: 11940 Repair Type: Non-Urgent Crossing Status: Found UCIP Comments: - Abandoned crossing.- Siphon breaker on LS not found due to dense vegetation, - An abandoned CMP riser and service pole found on LS.- It may need to be properly abandoned. FIELD_STRUCT_DESC: *ABANDONED* 6-inch steel irrigation discharge pipe through the levee, 6.7 feet below the crown. Pump and gate valve in a pump house on the waterside (WS) slope. Siphon breaker and service pole on the landside (LS) slope. (Retention of a 6-inch pipe through the levee, 6.5 feet below the crown, a pump and a gate valve in a pump house on the WS slope, and a siphon breaker and a service pole on the LS slope authorized under Automatic Board Order (ABO) issued as Permit No. 11194, 1975 - Gerald E. and William M. Robinson, et al.). [Additional Reference(s): DWR Levee Log. USACE Sacramento O&M Manual 103, June 1954, (Station ""J"" 2+73), invert elevation 18 feet]. FS Date: 4/25/2013

WS- abandoned pump house on levee slope. Dense vegetation on levee slope.

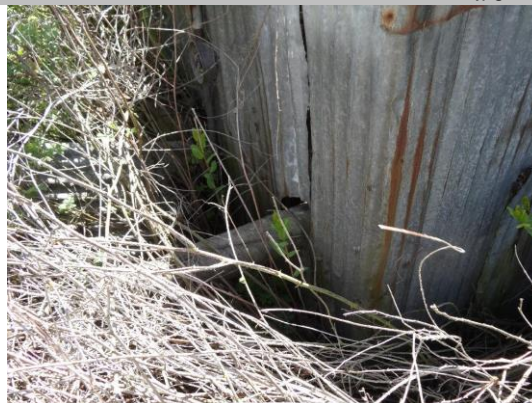
Photo 2 of 3 : UCIP_FA_2018_12546_20313.jpg

WS- pipe daylight from levee slope to pump house.

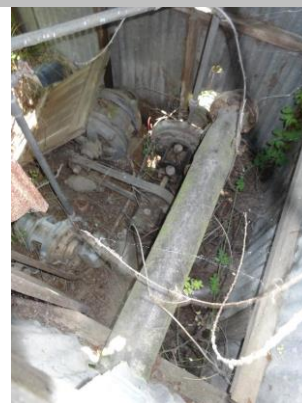
Photo 3 of 3 : UCIP_FA_2018_12546_20315.jpg

Comment Code						
Inspector Comment						
FS_ID:12546 DS_ID:20866 EP_NO: 11940 Repair Type: Non-Urgent Crossing Status: Found UCIP Comments: - Abandoned crossing.- Siphon breaker on LS not found due to dense vegetation, - An abandoned CMP riser and service pole found on LS.- It may need to be properly abandoned. FIELD_STRUCT_DESC: *ABANDONED* 6-inch steel irrigation discharge pipe through the levee, 6.7 feet below the crown. Pump and gate valve in a pump house on the waterside (WS) slope. Siphon breaker and service pole on the landside (LS) slope. (Retention of a 6-inch pipe through the levee, 6.5 feet below the crown, a pump and a gate valve in a pump house on the WS slope, and a siphon breaker and a service pole on the LS slope authorized under Automatic Board Order (ABO) issued as Permit No. 11194, 1975 - Gerald E. and William M. Robinson, et al.). [Additional Reference(s): DWR Levee Log. USACE Sacramento O&M Manual 103, June 1954, (Station ""J"" 2+73), invert elevation 18 feet]. FS Date: 4/25/2013

WS- abandoned gate valve, pump, and pipe in pump house

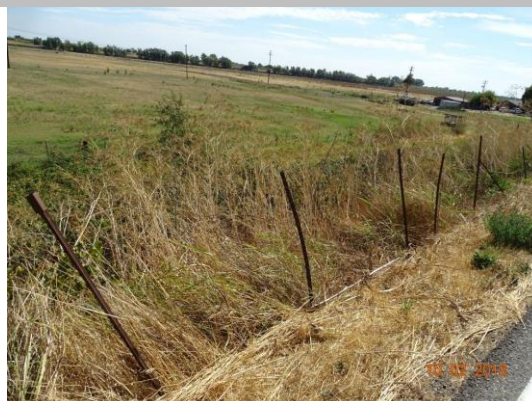
Photo 1 of 1 : FA_2018_RD0556_19_38_20181003_00073.jpg

LM Start	4.63	Rating **	M	Issue No.	38
LM End	4.84	Issue Type +	En	Location *	LS
Category	Earthen Levee			GPS Latitude/Longitude	
				Start	End
Item	Encroachments			38.203693 °	38.200593 °
				-121.556683 °	-121.557208 °
DWR ID	DWR_RD0556_02_s_2012_38				
Comment Code					
FE : Fence					
Inspector Comment					
Remove this old fence from the levee section landside.

View of old fence posts on land side slope (October 2018).

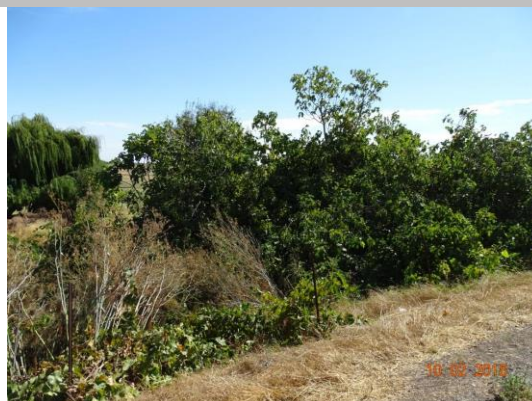
Photo 1 of 1 : FA_2018_RD0556_19_58_20181003_00072.jpg

LM Start	4.64	Rating **	M	Issue No.	58
LM End	4.64	Issue Type +	En	Location *	LS
Category	Earthen Levee			GPS Latitude/Longitude	
				Start	End
Item	Vegetation			38.203480 °	38.203480 °
				-121.556824 °	-121.556824 °
DWR ID	DWR_RD0556_02_s_2018_58				
Comment Code					
V6 : Landscaping					
Inspector Comment					
Remove fig tree.

View of fig tree on land side slope (October 2018).

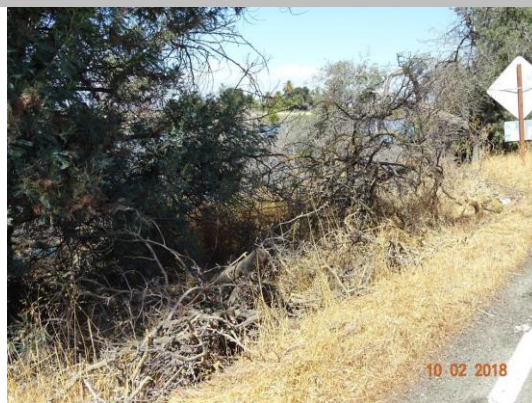
Photo 1 of 1 : FA_2018_RD0556_19_27_20181003_00068.jpg

LM Start	4.65	Rating **	M	Issue No.	27
LM End	4.65	Issue Type +	Ma	Location *	WS
Category	Earthen Levee			GPS Latitude/Longitude	
				Start	End
Item	Encroachments			38.203425 °	38.203425 °
				-121.556845 °	-121.556845 °
DWR ID	DWR_RD0556_02_s_2017_27				
Comment Code					
TR : Tree or limb					
Inspector Comment					
Remove fallen tree.

View of fallen tree on the water side slope (October 2018).

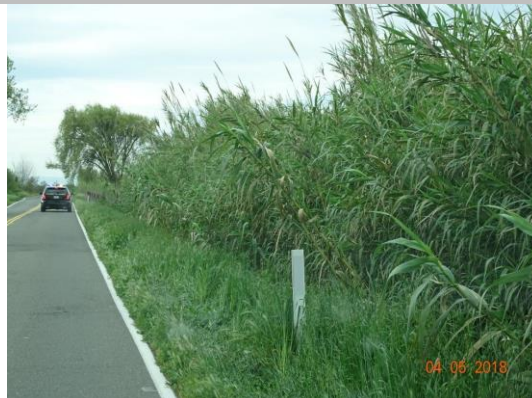
Photo 1 of 1 : FA_2018_RD0556_19_59_20180925_00020.jpg

LM Start	4.68	Rating **	U	Issue No.	59
LM End	4.72	Issue Type +	Ma	Location *	WS
Category	Earthen Levee			GPS Latitude/Longitude	
				Start	End
Item	Vegetation			38.202896 °	38.202429 °
				-121.556890 °	-121.556962 °
DWR ID	DWR_RD0556_02_s_2018_59				
Comment Code					
V2 : Remove the wild growth other than native grasses from the levee slopes.					
Inspector Comment					
Remove arundo.

Remove waterside arundo.

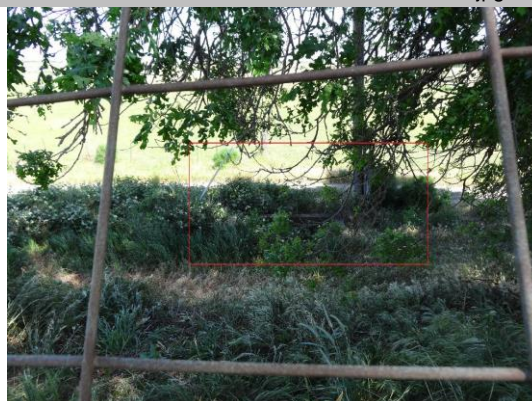
Photo 2 of 3 : UCIP_FA_2018_12547_20319.jpg

Comment Code						
Inspector Comment						
FS_ID:12547 DS_ID:20867 EP_NO: 11199 Repair Type: Non-Urgent Crossing Status: Indicator Found UCIP Comments: - pump, gate valve and pumphouse not found on waterward slope.- an abandoned electric control panel found on WS.- may need to be properly abandoned. FIELD_STRUCT_DESC: 6-inch steel irrigation discharge pipe through the levee, 6.5 feet below the crown. Siphon and concrete spill box with two 8-inch openings. (Retention of a 6-inch pipe through the levee, 6.5 feet below the crown, a pump and a gate valve in a pump house on the waterside [WS] slope, and a siphon breaker and a service pole on the landside [LS] slope authorized under Automatic Board Order (ABO) issued as Permit No. 11199, 1975 - Toshi Tokuyoshi, et al.). [Additional Reference(s): DWR Levee Log. USACE Sacramento O&M Manual 103, June 1954, (Station ""H"" 159+97), invert elevation 17.9 feet]. FS Date: 4/25/2013

LS- concrete distribution box near levee toe.

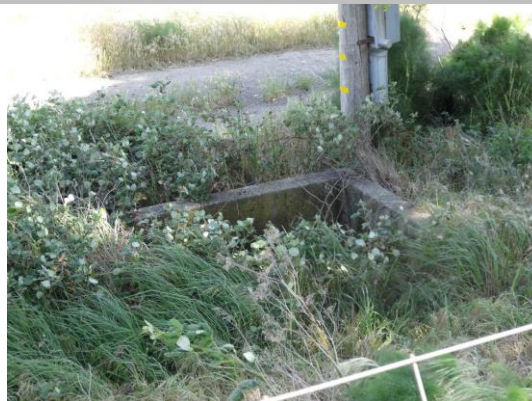
Photo 3 of 3 : UCIP_FA_2018_12547_20318.jpg

LS- power pole and a concrete distribution box near levee toe.

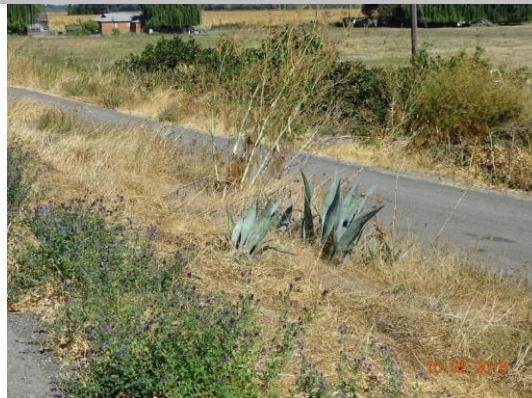
Photo 1 of 1 : FA_2018_RD0556_19_60_20181003_00070.jpg

LM Start	4.79	Rating **	M	Issue No.	60
LM End	4.79	Issue Type +	En	Location *	LS
Category	Earthen Levee			GPS Latitude/Longitude	
				Start	End
Item	Vegetation			38.201402°	38.201402°
				-121.557108°	-121.557108°
DWR ID	DWR_RD0556_02_s_2018_60				
Comment Code					
V6 : Landscaping					
Inspector Comment					
Remove cactus before more become established.

View of cactus on the land side slope (October 2018).

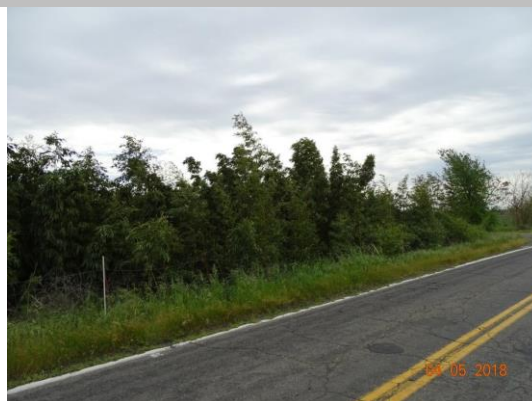
Photo 1 of 1 : FA_2018_RD0556_19_61_20180925_00021.jpg

LM Start	4.82	Rating **	U	Issue No.	61
LM End	4.82	Issue Type +	En	Location *	LS
Category	Earthen Levee			GPS Latitude/Longitude	
				Start	End
Item	Vegetation			38.201002°	38.201002°
				-121.557170°	-121.557170°
DWR ID	DWR_RD0556_02_s_2018_61				
Comment Code					
V6 : Landscaping					
Inspector Comment					
Remove bamboo.

Landside bamboo should be removed to allow inspection and access.

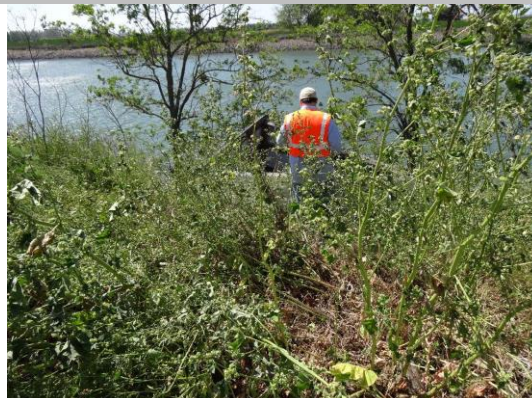
Photo 1 of 3 : UCIP_FA_2018_12564_20347.jpg

Comment Code						
Inspector Comment						
FS_ID:12564 DS_ID:20868 EP_NO: 11191 Repair Type: Non-Urgent Crossing Status: Found UCIP Comments: - needs to fix CMP riser. FIELD_STRUCT_DESC: 8-inch irrigation discharge pipe of an unknown material through the levee, 5.7 feet below the crown. Pump on the waterside (WS) slope. Gate valve on the WS berm. Siphon breaker and service pole on the landside (LS) slope. (Retention of an 8-inch pipe through the levee, 5.7 feet below the crown, a pump on the WS slope, a gate valve on the WS berm, and a siphon breaker and a service pole on the LS slope authorized under Automatic Board Order (ABO) issued as Permit No. 11191, 1975 - Pacific Fruit Exchange). [Additional Reference(s): DWR Levee Log]. FS Date: 4/25/2013

WS- pump house on levee slope.

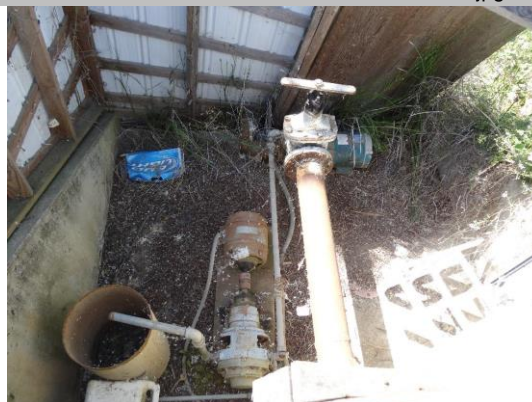
Photo 2 of 3 : UCIP_FA_2018_12564_20346.jpg

WS- pump, pipe and gate valve in pump house.

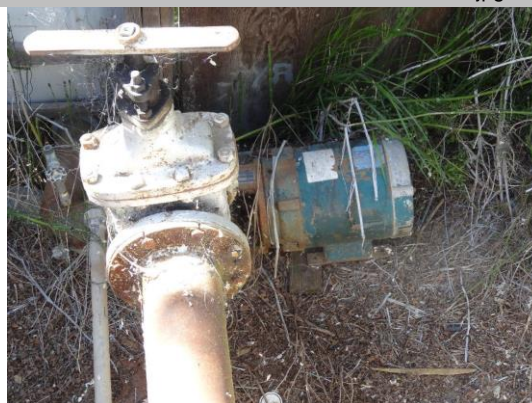
Photo 3 of 3 : UCIP_FA_2018_12564_20351.jpg

Comment Code						
Inspector Comment						
FS_ID:12564 DS_ID:20868 EP_NO: 11191 Repair Type: Non-Urgent Crossing Status: Found UCIP Comments: - needs to fix CMP riser. FIELD_STRUCT_DESC: 8-inch irrigation discharge pipe of an unknown material through the levee, 5.7 feet below the crown. Pump on the waterside (WS) slope. Gate valve on the WS berm. Siphon breaker and service pole on the landside (LS) slope. (Retention of an 8-inch pipe through the levee, 5.7 feet below the crown, a pump on the WS slope, a gate valve on the WS berm, and a siphon breaker and a service pole on the LS slope authorized under Automatic Board Order (ABO) issued as Permit No. 11191, 1975 - Pacific Fruit Exchange). [Additional Reference(s): DWR Levee Log]. FS Date: 4/25/2013

WS- closer look at pump, pipe and gate valve in pump house.

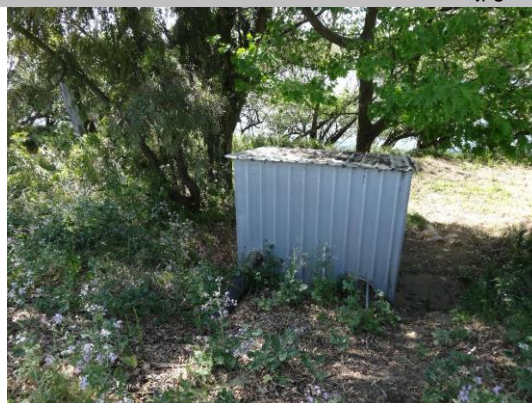
Photo 1 of 3 : UCIP_FA_2018_52733_20364.jpg

Comment Code					
Inspector Comment					
FS_ID:52733 DS_ID:20869 EP_NO: 11185 Repair Type: Urgent Crossing Status: Found UCIP Comments: 07/12/2018 Pit on WS is covered with plywood. Water pump is running, no leaks detected. LS part of crossing was reconstructed. New pipe was installed after CMP riser to supply water to sand filters. Remains Urgent due to large pit on WS that needs to be backfilled. (O.Yakimov-DWR UCIP)04/25/2013 Large pit on levee berm. FIELD_STRUCT_DESC: 8-inch irrigation discharge pipe of an unknown material through the levee, 5.7 feet below the crown. Pump and gate valve in a pump house on the waterside (WS) slope. Siphon breaker, concrete box, and service pole on the landside (LS) slope. (Retention of an 8-inch pipe through the levee, 5.7 feet below the crown, a pump and a gate valve in a pump house on the WS slope, and a siphon breaker and a service pole on the LS slope authorized under Automatic Board Order (ABO) issued as Permit No. 11185, 1975 - R. Walter Langhart). [Additional Reference(s): DWR Levee Log]. FS Date: 7/13/2018

WS- pump house on levee slope

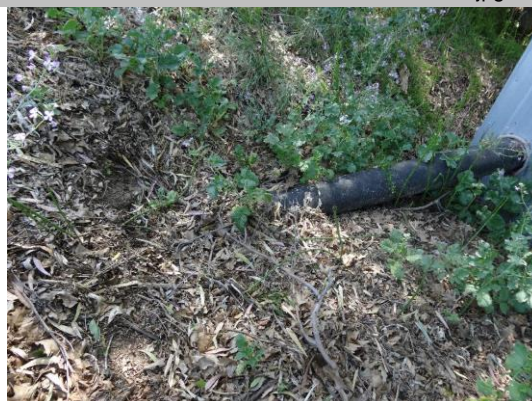
Photo 2 of 3 : UCIP_FA_2018_52733_20363.jpg

Comment Code						
Inspector Comment						
FS_ID:52733						
DS_ID:20869						
EP_NO: 11185						
Repair Type: Urgent						
Crossing Status: Found						
UCIP Comments: 07/12/2018 Pit on WS is covered with plywood.						
Water pump is running, no leaks detected. LS part of crossing was reconstructed. New pipe was installed after CMP riser to supply water to sand filters. Remains Urgent due to large pit on WS that needs to be backfilled. (O.Yakimov-DWR UCIP)04/25/2013 Large pit on levee berm.						
FIELD_STRUCT_DESC: 8-inch irrigation discharge pipe of an unknown material through the levee, 5.7 feet below the crown. Pump and gate valve in a pump house on the waterside (WS) slope. Siphon breaker, concrete box, and service pole on the landside (LS) slope. (Retention of an 8-inch pipe through the levee, 5.7 feet below the crown, a pump and a gate valve in a pump house on the WS slope, and a siphon breaker and a service pole on the LS slope authorized under Automatic Board Order (ABO) issued as Permit No. 11185, 1975 - R. Walter Langhart).

WS- pipe daylight from the levee.

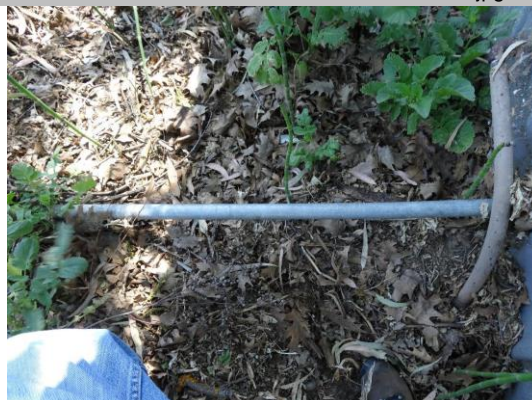
Photo 3 of 3 : UCIP_FA_2018_52733_20366.jpg

WS- electric conduit daylight near pump house.

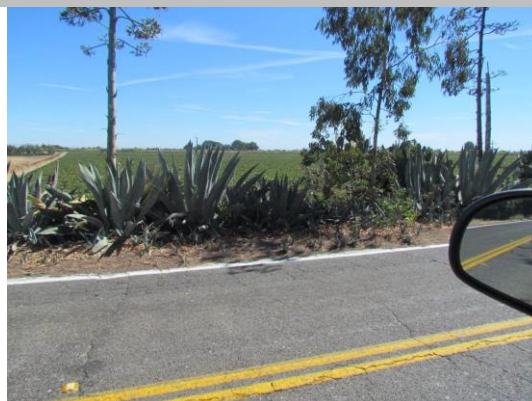
Photo 1 of 1 : FA_2018_RD0556_19_31_20180925_00007.jpg

LM Start	5.40	Rating **	M	Issue No.	31
LM End	5.44	Issue Type +	En	Location *	LS
Category	Earthen Levee			GPS Latitude/Longitude	
				Start	End
Item	Vegetation			38.193760 °	38.193445 °
				-121.562458 °	-121.562895 °
DWR ID	DWR_RD0556_02_s_2012_31				
Comment Code					
V6 : Landscaping					
Inspector Comment					
Control the wild growth within the landscaping. This choice of plant has taken over the levee slope and shoulder making it imposible to view the slope and ground.

RD 556 Unit 2 levee mile 5.40-5.44 landside levee shoulder and slope looking downstream.
