**Flood Control Project Maintenance
Levee Inspections**

Fall 2019 Levee Maintenance Deficiency Summary Report

Sacramento River Basin

Reclamation District No. 0556 Upper Andrus

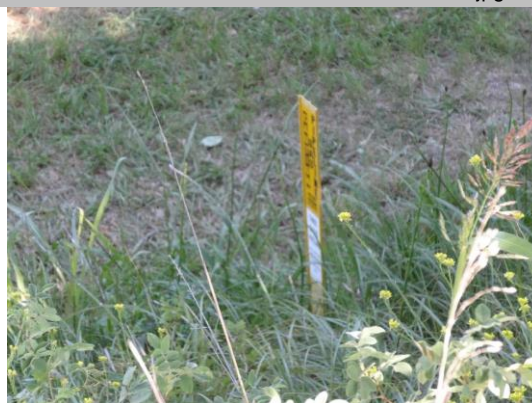
Photo 1 of 3 : UCIP_FA_2019_45564_74151.jpg

Gasline marker present on LS.

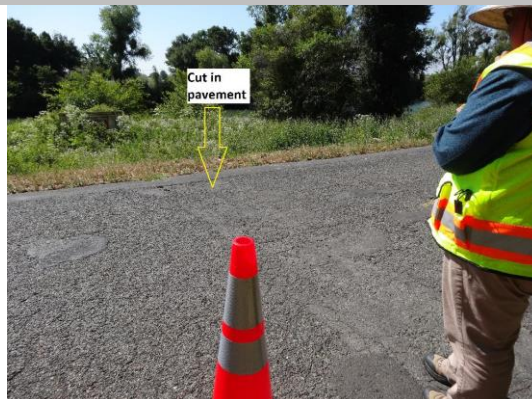
Photo 2 of 3 : UCIP_FA_2019_45564_74146.jpg

View of WS; cut in pavement in alignment with arrow and Olivia indicating location of crossing trench.

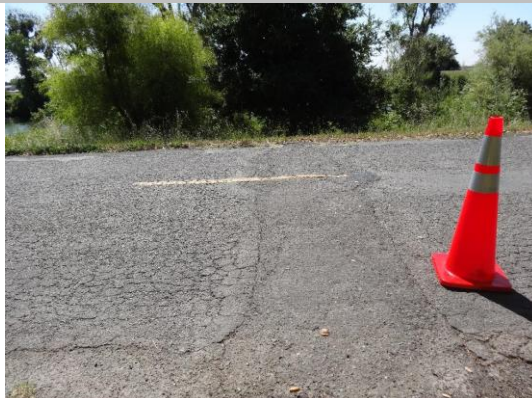
Photo 2 of 3 : UCIP_FA_2019_45664_74191.jpg

View of WS with cuts visible on pavement.

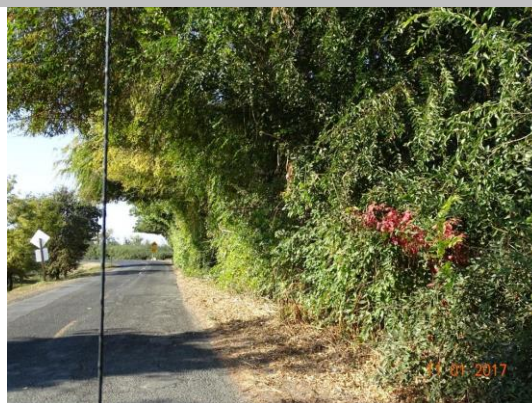
Photo 1 of 1 : FA_2019_RD0556_18_24_20190826_00006.jpg

LM Start	0.87	Rating **	U	Issue No.	24
LM End	0.87	Issue Type +	En	Location *	LS
Category	Earthen Levee			GPS Latitude/Longitude	
				Start	End
Item	Vegetation			38.228820 °	38.228820 °
				-121.525853 °	-121.525853 °
DWR ID	DWR_RD0556_01_f_2017_24				
Comment Code					
V6 : Landscaping					
Inspector Comment

Trim/thin landscaping to allow inspection and access to levee slope and toe.

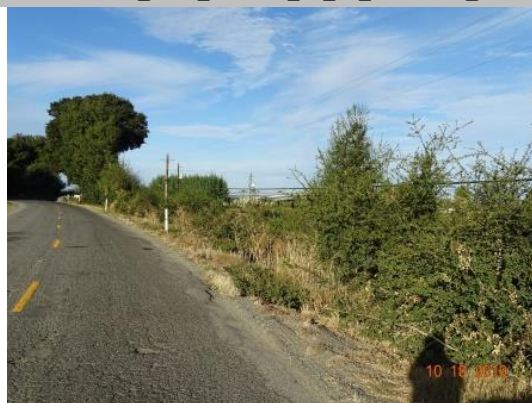
Photo 1 of 1 : FA 2019 RD0556 18 49 20191021 00064.jpg

View looking downstream at thick vegetation the landside slope (Fall 2019).

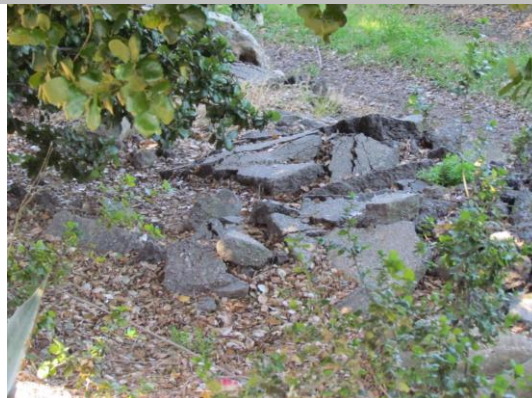
Photo 2 of 3 : FA_2019_RD0556_18_27_20190826_00010.jpg

View of concrete rubble on landside slope and toe.

LM Start	1.34	Rating **	U	Issue No.	27 (cont)	
LM End	1.37	Issue Type +	En	Location *	LS	
Category	Earthen Levee			GPS Latitude/Longitude		
				Start		End
Item	Encroachments			38.227521°		38.227320°
				-121.532393°		-121.532710°
DWR ID	DWR_RD0556_01_s_2013_27					
Comment Code						
DE : Debris						
Inspector Comment						
Remove the pile of asphalt and concrete from the toe of levee.

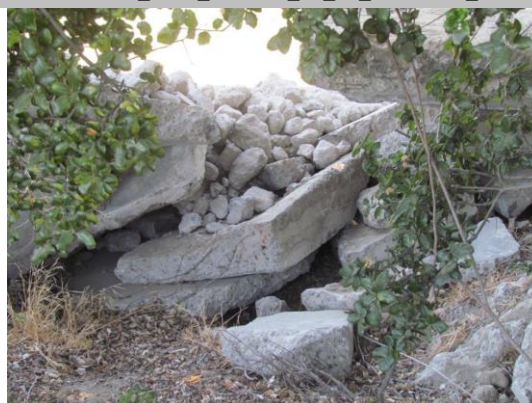
Photo 3 of 3 : FA_2019_RD0556_18_27_20190826_00011.jpg

View concrete rubble on landside slope.

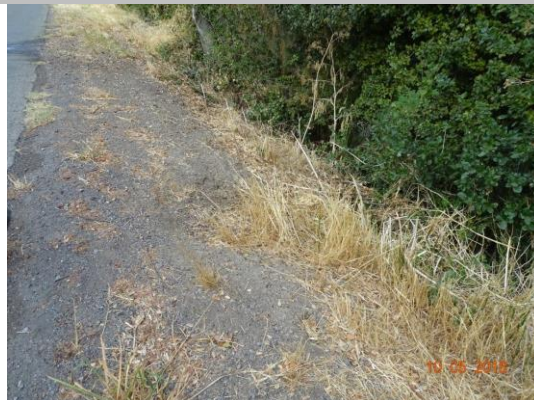
Photo 1 of 1 : FA_2019_RD0556_18_22_20190826_00003.jpg

LM Start	1.50	Rating **	M	Issue No.	22
LM End	1.50	Issue Type +	Ma	Location *	LS
Category	Earthen Levee			GPS Latitude/Longitude	
				Start	End
Item	Erosion / Bank Caving			38.225840 °	38.225840 °
				-121.534157 °	-121.534157 °
DWR ID	DWR_RD0556_01_s _ 2012_22				
Comment Code					
E1 : Note and monitor erosion site.					
Inspector Comment					
Dip at the top of the landside slope is greater than 3".

View of dip at the top of the landside slope (October 2018).

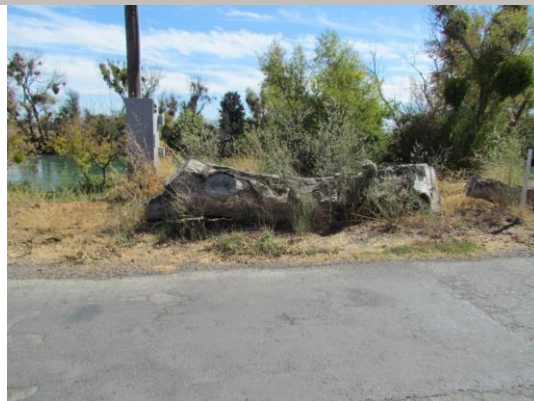
Photo 1 of 1 : FA_2019_RD0556_18_9_20190826_00001.jpg

LM Start	1.55	Rating **	A/W	Issue No.	9
LM End	1.57	Issue Type +	En	Location *	WS
Category	Earthen Levee			GPS Latitude/Longitude	
				Start	End
Item	Encroachments			38.225191 °	38.224976 °
				-121.534799 °	-121.535043 °
DWR ID	DWR_RD0556_01_s _ 2012_9				
Comment Code					
TR : Tree or limb					
Inspector Comment					
These cut up tree sections remain on the waterward slope to prevent parking in the area.

Cut tree sections on the waterside levee shoulder remain to prevent parking.

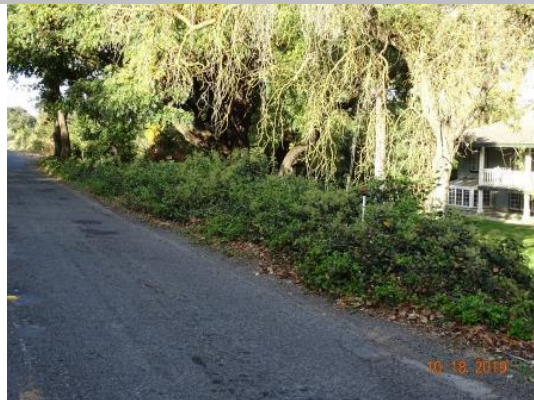
Photo 1 of 1 : FA_2019_RD0556_18_51_20191021_00065.jpg

LM Start	1.66	Rating **	U	Issue No.	51
LM End	1.69	Issue Type +	En	Location *	LS
Category	Earthen Levee			GPS Latitude/Longitude	
				Start	End
Item	Vegetation			38.224487 °	38.224355 °
				-121.536492 °	-121.537055 °
DWR ID	DWR_RD0556_01_f_2019_51				
Comment Code					
V6 : Landscaping					
Inspector Comment

View looking downstream at landscaping on the landside slope (Fall 2019).

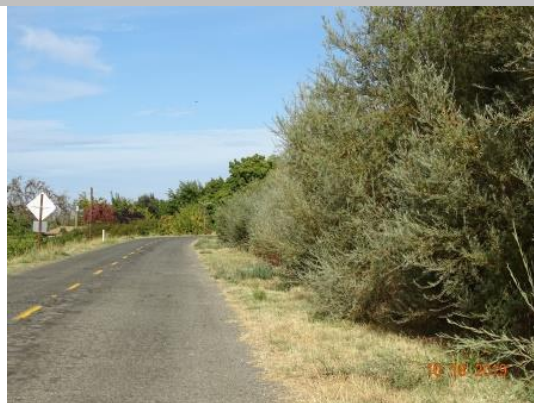
Photo 1 of 1 : FA_2019_RD0556_18_59_20191021_00077.jpg

LM Start	1.76	Rating **	U	Issue No.	59
LM End	2.50	Issue Type +	Ma	Location *	WS
Category	Earthen Levee			GPS Latitude/Longitude	
				Start	End
Item	Vegetation			38.224070 °	38.217322 °
				-121.538263 °	-121.543601 °
DWR ID	DWR_RD0556_01_f_2019_59				
Comment Code					
V2 : Remove the wild growth other than native grasses from the levee slopes.					
Inspector Comment

View looking upstream at thick vegetation on the waterside slope (Fall 2019).

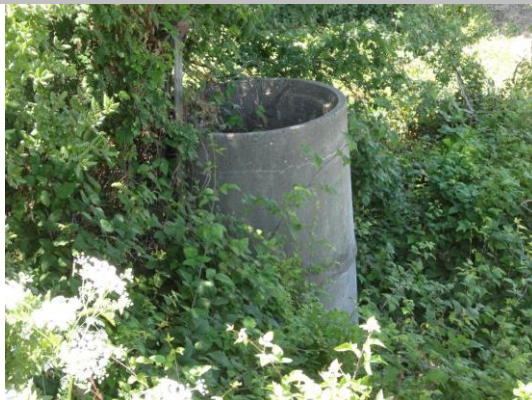
Photo 3 of 3 : UCIP_FA_2019_45764_74262.jpg

Standpipe on LS next to service pole.

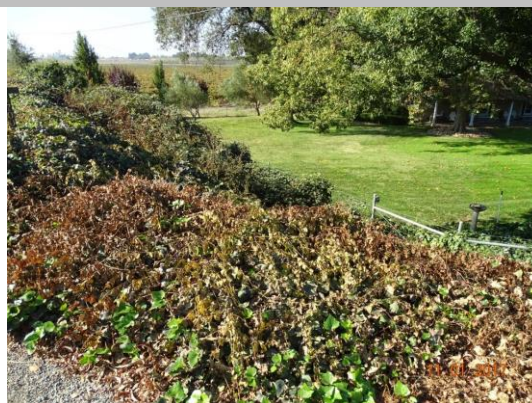
Photo 1 of 1 : FA_2019_RD0556_18_25_20190826_00007.jpg

Unpermitted fence covered in berry vines along landside levee toe should be moved back 10 feet to allow access.

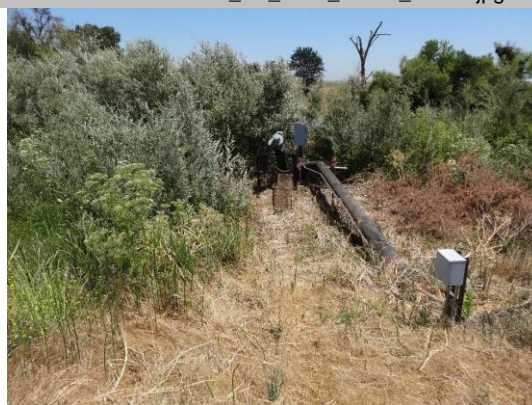
Photo 1 of 3 : UCIP_FA_2019_45786_74280.jpg

Comment Code						
Inspector Comment						
DS_ID:20830						
FS_ID:45786						
EP_NO: 2392						
Repair Type: Non-Urgent						
Crossing Status: Found						
UCIP Comments: Hole and exposed depression adjacent to pipe at LS.						
Dense vegetation on WS and LS limited visibility.						
FIELD_STRUCT_DESC: 12-inch steel irrigation discharge pipe through						
the levee, 3 feet below the crown. Slant pump on the waterside (WS)						
bank. 1-inch electrical conduit through the levee, beside the 12-inch						
pipe, visible on the WS. Service pole and two standpipes at the						
landside (LS) toe. One of the two standpipes is 6 inches. (Plans for the						
installation of a pumping plant and a steel pipe through the levee						
authorized under Permit No. 2392, 1956 - Loyal D. Mealer). [Additional						
Reference(s): DWR Levee Log].						
FS Date: 5/27/2015

WS view: Slant pump, 12-inch and 1-inch pipe through levee.

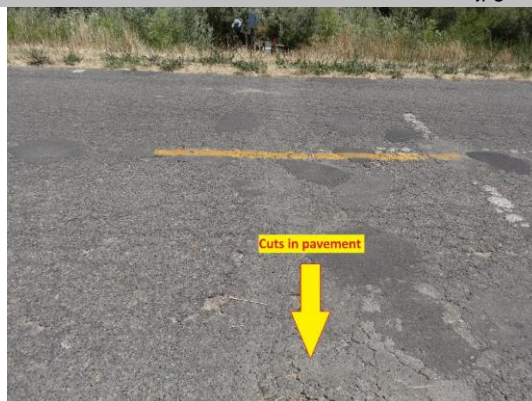
Photo 2 of 3 : UCIP_FA_2019_45786_74281.jpg

View toward WS with cuts in pavement in alignment with pipe on WS

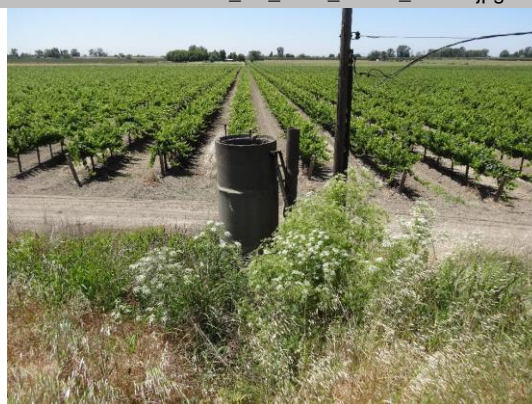
Photo 3 of 3 : UCIP_FA_2019_45786_74282.jpg

LS: 2 standpipes and service pole.

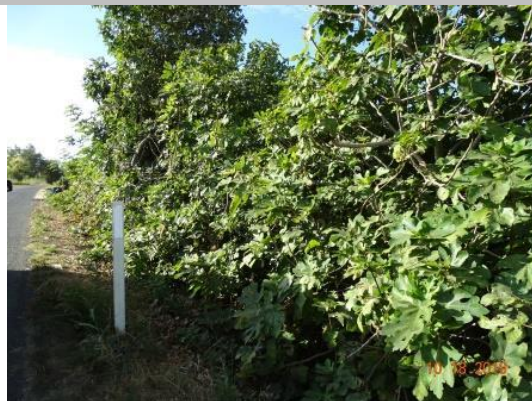
Photo 1 of 1 : FA_2019_RD0556_18_53_20191021_00066.jpg

LM Start	2.32	Rating **	U	Issue No.	53
LM End	2.32	Issue Type +	Ma	Location *	LS
Category	Earthen Levee			GPS Latitude/Longitude	
				Start	End
Item	Trim / Thin Trees			38.219813 °	38.219813 °
				-121.544032 °	-121.544032 °
DWR ID	DWR_RD0556_01_f_2019_53				
Comment Code					
T2 : Thin trees to allow visibility of the ground and room to flood fight.					
Inspector Comment

View looking downstream at fig tree on the landside slope (Fall 2019).

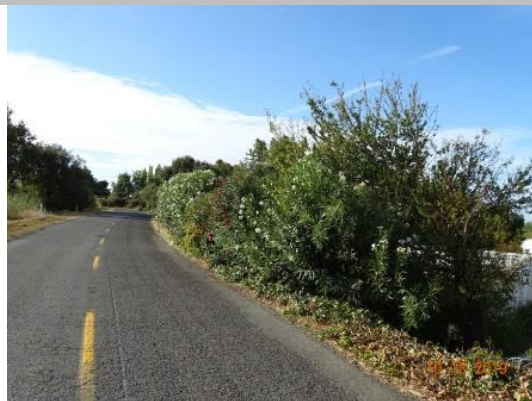
Photo 1 of 1 : FA_2019_RD0556_18_31_20191021_00067.jpg

LM Start	2.38	Rating **	U	Issue No.	31
LM End	2.43	Issue Type +	En	Location *	LS
Category	Earthen Levee			GPS Latitude/Longitude	
				Start	End
Item	Vegetation			38.219037 °	38.218342 °
				-121.543847 °	-121.543842 °
DWR ID	DWR_RD0556_01_s_2017_31				
Comment Code					
V6 : Landscaping					
Inspector Comment

View looking downstream at landscaping on the landside slope (Fall 2019).

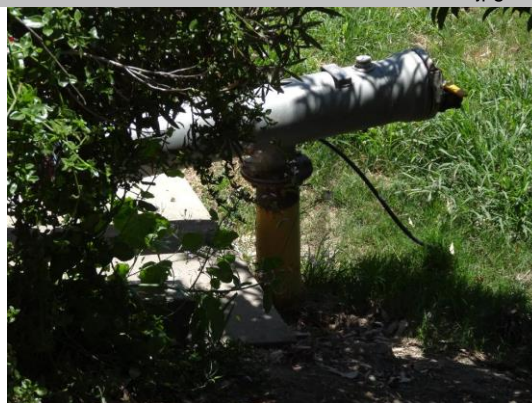
Photo 1 of 3 : UCIP_FA_2019_52734_74287.jpg

Closeup of 8-inch and 1.5-inch pipes and platform off LS toe.

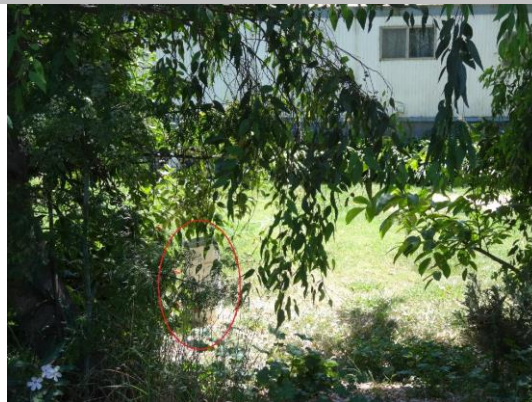
Photo 2 of 3 : UCIP_FA_2019_52734_74288.jpg

Concrete standpipe off LS toe.

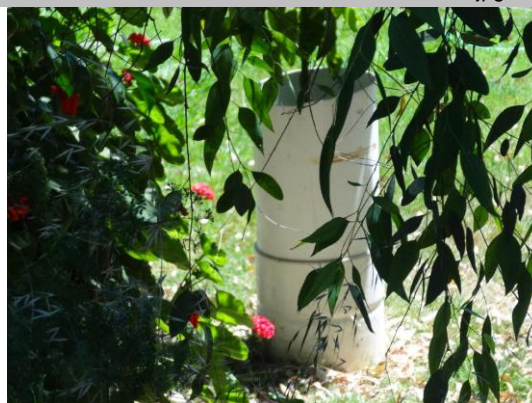
Photo 3 of 3 : UCIP_FA_2019_52734_74289.jpg

Comment Code						
Inspector Comment						
DS_ID:20831 FS_ID:52734 EP_NO: 11169 Repair Type: Non-Urgent Crossing Status: Found UCIP Comments: 07/12/2018 Hole near air vent on LS slope is still present but haven't increased in size. Pipe was running at the time of site visit, no leaks detected. Downgraded to "Non-Urgent" due to absence of levee threat. (O.Yakimov-DWR UCIP)05/27/2015 2'x2' hole on levee off LS shoulder. FIELD_STRUCT_DESC: 8-inch steel irrigation discharge pipe through the levee, 3.7 feet below the crown. 1-inch air valve. Pump and switch panel on the waterside (WS) berm. Service pole on the landside (LS). 9-foot by 3-foot concrete standpipe on the LS. 3 cables encased in a 1.5-inch steel conduit through the levee and on the WS, alongside the 8-inch pipe, disconnected on the WS. (Retention of an 8-inch pipe through the levee, 3.7 feet below the crown, a pump and a switch panel on the WS berm, and a service pole on the LS authorized under Automatic Board Order (ABO) issued as Permit No. 11169, 1975 - Darrell T. and B. M. Mealer). [Additional Reference(s): DWR Levee Log. USACE Sacramento O&M Manual 103, June 1954, (Station ""R"" 482+49.3), invert elevation 16 feet]. FS Date: 7/12/2018 1:51:13 PM

Closeup of concrete standpipe off LS toe.

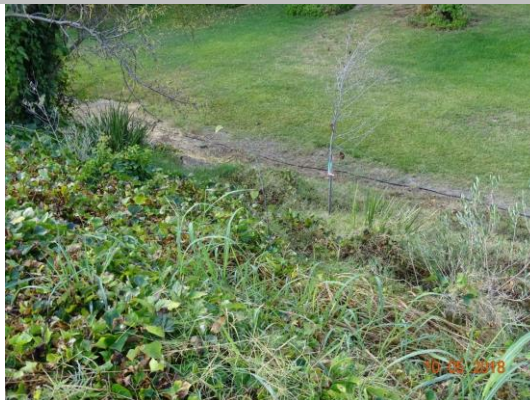
Photo 1 of 1 : FA_2019_RD0556_18_26_20190826_00008.jpg

Newly planted tree on the land side slope (October 2018).

LM Start	2.54	Rating **	M	Issue No.	26
LM End	2.54	Issue Type +	En	Location *	LS
Category	Earthen Levee			GPS Latitude/Longitude	
				Start	End
Item	Encroachments			38.216850 °	38.216850 °
				-121.543302 °	-121.543302 °
DWR ID	DWR_RD0556_01_f_2018_26				
Comment Code					
TR : Tree or limb					
Inspector Comment					
Remove new trees from levee slope.

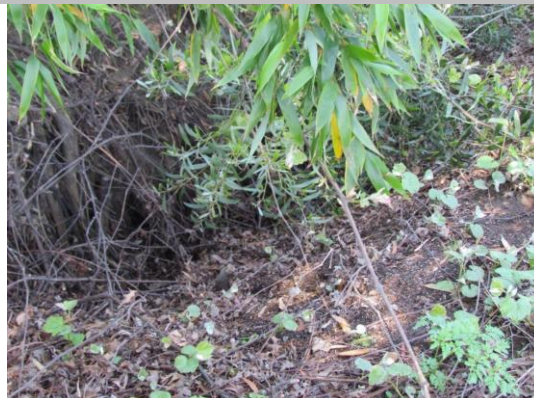
Photo 1 of 2 : FA_2019_RD0556_18_33_20190826_00017.jpg

View of fallen tree damage to shoulder and slope.

LM Start	2.72	Rating **	U	Issue No.	33
LM End	2.72	Issue Type +	Ma	Location *	LS
Category	Earthen Levee			GPS Latitude/Longitude	
				Start	End
Item	Slope Stability			38.215107°	38.215107°
				-121.540677°	-121.540677°
DWR ID	DWR_RD0556_01_s_2017_33				
Comment Code					
S1 : Repair slope instability.					
Inspector Comment					
Fallen tree on landside. Remove the fallen tree and repair the levee damage.

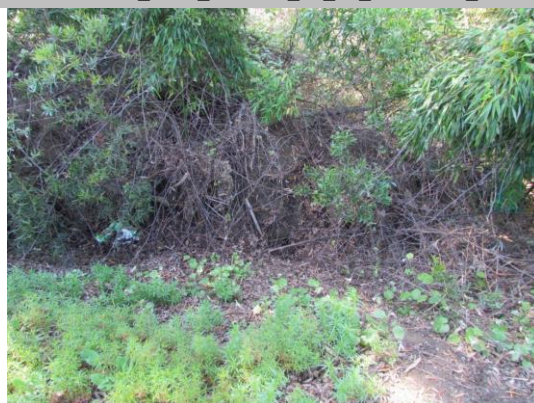
Photo 2 of 2 : FA_2019_RD0556_18_33_20190826_00018.jpg

View of the root ball of the fallen tree on slope landward.

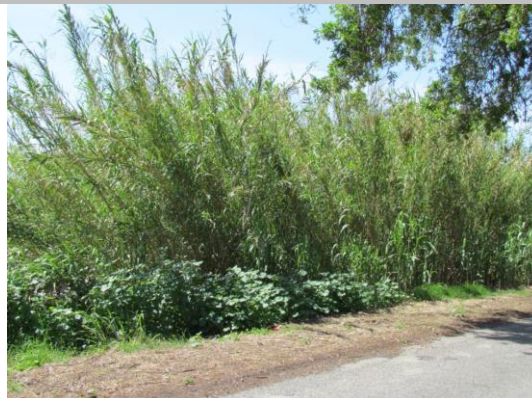
Photo 1 of 1 : FA_2019_RD0556_18_35_20190826_00020.jpg

LM Start	3.12	Rating **	U	Issue No.	35
LM End	3.14	Issue Type +	Ma	Location *	WS
Category	Earthen Levee			GPS Latitude/Longitude	
				Start	End
Item	Vegetation			38.211103°	38.210970°
				-121.537993°	-121.538370°
DWR ID	DWR_RD0556_01_s_2017_35				
Comment Code					
V2 : Remove the wild growth other than native grasses from the levee slopes.					
Inspector Comment					
Remove the arundo from the waterside slope.

View of arundo on waterside slope.

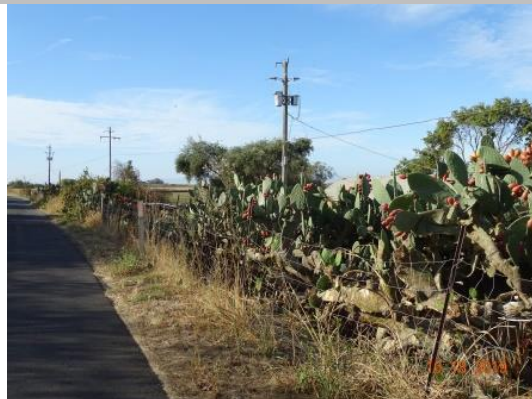
Photo 1 of 1 : FA_2019_RD0556_18_29_20191021_00071.jpg

LM Start	3.38	Rating **	U	Issue No.	29
LM End	3.42	Issue Type +	En	Location *	LS
Category	Earthen Levee			GPS Latitude/Longitude	
				Start	End
Item	Vegetation			38.208755 °	38.208191 °
				-121.541395 °	-121.541578 °
DWR ID	DWR_RD0556_01_f_2017_29				
Comment Code					
V6 : Landscaping					
Inspector Comment					
Large cactus growing on shoulder and slope should be removed to allow inspection and access.

View looking downstream at cactus on the landside slope (Fall 2019).

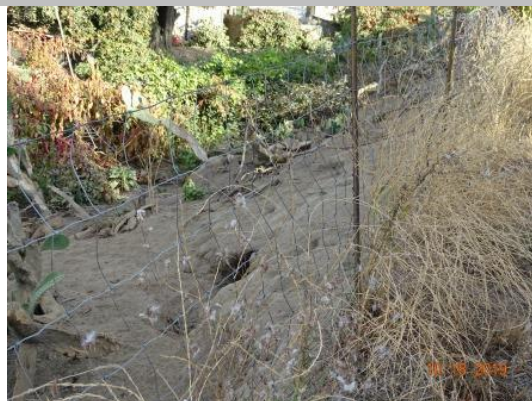
Photo 2 of 2 : FA_2019_RD0556_18_56_20191021_00073.jpg

LM Start	3.41	Rating **	U	Issue No.	56
LM End	3.41	Issue Type +	Ma	Location *	LS
Category	Earthen Levee			GPS Latitude/Longitude	
				Start	End
Item	Slope Stability			38.208210 °	38.208210 °
				-121.541588 °	-121.541588 °
DWR ID	DWR_RD0556_01_f_2019_56				
Comment Code					
S2 : Repair the levee slope damaged by foot traffic and prevent access where possible.					
Inspector Comment					
Slope worn down by goats

View looking upstream at levee terracing on the landside slope due to goats (Fall 2019).

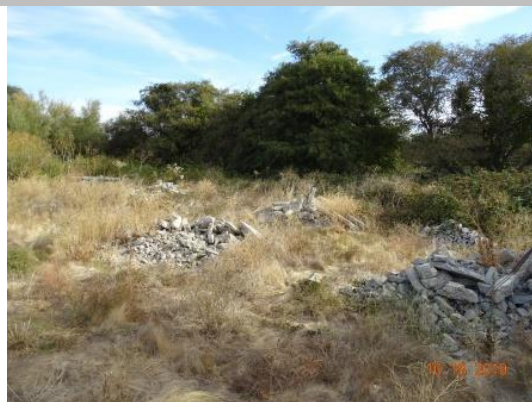
Photo 1 of 1 : FA_2019_RD0556_18_58_20191021_00075.jpg

LM Start	3.46	Rating **	U	Issue No.	58
LM End	3.46	Issue Type +	En	Location *	WS
Category	Earthen Levee			GPS Latitude/Longitude	
				Start	End
Item	Encroachments			38.207585 °	38.207585 °
				-121.541678 °	-121.541678 °
DWR ID	DWR_RD0556_01_f_2019_58				
Comment Code					
DE : Debris					
Inspector Comment					
Remove concrete debris piles

View of large concrete debris piles on the waterside shoulder. The waterside shoulder is much larger in this section. (Fall 2019).

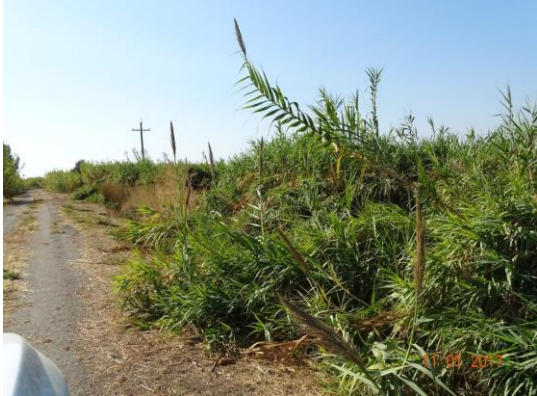
Photo 1 of 1 : FA_2019_RD0556_18_39_20190826_00023.jpg

View of dense growth of wild vegetation, berry vines and arundo on

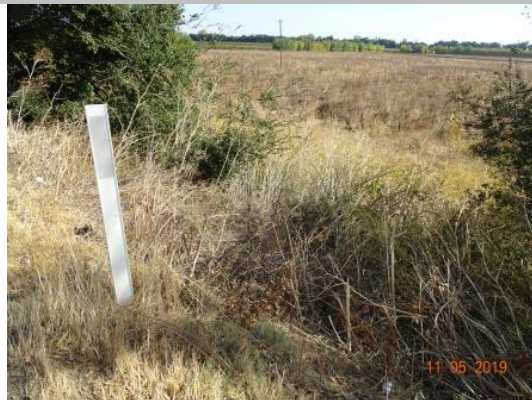
Photo 1 of 1 : FA_2019_RD0556_19_91_20191107_00102.jpg

LM Start	0.26	Rating **	U	Issue No.	91
LM End	0.43	Issue Type +	Ma	Location *	LS
Category	Earthen Levee			GPS Latitude/Longitude	
				Start	End
Item	Vegetation			38.238643 °	38.238147 °
				-121.522977 °	-121.526023 °
DWR ID	DWR_RD0556_02_f_2019_91				
Comment Code					
V1 : Control annual grass and weeds on the levee slopes and easements.					
Inspector Comment

View of thick vegetation on the landside slope (Fall 2019).

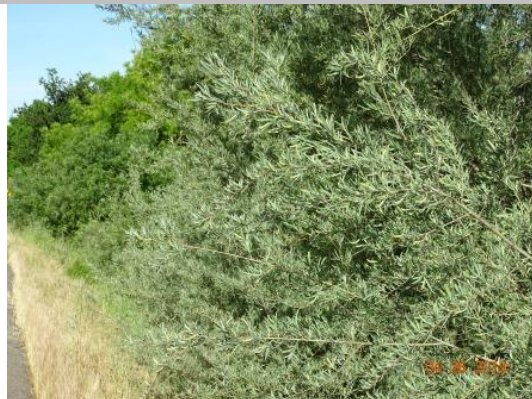
Photo 1 of 1 : FA_2019_RD0556_19_51_20190826_00030.jpg

LM Start	0.58	Rating **	U	Issue No.	51
LM End	1.49	Issue Type +	Ma	Location *	WS
Category	Earthen Levee			GPS Latitude/Longitude	
				Start	End
Item	Vegetation			38.237712 °	38.240240 °
				-121.528657 °	-121.545037 °
DWR ID	DWR_RD0556_02_f_2018_51				
Comment Code					
V2 : Remove the wild growth other than native grasses from the levee slopes.					
Inspector Comment					
Remove wildgrowth 20' down the waterside slope.

View looking downstream at wildgrowth on the waterside slope (Spring 2019).

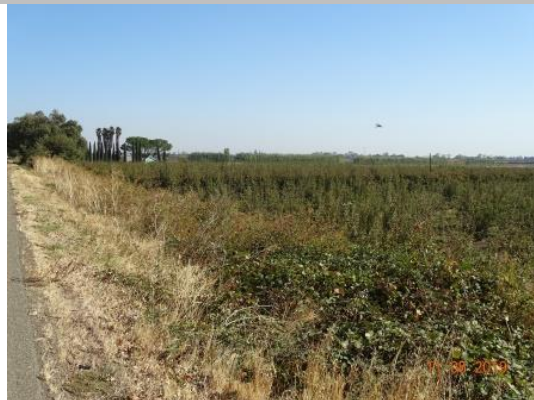
Photo 1 of 1 : FA_2019_RD0556_19_90_20191107_00101.jpg

LM Start	0.65	Rating **	U	Issue No.	90
LM End	1.75	Issue Type +	Ma	Location *	LS
Category	Earthen Levee			GPS Latitude/Longitude	
				Start	End
Item	Vegetation			38.237408 °	38.240955 °
				-121.530048 °	-121.549669 °
DWR ID	DWR_RD0556_02_f_2019_90				
Comment Code					
V2 : Remove the wild growth other than native grasses from the levee slopes.					
Inspector Comment					
Blackberries are on the landside slope.

View looking upstream at thick vegetation on the landside slope (Fall 2019).

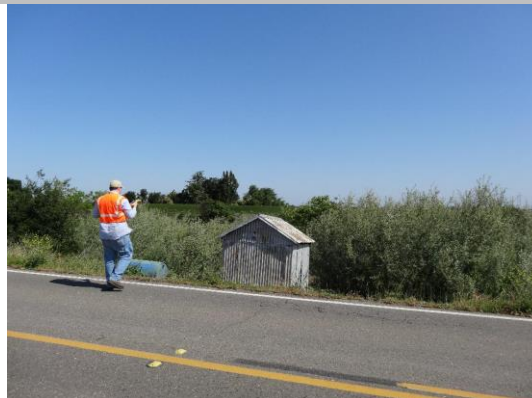
Photo 1 of 3 : UCIP_FA_2019_12512_20245.jpg

Comment Code					
Inspector Comment					
DS_ID:20851 FS_ID:12512 EP_NO: 11186 Repair Type: Non-Urgent Crossing Status: Found UCIP Comments: - a concrete box on LS- water is leaking from priming plastic tank and causing surface erosion on levee slope. FIELD_STRUCT_DESC: 4-inch steel irrigation discharge pipe through the levee, 4.3 feet below the crown. Pump and gate valve in a pump house on the waterside (WS) berm. Siphon breaker and service pole on the landside (LS) slope. Concrete spill box with three 8-inch openings. (Retention of a 4-inch pipe through the levee, 4.3 feet below the crown, a pump in a pump house on the WS berm, and a siphon breaker and a service pole on the LS slope authorized under Automatic Board Order (ABO) issued as Permit No. 11186, 1975 - Margaret M. Marks). [Additional Reference(s): DWR Levee Log. USACE Sacramento O&M Manual 103, June 1954, (Station ""J"" 192+00), 6-inch pipe referenced, invert elevation 18.8 feet]. FS Date: 4/25/2013

WS- pump house on levee berm

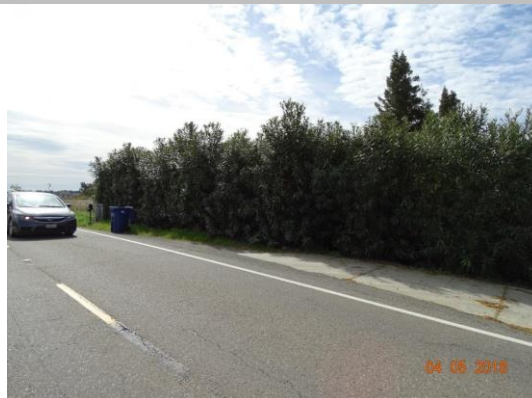
Photo 1 of 1 : FA_2019_RD0556_19_26_20190826_00011.jpg

LM Start	1.14	Rating **	U	Issue No.	26
LM End	1.14	Issue Type +	En	Location *	LS
Category	Earthen Levee			GPS Latitude/Longitude	
				Start	End
Item	Vegetation			38.239005 °	38.239005 °
				-121.538772 °	-121.538772 °
DWR ID	DWR_RD0556_02_f_2017_26				
Comment Code					
V6 : Landscaping					
Inspector Comment					
Trim/thin oleanders on the landside of the levee.

Manage oleanders to allow inspection and access.

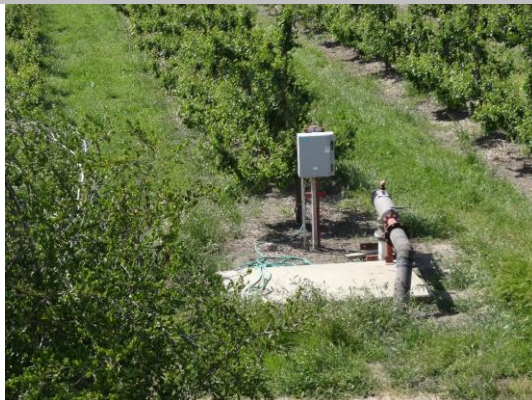
Photo 1 of 3 : UCIP_FA_2019_12573_20381.jpg

Comment Code					
Inspector Comment					
DS_ID:20852 FS_ID:12573 EP_NO: 11187 Repair Type: Non-Urgent Crossing Status: Found UCIP Comments: - gap between 6-inch pipe and 10-inch pipe needs to be sealed. FIELD_STRUCT_DESC: 6-inch steel irrigation discharge pipe sleeved through a 10-inch steel pipe through the levee, 4.8 feet below the crown. Pump on the riverbank. (Retention of a 10-inch pipe through the levee, 4.8 feet below the crown, a flap gate on the waterside (WS) end, landside (LS) end open, used to sleeve portable irrigation pipe, authorized under Automatic Board Order (ABO) issued as Permit No. 11187, 1975 - Ernest and Alvine Machado). [Additional Reference(s): DWR Levee Log]. FS Date: 4/25/2013

LS- 6-inch steel pipe on orchard.

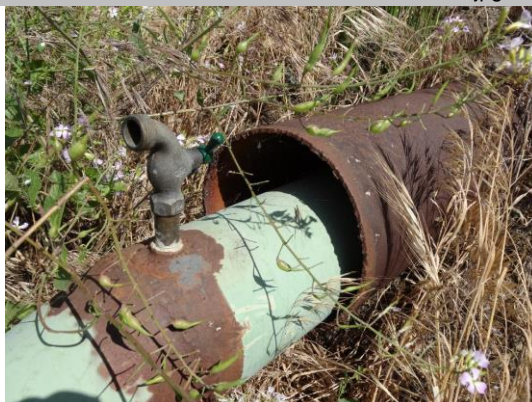
Photo 2 of 3 : UCIP_FA_2019_12573_20380.jpg

LS- 6-inch steel pipe sleeved through 10-inch steel pipe. 6" pipe is attached with air release valve.

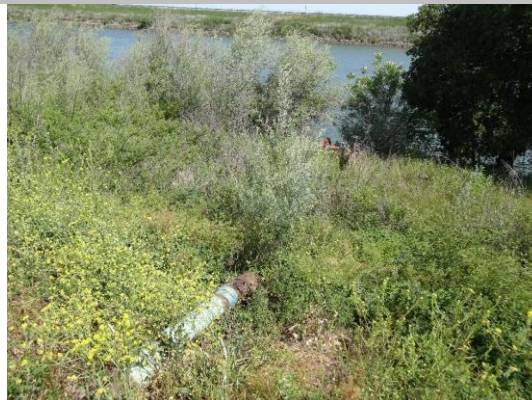
Photo 3 of 3 : UCIP_FA_2019_12573_20383.jpg

Comment Code						
Inspector Comment						
DS_ID:20852 FS_ID:12573 EP_NO: 11187 Repair Type: Non-Urgent Crossing Status: Found UCIP Comments: - gap between 6-inch pipe and 10-inch pipe needs to be sealed. FIELD_STRUCT_DESC: 6-inch steel irrigation discharge pipe sleeved through a 10-inch steel pipe through the levee, 4.8 feet below the crown. Pump on the riverbank. (Retention of a 10-inch pipe through the levee, 4.8 feet below the crown, a flap gate on the waterside (WS) end, landside (LS) end open, used to sleeve portable irrigation pipe, authorized under Automatic Board Order (ABO) issued as Permit No. 11187, 1975 - Ernest and Alvine Machado). [Additional Reference(s): DWR Levee Log]. FS Date: 4/25/2013

WS- 6-inch steel pipe on levee slope

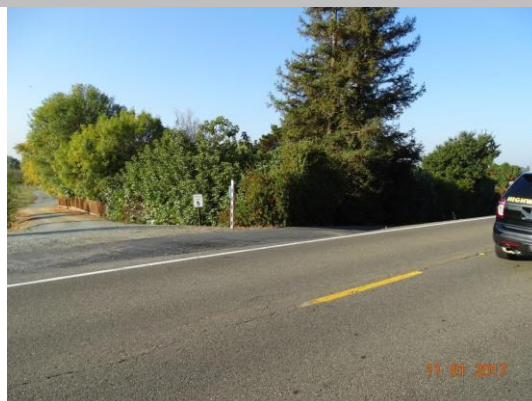
Photo 1 of 1 : FA_2019_RD0556_19_28_20190826_00013.jpg

LM Start	1.31	Rating **	U	Issue No.	28
LM End	1.31	Issue Type +	En	Location *	LS
Category	Earthen Levee			GPS Latitude/Longitude	
				Start	End
Item	Vegetation			38.239677 °	38.239677 °
				-121.541715 °	-121.541716 °
DWR ID	DWR_RD0556_02_f_2017_28				
Comment Code					
V6 : Landscaping					
Inspector Comment					
Trim/thin oleanders on the landside of the levee.

View of oleanders on the landside of the levee.

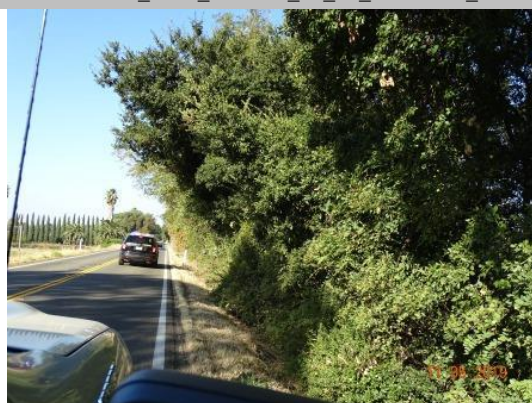
Photo 1 of 1 : FA_2019_RD0556_19_66_20191107_00083.jpg

LM Start	1.37	Rating **	U	Issue No.	66
LM End	1.43	Issue Type +	Ma	Location *	WS
Category	Earthen Levee			GPS Latitude/Longitude	
				Start	End
Item	Trim / Thin Trees			38.239888 °	38.240080 °
				-121.542833 °	-121.543942 °
DWR ID	DWR_RD0556_02_f_2019_66				
Comment Code					
T1 : Trim trees to at least five feet above ground level.					
Inspector Comment

View looking downstream at thick trees on the waterside slope (Fall 2019).

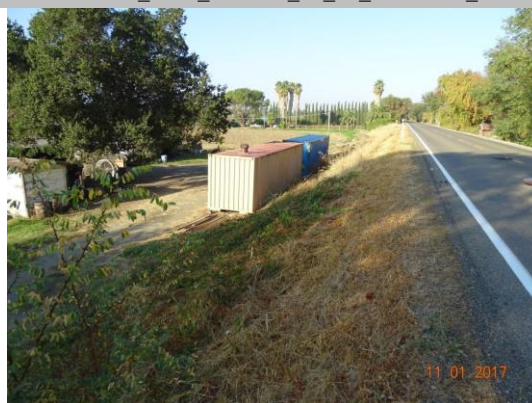
Photo 1 of 1 : FA_2019_RD0556_19_29_20190826_00014.jpg

LM Start	1.39	Rating **	U	Issue No.	29
LM End	1.39	Issue Type +	En	Location *	LS
Category	Earthen Levee			GPS Latitude/Longitude	
				Start	End
Item	Encroachments			38.239935 °	38.239935 °
				-121.543148 °	-121.543148 °
DWR ID	DWR_RD0556_02_f_2017_29				
Comment Code					
EQ : Equipment					
Inspector Comment					
Remove/relocate the two large sea-train shipping containers to at least 10 feet from the landside toe to allow inspection and access.

View of two large sea-train shipping containers at the landside toe.

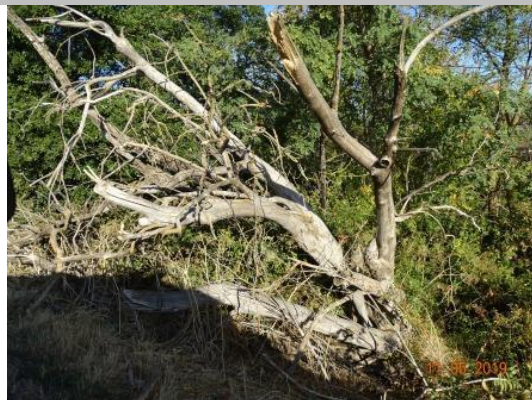
Photo 1 of 1 : FA_2019_RD0556_19_48_20191107_00084.jpg

LM Start	1.46	Rating **	U	Issue No.	48
LM End	1.46	Issue Type +	Ma	Location *	WS
Category	Earthen Levee			GPS Latitude/Longitude	
				Start	End
Item	Encroachments			38.240157°	38.240157°
				-121.544530°	-121.544530°
DWR ID	DWR_RD0556_02_f_2019_48				
Comment Code					
TR : Tree or limb					
Inspector Comment					
Remove down dead tree on waterside slope

View of downed dead tree on the waterside slope (Fall 2019).

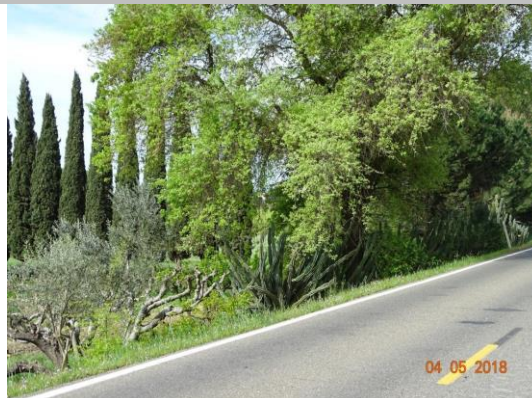
Photo 1 of 1 : FA_2019_RD0556_19_41_20190826_00024.jpg

LM Start	1.48	Rating **	U	Issue No.	41
LM End	1.48	Issue Type +	En	Location *	LS
Category	Earthen Levee			GPS Latitude/Longitude	
				Start	End
Item	Vegetation			38.240212 °	38.240212 °
				-121.544719 °	-121.544719 °
DWR ID	DWR_RD0556_02_s_2018_41				
Comment Code					
V6 : Landscaping					
Inspector Comment					
Cactus and other landscaping should be removed and managed to allow access and inspection.

View of cactus and other landscaping.

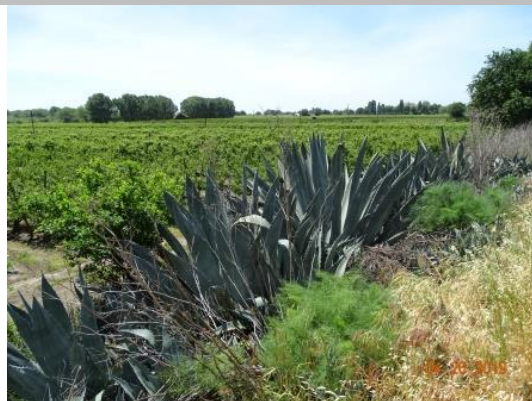
Photo 1 of 1 : FA_2019_RD0556_19_47_20190826_00028.jpg

LM Start	1.57	Rating **	U	Issue No.	47
LM End	1.57	Issue Type +	En	Location *	LS
Category	Earthen Levee			GPS Latitude/Longitude	
				Start	End
Item	Vegetation			38.240455 °	38.240455 °
				-121.546362 °	-121.546362 °
DWR ID	DWR_RD0556_02_s_2019_47				
Comment Code					
V6 : Landscaping					
Inspector Comment					
Remove cactus from the landside slope.

View looking downstream at cactus on the landside slope (Spring 2019).

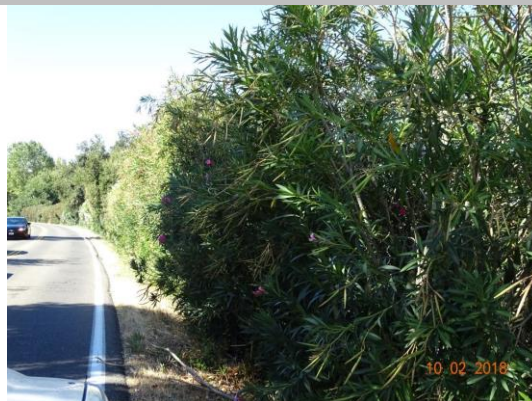
Photo 1 of 1 : FA_2019_RD0556_19_70_20190826_00037.jpg

LM Start	1.82	Rating **	U	Issue No.	70
LM End	1.92	Issue Type +	En	Location *	WS
Category	Earthen Levee			GPS Latitude/Longitude	
				Start	End
Item	Vegetation			38.241010 °	38.240618 °
				-121.551033 °	-121.552747 °
DWR ID	DWR_RD0556_02_f_2018_70				
Comment Code					
V6 : Landscaping					
Inspector Comment					
Thin oleanders to allow view down the levee slope.

View looking downstream at oleanders (October 2018).

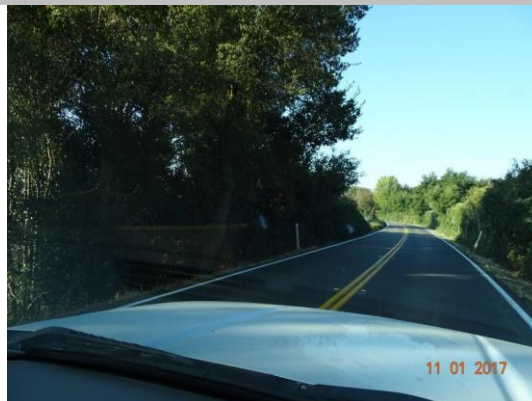
Photo 1 of 1 : FA_2019_RD0556_19_30_20190826_00015.jpg

LM Start	1.83	Rating **	U	Issue No.	30
LM End	1.99	Issue Type +	En	Location *	LS
Category	Earthen Levee			GPS Latitude/Longitude	
				Start	End
Item	Vegetation			38.240955 °	38.240024 °
				-121.551233 °	-121.553860 °
DWR ID	DWR_RD0556_02_f_2017_30				
Comment Code					
V6 : Landscaping					
Inspector Comment					
Remove/thin various landscaping including trees, bushes, and a large cactus.

Trim/thin oleanders on landside slope.

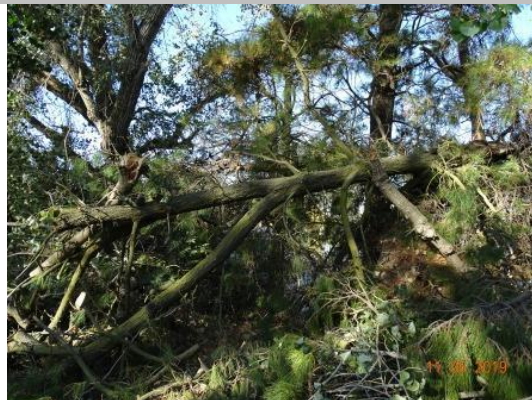
Photo 1 of 1 : FA_2019_RD0556_19_57_20191107_00086.jpg

LM Start	2.12	Rating **	U	Issue No.	57
LM End	2.12	Issue Type +	Ma	Location *	WS
Category	Earthen Levee			GPS Latitude/Longitude	
				Start	End
Item	Encroachments			38.238887 °	38.238887 °
				-121.555570 °	-121.555570 °
DWR ID	DWR_RD0556_02_f_2019_57				
Comment Code					
TR : Tree or limb					
Inspector Comment					
Remove downed tree.

Down tree on the waterside shoulder (Fall 2019).

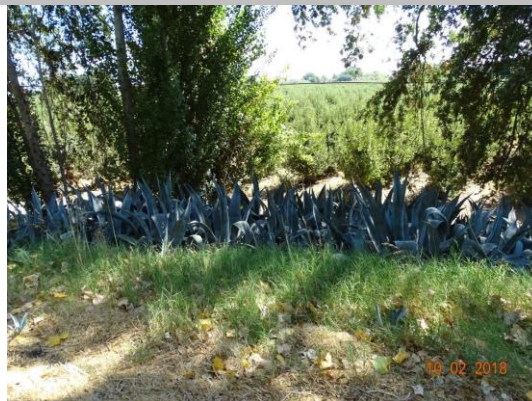
Photo 1 of 1 : FA_2019_RD0556_19_87_20190826_00043.jpg

LM Start	2.13	Rating **	U	Issue No.	87
LM End	2.13	Issue Type +	En	Location *	LS
Category	Earthen Levee			GPS Latitude/Longitude	
				Start	End
Item	Vegetation			38.238780 °	38.238780 °
				-121.555717 °	-121.555717 °
DWR ID	DWR_RD0556_02_f_2018_87				
Comment Code					
V6 : Landscaping					
Inspector Comment					
Cactus should be removed from the landside slope.

View of cactus on the landside slope (October 2018).

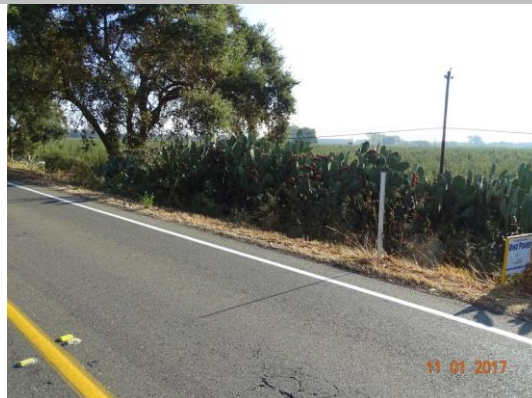
Photo 1 of 1 : FA_2019_RD0556_19_33_20190826_00018.jpg

LM Start	2.22	Rating **	U	Issue No.	33
LM End	2.22	Issue Type +	En	Location *	LS
Category	Earthen Levee			GPS Latitude/Longitude	
				Start	End
Item	Vegetation			38.237883 °	38.237883 °
				-121.556958 °	-121.556958 °
DWR ID	DWR_RD0556_02_f_2017_33				
Comment Code					
V6 : Landscaping					
Inspector Comment					
Large growth of prickly pear cactus should be removed to allow inspection and access.

View of large growth of prickly pear cactus.

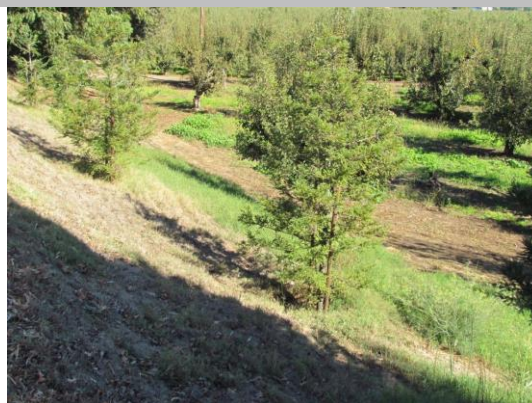
Photo 1 of 1 : FA_2019_RD0556_19_1_20190826_00001.jpg

LM Start	2.28	Rating **	M	Issue No.	1
LM End	2.28	Issue Type +	En	Location *	LS
Category	Earthen Levee			GPS Latitude/Longitude	
				Start	End
Item	Vegetation			38.237156 °	38.237156 °
				-121.557640 °	-121.557640 °
DWR ID	DWR_RD0556_02_f _ 2015_1				
Comment Code					
V6 : Landscaping					
Inspector Comment					
These unauthorized planted redwoods have been reported in the past inspections. The District needs to have the owner remove them from the levee slope.

RD 556 Unit 2 Levee mile 2.28 unauthorized planting of redwood trees planted on the slope.

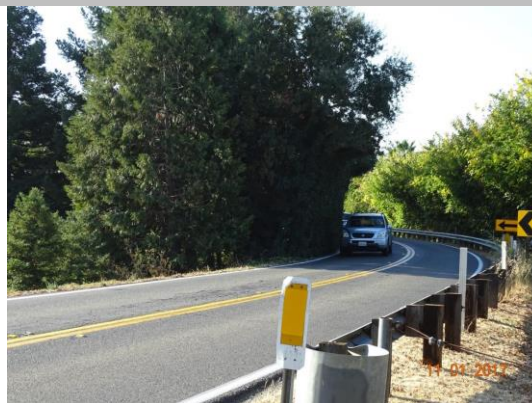
Photo 1 of 1 : FA_2019_RD0556_19_35_20190826_00019.jpg

LM Start	2.29	Rating **	U	Issue No.	35
LM End	2.33	Issue Type +	En	Location *	LS
Category	Earthen Levee			GPS Latitude/Longitude	
				Start	End
Item	Vegetation			38.237060°	38.236545°
				-121.557782°	-121.557910°
DWR ID	DWR_RD0556_02_f_2017_35				
Comment Code					
V6 : Landscaping					
Inspector Comment					
Trim/thin oleanders to allow inspection and access to landside slope and toe.

View of oleanders on the landside slope and toe.

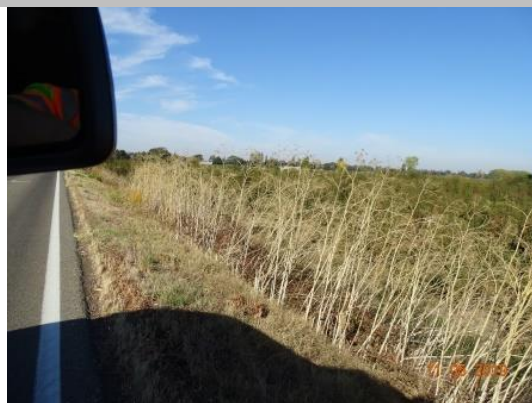
Photo 1 of 1 : FA_2019_RD0556_19_89_20191107_00100.jpg

LM Start	2.33	Rating **	U	Issue No.	89
LM End	2.71	Issue Type +	Ma	Location *	LS
Category	Earthen Levee			GPS Latitude/Longitude	
				Start	End
Item	Vegetation			38.236485 °	38.231222 °
				-121.557950 °	-121.556285 °
DWR ID	DWR_RD0556_02_f_2019_89				
Comment Code					
V2 : Remove the wild growth other than native grasses from the levee slopes.					
Inspector Comment

View looking upstream at thick vegetation on the landside slope (Fall 2019).

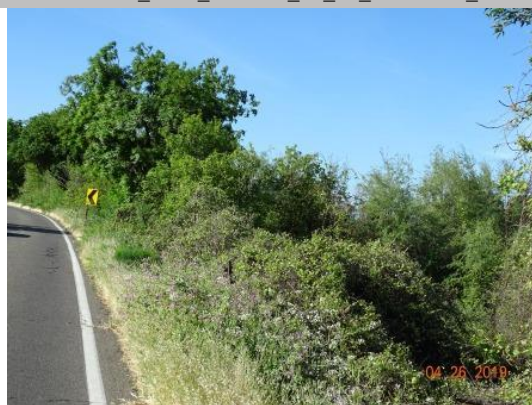
Photo 1 of 1 : FA_2019_RD0556_19_21_20190826_00008.jpg

LM Start	2.34	Rating **	U	Issue No.	21
LM End	2.77	Issue Type +	Ma	Location *	WS
Category	Earthen Levee			GPS Latitude/Longitude	
				Start	End
Item	Vegetation			38.236317 °	38.230478 °
				-121.557996 °	-121.555821 °
DWR ID	DWR_RD0556_02_s_2019_21				
Comment Code					
V2 : Remove the wild growth other than native grasses from the levee slopes.					
Inspector Comment					
Remove wild growth 20' down the waterside slope.

View looking downstream at thick wildgrowth on the waterside shoulder (Spring 2019).

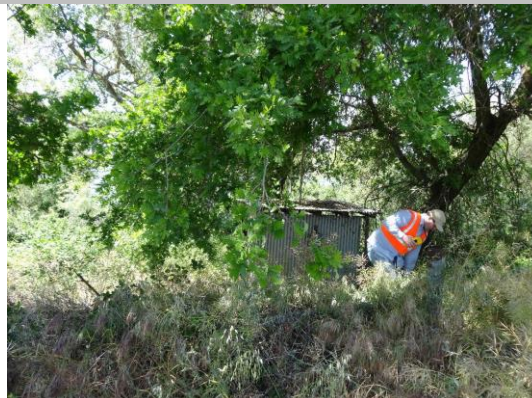
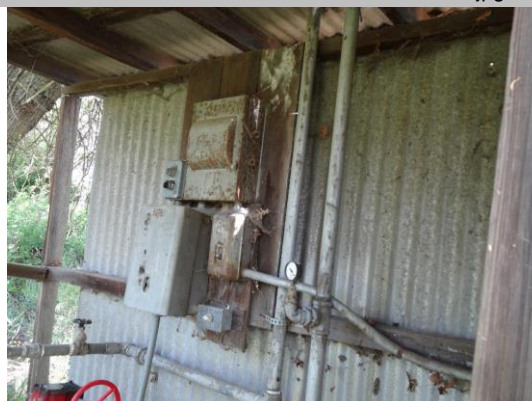
Comment Code					
Inspector Comment					
DS_ID:20859 FS_ID:12574 EP_NO: 11181 Repair Type: Non-Urgent Crossing Status: Found UCIP Comments: - Needs to clean CMP riser for proper functioning of siphon breaker. FIELD_STRUCT_DESC: 10-inch steel irrigation discharge pipe through the levee, 5.8 feet below the crown. Pump and gate valve in a pump house on the waterside (WS) slope. Siphon breaker and service pole on the landside (LS) slope. (Retention of a 10-inch pipe through the levee, 5.8 feet below the crown, a pump and a gate valve in a pump house on the WS slope, and a siphon breaker and a service pole on the LS slope authorized under Automatic Board Order (ABO) issued as Permit No. 11181, 1975 - Robert E. and G. P. Collins). [Additional Reference(s): DWR Levee Log. USACE Sacramento O&M Manual 103, June 1954, (Station ""J"" 115+25), invert elevation 18.5 feet]. FS Date: 4/25/2013

WS- pump house on levee berm

WS- power control panel and electric conduit in pump house.

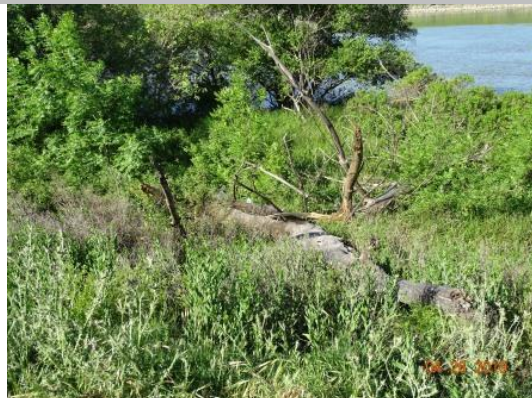
Photo 1 of 1 : FA_2019_RD0556_19_44_20190826_00025.jpg

LM Start	2.69	Rating **	M	Issue No.	44
LM End	2.69	Issue Type +	Ma	Location *	WS
Category	Earthen Levee			GPS Latitude/Longitude	
				Start	End
Item	Encroachments			38.231494 °	38.231494 °
				-121.556474 °	-121.556474 °
DWR ID	DWR_RD0556_02_s_2018_44				
Comment Code					
TR : Tree or limb					
Inspector Comment					
Remove fallen tree from the waterside shoulder.

View of fallen tree within 20' of the waterside shoulder (Spring 2019).

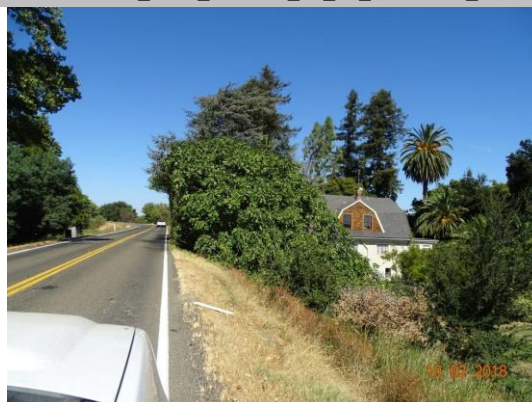
Photo 1 of 1 : FA_2019_RD0556_19_46_20190826_00027.jpg

LM Start	2.86	Rating **	M	Issue No.	46
LM End	2.86	Issue Type +	En	Location *	LS
Category	Earthen Levee			GPS Latitude/Longitude	
				Start	End
Item	Vegetation			38.229195 °	38.229195 °
				-121.555337 °	-121.555337 °
DWR ID	DWR_RD0556_02_f _ 2019_46				
Comment Code					
V6 : Landscaping					
Inspector Comment

View looking upstream at beginning of landscaping on landside (October 2018).

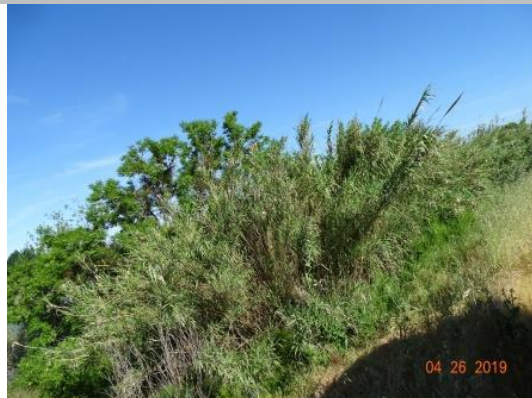
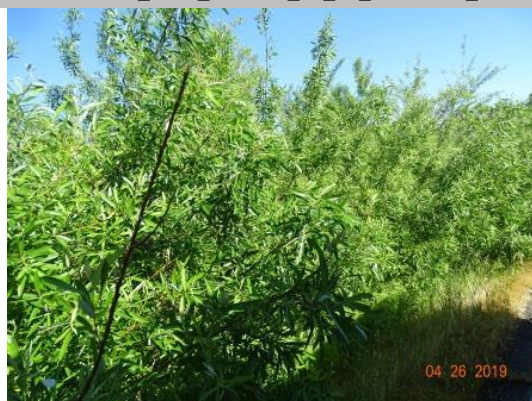
LM Start	2.90	Rating **	U	Issue No.	76
LM End	5.10	Issue Type +	Ma	Location *	WS
Category	Earthen Levee			GPS Latitude/Longitude	
				Start	End
Item	Vegetation			38.228683 °	38.197183 °
				-121.555352 °	-121.559049 °
DWR ID	DWR_RD0556_02_f_2018_76				
Comment Code					
V2 : Remove the wild growth other than native grasses from the levee slopes.					
Inspector Comment					
Remove vegetation 20' from the waterside slope including patches of arundo.

View looking upstream at arundo on the waterside slope (Spring 2019).

View looking upstream at thick wildgrowth on the waterside slope (Spring 2019).

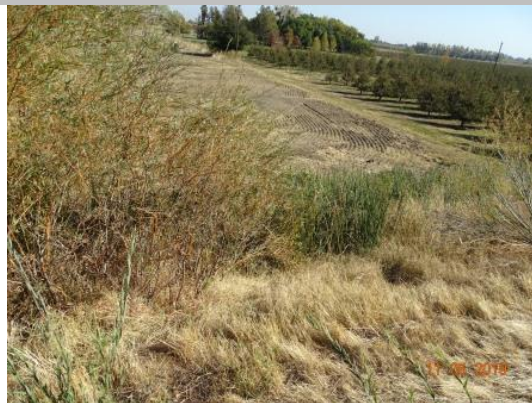
Photo 1 of 1 : FA_2019_RD0556_19_86_20191107_00098.jpg

LM Start	2.90	Rating **	U	Issue No.	86
LM End	3.26	Issue Type +	Ma	Location *	LS
Category	Earthen Levee			GPS Latitude/Longitude	
				Start	End
Item	Vegetation			38.228627 °	38.223450 °
				-121.555220 °	-121.555398 °
DWR ID	DWR_RD0556_02_f_2019_86				
Comment Code					
V2 : Remove the wild growth other than native grasses from the levee slopes.					
Inspector Comment

View of thick vegetation on the landside slope (Fall 2019).

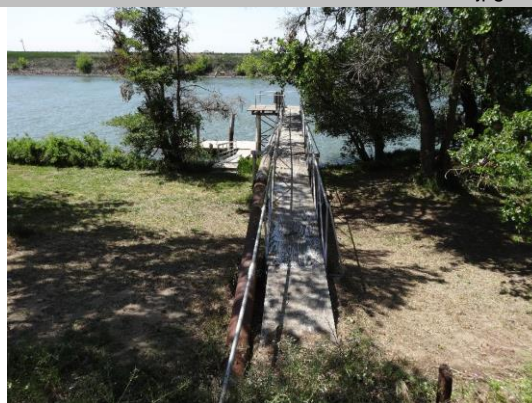
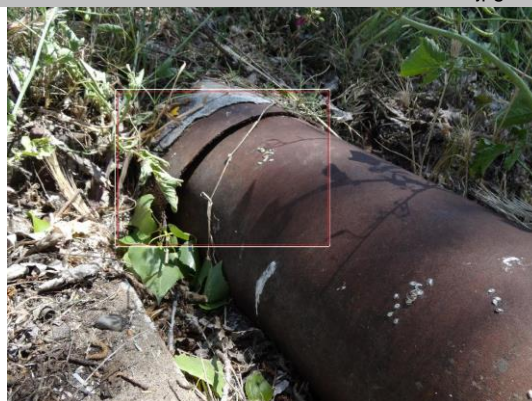
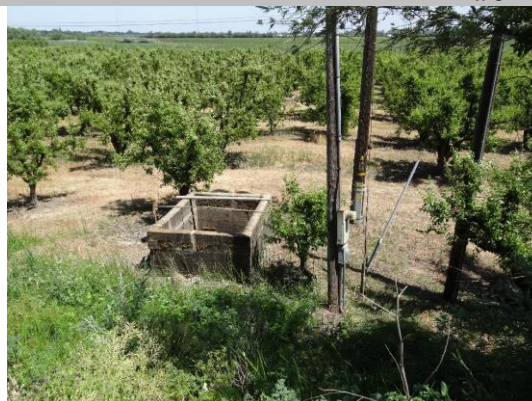
Comment Code						
Inspector Comment						
DS_ID:20862 FS_ID:12525 EP_NO: N/A Repair Type: Non-Urgent Crossing Status: Found UCIP Comments: - 9-inch steel pipe sleeved through 12-inch pipe.- needs to seal gap between two pipes. FIELD_STRUCT_DESC: 9-inch steel pipe sleeved through a 12-inch steel irrigation discharge pipe through the levee, 6 feet below the crown. Pump on a pile structure in the river. Steel walkway to the pump and wood steps on the waterside (WS) slope. Concrete spill box with two 8-inch openings. (Retention of a 12-inch pipe through the levee, 6 feet below the crown, a pump on a pile structure in the river, a steel walkway to the pump, and wood steps on the WS slope authorized under Automatic Board Order (ABO) issued as Permit No. 11193, 1975 - Gertrude M. Reid). [Additional Reference(s): DWR Levee Log. USACE Sacramento O&M Manual 103, June 1954, (Station ""J"" 80+79), invert elevation 18.3 feet]. FS Date: 4/25/2013

WS- walkway, pump, and pipe on steel pile structure in the river.

WS- 9-inch pipe sleeved through 10 inch steel pipe.

LS- a concrete spill box on landside of the levee.

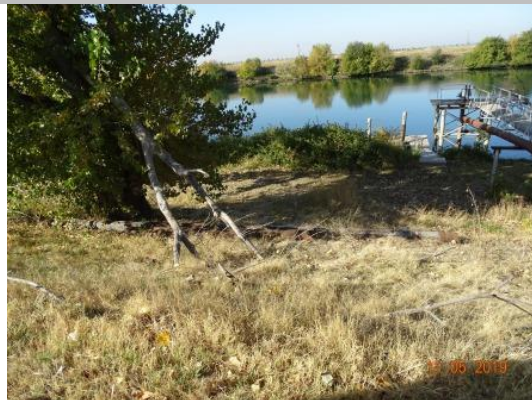
Photo 1 of 1 : FA_2019_RD0556_19_59_20191107_00087.jpg

LM Start	3.07	Rating **	M	Issue No.	59
LM End	3.07	Issue Type +	En	Location *	WS
Category	Earthen Levee			GPS Latitude/Longitude	
				Start	End
Item	Encroachments			38.226155 °	38.226155 °
				-121.555273 °	-121.555273 °
DWR ID	DWR_RD0556_02_f_2019_59				
Comment Code					
MA : Material					
Inspector Comment					
There is an abandoned uninstalled pipe on waterside.

View of abandoned uninstalled pipe on the waterside toe (Fall 2019).

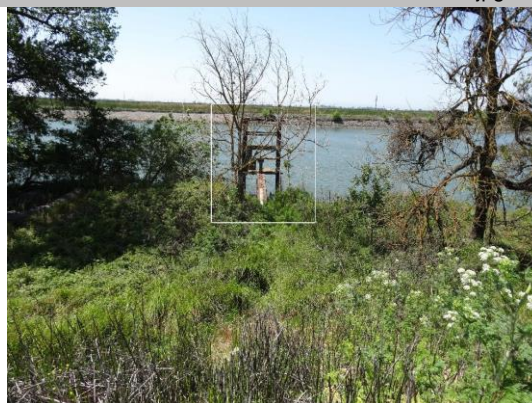
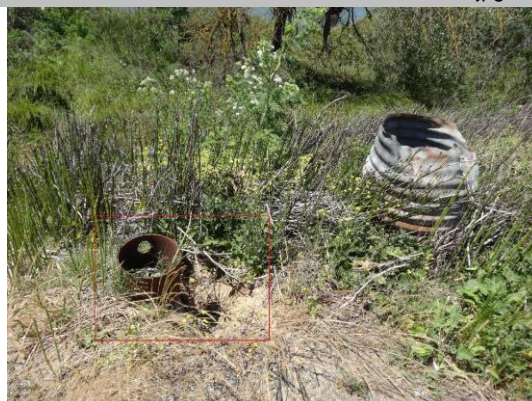
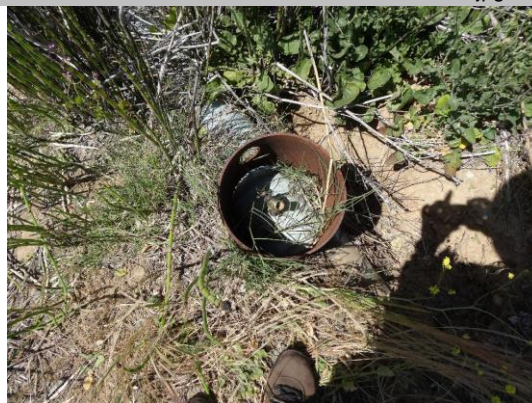
Comment Code					
Inspector Comment					
DS_ID:20863 FS_ID:12527 EP_NO: 11181 Repair Type: Non-Urgent Crossing Status: Found UCIP Comments: - needs to fix siphon breaker FIELD_STRUCT_DESC: 10-inch steel irrigation discharge pipe through the levee, 4.8 feet below the crown. Steel walkway to the pump on a pile structure in the river. Siphon breaker on the waterside (WS). Service pole on the landside (LS) slope. Concrete spill box with two 15-inch openings on the LS. (Retention of a 10-inch pipe through the levee, 4.8 feet below the crown, a steel walkway to the pump on a pile structure in the river, and a siphon breaker and a service pole on the LS slope authorized under Automatic Board Order (ABO) issued as Permit No. 11181, 1975 - Robert E. and G. P. Collins). [Additional Reference(s): DWR Levee Log. USACE Sacramento O&M Manual 103, June 1954, (Station ""J"" 58+00), invert elevation 18.2 feet]. FS Date: 4/25/2013

WS- pump, pipe, and walkway on steel structure in the stream.

WS- siphon breaker and abandoned CMP riser laying adjacent to it.

WS- siphon breaker on levee slope.
