**Flood Control Project Maintenance
Levee Inspections**

Fall 2019 Levee Maintenance Deficiency Summary Report

Sacramento River Basin

Reclamation District No. 0556 Upper Andrus

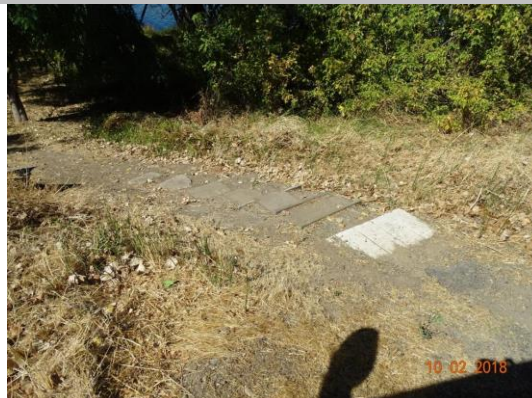
Photo 1 of 1 : FA_2019_RD0556_19_78_20190826_00041.jpg

LM Start	3.54	Rating **	M	Issue No.	78
LM End	3.54	Issue Type +	En	Location *	WS
Category	Earthen Levee			GPS Latitude/Longitude	
				Start	End
Item	Encroachments			38.219407 °	38.219407 °
				-121.556280 °	-121.556280 °
DWR ID	DWR_RD0556_02_f_2018_78				
Comment Code					
ST : Stairway					
Inspector Comment					
Stairs encroaching into slope do not have a permit.

View of stairs on waterside slope (October 2018).

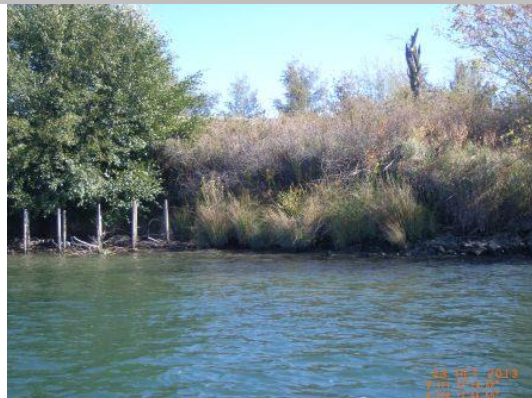
Photo 1 of 1 : FA_2019_RD0556_19_16_20190826_00004.jpg

LM Start	3.58	Rating **	M	Issue No.	16
LM End	3.64	Issue Type +	Ma	Location *	WS
Category	Supplemental			GPS Latitude/Longitude	
				Start	End
Item	2017 USACE Erosion Survey			38.218951 °	38.218104 °
				-121.556689 °	-121.556819 °
DWR ID	DWR_RD0556_02_f_2018_16				
Comment Code					
Inspector Comment					
2017 Site ID: SAC 22.7 L					
Status: Eroding					
2017 Field Notes: Minor new erosion at toe.					
Site History: 1997 - Scallops into berm and very close to levee toe.					
2005 - Brush boxes present. 2011 - New toe scour and freshly fallen tree. 2012 - New tree popout has taken significant portion of soil out of the levee.

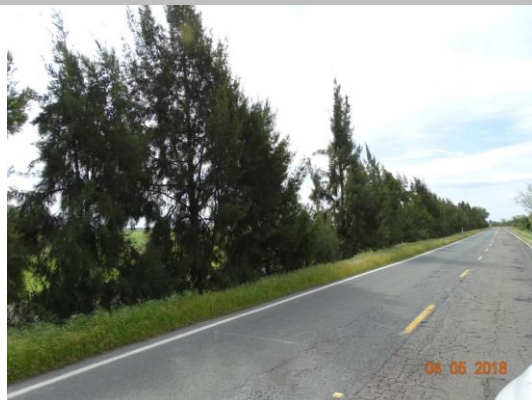
Photo 1 of 1 : FA_2019_RD0556_19_49_20190826_00029.jpg

LM Start	3.58	Rating **	U	Issue No.	49
LM End	3.74	Issue Type +	En	Location *	LS
Category	Earthen Levee			GPS Latitude/Longitude	
				Start	End
Item	Vegetation			38.218889 °	38.216543 °
				-121.556388 °	-121.556777 °
DWR ID	DWR_RD0556_02_s_2018_49				
Comment Code					
V6 : Landscaping					
Inspector Comment					
A row of evergreen trees block inspection and access. They should be trimmed to 5' above the levee.

View of landscaping trees on the landside.

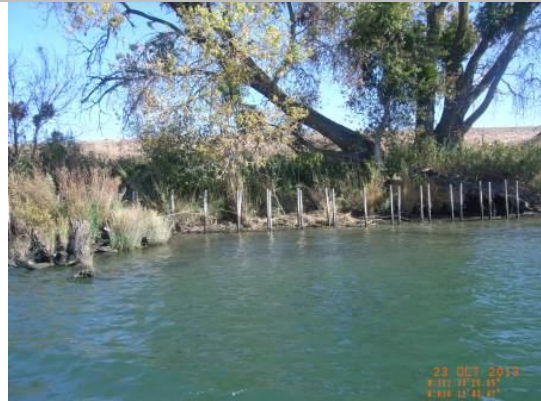
Photo 1 of 1 : FA_2019_RD0556_19_15_20190826_00003.jpg

LM Start	3.95	Rating **	M	Issue No.	15
LM End	4.12	Issue Type +	Ma	Location *	WS
Category	Supplemental			GPS Latitude/Longitude	
				Start	End
Item	2017 USACE Erosion Survey			38.213581 °	38.211112 °
				-121.557197 °	-121.557042 °
DWR ID	DWR_RD0556_02_f_2018_15				
Comment Code					
Inspector Comment					
2017 Site ID: SAC 22.5 L Status: Eroding 2017 Field Notes: New lower bank erosion at the upstream end. Locals placed rock in some erosion pockets. Site History: 2002 - Spot rock along berm, but not in the erosion pockets. 2005 - Some new minor stone revetment at the upstream end. Brush boxes present. 2006 - Currently installing new brush in downstream brush boxes. 2007 - Rock in middle portion for about 150 ft. 2010 - Some attempt at repairs but still has pockets of erosion. 2012 - More erosion along the toe.

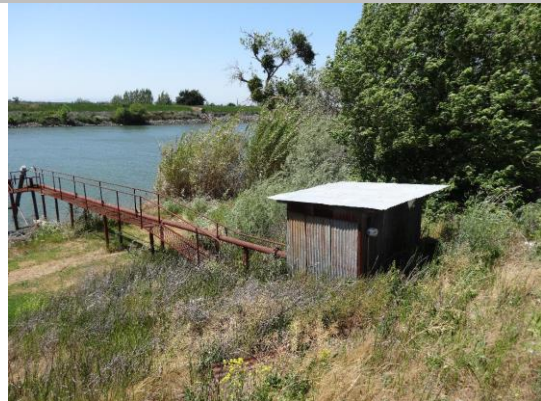
Photo 1 of 3 : UCIP_FA_2019_12543_20302.jpg

Comment Code						
Inspector Comment						
DS_ID:20864 FS_ID:12543 EP_NO: 11197 Repair Type: Non-Urgent Crossing Status: Found UCIP Comments: Electric control panel in pump house.Needs cleaning of CMP riser on landside. FIELD_STRUCT_DESC: 6-inch steel irrigation discharge pipe through the levee, 6.5 feet below the crown. Slant pump on a steel pile structure in the river. Walkway to the pump. Gate valve in a pump house on the waterside (WS) slope. Siphon breaker and service poles on the landside (LS) slope. Concrete standpipe on the LS. (Retention of a 6-inch pipe through the levee, 6.5 feet below the crown, a pump and a gate valve in a pump house on the WS slope, and a siphon breaker and a service pole on the LS slope authorized under Automatic Board Order (ABO) issued as Permit No. 11197, 1975 - Richard T. and Mary B. Souza). [Additional Reference(s): DWR Levee Log. USACE Sacramento O&M Manual 103, June 1954, (Station ""J"" 32+40), invert elevation 18.1 feet]. FS Date: 4/25/2013

WS- pipe and pump on steel pile structure. Steel walkway from pump house to the pump on steel structure.

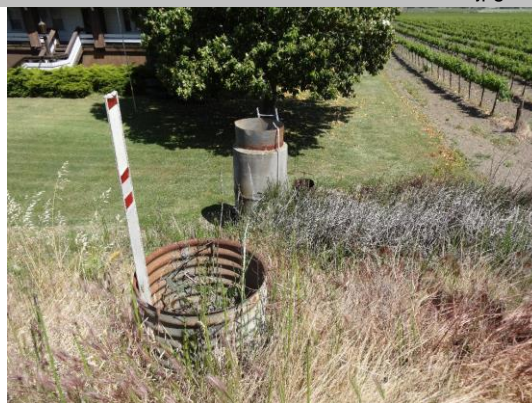
Photo 2 of 3 : UCIP_FA_2019_12543_20301.jpg

Comment Code						
Inspector Comment						
DS_ID:20864 FS_ID:12543 EP_NO: 11197 Repair Type: Non-Urgent Crossing Status: Found UCIP Comments: Electric control panel in pump house.Needs cleaning of CMP riser on landside. FIELD_STRUCT_DESC: 6-inch steel irrigation discharge pipe through the levee, 6.5 feet below the crown. Slant pump on a steel pile structure in the river. Walkway to the pump. Gate valve in a pump house on the waterside (WS) slope. Siphon breaker and service poles on the landside (LS) slope. Concrete standpipe on the LS. (Retention of a 6-inch pipe through the levee, 6.5 feet below the crown, a pump and a gate valve in a pump house on the WS slope, and a siphon breaker and a service pole on the LS slope authorized under Automatic Board Order (ABO) issued as Permit No. 11197, 1975 - Richard T. and Mary B. Souza). [Additional Reference(s): DWR Levee Log. USACE Sacramento O&M Manual 103, June 1954, (Station ""J"" 32+40), invert elevation 18.1 feet]. FS Date: 4/25/2013

LS- siphon breaker in CMP riser and concrete standpipe behind CMP riser.

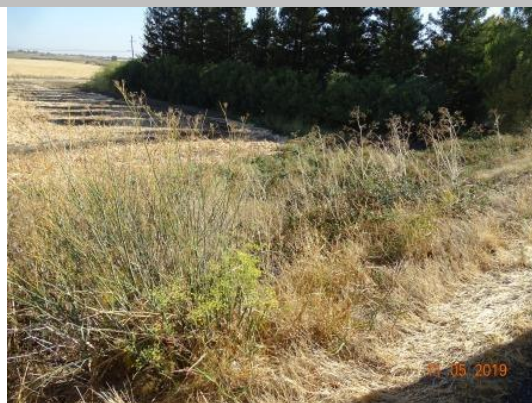
Photo 1 of 1 : FA_2019_RD0556_19_52_20191107_00096.jpg

LM Start	4.01	Rating **	U	Issue No.	52
LM End	5.02	Issue Type +	Ma	Location *	LS
Category	Earthen Levee			GPS Latitude/Longitude	
				Start	End
Item	Vegetation			38.212662 °	38.198213 °
				-121.556808 °	-121.558407 °
DWR ID	DWR_RD0556_02_s_2018_52				
Comment Code					
V2 : Remove the wild growth other than native grasses from the levee slopes.					
Inspector Comment					
Blackberries are located at the landside toe.

View of vegetation on the landside slope. Weeds are obscuring the large blackberry vines at the landside toe (Fall 2019).

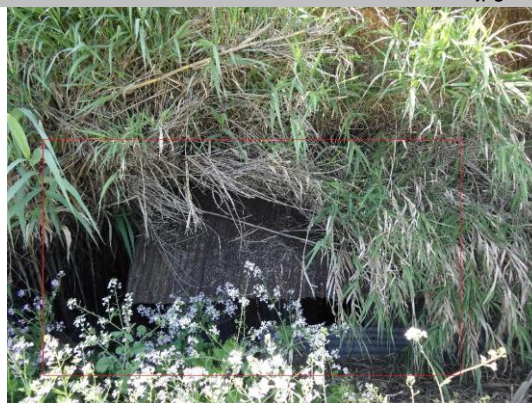
Photo 2 of 3 : UCIP_FA_2019_12545_20309.jpg

Comment Code						
Inspector Comment						
DS_ID:20865 FS_ID:12545 EP_NO: 11194 Repair Type: Non-Urgent Crossing Status: Found UCIP Comments: - CMP riser found abandoned on LS slope. Due to dense vegetation siphon breaker could not be found.- Dense vegetation on both sides of the levee.- Oil leaks from pump set. FIELD_STRUCT_DESC: 8-inch steel irrigation discharge pipe through the levee, 6.7 feet below the crown. Pump and gate valve in a pump house on the waterside (WS) slope. Siphon breaker on the landside (LS) slope. (Retention of an 8-inch pipe through the levee, 6.7 feet below the crown, a pump and a gate valve in a pump house on the WS slope, and a siphon breaker on the LS slope authorized under Automatic Board Order (ABO) issued as Permit No. 11194, 1975 - Gerald E. and William M. Robinson, et al.). [Additional Reference(s): DWR Levee Log. USACE Sacramento O&M Manual 103, June 1954, (Station ""J"" 18+20), invert elevation 18 feet]. FS Date: 4/25/2013

WS- pump house inside the dense vegetation.

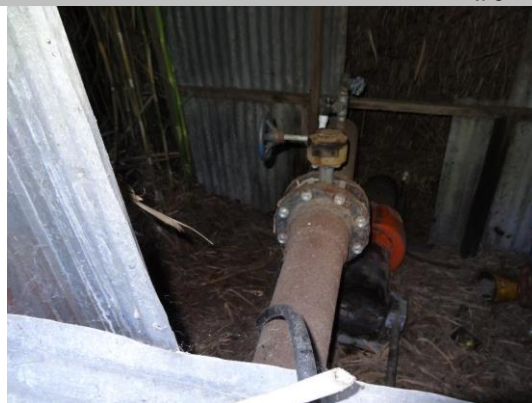
Photo 3 of 3 : UCIP_FA_2019_12545_20308.jpg

WS- pump, gate valve and pipe in pump house.

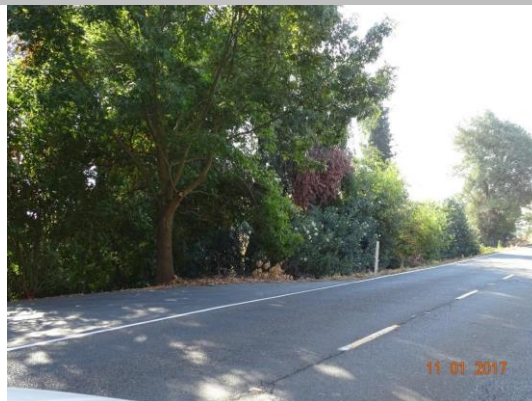
Photo 1 of 1 : FA_2019_RD0556_19_36_20190826_00020.jpg

LM Start	4.41	Rating **	U	Issue No.	36
LM End	4.44	Issue Type +	En	Location *	LS
Category	Earthen Levee			GPS Latitude/Longitude	
				Start	End
Item	Vegetation			38.206832 °	38.206418 °
				-121.556783 °	-121.556770 °
DWR ID	DWR_RD0556_02_f_2017_36				
Comment Code					
V6 : Landscaping					
Inspector Comment					
Oleanders, trees, and other landscaping should be trimmed to allow inspection and access to the landside slope and toe.

View of landscaping on the landside.

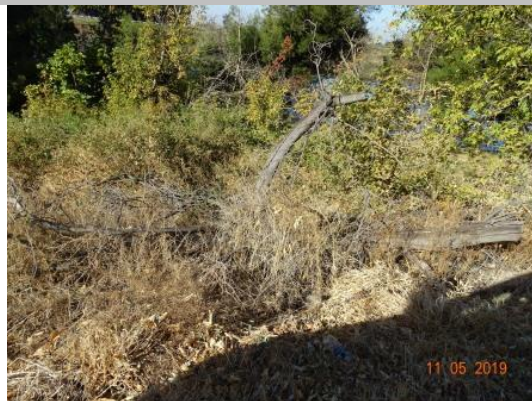
Photo 1 of 1 : FA_2019_RD0556_19_54_20191107_00089.jpg

LM Start	4.43	Rating **	U	Issue No.	54
LM End	4.43	Issue Type +	En	Location *	WS
Category	Earthen Levee			GPS Latitude/Longitude	
				Start	End
Item	Encroachments			38.206628 °	38.206628 °
				-121.556829 °	-121.556829 °
DWR ID	DWR_RD0556_02_s_2018_54				
Comment Code					
TR : Tree or limb					
Inspector Comment					
Remove fallen tree and other woody debris on waterside slope

View of fallen tree and limbs on the waterside slope (Fall 2019).

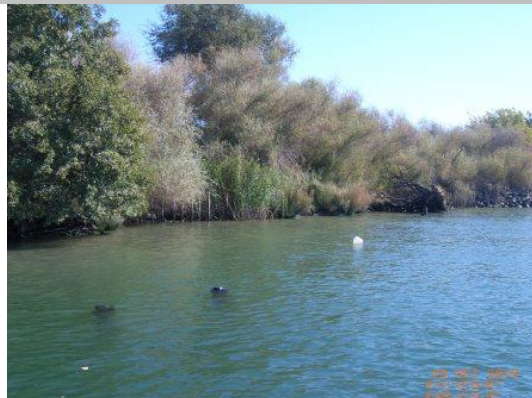
Photo 1 of 1 : FA_2019_RD0556_19_14_20190826_00002.jpg

LM Start	4.45	Rating **	M	Issue No.	14
LM End	4.49	Issue Type +	Ma	Location *	WS
Category	Supplemental			GPS Latitude/Longitude	
				Start	End
Item	2017 USACE Erosion Survey			38.206377 °	38.205729 °
				-121.557184 °	-121.557108 °
DWR ID	DWR_RD0556_02_f_2018_14				
Comment Code					
Inspector Comment					
2017 Site ID: SAC 21.9 L					
Status: Eroding					
2017 Field Notes: No observed change..					
Site History: 2013 - Erosion pockets encroaching on levee foundation.

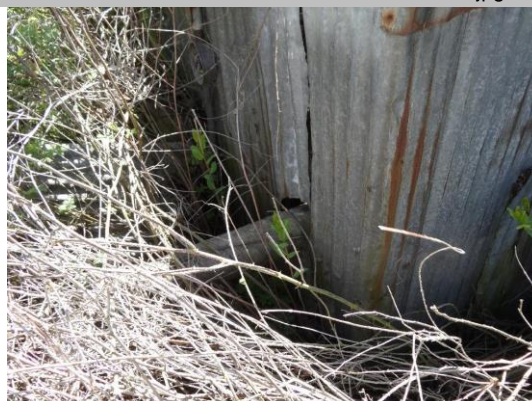
Photo 2 of 3 : UCIP_FA_2019_12546_20313.jpg

Comment Code						
Inspector Comment						
DS_ID:20866 FS_ID:12546 EP_NO: 11940 Repair Type: Non-Urgent Crossing Status: Found UCIP Comments: - Abandoned crossing.- Siphon breaker on LS not found due to dense vegetation, - An abandoned CMP riser and service pole found on LS.- It may need to be properly abandoned. FIELD_STRUCT_DESC: *ABANDONED* 6-inch steel irrigation discharge pipe through the levee, 6.7 feet below the crown. Pump and gate valve in a pump house on the waterside (WS) slope. Siphon breaker and service pole on the landside (LS) slope. (Retention of a 6-inch pipe through the levee, 6.5 feet below the crown, a pump and a gate valve in a pump house on the WS slope, and a siphon breaker and a service pole on the LS slope authorized under Automatic Board Order (ABO) issued as Permit No. 11194, 1975 - Gerald E. and William M. Robinson, et al.). [Additional Reference(s): DWR Levee Log. USACE Sacramento O&M Manual 103, June 1954, (Station ""J"" 2+73), invert elevation 18 feet]. FS Date: 4/25/2013

WS- pipe daylight from levee slope to pump house.

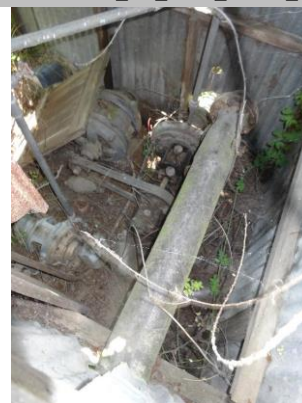
Photo 3 of 3 : UCIP_FA_2019_12546_20315.jpg

WS- abandoned gate valve, pump, and pipe in pump house

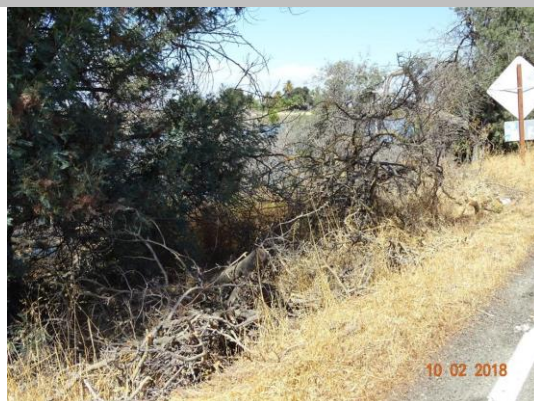
Photo 1 of 1 : FA_2019_RD0556_19_27_20190826_00012.jpg

View of fallen tree on the waterside slope (October 2018).

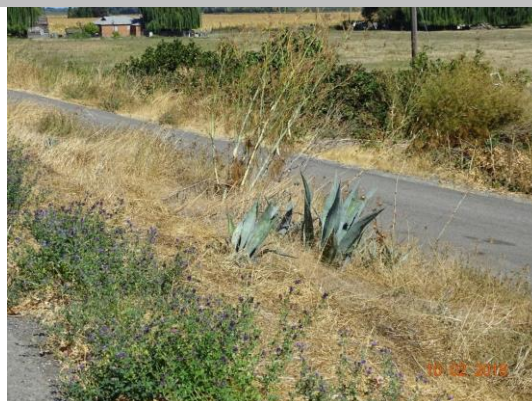
Photo 1 of 1 : FA_2019_RD0556_19_60_20190826_00035.jpg

LM Start	4.79	Rating **	M	Issue No.	60
LM End	4.79	Issue Type +	En	Location *	LS
Category	Earthen Levee			GPS Latitude/Longitude	
				Start	End
Item	Vegetation			38.201402°	38.201402°
				-121.557108°	-121.557108°
DWR ID	DWR_RD0556_02_s_2018_60				
Comment Code					
V6 : Landscaping					
Inspector Comment					
Remove cactus before more can become established.

View of cactus on the landside slope (October 2018).

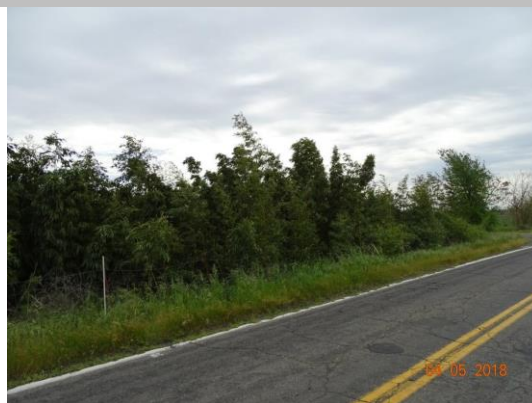
Photo 1 of 1 : FA_2019_RD0556_19_61_20190826_00036.jpg

LM Start	4.82	Rating **	U	Issue No.	61
LM End	4.82	Issue Type +	En	Location *	LS
Category	Earthen Levee			GPS Latitude/Longitude	
				Start	End
Item	Vegetation			38.201002°	38.201002°
				-121.557170°	-121.557170°
DWR ID	DWR_RD0556_02_s_2018_61				
Comment Code					
V6 : Landscaping					
Inspector Comment					
Landside bamboo should be removed to allow inspection and access.

View of landside bamboo.

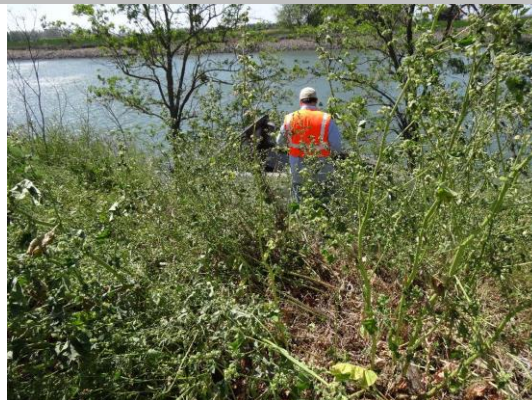
Photo 1 of 3 : UCIP_FA_2019_12564_20347.jpg

Comment Code						
Inspector Comment						
DS_ID:20868 FS_ID:12564 EP_NO: 11191 Repair Type: Non-Urgent Crossing Status: Found UCIP Comments: - needs to fix CMP riser. FIELD_STRUCT_DESC: 8-inch irrigation discharge pipe of an unknown material through the levee, 5.7 feet below the crown. Pump on the waterside (WS) slope. Gate valve on the WS berm. Siphon breaker and service pole on the landside (LS) slope. (Retention of an 8-inch pipe through the levee, 5.7 feet below the crown, a pump on the WS slope, a gate valve on the WS berm, and a siphon breaker and a service pole on the LS slope authorized under Automatic Board Order (ABO) issued as Permit No. 11191, 1975 - Pacific Fruit Exchange). [Additional Reference(s): DWR Levee Log]. FS Date: 4/25/2013

WS- pump house on levee slope.

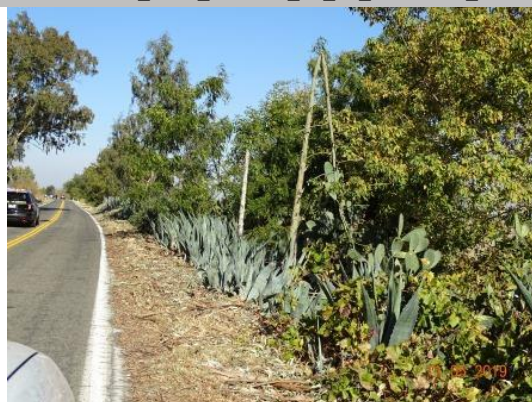
Photo 1 of 1 : FA_2019_RD0556_19_37_20191107_00095.jpg

LM Start	5.08	Rating **	U	Issue No.	37
LM End	5.16	Issue Type +	En	Location *	LS
Category	Earthen Levee			GPS Latitude/Longitude	
				Start	End
Item	Vegetation			38.197407°	38.196388°
				-121.558950°	-121.559558°
DWR ID	DWR_RD0556_02_f_2017_37				
Comment Code					
V6 : Landscaping					
Inspector Comment					
Remove large cactus to allow inspection and access to the landside slope and toe.

View looking upstream at cactus on the landside slope (Fall 2019).

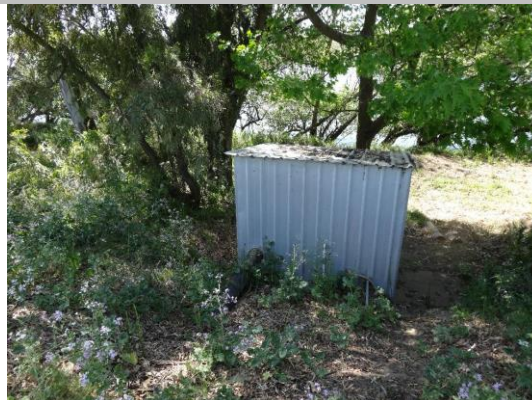
Photo 1 of 3 : UCIP_FA_2019_52733_20364.jpg

Comment Code						
Inspector Comment						
DS_ID:20869 FS_ID:52733 EP_NO: 11185 Repair Type: Urgent Crossing Status: Found UCIP Comments: 07/12/2018 Pit on WS is covered with plywood. Water pump is running, no leaks detected. LS part of crossing was reconstructed. New pipe was installed after CMP riser to supply water to sand filters. Remains Urgent due to large pit on WS that needs to be backfilled. (O.Yakimov-DWR UCIP)04/25/2013 Large pit on levee berm. FIELD_STRUCT_DESC: 8-inch irrigation discharge pipe of an unknown material through the levee, 5.7 feet below the crown. Pump and gate valve in a pump house on the waterside (WS) slope. Siphon breaker, concrete box, and service pole on the landside (LS) slope. (Retention of an 8-inch pipe through the levee, 5.7 feet below the crown, a pump and a gate valve in a pump house on the WS slope, and a siphon breaker and a service pole on the LS slope authorized under Automatic Board Order (ABO) issued as Permit No. 11185, 1975 - R. Walter Langhart). [Additional Reference(s): DWR Levee Log]. FS Date: 7/13/2018

WS- pump house on levee slope

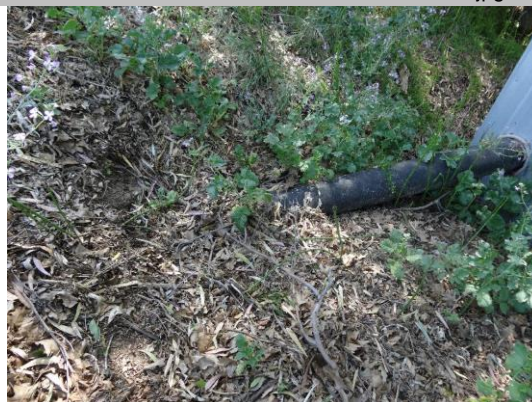
Photo 2 of 3 : UCIP_FA_2019_52733_20363.jpg

WS- pipe daylight from the levee.

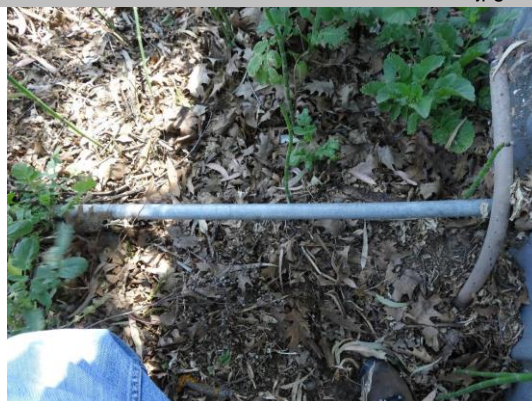
Photo 3 of 3 : UCIP_FA_2019_52733_20366.jpg

Comment Code					
Inspector Comment					
DS_ID:20869 FS_ID:52733 EP_NO: 11185 Repair Type: Urgent Crossing Status: Found UCIP Comments: 07/12/2018 Pit on WS is covered with plywood. Water pump is running, no leaks detected. LS part of crossing was reconstructed. New pipe was installed after CMP riser to supply water to sand filters. Remains Urgent due to large pit on WS that needs to be backfilled. (O.Yakimov-DWR UCIP)04/25/2013 Large pit on levee berm. FIELD_STRUCT_DESC: 8-inch irrigation discharge pipe of an unknown material through the levee, 5.7 feet below the crown. Pump and gate valve in a pump house on the waterside (WS) slope. Siphon breaker, concrete box, and service pole on the landside (LS) slope. (Retention of an 8-inch pipe through the levee, 5.7 feet below the crown, a pump and a gate valve in a pump house on the WS slope, and a siphon breaker and a service pole on the LS slope authorized under Automatic Board Order (ABO) issued as Permit No. 11185, 1975 - R. Walter Langhart). [Additional Reference(s): DWR Levee Log]. FS Date: 7/13/2018

WS- electric conduit daylight near pump house.

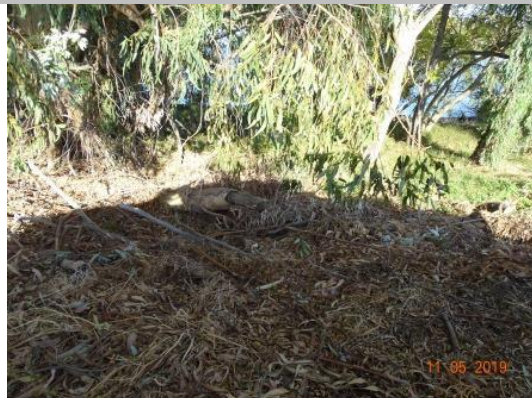
Photo 1 of 1 : FA_2019_RD0556_19_69_20191107_00090.jpg

LM Start	5.35	Rating **	U	Issue No.	69
LM End	5.35	Issue Type +	Ma	Location *	WS
Category	Earthen Levee			GPS Latitude/Longitude	
				Start	End
Item	Encroachments			38.194337°	38.194337°
				-121.561698°	-121.561698°
DWR ID	DWR_RD0556_02_f_2019_69				
Comment Code					
TR : Tree or limb					
Inspector Comment					
Remove fallen tree limbs from the waterside shoulder.

View of large fallen tree limbs on the waterside shoulder. Leaves are obscuring the largest branches (Fall 2019).

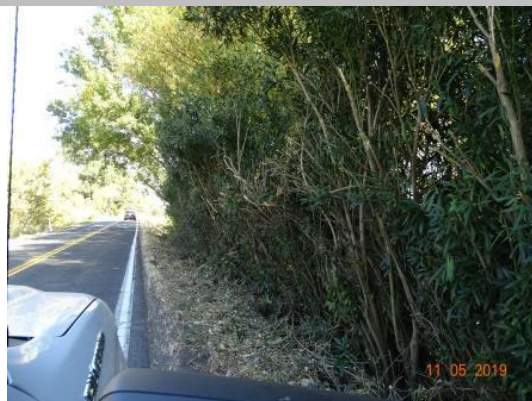
Photo 1 of 1 : FA_2019_RD0556_19_31_20191107_00094.jpg

LM Start	5.40	Rating **	U	Issue No.	31
LM End	5.44	Issue Type +	En	Location *	LS
Category	Earthen Levee			GPS Latitude/Longitude	
				Start	End
Item	Vegetation			38.193760 °	38.193445 °
				-121.562458 °	-121.562895 °
DWR ID	DWR_RD0556_02_s_2012_31				
Comment Code					
V6 : Landscaping					
Inspector Comment					
Remove cactus and thin oleanders to allow view down landside slope.

View looking upstream at landscaping on the landside shoulder (Fall 2019).

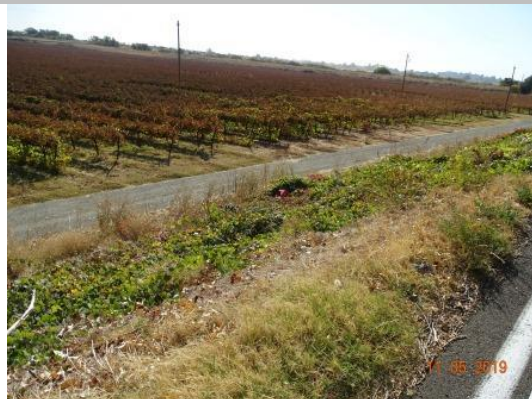
Photo 1 of 1 : FA_2019_RD0556_19_81_20191107_00093.jpg

LM Start	5.50	Rating **	M	Issue No.	81
LM End	5.56	Issue Type +	Ma	Location *	LS
Category	Earthen Levee			GPS Latitude/Longitude	
				Start	End
Item	Vegetation			38.192910 °	38.192550 °
				-121.563913 °	-121.564972 °
DWR ID	DWR_RD0556_02_f_2019_81				
Comment Code					
V2 : Remove the wild growth other than native grasses from the levee slopes.					
Inspector Comment					
Blackberries at landside toe need removal.

View looking downstream at blackberries at the landside toe (Fall 2019).

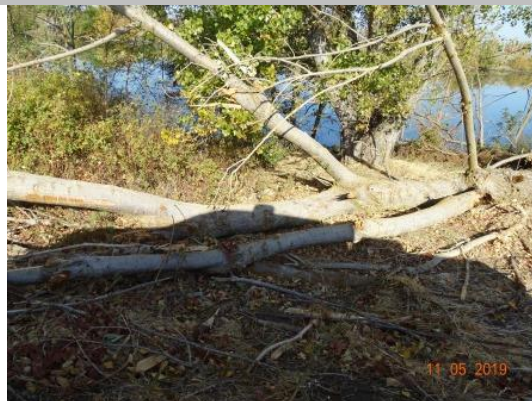
Photo 1 of 1 : FA_2019_RD0556_19_74_20191107_00091.jpg

LM Start	5.53	Rating **	U	Issue No.	74
LM End	5.53	Issue Type +	Ma	Location *	WS
Category	Earthen Levee			GPS Latitude/Longitude	
				Start	End
Item	Encroachments			38.192803 °	38.192803 °
				-121.564388 °	-121.564388 °
DWR ID	DWR_RD0556_02_f_2019_74				
Comment Code					
TR : Tree or limb					
Inspector Comment					
Remove fallen tree from the waterside slope.

View of large fallen tree on the waterside slope (Fall 2019).
