Flood Control Project Maintenance Levee Inspections

Fall 2020 Levee Maintenance Deficiency Summary Report

Sacramento River Basin

Reclamation District No. 0556 Upper Andrus

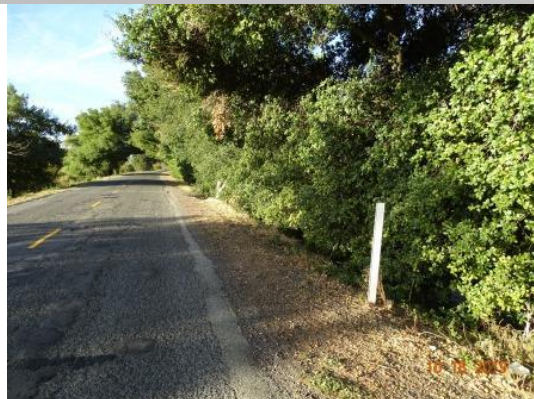
Photo 1 of 1 : FA_2020_RD0556_18_21_20200910_00005.jpg

LM Start	0.00	Rating **	U	Issue No.	21
LM End	0.57	Issue Type +	Ma	Location *	LS
Category	Earthen Levee			GPS Latitude/Longitude	
				Start	End
Item	Trim / Thin Trees			38.239100 °	38.232070 °
				-121.518250 °	-121.522067 °
DWR ID	DWR_RD0556_01_s_2017_21				
Comment Code					
T2 : Thin trees to allow visibility of the ground and room to flood fight.					
Inspector Comment

View looking downstream at thick trees on the landside slope (Fall 2019).

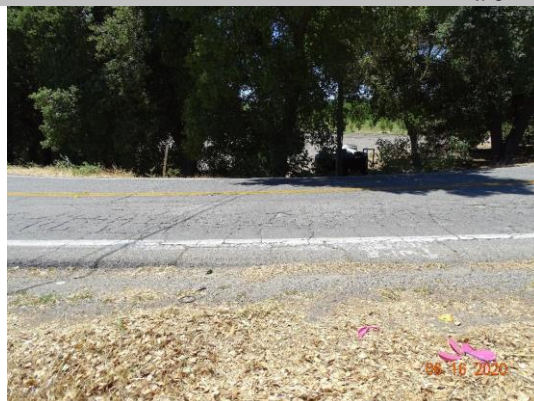
Photo 1 of 3 : UCIP_FA_2020_61316_88594.jpg

LM Start	0.01	Rating **	M	Issue No.	70
LM End	0.01	Issue Type +	En	Location *	
Category	Supplemental			GPS Latitude/Longitude	
				Start	End
Item	DWR UCIP Field Study			38.238980 °	38.238980 °
				-121.518153 °	-121.518153 °
DWR ID	20832

Comment Code					
Inspector Comment					
DS_ID:20832 FS_ID:61316 EP_NO: 6601 Repair Type: Non-Urgent EVAL Issue: Pipe Not Found Crossing Status: Indicator Found UCIP Comments: 06/16/2020 Record updated from No Action Needed to Non-Urgent. Crossing not found. Overhead telephone line across the levee at this location. (O.Yakimov - DWR UCIP) 05/01/2013 Telephone conduit through levee berm and Georgiana Slough. It does not go through levee section. (P.Amatya - DWR UCIP) FIELD_STRUCT_DESC: Unknown diameter and material telephone conduit across Georgiana Slough and through its levees, 3.5 feet below the crown. (Plans to place an armored submarine cable across Georgiana Slough and through its levees authorized under Permit 6601, 1969 - General Telephone Company of California). [Additional Reference(s): DWR Levee Log]. FS Date: 6/16/2020 1:06:36 PM

Top of Levee: View of levee crown looking from waterside

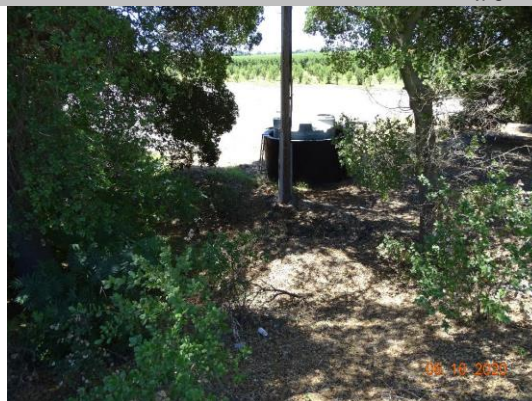
Photo 2 of 3 : UCIP_FA_2020_61316_88595.jpg

Land-Side: Telephone line pole at landside toe

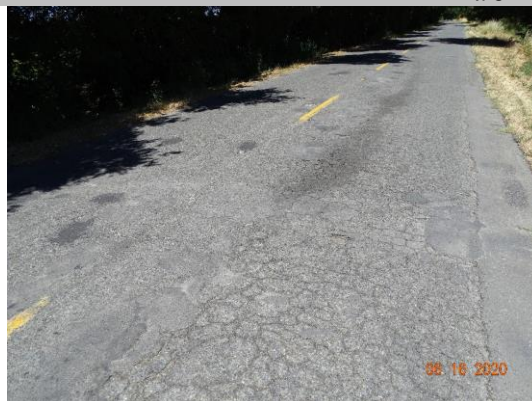
Photo 1 of 3 : UCIP_FA_2020_61317_88596.jpg

DS_ID:20820
FS_ID:61317
EP_NO: 3448
Repair Type: Non-Urgent
EVAL Issue: Safety Issue
Crossing Status: Indicator Found
UCIP Comments: 06/16/2020 Record remains Non-Urgent. No inspection records were available to determine status of line through the levee. Due to overgrown vegetation on waterside unable to inspect levee slope. Gas line marker not found. (O.Yakimov - DWR UCIP)
Dense vegetation inhibited visibility of gas line marker on WS. Need to contact owner to determine status of crossing.
FIELD_STRUCT_DESC: 4.5-inch steel natural gas pipeline through the levee, 4 feet below the crown. Location marker on the waterside (WS) shoulder. Cut in pavement visible at the crossing. Gas line marker on the landside (LS) and on the opposite bank at Reclamation District No. 263 (RD0263). Pipe not located in February 1991. (Plans for construction of a 4.5-inch gas line across Georgiana Slough from Andrus Island to Tyler Island authorized under Permit No. 3448, 1960 - Pacific Gas and Electric Company [PG&E]). [Additional Reference(s): DWR Levee Log].

Top of Levee: View of levee crown looking upstream

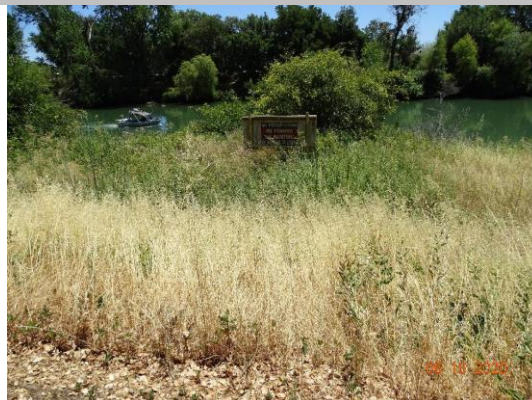
Photo 2 of 3 : UCIP_FA_2020_61317_88597.jpg

Water-Side: View of levee slope looking from crown

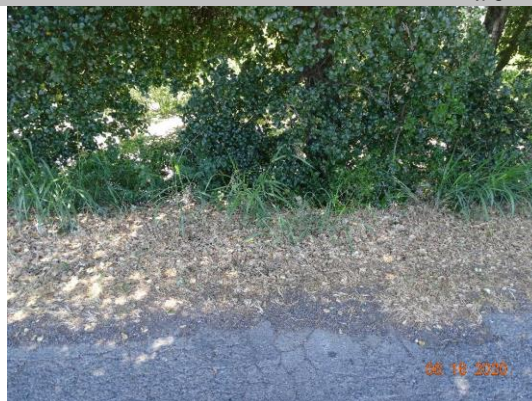
Photo 3 of 3 : UCIP_FA_2020_61317_88598.jpg

Land-Side: Overview of landside at the crossing

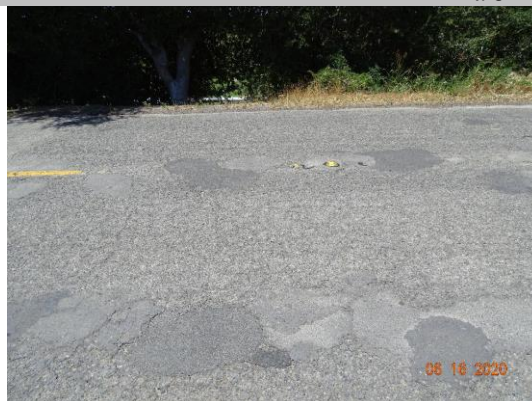
Photo 1 of 3 : UCIP_FA_2020_61333_88640.jpg

LM Start	0.53	Rating **	M	Issue No.	72
LM End	0.53	Issue Type +	En	Location *	
Category	Supplemental		GPS Latitude/Longitude		
			Start	End	
Item	DWR UCIP Field Study		38.232466 °	38.232466 °	
			-121.521609 °	-121.521609 °	
DWR ID	21454

DS_ID:21454
 FS_ID:61333
 EP_NO: N/A
 Repair Type: Non-Urgent
 EVAL Issue: Pipe Not Found
 Crossing Status: Not Found
 UCIP Comments: 06/16/2020 Record is Non-Urgent. Crossing not found. No permit has been identified authorizing pipe. Pipe shown in as-built drawing 50-04-2671 revision 1 from 06 February 1951. Unable to locate this crossing in as-built drawing 50-04-2671 revision 2 from 29 December 1952. (O.Yakimov - DWR UCIP)
 FIELD_STRUCT_DESC: 10-inch steel irrigation discharge pipe through the levee, at an unknown depth. Pump on the waterside (WS). 5-foot by 7-foot concrete distribution box on the landside (LS). Irrigation ditch on the LS.
 FS Date: 6/16/2020 1:45:44 PM

Top of Levee: View of levee crown looking from waterside

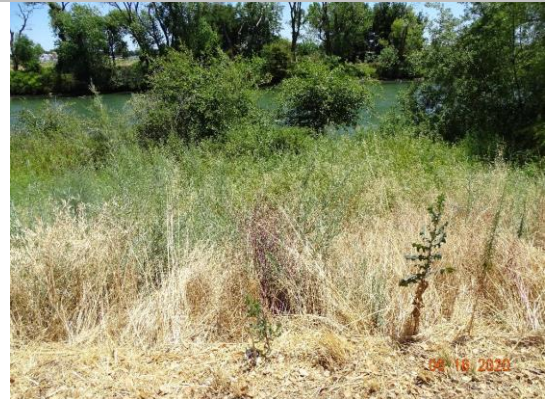
Photo 2 of 3 : UCIP_FA_2020_61333_88641.jpg

Water-Side: View of levee slope looking from crown

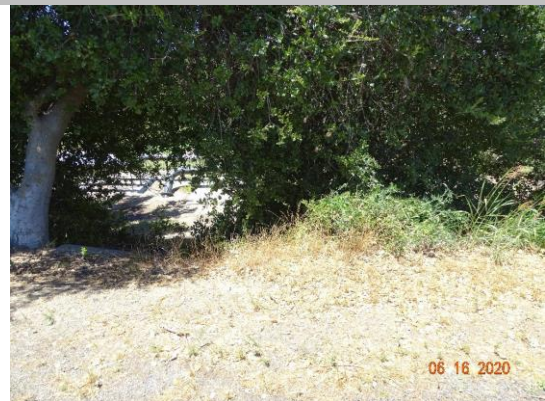
Photo 3 of 3 : UCIP_FA_2020_61333_88642.jpg

Land-Side: View of levee slope looking from crown

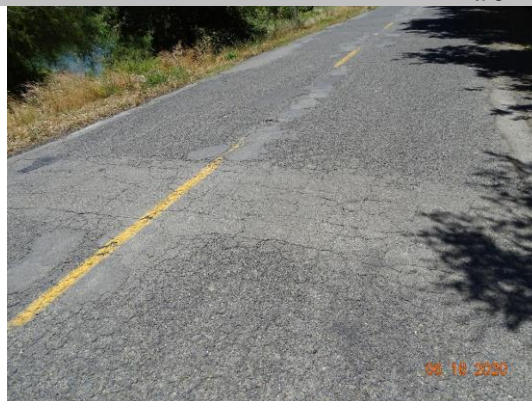
Photo 1 of 3 : UCIP_FA_2020_61336_88649.jpg

Comment Code					
Inspector Comment					
DS_ID:20821 FS_ID:61336 EP_NO: 5548 Repair Type: Non-Urgent EVAL Issue: Limited Inspection/No UCIP Evaluation Crossing Status: Found UCIP Comments: 06/16/2020 Record remains Non-Urgent. Unable to inspect waterside slope due to overgrown vegetation. Unable to find pump on waterside, instead, a gas pump and screen filters installed on landside. Unable to find a permit for modification. (O.Yakimov - DWR UCIP) 05/13/2015 Dense vegetation prevents inspection of WS slope. (K.Fazel - DWR UCIP) FIELD_STRUCT_DESC: 12-inch steel irrigation discharge pipe through the levee, 5 feet below the crown. 1.25-inch electrical conduit through the levee at the same location. Pump and screen filters on the landside. Concrete steps on the landside (LS) slope. Cuts in pavement visible at the crossing. Siphon breaker on waterside shoulder. (Plans to install a pump with a 12-inch discharge pipe and one electrical conduit through the levee authorized under Permit No. 5548, 1966 - George K. Adams). [Additional Reference(s): DWR Levee Log]. FS Date: 6/16/2020 1:47:59 PM

Top of Levee: View of levee crown looking downstream

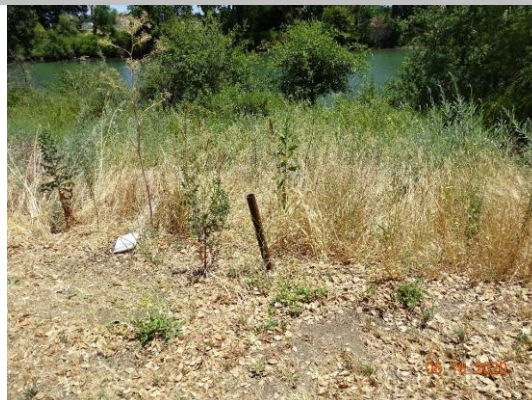
Photo 2 of 3 : UCIP_FA_2020_61336_88650.jpg

Water-Side: View of levee slope looking from crown

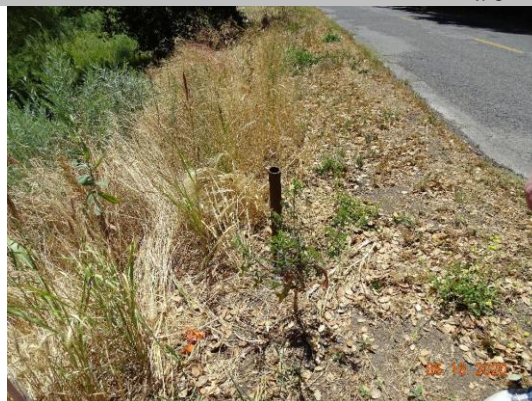
Photo 3 of 3 : UCIP_FA_2020_61336_88651.jpg

Water-Side: Air vent pipe on levee shoulder

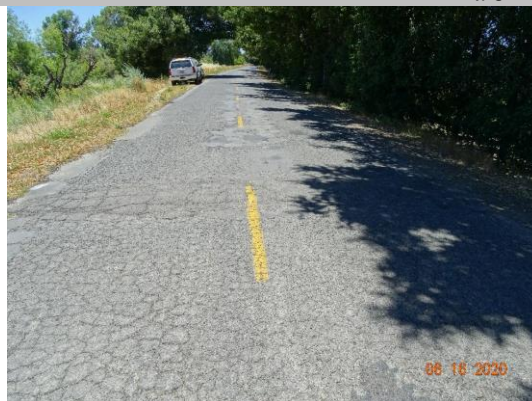
Photo 1 of 3 : UCIP_FA_2020_61344_88653.jpg

Top of Levee: View of levee crown looking downstream

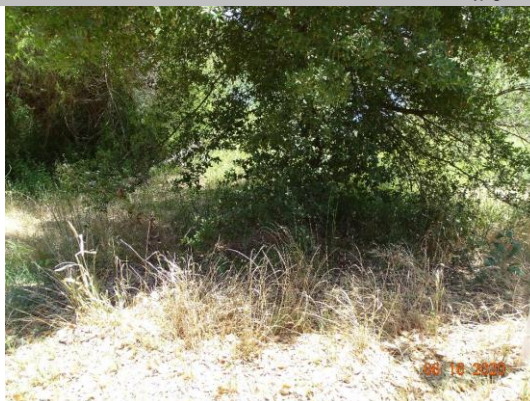
Photo 2 of 3 : UCIP_FA_2020_61344_88654.jpg

Water-Side: View of levee slope looking from crown

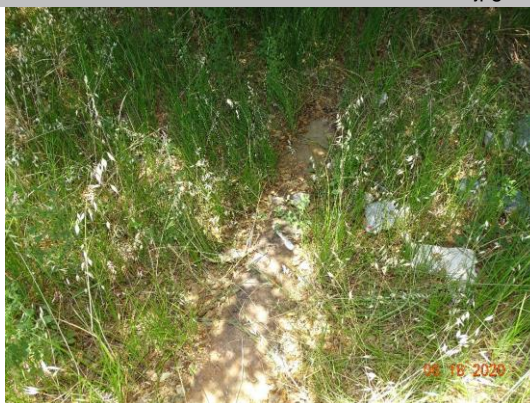
Photo 3 of 3 : UCIP_FA_2020_61344_88657.jpg

Water-Side: Abandoned pipe on levee slope

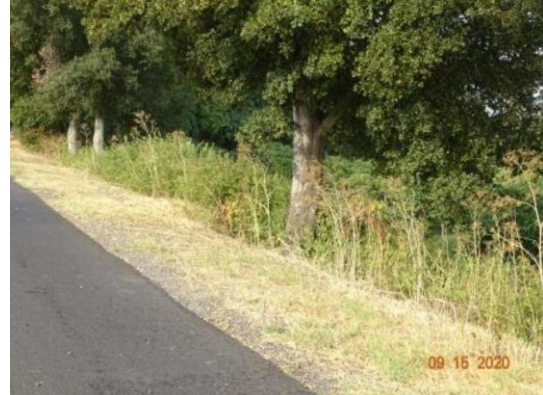
Photo 1 of 1 : FA_2020_RD0556_18_65_20200915_00090.jpg

LM Start	0.82	Rating **	U	Issue No.	65
LM End	0.85	Issue Type +	Ma	Location *	LS
Category	Earthen Levee			GPS Latitude/Longitude	
				Start	End
Item	Vegetation			38.229278 °	38.229013 °
				-121.525103 °	-121.525562 °
DWR ID	DWR_RD0556_01_f _ 2020_65				
Comment Code					
V2 : Remove the wild growth other than native grasses from the levee slopes.					
Inspector Comment

View looking downstream at vegetation on the landside slope (Fall 2020).

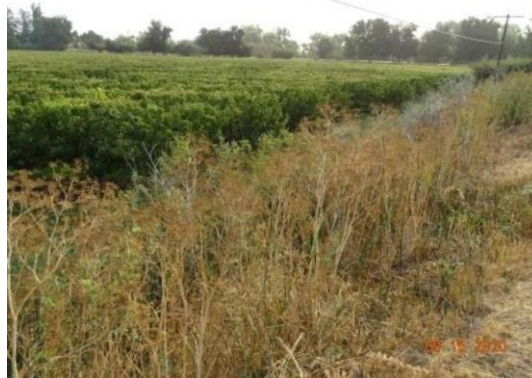
Photo 1 of 1 : FA_2020_RD0556_18_66_20200915_00091.jpg

LM Start	0.98	Rating **	U	Issue No.	66
LM End	1.57	Issue Type +	Ma	Location *	LS
Category	Earthen Levee			GPS Latitude/Longitude	
				Start	End
Item	Vegetation			38.227653 °	38.225012 °
				-121.527032 °	-121.535035 °
DWR ID	DWR_RD0556_01_f_2020_66				
Comment Code					
V2 : Remove the wild growth other than native grasses from the levee slopes.					
Inspector Comment

View looking upstream at annual vegetation on the landside slope (Fall 2020).

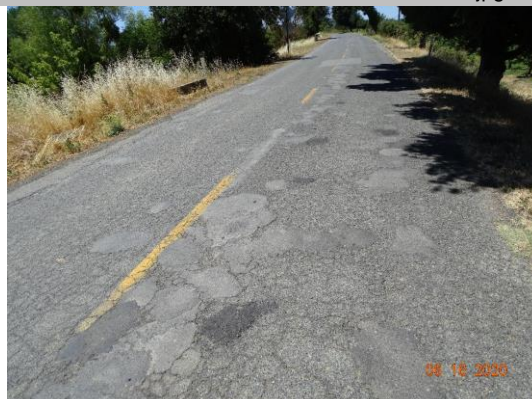
Photo 1 of 3 : UCIP_FA_2020_61348_88660.jpg

LM Start	1.17	Rating **	M	Issue No.	75	
LM End	1.17	Issue Type +	En	Location *		
Category	Supplemental			GPS Latitude/Longitude		
				Start	End	
Item	DWR UCIP Field Study			38.227534 °	38.227534 °	
				-121.529396 °	-121.529396 °	
DWR ID	25106

Comment Code						
Inspector Comment						
DS_ID:25106 FS_ID:61348 EP_NO: N/A Repair Type: Non-Urgent EVAL Issue: Unauthorized Encroachment Crossing Status: Found UCIP Comments: 06/16/2020 Record remains Non-Urgent. No permit has been found authorizing this pipe through the levee. Erosion site mentioned in previous inspection comment is not detected. Pipe is running- no leaks detected. (O.Yakimov - DWR UCIP) 05/27/2015 Possible erosion above pipe on LS needs attention. (K.Fazel - DWR UCIP) FIELD_STRUCT_DESC: 8-inch steel irrigation pipe through the levee, at an unknown depth. Pump, butterfly valve, siphon breaker, and screen filter on landside. Power pole with distribution panel on the LS. This crossing was field discovered. FS Date: 6/16/2020 2:39:20 PM

Top of Levee: View of levee crown looking downstream

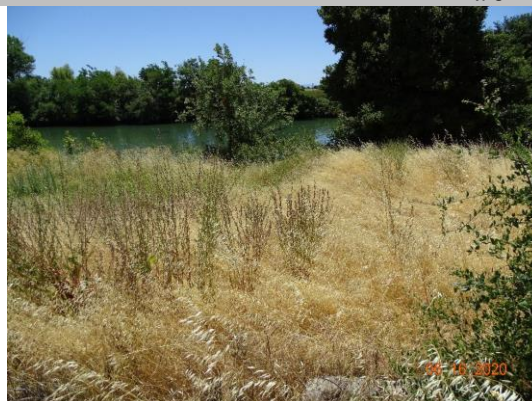
Photo 2 of 3 : UCIP_FA_2020_61348_88659.jpg

Water-Side: View of levee slope looking from crown

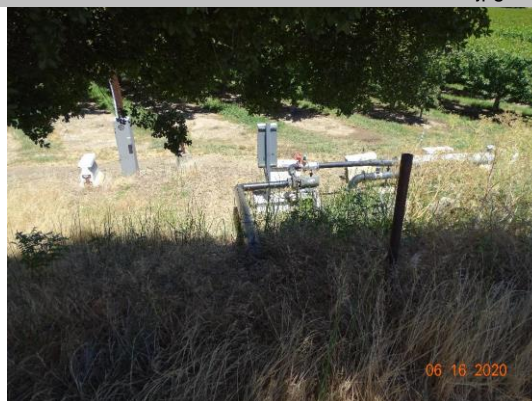
Photo 3 of 3 : UCIP_FA_2020_61348_88661.jpg

Land-Side: View of levee slope looking from crown

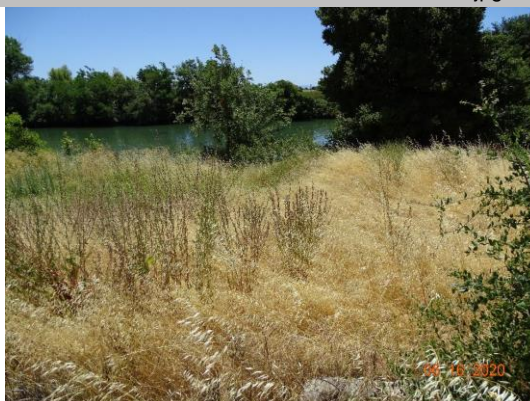
Photo 2 of 3 : UCIP_FA_2020_61377_88666.jpg

Water-Side: View of levee slope looking from crown

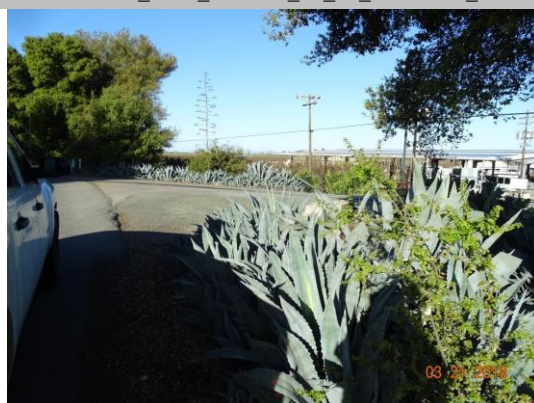
Photo 1 of 1 : FA_2020_RD0556_18_45_20200910_00028.jpg

LM Start	1.31	Rating **	U	Issue No.	45
LM End	1.33	Issue Type +	En	Location *	LS
Category	Earthen Levee			GPS Latitude/Longitude	
				Start	End
Item	Vegetation			38.227775 °	38.227651 °
				-121.531810 °	-121.532159 °
DWR ID	DWR_RD0556_01_s_2018_45				
Comment Code					
V6 : Landscaping					
Inspector Comment					
Remove cactus and trim trees.

View of cactus on the landside shoulder (Spring 2019).

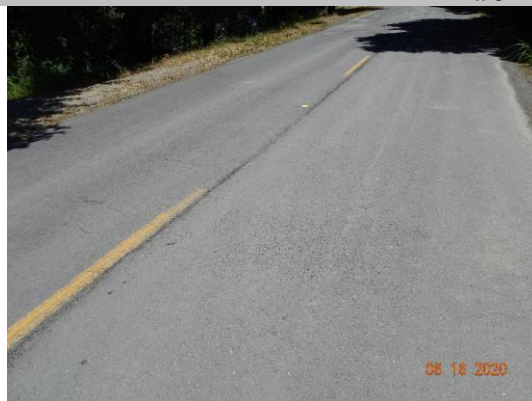
Photo 1 of 3 : UCIP_FA_2020_61398_88672.jpg

DS_ID:20825
FS_ID:61398
EP_NO: 13302
Repair Type: Non-Urgent
EVAL Issue: Levee Damage or Threat for Levee Damage
Crossing Status: Found
UCIP Comments: 06/16/2020 Record remains Non-Urgent. Concrete standpipe on landside has been replaced with a pressure tank. Unable to find a permit for modification. Depression around air release vent on landside shoulder about 2 feet in diameter and 1/2-foot deep. (O.Yakimov - DWR UCIP)
05/27/2015 Seal beneath siphon breaker off LS toe leaking. Rodent activity near crown off LS shoulder. Need to contact owner about leaky seal. Dense vegetation prevented inspection of WS slope. (K.Fazel - DWR UCIP)
FIELD_STRUCT_DESC: 6-inch steel irrigation discharge pipe and 2-inch galvanized iron electrical conduit through the levee, 2 feet below the crown. Siphon valve on the landside (LS) shoulder. Pump, gate valve, and pressure tank at the LS toe. Service pole and electrical box at the LS toe. 6-inch polyvinyl chloride (PVC) standpipe adjacent to the pipe off the LS toe. (Plans to install a 6-inch irrigation pipe and electrical conduit through the levee authorized under Permit No. 13302, 1981 - Kaydix Ranch). [Additional Reference(s): DWR Levee Log. USACE Sacramento O&M Manual 103, June 1954, (Station "R" 540+85), invert elevation 16.3 feet].

Top of Levee: View of levee crown looking downstream

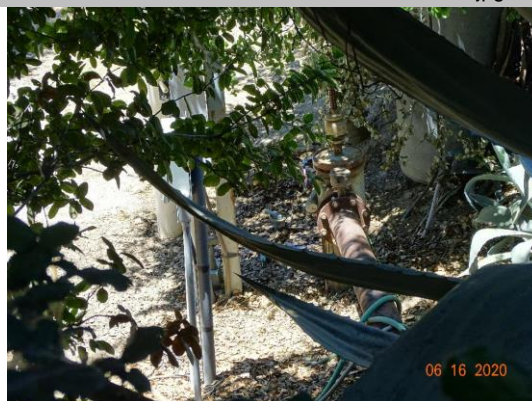
Photo 2 of 3 : UCIP_FA_2020_61398_88668.jpg

Land-Side: View of levee slope looking from crown

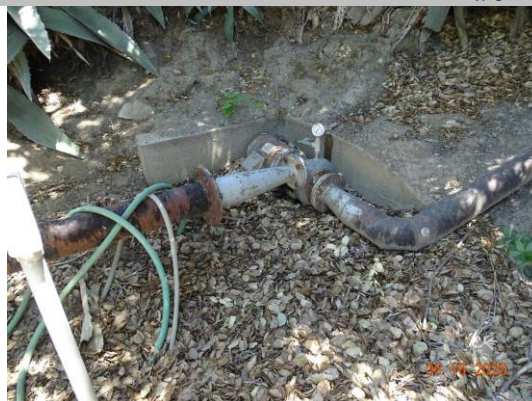
Photo 3 of 3 : UCIP_FA_2020_61398_88669.jpg

LM Start	1.33	Rating **	M	Issue No.	77 (cont)
LM End	1.33	Issue Type +	En	Location *	
Category	Supplemental			GPS Latitude/Longitude	
				Start	End
Item	DWR UCIP Field Study			38.227622 °	38.227622 °
				-121.532154 °	-121.532154 °
DWR ID	20825

Land-Side: Pump at levee toe

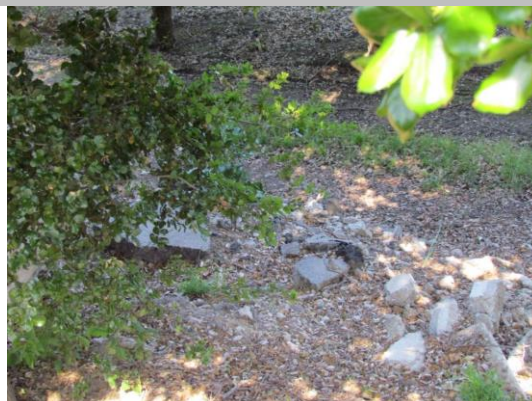
Photo 1 of 1 : FA_2020_RD0556_18_27_20200910_00012.jpg

LM Start	1.34	Rating **	U	Issue No.	27
LM End	1.37	Issue Type +	En	Location *	LS
Category	Earthen Levee			GPS Latitude/Longitude	
				Start	End
Item	Encroachments			38.227521 °	38.227320 °
				-121.532393 °	-121.532710 °
DWR ID	DWR_RD0556_01_s_2013_27				
Comment Code					
DE : Debris					
Inspector Comment					
Remove the pile of asphalt and concrete from the toe of levee.

View of concrete rubble at landside toe.

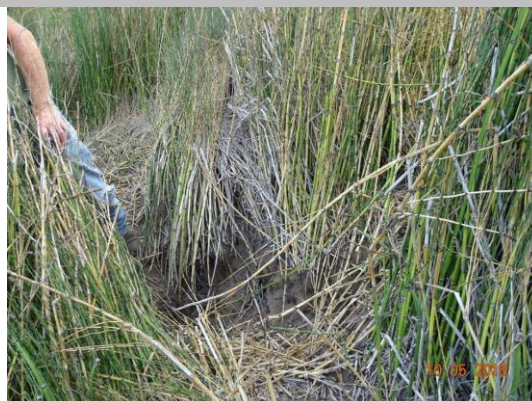
Photo 1 of 1 : FA_2020_RD0556_18_40_20200910_00024.jpg

LM Start	1.43	Rating **	M	Issue No.	40
LM End	1.43	Issue Type +	Ma	Location *	LS
Category	Earthen Levee			GPS Latitude/Longitude	
				Start	End
Item	Erosion / Bank Caving			38.226537 °	38.226537 °
				-121.533512 °	-121.533512 °
DWR ID	DWR_RD0556_01_f_2012_40				
Comment Code					
E1 : Note and monitor erosion site.					
Inspector Comment					
Erosion is covered by vegetation.

View of erosion that is covered by vegetation on the landside slope (October 2018).

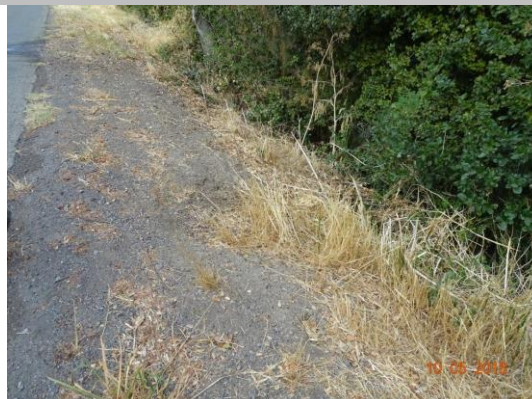
Photo 1 of 1 : FA_2020_RD0556_18_22_20200910_00006.jpg

LM Start	1.50	Rating **	M	Issue No.	22
LM End	1.50	Issue Type +	Ma	Location *	LS
Category	Earthen Levee			GPS Latitude/Longitude	
				Start	End
Item	Erosion / Bank Caving			38.225840 °	38.225840 °
				-121.534157 °	-121.534157 °
DWR ID	DWR_RD0556_01_s_2012_22				
Comment Code					
E1 : Note and monitor erosion site.					
Inspector Comment					
Dip at the top of the landside slope is greater than 3".

View of dip at the top of the landside slope (October 2018).

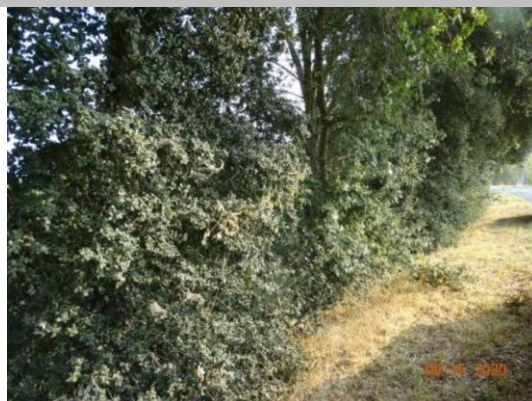
Photo 1 of 1 : FA_2020_RD0556_18_46_20200915_00092.jpg

LM Start	1.55	Rating **	U	Issue No.	46
LM End	1.64	Issue Type +	Ma	Location *	LS
Category	Earthen Levee			GPS Latitude/Longitude	
				Start	End
Item	Trim / Thin Trees			38.225268 °	38.224587 °
				-121.534733 °	-121.536129 °
DWR ID	DWR_RD0556_01_s_2018_46				
Comment Code					
T1 : Trim trees to at least five feet above ground level.					
Inspector Comment

View looking upstream at thick trees on the landside slope (Fall 2020).

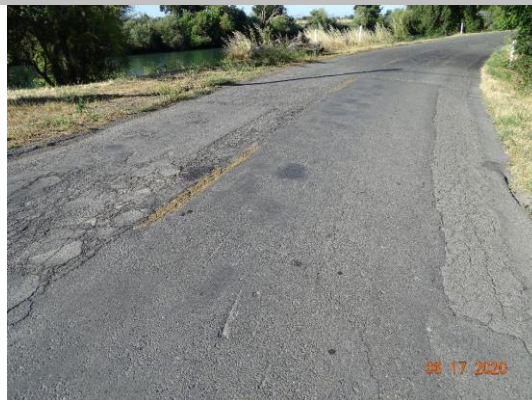
Photo 1 of 3 : UCIP_FA_2020_61399_88676.jpg

DS_ID:20827
FS_ID:61399
EP_NO: 11169
Repair Type: Non-Urgent
EVAL Issue: Unauthorized Modification or Non-Compliant Permit
Crossing Status: Found
UCIP Comments: 06/17/2020 Record remains Non-Urgent. Modifications to the crossing have been made after last UCIP inspection. Unable to find a permit for modifications. Enforcement case ENF 9545 open for this crossing. No permit has been identified authorizing original pipe. Need to have CVFPB review ABO and determine current owner. (O.Yakimov - DWR UCIP)
03/27/2015 Dense vegetation on LS and WS limited accessibility. (K.Fazel - DWR - UCIP)
FIELD_STRUCT_DESC: 6-inch steel irrigation discharge pipe through the levee, 3.5 feet below the crown. Pump, butterfly valve, filler pump and pipe on the waterside (WS) berm. 2-inch electrical conduit through the levee. Service pole with electric meter and panel on waterside shoulder. (Retention of a 10-inch pipe through the levee, 3.5 feet below the crown, and a pump and a gate valve on the WS berm authorized under Automatic Board Order (ABO) issued as Permit No. 11169, 1975 - Darrell T. and B. M. Mealer). [Additional Reference(s): DWR Levee Log, 10-inch pipe referenced. USACE Sacramento O&M Manual 103, June 1954, (Station ""R"" 528+02.1), 10-inch pipe referenced, invert elevation 16.6 feet].

Top of Levee: View of levee crown looking downstream

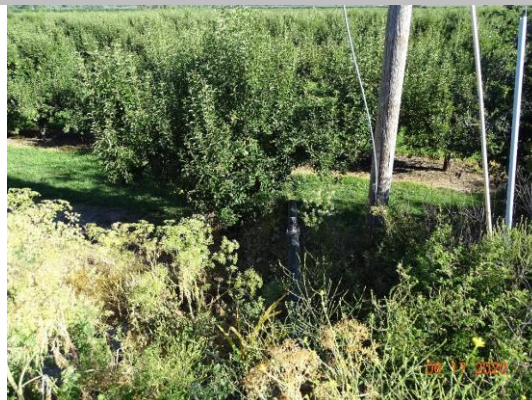
Photo 2 of 3 : UCIP_FA_2020_61399_88677.jpg

Land-Side: View of levee slope looking from crown

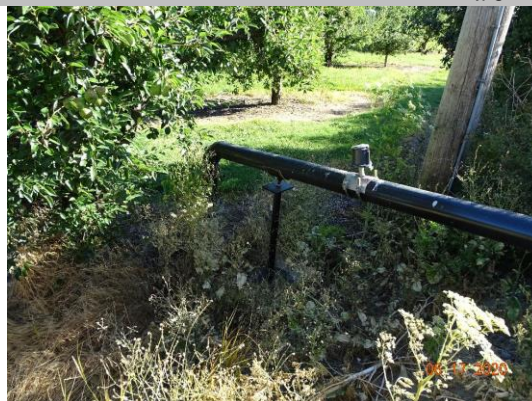
Photo 3 of 3 : UCIP_FA_2020_61399_88675.jpg

Land-Side: Pipe and junction pole at levee toe

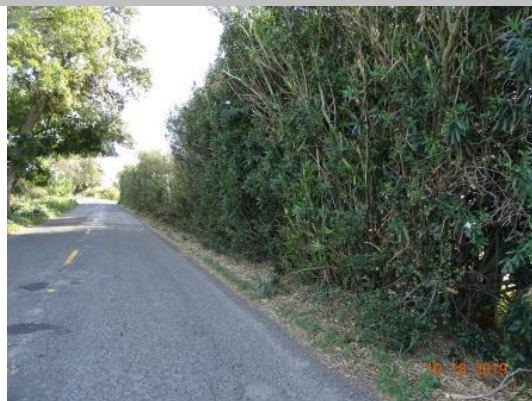
Photo 1 of 1 : FA_2020_RD0556_18_17_20200910_00003.jpg

LM Start	1.65	Rating **	U	Issue No.	17
LM End	1.70	Issue Type +	En	Location *	WS
Category	Earthen Levee			GPS Latitude/Longitude	
				Start	End
Item	Vegetation			38.224623 °	38.224408 °
				-121.536320 °	-121.537180 °
DWR ID	DWR_RD0556_01_s_2012_17				
Comment Code					
V6 : Landscaping					
Inspector Comment					
Oleanders blocking view down waterside slope

View looking upstream at thick oleanders on the waterside slope (Fall 2019).

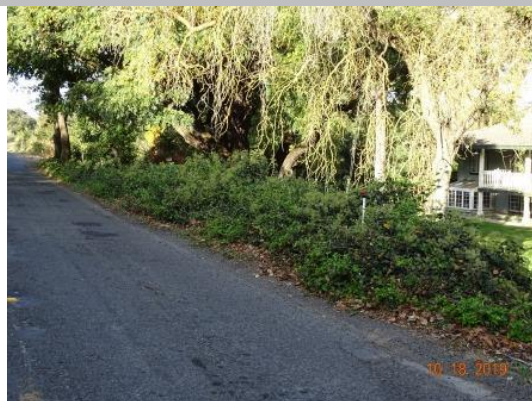
Photo 1 of 1 : FA_2020_RD0556_18_51_20200910_00032.jpg

LM Start	1.66	Rating **	U	Issue No.	51
LM End	1.69	Issue Type +	En	Location *	LS
Category	Earthen Levee			GPS Latitude/Longitude	
				Start	End
Item	Vegetation			38.224487 °	38.224355 °
				-121.536492 °	-121.537055 °
DWR ID	DWR_RD0556_01_f_2019_51				
Comment Code					
V6 : Landscaping					
Inspector Comment

View looking downstream at landscaping on the landside slope (Fall 2019).

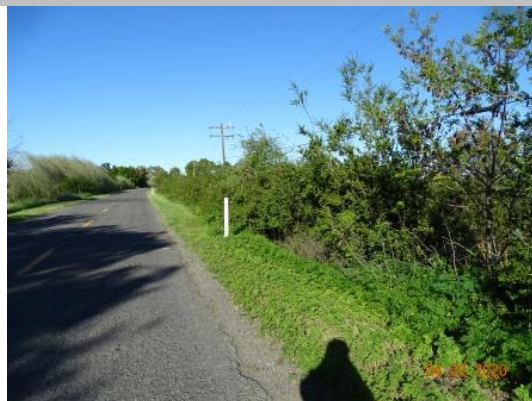
Photo 1 of 1 : FA_2020_RD0556_18_19_20200910_00004.jpg

LM Start	1.71	Rating **	U	Issue No.	19
LM End	1.89	Issue Type +	Ma	Location *	LS
Category	Earthen Levee			GPS Latitude/Longitude	
				Start	End
Item	Vegetation			38.224301 °	38.223783 °
				-121.537367 °	-121.540572 °
DWR ID	DWR_RD0556_01_s_2020_19				
Comment Code					
V2 : Remove the wild growth other than native grasses from the levee slopes.					
Inspector Comment

View looking downstream at thick wild vegetation on the landside slope (Spring 2020).

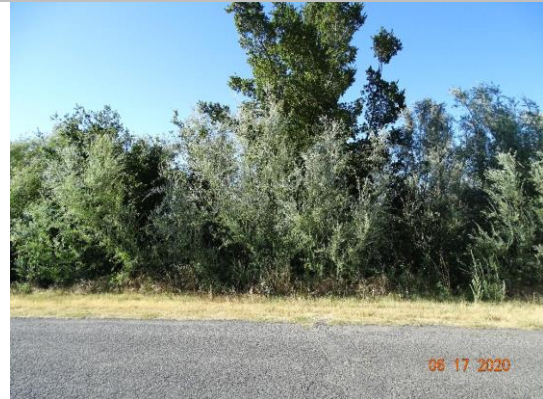
Photo 2 of 3 : UCIP_FA_2020_61400_88682.jpg

Comment Code						
Inspector Comment						
DS_ID:20828 FS_ID:61400 EP_NO: 3735 Repair Type: Non-Urgent EVAL Issue: Limited Inspection/No UCIP Evaluation Crossing Status: Indicator Found UCIP Comments: 06/17/2020 Record remains Non-Urgent. Overgrown vegetation on waterside limits levee slope inspection. (O.Yakimov - DWR UCIP) 05/27/2015 Dense vegetation on LS and WS limited accessibility. (K.Fazel - DWR - UCIP) FIELD_STRUCT_DESC: 4-inch electrical conduit of an unknown material under Georgiana Slough and through its levees, 4 feet below the crown. Pump on the waterside (WS) berm. Power pole on the landside (LS) in alignment with the cuts in the pavement. (Plans for installation of a 12-kilovolt submarine cable under Georgiana Slough and through its levees authorized under Permit No. 3735, 1961 - Pacific Gas and Electric Company [PG&E]). [Additional Reference(s): DWR Levee Log]. FS Date: 6/17/2020 11:39:33 AM

Water-Side: Overview of vegetation on waterside

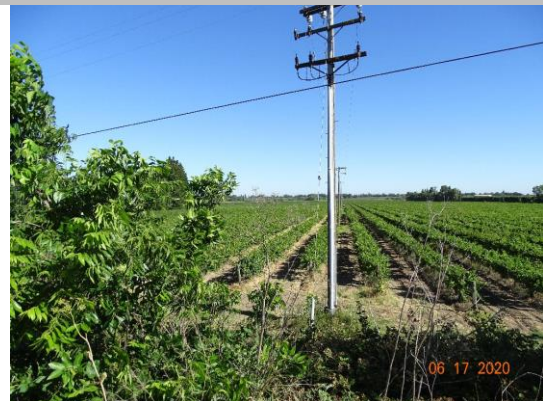
Photo 3 of 3 : UCIP_FA_2020_61400_88683.jpg

Land-Side: Overview of landside from crown

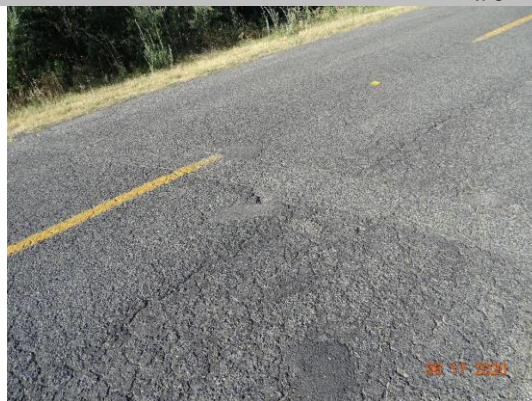
Photo 1 of 3 : UCIP_FA_2020_61314_88741.jpg

Comment Code						
Inspector Comment						
DS_ID:21510 FS_ID:61314 EP_NO: N/A Repair Type: Non-Urgent EVAL Issue: Pipe Not Found Crossing Status: Not Found UCIP Comments: 06/17/2020 Record is Non-Urgent. Crossing not found. No permit has been identified authorizing pipe. Pipe shown in as-built drawing 50-04-2671 revision 1 from 06 February 1951. Unable to locate this crossing in as-built drawing 50-04-2671 revision 2 from 29 December 1952. (O.Yakimov - DWR UCIP) FIELD_STRUCT_DESC: 8-inch steel irrigation pipe, pump on waterside of the levee, a 36-inch concrete distribution chamber on landside, a 12-inch riser with flood valve at Station R 516+00. O&M Manual Sac 103, June 1954 FS Date: 6/17/2020

Top of Levee: View of levee crown at potential crossing

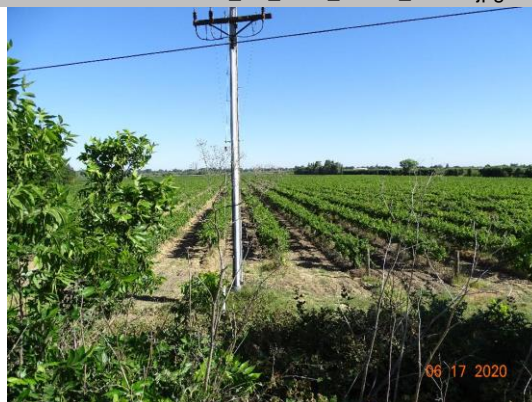
Photo 2 of 3 : UCIP_FA_2020_61314_88739.jpg

Land-Side: Overview of landside from crown

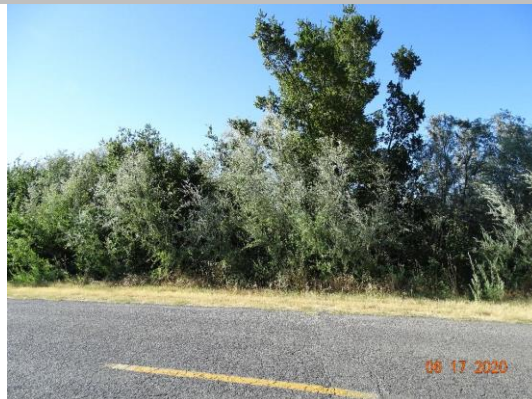
Photo 3 of 3 : UCIP_FA_2020_61314_88740.jpg

Water-Side: Overview of waterside from crown

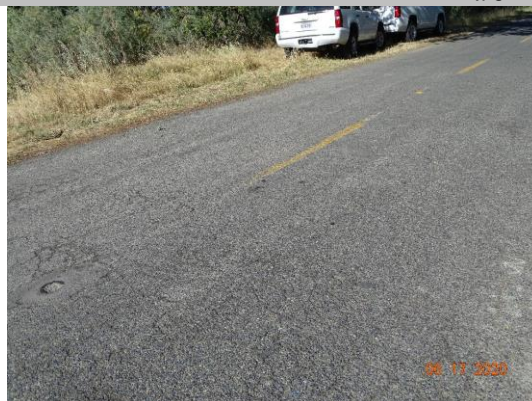
Photo 1 of 3 : UCIP_FA_2020_61414_88746.jpg

Comment Code					
Inspector Comment					
DS_ID:20829 FS_ID:61414 EP_NO: 11178 Repair Type: Non-Urgent EVAL Issue: Levee Damage or Threat for Levee Damage Crossing Status: Found UCIP Comments: 06/17/2020 Record remains Non-Urgent. Depression on landside levee slope less than 1/2-foot-deep in pipe alignment. Vegetation on both levee slopes. Limited visibility through vegetation restrains complete evaluation of slope condition. Electric meter is energized. No permit has been identified authorizing pipe. Need to have CVFPB review ABO and determine current owner. (O.Yakimov - DWR UCIP) 05/27/2015 Dense vegetation on WS and LS. Some oil leakage inside pumphouse. (K. Fazel - DWR UCIP) FIELD_STRUCT_DESC: 8-inch steel irrigation discharge pipe through the levee, 3.7 feet below the crown. 2-inch electrical conduit through the levee, next to the 8-inch discharge pipe. 1-inch air valve and pump on the waterside (WS) berm. Service pole on the landside (LS) slope. Tin and wood pump house on the WS berm. 12-foot by 3-foot concrete standpipe on the LS. (Retention of an 8-inch pipe through the levee, 3.7 feet below the crown, a pump on the WS berm, and a service pole on the LS slope authorized under Automatic Board Order (ABO) issued as Permit No. 11178, 1975 - Allena D. Swett). [Additional Reference(s): DWR Levee Log. USACE Sacramento O&M Manual 103, June 1954, (Station ""R"" 511+00), invert elevation 16.4 feet]. FS Date: 6/17/2020 10:33:05 AM

Top of Levee: View of levee crown looking downstream

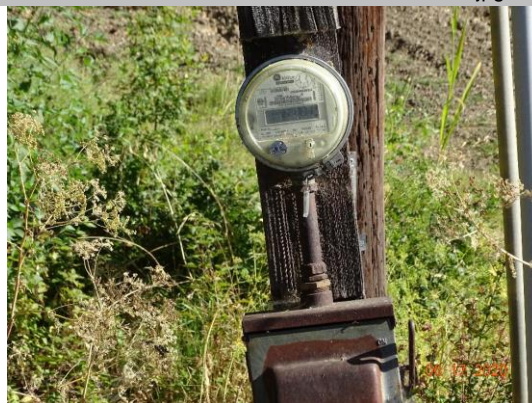
Photo 3 of 3 : UCIP_FA_2020_61414_88748.jpg

Land-Side: Electric meter and panel

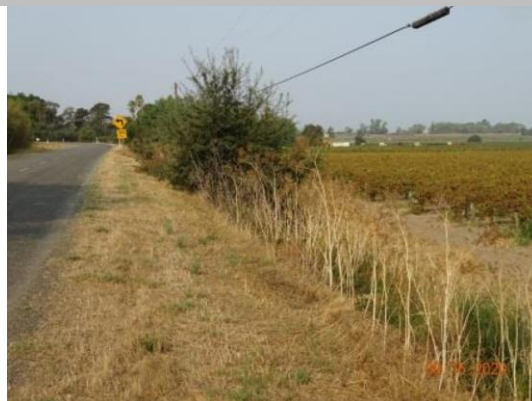
Photo 1 of 1 : FA_2020_RD0556_18_49_20200915_00093.jpg

LM Start	1.94	Rating **	U	Issue No.	49
LM End	2.27	Issue Type +	Ma	Location *	LS
Category	Earthen Levee			GPS Latitude/Longitude	
				Start	End
Item	Vegetation			38.223690 °	38.220648 °
				-121.541635 °	-121.544297 °
DWR ID	DWR_RD0556_01_f _ 2020_49				
Comment Code					
V2 : Remove the wild growth other than native grasses from the levee slopes.					
Inspector Comment

View looking downstream at vegetation on the landside slope (Fall 2020).

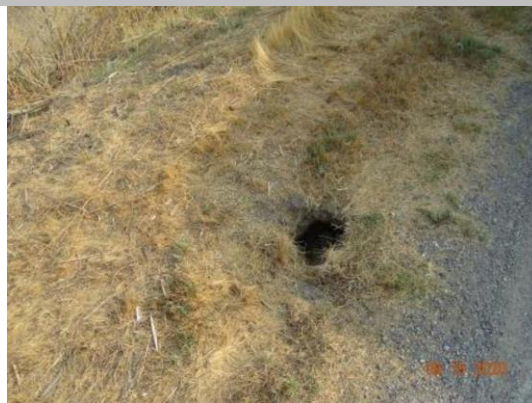
Photo 1 of 2 : FA_2020_RD0556_18_61_20200915_00094.jpg

LM Start	2.05	Rating **	U	Issue No.	61
LM End	2.07	Issue Type +	Ma	Location *	LS
Category	Earthen Levee			GPS Latitude/Longitude	
				Start	End
Item	Animal Control			38.223487 °	38.223340 °
				-121.543482 °	-121.543917 °
DWR ID	DWR_RD0556_01_f _ 2020_61				
Comment Code					
A1 : Exterminate rodents and backfill and compact or grout burrows.					
Inspector Comment

View of large animal hole on the landside hinge (Fall 2020).

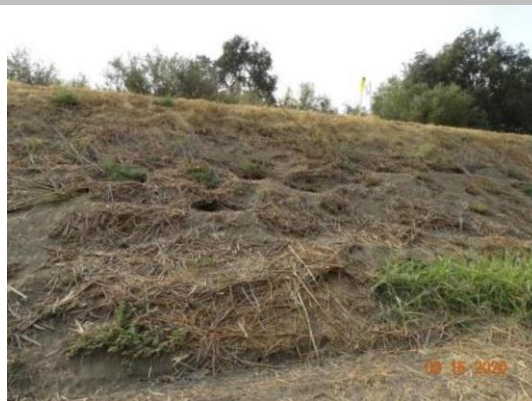
Photo 2 of 2 : FA_2020_RD0556_18_61_20200915_00095.jpg

View of multiple squirrel holes in the landside slope (Fall 2020).

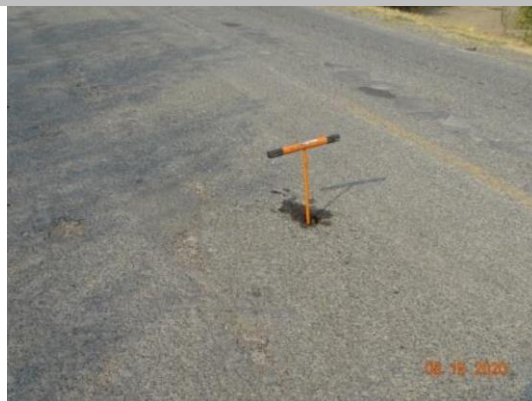
Photo 1 of 1 : FA_2020_RD0556_18_67_20200915_00096.jpg

LM Start	2.06	Rating **	U	Issue No.	67
LM End	2.06	Issue Type +	Ma	Location *	CR
Category	Earthen Levee			GPS Latitude/Longitude	
				Start	End
Item	Animal Control			38.223373 °	38.223373 °
				-121.543763 °	-121.543763 °
DWR ID	DWR_RD0556_01_f_2020_67				
Comment Code					
A1 : Exterminate rodents and backfill and compact or grout burrows.					
Inspector Comment					
Hole at least two feet deep. Directly next to animal holes on the landside slope.

View of animal hole at least two feet deep in the crown of the levee (Fall 2020).

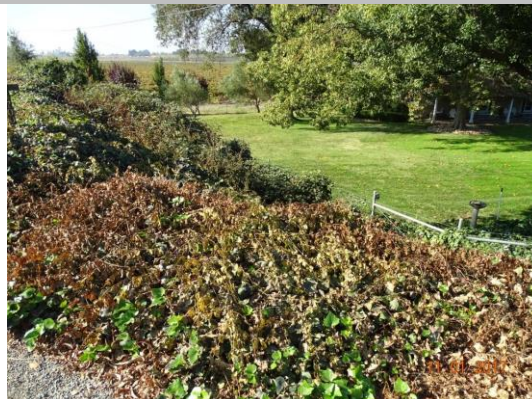
Photo 1 of 1 : FA_2020_RD0556_18_25_20200910_00010.jpg

LM Start	2.09	Rating **	U	Issue No.	25
LM End	2.11	Issue Type +	En	Location *	LS
Category	Earthen Levee			GPS Latitude/Longitude	
				Start	End
Item	Encroachments			38.223087 °	38.222850 °
				-121.544140 °	-121.544330 °
DWR ID	DWR_RD0556_01_f_2017_25				
Comment Code					
FE : Fence					
Inspector Comment

Unpermitted fence covered in berry vines along landside levee toe should be moved back 10 feet to allow access.

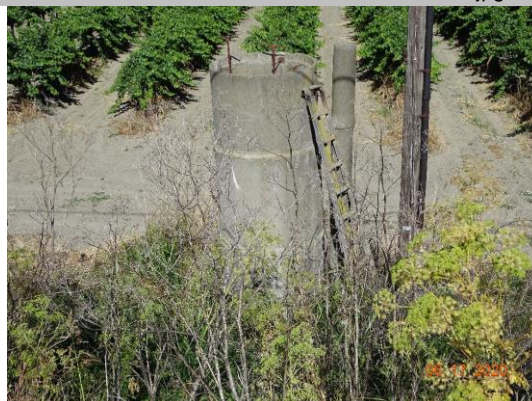
Photo 1 of 3 : UCIP_FA_2020_61459_88910.jpg

DS_ID:20830
FS_ID:61459
EP_NO: 2392
Repair Type: Non-Urgent
EVAL Issue: Limited Inspection/No UCIP Evaluation
Crossing Status: Found
UCIP Comments: 06/17/2020 Record remains Non-Urgent. Unable to evaluate levee slopes condition due to overgrown vegetation. (O.Yakimov - DWR UCIP)
05/27/2015 Hole and exposed depression adjacent to pipe at LS. Dense vegetation on WS and LS limited visibility. (K.Fazel - DWR UCIP)
FIELD_STRUCT_DESC: 12-inch steel irrigation discharge pipe through the levee, 3 feet below the crown. Slant pump on the waterside (WS) bank. 1-inch electrical conduit through the levee, beside the 12-inch pipe, visible on the WS. Service pole and two standpipes at the landside (LS) toe. One of the two standpipes is 6 inches. (Plans for the installation of a pumping plant and a steel pipe through the levee authorized under Permit No. 2392, 1956 - Loyal D. Mealer). [Additional Reference(s): DWR Levee Log].

Land-Side: Junction pole and two concrete standpipes at levee toe

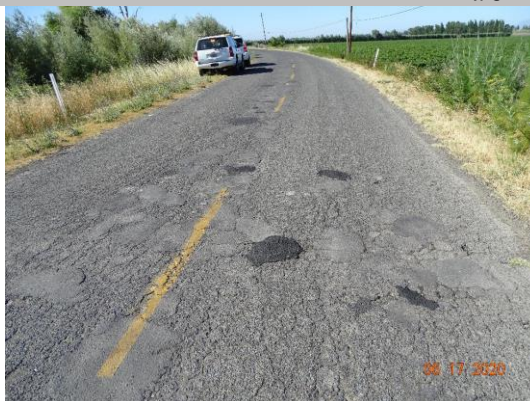
Photo 2 of 3 : UCIP_FA_2020_61459_88907.jpg

Top of Levee: View of levee crown looking downstream

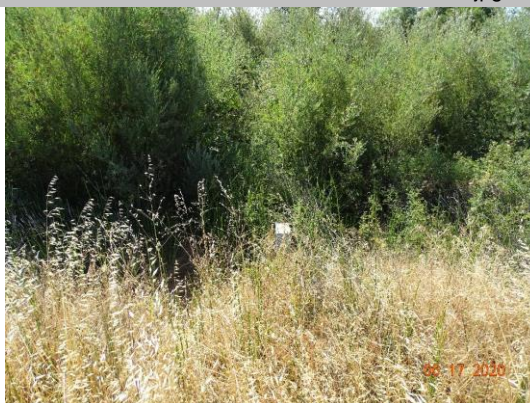
Photo 3 of 3 : UCIP_FA_2020_61459_88908.jpg

Water-Side: View of levee slope looking from crown

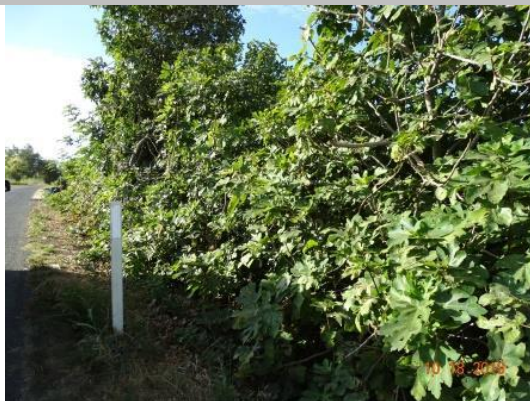
Photo 1 of 1 : FA_2020_RD0556_18_53_20200910_00034.jpg

LM Start	2.32	Rating **	U	Issue No.	53
LM End	2.32	Issue Type +	Ma	Location *	LS
Category	Earthen Levee			GPS Latitude/Longitude	
				Start	End
Item	Trim / Thin Trees			38.219813 °	38.219813 °
				-121.544032 °	-121.544032 °
DWR ID	DWR_RD0556_01_f_2019_53				
Comment Code					
T2 : Thin trees to allow visibility of the ground and room to flood fight.					
Inspector Comment

View looking downstream at fig tree on the landside slope (Fall 2019).

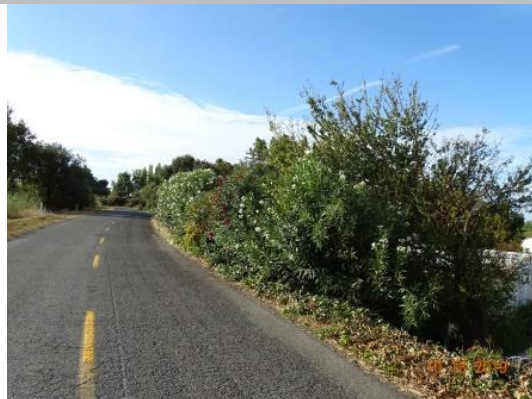
Photo 1 of 1 : FA_2020_RD0556_18_31_20200910_00016.jpg

LM Start	2.38	Rating **	U	Issue No.	31
LM End	2.47	Issue Type +	En	Location *	LS
Category	Earthen Levee			GPS Latitude/Longitude	
				Start	End
Item	Vegetation			38.219037 °	38.217781 °
				-121.543847 °	-121.543817 °
DWR ID	DWR_RD0556_01_s_2017_31				
Comment Code					
V6 : Landscaping					
Inspector Comment

View looking downstream at landscaping on the landside slope (Fall 2019).

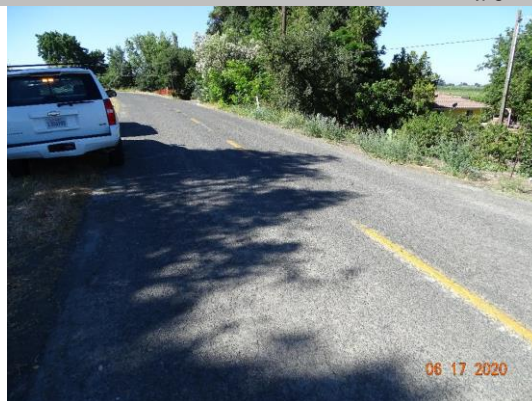
Photo 1 of 3 : UCIP_FA_2020_61499_89027.jpg

Comment Code						
Inspector Comment						
DS_ID:20831 FS_ID:61499 EP_NO: 11169 Repair Type: Non-Urgent EVAL Issue: Levee Damage or Threat for Levee Damage Crossing Status: Found UCIP Comments: 06/17/2020 Record remains Non-Urgent. 2-foot diameter sinkhole is still present on landside shoulder around air vent, size of hole is not growing over time. Electrical conduit is open on waterside slope with wires cut and not insulated. No permit has been identified authorizing pipe. Need to have CVFPB review ABO and determine current owner. (O.Yakimov - DWR UCIP) 07/12/2018 Hole near air vent on LS slope is still present but haven't increased in size. Pipe was running at the time of site visit, no leaks detected. Downgraded to "Non-Urgent" due to absence of levee threat. (O.Yakimov - DWR UCIP) 05/27/2015 2'x 2' hole on levee off LS shoulder. FIELD_STRUCT_DESC: 8-inch steel irrigation discharge pipe through the levee, 3.7 feet below the crown. 1-inch air valve. Pump and switch panel on the waterside (WS) berm. Service pole on the landside (LS). 9-foot by 3-foot concrete standpipe on the LS. 3 cables encased in a 1.5-inch steel conduit through the levee and on the WS, alongside the 8-inch pipe, disconnected on the WS. (Retention of an 8-inch pipe through the levee, 3.7 feet below the crown, a pump and a switch panel on the WS berm, and a service pole on the LS authorized under Automatic Board Order (ABO) issued as Permit No. 11169, 1975 - Darrell T. and B. M. Mealer). [Additional Reference(s): DWR Levee Log. USACE Sacramento O&M Manual 103, June 1954, (Station ""R"" 482+49.3), invert elevation 16 feet]. FS Date: 6/17/2020 10:55:51 AM

Top of Levee: View of levee crown looking downstream

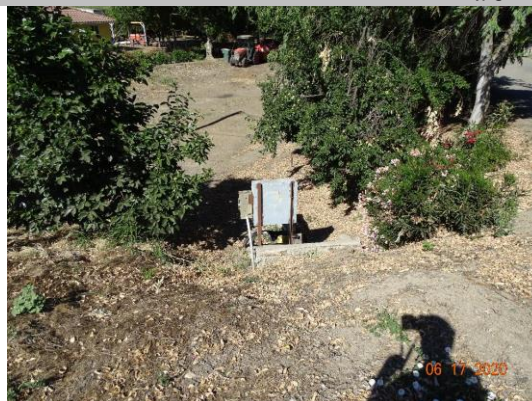
Photo 2 of 3 : UCIP_FA_2020_61499_89030.jpg

Land-Side: View of levee slope looking from crown

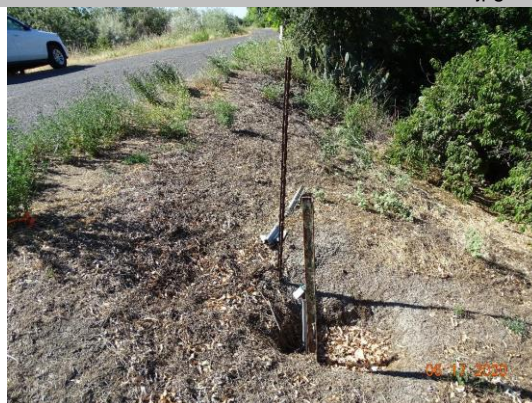
Photo 3 of 3 : UCIP_FA_2020_61499_89029.jpg

Land-Side: Overview of levee shoulder

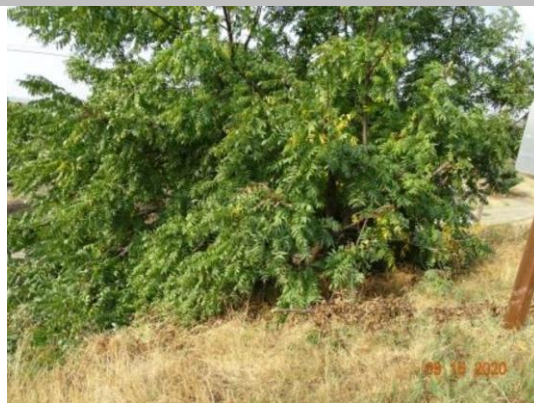
Photo 1 of 1 : FA_2020_RD0556_18_68_20200915_00089.jpg

LM Start	2.63	Rating **	U	Issue No.	68
LM End	2.63	Issue Type +	Ma	Location *	LS
Category	Earthen Levee			GPS Latitude/Longitude	
				Start	End
Item	Trim / Thin Trees			38.215850 °	38.215850 °
				-121.542045 °	-121.542045 °
DWR ID	DWR_RD0556_01_f _ 2020_68				
Comment Code					
T1 : Trim trees to at least five feet above ground level.					
Inspector Comment

View of thick tree on the landside slope (Fall 2020).

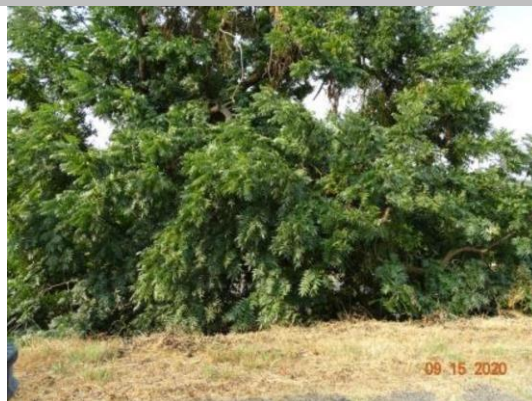
Photo 1 of 1 : FA_2020_RD0556_18_69_20200915_00097.jpg

LM Start	2.69	Rating **	U	Issue No.	69
LM End	2.69	Issue Type +	Ma	Location *	LS
Category	Earthen Levee			GPS Latitude/Longitude	
				Start	End
Item	Trim / Thin Trees			38.215382 °	38.215382 °
				-121.541247 °	-121.541247 °
DWR ID	DWR_RD0556_01_f _ 2020_69				
Comment Code					
T1 : Trim trees to at least five feet above ground level.					
Inspector Comment

View of thick tree on the landside slope (Fall 2020).

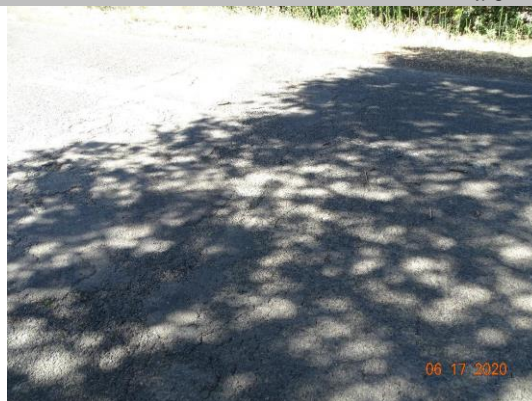
Photo 1 of 3 : UCIP_FA_2020_61501_89042.jpg

Comment Code					
Inspector Comment					
DS_ID:20848 FS_ID:61501 EP_NO: 11167 Repair Type: Non-Urgent EVAL Issue: Unauthorized Modification or Non-Compliant Permit Crossing Status: Found UCIP Comments: 06/17/2020 Record remains Non-Urgent. Unable to find a permit for sleeving 3-inch pipe through 8-inch pipe. No permit has been identified authorizing original pipe through the levee. Need to have CVFPB review ABO and determine current owner. (O.Yakimov - DWR UCIP) 06/05/2015 Pipe appears out of use; if so, coordinate with owner to abandon properly per Title 23. (K.Fazel - DWR UCIP) FIELD_STRUCT_DESC: 3-inch steel irrigation discharge pipe sleeved through the 8-inch steel pipe, 3 feet below the crown. Annular space appears to be grouted. 3-inch pipe connected to the pump on the waterside (WS). 0.75-inch primer pipe. Gate valve on the WS berm. Polyvinyl chloride (PVC) standpipe off the landside (LS) toe, previously a 6-foot by 3-foot concrete standpipe. (8-inch pipe [HLM 2.70] authorized under Automatic Board Order (ABO) issued as Permit No. 11167, 1975 - Russel G. Graham). [Additional Reference(s): DWR Levee Log. USACE Sacramento O&M Manual 103, June 1954, (Station ""R"" 468+52.7), invert elevation 15.9 feet]. FS Date: 6/17/2020 11:55:47 AM

Top of Levee: View of levee crown looking from waterside

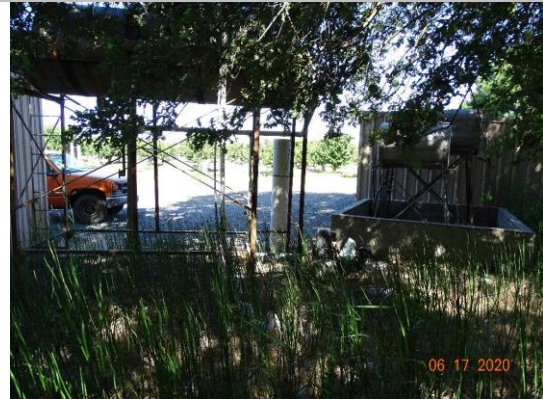
Photo 2 of 3 : UCIP_FA_2020_61501_89043.jpg

Land-Side: PVC standpipe off levee toe

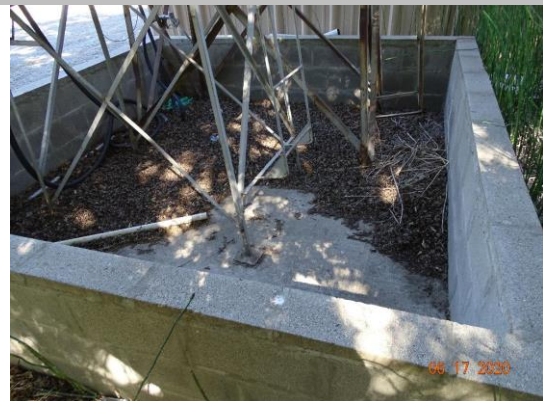
Photo 3 of 3 : UCIP_FA_2020_61501_89044.jpg

Land-Side: Water tank support structure on landside

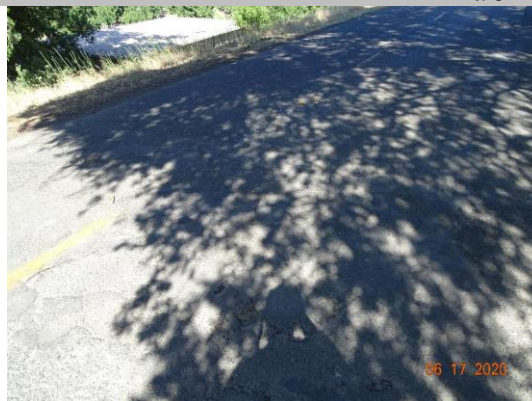
Photo 1 of 3 : UCIP_FA_2020_61500_89041.jpg

DS_ID:20833
 FS_ID:61500
 EP_NO: 11167
 Repair Type: Non-Urgent
 EVAL Issue: Unauthorized Modification or Non-Compliant Permit
 Crossing Status: Found
 UCIP Comments: 06/17/2020 Record is Non-Urgent. Unable to find a permit for sleeving 10-inch pipe through 12-inch pipe. Unauthorized encroachment recorded in Levee Log prior to 2011. Need to have CVFPB review ABO and determine current owner. (O.Yakimov - DWR UCIP)
 FIELD_STRUCT_DESC: 10-inch steel irrigation pipe sleeved through 12-inch steel pipe through levee, 4.0 feet below crown. Slant pump and gate valve on bank. 2-inch conduit through the levee 2 feet below crown. Service pole at landward toe. (12-inch pipe [HLM 2.70] authorized under Automatic Board Order (ABO) issued as Permit No. 11167, 1975 - Russel G. Graham).
 FS Date: 6/17/2020

Top of Levee: View of levee crown looking upstream

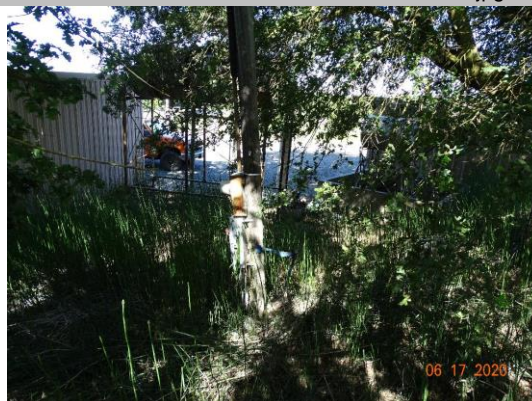
Photo 2 of 3 : UCIP_FA_2020_61500_89035.jpg

Land-Side: View of levee slope looking from crown

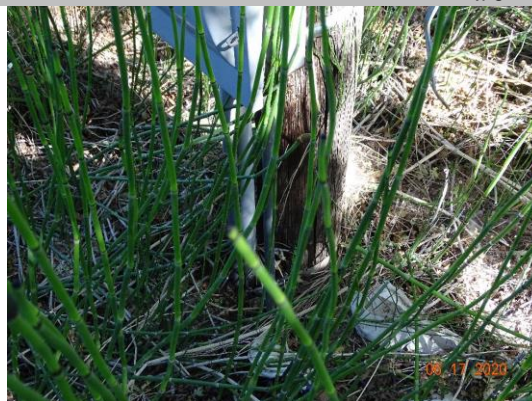
Photo 3 of 3 : UCIP_FA_2020_61500_89036.jpg

Land-Side: Conduits enter the ground at service pole

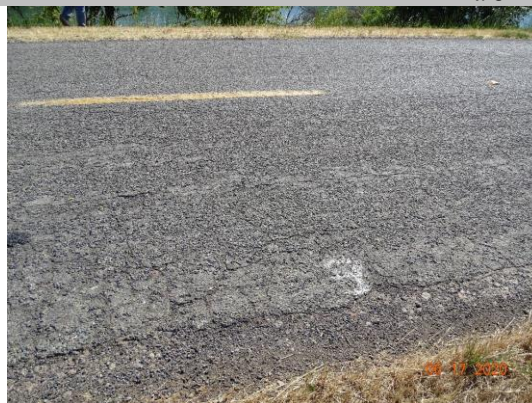
Photo 1 of 3 : UCIP_FA_2020_61276_89049.jpg

LM Start	2.88	Rating **	M	Issue No.	86	
LM End	2.88	Issue Type +	En	Location *		
Category	Supplemental			GPS Latitude/Longitude		
				Start		End
Item	DWR UCIP Field Study			38.213713 °		38.213713 °
				-121.538547 °		-121.538547 °
DWR ID	21456					
Comment Code						
Inspector Comment						
DS_ID:21456 FS_ID:61276 EP_NO: N/A Repair Type: Non-Urgent EVAL Issue: Pipe Not Found Crossing Status: Not Found UCIP Comments: 06/17/2020 Record is Non-Urgent. Crossing not found. No permit has been identified authorizing pipe. (O.Yakimov - DWR UCIP) FIELD_STRUCT_DESC: Unknown diameter pipe to irrigation ditch at unknown depth below crown. 18-inch diameter and 8 ft tall standpipe on LS. Found only in As Built Drawing # 50-04-2631 approximately at Station 458+50. FS Date: 6/17/2020

Top of Levee: View of levee crown looking towards waterside

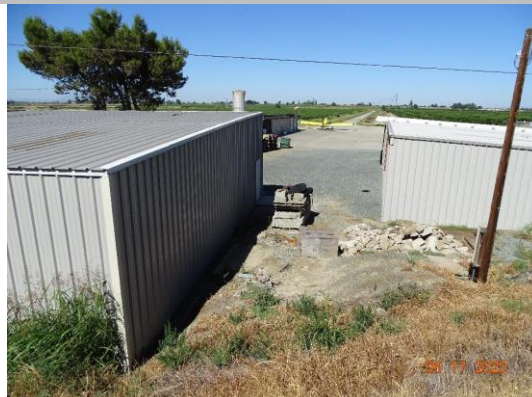
Photo 2 of 3 : UCIP_FA_2020_61276_89050.jpg

Land-Side: View of levee slope looking from crown. Irrigation ditch along runway on background
