Flood Control Project Maintenance Levee Inspections

Fall 2020 Levee Maintenance Deficiency Summary Report

Sacramento River Basin

Reclamation District No. 0556 Upper Andrus

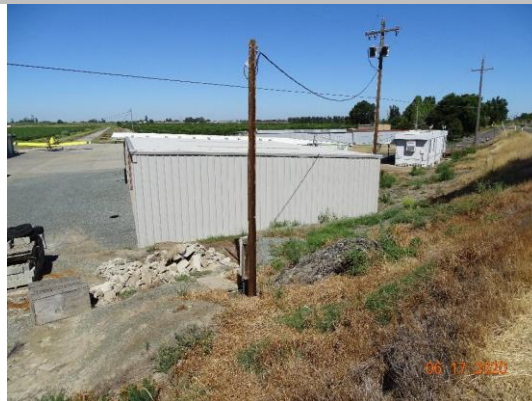
Photo 3 of 3 : UCIP_FA_2020_61276_89051.jpg

Land-Side: Overview of levee slope. Aircraft hangar and runway on landside

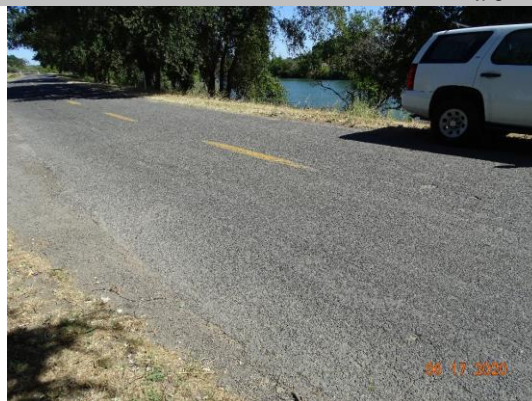
Photo 1 of 3 : UCIP_FA_2020_61533_89067.jpg

LM Start	2.96	Rating **	M	Issue No.	87	
LM End	2.96	Issue Type +	En	Location *		
Category	Supplemental			GPS Latitude/Longitude		
				Start		End
Item	DWR UCIP Field Study			38.212706 °		38.212706 °
				-121.537642 °		-121.537642 °
DWR ID	25110					
Comment Code						
Inspector Comment						
DS_ID:25110 FS_ID:61533 EP_NO: N/A Repair Type: Non-Urgent EVAL Issue: Unauthorized Encroachment Crossing Status: Found UCIP Comments: 06/17/2020 Record updated from No Action Needed to Non-Urgent. No permit has been found authorizing this pipe through the levee. Unable to evaluate condition of levee slopes due to overgrown vegetation. (O.Yakimov - DWR UCIP) FIELD_STRUCT_DESC: 1-inch steel domestic water line with a spigot, 5 feet below the crown. Visible through the landside (LS) slope only. This water line was field discovered. FS Date: 6/17/2020 1:47:50 PM

Top of Levee: View of levee crown looking upstream

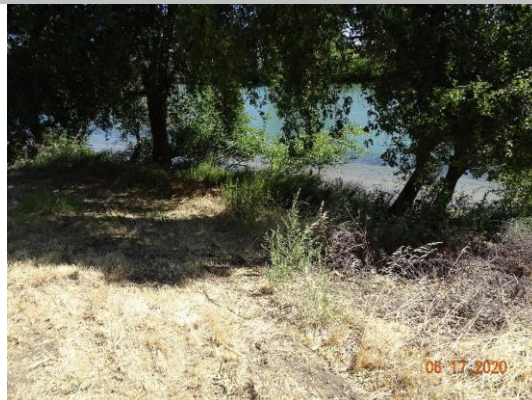
Photo 2 of 3 : UCIP_FA_2020_61533_89068.jpg

Water-Side: View of levee slope looking from crown

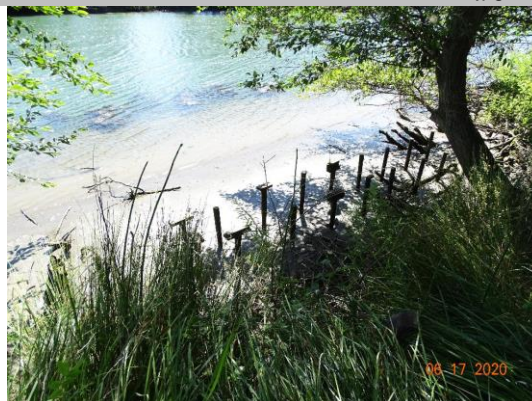
Photo 3 of 3 : UCIP_FA_2020_61533_89069.jpg

Water-Side: Abandoned pipes at riverbank

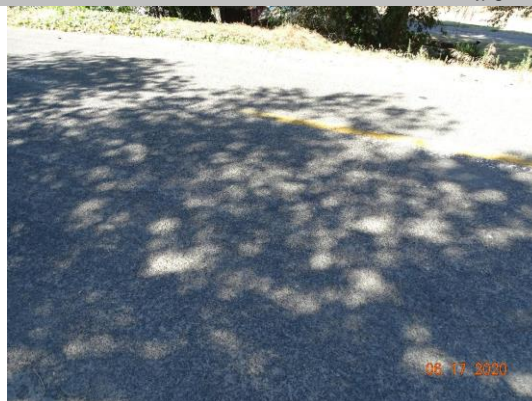
Photo 1 of 3 : UCIP_FA_2020_61283_89062.jpg

DS_ID:20819
 FS_ID:61283
 EP_NO: 11177
 Repair Type: Non-Urgent
 EVAL Issue: Limited Inspection/No UCIP Evaluation
 Crossing Status: Indicator Found
 UCIP Comments: 06/17/2020 Record is Non-Urgent. Unable to find pipe on waterside due to overgrown vegetation. 6-inch steel pipe on the top of 36-inch concrete standpipe. No permit has been identified authorizing pipe. Need to have CVFPB review ABO and determine current owner. (O.Yakimov - DWR UCIP)
 FIELD_STRUCT_DESC: 10-inch irrigation pipe through levee, 3.0 feet below crown. 36-inch concrete standpipe at landside toe. Waterward end is open. (10-inch pipe [HLM 2.96] authorized under Automatic Board Order (ABO) issued as Permit No. 11177, 1975 - Vernal Silva, et al). [Additional Reference(s): DWR Levee Log, year unknown (HLM 2.96). USACE Sacramento O&M Manual, Unit 103, June 1954, Revised 29 December 2016, (Station "R" 454+82.8), listed as 10-inch pipe. FS Date: 6/17/2020

Top of Levee: View of levee crown looking from waterside

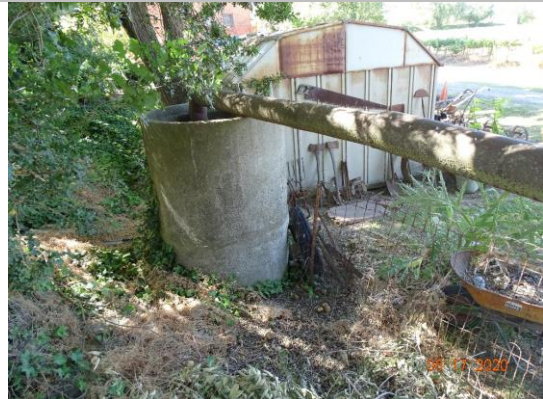
Photo 2 of 3 : UCIP_FA_2020_61283_89060.jpg

Land-Side: View of levee slope looking from crown. Concrete standpipe at levee toe

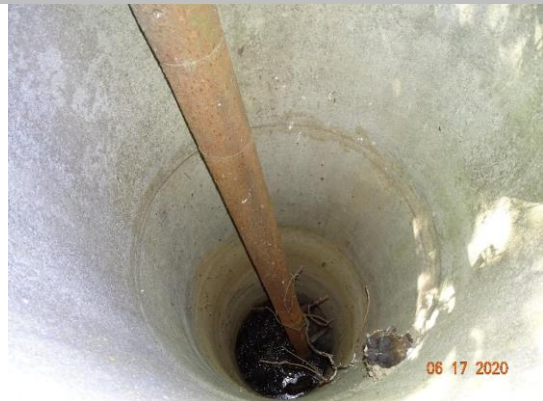
Photo 3 of 3 : UCIP_FA_2020_61283_89061.jpg

Land-Side: View inside of concrete standpipe

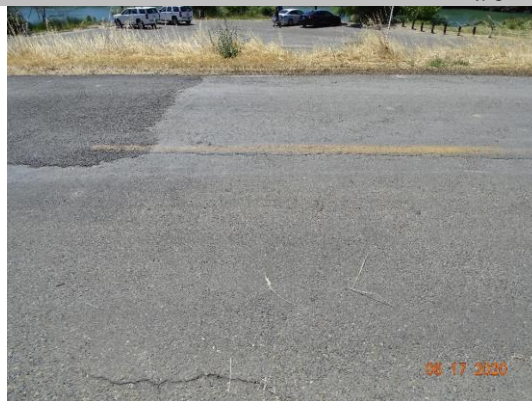
Photo 1 of 3 : UCIP_FA_2020_61310_89071.jpg

LM Start	3.07	Rating **	M	Issue No.	89	
LM End	3.07	Issue Type +	En	Location *		
Category	Supplemental			GPS Latitude/Longitude		
				Start		End
Item	DWR UCIP Field Study			38.211333 °		38.211333 °
				-121.537198 °		-121.537198 °
DWR ID	21436					
Comment Code						
Inspector Comment						
DS_ID:21436 FS_ID:61310 EP_NO: N/A Repair Type: Non-Urgent EVAL Issue: Pipe Not Found Crossing Status: Not Found UCIP Comments: 06/17/2020 Record is Non-Urgent. Crossing not found. No permit has been identified authorizing pipe. (O.Yakimov - DWR UCIP) FIELD_STRUCT_DESC: 12-inch steel pipe. 12-ft x 42-inch concrete standpipe. [Additional Reference(s):USACE Sacramento O&M Manual, Unit 103, June 1954, Revised 29 December 2016, (Station "R" 446+36), listed as 12-inch pipe. FS Date: 6/17/2020

Top of Levee: View of levee crown looking from landside shoulder

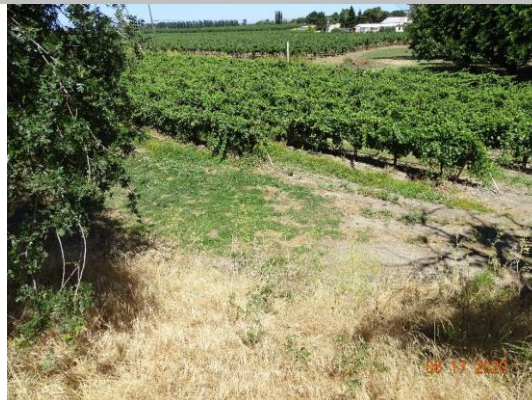
Photo 2 of 3 : UCIP_FA_2020_61310_89070.jpg

Land-Side: View of levee slope looking from crown

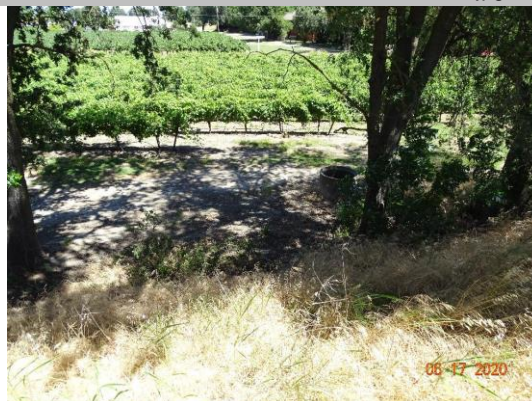
Photo 2 of 3 : UCIP_FA_2020_61290_89075.jpg

Land-Side: View of levee slope looking from crown

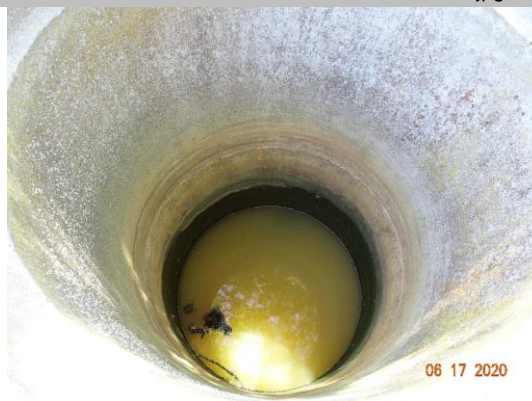
Photo 3 of 3 : UCIP_FA_2020_61290_89076.jpg

Land-Side: View inside of 60-inch concrete standpipe

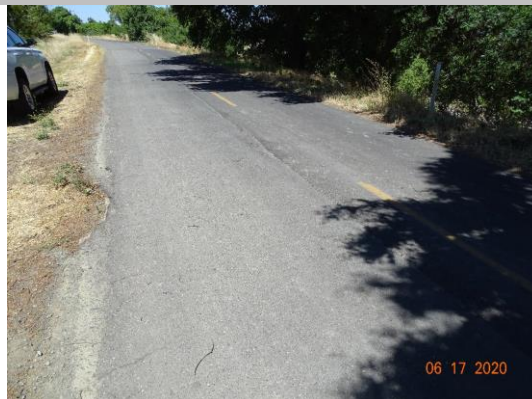
Photo 1 of 3 : UCIP_FA_2020_61291_89080.jpg

DS_ID:20836
FS_ID:61291
EP_NO: 11174
Repair Type: Urgent
EVAL Issue: Levee Integrity
Crossing Status: Found
UCIP Comments: 06/17/2020 Record is Urgent. 30-feet long, 3-feet wide, and 1-foot deep trench was excavated along landside levee toe. Soil is wet at the bottom of trench. Soil depression on waterside shoulder in pipe alignment. Intake pipe and pipe from pumphouse towards levee slope have been replaced. Unable to find a permit for modifications. No permit has been identified authorizing original pipe through the levee. Need to have CVFPB review ABO and determine current owner. (O.Yakimov - DWR UCIP)
FIELD_STRUCT_DESC: 6-inch steel irrigation pipe through levee, 3.4 feet below crown. Pump in pump house on berm. Service pole on landward slope. Gate valve located underground and 48-inch concrete standpipe at landside toe. 1-inch electrical conduit at this location. (6-inch pipe [HLM 3.18] authorized under Automatic Board Order (ABO) issued as Permit No. 11174, 1975 - Delores M. Pollard). [Additional Reference(s): DWR Levee Log, unknown year (HLM 3.18).USACE Sacramento O&M Manual, Unit 103, June 1954, Revised 29 December 2016, (Station 441+19.6), listed as 6-inch pipe.

Top of Levee: View of levee crown looking downstream

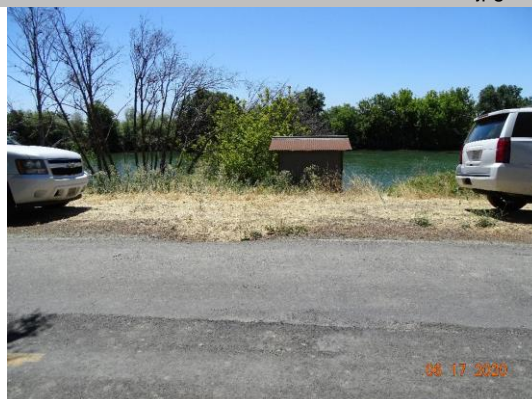
Photo 2 of 3 : UCIP_FA_2020_61291_89081.jpg

Overview of Levee: Levee crown and pumphouse on waterside berm

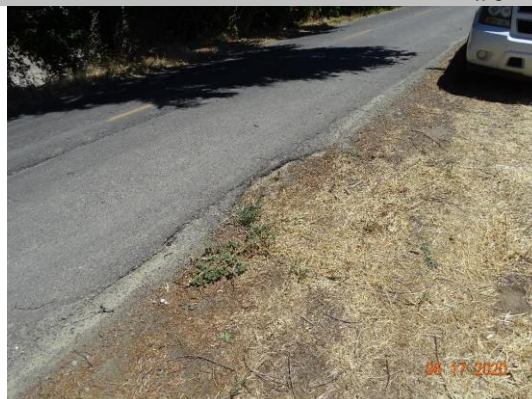
Photo 3 of 3 : UCIP_FA_2020_61291_89090.jpg

Water-Side: Soil depression in pipe alignment on levee shoulder

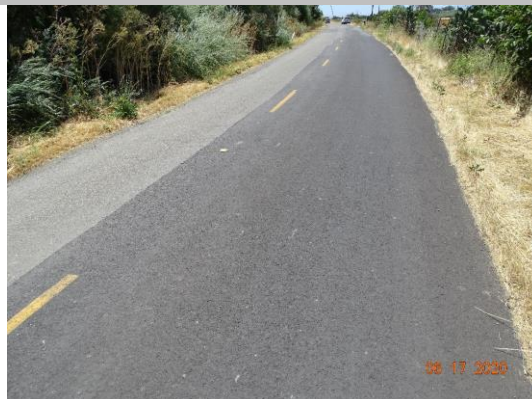
Photo 1 of 3 : UCIP_FA_2020_61299_89098.jpg

Top of Levee: View of levee crown looking downstream

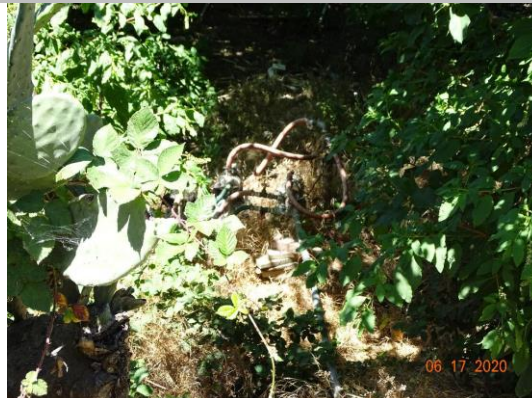
Photo 2 of 3 : UCIP_FA_2020_61299_89099.jpg

Land-Side: Small pump at levee toe

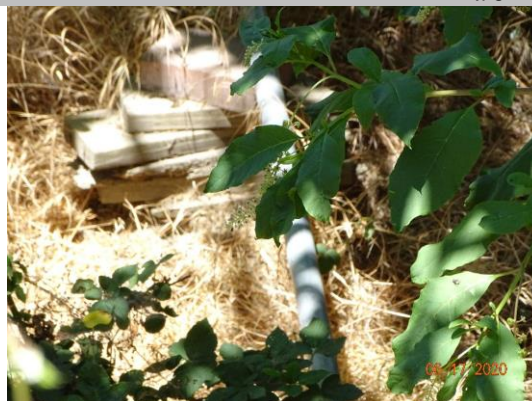
Photo 3 of 3 : UCIP_FA_2020_61299_89100.jpg

Land-Side: Water supply pipe on levee slope

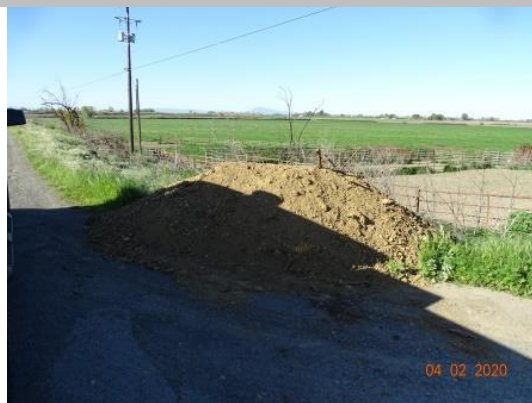
Photo 1 of 1 : FA_2020_RD0556_18_12_20200910_00002.jpg

LM Start	3.43	Rating **	U	Issue No.	12
LM End	3.43	Issue Type +	En	Location *	LS
Category	Earthen Levee			GPS Latitude/Longitude	
				Start	End
Item	Encroachments			38.208033 °	38.208033 °
				-121.541627 °	-121.541627 °
DWR ID	DWR_RD0556_01_s_2020_12				
Comment Code					
MA : Material					
Inspector Comment					
Pile of dirt on landside hinge.

View of dirt pile on the landside hinge (Spring 2020).

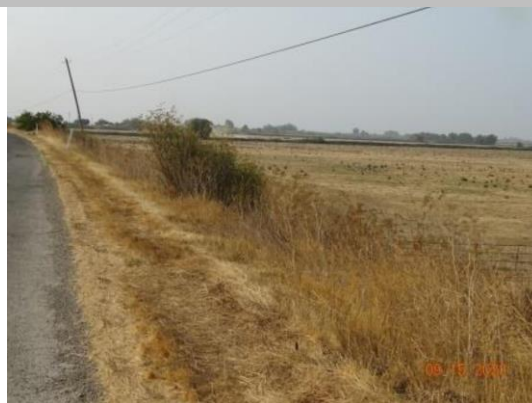
Photo 1 of 1 : FA_2020_RD0556_18_41_20200915_00098.jpg

LM Start	3.45	Rating **	U	Issue No.	41
LM End	3.81	Issue Type +	Ma	Location *	LS
Category	Earthen Levee			GPS Latitude/Longitude	
				Start	End
Item	Vegetation			38.207703 °	38.202615 °
				-121.541717 °	-121.540807 °
DWR ID	DWR_RD0556_01_s_2020_41				
Comment Code					
V2 : Remove the wild growth other than native grasses from the levee slopes.					
Inspector Comment

View looking downstream at vegetation on the landside slope (Fall 2020).

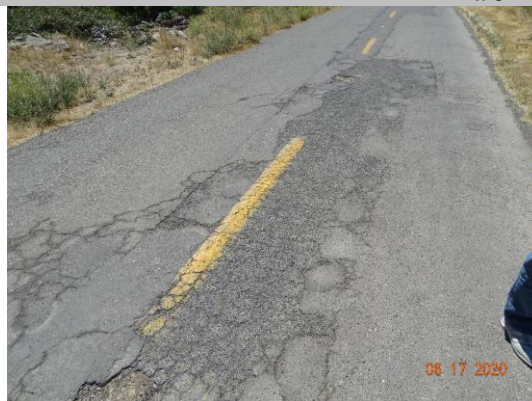
Photo 1 of 3 : UCIP_FA_2020_61300_89104.jpg

Top of Levee: View of levee crown looking downstream

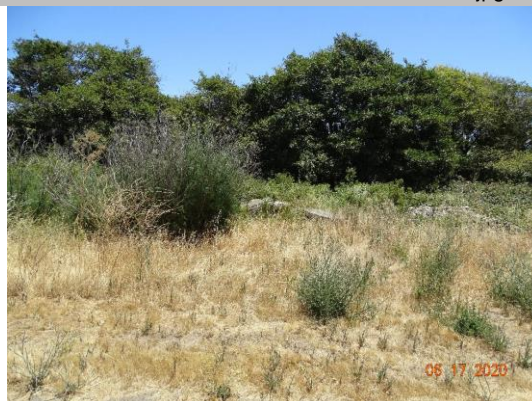
Photo 2 of 3 : UCIP_FA_2020_61300_89105.jpg

Water-Side: View of levee slope looking from crown

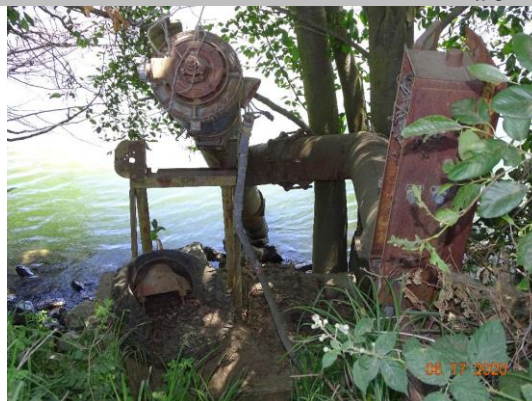
Photo 3 of 3 : UCIP_FA_2020_61300_89106.jpg

DS_ID:20839
FS_ID:61300
EP_NO: 10488
Repair Type: Non-Urgent
EVAL Issue: Unauthorized Encroachment, installed decades prior
Crossing Status: Found
UCIP Comments: 06/17/2020 Record is Non-Urgent. Crossing appears abandoned. Power supply wires are disconnected near slant pump and on service pole. No permit has been identified authorizing pipe. Need to have CVFPB review ABO and determine current owner. (O.Yakimov - DWR UCIP)

Water-Side: Abandoned slant pump on riverbank

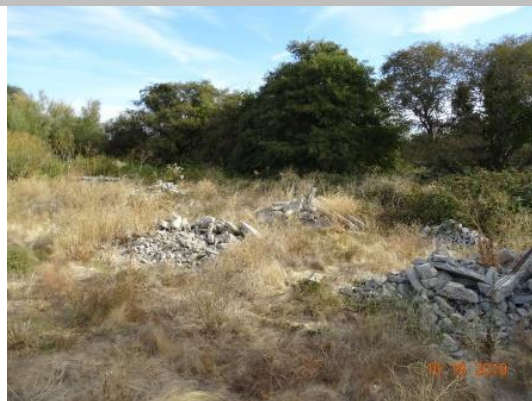
Photo 1 of 1 : FA_2020_RD0556_18_58_20200910_00040.jpg

LM Start	3.46	Rating **	U	Issue No.	58
LM End	3.46	Issue Type +	En	Location *	WS
Category	Earthen Levee			GPS Latitude/Longitude	
				Start	End
Item	Encroachments			38.207585 °	38.207585 °
				-121.541678 °	-121.541678 °
DWR ID	DWR_RD0556_01_f _ 2019_58				
Comment Code					
DE : Debris					
Inspector Comment					
Remove concrete debris piles

View of large concrete debris piles on the waterside shoulder. The waterside shoulder is much larger in this section. (Fall 2019).

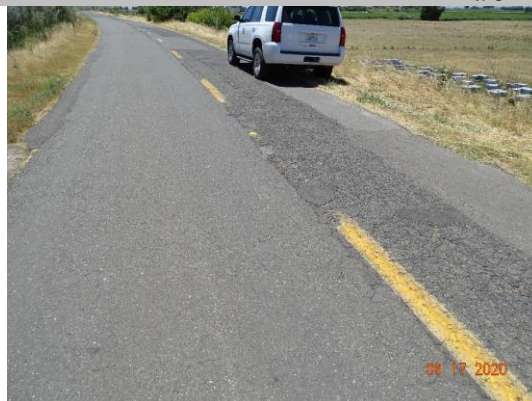
Photo 1 of 3 : UCIP_FA_2020_61301_89118.jpg

Top of Levee: View of levee crown looking downstream

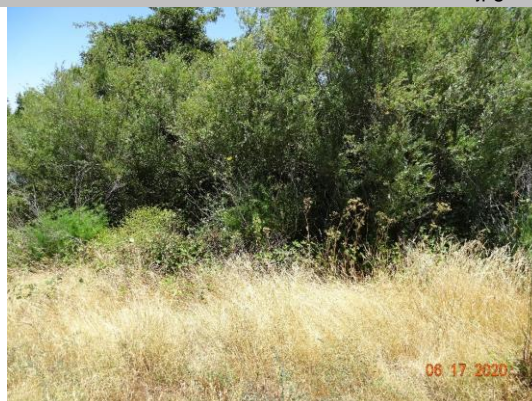
Photo 2 of 3 : UCIP_FA_2020_61301_89117.jpg

Water-Side: View of levee slope looking from crown

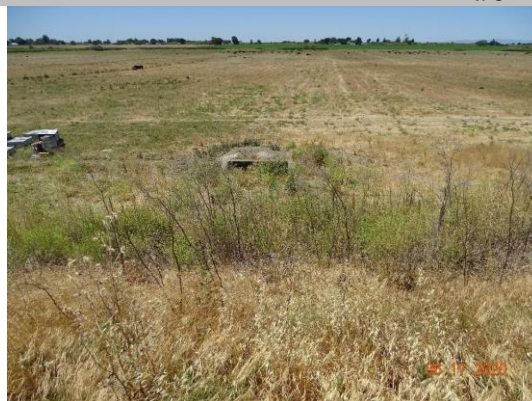
Photo 3 of 3 : UCIP_FA_2020_61301_89119.jpg

Comment Code						
Inspector Comment						
DS_ID:20840 FS_ID:61301 EP_NO: 11161 Repair Type: Urgent EVAL Issue: Levee Integrity Crossing Status: Found UCIP Comments: 06/17/2020 Record is Urgent. Subsidence on landside shoulder measured 2' x 3' x 1.5'-deep around air vent. Crossing appears abandoned. Fence on landside slope and overgrown vegetation on both slopes prevent from detailed inspection of levee. No permit has been identified authorizing pipe. Need to have CVFPB review ABO and determine current owner. (O.Yakimov - DWR UCIP) FIELD_STRUCT_DESC: 10-inch steel pipe through levee, 11.2 feet below crown. 2-inch air and vacuum valve and concrete spill box on landside of the levee. (ABO 11161 - Dorsie). O&M Manual Sac 103, June 1954 FS Date: 6/17/2020

Land-Side: View of levee slope looking from crown

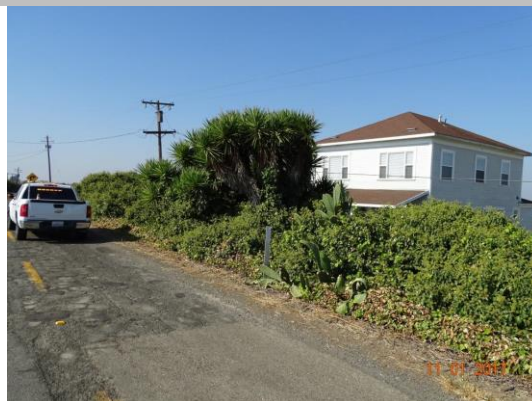
Photo 1 of 1 : FA_2020_RD0556_18_30_20200910_00015.jpg

LM Start	3.89	Rating **	U	Issue No.	30
LM End	3.91	Issue Type +	En	Location *	LS
Category	Earthen Levee			GPS Latitude/Longitude	
				Start	End
Item	Vegetation			38.201823 °	38.201672 °
				-121.541687 °	-121.542133 °
DWR ID	DWR_RD0556_01_f_2017_30				
Comment Code					
V6 : Landscaping					
Inspector Comment					
Trim/thin landscaping to allow inspection and access to levee slope and toe.

View of landscaping on levee slope and toe.

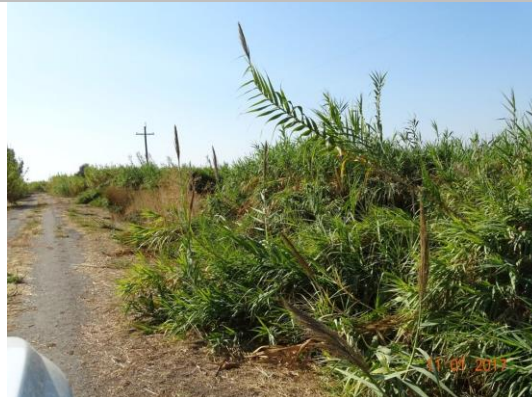
Photo 1 of 1 : FA_2020_RD0556_18_39_20200910_00023.jpg

LM Start	3.93	Rating **	U	Issue No.	39
LM End	5.10	Issue Type +	Ma	Location *	LS
Category	Earthen Levee			GPS Latitude/Longitude	
				Start	End
Item	Vegetation			38.201571 °	38.190115 °
				-121.542446 °	-121.557642 °
DWR ID	DWR_RD0556_01_f_2017_39				
Comment Code					
V2 : Remove the wild growth other than native grasses from the levee slopes.					
Inspector Comment					
Remove wild growth including berry vines and arundo from landside slope and toe to allow for inspection and access.

View of dense growth of wild vegetation, berry vines and arundo on landside slope and toe

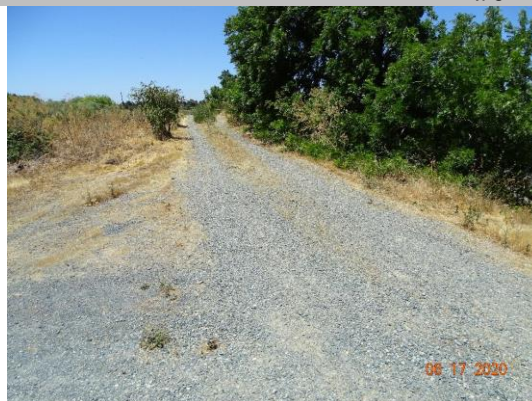
Photo 1 of 3 : UCIP_FA_2020_61302_89123.jpg

Top of Levee: View of levee crown looking downstream

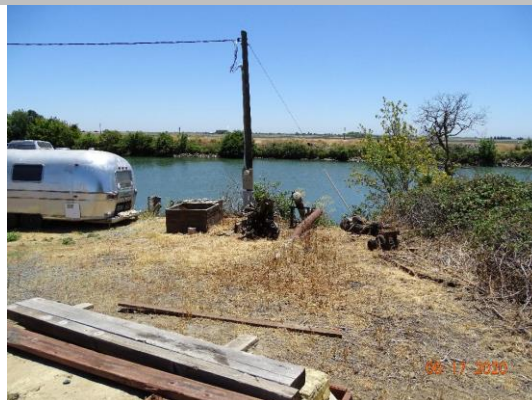
Photo 2 of 3 : UCIP_FA_2020_61302_89124.jpg

Water-Side: View of levee slope looking from crown

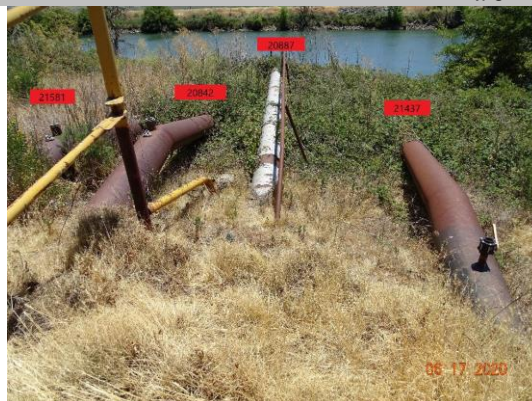
Photo 2 of 3 : UCIP_FA_2020_61315_89138.jpg

DS_ID:21581
FS_ID:61315
EP_NO: 13030
Repair Type: Non-Urgent
EVAL Issue: Unauthorized Modification or Non-Compliant Permit
Crossing Status: Found
UCIP Comments: 06/17/2020 Record is Non-Urgent. Pipe diameter field measured as 20-inch on both slopes. On landside berm pipe diameter changes from 20 inch to 18 inch. Unable to find a permit for modification of this crossing. No permit has been identified authorizing original O&M pipe through the levee. (O.Yakimov - DWR UCIP)
FIELD_STRUCT_DESC: 18-inch steel drainage pipes through levee, 4.3 feet below crown. Pumps on landward side and 4-inch air valve.
[Additional Reference(s): DWR Levee Log, unk yr (HLM 4.01). USACE Sacramento O&M Manual, Unit 103, June 1954, Revised 29 December 2016, (Station 397+36.3), listed as 20-inch pipe].
FS Date: 6/17/2020

Water-Side: Pipes on waterside berm

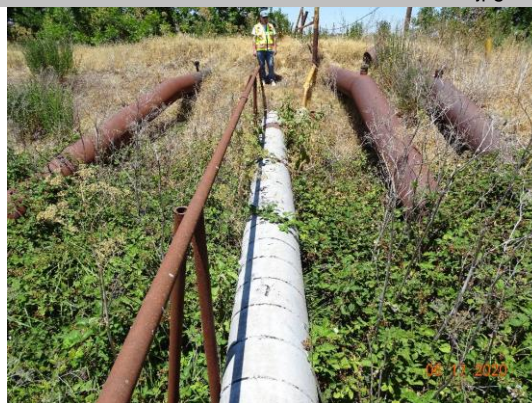
Photo 3 of 3 : UCIP_FA_2020_61315_89139.jpg

Water-Side: Pipes on waterside berm and levee slope on background

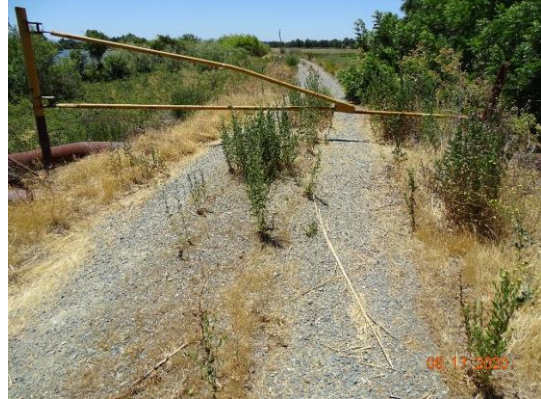
Photo 1 of 3 : UCIP_FA_2020_61303_89144.jpg

Top of Levee: View of levee crown looking downstream

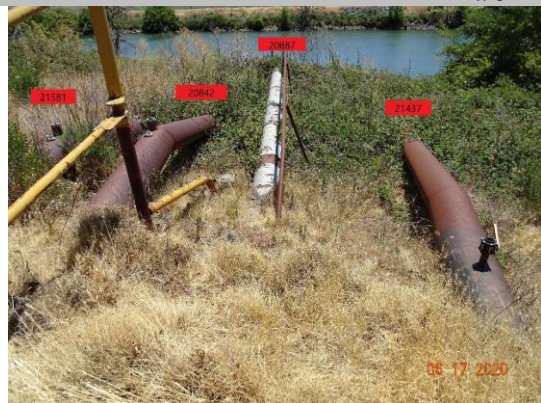
Photo 2 of 3 : UCIP_FA_2020_61303_89146.jpg

DS_ID:20842
FS_ID:61303
EP_NO: 13030
Repair Type: Non-Urgent
EVAL Issue: Unauthorized Modification or Non-Compliant Permit
Crossing Status: Found
UCIP Comments: 06/17/2020 Record is Non-Urgent. Pipe diameter field measured as 20-inch on both slopes. On landside berm pipe diameter changes from 20 inch to 18 inch. Debris of 20-inch pipe welded to 16-inch pipe with open end found next to this crossing on landside berm. Unable to find a permit for modification of this crossing. No permit has been identified authorizing original O&M pipe through the levee. (O.Yakimov - DWR UCIP)
FIELD_STRUCT_DESC: 16-inch steel drainage pipes through levee, 4.3 feet below crown. Pumps on landward side and 4-inch air valve.
[Additional Reference(s): DWR Levee Log, unk yr (HLM 4.01). USACE Sacramento O&M Manual, Unit 103, June 1954, Revised 29 December 2016, (Station 397+20.5), listed as 16-inch pipe].
FS Date: 6/17/2020

Water-Side: Pipes on waterside berm

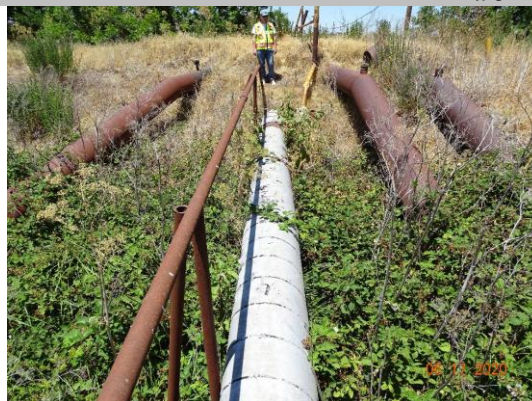
Photo 3 of 3 : UCIP_FA_2020_61303_89147.jpg

Water-Side: Pipes on waterside berm looking from riverbank

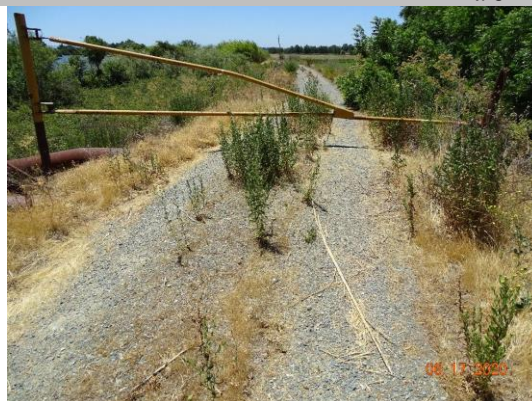
Photo 1 of 3 : UCIP_FA_2020_61309_89149.jpg

DS_ID:20887
 FS_ID:61309
 EP_NO: 13030
 Repair Type: Non-Urgent
 EVAL Issue: Abandoned encroachment
 Crossing Status: Found
 UCIP Comments: 06/17/2020 Record is Non-Urgent. Crossing appears abandoned. Unable to find this crossing on landside. (O.Yakimov - DWR UCIP)
 FIELD_STRUCT_DESC: 20-inch steel drainage pipeline through the levee, 3.2 ft. below the levee crown; pump and siphon breaker on landside. Concrete saddle on waterside of the levee. (20-inch pipe authorized under Permit No. 13030, 1980 - Reclamation District 556).
 FS Date: 6/17/2020

Top of Levee: View of levee crown looking downstream

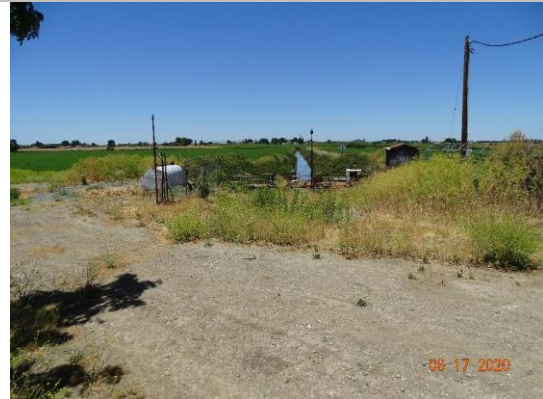
Photo 2 of 3 : UCIP_FA_2020_61309_89148.jpg

Land-Side: Pumping station at drainage channel

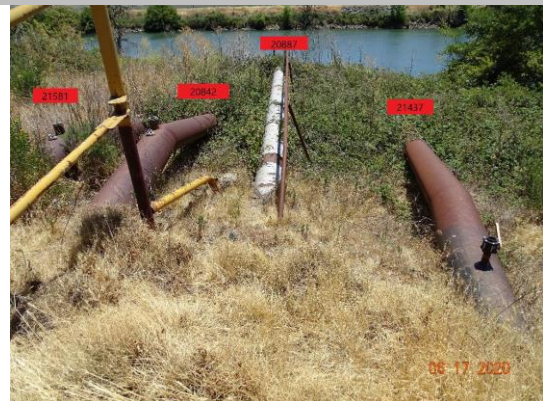
Photo 3 of 3 : UCIP_FA_2020_61309_89150.jpg

Water-Side: Pipes on waterside berm

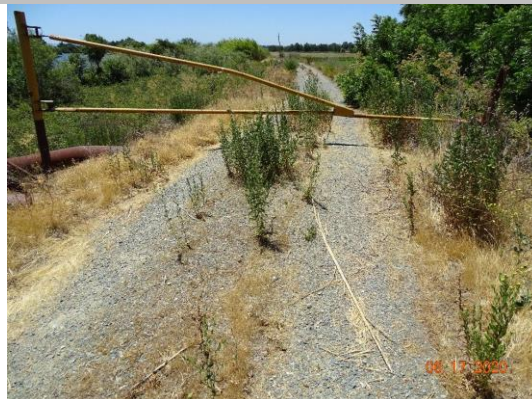
Photo 1 of 3 : UCIP_FA_2020_61311_89154.jpg

DS_ID:21437
FS_ID:61311
EP_NO: 10526
Repair Type: Non-Urgent
EVAL Issue: Unauthorized Modification or Non-Compliant Permit
Crossing Status: Found
UCIP Comments: 06/17/2020 Record is Non-Urgent. Pipe diameter field measured as 20-inch on both slopes. Unable to find a permit for modification of this crossing. (O.Yakimov - DWR UCIP)

FIELD_STRUCT_DESC: 24-inch steel drainage pipes 3.5 ft below levee crown. Pumping plant on landside. 6" air valve, concrete saddle & wood beam on waterside. This crossing replaces 24-inch pipe (see DSID 25634). (24-inch pipe authorized under Permit No. 10526, 1975 - Reclamation District 556). [Additional Reference(s): USACE Sacramento O&M Manual, Unit 103, June 1954, Revised 29 December 2016, (Station 397+36.3), listed as 24-inch pipe].
FS Date: 6/17/2020

Top of Levee: View of levee crown looking downstream

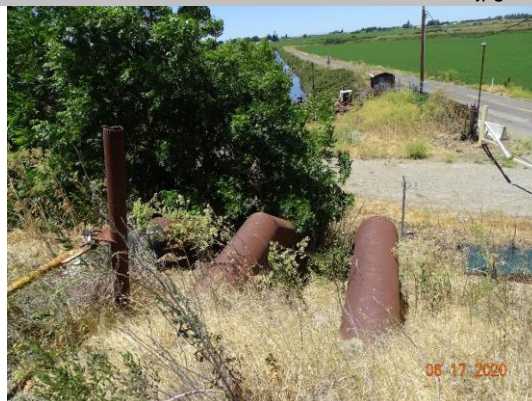
Photo 2 of 3 : UCIP_FA_2020_61311_89155.jpg

Land-Side: View of pipes on levee shoulder

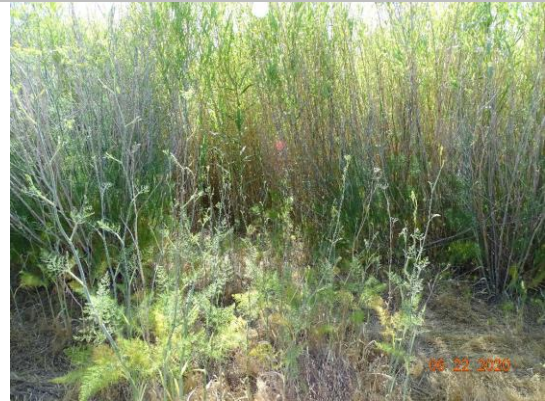
Photo 2 of 3 : UCIP_FA_2020_61304_89162.jpg

Water-Side: View of levee slope looking from crown

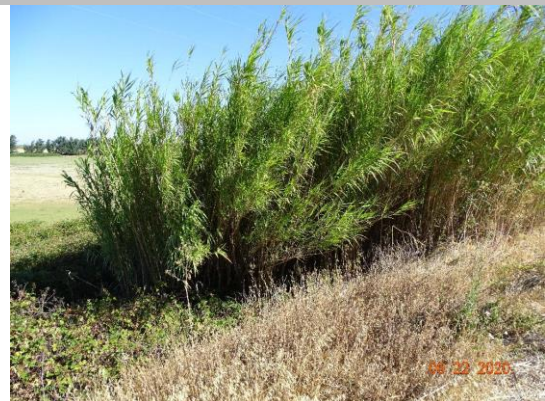
Photo 3 of 3 : UCIP_FA_2020_61304_89164.jpg

Land-Side: View of levee slope looking from crown

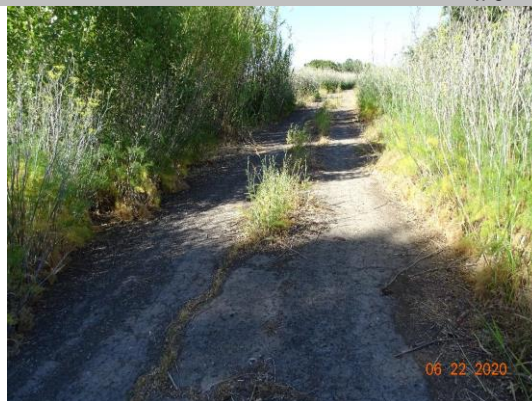
Photo 1 of 3 : UCIP_FA_2020_61312_89165.jpg

LM Start	4.42	Rating **	M	Issue No.	101	
LM End	4.42	Issue Type +	En	Location *		
Category	Supplemental			GPS Latitude/Longitude		
				Start		End
Item	DWR UCIP Field Study			38.196231 °		38.196231 °
				-121.547833 °		-121.547833 °
DWR ID	21438					
Comment Code						
Inspector Comment						
DS_ID:21438 FS_ID:61312 EP_NO: N/A Repair Type: Non-Urgent EVAL Issue: Limited Inspection/No UCIP Evaluation Crossing Status: Not Found UCIP Comments: 06/22/2020 Record is Non-Urgent. Crossing not found. Overgrown vegetation and trees on both slopes. Fence at landside toe. Unable to evaluate levee condition at this place. No permit has been identified authorizing pipe. (O.Yakimov - DWR UCIP) FIELD_STRUCT_DESC: 12-inch steel pipe. 3-24" lateral headgates on landside and pump on waterside of the levee. O&M Manual Sac 103, June 1954 FS Date: 6/22/2020

Top of Levee: View of levee crown looking downstream

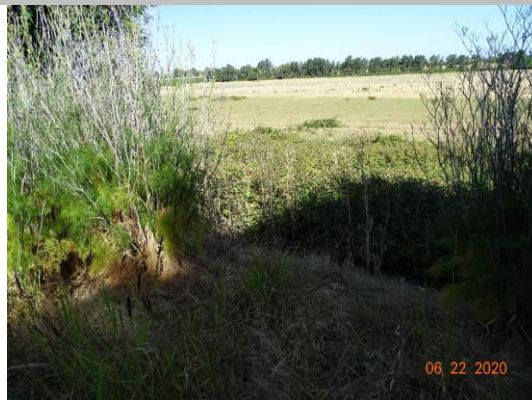
Photo 2 of 3 : UCIP_FA_2020_61312_89166.jpg

Land-Side: View of levee slope looking from crown

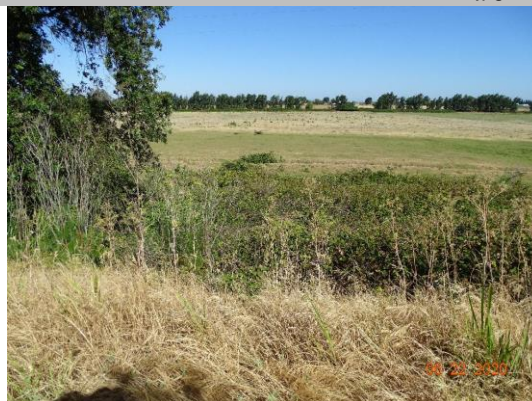
Photo 3 of 3 : UCIP_FA_2020_61312_89168.jpg

Land-Side: Overgrown vegetation and fence at levee toe

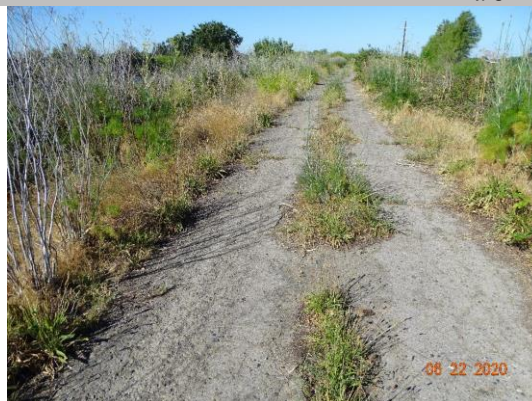
Photo 1 of 3 : UCIP_FA_2020_61305_89171.jpg

DS_ID:20844
FS_ID:61305
EP_NO: 11172
Repair Type: Non-Urgent
EVAL Issue: Limited Inspection/No UCIP Evaluation
Crossing Status: Indicator Found
UCIP Comments: 06/22/2020 Record is Non-Urgent. Overgrown vegetation on both slopes limit inspection. Power supply is connected to service pole on landside slope, although electric meter is missing. Crossing appears abandoned. Unauthorized encroachment recorded in Levee Log prior to 2011. Need to have CVFPB review ABO and determine current owner. (O.Yakimov - DWR UCIP)

FIELD_STRUCT_DESC: 12-inch pipe through levee 4.0 feet below crown. Pump in pumphouse on berm. Siphon breaker on landward shoulder. Service pole on landward, slope distribution box on landward toe. (ABO 11172 - Pacific Fruit Exchange).
FS Date: 6/22/2020

Top of Levee: View of levee crown looking downstream

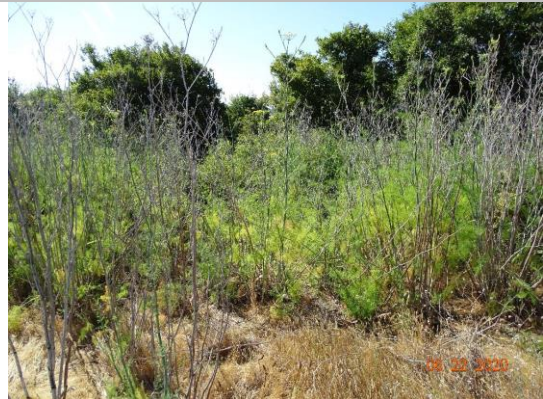
Photo 2 of 3 : UCIP_FA_2020_61305_89173.jpg

Water-Side: View of levee slope looking from crown

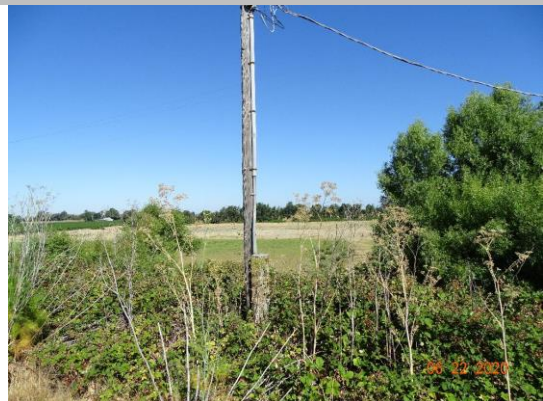
Photo 3 of 3 : UCIP_FA_2020_61305_89169.jpg

Land-Side: View of levee slope looking from crown

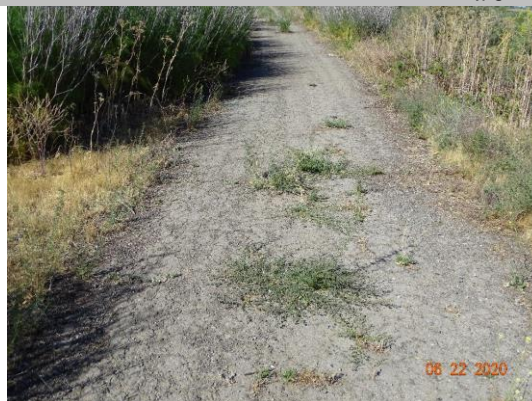
Photo 1 of 3 : UCIP_FA_2020_61306_89176.jpg

Comment Code						
Inspector Comment						
DS_ID:20845 FS_ID:61306 EP_NO: 11168 Repair Type: Non-Urgent EVAL Issue: Limited Inspection/No UCIP Evaluation Crossing Status: Indicator Found UCIP Comments: 06/22/2020 Record is Non-Urgent. Overgrown vegetation on both slopes limits inspection of the crossing. Concrete standpipe located at landside levee toe. No permit has been identified authorizing pipe. Need to have CVFPB review ABO and determine current owner. (O.Yakimov - DWR UCIP) FIELD_STRUCT_DESC: 10-inch pipe through levee 3.0 feet below crown. Siphon breaker on landward shoulder. 36-inch standpipe on landside of the levee. (ABO 11168- Langhart). O&M Manual Sac 103, June 1954 FS Date: 6/22/2020

Top of Levee: View of levee crown looking downstream

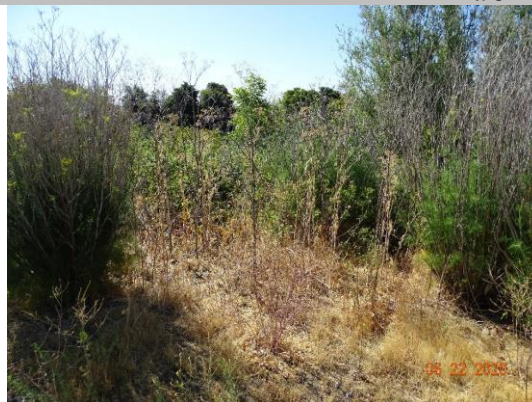
Photo 2 of 3 : UCIP_FA_2020_61306_89175.jpg

Water-Side: View of levee slope looking from crown

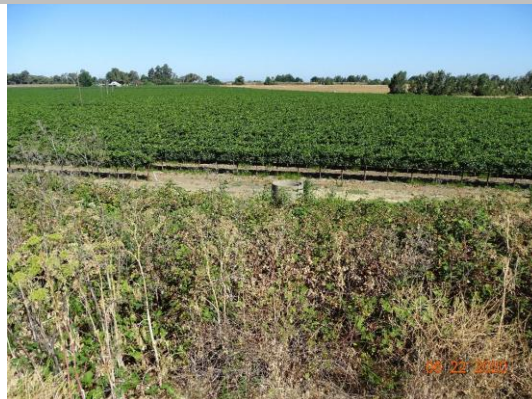
Photo 3 of 3 : UCIP_FA_2020_61306_89174.jpg

Land-Side: View of levee slope looking from crown

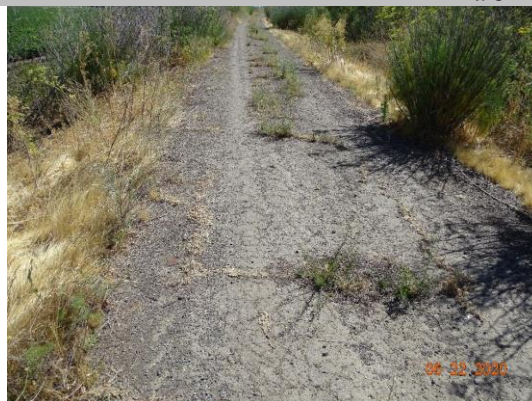
Photo 1 of 3 : UCIP_FA_2020_61307_89177.jpg

DS_ID:20846
 FS_ID:61307
 EP_NO: 11168
 Repair Type: Non-Urgent
 EVAL Issue: Limited Inspection/No UCIP Evaluation
 Crossing Status: Indicator Found
 UCIP Comments: 06/22/2020 Record is Non-Urgent. Concrete standpipe and junction pole at landside levee toe. Dense vegetation on both slopes limits inspection of this crossing. No permit has been identified authorizing pipe. Need to have CVFPB review ABO and determine current owner. (O.Yakimov - DWR UCIP)
 FIELD_STRUCT_DESC: 10-inch pipe through levee, 4.0 feet below crown. Siphon Breaker on landward slope. A 9 ft x 42-inch concrete standpipe. (ABO 11168 - Langhart). O&M Manual Sac 103, June 1954
 FS Date: 6/22/2020

Top of Levee: View of levee crown looking downstream

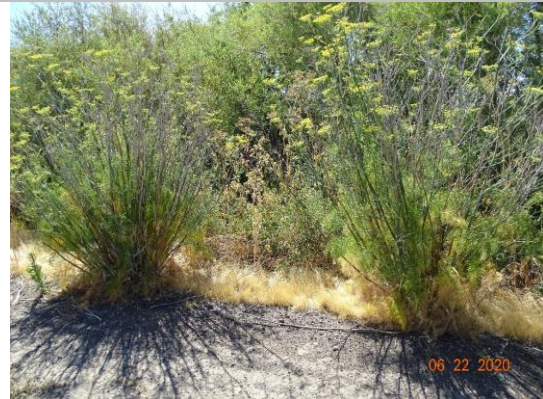
Photo 2 of 3 : UCIP_FA_2020_61307_89179.jpg

Water-Side: View of levee slope looking from crown

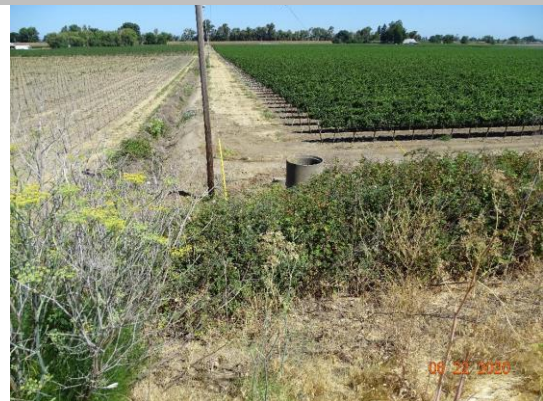
Photo 3 of 3 : UCIP_FA_2020_61307_89178.jpg

Land-Side: Concrete standpipe and junction pole at levee toe

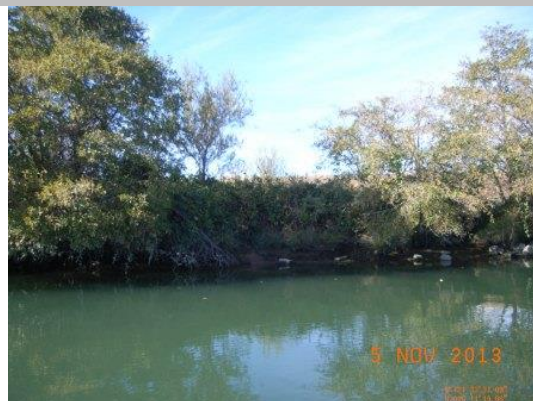
Photo 1 of 1 : FA_2020_RD0556_18_37_20200910_00021.jpg

LM Start	5.12	Rating **	M	Issue No.	37
LM End	5.34	Issue Type +	Ma	Location *	WS
Category	Supplemental			GPS Latitude/Longitude	
				Start	End
Item	2017 USACE Erosion Survey			38.189775 °	38.187369 °
				-121.557729 °	-121.560247 °
DWR ID	DWR_RD0556_01_f_2018_37				
Comment Code					
Inspector Comment					
2017 Site ID: GEO 7.0 R					
Status: Eroding					
2017 Field Notes: Site extended downstream. Large erosion pockets and significant toe erosion.					
Site History: 1997 - Toe damaged rock. 1999 - One pocket filled with gravel. 2000 - Eroding beach with some biotech rolls and stakes; some gravel on slope. 2001 - Staked, low fascine walls at bankline. 2005 - Stone revetment in between pockets. 2006 - New rock on upper slope behind brush boxes at the upstream end, Stone is sliding off the hard toe. 2016 - Fresh erosion observed.

USACE 2013 Photo #1

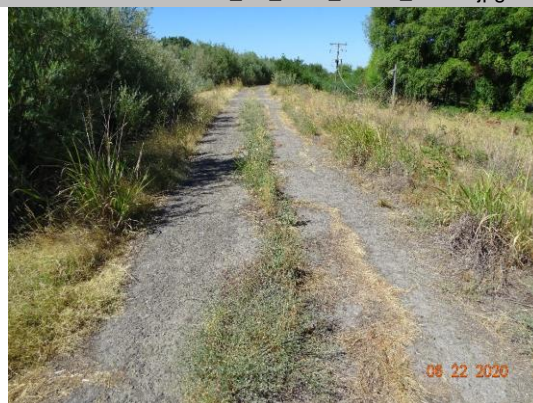
Photo 1 of 3 : UCIP_FA_2020_61313_89181.jpg

LM Start	5.31	Rating **	M	Issue No.	105	
LM End	5.31	Issue Type +	En	Location *		
Category	Supplemental			GPS Latitude/Longitude		
				Start		End
Item	DWR UCIP Field Study			38.187831 °		38.187831 °
				-121.560061 °		-121.560061 °
DWR ID	21453					
Comment Code						
Inspector Comment						
DS_ID:21453 FS_ID:61313 EP_NO: N/A Repair Type: Non-Urgent EVAL Issue: Limited Inspection/No UCIP Evaluation Crossing Status: Not Found UCIP Comments: 06/22/2020 Record is Non-Urgent. Dense vegetation on both levee slopes prevents inspection of this site. Crossing not found. No permit has been identified authorizing pipe. (O.Yakimov - DWR UCIP) FIELD_STRUCT_DESC: 6-inch steel pipe. 1-inch air and vacuum valve, 6 ft x 42-inch concrete standpipe. O&M Manual Sac 103, June 1954 FS Date: 6/22/2020

Top of Levee: View of levee crown looking downstream

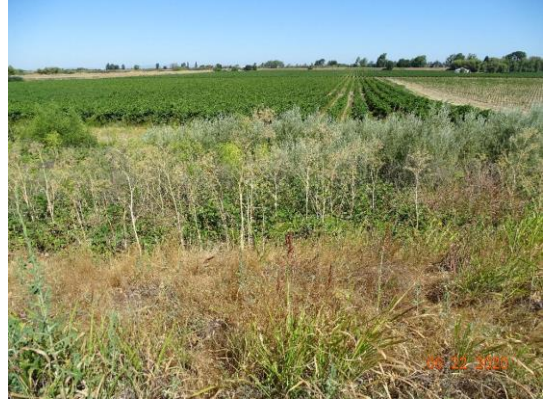
Photo 2 of 3 : UCIP_FA_2020_61313_89182.jpg

Land-Side: View of levee slope looking from crown

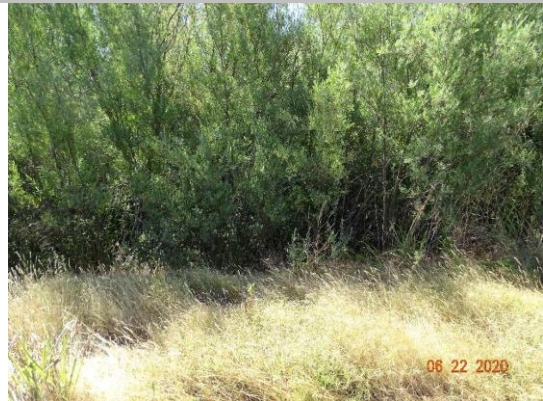
Photo 3 of 3 : UCIP_FA_2020_61313_89183.jpg

Water-Side: View of levee slope looking from crown

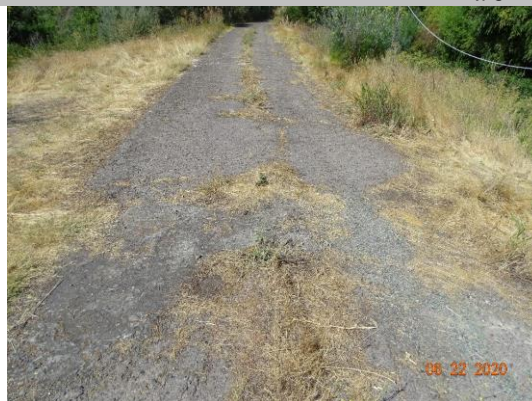
Photo 1 of 3 : UCIP_FA_2020_61308_89184.jpg

Comment Code						
Inspector Comment						
DS_ID:20847 FS_ID:61308 EP_NO: 10489 Repair Type: Non-Urgent EVAL Issue: Unauthorized Modification or Non-Compliant Permit Crossing Status: Found UCIP Comments: 06/22/2020 Record is Non-Urgent. Slant pump was removed and replaced with smaller pump on pile structure at riverbank. Unable to find a permit for modification. (O.Yakimov - DWR UCIP) FIELD_STRUCT_DESC: 10-inch pipe through levee, 3.5 feet below crown. Pump on pile structure at riverbank. 1-inch electrical conduit through levee at this location. Siphon breaker in CMP riser on landward slope. A 9 ft x 42-inch concrete standpipe on landside. Service pole with electric meter and connection panel at landside toe. Two sand media filters on landside. (App. 10489 - Dorsie). O&M Manual Sac 103, June 1954. FS Date: 6/22/2020

Top of Levee: View of levee crown looking downstream

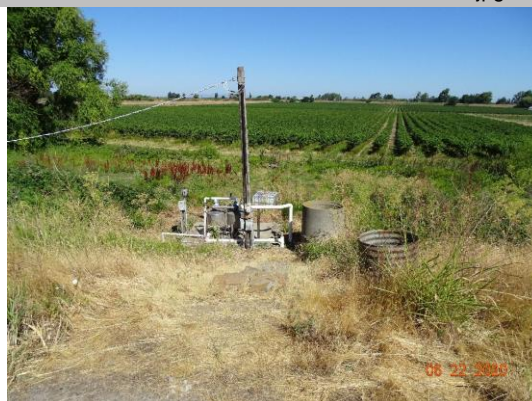
Photo 2 of 3 : UCIP_FA_2020_61308_89185.jpg

Land-Side: View of levee slope looking from crown

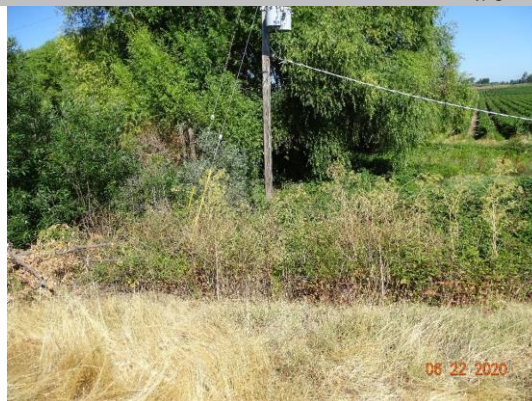
Photo 2 of 3 : UCIP_FA_2020_61286_89194.jpg

Land-Side: View of levee slope looking from crown

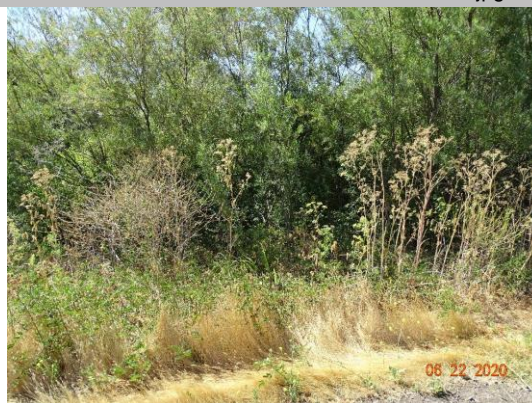
Photo 3 of 3 : UCIP_FA_2020_61286_89195.jpg

Water-Side: View of levee slope looking from crown

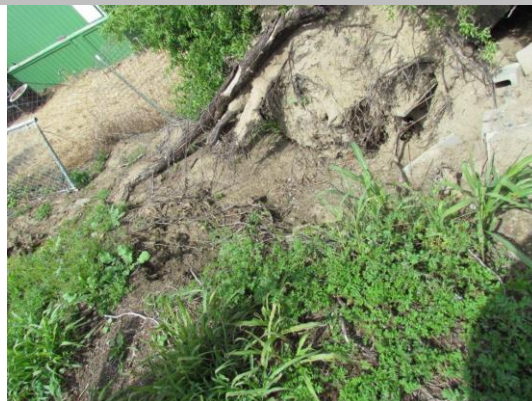
Photo 1 of 1 : FA_2020_RD0556_18_44_20200910_00026.jpg

LM Start	5.46	Rating **	U	Issue No.	44
LM End	5.46	Issue Type +	En	Location *	LS
Category	Earthen Levee			GPS Latitude/Longitude	
				Start	End
Item	Encroachments			38.186593 °	38.186593 °
				-121.562217 °	-121.562217 °
DWR ID	DWR_RD0556_01_s_2017_44				
Comment Code					
TR : Tree or limb					
Inspector Comment					
Remove the fallen tree from the landside slope and repair the damage to the slope.

View of fallen tree on landside slope and damage to the slope.

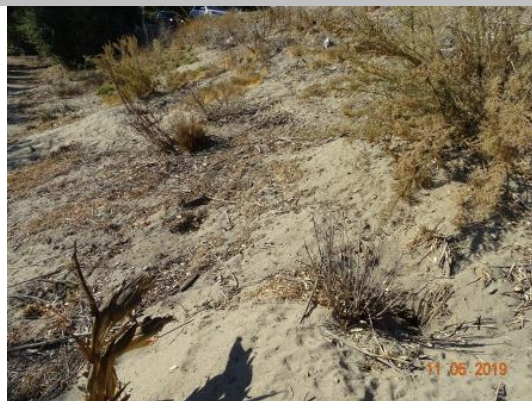
Photo 1 of 1 : FA_2020_RD0556_19_92_20200909_00060.jpg

LM Start	0.04	Rating **	U	Issue No.	92
LM End	0.11	Issue Type +	Ma	Location *	LS
Category	Earthen Levee			GPS Latitude/Longitude	
				Start	End
Item	Animal Control			38.239106 °	38.238912 °
				-121.518972 °	-121.520247 °
DWR ID	DWR_RD0556_02_f _ 2019_92				
Comment Code					
A1 : Exterminate rodents and backfill and compact or grout burrows.					
Inspector Comment					
Multiple fresh squirrel holes

View of multiple fresh squirrel holes in the landside slope (Fall 2019).

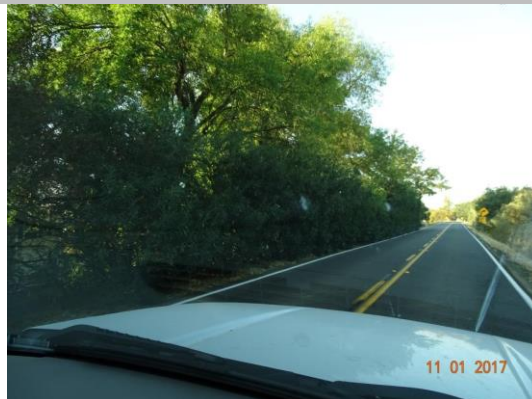
Photo 1 of 1 : FA_2020_RD0556_19_25_20200909_00010.jpg

LM Start	0.53	Rating **	U	Issue No.	25
LM End	0.55	Issue Type +	En	Location *	LS
Category	Earthen Levee			GPS Latitude/Longitude	
				Start	End
Item	Vegetation			38.237833 °	38.237810 °
				-121.527766 °	-121.528182 °
DWR ID	DWR_RD0556_02_f_2017_25				
Comment Code					
V6 : Landscaping					
Inspector Comment					
Trim/thin oleanders on the landside of the levee.

View of oleanders on the landside of the levee.

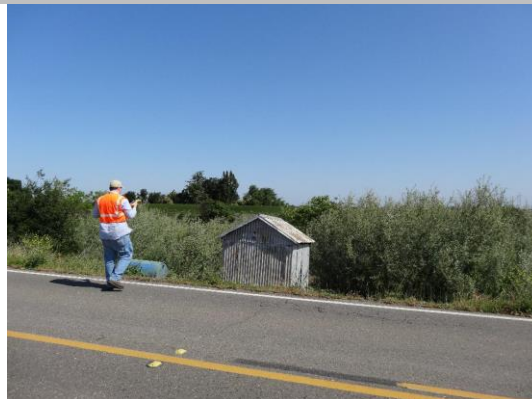
Photo 1 of 3 : UCIP_FA_2020_12512_20245.jpg

Comment Code						
Inspector Comment						
DS_ID:20851 FS_ID:12512 EP_NO: 11186 Repair Type: Non-Urgent EVAL Issue: Crossing Status: Found UCIP Comments: - a concrete box on LS- water is leaking from priming plastic tank and causing surface erosion on levee slope. FIELD_STRUCT_DESC: 4-inch steel irrigation discharge pipe through the levee, 4.3 feet below the crown. Pump and gate valve in a pump house on the waterside (WS) berm. Siphon breaker and service pole on the landside (LS) slope. Concrete spill box with three 8-inch openings. (Retention of a 4-inch pipe through the levee, 4.3 feet below the crown, a pump in a pump house on the WS berm, and a siphon breaker and a service pole on the LS slope authorized under Automatic Board Order (ABO) issued as Permit No. 11186, 1975 - Margaret M. Marks). [Additional Reference(s): DWR Levee Log. USACE Sacramento O&M Manual 103, June 1954, (Station ""J"" 192+00), 6-inch pipe referenced, invert elevation 18.8 feet]. FS Date: 4/25/2013

WS- pump house on levee berm

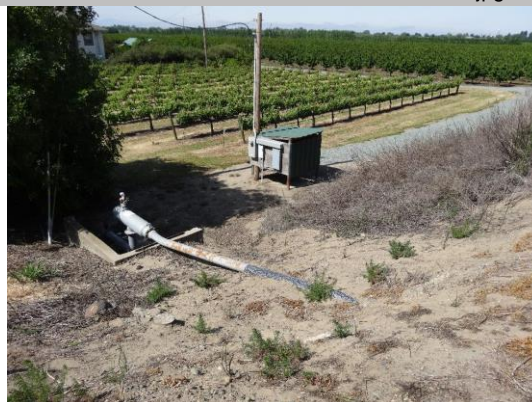
Photo 2 of 3 : UCIP_FA_2020_12512_20244.jpg

LS- steel pipe on a concrete box

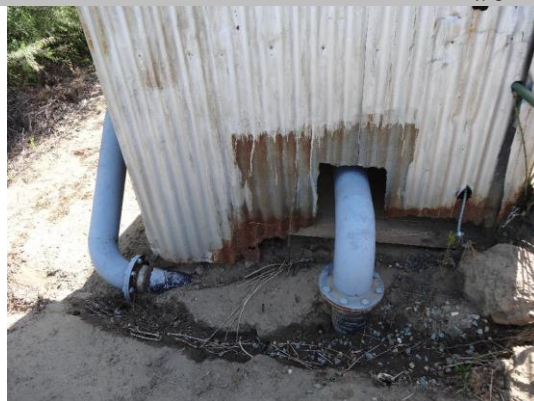
Photo 3 of 3 : UCIP_FA_2020_12512_20243.jpg

WS- pipe daylight from the pump house.

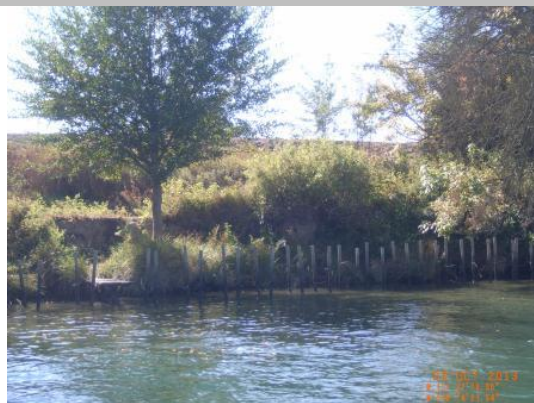
Photo 1 of 1 : FA_2020_RD0556_19_19_20200909_00007.jpg

LM Start	1.03	Rating **	M	Issue No.	19
LM End	1.15	Issue Type +	Ma	Location *	WS
Category	Supplemental			GPS Latitude/Longitude	
				Start	End
Item	2017 USACE Erosion Survey			38.238772 °	38.239265 °
				-121.536788 °	-121.538845 °
DWR ID	DWR RD0556 02 f 2018 19

2017 Site ID: SAC 25.2 L
 Status: Eroding
 2017 Field Notes: Minor new erosion observed.
 Site History: 1997 - Rock is in poor condition and has failed in many places. Scallops in berm with remnants of old rock in the toe area.
 2005 - Brush boxes present. 2013 - Site extended upstream approximately 300 ft to include new erosion pockets. 2015 - Minor new erosion at toe.

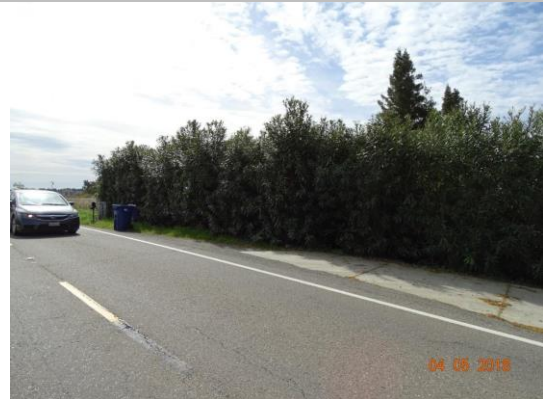
Photo 1 of 1 : FA_2020_RD0556_19_26_20200909_00011.jpg

LM Start	1.14	Rating **	U	Issue No.	26
LM End	1.14	Issue Type +	En	Location *	LS
Category	Earthen Levee			GPS Latitude/Longitude	
				Start	End
Item	Vegetation			38.239005 °	38.239005 °
				-121.538772 °	-121.538772 °
DWR ID	DWR_RD0556_02_f _ 2017_26				
Comment Code					
V6 : Landscaping					
Inspector Comment					
Trim/thin oleanders on the landside of the levee.

Manage oleanders to allow inspection and access.
