Flood Control Project Maintenance Levee Inspections

Fall 2020 Levee Maintenance Deficiency Summary Report

Sacramento River Basin

Reclamation District No. 0556 Upper Andrus

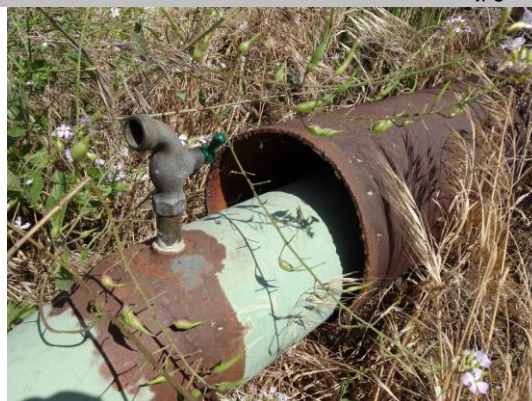
Photo 2 of 3 : UCIP_FA_2020_12573_20380.jpg

Comment Code						
Inspector Comment						
DS_ID:20852 FS_ID:12573 EP_NO: 11187 Repair Type: Non-Urgent EVAL Issue: Crossing Status: Found UCIP Comments: - gap between 6-inch pipe and 10-inch pipe needs to be sealed. FIELD_STRUCT_DESC: 6-inch steel irrigation discharge pipe sleeved through a 10-inch steel pipe through the levee, 4.8 feet below the crown. Pump on the riverbank. (Retention of a 10-inch pipe through the levee, 4.8 feet below the crown, a flap gate on the waterside (WS) end, landside (LS) end open, used to sleeve portable irrigation pipe, authorized under Automatic Board Order (ABO) issued as Permit No. 11187, 1975 - Ernest and Alvine Machado). [Additional Reference(s): DWR Levee Log]. FS Date: 4/25/2013

LS- 6-inch steel pipe sleeved through 10-inch steel pipe. 6" pipe is attached with air release valve.

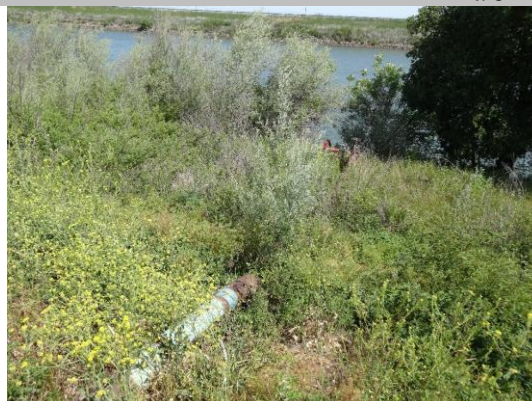
Photo 3 of 3 : UCIP_FA_2020_12573_20383.jpg

WS- 6-inch steel pipe on levee slope

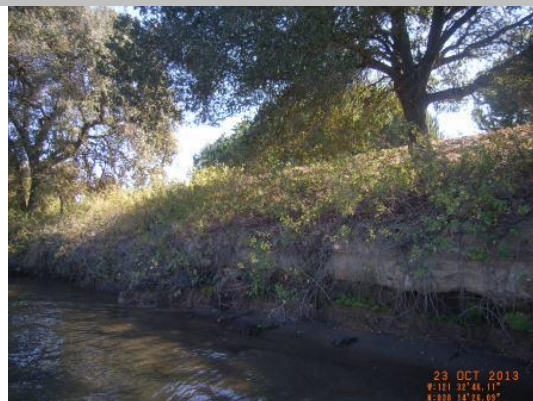
Photo 1 of 1 : FA_2020_RD0556_19_18_20200909_00006.jpg

LM Start	1.45	Rating **	M	Issue No.	18
LM End	1.59	Issue Type +	Ma	Location *	WS
Category	Supplemental			GPS Latitude/Longitude	
				Start	End
Item	2017 USACE Erosion Survey			38.240401 °	38.240772 °
				-121.544106 °	-121.546791 °
DWR ID	DWR_RD0556_02_f_2018_18				
Comment Code					
Inspector Comment					
2017 Site ID: SAC 24.8 L					
Status: Eroding					
2017 Field Notes: Significant lower bank erosion.					
Site History: 1997 - Slow erosion of the berm at the waterline; bench below water. 2005 - Brush boxes present. 2010 - Minor new erosion.					
2013 - There is little to no berm remaining at downstream end of this site. 2016 - New erosion on levee slope.

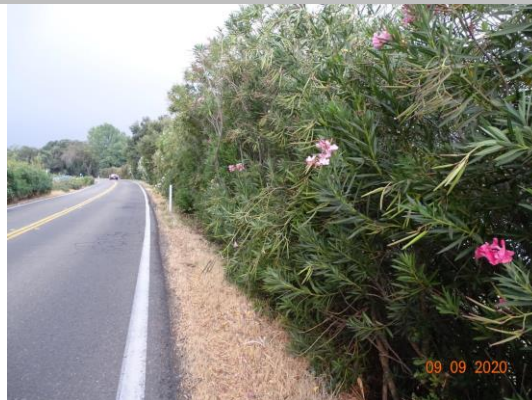
Photo 1 of 1 : FA_2020_RD0556_19_70_20200911_00061.jpg

LM Start	1.82	Rating **	U	Issue No.	70
LM End	1.92	Issue Type +	En	Location *	WS
Category	Earthen Levee			GPS Latitude/Longitude	
				Start	End
Item	Vegetation			38.241010 °	38.240618 °
				-121.551033 °	-121.552747 °
DWR ID	DWR_RD0556_02_f_2018_70				
Comment Code					
V6 : Landscaping					
Inspector Comment					
Thin oleanders to allow view down the levee slope.

View looking downstream at oleanders on the waterside slope (Fall 2020).

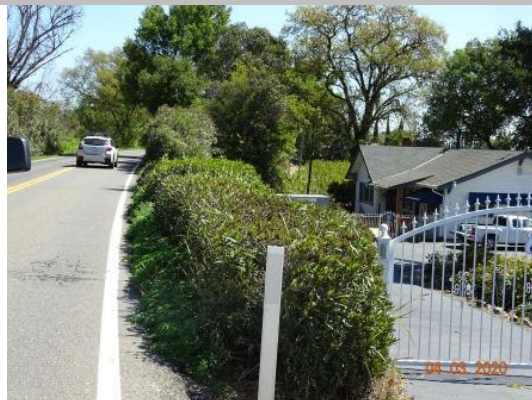
Photo 1 of 1 : FA_2020_RD0556_19_86_20200909_00056.jpg

LM Start	1.83	Rating **	U	Issue No.	86
LM End	1.87	Issue Type +	En	Location *	LS
Category	Earthen Levee			GPS Latitude/Longitude	
				Start	End
Item	Vegetation			38.240944 °	38.240851 °
				-121.551078 °	-121.551833 °
DWR ID	DWR_RD0556_02_s_2020_86				
Comment Code					
V6 : Landscaping					
Inspector Comment

View looking upstream at landscaping on the landside slope (Spring 2020).

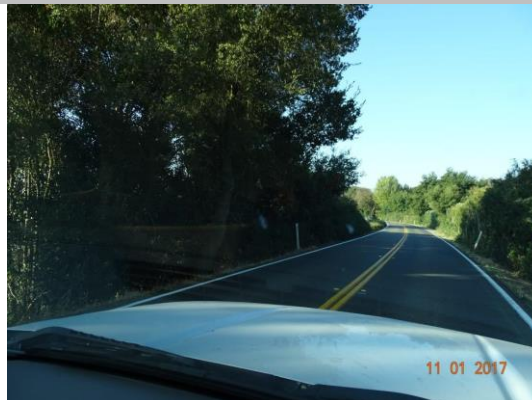
Photo 1 of 1 : FA_2020_RD0556_19_30_20200909_00015.jpg

LM Start	1.89	Rating **	U	Issue No.	30
LM End	1.99	Issue Type +	Ma	Location *	LS
Category	Earthen Levee			GPS Latitude/Longitude	
				Start	End
Item	Vegetation			38.240775 °	38.240024 °
				-121.552183 °	-121.553860 °
DWR ID	DWR_RD0556_02_f_2017_30				
Comment Code					
V7 : Trees / Woody Vegetation					
Inspector Comment					
Remove cactus on the landside slope.

Trim/thin oleanders on landside slope.

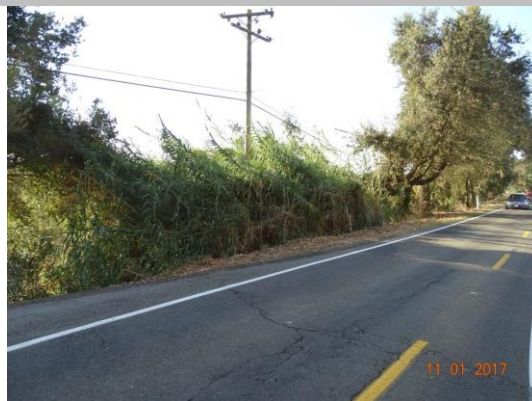
Photo 1 of 1 : FA_2020_RD0556_19_32_20200909_00017.jpg

LM Start	2.06	Rating **	U	Issue No.	32
LM End	2.06	Issue Type +	Ma	Location *	LS
Category	Earthen Levee			GPS Latitude/Longitude	
				Start	End
Item	Vegetation			38.239470 °	38.239470 °
				-121.554845 °	-121.554845 °
DWR ID	DWR_RD0556_02_s_2020_32				
Comment Code					
V7 : Trees / Woody Vegetation					
Inspector Comment					
Arundo growth should be removed to allow inspection and access to the landside slope and toe.

View of arundo on the landside slope and toe.

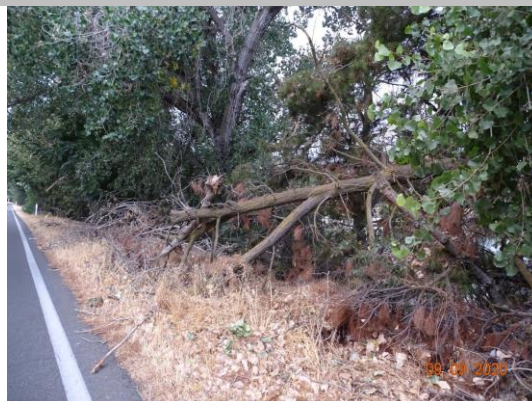
Photo 1 of 1 : FA_2020_RD0556_19_57_20200911_00062.jpg

LM Start	2.12	Rating **	U	Issue No.	57
LM End	2.12	Issue Type +	Ma	Location *	WS
Category	Earthen Levee			GPS Latitude/Longitude	
				Start	End
Item	Encroachments			38.238887 °	38.238887 °
				-121.555570 °	-121.555570 °
DWR ID	DWR_RD0556_02_f _ 2019_57				
Comment Code					
TR : Tree or limb					
Inspector Comment					
Remove downed tree.

View looking downstream at down tree on waterside shoulder (Fall 2020).

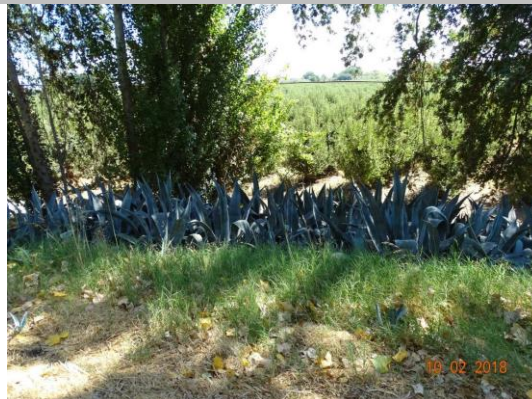
Photo 1 of 1 : FA_2020_RD0556_19_87_20200909_00057.jpg

LM Start	2.13	Rating **	U	Issue No.	87
LM End	2.13	Issue Type +	Ma	Location *	LS
Category	Earthen Levee			GPS Latitude/Longitude	
				Start	End
Item	Vegetation			38.238780 °	38.238780 °
				-121.555717 °	-121.555717 °
DWR ID	DWR_RD0556_02_f_2018_87				
Comment Code					
V7 : Trees / Woody Vegetation					
Inspector Comment					
Remove cactus from the landside slope.

View of cactus on the landside slope (October 2018).

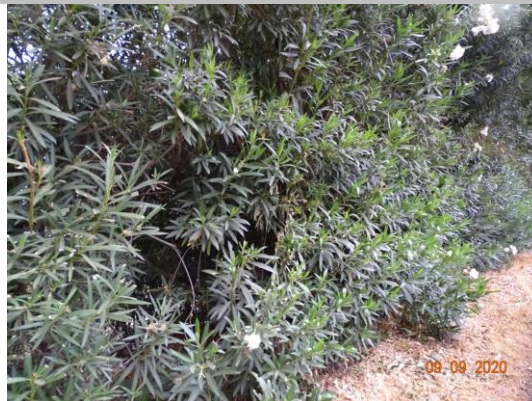
Photo 1 of 1 : FA_2020_RD0556_19_2_20200911_00063.jpg

LM Start	2.14	Rating **	U	Issue No.	2
LM End	2.14	Issue Type +	En	Location *	WS
Category	Earthen Levee			GPS Latitude/Longitude	
				Start	End
Item	Vegetation			38.238644 °	38.238644 °
				-121.555967 °	-121.555967 °
DWR ID	DWR_RD0556_02_f _ 2020_2				
Comment Code					
V6 : Landscaping					
Inspector Comment					
Trim oleanders on the waterside slope.

View looking upstream oleanders on the waterside slope (Fall 2020).

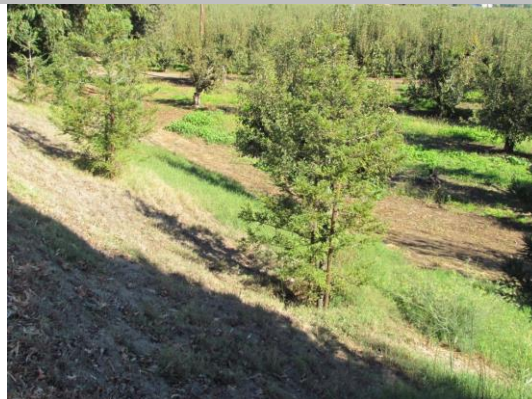
Photo 1 of 1 : FA_2020_RD0556_19_1_20200909_00001.jpg

LM Start	2.28	Rating **	M	Issue No.	1
LM End	2.28	Issue Type +	En	Location *	LS
Category	Earthen Levee			GPS Latitude/Longitude	
				Start	End
Item	Vegetation			38.237156 °	38.237156 °
				-121.557640 °	-121.557640 °
DWR ID	DWR_RD0556_02_f_2015_1				
Comment Code					
V6 : Landscaping					
Inspector Comment					
These unauthorized planted redwoods have been reported in the past inspections. The District needs to have the owner remove them from the levee slope.

RD 556 Unit 2 Levee mile 2.28 unauthorized planting of redwood trees planted on the slope.

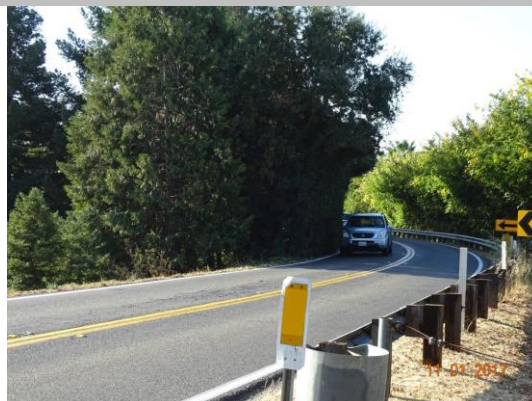
Photo 1 of 1 : FA_2020_RD0556_19_35_20200909_00019.jpg

LM Start	2.29	Rating **	U	Issue No.	35
LM End	2.33	Issue Type +	En	Location *	LS
Category	Earthen Levee			GPS Latitude/Longitude	
				Start	End
Item	Vegetation			38.237060 °	38.236545 °
				-121.557782 °	-121.557910 °
DWR ID	DWR_RD0556_02_f_2017_35				
Comment Code					
V6 : Landscaping					
Inspector Comment					
Trim/thin oleanders to allow inspection and access to landside slope and toe.

View of oleanders on the landside slope and toe.

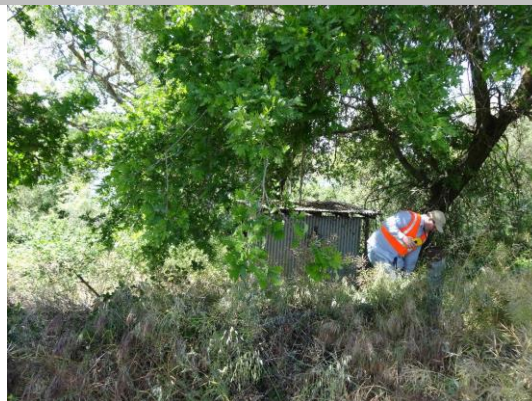
Photo 1 of 3 : UCIP_FA_2020_12574_20388.jpg

DS_ID:20859
FS_ID:12574
EP_NO: 11181
Repair Type: Non-Urgent
EVAL Issue:
Crossing Status: Found
UCIP Comments: - Needs to clean CMP riser for proper functioning of siphon breaker.
FIELD_STRUCT_DESC: 10-inch steel irrigation discharge pipe through the levee, 5.8 feet below the crown. Pump and gate valve in a pump house on the waterside (WS) slope. Siphon breaker and service pole on the landside (LS) slope. (Retention of a 10-inch pipe through the levee, 5.8 feet below the crown, a pump and a gate valve in a pump house on the WS slope, and a siphon breaker and a service pole on the LS slope authorized under Automatic Board Order (ABO) issued as Permit No. 11181, 1975 - Robert E. and G. P. Collins). [Additional Reference(s): DWR Levee Log. USACE Sacramento O&M Manual 103, June 1954, (Station ""J"" 115+25), invert elevation 18.5 feet].
FS Date: 4/25/2013

WS- pump house on levee berm

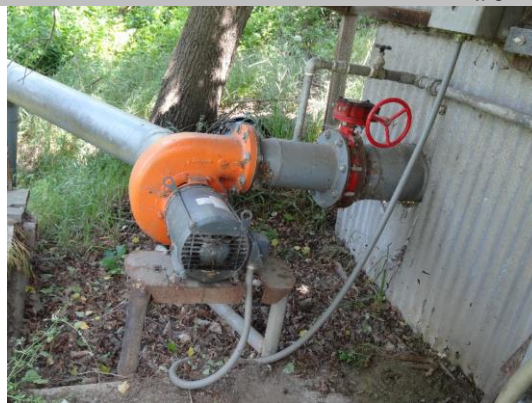
Photo 2 of 3 : UCIP_FA_2020_12574_20387.jpg

WS- pump, and gate valve in pump house.

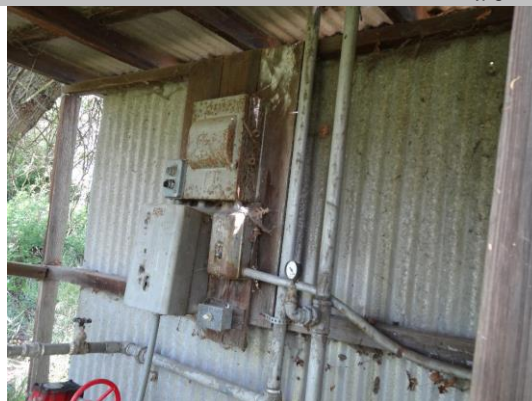
Photo 3 of 3 : UCIP_FA_2020_12574_20386.jpg

WS- power control panel and electric conduit in pump house.

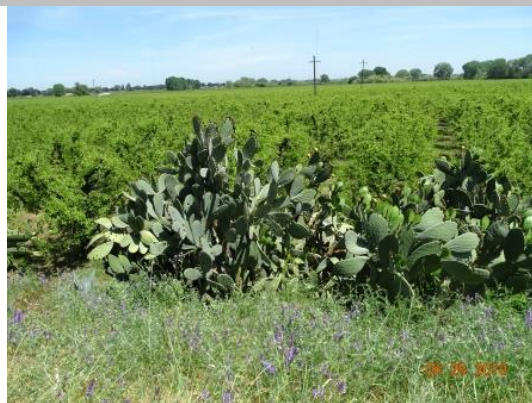
Photo 1 of 1 : FA_2020_RD0556_19_45_20200909_00027.jpg

View of cactus on the landside slope (Spring 2019).

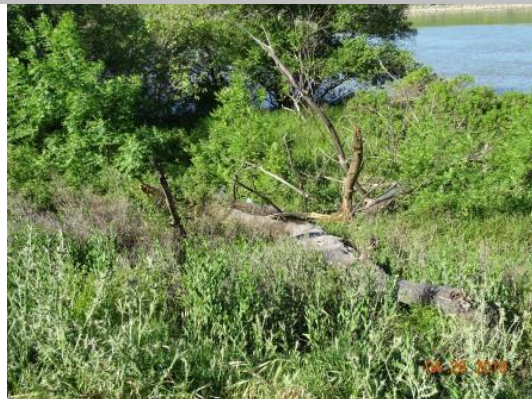
Photo 1 of 1 : FA_2020_RD0556_19_44_20200909_00026.jpg

LM Start	2.69	Rating **	M	Issue No.	44
LM End	2.69	Issue Type +	Ma	Location *	WS
Category	Earthen Levee			GPS Latitude/Longitude	
				Start	End
Item	Encroachments			38.231494 °	38.231494 °
				-121.556474 °	-121.556474 °
DWR ID	DWR_RD0556_02_s_2020_44				
Comment Code					
TR : Tree or limb					
Inspector Comment					
Remove fallen tree from the waterside shoulder.

View of fallen tree within 20' of the waterside shoulder (Spring 2019).

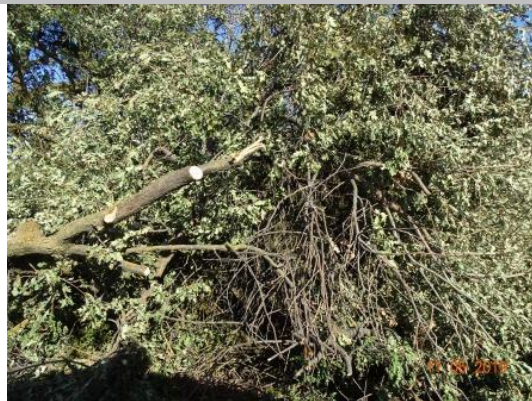
Photo 1 of 1 : FA_2020_RD0556_19_88_20200909_00058.jpg

LM Start	2.75	Rating **	U	Issue No.	88
LM End	2.75	Issue Type +	Ma	Location *	LS
Category	Earthen Levee			GPS Latitude/Longitude	
				Start	End
Item	Encroachments			38.230752 °	38.230752 °
				-121.556007 °	-121.556007 °
DWR ID	DWR_RD0556_02_f _ 2019_88				
Comment Code					
TR : Tree or limb					
Inspector Comment					
Broken tree limb blocking view of landside slope.

View of broken tree limb blocking the view of the landside slope (Fall 2019).

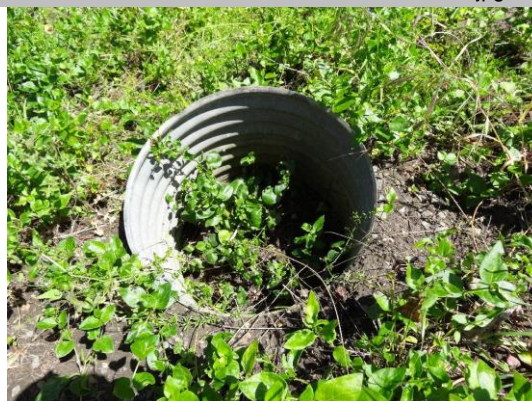
Photo 2 of 3 : UCIP_FA_2020_41713_20283.jpg

Comment Code					
Inspector Comment					
DS_ID:20849 FS_ID:41713 EP_NO: 11181 Repair Type: Non-Urgent EVAL Issue: Crossing Status: Found UCIP Comments: - Needs to clean siphon breaker CMP riser. FIELD_STRUCT_DESC: 6-inch irrigation discharge pipe of an unknown material through the levee, 6 feet below the crown. Pressure tank in a pump house on the waterside (WS) berm. Service pole, siphon breaker, and distribution box on the landside (LS) slope. (Retention of a 6-inch pipe through the levee, 6 feet below the crown; a pump, a gate valve, and a pressure tank on the WS berm; and a service pole on the LS slope authorized under Automatic Board Order (ABO) issued as Permit No. 11181, 1975 - Robert E. and G. P. Collins). [Additional Reference(s): DWR Levee Log]. FS Date: 4/25/2013

LS- siphon breaker in CMP riser on levee slope.

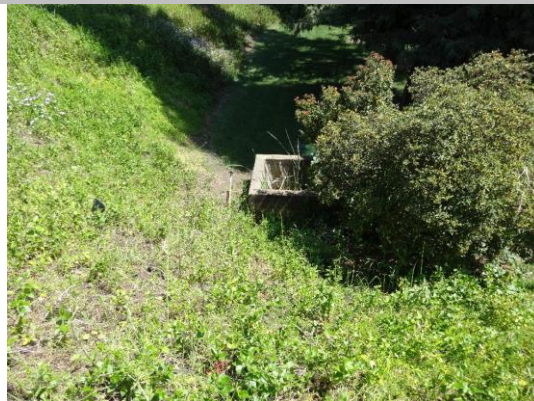
Photo 3 of 3 : UCIP_FA_2020_41713_20282.jpg

LS- concrete distribution box near toe of the levee

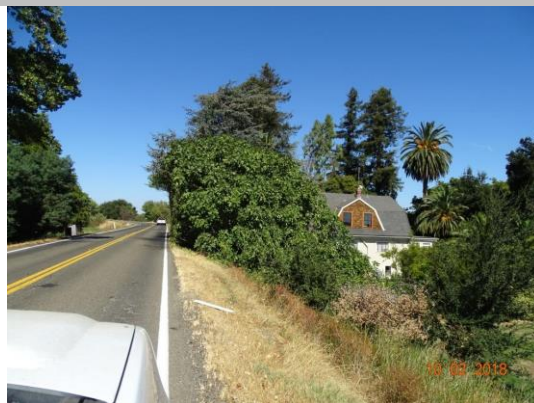
Photo 1 of 1 : FA_2020_RD0556_19_46_20200909_00028.jpg

LM Start	2.86	Rating **	M	Issue No.	46
LM End	2.86	Issue Type +	En	Location *	LS
Category	Earthen Levee			GPS Latitude/Longitude	
				Start	End
Item	Vegetation			38.229195 °	38.229195 °
				-121.555337 °	-121.555337 °
DWR ID	DWR_RD0556_02_f _ 2019_46				
Comment Code					
V6 : Landscaping					
Inspector Comment

View looking upstream at beginning of landscaping on landside (October 2018).

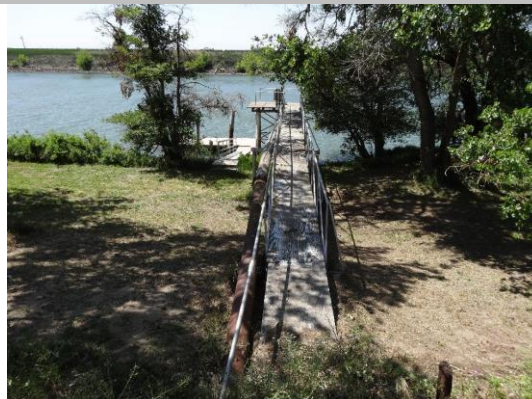
Photo 1 of 3 : UCIP_FA_2020_12525_20290.jpg

Comment Code					
Inspector Comment					
DS_ID:20862 FS_ID:12525 EP_NO: N/A Repair Type: Non-Urgent EVAL Issue: Crossing Status: Found UCIP Comments: - 9-inch steel pipe sleeved through 12-inch pipe.- needs to seal gap between two pipes. FIELD_STRUCT_DESC: 9-inch steel pipe sleeved through a 12-inch steel irrigation discharge pipe through the levee, 6 feet below the crown. Pump on a pile structure in the river. Steel walkway to the pump and wood steps on the waterside (WS) slope. Concrete spill box with two 8- inch openings. (Retention of a 12-inch pipe through the levee, 6 feet below the crown, a pump on a pile structure in the river, a steel walkway to the pump, and wood steps on the WS slope authorized under Automatic Board Order (ABO) issued as Permit No. 11193, 1975 - Gertrude M. Reid). [Additional Reference(s): DWR Levee Log. USACE Sacramento O&M Manual 103, June 1954, (Station ""J"" 80+79), invert elevation 18.3 feet]. FS Date: 4/25/2013

WS- walkway, pump, and pipe on steel pile structure in the river.

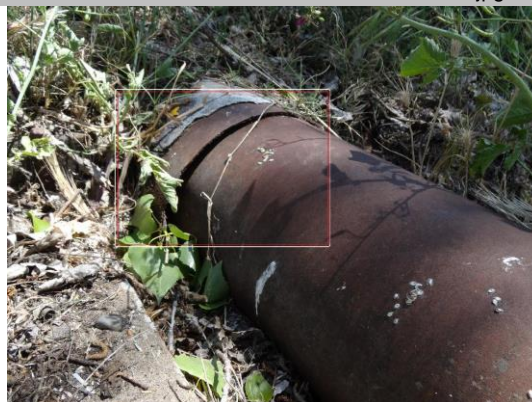
Photo 2 of 3 : UCIP_FA_2020_12525_20289.jpg

WS- 9-inch pipe sleeved through 10 inch steel pipe.

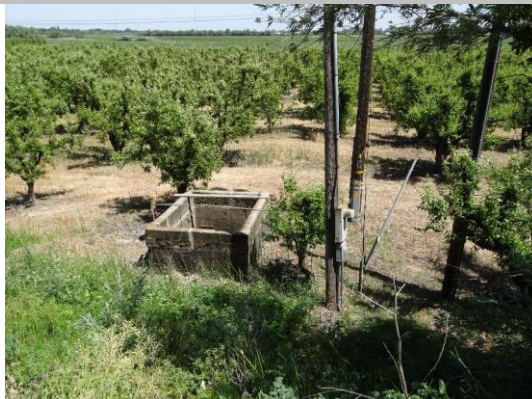
Photo 3 of 3 : UCIP_FA_2020_12525_20288.jpg

LS- a concrete spill box on landside of the levee.

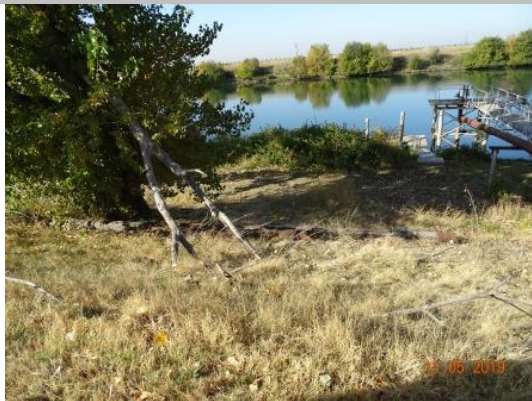
Photo 1 of 1 : FA_2020_RD0556_19_59_20200909_00040.jpg

LM Start	3.07	Rating **	M	Issue No.	59
LM End	3.07	Issue Type +	En	Location *	WS
Category	Earthen Levee			GPS Latitude/Longitude	
				Start	End
Item	Encroachments			38.226155 °	38.226155 °
				-121.555273 °	-121.555273 °
DWR ID	DWR_RD0556_02_f _ 2019_59				
Comment Code					
MA : Material					
Inspector Comment					
There is an abandoned uninstalled pipe on waterside.

View of abandoned uninstalled pipe on the waterside toe (Fall 2019).

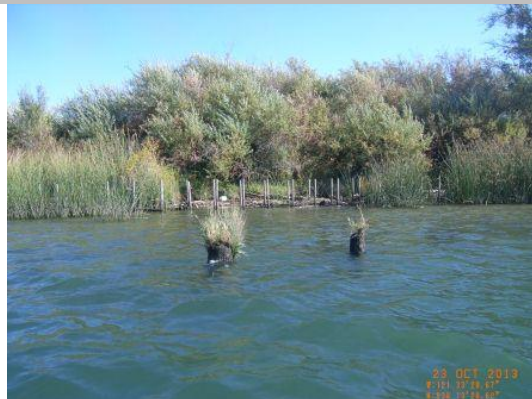
Photo 1 of 1 : FA_2020_RD0556_19_17_20200909_00005.jpg

LM Start	3.17	Rating **	M	Issue No.	17
LM End	3.28	Issue Type +	Ma	Location *	WS
Category	Supplemental			GPS Latitude/Longitude	
				Start	End
Item	2017 USACE Erosion Survey			38.224850 °	38.223233 °
				-121.555641 °	-121.555687 °
DWR ID	DWR_RD0556_02_f _ 2018_17				
Comment Code					
Inspector Comment					
2017 Site ID: SAC 23.2 L					
Status: Eroding					
2017 Field Notes: New erosion along lower bank.					
Site History: 2000 - Recently fallen cottonwood at the downstream end.					
2005 - Empty brush boxes. 2011 - A few trees have fallen since last					
year. 2012 - Potential new tree popout since last year. 2013 - New					
erosion at downstream end of site and a recent tree pop-out observed.					
2016 - New erosion at the toe.

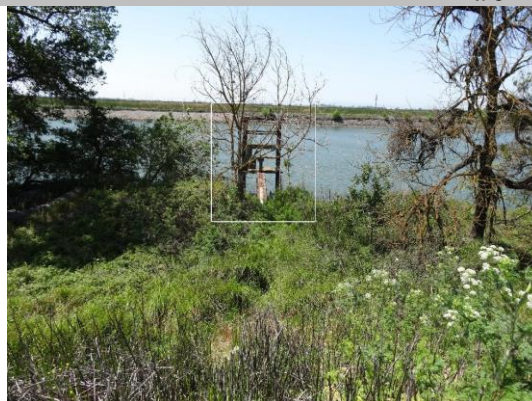
Photo 1 of 3 : UCIP_FA_2020_12527_20297.jpg

DS_ID:20863
FS_ID:12527
EP_NO: 11181
Repair Type: Non-Urgent
EVAL Issue:
Crossing Status: Found
UCIP Comments: - needs to fix siphon breaker
FIELD_STRUCT_DESC: 10-inch steel irrigation discharge pipe through the levee, 4.8 feet below the crown. Steel walkway to the pump on a pile structure in the river. Siphon breaker on the waterside (WS). Service pole on the landside (LS) slope. Concrete spill box with two 15-inch openings on the LS. (Retention of a 10-inch pipe through the levee, 4.8 feet below the crown, a steel walkway to the pump on a pile structure in the river, and a siphon breaker and a service pole on the LS slope authorized under Automatic Board Order (ABO) issued as Permit No. 11181, 1975 - Robert E. and G. P. Collins). [Additional Reference(s): DWR Levee Log. USACE Sacramento O&M Manual 103, June 1954, (Station ""J"" 58+00), invert elevation 18.2 feet].
FS Date: 4/25/2013

WS- pump, pipe, and walkway on steel structure in the stream.

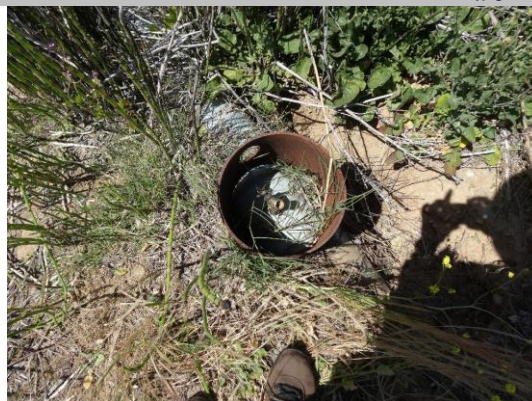
Photo 3 of 3 : UCIP_FA_2020_12527_20295.jpg

WS- siphon breaker on levee slope.

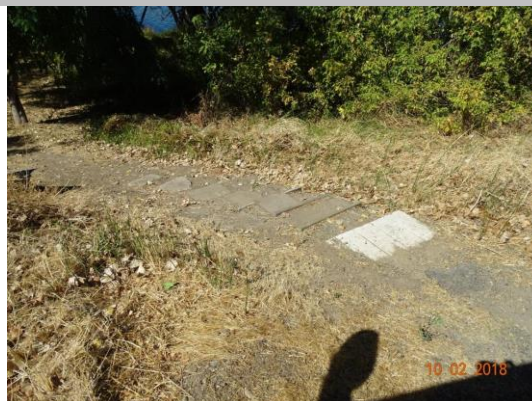
Photo 1 of 1 : FA_2020_RD0556_19_78_20200909_00052.jpg

LM Start	3.54	Rating **	M	Issue No.	78
LM End	3.54	Issue Type +	En	Location *	WS
Category	Earthen Levee			GPS Latitude/Longitude	
				Start	End
Item	Encroachments			38.219407 °	38.219407 °
				-121.556280 °	-121.556280 °
DWR ID	DWR_RD0556_02_f _ 2018_78				
Comment Code					
ST : Stairway					
Inspector Comment					
Stairs encroaching into slope do not have a permit.

View of stairs on waterside slope (October 2018).

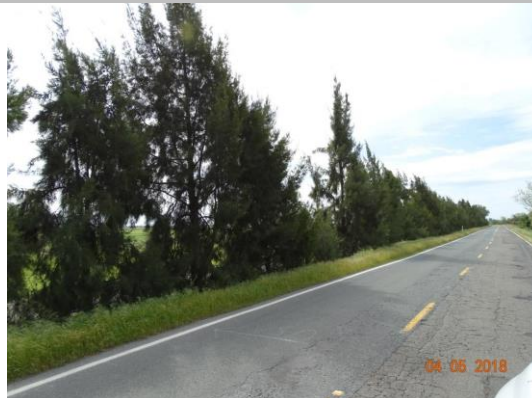
Photo 1 of 1 : FA_2020_RD0556_19_49_20200909_00031.jpg

LM Start	3.58	Rating **	U	Issue No.	49
LM End	3.74	Issue Type +	En	Location *	LS
Category	Earthen Levee			GPS Latitude/Longitude	
				Start	End
Item	Vegetation			38.218889 °	38.216543 °
				-121.556388 °	-121.556777 °
DWR ID	DWR_RD0556_02_s_2018_49				
Comment Code					
V6 : Landscaping					
Inspector Comment					
A row of evergreen trees block inspection and access. They should be trimmed to 5' above the levee.

View of landscaping trees on the landside.

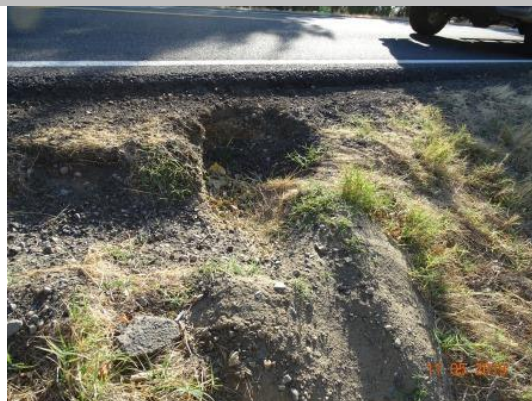
Photo 1 of 1 : FA_2020_RD0556_19_63_20200909_00044.jpg

LM Start	3.68	Rating **	M	Issue No.	63
LM End	3.68	Issue Type +	Ma	Location *	WS
Category	Earthen Levee			GPS Latitude/Longitude	
				Start	End
Item	Erosion / Bank Caving			38.217462 °	38.217462 °
				-121.556647 °	-121.556647 °
DWR ID	DWR_RD0556_02_f_2019_63				
Comment Code					
E2 : Schedule repair of erosion site prior to the next inspection.					
Inspector Comment					
Repair erosion on waterside shoulder

View of erosion on the waterside shoulder (Fall 2019).

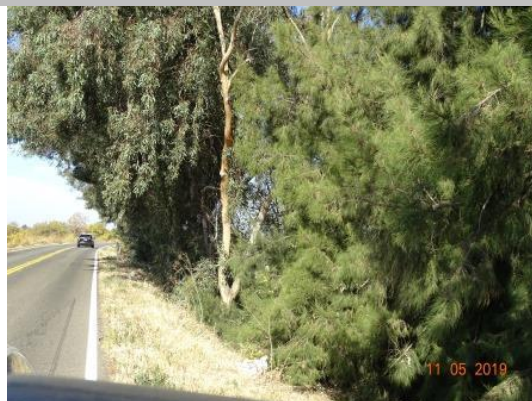
Photo 1 of 1 : FA_2020_RD0556_19_84_20200909_00055.jpg

LM Start	3.83	Rating **	M	Issue No.	84
LM End	3.87	Issue Type +	Ma	Location *	LS
Category	Earthen Levee			GPS Latitude/Longitude	
				Start	End
Item	Trim / Thin Trees			38.215223 °	38.214688 °
				-121.556903 °	-121.556868 °
DWR ID	DWR_RD0556_02_f_2018_84				
Comment Code					
T1 : Trim trees to at least five feet above ground level.					
Inspector Comment

View looking upstream at thick trees on the landside slope (Fall 2019).

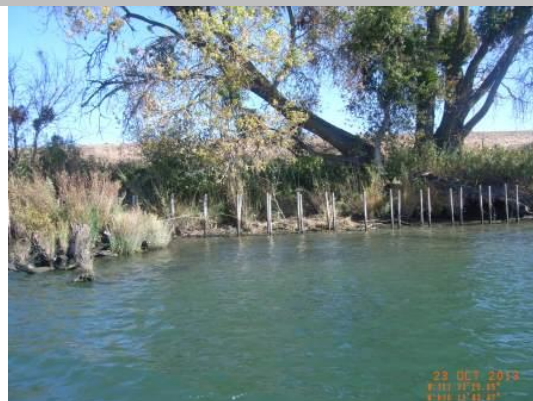
Photo 1 of 1 : FA_2020_RD0556_19_15_20200909_00003.jpg

2017 Site ID: SAC 22.5 L
Status: Eroding
2017 Field Notes: New lower bank erosion at the upstream end. Locals placed rock in some erosion pockets.
Site History: 2002 - Spot rock along berm, but not in the erosion pockets. 2005 - Some new minor stone revetment at the upstream end. Brush boxes present. 2006 - Currently installing new brush in downstream brush boxes. 2007 - Rock in middle portion for about 150 ft. 2010 - Some attempt at repairs but still has pockets of erosion. 2012 - More erosion along the toe.

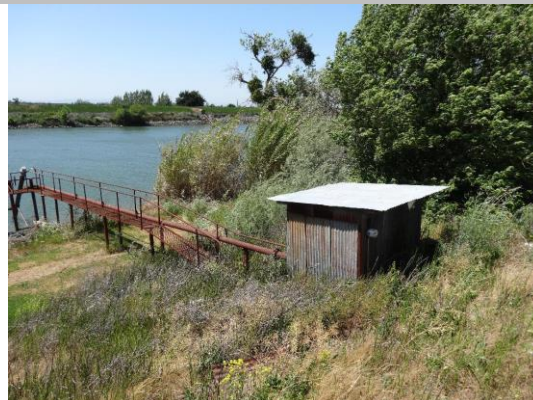
Photo 1 of 3 : UCIP_FA_2020_12543_20302.jpg

DS_ID:20864
FS_ID:12543
EP_NO: 11197
Repair Type: Non-Urgent
EVAL Issue:
Crossing Status: Found
UCIP Comments: Electric control panel in pump house.Needs cleaning of CMP riser on landside.
FIELD_STRUCT_DESC: 6-inch steel irrigation discharge pipe through the levee, 6.5 feet below the crown. Slant pump on a steel pile structure in the river. Walkway to the pump. Gate valve in a pump house on the waterside (WS) slope. Siphon breaker and service poles on the landside (LS) slope. Concrete standpipe on the LS. (Retention of a 6-inch pipe through the levee, 6.5 feet below the crown, a pump and a gate valve in a pump house on the WS slope, and a siphon breaker and a service pole on the LS slope authorized under Automatic Board Order (ABO) issued as Permit No. 11197, 1975 - Richard T. and Mary B. Souza). [Additional Reference(s): DWR Levee Log. USACE Sacramento O&M Manual 103, June 1954, (Station ""J"" 32+40), invert elevation 18.1 feet].

WS- pipe and pump on steel pile structure. Steel walkway from pump house to the pump on steel structure.

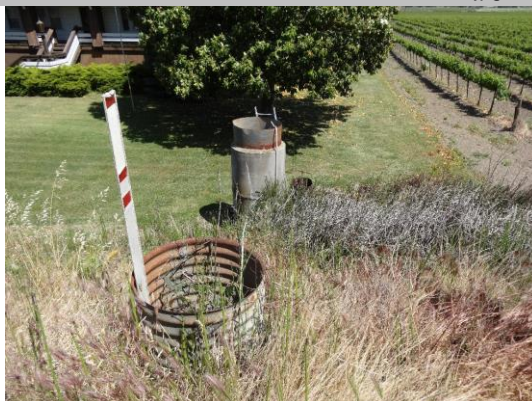
Photo 2 of 3 : UCIP_FA_2020_12543_20301.jpg

LS- siphon breaker in CMP riser and concrete standpipe behind CMP riser.

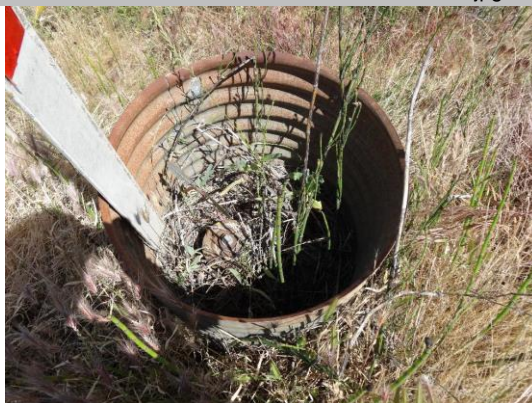
Photo 3 of 3 : UCIP_FA_2020_12543_20300.jpg

LS- siphon breaker in CMP riser. It needs cleaning.

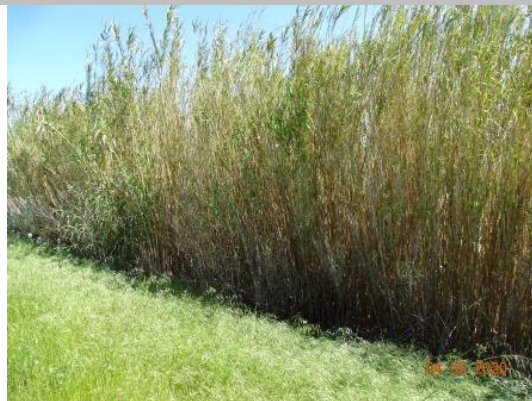
Photo 1 of 1 : FA_2020_RD0556_19_51_20200909_00032.jpg

LM Start	4.22	Rating **	U	Issue No.	51
LM End	4.22	Issue Type +	Ma	Location *	LS
Category	Earthen Levee			GPS Latitude/Longitude	
				Start	End
Item	Vegetation			38.209629 °	38.209629 °
				-121.556757 °	-121.556757 °
DWR ID	DWR_RD0556_02_s_2020_51				
Comment Code					
V7 : Trees / Woody Vegetation					
Inspector Comment					
Remove arundo from landside slope

View of thick arundo on the landside slope (Spring 2020).

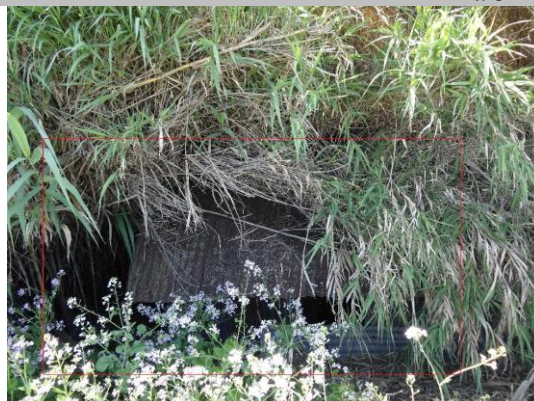
Photo 2 of 3 : UCIP_FA_2020_12545_20309.jpg

Comment Code					
Inspector Comment					
DS_ID:20865 FS_ID:12545 EP_NO: 11194 Repair Type: Non-Urgent EVAL Issue: Crossing Status: Found UCIP Comments: - CMP riser found abandoned on LS slope. Due to dense vegetation siphon breaker could not be found.- Dense vegetation on both sides of the levee.- Oil leaks from pump set. FIELD_STRUCT_DESC: 8-inch steel irrigation discharge pipe through the levee, 6.7 feet below the crown. Pump and gate valve in a pump house on the waterside (WS) slope. Siphon breaker on the landside (LS) slope. (Retention of an 8-inch pipe through the levee, 6.7 feet below the crown, a pump and a gate valve in a pump house on the WS slope, and a siphon breaker on the LS slope authorized under Automatic Board Order (ABO) issued as Permit No. 11194, 1975 - Gerald E. and William M. Robinson, et al.). [Additional Reference(s): DWR Levee Log. USACE Sacramento O&M Manual 103, June 1954, (Station ""J"" 18+20), invert elevation 18 feet]. FS Date: 4/25/2013

WS- pump house inside the dense vegetation.

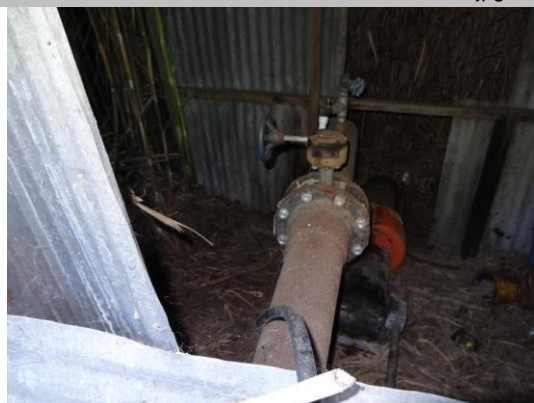
Photo 3 of 3 : UCIP_FA_2020_12545_20308.jpg

WS- pump, gate valve and pipe in pump house.

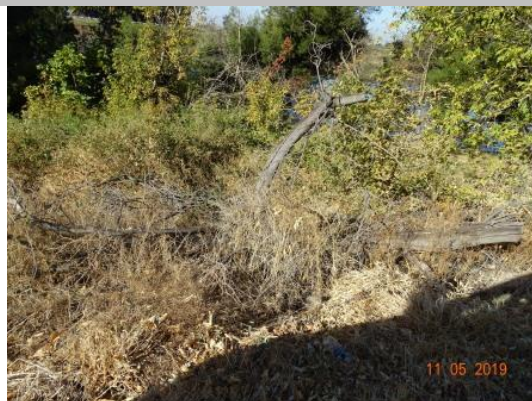
Photo 1 of 1 : FA_2020_RD0556_19_54_20200909_00035.jpg

LM Start	4.43	Rating **	M	Issue No.	54
LM End	4.43	Issue Type +	En	Location *	WS
Category	Earthen Levee			GPS Latitude/Longitude	
				Start	End
Item	Encroachments			38.206628 °	38.206628 °
				-121.556829 °	-121.556829 °
DWR ID	DWR_RD0556_02_s_2018_54				
Comment Code					
TR : Tree or limb					
Inspector Comment					
Remove fallen tree and other woody debris on waterside slope

View of fallen tree and limbs on the waterside slope (Fall 2019).

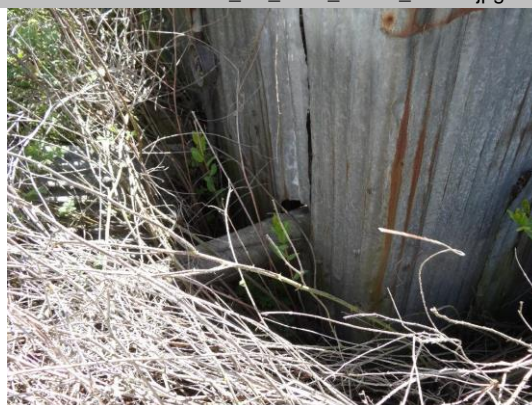
Photo 2 of 3 : UCIP_FA_2020_12546_20313.jpg

Comment Code					
Inspector Comment					
DS_ID:20866 FS_ID:12546 EP_NO: 11940 Repair Type: Non-Urgent EVAL Issue: Crossing Status: Found UCIP Comments: - Abandoned crossing.- Siphon breaker on LS not found due to dense vegetation, - An abandoned CMP riser and service pole found on LS.- It may need to be properly abandoned. FIELD_STRUCT_DESC: *ABANDONED* 6-inch steel irrigation discharge pipe through the levee, 6.7 feet below the crown. Pump and gate valve in a pump house on the waterside (WS) slope. Siphon breaker and service pole on the landside (LS) slope. (Retention of a 6-inch pipe through the levee, 6.5 feet below the crown, a pump and a gate valve in a pump house on the WS slope, and a siphon breaker and a service pole on the LS slope authorized under Automatic Board Order (ABO) issued as Permit No. 11194, 1975 - Gerald E. and William M. Robinson, et al.). [Additional Reference(s): DWR Levee Log. USACE Sacramento O&M Manual 103, June 1954, (Station ""J"" 2+73), invert elevation 18 feet]. FS Date: 4/25/2013

WS- pipe daylight from levee slope to pump house.

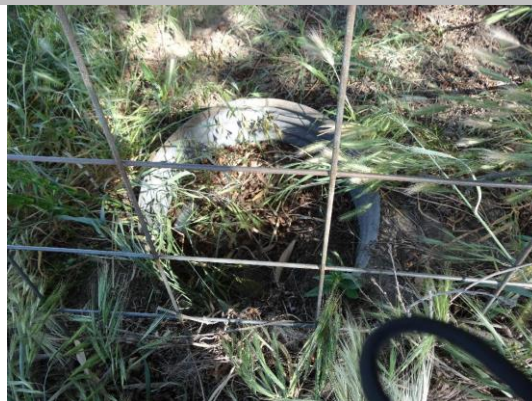
Photo 1 of 3 : UCIP_FA_2020_12547_20320.jpg

Comment Code					
Inspector Comment					
DS_ID:20867 FS_ID:12547 EP_NO: 11199 Repair Type: Non-Urgent EVAL Issue: Crossing Status: Indicator Found UCIP Comments: - pump, gate valve and pumphouse not found on waterward slope.- an abandoned electric control panel found on WS.- may need to be properly abandoned. FIELD_STRUCT_DESC: 6-inch steel irrigation discharge pipe through the levee, 6.5 feet below the crown. Siphon and concrete spill box with two 8-inch openings. (Retention of a 6-inch pipe through the levee, 6.5 feet below the crown, a pump and a gate valve in a pump house on the waterside [WS] slope, and a siphon breaker and a service pole on the landside [LS] slope authorized under Automatic Board Order (ABO) issued as Permit No. 11199, 1975 - Toshi Tokuyoshi, et al.). [Additional Reference(s): DWR Levee Log. USACE Sacramento O&M Manual 103, June 1954, (Station ""H"" 159+97), invert elevation 17.9 feet]. FS Date: 4/25/2013

LS- obstructed siphon breaker in CMP riser on levee slope.

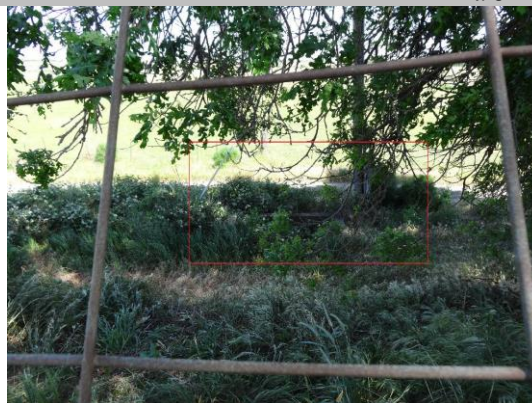
Photo 2 of 3 : UCIP_FA_2020_12547_20319.jpg

LS- concrete distribution box near levee toe.

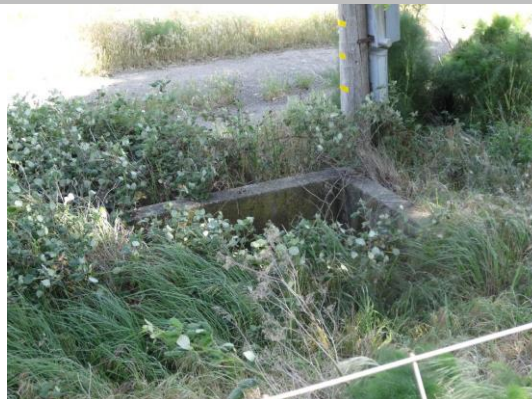
Photo 3 of 3 : UCIP_FA_2020_12547_20318.jpg

LS- power pole and a concrete distribution box near levee toe.

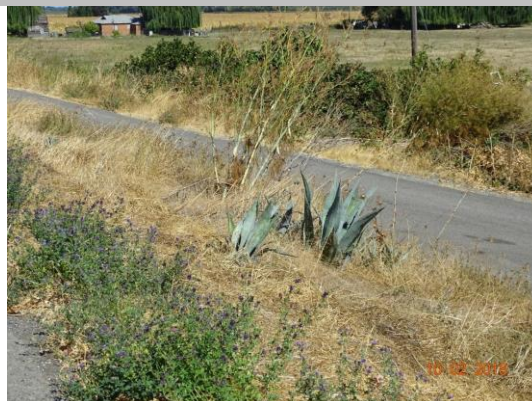
Photo 1 of 1 : FA_2020_RD0556_19_60_20200909_00041.jpg

LM Start	4.79	Rating **	M	Issue No.	60
LM End	4.79	Issue Type +	Ma	Location *	LS
Category	Earthen Levee			GPS Latitude/Longitude	
				Start	End
Item	Vegetation			38.201402 °	38.201402 °
				-121.557108 °	-121.557108 °
DWR ID	DWR_RD0556_02_s_2018_60				
Comment Code					
V2 : Remove the wild growth other than native grasses from the levee slopes.					
Inspector Comment					
Remove cactus before more can become established.

View of cactus on the landside slope (October 2018).

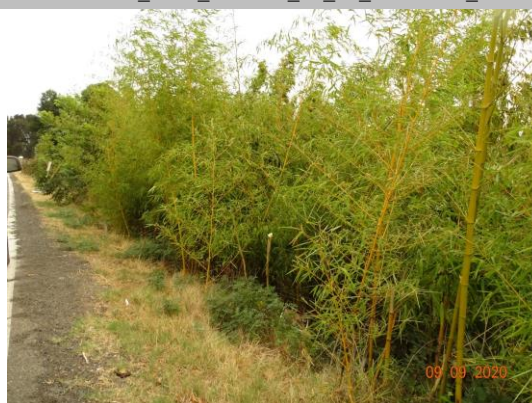
Photo 1 of 1 : FA_2020_RD0556_19_61_20200911_00070.jpg

LM Start	4.82	Rating **	U	Issue No.	61
LM End	4.82	Issue Type +	En	Location *	LS
Category	Earthen Levee			GPS Latitude/Longitude	
				Start	End
Item	Vegetation			38.201002 °	38.201002 °
				-121.557170 °	-121.557170 °
DWR ID	DWR_RD0556_02_s_2018_61				
Comment Code					
V6 : Landscaping					
Inspector Comment					
Landside bamboo should be removed to allow inspection and access.

View looking downstream at bamboo on the landside slope (Fall 2020).

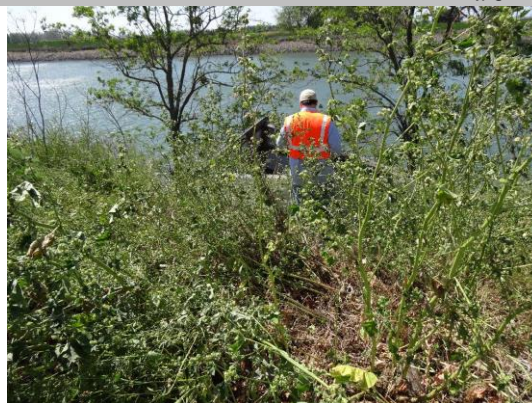
Photo 1 of 3 : UCIP_FA_2020_12564_20347.jpg

Comment Code						
Inspector Comment						
DS_ID:20868 FS_ID:12564 EP_NO: 11191 Repair Type: Non-Urgent EVAL Issue: Crossing Status: Found UCIP Comments: - needs to fix CMP riser. FIELD_STRUCT_DESC: 8-inch irrigation discharge pipe of an unknown material through the levee, 5.7 feet below the crown. Pump on the waterside (WS) slope. Gate valve on the WS berm. Siphon breaker and service pole on the landside (LS) slope. (Retention of an 8-inch pipe through the levee, 5.7 feet below the crown, a pump on the WS slope, a gate valve on the WS berm, and a siphon breaker and a service pole on the LS slope authorized under Automatic Board Order (ABO) issued as Permit No. 11191, 1975 - Pacific Fruit Exchange). [Additional Reference(s): DWR Levee Log]. FS Date: 4/25/2013

WS- pump house on levee slope.

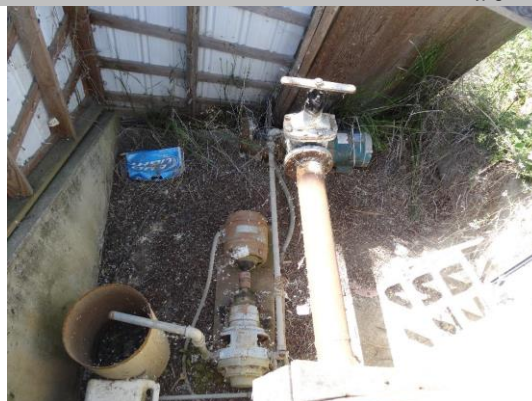
Photo 2 of 3 : UCIP_FA_2020_12564_20346.jpg

LM Start	4.95	Rating **	M	Issue No.	103 (cont)
LM End	4.95	Issue Type +	En	Location *	
Category	Supplemental		GPS Latitude/Longitude		
			Start	End	
Item	DWR UCIP Field Study		38.199133 °	38.199133 °	
			-121.557939 °	-121.557939 °	
DWR ID	20868

WS- pump, pipe and gate valve in pump house.

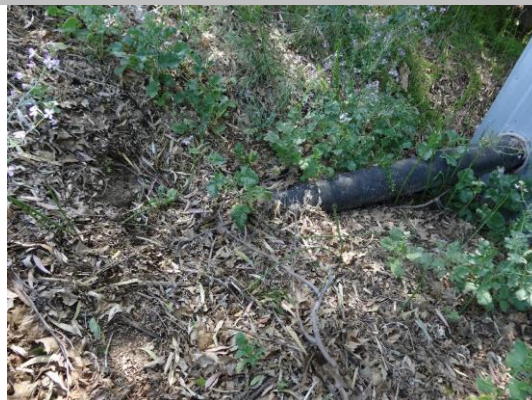
Photo 2 of 3 : UCIP_FA_2020_52733_20363.jpg

Comment Code						
Inspector Comment						
DS_ID:20869 FS_ID:52733 EP_NO: 11185 Repair Type: Urgent EVAL Issue: Crossing Status: Found UCIP Comments: 07/12/2018 Pit on WS is covered with plywood. Water pump is running, no leaks detected. LS part of crossing was reconstructed. New pipe was installed after CMP riser to supply water to sand filters. Remains Urgent due to large pit on WS that needs to be backfilled. (O.Yakimov-DWR UCIP)04/25/2013 Large pit on levee berm. FIELD_STRUCT_DESC: 8-inch irrigation discharge pipe of an unknown material through the levee, 5.7 feet below the crown. Pump and gate valve in a pump house on the waterside (WS) slope. Siphon breaker, concrete box, and service pole on the landside (LS) slope. (Retention of an 8-inch pipe through the levee, 5.7 feet below the crown, a pump and a gate valve in a pump house on the WS slope, and a siphon breaker and a service pole on the LS slope authorized under Automatic Board Order (ABO) issued as Permit No. 11185, 1975 - R. Walter Langhart). [Additional Reference(s): DWR Levee Log]. FS Date: 7/13/2018

WS- pipe daylight from the levee.

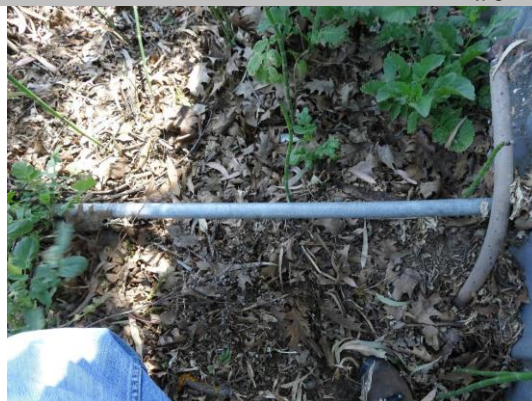
Photo 3 of 3 : UCIP_FA_2020_52733_20366.jpg

LM Start	5.21	Rating **	U	Issue No.	104 (cont)
LM End	5.21	Issue Type +	En	Location *	
Category	Supplemental			GPS Latitude/Longitude	
				Start	End
Item	DWR UCIP Field Study			38.195755 °	38.195755 °
				-121.560078 °	-121.560078 °
DWR ID	20869

WS- electric conduit daylight near pump house.

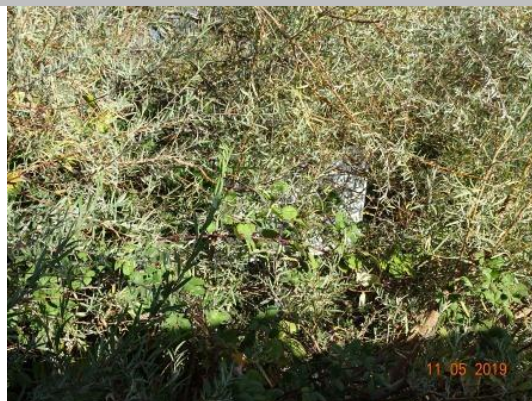
Photo 1 of 1 : FA_2020_RD0556_19_80_20200909_00054.jpg

LM Start	5.58	Rating **	A/W	Issue No.	80
LM End	5.72	Issue Type +	Ob	Location *	WS
Category	Earthen Levee			GPS Latitude/Longitude	
				Start	End
Item	Vegetation			38.192530 °	38.191865 °
				-121.565352 °	-121.567757 °
DWR ID	DWR_RD0556_02_f_2019_80				
Comment Code					
V8 : Environmental Requirements.					
Inspector Comment					
This is a DWR Revegetation Site.

View of environmental mitigation sign on the waterside slope. The sign is mostly obscured by vegetation (Fall 2019).

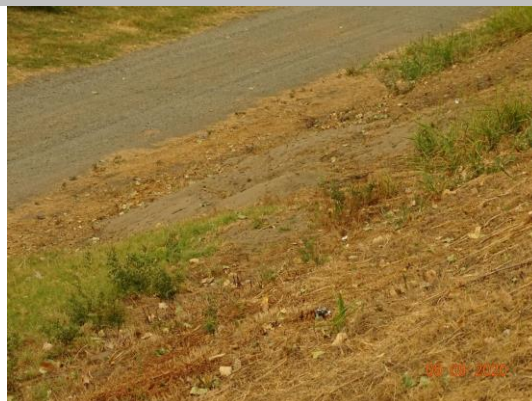
Photo 1 of 1 : FA_2020_RD0556_19_79_20200911_00067.jpg

LM Start	5.64	Rating **	U	Issue No.	79
LM End	5.64	Issue Type +	Ma	Location *	LS
Category	Earthen Levee			GPS Latitude/Longitude	
				Start	End
Item	Animal Control			38.192237 °	38.192237 °
				-121.566368 °	-121.566368 °
DWR ID	DWR_RD0556_02_f_2018_79				
Comment Code					
A3 : No rodents visible, but rodent burrows visible; need to backfill and compact or grout burrows.					
Inspector Comment					
More than 2 cubic feet of soil was removed between the two large burrow holes.

View looking downstream at burrow holes on the landside slope (Fall 2020).
