## Flood Control Project Maintenance Levee Inspections

### Fall 2021 Levee Maintenance Deficiency Summary Report

#### Sacramento River Basin

**Reclamation District No. 0556 Upper Andrus**

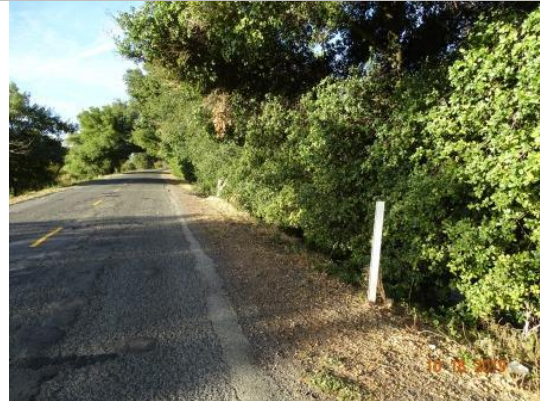
Photo 1 of 1 : FA\_2021\_RD0556\_18\_21\_20210830\_00005.jpg

LM Start	0.00	Rating **	U	Issue No.	21
LM End	0.57	Issue Type +	Ma	Location *	LS
Category	Earthen Levee			GPS Latitude/Longitude	
				Start	End
Item	Trim / Thin Trees			38.239100 °	38.232070 °
				-121.518250 °	-121.522067 °
DWR ID	DWR_RD0556_01_s_2017_21				
Comment Code					
T2 : Thin trees to allow visibility of the ground and room to flood fight.					
Inspector Comment

View looking downstream at thick trees on the landside slope (Fall 2019).

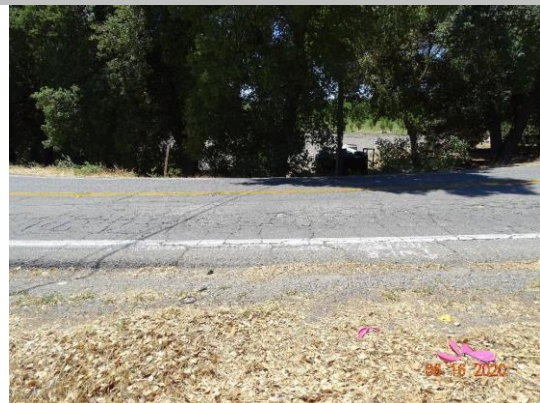
Photo 1 of 3 : UCIP\_FA\_2021\_61316\_88594.jpg

Comment Code						
Inspector Comment						
DS_ID:20832 FS_ID:61316 EP_NO: 6601 Repair Type: Non-Urgent EVAL Issue: Pipe Not Found Crossing Status: Indicator Found UCIP Comments: 06/16/2020 Record updated from No Action Needed to Non-Urgent. Crossing not found. Overhead telephone line across the levee at this location. (O.Yakimov - DWR UCIP) 05/01/2013 Telephone conduit through levee berm and Georgiana Slough. It does not go through levee section. (P.Amatya - DWR UCIP) FIELD_STRUCT_DESC: Unknown diameter and material telephone conduit across Georgiana Slough and through its levees, 3.5 feet below the crown. (Armored submarine cable under Georgiana Slough and through levees authorized under Permit No. 6601, 1969 - General Telephone Company of California). [Additional Reference(s): DWR Levee Log, unk.yr. (HLM 0.01)]. FS Date: 6/16/2020 1:06:36 PM

Top of Levee: View of levee crown looking from waterside

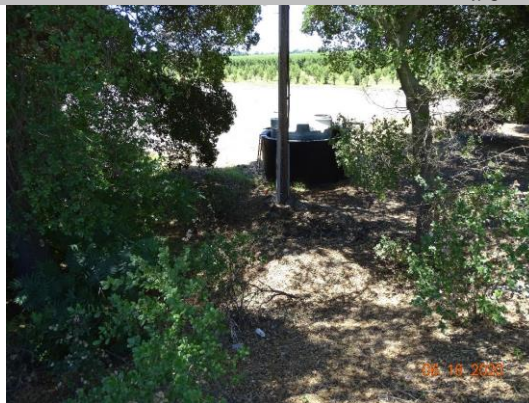
Photo 2 of 3 : UCIP\_FA\_2021\_61316\_88595.jpg

Land-Side: Telephone line pole at landside toe

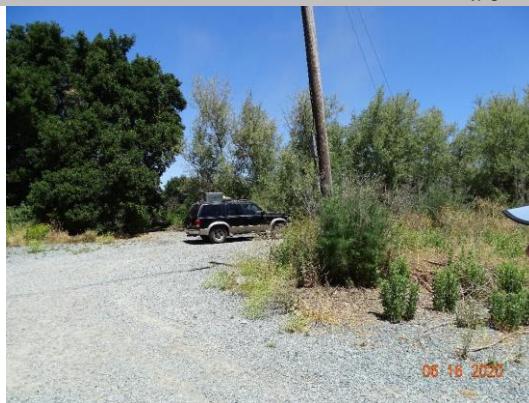
Photo 3 of 3 : UCIP\_FA\_2021\_61316\_88592.jpg

Water-Side: Telephone line pole on waterside berm. Overhead telephone line crossing the levee

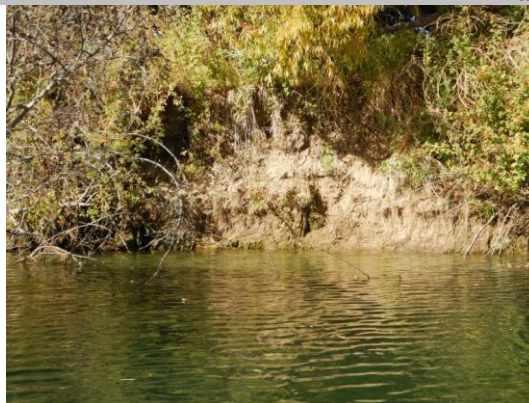
Photo 1 of 2 : FA\_2021\_RD0556\_18\_43\_20211218\_40.jpg

LM Start	0.38	Rating **	M	Issue No.	43
LM End	0.58	Issue Type +	Ma	Location *	WS
Category	Supplemental			GPS Latitude/Longitude	
				Start	End
Item	2018 USACE Erosion Survey			38.234038 °	38.231879 °
				-121.519817 °	-121.522003 °
DWR ID					
Comment Code					
Inspector Comment					
2018 Site ID: GEO 11.8 R					
Status: Eroding					
2018 Field Notes: No observed change.					
Site History: 2017 - Tree popout popouts eminent , significant toe erosion and whole bank failure in sections

USACE 2018 Erosion Photo #1

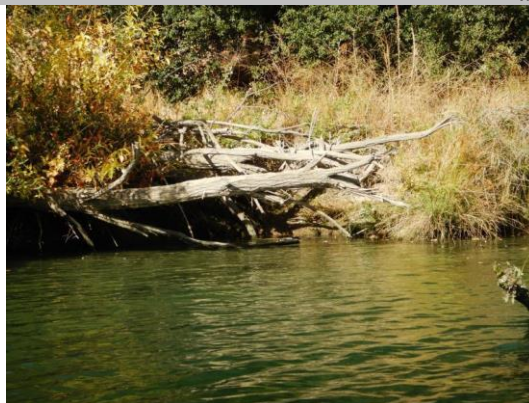
Photo 2 of 2 : FA\_2021\_RD0556\_18\_43\_20211218\_41.jpg

USACE 2018 Erosion Photo #2

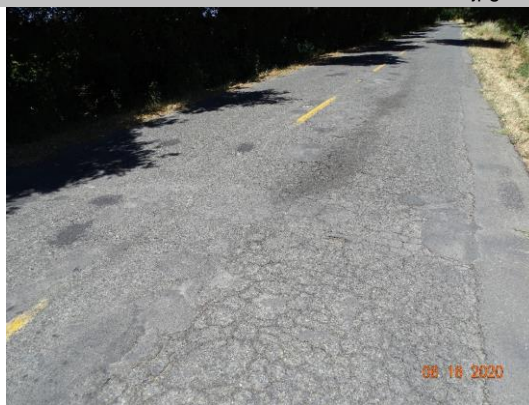
Photo 1 of 3 : UCIP\_FA\_2021\_61317\_88596.jpg

DS\_ID:20820  
 FS\_ID:61317  
 EP\_NO: 3448  
 Repair Type: Non-Urgent  
 EVAL Issue: Safety Issue  
 Crossing Status: Indicator Found  
 UCIP Comments: 06/16/2020 Record remains Non-Urgent. No inspection records were available to determine status of line through the levee. Due to overgrown vegetation on waterside unable to inspect levee slope. Gas line marker not found. (O.Yakimov - DWR UCIP)  
 Dense vegetation inhibited visibility of gas line marker on WS. Need to contact owner to determine status of crossing.  
 FIELD\_STRUCT\_DESC: 4.5-inch steel natural gas pipeline through the levee, 4 feet below the crown. Location marker on the waterside (WS) shoulder. Cut in pavement visible at the crossing. Gas line marker on the landside (LS) and on the opposite bank at Reclamation District No. 263 (RD0263). Pipe not located in February 1991. (4.5-inch gas line across Georgiana Slough authorized under Permit No. 3448, 1960 - Pacific Gas and Electric Company). [Additional Reference(s): DWR Levee Log, unk.yr. (HLM 0.43).

Top of Levee: View of levee crown looking upstream

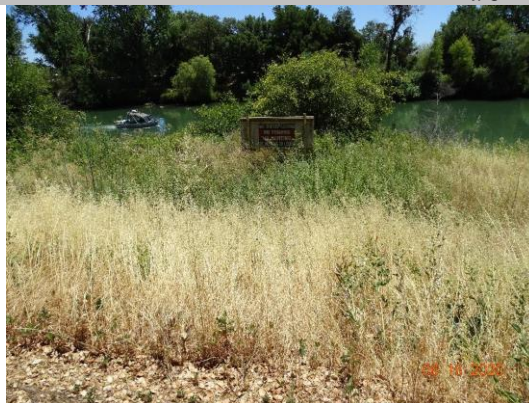
Photo 2 of 3 : UCIP\_FA\_2021\_61317\_88597.jpg

Water-Side: View of levee slope looking from crown

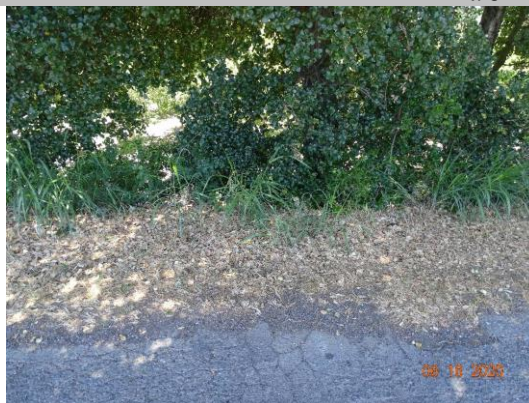
Photo 3 of 3 : UCIP\_FA\_2021\_61317\_88598.jpg

Land-Side: Overview of landside at the crossing

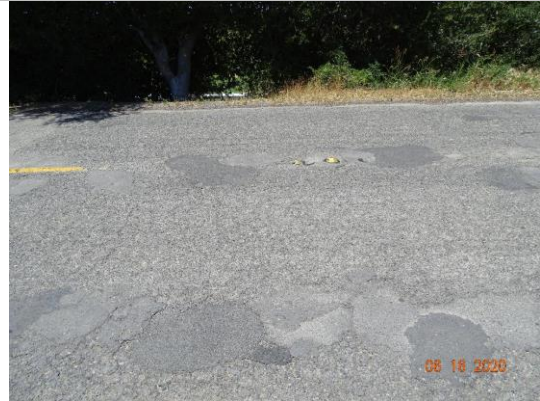
Photo 1 of 3 : UCIP\_FA\_2021\_61333\_88640.jpg

DS\_ID:21454  
FS\_ID:61333  
EP\_NO: N/A  
Repair Type: Non-Urgent  
EVAL Issue: Pipe Not Found  
Crossing Status: Not Found  
UCIP Comments: 06/16/2020 Record is Non-Urgent. Crossing not found. No permit has been identified authorizing pipe. USACE As-Built Drawing No. 50-04-2671 Revision 1 (Feb 6, 1951), Sheet 6, approx. Station 185+00, dated 25 January 1951, shows 10-inch pipe crossing the levee at this location, while Revision 2 (December 29, 1952) of this drawing does not. No reference in O&M SAC103 to this crossing found. (O.Yakimov - DWR UCIP)  
FIELD\_STRUCT\_DESC: 10-inch steel irrigation discharge pipe through the levee, at an unknown depth. Pump on the waterside (WS). 5-foot by 7-foot concrete distribution box on the landside (LS). Irrigation ditch on the LS.  
FS Date: 6/16/2020 1:45:44 PM

Top of Levee: View of levee crown looking from waterside

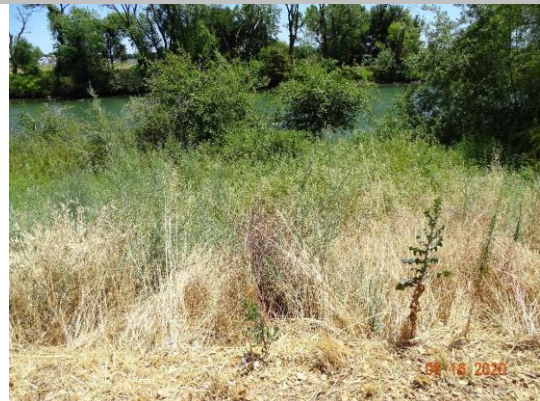
Photo 2 of 3 : UCIP\_FA\_2021\_61333\_88641.jpg

Water-Side: View of levee slope looking from crown

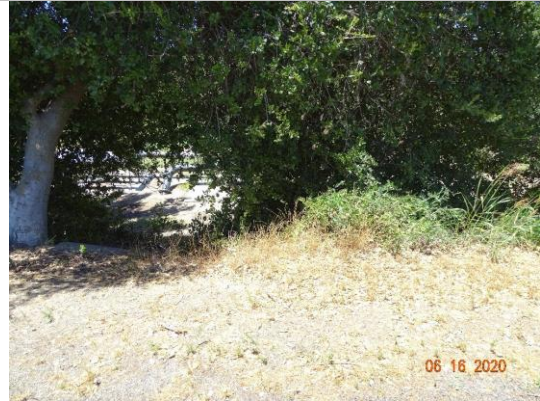
Photo 3 of 3 : UCIP\_FA\_2021\_61333\_88642.jpg

Land-Side: View of levee slope looking from crown

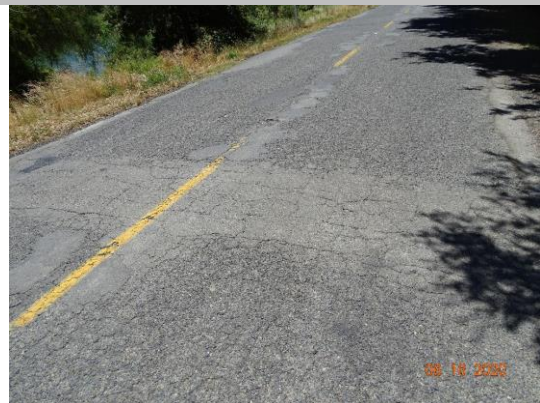
Photo 1 of 3 : UCIP\_FA\_2021\_61336\_88649.jpg

DS\_ID:20821  
 FS\_ID:61336  
 EP\_NO: 5548  
 Repair Type: Non-Urgent  
 EVAL Issue: Limited Inspection/No UCIP Evaluation  
 Crossing Status: Found  
 UCIP Comments: 06/16/2020 Record remains Non-Urgent. Unable to inspect waterside slope due to overgrown vegetation. Unable to find pump on waterside, instead, a gas pump and screen filters installed on landside. Unable to find a permit for modification. (O.Yakimov - DWR UCIP)  
 05/13/2015 Dense vegetation prevents inspection of WS slope. (K.Fazel - DWR UCIP)  
 FIELD\_STRUCT\_DESC: 12-inch steel irrigation discharge pipe through the levee, 5 feet below the crown. 1.25-inch electrical conduit through the levee at the same location. Pump and screen filters on the landside. Concrete steps on the landside (LS) slope. Cuts in pavement visible at the crossing. Siphon breaker on waterside shoulder. (12-inch pipe authorized under Permit No. 5548, 1966 - George K. Adams).

Top of Levee: View of levee crown looking downstream

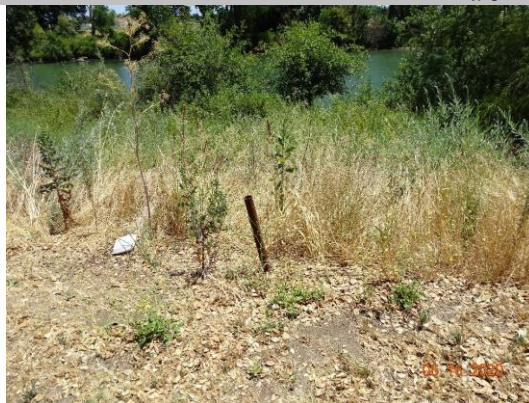
Photo 2 of 3 : UCIP\_FA\_2021\_61336\_88650.jpg

Water-Side: View of levee slope looking from crown

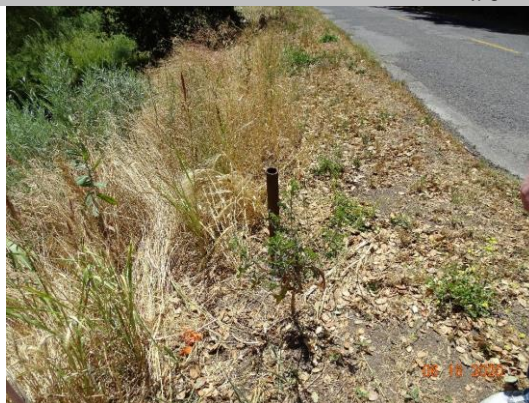
Photo 3 of 3 : UCIP\_FA\_2021\_61336\_88651.jpg

Water-Side: Air vent pipe on levee shoulder

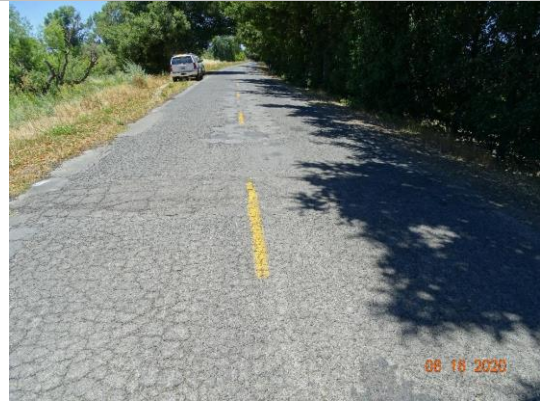
Photo 1 of 3 : UCIP\_FA\_2021\_61344\_88653.jpg

Comment Code						
Inspector Comment						
DS_ID:20826 FS_ID:61344 EP_NO: 5548A Repair Type: Non-Urgent EVAL Issue: Abandoned encroachment Crossing Status: Found UCIP Comments: 06/16/2020 Record remains Non-Urgent. Crossing appears abandoned. Unable to locate a pump on waterside. Wires are disconnected on service pole, electric meter removed. (O.Yakimov - DWR UCIP) 05/27/2015 Dense vegetation prevented inspection of WS slope. (K.Fazel - DWR UCIP) FIELD_STRUCT_DESC: 14-inch steel irrigation discharge pipe through the levee, 5 feet below the crown. Pump on the waterside (WS). Electrical conduit through the levee at the same location. Pole with electrical panel at the landside (LS) toe. Standpipe at the LS toe. (14-inch pipe authorized under Permit No. 5548A, 1981 - Kaydix Company). [Additional Reference(s): DWR Levee Log, unk.yr. (HLM 0.55)]. FS Date: 6/16/2020 2:19:29 PM

Top of Levee: View of levee crown looking downstream

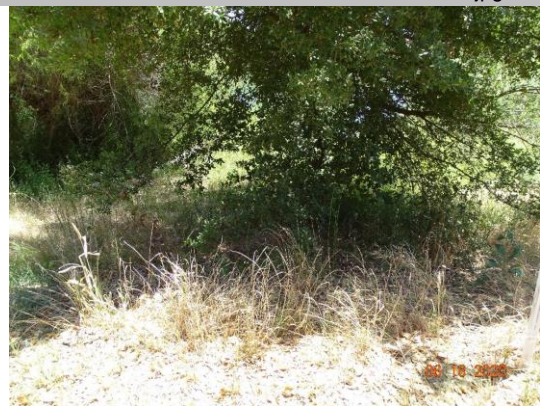
Photo 2 of 3 : UCIP\_FA\_2021\_61344\_88654.jpg

Water-Side: View of levee slope looking from crown

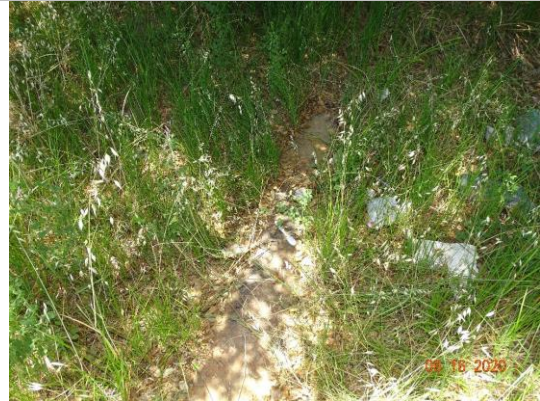
Photo 3 of 3 : UCIP\_FA\_2021\_61344\_88657.jpg

Water-Side: Abandoned pipe on levee slope

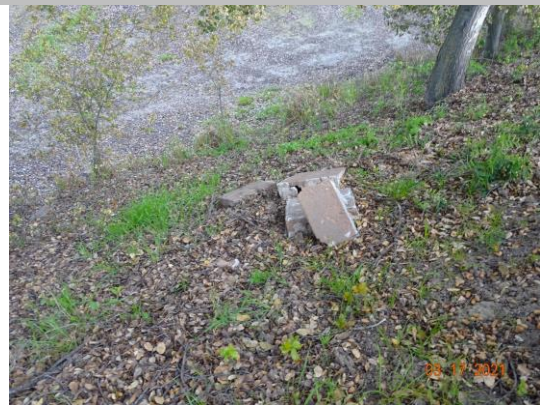
Photo 1 of 1 : FA\_2021\_RD0556\_18\_85\_20211004\_00159.jpg

LM Start	0.58	Rating **	A/W	Issue No.	85
LM End	0.58	Issue Type +	En	Location *	LS
Category	Earthen Levee			GPS Latitude/Longitude	
				Start	End
Item	Encroachments			38.231902 °	38.231902 °
				-121.522242 °	-121.522242 °
DWR ID	DWR_RD0556_01_f_2021_85				
Comment Code					
DE : Debris					
Inspector Comment					
Large bricks on the landside slope acting as revetment.

View of bricks on the landside slope (Spring 2021).

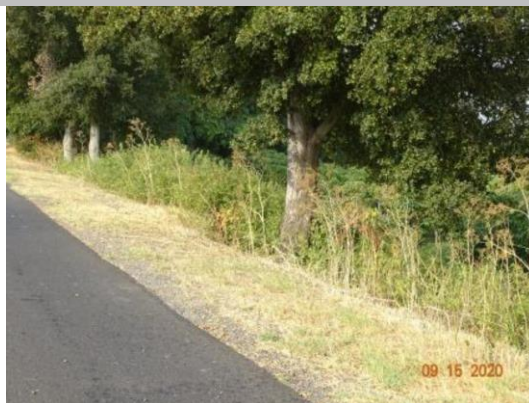
Photo 1 of 1 : FA\_2021\_RD0556\_18\_65\_20210830\_00035.jpg

LM Start	0.82	Rating **	U	Issue No.	65
LM End	0.85	Issue Type +	Ma	Location *	LS
Category	Earthen Levee			GPS Latitude/Longitude	
				Start	End
Item	Vegetation			38.229278 °	38.229013 °
				-121.525103 °	-121.525562 °
DWR ID	DWR_RD0556_01_f_2020_65				
Comment Code					
V2 : Remove the wild growth other than native grasses from the levee slopes.					
Inspector Comment

View looking downstream at vegetation on the landside slope (Fall 2020).

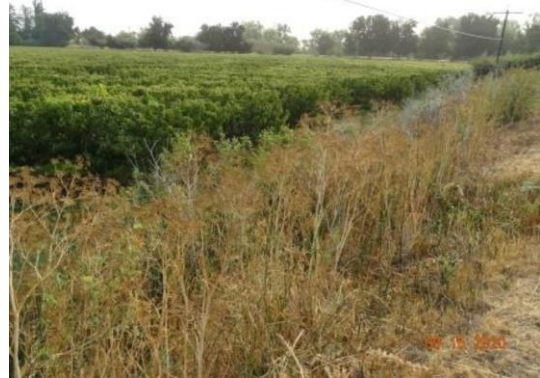
Photo 1 of 1 : FA\_2021\_RD0556\_18\_66\_20210830\_00036.jpg

LM Start	0.98	Rating **	U	Issue No.	66
LM End	1.17	Issue Type +	Ma	Location *	LS
Category	Earthen Levee			GPS Latitude/Longitude	
				Start	End
Item	Vegetation			38.227653 °	38.227574 °
				-121.527032 °	-121.529479 °
DWR ID	DWR_RD0556_01_f _ 2020_66				
Comment Code					
V2 : Remove the wild growth other than native grasses from the levee slopes.					
Inspector Comment

View looking upstream at annual vegetation on the landside slope (Fall 2020).

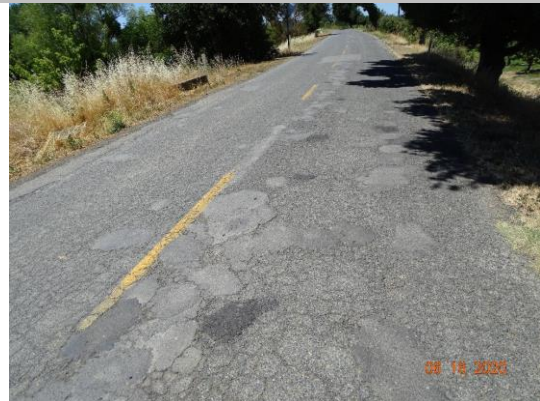
Photo 1 of 3 : UCIP\_FA\_2021\_61348\_88660.jpg

Comment Code						
Inspector Comment						
DS_ID:25106 FS_ID:61348 EP_NO: N/A Repair Type: Non-Urgent EVAL Issue: Unauthorized Encroachment Crossing Status: Found UCIP Comments: 06/16/2020 Record remains Non-Urgent. No permit has been found authorizing this pipe through the levee. Erosion site mentioned in previous inspection comment is not detected. Pipe is running- no leaks detected. (O.Yakimov - DWR UCIP) 05/27/2015 Possible erosion above pipe on LS needs attention. (K.Fazel - DWR UCIP) FIELD_STRUCT_DESC: 8-inch steel irrigation pipe through the levee, at an unknown depth. Pump, butterfly valve, siphon breaker, and screen filter on landside. Power pole with distribution panel on the LS. FS Date: 6/16/2020 2:39:20 PM

Top of Levee: View of levee crown looking downstream

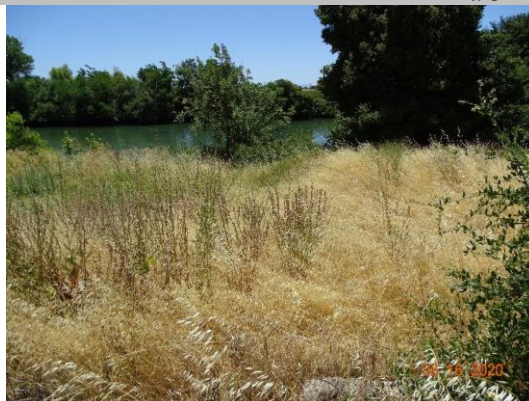
Photo 2 of 3 : UCIP\_FA\_2021\_61348\_88659.jpg

Water-Side: View of levee slope looking from crown

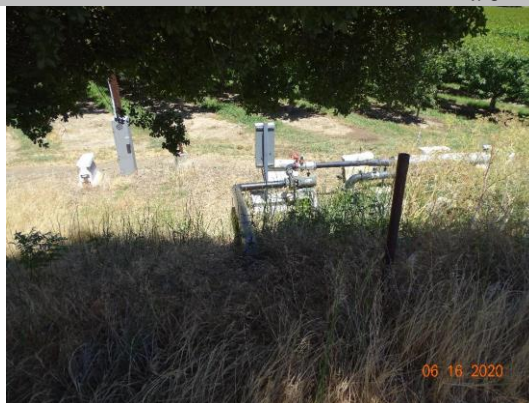
Photo 3 of 3 : UCIP\_FA\_2021\_61348\_88661.jpg

Land-Side: View of levee slope looking from crown

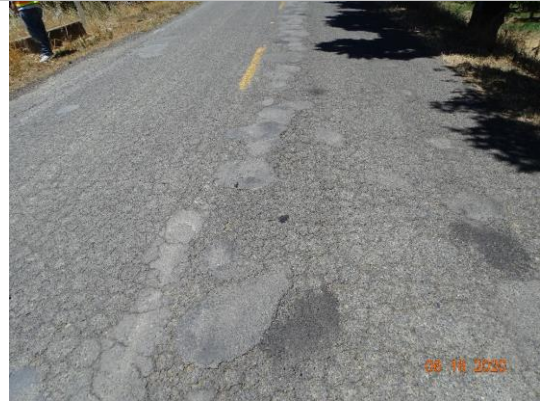
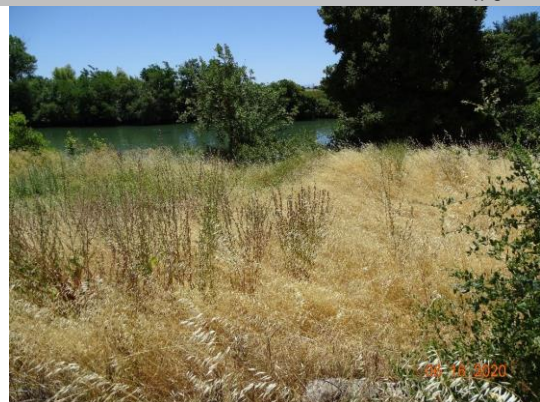
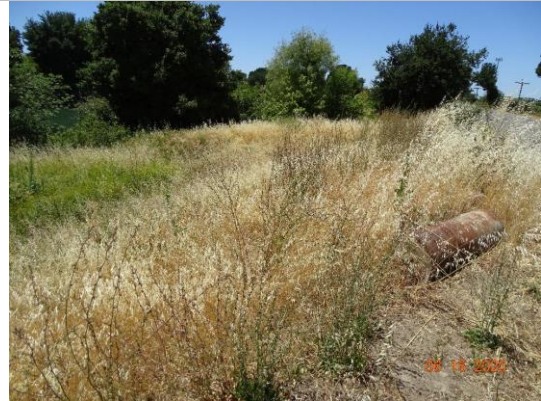
LM Start	<b>1.17</b>	Rating **	M	Issue No.	<b>93 (cont)</b>
LM End	<b>1.17</b>	Issue Type +	En	Location *

DS\_ID:20823  
FS\_ID:61377  
EP\_NO: 11169  
Repair Type: Non-Urgent  
EVAL Issue: Limited Inspection/No UCIP Evaluation  
Crossing Status: Found  
UCIP Comments: 06/16/2020 Record remains Non-Urgent. Due to overgrown vegetation on waterside slope and thick layer of leaves on landside slope unable to evaluate levee condition. Previous inspection notes mention pipe abandoned in place. No permit has been identified authorizing pipe. Need to have CVFPB review ABO and determine current owner. (O.Yakimov - DWR UCIP)  
05/27/2015 Appears abandoned in place and if so should be done so properly. Dense vegetation on WS limits visibility. (K.Fazel - DWR UCIP)  
FIELD\_STRUCT\_DESC: 10-inch steel irrigation discharge pipe through the levee, 3.8 feet below the crown. Located at the lower end of the rock revetment. (10-inch pipe [HLM 1.16] authorized under Automatic Board Order (ABO) issued as Permit No. 11169, 1975 - Darrell T. and B. M. Mealer). (Replacement of an existing 10-inch diameter suction pipe with a 10-inch slant propeller pump authorized under Permit No. 4848, 1965 - Kaydix Ranch Company). [Additional Reference(s): DWR Levee Log, unk.yr. (HLM 1.17). USACE Sacramento O&M Manual, Unit 103, June 1954, Revised 29 December 2016, (Station 'R' 548+59.8), listed as 10-inch pipe. USACE As-Built Drawing No. 50-04-2671, Sheet 5, Station 548+59.8, 25 January 1951, Revised 18 Dec. 1952].

Top of Levee: View of levee crown looking downstream

Water-Side: View of levee slope looking from crown

Water-Side: Overview of levee slope looking downstream

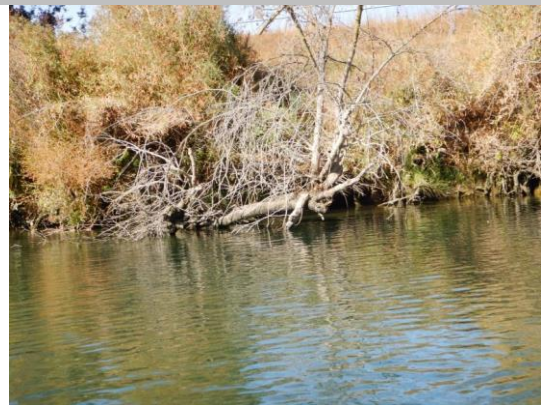
Photo 1 of 2 : FA\_2021\_RD0556\_18\_42\_20211218\_38.jpg

2018 Site ID: GEO 10.9 R  
 Status: Eroding  
 2018 Field Notes: New erosion throughout site.  
 Site History: 2017 - Significant toe erosion and whole bank failure in sections, large pockets from tree popouts.

USACE 2018 Erosion Photo #1

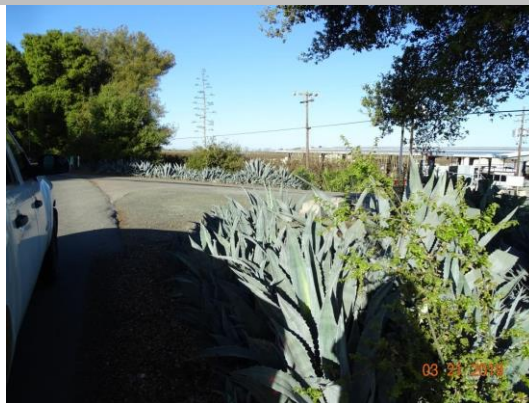
Photo 1 of 1 : FA\_2021\_RD0556\_18\_45\_20210830\_00025.jpg

LM Start	1.31	Rating **	U	Issue No.	45
LM End	1.33	Issue Type +	En	Location *	LS
Category	Earthen Levee			GPS Latitude/Longitude	
				Start	End
Item	Vegetation			38.227775 °	38.227651 °
				-121.531810 °	-121.532159 °
DWR ID	DWR_RD0556_01_s_2018_45				
Comment Code					
V6 : Landscaping					
Inspector Comment					
Remove cactus and trim trees.

View of cactus on the landside shoulder (Spring 2019).

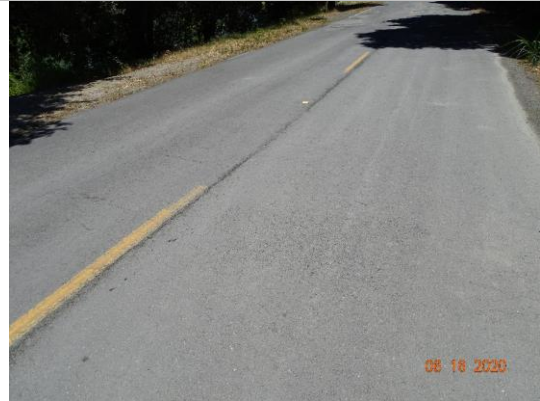
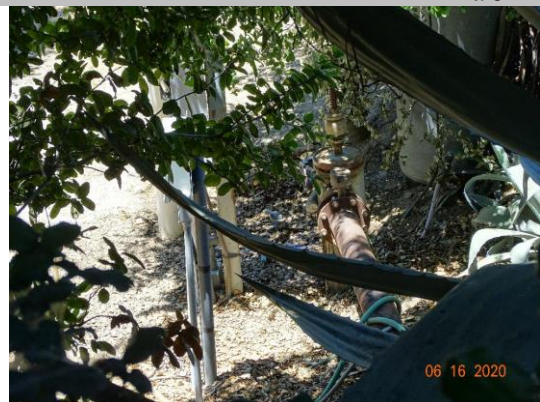
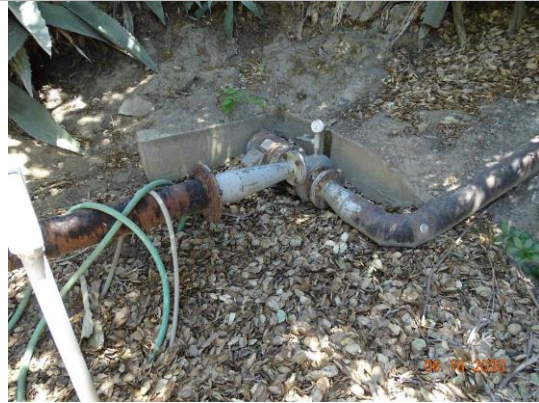
LM Start	1.33	Rating **	M	Issue No.	94 (cont)
LM End	1.33	Issue Type +	En	Location *

DS\_ID:20825  
FS\_ID:61398  
EP\_NO: 13302  
Repair Type: Non-Urgent  
EVAL Issue: Levee Damage or Threat for Levee Damage  
Crossing Status: Found  
UCIP Comments: 06/16/2020 Record remains Non-Urgent. Concrete standpipe on landside has been replaced with a pressure tank. Unable to find a permit for modification. Depression around air release vent on landside shoulder about 2 feet in diameter and 1/2-foot deep. (O.Yakimov - DWR UCIP)  
05/27/2015 Seal beneath siphon breaker off LS toe leaking. Rodent activity near crown off LS shoulder. Need to contact owner about leaky seal. Dense vegetation prevented inspection of WS slope. (K.Fazel - DWR UCIP)  
FIELD\_STRUCT\_DESC: 6-inch steel irrigation discharge pipe and 2-inch galvanized iron electrical conduit through the levee, 2 feet below the crown. Siphon valve on the landside (LS) shoulder. Pump, gate valve, and pressure tank at the LS toe. Service pole and electrical box at the LS toe. 6-inch polyvinyl chloride (PVC) standpipe adjacent to the pipe off the LS toe. (6-inch pipe authorized under Permit No. 13302, 1981 - Kaydix Ranch). [Additional Reference(s): DWR Levee Log, unk.yr. (HLM 1.32). USACE Sacramento O&M Manual, Unit 103, June 1954, Revised 29 December 2016, (Station 'R' 540+85), listed as 2-inch pipe. USACE As-Built Drawing No. 50-04-2671, Sheet 5, Station 540+85, 25 January 1951, Revised 18 Dec. 1952, listed as 2-inch pipe]. FS Date: 6/16/2020 4:21:56 PM

Top of Levee: View of levee crown looking downstream

Land-Side: View of levee slope looking from crown

Land-Side: Pump at levee toe

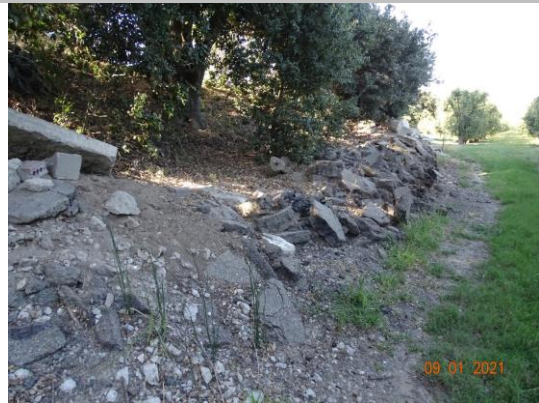
Photo 1 of 1 : FA\_2021\_RD0556\_18\_27\_20210901\_00156.jpg

LM Start	1.34	Rating **	A/W	Issue No.	27
LM End	1.37	Issue Type +	En	Location *	LS
Category	Earthen Levee			GPS Latitude/Longitude	
				Start	End
Item	Encroachments			38.227521 °	38.227320 °
				-121.532393 °	-121.532710 °
DWR ID	DWR_RD0556_01_s_2013_27				
Comment Code					
DE : Debris					
Inspector Comment					
Concrete at toe of levee is acting like a stability berm.

View looking downstream at concrete rubble at landside toe (Fall 2021).

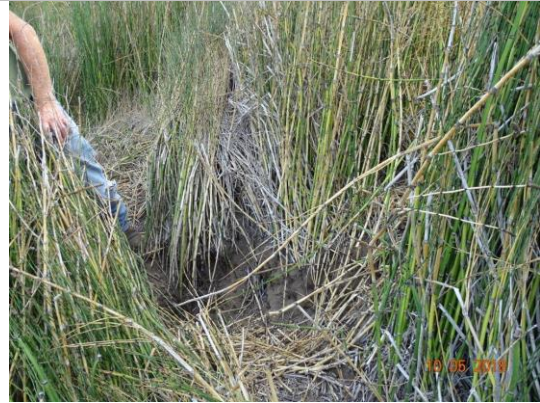
Photo 1 of 1 : FA\_2021\_RD0556\_18\_40\_20210830\_00020.jpg

LM Start	1.43	Rating **	M	Issue No.	40
LM End	1.43	Issue Type +	Ma	Location *	LS
Category	Earthen Levee			GPS Latitude/Longitude	
				Start	End
Item	Erosion / Bank Caving			38.226537 °	38.226537 °
				-121.533512 °	-121.533512 °
DWR ID	DWR_RD0556_01_f _ 2012_40				
Comment Code					
E1 : Note and monitor erosion site.					
Inspector Comment					
Erosion is covered by vegetation.

View of erosion that is covered by vegetation on the landside slope (October 2018).

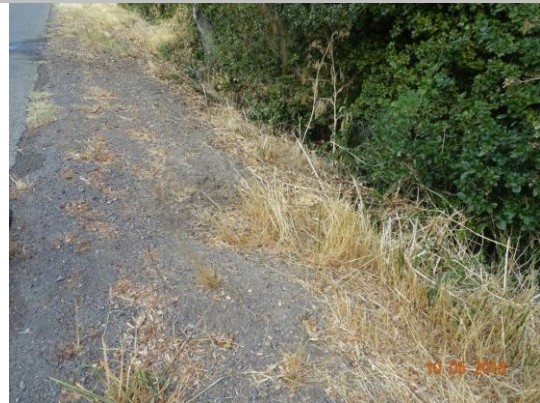
Photo 1 of 1 : FA\_2021\_RD0556\_18\_22\_20210830\_00006.jpg

LM Start	1.50	Rating **	M	Issue No.	22
LM End	1.50	Issue Type +	Ma	Location *	LS
Category	Earthen Levee			GPS Latitude/Longitude	
				Start	End
Item	Erosion / Bank Caving			38.225840 °	38.225840 °
				-121.534157 °	-121.534157 °
DWR ID	DWR_RD0556_01_s_2012_22				
Comment Code					
E1 : Note and monitor erosion site.					
Inspector Comment					
Dip at the top of the landside slope is greater than 3".

View of dip at the top of the landside slope (October 2018).

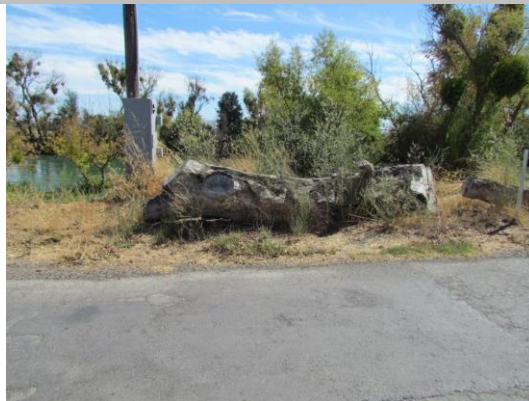
Photo 1 of 1 : FA\_2021\_RD0556\_18\_9\_20210830\_00001.jpg

LM Start	1.55	Rating **	A/W	Issue No.	9
LM End	1.57	Issue Type +	En	Location *	WS
Category	Earthen Levee			GPS Latitude/Longitude	
				Start	End
Item	Encroachments			38.225191 °	38.224976 °
				-121.534799 °	-121.535043 °
DWR ID	DWR_RD0556_01_s_2012_9				
Comment Code					
TR : Tree or limb					
Inspector Comment					
These cut up tree sections remain on the waterward slope to prevent parking in the area.

Cut tree sections on the waterside levee shoulder remain to prevent parking.

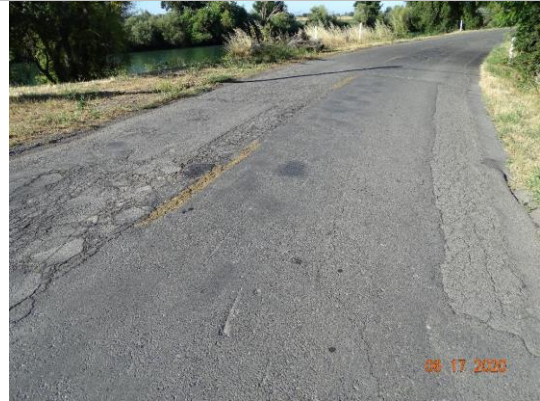
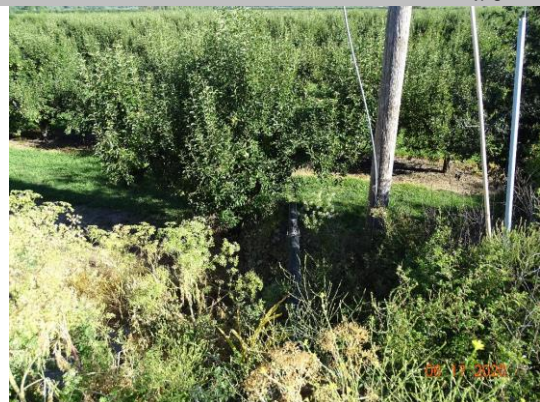
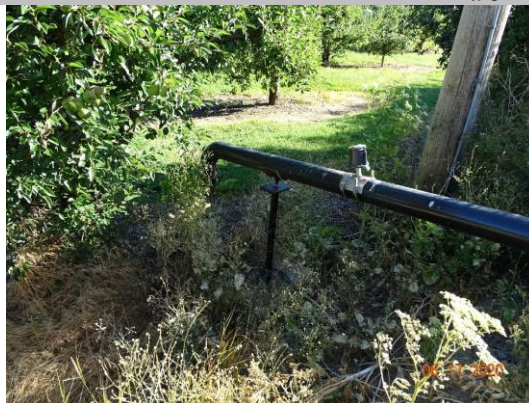
LM Start	<b>1.57</b>	Rating **	M	Issue No.	<b>95 (cont)</b>
LM End	<b>1.57</b>	Issue Type +	En	Location *

DS\_ID:20827  
FS\_ID:61399  
EP\_NO: 11169  
Repair Type: Non-Urgent  
EVAL Issue: Unauthorized Modification or Non-Compliant Permit  
Crossing Status: Found  
UCIP Comments: 06/17/2020 Record remains Non-Urgent.  
Modifications to the crossing have been made after last UCIP inspection. Unable to find a permit for modifications. Enforcement case ENF 9545 open for this crossing. No permit has been identified authorizing original pipe. Need to have CVFPB review ABO and determine current owner. (O.Yakimov - DWR UCIP)  
03/27/2015 Dense vegetation on LS and WS limited accessibility. (K.Fazel - DWR - UCIP)  
FIELD\_STRUCT\_DESC: 6-inch steel irrigation discharge pipe through the levee, 3.5 feet below the crown. Pump, butterfly valve, filler pump and pipe on the waterside (WS) berm. 2-inch electrical conduit through the levee. Service pole with electric meter and panel on waterside shoulder. (10-inch pipe [HLM 1.56] authorized under Automatic Board Order (ABO) issued as Permit No. 11169, 1975 - Darrell T. and B. M. Mealer). [Additional Reference(s): DWR Levee Log, unk.yr. (HLM 1.56), listed as 10-inch pipe. USACE Sacramento O&M Manual, Unit 103, June 1954, Revised 29 December 2016, (Station 'R' 528+02.1), listed as 10-inch pipe. USACE As-Built Drawing No. 50-04-2671, Sheet 4, near Station 528+00, 25 January 1951, Revised 18 Dec. 1952, listed as 10-inch pipe].

Top of Levee: View of levee crown looking downstream

Land-Side: View of levee slope looking from crown

Land-Side: Pipe and junction pole at levee toe

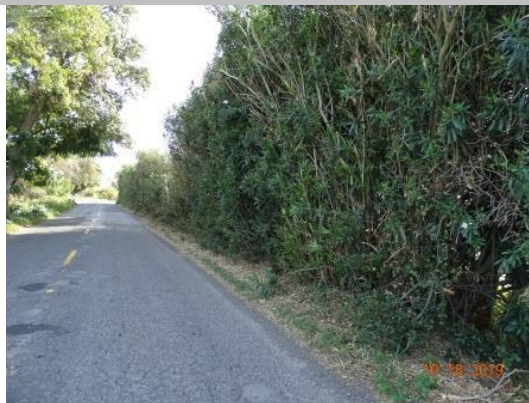
Photo 1 of 1 : FA\_2021\_RD0556\_18\_17\_20210830\_00002.jpg

LM Start	1.65	Rating **	U	Issue No.	17
LM End	1.70	Issue Type +	En	Location *	WS
Category	Earthen Levee			GPS Latitude/Longitude	
				Start	End
Item	Vegetation			38.224623 °	38.224408 °
				-121.536320 °	-121.537180 °
DWR ID	DWR_RD0556_01_s_2012_17				
Comment Code					
V6 : Landscaping					
Inspector Comment					
Oleanders blocking view down waterside slope

View looking upstream at thick oleanders on the waterside slope (Fall 2019).

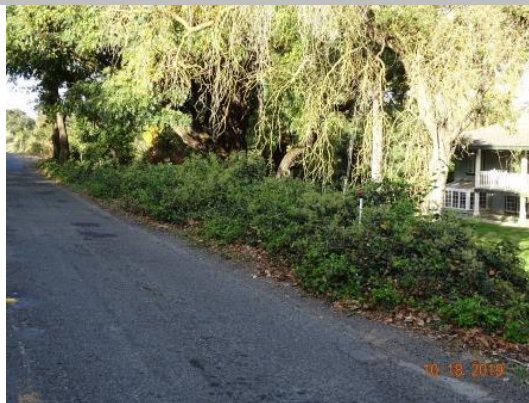
Photo 1 of 1 : FA\_2021\_RD0556\_18\_51\_20210830\_00029.jpg

LM Start	1.66	Rating **	U	Issue No.	51
LM End	1.69	Issue Type +	En	Location *	LS
Category	Earthen Levee			GPS Latitude/Longitude	
				Start	End
Item	Vegetation			38.224487 °	38.224355 °
				-121.536492 °	-121.537055 °
DWR ID	DWR_RD0556_01_f_2019_51				
Comment Code					
V6 : Landscaping					
Inspector Comment

View looking downstream at landscaping on the landside slope (Fall 2019).

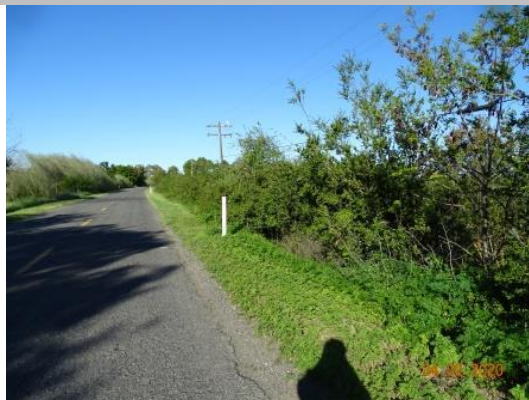
Photo 1 of 1 : FA\_2021\_RD0556\_18\_19\_20210830\_00003.jpg

LM Start	1.71	Rating **	U	Issue No.	19
LM End	1.89	Issue Type +	Ma	Location *	LS
Category	Earthen Levee			GPS Latitude/Longitude	
				Start	End
Item	Vegetation			38.224301 °	38.223783 °
				-121.537367 °	-121.540572 °
DWR ID	DWR_RD0556_01_s_2020_19				
Comment Code					
V2 : Remove the wild growth other than native grasses from the levee slopes.					
Inspector Comment

View looking downstream at thick wild vegetation on the landside slope (Spring 2020).

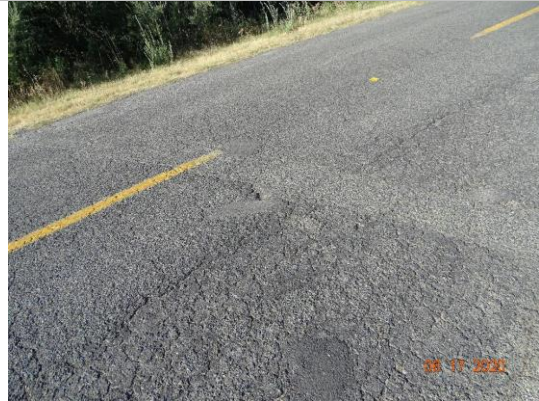
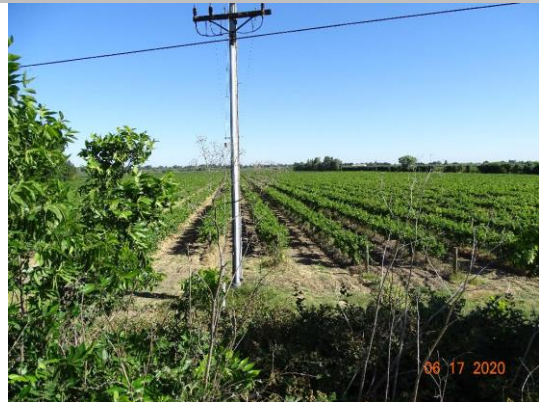
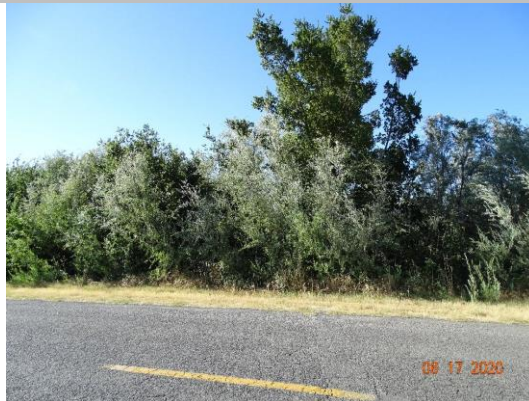
LM Start	1.79	Rating **	M	Issue No.	96 (cont)
LM End	1.79	Issue Type +	En	Location *

LM Start	1.79	Rating **	M	Issue No.	96	
LM End	1.79	Issue Type +	En	Location *		
Category	Supplemental			GPS Latitude/Longitude		
				Start	End	
Item	DWR UCIP Field Study			38.223976 °	38.223976 °	
				-121.538842 °	-121.538842 °	
DWR ID	21510					
Comment Code						
Inspector Comment						
DS_ID:21510 FS_ID:61314 EP_NO: N/A Repair Type: Non-Urgent EVAL Issue: Pipe Not Found Crossing Status: Not Found UCIP Comments: 06/17/2020 Record is Non-Urgent. Crossing not found. No permit has been identified authorizing pipe. (O.Yakimov - DWR UCIP) FIELD_STRUCT_DESC: 8-inch steel irrigation pipe, pump on waterside of the levee, a 36-inch concrete distribution chamber on landside. Pipe shown in as-built drawing 50-04-2671 revision 1 from 06 February 1951. This crossing not found in as-built drawing 50-04-2671 revision 2 from 29 December 1952. FS Date: 6/17/2020

Top of Levee: View of levee crown at potential crossing

Land-Side: Overview of landside from crown

Water-Side: Overview of waterside from crown

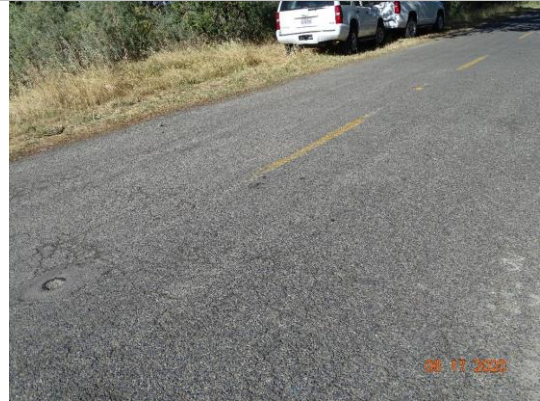
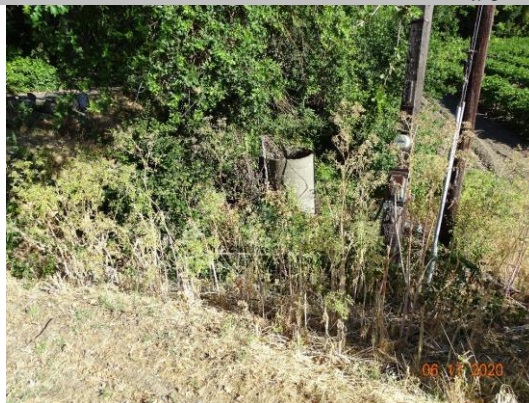
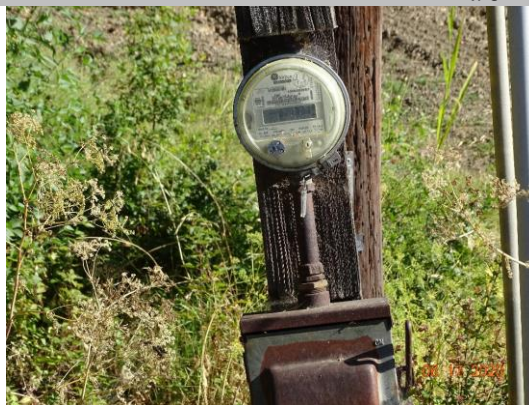
LM Start	<b>1.89</b>	Rating **	M	Issue No.	<b>97 (cont)</b>
LM End	<b>1.89</b>	Issue Type +	En	Location *	
Category	Supplemental		GPS Latitude/Longitude		
			Start	End	
Item	DWR UCIP Field Study		38.223760 °	38.223760 °	
			-121.540629 °	-121.540629 °	
DWR ID	20829

Comment Code					
Inspector Comment					
DS_ID:20829 FS_ID:61414 EP_NO: 11178 Repair Type: Non-Urgent EVAL Issue: Levee Damage or Threat for Levee Damage Crossing Status: Found UCIP Comments: 06/17/2020 Record remains Non-Urgent. Depression on landside levee slope less than 1/2-foot-deep in pipe alignment. Vegetation on both levee slopes. Limited visibility through vegetation restrains complete evaluation of slope condition. Electric meter is energized. No permit has been identified authorizing pipe. Need to have CVFPB review ABO and determine current owner. (O.Yakimov - DWR UCIP) 05/27/2015 Dense vegetation on WS and LS. Some oil leakage inside pumphouse. (K. Fazel - DWR UCIP) FIELD_STRUCT_DESC: 8-inch steel irrigation discharge pipe through the levee, 3.7 feet below the crown. 2-inch electrical conduit through the levee, next to the 8-inch discharge pipe. 1-inch air valve and pump on the waterside (WS) berm. Service pole on the landside (LS) slope. Tin and wood pump house on the WS berm. 12-foot by 3-foot concrete standpipe on the LS. (8-inch pipe [HLM 1.88] authorized under Automatic Board Order (ABO) issued as Permit No. 11178, 1975 - Allena D. Swett). [Additional Reference(s): DWR Levee Log, unk.yr. (HLM 1.88). USACE Sacramento O&M Manual, Unit 103, June 1954, Revised 29 December 2016, (Station 'R' 511+00), listed as 8-inch pipe. USACE As-Built Drawing No. 50-04-2671, Sheet 4, Station 511+00, 25 January 1951, Revised 18 Dec. 1952]. FS Date: 6/17/2020 10:33:05 AM

Top of Levee: View of levee crown looking downstream

Land-Side: View of levee slope looking from crown. Service pole on shoulder, concrete standpipe at levee toe

Land-Side: Electric meter and panel

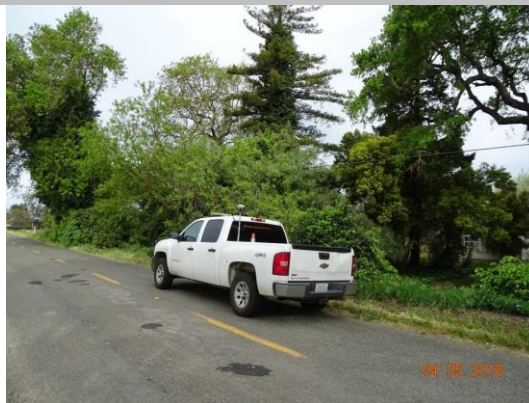
Photo 1 of 1 : FA\_2021\_RD0556\_18\_47\_20210830\_00027.jpg

LM Start	1.91	Rating **	U	Issue No.	47
LM End	1.93	Issue Type +	En	Location *	LS
Category	Earthen Levee			GPS Latitude/Longitude	
				Start	End
Item	Vegetation			38.223736 °	38.223673 °
				-121.541036 °	-121.541453 °
DWR ID	DWR_RD0556_01_s_2018_47				
Comment Code					
V6 : Landscaping					
Inspector Comment					
Dense vegetation prevents inspection and access.

Landscaping should be thinned.

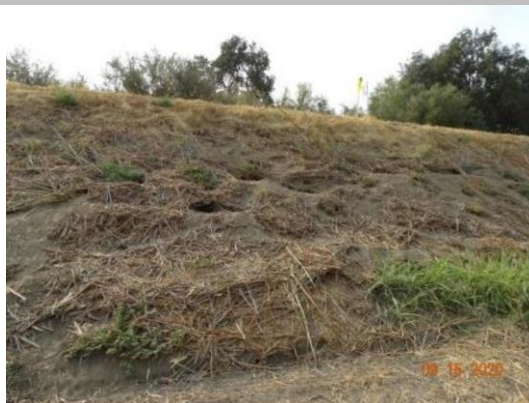
Photo 1 of 1 : FA\_2021\_RD0556\_18\_61\_20210830\_00034.jpg

LM Start	2.05	Rating **	M	Issue No.	61
LM End	2.07	Issue Type +	Ma	Location *	LS
Category	Earthen Levee			GPS Latitude/Longitude	
				Start	End
Item	Animal Control			38.223487 °	38.223340 °
				-121.543482 °	-121.543917 °
DWR ID	DWR_RD0556_01_f_2020_61				
Comment Code					
A1 : Exterminate rodents and backfill and compact or grout burrows.					
Inspector Comment

View of multiple squirrel holes in the landside slope (Fall 2020).

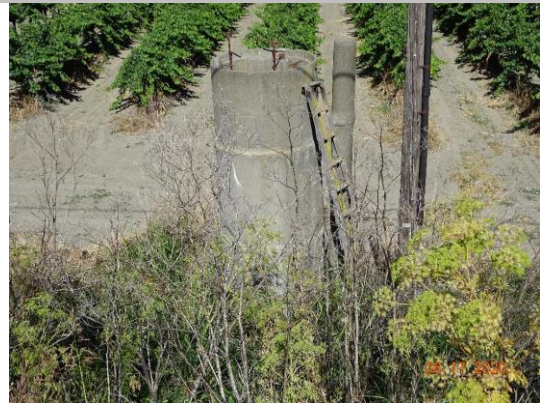
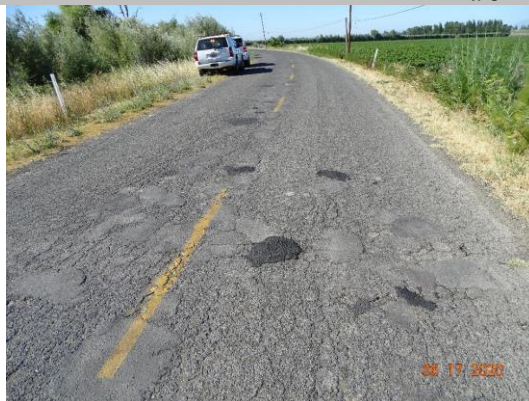
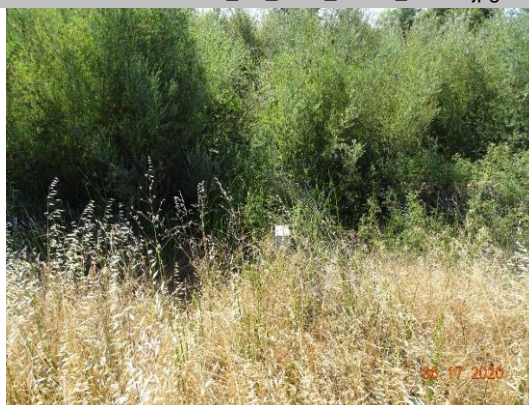
Comment Code					
Inspector Comment					
DS_ID:20830 FS_ID:61459 EP_NO: 2392 Repair Type: Non-Urgent EVAL Issue: Limited Inspection/No UCIP Evaluation Crossing Status: Found UCIP Comments: 06/17/2020 Record remains Non-Urgent. Unable to evaluate levee slopes condition due to overgrown vegetation. (O.Yakimov - DWR UCIP) 05/27/2015 Hole and exposed depression adjacent to pipe at LS. Dense vegetation on WS and LS limited visibility. (K.Fazel - DWR UCIP) FIELD_STRUCT_DESC: 12-inch steel irrigation discharge pipe through the levee, 3 feet below the crown. Slant pump on the waterside (WS) bank. 1-inch electrical conduit through the levee, beside the 12-inch pipe, visible on the WS. Service pole and two standpipes at the landside (LS) toe. One of the two standpipes is 6 inches. (Pumping plant and a 12-inch steel pipe through the levee authorized under Permit No. 2392, 1956 - Loyal D. Mealer). (Construction a new support for existing slant pump and 12-inch pipe authorized under Permit No. 2392A, 1971 - Allena Mealer Swett). [Additional Reference(s): DWR Levee Log, unk.yr. (HLM 2.13)]. FS Date: 6/17/2020 4:09:36 PM

Land-Side: Junction pole and two concrete standpipes at levee toe

Top of Levee: View of levee crown looking downstream

Water-Side: View of levee slope looking from crown

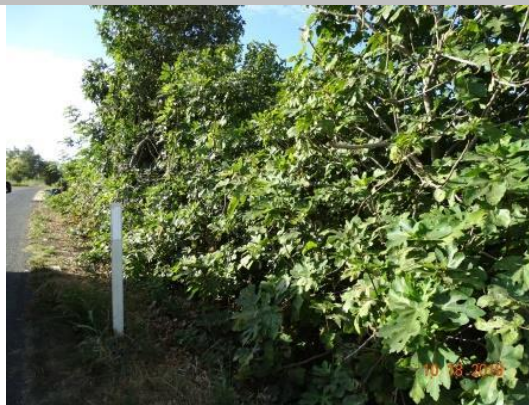
Photo 1 of 1 : FA\_2021\_RD0556\_18\_53\_20210830\_00030.jpg

LM Start	2.32	Rating **	U	Issue No.	53
LM End	2.32	Issue Type +	Ma	Location *	LS
Category	Earthen Levee			GPS Latitude/Longitude	
				Start	End
Item	Trim / Thin Trees			38.219813 °	38.219813 °
				-121.544032 °	-121.544032 °
DWR ID	DWR_RD0556_01_f_2019_53				
Comment Code					
T2 : Thin trees to allow visibility of the ground and room to flood fight.					
Inspector Comment

View looking downstream at fig tree on the landside slope (Fall 2019).

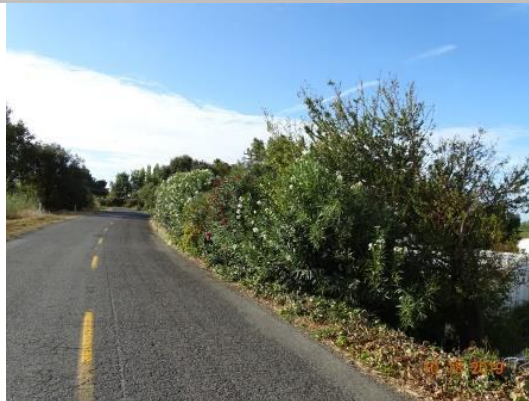
Photo 1 of 1 : FA\_2021\_RD0556\_18\_31\_20210830\_00013.jpg

LM Start	2.38	Rating **	U	Issue No.	31
LM End	2.47	Issue Type +	En	Location *	LS
Category	Earthen Levee			GPS Latitude/Longitude	
				Start	End
Item	Vegetation			38.219037 °	38.217781 °
				-121.543847 °	-121.543817 °
DWR ID	DWR_RD0556_01_s _ 2017_31				
Comment Code					
V6 : Landscaping					
Inspector Comment

View looking downstream at landscaping on the landside slope (Fall 2019).

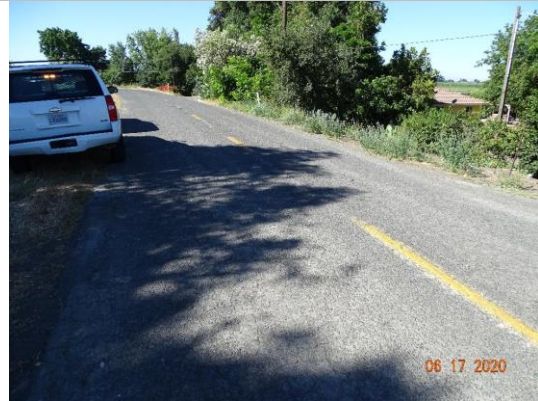
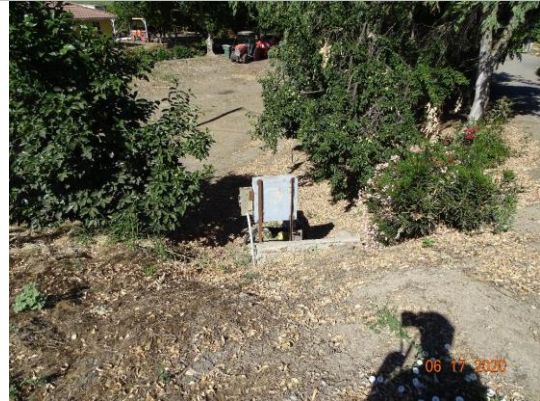
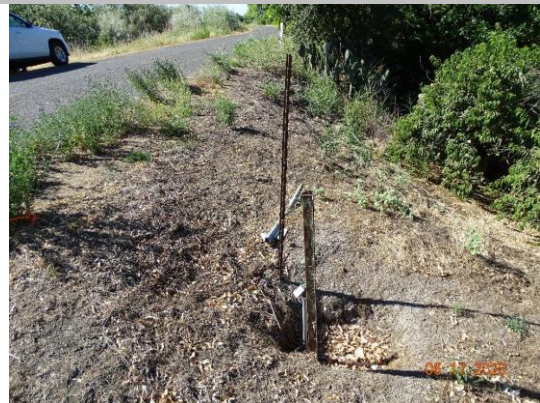
Comment Code						
Inspector Comment						
DS_ID:20831 FS_ID:61499 EP_NO: 11169 Repair Type: Non-Urgent EVAL Issue: Levee Damage or Threat for Levee Damage Crossing Status: Found UCIP Comments: 06/17/2020 Record remains Non-Urgent. 2-foot diameter sinkhole is still present on landside shoulder around air vent, size of hole is not growing over time. Electrical conduit is open on waterside slope with wires cut and not insulated. No permit has been identified authorizing pipe. Need to have CVFPB review ABO and determine current owner. (O.Yakimov - DWR UCIP) 07/12/2018 Hole near air vent on LS slope is still present but haven't increased in size. Pipe was running at the time of site visit, no leaks detected. Downgraded to "Non-Urgent" due to absence of levee threat. (O.Yakimov - DWR UCIP) 05/27/2015 2'x 2' hole on levee off LS shoulder. FIELD_STRUCT_DESC: 8-inch steel irrigation discharge pipe through the levee, 3.7 feet below the crown. 1-inch air valve. Pump and switch panel on the waterside (WS) berm. Service pole on the landside (LS). 9-foot by 3-foot concrete standpipe on the LS. 3 cables encased in a 1.5-inch steel conduit through the levee and on the WS, alongside the 8-inch pipe, disconnected on the WS. (8-inch pipe [HLM 2.44] authorized under Automatic Board Order (ABO) issued as Permit No. 11169, 1975 - Darrell T. and B. M. Mealer). [Additional Reference(s): DWR Levee Log, unk.yr. (HLM 2.44). USACE Sacramento O&M Manual, Unit 103, June 1954, Revised 29 December 2016, (Station 'R' 482+49.3), listed as 8-inch pipe. USACE As-Built Drawing No. 50-04-2671, Sheet 3, Station 482+49.3, 25 January 1951, Revised 18 Dec. 1952]. FS Date: 6/17/2020 10:55:51 AM

Top of Levee: View of levee crown looking downstream

Land-Side: View of levee slope looking from crown

Land-Side: Overview of levee shoulder

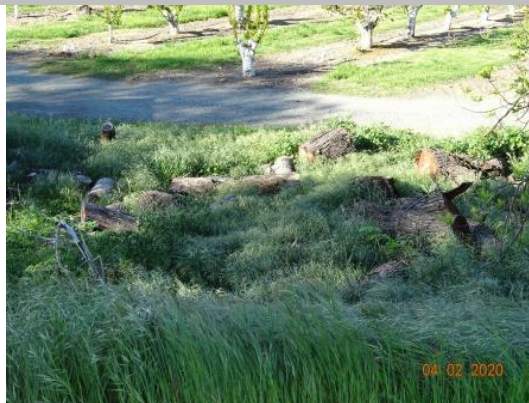
Photo 1 of 1 : FA\_2021\_RD0556\_18\_32\_20210830\_00014.jpg

LM Start	2.69	Rating **	M	Issue No.	32
LM End	2.69	Issue Type +	En	Location *	LS
Category	Earthen Levee			GPS Latitude/Longitude	
				Start	End
Item	Encroachments			38.215375 °	38.215375 °
				-121.541258 °	-121.541258 °
DWR ID	DWR_RD0556_01_s_2020_32				
Comment Code					
FW : Firewood					
Inspector Comment					
Several large chunks of wood should be removed from landside toe.

View of large tree trunk sections on the landside hinge (Spring 2020).

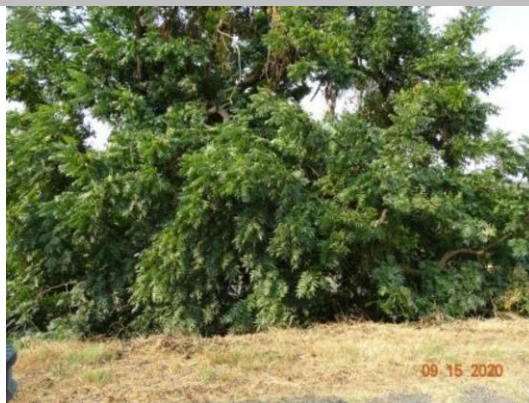
Photo 1 of 1 : FA\_2021\_RD0556\_18\_69\_20210830\_00037.jpg

LM Start	2.69	Rating **	U	Issue No.	69
LM End	2.69	Issue Type +	Ma	Location *	LS
Category	Earthen Levee			GPS Latitude/Longitude	
				Start	End
Item	Trim / Thin Trees			38.215382 °	38.215382 °
				-121.541247 °	-121.541247 °
DWR ID	DWR_RD0556_01_f_2020_69				
Comment Code					
T1 : Trim trees to at least five feet above ground level.					
Inspector Comment

View of thick tree on the landside slope (Fall 2020).

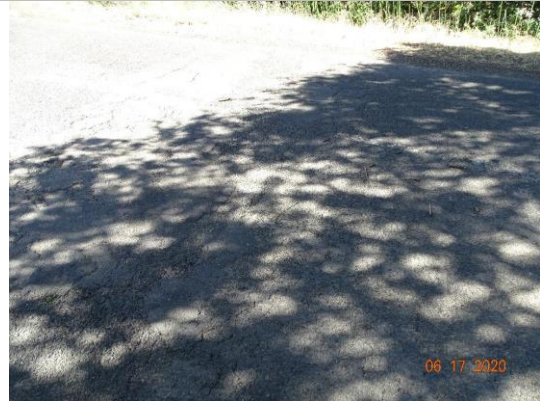
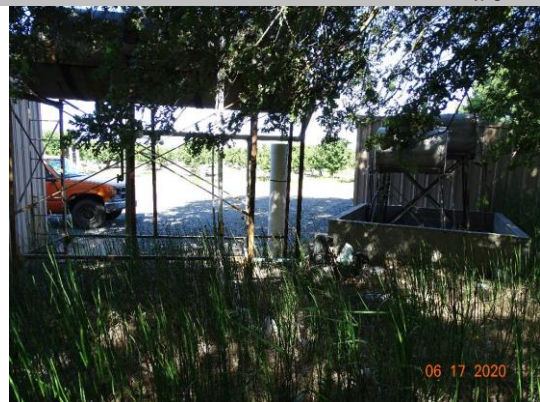
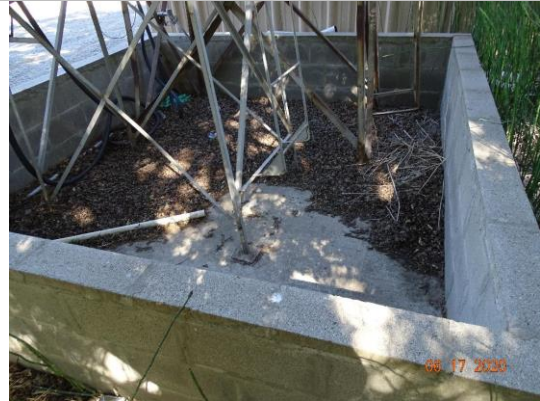
DS\_ID:20848  
FS\_ID:61501  
EP\_NO: 11167  
Repair Type: Non-Urgent  
EVAL Issue: Unauthorized Modification or Non-Compliant Permit  
Crossing Status: Found  
UCIP Comments: 06/17/2020 Record remains Non-Urgent. Unable to find a permit for sleeving 3-inch pipe through 8-inch pipe. No permit has been identified authorizing original pipe through the levee. Need to have CVFPB review ABO and determine current owner. (O.Yakimov - DWR UCIP)  
06/05/2015 Pipe appears out of use; if so, coordinate with owner to abandon properly per Title 23. (K.Fazel - DWR UCIP)  
FIELD\_STRUCT\_DESC: 3-inch steel irrigation discharge pipe sleeved through the 8-inch steel pipe, 3 feet below the crown. Annular space appears to be grouted. 3-inch pipe connected to the pump on the waterside (WS). 0.75-inch primer pipe. Gate valve on the WS berm. Polyvinyl chloride (PVC) standpipe off the landside (LS) toe, previously a 6-foot by 3-foot concrete standpipe. (8-inch pipe [HLM 2.70] authorized under Automatic Board Order (ABO) issued as Permit No. 11167, 1975 - Russel G. Graham). [Additional Reference(s): DWR Levee Log, unk.yr. (HLM 2.70). USACE Sacramento O&M Manual, Unit 103, June 1954, Revised 29 December 2016, (Station 'R' 468+52.7), listed as 8-inch pipe. USACE As-Built Drawing No. 50-04-2671, Sheet 3, Station 468+52.7, 25 January 1951, Revised 18 Dec. 1952, listed as 8-inch pipe].

Top of Levee: View of levee crown looking from waterside

Land-Side: PVC standpipe off levee toe

Land-Side: Water tank support structure on landside
