## Flood Control Project Maintenance Levee Inspections

### Fall 2021 Levee Maintenance Deficiency Summary Report

#### Sacramento River Basin

**Reclamation District No. 0556 Upper Andrus**

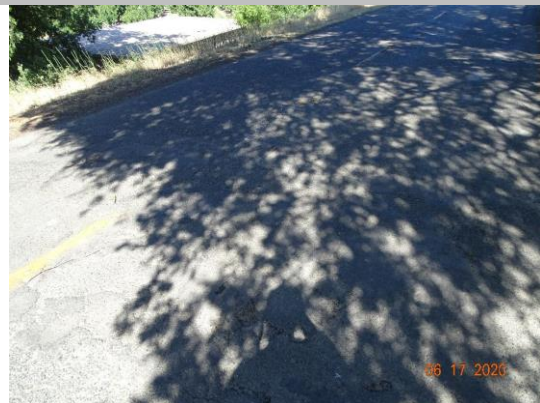
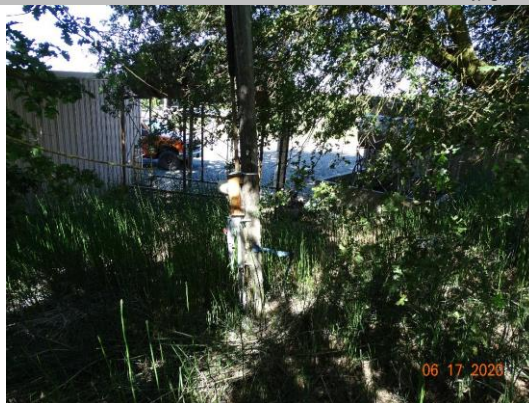
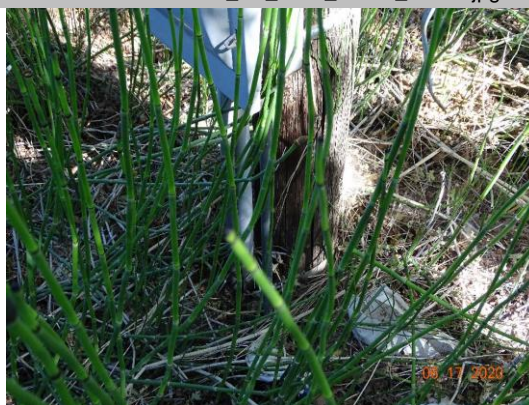
DS\_ID:20833  
 FS\_ID:61500  
 EP\_NO: 11167  
 Repair Type: Non-Urgent  
 EVAL Issue: Unauthorized Modification or Non-Compliant Permit  
 Crossing Status: Found  
 UCIP Comments: 06/17/2020 Record is Non-Urgent. Unable to find a permit for sleeving 10-inch pipe through 12-inch pipe. Unauthorized encroachment recorded in Levee Log prior to 2011. Need to have CVFPB review ABO and determine current owner. (O.Yakimov - DWR UCIP)  
 FIELD\_STRUCT\_DESC: 10-inch steel irrigation pipe sleeved through 12-inch steel pipe through levee, 4.0 feet below crown. Slant pump and gate valve on bank. 2-inch conduit through the levee 2 feet below crown. Service pole at landward toe. (12-inch pipe [HLM 2.7] authorized under Automatic Board Order (ABO) issued as Permit No. 11167, 1975 - Russel G. Graham). [Additional Reference(s): DWR Levee Log, unk.yr. (HLM 2.70)].  
 FS Date: 6/17/2020

Top of Levee: View of levee crown looking upstream

Land-Side: View of levee slope looking from crown

Land-Side: Conduits enter the ground at service pole

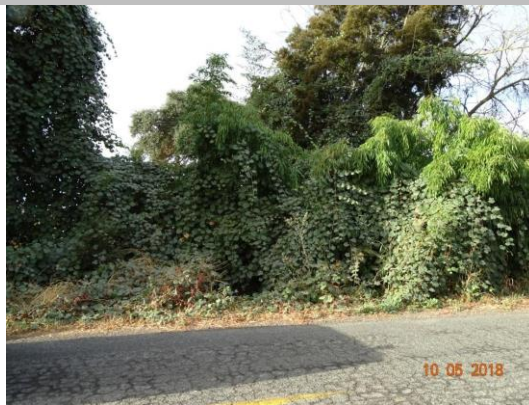
Photo 1 of 1 : FA\_2021\_RD0556\_18\_48\_20210830\_00028.jpg

LM Start	2.72	Rating **	U	Issue No.	48
LM End	2.72	Issue Type +	En	Location *	LS
Category	Earthen Levee			GPS Latitude/Longitude	
				Start	End
Item	Vegetation			38.215085 °	38.215085 °
				-121.540724 °	-121.540724 °
DWR ID	DWR_RD0556_01_f_2018_48				
Comment Code					
V6 : Landscaping					
Inspector Comment					
Remove wild grapes and bamboo from landside.

View of wild grapes and bamboo on the landside slope (Fall 2018).

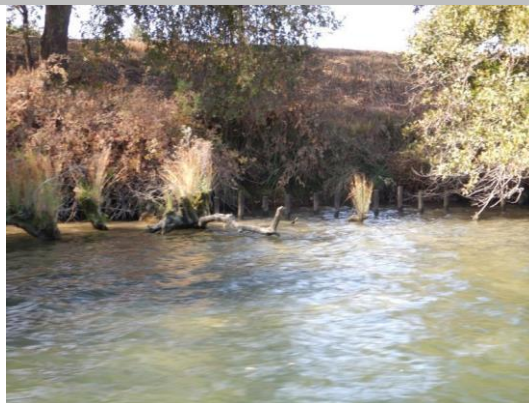
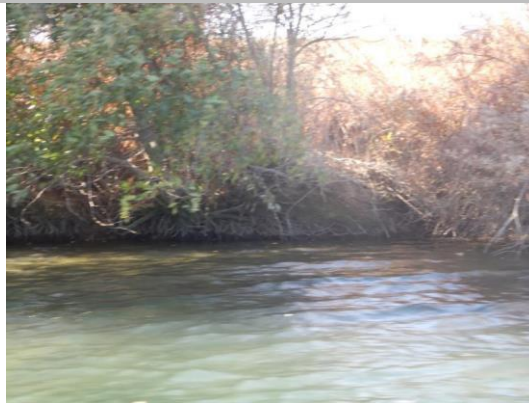
LM Start	2.85	Rating **	M	Issue No.	37
LM End	2.98	Issue Type +	Ma	Location *	WS
Category	Supplemental			GPS Latitude/Longitude	
				Start	End
Item	2018 USACE Erosion Survey			38.214144 °	38.212577 °
				-121.538692 °	-121.537244 °
DWR ID					
Comment Code					
Inspector Comment					
2018 Site ID: GEO 9.2 R					
Status: Eroding					
2018 Field Notes: New erosion along toe.					
Site History: 2017 - Toe erosion.

USACE 2018 Erosion Photo #1

USACE 2018 Erosion Photo #2

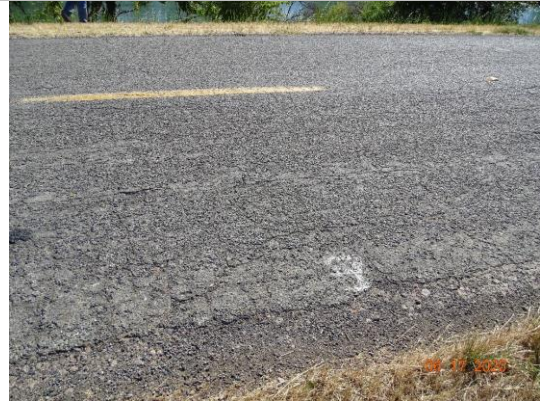
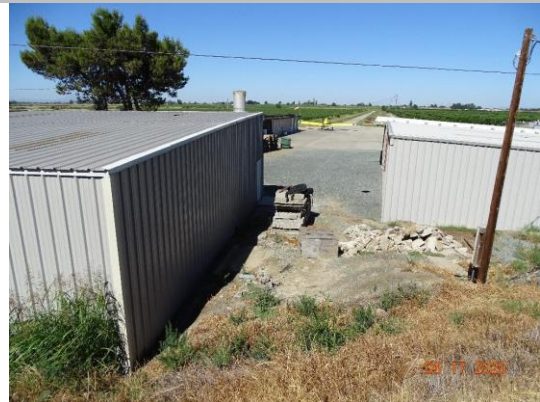
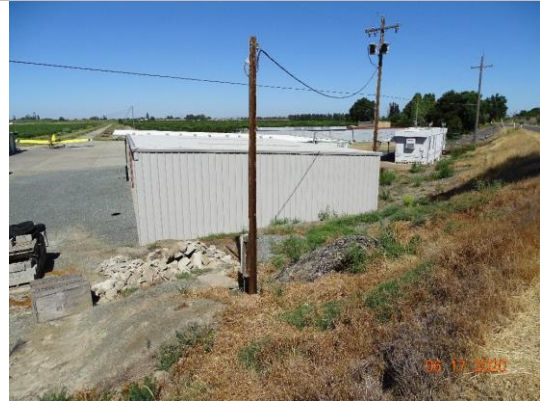
Comment Code						
Inspector Comment						
DS_ID:21456 FS_ID:61276 EP_NO: N/A Repair Type: Non-Urgent EVAL Issue: Pipe Not Found Crossing Status: Not Found UCIP Comments: 06/17/2020 Record is Non-Urgent. Crossing not found. No permit has been identified authorizing pipe. (O.Yakimov - DWR UCIP)						
FIELD_STRUCT_DESC: Unknown diameter pipe to irrigation ditch at unknown depth below crown appears through the levee. 18-inch diameter and 8 ft tall standpipe on LS. Found only in USACE As-Built Drawing No. 50-04-2671, Sheet 2, approx. Station 458+50, 25 January 1951]. As-Built drawing doesn't give details on pipe material and size. FS Date: 6/17/2020

Top of Levee: View of levee crown looking towards waterside

Land-Side: View of levee slope looking from crown. Irrigation ditch along runway on background

Land-Side: Overview of levee slope. Aircraft hangar and runway on landside

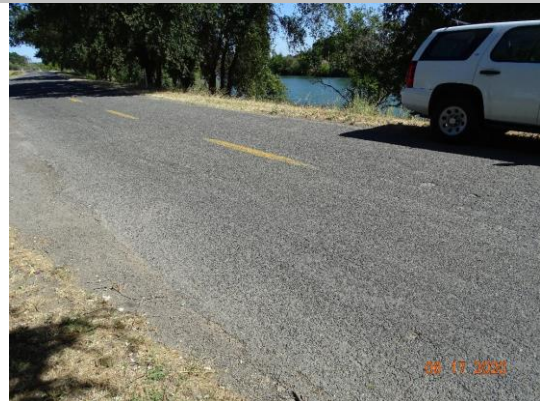
Photo 1 of 3 : UCIP\_FA\_2021\_61533\_89067.jpg

DS\_ID:25110  
 FS\_ID:61533  
 EP\_NO: N/A  
 Repair Type: Non-Urgent  
 EVAL Issue: Unauthorized Encroachment  
 Crossing Status: Found  
 UCIP Comments: 06/17/2020 Record updated from No Action Needed to Non-Urgent. No permit has been found authorizing this pipe through the levee. Unable to evaluate condition of levee slopes due to overgrown vegetation. (O.Yakimov - DWR UCIP)  
 FIELD\_STRUCT\_DESC: 1-inch steel domestic water line with a spigot, 5 feet below the crown. Visible through the landside (LS) slope only. This water line was field discovered.  
 FS Date: 6/17/2020 1:47:50 PM

Top of Levee: View of levee crown looking upstream

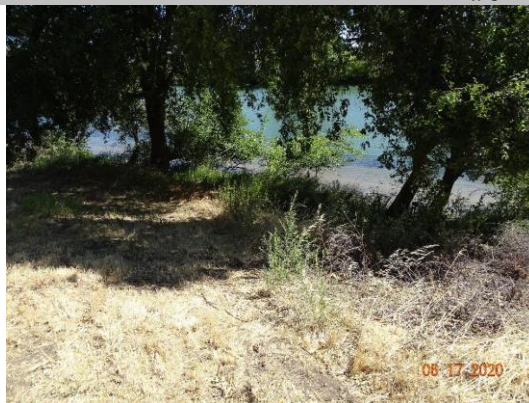
Photo 2 of 3 : UCIP\_FA\_2021\_61533\_89068.jpg

Water-Side: View of levee slope looking from crown

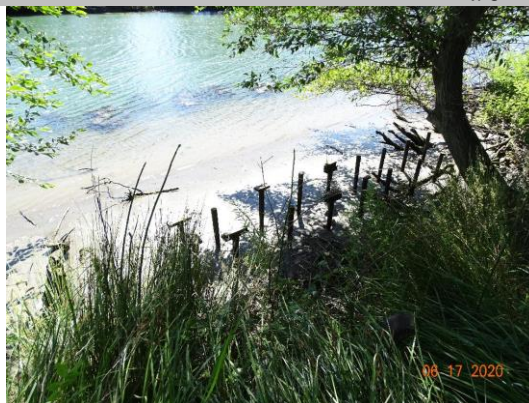
Photo 3 of 3 : UCIP\_FA\_2021\_61533\_89069.jpg

Water-Side: Abandoned pipes at riverbank

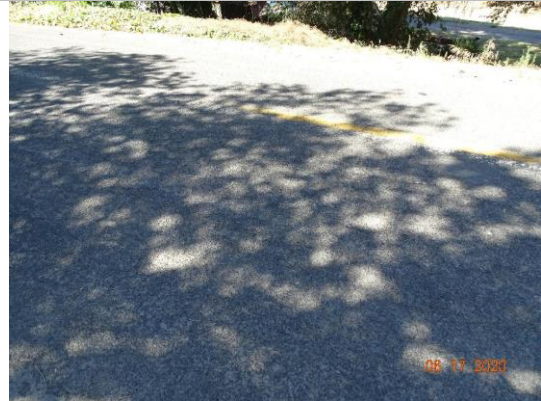
Photo 1 of 3 : UCIP\_FA\_2021\_61283\_89062.jpg

Comment Code						
Inspector Comment						
DS_ID:20819 FS_ID:61283 EP_NO: 11177 Repair Type: Non-Urgent EVAL Issue: Limited Inspection/No UCIP Evaluation Crossing Status: Indicator Found UCIP Comments: 06/17/2020 Record is Non-Urgent. Unable to find pipe on waterside due to overgrown vegetation. 6-inch steel pipe on the top of 36-inch concrete standpipe. No permit has been identified authorizing pipe. Need to have CVFPB review ABO and determine current owner. (O.Yakimov - DWR UCIP) FIELD_STRUCT_DESC: 10-inch irrigation pipe through levee, 3.0 feet below crown. 36-inch concrete standpipe at landside toe. Waterward end is open. (10-inch pipe [HLM 2.96] authorized under Automatic Board Order (ABO) issued as Permit No. 11177, 1975 - Vernal Silva, et al). [Additional Reference(s): DWR Levee Log, unk. yr. (HLM 2.96). USACE Sacramento O&M Manual, Unit 103, June 1954, Revised 29 December 2016, (Station 'R' 454+82.8), listed as 10-inch pipe. USACE As-Built Drawing No. 50-04-2671, Sheet 2, Station 454+82.8, 25 January 1951, Revised 18 Dec. 1952]. FS Date: 6/17/2020

Top of Levee: View of levee crown looking from waterside

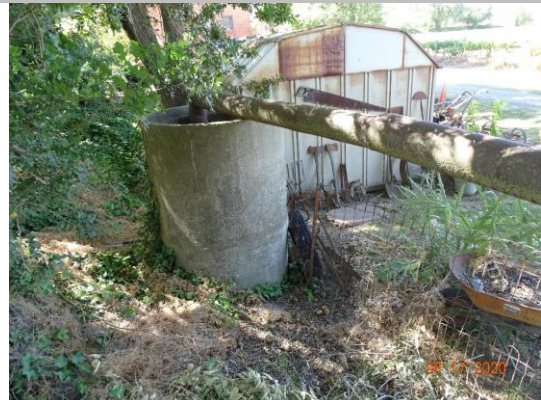
Photo 2 of 3 : UCIP\_FA\_2021\_61283\_89060.jpg

Land-Side: View of levee slope looking from crown. Concrete standpipe at levee toe

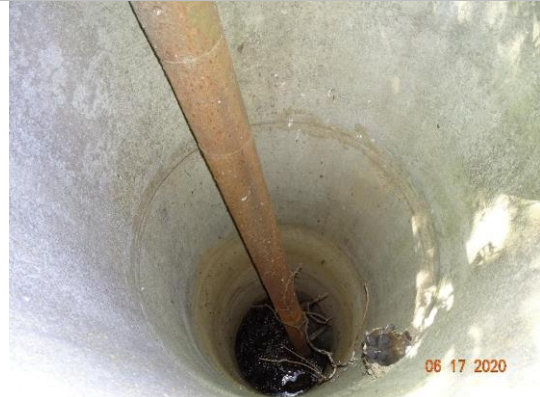
Photo 3 of 3 : UCIP\_FA\_2021\_61283\_89061.jpg

Land-Side: View inside of concrete standpipe

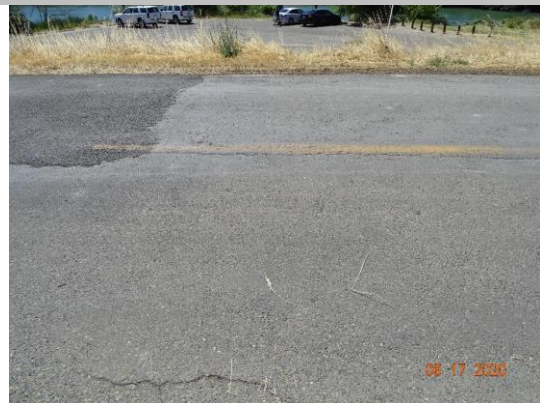
Photo 1 of 3 : UCIP\_FA\_2021\_61310\_89071.jpg

DS\_ID:21436  
FS\_ID:61310  
EP\_NO: N/A  
Repair Type: Non-Urgent  
EVAL Issue: Pipe Not Found  
Crossing Status: Not Found  
UCIP Comments: 06/17/2020 Record is Non-Urgent. Crossing not found. No permit has been identified authorizing pipe. (O.Yakimov - DWR UCIP)

FIELD\_STRUCT\_DESC: 12-inch steel pipe. 12-ft x 42-inch concrete standpipe. [Additional Reference(s): USACE Sacramento O&M Manual, Unit 103, June 1954, Revised 29 December 2016, (Station 'R' 446+36), listed as 12-inch pipe.  
FS Date: 6/17/2020

Top of Levee: View of levee crown looking from landside shoulder

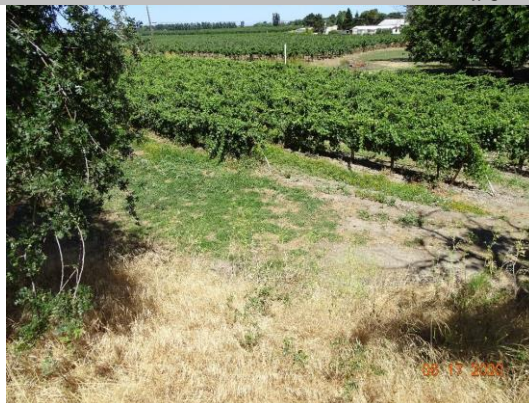
Photo 2 of 3 : UCIP\_FA\_2021\_61310\_89070.jpg

Land-Side: View of levee slope looking from crown

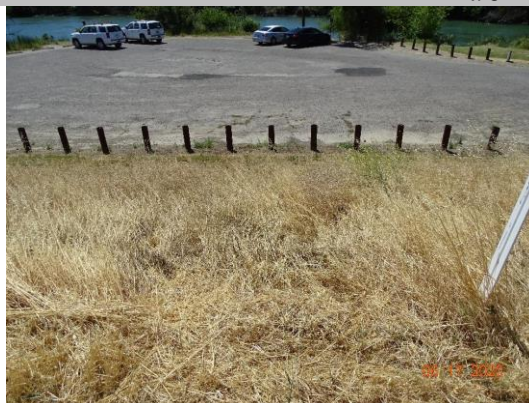
Photo 3 of 3 : UCIP\_FA\_2021\_61310\_89073.jpg

Water-Side: View of levee slope looking from crown

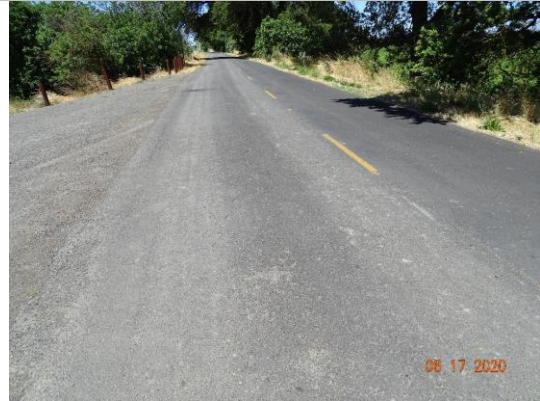
Photo 1 of 3 : UCIP\_FA\_2021\_61290\_89074.jpg

DS\_ID:20835  
FS\_ID:61290  
EP\_NO: 11174  
Repair Type: Non-Urgent  
EVAL Issue: Unauthorized Encroachment, installed decades prior  
Crossing Status: Indicator Found  
UCIP Comments: 06/17/2020 Record is Non-Urgent. Found 60-inch diameter concrete standpipe at landside toe filled with water. Pipe not visible on either levee side. Unauthorized encroachment recorded in Levee Log prior to 2011. Need to have CVFPB review ABO and determine current owner. (O.Yakimov - DWR UCIP)  
FIELD\_STRUCT\_DESC: 10-inch pipe through levee, 3.0 feet below crown. (10-inch pipe [HLM 3.09] authorized under Automatic Board Order (ABO) issued as Permit No. 11174, 1975 - Delores M. Pollard). [Additional Reference(s): DWR Levee Log, unk.yr. (HLM 3.09)]. USACE As-Built Drawing No. 50-04-2671, Sheet 2, near Station 450+00, 25 January 1951, Revised 18 Dec. 1952, listed as 10-inch pipe].  
FS Date: 6/17/2020

Top of Levee: View of levee crown looking downstream

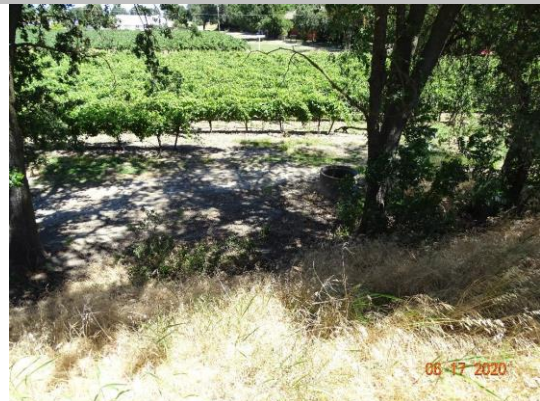
Photo 2 of 3 : UCIP\_FA\_2021\_61290\_89075.jpg

Land-Side: View of levee slope looking from crown

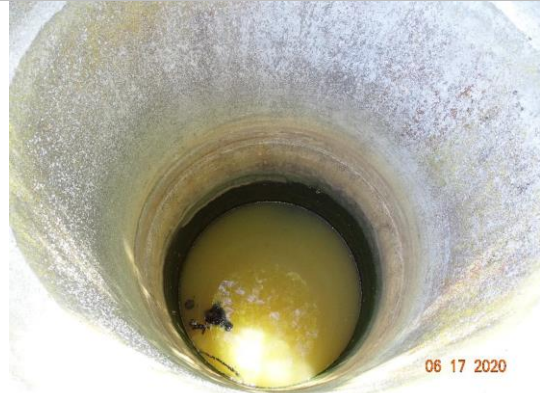
Photo 3 of 3 : UCIP\_FA\_2021\_61290\_89076.jpg

Land-Side: View inside of 60-inch concrete standpipe

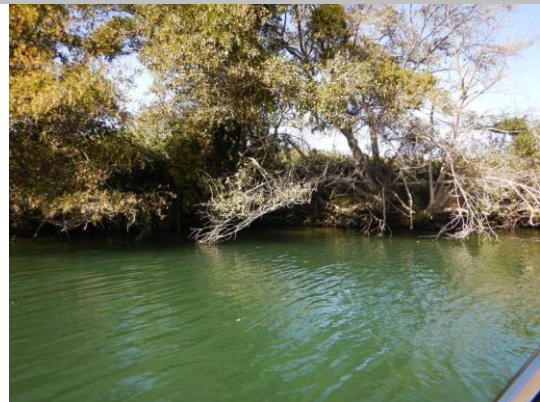
Photo 1 of 2 : FA\_2021\_RD0556\_18\_36\_20211218\_9.jpg

LM Start	3.18	Rating **	M	Issue No.	36
LM End	3.50	Issue Type +	Ma	Location *	WS
Category	Supplemental			GPS Latitude/Longitude	
				Start	End
Item	2018 USACE Erosion Survey			38.210674 °	38.206919 °
				-121.538854 °	-121.541559 °
DWR ID					
Comment Code					
Inspector Comment					
2018 Site ID: GEO 9.0 R					
Status: Eroding					
2018 Field Notes: Site extended downstream.					
Site History: 2017 - Toe erosion and failed revetment.

USACE 2018 Erosion Photo #1

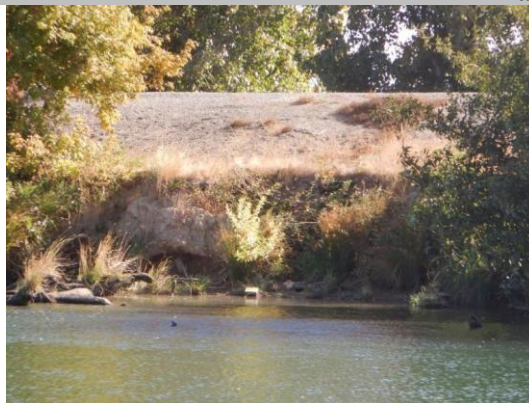
Photo 2 of 2 : FA\_2021\_RD0556\_18\_36\_20211218\_17.jpg

USACE 2018 Erosion Photo #2

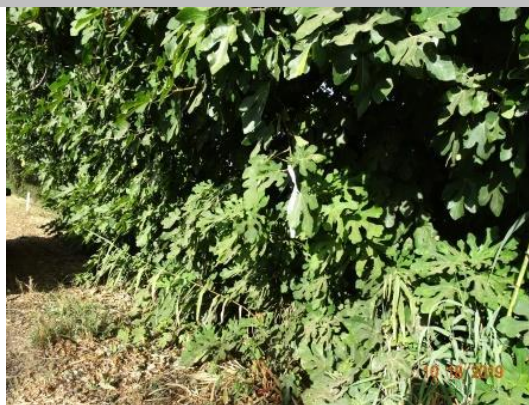
Photo 1 of 1 : FA\_2021\_RD0556\_18\_55\_20210830\_00032.jpg

View of fig tree on the landside slope (Fall 2019).

LM Start	3.18	Rating **	U	Issue No.	55
LM End	3.18	Issue Type +	Ma	Location *	LS
Category	Earthen Levee			GPS Latitude/Longitude	
				Start	End
Item	Trim / Thin Trees			38.210745 °	38.210745 °
				-121.538967 °	-121.538967 °
DWR ID	DWR_RD0556_01_f_2019_55				
Comment Code					
T2 : Thin trees to allow visibility of the ground and room to flood fight.					
Inspector Comment

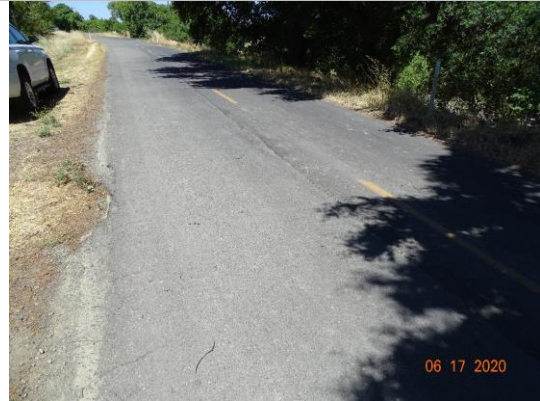
Photo 1 of 3 : UCIP\_FA\_2021\_61291\_89080.jpg

DS\_ID:20836  
FS\_ID:61291  
EP\_NO: 11174  
Repair Type: Urgent  
EVAL Issue: Levee Integrity  
Crossing Status: Found  
UCIP Comments: 06/17/2020 Record is Urgent. 30-feet long, 3-feet wide, and 1-foot deep trench was excavated along landside levee toe. Soil is wet at the bottom of trench. Soil depression on waterside shoulder in pipe alignment. Intake pipe and pipe from pumphouse towards levee slope have been replaced. Unable to find a permit for modifications. No permit has been identified authorizing original pipe through the levee. Need to have CVFPB review ABO and determine current owner. (O.Yakimov - DWR UCIP)  
FIELD\_STRUCT\_DESC: 6-inch steel irrigation pipe through levee, 3.4 feet below crown. Pump in pump house on berm. Service pole on landward slope. Gate valve located underground and 48-inch concrete standpipe at landside toe. 1-inch electrical conduit at this location. (6-inch pipe [HLM 3.18] authorized under Automatic Board Order (ABO) issued as Permit No. 11174, 1975 - Delores M. Pollard). [Additional Reference(s): DWR Levee Log, unk.yr. (HLM 3.18). USACE Sacramento O&M Manual, Unit 103, June 1954, Revised 29 December 2016, (Station 441+19.6), listed as 6-inch pipe. USACE As-Built Drawing No. 50-04-2671, Sheet 2, near Station 440+00, 25 January 1951, Revised 18 Dec. 1952. USACE As-Built Drawing No. 50-04-2631, Sheet 11, Station 441+19.6, March 1950, Revised 16 Dec.1952].

Top of Levee: View of levee crown looking downstream

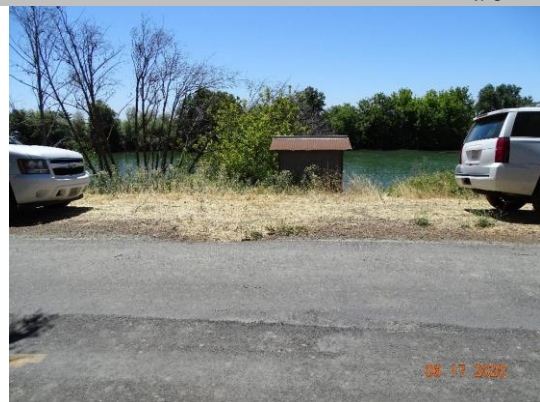
Photo 2 of 3 : UCIP\_FA\_2021\_61291\_89081.jpg

Overview of Levee: Levee crown and pumphouse on waterside berm

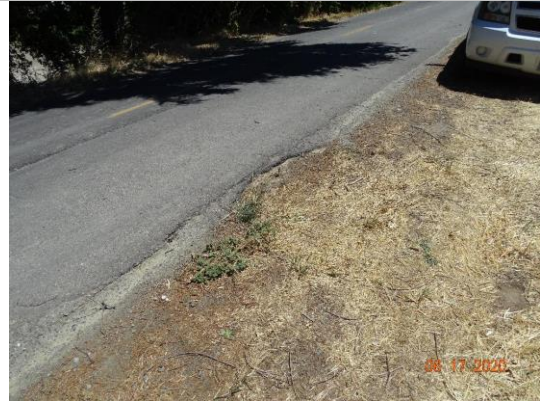
Photo 3 of 3 : UCIP\_FA\_2021\_61291\_89090.jpg

Water-Side: Soil depression in pipe alignment on levee shoulder

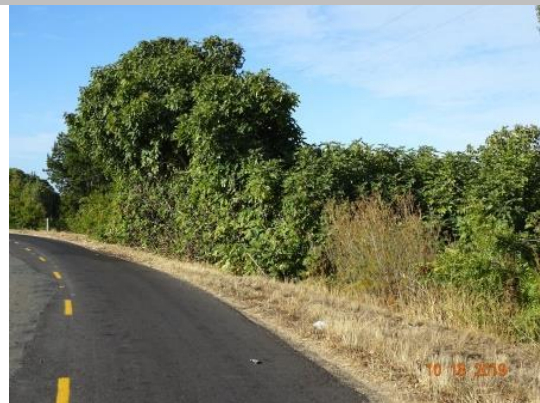
Photo 1 of 1 : FA\_2021\_RD0556\_18\_38\_20210830\_00018.jpg

View looking downstream at thick tree growth on the landside slope (Fall 2019).

LM Start	3.22	Rating **	U	Issue No.	38
LM End	3.29	Issue Type +	Ma	Location *	LS
Category	Earthen Levee			GPS Latitude/Longitude	
				Start	End
Item	Trim / Thin Trees			38.210493 °	38.209842 °
				-121.539760 °	-121.540658 °
DWR ID	DWR_RD0556_01_s_2017_38				
Comment Code					
T2 : Thin trees to allow visibility of the ground and room to flood fight.					
Inspector Comment					
Remove the wild tree growth and vegetation from the landside levee slope and toe so the ground can be seen.

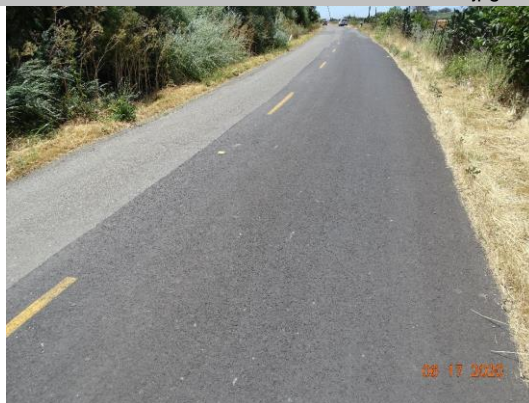
Photo 1 of 3 : UCIP\_FA\_2021\_61299\_89098.jpg

Comment Code					
Inspector Comment					
DS_ID:20838 FS_ID:61299 EP_NO: N/A Repair Type: Non-Urgent EVAL Issue: Limited Inspection/No UCIP Evaluation Crossing Status: Found UCIP Comments: 06/17/2020 Record is Non-Urgent. Waterside slope is covered with trees and brush - unable to access. Fence on landside shoulder prevents access to landside. Pump and pipe is visible on landside slope, pump is running. Unauthorized encroachment recorded in Levee Log prior to 2011. (O.Yakimov - DWR UCIP) FIELD_STRUCT_DESC: 2-inch pipe through levee, 3.0 feet below crown. Pump on landside berm. (2-inch pipe [HLM 3.36] authorized under Automatic Board Order (ABO) issued as Permit No. 11165, 1975 - Elroy and Helen Gomez). [Additional Reference(s): DWR Levee Log, unk.yr. (HLM 3.36)]. FS Date: 6/17/2020 8:40:57 AM

Top of Levee: View of levee crown looking downstream

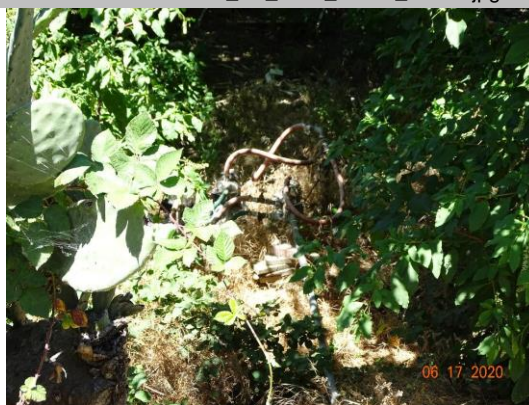
Photo 2 of 3 : UCIP\_FA\_2021\_61299\_89099.jpg

Land-Side: Small pump at levee toe

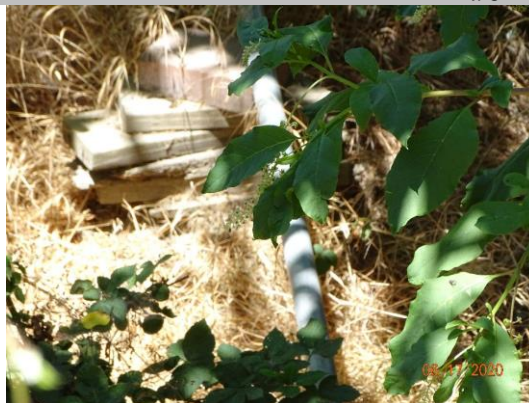
Photo 3 of 3 : UCIP\_FA\_2021\_61299\_89100.jpg

Land-Side: Water supply pipe on levee slope

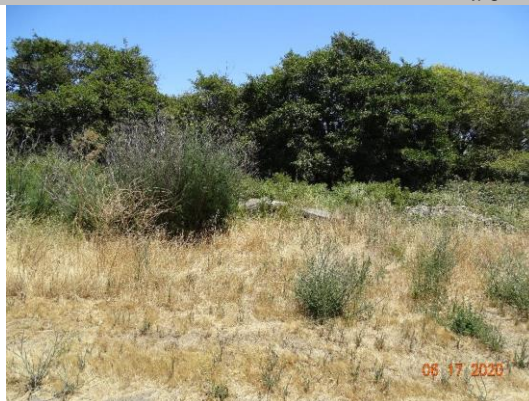
Photo 2 of 3 : UCIP\_FA\_2021\_61300\_89105.jpg

Water-Side: View of levee slope looking from crown

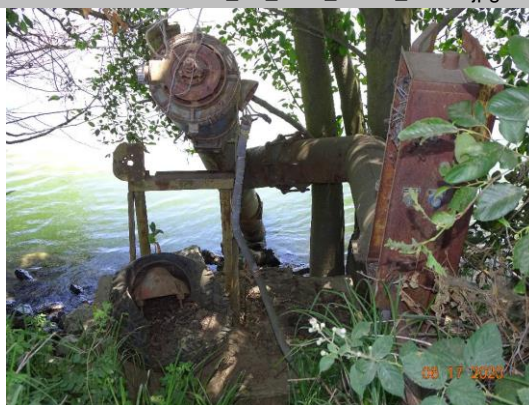
Photo 3 of 3 : UCIP\_FA\_2021\_61300\_89106.jpg

Water-Side: Abandoned slant pump on riverbank

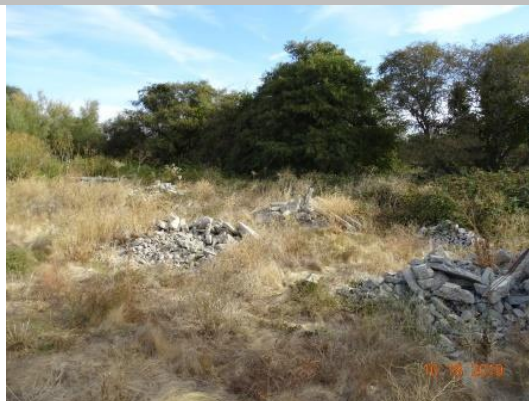
Photo 1 of 1 : FA\_2021\_RD0556\_18\_58\_20210830\_00033.jpg

View of large concrete debris piles on the waterside shoulder. The waterside shoulder is much larger in this section. (Fall 2019).

LM Start	3.46	Rating **	U	Issue No.	58
LM End	3.46	Issue Type +	En	Location *	WS
Category	Earthen Levee			GPS Latitude/Longitude	
				Start	End
Item	Encroachments			38.207585 °	38.207585 °
				-121.541678 °	-121.541678 °
DWR ID	DWR_RD0556_01_f_2019_58				
Comment Code					
DE : Debris					
Inspector Comment					
Remove concrete debris piles.

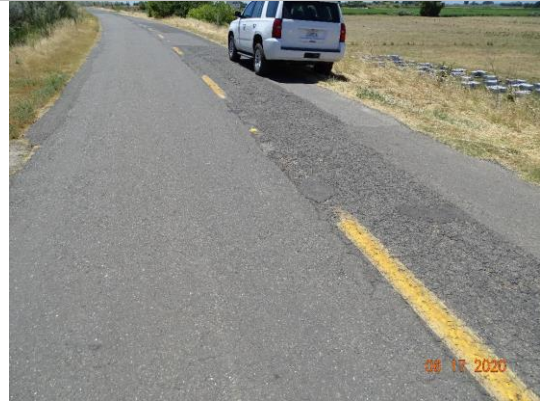
Photo 1 of 3 : UCIP\_FA\_2021\_61301\_89118.jpg

DS\_ID:20840  
FS\_ID:61301  
EP\_NO: 11161  
Repair Type: Urgent  
EVAL Issue: Levee Integrity  
Crossing Status: Found  
UCIP Comments: 06/17/2020 Record is Urgent. Subsidence on landside shoulder measured 2' x 3' x 1.5'-deep around air vent. Crossing appears abandoned. Fence on landside slope and overgrown vegetation on both slopes prevent from detailed inspection of levee. No permit has been identified authorizing pipe. Need to have CVFPB review ABO and determine current owner. (O.Yakimov - DWR UCIP)  
FIELD\_STRUCT\_DESC: 10-inch steel pipe through levee, 11.2 feet below crown. 2-inch air and vacuum valve and concrete spill box on landside of the levee. (10-inch pipe [HLM 3.57] authorized under Automatic Board Order (ABO) issued as Permit No. 11161, 1975 - L.J. Gamble & M. P. Darsie). [Additional Reference(s): DWR Levee Log, unk.yr. (HLM 3.57). USACE Sacramento O&M Manual, Unit 103, June 1954, Revised 29 December 2016, (Station 'R' 421+08.7), listed as 12-inch pipe. USACE As-Built Drawing No. 50-04-2671, Sheet 2, near Station 420+55, 25 January 1951, Revised 18 Dec. 1952, listed as 12-inch pipe. USACE As-Built Drawing No. 50-04-2631, Sheet 11, Station 421+08.7, March 1950, Revised 16 Dec. 1952, listed as 12-inch pipe].

Top of Levee: View of levee crown looking downstream

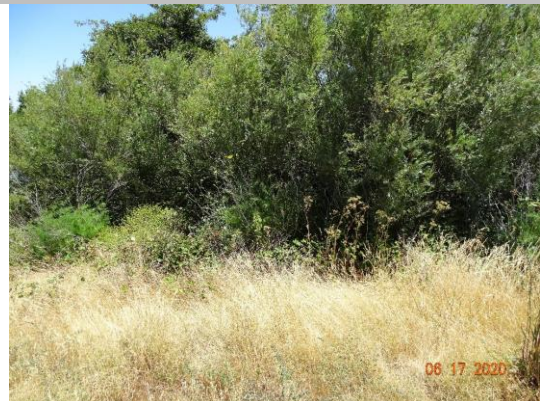
Photo 2 of 3 : UCIP\_FA\_2021\_61301\_89117.jpg

Water-Side: View of levee slope looking from crown

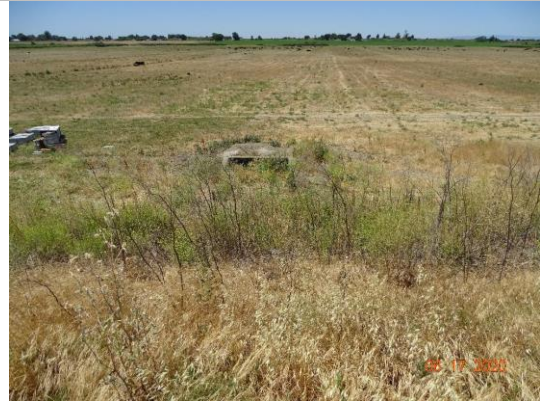
Photo 3 of 3 : UCIP\_FA\_2021\_61301\_89119.jpg

Land-Side: View of levee slope looking from crown

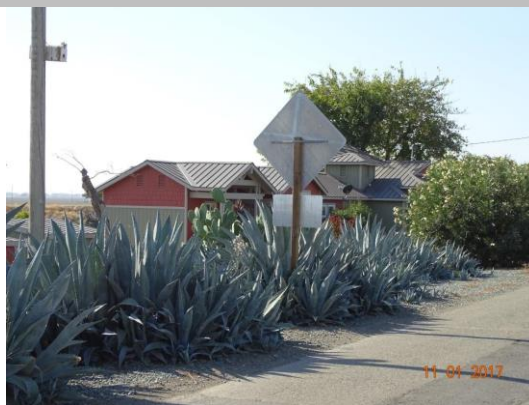
Photo 1 of 1 : FA\_2021\_RD0556\_18\_34\_20210830\_00016.jpg

LM Start	3.93	Rating **	U	Issue No.	34
LM End	3.98	Issue Type +	En	Location *	WS
Category	Earthen Levee			GPS Latitude/Longitude	
				Start	End
Item	Vegetation			38.201603 °	38.201273 °
				-121.542352 °	-121.543328 °
DWR ID	DWR_RD0556_01_f_2017_34				
Comment Code					
V6 : Landscaping					
Inspector Comment					
Remove large cactus from waterside shoulder to allow inspection and access.

View of large cactus on waterside shoulder.

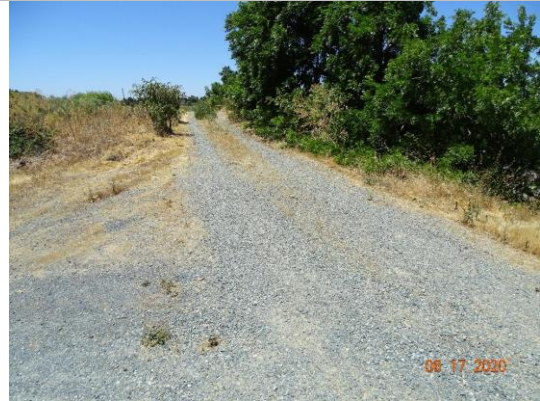
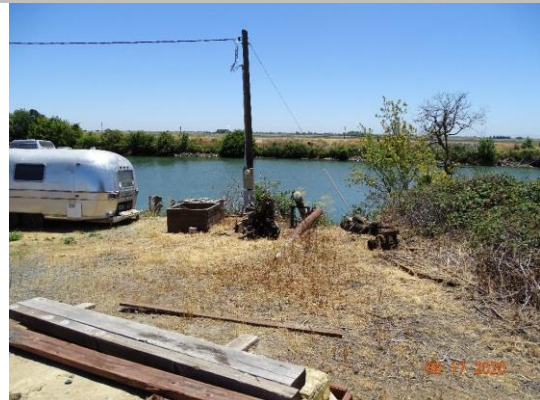
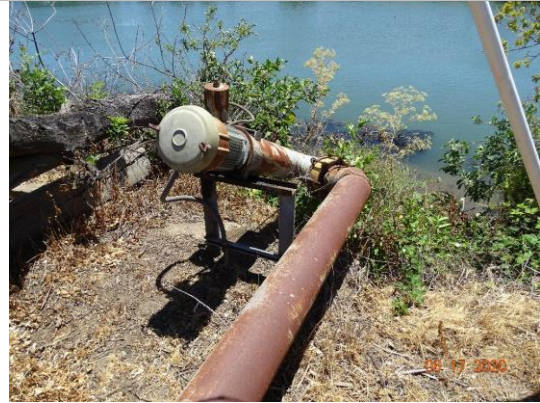
LM Start	4.01	Rating **	M	Issue No.	111 (cont)
LM End	4.01	Issue Type +	En	Location *

Comment Code					
Inspector Comment					
DS_ID:20841 FS_ID:61302 EP_NO: N/A Repair Type: Non-Urgent EVAL Issue: Unauthorized Encroachment, installed decades prior Crossing Status: Found UCIP Comments: 06/17/2020 Record is Non-Urgent. No permit has been identified authorizing pipe. (O.Yakimov - DWR UCIP)  FIELD_STRUCT_DESC: 8-inch pipe through levee, 3.7 feet below crown. Slant pump on waterward berm. Siphon breaker on landside shoulder, concrete spill box on landside of the levee. (8-inch pipe [HLM 4.00] authorized under Automatic Board Order (ABO) issued as Permit No. 11160, 1975 - Fred L. & H.E. Dumbacher). (Remodeling of pumphouse authorized under Permit No. 18590, 2011 - Donna Blower). [Additional Reference(s): DWR Levee Log, unk.yr. (HLM 4.00). USACE Sacramento O&M Manual, Unit 103, June 1954, Revised 29 December 2016, (Station 'R' 398+11.4), listed as 8-inch pipe. USACE As-Built Drawing No. 50-04-2631, Sheet 10, Station 398+11.4, March 1950, Revised 16 Dec.1952]. FS Date: 6/17/2020

Top of Levee: View of levee crown looking downstream

Water-Side: View of levee slope looking from crown

Water-Side: Slant pump at riverbank

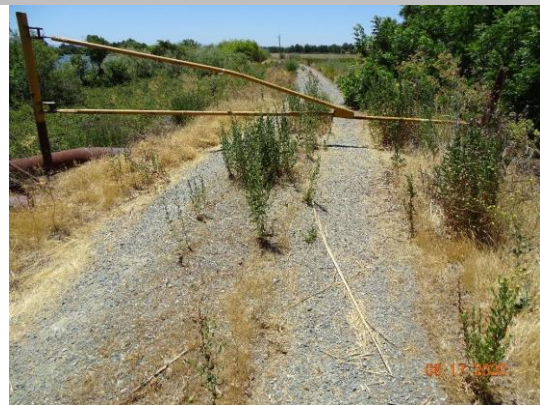
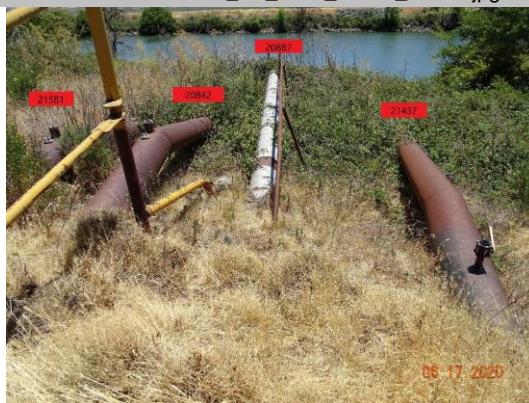
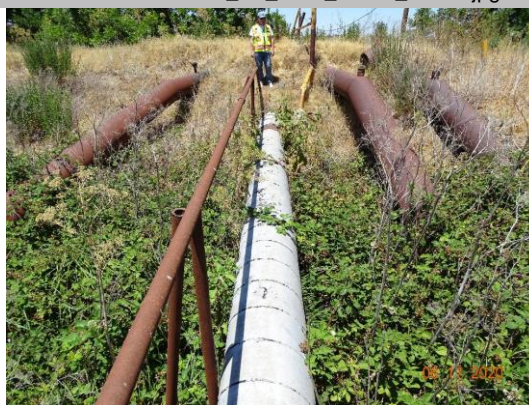
LM Start	4.02	Rating **	M	Issue No.	112 (cont)
LM End	4.02	Issue Type +	En	Location *	
Category	Supplemental			GPS Latitude/Longitude	
				Start	End
Item	DWR UCIP Field Study			38.201035 °	38.201035 °
				-121.543936 °	-121.543936 °
DWR ID	21581

DS\_ID:21581  
 FS\_ID:61315  
 EP\_NO: 13030  
 Repair Type: Non-Urgent  
 EVAL Issue: Unauthorized Modification or Non-Compliant Permit  
 Crossing Status: Found  
 UCIP Comments: 06/17/2020 Record is Non-Urgent. Pipe diameter field measured as 20-inch on both slopes. On landside berm pipe diameter changes from 20 inch to 18 inch. Unable to find a permit for modification of this crossing. No permit has been identified authorizing original O&M pipe through the levee. (O.Yakimov - DWR UCIP)  
 FIELD\_STRUCT\_DESC: 18-inch steel drainage pipes through levee, 4.3 feet below crown. Pumps on landward side and 4-inch air valve. (18-inch pipe [HLM 4.01] authorized under Automatic Board Order (ABO) issued as Permit No. 11175, 1975 - RD0556). [Additional Reference(s): DWR Levee Log, unk.yr. (HLM 4.01). USACE Sacramento O&M Manual, Unit 103, June 1954, Revised 29 December 2016, (Station 397+36.3), listed as 20-inch pipe]. USACE As-Built Drawing No. 50-04-2631, Sheet 10, Station 397+36.3, March 1950, Revised 16 Dec.1952, listed as 20-inch pipe].

Top of Levee: View of levee crown looking downstream

Water-Side: Pipes on waterside berm

Water-Side: Pipes on waterside berm and levee slope on background

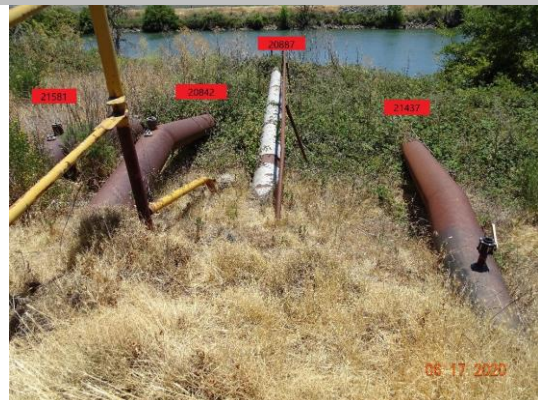
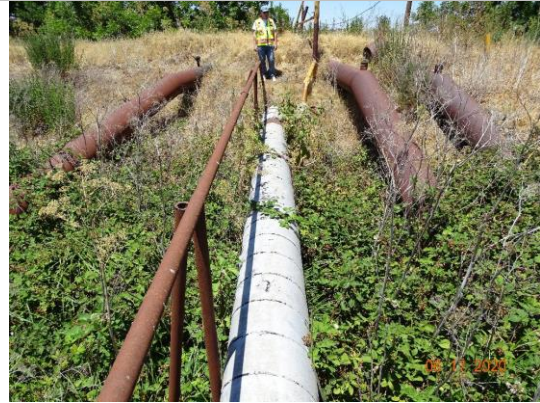
LM Start	4.02	Rating **	M	Issue No.	113 (cont)
LM End	4.02	Issue Type +	En	Location *	
Category	Supplemental			GPS Latitude/Longitude	
				Start	End
Item	DWR UCIP Field Study			38.201032 °	38.201032 °
				-121.543946 °	-121.543946 °
DWR ID	20842

DS\_ID:20842  
FS\_ID:61303  
EP\_NO: 13030  
Repair Type: Non-Urgent  
EVAL Issue: Unauthorized Modification or Non-Compliant Permit  
Crossing Status: Found  
UCIP Comments: 06/17/2020 Record is Non-Urgent. Pipe diameter field measured as 20-inch on both slopes. On landside berm pipe diameter changes from 20 inch to 18 inch. Debris of 20-inch pipe welded to 16-inch pipe with open end found next to this crossing on landside berm. Unable to find a permit for modification of this crossing. No permit has been identified authorizing original O&M pipe through the levee. (O.Yakimov - DWR UCIP)  
FIELD\_STRUCT\_DESC: 16-inch steel drainage pipes through levee, 4.3 feet below crown. Pumps on landward side and 4-inch air valve. (16-inch pipe [HLM 4.01] authorized under Automatic Board Order (ABO) issued as Permit No. 11175, 1975 - RD0556). [Additional Reference(s): DWR Levee Log, unk.yr. (HLM 4.01). USACE Sacramento O&M Manual, Unit 103, June 1954, Revised 29 December 2016, (Station 397+20.5), listed as 16-inch pipe. USACE As-Built Drawing No. 50-04-2631, Sheet 10, Station 397+20.5, March 1950, Revised 16 Dec.1952, listed as 12-inch pipe].

Water-Side: Pipes on waterside berm

Water-Side: Pipes on waterside berm looking from riverbank

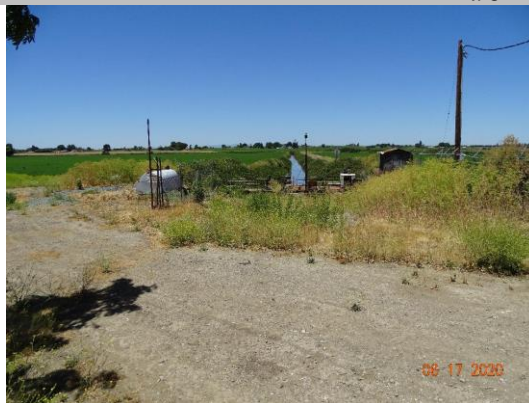
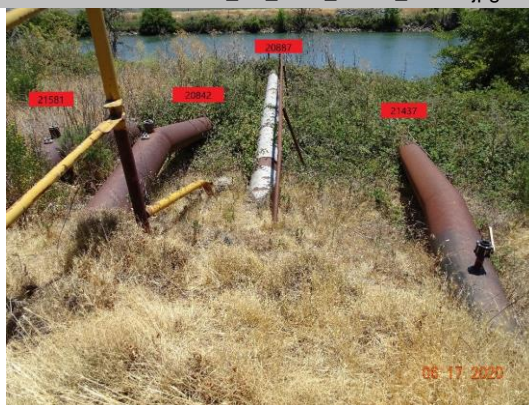
LM Start	<b>4.02</b>	Rating **	M	Issue No.	<b>114 (cont)</b>
LM End	<b>4.02</b>	Issue Type +	En	Location *	
Category	Supplemental		GPS Latitude/Longitude		
			Start	End	
Item	DWR UCIP Field Study		38.201026 °	38.201026 °	
			-121.543960 °	-121.543960 °	
DWR ID	20887

DS\_ID:20887  
 FS\_ID:61309  
 EP\_NO: 13030  
 Repair Type: Non-Urgent  
 EVAL Issue: Abandoned encroachment  
 Crossing Status: Found  
 UCIP Comments: 06/17/2020 Record is Non-Urgent. Crossing appears abandoned. Unable to find this crossing on landside. (O.Yakimov - DWR UCIP)  
 FIELD\_STRUCT\_DESC: 20-inch steel drainage pipeline through the levee, 3.2 ft. below the levee crown; pump and siphon breaker on landside. Concrete saddle on waterside of the levee. (20-inch pipe authorized under Permit No. 13030, 1980 - Reclamation District 556).  
 FS Date: 6/17/2020

Land-Side: Pumping station at drainage channel

Water-Side: Pipes on waterside berm

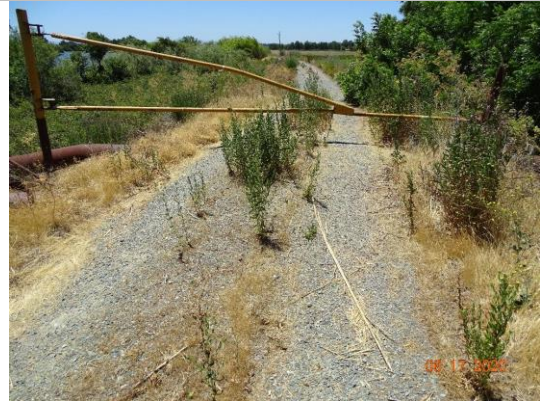
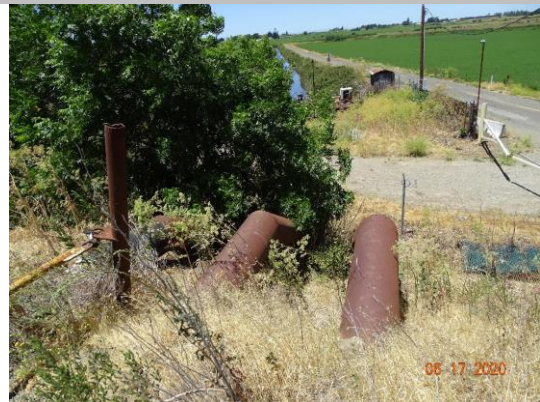
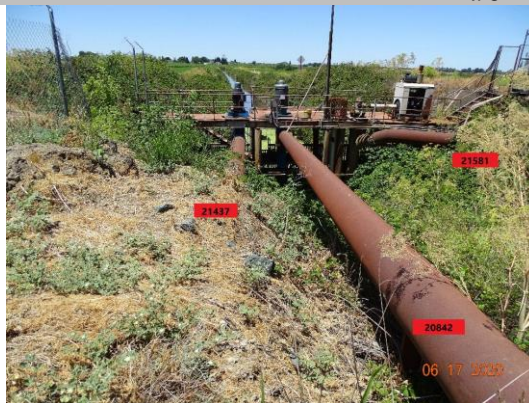
LM Start	<b>4.02</b>	Rating **	M	Issue No.	<b>115 (cont)</b>
LM End	<b>4.02</b>	Issue Type +	En	Location *

DS\_ID:21437  
FS\_ID:61311  
EP\_NO: 10526  
Repair Type: Non-Urgent  
EVAL Issue: Unauthorized Modification or Non-Compliant Permit  
Crossing Status: Found  
UCIP Comments: 06/17/2020 Record is Non-Urgent. Pipe diameter field measured as 20-inch on both slopes. Unable to find a permit for modification of this crossing. (O.Yakimov - DWR UCIP)

FIELD\_STRUCT\_DESC: 24-inch steel drainage pipes 3.5 ft below levee crown. Pumping plant on landside. 6" air valve, concrete saddle & wood beam on waterside. This crossing replaces 24-inch pipe (see DSID 25634). (24-inch pipe authorized under Permit No. 10526, 1975 - Reclamation District 556). [Additional Reference(s): USACE Sacramento O&M Manual, Unit 103, June 1954, Revised 29 December 2016, (Station 397+36.3), listed as 24-inch pipe. USACE As-Built Drawing No. 50-04-2631, Sheet 10, Station 397+36.3, March 1950, Revised 16 Dec.1952].  
FS Date: 6/17/2020

Top of Levee: View of levee crown looking downstream

Land-Side: View of pipes on levee shoulder

Land-Side: Pumping station at drainage channel

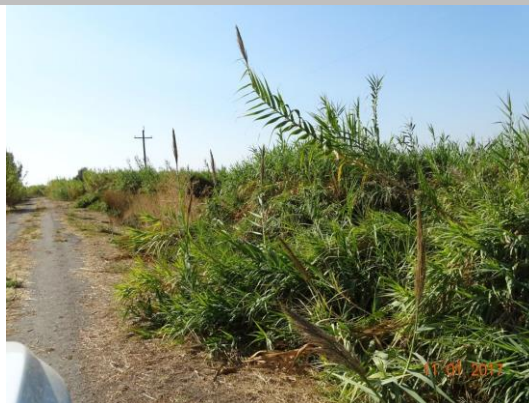
Photo 1 of 1 : FA\_2021\_RD0556\_18\_39\_20210830\_00019.jpg

LM Start	4.22	Rating **	U	Issue No.	39
LM End	5.10	Issue Type +	Ma	Location *	LS
Category	Earthen Levee			GPS Latitude/Longitude	
				Start	End
Item	Vegetation			38.198884 °	38.190134 °
				-121.546223 °	-121.557559 °
DWR ID	DWR_RD0556_01_f_2017_39				
Comment Code					
V2 : Remove the wild growth other than native grasses from the levee slopes.					
Inspector Comment					
Remove wild growth including berry vines and arundo from landside slope and toe to allow for inspection and access.

View of dense growth of wild vegetation, berry vines and arundo on landside slope and toe.

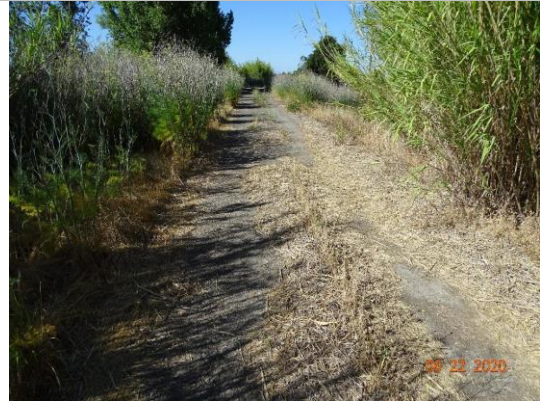
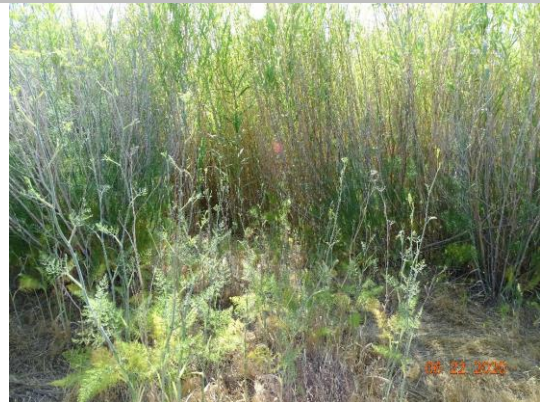
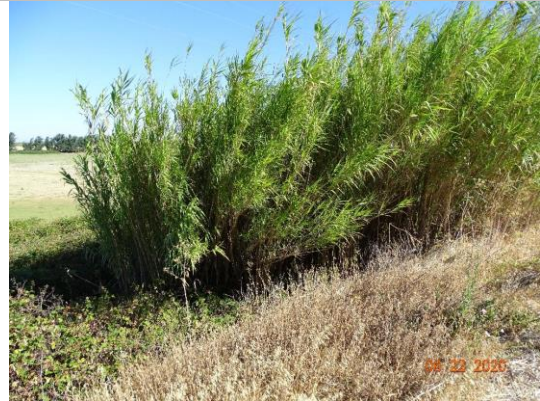
LM Start	<b>4.36</b>	Rating **	M	Issue No.	<b>116 (cont)</b>
LM End	<b>4.36</b>	Issue Type +	En	Location *

Comment Code						
Inspector Comment						
DS_ID:20843 FS_ID:61304 EP_NO: 5925 Repair Type: Non-Urgent EVAL Issue: Safety Issue Crossing Status: Not Found UCIP Comments: 06/22/2020 Record is Non-Urgent. Overgrown vegetation and trees on both slopes prevent levee inspection at this crossing. No inspection records were available to determine status of line through the levee. Crossing not found. No markers found to identify crossing alignment. (O.Yakimov - DWR UCIP) FIELD_STRUCT_DESC: 8-1/2 inch gas line through levee 3.0 feet below crown, and across Georgiana Slough with sign. (8-inch gas line authorized under Permit No. 5925, 1967 - PG&E). [Additional Reference(s): DWR Levee Log, unk.yr. (HLM 4.35)]. FS Date: 6/22/2020

Top of Levee: View of levee crown looking downstream

Water-Side: View of levee slope looking from crown

Land-Side: View of levee slope looking from crown

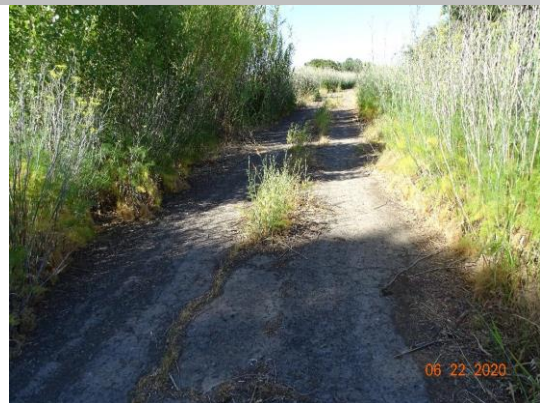
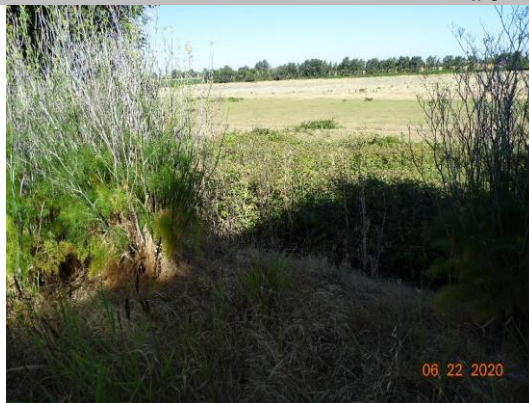
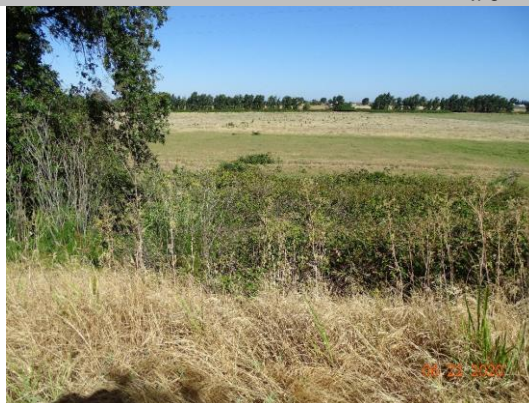
LM Start	<b>4.42</b>	Rating **	M	Issue No.	<b>117 (cont)</b>
LM End	<b>4.42</b>	Issue Type +	En	Location *	
Category	Supplemental		GPS Latitude/Longitude		
			Start	End	
Item	DWR UCIP Field Study		38.196231 °	38.196231 °	
			-121.547833 °	-121.547833 °	
DWR ID	21438

DS\_ID:21438  
 FS\_ID:61312  
 EP\_NO: N/A  
 Repair Type: Non-Urgent  
 EVAL Issue: Limited Inspection/No UCIP Evaluation  
 Crossing Status: Not Found  
 UCIP Comments: 06/22/2020 Record is Non-Urgent. Crossing not found. Overgrown vegetation and trees on both slopes. Fence at landside toe. Unable to evaluate levee condition at this place. No permit has been identified authorizing pipe. (O.Yakimov - DWR UCIP)  
 FIELD\_STRUCT\_DESC: 12-inch steel pipe through the levee at unknown depth. 3-24" lateral headgates on landside and pump on waterside of the levee. [Additional Reference(s):USACE Sacramento O&M Manual, Unit 103, June 1954, Revised 29 December 2016, (Station 'R' 377+00), listed as 12-inch pipe. USACE As-Built Drawing No. 50-04-2631, Sheet 9, Station 377+00, March 1950, Revised 16 Dec.1952].  
 FS Date: 6/22/2020

Top of Levee: View of levee crown looking downstream

Land-Side: View of levee slope looking from crown

Land-Side: Overgrown vegetation and fence at levee toe

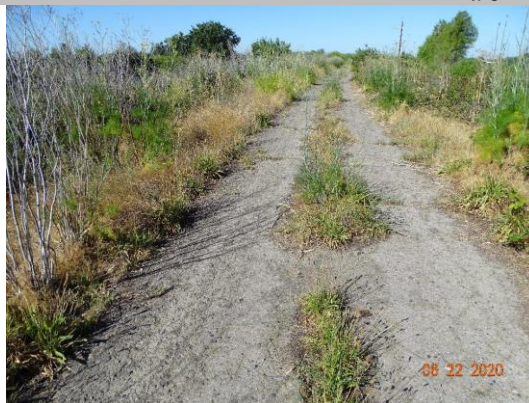
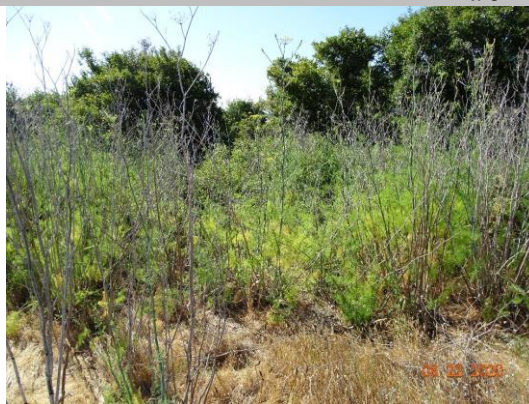
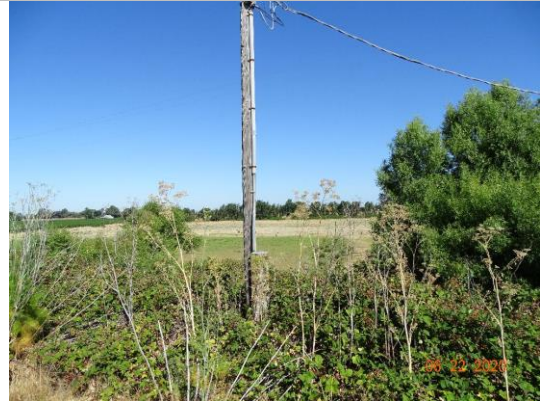
LM Start	<b>4.47</b>	Rating **	M	Issue No.	<b>118 (cont)</b>
LM End	<b>4.47</b>	Issue Type +	En	Location *

Comment Code						
Inspector Comment						
DS_ID:20844 FS_ID:61305 EP_NO: 11172 Repair Type: Non-Urgent EVAL Issue: Limited Inspection/No UCIP Evaluation Crossing Status: Indicator Found UCIP Comments: 06/22/2020 Record is Non-Urgent. Overgrown vegetation on both slopes limit inspection. Power supply is connected to service pole on landside slope, although electric meter is missing. Crossing appears abandoned. Unauthorized encroachment recorded in Levee Log prior to 2011. Need to have CVFPB review ABO and determine current owner. (O.Yakimov - DWR UCIP)  FIELD_STRUCT_DESC: 12-inch pipe through levee 4.0 feet below crown. Pump in pumphouse on berm. Siphon breaker on landward shoulder. Service pole on landward, slope distribution box on landward toe. (12-inch pipe [HLM 4.46] authorized under Automatic Board Order (ABO) issued as Permit No. 11172, 1975 - Pacific Fruit Exchange). [Additional Reference(s): DWR Levee Log, unk.yr. (HLM 4.46)]. FS Date: 6/22/2020

Top of Levee: View of levee crown looking downstream

Water-Side: View of levee slope looking from crown

Land-Side: View of levee slope looking from crown

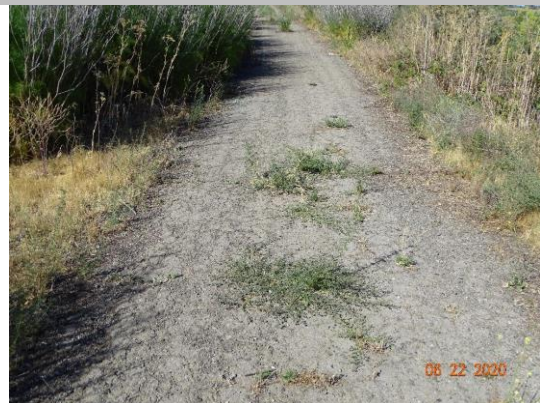
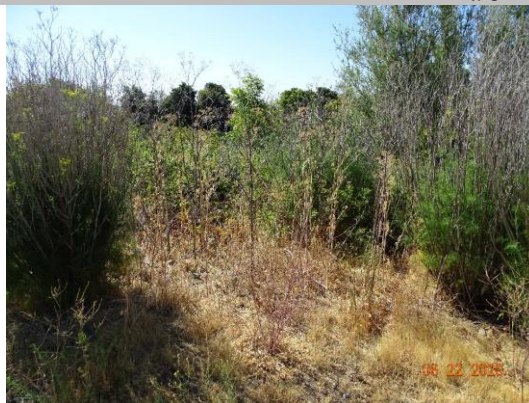
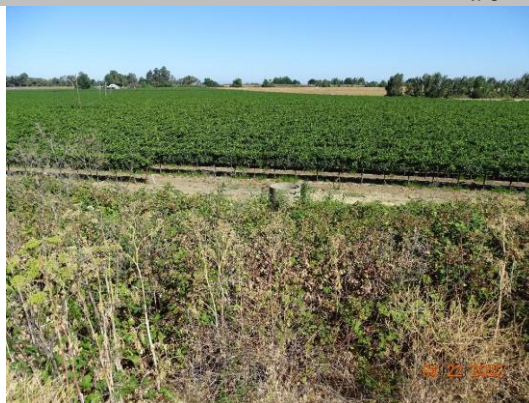
LM Start	4.67	Rating **	M	Issue No.	119 (cont)
LM End	4.67	Issue Type +	En	Location *	
Category	Supplemental			GPS Latitude/Longitude	
				Start	End
Item	DWR UCIP Field Study			38.194043 °	38.194043 °
				-121.551391 °	-121.551391 °
DWR ID	20845

DS\_ID:20845  
 FS\_ID:61306  
 EP\_NO: 11168  
 Repair Type: Non-Urgent  
 EVAL Issue: Limited Inspection/No UCIP Evaluation  
 Crossing Status: Indicator Found  
 UCIP Comments: 06/22/2020 Record is Non-Urgent. Overgrown vegetation on both slopes limits inspection of the crossing. Concrete standpipe located at landside levee toe. No permit has been identified authorizing pipe. Need to have CVFPB review ABO and determine current owner. (O.Yakimov - DWR UCIP)  
 FIELD\_STRUCT\_DESC: 10-inch pipe through levee 3.0 feet below crown. Siphon breaker on landward shoulder. 36-inch standpipe on landside of the levee. (10-inch pipe [HLM 4.66] authorized under Automatic Board Order (ABO) issued as Permit No. 11168, 1975 - Walter Langhart). [Additional Reference(s): DWR Levee Log, unk.yr. (HLM 4.66).USACE Sacramento O&M Manual, Unit 103, June 1954, Revised 29 December 2016, (Station 'R' 362+50), listed as 8-inch pipe. USACE As-Built Drawing No. 50-04-2631, Sheet 9, Station 362+50, March 1950, Revised 16 Dec.1952, listed as 8-inch pipe].

Top of Levee: View of levee crown looking downstream

Water-Side: View of levee slope looking from crown

Land-Side: View of levee slope looking from crown

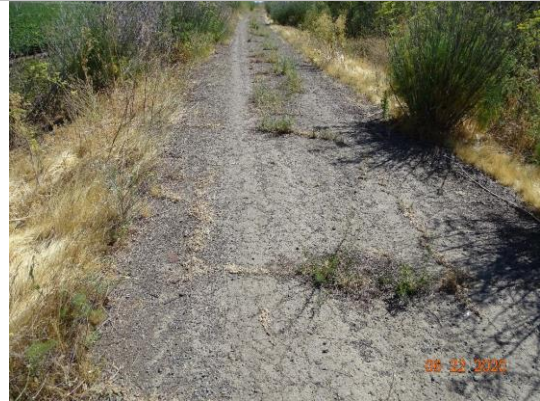
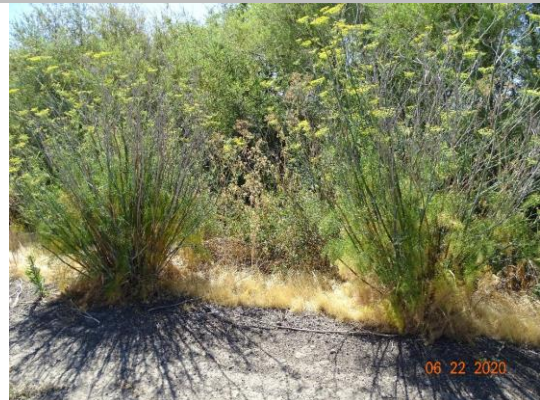
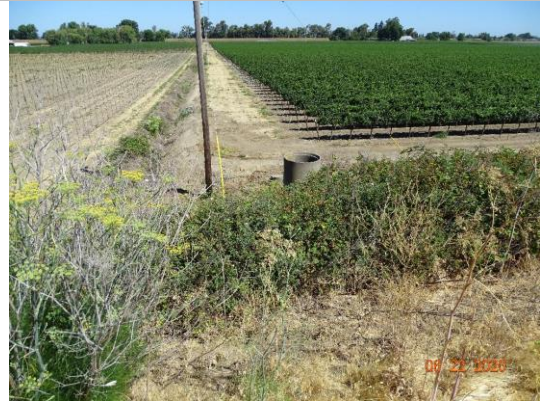
Comment Code					
Inspector Comment					
DS_ID:20846 FS_ID:61307 EP_NO: 11168 Repair Type: Non-Urgent EVAL Issue: Limited Inspection/No UCIP Evaluation Crossing Status: Indicator Found UCIP Comments: 06/22/2020 Record is Non-Urgent. Concrete standpipe and junction pole at landside levee toe. Dense vegetation on both slopes limits inspection of this crossing. No permit has been identified authorizing pipe. Need to have CVFPB review ABO and determine current owner. (O.Yakimov - DWR UCIP) FIELD_STRUCT_DESC: 10-inch pipe through levee, 4.0 feet below crown. Siphon Breaker on landward slope. A 9 ft x 42-inch concrete standpipe. (12-inch pipe authorized under Permit No. 1281, 1948 - Walter Langhart). (10-inch pipe [HLM 5.09] authorized under Automatic Board Order (ABO) issued as Permit No. 11168, 1975 - Walter Langhart). [Additional Reference(s): DWR Levee Log, unk.yr. (HLM 5.09). USACE Sacramento O&M Manual, Unit 103, June 1954, Revised 29 December 2016, (Station 'R' 340+14.1), listed as 12-inch pipe. USACE As-Built Drawing No. 50-04-2631, Sheet 9, Station 340+14.1, March 1950, Revised 16 Dec.1952, listed as 12-inch pipe]. FS Date: 6/22/2020

LM Start	<b>5.10</b>	Rating **	M	Issue No.	<b>120 (cont)</b>
LM End	<b>5.10</b>	Issue Type +	En	Location *

Top of Levee: View of levee crown looking downstream

Water-Side: View of levee slope looking from crown

Land-Side: Concrete standpipe and junction pole at levee toe
