## Flood Control Project Maintenance Levee Inspections

### Fall 2021 Levee Maintenance Deficiency Summary Report

#### Sacramento River Basin

**Reclamation District No. 0556 Upper Andrus**

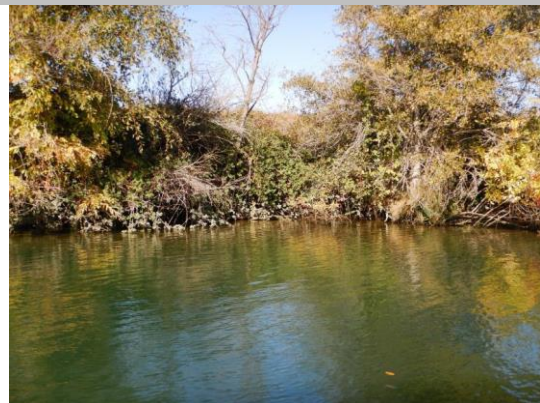
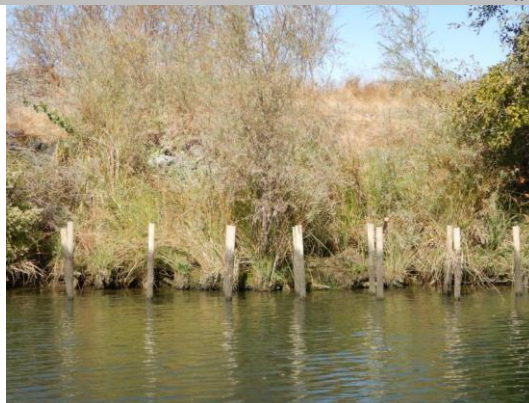
USACE 2018 Erosion Photo #1

LM Start	<b>5.12</b>	Rating **	M	Issue No.	<b>20</b>
LM End	<b>5.34</b>	Issue Type +	Ma	Location *	WS
Category	Supplemental			GPS Latitude/Longitude	
				Start	End
Item	2018 USACE Erosion Survey			38.189775 °	38.187369 °
				-121.557729 °	-121.560247 °
DWR ID

2018 Site ID: GEO 7.0 R  
 Status: Eroding  
 2018 Field Notes: Minor new toe erosion.  
 Site History: 1997 - Toe damaged rock. 1999 - One pocket filled with gravel. 2000 - Eroding beach with some biotech rolls and stakes; some gravel on slope. 2001 - Staked, low fascine walls at bankline. 2005 - Stone revetment in between pockets. 2006 - New rock on upper slope behind brush boxes at the upstream end, Stone is sliding off the hard toe. 2016 - Fresh erosion observed. 2017 - Site extended downstream. Large erosion pockets and significant toe erosion.

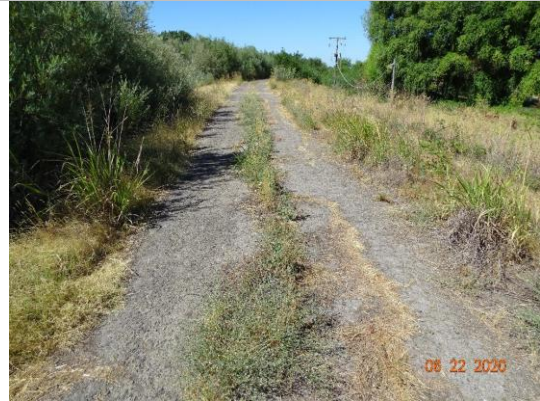
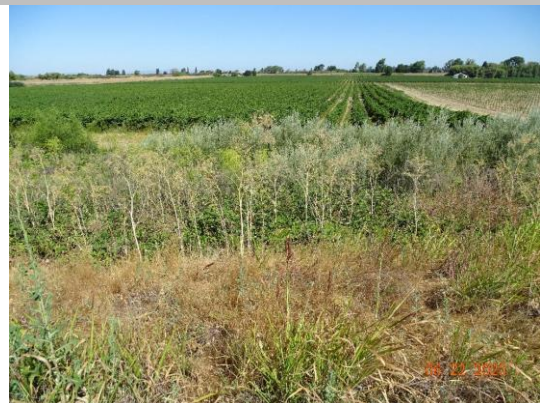
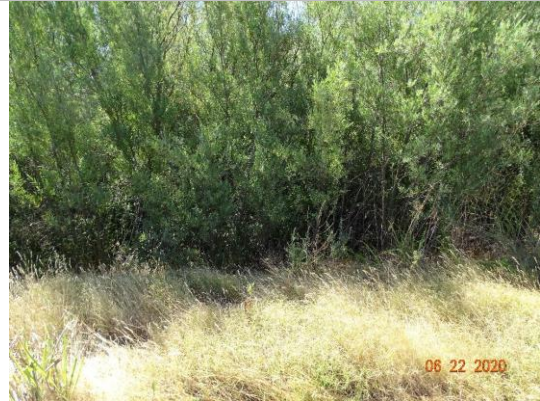
DS\_ID:21453  
FS\_ID:61313  
EP\_NO: N/A  
Repair Type: Non-Urgent  
EVAL Issue: Limited Inspection/No UCIP Evaluation  
Crossing Status: Not Found  
UCIP Comments: 06/22/2020 Record is Non-Urgent. Dense vegetation on both levee slopes prevents inspection of this site. Crossing not found. No permit has been identified authorizing pipe. (O.Yakimov - DWR UCIP)  
FIELD\_STRUCT\_DESC: 6-inch steel pipe. 1-inch air and vacuum valve, 6 ft x 42-inch concrete standpipe. [Additional Reference(s):USACE Sacramento O&M Manual, Unit 103, June 1954, Revised 29 December 2016, (Station 'R' 328+28.2), listed as 6-inch pipe. USACE As-Built Drawing No. 50-04-2631, Sheet 8, Station 328+28.2, March 1950, Revised 16 Dec.1952].  
FS Date: 6/22/2020

LM Start	<b>5.31</b>	Rating **	M	Issue No.	<b>121 (cont)</b>
LM End	<b>5.31</b>	Issue Type +	En	Location *

Top of Levee: View of levee crown looking downstream

Land-Side: View of levee slope looking from crown

Water-Side: View of levee slope looking from crown

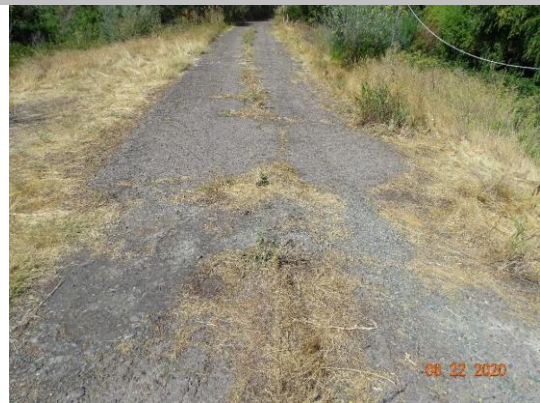
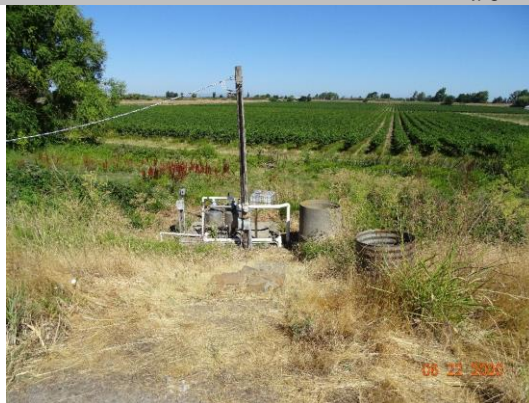
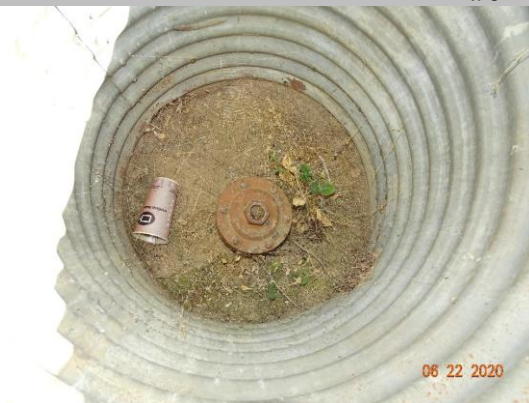
LM Start	5.33	Rating **	M	Issue No.	122
LM End	5.33	Issue Type +	En	Location *	
Category	Supplemental			GPS Latitude/Longitude	
				Start	End
Item	DWR UCIP Field Study			38.187651 °	38.187651 °
				-121.560247 °	-121.560247 °
DWR ID	20847

DS\_ID:20847  
 FS\_ID:61308  
 EP\_NO: 10489  
 Repair Type: Non-Urgent  
 EVAL Issue: Unauthorized Modification or Non-Compliant Permit  
 Crossing Status: Found  
 UCIP Comments: 06/22/2020 Record is Non-Urgent. Slant pump was removed and replaced with smaller pump on pile structure at riverbank. Unable to find a permit for modification. (O.Yakimov - DWR UCIP)  
 FIELD\_STRUCT\_DESC: 10-inch pipe through levee, 3.5 feet below crown. Pump on pile structure at riverbank. 1-inch electrical conduit through levee at this location. Siphon breaker in CMP riser on landward slope. A 9 ft x 42-inch concrete standpipe on landside. Service pole with electric meter and connection panel at landside toe. Two sand media filters on landside. This crossing replaces 6-inch pipe (see DSID 25650). (10-inch pipe authorized under Permit No. 10489, 1975 - Daecie and Gamble). [Additional Reference(s): DWR Levee Log, unk.yr. (HLM 5.32). USACE Sacramento O&M Manual, Unit 103, June 1954, Revised 29 December 2016, (Station 'R' 327+63.7), listed as 8-inch pipe. USACE As-Built Drawing No. 50-04-2631, Sheet 8, Station 327+63.7, March 1950, Revised 16 Dec.1952, listed as 8-inch pipe].

Top of Levee: View of levee crown looking downstream

Land-Side: View of levee slope looking from crown

Land-Side: Siphon breaker inside of CMP riser on levee slope

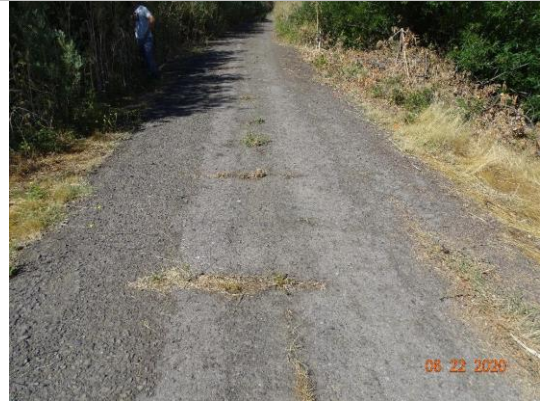
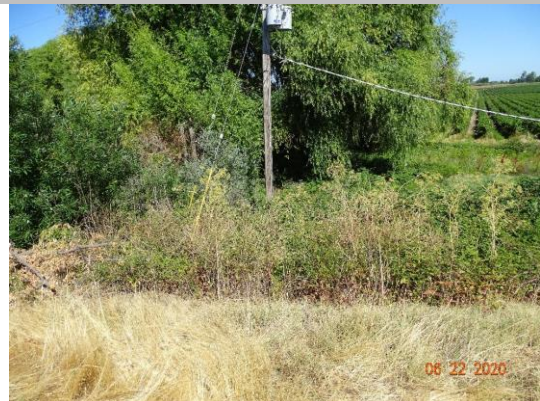
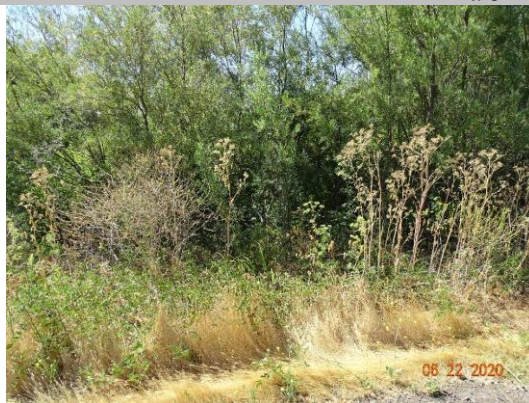
DS\_ID:20834  
FS\_ID:61286  
EP\_NO: 11161  
Repair Type: Non-Urgent  
EVAL Issue: Limited Inspection/No UCIP Evaluation  
Crossing Status: Not Found  
UCIP Comments: 06/22/2020 Record is Non-Urgent. Crossing not found. Overgrown vegetation on both levee slopes limits inspection of the crossing. Unauthorized encroachment recorded in Levee Log prior to 2011. Need to have CVFPB review ABO and determine current owner. (O.Yakimov - DWR UCIP)

LM Start	<b>5.34</b>	Rating **	M	Issue No.	<b>123 (cont)</b>
LM End	<b>5.34</b>	Issue Type +	En	Location *

Top of Levee: View of levee crown looking downstream

Land-Side: View of levee slope looking from crown

Water-Side: View of levee slope looking from crown

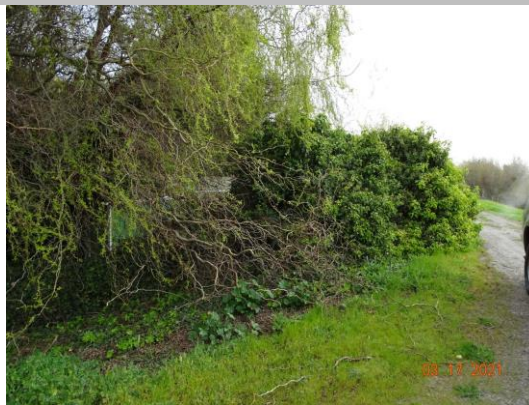
LM Start	5.48	Rating **	U	Issue No.	44
LM End	5.48	Issue Type +	En	Location *	LS
Category	Earthen Levee			GPS Latitude/Longitude	
				Start	End
Item	Vegetation			38.186448 °	38.186447 °
				-121.562673 °	-121.562674 °
DWR ID	DWR_RD0556_01_s_2021_44				
Comment Code					
V6 : Landscaping					
Inspector Comment

View looking downstream landscaping shrubs on the landside slope (Spring 2021).

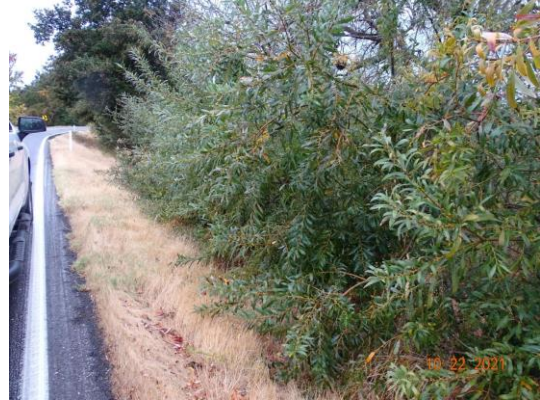
LM Start	0.63	Rating **	U	Issue No.	34
LM End	0.63	Issue Type +	Ma	Location *	WS
Category	Earthen Levee			GPS Latitude/Longitude	
				Start	End
Item	Trim / Thin Trees			38.237530 °	38.237530 °
				-121.529552 °	-121.529552 °
DWR ID	DWR_RD0556_02_f_2021_34				
Comment Code					
T2 : Thin trees to allow visibility of the ground and room to flood fight.					
Inspector Comment

View looking downstream at thick tree on the waterside slope (Fall 2021).

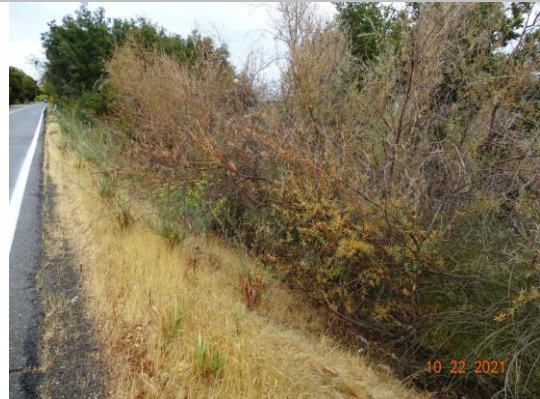
LM Start	0.74	Rating **	U	Issue No.	81
LM End	0.85	Issue Type +	Ma	Location *	LS
Category	Earthen Levee			GPS Latitude/Longitude	
				Start	End
Item	Vegetation			38.237577 °	38.237842 °
				-121.531594 °	-121.533616 °
DWR ID	DWR_RD0556_02_s_2021_81				
Comment Code					
V7 : Trees / Woody Vegetation					
Inspector Comment

View looking upstream at thick vegetation on the landside slope (Fall 2021).

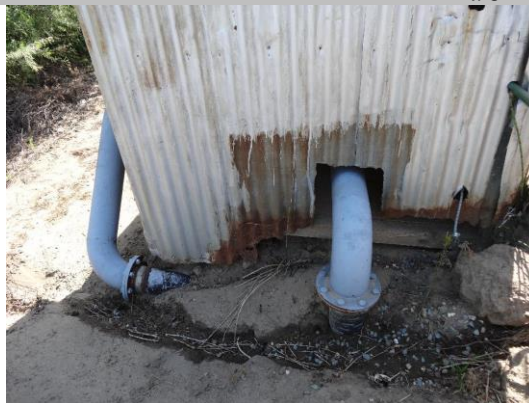
LM Start	<b>0.94</b>	Rating **	M	Issue No.	<b>121 (cont)</b>
LM End	<b>0.94</b>	Issue Type +	En	Location *	
Category	Supplemental		GPS Latitude/Longitude		
			Start	End	
Item	DWR UCIP Field Study		38.238125 °	38.238125 °	
			-121.535267 °	-121.535267 °	
DWR ID	20851

WS- pipe daylight from the pump house.

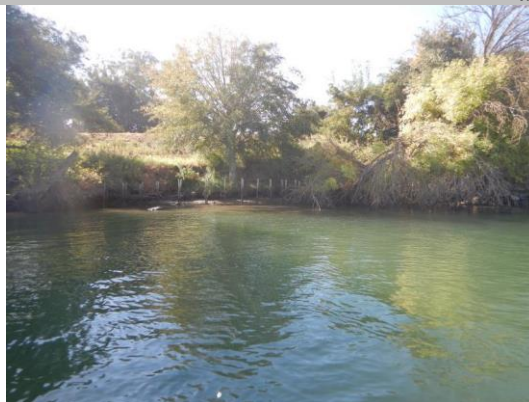
USACE 2018 Erosion Photo #2

2018 Site ID: SAC 25.2 L  
Status: Eroding  
2018 Field Notes: Additional erosion along toe. Site extended upstream.  
Site History: 1997 - Rock is in poor condition and has failed in many places. Scallops in berm with remnants of old rock in the toe area.  
2005 - Brush boxes present. 2013 - Site extended upstream approximately 300 ft to include new erosion pockets. 2015 - Minor new erosion at toe. 2017 - Minor new erosion observed.

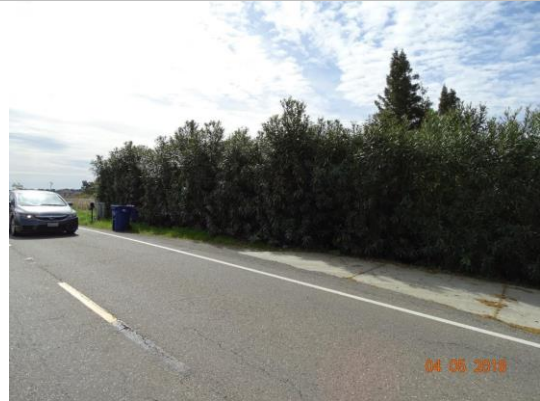
LM Start	1.11	Rating **	U	Issue No.	26
LM End	1.11	Issue Type +	En	Location *	LS
Category	Earthen Levee			GPS Latitude/Longitude	
				Start	End
Item	Vegetation			38.238857 °	38.238857 °
				-121.538310 °	-121.538310 °
DWR ID	DWR_RD0556_02_f _ 2017_26				
Comment Code					
V6 : Landscaping					
Inspector Comment					
Trim/thin oleanders on the landside of the levee.

Manage oleanders to allow inspection and access.

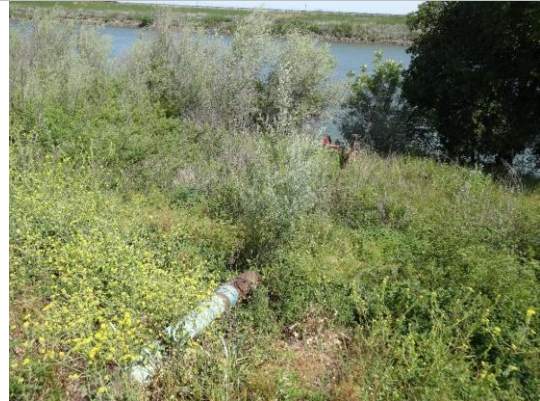
LM Start	<b>1.22</b>	Rating **	M	Issue No.	<b>122 (cont)</b>
LM End	<b>1.22</b>	Issue Type +	En	Location *	
Category	Supplemental			GPS Latitude/Longitude	
				Start	End
Item	DWR UCIP Field Study			38.239327 °	38.239327 °
				-121.540190 °	-121.540190 °
DWR ID	20852

WS- 6-inch steel pipe on levee slope

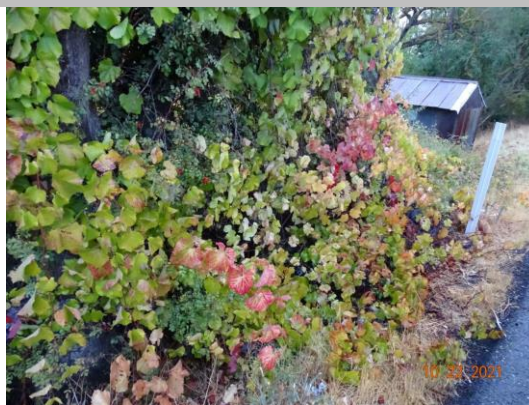
LM Start	1.43	Rating **	U	Issue No.	40
LM End	1.43	Issue Type +	Ma	Location *	WS
Category	Earthen Levee			GPS Latitude/Longitude	
				Start	End
Item	Trim / Thin Trees			38.240060 °	38.240060 °
				-121.543884 °	-121.543884 °
DWR ID	DWR_RD0556_02_f_2021_40				
Comment Code					
T2 : Thin trees to allow visibility of the ground and room to flood fight.					
Inspector Comment

View looking upstream at thick vegetation on the waterside slope (Fall 2021).

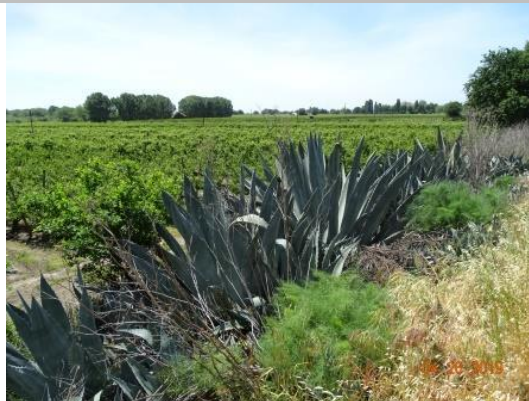
LM Start	1.57	Rating **	U	Issue No.	47
LM End	1.57	Issue Type +	Ma	Location *	LS
Category	Earthen Levee			GPS Latitude/Longitude	
				Start	End
Item	Vegetation			38.240455 °	38.240455 °
				-121.546362 °	-121.546362 °
DWR ID	DWR_RD0556_02_s_2019_47				
Comment Code					
V7 : Trees / Woody Vegetation					
Inspector Comment					
Remove cactus from the landside slope.

View looking downstream at cactus on the landside slope (Spring 2019).

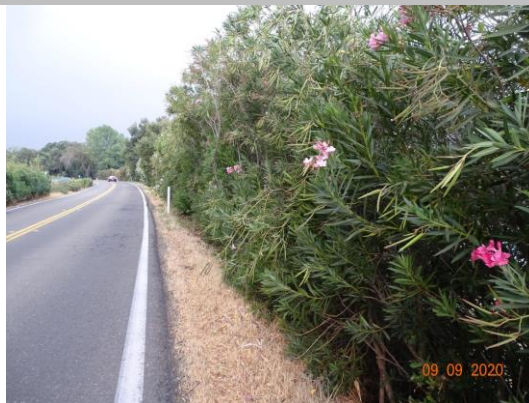
Photo 1 of 1 : FA\_2021\_RD0556\_19\_70\_20210830\_00045.jpg

LM Start	1.82	Rating **	U	Issue No.	70
LM End	1.92	Issue Type +	En	Location *	WS
Category	Earthen Levee			GPS Latitude/Longitude	
				Start	End
Item	Vegetation			38.241010 °	38.240618 °
				-121.551033 °	-121.552747 °
DWR ID	DWR_RD0556_02_f_2018_70				
Comment Code					
V6 : Landscaping					
Inspector Comment					
Thin oleanders to allow view down the levee slope.

View looking downstream at oleanders on the waterside slope (Fall 2020).

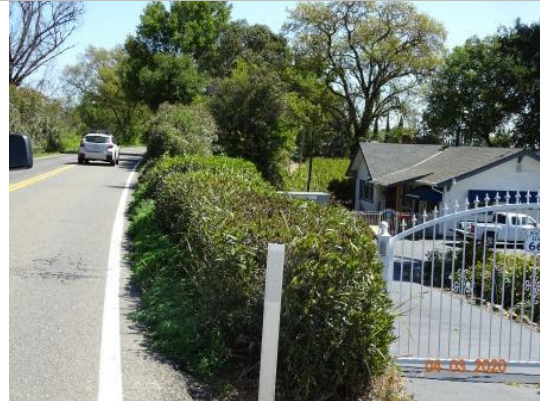
Photo 1 of 1 : FA\_2021\_RD0556\_19\_86\_20210830\_00054.jpg

LM Start	1.83	Rating **	U	Issue No.	86
LM End	1.87	Issue Type +	En	Location *	LS
Category	Earthen Levee			GPS Latitude/Longitude	
				Start	End
Item	Vegetation			38.240944 °	38.240851 °
				-121.551078 °	-121.551833 °
DWR ID	DWR_RD0556_02_s_2020_86				
Comment Code					
V6 : Landscaping					
Inspector Comment

View looking upstream at landscaping on the landside slope (Spring 2020).

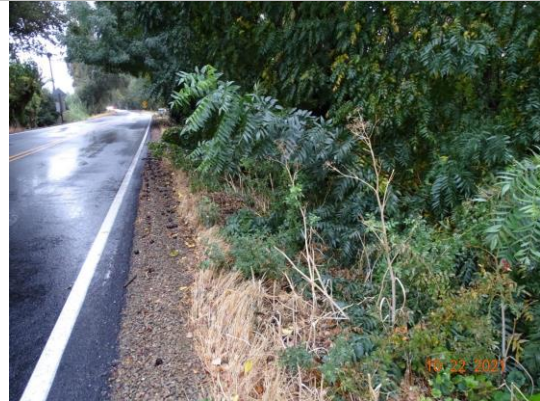
Photo 1 of 1 : FA\_2021\_RD0556\_19\_68\_20211022\_00097.jpg

LM Start	2.02	Rating **	U	Issue No.	68
LM End	2.06	Issue Type +	En	Location *	WS
Category	Earthen Levee			GPS Latitude/Longitude	
				Start	End
Item	Vegetation			38.239807 °	38.239409 °
				-121.554221 °	-121.554889 °
DWR ID	DWR_RD0556_02_f_2021_68				
Comment Code					
V6 : Landscaping					
Inspector Comment

View looking downstream at landscaping on the waterside slope (Fall 2021).

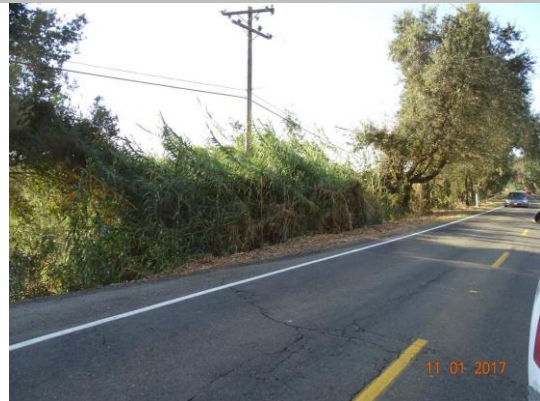
Photo 1 of 1 : FA\_2021\_RD0556\_19\_32\_20210830\_00017.jpg

LM Start	2.06	Rating **	U	Issue No.	32
LM End	2.06	Issue Type +	Ma	Location *	LS
Category	Earthen Levee			GPS Latitude/Longitude	
				Start	End
Item	Vegetation			38.239470 °	38.239470 °
				-121.554845 °	-121.554845 °
DWR ID	DWR_RD0556_02_s_2020_32				
Comment Code					
V7 : Trees / Woody Vegetation					
Inspector Comment					
Arundo growth should be removed to allow inspection and access to the landside slope and toe.

View of arundo on the landside slope and toe.

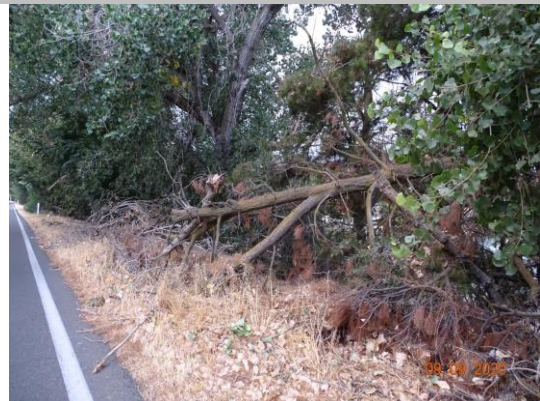
Photo 1 of 1 : FA\_2021\_RD0556\_19\_57\_20210830\_00037.jpg

LM Start	2.12	Rating **	U	Issue No.	57
LM End	2.12	Issue Type +	Ma	Location *	WS
Category	Earthen Levee			GPS Latitude/Longitude	
				Start	End
Item	Encroachments			38.238885 °	38.238885 °
				-121.555597 °	-121.555597 °
DWR ID	DWR_RD0556_02_f_2019_57				
Comment Code					
TR : Tree or limb					
Inspector Comment					
Remove downed tree.

View looking downstream at down tree on waterside shoulder (Fall 2020).

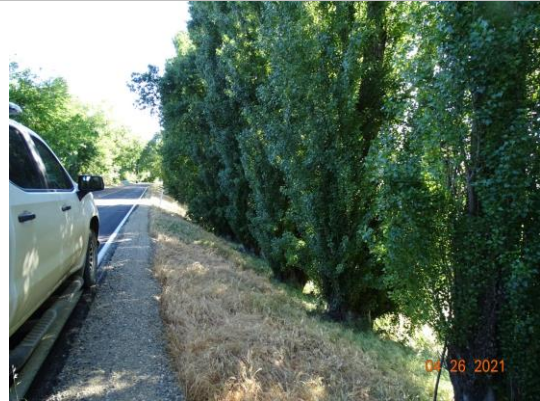
Photo 1 of 1 : FA\_2021\_RD0556\_19\_73\_20210830\_00047.jpg

LM Start	2.13	Rating **	U	Issue No.	73
LM End	2.17	Issue Type +	En	Location *	LS
Category	Earthen Levee			GPS Latitude/Longitude	
				Start	End
Item	Vegetation			38.238760 °	38.238312 °
				-121.555764 °	-121.556357 °
DWR ID	DWR_RD0556_02_s_2021_73				
Comment Code					
V6 : Landscaping					
Inspector Comment

View looking downstream at thick landscaping trees on the landside slope (Spring 2021).

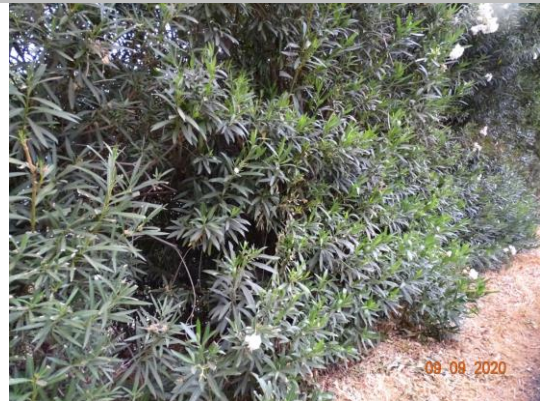
Photo 1 of 1 : FA\_2021\_RD0556\_19\_2\_20210830\_00002.jpg

LM Start	2.14	Rating **	U	Issue No.	2
LM End	2.14	Issue Type +	En	Location *	WS
Category	Earthen Levee			GPS Latitude/Longitude	
				Start	End
Item	Vegetation			38.238644 °	38.238644 °
				-121.555967 °	-121.555967 °
DWR ID	DWR_RD0556_02_f_2020_2				
Comment Code					
V6 : Landscaping					
Inspector Comment					
Trim oleanders on the waterside slope.

View looking upstream oleanders on the waterside slope (Fall 2020).

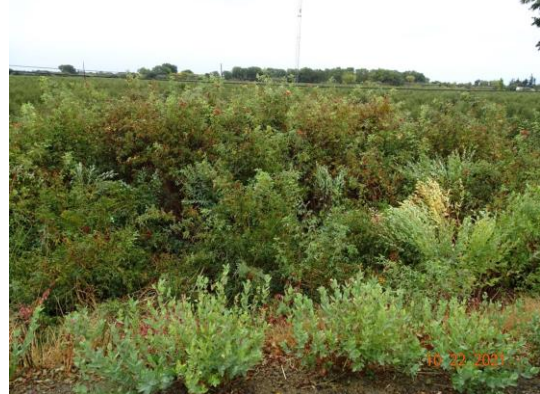
Photo 1 of 1 : FA\_2021\_RD0556\_19\_111\_20211022\_00105.jpg

LM Start	2.23	Rating **	U	Issue No.	111
LM End	2.23	Issue Type +	Ma	Location *	LS
Category	Earthen Levee			GPS Latitude/Longitude	
				Start	End
Item	Vegetation			38.237741 °	38.237741 °
				-121.557062 °	-121.557062 °
DWR ID	DWR_RD0556_02_f_2021_111				
Comment Code					
V2 : Remove the wild growth other than native grasses from the levee slopes.					
Inspector Comment

View of thick vegetation on the landside slope (Fall 2021).

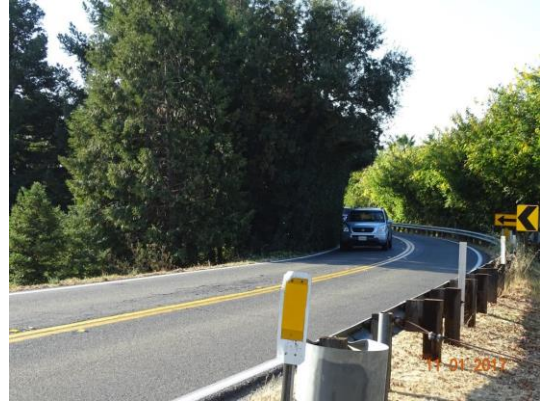
Photo 1 of 1 : FA\_2021\_RD0556\_19\_35\_20210830\_00019.jpg

LM Start	2.29	Rating **	U	Issue No.	35
LM End	2.33	Issue Type +	En	Location *	LS
Category	Earthen Levee			GPS Latitude/Longitude	
				Start	End
Item	Vegetation			38.237060 °	38.236545 °
				-121.557782 °	-121.557910 °
DWR ID	DWR_RD0556_02_f_2017_35				
Comment Code					
V6 : Landscaping					
Inspector Comment					
Trim/thin oleanders to allow inspection and access to landside slope and toe.

View of oleanders on the landside slope and toe.

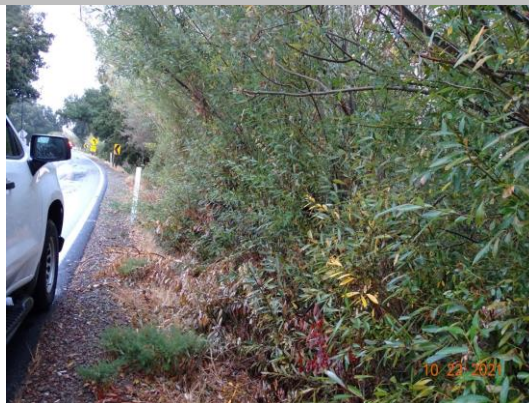
Photo 1 of 1 : FA\_2021\_RD0556\_19\_89\_20211022\_00098.jpg

LM Start	2.39	Rating **	U	Issue No.	89
LM End	2.39	Issue Type +	Ma	Location *	WS
Category	Earthen Levee			GPS Latitude/Longitude	
				Start	End
Item	Trim / Thin Trees			38.235578 °	38.235578 °
				-121.558105 °	-121.558105 °
DWR ID	DWR_RD0556_02_f_2021_89				
Comment Code					
T2 : Thin trees to allow visibility of the ground and room to flood fight.					
Inspector Comment

View looking downstream at thick trees on the landside slope (Fall 2021).

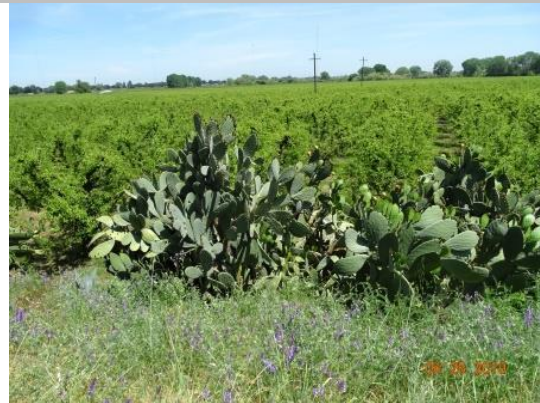
Photo 1 of 1 : FA\_2021\_RD0556\_19\_45\_20210830\_00026.jpg

LM Start	2.43	Rating **	U	Issue No.	45
LM End	2.45	Issue Type +	Ma	Location *	LS
Category	Earthen Levee			GPS Latitude/Longitude	
				Start	End
Item	Vegetation			38.235036 °	38.234721 °
				-121.558011 °	-121.557952 °
DWR ID	DWR_RD0556_02_s_2019_45				
Comment Code					
V7 : Trees / Woody Vegetation					
Inspector Comment					
Remove cactus from the landside slope.

View of cactus on the landside slope (Spring 2019).

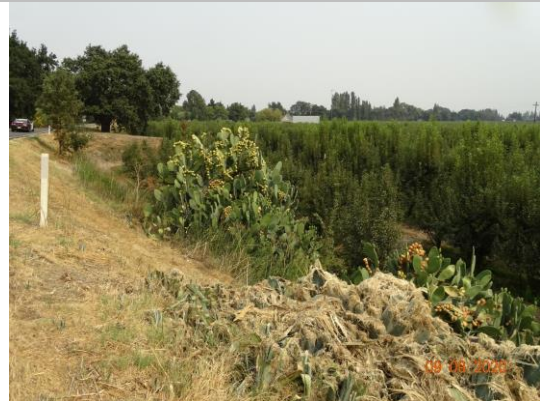
Photo 1 of 1 : FA\_2021\_RD0556\_19\_76\_20210830\_00049.jpg

LM Start	2.54	Rating **	U	Issue No.	76
LM End	2.54	Issue Type +	Ma	Location *	LS
Category	Earthen Levee			GPS Latitude/Longitude	
				Start	End
Item	Vegetation			38.233487 °	38.233487 °
				-121.557639 °	-121.557639 °
DWR ID	DWR_RD0556_02_s_2020_76				
Comment Code					
V7 : Trees / Woody Vegetation					
Inspector Comment					
Remove cactus on the landside toe.

View of large cactus on the landside slope (Fall 2020).

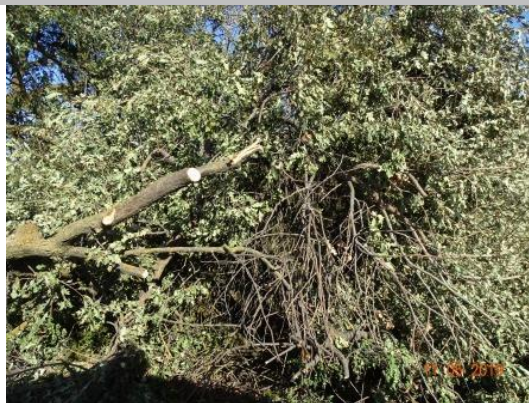
Photo 1 of 1 : FA\_2021\_RD0556\_19\_88\_20210830\_00056.jpg

LM Start	2.75	Rating **	U	Issue No.	88
LM End	2.75	Issue Type +	Ma	Location *	LS
Category	Earthen Levee			GPS Latitude/Longitude	
				Start	End
Item	Encroachments			38.230752 °	38.230752 °
				-121.556007 °	-121.556007 °
DWR ID	DWR_RD0556_02_f_2019_88				
Comment Code					
TR : Tree or limb					
Inspector Comment					
Broken tree limb blocking view of landside slope.

View of broken tree limb blocking the view of the landside slope (Fall 2019).

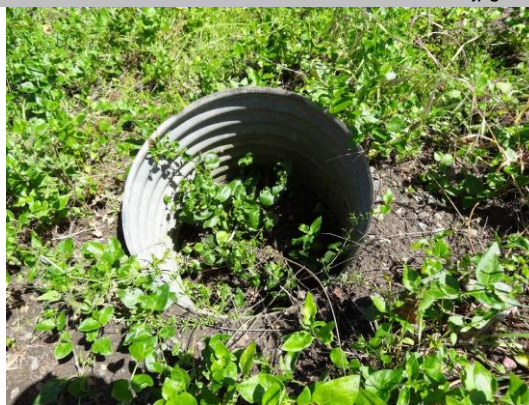
Photo 2 of 3 : UCIP\_FA\_2021\_41713\_20283.jpg

Comment Code						
Inspector Comment						
DS_ID:20849 FS_ID:41713 EP_NO: 11181 Repair Type: Non-Urgent EVAL Issue: Crossing Status: Found UCIP Comments: - Needs to clean siphon breaker CMP riser. FIELD_STRUCT_DESC: 6-inch irrigation discharge pipe of an unknown material through the levee, 6 feet below the crown. Pressure tank in a pump house on the waterside (WS) berm. Service pole, siphon breaker, and distribution box on the landside (LS) slope. (Retention of a 6-inch pipe through the levee, 6 feet below the crown; a pump, a gate valve, and a pressure tank on the WS berm; and a service pole on the LS slope authorized under Automatic Board Order (ABO) issued as Permit No. 11181, 1975 - Robert E. and G. P. Collins). [Additional Reference(s): DWR Levee Log]. FS Date: 4/25/2013

LS- siphon breaker in CMP riser on levee slope.

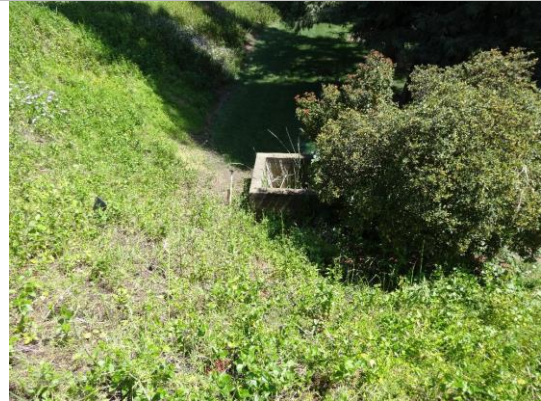
Photo 3 of 3 : UCIP\_FA\_2021\_41713\_20282.jpg

LM Start	<b>2.84</b>	Rating **	M	Issue No.	<b>124 (cont)</b>
LM End	<b>2.84</b>	Issue Type +	En	Location *	
Category	Supplemental			GPS Latitude/Longitude	
				Start	End
Item	DWR UCIP Field Study			38.229524 °	38.229524 °
				-121.555404 °	-121.555404 °
DWR ID	20849

LS- concrete distribution box near toe of the levee

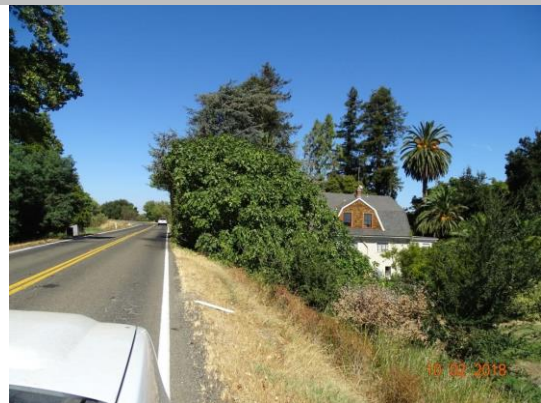
Photo 1 of 1 : FA\_2021\_RD0556\_19\_46\_20210830\_00027.jpg

LM Start	2.86	Rating **	U	Issue No.	46
LM End	2.87	Issue Type +	En	Location *	LS
Category	Earthen Levee			GPS Latitude/Longitude	
				Start	End
Item	Vegetation			38.229195 °	38.229082 °
				-121.555337 °	-121.555316 °
DWR ID	DWR_RD0556_02_f_2019_46				
Comment Code					
V6 : Landscaping					
Inspector Comment

View looking upstream at beginning of landscaping on landside (October 2018).

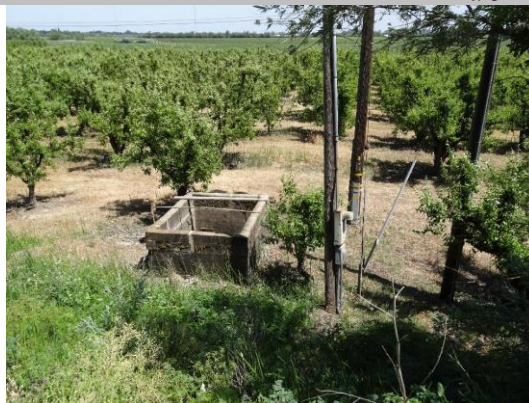
Photo 3 of 3 : UCIP\_FA\_2021\_12525\_20288.jpg

LM Start	<b>3.07</b>	Rating **	M	Issue No.	<b>125 (cont)</b>
LM End	<b>3.07</b>	Issue Type +	En	Location *	
Category	Supplemental		GPS Latitude/Longitude		
			Start	End	
Item	DWR UCIP Field Study		38.226225 °	38.226225 °	
			-121.555236 °	-121.555236 °	
DWR ID	20862

LS- a concrete spill box on landside of the levee.

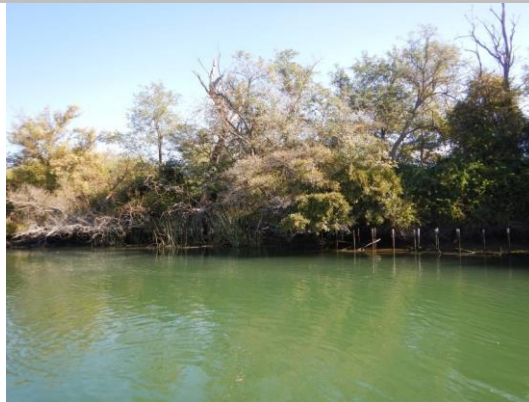
Photo 2 of 2 : FA\_2021\_RD0556\_19\_17\_20211218\_58.jpg

2018 Site ID: SAC 23.2 L  
 Status: Eroding  
 2018 Field Notes: Additional tree popouts and new erosion throughout site.  
 Site History: 2000 - Recently fallen cottonwood at the downstream end.  
 2005 - Empty brush boxes. 2011 - A few trees have fallen since last year. 2012 - Potential new tree popout since last year. 2013 - New erosion at downstream end of site and a recent tree pop-out observed.  
 2016 - New erosion at the toe. 2017 - New erosion along lower bank.

USACE 2018 Erosion Photo #2

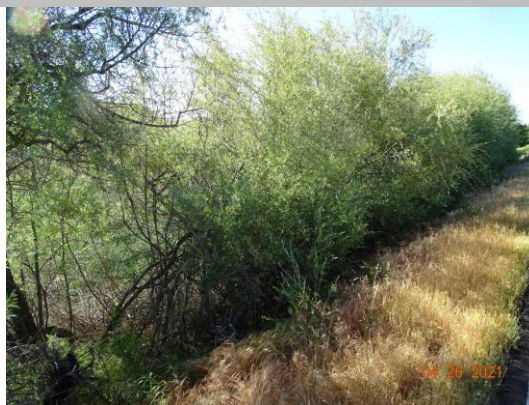
Photo 1 of 1 : FA\_2021\_RD0556\_19\_61\_20210830\_00040.jpg

LM Start	3.24	Rating **	U	Issue No.	61
LM End	3.26	Issue Type +	Ma	Location *	LS
Category	Earthen Levee			GPS Latitude/Longitude	
				Start	End
Item	Vegetation			38.223707 °	38.223457 °
				-121.555396 °	-121.555414 °
DWR ID	DWR_RD0556_02_s_2021_61				
Comment Code					
V7 : Trees / Woody Vegetation					
Inspector Comment

View looking downstream at willows on the landside slope (Spring 2021).

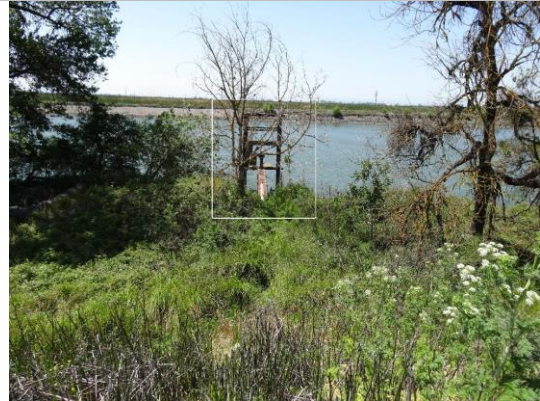
Photo 1 of 3 : UCIP\_FA\_2021\_12527\_20297.jpg

DS\_ID:20863  
FS\_ID:12527  
EP\_NO: 11181  
Repair Type: Non-Urgent  
EVAL Issue:  
Crossing Status: Found  
UCIP Comments: - needs to fix siphon breaker  
FIELD\_STRUCT\_DESC: 10-inch steel irrigation discharge pipe through the levee, 4.8 feet below the crown. Steel walkway to the pump on a pile structure in the river. Siphon breaker on the waterside (WS). Service pole on the landside (LS) slope. Concrete spill box with two 15-inch openings on the LS. (Retention of a 10-inch pipe through the levee, 4.8 feet below the crown, a steel walkway to the pump on a pile structure in the river, and a siphon breaker and a service pole on the LS slope authorized under Automatic Board Order (ABO) issued as Permit No. 11181, 1975 - Robert E. and G. P. Collins). [Additional Reference(s): DWR Levee Log. USACE Sacramento O&M Manual 103, June 1954, (Station ""J"" 58+00), invert elevation 18.2 feet].  
FS Date: 4/25/2013

WS- pump, pipe, and walkway on steel structure in the stream.

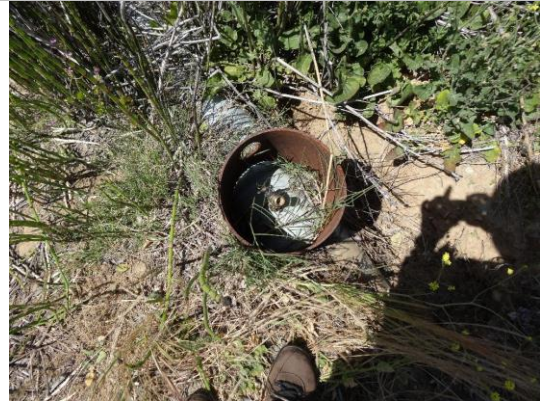
Photo 3 of 3 : UCIP\_FA\_2021\_12527\_20295.jpg

WS- siphon breaker on levee slope.

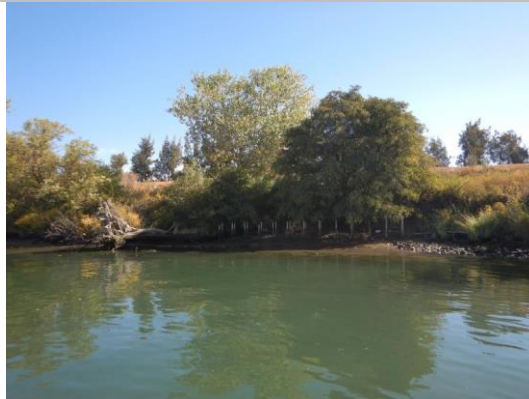
Photo 2 of 2 : FA\_2021\_RD0556\_19\_16\_20211218\_9.jpg

LM Start	3.58	Rating **	M	Issue No.	16
LM End	3.64	Issue Type +	Ma	Location *	WS
Category	Supplemental			GPS Latitude/Longitude	
				Start	End
Item	2018 USACE Erosion Survey			38.218951 °	38.218104 °
				-121.556689 °	-121.556819 °
DWR ID					
Comment Code					
Inspector Comment					
2018 Site ID: SAC 22.7 L					
Status: Eroding					
2018 Field Notes: No observed change.					
Site History: 1997 - Scallops into berm and very close to levee toe.					
2005 - Brush boxes present. 2011 - New toe scour and freshly fallen tree. 2012 - New tree popout has taken significant portion of soil out of the levee. 2017 - Minor new erosion at toe.

USACE 2018 Erosion Photo #2

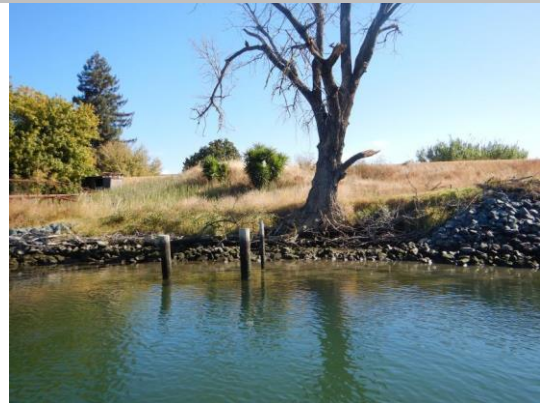
Photo 1 of 2 : FA\_2021\_RD0556\_19\_15\_20211218\_6.jpg

LM Start	3.95	Rating **	M	Issue No.	15
LM End	4.12	Issue Type +	Ma	Location *	WS
Category	Supplemental			GPS Latitude/Longitude	
				Start	End
Item	2018 USACE Erosion Survey			38.213581 °	38.211112 °
				-121.557197 °	-121.557042 °
DWR ID					
Comment Code					
Inspector Comment					
2018 Site ID: SAC 22.5 L Status: Eroding 2018 Field Notes: Minor new erosion at toe. Site History: 2002 - Spot rock along berm, but not in the erosion pockets. 2005 - Some new minor stone revetment at the upstream end. Brush boxes present. 2006 - Currently installing new brush in downstream brush boxes. 2007 - Rock in middle portion for about 150 ft. 2010 - Some attempt at repairs but still has pockets of erosion. 2012 - More erosion along the toe. 2017 - New lower bank erosion at the upstream end. Locals placed rock in some erosion pockets.

USACE 2018 Erosion Photo #1

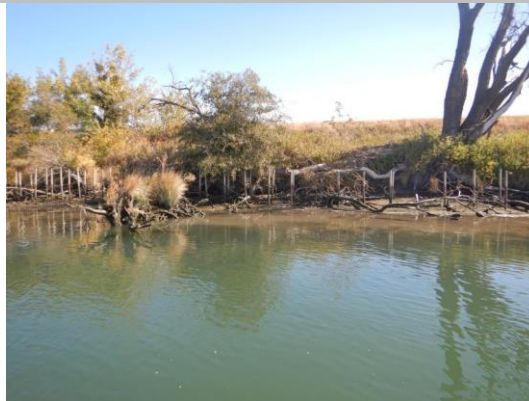
Photo 2 of 2 : FA\_2021\_RD0556\_19\_15\_20211218\_7.jpg

USACE 2018 Erosion Photo #2

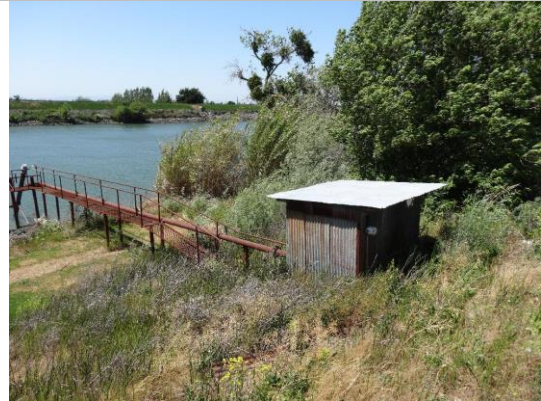
Photo 1 of 3 : UCIP\_FA\_2021\_12543\_20302.jpg

Comment Code					
Inspector Comment					
DS_ID:20864 FS_ID:12543 EP_NO: 11197 Repair Type: Non-Urgent EVAL Issue: Crossing Status: Found UCIP Comments: Electric control panel in pump house.Needs cleaning of CMP riser on landside. FIELD_STRUCT_DESC: 6-inch steel irrigation discharge pipe through the levee, 6.5 feet below the crown. Slant pump on a steel pile structure in the river. Walkway to the pump. Gate valve in a pump house on the waterside (WS) slope. Siphon breaker and service poles on the landside (LS) slope. Concrete standpipe on the LS. (Retention of a 6-inch pipe through the levee, 6.5 feet below the crown, a pump and a gate valve in a pump house on the WS slope, and a siphon breaker and a service pole on the LS slope authorized under Automatic Board Order (ABO) issued as Permit No. 11197, 1975 - Richard T. and Mary B. Souza). [Additional Reference(s): DWR Levee Log. USACE Sacramento O&M Manual 103, June 1954, (Station ""J"" 32+40), invert elevation 18.1 feet]. FS Date: 4/25/2013

WS- pipe and pump on steel pile structure. Steel walkway from pump house to the pump on steel structure.

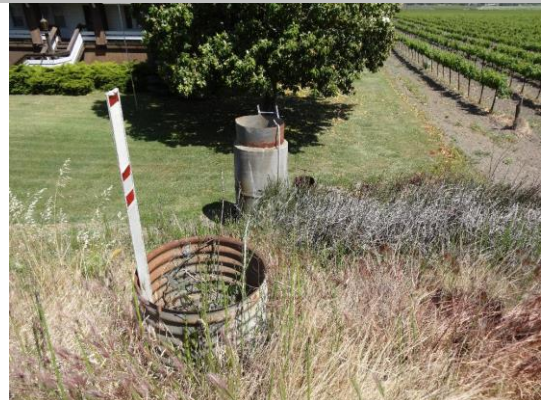
Photo 2 of 3 : UCIP\_FA\_2021\_12543\_20301.jpg

LS- siphon breaker in CMP riser and concrete standpipe behind CMP riser.

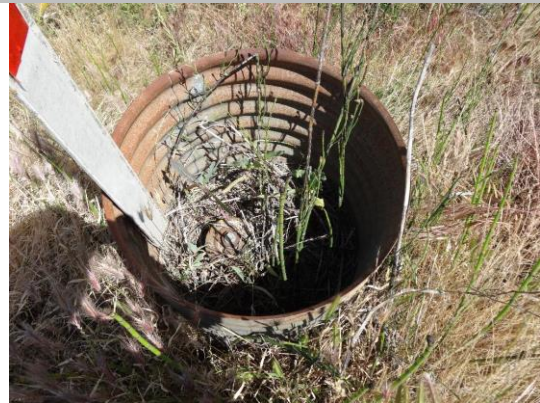
Photo 3 of 3 : UCIP\_FA\_2021\_12543\_20300.jpg

LS- siphon breaker in CMP riser. It needs cleaning.

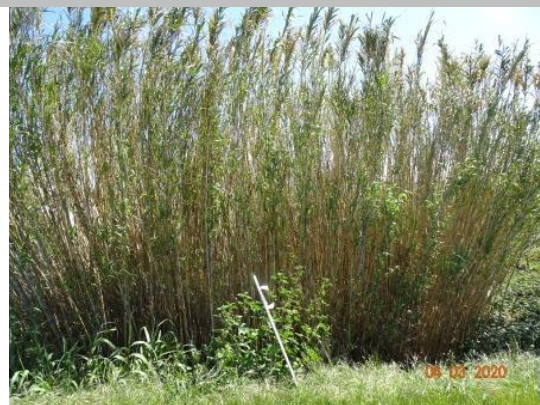
Photo 1 of 1 : FA\_2021\_RD0556\_19\_71\_20210830\_00046.jpg

LM Start	4.01	Rating **	U	Issue No.	71
LM End	4.01	Issue Type +	Ma	Location *	LS
Category	Earthen Levee			GPS Latitude/Longitude	
				Start	End
Item	Vegetation			38.212672 °	38.212672 °
				-121.556759 °	-121.556759 °
DWR ID	DWR_RD0556_02_s_2020_71				
Comment Code					
V7 : Trees / Woody Vegetation					
Inspector Comment					
Arundo on the landside slope.

View of thick arundo on the landside slope (Spring 2020).

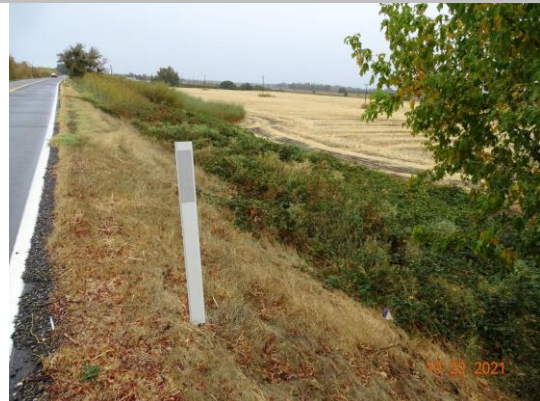
Photo 1 of 1 : FA\_2021\_RD0556\_19\_105\_20211022\_00104.jpg

LM Start	4.13	Rating **	U	Issue No.	105
LM End	4.32	Issue Type +	Ma	Location *	LS
Category	Earthen Levee			GPS Latitude/Longitude	
				Start	End
Item	Vegetation			38.210922 °	38.208171 °
				-121.556735 °	-121.556800 °
DWR ID	DWR_RD0556_02_f_2021_105				
Comment Code					
V2 : Remove the wild growth other than native grasses from the levee slopes.					
Inspector Comment

View looking upstream at thick vegetation on the landside slope (Fall 2021).

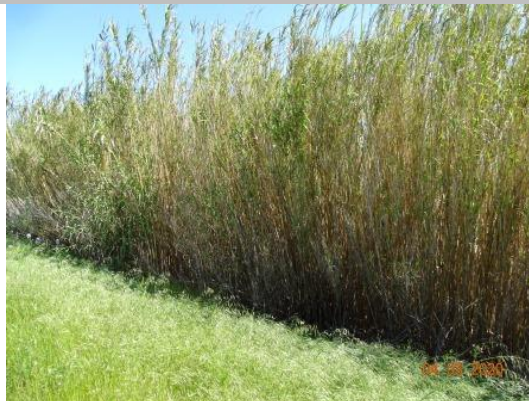
Photo 1 of 1 : FA\_2021\_RD0556\_19\_51\_20210830\_00031.jpg

LM Start	4.22	Rating **	U	Issue No.	51
LM End	4.33	Issue Type +	Ma	Location *	LS
Category	Earthen Levee			GPS Latitude/Longitude	
				Start	End
Item	Vegetation			38.209629 °	38.208062 °
				-121.556757 °	-121.556807 °
DWR ID	DWR_RD0556_02_s_2020_51				
Comment Code					
V7 : Trees / Woody Vegetation					
Inspector Comment					
Remove arundo from landside slope and willows on the landside toe.

View of thick arundo on the landside slope (Spring 2020).

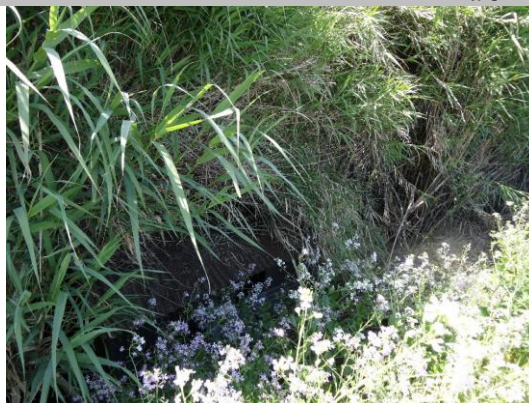
Photo 1 of 3 : UCIP\_FA\_2021\_12545\_20310.jpg

Comment Code						
Inspector Comment						
DS_ID:20865 FS_ID:12545 EP_NO: 11194 Repair Type: Non-Urgent EVAL Issue: Crossing Status: Found UCIP Comments: - CMP riser found abandoned on LS slope. Due to dense vegetation siphon breaker could not be found.- Dense vegetation on both sides of the levee.- Oil leaks from pump set. FIELD_STRUCT_DESC: 8-inch steel irrigation discharge pipe through the levee, 6.7 feet below the crown. Pump and gate valve in a pump house on the waterside (WS) slope. Siphon breaker on the landside (LS) slope. (Retention of an 8-inch pipe through the levee, 6.7 feet below the crown, a pump and a gate valve in a pump house on the WS slope, and a siphon breaker on the LS slope authorized under Automatic Board Order (ABO) issued as Permit No. 11194, 1975 - Gerald E. and William M. Robinson, et al.). [Additional Reference(s): DWR Levee Log. USACE Sacramento O&M Manual 103, June 1954, (Station ""J"" 18+20), invert elevation 18 feet]. FS Date: 4/25/2013

WS- pump house not visible due to the dense vegetation.

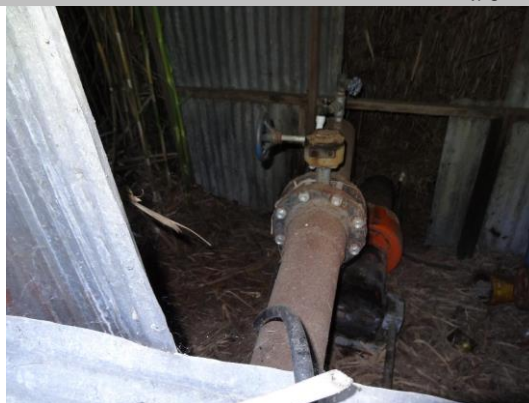
Photo 3 of 3 : UCIP\_FA\_2021\_12545\_20308.jpg

WS- pump, gate valve and pipe in pump house.

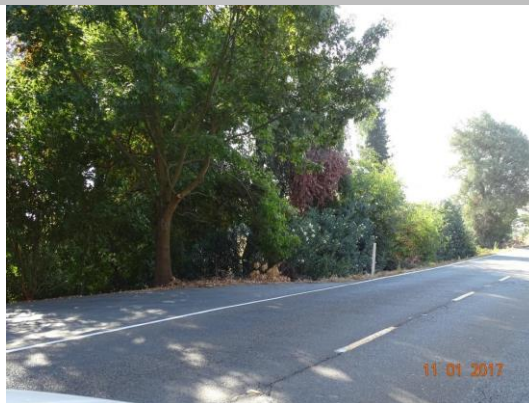
Photo 1 of 1 : FA\_2021\_RD0556\_19\_36\_20210830\_00020.jpg

LM Start	4.41	Rating **	U	Issue No.	36
LM End	4.44	Issue Type +	En	Location *	LS
Category	Earthen Levee			GPS Latitude/Longitude	
				Start	End
Item	Vegetation			38.206832 °	38.206418 °
				-121.556783 °	-121.556770 °
DWR ID	DWR_RD0556_02_f_2017_36				
Comment Code					
V6 : Landscaping					
Inspector Comment					
Oleanders, trees, and other landscaping should be trimmed to allow inspection and access to the landside slope and toe.

View of landscaping on the landside.

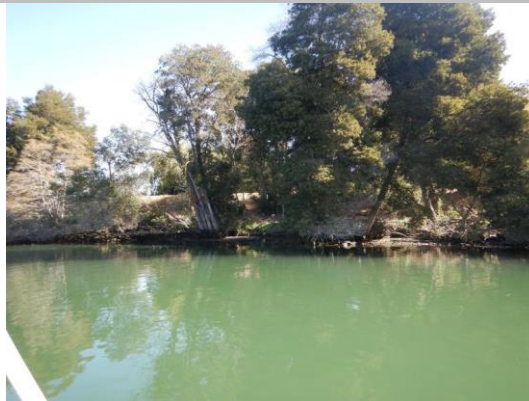
Photo 1 of 2 : FA\_2021\_RD0556\_19\_14\_20211218\_4.jpg

LM Start	4.44	Rating **	M	Issue No.	14
LM End	4.49	Issue Type +	Ma	Location *	WS
Category	Supplemental			GPS Latitude/Longitude	
				Start	End
Item	2018 USACE Erosion Survey			38.206377 °	38.205729 °
				-121.557184 °	-121.557108 °
DWR ID					
Comment Code					
Inspector Comment					
2018 Site ID: SAC 21.9 L					
Status: Eroding					
2018 Field Notes: No observed change.					
Site History: 2013 - Erosion pockets encroaching on levee foundation.

USACE 2018 Erosion Photo #1

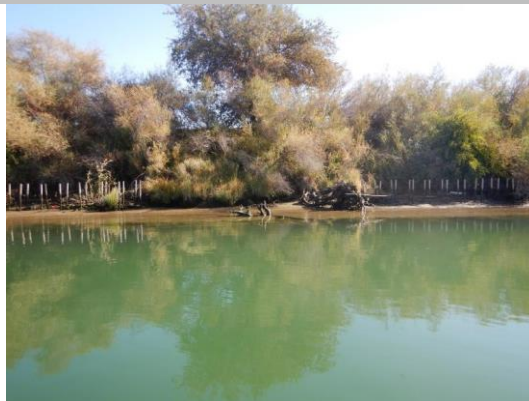
Photo 2 of 2 : FA\_2021\_RD0556\_19\_14\_20211218\_5.jpg

USACE 2018 Erosion Photo #2

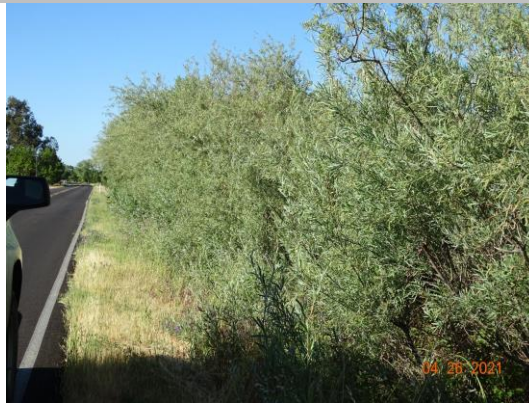
Photo 1 of 1 : FA\_2021\_RD0556\_19\_67\_20210830\_00044.jpg

LM Start	4.46	Rating **	U	Issue No.	67
LM End	4.47	Issue Type +	Ma	Location *	WS
Category	Earthen Levee			GPS Latitude/Longitude	
				Start	End
Item	Vegetation			38.206205 °	38.205968 °
				-121.556820 °	-121.556820 °
DWR ID	DWR_RD0556_02_s_2021_67				
Comment Code					
V7 : Trees / Woody Vegetation					
Inspector Comment

View looking downstream at willows on the waterside slope (Spring 2021).

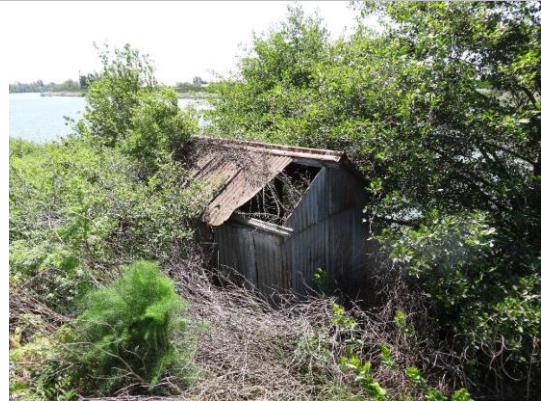
Photo 1 of 3 : UCIP\_FA\_2021\_12546\_20314.jpg

Comment Code						
Inspector Comment						
DS_ID:20866 FS_ID:12546 EP_NO: 11940 Repair Type: Non-Urgent EVAL Issue: Crossing Status: Found UCIP Comments: - Abandoned crossing.- Siphon breaker on LS not found due to dense vegetation, - An abandoned CMP riser and service pole found on LS.- It may need to be properly abandoned. FIELD_STRUCT_DESC: *ABANDONED* 6-inch steel irrigation discharge pipe through the levee, 6.7 feet below the crown. Pump and gate valve in a pump house on the waterside (WS) slope. Siphon breaker and service pole on the landside (LS) slope. (Retention of a 6-inch pipe through the levee, 6.5 feet below the crown, a pump and a gate valve in a pump house on the WS slope, and a siphon breaker and a service pole on the LS slope authorized under Automatic Board Order (ABO) issued as Permit No. 11194, 1975 - Gerald E. and William M. Robinson, et al.). [Additional Reference(s): DWR Levee Log. USACE Sacramento O&M Manual 103, June 1954, (Station ""J"" 2+73), invert elevation 18 feet]. FS Date: 4/25/2013

WS- abandoned pump house on levee slope. Dense vegetation on levee slope.

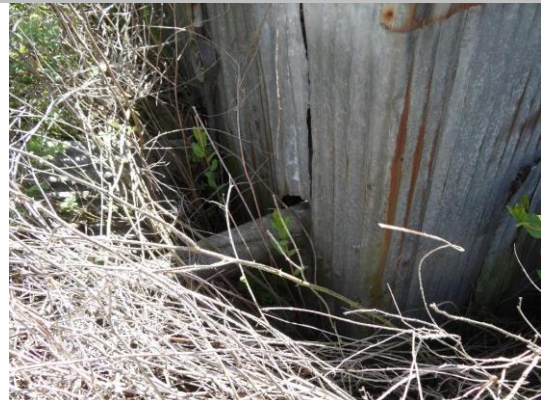
Photo 2 of 3 : UCIP\_FA\_2021\_12546\_20313.jpg

WS- pipe daylight from levee slope to pump house.

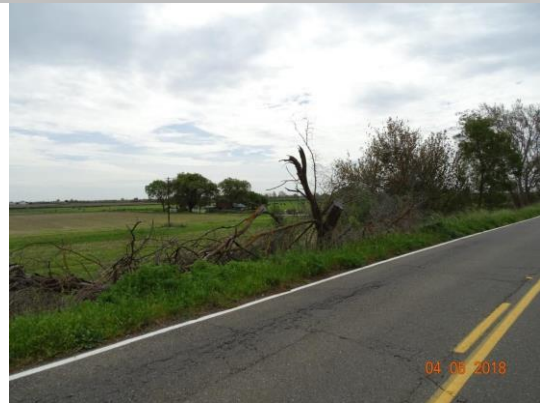
Photo 1 of 1 : FA\_2021\_RD0556\_19\_56\_20210830\_00036.jpg

LM Start	4.57	Rating **	U	Issue No.	56
LM End	4.57	Issue Type +	Ma	Location *	LS
Category	Earthen Levee			GPS Latitude/Longitude	
				Start	End
Item	Encroachments			38.204558 °	38.204544 °
				-121.556773 °	-121.556769 °
DWR ID	DWR_RD0556_02_s_2018_56				
Comment Code					
TR : Tree or limb					
Inspector Comment					
Remove dead tree/limb from the landside.

Fallen tree on landside should be removed.

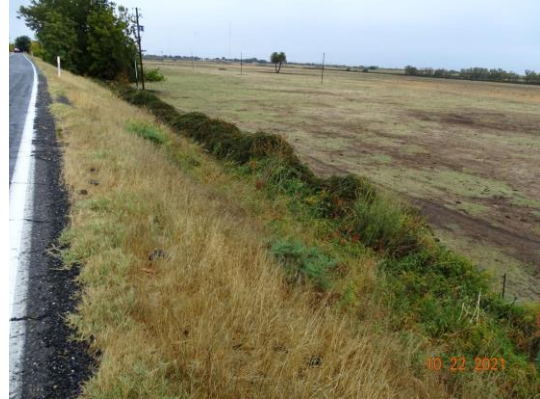
Photo 1 of 1 : FA\_2021\_RD0556\_19\_102\_20211022\_00102.jpg

LM Start	4.62	Rating **	U	Issue No.	102
LM End	4.99	Issue Type +	Ma	Location *	LS
Category	Earthen Levee			GPS Latitude/Longitude	
				Start	End
Item	Vegetation			38.203902 °	38.198631 °
				-121.556775 °	-121.558196 °
DWR ID	DWR_RD0556_02_f_2021_102				
Comment Code					
V2 : Remove the wild growth other than native grasses from the levee slopes.					
Inspector Comment					
Blackberries on the landside slope.

View looking upstream at blackberries on the landside slope (Fall 2021).

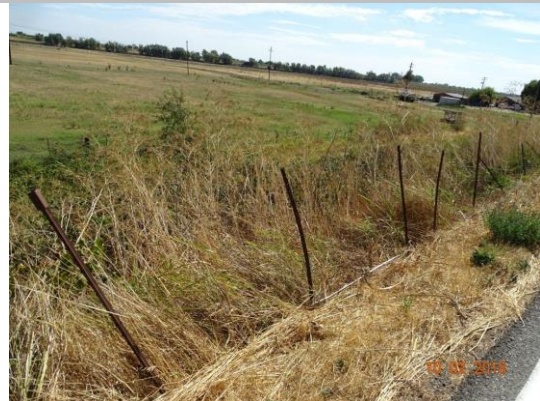
Photo 1 of 1 : FA\_2021\_RD0556\_19\_38\_20210830\_00022.jpg

LM Start	4.63	Rating **	M	Issue No.	38
LM End	4.84	Issue Type +	En	Location *	LS
Category	Earthen Levee			GPS Latitude/Longitude	
				Start	End
Item	Encroachments			38.203693 °	38.200593 °
				-121.556683 °	-121.557208 °
DWR ID	DWR_RD0556_02_s_2012_38				
Comment Code					
FE : Fence					
Inspector Comment					
Remove this old fence from the levee section landside.

View of old fence posts on landside slope (October 2018).

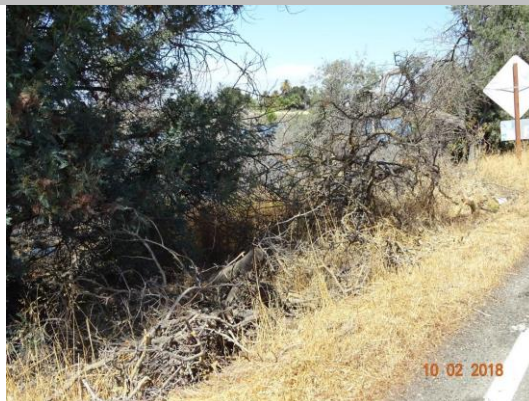
Photo 1 of 1 : FA\_2021\_RD0556\_19\_27\_20210830\_00013.jpg

LM Start	4.65	Rating **	M	Issue No.	27
LM End	4.65	Issue Type +	Ma	Location *	WS
Category	Earthen Levee			GPS Latitude/Longitude	
				Start	End
Item	Encroachments			38.203425 °	38.203425 °
				-121.556845 °	-121.556845 °
DWR ID	DWR_RD0556_02_s_2017_27				
Comment Code					
TR : Tree or limb					
Inspector Comment					
Remove fallen tree from waterside slope.

View of fallen tree on the waterside slope (October 2018).

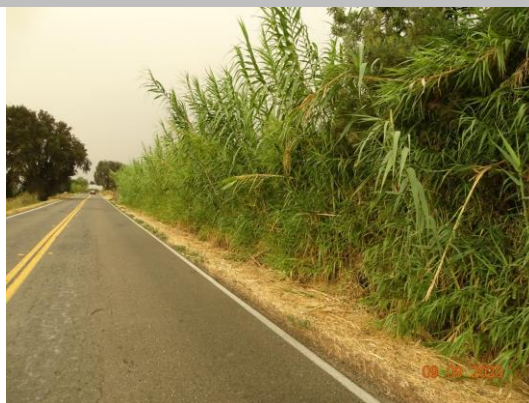
Photo 1 of 1 : FA\_2021\_RD0556\_19\_3\_20210830\_00003.jpg

LM Start	4.68	Rating **	U	Issue No.	3
LM End	4.72	Issue Type +	Ma	Location *	WS
Category	Earthen Levee			GPS Latitude/Longitude	
				Start	End
Item	Vegetation			38.202942 °	38.202431 °
				-121.556870 °	-121.556960 °
DWR ID	DWR_RD0556_02_f_2020_3				
Comment Code					
V7 : Trees / Woody Vegetation					
Inspector Comment					
Cut arundo back 20' from waterside slope.

View of looking downstream at arundo on the waterside slope (Fall 2020).

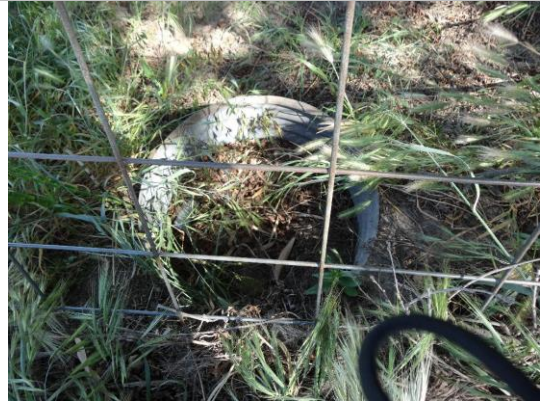
Photo 1 of 3 : UCIP\_FA\_2021\_12547\_20320.jpg

Comment Code					
Inspector Comment					
DS_ID:20867 FS_ID:12547 EP_NO: 11199 Repair Type: Non-Urgent EVAL Issue: Crossing Status: Indicator Found UCIP Comments: - pump, gate valve and pumphouse not found on waterward slope.- an abandoned electric control panel found on WS.- may need to be properly abandoned. FIELD_STRUCT_DESC: 6-inch steel irrigation discharge pipe through the levee, 6.5 feet below the crown. Siphon and concrete spill box with two 8-inch openings. (Retention of a 6-inch pipe through the levee, 6.5 feet below the crown, a pump and a gate valve in a pump house on the waterside [WS] slope, and a siphon breaker and a service pole on the landside [LS] slope authorized under Automatic Board Order (ABO) issued as Permit No. 11199, 1975 - Toshi Tokuyoshi, et al.). [Additional Reference(s): DWR Levee Log. USACE Sacramento O&M Manual 103, June 1954, (Station ""H"" 159+97), invert elevation 17.9 feet]. FS Date: 4/25/2013

LS- obstructed siphon breaker in CMP riser on levee slope.
