## Flood Control Project Maintenance Levee Inspections

### Fall 2021 Levee Maintenance Deficiency Summary Report

#### Sacramento River Basin

**Reclamation District No. 0556 Upper Andrus**

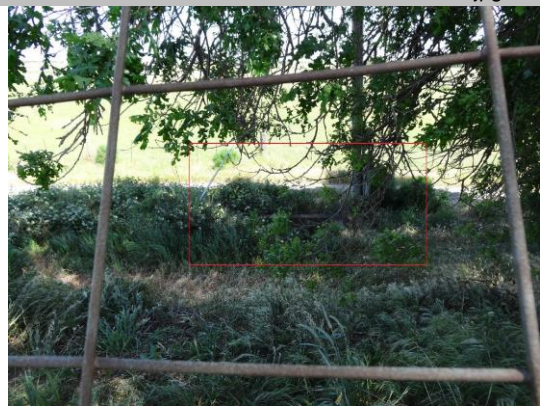
Photo 2 of 3 : UCIP\_FA\_2021\_12547\_20319.jpg

LS- concrete distribution box near levee toe.

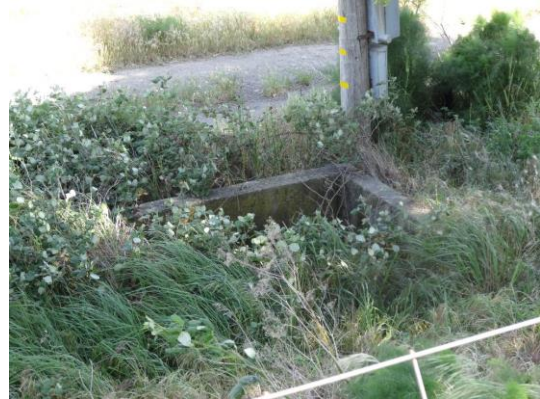
Photo 3 of 3 : UCIP\_FA\_2021\_12547\_20318.jpg

LS- power pole and a concrete distribution box near levee toe.

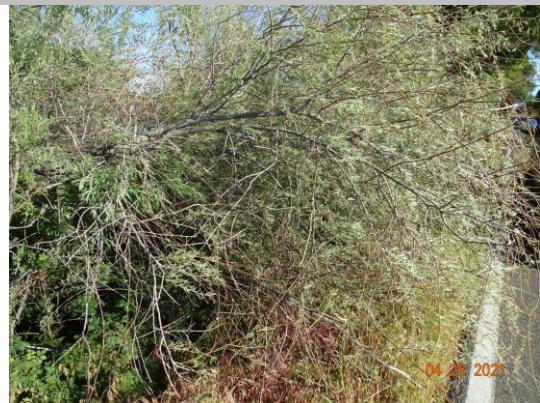
Photo 1 of 1 : FA\_2021\_RD0556\_19\_66\_20210830\_00043.jpg

LM Start	4.85	Rating **	U	Issue No.	66
LM End	4.87	Issue Type +	Ma	Location *	WS
Category	Earthen Levee			GPS Latitude/Longitude	
				Start	End
Item	Vegetation			38.200543 °	38.200246 °
				-121.557286 °	-121.557380 °
DWR ID	DWR_RD0556_02_s_2021_66				
Comment Code					
V7 : Trees / Woody Vegetation					
Inspector Comment

View looking upstream at willows on the waterside slope (Spring 2021).

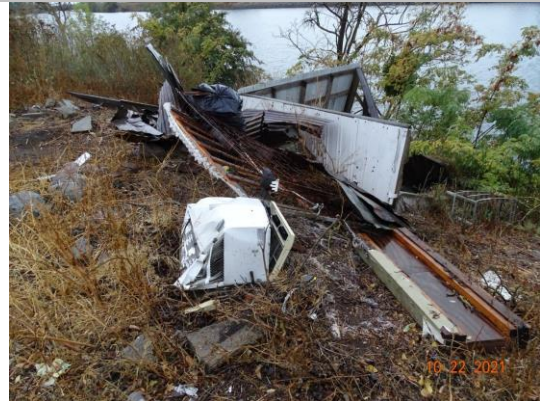
Photo 1 of 1 : FA\_2021\_RD0556\_19\_95\_20211022\_00101.jpg

LM Start	4.95	Rating **	U	Issue No.	95
LM End	4.95	Issue Type +	Ma	Location *	WS
Category	Earthen Levee			GPS Latitude/Longitude	
				Start	End
Item	Encroachments			38.199147 °	38.199147 °
				-121.557965 °	-121.557965 °
DWR ID	DWR_RD0556_02_f_2021_95				
Comment Code					
GA : Garbage					
Inspector Comment					
Remove garbage on the waterside slope.

View of garbage on the waterside slope (Fall 2021).

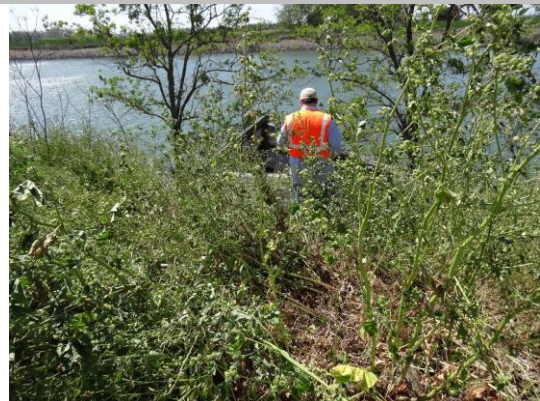
Photo 1 of 3 : UCIP\_FA\_2021\_12564\_20347.jpg

Comment Code					
Inspector Comment					
DS_ID:20868 FS_ID:12564 EP_NO: 11191 Repair Type: Non-Urgent EVAL Issue: Crossing Status: Found UCIP Comments: - needs to fix CMP riser. FIELD_STRUCT_DESC: 8-inch irrigation discharge pipe of an unknown material through the levee, 5.7 feet below the crown. Pump on the waterside (WS) slope. Gate valve on the WS berm. Siphon breaker and service pole on the landside (LS) slope. (Retention of an 8-inch pipe through the levee, 5.7 feet below the crown, a pump on the WS slope, a gate valve on the WS berm, and a siphon breaker and a service pole on the LS slope authorized under Automatic Board Order (ABO) issued as Permit No. 11191, 1975 - Pacific Fruit Exchange). [Additional Reference(s): DWR Levee Log]. FS Date: 4/25/2013

WS- pump house on levee slope.

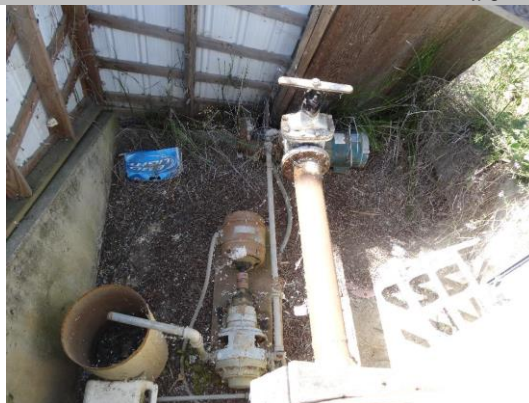
Photo 2 of 3 : UCIP\_FA\_2021\_12564\_20346.jpg

WS- pump, pipe and gate valve in pump house.

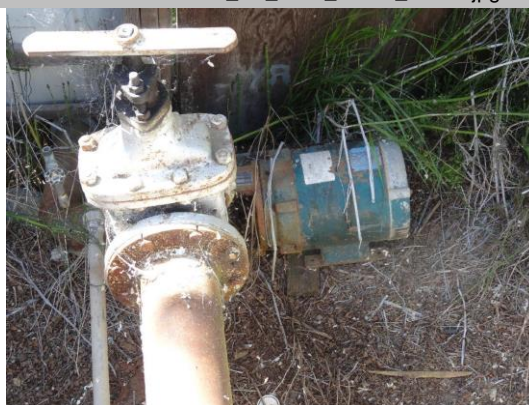
Photo 3 of 3 : UCIP\_FA\_2021\_12564\_20351.jpg

WS- closer look at pump, pipe and gate valve in pump house.

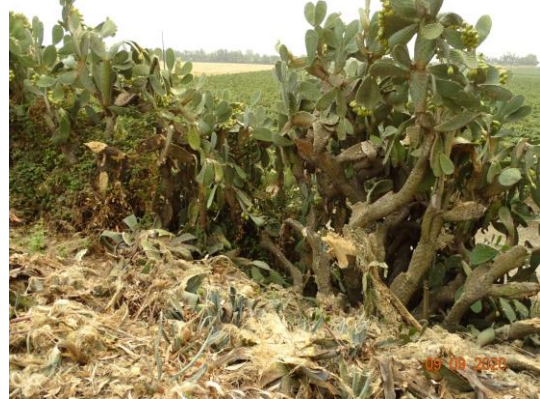
Photo 1 of 1 : FA\_2021\_RD0556\_19\_37\_20210830\_00021.jpg

LM Start	5.08	Rating **	U	Issue No.	37
LM End	5.16	Issue Type +	Ma	Location *	LS
Category	Earthen Levee			GPS Latitude/Longitude	
				Start	End
Item	Vegetation			38.197407 °	38.196388 °
				-121.558950 °	-121.559558 °
DWR ID	DWR_RD0556_02_f_2017_37				
Comment Code					
V7 : Trees / Woody Vegetation					
Inspector Comment					
Remove large cactus partway down the landside slope.

View looking upstream at cactus partway down the landside slope (Fall 2020).

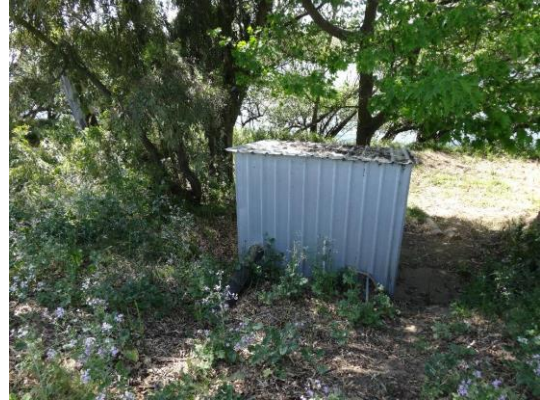
Photo 1 of 3 : UCIP\_FA\_2021\_52733\_20364.jpg

Comment Code						
Inspector Comment						
DS_ID:20869 FS_ID:52733 EP_NO: 11185 Repair Type: Urgent EVAL Issue: Crossing Status: Found UCIP Comments: 07/12/2018 Pit on WS is covered with plywood. Water pump is running, no leaks detected. LS part of crossing was reconstructed. New pipe was installed after CMP riser to supply water to sand filters. Remains Urgent due to large pit on WS that needs to be backfilled. (O.Yakimov-DWR UCIP)04/25/2013 Large pit on levee berm. FIELD_STRUCT_DESC: 8-inch irrigation discharge pipe of an unknown material through the levee, 5.7 feet below the crown. Pump and gate valve in a pump house on the waterside (WS) slope. Siphon breaker, concrete box, and service pole on the landside (LS) slope. (Retention of an 8-inch pipe through the levee, 5.7 feet below the crown, a pump and a gate valve in a pump house on the WS slope, and a siphon breaker and a service pole on the LS slope authorized under Automatic Board Order (ABO) issued as Permit No. 11185, 1975 - R. Walter Langhart). [Additional Reference(s): DWR Levee Log]. FS Date: 7/13/2018

WS- pump house on levee slope

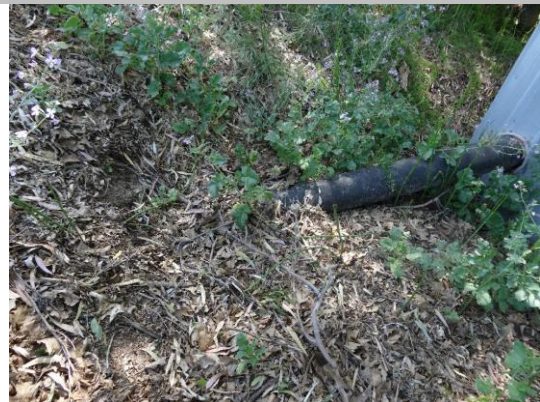
Photo 2 of 3 : UCIP\_FA\_2021\_52733\_20363.jpg

WS- pipe daylight from the levee.

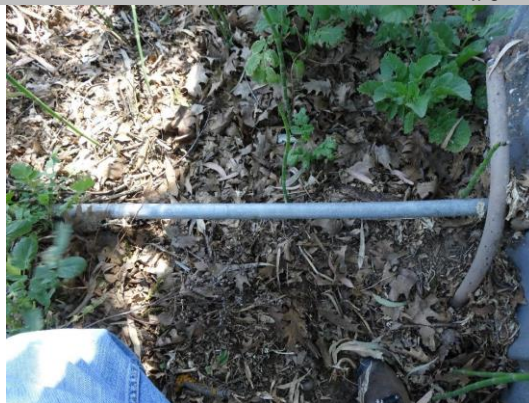
Photo 3 of 3 : UCIP\_FA\_2021\_52733\_20366.jpg

WS- electric conduit daylight near pump house.

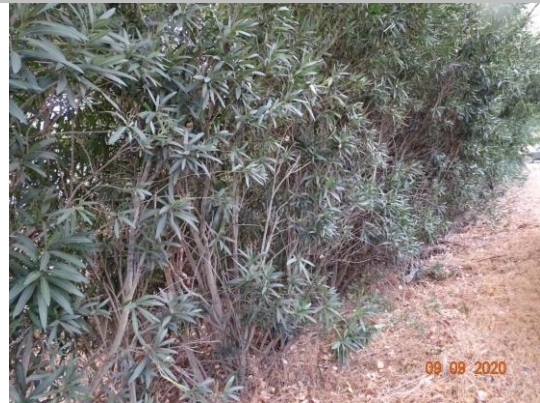
Photo 1 of 1 : FA\_2021\_RD0556\_19\_31\_20210830\_00016.jpg

LM Start	5.40	Rating **	U	Issue No.	31
LM End	5.44	Issue Type +	En	Location *	LS
Category	Earthen Levee			GPS Latitude/Longitude	
				Start	End
Item	Vegetation			38.193760 °	38.193445 °
				-121.562458 °	-121.562895 °
DWR ID	DWR_RD0556_02_s_2012_31				
Comment Code					
V6 : Landscaping					
Inspector Comment					
Thin oleanders to allow view down landside slope.

View looking downstream of oleanders on the landside slope (Fall 2020).

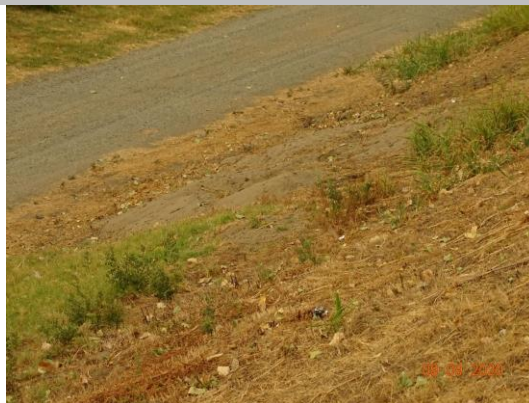
Photo 1 of 1 : FA\_2021\_RD0556\_19\_79\_20210830\_00051.jpg

LM Start	5.64	Rating **	U	Issue No.	79
LM End	5.64	Issue Type +	Ma	Location *	LS
Category	Earthen Levee			GPS Latitude/Longitude	
				Start	End
Item	Animal Control			38.192237 °	38.192237 °
				-121.566368 °	-121.566368 °
DWR ID	DWR_RD0556_02_f_2018_79				
Comment Code					
A3 : No rodents visible, but rodent burrows visible; need to backfill and compact or grout burrows.					
Inspector Comment					
More than 2 cubic feet of soil was removed between the two large burrow holes.

View looking downstream at burrow holes on the landside slope (Fall 2020).
