**Flood Control Project Maintenance
Levee Inspections
Fall 2022 Levee Maintenance Deficiency Summary Report**

Sacramento River Basin

**Flood Control Project Maintenance
Levee Inspections
LMA District Cover Sheet**

Reclamation District No. 0556 Upper Andrus

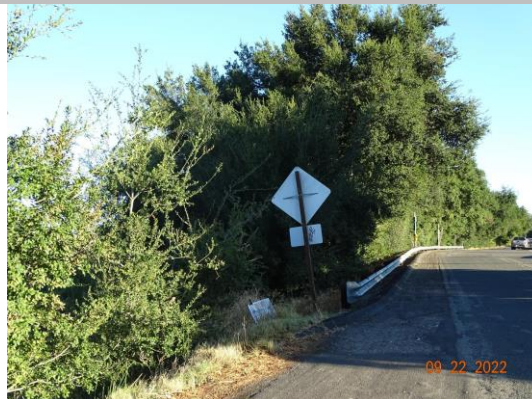
Photo 1 of 1 : FA_2022_RD0556_18_21_20221004_00171.jpg

LM Start	0.00	Rating **	U	Issue No.	21
LM End	0.57	Issue Type +	Ma	Location *	LS
Category	Earthen Levee			GPS Latitude/Longitude	
				Start	End
Item	Trim / Thin Trees			38.239100 °	38.232070 °
				-121.518250 °	-121.522067 °
DWR ID	DWR_RD0556_01_s _ 2017_21				
Comment Code					
T1 : Trim and thin trees to at least five feet above ground level to allow visibility of the ground and room to flood fight.					
Inspector Comment

View of the vegetation on the LS slope (Fall 2022).

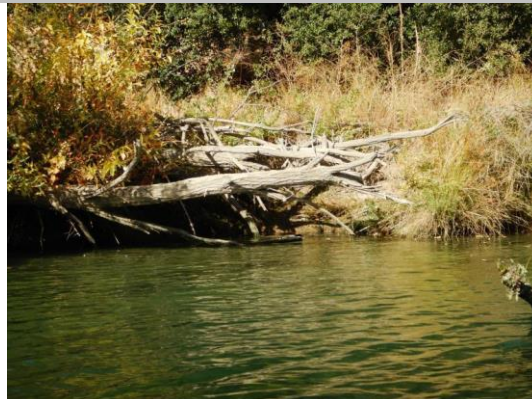
Photo 2 of 2 : FA_2022_RD0556_18_43_20220831_00028.jpg

LM Start	0.38	Rating **	M	Issue No.	43 (cont)
LM End	0.58	Issue Type +	Ma	Location *	WS

USACE 2018 Erosion Photo #2

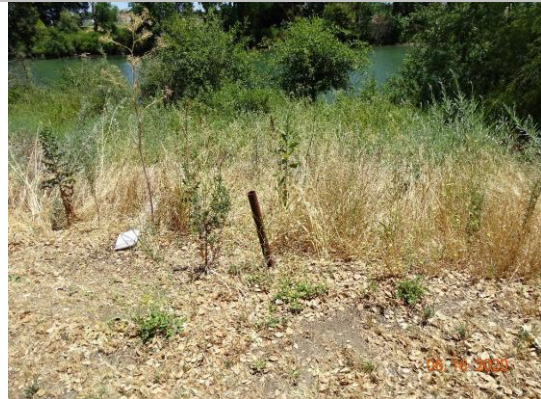
Photo 1 of 3 : UCIP_FA_2022_61336_88650.jpg

Comment Code						
Inspector Comment						
DS_ID:20821 FS_ID:61336 EP_NO: 5548 Repair Type: Non-Urgent EVAL Issue: 10, Unauthorized Modification or Non-Compliant Permit Crossing Status: Found UCIP Comments: 06/16/2020 Record remains Non-Urgent. Unable to inspect waterside slope due to overgrown vegetation. Unable to find pump on waterside, instead, a gas pump and screen filters installed on landside. Unable to find a permit for modification. (O.Yakimov - DWR UCIP) 05/13/2015 Dense vegetation prevents inspection of WS slope. (K.Fazel - DWR UCIP) FIELD_STRUCT_DESC: 12-inch steel irrigation discharge pipe through the levee, 5 feet below the crown. 1.25-inch electrical conduit through the levee at the same location. Pump and screen filters on the landside. Concrete steps on the landside (LS) slope. Cuts in pavement visible at the crossing. Siphon breaker on waterside shoulder. (12-inch pipe authorized under Permit No. 5548, 1966 - George K. Adams). [Additional Reference(s): DWR Levee Log, unk.yr. (HLM 0.54)]. FS Date: 6/16/2020 1:47:59 PM

Water-Side: View of levee slope looking from crown

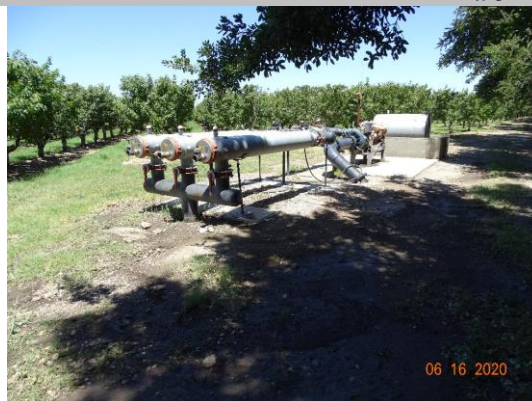
Photo 3 of 3 : UCIP_FA_2022_61336_88646.jpg

LM Start	0.53	Rating **	M	Issue No.	112 (cont)
LM End	0.53	Issue Type +	En	Location *	
Category	Supplemental			GPS Latitude/Longitude	
				Start	End
Item	DWR UCIP Field Study			38.232450 °	38.232450 °
				-121.521624 °	-121.521624 °
DWR ID	20821

Land-Side: Screen filters and new pump on landside

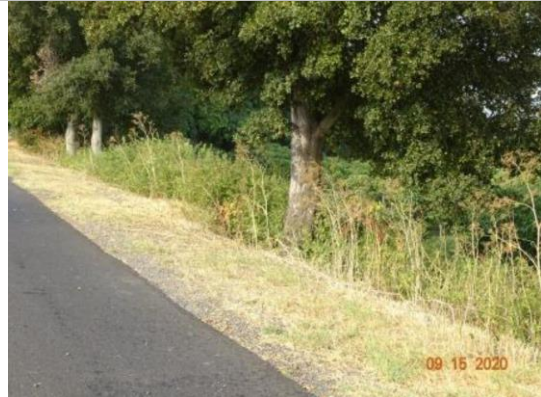
Photo 1 of 1 : FA_2022_RD0556_18_65_20220831_00041.jpg

LM Start	0.82	Rating **	U	Issue No.	65
LM End	0.85	Issue Type +	Ma	Location *	LS
Category	Earthen Levee			GPS Latitude/Longitude	
				Start	End
Item	Vegetation			38.229278 °	38.229013 °
				-121.525103 °	-121.525562 °
DWR ID	DWR_RD0556_01_f_2020_65				
Comment Code					
V2 : Remove the wild growth and woody vegetation other than native grasses from the levee slopes.					
Inspector Comment

View looking downstream at vegetation on the landside slope (Fall 2020).

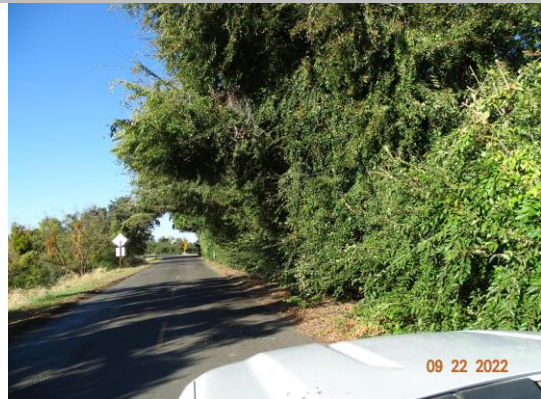
Photo 1 of 1 : FA_2022_RD0556_18_24_20221004_00172.jpg

LM Start	0.87	Rating **	U	Issue No.	24
LM End	0.92	Issue Type +	En	Location *	LS
Category	Earthen Levee			GPS Latitude/Longitude	
				Start	End
Item	Vegetation			38.228820 °	38.228419 °
				-121.525853 °	-121.526477 °
DWR ID	DWR_RD0556_01_f_2017_24				
Comment Code					
V6 : Landscaping					
Inspector Comment

View of the vegetation on the LS slope (Fall 2022).

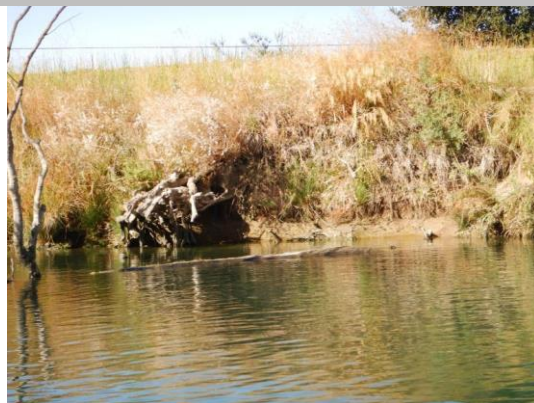
Photo 2 of 2 : FA_2022_RD0556_18_42_20220831_00026.jpg

LM Start	1.20	Rating **	M	Issue No.	42
LM End	1.53	Issue Type +	Ma	Location *	WS
Category	Supplemental			GPS Latitude/Longitude	
				Start	End
Item	2018 USACE Erosion Survey			38.227615 °	38.225374 °
				-121.529894 °	-121.534406 °
DWR ID	DWR_RD0556_01_s_2022_42				
Comment Code					
Inspector Comment					
2018 Site ID: GEO 10.9 R					
Status: Eroding					
2018 Field Notes: New erosion throughout site.					
Site History: 2017 - Significant toe erosion and whole bank failure in sections, large pockets from tree popouts.

USACE 2018 Erosion Photo #2

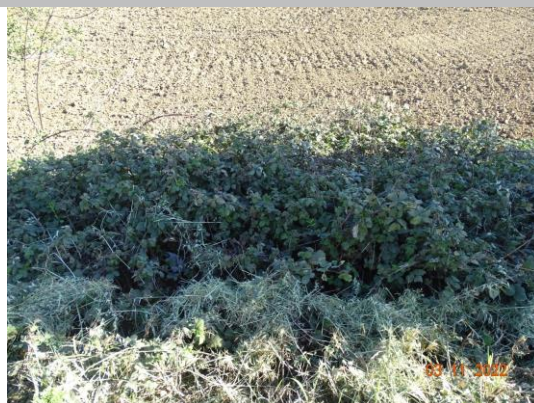
Photo 1 of 1 : FA_2022_RD0556_18_81_20220831_00044.jpg

LM Start	1.21	Rating **	U	Issue No.	81
LM End	1.21	Issue Type +	Ma	Location *	LS
Category	Earthen Levee			GPS Latitude/Longitude	
				Start	End
Item	Vegetation			38.227783 °	38.227783 °
				-121.530067 °	-121.530067 °
DWR ID	DWR_RD0556_01_s_2022_81				
Comment Code					
V2 : Remove the wild growth and woody vegetation other than native grasses from the levee slopes.					
Inspector Comment					
Blackberries on the landside slope.

View of blackberries on the landside slope (Spring 2022).

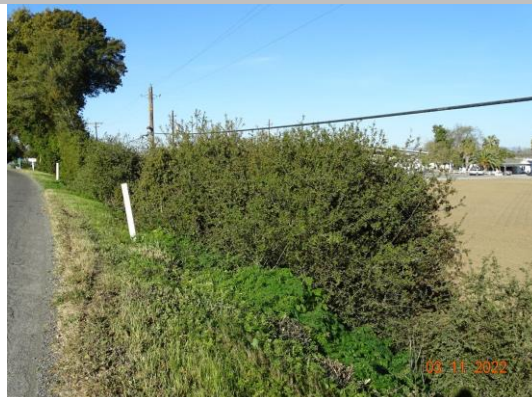
Photo 1 of 1 : FA_2022_RD0556_18_87_20220831_00049.jpg

LM Start	1.26	Rating **	U	Issue No.	87
LM End	1.30	Issue Type +	Ma	Location *	LS
Category	Earthen Levee			GPS Latitude/Longitude	
				Start	End
Item	Trim / Thin Trees			38.227980 °	38.227813 °
				-121.530967 °	-121.531751 °
DWR ID	DWR_RD0556_01_s_2022_87				
Comment Code					
T1 : Trim and thin trees to at least five feet above ground level to allow visibility of the ground and room to flood fight.					
Inspector Comment

View looking downstream at trees on the landside slope (Spring 2022).

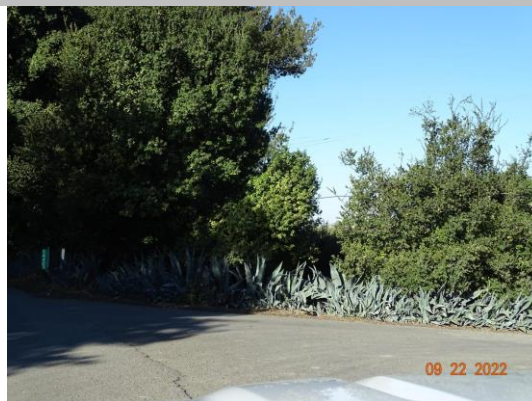
Photo 1 of 1 : FA_2022_RD0556_18_45_20221004_00173.jpg

LM Start	1.31	Rating **	U	Issue No.	45
LM End	1.33	Issue Type +	En	Location *	LS
Category	Earthen Levee			GPS Latitude/Longitude	
				Start	End
Item	Vegetation			38.227775 °	38.227651 °
				-121.531810 °	-121.532159 °
DWR ID	DWR_RD0556_01_s_2018_45				
Comment Code					
V6 : Landscaping					
Inspector Comment					
Remove cactus and trim trees.

View of the cactus on the LS shoulder (Fall 2022).

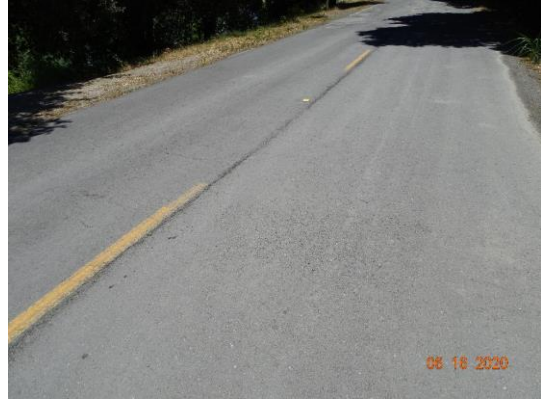
Photo 1 of 3 : UCIP_FA_2022_61398_88672.jpg

DS_ID:20825
FS_ID:61398
EP_NO: 13302
Repair Type: Non-Urgent
EVAL Issue: 6, Levee Damage or Threat for Levee Damage
Crossing Status: Found
UCIP Comments: 06/16/2020 Record remains Non-Urgent. Concrete standpipe on landside has been replaced with a pressure tank. Unable to find a permit for modification. Depression around air release vent on landside shoulder about 2 feet in diameter and 1/2-foot deep. (O.Yakimov - DWR UCIP)
05/27/2015 Seal beneath siphon breaker off LS toe leaking. Rodent activity near crown off LS shoulder. Need to contact owner about leaky seal. Dense vegetation prevented inspection of WS slope. (K.Fazel - DWR UCIP)
FIELD_STRUCT_DESC: 6-inch steel irrigation discharge pipe and 2-inch galvanized iron electrical conduit through the levee, 2 feet below the crown. Siphon valve on the landside (LS) shoulder. Pump, gate valve, and pressure tank at the LS toe. Service pole and electrical box at the LS toe. 6-inch polyvinyl chloride (PVC) standpipe adjacent to the pipe off the LS toe. (6-inch pipe authorized under Permit No. 13302, 1981 - Kaydix Ranch). [Additional Reference(s): DWR Levee Log, unk.yr. (HLM 1.32). USACE Sacramento O&M Manual, Unit 103, June 1954, Revised 29 December 2016, (Station 'R' 540+85), listed as 2-inch pipe. USACE As-Built Drawing No. 50-04-2671, Sheet 5, Station 540+85, 25 January 1951, Revised 18 Dec. 1952, listed as 2-inch pipe]. FS Date: 6/16/2020 4:21:56 PM

Top of Levee: View of levee crown looking downstream

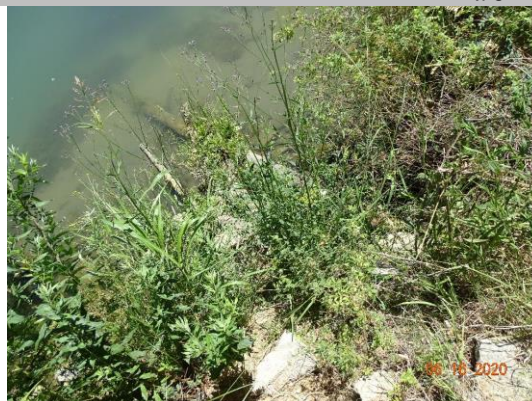
Photo 3 of 3 : UCIP_FA_2022_61398_88673.jpg

LM Start	1.33	Rating **	M	Issue No.	113 (cont)
LM End	1.33	Issue Type +	En	Location *	
Category	Supplemental			GPS Latitude/Longitude	
				Start	End
Item	DWR UCIP Field Study			38.227622 °	38.227622 °
				-121.532154 °	-121.532154 °
DWR ID	20825

Water-Side: Intake pipe at riverbank

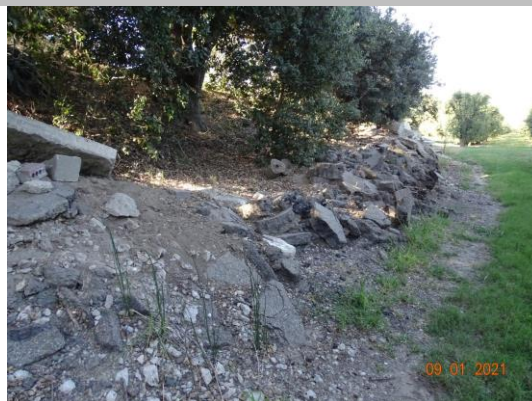
Photo 1 of 1 : FA_2022_RD0556_18_27_20220831_00009.jpg

LM Start	1.34	Rating **	A/W	Issue No.	27
LM End	1.37	Issue Type +	En	Location *	LS
Category	Earthen Levee			GPS Latitude/Longitude	
				Start	End
Item	Encroachments			38.227521 °	38.227320 °
				-121.532393 °	-121.532710 °
DWR ID	DWR_RD0556_01_s_2013_27				
Comment Code					
DE : Debris					
Inspector Comment					
Concrete at toe of levee is acting like a stability berm.

View looking downstream at concrete rubble at landside toe (Fall 2021).

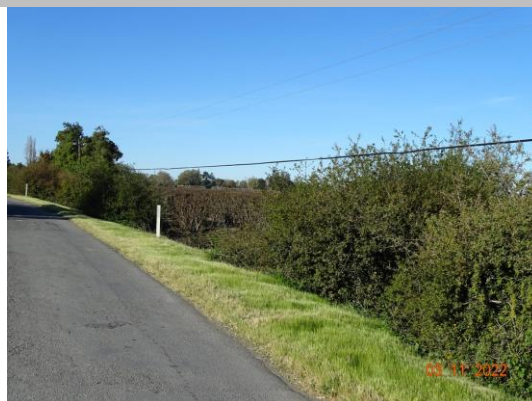
Photo 1 of 1 : FA_2022_RD0556_18_88_20220831_00050.jpg

LM Start	1.37	Rating **	U	Issue No.	88
LM End	1.54	Issue Type +	Ma	Location *	LS
Category	Earthen Levee			GPS Latitude/Longitude	
				Start	End
Item	Trim / Thin Trees			38.227286 °	38.225374 °
				-121.532724 °	-121.534665 °
DWR ID	DWR_RD0556_01_s_2022_88				
Comment Code					
T1 : Trim and thin trees to at least five feet above ground level to allow visibility of the ground and room to flood fight.					
Inspector Comment

View looking downstream at trees on the landside slope (Spring 2022).

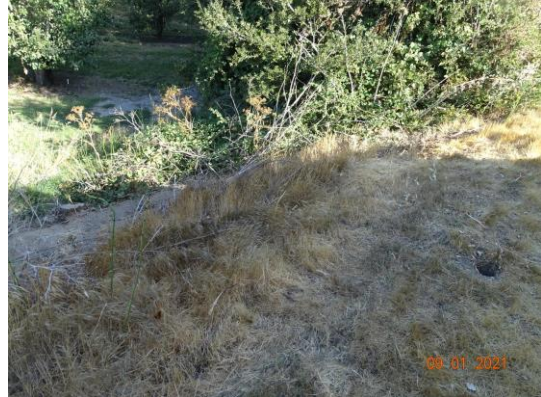
Photo 1 of 1 : FA_2022_RD0556_18_82_20220831_00045.jpg

LM Start	1.43	Rating **	M	Issue No.	82
LM End	1.43	Issue Type +	Ma	Location *	LS
Category	Earthen Levee			GPS Latitude/Longitude	
				Start	End
Item	Animal Control			38.226537 °	38.226537 °
				-121.533351 °	-121.533351 °
DWR ID	DWR_RD0556_01_f_2021_82				
Comment Code					
A1 : Exterminate rodents and backfill and compact or grout burrows.					
Inspector Comment

View of animal holes in landside hinge and slope (Fall 2021).

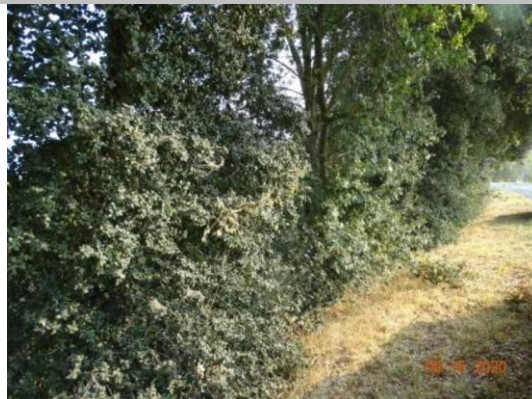
Photo 1 of 1 : FA_2022_RD0556_18_46_20220831_00031.jpg

LM Start	1.55	Rating **	U	Issue No.	46
LM End	1.64	Issue Type +	Ma	Location *	LS
Category	Earthen Levee			GPS Latitude/Longitude	
				Start	End
Item	Trim / Thin Trees			38.225268 °	38.224587 °
				-121.534733 °	-121.536129 °
DWR ID	DWR_RD0556_01_s_2018_46				
Comment Code					
T1 : Trim and thin trees to at least five feet above ground level to allow visibility of the ground and room to flood fight.					
Inspector Comment

View looking upstream at thick trees on the landside slope (Fall 2020).

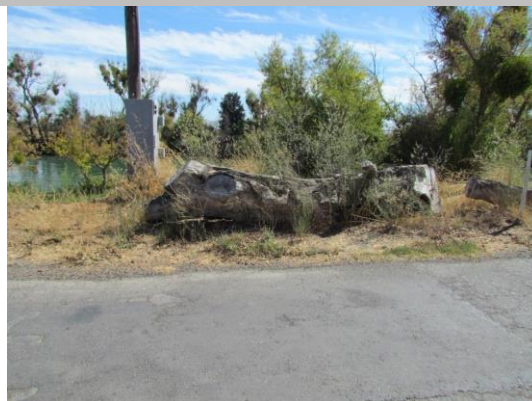
Photo 1 of 1 : FA_2022_RD0556_18_9_20220831_00001.jpg

LM Start	1.55	Rating **	A/W	Issue No.	9
LM End	1.57	Issue Type +	En	Location *	WS
Category	Earthen Levee			GPS Latitude/Longitude	
				Start	End
Item	Trim / Thin Trees			38.225191 °	38.224976 °
				-121.534799 °	-121.535043 °
DWR ID	DWR_RD0556_01_s_2012_9				
Comment Code					
T2 : Tree or limb.					
Inspector Comment					
These cut up tree sections remain on the waterward slope to prevent parking in the area.

Cut tree sections on the waterside levee shoulder remain to prevent parking.

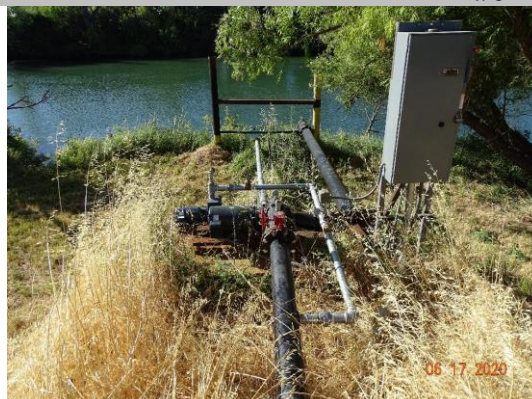
Photo 3 of 3 : UCIP_FA_2022_61399_88679.jpg

LM Start	1.57	Rating **	M	Issue No.	114 (cont)
LM End	1.57	Issue Type +	En	Location *	
Category	Supplemental		GPS Latitude/Longitude		
			Start	End	
Item	DWR UCIP Field Study		38.225001 °	38.225001 °	
			-121.535007 °	-121.535007 °	
DWR ID	20827

Water-Side: Pump, filler pump and line, butterfly valve on levee berm

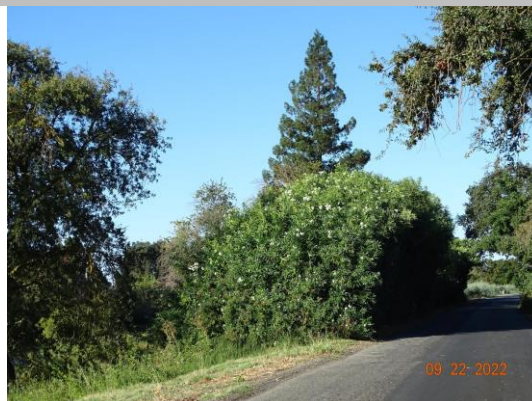
Photo 1 of 1 : FA_2022_RD0556_18_17_20221004_00177.jpg

LM Start	1.65	Rating **	U	Issue No.	17
LM End	1.70	Issue Type +	En	Location *	WS
Category	Earthen Levee			GPS Latitude/Longitude	
				Start	End
Item	Vegetation			38.224623 °	38.224408 °
				-121.536320 °	-121.537180 °
DWR ID	DWR_RD0556_01_s_2012_17				
Comment Code					
V6 : Landscaping					
Inspector Comment					
Oleanders blocking view down waterside slope

View of the oleander on the WS shoulder and slope (Fall 2022).

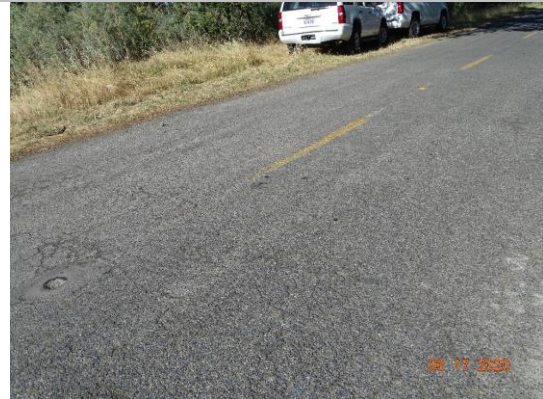
Photo 1 of 3 : UCIP_FA_2022_61414_88746.jpg

Comment Code						
Inspector Comment						
DS_ID:20829 FS_ID:61414 EP_NO: 11178 Repair Type: Non-Urgent EVAL Issue: 6, Levee Damage or Threat for Levee Damage Crossing Status: Found UCIP Comments: 06/17/2020 Record remains Non-Urgent. Depression on landside levee slope less than 1/2-foot-deep in pipe alignment. Vegetation on both levee slopes. Limited visibility through vegetation restrains complete evaluation of slope condition. Electric meter is energized. No permit has been identified authorizing pipe. Need to have CVFPB review ABO and determine current owner. (O.Yakimov - DWR UCIP) 05/27/2015 Dense vegetation on WS and LS. Some oil leakage inside pumphouse. (K. Fazel - DWR UCIP) FIELD_STRUCT_DESC: 8-inch steel irrigation discharge pipe through the levee, 3.7 feet below the crown. 2-inch electrical conduit through the levee, next to the 8-inch discharge pipe. 1-inch air valve and pump on the waterside (WS) berm. Service pole on the landside (LS) slope. Tin and wood pump house on the WS berm. 12-foot by 3-foot concrete standpipe on the LS. (8-inch pipe [HLM 1.88] authorized under Automatic Board Order (ABO) issued as Permit No. 11178, 1975 - Allena D. Swett). [Additional Reference(s): DWR Levee Log, unk.yr. (HLM 1.88). USACE Sacramento O&M Manual, Unit 103, June 1954, Revised 29 December 2016, (Station 'R' 511+00), listed as 8-inch pipe. USACE As-Built Drawing No. 50-04-2671, Sheet 4, Station 511+00, 25 January 1951, Revised 18 Dec. 1952]. FS Date: 6/17/2020 10:33:05 AM

Top of Levee: View of levee crown looking downstream

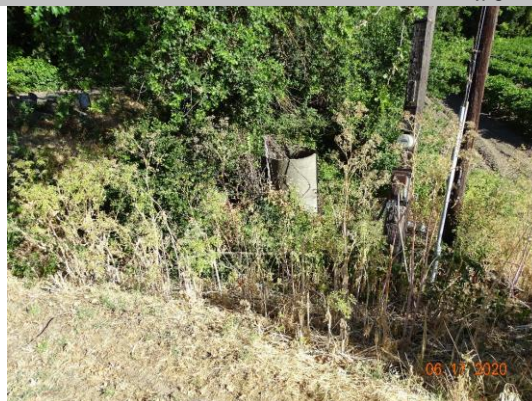
Photo 2 of 3 : UCIP_FA_2022_61414_88747.jpg

LM Start	1.89	Rating **	M	Issue No.	115 (cont)
LM End	1.89	Issue Type +	En	Location *	
Category	Supplemental		GPS Latitude/Longitude		
			Start	End	
Item	DWR UCIP Field Study		38.223760 °	38.223760 °	
			-121.540629 °	-121.540629 °	
DWR ID	20829

Land-Side: View of levee slope looking from crown. Service pole on shoulder, concrete standpipe at levee toe

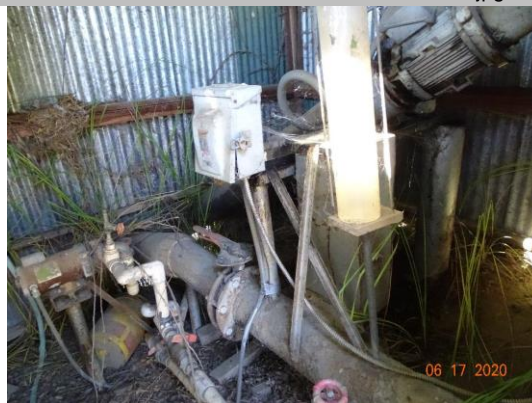
Photo 3 of 3 : UCIP_FA_2022_61414_88743.jpg

LM Start	1.89	Rating **	M	Issue No.	115 (cont)
LM End	1.89	Issue Type +	En	Location *

Water-Side: View inside of pumphouse

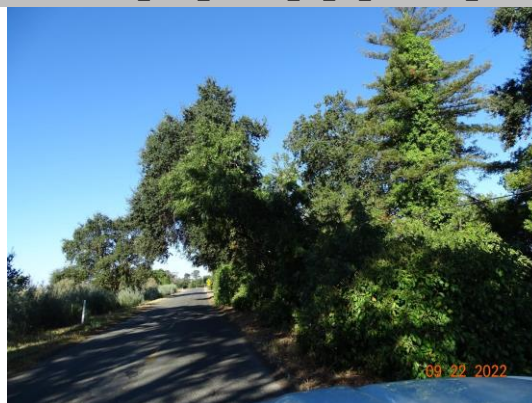
Photo 1 of 1 : FA_2022_RD0556_18_47_20221004_00179.jpg

LM Start	1.91	Rating **	U	Issue No.	47
LM End	1.93	Issue Type +	En	Location *	LS
Category	Earthen Levee			GPS Latitude/Longitude	
				Start	End
Item	Vegetation			38.223736 °	38.223673 °
				-121.541036 °	-121.541453 °
DWR ID	DWR_RD0556_01_s_2018_47				
Comment Code					
V6 : Landscaping					
Inspector Comment					
Dense vegetation prevents inspection and access.

View of the landscaping on the LS slope (Fall 2022).

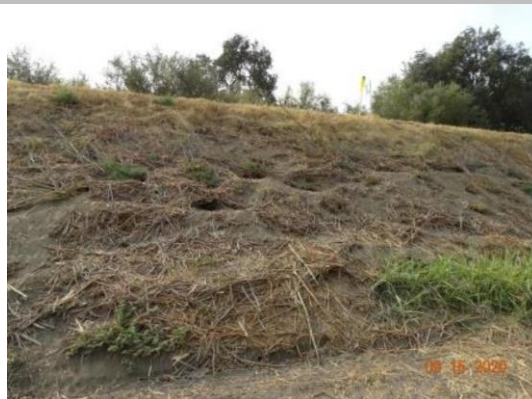
Photo 1 of 1 : FA_2022_RD0556_18_61_20220831_00039.jpg

LM Start	2.05	Rating **	M	Issue No.	61
LM End	2.07	Issue Type +	Ma	Location *	LS
Category	Earthen Levee			GPS Latitude/Longitude	
				Start	End
Item	Animal Control			38.223487 °	38.223340 °
				-121.543482 °	-121.543917 °
DWR ID	DWR_RD0556_01_f_2020_61				
Comment Code					
A1 : Exterminate rodents and backfill and compact or grout burrows.					
Inspector Comment

View of multiple squirrel holes in the landside slope (Fall 2020).

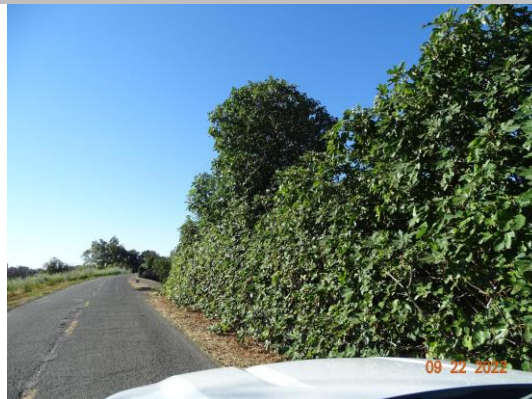
Photo 1 of 1 : FA_2022_RD0556_18_53_20221004_00180.jpg

LM Start	2.32	Rating **	U	Issue No.	53
LM End	2.32	Issue Type +	En	Location *	LS
Category	Earthen Levee			GPS Latitude/Longitude	
				Start	End
Item	Vegetation			38.219813 °	38.219813 °
				-121.544032 °	-121.544032 °
DWR ID	DWR_RD0556_01_f_2019_53				
Comment Code					
V6 : Landscaping					
Inspector Comment

View of the landscaping on the LS slope (Fall 2022).

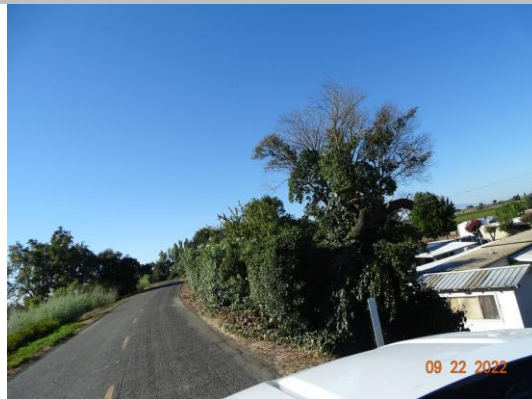
Photo 1 of 1 : FA_2022_RD0556_18_31_20221004_00181.jpg

LM Start	2.38	Rating **	U	Issue No.	31
LM End	2.47	Issue Type +	En	Location *	LS
Category	Earthen Levee			GPS Latitude/Longitude	
				Start	End
Item	Vegetation			38.219037 °	38.217781 °
				-121.543847 °	-121.543817 °
DWR ID	DWR_RD0556_01_s_2017_31				
Comment Code					
V6 : Landscaping					
Inspector Comment

View of the landscaping along the LS slope (Fall 2022).

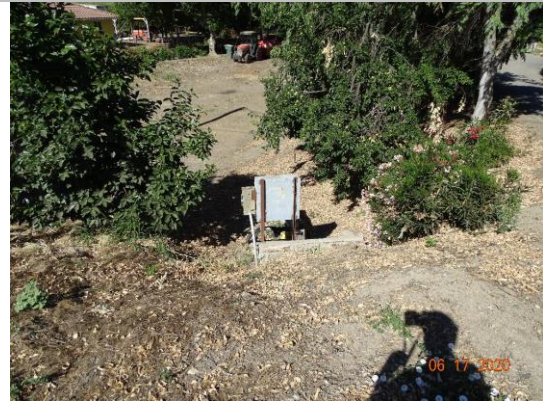
Photo 1 of 3 : UCIP_FA_2022_61499_89030.jpg

Comment Code						
Inspector Comment						
DS_ID:20831 FS_ID:61499 EP_NO: 11169 Repair Type: Non-Urgent EVAL Issue: 6, Levee Damage or Threat for Levee Damage Crossing Status: Found UCIP Comments: 06/17/2020 Record remains Non-Urgent. 2-foot diameter sinkhole is still present on landside shoulder around air vent, size of hole is not growing over time. Electrical conduit is open on waterside slope with wires cut and not insulated. No permit has been identified authorizing pipe. Need to have CVFPB review ABO and determine current owner. (O.Yakimov - DWR UCIP) 07/12/2018 Hole near air vent on LS slope is still present but haven't increased in size. Pipe was running at the time of site visit, no leaks detected. Downgraded to "Non-Urgent" due to absence of levee threat. (O.Yakimov - DWR UCIP) 05/27/2015 2'x 2' hole on levee off LS shoulder. FIELD_STRUCT_DESC: 8-inch steel irrigation discharge pipe through the levee, 3.7 feet below the crown. 1-inch air valve. Pump and switch panel on the waterside (WS) berm. Service pole on the landside (LS). 9-foot by 3-foot concrete standpipe on the LS. 3 cables encased in a 1.5-inch steel conduit through the levee and on the WS, alongside the 8-inch pipe, disconnected on the WS. (8-inch pipe [HLM 2.44] authorized under Automatic Board Order (ABO) issued as Permit No. 11169, 1975 - Darrell T. and B. M. Mealer). [Additional Reference(s): DWR Levee Log, unk.yr. (HLM 2.44). USACE Sacramento O&M Manual, Unit 103, June 1954, Revised 29 December 2016, (Station 'R' 482+49.3), listed as 8-inch pipe. USACE As-Built Drawing No. 50-04-2671, Sheet 3, Station 482+49.3, 25 January 1951, Revised 18 Dec. 1952]. FS Date: 6/17/2020 10:55:51 AM

Land-Side: View of levee slope looking from crown

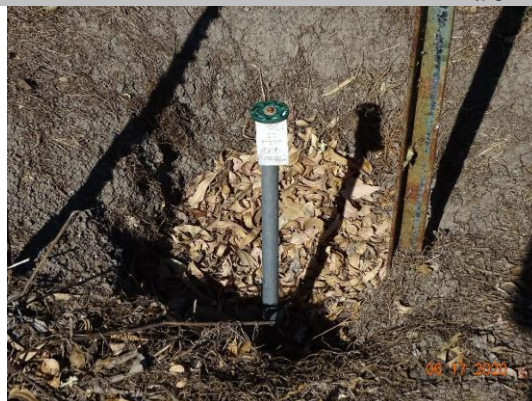
Photo 2 of 3 : UCIP_FA_2022_61499_89028.jpg

LM Start	2.44	Rating **	M	Issue No.	116 (cont)
LM End	2.44	Issue Type +	En	Location *	
Category	Supplemental		GPS Latitude/Longitude		
			Start	End	
Item	DWR UCIP Field Study		38.218242 °	38.218242 °	
			-121.543807 °	-121.543807 °	
DWR ID	20831

Land-Side: Sinkhole around air vent on levee shoulder

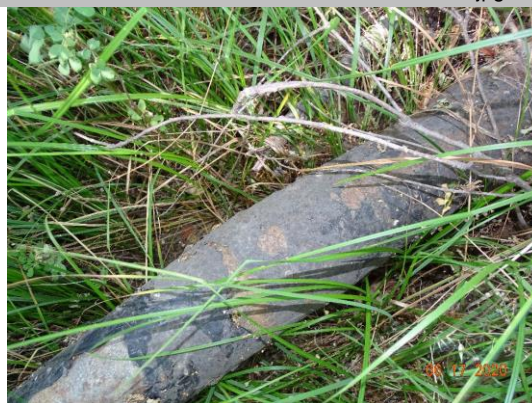
Photo 3 of 3 : UCIP_FA_2022_61499_89034.jpg

Water-Side: Open electrical conduit with wires inside on levee slope

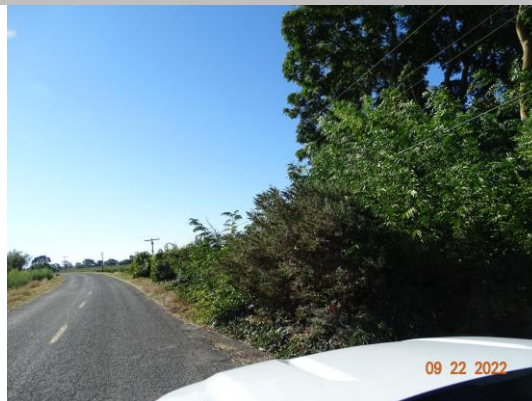
Photo 1 of 1 : FA_2022_RD0556_18_54_20221004_00182.jpg

LM Start	2.51	Rating **	U	Issue No.	54
LM End	2.54	Issue Type +	En	Location *	LS
Category	Earthen Levee			GPS Latitude/Longitude	
				Start	End
Item	Vegetation			38.217229 °	38.216830 °
				-121.543577 °	-121.543233 °
DWR ID	DWR_RD0556_01_f_2019_54				
Comment Code					
V6 : Landscaping					
Inspector Comment

View of the landscaping on the LS slope (Fall 2022).

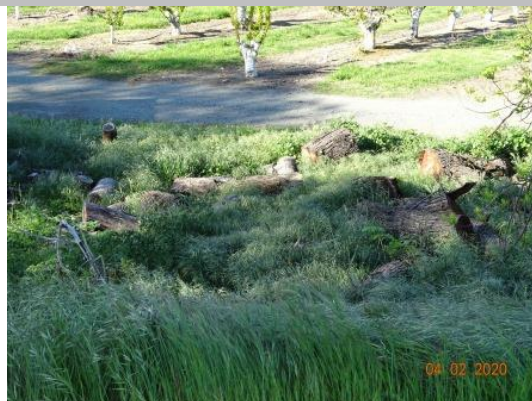
Photo 1 of 1 : FA_2022_RD0556_18_32_20220831_00014.jpg

LM Start	2.69	Rating **	M	Issue No.	32
LM End	2.69	Issue Type +	En	Location *	LS
Category	Earthen Levee			GPS Latitude/Longitude	
				Start	End
Item	Encroachments			38.215375 °	38.215375 °
				-121.541258 °	-121.541258 °
DWR ID	DWR_RD0556_01_s_2020_32				
Comment Code					
FW : Firewood					
Inspector Comment					
Several large chunks of wood should be removed from landside toe.

View of large tree trunk sections on the landside hinge (Spring 2020).

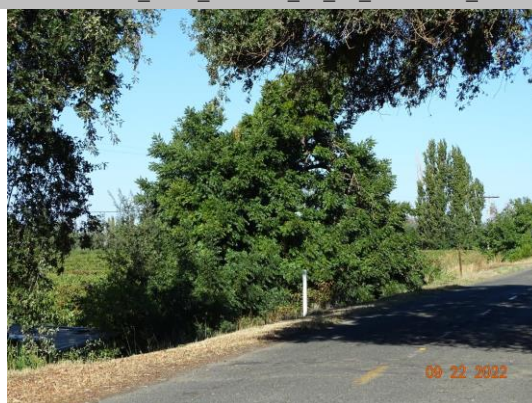
Photo 1 of 1 : FA_2022_RD0556_18_69_20221004_00184.jpg

LM Start	2.69	Rating **	U	Issue No.	69
LM End	2.69	Issue Type +	Ma	Location *	LS
Category	Earthen Levee			GPS Latitude/Longitude	
				Start	End
Item	Trim / Thin Trees			38.215382 °	38.215382 °
				-121.541247 °	-121.541247 °
DWR ID	DWR_RD0556_01_f_2020_69				
Comment Code					
T1 : Trim and thin trees to at least five feet above ground level to allow visibility of the ground and room to flood fight.					
Inspector Comment

View of the tree on the LS slope (Fall 2022).

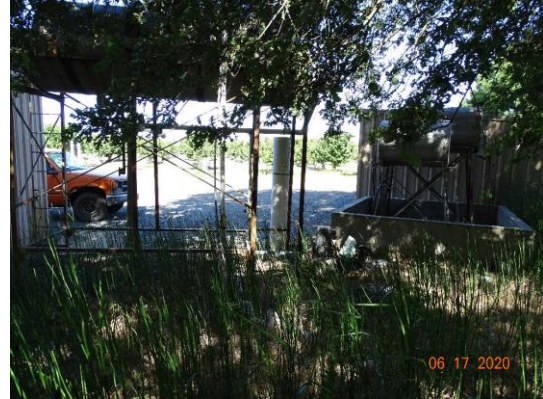
Photo 1 of 3 : UCIP_FA_2022_61501_89043.jpg

DS_ID:20848
FS_ID:61501
EP_NO: 11167
Repair Type: Non-Urgent
EVAL Issue: 10, Unauthorized Modification or Non-Compliant Permit
Crossing Status: Found
UCIP Comments: 06/17/2020 Record remains Non-Urgent. Unable to find a permit for sleeving 3-inch pipe through 8-inch pipe. No permit has been identified authorizing original pipe through the levee. Need to have CVFPB review ABO and determine current owner. (O.Yakimov - DWR UCIP)
06/05/2015 Pipe appears out of use; if so, coordinate with owner to abandon properly per Title 23. (K.Fazel - DWR UCIP)
FIELD_STRUCT_DESC: 3-inch steel irrigation discharge pipe sleeved through the 8-inch steel pipe, 3 feet below the crown. Annular space appears to be grouted. 3-inch pipe connected to the pump on the waterside (WS). 0.75-inch primer pipe. Gate valve on the WS berm. Polyvinyl chloride (PVC) standpipe off the landside (LS) toe, previously a 6-foot by 3-foot concrete standpipe. (8-inch pipe [HLM 2.70] authorized under Automatic Board Order (ABO) issued as Permit No. 11167, 1975 - Russel G. Graham). [Additional Reference(s): DWR Levee Log, unk.yr. (HLM 2.70). USACE Sacramento O&M Manual, Unit 103, June 1954, Revised 29 December 2016, (Station 'R' 468+52.7), listed as 8-inch pipe. USACE As-Built Drawing No. 50-04-2671, Sheet 3, Station 468+52.7, 25 January 1951, Revised 18 Dec. 1952, listed as 8-inch pipe].

Land-Side: PVC standpipe off levee toe

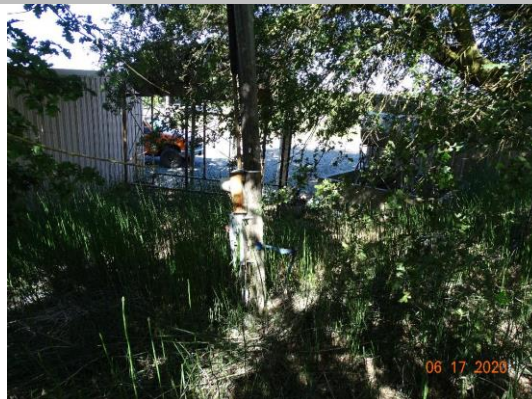
Photo 2 of 3 : UCIP_FA_2022_61500_89035.jpg

LM Start	2.71	Rating **	M	Issue No.	118 (cont)
LM End	2.71	Issue Type +	En	Location *	
Category	Supplemental		GPS Latitude/Longitude		
			Start	End	
Item	DWR UCIP Field Study		38.215223 °	38.215223 °	
			-121.540953 °	-121.540953 °	
DWR ID	20833

Land-Side: View of levee slope looking from crown

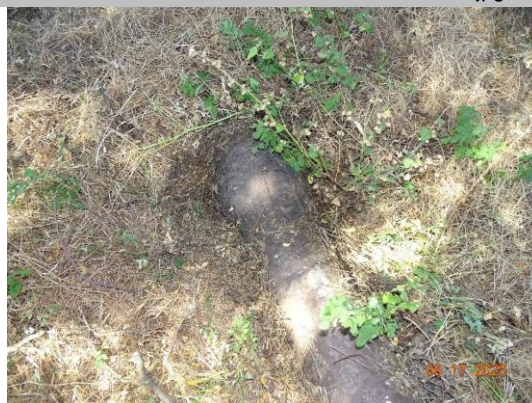
Photo 3 of 3 : UCIP_FA_2022_61500_89039.jpg

Water-Side: 12-inch to 10-inch sleeved pipe connection on levee slope

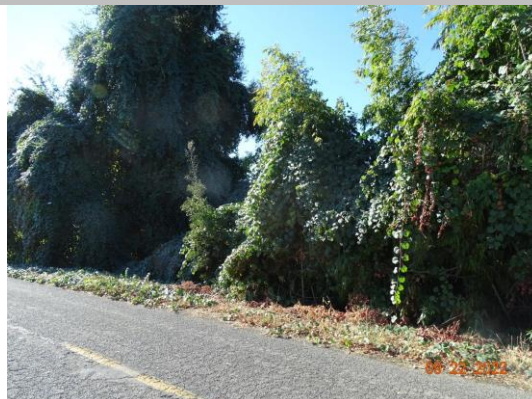
Photo 1 of 1 : FA_2022_RD0556_18_48_20221004_00183.jpg

LM Start	2.72	Rating **	U	Issue No.	48
LM End	2.72	Issue Type +	En	Location *	LS
Category	Earthen Levee			GPS Latitude/Longitude	
				Start	End
Item	Vegetation			38.215085 °	38.215085 °
				-121.540724 °	-121.540724 °
DWR ID	DWR_RD0556_01_f_2018_48				
Comment Code					
V6 : Landscaping					
Inspector Comment					
Remove wild grapes and bamboo from landside.

View of the landscaping on the LS slope (Fall 2022).

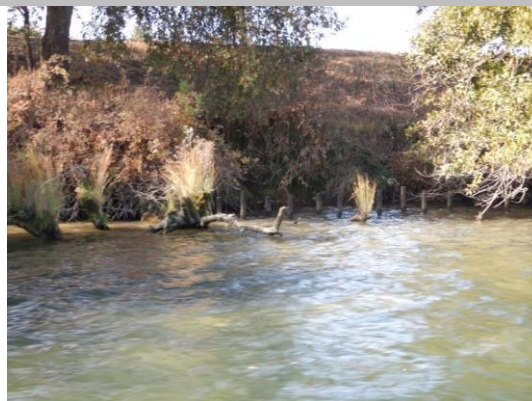
Photo 1 of 2 : FA_2022_RD0556_18_37_20220831_00019.jpg

LM Start	2.85	Rating **	M	Issue No.	37
LM End	2.98	Issue Type +	Ma	Location *	WS
Category	Supplemental			GPS Latitude/Longitude	
				Start	End
Item	2018 USACE Erosion Survey			38.214144 °	38.212577 °
				-121.538692 °	-121.537244 °
DWR ID	DWR_RD0556_01_s_2022_37				
Comment Code					
Inspector Comment					
2018 Site ID: GEO 9.2 R					
Status: Eroding					
2018 Field Notes: New erosion along toe.					
Site History: 2017 - Toe erosion.

USACE 2018 Erosion Photo #1

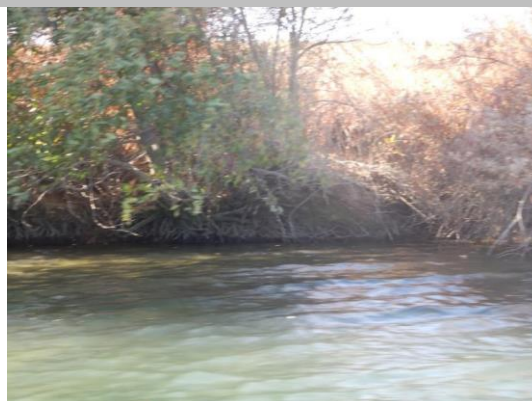
Photo 2 of 2 : FA_2022_RD0556_18_37_20220831_00020.jpg

USACE 2018 Erosion Photo #2

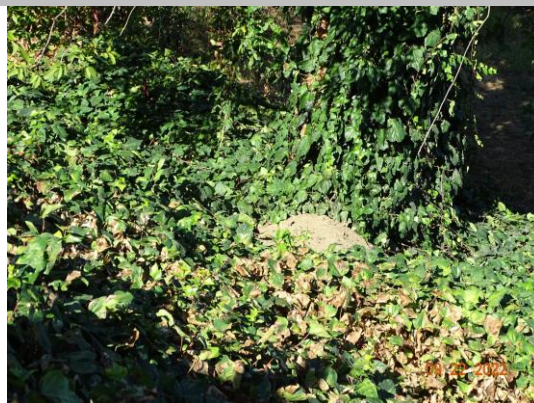
Photo 1 of 1 : FA_2022_RD0556_18_28_20221004_00185.jpg

LM Start	3.14	Rating **	M	Issue No.	28
LM End	3.26	Issue Type +	Ma	Location *	LS
Category	Earthen Levee			GPS Latitude/Longitude	
				Start	End
Item	Animal Control			38.210985 °	38.210160 °
				-121.538372 °	-121.540300 °
DWR ID	DWR_RD0556_01_f_2017_28				
Comment Code					
A1 : Exterminate rodents and backfill and compact or grout burrows.					
Inspector Comment

View of the burrow on the LS slope (Fall 2022).

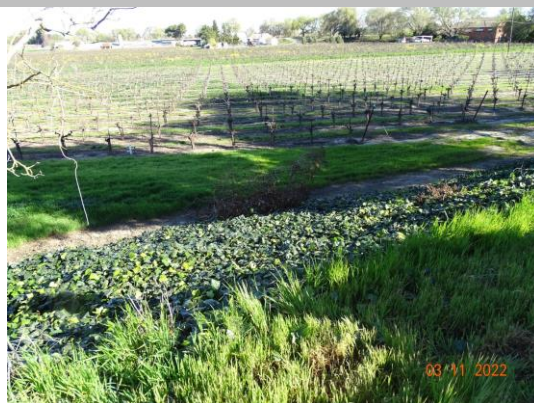
Photo 1 of 1 : FA_2022_RD0556_18_93_20220831_00051.jpg

LM Start	3.15	Rating **	M	Issue No.	93
LM End	3.15	Issue Type +	En	Location *	LS
Category	Earthen Levee			GPS Latitude/Longitude	
				Start	End
Item	Vegetation			38.210908 °	38.210908 °
				-121.538523 °	-121.538523 °
DWR ID	DWR_RD0556_01_s_2022_93				
Comment Code					
V6 : Landscaping					
Inspector Comment					
Ivy on the landside slope.

View of ivy on the landside slope (Spring 2022).

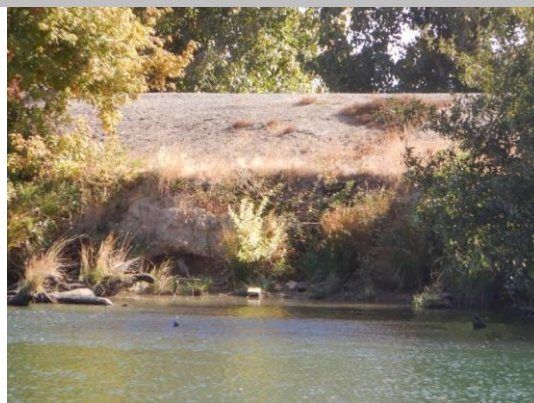
Photo 2 of 2 : FA_2022_RD0556_18_36_20220831_00018.jpg

LM Start	3.18	Rating **	M	Issue No.	36
LM End	3.50	Issue Type +	Ma	Location *	WS
Category	Supplemental			GPS Latitude/Longitude	
				Start	End
Item	2018 USACE Erosion Survey			38.210674 °	38.206919 °
				-121.538854 °	-121.541559 °
DWR ID	DWR_RD0556_01_s_2022_36				
Comment Code					
Inspector Comment					
2018 Site ID: GEO 9.0 R					
Status: Eroding					
2018 Field Notes: Site extended downstream.					
Site History: 2017 - Toe erosion and failed revetment.

USACE 2018 Erosion Photo #2

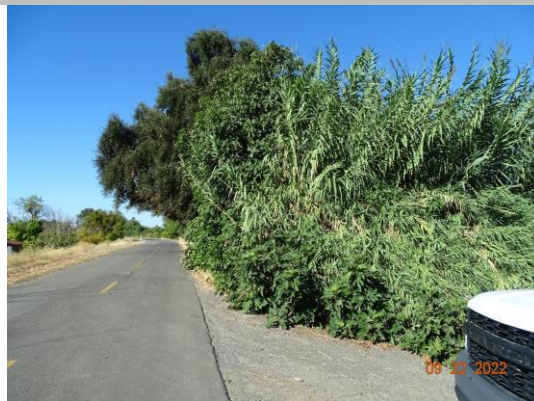
Photo 1 of 1 : FA_2022_RD0556_18_55_20221004_00186.jpg

LM Start	3.18	Rating **	U	Issue No.	55
LM End	3.18	Issue Type +	Ma	Location *	LS
Category	Earthen Levee			GPS Latitude/Longitude	
				Start	End
Item	Trim / Thin Trees			38.210745 °	38.210745 °
				-121.538967 °	-121.538967 °
DWR ID	DWR_RD0556_01_f_2019_55				
Comment Code					
T1 : Trim and thin trees to at least five feet above ground level to allow visibility of the ground and room to flood fight.					
Inspector Comment

View of the trees on the LS slope (Fall 2022).

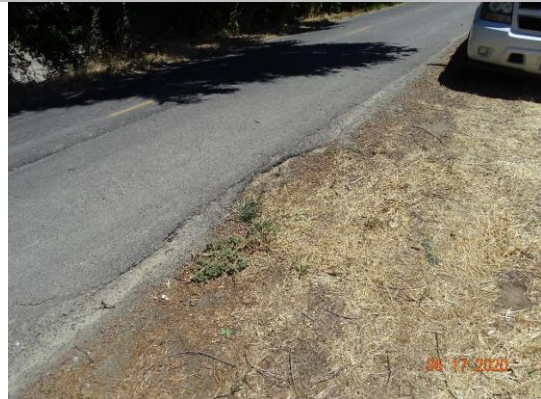
Photo 1 of 3 : UCIP_FA_2022_61291_89090.jpg

Comment Code						
Inspector Comment						
DS_ID:20836 FS_ID:61291 EP_NO: 11174 Repair Type: Urgent EVAL Issue: 2a, Levee Integrity Crossing Status: Found UCIP Comments: 06/17/2020 Record is Urgent. 30-feet long, 3-feet wide, and 1-foot deep trench was excavated along landside levee toe. Soil is wet at the bottom of trench. Soil depression on waterside shoulder in pipe alignment. Intake pipe and pipe from pumphouse towards levee slope have been replaced. Unable to find a permit for modifications. No permit has been identified authorizing original pipe through the levee. Need to have CVFPB review ABO and determine current owner. (O.Yakimov - DWR UCIP) FIELD_STRUCT_DESC: 6-inch steel irrigation pipe through levee, 3.4 feet below crown. Pump in pump house on berm. Service pole on landward slope. Gate valve located underground and 48-inch concrete standpipe at landside toe. 1-inch electrical conduit at this location. (6-inch pipe [HLM 3.18] authorized under Automatic Board Order (ABO) issued as Permit No. 11174, 1975 - Delores M. Pollard). [Additional Reference(s): DWR Levee Log, unk.yr. (HLM 3.18). USACE Sacramento O&M Manual, Unit 103, June 1954, Revised 29 December 2016, (Station 441+19.6), listed as 6-inch pipe. USACE As-Built Drawing No. 50-04-2671, Sheet 2, near Station 440+00, 25 January 1951, Revised 18 Dec. 1952. USACE As-Built Drawing No. 50-04-2631, Sheet 11, Station 441+19.6, March 1950, Revised 16 Dec.1952]. FS Date: 6/17/2020

Water-Side: Soil depression in pipe alignment on levee shoulder

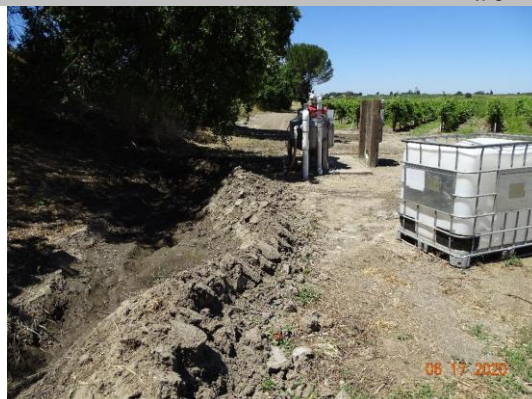
Photo 3 of 3 : UCIP_FA_2022_61291_89086.jpg

LM Start	3.19	Rating **	U	Issue No.	119 (cont)
LM End	3.19	Issue Type +	En	Location *	
Category	Supplemental		GPS Latitude/Longitude		
			Start	End	
Item	DWR UCIP Field Study		38.210683 °	38.210683 °	
			-121.539125 °	-121.539125 °	
DWR ID	20836

Overview of Levee: Overview of trench dug along landside toe

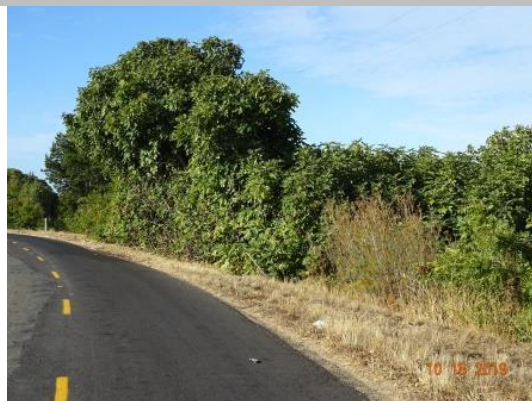
Photo 1 of 1 : FA_2022_RD0556_18_38_20220831_00021.jpg

LM Start	3.22	Rating **	U	Issue No.	38
LM End	3.23	Issue Type +	Ma	Location *	LS
Category	Earthen Levee			GPS Latitude/Longitude	
				Start	End
Item	Trim / Thin Trees			38.210493 °	38.210446 °
				-121.539760 °	-121.539804 °
DWR ID	DWR_RD0556_01_s_2017_38				
Comment Code					
T1 : Trim and thin trees to at least five feet above ground level to allow visibility of the ground and room to flood fight.					
Inspector Comment					
Remove the wild tree growth and vegetation from the landside levee slope and toe so the ground can be seen.

View looking downstream at thick tree growth on the landside slope (Fall 2019).

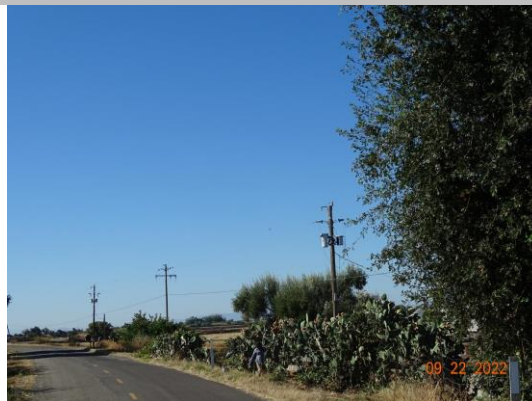
Photo 1 of 1 : FA_2022_RD0556_18_29_20221004_00187.jpg

LM Start	3.36	Rating **	U	Issue No.	29
LM End	3.42	Issue Type +	En	Location *	LS
Category	Earthen Levee			GPS Latitude/Longitude	
				Start	End
Item	Vegetation			38.208917 °	38.208191 °
				-121.541338 °	-121.541578 °
DWR ID	DWR_RD0556_01_f_2017_29				
Comment Code					
V6 : Landscaping					
Inspector Comment					
Large cactus growing on shoulder and slope should be removed to allow inspection and access.

View of the cactus on the LS slope (Fall 2022).

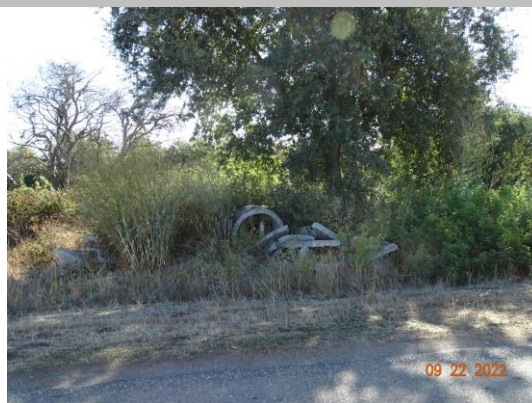
Photo 1 of 1 : FA_2022_RD0556_18_58_20221004_00188.jpg

LM Start	3.46	Rating **	U	Issue No.	58
LM End	3.46	Issue Type +	En	Location *	WS
Category	Earthen Levee			GPS Latitude/Longitude	
				Start	End
Item	Encroachments			38.207585 °	38.207585 °
				-121.541678 °	-121.541678 °
DWR ID	DWR_RD0556_01_f_2019_58				
Comment Code					
DE : Debris					
Inspector Comment					
Remove concrete debris piles.

View of the concrete debris on the WS slope (Fall 2022).

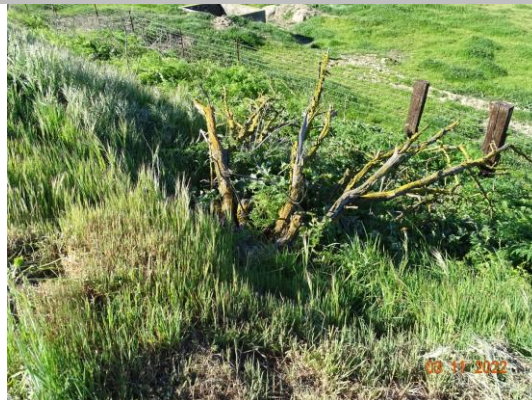
Photo 1 of 1 : FA_2022_RD0556_18_95_20220831_00052.jpg

LM Start	3.56	Rating **	M	Issue No.	95
LM End	3.56	Issue Type +	Ma	Location *	LS
Category	Earthen Levee			GPS Latitude/Longitude	
				Start	End
Item	Trim / Thin Trees			38.206078 °	38.206078 °
				-121.541743 °	-121.541743 °
DWR ID	DWR_RD0556_01_s_2022_95				
Comment Code					
T2 : Tree or limb.					
Inspector Comment

View of down tree limbs on the landside slope (Spring 2022).

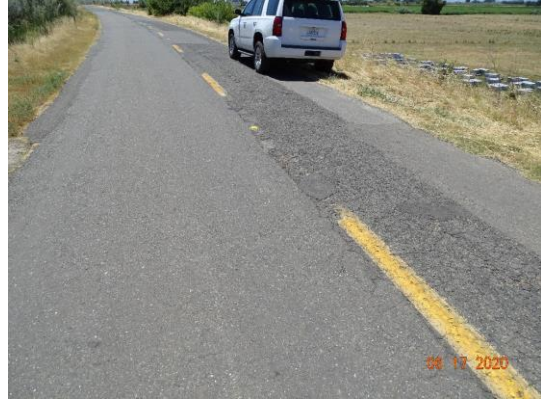
Photo 1 of 3 : UCIP_FA_2022_61301_89118.jpg

DS_ID:20840
FS_ID:61301
EP_NO: 11161
Repair Type: Urgent
EVAL Issue: 2b, Levee Integrity
Crossing Status: Found
UCIP Comments: 06/17/2020 Record is Urgent. Subsidence on landside shoulder measured 2' x 3' x 1.5'-deep around air vent. Crossing appears abandoned. Fence on landside slope and overgrown vegetation on both slopes prevent from detailed inspection of levee. No permit has been identified authorizing pipe. Need to have CVFPB review ABO and determine current owner. (O.Yakimov - DWR UCIP)
FIELD_STRUCT_DESC: 10-inch steel pipe through levee, 11.2 feet below crown. 2-inch air and vacuum valve and concrete spill box on landside of the levee. (10-inch pipe [HLM 3.57] authorized under Automatic Board Order (ABO) issued as Permit No. 11161, 1975 - L.J. Gamble & M. P. Darsie). [Additional Reference(s): DWR Levee Log, unk.yr. (HLM 3.57). USACE Sacramento O&M Manual, Unit 103, June 1954, Revised 29 December 2016, (Station 'R' 421+08.7), listed as 12-inch pipe. USACE As-Built Drawing No. 50-04-2671, Sheet 2, near Station 420+55, 25 January 1951, Revised 18 Dec. 1952, listed as 12-inch pipe. USACE As-Built Drawing No. 50-04-2631, Sheet 11, Station 421+08.7, March 1950, Revised 16 Dec.1952, listed as 12-inch pipe].

Top of Levee: View of levee crown looking downstream

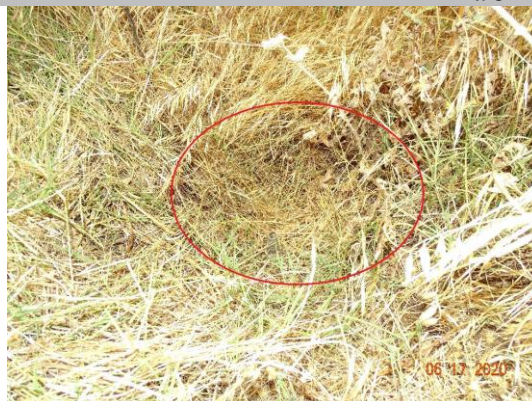
Photo 3 of 3 : UCIP_FA_2022_61301_89122.jpg

LM Start	3.57	Rating **	U	Issue No.	120 (cont)
LM End	3.57	Issue Type +	En	Location *	
Category	Supplemental			GPS Latitude/Longitude	
				Start	End
Item	DWR UCIP Field Study			38.205892 °	38.205892 °
				-121.541679 °	-121.541679 °
DWR ID	20840

Land-Side: Sinkhole around air vent on levee shoulder

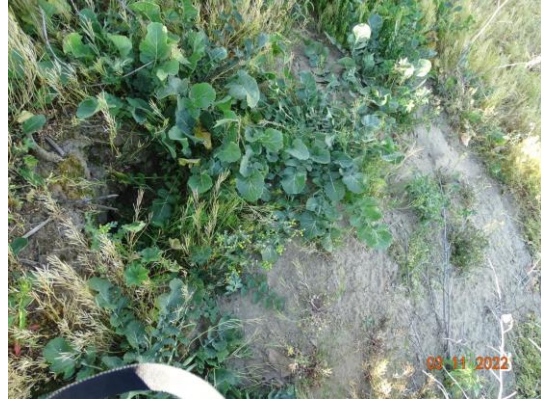
Photo 1 of 1 : FA_2022_RD0556_18_98_20220831_00054.jpg

LM Start	3.83	Rating **	M	Issue No.	98
LM End	3.83	Issue Type +	Ma	Location *	LS
Category	Earthen Levee			GPS Latitude/Longitude	
				Start	End
Item	Animal Control			38.202239 °	38.202239 °
				-121.540945 °	-121.540945 °
DWR ID	DWR_RD0556_01_s_2022_98				
Comment Code					
A1 : Exterminate rodents and backfill and compact or grout burrows.					
Inspector Comment					
One large fresh rodent hole. Multiple traps present.

View of large rodent hole in the landside slope (Spring 2022).

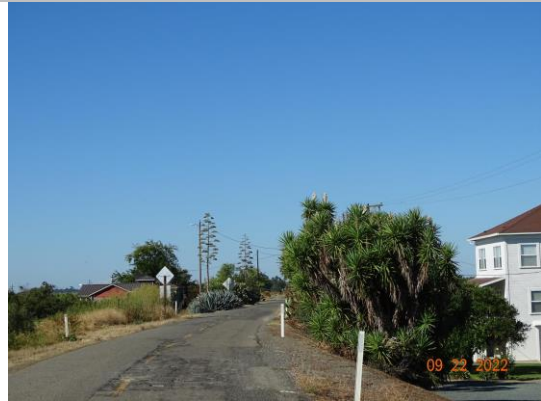
Photo 1 of 1 : FA_2022_RD0556_18_30_20221004_00189.jpg

LM Start	3.84	Rating **	U	Issue No.	30
LM End	3.91	Issue Type +	En	Location *	LS
Category	Earthen Levee			GPS Latitude/Longitude	
				Start	End
Item	Vegetation			38.202061 °	38.201672 °
				-121.541113 °	-121.542133 °
DWR ID	DWR_RD0556_01_f_2017_30				
Comment Code					
V6 : Landscaping					
Inspector Comment					
Trim/thin landscaping to allow inspection and access to levee slope and toe.

View of the landscaping on the LS slope (Fall 2022).

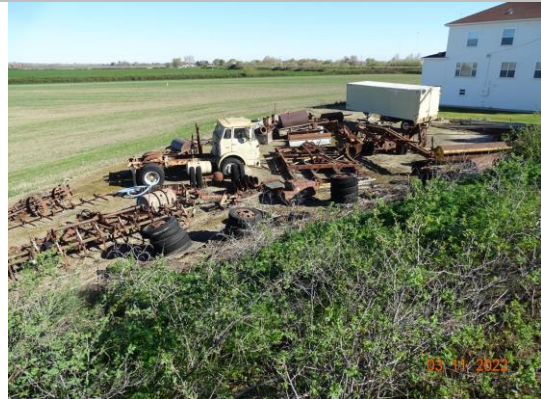
Photo 1 of 1 : FA_2022_RD0556_18_100_20220831_00056.jpg

LM Start	3.94	Rating **	M	Issue No.	100
LM End	3.94	Issue Type +	En	Location *	LS
Category	Earthen Levee			GPS Latitude/Longitude	
				Start	End
Item	Encroachments			38.201514 °	38.201514 °
				-121.542594 °	-121.542594 °
DWR ID	DWR_RD0556_01_s _ 2022_100				
Comment Code					
EQ : Equipment					
Inspector Comment					
Move equipment off of landside toe.

View of equipment stored at landside toe (Spring 2022).

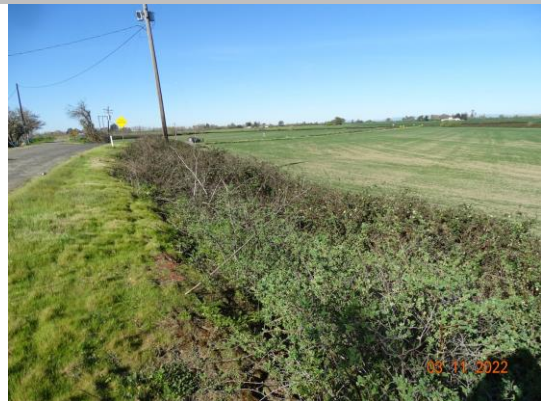
Photo 1 of 1 : FA_2022_RD0556_18_99_20220831_00055.jpg

LM Start	3.94	Rating **	U	Issue No.	99
LM End	3.96	Issue Type +	Ma	Location *	LS
Category	Earthen Levee			GPS Latitude/Longitude	
				Start	End
Item	Vegetation			38.201514 °	38.201402 °
				-121.542595 °	-121.542958 °
DWR ID	DWR_RD0556_01_s _ 2022_99				
Comment Code					
V2 : Remove the wild growth and woody vegetation other than native grasses from the levee slopes.					
Inspector Comment					
Blackberries on landside slope.

View looking downstream at vegetation on the landside slope (Spring 2022).

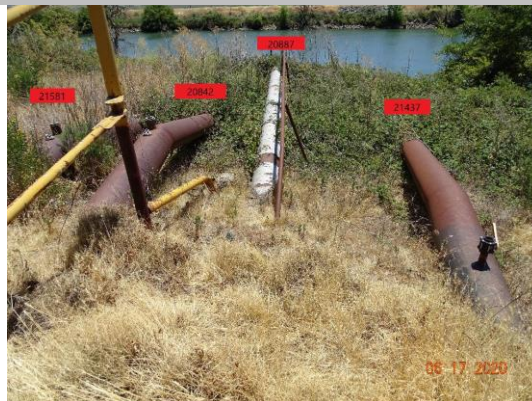
Photo 1 of 3 : UCIP_FA_2022_61315_89138.jpg

DS_ID:21581
FS_ID:61315
EP_NO: 13030
Repair Type: Non-Urgent
EVAL Issue: 10, Unauthorized Modification or Non-Compliant Permit
Crossing Status: Found
UCIP Comments: 06/17/2020 Record is Non-Urgent. Pipe diameter field measured as 20-inch on both slopes. On landside berm pipe diameter changes from 20 inch to 18 inch. Unable to find a permit for modification of this crossing. No permit has been identified authorizing original O&M pipe through the levee. (O.Yakimov - DWR UCIP)
FIELD_STRUCT_DESC: 18-inch steel drainage pipes through levee, 4.3 feet below crown. Pumps on landward side and 4-inch air valve. (18-inch pipe [HLM 4.01] authorized under Automatic Board Order (ABO) issued as Permit No. 11175, 1975 - RD0556). [Additional Reference(s): DWR Levee Log, unk.yr. (HLM 4.01). USACE Sacramento O&M Manual, Unit 103, June 1954, Revised 29 December 2016, (Station 397+36.3), listed as 20-inch pipe]. USACE As-Built Drawing No. 50-04-2631, Sheet 10, Station 397+36.3, March 1950, Revised 16 Dec.1952, listed as 20-inch pipe].

Water-Side: Pipes on waterside berm

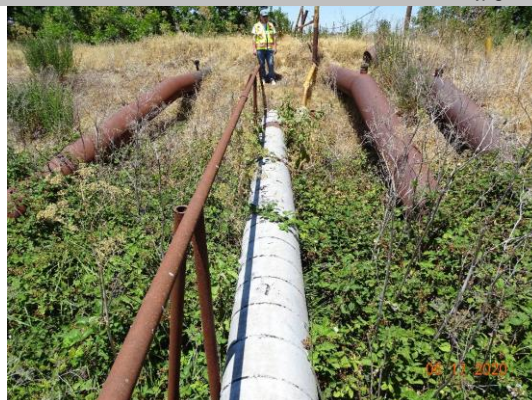
Photo 2 of 3 : UCIP_FA_2022_61315_89139.jpg

Water-Side: Pipes on waterside berm and levee slope on background

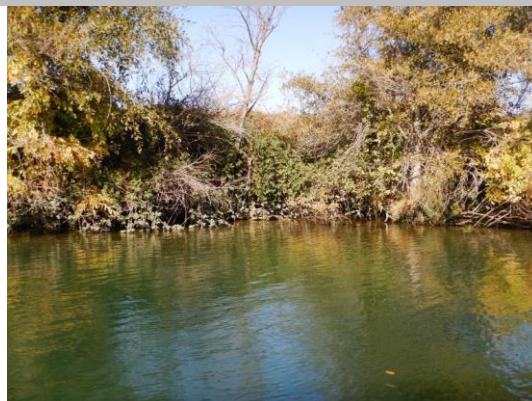
Photo 1 of 2 : FA_2022_RD0556_18_20_20220831_00004.jpg

2018 Site ID: GEO 7.0 R
 Status: Eroding
 2018 Field Notes: Minor new toe erosion.
 Site History: 1997 - Toe damaged rock. 1999 - One pocket filled with gravel. 2000 - Eroding beach with some biotech rolls and stakes; some gravel on slope. 2001 - Staked, low fascine walls at bankline. 2005 - Stone revetment in between pockets. 2006 - New rock on upper slope behind brush boxes at the upstream end. Stone is sliding off the hard toe. 2016 - Fresh erosion observed. 2017 - Site extended downstream. Large erosion pockets and significant toe erosion.

USACE 2018 Erosion Photo #1

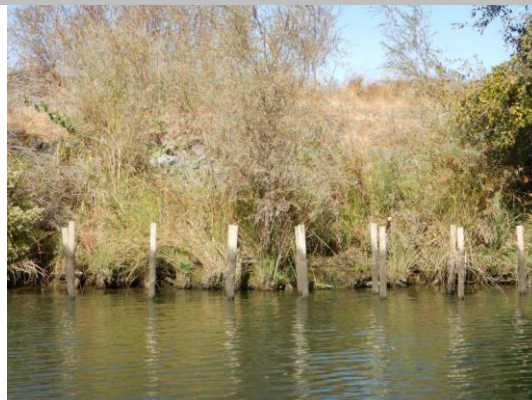
Photo 2 of 2 : FA_2022_RD0556_18_20_20220831_00005.jpg

USACE 2018 Erosion Photo #2

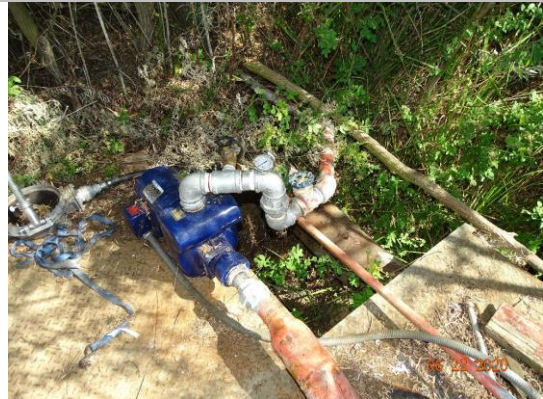
Photo 3 of 3 : UCIP_FA_2022_61308_89191.jpg

DS_ID:20847
FS_ID:61308
EP_NO: 10489
Repair Type: Non-Urgent
EVAL Issue: 10, Unauthorized Modification or Non-Compliant Permit
Crossing Status: Found
UCIP Comments: 06/22/2020 Record is Non-Urgent. Slant pump was removed and replaced with smaller pump on pile structure at riverbank. Unable to find a permit for modification. (O.Yakimov - DWR UCIP)
FIELD_STRUCT_DESC: 10-inch pipe through levee, 3.5 feet below crown. Pump on pile structure at riverbank. 1-inch electrical conduit through levee at this location. Siphon breaker in CMP riser on landward slope. A 9 ft x 42-inch concrete standpipe on landside. Service pole with electric meter and connection panel at landside toe. Two sand media filters on landside. This crossing replaces 6-inch pipe (see DSID 25650). (10-inch pipe authorized under Permit No. 10489, 1975 - Daecie and Gamble). [Additional Reference(s): DWR Levee Log, unk.yr. (HLM 5.32). USACE Sacramento O&M Manual, Unit 103, June 1954, Revised 29 December 2016, (Station 'R' 327+63.7), listed as 8-inch pipe. USACE As-Built Drawing No. 50-04-2631, Sheet 8, Station 327+63.7, March 1950, Revised 16 Dec.1952, listed as 8-inch pipe].

Water-Side: Pump on pile structure looks recently replaced
