**Flood Control Project Maintenance
Levee Inspections
Fall 2022 Levee Maintenance Deficiency Summary Report**

Sacramento River Basin

**Flood Control Project Maintenance
Levee Inspections
LMA District Cover Sheet**

Reclamation District No. 0556 Upper Andrus

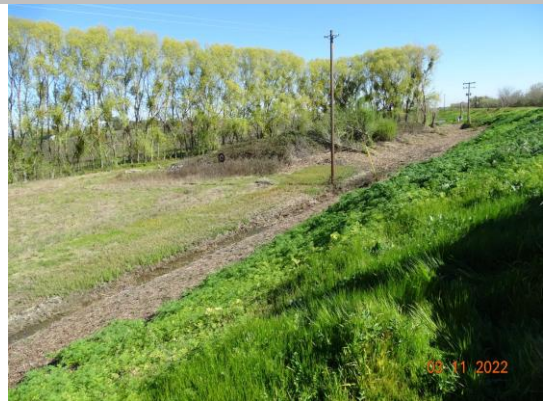
Photo 1 of 1 : FA_2022_RD0556_18_107_20220831_00058.jpg

LM Start	5.40	Rating **	A/W	Issue No.	107
LM End	5.40	Issue Type +	Ob	Location *	LS
Category	Earthen Levee			GPS Latitude/Longitude	
				Start	End
Item	Seepage / Sandboils			38.186915 °	38.186915 °
				-121.561320 °	-121.561320 °
DWR ID	DWR_RD0556_01_s_2022_107				
Comment Code					
SS : Seepage / Sandboils					
Inspector Comment					
Possible seepage at landside toe.

View of possible seepage in small ditch at landside toe (Spring 2022).

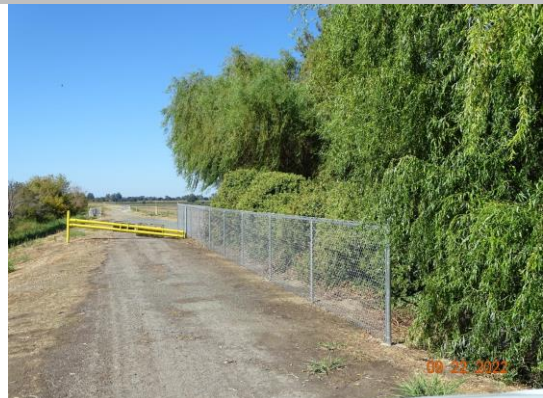
Photo 1 of 1 : FA_2022_RD0556_18_90_20221004_00191.jpg

LM Start	5.46	Rating **	M	Issue No.	90
LM End	5.48	Issue Type +	En	Location *	LS
Category	Earthen Levee			GPS Latitude/Longitude	
				Start	End
Item	Encroachments			38.186565 °	38.186479 °
				-121.562233 °	-121.562519 °
DWR ID	DWR_RD0556_01_f_2022_90				
Comment Code					
FE : Fence					
Inspector Comment

View of the fence on the on LS shoulder (Fall 2022).

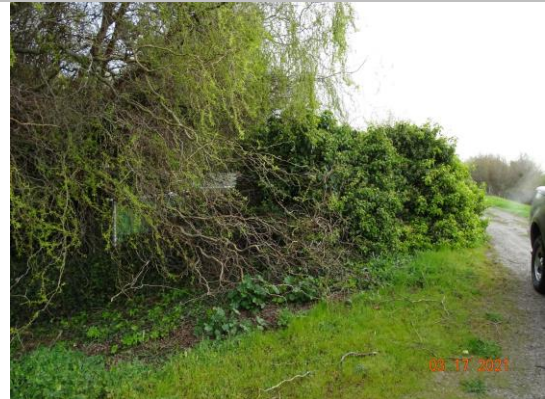
Photo 1 of 1 : FA_2022_RD0556_18_44_20220831_00029.jpg

LM Start	5.48	Rating **	U	Issue No.	44
LM End	5.48	Issue Type +	En	Location *	LS
Category	Earthen Levee			GPS Latitude/Longitude	
				Start	End
Item	Vegetation			38.186448 °	38.186447 °
				-121.562673 °	-121.562674 °
DWR ID	DWR_RD0556_01_s_2021_44				
Comment Code					
V6 : Landscaping					
Inspector Comment

View looking downstream landscaping shrubs on the landside slope (Spring 2021).

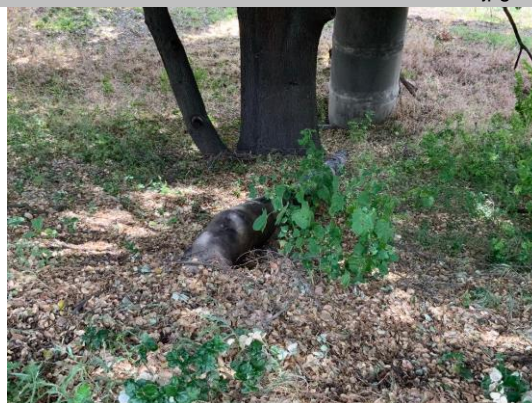
Photo 3 of 3 : UCIP_FA_2022_76291_113335.jpg

Comment Code					
Inspector Comment					
DS_ID:20858 FS_ID:76291 EP_NO: 11179 Repair Type: Urgent EVAL Issue: 2a, Levee Integrity Crossing Status: Found UCIP Comments: 05/12/2022 The record has been upgraded from No Action Needed to Urgent. WS slope and berm near water has significant erosion greater than 1 foot. There is also excavation around the WS berm exposing the pipe that is greater than 1 foot. Recommend inspection in excavations that are causing a safety hazard. Crossing will be monitored until funding becomes available to address the issues. No permit other than ABO was found authorizing this encroachment. CVFPB will need to review crossing to determine owner. The UCIP inspection was completed with GEI staff, A. Lau. (H. Dunn – GEI) FIELD_STRUCT_DESC: 12-inch irrigation discharge pipe of an unknown material through the levee, 4.8 feet below the crown. Pump on a pile structure in the river. Service pole on each slope. (Retention of a 12-inch pipe through the levee, 4.8 feet below the crown, a pump on a pile structure in the river, and a service pole on each slope authorized under Automatic Board Order (ABO) issued as Permit No. 11179, 1975 - George K. Adams Ranches, Inc). [Additional Reference(s): DWR Levee Log]. FS Date: 5/12/2022 1:22:06 PM

LS view: Closeup of exposed pipe on slope.

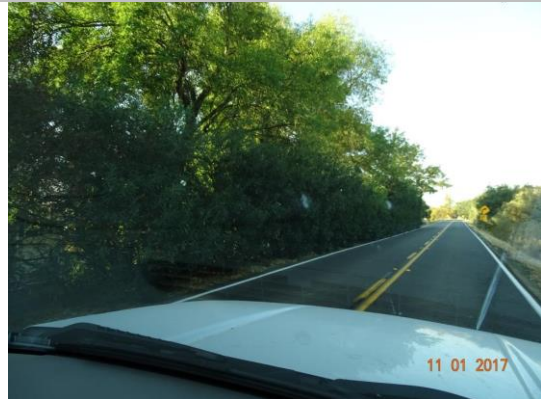
Photo 1 of 1 : FA_2022_RD0556_19_25_20220831_00018.jpg

LM Start	0.53	Rating **	U	Issue No.	25
LM End	0.56	Issue Type +	En	Location *	LS
Category	Earthen Levee			GPS Latitude/Longitude	
				Start	End
Item	Vegetation			38.237833 °	38.237725 °
				-121.527766 °	-121.528428 °
DWR ID	DWR_RD0556_02_f _ 2017_25				
Comment Code					
V6 : Landscaping					
Inspector Comment					
Trim/thin oleanders on the landside of the levee.

View of oleanders on the landside of the levee.

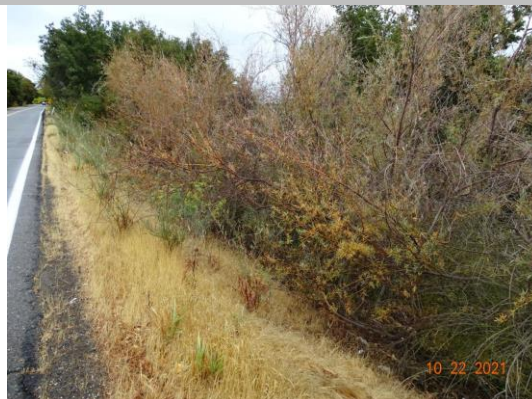
Photo 1 of 1 : FA_2022_RD0556_19_81_20220831_00058.jpg

LM Start	0.74	Rating **	U	Issue No.	81
LM End	0.85	Issue Type +	Ma	Location *	LS
Category	Earthen Levee			GPS Latitude/Longitude	
				Start	End
Item	Trim / Thin Trees			38.237577 °	38.237842 °
				-121.531594 °	-121.533616 °
DWR ID	DWR_RD0556_02_s_2021_81				
Comment Code					
T1 : Trim and thin trees to at least five feet above ground level to allow visibility of the ground and room to flood fight.					
Inspector Comment

View looking upstream at thick vegetation on the landside slope (Fall 2021).

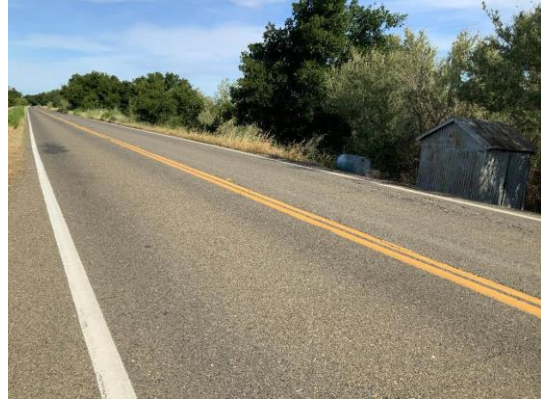
Photo 1 of 3 : UCIP_FA_2022_76293_113385.jpg

DS_ID:20851
FS_ID:76293
EP_NO: 11186
Repair Type: Non-Urgent
EVAL Issue: 6, Levee Damage or Threat for Levee Damage
Crossing Status: Found
UCIP Comments: 05/12/2022 The record remains Non-Urgent. The plastic tank on WS is still leaking, causing minor erosion on the WS slope. Recommend repair of tank or hose to prevent further erosion. No permit other than ABO permit was found authorizing this encroachment. CVFPB will need to review crossing to determine owner. The UCIP inspection was completed with GEI staff, A. Lao. (H. Dunn – GEI)

04/25/2013 a concrete box on LS. Water is leaking from priming plastic tank and causing surface erosion on levee slope. (P. Amatya - DWR)
FIELD_STRUCT_DESC: 4-inch steel irrigation discharge pipe through the levee, 4.3 feet below the crown. Pump and gate valve in a pump house on the waterside (WS) berm. Siphon breaker and service pole on the landside (LS) slope. Concrete spill box with three 8-inch openings. (Retention of a 4-inch pipe through the levee, 4.3 feet below the crown, a pump in a pump house on the WS berm, and a siphon breaker and a service pole on the LS slope authorized under Automatic Board Order (ABO) issued as Permit No. 11186, 1975 - Margaret M. Marks).
[Additional Reference(s): DWR Levee Log. USACE Sacramento O&M Manual 103, June 1954, (Station ""J"" 192+00), 6-inch pipe referenced, invert elevation 18.8 feet].
FS Date: 5/12/2022 3:13:00 PM

Levee crown.

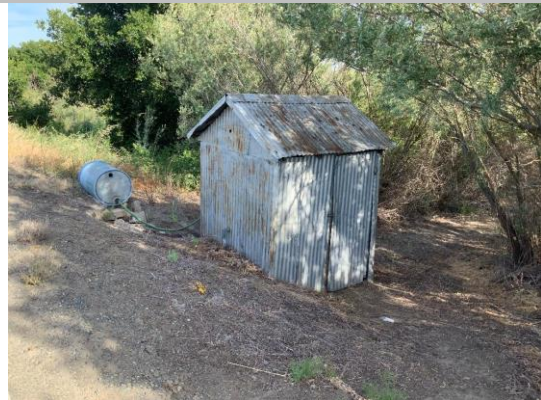
Photo 2 of 3 : UCIP_FA_2022_76293_113386.jpg

WS view: Pump house and tank on slope from crown.

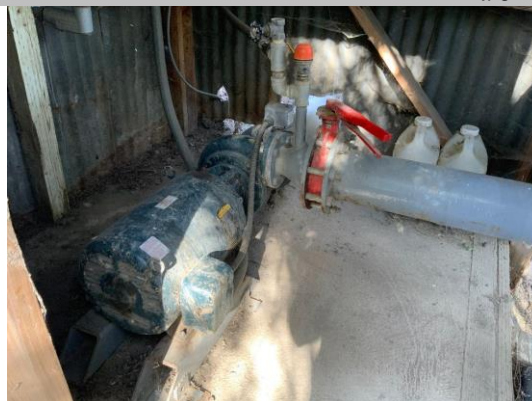
Photo 3 of 3 : UCIP_FA_2022_76293_113380.jpg

WS view: Closeup of pump in pumphouse on slope.

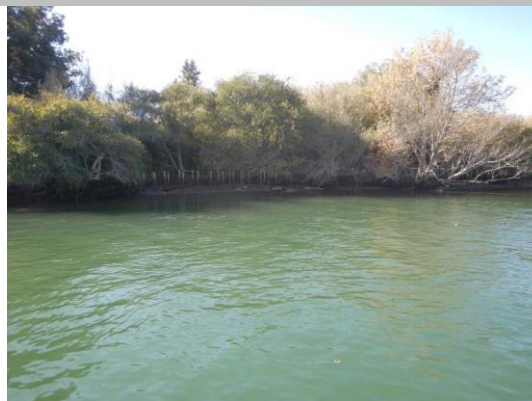
Photo 1 of 2 : FA_2022_RD0556_19_19_20220831_00015.jpg

2018 Site ID: SAC 25.2 L
 Status: Eroding
 2018 Field Notes: Additional erosion along toe. Site extended upstream.
 Site History: 1997 - Rock is in poor condition and has failed in many places. Scallops in berm with remnants of old rock in the toe area.
 2005 - Brush boxes present. 2013 - Site extended upstream approximately 300 ft to include new erosion pockets. 2015 - Minor new erosion at toe. 2017 - Minor new erosion observed.

USACE 2018 Erosion Photo #1

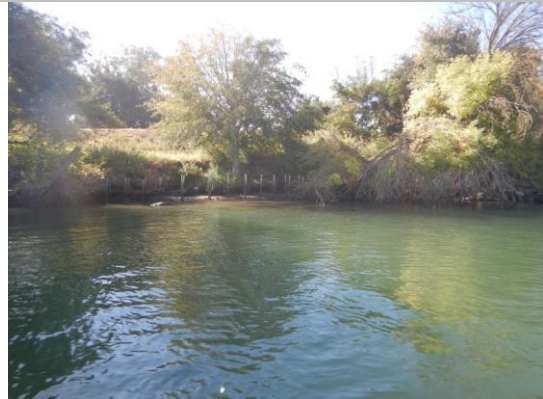
Photo 2 of 2 : FA_2022_RD0556_19_19_20220831_00016.jpg

USACE 2018 Erosion Photo #2

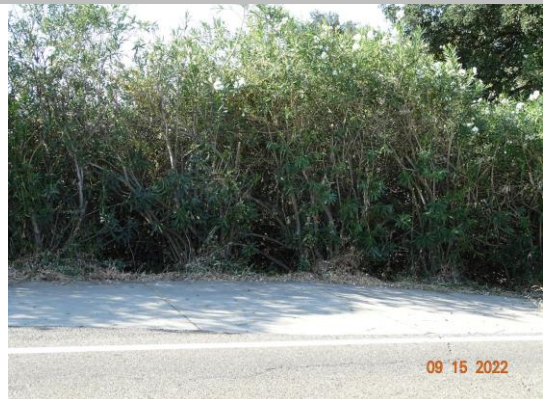
Photo 1 of 1 : FA_2022_RD0556_19_26_20221003_00069.jpg

LM Start	1.11	Rating **	U	Issue No.	26
LM End	1.11	Issue Type +	En	Location *	LS
Category	Earthen Levee			GPS Latitude/Longitude	
				Start	End
Item	Vegetation			38.238857 °	38.238857 °
				-121.538310 °	-121.538310 °
DWR ID	DWR_RD0556_02_f _ 2017_26				
Comment Code					
V6 : Landscaping					
Inspector Comment					
Trim/thin oleanders on the landside of the levee.

View of the oleander on the LS slope (Fall 2022).

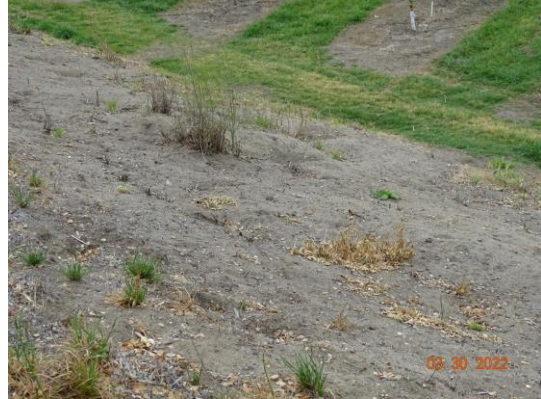
Photo 1 of 1 : FA_2022_RD0556_19_75_20220831_00053.jpg

LM Start	1.20	Rating **	M	Issue No.	75
LM End	1.26	Issue Type +	Ma	Location *	LS
Category	Earthen Levee			GPS Latitude/Longitude	
				Start	End
Item	Animal Control			38.239226 °	38.239473 °
				-121.539869 °	-121.540962 °
DWR ID	DWR_RD0556_02_s_2022_75				
Comment Code					
A3 : No rodents visible, but rodent burrows visible; need to backfill and compact or grout burrows.					
Inspector Comment

View of animal holes in the landside slope (Spring 2022).

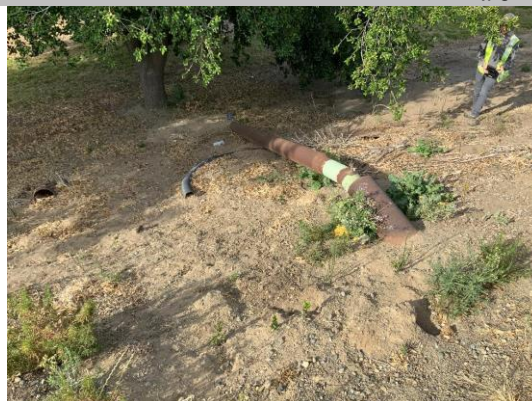
Photo 2 of 3 : UCIP_FA_2022_76294_113392.jpg

LS view: Pipe visible on the slope from crown.

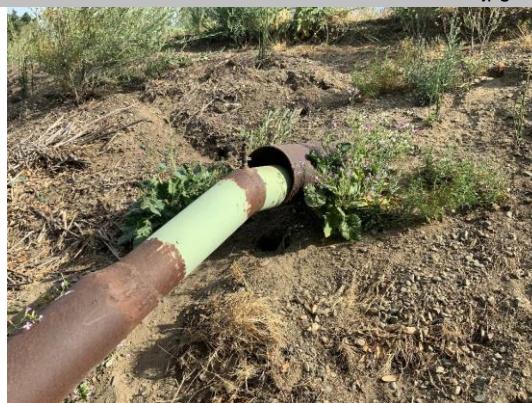
Photo 3 of 3 : UCIP_FA_2022_76294_113393.jpg

LS view: Closeup of gap between pipe on slope.

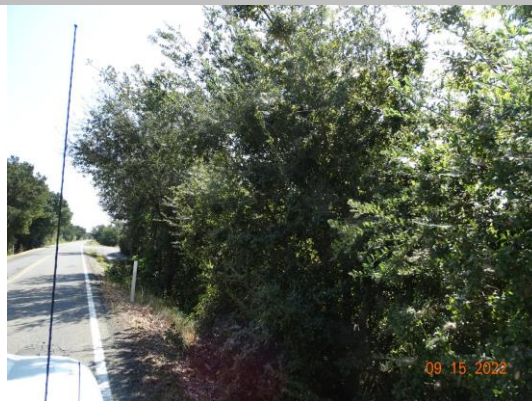
Photo 1 of 1 : FA_2022_RD0556_19_115_20221003_00086.jpg

LM Start	1.32	Rating **	M	Issue No.	115
LM End	1.32	Issue Type +	Ma	Location *	LS
Category	Earthen Levee			GPS Latitude/Longitude	
				Start	End
Item	Trim / Thin Trees			38.239681 °	38.239681 °
				-121.541945 °	-121.541945 °
DWR ID	DWR_RD0556_02_f_2021_115				
Comment Code					
T1 : Trim and thin trees to at least five feet above ground level to allow visibility of the ground and room to flood fight.					
Inspector Comment

View of the trees on the LS slope (Fall 2022).

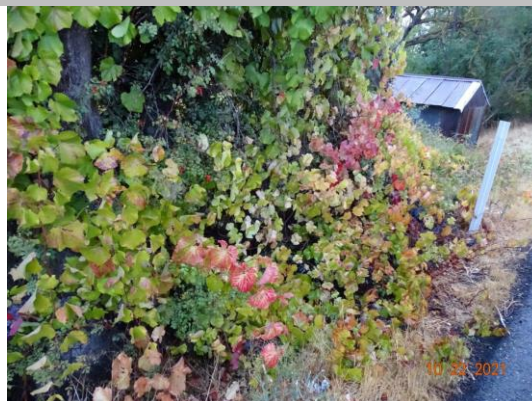
Photo 1 of 1 : FA_2022_RD0556_19_40_20220831_00029.jpg

LM Start	1.43	Rating **	U	Issue No.	40
LM End	1.43	Issue Type +	Ma	Location *	WS
Category	Earthen Levee			GPS Latitude/Longitude	
				Start	End
Item	Trim / Thin Trees			38.240060 °	38.240060 °
				-121.543884 °	-121.543884 °
DWR ID	DWR_RD0556_02_f_2021_40				
Comment Code					
T1 : Trim and thin trees to at least five feet above ground level to allow visibility of the ground and room to flood fight.					
Inspector Comment

View looking upstream at thick vegetation on the waterside slope (Fall 2021).

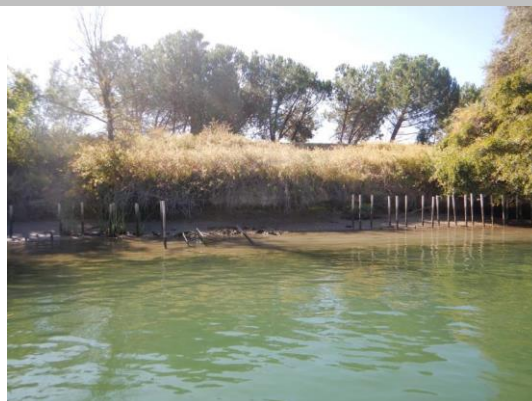
Photo 1 of 2 : FA_2022_RD0556_19_18_20220831_00013.jpg

LM Start	1.45	Rating **	M	Issue No.	18	
LM End	1.59	Issue Type +	Ma	Location *	WS	
Category	Supplemental			GPS Latitude/Longitude		
				Start	End	
Item	2018 USACE Erosion Survey			38.240401 °	38.240772 °	
				-121.544106 °	-121.546791 °	
DWR ID	DWR_RD0556_02_s_2022_18					
Comment Code						
Inspector Comment						
2018 Site ID: SAC 24.8 L						
Status: Eroding						
2018 Field Notes: Site extended upstream.						
Site History: 1997 - Slow erosion of the berm at the waterline; bench below water. 2005 - Brush boxes present. 2010 - Minor new erosion.						
2013 - There is little to no berm remaining at downstream end of this site. 2016 - New erosion on levee slope. 2017 - Significant lower bank erosion.

USACE 2018 Erosion Photo #1

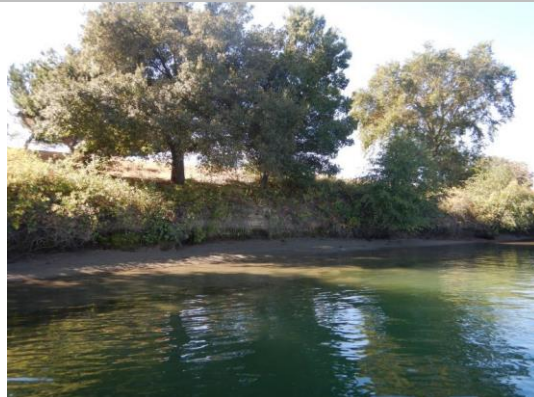
Photo 2 of 2 : FA_2022_RD0556_19_18_20220831_00014.jpg

USACE 2018 Erosion Photo #2

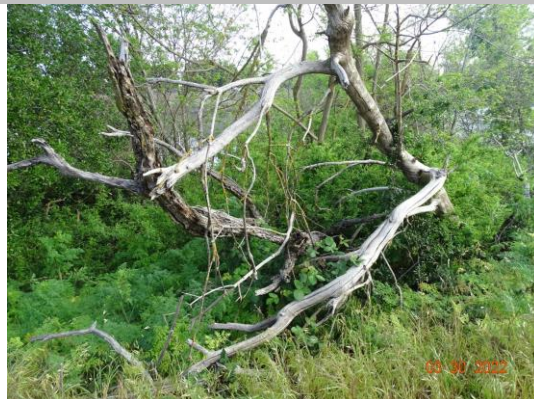
Photo 1 of 1 : FA_2022_RD0556_19_50_20220831_00036.jpg

LM Start	1.47	Rating **	U	Issue No.	50
LM End	1.47	Issue Type +	Ma	Location *	WS
Category	Earthen Levee			GPS Latitude/Longitude	
				Start	End
Item	Trim / Thin Trees			38.240183 °	38.240183 °
				-121.544567 °	-121.544567 °
DWR ID	DWR_RD0556_02_f_2021_50				
Comment Code					
T2 : Tree or limb.					
Inspector Comment

View of down tree on the landside slope (Spring 2022).

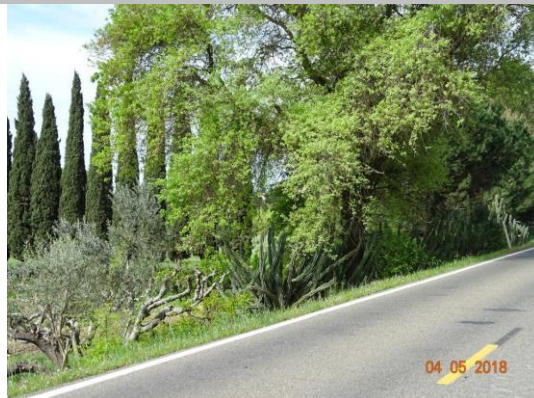
Photo 1 of 1 : FA_2022_RD0556_19_41_20220831_00030.jpg

LM Start	1.47	Rating **	U	Issue No.	41
LM End	1.47	Issue Type +	En	Location *	LS
Category	Earthen Levee			GPS Latitude/Longitude	
				Start	End
Item	Vegetation			38.240175 °	38.240175 °
				-121.544683 °	-121.544683 °
DWR ID	DWR_RD0556_02_s_2018_41				
Comment Code					
V6 : Landscaping					
Inspector Comment					
Cactus on the landside slope.

View of cactus and other landscaping.

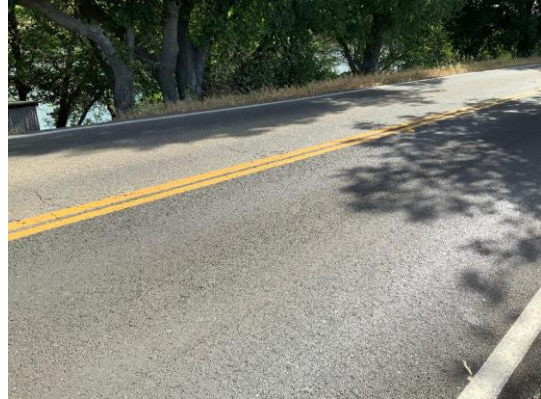
Photo 1 of 3 : UCIP_FA_2022_76296_113408.jpg

Comment Code					
Inspector Comment					
DS_ID:20854 FS_ID:76296 EP_NO: N/A Repair Type: Non-Urgent EVAL Issue: 10, Unauthorized Modification or Non-Compliant Permit Crossing Status: Found UCIP Comments: 05/12/2022 The record has been upgraded from No Action Needed to Non-Urgent. Modification of new filtration system on LS toe. No permit was found authorizing this encroachment. CVFPB will need to review crossing to determine owner. Pump was running during. The UCIP inspection was completed with GEI staff, A. Lao. (H. Dunn – GEI) 04/25/2013 Pump was running during field survey. (P. Amatya - DWR) FIELD_STRUCT_DESC: 8-inch steel irrigation discharge pipe through the levee, 5.5 feet below the crown. Pump and gate valve on the waterside (WS) berm. Siphon breaker and service pole on the landside (LS) slope. Concrete standpipe on the LS. (Retention of an 8-inch pipe through the levee, 7.7 feet below the crown, a pump and a gate valve in a pump house on the WS berm, and a siphon breaker and a service pole on the LS slope authorized under Automatic Board Order (ABO) issued as Permit No. 11181, 1975 - Robert E. and G. P. Collins). [Additional Reference(s): DWR Levee Log. USACE Sacramento O&M Manual 103, June 1954, (Station ""J"" 149+10), invert elevation 18.6 feet]. FS Date: 5/12/2022 3:39:19 PM

Levee crown.

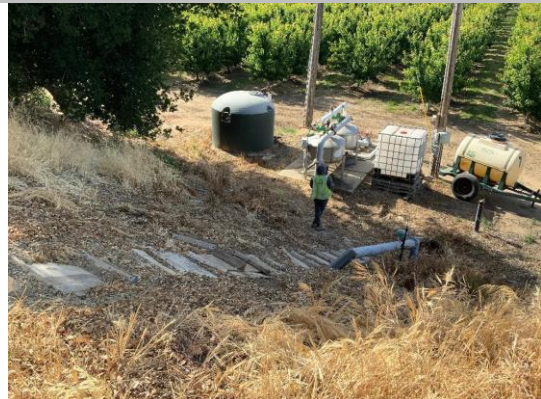
Photo 2 of 3 : UCIP_FA_2022_76296_113409.jpg

LS view: Slope with pipe and toe from crown.

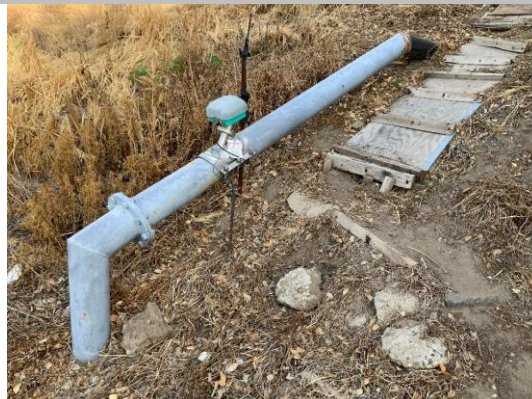
Photo 3 of 3 : UCIP_FA_2022_76296_113410.jpg

LS view: Closeup of pipe on slope from toe.

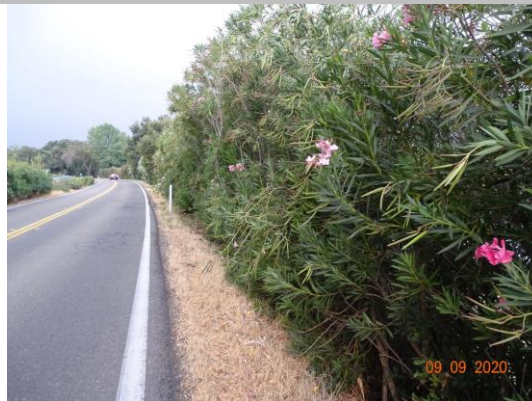
Photo 1 of 1 : FA_2022_RD0556_19_70_20220831_00050.jpg

LM Start	1.82	Rating **	U	Issue No.	70
LM End	1.92	Issue Type +	En	Location *	WS
Category	Earthen Levee			GPS Latitude/Longitude	
				Start	End
Item	Vegetation			38.241010 °	38.240618 °
				-121.551033 °	-121.552747 °
DWR ID	DWR_RD0556_02_f_2018_70				
Comment Code					
V6 : Landscaping					
Inspector Comment					
Thin oleanders to allow view down the levee slope.

View looking downstream at oleanders on the waterside slope (Fall 2020).

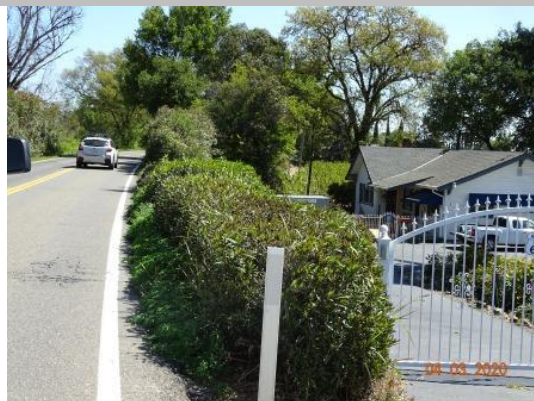
Photo 1 of 1 : FA_2022_RD0556_19_86_20220831_00060.jpg

LM Start	1.83	Rating **	U	Issue No.	86
LM End	1.87	Issue Type +	En	Location *	LS
Category	Earthen Levee			GPS Latitude/Longitude	
				Start	End
Item	Vegetation			38.240944 °	38.240851 °
				-121.551078 °	-121.551833 °
DWR ID	DWR_RD0556_02_s_2020_86				
Comment Code					
V6 : Landscaping					
Inspector Comment

View looking upstream at landscaping on the landside slope (Spring 2020).

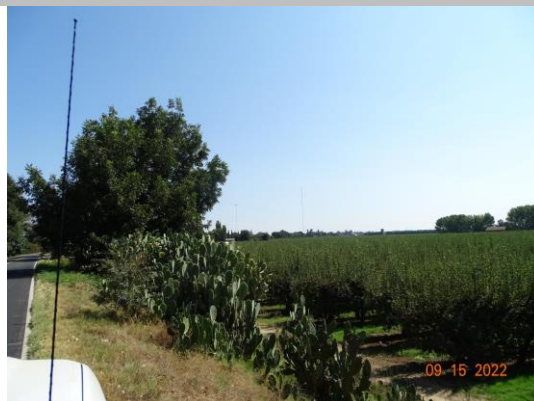
Photo 1 of 1 : FA_2022_RD0556_19_30_20221003_00084.jpg

LM Start	1.89	Rating **	U	Issue No.	30
LM End	1.99	Issue Type +	En	Location *	LS
Category	Earthen Levee			GPS Latitude/Longitude	
				Start	End
Item	Vegetation			38.240775 °	38.240024 °
				-121.552183 °	-121.553860 °
DWR ID	DWR_RD0556_02_f_2017_30				
Comment Code					
V6 : Landscaping					
Inspector Comment					
Remove cactus on the landside slope.

View of the cactus on the LS slope (Fall 2022).

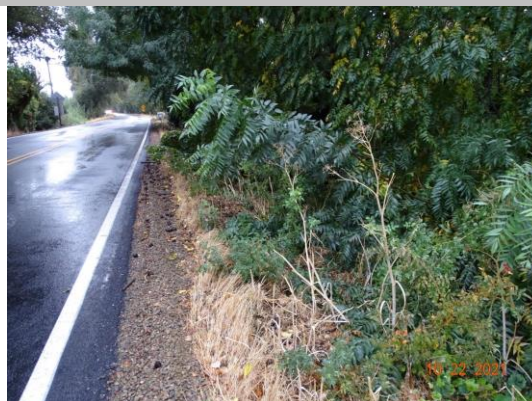
Photo 1 of 1 : FA_2022_RD0556_19_68_20220831_00049.jpg

LM Start	2.02	Rating **	U	Issue No.	68
LM End	2.06	Issue Type +	En	Location *	WS
Category	Earthen Levee			GPS Latitude/Longitude	
				Start	End
Item	Vegetation			38.239807 °	38.239409 °
				-121.554221 °	-121.554889 °
DWR ID	DWR_RD0556_02_f_2021_68				
Comment Code					
V6 : Landscaping					
Inspector Comment

View looking downstream at landscaping on the waterside slope (Fall 2021).

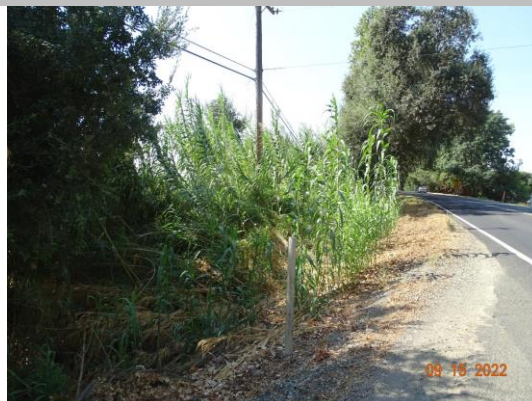
Photo 1 of 1 : FA_2022_RD0556_19_32_20221003_00083.jpg

LM Start	2.06	Rating **	U	Issue No.	32
LM End	2.06	Issue Type +	Ma	Location *	LS
Category	Earthen Levee			GPS Latitude/Longitude	
				Start	End
Item	Trim / Thin Trees			38.239470 °	38.239470 °
				-121.554845 °	-121.554845 °
DWR ID	DWR_RD0556_02_s_2020_32				
Comment Code					
T1 : Trim and thin trees to at least five feet above ground level to allow visibility of the ground and room to flood fight.					
Inspector Comment					
Arundo growth should be removed to allow inspection and access to the landside slope and toe.

View of the arundo on the LS slope (Fall 2022).

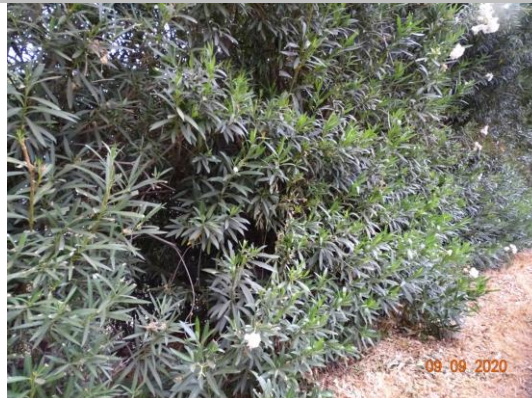
Photo 1 of 1 : FA_2022_RD0556_19_2_20220831_00002.jpg

LM Start	2.14	Rating **	U	Issue No.	2
LM End	2.14	Issue Type +	En	Location *	WS
Category	Earthen Levee			GPS Latitude/Longitude	
				Start	End
Item	Vegetation			38.238644 °	38.238644 °
				-121.555967 °	-121.555967 °
DWR ID	DWR_RD0556_02_f _ 2020_2				
Comment Code					
V6 : Landscaping					
Inspector Comment					
Trim oleanders on the waterside slope.

View looking upstream oleanders on the waterside slope (Fall 2020).

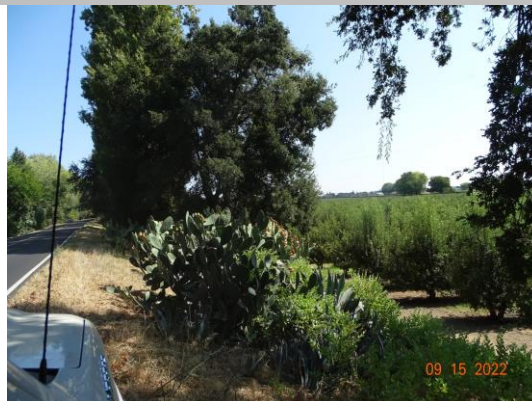
Photo 1 of 1 : FA_2022_RD0556_19_33_20221003_00082.jpg

LM Start	2.19	Rating **	U	Issue No.	33
LM End	2.22	Issue Type +	En	Location *	LS
Category	Earthen Levee			GPS Latitude/Longitude	
				Start	End
Item	Vegetation			38.238172 °	38.237883 °
				-121.556502 °	-121.556958 °
DWR ID	DWR_RD0556_02_f_2017_33				
Comment Code					
V6 : Landscaping					
Inspector Comment					
Large growth of prickly pear cactus should be removed to allow inspection and access.

View of the cactus on the LS slope (Fall 2022).

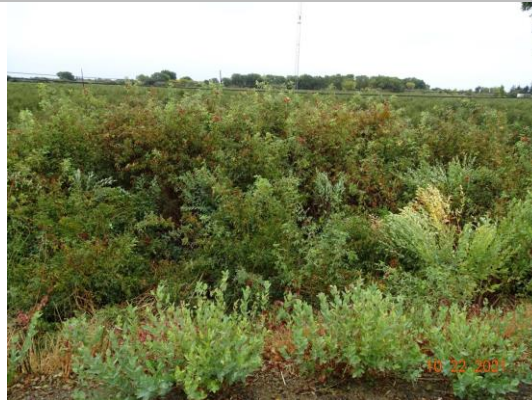
Photo 1 of 1 : FA_2022_RD0556_19_111_20220831_00066.jpg

LM Start	2.23	Rating **	U	Issue No.	111
LM End	2.23	Issue Type +	En	Location *	LS
Category	Earthen Levee			GPS Latitude/Longitude	
				Start	End
Item	Vegetation			38.237741 °	38.237741 °
				-121.557062 °	-121.557062 °
DWR ID	DWR_RD0556_02_f_2021_111				
Comment Code					
V6 : Landscaping					
Inspector Comment					
Cactus on landside slope.

View of thick vegetation on the landside slope (Fall 2021).

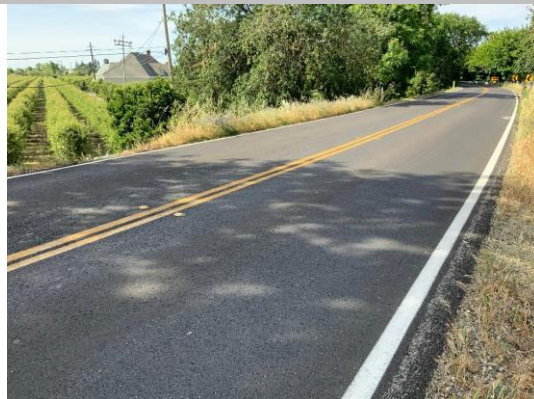
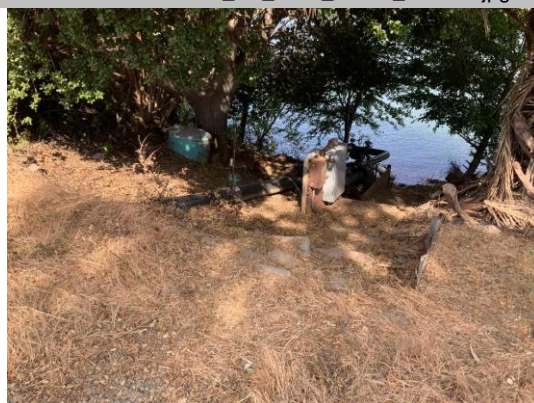
LM Start	2.25	Rating **	M	Issue No.	124 (cont)
LM End	2.25	Issue Type +	En	Location *

Comment Code						
Inspector Comment						
DS_ID:20857 FS_ID:76299 EP_NO: 5986 Repair Type: Non-Urgent EVAL Issue: 10, Unauthorized Modification or Non-Compliant Permit Crossing Status: Found UCIP Comments: 05/12/2022 The record has been upgraded from No Action Needed to Non-Urgent. Modifications to crossing, pump and pipe sections on WS appear new and new filtration system on LS toe . The UCIP inspection was completed with GEI staff, A. Lao. (H. Dunn – GEI)04/25/2013 Service pole on LS. Siphon breaker not found on landward slope. (P. Amatya - DWR) FIELD_STRUCT_DESC: 12-inch steel irrigation discharge pipe through the levee, 3.5 feet below the crown. Pump on the waterside (WS) slope. 1.25-inch electrical conduit through the levee. (Plans for installation of a pump on the WS berm and a discharge pipe through the levee authorized under Permit No. 5986, 1968 - Malcolm McCormack). [Additional Reference(s): DWR Levee Log]. FS Date: 5/12/2022 4:03:00 PM

Levee crown.

WS view: Toe from crown.

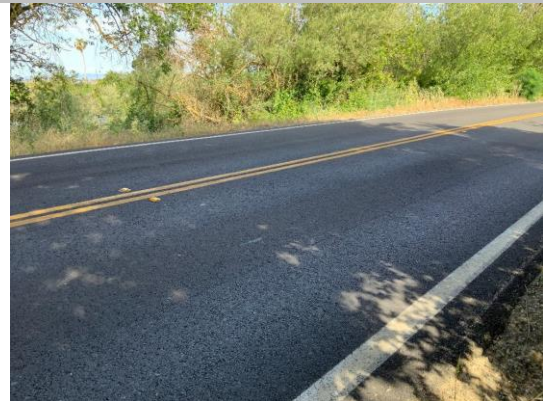
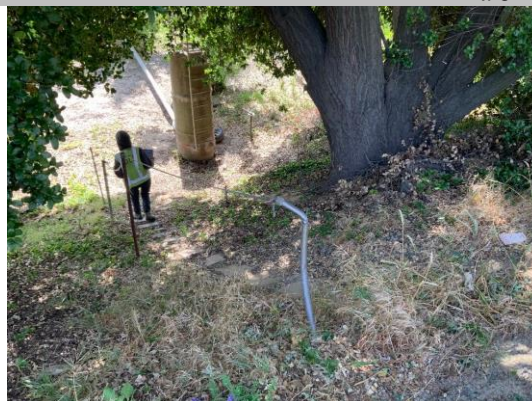
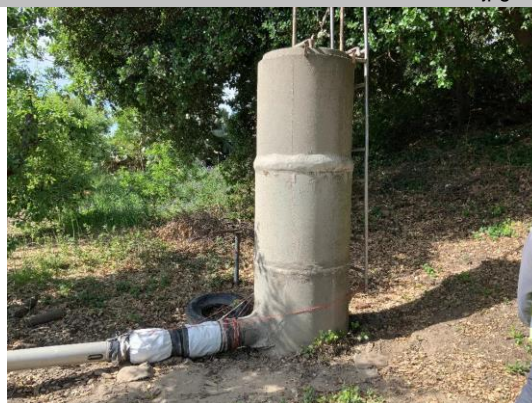
LM Start	2.42	Rating **	M	Issue No.	125 (cont)
LM End	2.42	Issue Type +	En	Location *	
Category	Supplemental		GPS Latitude/Longitude		
			Start	End	
Item	DWR UCIP Field Study		38.235261 °	38.235261 °	
			-121.558059 °	-121.558059 °	
DWR ID	20859

Comment Code					
Inspector Comment					
DS_ID:20859 FS_ID:76301 EP_NO: 11181 Repair Type: Non-Urgent EVAL Issue: 11, Maintenance Compliance Issue Crossing Status: Found UCIP Comments: 05/12/2022 The record remains Non-Urgent. LS riser is filled with dirt, recommend cleaning out. No permit other than ABO permit was found authorizing this encroachment. CVFPB will need to review crossing to determine owner. The UCIP inspection was completed with GEI staff, A. Lao. (H. Dunn – GEI) 04/25/2014 Needs to clean CMP riser for proper functioning of siphon breaker. (P. Amatya - DWR) FIELD_STRUCT_DESC: 10-inch steel irrigation discharge pipe through the levee, 5.8 feet below the crown. Pump and gate valve in a pump house on the waterside (WS) slope. Siphon breaker and service pole on the landside (LS) slope. (Retention of a 10-inch pipe through the levee, 5.8 feet below the crown, a pump and a gate valve in a pump house on the WS slope, and a siphon breaker and a service pole on the LS slope authorized under Automatic Board Order (ABO) issued as Permit No. 11181, 1975 - Robert E. and G. P. Collins). [Additional Reference(s): DWR Levee Log. USACE Sacramento O&M Manual 103, June 1954, (Station ""J"" 115+25), invert elevation 18.5 feet]. FS Date: 5/12/2022 4:20:11 PM

Levee crown.

LS view: Riser visible at toe from crown.

LS view: Closeup of riser and pipe at toe.

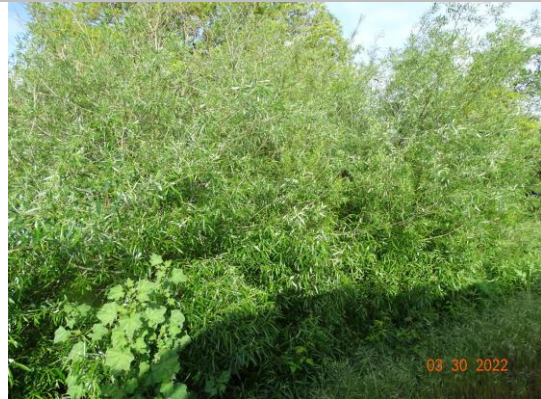
Photo 1 of 1 : FA_2022_RD0556_19_90_20220831_00063.jpg

LM Start	2.44	Rating **	U	Issue No.	90
LM End	2.44	Issue Type +	Ma	Location *	WS
Category	Earthen Levee			GPS Latitude/Longitude	
				Start	End
Item	Trim / Thin Trees			38.234843 °	38.234843 °
				-121.558028 °	-121.558028 °
DWR ID	DWR_RD0556_02_f _ 2021_90				
Comment Code					
T1 : Trim and thin trees to at least five feet above ground level to allow visibility of the ground and room to flood fight.					
Inspector Comment

View of thick willows on the waterside slope (Spring 2022).

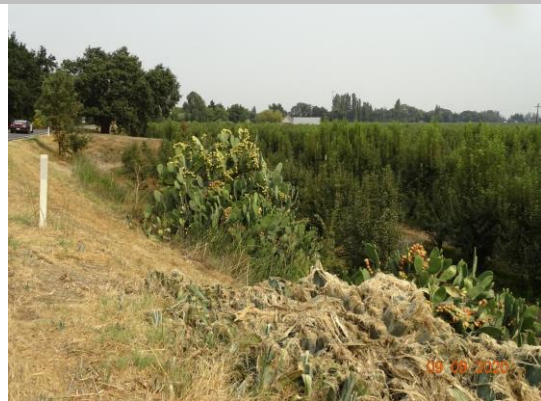
Photo 1 of 1 : FA_2022_RD0556_19_76_20220831_00054.jpg

LM Start	2.54	Rating **	U	Issue No.	76
LM End	2.54	Issue Type +	En	Location *	LS
Category	Earthen Levee			GPS Latitude/Longitude	
				Start	End
Item	Vegetation			38.233487 °	38.233487 °
				-121.557639 °	-121.557639 °
DWR ID	DWR_RD0556_02_s_2020_76				
Comment Code					
V6 : Landscaping					
Inspector Comment					
Remove cactus on the landside toe.

View of large cactus on the landside slope (Fall 2020).

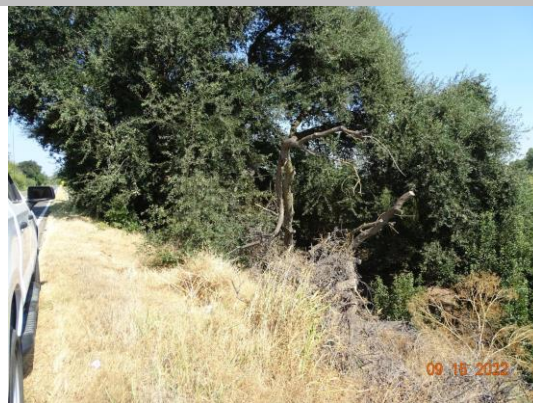
Photo 1 of 1 : FA_2022_RD0556_19_88_20221003_00080.jpg

LM Start	2.75	Rating **	U	Issue No.	88
LM End	2.75	Issue Type +	Ma	Location *	LS
Category	Earthen Levee			GPS Latitude/Longitude	
				Start	End
Item	Trim / Thin Trees			38.230752 °	38.230752 °
				-121.556007 °	-121.556007 °
DWR ID	DWR_RD0556_02_f_2019_88				
Comment Code					
T2 : Tree or limb.					
Inspector Comment					
Broken tree limb blocking view of landside slope.

View of the tree limb on the LS slope (Fall 2022).

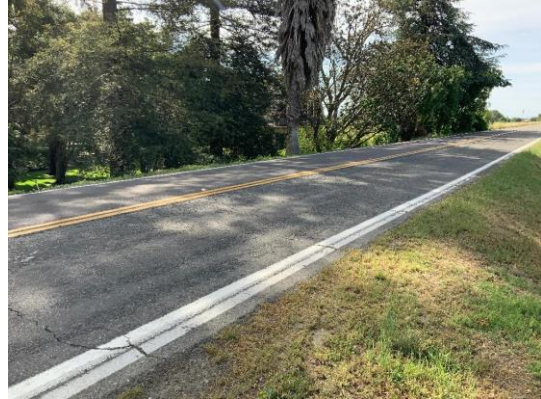
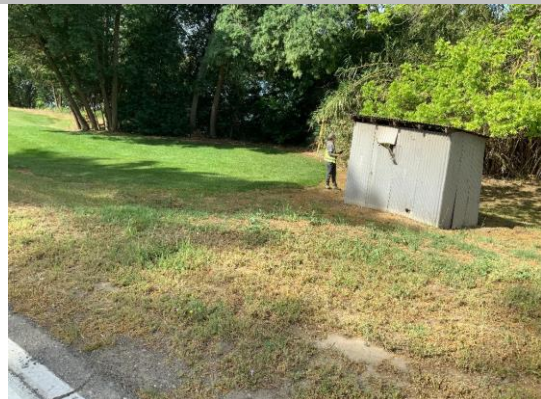
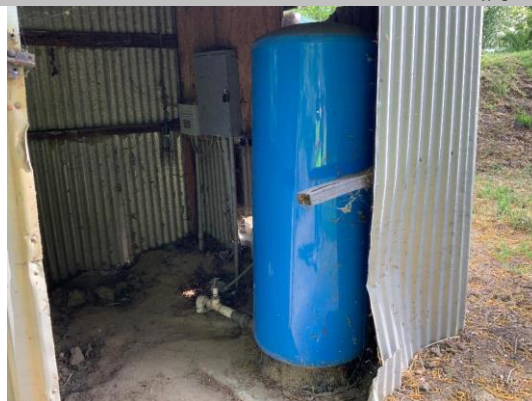
LM Start	2.84	Rating **	M	Issue No.	126 (cont)
LM End	2.84	Issue Type +	En	Location *

Comment Code					
Inspector Comment					
DS_ID:20849 FS_ID:76302 EP_NO: 11181 Repair Type: Non-Urgent EVAL Issue: 11, Maintenance Compliance Issue Crossing Status: Found UCIP Comments: 05/12/2022 The record remains Non-Urgent. Appears abandoned, no pump or pipe seen in WS pumphouse. Owner will need to coordinate with the CVFPB to meet Title 23 requirements. LS riser is filled with dirt, recommend removal if still in use. No permit other than ABO permit was found authorizing this encroachment. CVFPB will need to review crossing to determine owner. The UCIP inspection was completed with GEI staff, A. Lao. (H. Dunn – GEI) 04/25/2014 Needs to clean siphon breaker CMP riser. (P. Amatya - DWR) FIELD_STRUCT_DESC: 6-inch irrigation discharge pipe of an unknown material through the levee, 6 feet below the crown. Pressure tank in a pump house on the waterside (WS) berm. Service pole, siphon breaker, and distribution box on the landside (LS) slope. (Retention of a 6-inch pipe through the levee, 6 feet below the crown; a pump, a gate valve, and a pressure tank on the WS berm; and a service pole on the LS slope authorized under Automatic Board Order (ABO) issued as Permit No. 11181, 1975 - Robert E. and G. P. Collins). [Additional Reference(s): DWR Levee Log]. FS Date: 5/12/2022 4:27:14 PM

Levee crown.

WS view: Pumphouse visible on toe from crown.

WS view: Tank inside pumphouse, no pump.

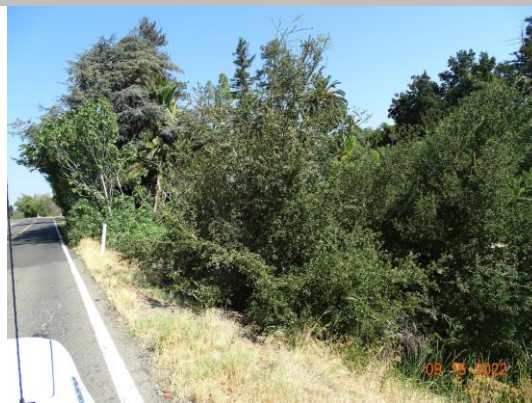
Photo 1 of 1 : FA_2022_RD0556_19_46_20221003_00079.jpg

LM Start	2.86	Rating **	U	Issue No.	46
LM End	2.87	Issue Type +	En	Location *	LS
Category	Earthen Levee			GPS Latitude/Longitude	
				Start	End
Item	Vegetation			38.229195 °	38.229082 °
				-121.555337 °	-121.555316 °
DWR ID	DWR_RD0556_02_f_2019_46				
Comment Code					
V6 : Landscaping					
Inspector Comment

View of the landscaping on the LS slope (Fall 2022).

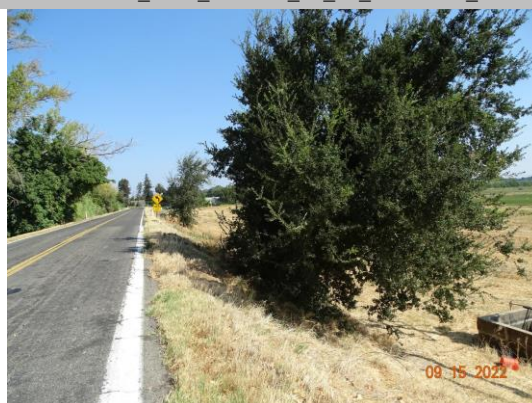
Photo 1 of 1 : FA_2022_RD0556_19_62_20221003_00078.jpg

LM Start	3.07	Rating **	M	Issue No.	62
LM End	3.07	Issue Type +	Ma	Location *	LS
Category	Earthen Levee			GPS Latitude/Longitude	
				Start	End
Item	Trim / Thin Trees			38.226265 °	38.226265 °
				-121.555233 °	-121.555233 °
DWR ID	DWR_RD0556_02_s_2022_62				
Comment Code					
T1 : Trim and thin trees to at least five feet above ground level to allow visibility of the ground and room to flood fight.					
Inspector Comment

View of the tree on the LS slope (Fall 2022).

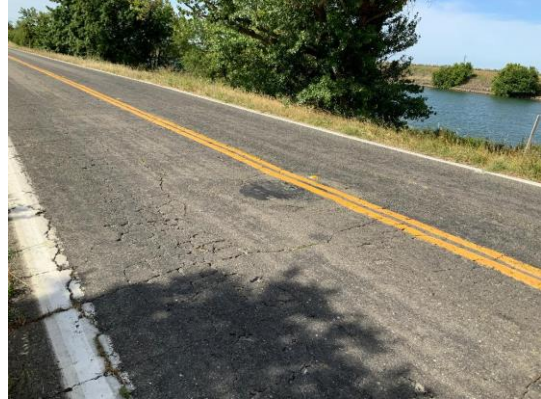
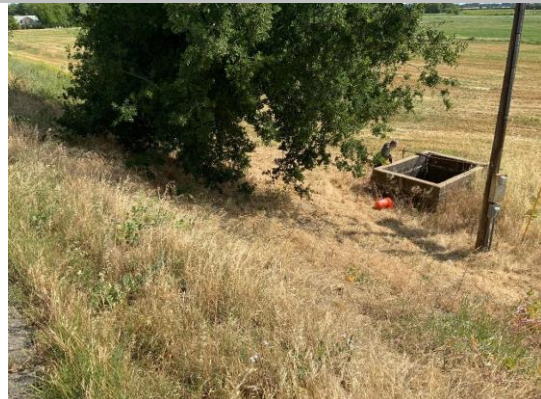
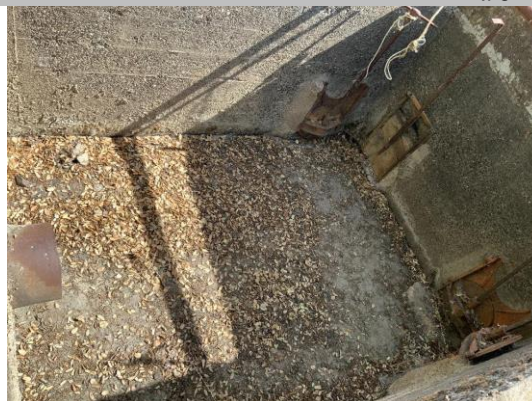
LM Start	3.07	Rating **	U	Issue No.	127 (cont)
LM End	3.07	Issue Type +	En	Location *

Comment Code					
Inspector Comment					
DS_ID:20862 FS_ID:76303 EP_NO: N/A Repair Type: Urgent EVAL Issue: 3b, Flood Risk Crossing Status: Found UCIP Comments: 05/12/2022 Record updated from Non-Urgent to Urgent. Modification of sleeving the pipe, and gap in between pipe and sleeve, causes flood risk concern. The UCIP inspection was completed with GEI staff, A. Lao. (H. Dunn – GEI) 04/25/2013 9-inch steel pipe sleeved through 12-inch pipe. Needs to seal gap between two pipes. (P. Amatya - DWR) FIELD_STRUCT_DESC: 9-inch steel pipe sleeved through a 12-inch steel irrigation discharge pipe through the levee, 6 feet below the crown. Pump on a pile structure in the river. Steel walkway to the pump and wood steps on the waterside (WS) slope. Concrete spill box with two 8-inch openings. (12-inch steel discharge pipe (F) authorized under Permit No. 1173, 1947 - Reclamation District No. 556). (Retention of a 12-inch pipe through the levee, 6 feet below the crown, a pump on a pile structure in the river, a steel walkway to the pump, and wood steps on the WS slope authorized under Automatic Board Order (ABO) issued as Permit No. 11193, 1975 - Gertrude M. Reid). [Additional Reference(s): DWR Levee Log. USACE Sacramento O&M Manual 103, June 1954, (Station ""J"" 80+79), invert elevation 18.3 feet]. FS Date: 5/12/2022 12:09:29 PM

Levee crown.

LS view: Distribution box at toe from crown.

LS view: Pipe outlet in box at toe.

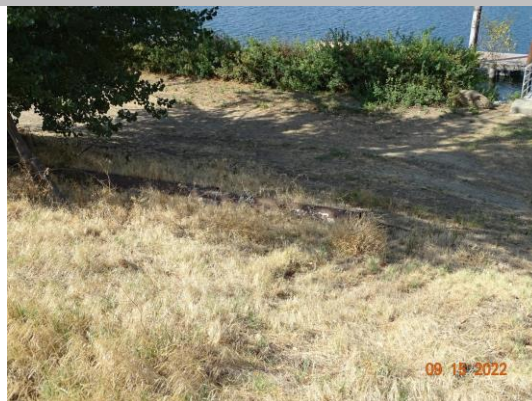
Photo 1 of 1 : FA_2022_RD0556_19_59_20221003_00077.jpg

LM Start	3.07	Rating **	M	Issue No.	59
LM End	3.07	Issue Type +	En	Location *	WS
Category	Earthen Levee			GPS Latitude/Longitude	
				Start	End
Item	Encroachments			38.226155 °	38.226155 °
				-121.555273 °	-121.555273 °
DWR ID	DWR_RD0556_02_f _ 2019_59				
Comment Code					
MA : Material					
Inspector Comment					
There is an abandoned uninstalled pipe on waterside.

View of the abandoned pipe along the WS toe (Fall 2022).

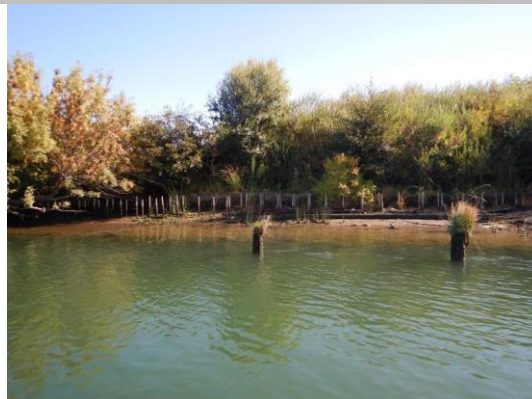
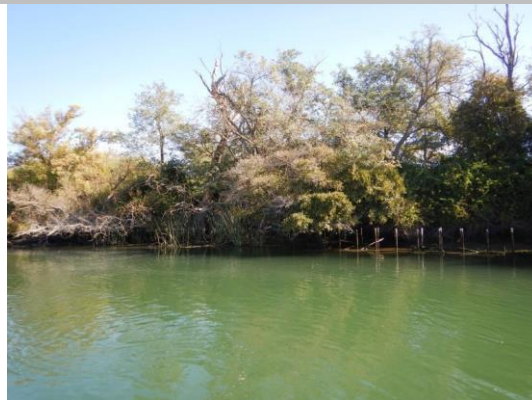
LM Start	3.16	Rating **	M	Issue No.	17 (cont)
LM End	3.28	Issue Type +	Ma	Location *	WS

2018 Site ID: SAC 23.2 L
 Status: Eroding
 2018 Field Notes: Additional tree popouts and new erosion throughout site.
 Site History: 2000 - Recently fallen cottonwood at the downstream end.
 2005 - Empty brush boxes. 2011 - A few trees have fallen since last year.
 2012 - Potential new tree popout since last year. 2013 - New erosion at downstream end of site and a recent tree pop-out observed.
 2016 - New erosion at the toe. 2017 - New erosion along lower bank.

USACE 2018 Erosion Photo #1

USACE 2018 Erosion Photo #2

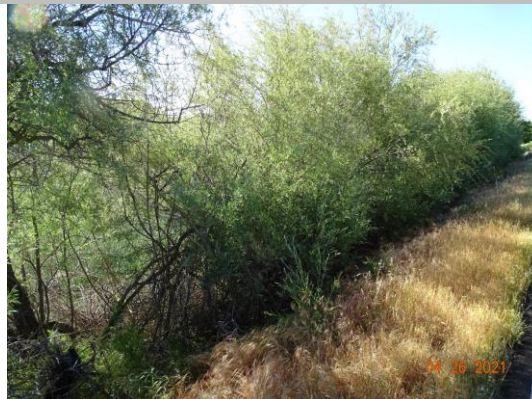
Photo 1 of 1 : FA_2022_RD0556_19_61_20220831_00045.jpg

LM Start	3.24	Rating **	U	Issue No.	61
LM End	3.26	Issue Type +	Ma	Location *	LS
Category	Earthen Levee			GPS Latitude/Longitude	
				Start	End
Item	Trim / Thin Trees			38.223707 °	38.223457 °
				-121.555396 °	-121.555414 °
DWR ID	DWR_RD0556_02_s_2021_61				
Comment Code					
T1 : Trim and thin trees to at least five feet above ground level to allow visibility of the ground and room to flood fight.					
Inspector Comment

View looking downstream at willows on the landside slope (Spring 2021).

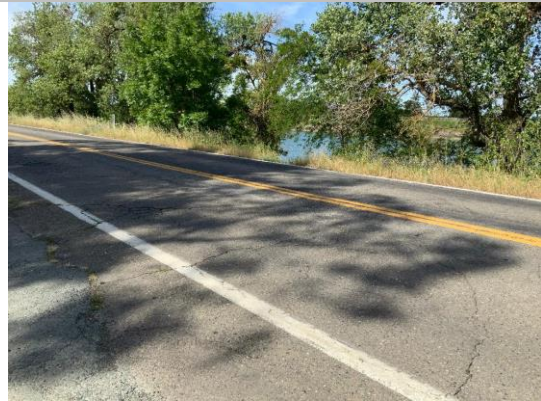
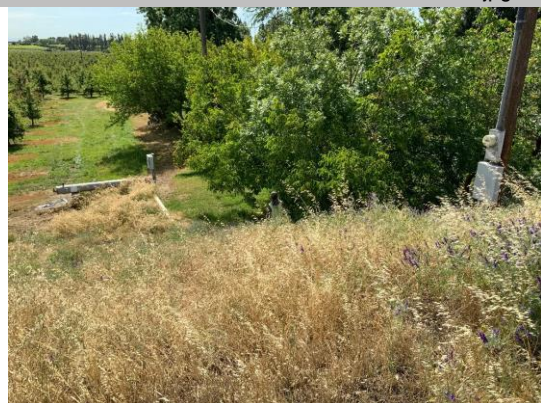
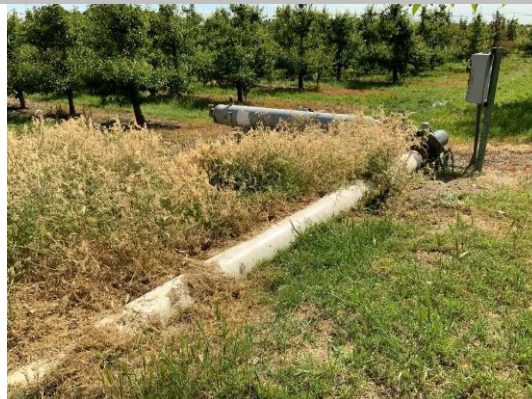
LM Start	3.51	Rating **	M	Issue No.	128 (cont)
LM End	3.51	Issue Type +	En	Location *

Comment Code					
Inspector Comment					
DS_ID:20863 FS_ID:76304 EP_NO: 11181 Repair Type: Non-Urgent EVAL Issue: 10, Unauthorized Modification or Non-Compliant Permit Crossing Status: Found UCIP Comments: 05/12/2022 The record remains Non-Urgent. Modification to crossing, screen filter added on LS and removal of concrete spill box on LS. Filter is leaking off of the LS toe, recommend repair. Dense vegetation over majority of WS pipe. No permit other than ABO permit was found authorizing this encroachment. CVFPB will need to review crossing to determine owner. The UCIP inspection was completed with GEI staff, A. Lao. (H. Dunn – GEI) 04/25/22 Needs to fix siphon breaker. (P. Amatya -DWR) FIELD_STRUCT_DESC: 10-inch steel irrigation discharge pipe through the levee, 4.8 feet below the crown. Steel walkway to the pump on a pile structure in the river. Siphon breaker on the waterside (WS). Service pole on the landside (LS) slope. Concrete spill box with two 15-inch openings on the LS. (Retention of a 10-inch pipe through the levee, 4.8 feet below the crown, a steel walkway to the pump on a pile structure in the river, and a siphon breaker and a service pole on the LS slope authorized under Automatic Board Order (ABO) issued as Permit No. 11181, 1975 - Robert E. and G. P. Collins). [Additional Reference(s): DWR Levee Log. USACE Sacramento O&M Manual 103, June 1954, (Station ""J"" 58+00), invert elevation 18.2 feet]. FS Date: 5/12/2022 12:22:49 PM

Levee crown.

LS view: Meter on slope from crown.

LS view: Closeup of pipe, meter box, and filter off toe.

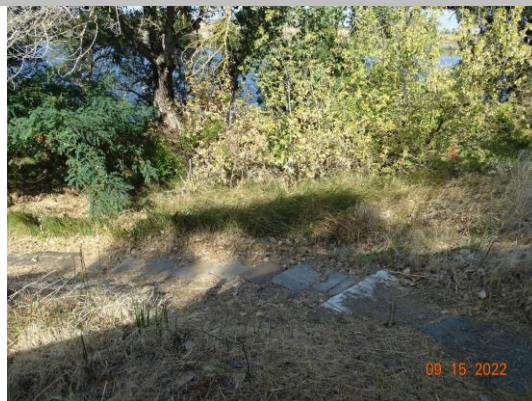
Photo 1 of 1 : FA_2022_RD0556_19_78_20221003_00070.jpg

LM Start	3.54	Rating **	M	Issue No.	78
LM End	3.54	Issue Type +	En	Location *	WS
Category	Earthen Levee			GPS Latitude/Longitude	
				Start	End
Item	Encroachments			38.219407 °	38.219407 °
				-121.556280 °	-121.556280 °
DWR ID	DWR_RD0556_02_f _ 2018_78				
Comment Code					
ST : Stairway					
Inspector Comment					
Stairs encroaching into slope do not have a permit.

View of the steps on the WS slope (Fall 2022).

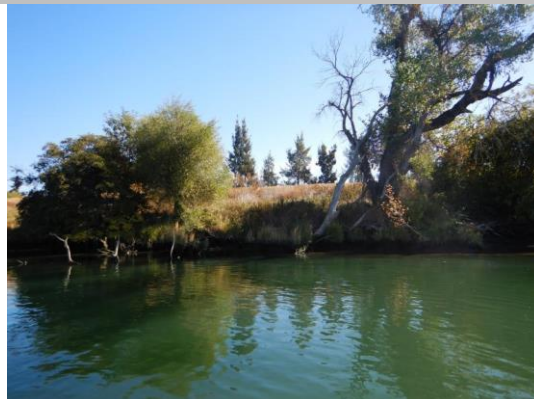
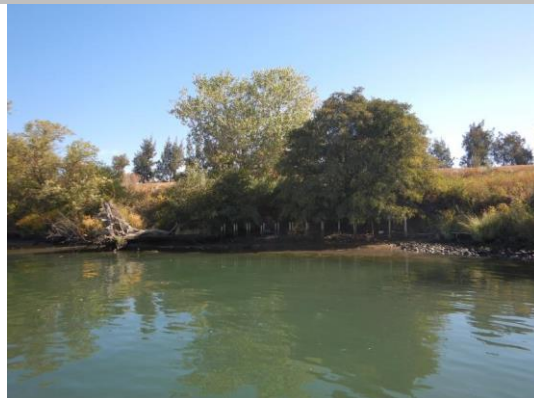
LM Start	3.58	Rating **	M	Issue No.	16
LM End	3.64	Issue Type +	Ma	Location *	WS
Category	Supplemental			GPS Latitude/Longitude	
				Start	End
Item	2018 USACE Erosion Survey			38.218951 °	38.218104 °
				-121.556689 °	-121.556819 °
DWR ID	DWR_RD0556_02_s_2022_16				
Comment Code					
Inspector Comment					
2018 Site ID: SAC 22.7 L					
Status: Eroding					
2018 Field Notes: No observed change.					
Site History: 1997 - Scallops into berm and very close to levee toe.					
2005 - Brush boxes present. 2011 - New toe scour and freshly fallen tree. 2012 - New tree popout has taken significant portion of soil out of the levee. 2017 - Minor new erosion at toe.

USACE 2018 Erosion Photo #1

USACE 2018 Erosion Photo #2

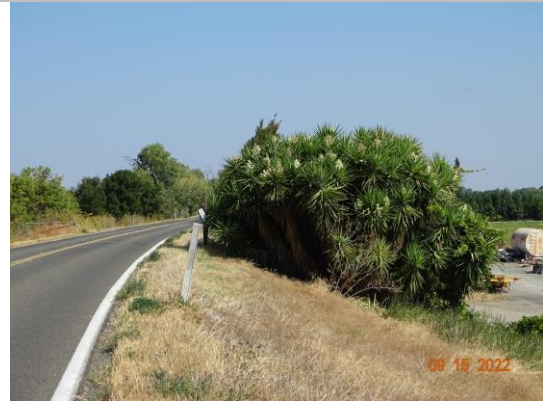
Photo 1 of 1 : FA_2022_RD0556_19_108_20221003_00076.jpg

LM Start	3.79	Rating **	U	Issue No.	108
LM End	3.79	Issue Type +	En	Location *	LS
Category	Earthen Levee			GPS Latitude/Longitude	
				Start	End
Item	Vegetation			38.215818 °	38.215818 °
				-121.556840 °	-121.556840 °
DWR ID	DWR_RD0556_02_f_2022_108				
Comment Code					
V6 : Landscaping					
Inspector Comment

View of the landscaping on the LS slope (Fall 2022).

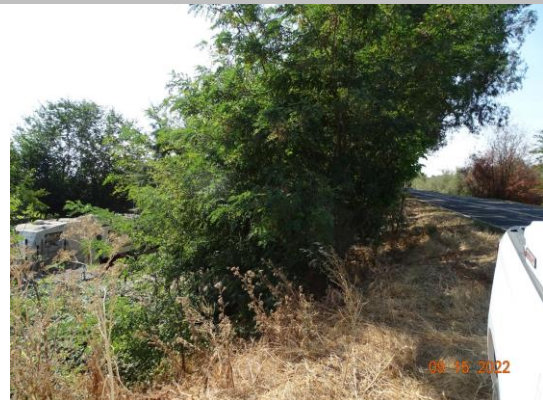
Photo 1 of 1 : FA_2022_RD0556_19_84_20221003_00075.jpg

LM Start	3.83	Rating **	M	Issue No.	84
LM End	3.86	Issue Type +	Ma	Location *	LS
Category	Earthen Levee			GPS Latitude/Longitude	
				Start	End
Item	Trim / Thin Trees			38.215223 °	38.214849 °
				-121.556903 °	-121.556865 °
DWR ID	DWR_RD0556_02_f_2018_84				
Comment Code					
T1 : Trim and thin trees to at least five feet above ground level to allow visibility of the ground and room to flood fight.					
Inspector Comment

View of the trees on the LS slope (Fall 2022).

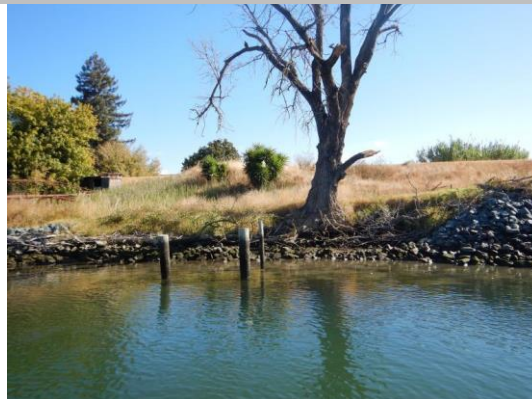
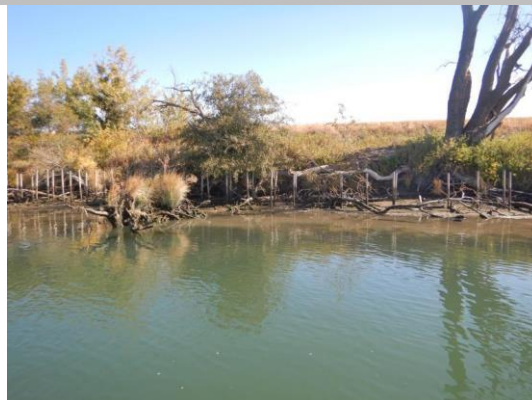
Site History: 2002 - Spot rock along berm, but not in the erosion pockets. 2005 - Some new minor stone revetment at the upstream end. Brush boxes present. 2006 - Currently installing new brush in downstream brush boxes. 2007 - Rock in middle portion for about 150 ft. 2010 - Some attempt at repairs but still has pockets of erosion. 2012 - More erosion along the toe. 2017 - New lower bank erosion at the upstream end. Locals placed rock in some erosion pockets.

USACE 2018 Erosion Photo #1

USACE 2018 Erosion Photo #2

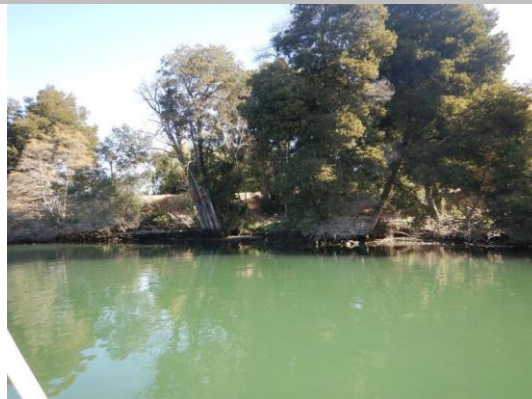
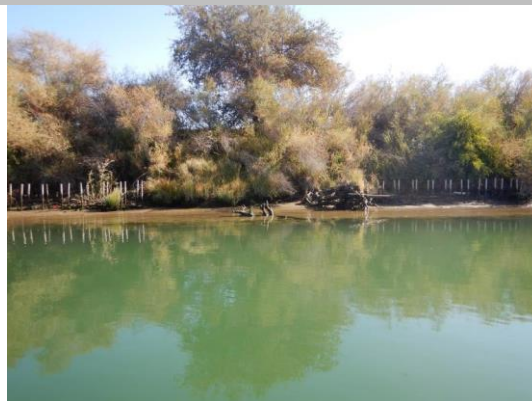
LM Start	4.44	Rating **	M	Issue No.	14
LM End	4.49	Issue Type +	Ma	Location *	WS
Category	Supplemental			GPS Latitude/Longitude	
				Start	End
Item	2018 USACE Erosion Survey			38.206377 °	38.205729 °
				-121.557184 °	-121.557108 °
DWR ID	DWR_RD0556_02_s_2022_14				
Comment Code					
Inspector Comment					
2018 Site ID: SAC 21.9 L					
Status: Eroding					
2018 Field Notes: No observed change.					
Site History: 2013 - Erosion pockets encroaching on levee foundation.

USACE 2018 Erosion Photo #1

USACE 2018 Erosion Photo #2
