**Flood Control Project Maintenance
Levee Inspections
Fall 2022 Levee Maintenance Deficiency Summary Report**

Sacramento River Basin

**Flood Control Project Maintenance
Levee Inspections
LMA District Cover Sheet**

Reclamation District No. 0556 Upper Andrus

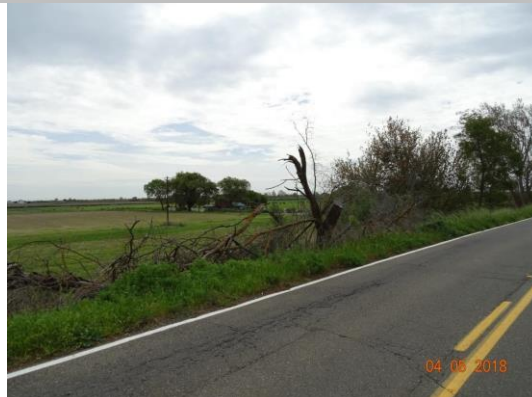
Photo 1 of 1 : FA_2022_RD0556_19_56_20220831_00040.jpg

LM Start	4.57	Rating **	U	Issue No.	56
LM End	4.57	Issue Type +	Ma	Location *	LS
Category	Earthen Levee			GPS Latitude/Longitude	
				Start	End
Item	Trim / Thin Trees			38.204558 °	38.204544 °
				-121.556773 °	-121.556769 °
DWR ID	DWR_RD0556_02_s_2018_56				
Comment Code					
T2 : Tree or limb.					
Inspector Comment					
Remove dead tree/limb from the landside.

Fallen tree on landside should be removed.

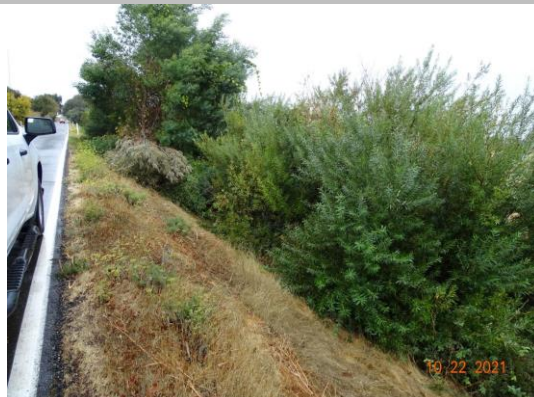
Photo 1 of 1 : FA_2022_RD0556_19_60_20220831_00044.jpg

LM Start	4.57	Rating **	U	Issue No.	60
LM End	4.57	Issue Type +	Ma	Location *	LS
Category	Earthen Levee			GPS Latitude/Longitude	
				Start	End
Item	Trim / Thin Trees			38.204537 °	38.204537 °
				-121.556782 °	-121.556782 °
DWR ID	DWR_RD0556_02_s_2021_60				
Comment Code					
T1 : Trim and thin trees to at least five feet above ground level to allow visibility of the ground and room to flood fight.					
Inspector Comment

View looking upstream at thick trees on the landside slope (Fall 2021).

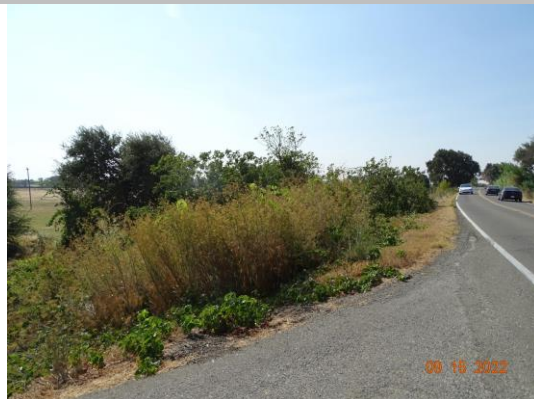
Photo 1 of 1 : FA_2022_RD0556_19_58_20221003_00073.jpg

LM Start	4.64	Rating **	U	Issue No.	58
LM End	4.64	Issue Type +	Ma	Location *	LS
Category	Earthen Levee			GPS Latitude/Longitude	
				Start	End
Item	Trim / Thin Trees			38.203480 °	38.203480 °
				-121.556824 °	-121.556824 °
DWR ID	DWR_RD0556_02_s_2018_58				
Comment Code					
T1 : Trim and thin trees to at least five feet above ground level to allow visibility of the ground and room to flood fight.					
Inspector Comment					
Remove fig tree from the landside slope.

View of the LS vegetation and fig tree in the background (Fall 2022).

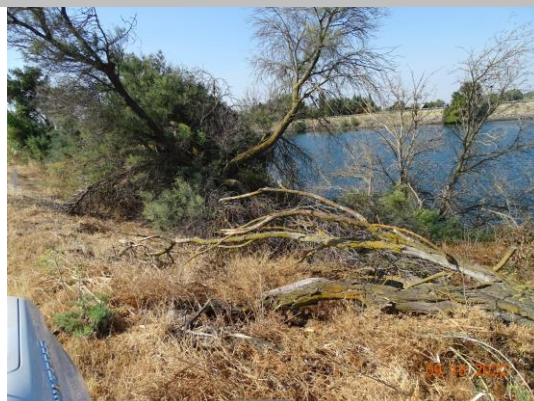
Photo 1 of 1 : FA_2022_RD0556_19_27_20221003_00071.jpg

LM Start	4.65	Rating **	M	Issue No.	27
LM End	4.65	Issue Type +	Ma	Location *	WS
Category	Earthen Levee			GPS Latitude/Longitude	
				Start	End
Item	Trim / Thin Trees			38.203425 °	38.203425 °
				-121.556845 °	-121.556845 °
DWR ID	DWR_RD0556_02_s_2017_27				
Comment Code					
T2 : Tree or limb.					
Inspector Comment					
Remove fallen tree from waterside slope.

View of the fallen tree on the WS slope (Fall 2022).

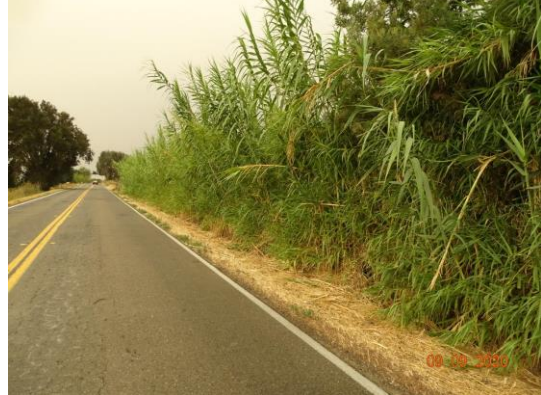
Photo 1 of 1 : FA_2022_RD0556_19_3_20220831_00003.jpg

LM Start	4.68	Rating **	U	Issue No.	3
LM End	4.72	Issue Type +	Ma	Location *	WS
Category	Earthen Levee			GPS Latitude/Longitude	
				Start	End
Item	Vegetation			38.202942 °	38.202431 °
				-121.556870 °	-121.556960 °
DWR ID	DWR_RD0556_02_f_2020_3				
Comment Code					
V2 : Remove the wild growth and woody vegetation other than native grasses from the levee slopes.					
Inspector Comment					
Cut arundo back 20' from waterside slope.

View looking downstream at arundo on the waterside slope (Fall 2020).

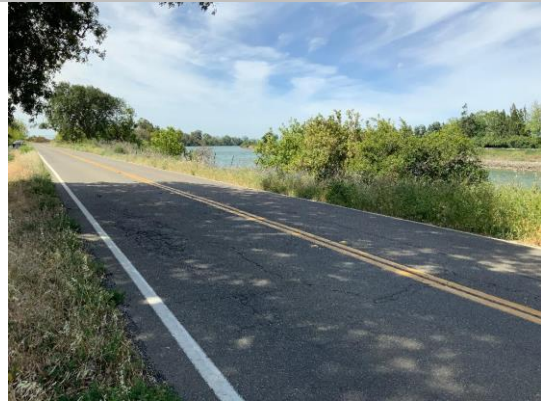
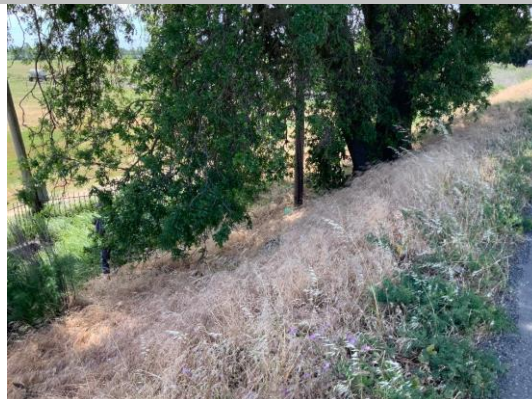
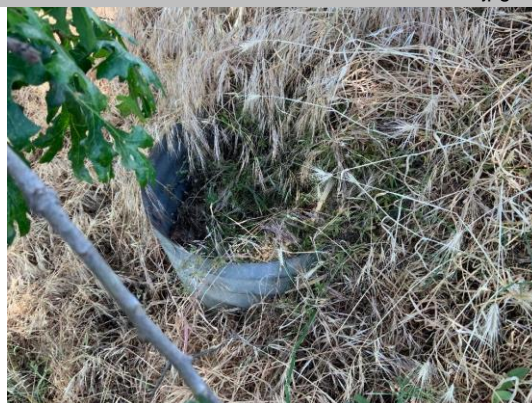
Comment Code					
Inspector Comment					
DS_ID:20867 FS_ID:76308 EP_NO: 11199 Repair Type: Non-Urgent EVAL Issue: 11, Maintenance Compliance Issue Crossing Status: Indicator Found UCIP Comments: 05/12/2022 The record remains Non-Urgent. Appears abandoned, LS riser covered in vegetation, recommend cleaning out if still in use. WS control panel is destroyed and overgrown with vegetation. No permit other than ABO permit was found authorizing this encroachment. CVFPB will need to review crossing to determine owner. The UCIP inspection was completed with GEI staff, A. Lao. (H. Dunn – GEI) 04/25/2013 Pump, gate valve and pumphouse not found on waterward slope. An abandoned electric control panel found on WS. May need to be properly abandoned. (P. Amatya - DWR) FIELD_STRUCT_DESC: 6-inch steel irrigation discharge pipe through the levee, 6.5 feet below the crown. Siphon and concrete spill box with two 8-inch openings. (Retention of a 6-inch pipe through the levee, 6.5 feet below the crown, a pump and a gate valve in a pump house on the waterside [WS] slope, and a siphon breaker and a service pole on the landside [LS] slope authorized under Automatic Board Order (ABO) issued as Permit No. 11199, 1975 - Toshi Tokuyoshi, et al.). [Additional Reference(s): DWR Levee Log. USACE Sacramento O&M Manual 103, June 1954, (Station ""H"" 159+97), invert elevation 17.9 feet]. FS Date: 5/12/2022 1:01:48 PM

Levee crown.

LS view: Slope from crown.

LS view: Covered riser visible on slope.

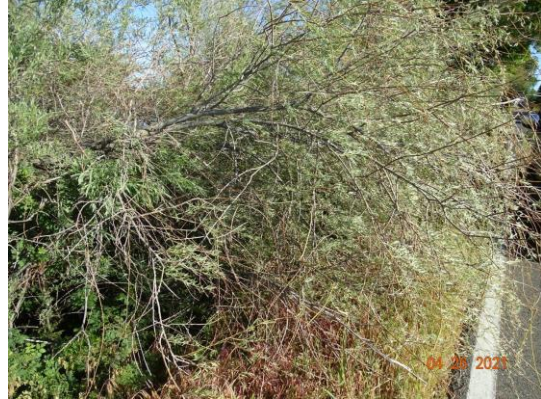
Photo 1 of 1 : FA_2022_RD0556_19_66_20220831_00047.jpg

LM Start	4.85	Rating **	U	Issue No.	66
LM End	4.87	Issue Type +	Ma	Location *	WS
Category	Earthen Levee			GPS Latitude/Longitude	
				Start	End
Item	Trim / Thin Trees			38.200543 °	38.200246 °
				-121.557286 °	-121.557380 °
DWR ID	DWR_RD0556_02_s_2021_66				
Comment Code					
T4 : Trim trees over roadway to at least 12 feet above ground level.					
Inspector Comment

View looking upstream at willows on the waterside slope (Spring 2021).

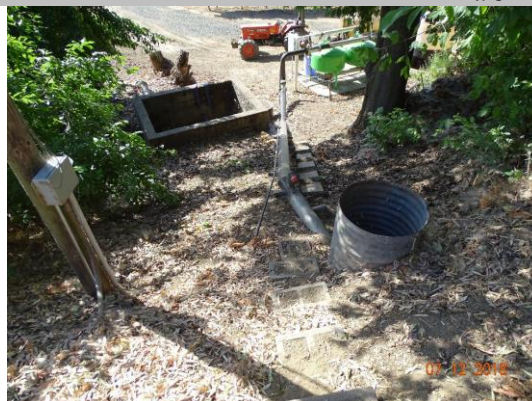
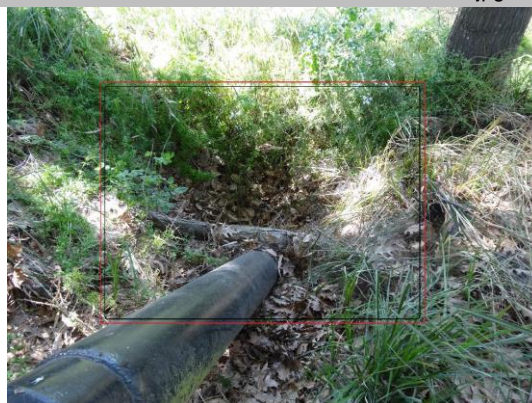
Comment Code					
Inspector Comment					
DS_ID:20869 FS_ID:76310 EP_NO: 11185 Repair Type: Urgent EVAL Issue: 2b, Levee Integrity Crossing Status: Found UCIP Comments: 05/12/2022 The record remains Urgent. There is still a deep pit on WS toe covered with plywood, causing a safety concern and levee integrity concern, recommend filling in with dirt. LS siphon in riser is covered with vegetation, recommend cleaning out. New filter installation on LS as well as modifications to the LS concrete box. No permit other than ABO permit was found authorizing this encroachment. CVFPB will need to review crossing to determine owner. The UCIP inspection was completed with GEI staff, A. Lau. (H. Dunn – GEI)07/12/2018 Pit on WS is covered with plywood. Water pump is running, no leaks detected. LS part of crossing was reconstructed. New pipe was installed after CMP riser to supply water to sand filters. Remains Urgent due to large pit on WS that needs to be backfilled. (O.Yakimov-DWR UCIP)04/25/2013 Large pit on levee berm. FIELD_STRUCT_DESC: 8-inch irrigation discharge pipe of an unknown material through the levee, 5.7 feet below the crown. Pump and gate valve in a pump house on the waterside (WS) slope. Siphon breaker, concrete box, and service pole on the landside (LS) slope. (Retention of an 8-inch pipe through the levee, 5.7 feet below the crown, a pump and a gate valve in a pump house on the WS slope, and a siphon breaker and a service pole on the LS slope authorized under Automatic Board Order (ABO) issued as Permit No. 11185, 1975 - R. Walter Langhart). [Additional Reference(s): DWR Levee Log]. FS Date: 5/12/2022 1:31:01 PM

View of LS slope at the crossing.

WS- intake pipe and pit on levee slope (center)

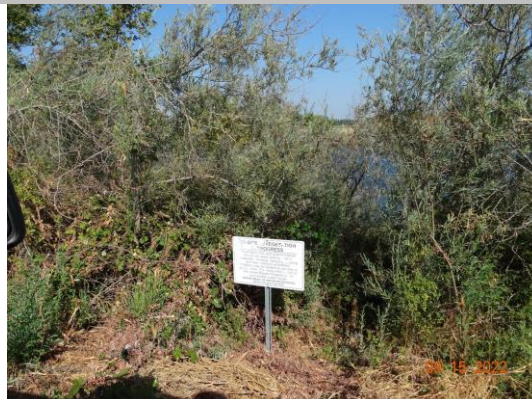
Photo 1 of 1 : FA_2022_RD0556_19_80_20221003_00072.jpg

LM Start	5.58	Rating **	A/W	Issue No.	80
LM End	5.72	Issue Type +	Ob	Location *	WS
Category	Earthen Levee			GPS Latitude/Longitude	
				Start	End
Item	Vegetation			38.192530 °	38.191865 °
				-121.565352 °	-121.567757 °
DWR ID	DWR_RD0556_02_f_2019_80				
Comment Code					
V5 : Environmental Requirements.					
Inspector Comment					
This is a DWR Revegetation Site.

View of the environmental mitigation sign on the WS slope (Fall 2022).

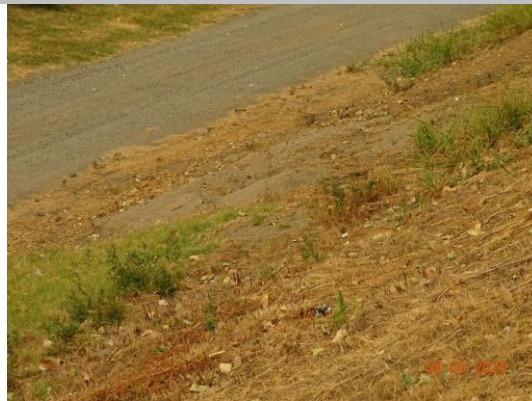
Photo 1 of 1 : FA_2022_RD0556_19_79_20220831_00056.jpg

LM Start	5.64	Rating **	U	Issue No.	79
LM End	5.64	Issue Type +	Ma	Location *	LS
Category	Earthen Levee			GPS Latitude/Longitude	
				Start	End
Item	Animal Control			38.192237 °	38.192237 °
				-121.566368 °	-121.566368 °
DWR ID	DWR_RD0556_02_f_2018_79				
Comment Code					
A3 : No rodents visible, but rodent burrows visible; need to backfill and compact or grout burrows.					
Inspector Comment					
More than 2 cubic feet of soil was removed between the two large burrow holes.

View looking downstream at burrow holes on the landside slope (Fall 2020).
