Flood Control Project Maintenance Levee Inspections

Fall 2023 Levee Maintenance Deficiency Summary Report

Sacramento River Basin

Reclamation District No. 0556 Upper Andrus

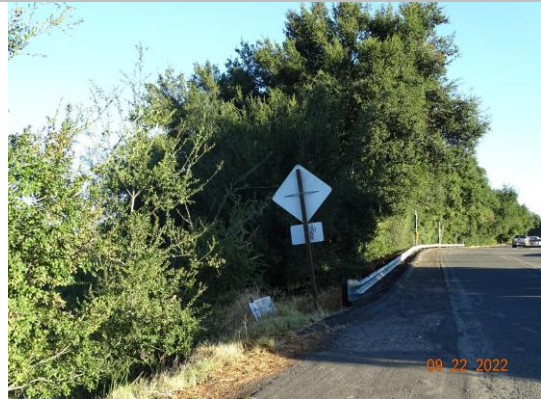
Photo 1 of 1 : FA_2023_RD0556_18_21_20231019_00006.jpg

LM Start	0.17	Rating **	U	Issue No.	21
LM End	0.57	Issue Type +	Ma	Location *	LS
Category	Earthen Levee			GPS Latitude/Longitude	
				Start	End
Item	Trim / Thin Trees			38.236723°	38.232070°
				-121.518079°	-121.522067°
DWR ID	DWR_RD0556_01_s_2017_21				
Comment Code					
T1 : Trim and thin trees to at least five feet above ground level to allow visibility of the ground and room to flood fight.					
Inspector Comment

View of the vegetation on the LS slope (Fall 2022).

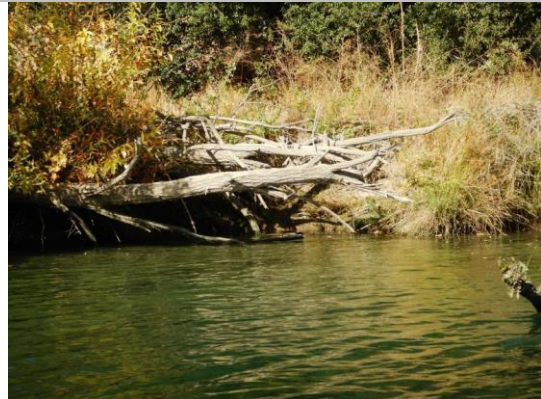
Photo 2 of 2 : FA_2023_RD0556_18_43_20231019_00027.jpg

LM Start	0.38	Rating **	M	Issue No.	43 (cont)
LM End	0.58	Issue Type +	Ma	Location *	WS
Category	Supplemental			GPS Latitude/Longitude	
				Start	End
Item	2018 USACE Erosion Survey			38.234038°	38.231879°
				-121.519817°	-121.522003°
DWR ID	DWR_RD0556_01_s_2022_43

USACE 2018 Erosion Photo #2

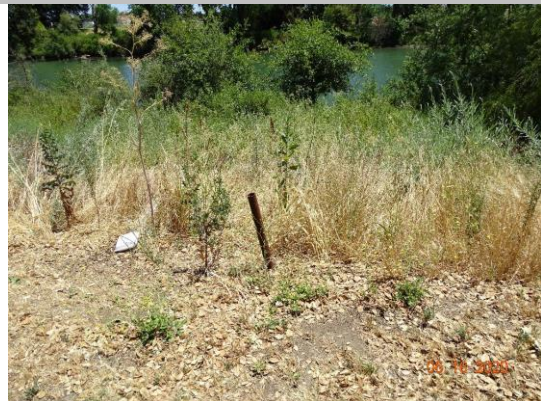
Photo 1 of 3 : UCIP_FA_2023_61336_88650.jpg

LM Start	0.53	Rating **	M	Issue No.	108
LM End	0.53	Issue Type +	En	Location *	
Category	Supplemental			GPS Latitude/Longitude	
				Start	End
Item	DWR UCIP Field Study			38.232450°	38.232450°
				-121.521624°	-121.521624°
DWR ID	20821

DS_ID:20821
 FS_ID:61336
 EP_NO: 5548
 Repair Type: Non-Urgent
 EVAL Issue: 10, Unauthorized Modification or Non-Compliant Permit
 Crossing Status: Found
 UCIP Comments: 06/16/2020 Record remains Non-Urgent. Unable to inspect waterside slope due to overgrown vegetation. Unable to find pump on waterside, instead, a gas pump and screen filters installed on landside. Unable to find a permit for modification. (O.Yakimov - DWR UCIP)
 05/13/2015 Dense vegetation prevents inspection of WS slope. (K.Fazel - DWR UCIP)
 FIELD_STRUCT_DESC: 12-inch steel irrigation discharge pipe through the levee, 5 feet below the crown. 1.25-inch electrical conduit through the levee at the same location. Pump and screen filters on the landside. Concrete steps on the landside (LS) slope. Cuts in pavement visible at the crossing. Siphon breaker on waterside shoulder. (12-inch pipe authorized under Permit No. 5548, 1966 - George K. Adams).

Water-Side: View of levee slope looking from crown

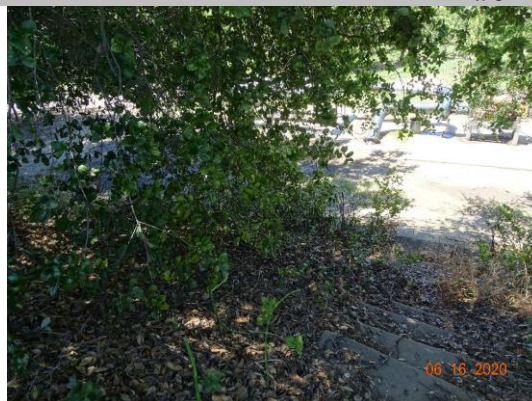
Photo 2 of 3 : UCIP_FA_2023_61336_88648.jpg

LM Start	0.53	Rating **	M	Issue No.	108 (cont)
LM End	0.53	Issue Type +	En	Location *	
Category	Supplemental		GPS Latitude/Longitude		
			Start	End	
Item	DWR UCIP Field Study		38.232450°	38.232450°	
			-121.521624°	-121.521624°	
DWR ID	20821

Land-Side: View of levee slope looking from crown

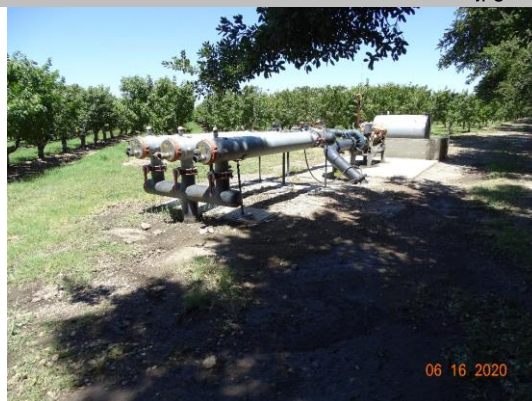
Photo 3 of 3 : UCIP_FA_2023_61336_88646.jpg

LM Start	0.53	Rating **	M	Issue No.	108 (cont)
LM End	0.53	Issue Type +	En	Location *

Land-Side: Screen filters and new pump on landside

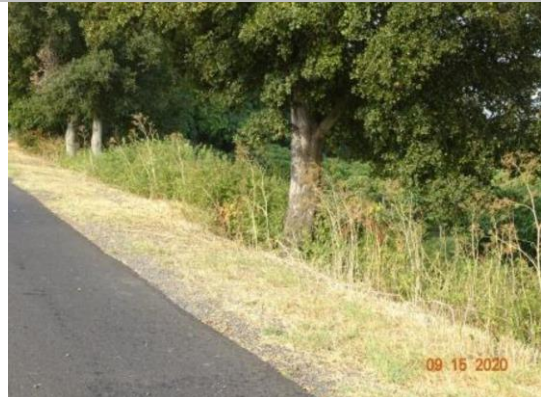
Photo 1 of 1 : FA_2023_RD0556_18_65_20231019_00038.jpg

LM Start	0.82	Rating **	M	Issue No.	65
LM End	0.83	Issue Type +	Ma	Location *	LS
Category	Earthen Levee			GPS Latitude/Longitude	
				Start	End
Item	Vegetation			38.229278°	38.229172°
				-121.525103°	-121.525279°
DWR ID	DWR_RD0556_01_f _ 2020_65				
Comment Code					
V2 : Remove the wild growth and woody vegetation other than native grasses from the levee slopes.					
Inspector Comment

View looking downstream at vegetation on the landside slope (Fall 2020).

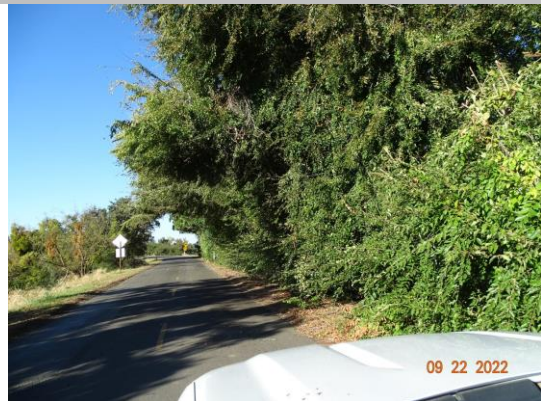
Photo 1 of 1 : FA_2023_RD0556_18_24_20231019_00007.jpg

LM Start	0.87	Rating **	U	Issue No.	24
LM End	0.92	Issue Type +	En	Location *	LS
Category	Earthen Levee			GPS Latitude/Longitude	
				Start	End
Item	Vegetation			38.228820°	38.228419°
				-121.525853°	-121.526477°
DWR ID	DWR_RD0556_01_f_2017_24				
Comment Code					
V6 : Landscaping					
Inspector Comment

View of the vegetation on the LS slope (Fall 2022).

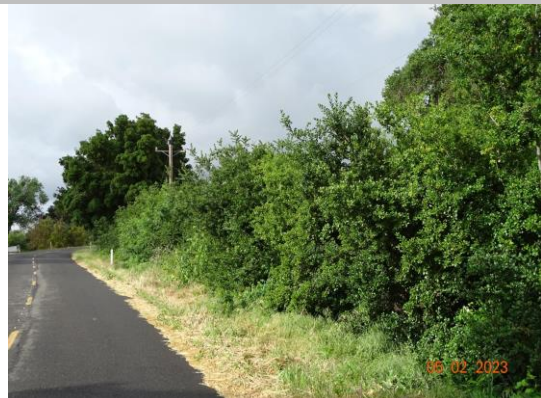
Photo 1 of 1 : FA_2023_RD0556_18_66_20231019_00039.jpg

LM Start	0.98	Rating **	U	Issue No.	66
LM End	1.17	Issue Type +	Ma	Location *	LS
Category	Earthen Levee			GPS Latitude/Longitude	
				Start	End
Item	Vegetation			38.227653°	38.227574°
				-121.527032°	-121.529479°
DWR ID	DWR_RD0556_01_f_2020_66				
Comment Code					
V2 : Remove the wild growth and woody vegetation other than native grasses from the levee slopes.					
Inspector Comment

View of the wild growth on the LS slope (Spring 2023).

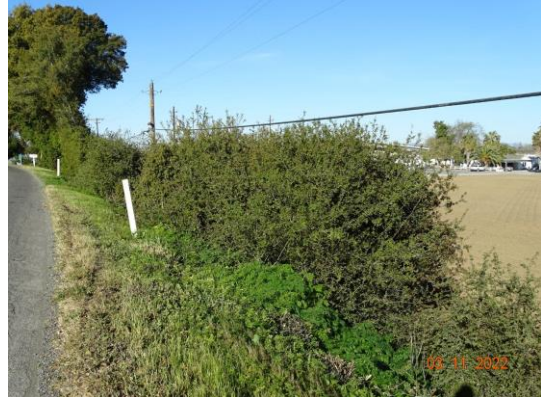
Photo 1 of 1 : FA_2023_RD0556_18_87_20231019_00045.jpg

LM Start	1.26	Rating **	U	Issue No.	87
LM End	1.30	Issue Type +	Ma	Location *	LS
Category	Earthen Levee			GPS Latitude/Longitude	
				Start	End
Item	Vegetation			38.227980°	38.227813°
				-121.530967°	-121.531751°
DWR ID	DWR_RD0556_01_s_2022_87				
Comment Code					
V2 : Remove the wild growth and woody vegetation other than native grasses from the levee slopes.					
Inspector Comment

View looking downstream at trees on the landside slope (Spring 2022).

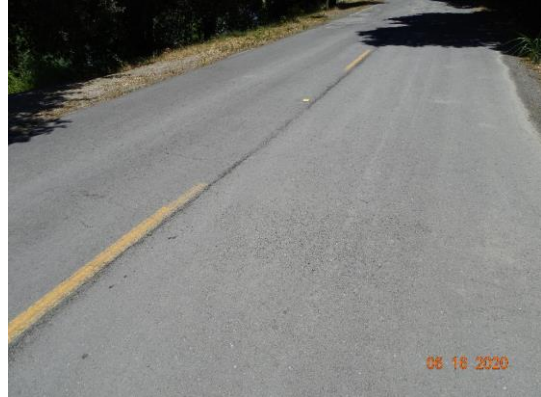
Photo 1 of 3 : UCIP_FA_2023_61398_88672.jpg

DS_ID:20825
FS_ID:61398
EP_NO: 13302
Repair Type: Non-Urgent
EVAL Issue: 6, Levee Damage or Threat for Levee Damage
Crossing Status: Found
UCIP Comments: 06/16/2020 Record remains Non-Urgent. Concrete standpipe on landside has been replaced with a pressure tank. Unable to find a permit for modification. Depression around air release vent on landside shoulder about 2 feet in diameter and 1/2-foot deep. (O.Yakimov - DWR UCIP)
05/27/2015 Seal beneath siphon breaker off LS toe leaking. Rodent activity near crown off LS shoulder. Need to contact owner about leaky seal. Dense vegetation prevented inspection of WS slope. (K.Fazel - DWR UCIP)
FIELD_STRUCT_DESC: 6-inch steel irrigation discharge pipe and 2-inch galvanized iron electrical conduit through the levee, 2 feet below the crown. Siphon valve on the landside (LS) shoulder. Pump, gate valve, and pressure tank at the LS toe. Service pole and electrical box at the LS toe. 6-inch polyvinyl chloride (PVC) standpipe adjacent to the pipe off the LS toe. (6-inch pipe authorized under Permit No. 13302, 1981 - Kaydix Ranch). [Additional Reference(s): DWR Levee Log, unk.yr. (HLM 1.32). USACE Sacramento O&M Manual, Unit 103, June 1954, Revised 29 December 2016, (Station 'R' 540+85), listed as 2-inch pipe. USACE As-Built Drawing No. 50-04-2671, Sheet 5, Station 540+85, 25 January 1951, Revised 18 Dec. 1952, listed as 2-inch pipe]. FS Date: 6/16/2020 4:21:56 PM

LM Start	1.33	Rating **	M	Issue No.	109 (cont)
LM End	1.33	Issue Type +	En	Location *

Top of Levee: View of levee crown looking downstream

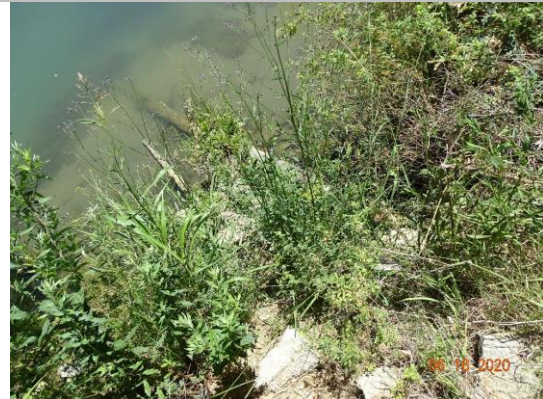
Photo 3 of 3 : UCIP_FA_2023_61398_88673.jpg

LM Start	1.33	Rating **	M	Issue No.	109 (cont)
LM End	1.33	Issue Type +	En	Location *	
Category	Supplemental		GPS Latitude/Longitude		
			Start	End	
Item	DWR UCIP Field Study		38.227622°	38.227622°	
			-121.532154°	-121.532154°	
DWR ID	20825

Water-Side: Intake pipe at riverbank

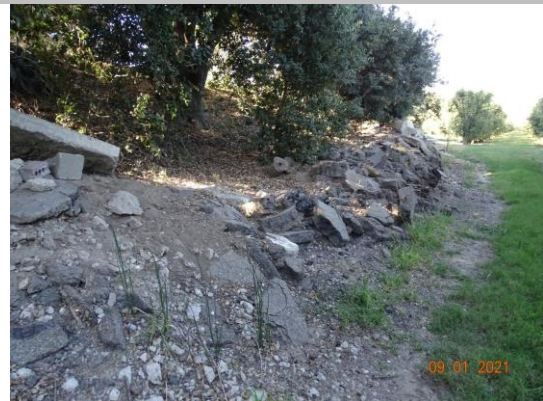
Photo 1 of 1 : FA_2023_RD0556_18_27_20231019_00008.jpg

LM Start	1.34	Rating **	A/W	Issue No.	27
LM End	1.37	Issue Type +	En	Location *	LS
Category	Earthen Levee			GPS Latitude/Longitude	
				Start	End
Item	Encroachments			38.227521°	38.227320°
				-121.532393°	-121.532710°
DWR ID	DWR_RD0556_01_s_2013_27				
Comment Code					
DE : Debris					
Inspector Comment					
Concrete at toe of levee is acting like a stability berm.

View looking downstream at concrete rubble at landside toe (Fall 2021).

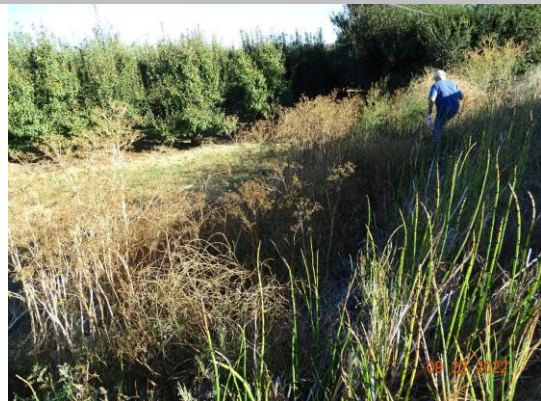
Photo 1 of 1 : FA_2023_RD0556_18_40_20231019_00022.jpg

LM Start	1.43	Rating **	M	Issue No.	40
LM End	1.43	Issue Type +	Ma	Location *	LS
Category	Earthen Levee			GPS Latitude/Longitude	
				Start	End
Item	Erosion / Bank Caving			38.226537°	38.226537°
				-121.533512°	-121.533512°
DWR ID	DWR_RD0556_01_f_2012_40				
Comment Code					
E1 : Note and monitor erosion site.					
Inspector Comment					
Erosion is covered by vegetation.

View of the erosion on the LS slope (Fall 2022).

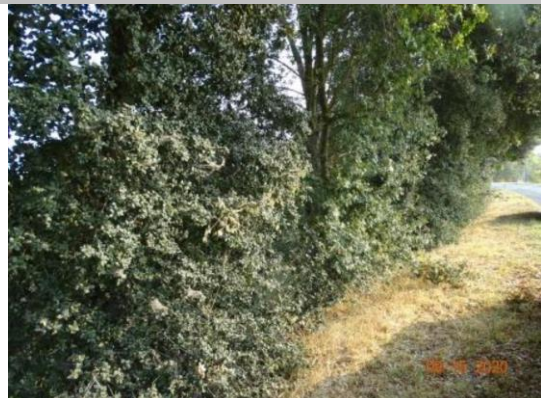
Photo 1 of 1 : FA_2023_RD0556_18_46_20231019_00030.jpg

LM Start	1.55	Rating **	U	Issue No.	46
LM End	1.64	Issue Type +	Ma	Location *	LS
Category	Earthen Levee			GPS Latitude/Longitude	
				Start	End
Item	Trim / Thin Trees			38.225268°	38.224587°
				-121.534733°	-121.536129°
DWR ID	DWR_RD0556_01_s_2018_46				
Comment Code					
T1 : Trim and thin trees to at least five feet above ground level to allow visibility of the ground and room to flood fight.					
Inspector Comment

View looking upstream at thick trees on the landside slope (Fall 2020).

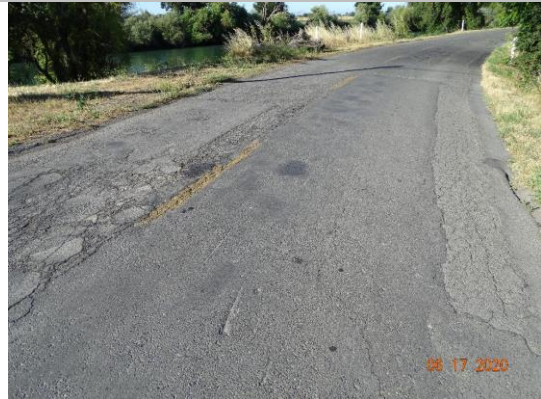
Photo 1 of 3 : UCIP_FA_2023_61399_88676.jpg

Comment Code						
Inspector Comment						
DS_ID:20827 FS_ID:61399 EP_NO: 11169 Repair Type: Non-Urgent EVAL Issue: 10, Unauthorized Modification or Non-Compliant Permit Crossing Status: Found UCIP Comments: 06/17/2020 Record remains Non-Urgent. Modifications to the crossing have been made after last UCIP inspection. Unable to find a permit for modifications. Enforcement case ENF 9545 open for this crossing. No permit has been identified authorizing original pipe. Need to have CVFPB review ABO and determine current owner. (O.Yakimov - DWR UCIP) 03/27/2015 Dense vegetation on LS and WS limited accessibility. (K.Fazel - DWR - UCIP) FIELD_STRUCT_DESC: 6-inch steel irrigation discharge pipe through the levee, 3.5 feet below the crown. Pump, butterfly valve, filler pump and pipe on the waterside (WS) berm. 2-inch electrical conduit through the levee. Service pole with electric meter and panel on waterside shoulder. (10-inch pipe [HLM 1.56] authorized under Automatic Board Order (ABO) issued as Permit No. 11169, 1975 - Darrell T. and B. M. Mealer). [Additional Reference(s): DWR Levee Log, unk.yr. (HLM 1.56), listed as 10-inch pipe. USACE Sacramento O&M Manual, Unit 103, June 1954, Revised 29 December 2016, (Station 'R' 528+02.1), listed as 10-inch pipe. USACE As-Built Drawing No. 50-04-2671, Sheet 4, near Station 528+00, 25 January 1951, Revised 18 Dec. 1952, listed as 10-inch pipe]. FS Date: 6/17/2020 9:36:26 AM

LM Start	1.57	Rating **	M	Issue No.	110 (cont)
LM End	1.57	Issue Type +	En	Location *

Top of Levee: View of levee crown looking downstream

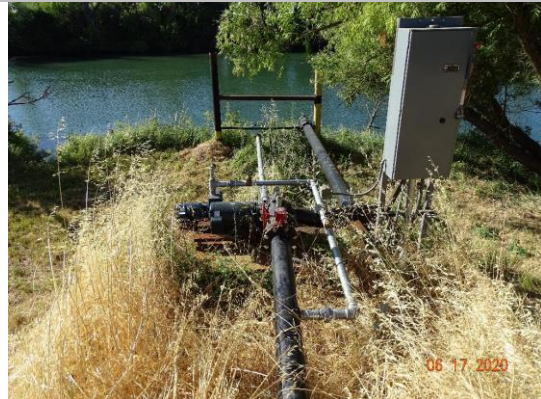
Photo 3 of 3 : UCIP_FA_2023_61399_88679.jpg

LM Start	1.57	Rating **	M	Issue No.	110 (cont)	
LM End	1.57	Issue Type +	En	Location *		
Category	Supplemental			GPS Latitude/Longitude		
				Start		End
Item	DWR UCIP Field Study			38.225001°		38.225001°
				-121.535007°		-121.535007°
DWR ID	20827

Water-Side: Pump, filler pump and line, butterfly valve on levee berm

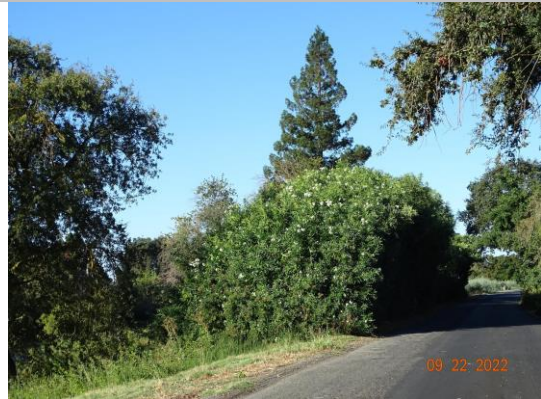
Photo 1 of 1 : FA_2023_RD0556_18_17_20231019_00002.jpg

LM Start	1.65	Rating **	U	Issue No.	17
LM End	1.70	Issue Type +	En	Location *	WS
Category	Earthen Levee			GPS Latitude/Longitude	
				Start	End
Item	Vegetation			38.224623°	38.224408°
				-121.536320°	-121.537180°
DWR ID	DWR_RD0556_01_s_2012_17				
Comment Code					
V6 : Landscaping					
Inspector Comment					
Oleanders blocking view down waterside slope

View of the oleander on the WS shoulder and slope (Fall 2022).

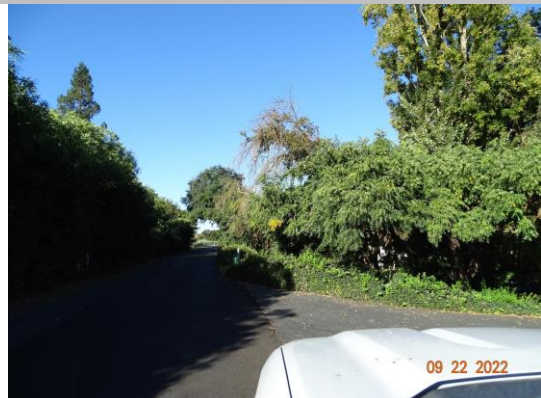
Photo 1 of 1 : FA_2023_RD0556_18_51_20231019_00003.jpg

LM Start	1.66	Rating **	U	Issue No.	51
LM End	1.69	Issue Type +	En	Location *	LS
Category	Earthen Levee			GPS Latitude/Longitude	
				Start	End
Item	Vegetation			38.224487°	38.224355°
				-121.536492°	-121.537055°
DWR ID	DWR_RD0556_01_f_2019_51				
Comment Code					
V6 : Landscaping					
Inspector Comment

View of the landscaping on the LS slope looking downstream (Fall 2022).

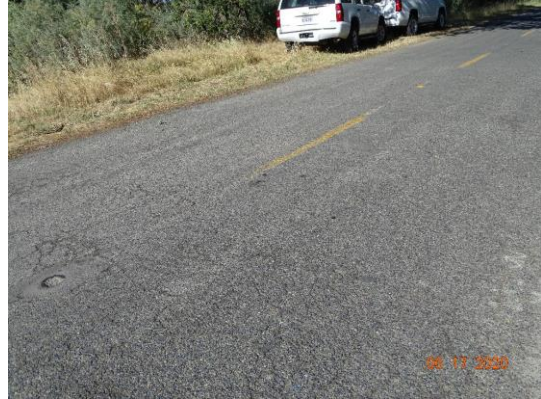
Photo 1 of 3 : UCIP_FA_2023_61414_88746.jpg

Comment Code					
Inspector Comment					
DS_ID:20829 FS_ID:61414 EP_NO: 11178 Repair Type: Non-Urgent EVAL Issue: 6, Levee Damage or Threat for Levee Damage Crossing Status: Found UCIP Comments: 06/17/2020 Record remains Non-Urgent. Depression on landside levee slope less than 1/2-foot-deep in pipe alignment. Vegetation on both levee slopes. Limited visibility through vegetation restrains complete evaluation of slope condition. Electric meter is energized. No permit has been identified authorizing pipe. Need to have CVFPB review ABO and determine current owner. (O.Yakimov - DWR UCIP) 05/27/2015 Dense vegetation on WS and LS. Some oil leakage inside pumphouse. (K. Fazel - DWR UCIP) FIELD_STRUCT_DESC: 8-inch steel irrigation discharge pipe through the levee, 3.7 feet below the crown. 2-inch electrical conduit through the levee, next to the 8-inch discharge pipe. 1-inch air valve and pump on the waterside (WS) berm. Service pole on the landside (LS) slope. Tin and wood pump house on the WS berm. 12-foot by 3-foot concrete standpipe on the LS. (8-inch pipe [HLM 1.88] authorized under Automatic Board Order (ABO) issued as Permit No. 11178, 1975 - Allena D. Swett). [Additional Reference(s): DWR Levee Log, unk.yr. (HLM 1.88). USACE Sacramento O&M Manual, Unit 103, June 1954, Revised 29 December 2016, (Station 'R' 511+00), listed as 8-inch pipe. USACE As-Built Drawing No. 50-04-2671, Sheet 4, Station 511+00, 25 January 1951, Revised 18 Dec. 1952]. FS Date: 6/17/2020 10:33:05 AM

Top of Levee: View of levee crown looking downstream

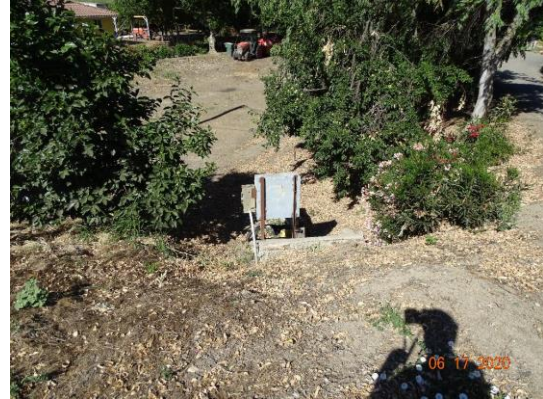
Photo 1 of 3 : UCIP_FA_2023_61499_89030.jpg

Comment Code						
Inspector Comment						
DS_ID:20831 FS_ID:61499 EP_NO: 11169 Repair Type: Non-Urgent EVAL Issue: 6, Levee Damage or Threat for Levee Damage Crossing Status: Found UCIP Comments: 06/17/2020 Record remains Non-Urgent. 2-foot diameter sinkhole is still present on landside shoulder around air vent, size of hole is not growing over time. Electrical conduit is open on waterside slope with wires cut and not insulated. No permit has been identified authorizing pipe. Need to have CVFPB review ABO and determine current owner. (O.Yakimov - DWR UCIP) 07/12/2018 Hole near air vent on LS slope is still present but haven't increased in size. Pipe was running at the time of site visit, no leaks detected. Downgraded to "Non-Urgent" due to absence of levee threat. (O.Yakimov - DWR UCIP) 05/27/2015 2'x 2' hole on levee off LS shoulder. FIELD_STRUCT_DESC: 8-inch steel irrigation discharge pipe through the levee, 3.7 feet below the crown. 1-inch air valve. Pump and switch panel on the waterside (WS) berm. Service pole on the landside (LS). 9-foot by 3-foot concrete standpipe on the LS. 3 cables encased in a 1.5-inch steel conduit through the levee and on the WS, alongside the 8-inch pipe, disconnected on the WS. (8-inch pipe [HLM 2.44] authorized under Automatic Board Order (ABO) issued as Permit No. 11169, 1975 - Darrell T. and B. M. Mealer). [Additional Reference(s): DWR Levee Log, unk.yr. (HLM 2.44). USACE Sacramento O&M Manual, Unit 103, June 1954, Revised 29 December 2016, (Station 'R' 482+49.3), listed as 8-inch pipe. USACE As-Built Drawing No. 50-04-2671, Sheet 3, Station 482+49.3, 25 January 1951, Revised 18 Dec. 1952]. FS Date: 6/17/2020 10:55:51 AM

Land-Side: View of levee slope looking from crown

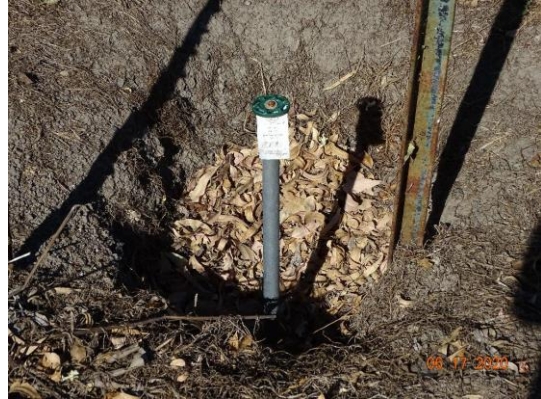
Photo 2 of 3 : UCIP_FA_2023_61499_89028.jpg

Land-Side: Sinkhole around air vent on levee shoulder

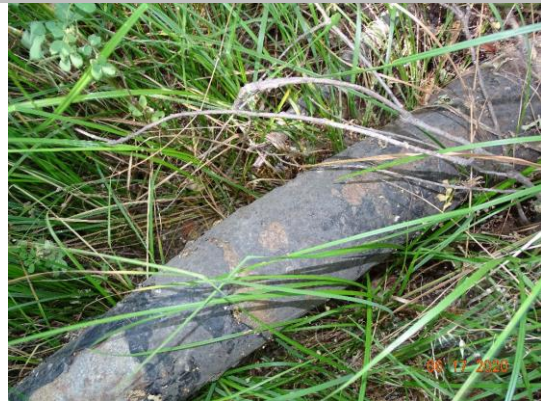
Photo 3 of 3 : UCIP_FA_2023_61499_89034.jpg

Water-Side: Open electrical conduit with wires inside on levee slope

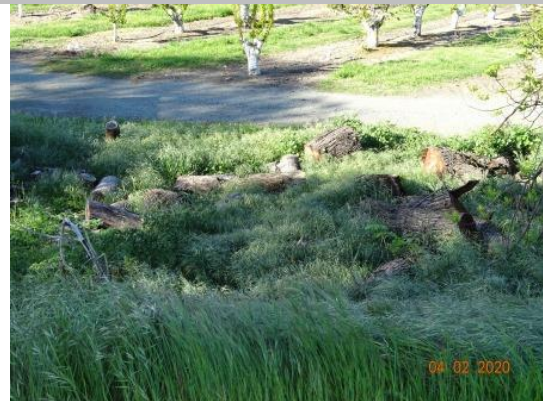
Photo 1 of 1 : FA_2023_RD0556_18_32_20231019_00013.jpg

LM Start	2.69	Rating **	M	Issue No.	32
LM End	2.69	Issue Type +	En	Location *	LS
Category	Earthen Levee			GPS Latitude/Longitude	
				Start	End
Item	Encroachments			38.215375°	38.215375°
				-121.541258°	-121.541258°
DWR ID	DWR_RD0556_01_s_2020_32				
Comment Code					
FW : Firewood					
Inspector Comment					
Several large chunks of wood should be removed from landside toe.

View of large tree trunk sections on the landside hinge (Spring 2020).

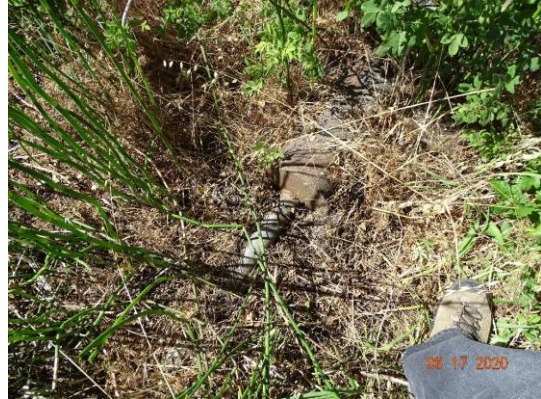
Photo 3 of 3 : UCIP_FA_2023_61501_89047.jpg

Water-Side: 3-inch pipe through 8-inch pipe sleeving connection on levee slope

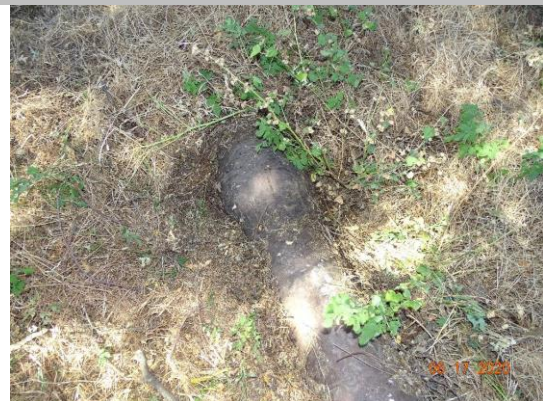
Photo 3 of 3 : UCIP_FA_2023_61500_89039.jpg

DS_ID:20833
FS_ID:61500
EP_NO: 11167
Repair Type: Non-Urgent
EVAL Issue: 10, Unauthorized Modification or Non-Compliant Permit
Crossing Status: Found
UCIP Comments: 06/17/2020 Record is Non-Urgent. Unable to find a permit for sleeving 10-inch pipe through 12-inch pipe. Unauthorized encroachment recorded in Levee Log prior to 2011. Need to have CVFPB review ABO and determine current owner. (O.Yakimov - DWR UCIP)
FIELD_STRUCT_DESC: 10-inch steel irrigation pipe sleeved through 12-inch steel pipe through levee, 4.0 feet below crown. Slant pump and gate valve on bank. 2-inch conduit through the levee 2 feet below crown. Service pole at landward toe. (12-inch pipe [HLM 2.7] authorized under Automatic Board Order (ABO) issued as Permit No. 11167, 1975 - Russel G. Graham). [Additional Reference(s): DWR Levee Log, unk.yr. (HLM 2.70)].
FS Date: 6/17/2020

Water-Side: 12-inch to 10-inch sleeved pipe connection on levee slope

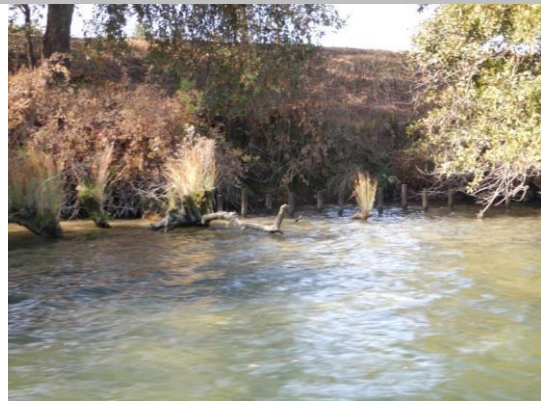
Photo 1 of 2 : FA_2023_RD0556_18_37_20231019_00018.jpg

LM Start	2.85	Rating **	M	Issue No.	37
LM End	2.98	Issue Type +	Ma	Location *	WS
Category	Supplemental			GPS Latitude/Longitude	
				Start	End
Item	2018 USACE Erosion Survey			38.214144°	38.212577°
				-121.538692°	-121.537244°
DWR ID	DWR_RD0556_01_s_2022_37				
Comment Code					
Inspector Comment					
2018 Site ID: GEO 9.2 R					
Status: Eroding					
2018 Field Notes: New erosion along toe.					
Site History: 2017 - Toe erosion.

USACE 2018 Erosion Photo #1

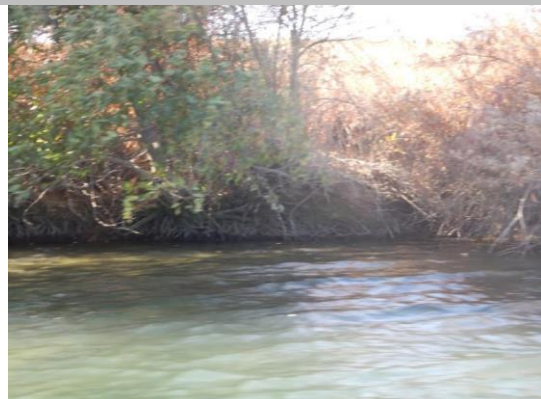
Photo 2 of 2 : FA_2023_RD0556_18_37_20231019_00019.jpg

USACE 2018 Erosion Photo #2

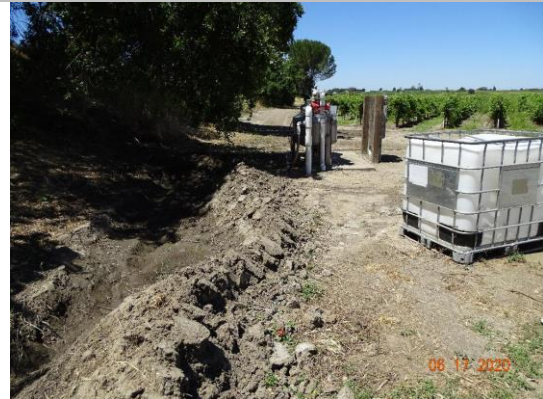
Photo 3 of 3 : UCIP_FA_2023_61291_89086.jpg

Overview of Levee: Overview of trench dug along landside toe

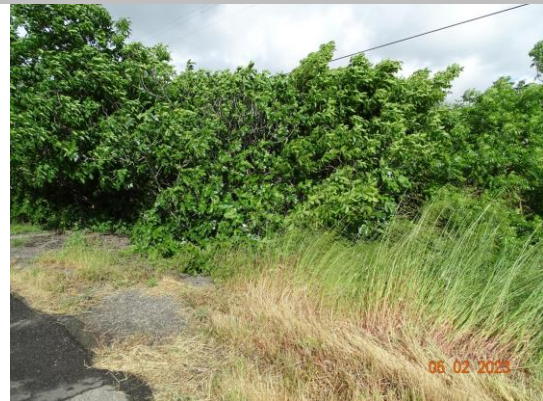
Photo 1 of 1 : FA_2023_RD0556_18_38_20231019_00020.jpg

LM Start	3.22	Rating **	U	Issue No.	38
LM End	3.23	Issue Type +	Ma	Location *	LS
Category	Earthen Levee			GPS Latitude/Longitude	
				Start	End
Item	Trim / Thin Trees			38.210493°	38.210446°
				-121.539760°	-121.539804°
DWR ID	DWR_RD0556_01_s_2017_38				
Comment Code					
T1 : Trim and thin trees to at least five feet above ground level to allow visibility of the ground and room to flood fight.					
Inspector Comment					
Remove the wild tree growth and vegetation from the landside levee slope and toe so the ground can be seen.

View of the wild growth on the LS slope (Spring 2023).

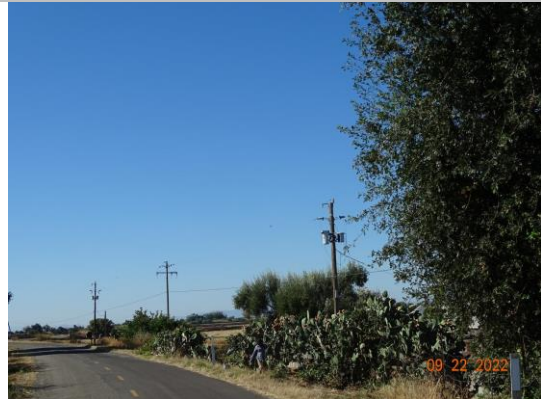
Photo 1 of 1 : FA_2023_RD0556_18_29_20231019_00010.jpg

LM Start	3.36	Rating **	U	Issue No.	29
LM End	3.42	Issue Type +	En	Location *	LS
Category	Earthen Levee			GPS Latitude/Longitude	
				Start	End
Item	Vegetation			38.208917°	38.208191°
				-121.541338°	-121.541578°
DWR ID	DWR_RD0556_01_f_2017_29				
Comment Code					
V6 : Landscaping					
Inspector Comment					
Large cactus growing on shoulder and slope should be removed to allow inspection and access.

View of the cactus on the LS slope (Fall 2022).

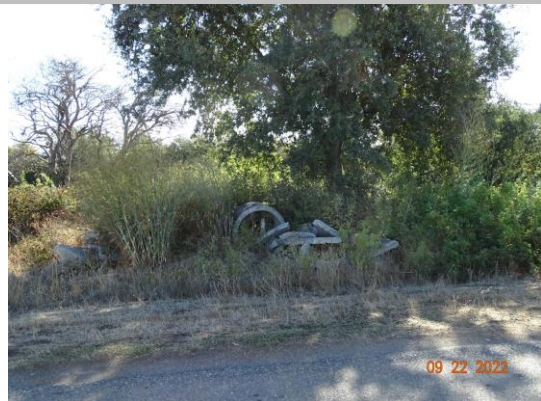
Photo 1 of 1 : FA_2023_RD0556_18_58_20231019_00037.jpg

LM Start	3.46	Rating **	U	Issue No.	58
LM End	3.46	Issue Type +	En	Location *	WS
Category	Earthen Levee			GPS Latitude/Longitude	
				Start	End
Item	Encroachments			38.207585°	38.207585°
				-121.541678°	-121.541678°
DWR ID	DWR_RD0556_01_f _ 2019_58				
Comment Code					
DE : Debris					
Inspector Comment					
Remove concrete debris piles.

View of the concrete debris on the WS slope (Fall 2022).

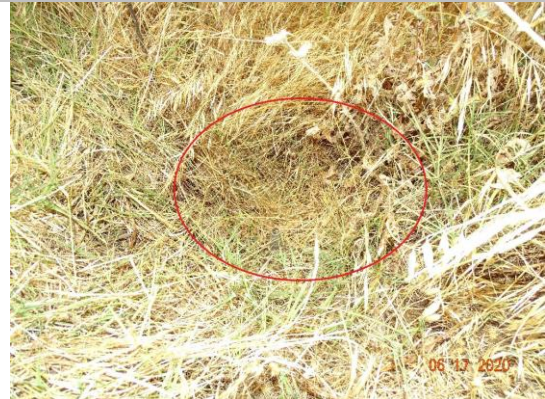
Photo 3 of 3 : UCIP_FA_2023_61301_89122.jpg

DS_ID:20840
FS_ID:61301
EP_NO: 11161
Repair Type: Urgent
EVAL Issue: 2b, Levee Integrity
Crossing Status: Found
UCIP Comments: 06/17/2020 Record is Urgent. Subsidence on landside shoulder measured 2' x 3' x 1.5'-deep around air vent. Crossing appears abandoned. Fence on landside slope and overgrown vegetation on both slopes prevent from detailed inspection of levee. No permit has been identified authorizing pipe. Need to have CVFPB review ABO and determine current owner. (O.Yakimov - DWR UCIP)
FIELD_STRUCT_DESC: 10-inch steel pipe through levee, 11.2 feet below crown. 2-inch air and vacuum valve and concrete spill box on landside of the levee. (10-inch pipe [HLM 3.57] authorized under Automatic Board Order (ABO) issued as Permit No. 11161, 1975 - L.J. Gamble & M. P. Darsie). [Additional Reference(s): DWR Levee Log, unk.yr. (HLM 3.57). USACE Sacramento O&M Manual, Unit 103, June 1954, Revised 29 December 2016, (Station 'R' 421+08.7), listed as 12-inch pipe. USACE As-Built Drawing No. 50-04-2671, Sheet 2, near Station 420+55, 25 January 1951, Revised 18 Dec. 1952, listed as 12-inch pipe. USACE As-Built Drawing No. 50-04-2631, Sheet 11, Station 421+08.7, March 1950, Revised 16 Dec. 1952, listed as 12-inch pipe].

Land-Side: Sinkhole around air vent on levee shoulder

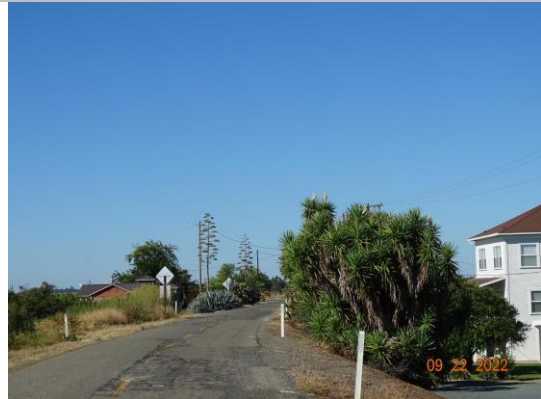
Photo 1 of 1 : FA_2023_RD0556_18_30_20231019_00011.jpg

LM Start	3.84	Rating **	U	Issue No.	30
LM End	3.91	Issue Type +	En	Location *	LS
Category	Earthen Levee			GPS Latitude/Longitude	
				Start	End
Item	Vegetation			38.202061°	38.201672°
				-121.541113°	-121.542133°
DWR ID	DWR_RD0556_01_f_2023_30				
Comment Code					
V6 : Landscaping					
Inspector Comment					
Trim/thin landscaping to allow inspection and access to levee slope and toe.

View of the landscaping on the LS slope (Fall 2022).

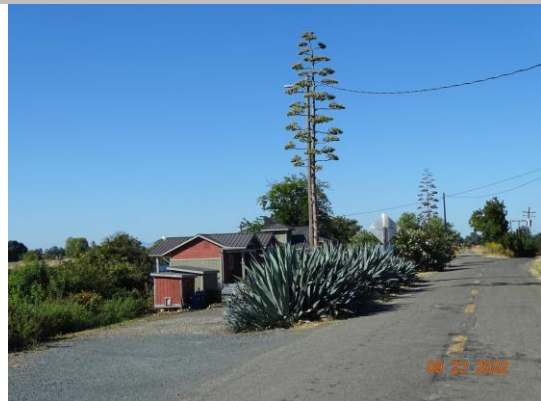
Photo 1 of 1 : FA_2023_RD0556_18_34_20231019_00015.jpg

LM Start	3.93	Rating **	U	Issue No.	34
LM End	3.98	Issue Type +	En	Location *	WS
Category	Earthen Levee			GPS Latitude/Longitude	
				Start	End
Item	Vegetation			38.201603°	38.201273°
				-121.542352°	-121.543328°
DWR ID	DWR_RD0556_01_f_2017_34				
Comment Code					
V6 : Landscaping					
Inspector Comment					
Remove large cactus from waterside shoulder to allow inspection and access.

View of the cactus on the WS shoulder (Fall 2022).

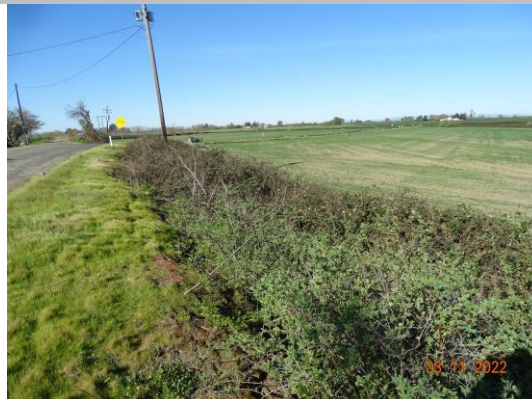
Photo 1 of 1 : FA_2023_RD0556_18_99_20231019_00049.jpg

LM Start	3.94	Rating **	U	Issue No.	99
LM End	3.96	Issue Type +	Ma	Location *	LS
Category	Earthen Levee			GPS Latitude/Longitude	
				Start	End
Item	Vegetation			38.201514°	38.201402°
				-121.542595°	-121.542958°
DWR ID	DWR_RD0556_01_s_2022_99				
Comment Code					
V2 : Remove the wild growth and woody vegetation other than native grasses from the levee slopes.					
Inspector Comment					
Blackberries on landside slope.

View looking downstream at vegetation on the landside slope (Spring 2022).

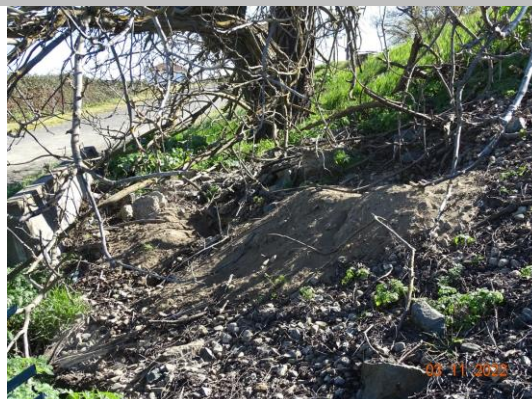
Photo 1 of 1 : FA_2023_RD0556_18_101_20231019_00051.jpg

LM Start	4.02	Rating **	M	Issue No.	101
LM End	4.02	Issue Type +	Ma	Location *	LS
Category	Earthen Levee			GPS Latitude/Longitude	
				Start	End
Item	Animal Control			38.201063°	38.201063°
				-121.543850°	-121.543850°
DWR ID	DWR_RD0556_01_s_2022_101				
Comment Code					
A1 : Exterminate rodents and backfill and compact or grout burrows.					
Inspector Comment

View of multiple animal holes in the landside slope (Spring 2022).

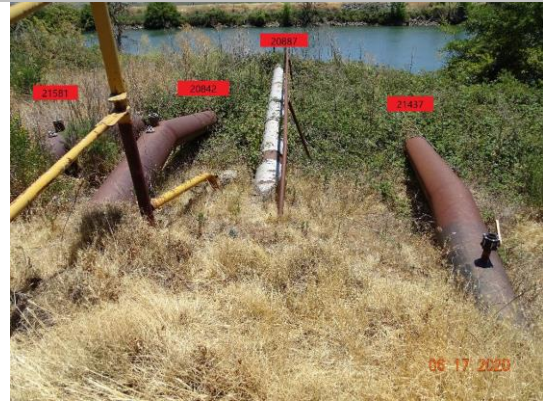
Photo 1 of 3 : UCIP_FA_2023_61315_89138.jpg

Comment Code					
Inspector Comment					
DS_ID:21581 FS_ID:61315 EP_NO: 13030 Repair Type: Non-Urgent EVAL Issue: 10, Unauthorized Modification or Non-Compliant Permit Crossing Status: Found UCIP Comments: 06/17/2020 Record is Non-Urgent. Pipe diameter field measured as 20-inch on both slopes. On landside berm pipe diameter changes from 20 inch to 18 inch. Unable to find a permit for modification of this crossing. No permit has been identified authorizing original O&M pipe through the levee. (O.Yakimov - DWR UCIP) FIELD_STRUCT_DESC: 18-inch steel drainage pipes through levee, 4.3 feet below crown. Pumps on landward side and 4-inch air valve. (18-inch pipe [HLM 4.01] authorized under Automatic Board Order (ABO) issued as Permit No. 11175, 1975 - RD0556). [Additional Reference(s): DWR Levee Log, unk.yr. (HLM 4.01). USACE Sacramento O&M Manual, Unit 103, June 1954, Revised 29 December 2016, (Station 397+36.3), listed as 20-inch pipe]. USACE As-Built Drawing No. 50-04-2631, Sheet 10, Station 397+36.3, March 1950, Revised 16 Dec.1952, listed as 20-inch pipe]. FS Date: 6/17/2020

Water-Side: Pipes on waterside berm

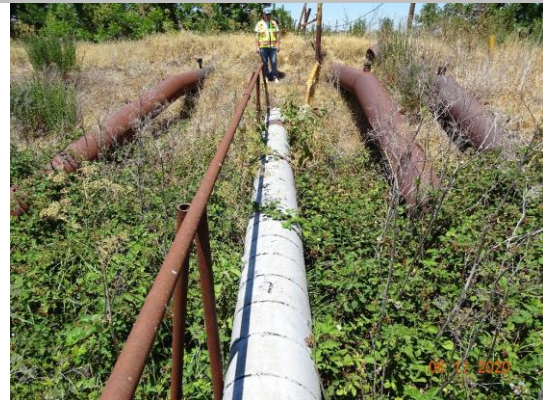
Photo 2 of 3 : UCIP_FA_2023_61315_89139.jpg

Water-Side: Pipes on waterside berm and levee slope on background

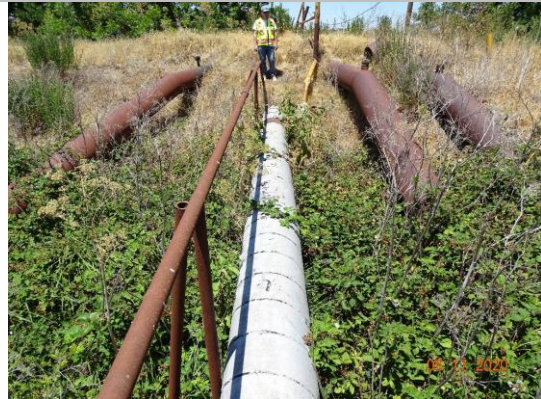
Photo 2 of 3 : UCIP_FA_2023_61303_89147.jpg

DS_ID:20842
FS_ID:61303
EP_NO: 13030
Repair Type: Non-Urgent
EVAL Issue: 10, Unauthorized Modification or Non-Compliant Permit
Crossing Status: Found
UCIP Comments: 06/17/2020 Record is Non-Urgent. Pipe diameter field measured as 20-inch on both slopes. On landside berm pipe diameter changes from 20 inch to 18 inch. Debris of 20-inch pipe welded to 16-inch pipe with open end found next to this crossing on landside berm. Unable to find a permit for modification of this crossing. No permit has been identified authorizing original O&M pipe through the levee. (O.Yakimov - DWR UCIP)
FIELD_STRUCT_DESC: 16-inch steel drainage pipe through levee, 4.3 feet below crown. Pump on landward side and 4-inch air valve. (16-inch pipe [HLM 4.01] authorized under Automatic Board Order (ABO) issued as Permit No. 11175, 1975 - RD0556). [Additional Reference(s): DWR Levee Log, unk.yr. (HLM 4.01). USACE Sacramento O&M Manual, Unit 103, June 1954, Revised 29 December 2016, (Station 397+20.5), listed as 16-inch pipe. USACE As-Built Drawing No. 50-04-2631, Sheet 10, Station 397+20.5, March 1950, Revised 16 Dec.1952, listed as 12-inch pipe].

Water-Side: Pipes on waterside berm looking from riverbank

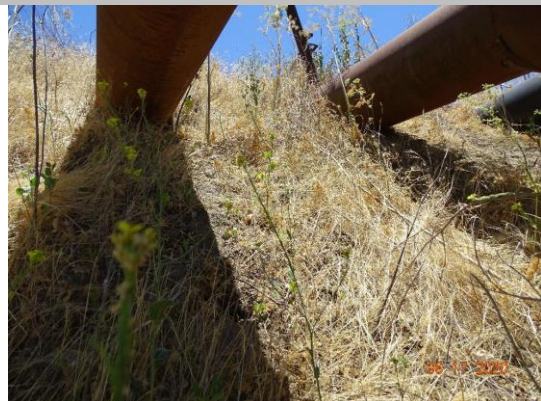
Photo 3 of 3 : UCIP_FA_2023_61303_89160.jpg

Land-Side: View of levee slope looking from toe

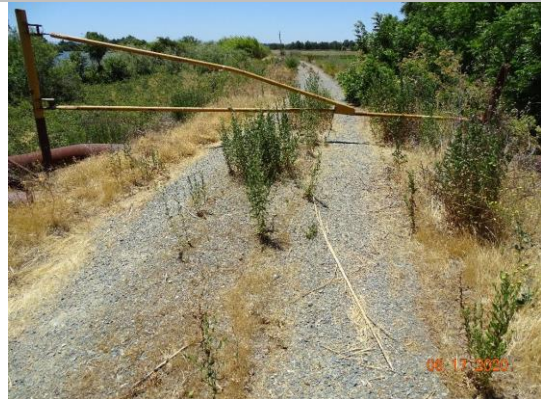
Photo 1 of 3 : UCIP_FA_2023_61311_89154.jpg

DS_ID:21437
FS_ID:61311
EP_NO: 10526
Repair Type: Non-Urgent
EVAL Issue: 10, Unauthorized Modification or Non-Compliant Permit
Crossing Status: Found
UCIP Comments: 06/17/2020 Record is Non-Urgent. Pipe diameter field measured as 20-inch on both slopes. Unable to find a permit for modification of this crossing. (O.Yakimov - DWR UCIP)

FIELD_STRUCT_DESC: 24-inch steel drainage pipes 3.5 ft below levee crown. Pumping plant on landside. 6" air valve, concrete saddle & wood beam on waterside. This crossing replaces 24-inch pipe (see DSID 25634). (24-inch pipe authorized under Permit No. 10526, 1975 - Reclamation District 556). [Additional Reference(s): USACE Sacramento O&M Manual, Unit 103, June 1954, Revised 29 December 2016, (Station 397+36.3), listed as 24-inch pipe. USACE As-Built Drawing No. 50-04-2631, Sheet 10, Station 397+36.3, March 1950, Revised 16 Dec.1952].
FS Date: 6/17/2020

Top of Levee: View of levee crown looking downstream

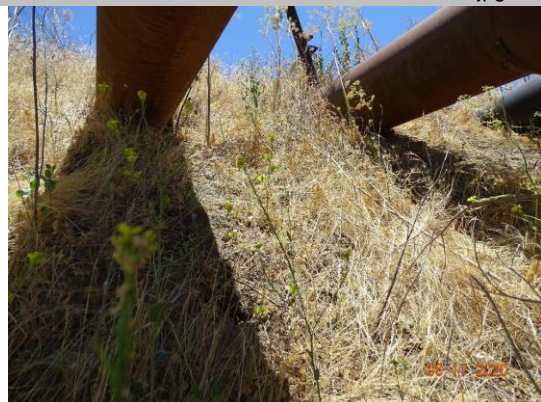
Photo 2 of 3 : UCIP_FA_2023_61311_89161.jpg

Land-Side: View of levee slope looking from toe

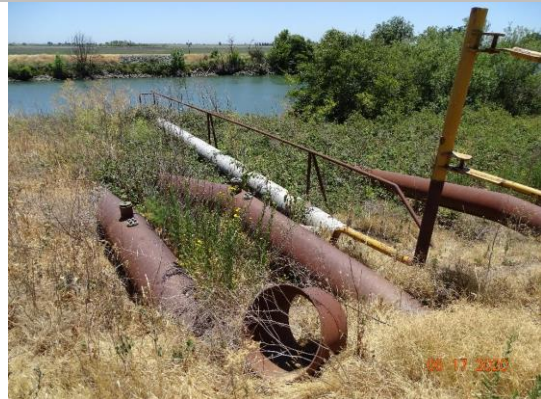
Photo 3 of 3 : UCIP_FA_2023_61311_89158.jpg

Water-Side: View of levee slope looking from crown

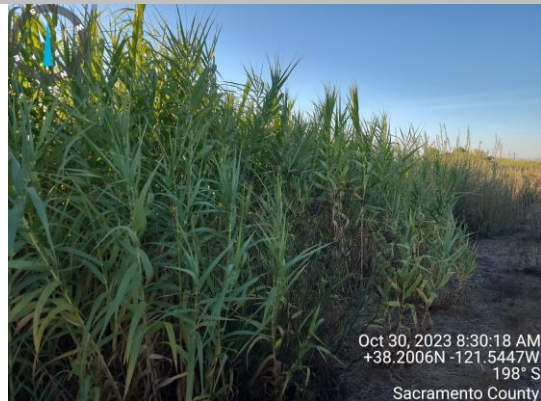
Photo 1 of 1 : FA_2023_RD0556_18_22_20231030_00093.jpg

LM Start	4.08	Rating **	U	Issue No.	22
LM End	4.08	Issue Type +	Ma	Location *	WS
Category	Earthen Levee			GPS Latitude/Longitude	
				Start	End
Item	Vegetation			38.200587°	38.200490°
				-121.544775°	-121.544894°
DWR ID	DWR_RD0556_01_f_2023_22				
Comment Code					
V2 : Remove the wild growth and woody vegetation other than native grasses from the levee slopes.					
Inspector Comment					
Remove arundo.

View of arundo on the waterside shoulder. Fall 2023.

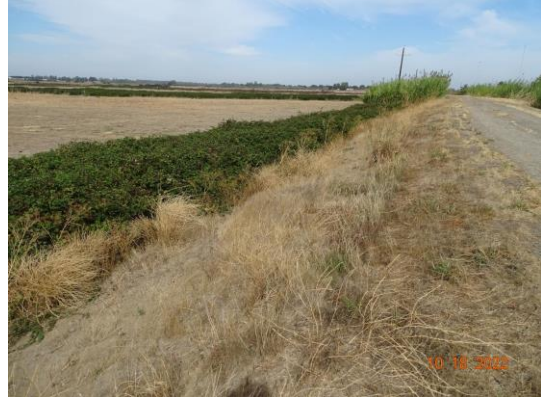
Photo 1 of 1 : FA_2023_RD0556_18_39_20231019_00021.jpg

LM Start	4.17	Rating **	M	Issue No.	39
LM End	4.33	Issue Type +	Ma	Location *	LS
Category	Earthen Levee			GPS Latitude/Longitude	
				Start	End
Item	Vegetation			38.199425°	38.197467°
				-121.545808°	-121.547146°
DWR ID	DWR_RD0556_01_f _ 2017_39				
Comment Code					
V2 : Remove the wild growth and woody vegetation other than native grasses from the levee slopes.					
Inspector Comment					
Blackberries at LS toe.

View of the blackberries on the LS toe (Fall 2022).

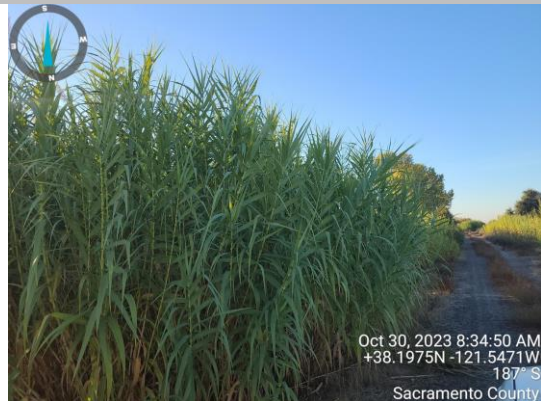
Photo 1 of 1 : FA_2023_RD0556_18_26_20231030_00095.jpg

LM Start	4.33	Rating **	U	Issue No.	26
LM End	4.37	Issue Type +	Ma	Location *	WS
Category	Earthen Levee			GPS Latitude/Longitude	
				Start	End
Item	Vegetation			38.197442°	38.196922°
				-121.547148°	-121.547413°
DWR ID	DWR_RD0556_01_f_2023_26				
Comment Code					
V2 : Remove the wild growth and woody vegetation other than native grasses from the levee slopes.					
Inspector Comment					
Remove arundo.

View of arundo on the waterside shoulder. Fall 2023.

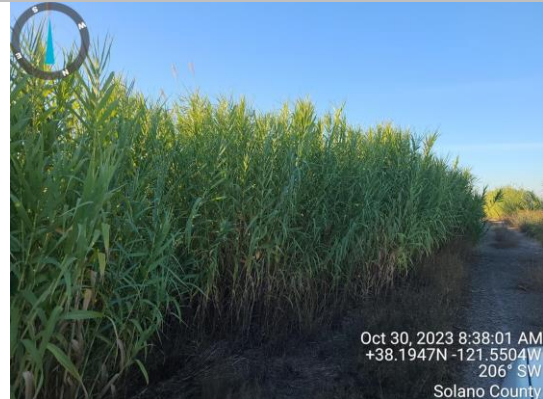
Photo 1 of 1 : FA_2023_RD0556_18_35_20231030_00096.jpg

LM Start	4.59	Rating **	U	Issue No.	35
LM End	4.62	Issue Type +	Ma	Location *	WS
Category	Earthen Levee			GPS Latitude/Longitude	
				Start	End
Item	Vegetation			38.194709°	38.194517°
				-121.550358°	-121.550709°
DWR ID	DWR_RD0556_01_f _ 2023_35				
Comment Code					
V2 : Remove the wild growth and woody vegetation other than native grasses from the levee slopes.					
Inspector Comment					
Remove arundo.

View of arundo on the waterside shoulder. Fall 2023.

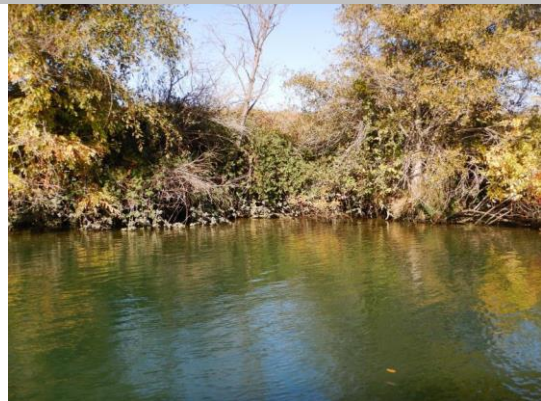
Photo 1 of 2 : FA_2023_RD0556_18_20_20231019_00004.jpg

LM Start	5.12	Rating **	M	Issue No.	20
LM End	5.34	Issue Type +	Ma	Location *	WS
Category	Supplemental			GPS Latitude/Longitude	
				Start	End
Item	2018 USACE Erosion Survey			38.189775°	38.187369°
				-121.557729°	-121.560247°
DWR ID	DWR_RD0556_01_s_2022_20				
Comment Code					
Inspector Comment					
2018 Site ID: GEO 7.0 R					
Status: Eroding					
2018 Field Notes: Minor new toe erosion.					
Site History: 1997 - Toe damaged rock. 1999 - One pocket filled with gravel. 2000 - Eroding beach with some biotech rolls and stakes; some gravel on slope. 2001 - Staked, low fascine walls at bankline. 2005 - Stone revetment in between pockets. 2006 - New rock on upper slope behind brush boxes at the upstream end, Stone is sliding off the hard toe. 2016 - Fresh erosion observed. 2017 - Site extended downstream. Large erosion pockets and significant toe erosion.

USACE 2018 Erosion Photo #1

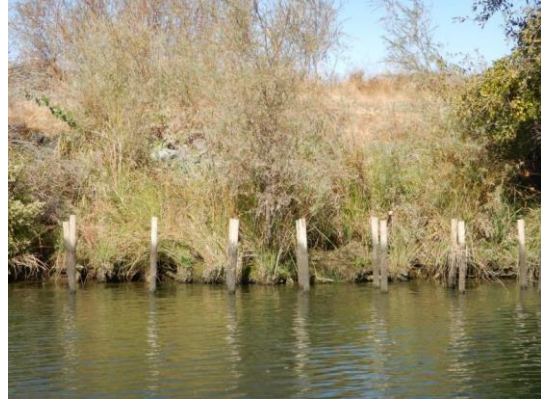
Photo 2 of 2 : FA_2023_RD0556_18_20_20231019_00005.jpg

USACE 2018 Erosion Photo #2

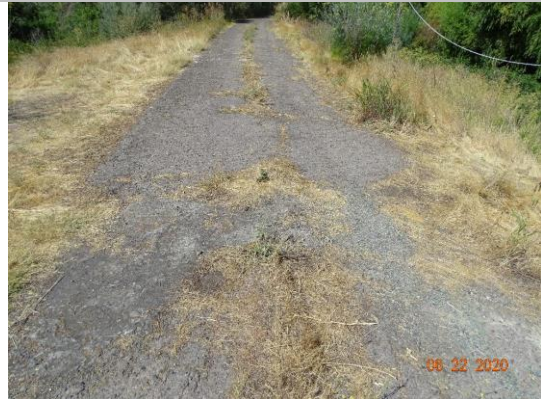
Photo 1 of 3 : UCIP_FA_2023_61308_89184.jpg

DS_ID:20847
 FS_ID:61308
 EP_NO: 10489
 Repair Type: Non-Urgent
 EVAL Issue: 10, Unauthorized Modification or Non-Compliant Permit
 Crossing Status: Found
 UCIP Comments: 06/22/2020 Record is Non-Urgent. Slant pump was removed and replaced with smaller pump on pile structure at riverbank. Unable to find a permit for modification. (O.Yakimov - DWR UCIP)
 FIELD_STRUCT_DESC: 10-inch pipe through levee, 3.5 feet below crown. Pump on pile structure at riverbank. 1-inch electrical conduit through levee at this location. Siphon breaker in CMP riser on landward slope. A 9 ft x 42-inch concrete standpipe on landside. Service pole with electric meter and connection panel at landside toe. Two sand media filters on landside. This crossing replaces 6-inch pipe (see DSID 25650). (10-inch pipe authorized under Permit No. 10489, 1975 - Daecie and Gamble). [Additional Reference(s): DWR Levee Log, unk.yr. (HLM 5.32). USACE Sacramento O&M Manual, Unit 103, June 1954, Revised 29 December 2016, (Station 'R' 327+63.7), listed as 8-inch pipe. USACE As-Built Drawing No. 50-04-2631, Sheet 8, Station 327+63.7, March 1950, Revised 16 Dec.1952, listed as 8-inch pipe].

Top of Levee: View of levee crown looking downstream

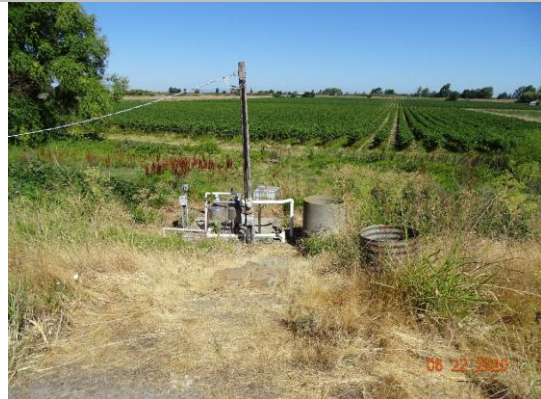
Photo 2 of 3 : UCIP_FA_2023_61308_89185.jpg

Land-Side: View of levee slope looking from crown

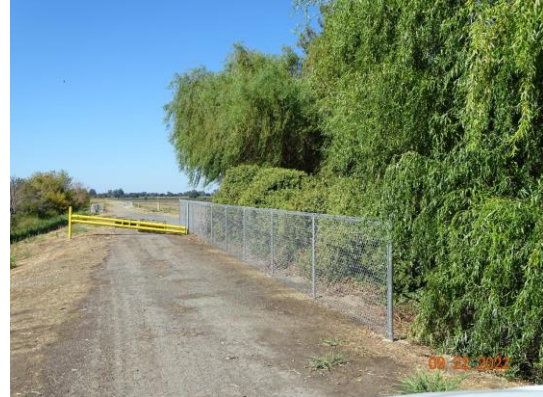
Photo 1 of 1 : FA_2023_RD0556_18_90_20231019_00047.jpg

LM Start	5.46	Rating **	M	Issue No.	90
LM End	5.48	Issue Type +	En	Location *	LS
Category	Earthen Levee			GPS Latitude/Longitude	
				Start	End
Item	Encroachments			38.186565°	38.186479°
				-121.562233°	-121.562519°
DWR ID	DWR_RD0556_01_f _ 2022_90				
Comment Code					
FE : Fence					
Inspector Comment

View of the fence on the on LS shoulder (Fall 2022).

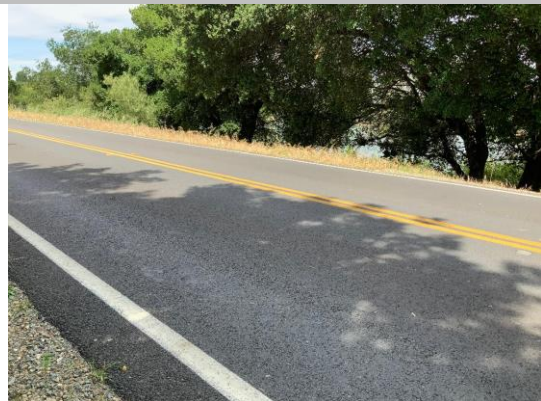
Photo 1 of 3 : UCIP_FA_2023_76291_113332.jpg

Comment Code					
Inspector Comment					
DS_ID:20858 FS_ID:76291 EP_NO: 11179 Repair Type: Urgent EVAL Issue: 2a, Levee Integrity Crossing Status: Found UCIP Comments: 05/12/2022 The record has been upgraded from No Action Needed to Urgent. WS slope and berm near water has significant erosion greater than 1 foot. There is also excavation around the WS berm exposing the pipe that is greater than 1 foot. Recommend filling in excavations that are causing a safety hazard. Crossing will be monitored until funding becomes available to address the issues. No permit other than ABO was found authorizing this encroachment. CVFPB will need to review crossing to determine owner. The UCIP inspection was completed with GEI staff, A. Lau. (H. Dunn – GEI) FIELD_STRUCT_DESC: 12-inch irrigation discharge pipe of an unknown material through the levee, 4.8 feet below the crown. Pump on a pile structure in the river. Service pole on each slope. (12-inch pipe [HLM 0.29] authorized under Automatic Board Order (ABO) issued as Permit No. 11179, 1975 - George K. Adams Ranches, Inc). [Additional Reference(s): DWR Levee Log, year unknown (HLM 0.29)]. FS Date: 5/12/2022 1:22:06 PM

Levee crown.

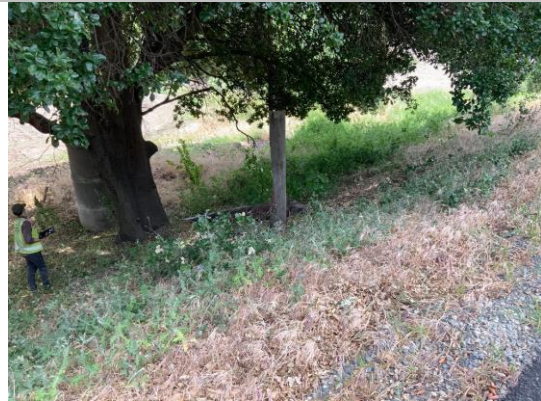
Photo 2 of 3 : UCIP_FA_2023_76291_113334.jpg

LS view: Toe from crown.

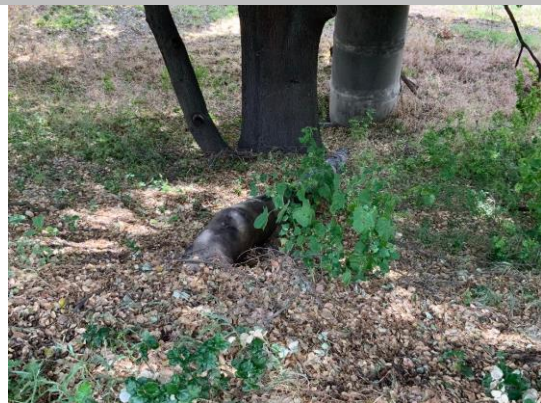
Photo 3 of 3 : UCIP_FA_2023_76291_113335.jpg

LS view: Closeup of exposed pipe on slope.

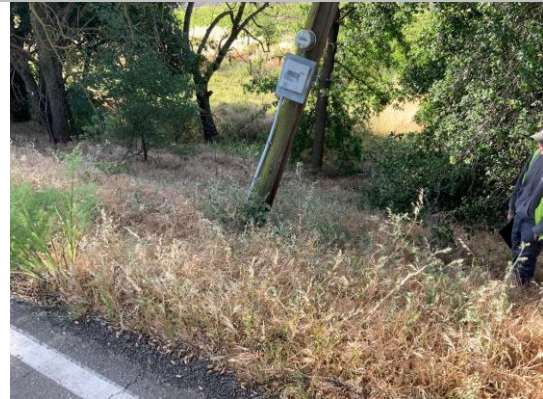
Photo 2 of 3 : UCIP_FA_2023_76292_113346.jpg

LS view: Slope and toe from crown.

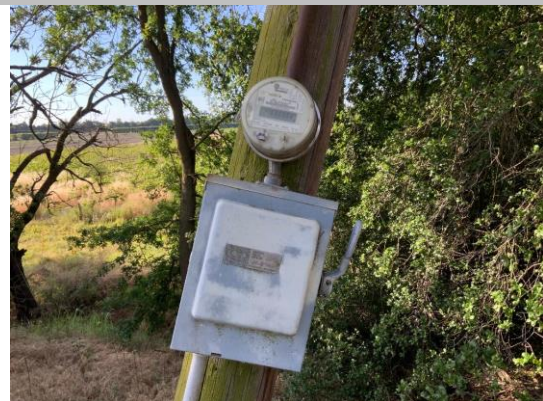
Photo 3 of 3 : UCIP_FA_2023_76292_113347.jpg

LS view: Closeup of meter pole.

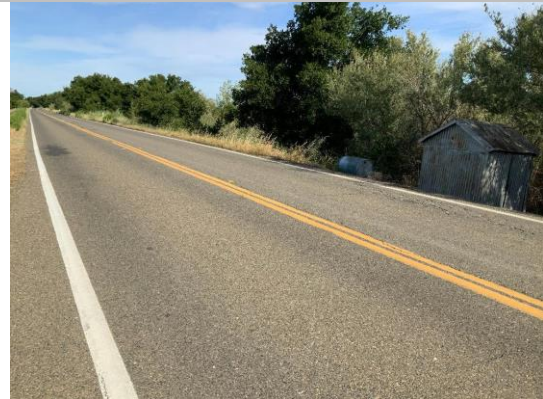
Photo 1 of 3 : UCIP_FA_2023_76293_113385.jpg

Comment Code					
Inspector Comment					
DS_ID:20851 FS_ID:76293 EP_NO: 11186 Repair Type: Non-Urgent EVAL Issue: 6, Levee Damage or Threat for Levee Damage Crossing Status: Found UCIP Comments: 05/12/2022 The record remains Non-Urgent. The plastic tank on WS is still leaking, causing minor erosion on the WS slope. Recommend repair of tank or hose to prevent further erosion. No permit other than ABO permit was found authorizing this encroachment. CVFPB will need to review crossing to determine owner. The UCIP inspection was completed with GEI staff, A. Lao. (H. Dunn – GEI) 04/25/2013 a concrete box on LS. Water is leaking from priming plastic tank and causing surface erosion on levee slope. (P. Amatya - DWR) FIELD_STRUCT_DESC: 4-inch steel irrigation discharge pipe through the levee, 4.3 feet below the crown. Pump and gate valve in a pump house on the waterside (WS) berm. Siphon breaker and service pole on the landside (LS) slope. Concrete spill box with three 8-inch openings. (4-inch pipe [HLM 0.95] authorized under Automatic Board Order (ABO) issued as Permit No. 11186, 1975 - Margaret M. Marks). [Additional Reference(s): DWR Levee Log, year unknown (HLM 0.95). USACE Sacramento O&M Manual, Unit 103, June 1954, Revised 29 December 2016, (Station "J" 192+00), listed as 6-inch pipe. USACE As-Built Drawing No. 50-04-2277, March 1946, Sheet 4, 192+00 "J", listed as 6-inch pipe]. FS Date: 5/12/2022 3:13:00 PM

Levee crown.

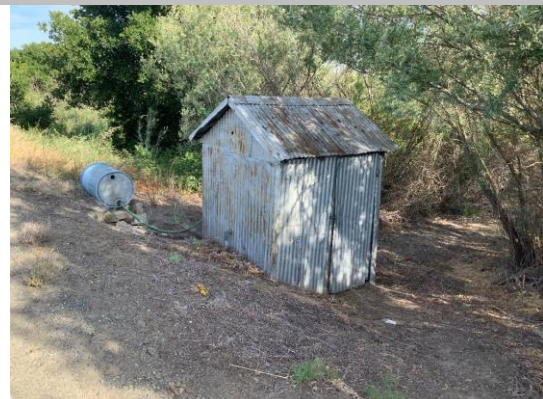
Photo 2 of 3 : UCIP_FA_2023_76293_113386.jpg

WS view: Pump house and tank on slope from crown.
