Flood Control Project Maintenance Levee Inspections

Fall 2023 Levee Maintenance Deficiency Summary Report

Sacramento River Basin

Reclamation District No. 0556 Upper Andrus

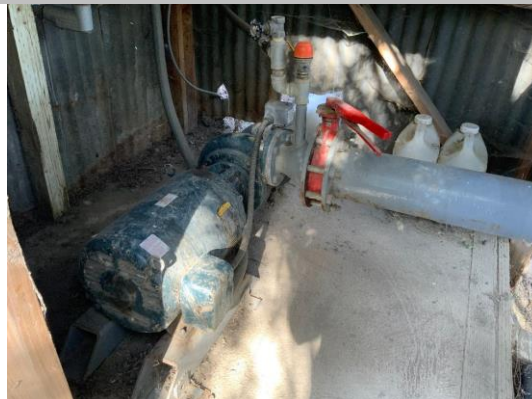
Photo 3 of 3 : UCIP_FA_2023_76293_113380.jpg

WS view: Closeup of pump in pumphouse on slope.

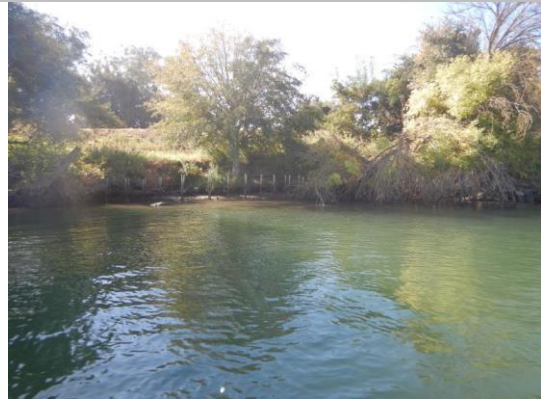
Photo 2 of 2 : FA_2023_RD0556_19_19_20231019_00016.jpg

LM Start	1.03	Rating **	M	Issue No.	19 (cont)
LM End	1.15	Issue Type +	Ma	Location *	WS
Category	Supplemental			GPS Latitude/Longitude	
				Start	End
Item	2018 USACE Erosion Survey			38.238772°	38.239265°
				-121.536788°	-121.538845°
DWR ID	DWR_RD0556_02_s_2022_19

USACE 2018 Erosion Photo #2

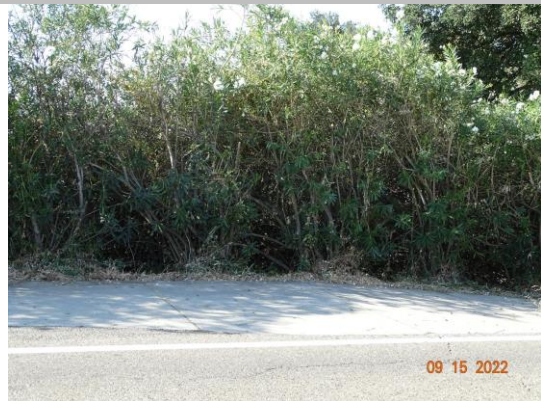
Photo 1 of 1 : FA_2023_RD0556_19_26_20231019_00019.jpg

LM Start	1.11	Rating **	U	Issue No.	26
LM End	1.11	Issue Type +	En	Location *	LS
Category	Earthen Levee			GPS Latitude/Longitude	
				Start	End
Item	Vegetation			38.238857°	38.238857°
				-121.538310°	-121.538310°
DWR ID	DWR_RD0556_02_f_2017_26				
Comment Code					
V6 : Landscaping					
Inspector Comment					
Trim/thin oleanders on the landside of the levee.

View of the oleander on the LS slope (Fall 2022).

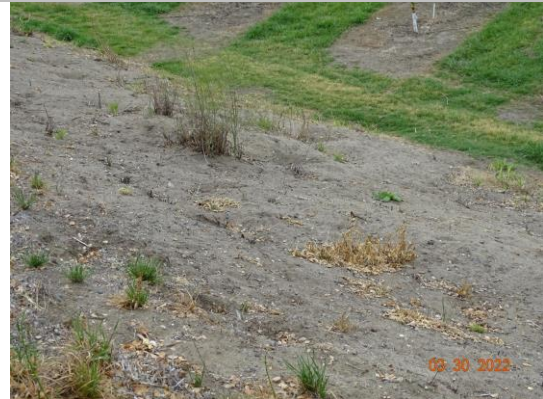
Photo 1 of 1 : FA_2023_RD0556_19_75_20231019_00052.jpg

LM Start	1.20	Rating **	M	Issue No.	75
LM End	1.26	Issue Type +	Ma	Location *	LS
Category	Earthen Levee			GPS Latitude/Longitude	
				Start	End
Item	Animal Control			38.239226°	38.239473°
				-121.539869°	-121.540962°
DWR ID	DWR_RD0556_02_s_2022_75				
Comment Code					
A3 : No rodents visible, but rodent burrows visible; need to backfill and compact or grout burrows.					
Inspector Comment

View of animal holes in the landside slope (Spring 2022).

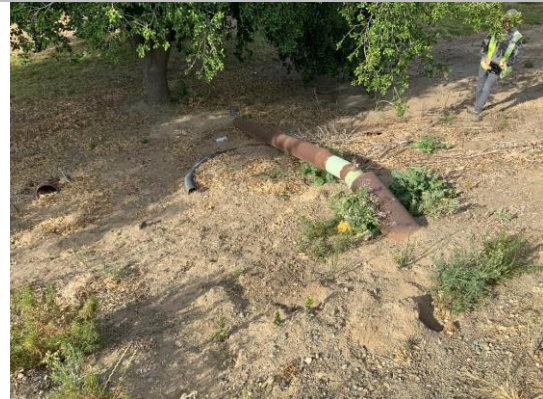
Photo 2 of 3 : UCIP_FA_2023_76294_113392.jpg

LS view: Pipe visible on the slope from crown.

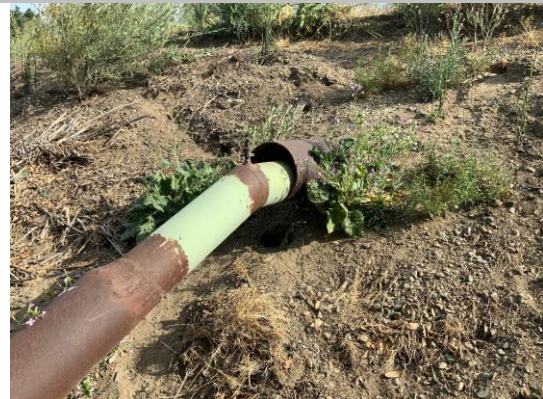
Photo 3 of 3 : UCIP_FA_2023_76294_113393.jpg

LS view: Closeup of gap between pipe on slope.

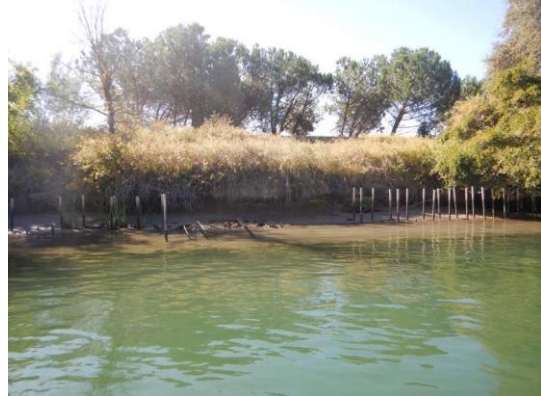
Photo 1 of 2 : FA_2023_RD0556_19_18_20231019_00013.jpg

LM Start	1.45	Rating **	M	Issue No.	18
LM End	1.59	Issue Type +	Ma	Location *	WS
Category	Supplemental			GPS Latitude/Longitude	
				Start	End
Item	2018 USACE Erosion Survey			38.240401°	38.240772°
				-121.544106°	-121.546791°
DWR ID	DWR_RD0556_02_s_2022_18				
Comment Code					
Inspector Comment					
2018 Site ID: SAC 24.8 L					
Status: Eroding					
2018 Field Notes: Site extended upstream.					
Site History: 1997 - Slow erosion of the berm at the waterline; bench below water. 2005 - Brush boxes present. 2010 - Minor new erosion. 2013 - There is little to no berm remaining at downstream end of this site. 2016 - New erosion on levee slope. 2017 - Significant lower bank erosion.

USACE 2018 Erosion Photo #1

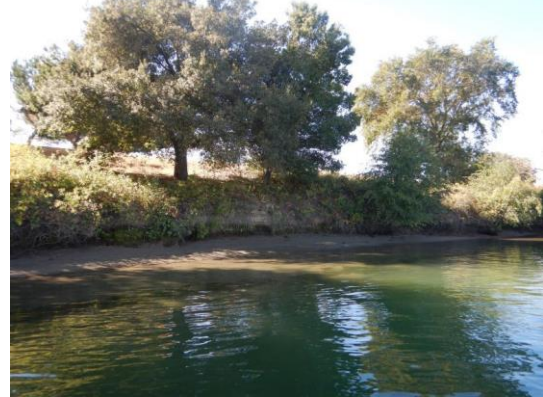
Photo 2 of 2 : FA_2023_RD0556_19_18_20231019_00014.jpg

USACE 2018 Erosion Photo #2

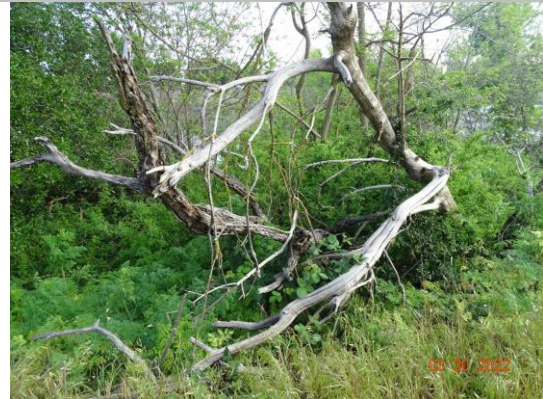
Photo 1 of 1 : FA_2023_RD0556_19_50_20231019_00036.jpg

LM Start	1.47	Rating **	U	Issue No.	50
LM End	1.47	Issue Type +	Ma	Location *	WS
Category	Earthen Levee			GPS Latitude/Longitude	
				Start	End
Item	Trim / Thin Trees			38.240183°	38.240183°
				-121.544567°	-121.544567°
DWR ID	DWR_RD0556_02_f _ 2021_50				
Comment Code					
T2 : Tree or limb.					
Inspector Comment

View of down tree on the landside slope (Spring 2022).

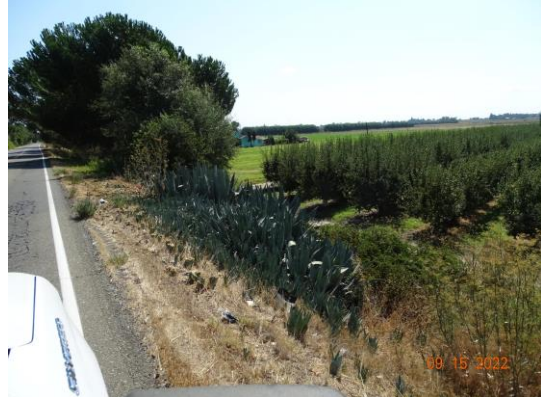
Photo 1 of 1 : FA_2023_RD0556_19_47_20231019_00034.jpg

LM Start	1.57	Rating **	U	Issue No.	47
LM End	1.57	Issue Type +	En	Location *	LS
Category	Earthen Levee			GPS Latitude/Longitude	
				Start	End
Item	Vegetation			38.240455°	38.240455°
				-121.546362°	-121.546362°
DWR ID	DWR_RD0556_02_s_ 2019_47				
Comment Code					
V6 : Landscaping					
Inspector Comment					
Remove cactus from the landside slope.

View of the cactus on the LS slope (Fall 2022).

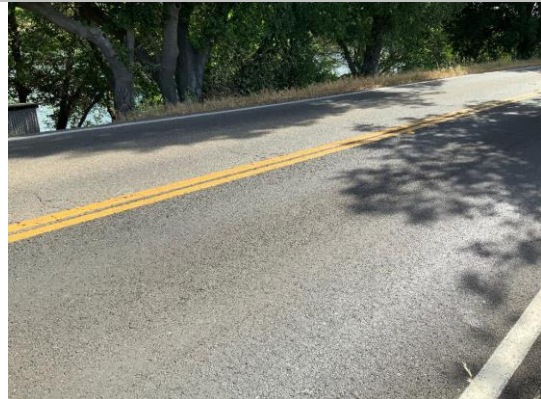
Photo 1 of 3 : UCIP_FA_2023_76296_113408.jpg

LM Start	1.78	Rating **	M	Issue No.	123
LM End	1.78	Issue Type +	En	Location *	
Category	Supplemental			GPS Latitude/Longitude	
				Start	End
Item	DWR UCIP Field Study			38.240998°	38.240998°
				-121.550265°	-121.550265°
DWR ID	20854

Comment Code					
Inspector Comment					
DS_ID:20854 FS_ID:76296 EP_NO: N/A Repair Type: Non-Urgent EVAL Issue: 10, Unauthorized Modification or Non-Compliant Permit Crossing Status: Found UCIP Comments: 05/12/2022 The record has been upgraded from No Action Needed to Non-Urgent. Modification of new filtration system on LS toe. No permit was found authorizing this encroachment. CVFPB will need to review crossing to determine owner. Pump was running during. The UCIP inspection was completed with GEI staff, A. Lao. (H. Dunn – GEI) 04/25/2013 Pump was running during field survey. (P. Amatya - DWR) FIELD_STRUCT_DESC: 8-inch steel irrigation discharge pipe through the levee, 5.5 feet below the crown. Pump and gate valve on the waterside (WS) berm. Siphon breaker and service pole on the landside (LS) slope. Concrete standpipe on the LS. (8-inch pipe [HLM 1.78] authorized under Automatic Board Order (ABO) issued as Permit No. 11181, 1975 - Robert E. and G. P. Collins). [Additional Reference(s): DWR Levee Log, year unknown (HLM 1.78). USACE Sacramento O&M Manual, Unit 103, June 1954, Revised 29 December 2016, (Station "J" 149+10), listed as 8-inch pipe. USACE As-Built Drawing No. 50-04-2277, March 1946, Sheet 3, 149+10 "J"]. FS Date: 5/12/2022 3:39:19 PM

Levee crown.

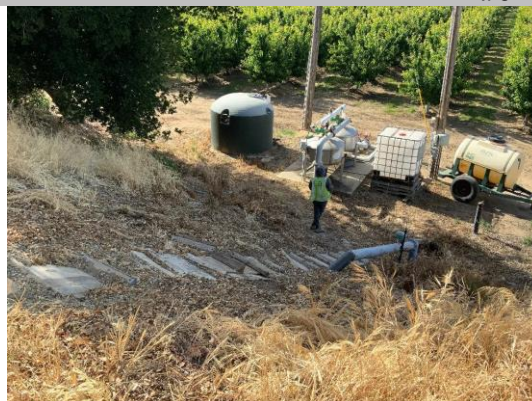
Photo 2 of 3 : UCIP_FA_2023_76296_113409.jpg

LS view: Slope with pipe and toe from crown.

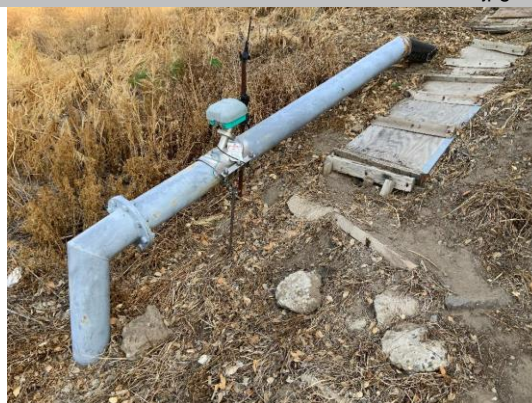
Photo 3 of 3 : UCIP_FA_2023_76296_113410.jpg

LS view: Closeup of pipe on slope from toe.

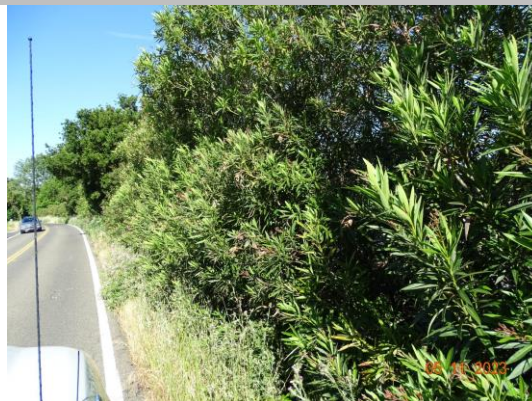
Photo 1 of 1 : FA_2023_RD0556_19_70_20231019_00049.jpg

LM Start	1.82	Rating **	U	Issue No.	70
LM End	1.92	Issue Type +	En	Location *	WS
Category	Earthen Levee			GPS Latitude/Longitude	
				Start	End
Item	Vegetation			38.241010°	38.240618°
				-121.551033°	-121.552747°
DWR ID	DWR_RD0556_02_f_2018_70				
Comment Code					
V6 : Landscaping					
Inspector Comment					
Thin oleanders to allow view down the levee slope.

View of the oleander on the WS slope (Spring 2023).

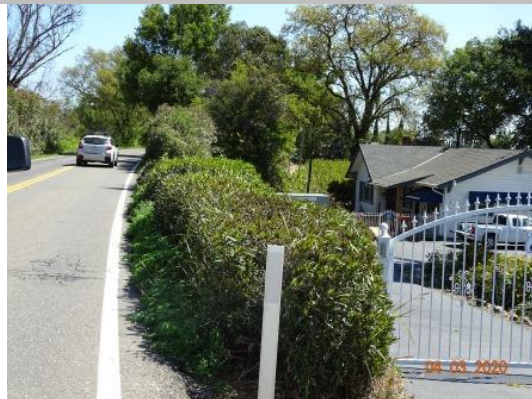
Photo 1 of 1 : FA_2023_RD0556_19_86_20231019_00059.jpg

LM Start	1.83	Rating **	U	Issue No.	86
LM End	1.87	Issue Type +	En	Location *	LS
Category	Earthen Levee			GPS Latitude/Longitude	
				Start	End
Item	Vegetation			38.240944°	38.240851°
				-121.551078°	-121.551833°
DWR ID	DWR_RD0556_02_f_2023_86				
Comment Code					
V6 : Landscaping					
Inspector Comment

View looking upstream at landscaping on the landside slope (Spring 2020).

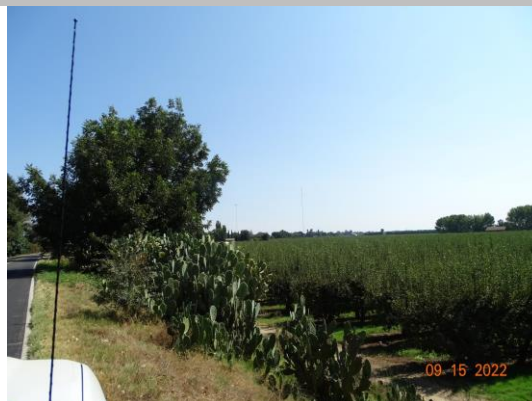
Photo 1 of 1 : FA_2023_RD0556_19_30_20231019_00021.jpg

LM Start	1.89	Rating **	U	Issue No.	30
LM End	1.99	Issue Type +	En	Location *	LS
Category	Earthen Levee			GPS Latitude/Longitude	
				Start	End
Item	Vegetation			38.240775 °	38.240024 °
				-121.552183 °	-121.553860 °
DWR ID	DWR_RD0556_02_f_2017_30				
Comment Code					
V6 : Landscaping					
Inspector Comment					
Remove cactus on the landside slope.

View of the cactus on the LS slope (Fall 2022).

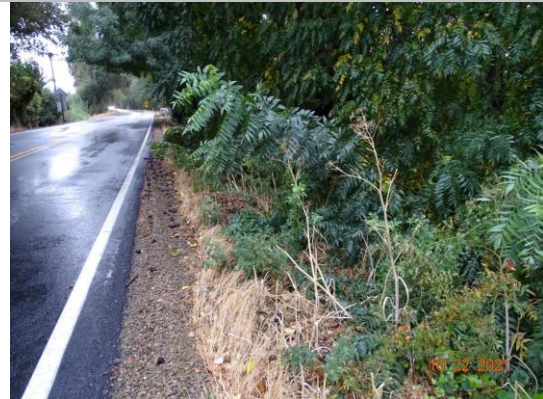
Photo 1 of 1 : FA_2023_RD0556_19_68_20231019_00048.jpg

LM Start	2.02	Rating **	U	Issue No.	68
LM End	2.06	Issue Type +	En	Location *	WS
Category	Earthen Levee			GPS Latitude/Longitude	
				Start	End
Item	Vegetation			38.239807°	38.239409°
				-121.554221°	-121.554889°
DWR ID	DWR_RD0556_02_f _ 2021_68				
Comment Code					
V6 : Landscaping					
Inspector Comment

View looking downstream at landscaping on the waterside slope (Fall 2021).

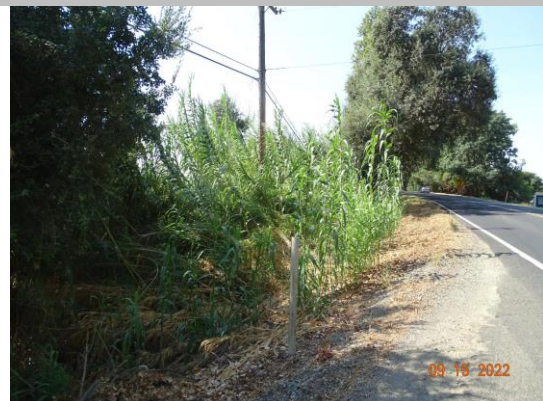
Photo 1 of 1 : FA_2023_RD0556_19_32_20231019_00023.jpg

LM Start	2.06	Rating **	U	Issue No.	32
LM End	2.06	Issue Type +	Ma	Location *	LS
Category	Earthen Levee			GPS Latitude/Longitude	
				Start	End
Item	Trim / Thin Trees			38.239470°	38.239470°
				-121.554845°	-121.554845°
DWR ID	DWR_RD0556_02_s_2020_32				
Comment Code					
T1 : Trim and thin trees to at least five feet above ground level to allow visibility of the ground and room to flood fight.					
Inspector Comment					
Arundo growth should be removed to allow inspection and access to the landside slope and toe.

View of the arundo on the LS slope (Fall 2022).

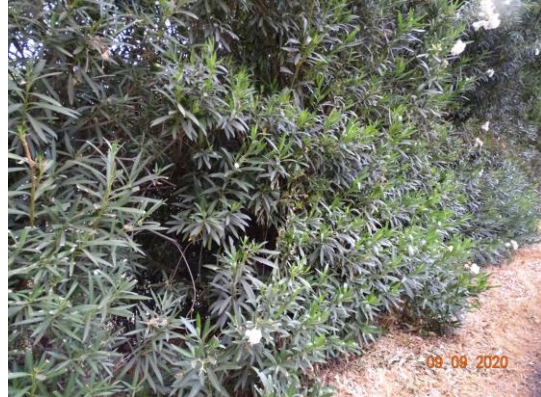
Photo 1 of 1 : FA_2023_RD0556_19_2_20231019_00002.jpg

LM Start	2.14	Rating **	U	Issue No.	2
LM End	2.14	Issue Type +	En	Location *	WS
Category	Earthen Levee			GPS Latitude/Longitude	
				Start	End
Item	Vegetation			38.238644°	38.238644°
				-121.555967°	-121.555967°
DWR ID	DWR_RD0556_02_f_2020_2				
Comment Code					
V6 : Landscaping					
Inspector Comment					
Trim oleanders on the waterside slope.

View looking upstream oleanders on the waterside slope (Fall 2020).

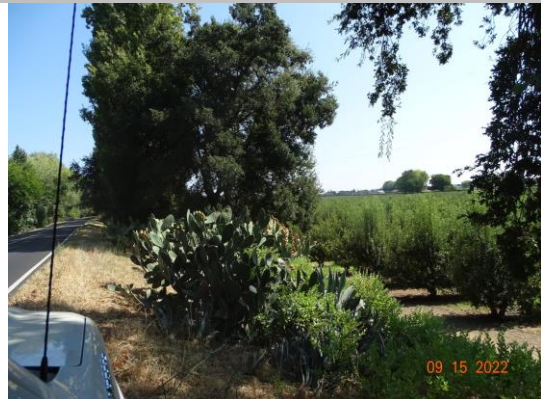
Photo 1 of 1 : FA_2023_RD0556_19_33_20231019_00024.jpg

LM Start	2.19	Rating **	U	Issue No.	33
LM End	2.22	Issue Type +	En	Location *	LS
Category	Earthen Levee			GPS Latitude/Longitude	
				Start	End
Item	Vegetation			38.238172°	38.237883°
				-121.556502°	-121.556958°
DWR ID	DWR_RD0556_02_f_2017_33				
Comment Code					
V6 : Landscaping					
Inspector Comment					
Large growth of prickly pear cactus should be removed to allow inspection and access.

View of the cactus on the LS slope (Fall 2022).

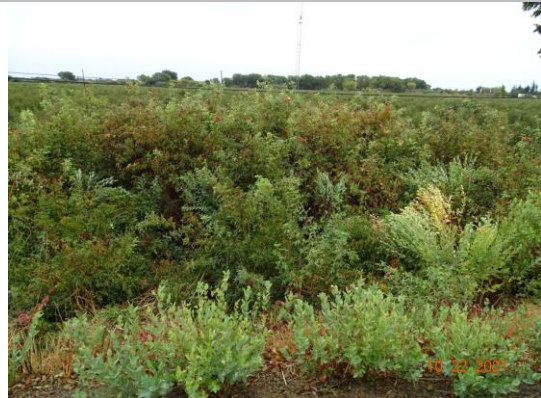
Photo 1 of 1 : FA_2023_RD0556_19_111_20231019_00066.jpg

LM Start	2.23	Rating **	U	Issue No.	111
LM End	2.23	Issue Type +	En	Location *	LS
Category	Earthen Levee			GPS Latitude/Longitude	
				Start	End
Item	Vegetation			38.237741°	38.237741°
				-121.557062°	-121.557062°
DWR ID	DWR_RD0556_02_f_2021_111				
Comment Code					
V6 : Landscaping					
Inspector Comment					
Cactus on landside slope.

View of thick vegetation on the landside slope (Fall 2021).

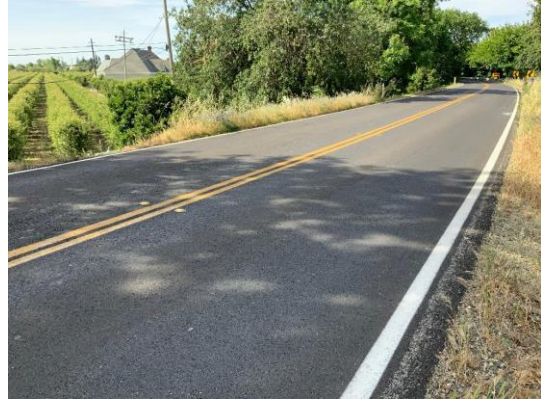
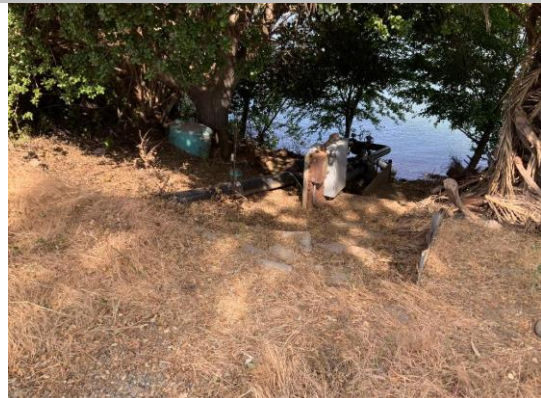
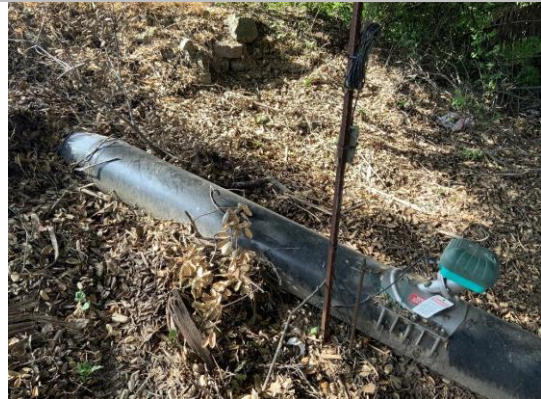
LM Start	2.25	Rating **	M	Issue No.	124 (cont)
LM End	2.25	Issue Type +	En	Location *

Comment Code					
Inspector Comment					
DS_ID:20857 FS_ID:76299 EP_NO: 5986 Repair Type: Non-Urgent EVAL Issue: 10, Unauthorized Modification or Non-Compliant Permit Crossing Status: Found UCIP Comments: 05/12/2022 The record has been upgraded from No Action Needed to Non-Urgent. Modifications to crossing, pump and pipe sections on WS appear new and new filtration system on LS toe . The UCIP inspection was completed with GEI staff, A. Lao. (H. Dunn – GEI)04/25/2013 Service pole on LS. Siphon breaker not found on landward slope. (P. Amatya - DWR) FIELD_STRUCT_DESC: 12-inch steel irrigation discharge pipe through the levee, 3.5 feet below the crown. Pump on the waterside (WS) slope. 1.25-inch and 2-inch electrical conduits through the levee. (Installation of a discharge pipe through the levee authorized under Permit No. 5986, 1968 - Malcolm McCormack. 2-inch electrical conduit to water pump authorized under Permit No. 14255, 1985 - Chuck Sterne). [Additional Reference(s): DWR Levee Log, year unknown (HLM 2.25), listed as 12-inch pipe and 1.25-inch electric conduit]. FS Date: 5/12/2022 4:03:00 PM

Levee crown.

WS view: Toe from crown.

WS view: Closeup of pipe on slope.

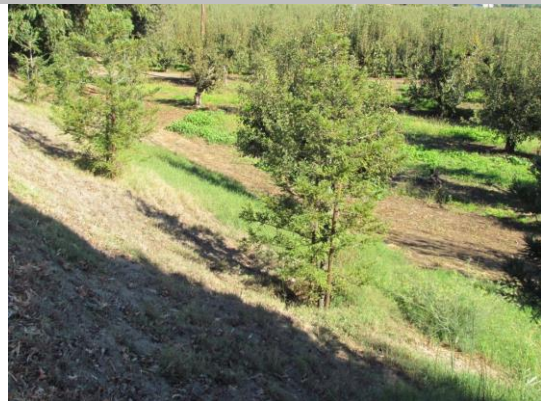
Photo 1 of 1 : FA_2023_RD0556_19_1_20231019_00001.jpg

LM Start	2.28	Rating **	M	Issue No.	1
LM End	2.28	Issue Type +	En	Location *	LS
Category	Earthen Levee		GPS Latitude/Longitude		
			Start	End	
Item	Vegetation		38.237156°	38.237156°	
			-121.557640°	-121.557640°	
DWR ID	DWR_RD0556_02_f_2015_1

RD 556 Unit 2 Levee mile 2.28 unauthorized planting of redwood trees planted on the slope.

These unauthorized planted redwoods have been reported in the past inspections. The District needs to have the owner remove them from the levee slope.

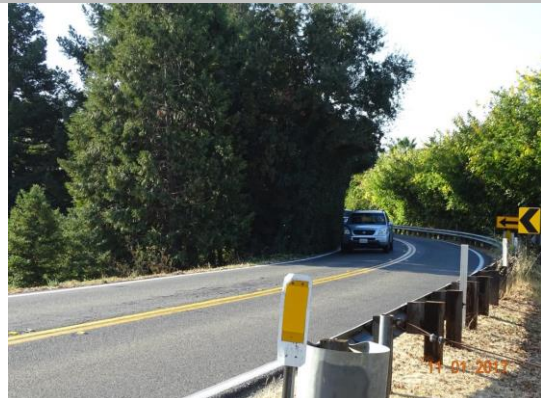
Photo 1 of 1 : FA_2023_RD0556_19_35_20231019_00026.jpg

LM Start	2.29	Rating **	U	Issue No.	35
LM End	2.33	Issue Type +	En	Location *	LS
Category	Earthen Levee		GPS Latitude/Longitude		
			Start	End	
Item	Vegetation		38.237060°	38.236545°	
			-121.557782°	-121.557910°	
DWR ID	DWR_RD0556_02_f_2017_35

View of oleanders on the landside slope and toe.

Trim/thin oleanders to allow inspection and access to landside slope and toe.

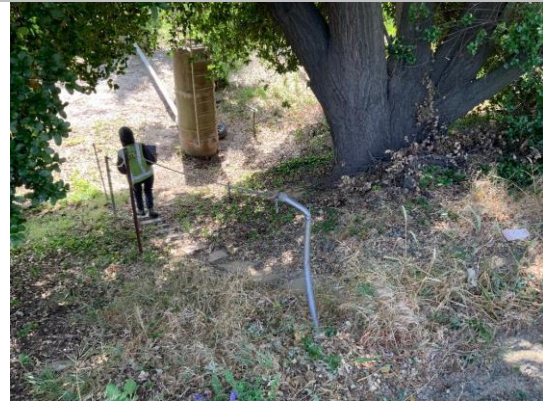
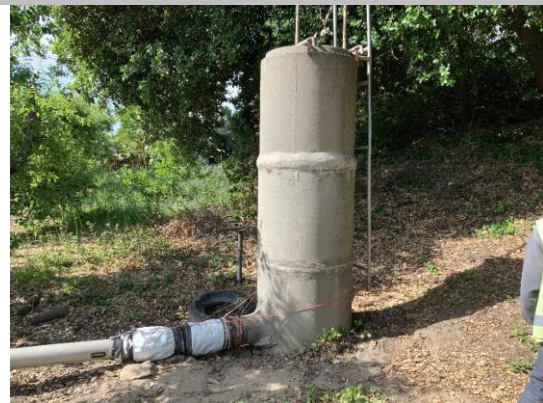
LM Start	2.42	Rating **	M	Issue No.	125 (cont)
LM End	2.42	Issue Type +	En	Location *	
Category	Supplemental		GPS Latitude/Longitude		
			Start	End	
Item	DWR UCIP Field Study		38.235261°	38.235261°	
			-121.558059°	-121.558059°	
DWR ID	20859

Comment Code					
Inspector Comment					
DS_ID:20859 FS_ID:76301 EP_NO: 11181 Repair Type: Non-Urgent EVAL Issue: 11, Maintenance Compliance Issue Crossing Status: Found UCIP Comments: 05/12/2022 The record remains Non-Urgent. LS riser is filled with dirt, recommend cleaning out. No permit other than ABO permit was found authorizing this encroachment. CVFPB will need to review crossing to determine owner. The UCIP inspection was completed with GEI staff, A. Lao. (H. Dunn – GEI) 04/25/2014 Needs to clean CMP riser for proper functioning of siphon breaker. (P. Amatya - DWR) FIELD_STRUCT_DESC: 10-inch steel irrigation discharge pipe through the levee, 5.8 feet below the crown. Pump and gate valve in a pump house on the waterside (WS) slope. Siphon breaker and service pole on the landside (LS) slope. (10-inch pipe [HLM 2.41] authorized under Automatic Board Order (ABO) issued as Permit No. 11181, 1975 - Robert E. and G. P. Collins). [Additional Reference(s): DWR Levee Log, year unknown (HLM 2.41). USACE Sacramento O&M Manual, Unit 103, June 1954, Revised 29 December 2016, (Station "J" 115+25), listed as 10-inch pipe. USACE As-Built Drawing No. 50-04-2277, March 1946, Sheet 3, Station 115+25 "J"]. FS Date: 5/12/2022 4:20:11 PM

Levee crown.

LS view: Riser visible at toe from crown.

LS view: Closeup of riser and pipe at toe.

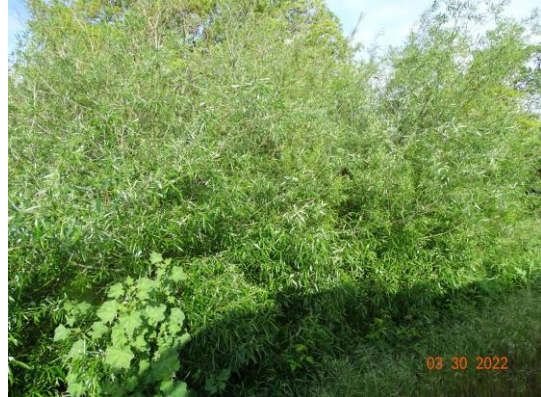
Photo 1 of 1 : FA_2023_RD0556_19_90_20231019_00062.jpg

LM Start	2.44	Rating **	U	Issue No.	90
LM End	2.44	Issue Type +	Ma	Location *	WS
Category	Earthen Levee			GPS Latitude/Longitude	
				Start	End
Item	Trim / Thin Trees			38.234843°	38.234843°
				-121.558028°	-121.558028°
DWR ID	DWR_RD0556_02_f _ 2021_90				
Comment Code					
T1 : Trim and thin trees to at least five feet above ground level to allow visibility of the ground and room to flood fight.					
Inspector Comment

View of thick willows on the waterside slope (Spring 2022).

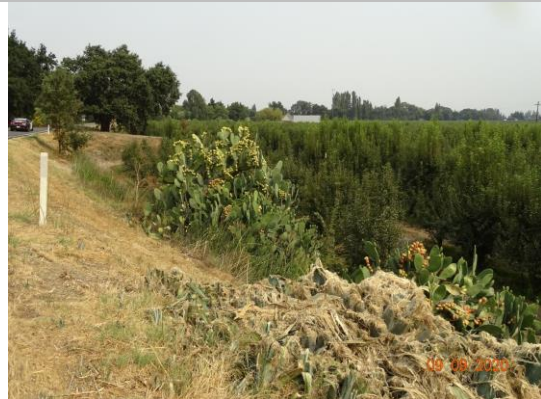
Photo 1 of 1 : FA_2023_RD0556_19_76_20231019_00053.jpg

LM Start	2.54	Rating **	U	Issue No.	76
LM End	2.54	Issue Type +	En	Location *	LS
Category	Earthen Levee			GPS Latitude/Longitude	
				Start	End
Item	Vegetation			38.233487°	38.233487°
				-121.557639°	-121.557639°
DWR ID	DWR_RD0556_02_s_2020_76				
Comment Code					
V6 : Landscaping					
Inspector Comment					
Remove cactus on the landside toe.

View of large cactus on the landside slope (Fall 2020).

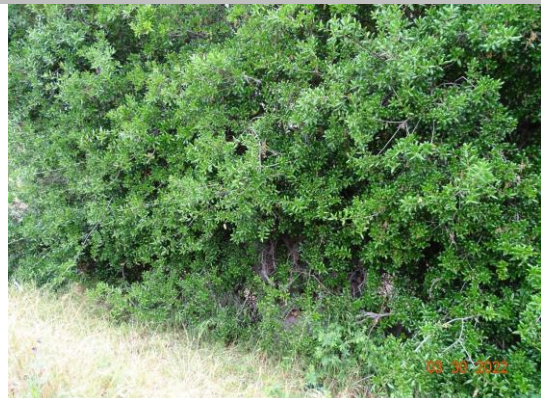
Photo 1 of 1 : FA_2023_RD0556_19_67_20231019_00047.jpg

LM Start	2.59	Rating **	U	Issue No.	67
LM End	2.59	Issue Type +	Ma	Location *	LS
Category	Earthen Levee			GPS Latitude/Longitude	
				Start	End
Item	Trim / Thin Trees			38.232883°	38.232883°
				-121.557301°	-121.557301°
DWR ID	DWR_RD0556_02_s_2022_67				
Comment Code					
T1 : Trim and thin trees to at least five feet above ground level to allow visibility of the ground and room to flood fight.					
Inspector Comment

View of thick trees needing trimming on the landside slope (Spring 2022).

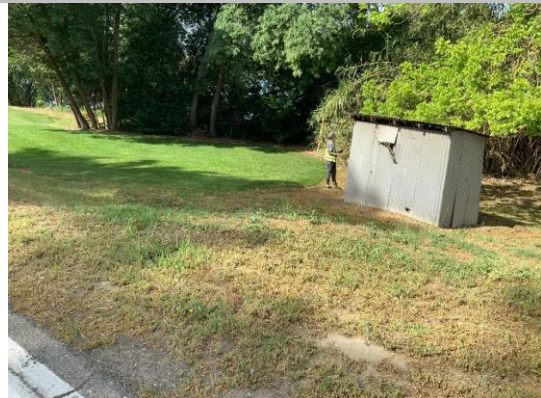
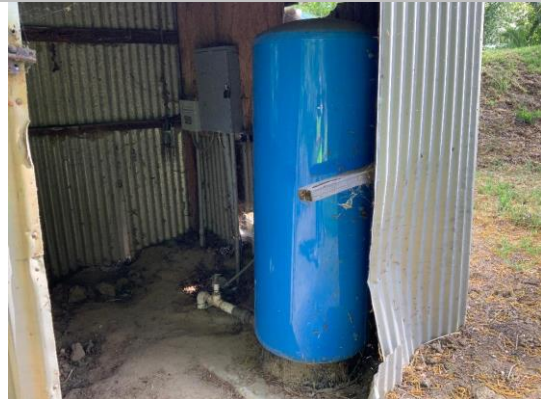
LM Start	2.84	Rating **	M	Issue No.	126 (cont)
LM End	2.84	Issue Type +	En	Location *

Comment Code					
Inspector Comment					
DS_ID:20849 FS_ID:76302 EP_NO: 11181 Repair Type: Non-Urgent EVAL Issue: 11, Maintenance Compliance Issue Crossing Status: Found UCIP Comments: 05/12/2022 The record remains Non-Urgent. Appears abandoned, no pump or pipe seen in WS pumphouse. Owner will need to coordinate with the CVFPB to meet Title 23 requirements. LS riser is filled with dirt, recommend removal if still in use. No permit other than ABO permit was found authorizing this encroachment. CVFPB will need to review crossing to determine owner. The UCIP inspection was completed with GEI staff, A. Lao. (H. Dunn – GEI) 04/25/2014 Needs to clean siphon breaker CMP riser. (P. Amatya - DWR) FIELD_STRUCT_DESC: 6-inch irrigation discharge pipe of an unknown material through the levee, 6 feet below the crown. Pressure tank in a pump house on the waterside (WS) berm. Service pole, siphon breaker, and distribution box on the landside (LS) slope. (6-inch pipe [HLM 2.84] authorized under Automatic Board Order (ABO) issued as Permit No. 11181, 1975 - Robert E. and G. P. Collins). [Additional Reference(s): DWR Levee Log, year unknown (HLM 2.84)]. FS Date: 5/12/2022 4:27:14 PM

Levee crown.

WS view: Pumphouse visible on toe from crown.

WS view: Tank inside pumphouse, no pump.

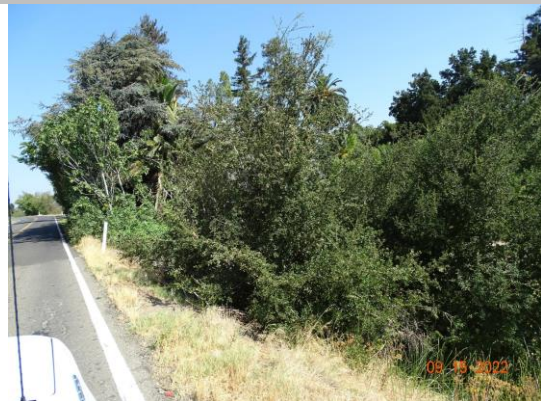
Photo 1 of 1 : FA_2023_RD0556_19_46_20231019_00033.jpg

LM Start	2.86	Rating **	U	Issue No.	46
LM End	2.87	Issue Type +	En	Location *	LS
Category	Earthen Levee			GPS Latitude/Longitude	
				Start	End
Item	Vegetation			38.229195°	38.229082°
				-121.555337°	-121.555316°
DWR ID	DWR_RD0556_02_f_2019_46				
Comment Code					
V6 : Landscaping					
Inspector Comment

View of the landscaping on the LS slope (Fall 2022).

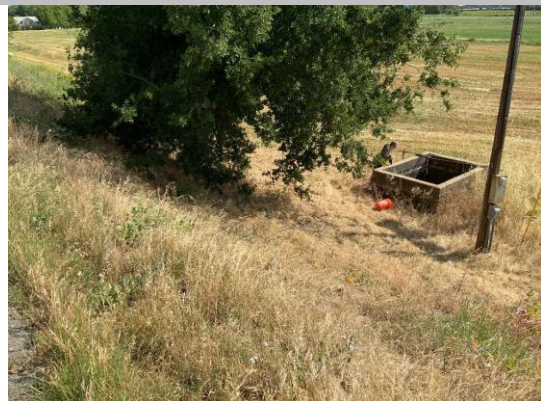
LM Start	3.07	Rating **	U	Issue No.	127 (cont)
LM End	3.07	Issue Type +	En	Location *

Comment Code						
Inspector Comment						
DS_ID:20862 FS_ID:76303 EP_NO: N/A Repair Type: Urgent EVAL Issue: 3b, Flood Risk Crossing Status: Found UCIP Comments: 05/12/2022 Record updated from Non-Urgent to Urgent. Modification of sleeving the pipe, and gap in between pipe and sleeve, causes flood risk concern. The UCIP inspection was completed with GEI staff, A. Lao. (H. Dunn – GEI) 04/25/2013 9-inch steel pipe sleeved through 12-inch pipe. Needs to seal gap between two pipes. (P. Amatya - DWR) FIELD_STRUCT_DESC: 9-inch steel pipe sleeved through a 12-inch steel irrigation discharge pipe through the levee, 6 feet below the crown. Pump on a pile structure in the river. Steel walkway to the pump and wood steps on the waterside (WS) slope. Concrete spill box with two 8-inch openings. (Six 12-inch steel discharge pipes (6 of 6) authorized under Permit No. 1173, 1947 - Reclamation District No. 556). (12-inch pipe [HLM 3.06] authorized under Automatic Board Order (ABO) issued as Permit No. 11193, 1975 - Gertrude M. Reid). [Additional Reference(s): DWR Levee Log, year unknown (HLM 3.06), listed as 12-inch pipe. USACE Sacramento O&M Manual, Unit 103, June 1954, Revised 29 December 2016, (Station "J" 80+79), listed as 12-inch pipe. USACE As-Built Drawing No. 50-04-2277, March 1946, Sheet 3, Station 80+79 "J", listed as 12-inch pipe]. FS Date: 5/12/2022 12:09:29 PM

Levee crown.

LS view: Distribution box at toe from crown.

LS view: Pipe outlet in box at toe.

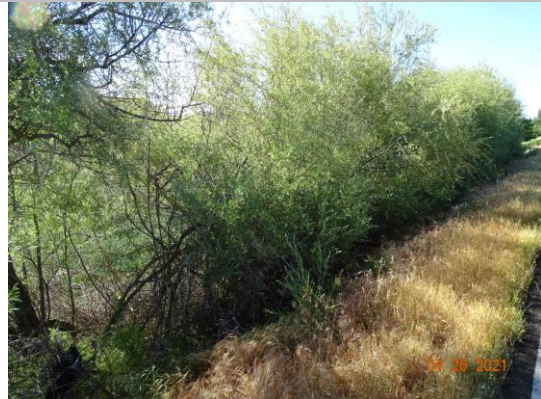
Photo 1 of 1 : FA_2023_RD0556_19_61_20231019_00044.jpg

LM Start	3.24	Rating **	U	Issue No.	61
LM End	3.26	Issue Type +	Ma	Location *	LS
Category	Earthen Levee			GPS Latitude/Longitude	
				Start	End
Item	Trim / Thin Trees			38.223707°	38.223457°
				-121.555396°	-121.555414°
DWR ID	DWR_RD0556_02_s_2021_61				
Comment Code					
T1 : Trim and thin trees to at least five feet above ground level to allow visibility of the ground and room to flood fight.					
Inspector Comment

View looking downstream at willows on the landside slope (Spring 2021).

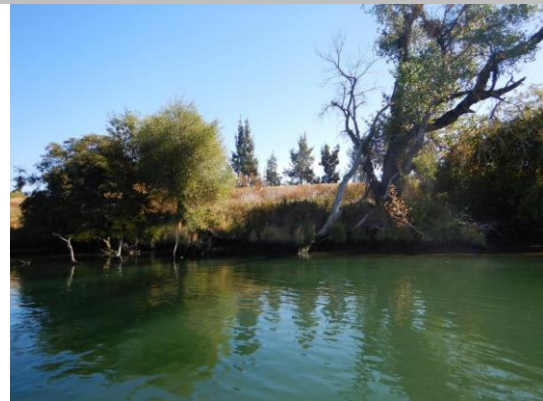
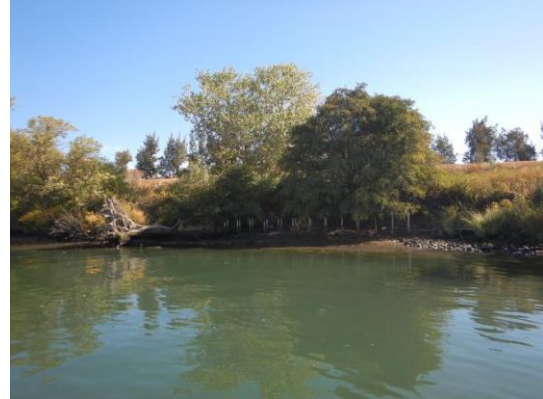
LM Start	3.58	Rating **	M	Issue No.	16 (cont)
LM End	3.64	Issue Type +	Ma	Location *	WS
Category	Supplemental			GPS Latitude/Longitude	
				Start	End
Item	2018 USACE Erosion Survey			38.218951°	38.218104°
				-121.556689°	-121.556819°
DWR ID	DWR_RD0556_02_s_2022_16

LM Start	3.58	Rating **	M	Issue No.	16
LM End	3.64	Issue Type +	Ma	Location *	WS
Category	Supplemental			GPS Latitude/Longitude	
				Start	End
Item	2018 USACE Erosion Survey			38.218951°	38.218104°
				-121.556689°	-121.556819°
DWR ID	DWR_RD0556_02_s_2022_16				
Comment Code					
Inspector Comment					
2018 Site ID: SAC 22.7 L					
Status: Eroding					
2018 Field Notes: No observed change.					
Site History: 1997 - Scallops into berm and very close to levee toe.					
2005 - Brush boxes present. 2011 - New toe scour and freshly fallen tree. 2012 - New tree popout has taken significant portion of soil out of the levee. 2017 - Minor new erosion at toe.

USACE 2018 Erosion Photo #1

USACE 2018 Erosion Photo #2

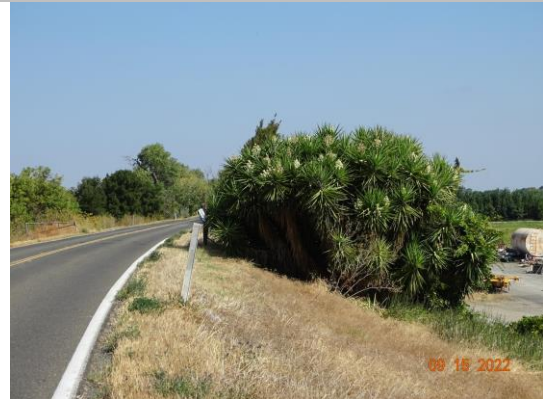
Photo 1 of 1 : FA_2023_RD0556_19_108_20231019_00065.jpg

LM Start	3.79	Rating **	U	Issue No.	108
LM End	3.79	Issue Type +	En	Location *	LS
Category	Earthen Levee			GPS Latitude/Longitude	
				Start	End
Item	Vegetation			38.215818°	38.215818°
				-121.556840°	-121.556840°
DWR ID	DWR_RD0556_02_f_2022_108				
Comment Code					
V6 : Landscaping					
Inspector Comment

View of the landscaping on the LS slope (Fall 2022).

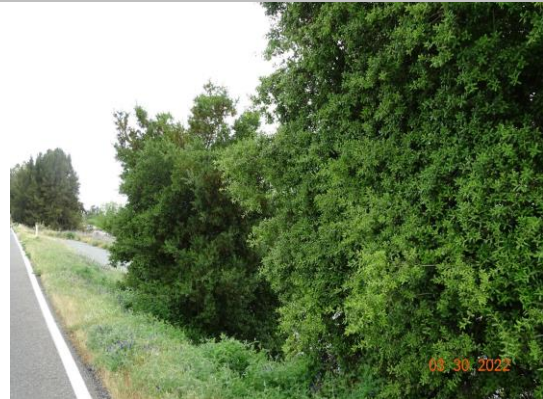
Photo 1 of 1 : FA_2023_RD0556_19_5_20231019_00004.jpg

LM Start	3.97	Rating **	U	Issue No.	5
LM End	3.97	Issue Type +	Ma	Location *	LS
Category	Earthen Levee			GPS Latitude/Longitude	
				Start	End
Item	Trim / Thin Trees			38.213244°	38.213244°
				-121.556803°	-121.556803°
DWR ID	DWR_RD0556_02_s_2021_5				
Comment Code					
T1 : Trim and thin trees to at least five feet above ground level to allow visibility of the ground and room to flood fight.					
Inspector Comment

View looking upstream at trees needing trimming on the landside slope (Spring 2022).

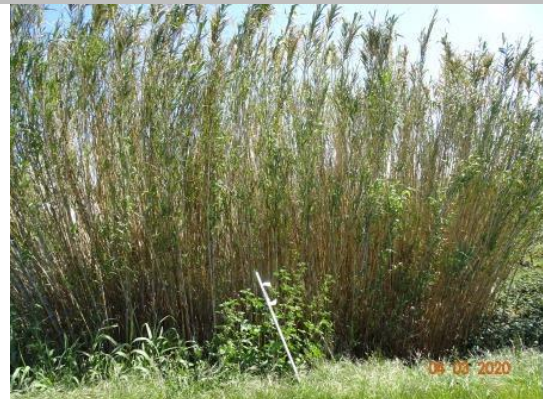
Photo 1 of 1 : FA_2023_RD0556_19_71_20231019_00050.jpg

LM Start	4.01	Rating **	U	Issue No.	71
LM End	4.01	Issue Type +	Ma	Location *	LS
Category	Earthen Levee			GPS Latitude/Longitude	
				Start	End
Item	Trim / Thin Trees			38.212672°	38.212672°
				-121.556759°	-121.556759°
DWR ID	DWR_RD0556_02_s_2020_71				
Comment Code					
T1 : Trim and thin trees to at least five feet above ground level to allow visibility of the ground and room to flood fight.					
Inspector Comment					
Arundo on the landside slope.

View of thick arundo on the landside slope (Spring 2020).

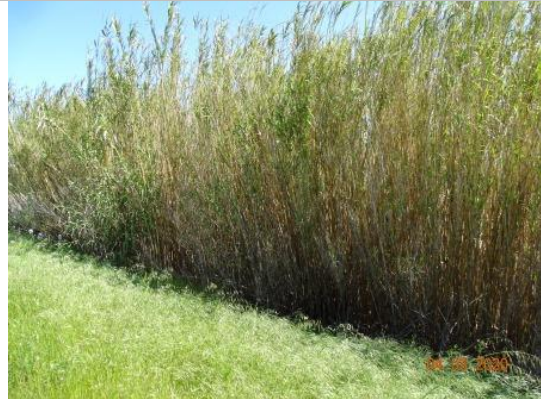
Photo 1 of 1 : FA_2023_RD0556_19_51_20231019_00037.jpg

LM Start	4.22	Rating **	U	Issue No.	51
LM End	4.33	Issue Type +	Ma	Location *	LS
Category	Earthen Levee			GPS Latitude/Longitude	
				Start	End
Item	Trim / Thin Trees			38.209629°	38.208062°
				-121.556757°	-121.556807°
DWR ID	DWR_RD0556_02_s_2020_51				
Comment Code					
T1 : Trim and thin trees to at least five feet above ground level to allow visibility of the ground and room to flood fight.					
Inspector Comment					
Remove arundo from landside slope and willows on the landside toe.

View of thick arundo on the landside slope (Spring 2020).

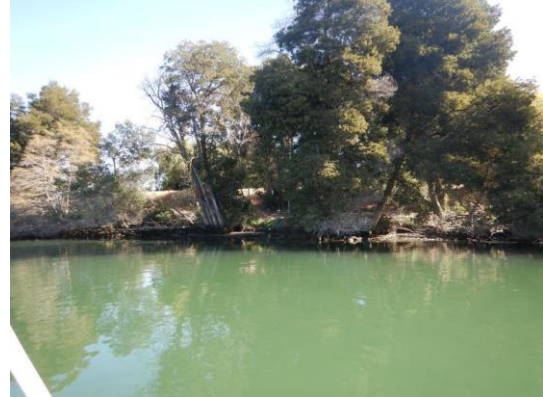
Photo 1 of 2 : FA_2023_RD0556_19_14_20231019_00005.jpg

LM Start	4.44	Rating **	M	Issue No.	14
LM End	4.49	Issue Type +	Ma	Location *	WS
Category	Supplemental			GPS Latitude/Longitude	
				Start	End
Item	2018 USACE Erosion Survey			38.206377°	38.205729°
				-121.557184°	-121.557108°
DWR ID	DWR_RD0556_02_s_2022_14				
Comment Code					
Inspector Comment					
2018 Site ID: SAC 21.9 L					
Status: Eroding					
2018 Field Notes: No observed change.					
Site History: 2013 - Erosion pockets encroaching on levee foundation.

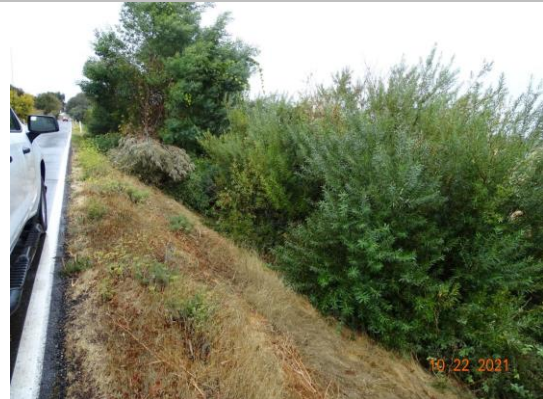
Photo 1 of 1 : FA_2023_RD0556_19_60_20231019_00043.jpg

LM Start	4.57	Rating **	U	Issue No.	60
LM End	4.57	Issue Type +	Ma	Location *	LS
Category	Earthen Levee			GPS Latitude/Longitude	
				Start	End
Item	Trim / Thin Trees			38.204537°	38.204537°
				-121.556782°	-121.556782°
DWR ID	DWR_RD0556_02_s_2021_60				
Comment Code					
T1 : Trim and thin trees to at least five feet above ground level to allow visibility of the ground and room to flood fight.					
Inspector Comment

View looking upstream at thick trees on the landside slope (Fall 2021).

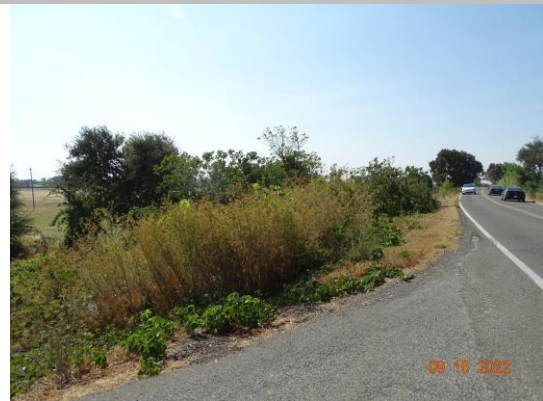
Photo 1 of 1 : FA_2023_RD0556_19_58_20231019_00041.jpg

LM Start	4.64	Rating **	U	Issue No.	58
LM End	4.64	Issue Type +	Ma	Location *	LS
Category	Earthen Levee			GPS Latitude/Longitude	
				Start	End
Item	Trim / Thin Trees			38.203480°	38.203480°
				-121.556824°	-121.556824°
DWR ID	DWR_RD0556_02_s_2018_58				
Comment Code					
T1 : Trim and thin trees to at least five feet above ground level to allow visibility of the ground and room to flood fight.					
Inspector Comment					
Remove fig tree from the landside slope.

View of the LS vegetation and fig tree in the background (Fall 2022).

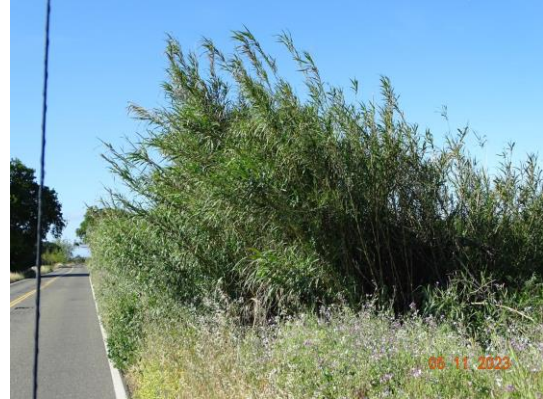
Photo 1 of 1 : FA_2023_RD0556_19_3_20231019_00003.jpg

LM Start	4.68	Rating **	U	Issue No.	3
LM End	4.72	Issue Type +	Ma	Location *	WS
Category	Earthen Levee			GPS Latitude/Longitude	
				Start	End
Item	Vegetation			38.202942°	38.202431°
				-121.556870°	-121.556960°
DWR ID	DWR_RD0556_02_f_2020_3				
Comment Code					
V2 : Remove the wild growth and woody vegetation other than native grasses from the levee slopes.					
Inspector Comment					
Cut arundo back 20' from waterside slope.

View of the arundo on the WS slope (Spring 2023).

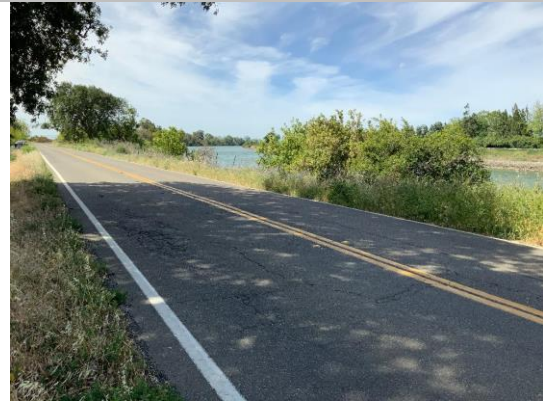
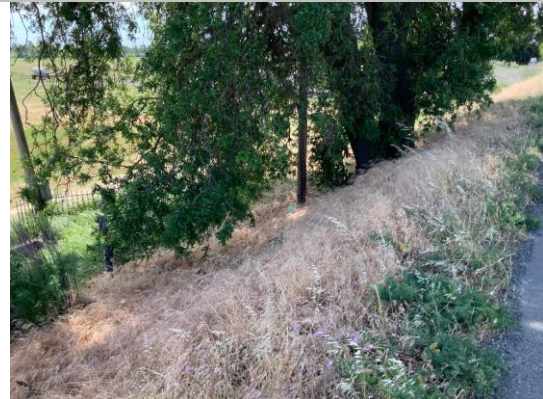
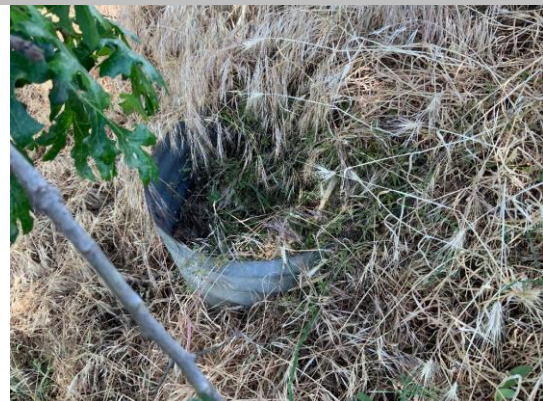
Comment Code					
Inspector Comment					
DS_ID:20867 FS_ID:76308 EP_NO: 11199 Repair Type: Non-Urgent EVAL Issue: 11, Maintenance Compliance Issue Crossing Status: Indicator Found UCIP Comments: 05/12/2022 The record remains Non-Urgent. Appears abandoned, LS riser covered in vegetation, recommend cleaning out if still in use. WS control panel is destroyed and overgrown with vegetation. No permit other than ABO permit was found authorizing this encroachment. CVFPB will need to review crossing to determine owner. The UCIP inspection was completed with GEI staff, A. Lao. (H. Dunn – GEI) 04/25/2013 Pump, gate valve and pumphouse not found on waterward slope. An abandoned electric control panel found on WS. May need to be properly abandoned. (P. Amatya - DWR) FIELD_STRUCT_DESC: 6-inch steel irrigation discharge pipe through the levee, 6.5 feet below the crown. Siphon and concrete spill box with two 8-inch openings. (6-inch pipe [HLM 4.72] authorized under Automatic Board Order (ABO) issued as Permit No. 11199, 1975 - Toshi Tokuyoshi, et al). [Additional Reference(s): DWR Levee Log, year unknown (HLM 4.72). USACE Sacramento O&M Manual, Unit 103, June 1954, Revised 29 December 2016, (Station "H" 159+97), listed as 6-inch pipe. USACE As-Built Drawing No. 50-04-2277, March 1946, Sheet 2, Station 159+97 "H"]. FS Date: 5/12/2022 1:01:48 PM

LS view: Covered riser visible on slope.

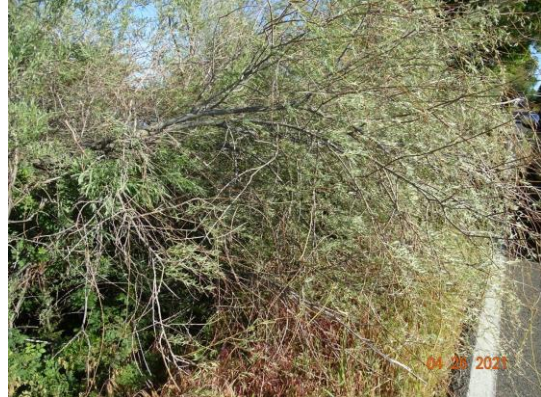
Photo 1 of 1 : FA_2023_RD0556_19_66_20231019_00046.jpg

LM Start	4.85	Rating **	U	Issue No.	66
LM End	4.87	Issue Type +	Ma	Location *	WS
Category	Earthen Levee			GPS Latitude/Longitude	
				Start	End
Item	Trim / Thin Trees			38.200543°	38.200246°
				-121.557286°	-121.557380°
DWR ID	DWR_RD0556_02_s_2021_66				
Comment Code					
T4 : Trim trees over roadway to at least 12 feet above ground level.					
Inspector Comment

View looking upstream at willows on the waterside slope (Spring 2021).

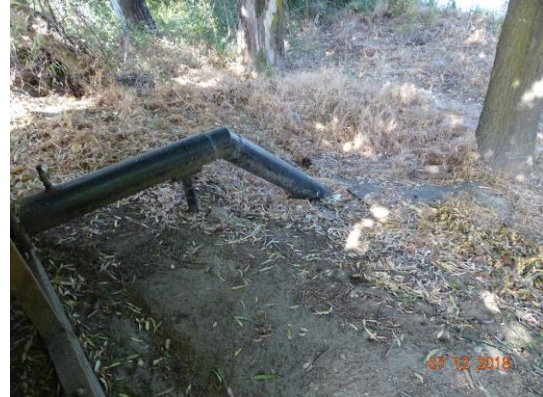
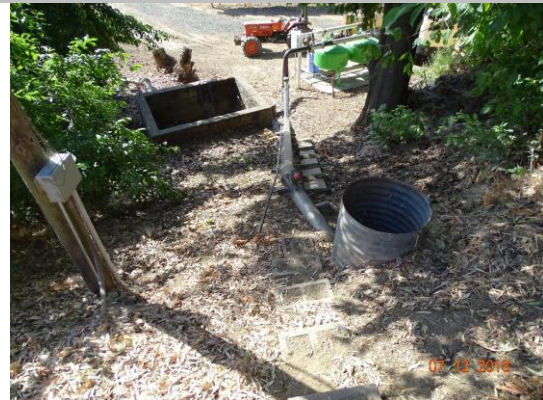
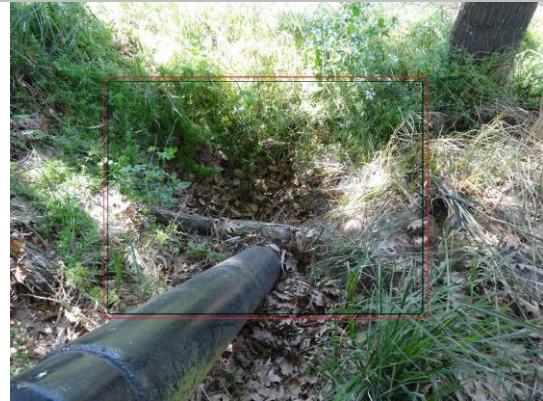
Comment Code					
Inspector Comment					
DS_ID:20869 FS_ID:76310 EP_NO: 11185 Repair Type: Urgent EVAL Issue: 2b, Levee Integrity Crossing Status: Found UCIP Comments: 05/12/2022 The record remains Urgent. There is still a deep pit on WS toe covered with plywood, causing a safety concern and levee integrity concern, recommend filling in with dirt. LS siphon in riser is covered with vegetation, recommend cleaning out. New filter installation on LS as well as modifications to the LS concrete box. No permit other than ABO permit was found authorizing this encroachment. CVFPB will need to review crossing to determine owner. The UCIP inspection was completed with GEI staff, A. Lau. (H. Dunn – GEI)07/12/2018 Pit on WS is covered with plywood. Water pump is running, no leaks detected. LS part of crossing was reconstructed. New pipe was installed after CMP riser to supply water to sand filters. Remains Urgent due to large pit on WS that needs to be backfilled. (O.Yakimov-DWR UCIP)04/25/2013 Large pit on levee berm. FIELD_STRUCT_DESC: 8-inch irrigation discharge pipe of an unknown material through the levee, 5.7 feet below the crown. Pump and gate valve in a pump house on the waterside (WS) slope. Siphon breaker, concrete box, and service pole on the landside (LS) slope. (8-inch pipe [HLM 5.21] authorized under Automatic Board Order (ABO) issued as Permit No. 11185, 1975 - R. Walter Langhart). [Additional Reference(s): DWR Levee Log, year unknown (HLM 5.21)]. FS Date: 5/12/2022 1:31:01 PM

View of pipe on WS and a pit covered by plywood.

WS- intake pipe and pit on levee slope (center)

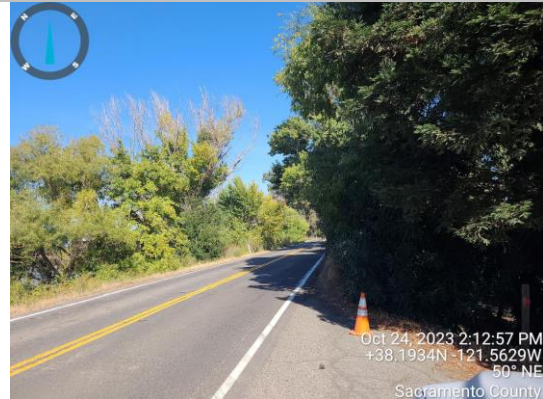
Photo 1 of 1 : FA_2023_RD0556_19_31_20231030_00104.jpg

LM Start	5.40	Rating **	U	Issue No.	31
LM End	5.44	Issue Type +	En	Location *	LS
Category	Earthen Levee			GPS Latitude/Longitude	
				Start	End
Item	Vegetation			38.193760°	38.193445°
				-121.562458°	-121.562895°
DWR ID	DWR_RD0556_02_s_2012_31				
Comment Code					
V6 : Landscaping					
Inspector Comment					
Thin oleanders to allow view down landside slope.

View of oleanders on the landside slope. Fall 2023.

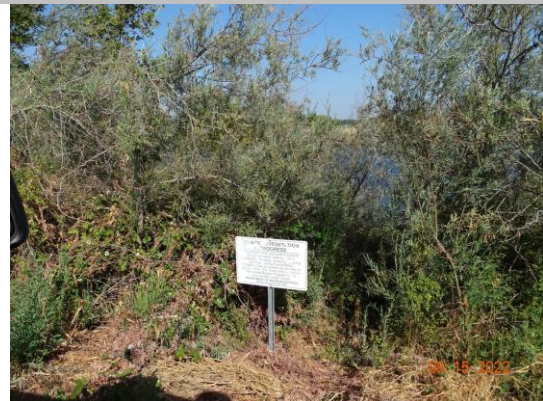
Photo 1 of 1 : FA_2023_RD0556_19_80_20231019_00056.jpg

LM Start	5.58	Rating **	A/W	Issue No.	80
LM End	5.72	Issue Type +	Ob	Location *	WS
Category	Earthen Levee			GPS Latitude/Longitude	
				Start	End
Item	Vegetation			38.192530°	38.191865°
				-121.565352°	-121.567757°
DWR ID	DWR_RD0556_02_f_2019_80				
Comment Code					
V5 : Environmental Requirements.					
Inspector Comment					
This is a DWR Revegetation Site.

View of the environmental mitigation sign on the WS slope (Fall 2022).
