**Flood Control Project Maintenance
Levee Inspections
Fall 2024 Levee Maintenance Deficiency Summary Report**

Sacramento River Basin

| RD0556 | Overall LMA Rating | Total LMA Miles | | | | | | |
|---|---|---|---|---|---|---|---|---|
| Reclamation District No. 0556 Upper Andrus | U | 11.20 | | | | | | |

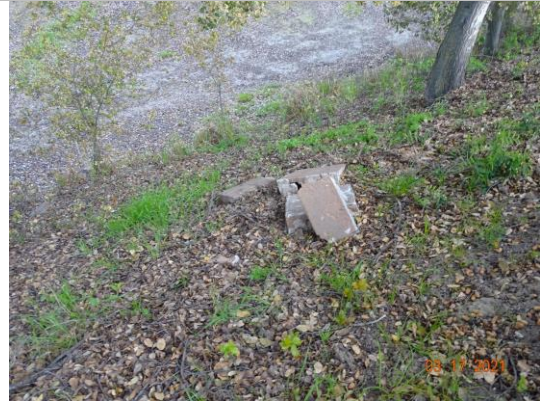
Photo 1 of 1 : FA_2024_RD0556_18_85_20241001_00043.jpg

| Large bricks on the landside slope acting as revetment. | | | | | |

View of bricks on the landside slope (Spring 2021).

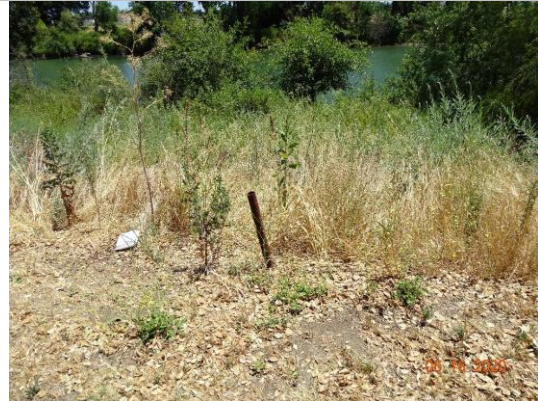
Photo 1 of 3 : UCIP_FA_2024_61336_88650.jpg

Water-Side: View of levee slope looking from crown

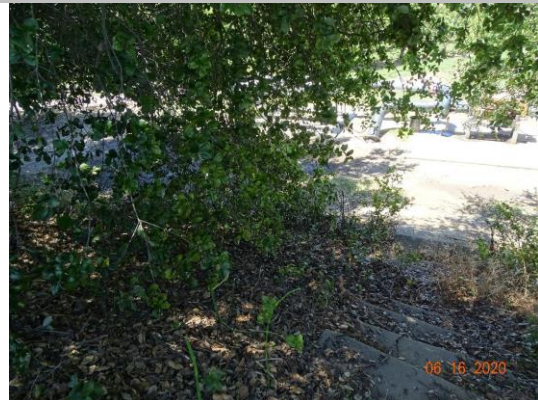
Photo 2 of 3 : UCIP_FA_2024_61336_88648.jpg

Land-Side: View of levee slope looking from crown

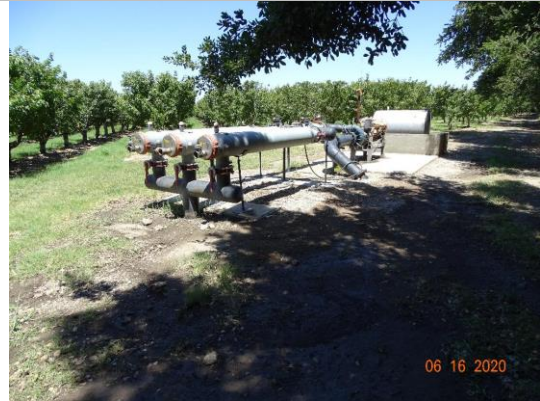
Photo 3 of 3 : UCIP_FA_2024_61336_88646.jpg

Land-Side: Screen filters and new pump on landside

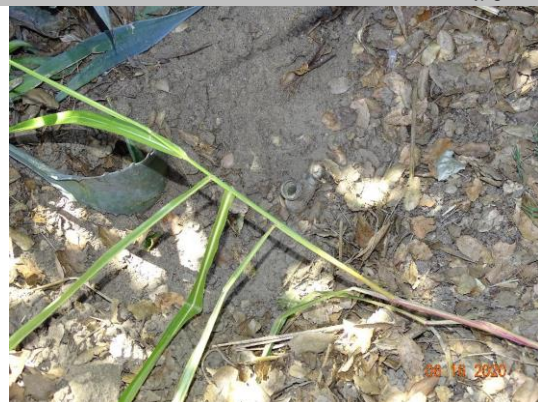
Photo 2 of 3 : UCIP_FA_2024_61398_88671.jpg

Land-Side: Air release valve on levee shoulder. Soil depression around it

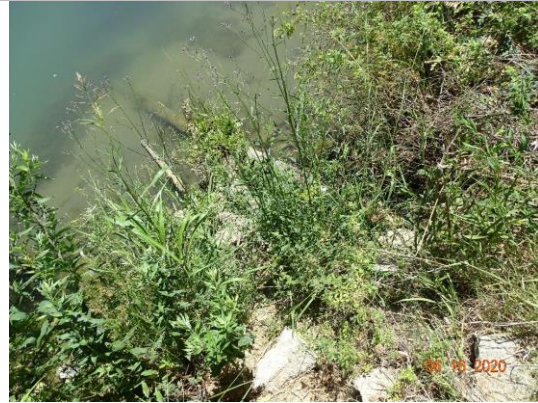
Photo 3 of 3 : UCIP_FA_2024_61398_88673.jpg

Water-Side: Intake pipe at riverbank

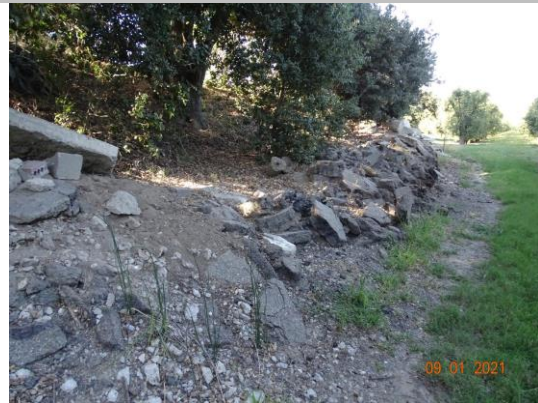
Photo 1 of 1 : FA_2024_RD0556_18_27_20241001_00007.jpg

| Concrete at toe of levee is acting like a stability berm. | | | | | |

View looking downstream at concrete rubble at landside toe (Fall 2021).

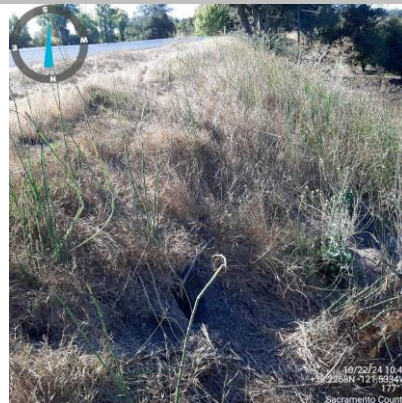
Photo 1 of 1 : FA_2024_RD0556_18_82_20241023_00089.jpg

View of animal holes in landside hinge and slope. (Fall 2024)

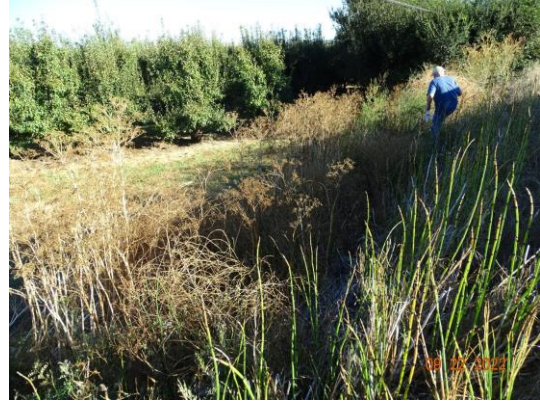
Photo 1 of 1 : FA_2024_RD0556_18_40_20241001_00020.jpg

| Erosion is covered by vegetation. | | | | | |

View of the erosion on the LS slope (Fall 2022).

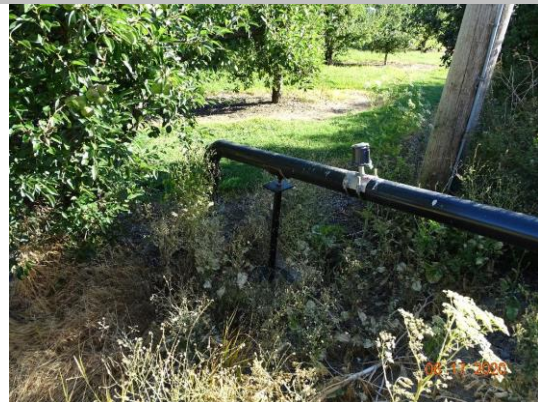
Photo 2 of 3 : UCIP_FA_2024_61399_88675.jpg

Land-Side: Pipe and junction pole at levee toe

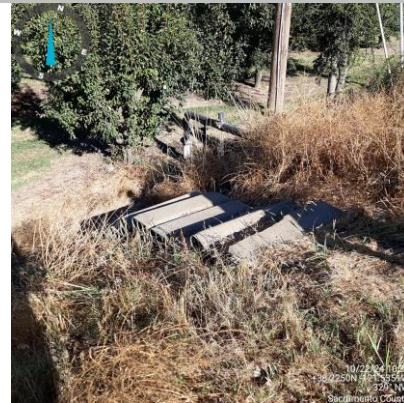
Photo 1 of 1 : FA_2024_RD0556_18_61_20241023_00091.jpg

View of staircase on the landside slope. (Fall 2024)

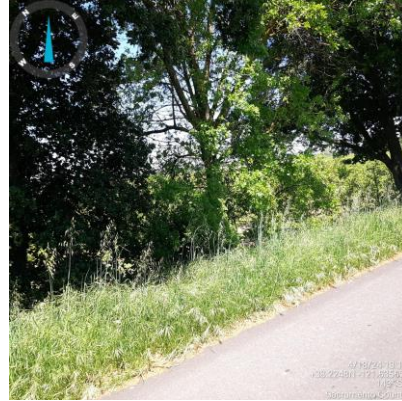
Photo 1 of 1 : FA_2024_RD0556_18_46_20241001_00028.jpg

View looking upstream at thick trees on the landside slope (Spring 2024).

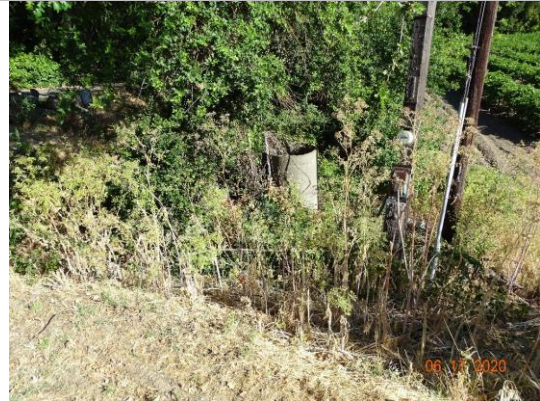
Photo 2 of 3 : UCIP_FA_2024_61414_88747.jpg

Land-Side: View of levee slope looking from crown. Service pole on shoulder, concrete standpipe at levee toe

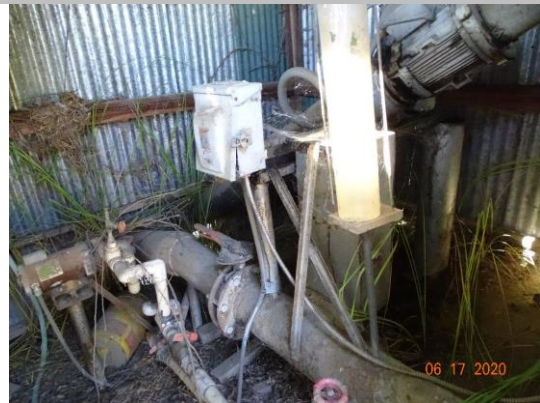
Photo 3 of 3 : UCIP_FA_2024_61414_88743.jpg

Water-Side: View inside of pumphouse

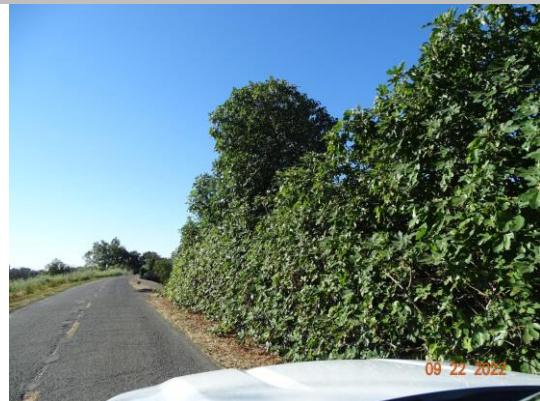
Photo 1 of 1 : FA_2024_RD0556_18_53_20241001_00032.jpg

View of the landscaping on the LS slope (Fall 2022).

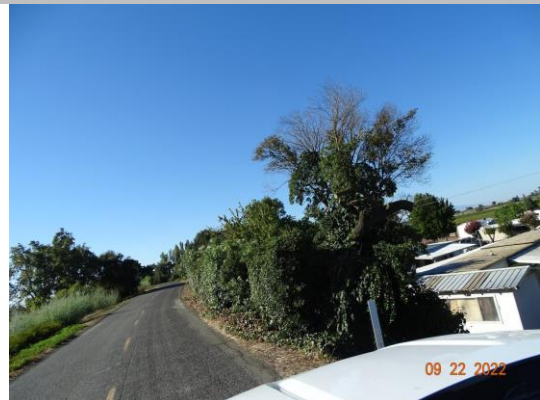
Photo 1 of 1 : FA_2024_RD0556_18_31_20241001_00011.jpg

View of the landscaping along the LS slope (Fall 2022).

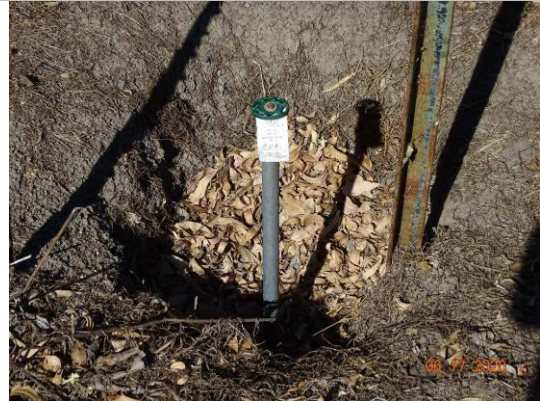
Photo 2 of 3 : UCIP_FA_2024_61499_89028.jpg

| DS_ID:20831 FS_ID:61499 EP_NO: 11169 Repair Type: Non-Urgent EVAL Issue: 6, Levee Damage or Threat for Levee Damage Crossing Status: Found UCIP Comments: 06/17/2020 Record remains Non-Urgent. 2-foot diameter sinkhole is still present on landside shoulder around air vent, size of hole is not growing over time. Electrical conduit is open on waterside slope with wires cut and not insulated. No permit has been identified authorizing pipe. Need to have CVFPB review ABO and determine current owner. (O.Yakimov - DWR UCIP) 07/12/2018 Hole near air vent on LS slope is still present but haven't increased in size. Pipe was running at the time of site visit, no leaks detected. Downgraded to "Non-Urgent" due to absence of levee threat. (O.Yakimov - DWR UCIP) 05/27/2015 2'x 2' hole on levee off LS shoulder. FIELD_STRUCT_DESC: 8-inch steel irrigation discharge pipe through the levee, 3.7 feet below the crown. 1-inch air valve. Pump and switch panel on the waterside (WS) berm. Service pole on the landside (LS). 9-foot by 3-foot concrete standpipe on the LS. 3 cables encased in a 1.5-inch steel conduit through the levee and on the WS, alongside the 8-inch pipe, disconnected on the WS. (8-inch pipe [HLM 2.44] authorized under Automatic Board Order (ABO) issued as Permit No. 11169, 1975 - Darrell T. and B. M. Mealer). [Additional Reference(s): DWR Levee Log, unk.yr. (HLM 2.44). USACE Sacramento O&M Manual, Unit 103, June 1954, Revised 29 December 2016, (Station 'R' 482+49.3), listed as 8-inch pipe. USACE As-Built Drawing No. 50-04-2671, Sheet 3, Station 482+49.3, 25 January 1951, Revised 18 Dec. 1952]. FS Date: 6/17/2020 10:55:51 AM | | | | | | |

Land-Side: Sinkhole around air vent on levee shoulder

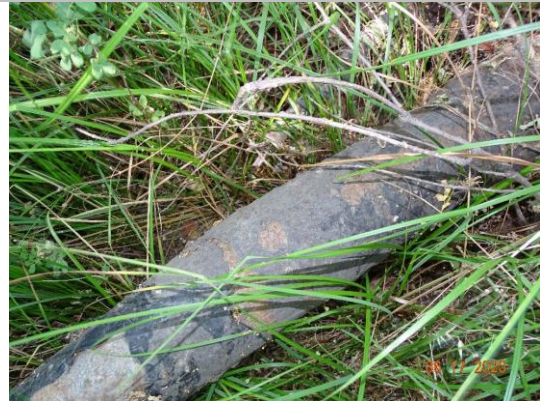
Photo 3 of 3 : UCIP_FA_2024_61499_89034.jpg

Water-Side: Open electrical conduit with wires inside on levee slope

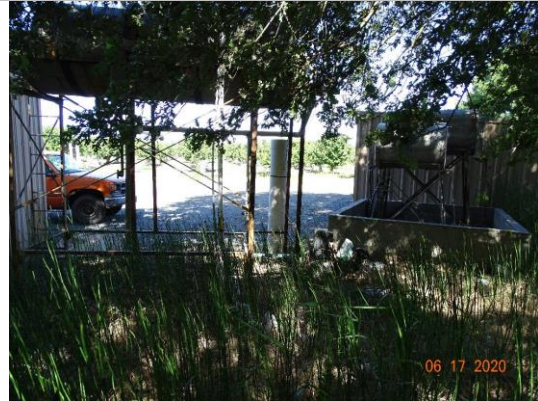
Photo 1 of 3 : UCIP_FA_2024_61501_89043.jpg

Land-Side: PVC standpipe off levee toe

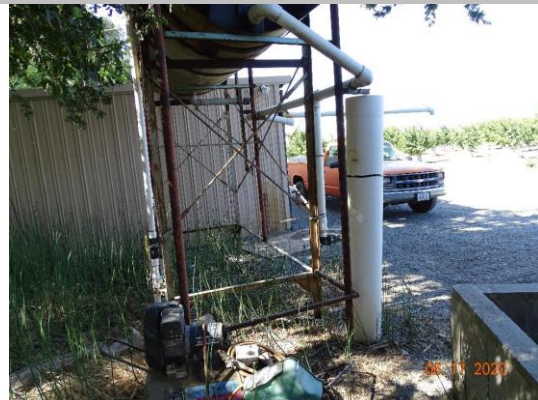
Photo 2 of 3 : UCIP_FA_2024_61501_89045.jpg

Land-Side: View of piping on landside

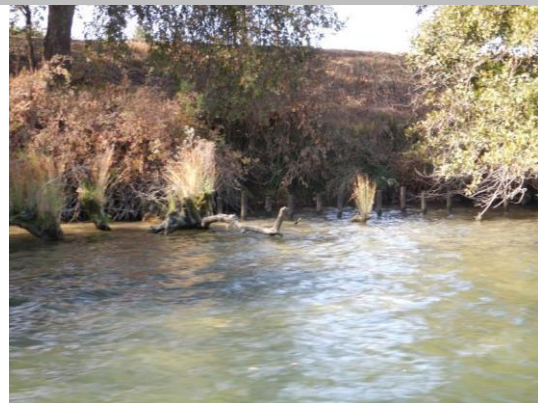
Photo 1 of 2 : FA_2024_RD0556_18_37_20241001_00017.jpg

| Site History: 2017 - Toe erosion. | | | | | |

USACE 2018 Erosion Photo #1

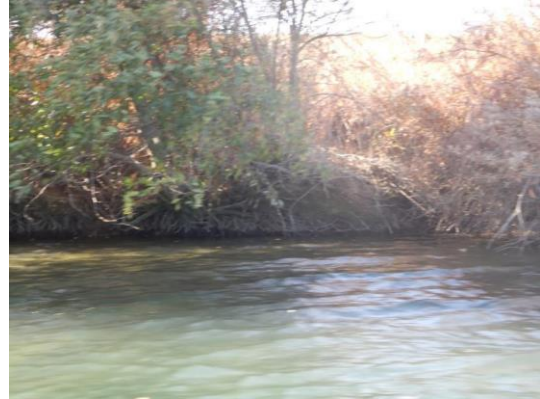
Photo 2 of 2 : FA_2024_RD0556_18_37_20241001_00018.jpg

USACE 2018 Erosion Photo #2

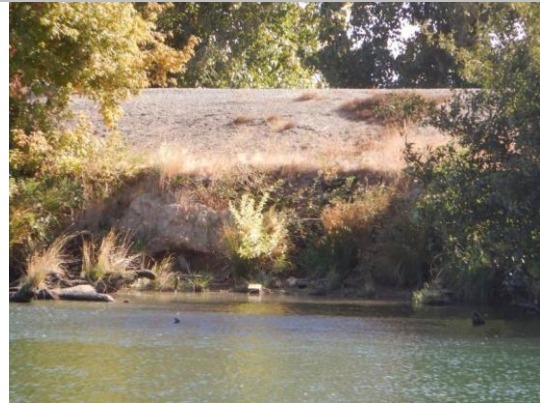
Photo 2 of 2 : FA_2024_RD0556_18_36_20241001_00016.jpg

| Site History: 2017 - Toe erosion and failed revetment. | | | | | |

USACE 2018 Erosion Photo #2

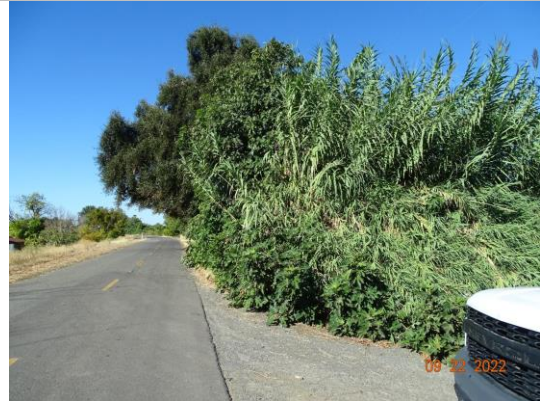
Photo 1 of 1 : FA_2024_RD0556_18_55_20241001_00034.jpg

| Some trimming was done but more work is needed. | | | | | |

View of the trees on the LS slope (Fall 2022).

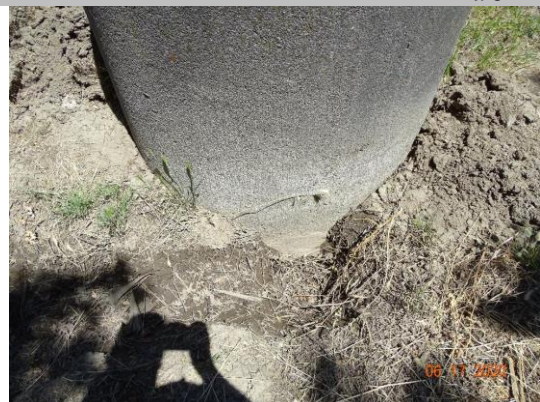
Photo 2 of 3 : UCIP_FA_2024_61291_89084.jpg

DS_ID:20836
FS_ID:61291
EP_NO: 11174
Repair Type: Urgent
EVAL Issue: 2a, Levee Integrity
Crossing Status: Found
UCIP Comments: 06/17/2020 Record is Urgent. 30-feet long, 3-feet wide, and 1-foot deep trench was excavated along landside levee toe. Soil is wet at the bottom of trench. Soil depression on waterside shoulder in pipe alignment. Intake pipe and pipe from pumphouse towards levee slope have been replaced. Unable to find a permit for modifications. No permit has been identified authorizing original pipe through the levee. Need to have CVFPB review ABO and determine current owner. (O.Yakimov - DWR UCIP)
FIELD_STRUCT_DESC: 6-inch steel irrigation pipe through levee, 3.4 feet below crown. Pump in pump house on berm. Service pole on landward slope. Gate valve located underground and 48-inch concrete standpipe at landside toe. 1-inch electrical conduit at this location. (6-inch pipe [HLM 3.18] authorized under Automatic Board Order (ABO) issued as Permit No. 11174, 1975 - Delores M. Pollard). [Additional Reference(s): DWR Levee Log, unk.yr. (HLM 3.18). USACE Sacramento O&M Manual, Unit 103, June 1954, Revised 29 December 2016, (Station 441+19.6), listed as 6-inch pipe. USACE As-Built Drawing No. 50-04-2671, Sheet 2, near Station 440+00, 25 January 1951, Revised 18 Dec. 1952. USACE As-Built Drawing No. 50-04-2631, Sheet 11, Station 441+19.6, March 1950, Revised 16 Dec.1952].

Land-Side: Trench at the base of standpipe

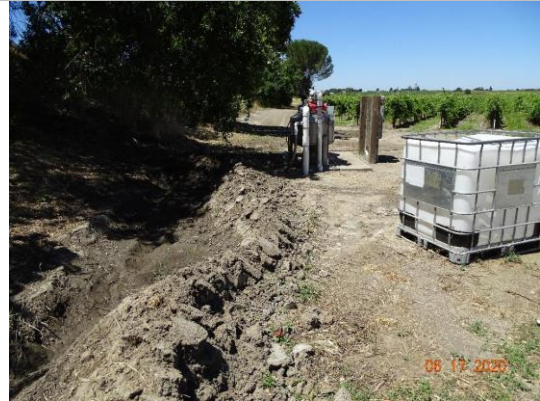
Photo 3 of 3 : UCIP_FA_2024_61291_89086.jpg

Overview of Levee: Overview of trench dug along landside toe

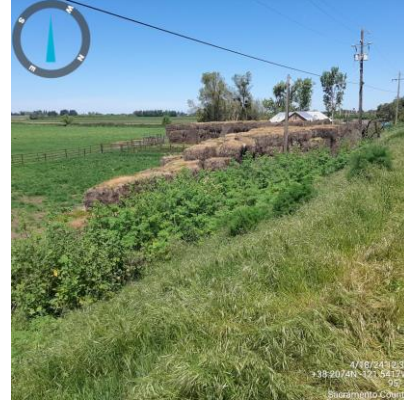
Photo 1 of 1 : FA_2024_RD0556_18_76_20241001_00041.jpg

View of fence and hay bales on the LS slope. (Spring 2024)

| Remove the fencing and hay bales at LS toe. | | | | | |

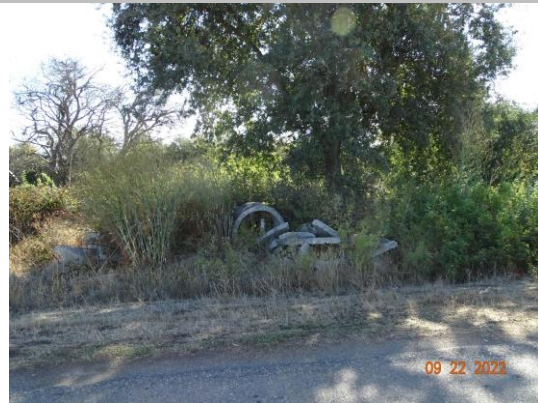
Photo 1 of 1 : FA_2024_RD0556_18_58_20241001_00036.jpg

View of the concrete debris on the WS slope (Fall 2022).

| Remove concrete debris piles. | | | | | |

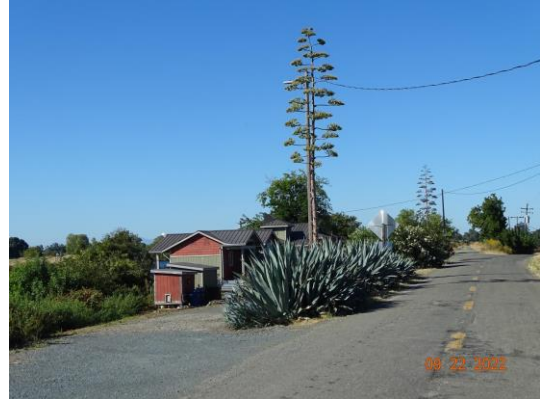
Photo 1 of 1 : FA_2024_RD0556_18_34_20241001_00013.jpg

View of the cactus on the WS shoulder (Fall 2022).

| Remove large cactus from waterside shoulder to allow inspection and access. | | | | | |

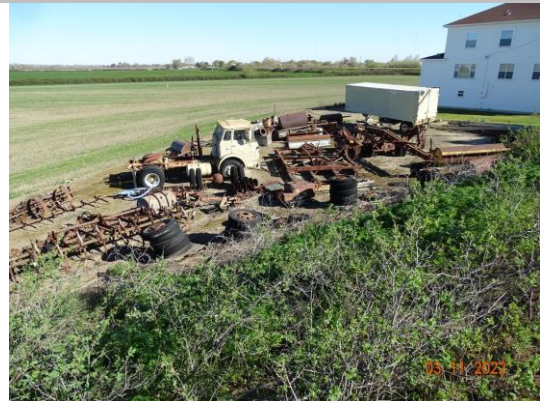
Photo 1 of 1 : FA_2024_RD0556_18_100_20241001_00047.jpg

View of equipment stored at landside toe (Spring 2022).

| Move equipment off of landside toe. | | | | | |

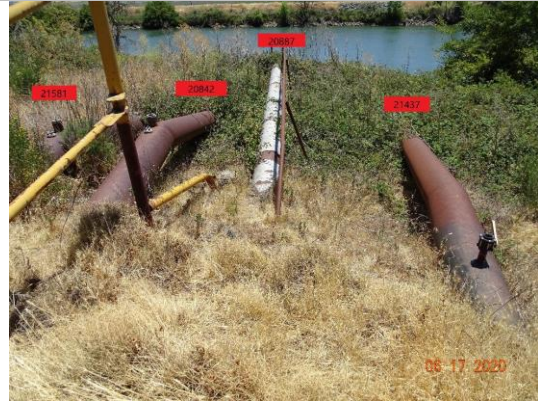
Photo 1 of 3 : UCIP_FA_2024_61315_89138.jpg

Water-Side: Pipes on waterside berm

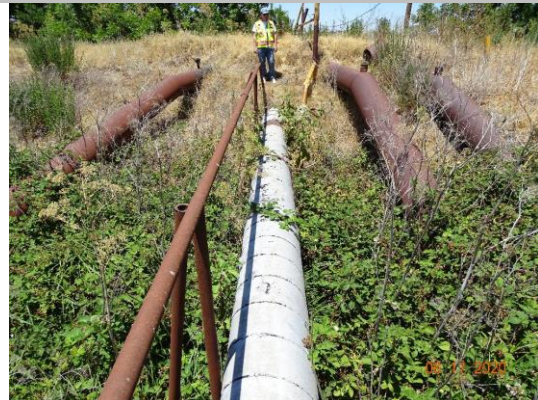
Photo 2 of 3 : UCIP_FA_2024_61315_89139.jpg

Water-Side: Pipes on waterside berm and levee slope on background

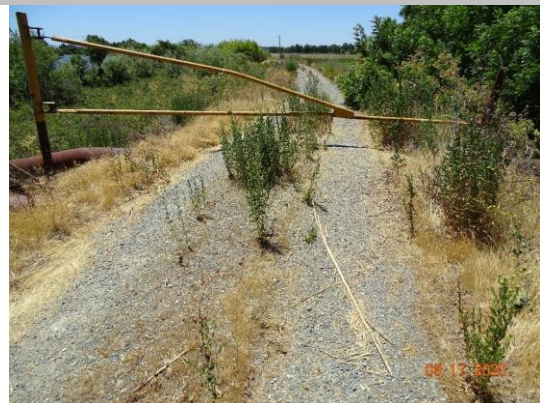
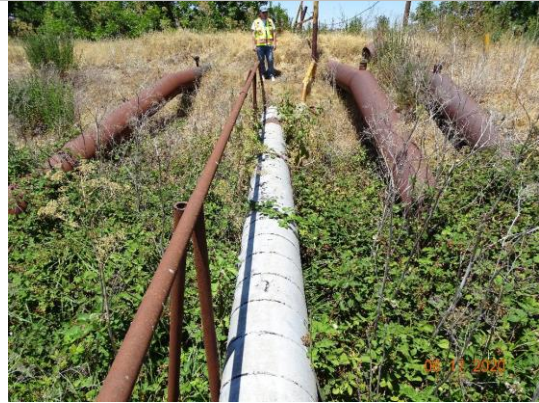
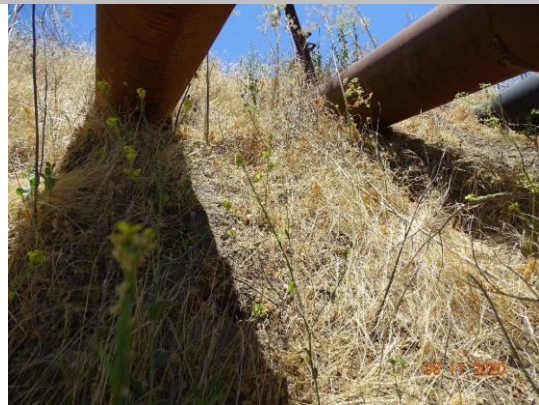
DS_ID:20842
FS_ID:61303
EP_NO: 13030
Repair Type: Non-Urgent
EVAL Issue: 10, Unauthorized Modification or Non-Compliant Permit
Crossing Status: Found
UCIP Comments: 06/17/2020 Record is Non-Urgent. Pipe diameter field measured as 20-inch on both slopes. On landside berm pipe diameter changes from 20 inch to 18 inch. Debris of 20-inch pipe welded to 16-inch pipe with open end found next to this crossing on landside berm. Unable to find a permit for modification of this crossing. No permit has been identified authorizing original O&M pipe through the levee. (O.Yakimov - DWR UCIP)
FIELD_STRUCT_DESC: 16-inch steel drainage pipe through levee, 4.3 feet below crown. Pump on landward side and 4-inch air valve. (16-inch pipe [HLM 4.01] authorized under Automatic Board Order (ABO) issued as Permit No. 11175, 1975 - RD0556). [Additional Reference(s): DWR Levee Log, unk.yr. (HLM 4.01). USACE Sacramento O&M Manual, Unit 103, June 1954, Revised 29 December 2016, (Station 397+20.5), listed as 16-inch pipe. USACE As-Built Drawing No. 50-04-2631, Sheet 10, Station 397+20.5, March 1950, Revised 16 Dec.1952, listed as 12-inch pipe].

Top of Levee: View of levee crown looking downstream

Water-Side: Pipes on waterside berm looking from riverbank

Land-Side: View of levee slope looking from toe

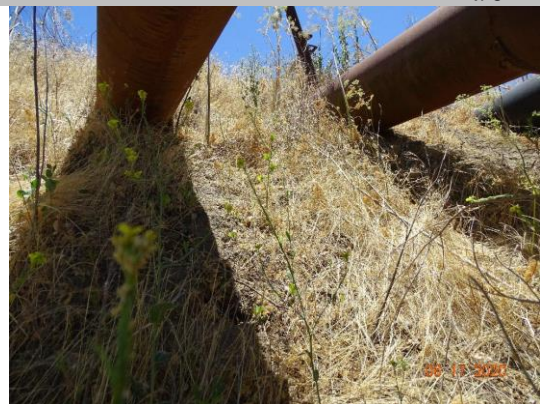
DS_ID:21437
FS_ID:61311
EP_NO: 10526
Repair Type: Non-Urgent
EVAL Issue: 10, Unauthorized Modification or Non-Compliant Permit
Crossing Status: Found
UCIP Comments: 06/17/2020 Record is Non-Urgent. Pipe diameter field measured as 20-inch on both slopes. Unable to find a permit for modification of this crossing. (O.Yakimov - DWR UCIP)

FIELD_STRUCT_DESC: 24-inch steel drainage pipes 3.5 ft below levee crown. Pumping plant on landside. 6" air valve, concrete saddle & wood beam on waterside. This crossing replaces 24-inch pipe (see DSID 25634). (24-inch pipe authorized under Permit No. 10526, 1975 - Reclamation District 556). [Additional Reference(s): USACE Sacramento O&M Manual, Unit 103, June 1954, Revised 29 December 2016, (Station 397+36.3), listed as 24-inch pipe. USACE As-Built Drawing No. 50-04-2631, Sheet 10, Station 397+36.3, March 1950, Revised 16 Dec.1952].
FS Date: 6/17/2020

Top of Levee: View of levee crown looking downstream

Land-Side: View of levee slope looking from toe

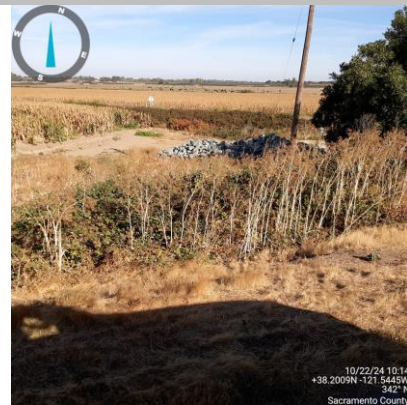
Photo 1 of 1 : FA_2024_RD0556_18_23_20241023_00095.jpg

View of vegetation on the landside slope. (Fall 2024)

| Remove blackberry bushes from landside slope. | | | | | |

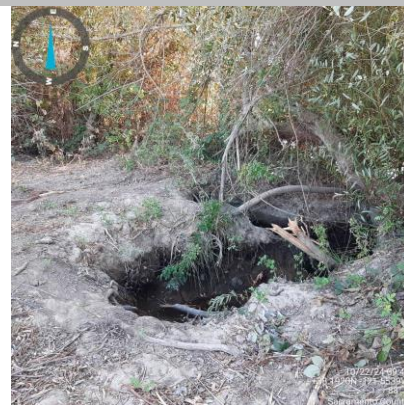
Photo 1 of 1 : FA_2024_RD0556_18_21_20241023_00096.jpg

| Vegetation control revealed large collapsed portion of waterside bank. Erosion believed to be old beaver den that has collapsed and eroded away over time. Erosion is on the waterside berm, outside of the levee prism and will be monitored by the LMA to track erosion progress. | | | | | |

View of erosion at the edge of the waterside berm. (Fall 2024)

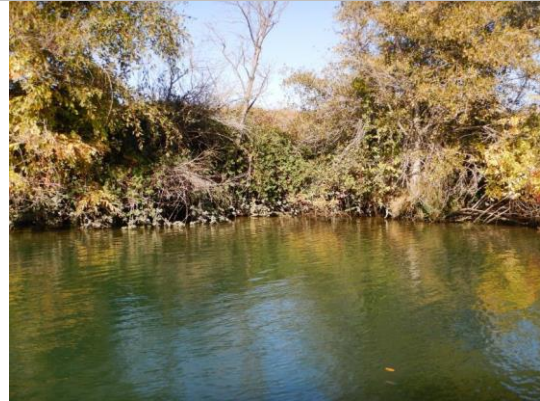
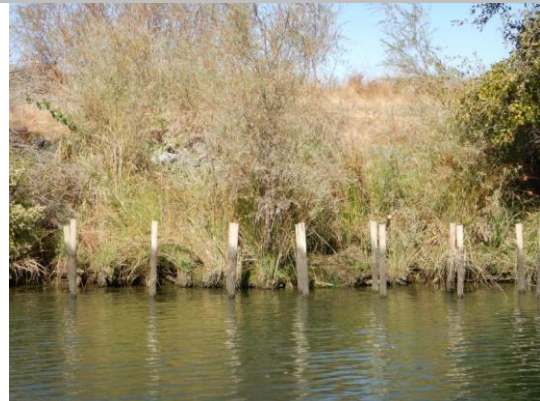
2018 Site ID: GEO 7.0 R
Status: Eroding
2018 Field Notes: Minor new toe erosion.
Site History: 1997 - Toe damaged rock. 1999 - One pocket filled with gravel. 2000 - Eroding beach with some biotech rolls and stakes; some gravel on slope. 2001 - Staked, low fascine walls at bankline. 2005 - Stone revetment in between pockets. 2006 - New rock on upper slope behind brush boxes at the upstream end, Stone is sliding off the hard toe. 2016 - Fresh erosion observed. 2017 - Site extended downstream. Large erosion pockets and significant toe erosion.

USACE 2018 Erosion Photo #1

USACE 2018 Erosion Photo #2

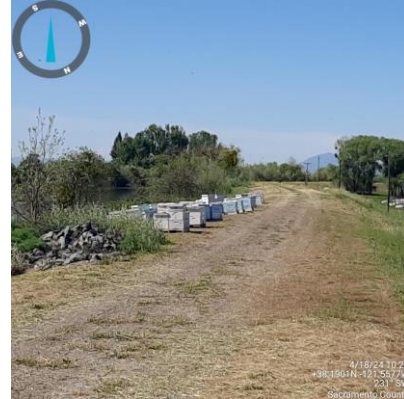
Photo 1 of 1 : FA_2024_RD0556_18_56_20241001_00035.jpg

View of bee boxes on the levee crown. (Spring 2024)

| Bee boxes on the crown should be removed. | | | | | |

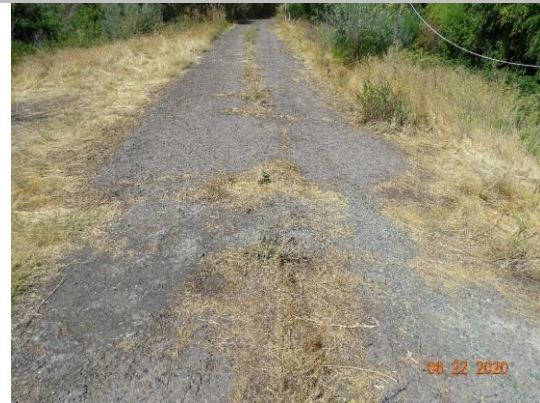
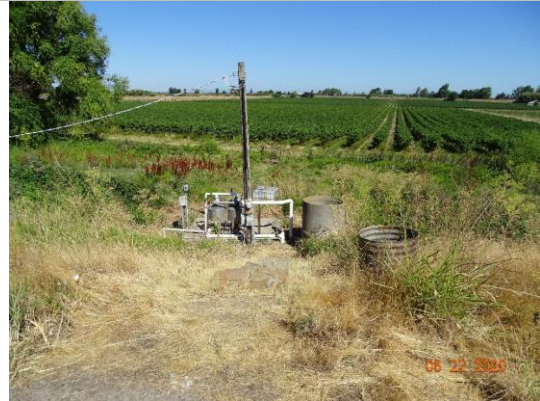
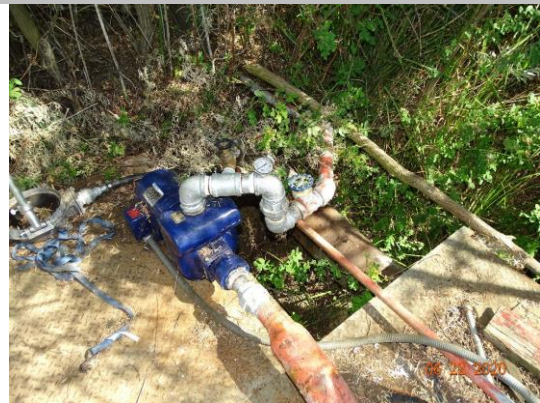
| DS_ID:20847 FS_ID:61308 EP_NO: 10489 Repair Type: Non-Urgent EVAL Issue: 10, Unauthorized Modification or Non-Compliant Permit Crossing Status: Found UCIP Comments: 06/22/2020 Record is Non-Urgent. Slant pump was removed and replaced with smaller pump on pile structure at riverbank. Unable to find a permit for modification. (O.Yakimov - DWR UCIP) FIELD_STRUCT_DESC: 10-inch pipe through levee, 3.5 feet below crown. Pump on pile structure at riverbank. 1-inch electrical conduit through levee at this location. Siphon breaker in CMP riser on landward slope. A 9 ft x 42-inch concrete standpipe on landside. Service pole with electric meter and connection panel at landside toe. Two sand media filters on landside. This crossing replaces 6-inch pipe (see DSID 25650). (10-inch pipe authorized under Permit No. 10489, 1975 - Daecie and Gamble). [Additional Reference(s): DWR Levee Log, unk.yr. (HLM 5.32). USACE Sacramento O&M Manual, Unit 103, June 1954, Revised 29 December 2016, (Station 'R' 327+63.7), listed as 8-inch pipe. USACE As-Built Drawing No. 50-04-2631, Sheet 8, Station 327+63.7, March 1950, Revised 16 Dec.1952, listed as 8-inch pipe]. FS Date: 6/22/2020 | | | | | |

Top of Levee: View of levee crown looking downstream

Land-Side: View of levee slope looking from crown

Water-Side: Pump on pile structure looks recently replaced

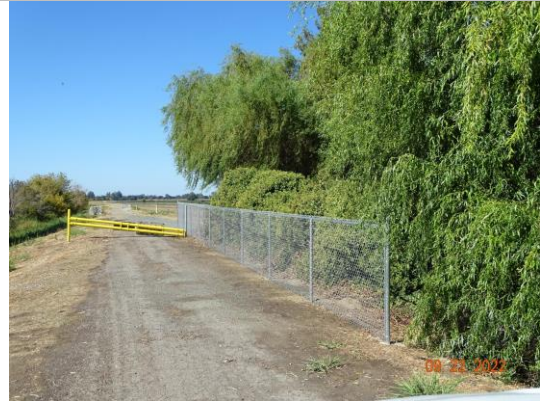
Photo 1 of 1 : FA_2024_RD0556_18_90_20241001_00044.jpg

View of the fence on the on LS shoulder (Fall 2022).

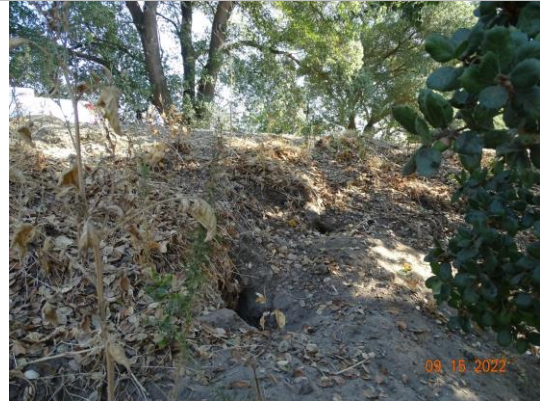
Photo 1 of 1 : FA_2024_RD0556_19_92_20241001_00057.jpg

| Multiple rodent holes on the landside slope. | | | | | |

View of the rodent holes looking up the LS slope (Fall 2022).

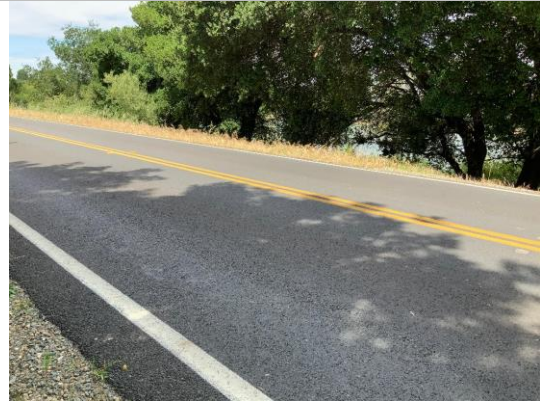
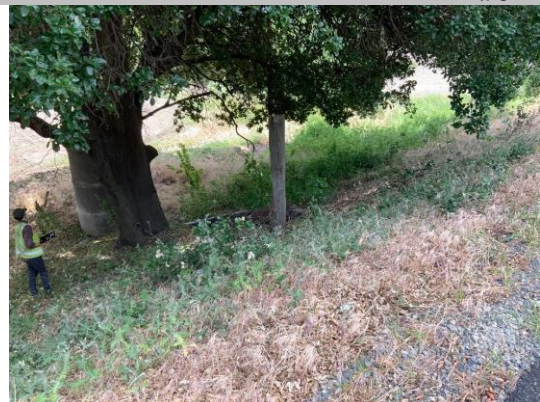
| DS_ID:20858 FS_ID:76291 EP_NO: 11179 Repair Type: Urgent EVAL Issue: 2a, Levee Integrity Crossing Status: Found UCIP Comments: 05/12/2022 The record has been upgraded from No Action Needed to Urgent. WS slope and berm near water has significant erosion greater than 1 foot. There is also excavation around the WS berm exposing the pipe that is greater than 1 foot. Recommend filling in excavations that are causing a safety hazard. Crossing will be monitored until funding becomes available to address the issues. No permit other than ABO was found authorizing this encroachment. CVFPB will need to review crossing to determine owner. The UCIP inspection was completed with GEI staff, A. Lau. (H. Dunn ? GEI) FIELD_STRUCT_DESC: 12-inch irrigation discharge pipe of an unknown material through the levee, 4.8 feet below the crown. Pump on a pile structure in the river. Service pole on each slope. (12-inch pipe [HLM 0.29] authorized under Automatic Board Order (ABO) issued as Permit No. 11179, 1975 - George K. Adams Ranches, Inc). [Additional Reference(s): DWR Levee Log, year unknown (HLM 0.29)]. FS Date: 5/12/2022 1:22:06 PM | | | | | |

Levee crown.

LS view: Toe from crown.

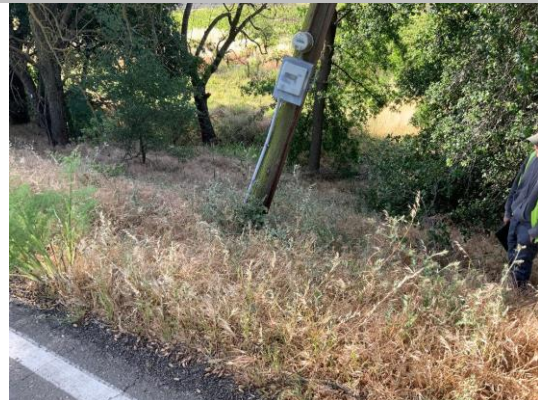
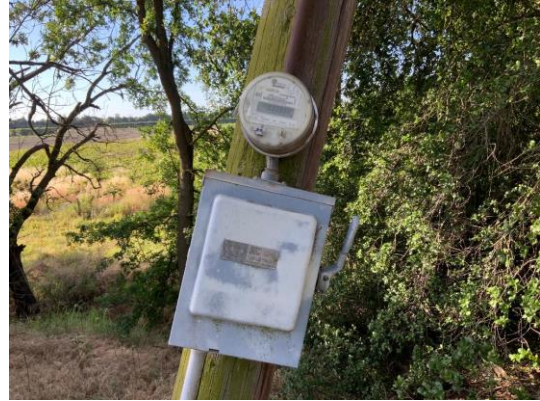
DS_ID:20850
FS_ID:76292
EP_NO: 11179
Repair Type: Urgent
EVAL Issue: 2b, Levee Integrity
Crossing Status: Found
UCIP Comments: 05/12/2022 The record has been upgraded from No Action Needed to Urgent. Deep hole greater than 1 foot on LS berm around pipe covered with leaves and causing a fall and safety concern. Recommend filling in with dirt. LS riser missing lid. No permit other than ABO permit was found authorizing this encroachment. CVFPB will need to review crossing to determine owner. The UCIP inspection was completed with GEI staff, A. Lau. (H. Dunn ? GEI) 04/25/2013 Pump house and gate valve not found. (P. Amatya - DWR)
FIELD_STRUCT_DESC: 10-inch steel irrigation discharge pipe through the levee, 4.8 feet below the crown. Slant pump and gate valve on the riverbank. Siphon breaker and service pole on the landside (LS) slope. Concrete spill box on the LS. (10-inch pipe [HLM 0.49] authorized under Automatic Board Order (ABO) issued as Permit No. 11179, 1975 - George K. Adams Ranches, Inc). [Additional Reference(s): DWR Levee Log, year unknown (HLM 0.49). USACE Sacramento O&M Manual, Unit 103, June 1954, Revised 29 December 2016, (Station "J" 217+52), listed as 10-inch pipe. USACE As-Built Drawing No. 50-04-2277, March 1946, Sheet 4, Station 217+52 "J"].

Levee crown with some visible cracking.

LS view: Slope and toe from crown.

LS view: Closeup of meter pole.

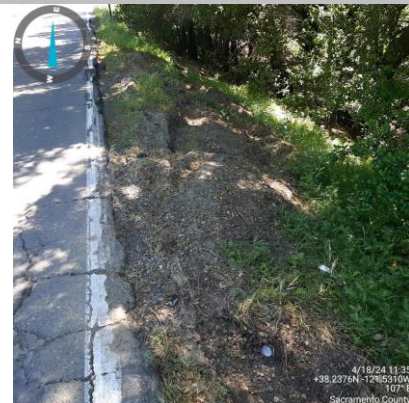
Photo 1 of 1 : FA_2024_RD0556_19_38_20241001_00028.jpg

View of vehicle rut on LS slope. (Spring 2024)

| E6 : Repair the levee slope damaged by vehicle traffic and prevent access where possible. | | | | | |
| LS slope needs to be backfilled and regraded to fix vehicle ruts. | | | | | |

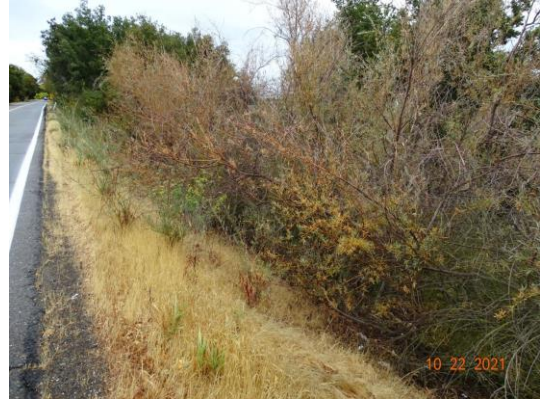
Photo 1 of 1 : FA_2024_RD0556_19_81_20241001_00051.jpg

View looking upstream at thick vegetation on the landside slope (Fall 2021).

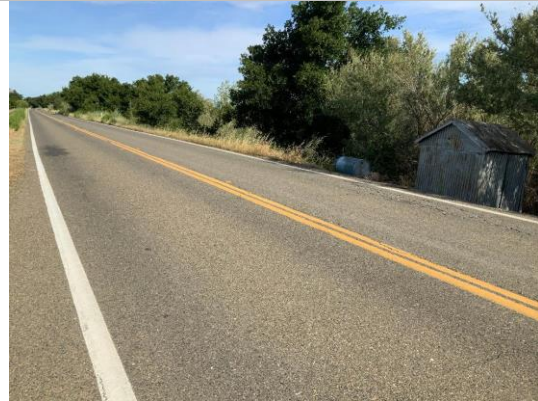
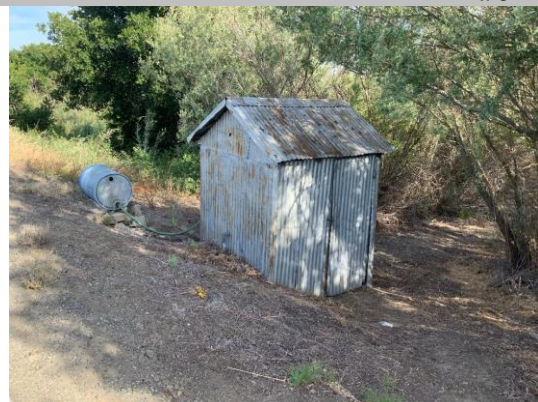
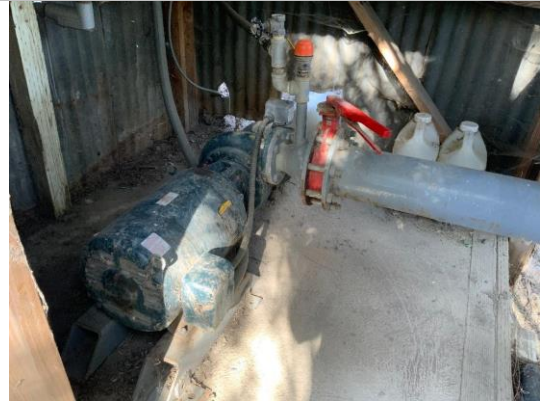
DS_ID:20851
FS_ID:76293
EP_NO: 11186
Repair Type: Non-Urgent
EVAL Issue: 6, Levee Damage or Threat for Levee Damage
Crossing Status: Found
UCIP Comments: 05/12/2022 The record remains Non-Urgent. The plastic tank on WS is still leaking, causing minor erosion on the WS slope. Recommend repair of tank or hose to prevent further erosion. No permit other than ABO permit was found authorizing this encroachment. CVFPB will need to review crossing to determine owner. The UCIP inspection was completed with GEI staff, A. Lao. (H. Dunn ? GEI)

04/25/2013 a concrete box on LS. Water is leaking from priming plastic tank and causing surface erosion on levee slope. (P. Amatya - DWR)
FIELD_STRUCT_DESC: 4-inch steel irrigation discharge pipe through the levee, 4.3 feet below the crown. Pump and gate valve in a pump house on the waterside (WS) berm. Siphon breaker and service pole on the landside (LS) slope. Concrete spill box with three 8-inch openings. (4-inch pipe [HLM 0.95] authorized under Automatic Board Order (ABO) issued as Permit No. 11186, 1975 - Margaret M. Marks). [Additional Reference(s): DWR Levee Log, year unknown (HLM 0.95). USACE Sacramento O&M Manual, Unit 103, June 1954, Revised 29 December 2016, (Station "J" 192+00), listed as 6-inch pipe. USACE As-Built Drawing No. 50-04-2277, March 1946, Sheet 4, 192+00 "J", listed as 6-inch pipe].
FS Date: 5/12/2022 3:13:00 PM

WS view: Pump house and tank on slope from crown.

WS view: Closeup of pump in pumphouse on slope.

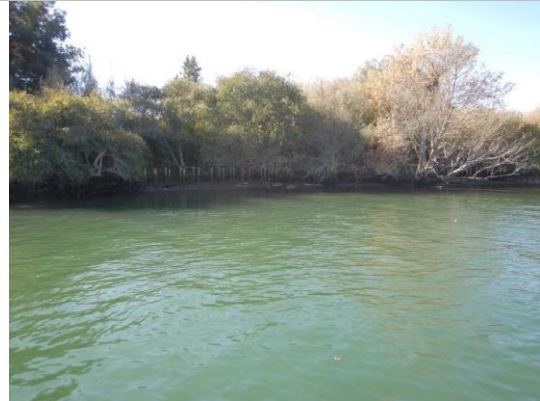
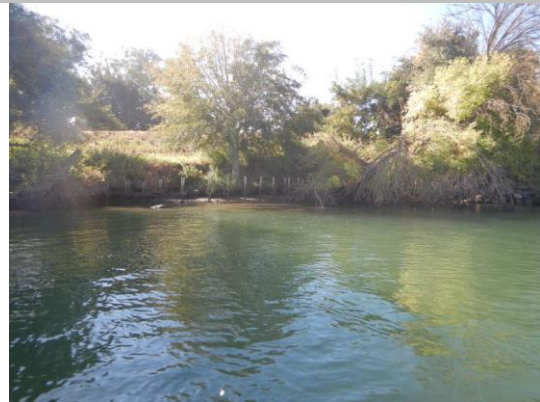
2018 Site ID: SAC 25.2 L
Status: Eroding
2018 Field Notes: Additional erosion along toe. Site extended upstream.
Site History: 1997 - Rock is in poor condition and has failed in many places. Scallops in berm with remnants of old rock in the toe area.
2005 - Brush boxes present. 2013 - Site extended upstream approximately 300 ft to include new erosion pockets. 2015 - Minor new erosion at toe. 2017 - Minor new erosion observed.

USACE 2018 Erosion Photo #1

USACE 2018 Erosion Photo #2

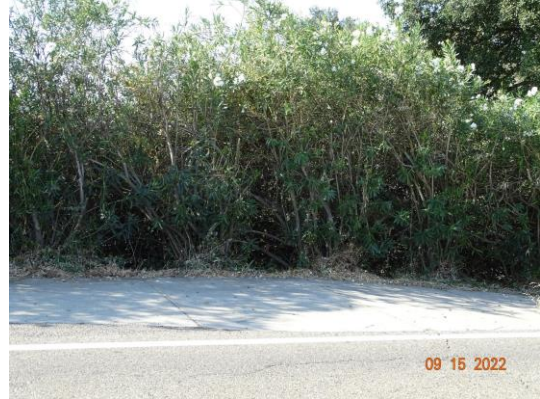
Photo 1 of 1 : FA_2024_RD0556_19_26_20241001_00018.jpg

View of the oleander on the LS slope (Fall 2022).

| Trim/thin oleanders on the landside of the levee. | | | | | |

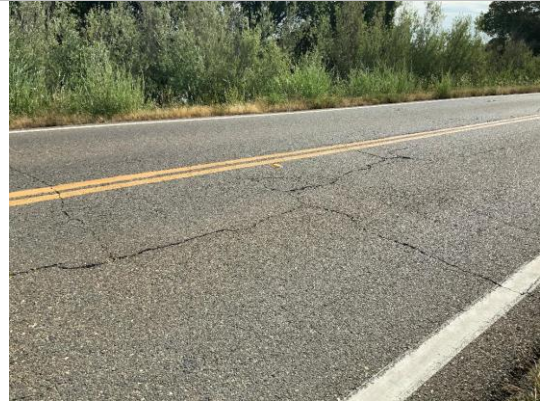
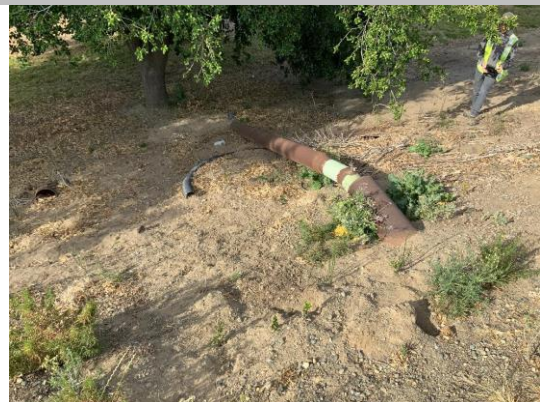
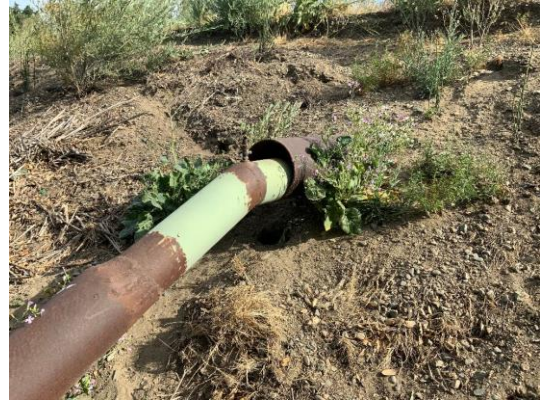
DS_ID:20852
FS_ID:76294
EP_NO: 11187
Repair Type: Urgent
EVAL Issue: 3b, Flood Risk
Crossing Status: Found
UCIP Comments: 05/12/2022 The record has been upgraded from Non-Urgent to Urgent. Still a gap between the 6 and 10-inch pipe that should be grouted, as it's causing a flood risk concern. Unable to find a permit for pipe sleeving. Appears abandoned, due to disconnected pump and pipe on LS toe. Owner will need to coordinate with the CVFPB to meet Title 23 requirements. No permit other than ABO permit was found authorizing this encroachment. CVFPB will need to review crossing to determine owner. The UCIP inspection was completed with GEI staff, A. Lao. (H. Dunn ? GEI) 04/25/2013 Gap between 6-inch pipe and 10-inch pipe needs to be sealed. (P. Amatya - DWR)
FIELD_STRUCT_DESC: 6-inch steel irrigation discharge pipe sleeved through a 10-inch steel pipe through the levee, 4.8 feet below the crown. Pump on the riverbank. (10-inch pipe [HLM 1.22] authorized under Automatic Board Order (ABO) issued as Permit No. 11187, 1975 - Ernest and Alvine Machado). [Additional Reference(s): DWR Levee Log, year unknown (HLM 1.22), listed as 10-inch pipe].

LS view: Pipe visible on the slope from crown.

LS view: Closeup of gap between pipe on slope.

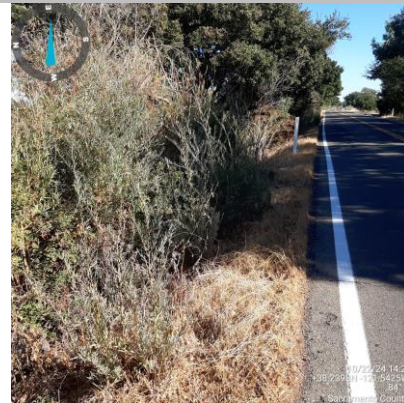
Photo 1 of 1 : FA_2024_RD0556_19_48_20241106_00094.jpg

View of tall vegetation on the waterside hinge. (Fall 2024)

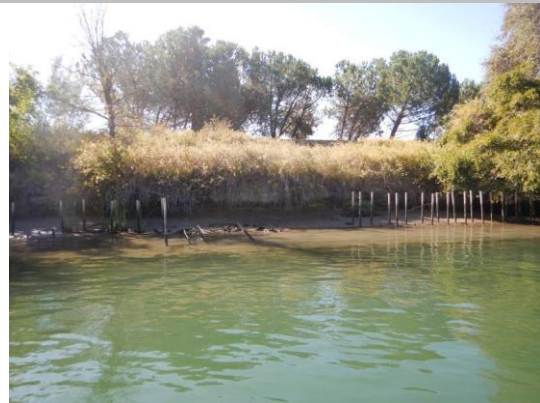
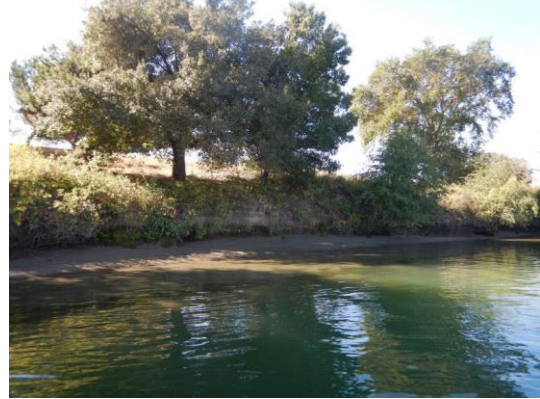
| 2013 - There is little to no berm remaining at downstream end of this site. 2016 - New erosion on levee slope. 2017 - Significant lower bank erosion. | | | | | |

USACE 2018 Erosion Photo #1

USACE 2018 Erosion Photo #2

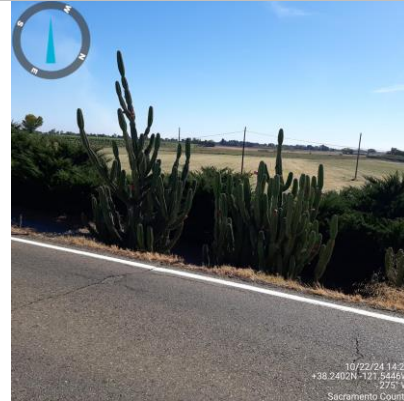
Photo 1 of 1 : FA_2024_RD0556_19_41_20241106_00095.jpg

| Cactus on the landside slope. | | | | | |

View of cactus and other landscaping on the landside slope. (Fall 2024)

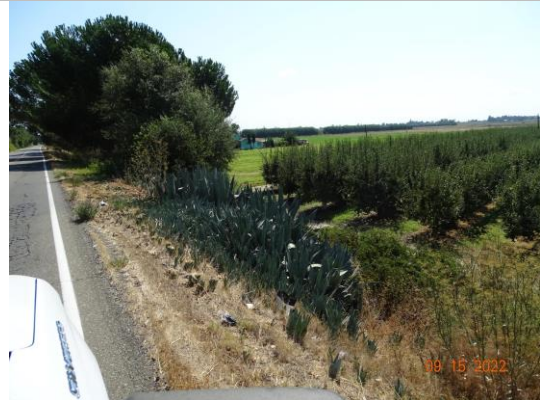
Photo 1 of 1 : FA_2024_RD0556_19_47_20241001_00032.jpg

View of the cactus on the LS slope (Fall 2022).

| Remove cactus from the landside slope. | | | | | |

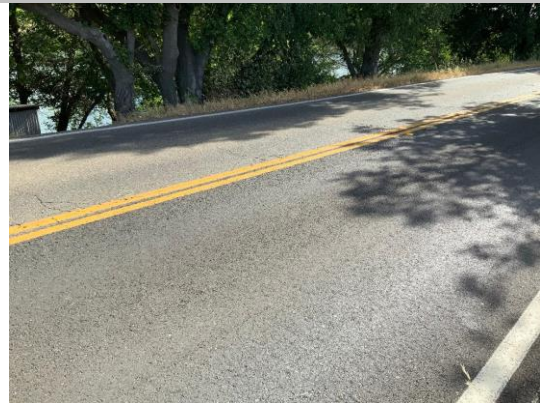
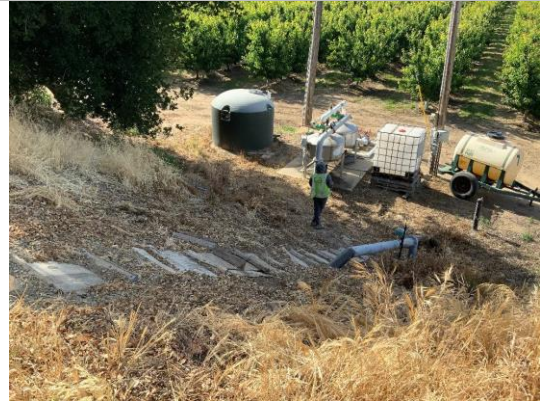
| DS_ID:20854 FS_ID:76296 EP_NO: N/A Repair Type: Non-Urgent EVAL Issue: 10, Unauthorized Modification or Non-Compliant Permit Crossing Status: Found UCIP Comments: 05/12/2022 The record has been upgraded from No Action Needed to Non-Urgent. Modification of new filtration system on LS toe. No permit was found authorizing this encroachment. CVFPB will need to review crossing to determine owner. Pump was running during. The UCIP inspection was completed with GEI staff, A. Lao. (H. Dunn ? GEI) 4/25/2013 Pump was running during field survey. (P. Amatya - DWR) FIELD_STRUCT_DESC: 8-inch steel irrigation discharge pipe through the levee, 5.5 feet below the crown. Pump and gate valve on the waterside (WS) berm. Siphon breaker and service pole on the landside (LS) slope. Concrete standpipe on the LS. (8-inch pipe [HLM 1.78] authorized under Automatic Board Order (ABO) issued as Permit No. 11181, 1975 - Robert E. and G. P. Collins). [Additional Reference(s): DWR Levee Log, year unknown (HLM 1.78). USACE Sacramento O&M Manual, Unit 103, June 1954, Revised 29 December 2016, (Station "J" 149+10), listed as 8-inch pipe. USACE As-Built Drawing No. 50-04-2277, March 1946, Sheet 3, 149+10 "J"]. FS Date: 5/12/2022 3:39:19 PM | | | | | |

LS view: Slope with pipe and toe from crown.

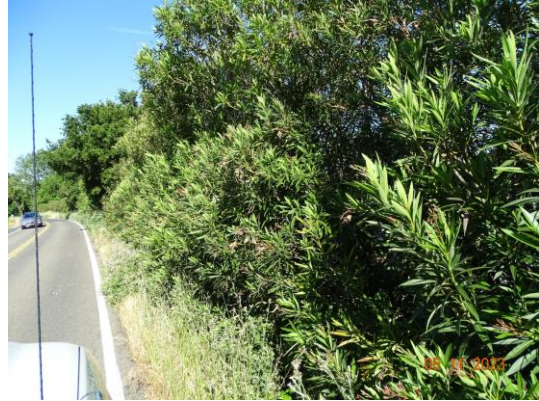
Photo 1 of 1 : FA_2024_RD0556_19_70_20241001_00043.jpg

View of the oleander on the WS slope (Spring 2023).

| Thin oleanders to allow view down the levee slope. | | | | | |

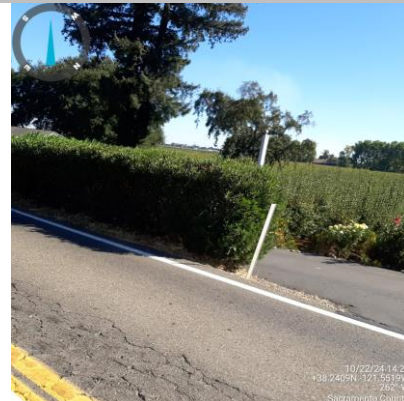
Photo 1 of 1 : FA_2024_RD0556_19_86_20241106_00096.jpg

View looking at landscaping on the landside slope (Fall 2024).

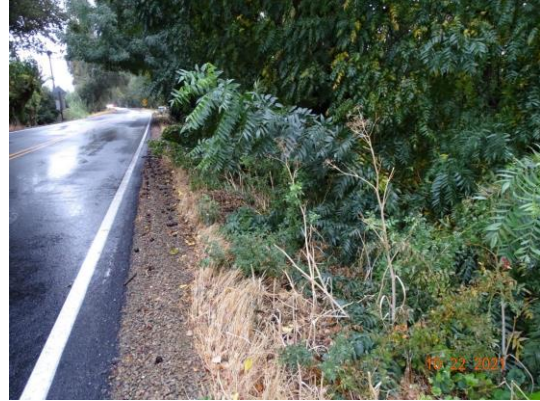
Photo 1 of 1 : FA_2024_RD0556_19_68_20241001_00042.jpg

View looking downstream at landscaping on the waterside slope (Fall 2021).

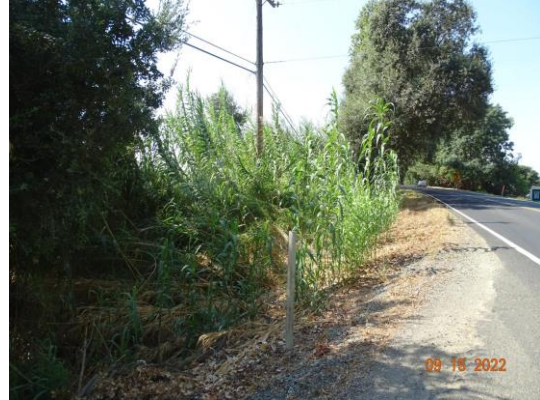
Photo 1 of 1 : FA_2024_RD0556_19_32_20241001_00023.jpg

View of the arundo on the LS slope (Fall 2022).

| Arundo growth should be removed to allow inspection and access to the landside slope and toe. | | | | | |

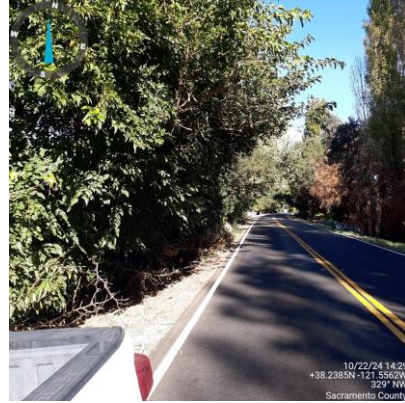
Photo 1 of 1 : FA_2024_RD0556_19_2_20241106_00097.jpg

View looking upstream oleanders on the waterside slope (Fall 2024).

| Trim oleanders on the waterside slope. | | | | | |

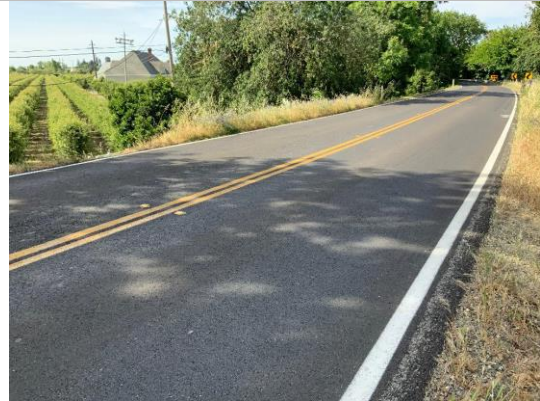
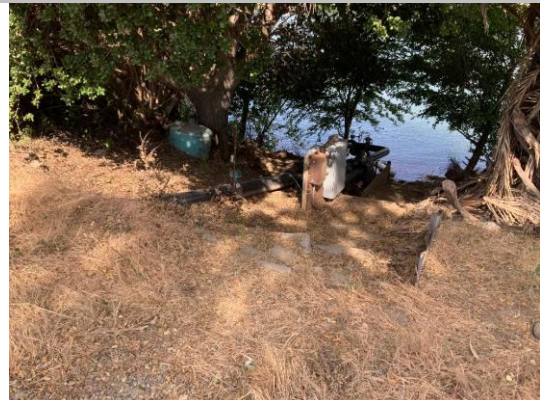
| DS_ID:20857 FS_ID:76299 EP_NO: 5986 Repair Type: Non-Urgent EVAL Issue: 10, Unauthorized Modification or Non-Compliant Permit Crossing Status: Found UCIP Comments: 05/12/2022 The record has been upgraded from No Action Needed to Non-Urgent. Modifications to crossing, pump and pipe sections on WS appear new and new filtration system on LS toe . The UCIP inspection was completed with GEI staff, A. Lao. (H. Dunn ? GEI 04/25/2013 Service pole on LS. Siphon breaker not found on landward slope. (P. Amatya - DWR) FIELD_STRUCT_DESC: 12-inch steel irrigation discharge pipe through the levee, 3.5 feet below the crown. Pump on the waterside (WS) slope. 1.25-inch and 2-inch electrical conduits through the levee. (Installation of a discharge pipe through the levee authorized under Permit No. 5986, 1968 - Malcolm McCormack. 2-inch electrical conduit to water pump authorized under Permit No. 14255, 1985 - Chuck Sterne). [Additional Reference(s): DWR Levee Log, year unknown (HLM 2.25), listed as 12-inch pipe and 1.25-inch electric conduit]. FS Date: 5/12/2022 4:03:00 PM | | | | | |

Levee crown.

WS view: Toe from crown.

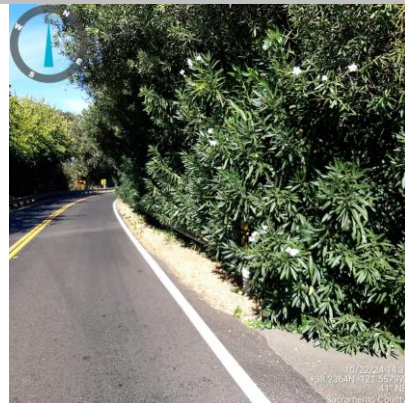
Photo 1 of 1 : FA_2024_RD0556_19_35_20241106_00100.jpg

View of oleanders on the landside slope. (Fall 2024)

| Trim/thin oleanders to allow inspection and access to landside slope and toe. | | | | | |
