**Flood Control Project Maintenance
Levee Inspections
Fall 2024 Levee Maintenance Deficiency Summary Report**

Sacramento River Basin

| RD0556 | Overall LMA Rating | Total LMA Miles | | | | | | |
|---|---|---|---|---|---|---|---|---|
| Reclamation District No. 0556 Upper Andrus | U | 11.20 | | | | | | |

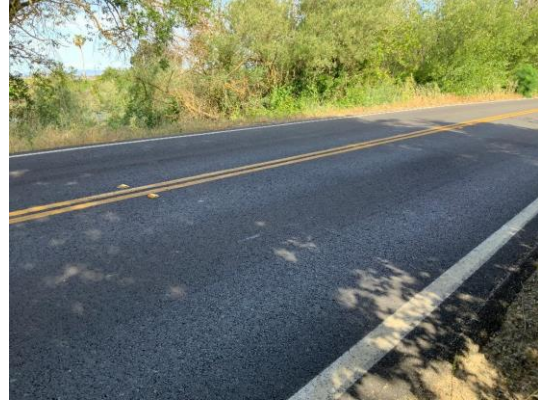
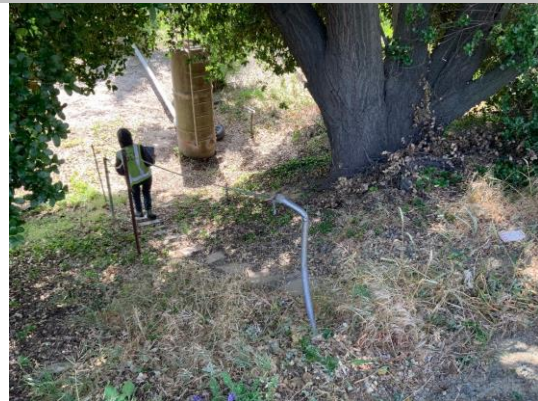
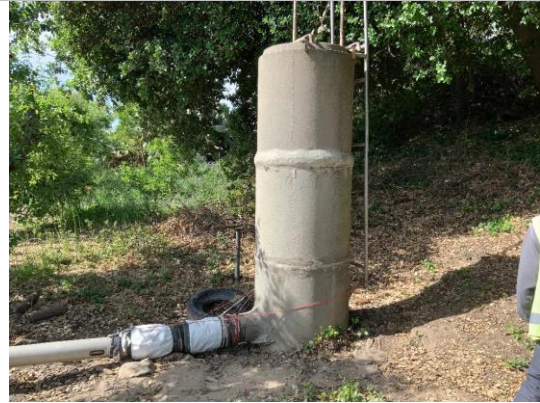
| DS_ID:20859 FS_ID:76301 EP_NO: 11181 Repair Type: Non-Urgent EVAL Issue: 11, Maintenance Compliance Issue Crossing Status: Found UCIP Comments: 05/12/2022 The record remains Non-Urgent. LS riser is filled with dirt, recommend cleaning out. No permit other than ABO permit was found authorizing this encroachment. CVFPB will need to review crossing to determine owner. The UCIP inspection was completed with GEI staff, A. Lao. (H. Dunn ? GEI) 04/25/2014 Needs to clean CMP riser for proper functioning of siphon breaker. (P. Amatya - DWR) FIELD_STRUCT_DESC: 10-inch steel irrigation discharge pipe through the levee, 5.8 feet below the crown. Pump and gate valve in a pump house on the waterside (WS) slope. Siphon breaker and service pole on the landside (LS) slope. (10-inch pipe [HLM 2.41] authorized under Automatic Board Order (ABO) issued as Permit No. 11181, 1975 - Robert E. and G. P. Collins). [Additional Reference(s): DWR Levee Log, year unknown (HLM 2.41). USACE Sacramento O&M Manual, Unit 103, June 1954, Revised 29 December 2016, (Station "J" 115+25), listed as 10-inch pipe. USACE As-Built Drawing No. 50-04-2277, March 1946, Sheet 3, Station 115+25 "J"]. FS Date: 5/12/2022 4:20:11 PM | | | | | |

LS view: Riser visible at toe from crown.

LS view: Closeup of riser and pipe at toe.

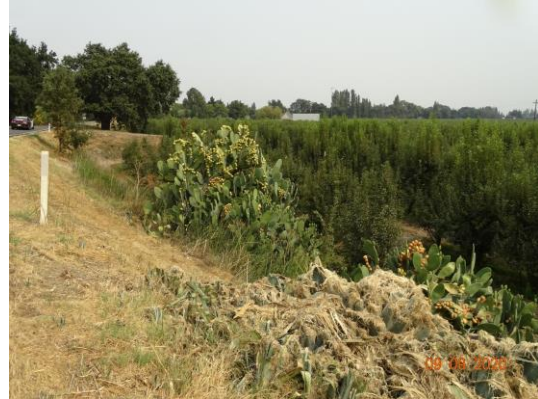
Photo 1 of 1 : FA_2024_RD0556_19_76_20241001_00047.jpg

View of large cactus on the landside slope (Fall 2020).

| Remove cactus on the landside toe. | | | | | |

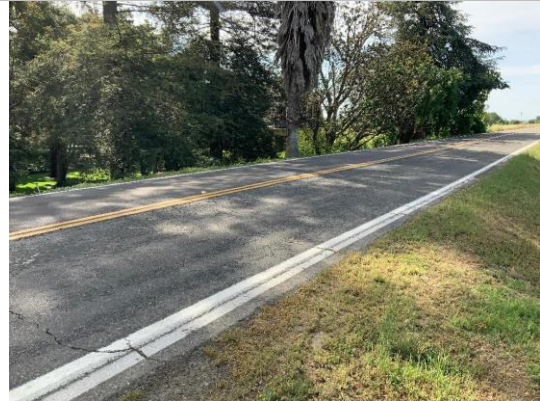
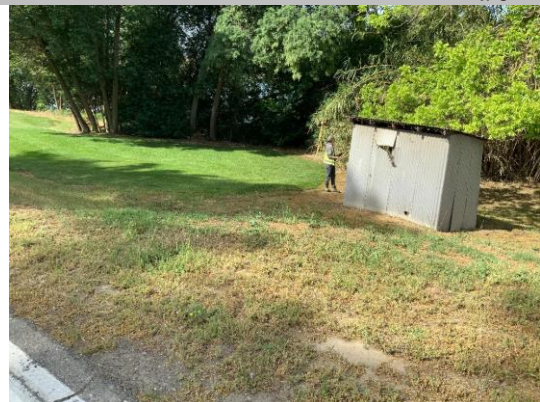
| DS_ID:20849 FS_ID:76302 EP_NO: 11181 Repair Type: Non-Urgent EVAL Issue: 11, Maintenance Compliance Issue Crossing Status: Found UCIP Comments: 05/12/2022 The record remains Non-Urgent. Appears abandoned, no pump or pipe seen in WS pumphouse. Owner will need to coordinate with the CVFPB to meet Title 23 requirements. LS riser is filled with dirt, recommend removal if still in use. No permit other than ABO permit was found authorizing this encroachment. CVFPB will need to review crossing to determine owner. The UCIP inspection was completed with GEI staff, A. Lao. (H. Dunn ? GEI)04/25/2014 Needs to clean siphon breaker CMP riser. (P. Amatya - DWR) FIELD_STRUCT_DESC: 6-inch irrigation discharge pipe of an unknown material through the levee, 6 feet below the crown. Pressure tank in a pump house on the waterside (WS) berm. Service pole, siphon breaker, and distribution box on the landside (LS) slope. (6-inch pipe [HLM 2.84] authorized under Automatic Board Order (ABO) issued as Permit No. 11181, 1975 - Robert E. and G. P. Collins). [Additional Reference(s): DWR Levee Log, year unknown (HLM 2.84)]. FS Date: 5/12/2022 4:27:14 PM | | | | | |

WS view: Pumphouse visible on toe from crown.

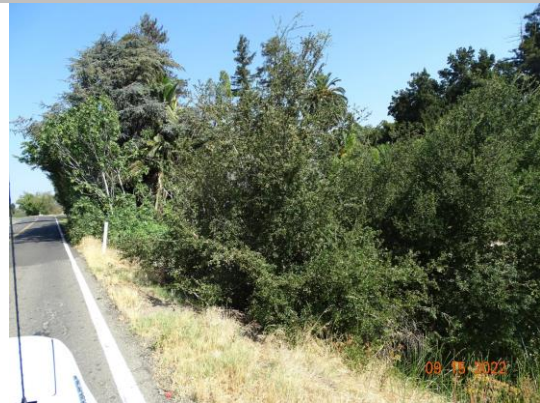
Photo 1 of 1 : FA_2024_RD0556_19_46_20241001_00031.jpg

View of the landscaping on the LS slope (Fall 2022).

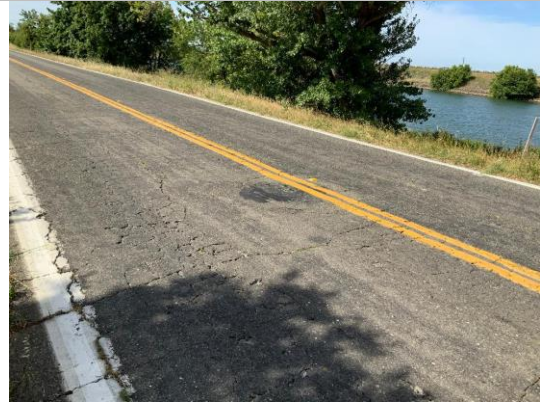
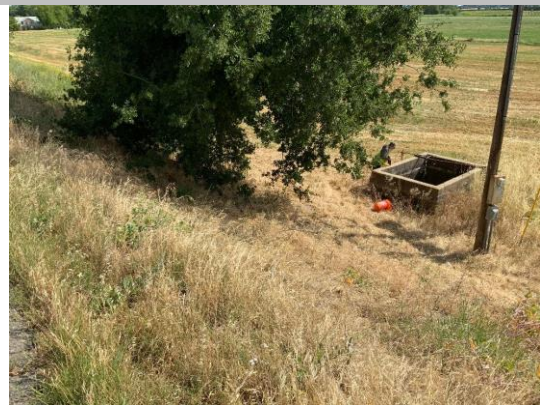
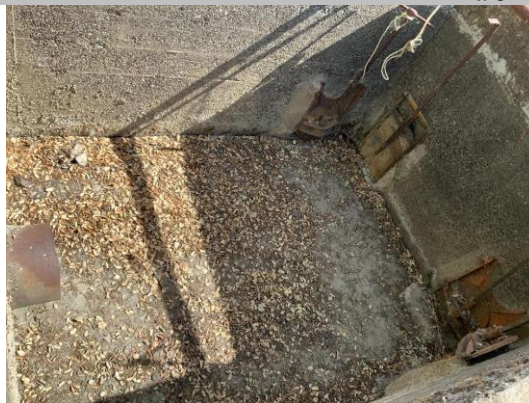
| DS_ID:20862 FS_ID:76303 EP_NO: N/A Repair Type: Urgent EVAL Issue: 3b, Flood Risk Crossing Status: Found UCIP Comments: 05/12/2022 Record updated from Non-Urgent to Urgent. Modification of sleeving the pipe, and gap in between pipe and sleeve, causes flood risk concern. The UCIP inspection was completed with GEI staff, A. Lao. (H. Dunn ? GEI)04/25/2013 9-inch steel pipe sleeved through 12-inch pipe. Needs to seal gap between two pipes. (P. Amatya - DWR) FIELD_STRUCT_DESC: 9-inch steel pipe sleeved through a 12-inch steel irrigation discharge pipe through the levee, 6 feet below the crown. Pump on a pile structure in the river. Steel walkway to the pump and wood steps on the waterside (WS) slope. Concrete spill box with two 8-inch openings. (Six 12-inch steel discharge pipes (pipe 6 of 6) authorized under Permit No. 1173, 1947 - Reclamation District No. 556). (12-inch pipe [HLM 3.06] authorized under Automatic Board Order (ABO) issued as Permit No. 11193, 1975 - Gertrude M. Reid). [Additional Reference(s): DWR Levee Log, year unknown (HLM 3.06), listed as 12-inch pipe. USACE Sacramento O&M Manual, Unit 103, June 1954, Revised 29 December 2016, (Station "J" 80+79), listed as 12-inch pipe. USACE As-Built Drawing No. 50-04-2277, March 1946, Sheet 3, Station 80+79 "J", listed as 12-inch pipe]. FS Date: 5/12/2022 12:09:29 PM | | | | | |

LS view: Distribution box at toe from crown.

LS view: Pipe outlet in box at toe.

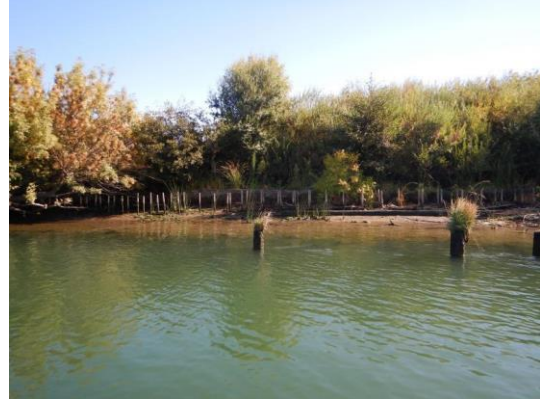
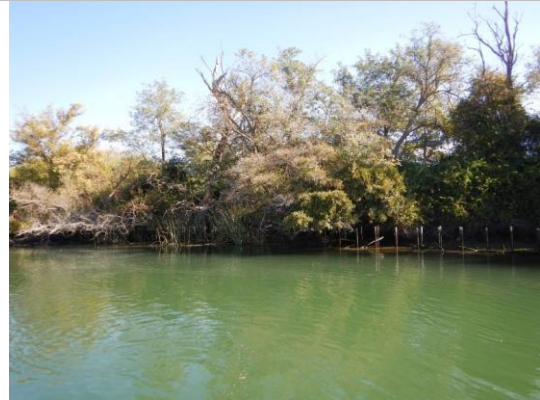
2018 Site ID: SAC 23.2 L
Status: Eroding
2018 Field Notes: Additional tree popouts and new erosion throughout site.
Site History: 2000 - Recently fallen cottonwood at the downstream end.
2005 - Empty brush boxes. 2011 - A few trees have fallen since last year. 2012 - Potential new tree popout since last year. 2013 - New erosion at downstream end of site and a recent tree pop-out observed.
2016 - New erosion at the toe. 2017 - New erosion along lower bank.

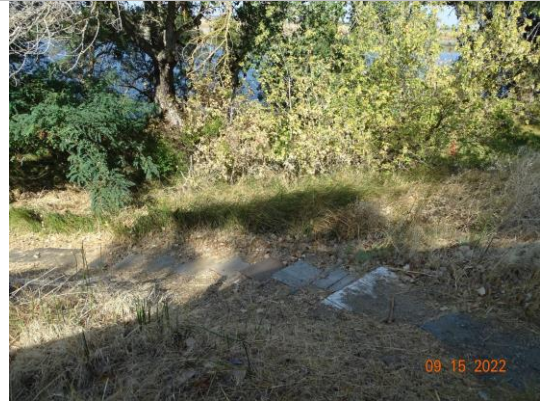
Photo 1 of 1 : FA_2024_RD0556_19_78_20241001_00048.jpg

| Stairs encroaching into slope do not have a permit. | | | | | |

View of the steps on the WS slope (Fall 2022).

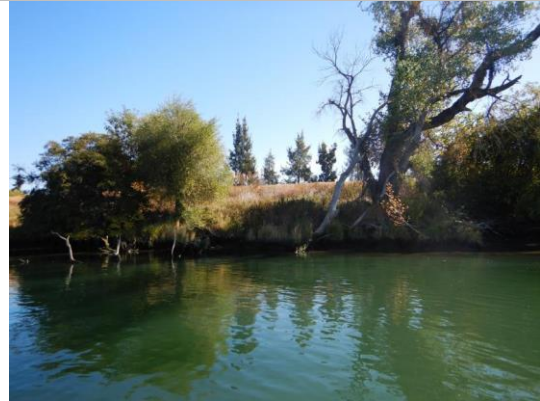
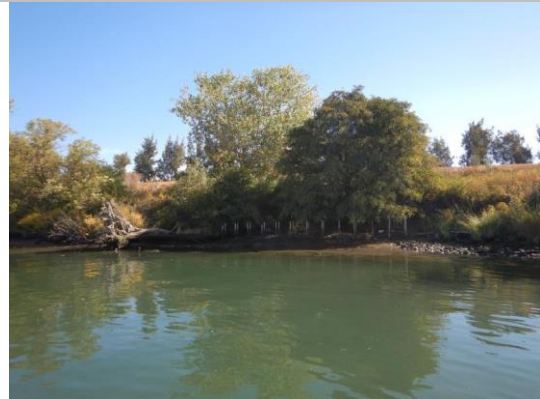
2018 Site ID: SAC 22.7 L
Status: Eroding
2018 Field Notes: No observed change.
Site History: 1997 - Scallops into berm and very close to levee toe.
2005 - Brush boxes present. 2011 - New toe scour and freshly fallen tree. 2012 - New tree popout has taken significant portion of soil out of the levee. 2017 - Minor new erosion at toe.

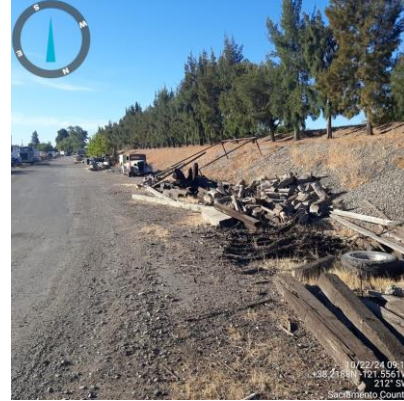
Photo 1 of 1 : FA_2024_RD0556_19_34_20241106_00101.jpg

View of material, vehicles, and equipment at the landside toe. (Fall 2024)

| Fire wood, old vehicles/farm equipment, and tanks stored at the seepage berm toe and should be removed. | | | | | |

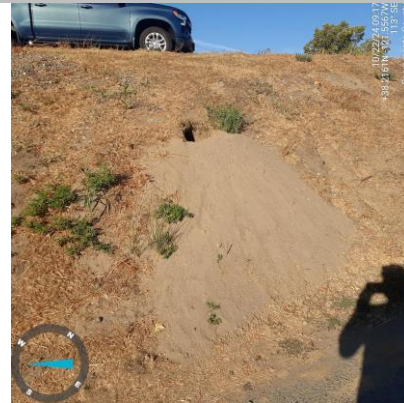
Photo 1 of 1 : FA_2024_RD0556_19_40_20241106_00102.jpg

View of large rodent hole on the landside slope. (Fall 2024)

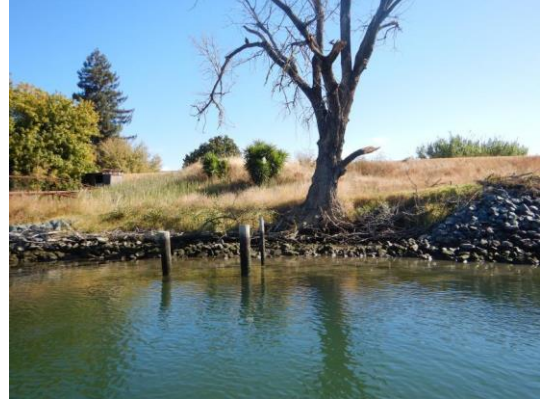
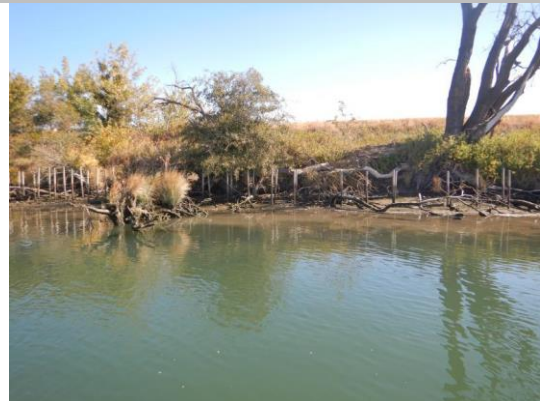
2018 Site ID: SAC 22.5 L
Status: Eroding
2018 Field Notes: Minor new erosion at toe.
Site History: 2002 - Spot rock along berm, but not in the erosion pockets. 2005 - Some new minor stone revetment at the upstream end. Brush boxes present. 2006 - Currently installing new brush in downstream brush boxes. 2007 - Rock in middle portion for about 150 ft. 2010 - Some attempt at repairs but still has pockets of erosion. 2012 - More erosion along the toe. 2017 - New lower bank erosion at the upstream end. Locals placed rock in some erosion pockets.

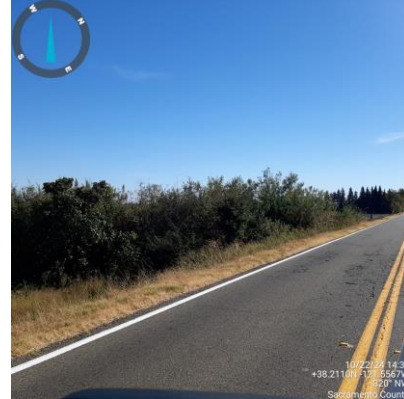
Photo 1 of 1 : FA_2024_RD0556_19_55_20241106_00104.jpg

View of thick trees on the landside slope. (Fall 2024)

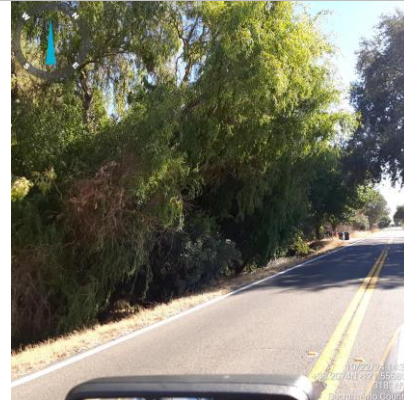
Photo 1 of 1 : FA_2024_RD0556_19_36_20241106_00107.jpg

View of landscaping on the landside slope. (Fall 2024)

| Oleanders, trees, and other landscaping should be trimmed to allow inspection and access to the landside slope and toe. | | | | | |

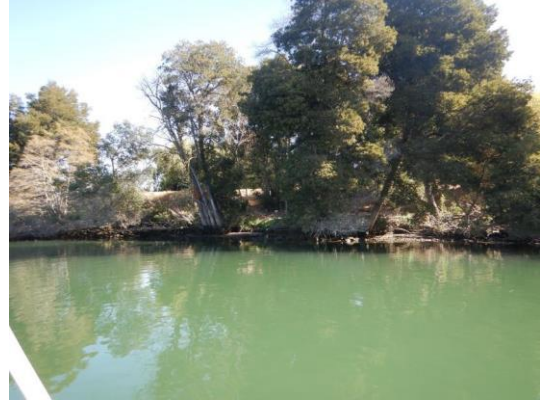
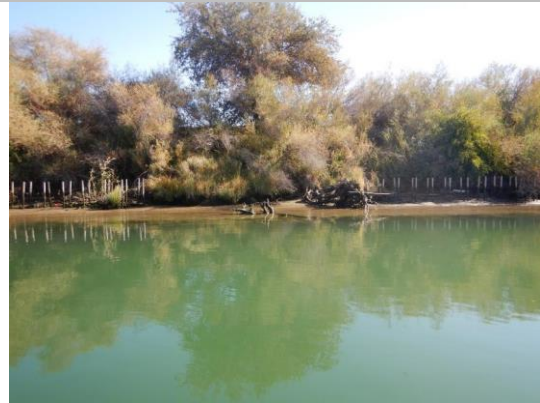
| 2018 Field Notes: No observed change. | | | | | |
| Site History: 2013 - Erosion pockets encroaching on levee foundation. | | | | | |

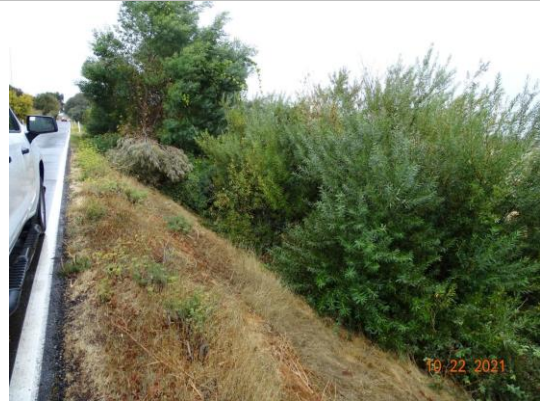
Photo 1 of 1 : FA_2024_RD0556_19_60_20241001_00038.jpg

View looking upstream at trees on the landside slope (Fall 2021).

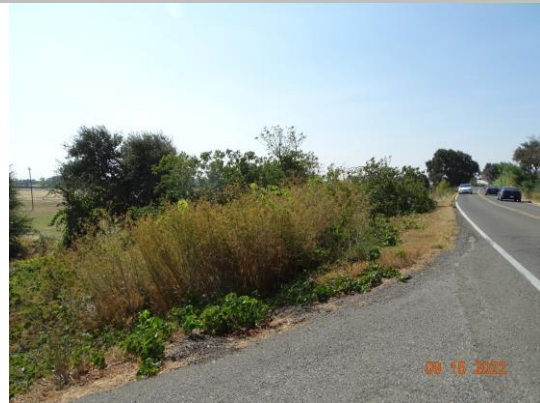
Photo 1 of 1 : FA_2024_RD0556_19_58_20241001_00036.jpg

View of the LS vegetation and fig tree in the background (Fall 2022).

| Remove fig tree from the landside slope. | | | | | |

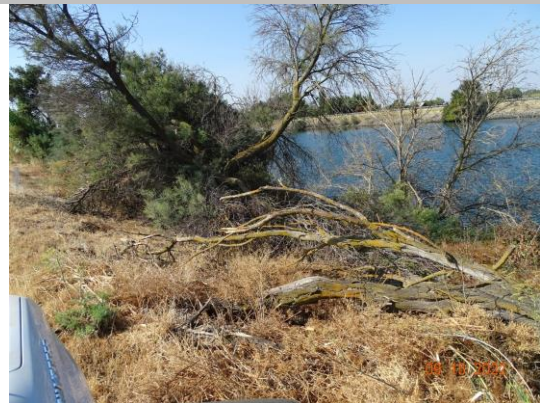
Photo 1 of 1 : FA_2024_RD0556_19_27_20241001_00019.jpg

View of overgrown and fallen trees on the WS slope (Fall 2022).

| Trim trees and remove fallen trees from waterside slope. | | | | | |

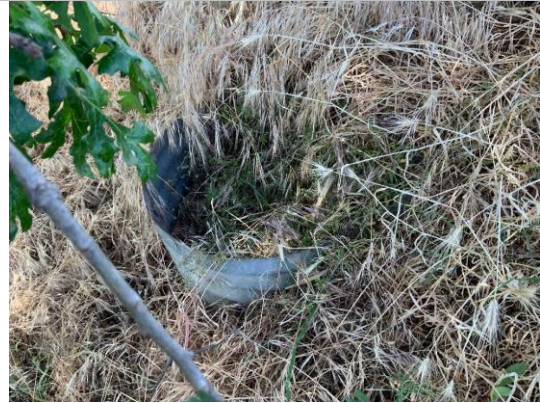
Photo 3 of 3 : UCIP_FA_2024_76308_113564.jpg

LS view: Covered riser visible on slope.

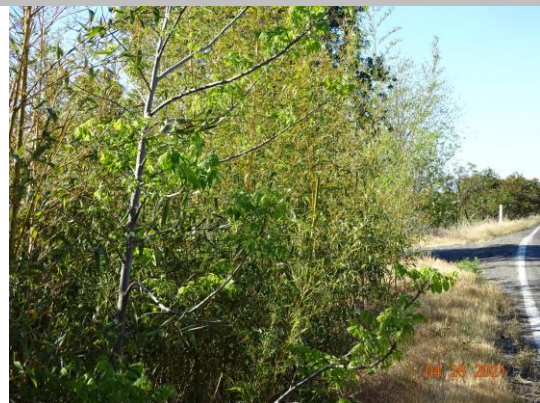
Photo 1 of 1 : FA_2024_RD0556_19_52_20241001_00034.jpg

View looking downstream at bamboo and trees of heaven on landside slope (Spring 2021).

| Bamboo and trees of heaven should be removed. | | | | | |

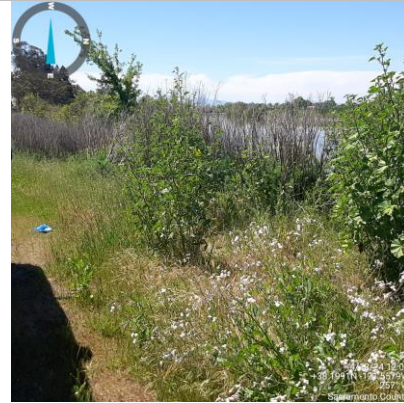
Photo 1 of 1 : FA_2024_RD0556_19_91_20241001_00056.jpg

View of tall vegetation on WS slope. (Spring 2024)

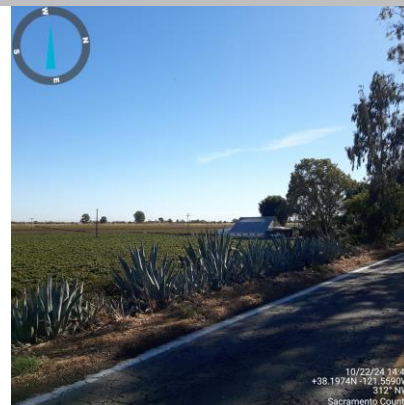
Photo 1 of 1 : FA_2024_RD0556_19_37_20241106_00106.jpg

View of century plants on the landside hinge/slope. (Fall 2024)

| Remove cactus, and century plants on the landside slope. | | | | | |

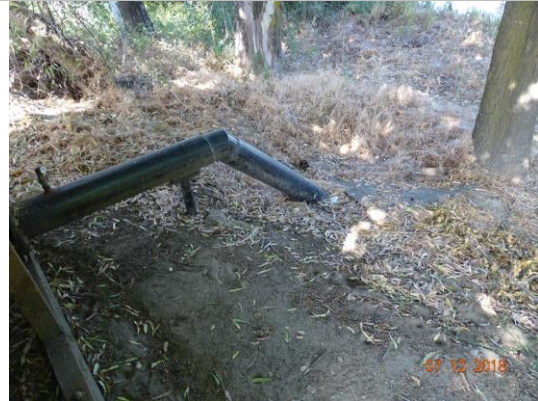
Photo 1 of 3 : UCIP_FA_2024_76310_77690.jpg

View of pipe on WS and a pit covered by plywood.

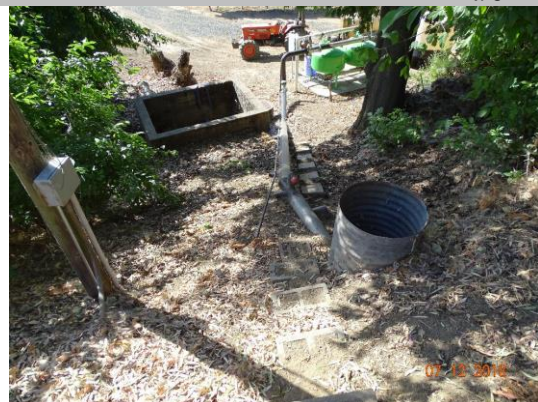
Photo 2 of 3 : UCIP_FA_2024_76310_77692.jpg

View of LS slope at the crossing.

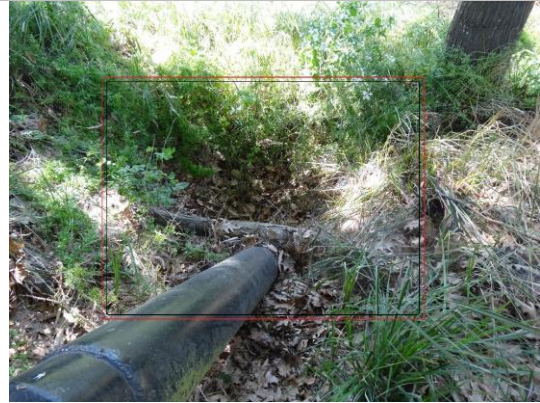
Photo 3 of 3 : UCIP_FA_2024_76310_20370.jpg

DS_ID:20869
FS_ID:76310
EP_NO: 11185
Repair Type: Urgent
EVAL Issue: 2b, Levee Integrity
Crossing Status: Found
UCIP Comments: 05/12/2022 The record remains Urgent. There is still a deep pit on WS toe covered with plywood, causing a safety concern and levee integrity concern, recommend filling in with dirt. LS siphon in riser is covered with vegetation, recommend cleaning out. New filter installation on LS as well as modifications to the LS concrete box. No permit other than ABO permit was found authorizing this encroachment. CVFPB will need to review crossing to determine owner. The UCIP inspection was completed with GEI staff, A. Lau. (H. Dunn ?
GEI 7/12/2018 Pit on WS is covered with plywood. Water pump is running, no leaks detected. LS part of crossing was reconstructed. New pipe was installed after CMP riser to supply water to sand filters. Remains Urgent due to large pit on WS that needs to be backfilled.

WS- intake pipe and pit on levee slope (center)

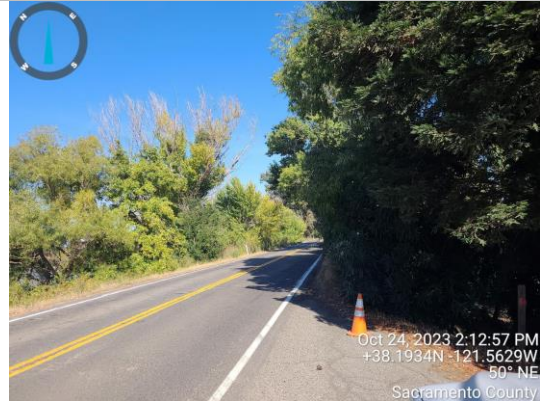
Photo 1 of 1 : FA_2024_RD0556_19_31_20241001_00022.jpg

View of oleanders on the landside slope. Fall 2023.

| Thin oleanders to allow view down landside slope. | | | | | |

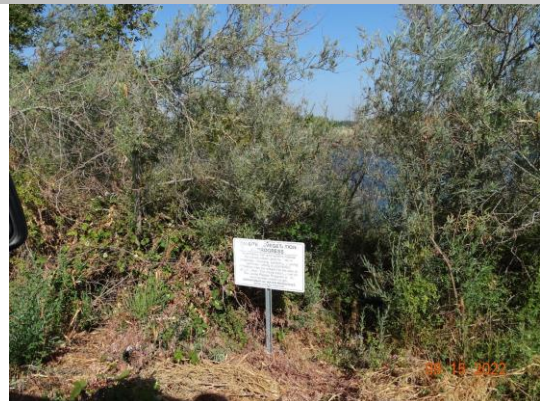
Photo 1 of 1 : FA_2024_RD0556_19_80_20241001_00050.jpg

| This is a DWR Revegetation Site. | | | | | |

View of the environmental mitigation sign on the WS slope (Fall 2022).
