**Flood Control Project Maintenance
Levee Inspections**
LMA District Cover Sheet
Spring 2015 Levee Inspection Results

Reclamation District No. 0556 Upper Andrus

Spring 2015 Levee Inspection Results

Waterway		Bank	Unit Miles
Unit No. 01 Georgiana Slough		Right	5.48

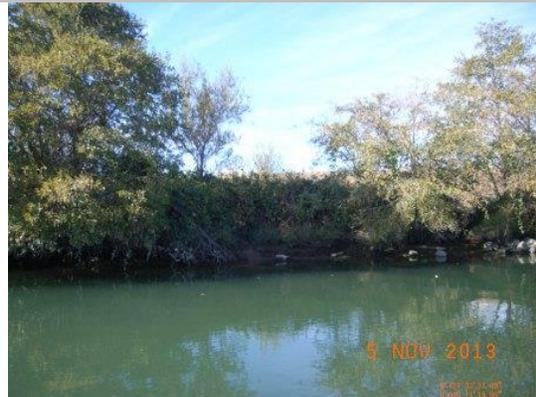
Photo 1 of 1 : SP_2015_RD0556_18_16_20150312_00004.jpg

LM Start	5.12	Rating **	M	Issue No.	16
LM End	5.29	Issue Type +	Ma	Location *	WS
Category	Supplemental			GPS Latitude/Longitude	
				Start	End
Item	USACE Erosion Survey			38.189775 °	38.187967 °
				-121.557729 °	-121.559572 °
DWR ID	DWR_RD0556_01_f_2014_16				
Action/Comments					
Inspector Comments: 1997 - Toe damaged rock. 1999 - One pocket filled with gravel. 2000 - Eroding beach with some biotech rolls and stakes; some gravel on slope. 2001 - Staked, low fascine walls at bankline. 2005 - Stone revetment in between pockets. 2006 - New rock on upper slope behind brush boxes at the upstream end, Stone is sliding off the hard toe. 2013: No observed changes. [2013 Site ID: GEO_7-0_R]

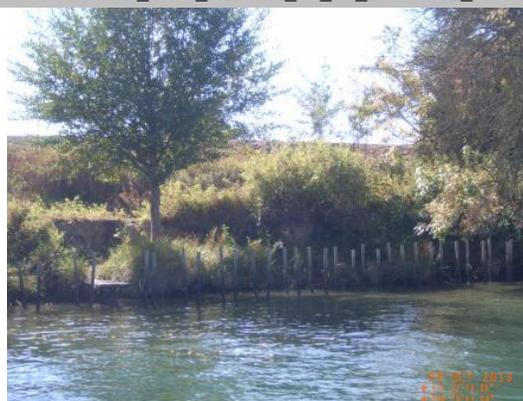
Photo 1 of 1 : SP_2015_RD0556_19_27_20150312_00009.jpg

LM Start	1.03	Rating **	M	Issue No.	27
LM End	1.15	Issue Type +	Ma	Location *	WS
Category	Supplemental			GPS Latitude/Longitude	
				Start	End
Item	USACE Erosion Survey			38.238772 °	38.239265 °
				-121.536788 °	-121.538845 °
DWR ID	DWR_RD0556_02_f_2014_27				
Action/Comments					
Inspector Comments: 1997 - Rock is in poor condition and has failed in many places. Scallops in berm with remnants of old rock in the toe area. 2005 - Brush boxes present. 2013: Site extended upstream approximately 300 ft to include new erosion pockets. [2013 Site ID: SAC_25-2_L]

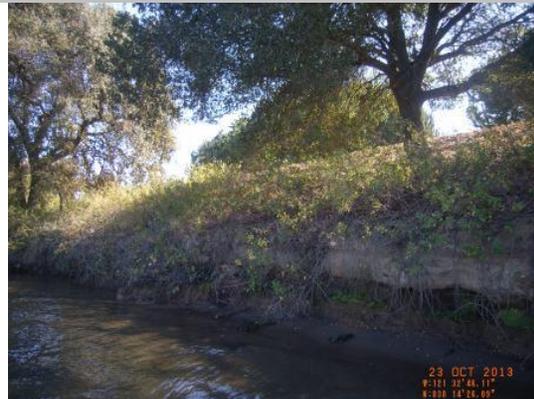
Photo 1 of 1 : SP_2015_RD0556_19_26_20150312_00008.jpg

LM Start	1.45	Rating **	M	Issue No.	26
LM End	1.59	Issue Type +	Ma	Location *	WS
Category	Supplemental			GPS Latitude/Longitude	
				Start	End
Item	USACE Erosion Survey			38.240401 °	38.240772 °
				-121.544106 °	-121.546791 °
DWR ID	DWR_RD0556_02_f_2014_26				
Action/Comments					
Inspector Comments: 1997 - Slow erosion of the berm at the waterline; bench below water. 2005 - Brush boxes present. 2010 - Minor new erosion. 2013: There is little to no berm remaining at downstream end of this site. [2013 Site ID: SAC_24-8_L]

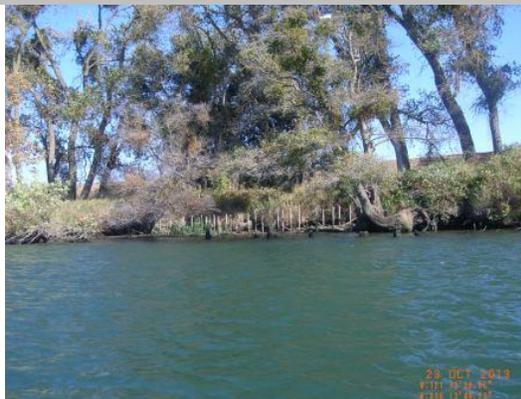
Photo 1 of 1 : SP_2015_RD0556_19_25_20150312_00007.jpg

LM Start	2.93	Rating **	M	Issue No.	25
LM End	3.04	Issue Type +	Ma	Location *	WS
Category	Supplemental			GPS Latitude/Longitude	
	Start		End		
Item	USACE Erosion Survey			38.228202 °	38.226601 °
				-121.555502 °	-121.555605 °
DWR ID	DWR_RD0556_02_f_2014_25				
Action/Comments					
Inspector Comments: 1997 - Few scallops in berm, some getting close to levee toe. 2005 - Brush boxes present. 2012 - More erosion of the toe since last year. 2013: No observed changes. [2013 Site ID: SAC_23-3_L]

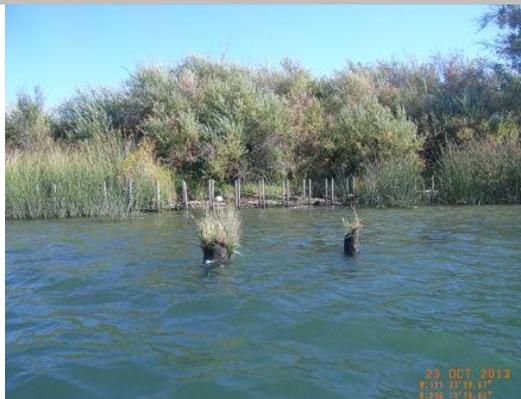
Photo 1 of 1 : SP_2015_RD0556_19_23_20150312_00005.jpg

LM Start	3.16	Rating **	M	Issue No.	23
LM End	3.28	Issue Type +	Ma	Location *	WS
Category	Supplemental			GPS Latitude/Longitude	
				Start	End
Item	USACE Erosion Survey			38.224850 °	38.223233 °
				-121.555641 °	-121.555687 °
DWR ID	DWR_RD0556_02_f_2014_23				
Action/Comments					
Inspector Comments: 2000 - Recently fallen cottonwood at the downstream end. 2005 - Empty brush boxes. 2011 - A few trees have fallen since last year. 2012 - Potential new tree popout since last year. 2013: New erosion at downstream end of site and a recent tree pop-out observed. [2013 Site ID: SAC_23-2_L]

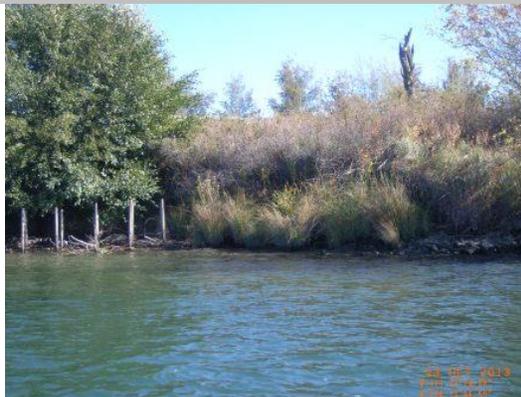
Photo 1 of 1 : SP_2015_RD0556_19_22_20150312_00004.jpg

LM Start	3.58	Rating **	M	Issue No.	22
LM End	3.64	Issue Type +	Ma	Location *	WS
Category	Supplemental			GPS Latitude/Longitude	
				Start	End
Item	USACE Erosion Survey			38.218951 °	38.218104 °
				-121.556689 °	-121.556819 °
DWR ID	DWR_RD0556_02_f_2014_22				
Action/Comments					
Inspector Comments: 1997 - Scallops into berm and very close to levee toe. 2005 - Brush boxes present. 2011 - New toe scour and freshly fallen tree. 2012 - New tree popout has taken significant portion of soil out of the levee. 2013: No observed changes. [2013 Site ID: SAC_22-7_L]

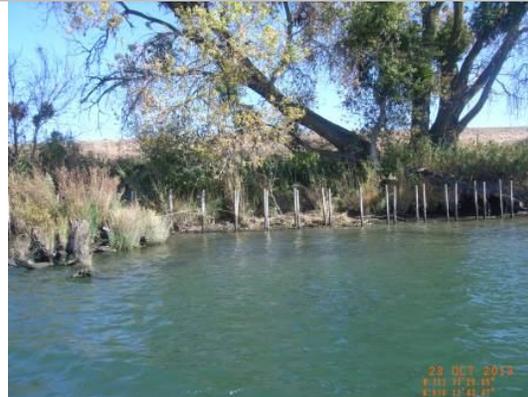
Photo 1 of 1 : SP_2015_RD0556_19_21_20150312_00003.jpg

LM Start	3.95	Rating **	M	Issue No.	21
LM End	4.12	Issue Type +	Ma	Location *	WS
Category	Supplemental		GPS Latitude/Longitude		
			Start	End	
Item	USACE Erosion Survey		38.213581 °	38.211112 °	
			-121.557197 °	-121.557042 °	
DWR ID	DWR_RD0556_02_f_2014_21				
Action/Comments					
Inspector Comments: 2002 - Spot rock along berm, but not in the erosion pockets. 2005 - Some new minor stone revetment at the upstream end. Brush boxes present. 2006 - Currently installing new brush in downstream brush boxes. 2007 - Rock in middle portion for about 150 ft. 2010 - Some attempt at repairs but still has pockets of erosion. 2012 - More erosion along the toe. 2013: No observed changes. [2013 Site ID: SAC_22-5_L]

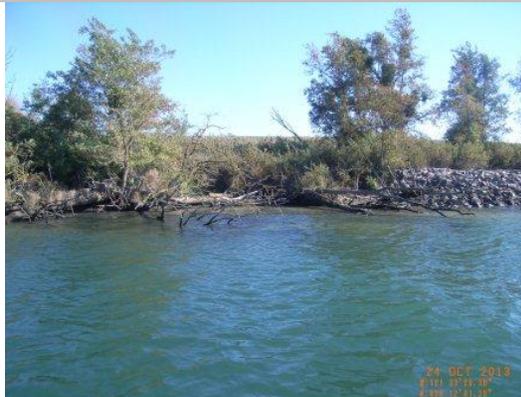
Photo 1 of 1 : SP_2015_RD0556_19_3_20150312_00001.jpg

LM Start	4.85	Rating **	M	Issue No.	3
LM End	4.88	Issue Type +	Ma	Location *	WS
Category	Supplemental			GPS Latitude/Longitude	
				Start	End
Item	USACE Erosion Survey			38.200646 °	38.200225 °
				-121.557606 °	-121.557749 °
DWR ID	DWR_RD0556_02_f_2014_3				
Action/Comments					
Inspector Comments: 1999 - Downstream 140 ft repaired with rock. 2010 - Lots of woody debris, but no changes to site. 2013: No observed changes. [2013 Site ID: SAC_21-5_L]
