**Flood Control Project Maintenance
Levee Inspections**

Maintenance Issue Types Only, Levee Inspection Report By Mile - Fall 2014

Reclamation District No. 0556 Upper Andrus

Waterway	Bank	Unit Miles	Inspection Start/End	Inspector
Unit No. 01 Georgiana Slough	Right	5.48	10/30/2014 10/30/2014	Herman Phillips

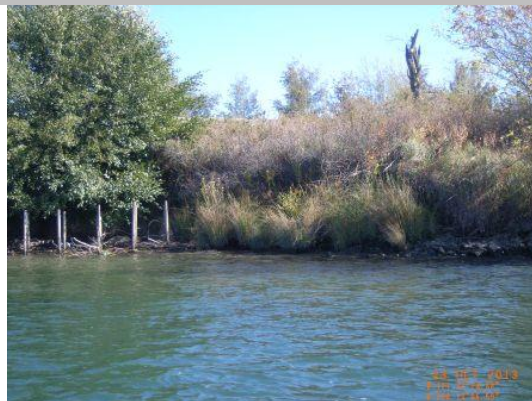
Photo 1 of 1 : FA_2014_RD0556_19_22_20141030_00004.jpg

LM Start	3.58	Rating **	M	Issue No.	22
LM End	3.63	Issue Type +	Ma	Location *	WS
Category	Supplemental			GPS Latitude/Longitude	
				Start	End
Item	USACE Erosion Survey			38.218951 °	38.218104 °
				-121.556689 °	-121.556819 °
DWR ID	DWR_RD0556_02_f_2014_22				
Action/Comments					
Inspector Comments: 1997 - Scallops into berm and very close to levee toe. 2005 - Brush boxes present. 2011 - New toe scour and freshly fallen tree. 2012 - New tree popout has taken significant portion of soil out of the levee. 2013: No observed changes. [2013 Site ID: SAC_22-7_L]

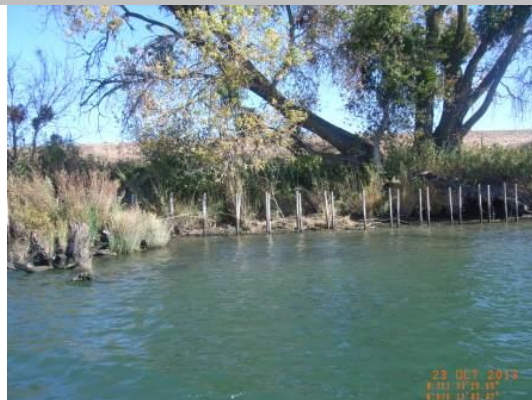
Photo 1 of 1 : FA_2014_RD0556_19_21_20141030_00003.jpg

LM Start	4.06	Rating **	M	Issue No.	21
LM End	4.11	Issue Type +	Ma	Location *	WS
Category	Supplemental			GPS Latitude/Longitude	
				Start	End
Item	USACE Erosion Survey			38.213581 °	38.211112 °
				-121.557197 °	-121.557042 °
DWR ID	DWR_RD0556_02_f_2014_21				
Action/Comments					
Inspector Comments: 2002 - Spot rock along berm, but not in the erosion pockets. 2005 - Some new minor stone revetment at the upstream end. Brush boxes present. 2006 - Currently installing new brush in downstream brush boxes. 2007 - Rock in middle portion for about 150 ft. 2010 - Some attempt at repairs but still has pockets of erosion. 2012 - More erosion along the toe. 2013: No observed changes. [2013 Site ID: SAC_22-5_L]

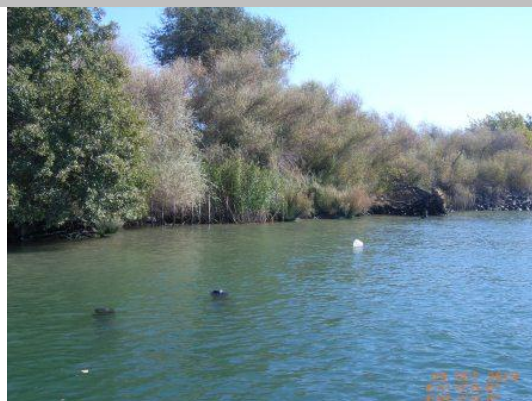
Photo 1 of 1 : FA_2014_RD0556_19_19_20141030_00002.jpg

LM Start	4.44	Rating **	M	Issue No.	19
LM End	4.48	Issue Type +	Ma	Location *	WS
Category	Supplemental			GPS Latitude/Longitude	
				Start	End
Item	USACE Erosion Survey			38.206379 °	38.205733 °
				-121.557089 °	-121.556999 °
DWR ID	DWR_RD0556_02_f_2014_19				
Action/Comments					
Inspector Comments: 2013: Erosion pockets encroaching on levee foundation. [2013 Site ID: SAC_21-9_L]

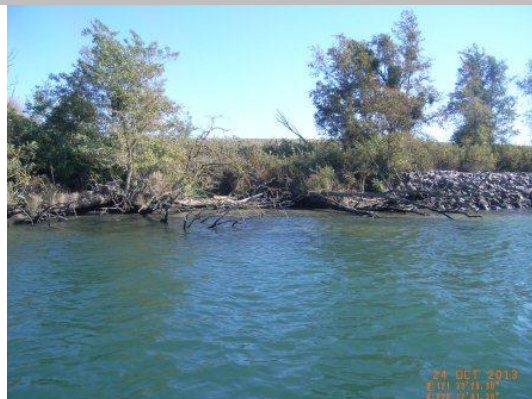
Photo 1 of 1 : FA_2014_RD0556_19_3_20141030_00001.jpg

LM Start	4.87	Rating **	M	Issue No.	3
LM End	4.88	Issue Type +	Ma	Location *	WS
Category	Supplemental			GPS Latitude/Longitude	
				Start	End
Item	USACE Erosion Survey			38.200646 °	38.200225 °
				-121.557606 °	-121.557749 °
DWR ID	DWR_RD0556_02_f_2014_3				
Action/Comments					
Inspector Comments: 1999 - Downstream 140 ft repaired with rock. 2010 - Lots of woody debris, but no changes to site. 2013: No observed changes. [2013 Site ID: SAC_21-5_L]
