**Flood Control Project Maintenance
Levee Inspections**

Maintenance Issue Types Only, Levee Inspection Report By Mile - Fall 2018

Reclamation District No. 0556 Upper Andrus

Waterway	Bank	Unit Miles	Inspection Start/End	Inspector
Unit No. 01 Georgiana Slough	Right	5.48	10/05/2018 10/05/2018	David Julian

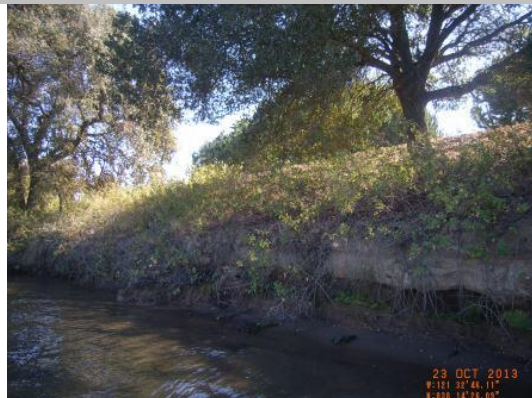
Photo 1 of 1 : FA_2018_RD0556_19_18_20181023_00080.jpg

LM Start	1.45	Rating **	M	Issue No.	18
LM End	1.59	Issue Type +	Ma	Location *	WS
Category	Supplemental			GPS Latitude/Longitude	
				Start	End
Item	2017 USACE Erosion Survey, DRAFT			38.240401°	38.240772°
				-121.544106°	-121.546791°
DWR ID	DWR_RD0556_02_f_2018_18				
Comment Code					
Inspector Comment					
2017 Site ID: SAC 24.8 L					
Status: Eroding					
2017 Field Notes: Significant lower bank erosion.					
Site History: 1997 - Slow erosion of the berm at the waterline; bench below water. 2005 - Brush boxes present. 2010 - Minor new erosion.					
2013 - There is little to no berm remaining at downstream end of this site. 2016 - New erosion on levee slope.
