**Flood Control Project Maintenance  
Levee Inspections**

## Maintenance Issue Types Only, Levee Inspection Report By Mile - Fall 2019

### Reclamation District No. 0556 Upper Andrus

Waterway	Bank	Unit Miles	Inspection Start/End	Inspector
Unit No. 01 Georgiana Slough	Right	5.48	10/18/2019 10/18/2019	David Julian

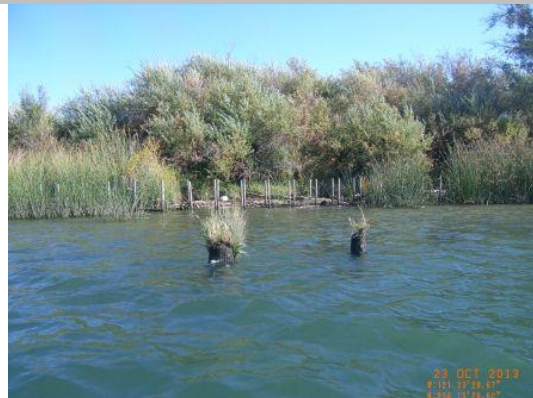
Photo 1 of 1 : FA\_2019\_RD0556\_19\_17\_20190826\_00005.jpg

LM Start	3.17	Rating **	M	Issue No.	17
LM End	3.28	Issue Type +	Ma	Location *	WS
Category	Supplemental			GPS Latitude/Longitude	
				Start	End
Item	2017 USACE Erosion Survey			38.224850 °	38.223233 °
				-121.555641 °	-121.555687 °
DWR ID	DWR_RD0556_02_f _ 2018_17				
Comment Code					
Inspector Comment					
2017 Site ID: SAC 23.2 L					
Status: Eroding					
2017 Field Notes: New erosion along lower bank.					
Site History: 2000 - Recently fallen cottonwood at the downstream end.					
2005 - Empty brush boxes. 2011 - A few trees have fallen since last year.					
2012 - Potential new tree popout since last year. 2013 - New erosion at downstream end of site and a recent tree pop-out observed.					
2016 - New erosion at the toe.

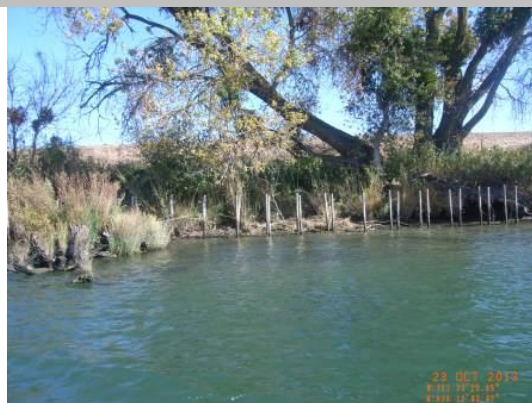
Photo 1 of 1 : FA\_2019\_RD0556\_19\_15\_20190826\_00003.jpg

LM Start	3.95	Rating **	M	Issue No.	15
LM End	4.12	Issue Type +	Ma	Location *	WS
Category	Supplemental			GPS Latitude/Longitude	
				Start	End
Item	2017 USACE Erosion Survey			38.213581 °	38.211112 °
				-121.557197 °	-121.557042 °
DWR ID	DWR_RD0556_02_f_2018_15				
Comment Code					
Inspector Comment					
2017 Site ID: SAC 22.5 L					
Status: Eroding					
2017 Field Notes: New lower bank erosion at the upstream end. Locals placed rock in some erosion pockets.					
Site History: 2002 - Spot rock along berm, but not in the erosion pockets. 2005 - Some new minor stone revetment at the upstream end. Brush boxes present. 2006 - Currently installing new brush in downstream brush boxes. 2007 - Rock in middle portion for about 150 ft. 2010 - Some attempt at repairs but still has pockets of erosion. 2012 - More erosion along the toe.
