**Flood Control Project Maintenance
Levee Inspections**

Maintenance Issue Types Only, Levee Inspection Report By Mile - Fall 2020

Reclamation District No. 0556 Upper Andrus

Waterway	Bank	Unit Miles	Inspection Start/End	Inspector
Unit No. 01 Georgiana Slough	Right	5.48	09/15/2020 09/15/2020	David Julian

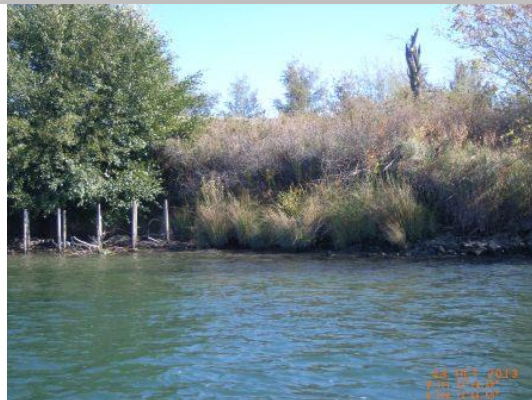
Photo 1 of 1 : FA_2020_RD0556_19_16_20200909_00004.jpg

LM Start	3.58	Rating **	M	Issue No.	16
LM End	3.64	Issue Type +	Ma	Location *	WS
Category	Supplemental			GPS Latitude/Longitude	
				Start	End
Item	2017 USACE Erosion Survey			38.218951 °	38.218104 °
				-121.556689 °	-121.556819 °
DWR ID	DWR_RD0556_02_f_2018_16				
Comment Code					
Inspector Comment					
2017 Site ID: SAC 22.7 L					
Status: Eroding					
2017 Field Notes: Minor new erosion at toe.					
Site History: 1997 - Scallops into berm and very close to levee toe.					
2005 - Brush boxes present. 2011 - New toe scour and freshly fallen tree. 2012 - New tree popout has taken significant portion of soil out of the levee.
