**Flood Control Project Maintenance
Levee Inspections**

Maintenance Issue Types Only, Levee Inspection Report By Mile - Fall 2022

Reclamation District No. 0556 Upper Andrus

Waterway	Bank	Unit Miles	Inspection Start/End	Inspector
Unit No. 01 Georgiana Slough	Right	5.48	09/22/2022 09/22/2022	Saskia Donovan

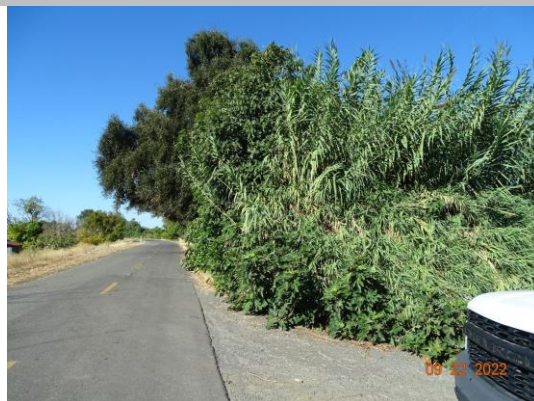
Photo 1 of 1 : FA_2022_RD0556_18_55_20221004_00186.jpg

LM Start	3.18	Rating **	U	Issue No.	55
LM End	3.18	Issue Type +	Ma	Location *	LS
Category	Earthen Levee			GPS Latitude/Longitude	
				Start	End
Item	Trim / Thin Trees			38.210745 °	38.210745 °
				-121.538967 °	-121.538967 °
DWR ID	DWR_RD0556_01_f_2019_55				
Comment Code					
T1 : Trim and thin trees to at least five feet above ground level to allow visibility of the ground and room to flood fight.					
Inspector Comment

View of the trees on the LS slope (Fall 2022).

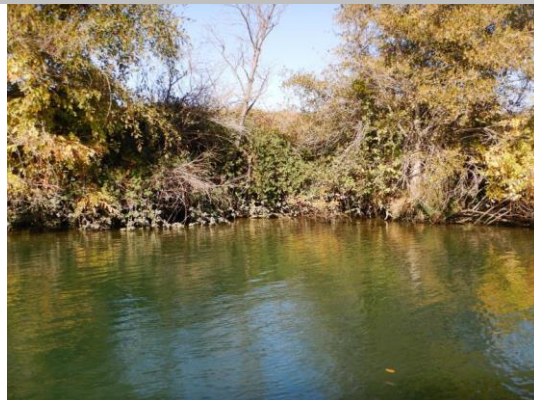
Photo 1 of 2 : FA_2022_RD0556_18_20_20220831_00004.jpg

2018 Site ID: GEO 7.0 R
Status: Eroding
2018 Field Notes: Minor new toe erosion.
Site History: 1997 - Toe damaged rock. 1999 - One pocket filled with gravel. 2000 - Eroding beach with some biotech rolls and stakes; some gravel on slope. 2001 - Staked, low fascine walls at bankline. 2005 - Stone revetment in between pockets. 2006 - New rock on upper slope behind brush boxes at the upstream end, Stone is sliding off the hard toe. 2016 - Fresh erosion observed. 2017 - Site extended downstream. Large erosion pockets and significant toe erosion.

LM Start	5.12	Rating **	M	Issue No.	20 (cont)
LM End	5.34	Issue Type +	Ma	Location *	WS

USACE 2018 Erosion Photo #1

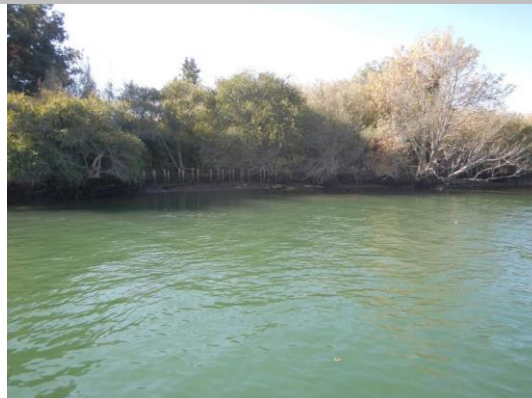
Photo 1 of 2 : FA_2022_RD0556_19_19_20220831_00015.jpg

LM Start	1.03	Rating **	M	Issue No.	19 (cont)
LM End	1.15	Issue Type +	Ma	Location *	WS

USACE 2018 Erosion Photo #1

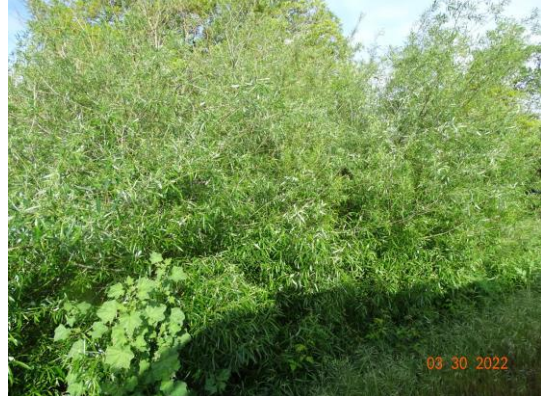
Photo 1 of 1 : FA_2022_RD0556_19_90_20220831_00063.jpg

LM Start	2.44	Rating **	U	Issue No.	90
LM End	2.44	Issue Type +	Ma	Location *	WS
Category	Earthen Levee			GPS Latitude/Longitude	
				Start	End
Item	Trim / Thin Trees			38.234843 °	38.234843 °
				-121.558028 °	-121.558028 °
DWR ID	DWR_RD0556_02_f _ 2021_90				
Comment Code					
T1 : Trim and thin trees to at least five feet above ground level to allow visibility of the ground and room to flood fight.					
Inspector Comment

View of thick willows on the waterside slope (Spring 2022).

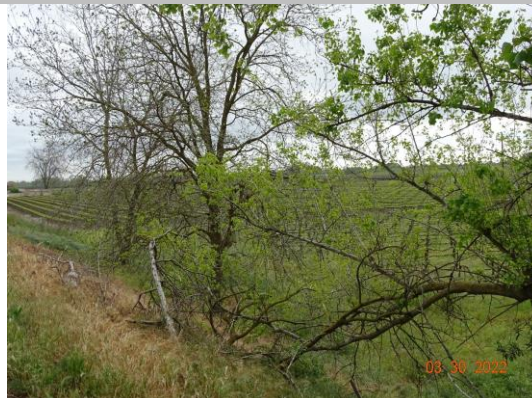
Photo 1 of 1 : FA_2022_RD0556_19_99_20220831_00065.jpg

LM Start	5.40	Rating **	M	Issue No.	99
LM End	5.40	Issue Type +	Ma	Location *	LS
Category	Earthen Levee			GPS Latitude/Longitude	
				Start	End
Item	Trim / Thin Trees			38.193846 °	38.193846 °
				-121.562461 °	-121.562461 °
DWR ID	DWR_RD0556_02_f _ 2021_99				
Comment Code					
T2 : Tree or limb.					
Inspector Comment

View of down tree limb on the landside slope (Spring 2022).

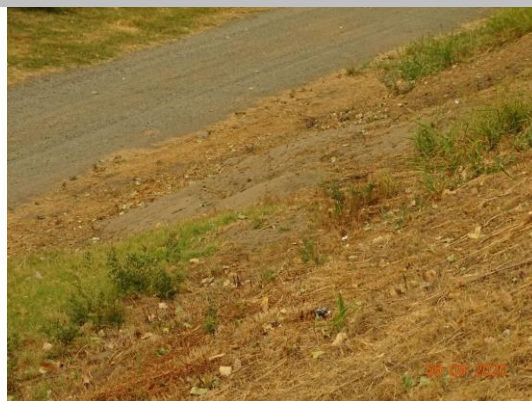
Photo 1 of 1 : FA_2022_RD0556_19_79_20220831_00056.jpg

LM Start	5.64	Rating **	U	Issue No.	79
LM End	5.64	Issue Type +	Ma	Location *	LS
Category	Earthen Levee			GPS Latitude/Longitude	
				Start	End
Item	Animal Control			38.192237 °	38.192237 °
				-121.566368 °	-121.566368 °
DWR ID	DWR_RD0556_02_f_2018_79				
Comment Code					
A3 : No rodents visible, but rodent burrows visible; need to backfill and compact or grout burrows.					
Inspector Comment					
More than 2 cubic feet of soil was removed between the two large burrow holes.

View looking downstream at burrow holes on the landside slope (Fall 2020).
