**Flood Control Project Maintenance
Levee Inspections**

Maintenance Issue Types Only, Levee Inspection Report By Mile - Fall 2023

Reclamation District No. 0556 Upper Andrus

Waterway	Bank	Unit Miles	Inspection Start/End	Inspector
Unit No. 01 Georgiana Slough	Right	5.48	10/30/2023 10/30/2023	Zach Jojola

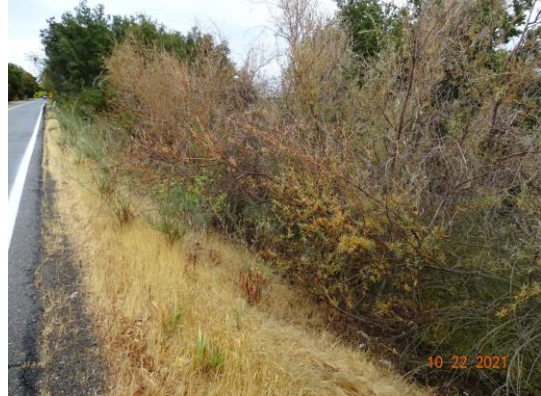
Photo 1 of 1 : FA_2023_RD0556_19_81_20231019_00057.jpg

LM Start	0.74	Rating **	U	Issue No.	81
LM End	0.85	Issue Type +	Ma	Location *	LS
Category	Earthen Levee			GPS Latitude/Longitude	
				Start	End
Item	Trim / Thin Trees			38.237577°	38.237842°
				-121.531594°	-121.533616°
DWR ID	DWR_RD0556_02_f_2023_81				
Comment Code					
T1 : Trim and thin trees to at least five feet above ground level to allow visibility of the ground and room to flood fight.					
Inspector Comment

View looking upstream at thick vegetation on the landside slope (Fall 2021).

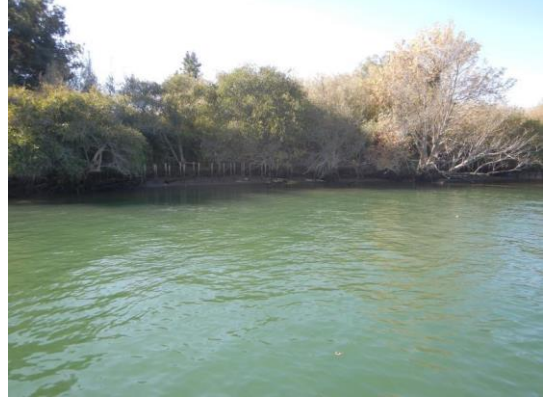
Photo 1 of 2 : FA_2023_RD0556_19_19_20231019_00015.jpg

LM Start	1.03	Rating **	M	Issue No.	19
LM End	1.15	Issue Type +	Ma	Location *	WS
Category	Supplemental			GPS Latitude/Longitude	
				Start	End
Item	2018 USACE Erosion Survey			38.238772°	38.239265°
				-121.536788°	-121.538845°
DWR ID	DWR_RD0556_02_s_2022_19				
Comment Code					
Inspector Comment					
2018 Site ID: SAC 25.2 L					
Status: Eroding					
2018 Field Notes: Additional erosion along toe. Site extended upstream.					
Site History: 1997 - Rock is in poor condition and has failed in many places. Scallops in berm with remnants of old rock in the toe area.					
2005 - Brush boxes present. 2013 - Site extended upstream approximately 300 ft to include new erosion pockets. 2015 - Minor new erosion at toe. 2017 - Minor new erosion observed.

USACE 2018 Erosion Photo #1

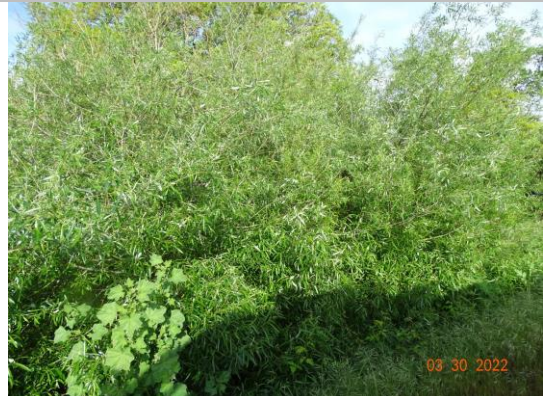
Photo 1 of 1 : FA_2023_RD0556_19_90_20231019_00062.jpg

LM Start	2.44	Rating **	U	Issue No.	90
LM End	2.44	Issue Type +	Ma	Location *	WS
Category	Earthen Levee			GPS Latitude/Longitude	
				Start	End
Item	Trim / Thin Trees			38.234843°	38.234843°
				-121.558028°	-121.558028°
DWR ID	DWR_RD0556_02_f_2021_90				
Comment Code					
T1 : Trim and thin trees to at least five feet above ground level to allow visibility of the ground and room to flood fight.					
Inspector Comment

View of thick willows on the waterside slope (Spring 2022).

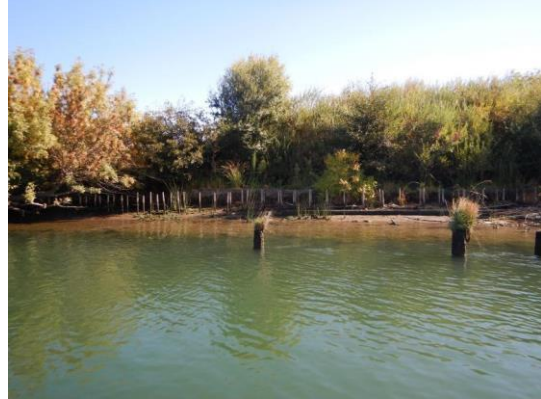
Photo 1 of 2 : FA_2023_RD0556_19_17_20231019_00011.jpg

2018 Site ID: SAC 23.2 L
 Status: Eroding
 2018 Field Notes: Additional tree popouts and new erosion throughout site.
 Site History: 2000 - Recently fallen cottonwood at the downstream end.
 2005 - Empty brush boxes. 2011 - A few trees have fallen since last year. 2012 - Potential new tree popout since last year. 2013 - New erosion at downstream end of site and a recent tree pop-out observed.
 2016 - New erosion at the toe. 2017 - New erosion along lower bank.

USACE 2018 Erosion Photo #1

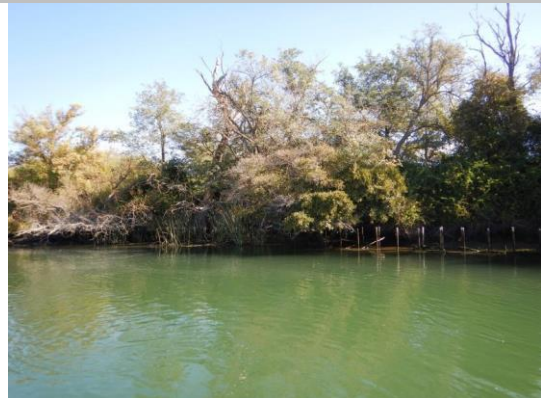
Photo 2 of 2 : FA_2023_RD0556_19_17_20231019_00012.jpg

USACE 2018 Erosion Photo #2

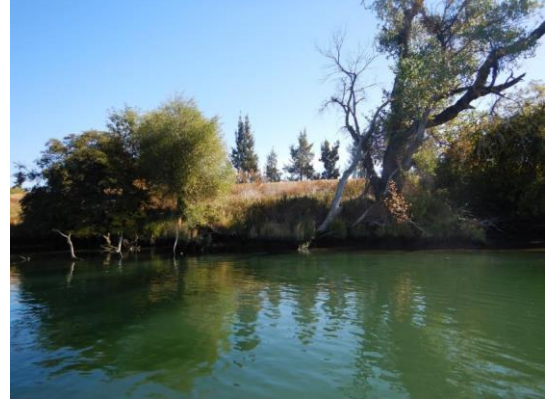
Photo 1 of 2 : FA_2023_RD0556_19_16_20231019_00009.jpg

LM Start	3.58	Rating **	M	Issue No.	16
LM End	3.64	Issue Type +	Ma	Location *	WS
Category	Supplemental			GPS Latitude/Longitude	
				Start	End
Item	2018 USACE Erosion Survey			38.218951°	38.218104°
				-121.556689°	-121.556819°
DWR ID	DWR_RD0556_02_s_2022_16				
Comment Code					
Inspector Comment					
2018 Site ID: SAC 22.7 L					
Status: Eroding					
2018 Field Notes: No observed change.					
Site History: 1997 - Scallops into berm and very close to levee toe.					
2005 - Brush boxes present. 2011 - New toe scour and freshly fallen tree. 2012 - New tree popout has taken significant portion of soil out of the levee. 2017 - Minor new erosion at toe.

USACE 2018 Erosion Photo #1

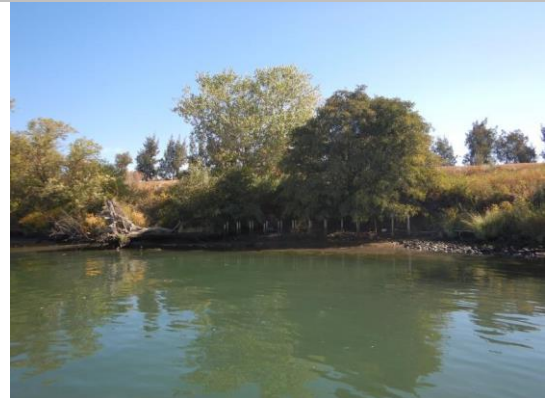
Photo 2 of 2 : FA_2023_RD0556_19_16_20231019_00010.jpg

USACE 2018 Erosion Photo #2

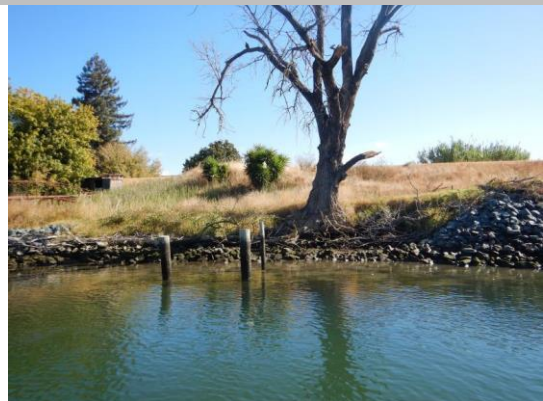
Photo 1 of 2 : FA_2023_RD0556_19_15_20231019_00007.jpg

LM Start	3.95	Rating **	M	Issue No.	15
LM End	4.12	Issue Type +	Ma	Location *	WS
Category	Supplemental			GPS Latitude/Longitude	
				Start	End
Item	2018 USACE Erosion Survey			38.213581°	38.211112°
				-121.557197°	-121.557042°
DWR ID	DWR_RD0556_02_s_2022_15				
Comment Code					
Inspector Comment					
2018 Site ID: SAC 22.5 L					
Status: Eroding					
2018 Field Notes: Minor new erosion at toe.					
Site History: 2002 - Spot rock along berm, but not in the erosion pockets. 2005 - Some new minor stone revetment at the upstream end. Brush boxes present. 2006 - Currently installing new brush in downstream brush boxes. 2007 - Rock in middle portion for about 150 ft. 2010 - Some attempt at repairs but still has pockets of erosion. 2012 - More erosion along the toe. 2017 - New lower bank erosion at the upstream end. Locals placed rock in some erosion pockets.

USACE 2018 Erosion Photo #1

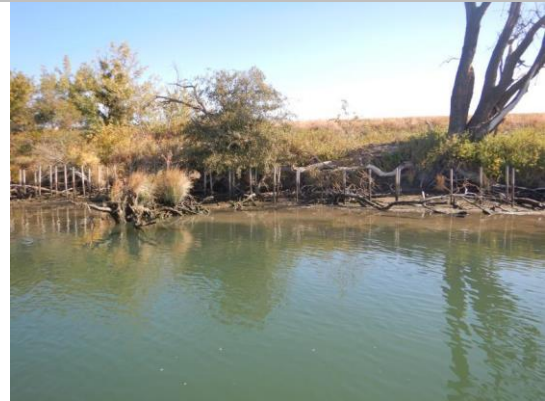
Photo 2 of 2 : FA_2023_RD0556_19_15_20231019_00008.jpg

USACE 2018 Erosion Photo #2

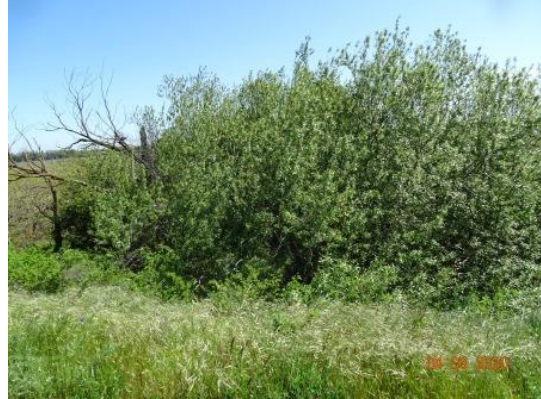
Photo 1 of 1 : FA_2023_RD0556_19_55_20231019_00039.jpg

LM Start	4.15	Rating **	U	Issue No.	55
LM End	4.15	Issue Type +	Ma	Location *	LS
Category	Earthen Levee			GPS Latitude/Longitude	
				Start	End
Item	Trim / Thin Trees			38.210623°	38.210623°
				-121.556733°	-121.556733°
DWR ID	DWR_RD0556_02_s_2020_55				
Comment Code					
T1 : Trim and thin trees to at least five feet above ground level to allow visibility of the ground and room to flood fight.					
Inspector Comment

View of thick tree on the landside slope (Spring 2020).

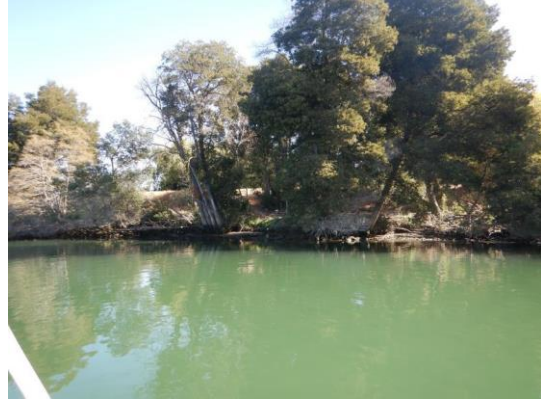
Photo 1 of 2 : FA_2023_RD0556_19_14_20231019_00005.jpg

LM Start	4.44	Rating **	M	Issue No.	14
LM End	4.49	Issue Type +	Ma	Location *	WS
Category	Supplemental			GPS Latitude/Longitude	
				Start	End
Item	2018 USACE Erosion Survey			38.206377°	38.205729°
				-121.557184°	-121.557108°
DWR ID	DWR_RD0556_02_s_2022_14				
Comment Code					
Inspector Comment					
2018 Site ID: SAC 21.9 L					
Status: Eroding					
2018 Field Notes: No observed change.					
Site History: 2013 - Erosion pockets encroaching on levee foundation.

USACE 2018 Erosion Photo #1

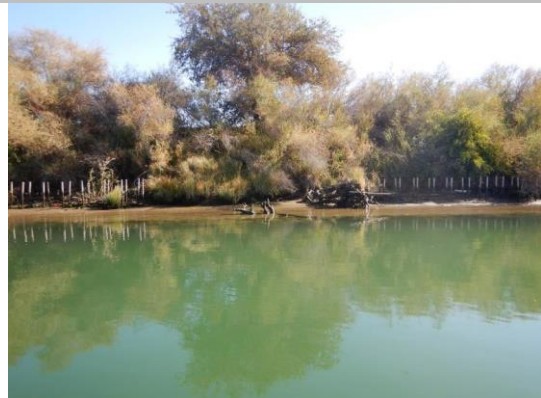
Photo 2 of 2 : FA_2023_RD0556_19_14_20231019_00006.jpg

USACE 2018 Erosion Photo #2
