**Flood Control Project Maintenance  
Levee Inspections**

**Fall 2011 Levee Maintenance Deficiency Summary Report**

**Reclamation District No. 0563 Tyler Island**

Waterway	Bank	Unit Miles
Unit No. 01 Georgiana Slough (Tyler Island)	Left	12.38

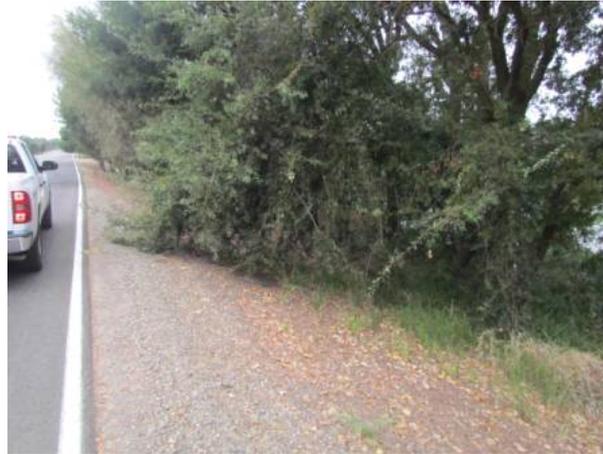
Looking southwest at overgrown tree on waterside slope.

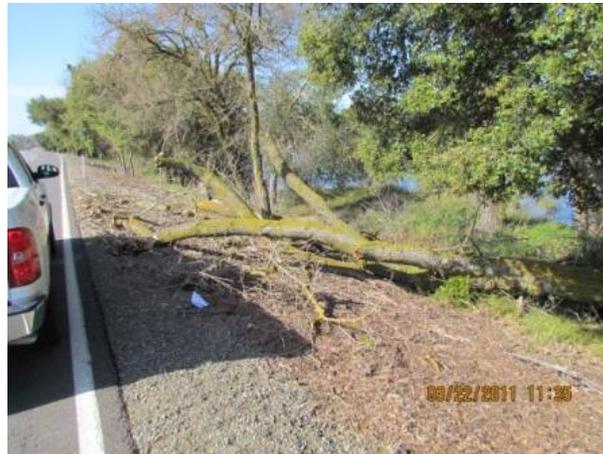
Levee Mile Report Line	4
Start Levee Mile	0.19
End Levee Mile	0.19
Location	Water Side
Category	Earthen Levee
Item	Encroachments

Looking south (downstream) at fallen tree limb on waterside slope.

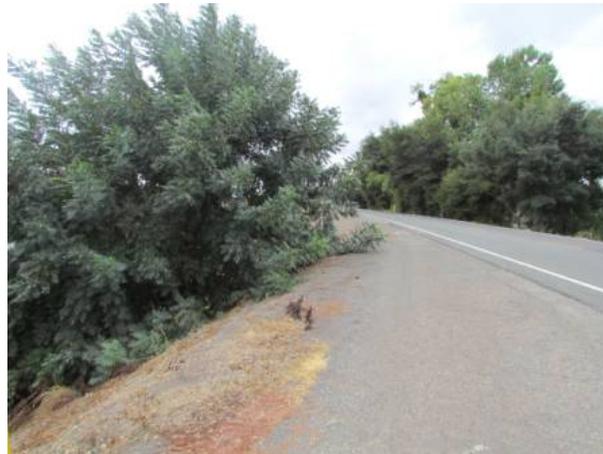
Levee Mile Report Line	6
Start Levee Mile	0.23
End Levee Mile	0.23
Location	Land Side
Category	Earthen Levee
Item	Trim / Thin Trees

Looking southwest at overgrown trees on landside slope.

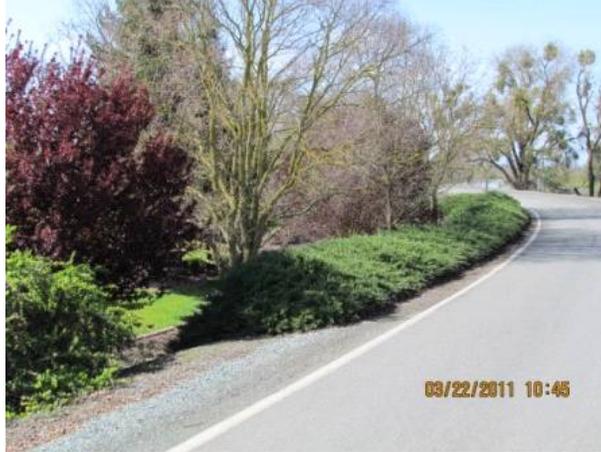
Levee Mile Report Line	7
Start Levee Mile	0.68
End Levee Mile	0.71
Location	Land Side
Category	Earthen Levee
Item	Encroachments
Looking southeast at dense landscaping on landside slope.	
richard_f_20110922_395.jpg

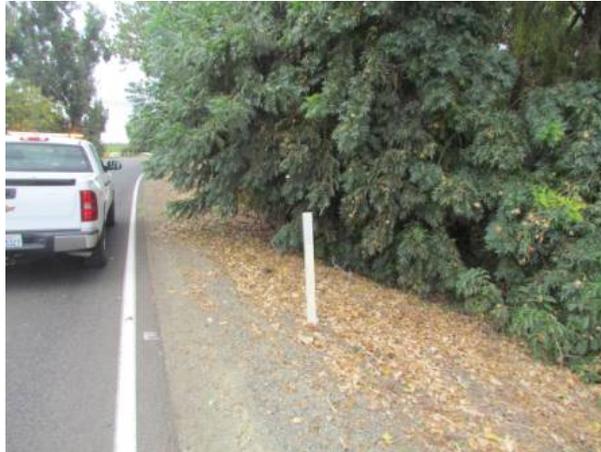
Levee Mile Report Line	8
Start Levee Mile	0.80
End Levee Mile	0.80
Location	Water Side
Category	Earthen Levee
Item	Trim / Thin Trees
Looking southwest at overgrown trees on waterside slope.	
richard_f_20111006_577.jpg

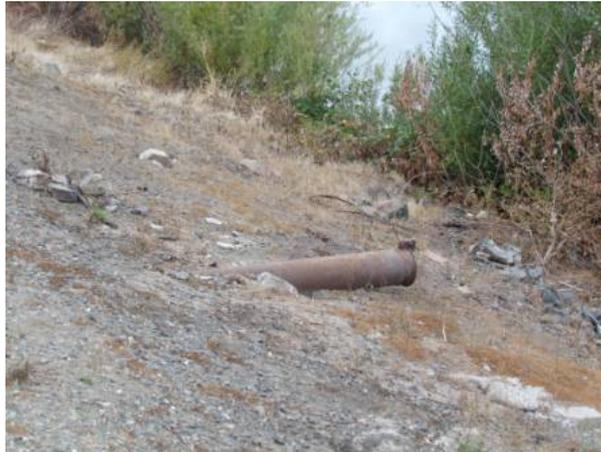
Levee Mile Report Line	11
Start Levee Mile	0.98
End Levee Mile	0.98
Location	Crown
Category	Earthen Levee
Item	Encroachments
Looking southwest at pipe on waterside slope.	
richard_f_20111006_578.jpg

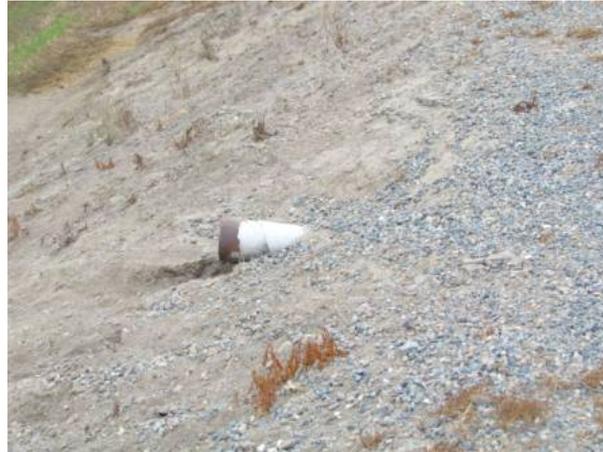
Levee Mile Report Line	11
Start Levee Mile	0.98
End Levee Mile	0.98
Location	Crown
Category	Earthen Levee
Item	Encroachments
Looking southwest at abandoned pipe on landside slope.	
richard_f_20111006_579.jpg

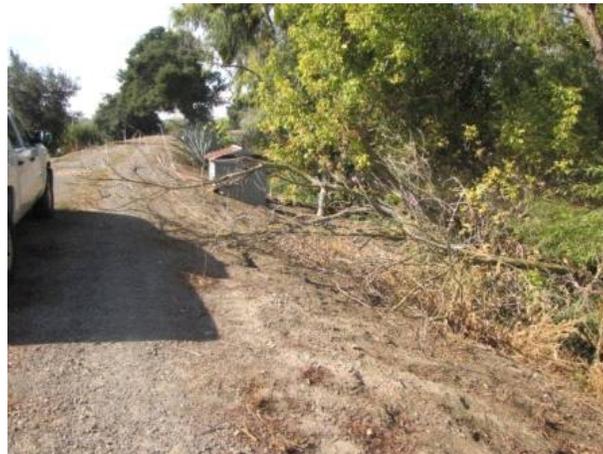
Levee Mile Report Line	19
Start Levee Mile	1.42
End Levee Mile	1.42
Location	Water Side
Category	Earthen Levee
Item	Encroachments
Looking south at down tree on waterside slope.	
richard_f_20110922_379.jpg

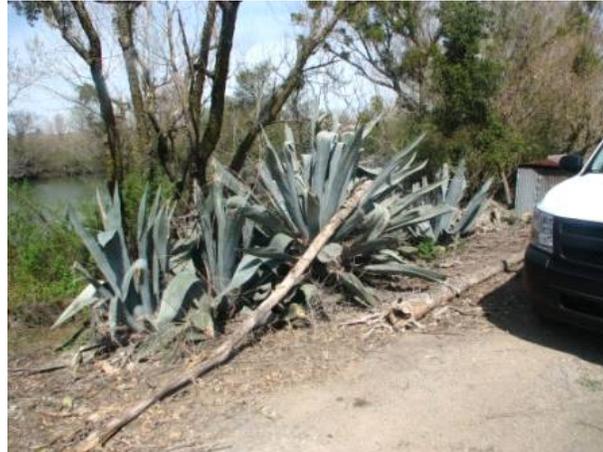
Levee Mile Report Line	20
Start Levee Mile	1.44
End Levee Mile	1.48
Location	Water Side
Category	Earthen Levee
Item	Vegetation
Century plant on waterward shoulder at LM 1.42	
richard_f_20110922_363.jpg

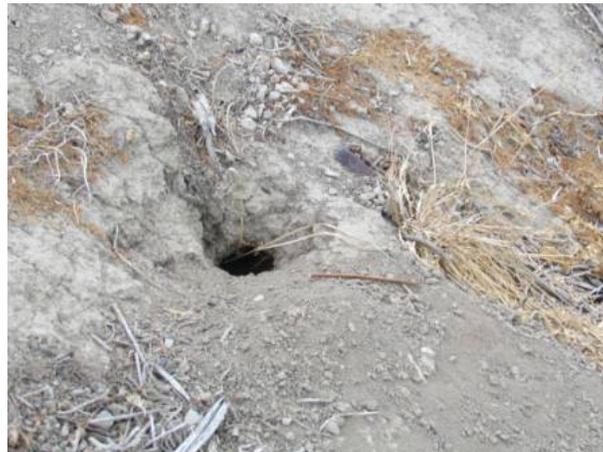
Levee Mile Report Line	26
Start Levee Mile	1.77
End Levee Mile	1.77
Location	Land Side
Category	Earthen Levee
Item	Animal Control
Looking west at rodent hole on landside slope.	
richard_f_20111006_581.jpg

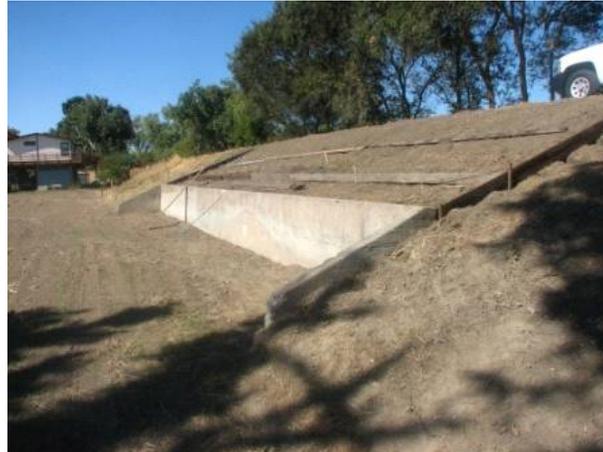
Levee Mile Report Line	27
Start Levee Mile	1.86
End Levee Mile	1.86
Location	Land Side
Category	Earthen Levee
Item	Encroachments

Unauthorized retaining wall on landside toe.

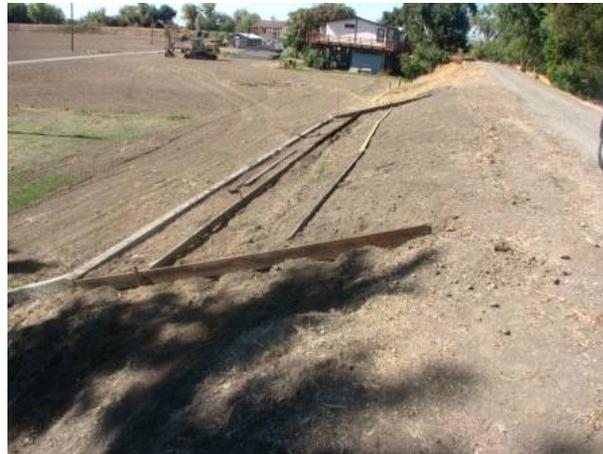
Levee Mile Report Line	27
Start Levee Mile	1.86
End Levee Mile	1.86
Location	Land Side
Category	Earthen Levee
Item	Encroachments

Looking southeast at top of retaining wall.

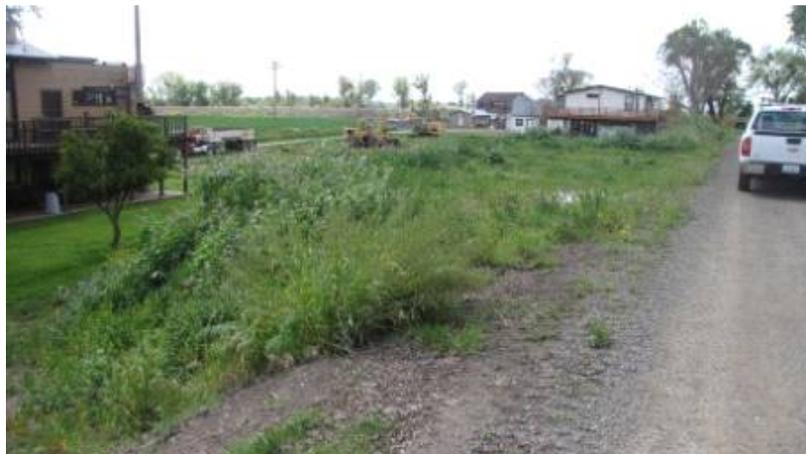
Levee Mile Report Line	27
Start Levee Mile	1.86
End Levee Mile	1.86
Location	Land Side
Category	Earthen Levee
Item	Encroachments

Looking southeast at earthen pad on landside shoulder covering retaining wall.

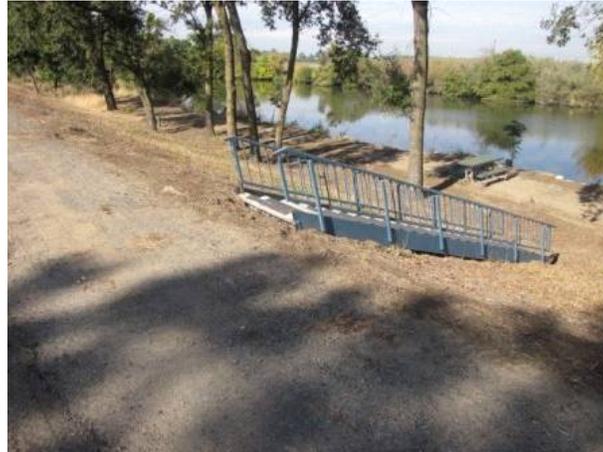
Levee Mile Report Line	27
Start Levee Mile	1.86
End Levee Mile	1.86
Location	Land Side
Category	Earthen Levee
Item	Encroachments
Looking west at metal stairs on waterside slope.	
richard_f_20110922_405.jpg

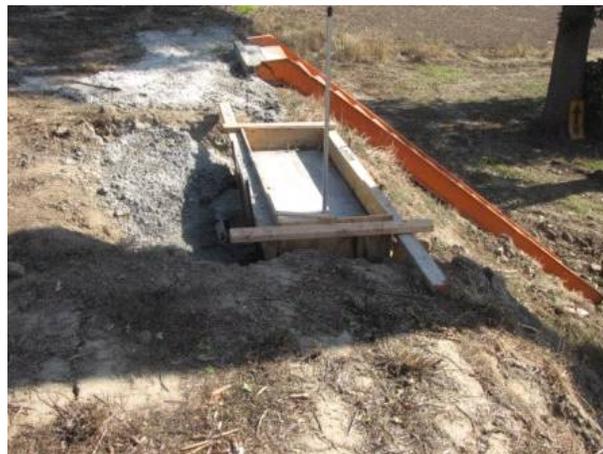
Levee Mile Report Line	27
Start Levee Mile	1.86
End Levee Mile	1.86
Location	Land Side
Category	Earthen Levee
Item	Encroachments
Looking north at deadman for metal walkway on earthen pad on landside shoulder.	
richard_f_20110922_407.jpg

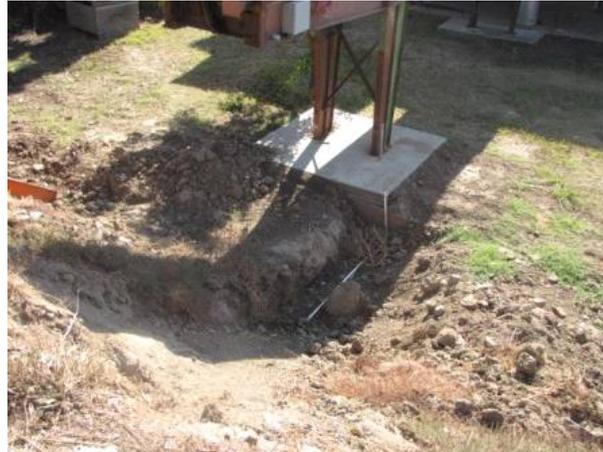
Levee Mile Report Line	27
Start Levee Mile	1.86
End Levee Mile	1.86
Location	Land Side
Category	Earthen Levee
Item	Encroachments

Looking east at electrical conduit in trench on landside toe and concrete pad for walkway.

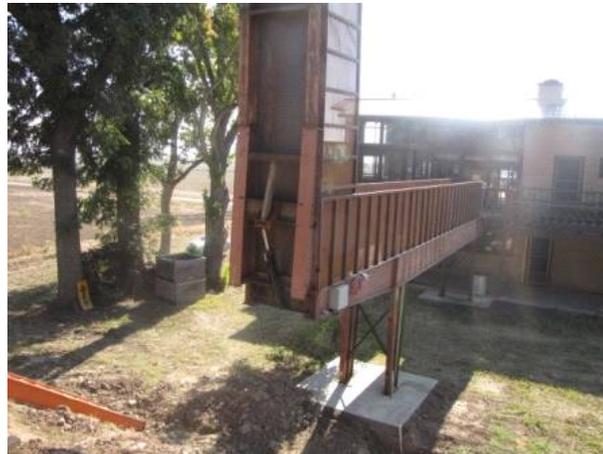
Levee Mile Report Line	27
Start Levee Mile	1.86
End Levee Mile	1.86
Location	Land Side
Category	Earthen Levee
Item	Encroachments

Looking east at metal walkway on landside.

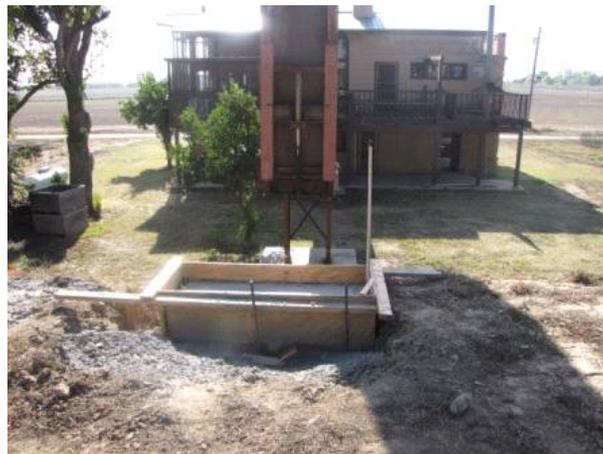
Levee Mile Report Line	27
Start Levee Mile	1.86
End Levee Mile	1.86
Location	Land Side
Category	Earthen Levee
Item	Encroachments

Looking east at deadman on landside shoulder.

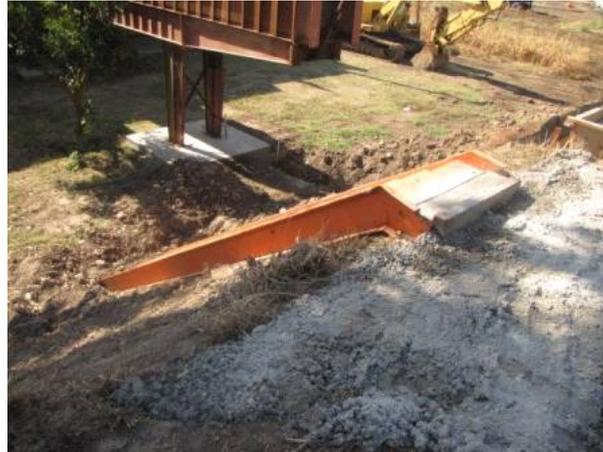
Levee Mile Report Line	27
Start Levee Mile	1.86
End Levee Mile	1.86
Location	Land Side
Category	Earthen Levee
Item	Encroachments
Looking southeast at temporary metal stairs on landside slope.	
richard_f_20110922_411.jpg

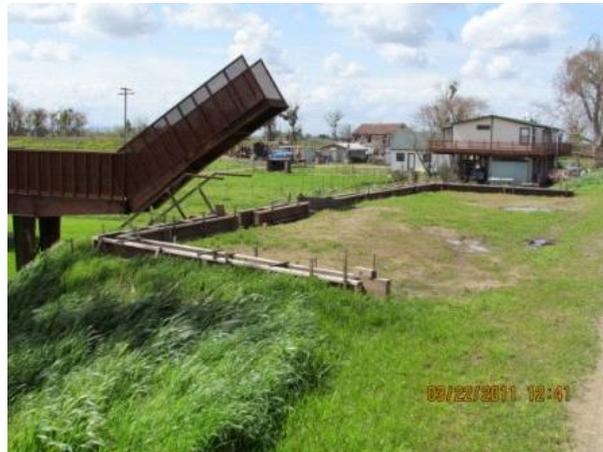
Levee Mile Report Line	27
Start Levee Mile	1.86
End Levee Mile	1.86
Location	Land Side
Category	Earthen Levee
Item	Encroachments
Looking southeast at framing for footings on landside shoulder.	
richard_f_20110922_412.jpg

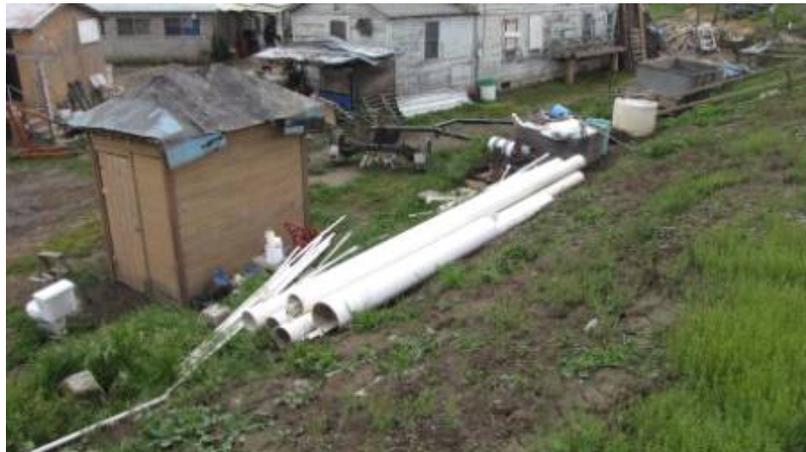
Levee Mile Report Line	29
Start Levee Mile	1.96
End Levee Mile	1.98
Location	Land Side
Category	Earthen Levee
Item	Encroachments
Looking southeast at material and equipment on landside slope and toe.	
richard_f_20110922_366.jpg

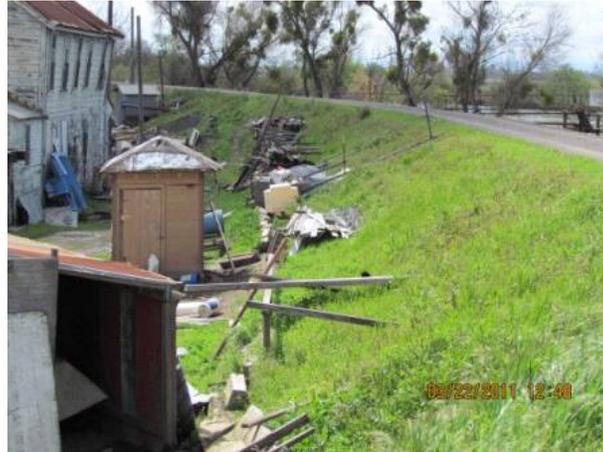
Levee Mile Report Line	29
Start Levee Mile	1.96
End Levee Mile	1.98
Location	Land Side
Category	Earthen Levee
Item	Encroachments
Looking south at farming equipment & garbage on landside toe.	
richard_f_20110922_367.jpg

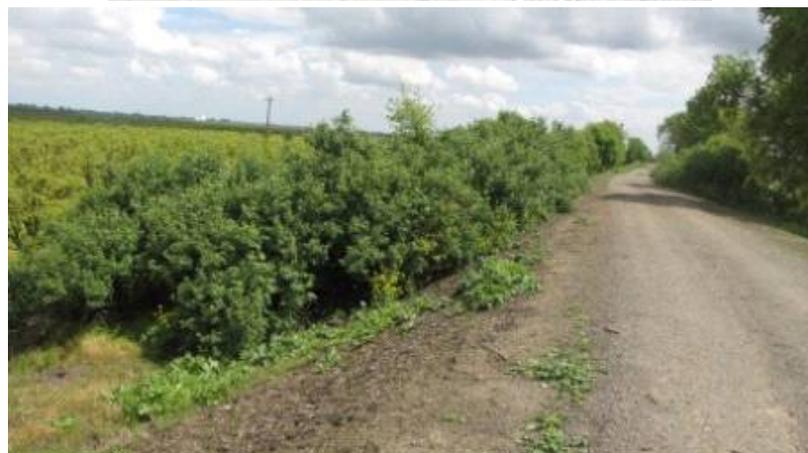
Levee Mile Report Line	34
Start Levee Mile	2.44
End Levee Mile	2.45
Location	Land Side
Category	Earthen Levee
Item	Vegetation
Looking southeast at elderberry on the landside slope and toe.	
richard_f_20110922_368.jpg

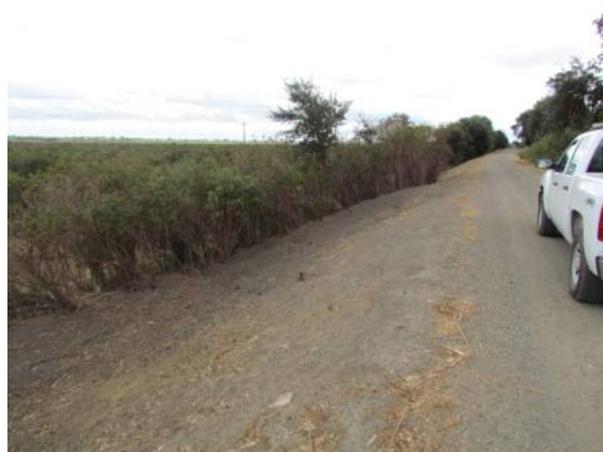
Levee Mile Report Line	34
Start Levee Mile	2.44
End Levee Mile	2.45
Location	Land Side
Category	Earthen Levee
Item	Vegetation
Look southeast at updated (10/11) view of elderberries on landside slope.	
richard_f_20111006_582.jpg

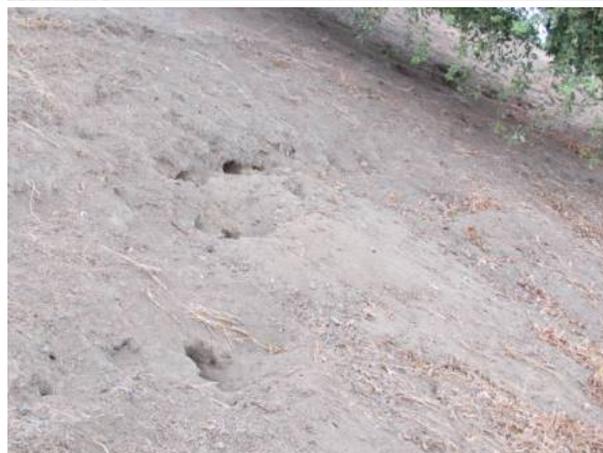
Levee Mile Report Line	37
Start Levee Mile	2.58
End Levee Mile	2.61
Location	Land Side
Category	Earthen Levee
Item	Animal Control
Looking northeast at rodent holes on landside slope.	
richard_f_20111006_584.jpg

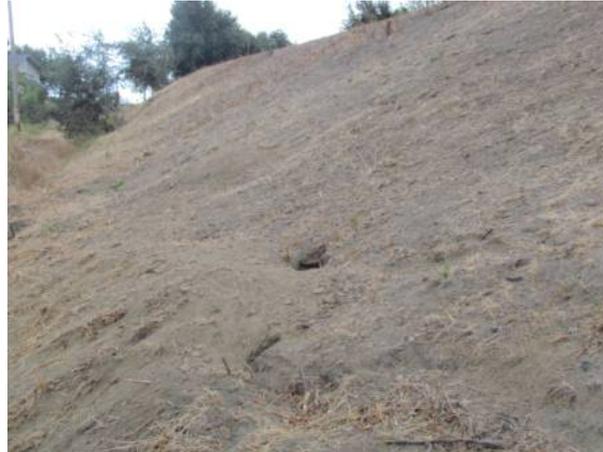
Levee Mile Report Line	37
Start Levee Mile	2.58
End Levee Mile	2.61
Location	Land Side
Category	Earthen Levee
Item	Animal Control
Looking southwest at rodent holes on landside slope.	
richard_f_20111006_585.jpg

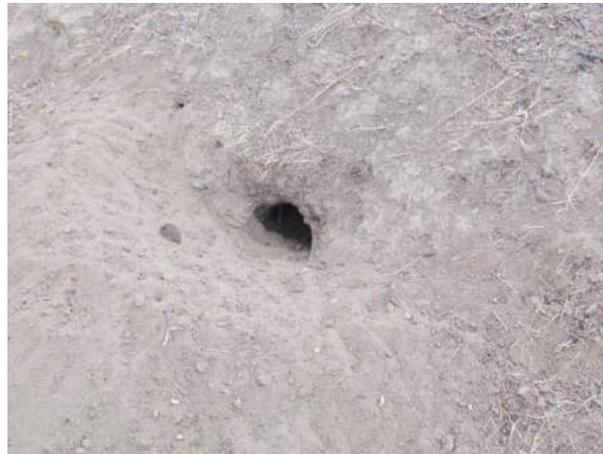
Levee Mile Report Line	37
Start Levee Mile	2.58
End Levee Mile	2.61
Location	Land Side
Category	Earthen Levee
Item	Animal Control
Looking east at rodent hole on landside slope.	
richard_f_20111006_586.jpg

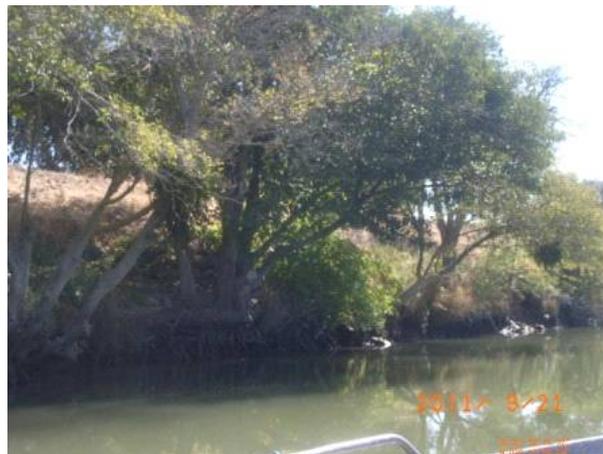
Levee Mile Report Line	39
Start Levee Mile	2.63
End Levee Mile	2.77
Location	Water Side
Category	Supplemental
Item	USACE Erosion Survey
USACE 2011 Photo #1	
USACE2011_GEO_9-3_L_1.jpg

38	2.59	2.59	Earthen Levee	Trim / Thin Trees	WS	W	Trim trees to at least five feet above ground level.	38.215047 ° -121.538604 °	38.215047 ° -121.538604 °	20
39	2.63	2.77	Supplemental	USACE Erosion Survey	WS	M	Inspector Comments: 1997 - Loss of rock at toe; pockets of upper berm erosion; very narrow berm width; toe rock problem; erosion pockets in rock. 2002 - New brush boxes at toe of the worst spots. 2005 - Upstream 200 ft removed because of the wide berm. 2006 - Some rock pockets behind the brush boxes at the upstream end. 2010 - Some new erosion. 2011: No observed change. [2011 Site ID: GEO_9-3_L]	38.214133 ° -121.537778 °	38.211737 ° -121.535436 °	39 Y
40	2.64	2.71	Earthen Levee	Trim / Thin Trees	WS	W	Trim trees to at least five feet above ground level.	38.214567 ° -121.537945 °	38.213728 ° -121.537272 °	21
41	2.68	2.68	Earthen Levee	Trim / Thin Trees	LS	M	Trim trees to at least five feet above ground level.	38.214055 ° -121.537533 °	38.214055 ° -121.537533 °	86

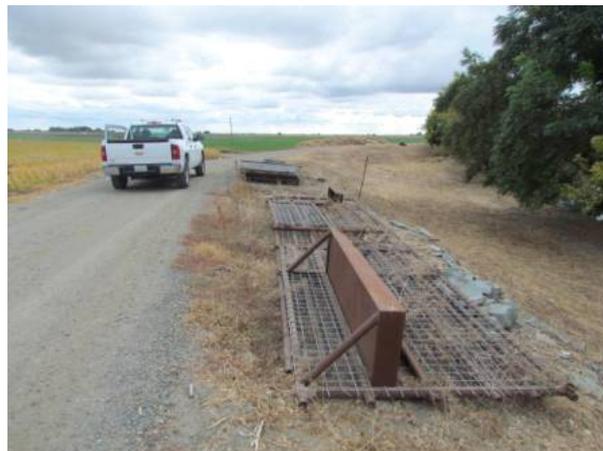
Levee Mile Report Line	44
Start Levee Mile	2.90
End Levee Mile	2.90
Location	Water Side
Category	Earthen Levee
Item	Encroachments
Looking southwest at fencing on waterside shoulder.	
richard_f_20111006_587.jpg

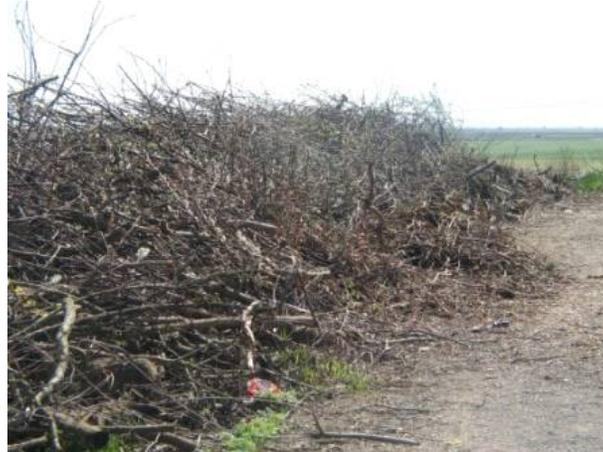
Levee Mile Report Line	45
Start Levee Mile	2.94
End Levee Mile	2.94
Location	Land Side
Category	Earthen Levee
Item	Encroachments
Prunings on landward shoulder from LM 2.93 to 2.95	
richard_f_20110922_372.jpg

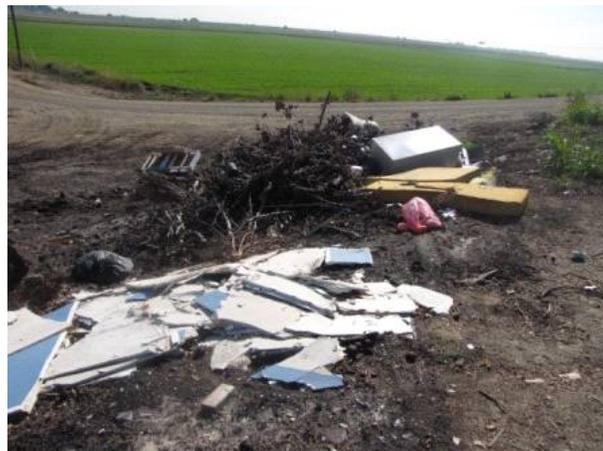
Levee Mile Report Line	45
Start Levee Mile	2.94
End Levee Mile	2.94
Location	Land Side
Category	Earthen Levee
Item	Encroachments
Looking south at pruning and garbage pile on landside slope	
richard_f_20110922_374.jpg

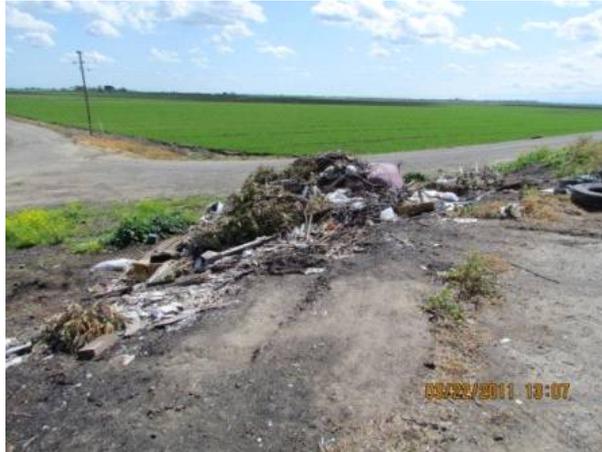
Levee Mile Report Line	45
Start Levee Mile	2.94
End Levee Mile	2.94
Location	Land Side
Category	Earthen Levee
Item	Encroachments
Looking southeast at garbage on landside shoulder as of 03/22/11	
richard_f_20110922_375.jpg

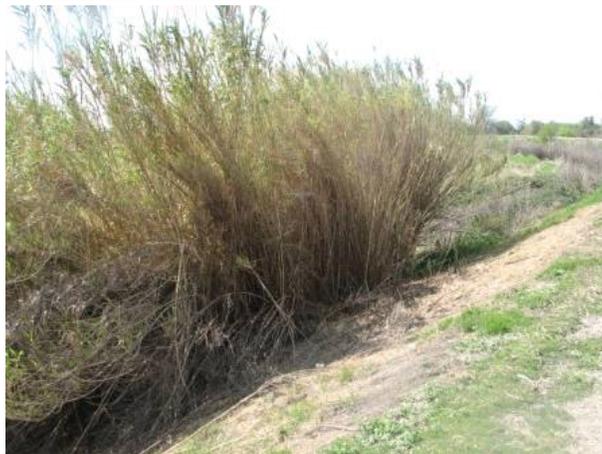
Levee Mile Report Line	47
Start Levee Mile	3.06
End Levee Mile	3.12
Location	Land Side
Category	Earthen Levee
Item	Vegetation
Bamboo at landward toe at LM 3.05	
richard_f_20110922_376.jpg

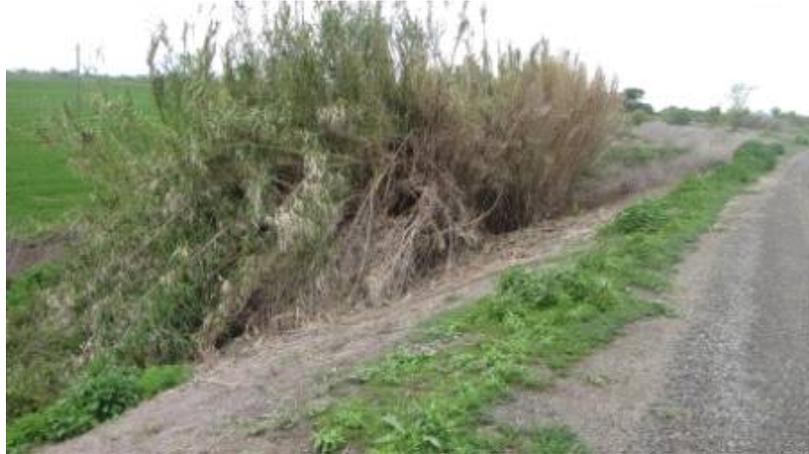
Levee Mile Report Line	47
Start Levee Mile	3.06
End Levee Mile	3.12
Location	Land Side
Category	Earthen Levee
Item	Vegetation

Looking southeast at updated view of bamboo on landside slope and toe.

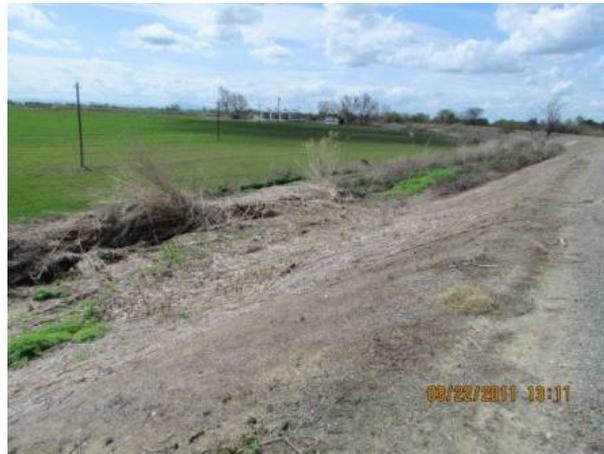
Levee Mile Report Line	47
Start Levee Mile	3.06
End Levee Mile	3.12
Location	Land Side
Category	Earthen Levee
Item	Vegetation

Looking southeast after bamboo has been removed. Great Job!!

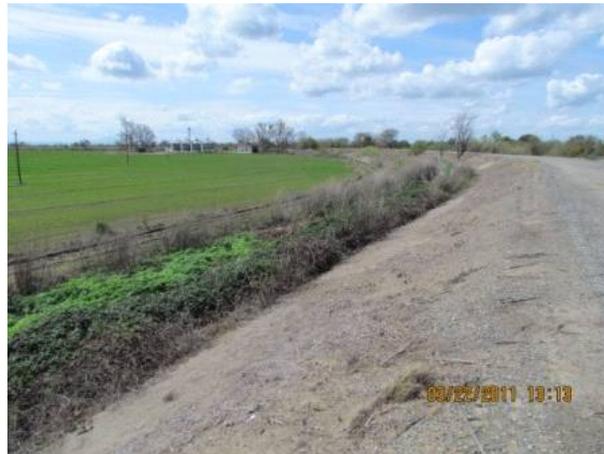
Levee Mile Report Line	48
Start Levee Mile	3.09
End Levee Mile	3.28
Location	Land Side
Category	Earthen Levee
Item	Vegetation

Looking southeast at berryvines on landside toe.

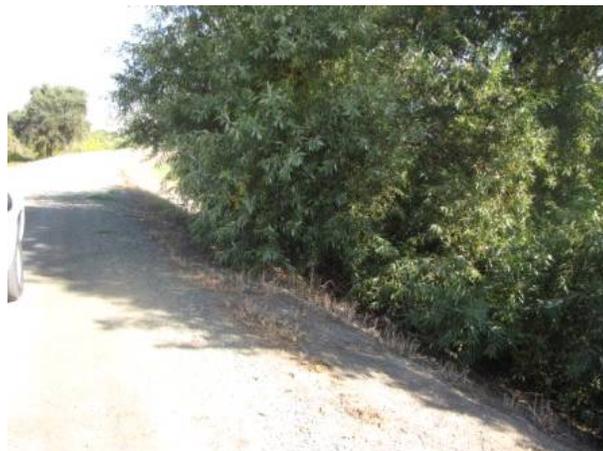
Levee Mile Report Line	50
Start Levee Mile	3.28
End Levee Mile	3.28
Location	Land Side
Category	Earthen Levee
Item	Trim / Thin Trees
Looking southeast at dense tree on landside slope and toe.	
richard_f_20110922_417.jpg

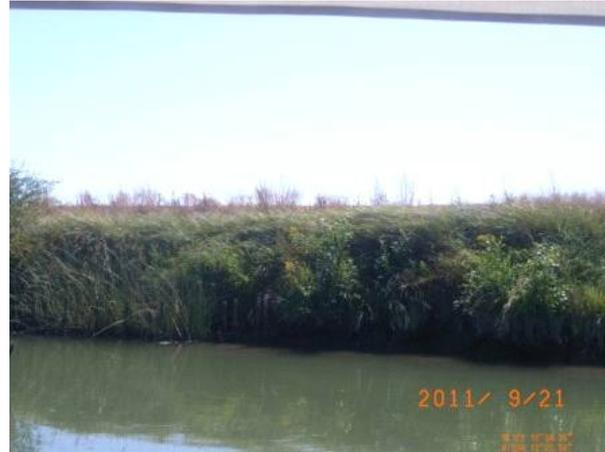
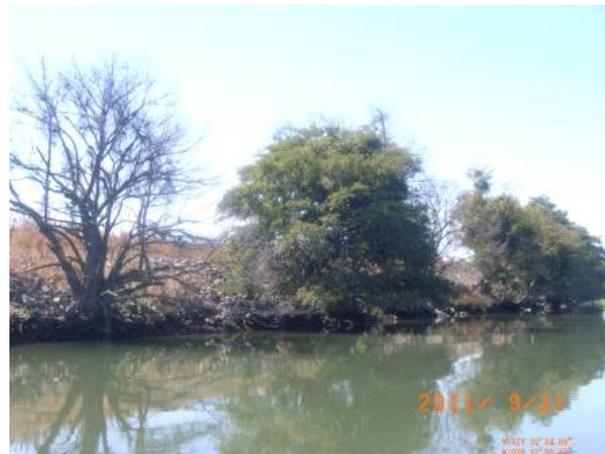
Levee Mile Report Line	52
Start Levee Mile	4.00
End Levee Mile	4.03
Location	Water Side
Category	Supplemental
Item	USACE Erosion Survey
USACE 2011 Photo #1	
USACE2011_GEO_8-3_L_1.jpg

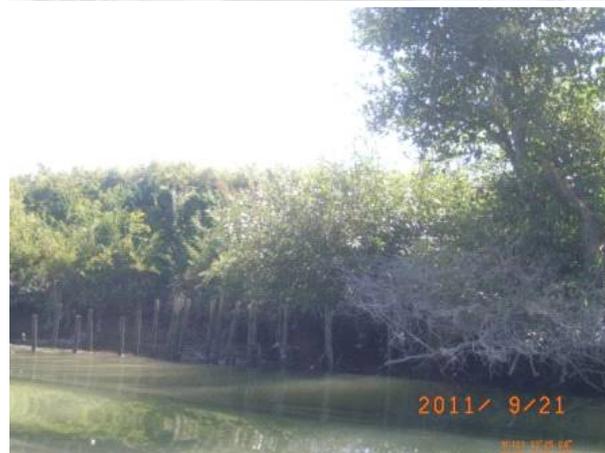
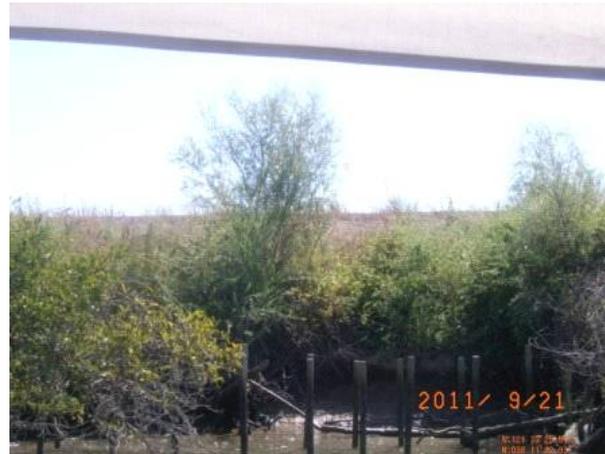
Levee Mile Report Line	54
Start Levee Mile	5.02
End Levee Mile	5.10
Location	Water Side
Category	Supplemental
Item	USACE Erosion Survey
USACE 2011 Photo #1	
USACE2011_GEO_7-2_L_1.jpg

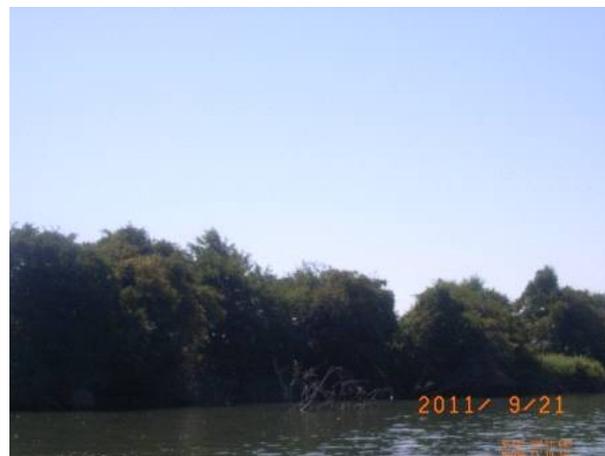
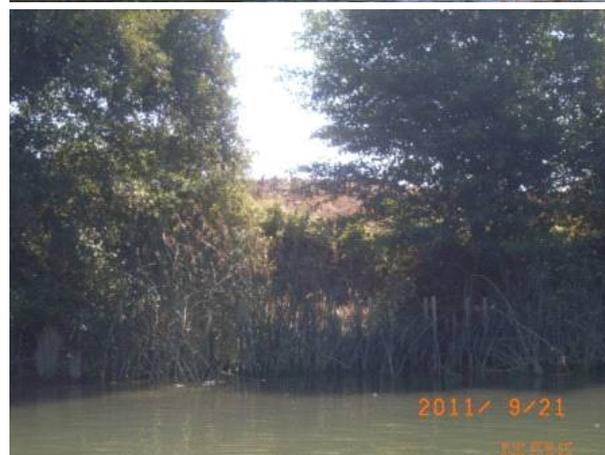
Levee Mile Report Line	55
Start Levee Mile	5.26
End Levee Mile	5.44
Location	Water Side
Category	Supplemental
Item	USACE Erosion Survey
USACE 2011 Photo #1	
USACE2011_GEO_6-8_L_1.jpg

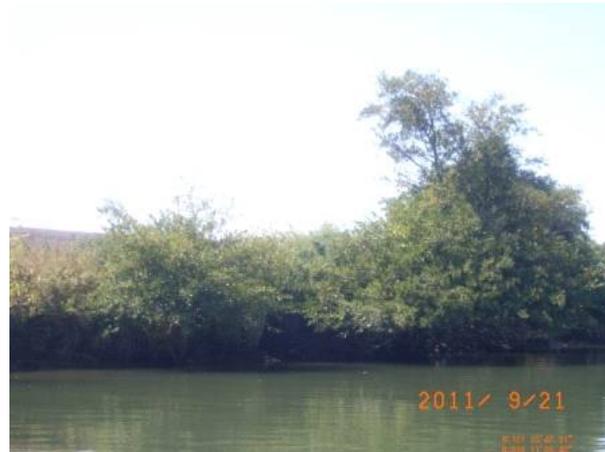
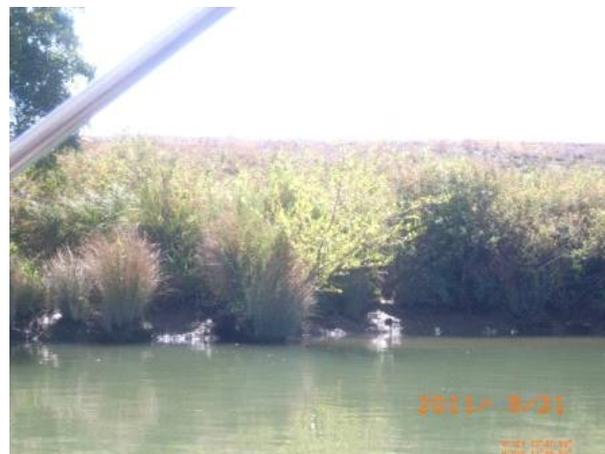
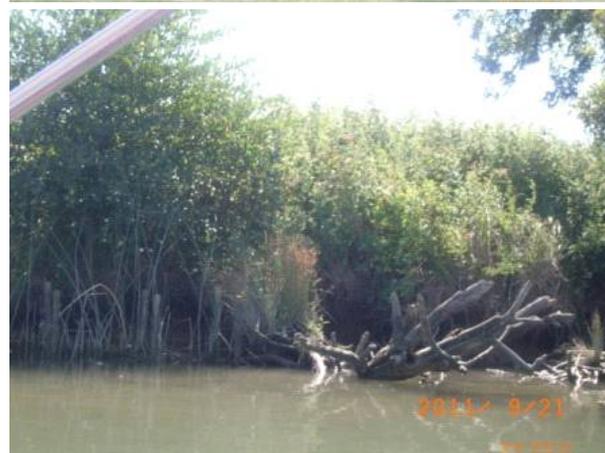
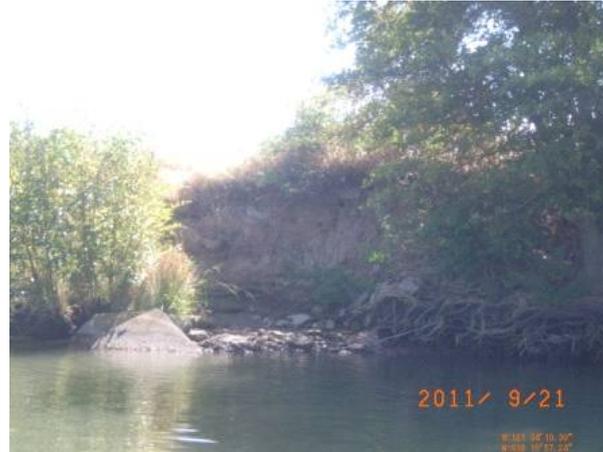
Levee Mile Report Line	56
Start Levee Mile	5.53
End Levee Mile	6.32
Location	Water Side
Category	Supplemental
Item	USACE Erosion Survey
USACE 2011 Photo #1	
USACE2011_GEO_6-3_L_1.jpg

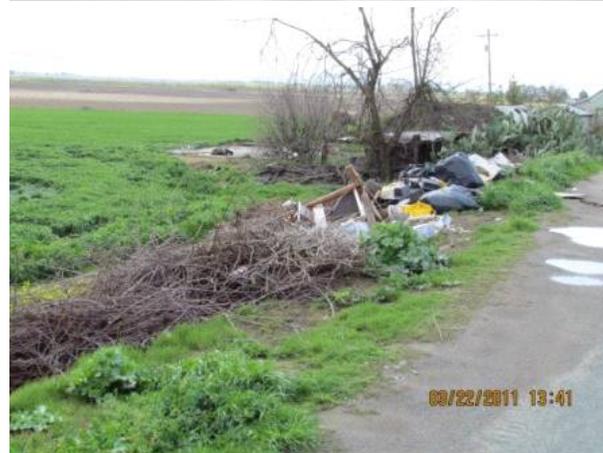
Levee Mile Report Line	57
Start Levee Mile	6.03
End Levee Mile	6.03
Location	Land Side
Category	Earthen Levee
Item	Encroachments
Looking southeast at garbage and prunings on landside slope.	
richard_f_20110922_418.jpg

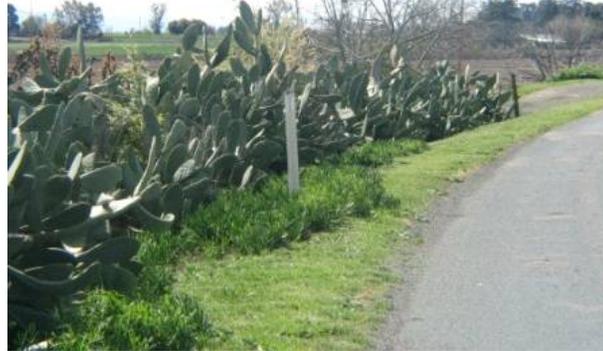
Levee Mile Report Line	58
Start Levee Mile	6.04
End Levee Mile	6.08
Location	Land Side
Category	Earthen Levee
Item	Vegetation
Large Cactus plant on landward slope from LM 6.04 to 6.08	
richard_f_20110922_380.jpg

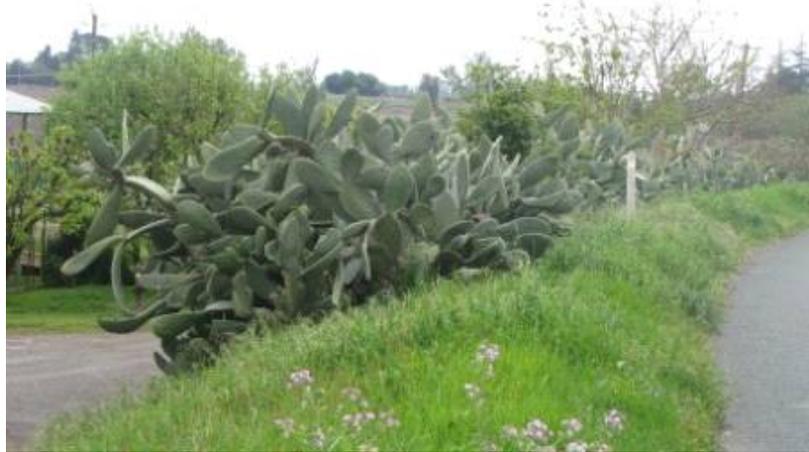
Levee Mile Report Line	58
Start Levee Mile	6.04
End Levee Mile	6.08
Location	Land Side
Category	Earthen Levee
Item	Vegetation
Looking at north end of cactus on the landside slope.	
richard_f_20110922_381.jpg

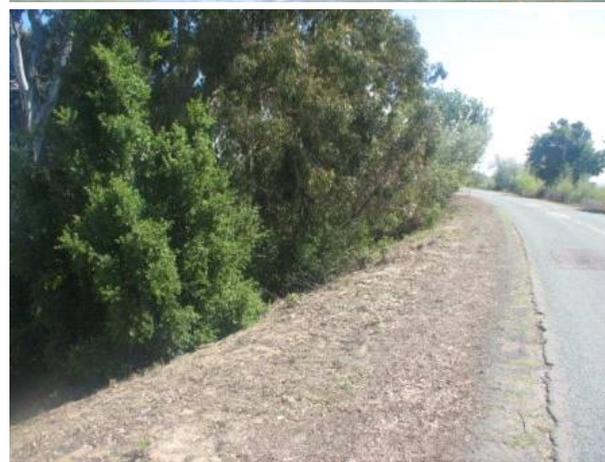
Levee Mile Report Line	65
Start Levee Mile	6.90
End Levee Mile	6.94
Location	Land Side
Category	Earthen Levee
Item	Trim / Thin Trees

Side view of dense trees along landside slope and shoulder.

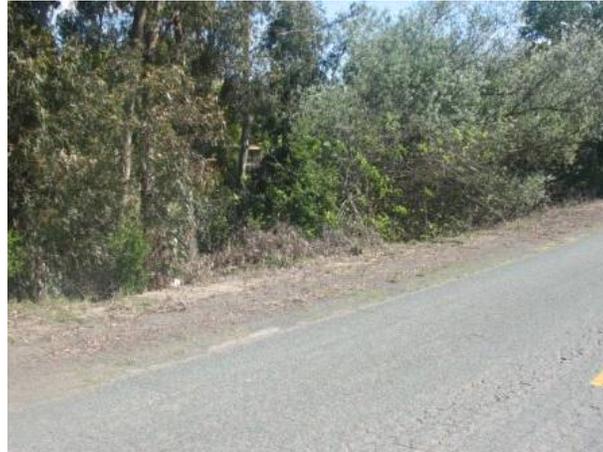
Levee Mile Report Line	65
Start Levee Mile	6.90
End Levee Mile	6.94
Location	Land Side
Category	Earthen Levee
Item	Trim / Thin Trees

Front view of dense trees along landside shoulder and slope.

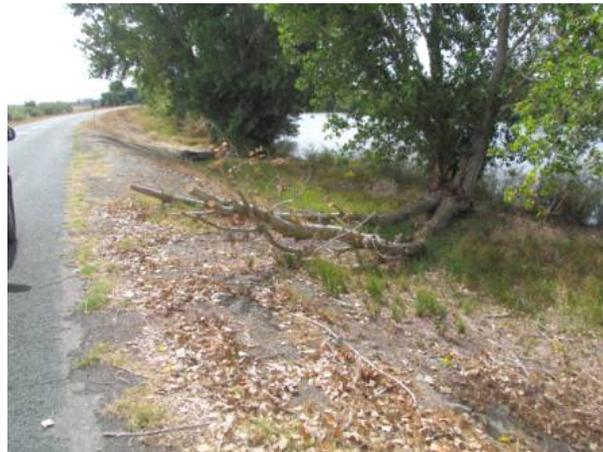
Levee Mile Report Line	70
Start Levee Mile	7.66
End Levee Mile	7.66
Location	Water Side
Category	Earthen Levee
Item	Encroachments

Looking southwest at down limbs on waterside slope.

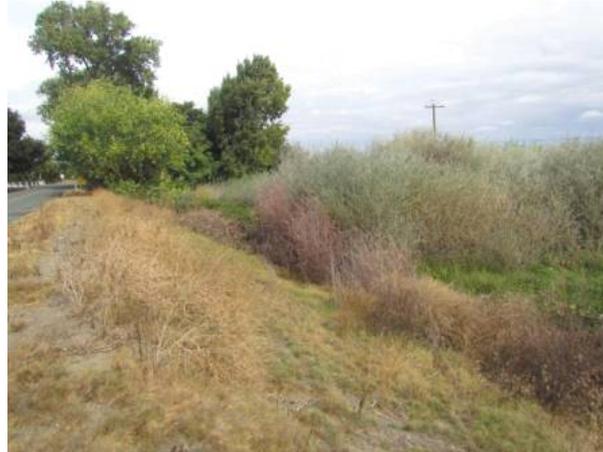
Levee Mile Report Line	72
Start Levee Mile	7.97
End Levee Mile	7.99
Location	Land Side
Category	Earthen Levee
Item	Vegetation
Looking northeast at dense vegetation on landside toe.	
richard_f_20111006_590.jpg

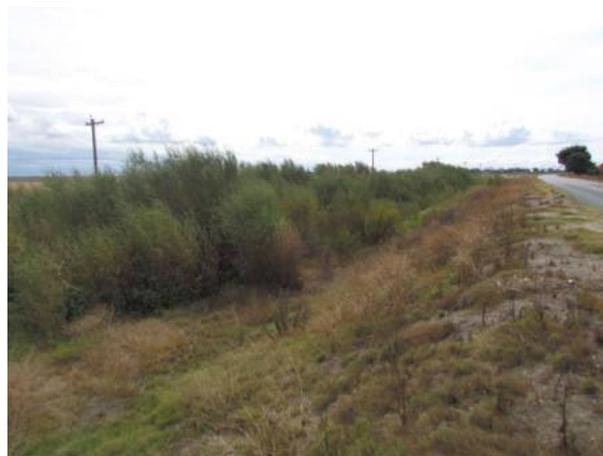
Levee Mile Report Line	72
Start Levee Mile	7.97
End Levee Mile	7.99
Location	Land Side
Category	Earthen Levee
Item	Vegetation
Looking southwest at dense vegetation on landside toe.	
richard_f_20111006_591.jpg

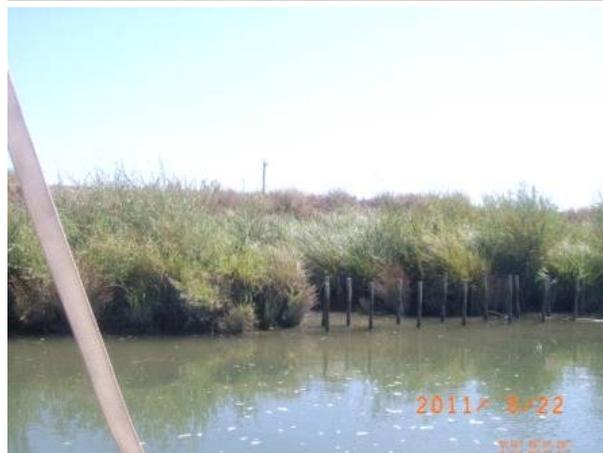
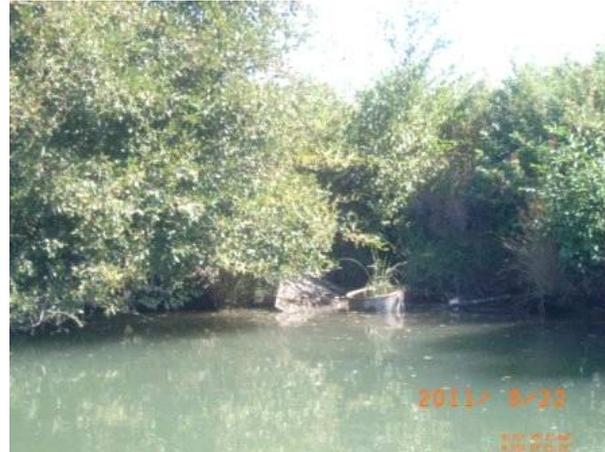
Levee Mile Report Line	73
Start Levee Mile	8.01
End Levee Mile	8.19
Location	Water Side
Category	Supplemental
Item	USACE Erosion Survey
USACE 2011 Photo #1	
USACE2011_GEO_4-3_L_1.jpg

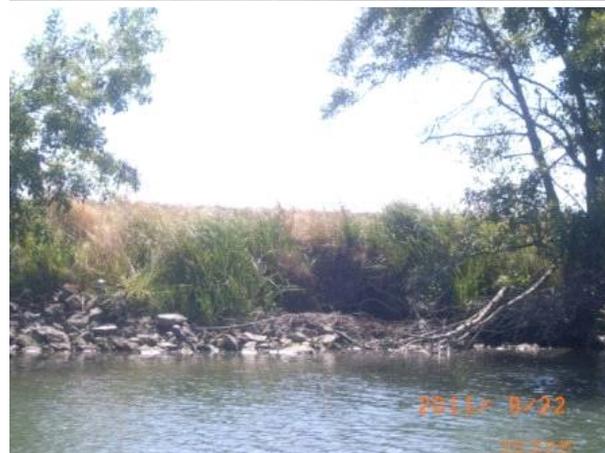
74	8.18	8.63	Supplemental	USACE Erosion Survey	WS	U	Inspector Comments: 1997 - Pockets of erosion into the levee at the water line. Alders are being undercut and rotating out into the channel. Damaged rock at upstream end. 2000 - New minor erosion. 2001 - Staked low fascine walls at bankline. 2002 - New "Brush Boxes" along the bank toe. 2003 - New erosion pockets in the middle of the site. 2005 - Some new bundles in the brush boxes. 2011: Site upgraded to CRITICAL. Significant new erosion. Sites 3.6, 3.7, 3.71, and 4.0 were combined. [2011 Site ID: GEO_3-8_L]	38.156987 ° -121.587427 °	38.152919 ° -121.591129 °	48 Y

Levee Mile Report Line	74
Start Levee Mile	8.18
End Levee Mile	8.63
Location	Water Side
Category	Supplemental
Item	USACE Erosion Survey
USACE 2011 Photo #1	
USACE2011_GEO_3-8_L_1.jpg

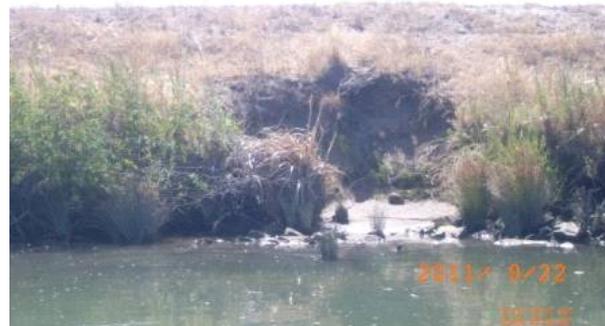
Levee Mile Report Line	74
Start Levee Mile	8.18
End Levee Mile	8.63
Location	Water Side
Category	Supplemental
Item	USACE Erosion Survey
USACE 2011 Photo #3	
USACE2011_GEO_3-8_L_3.jpg

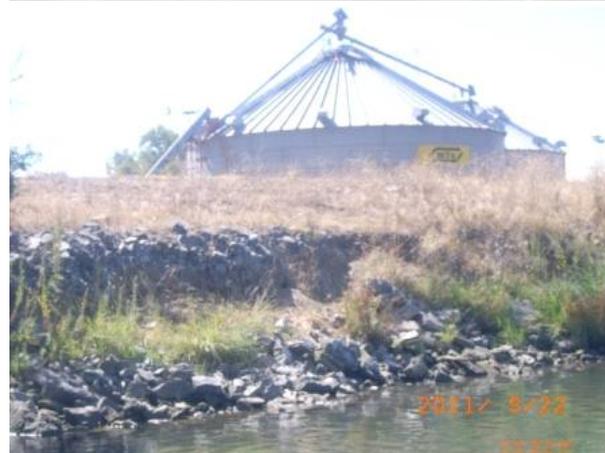
Levee Mile Report Line	74
Start Levee Mile	8.18
End Levee Mile	8.63
Location	Water Side
Category	Supplemental
Item	USACE Erosion Survey
USACE 2011 Photo #4	
USACE2011_GEO_3-8_L_4.jpg

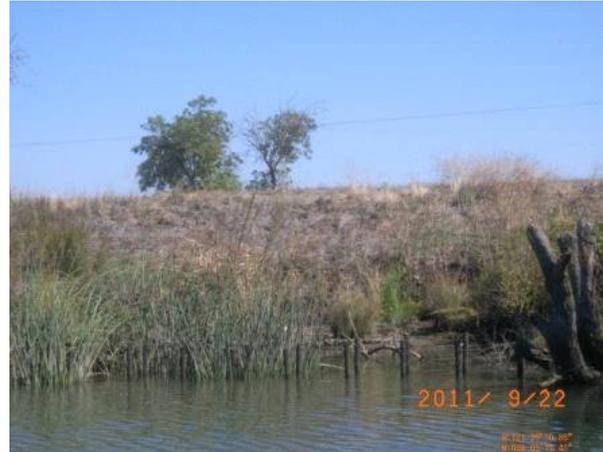
Levee Mile Report Line	74
Start Levee Mile	8.18
End Levee Mile	8.63
Location	Water Side
Category	Supplemental
Item	USACE Erosion Survey
USACE 2011 Photo #5	
USACE2011_GEO_3-8_L_5.jpg

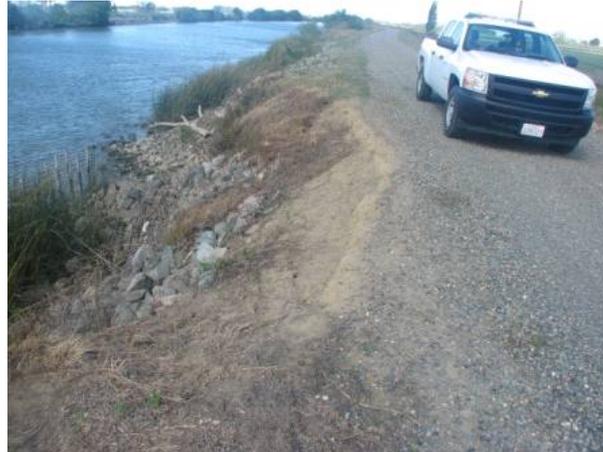
Levee Mile Report Line	82
Start Levee Mile	10.44
End Levee Mile	10.44
Location	Water Side
Category	Earthen Levee
Item	Erosion / Bank Caving

Looking downstream at erosion site on waterside slope and shoulder.

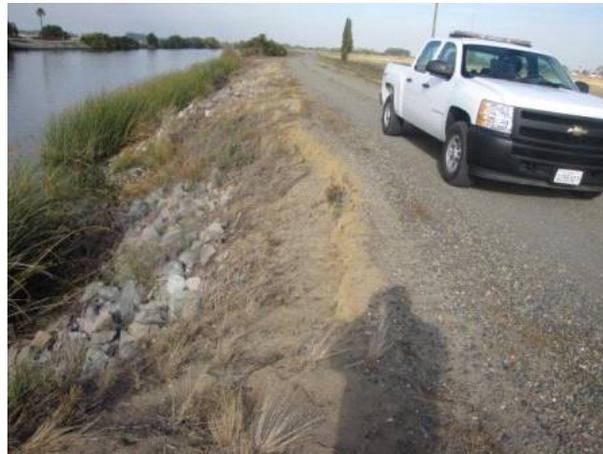
Levee Mile Report Line	82
Start Levee Mile	10.44
End Levee Mile	10.44
Location	Water Side
Category	Earthen Levee
Item	Erosion / Bank Caving

Looking north at updated picture of erosion site as of October 2010

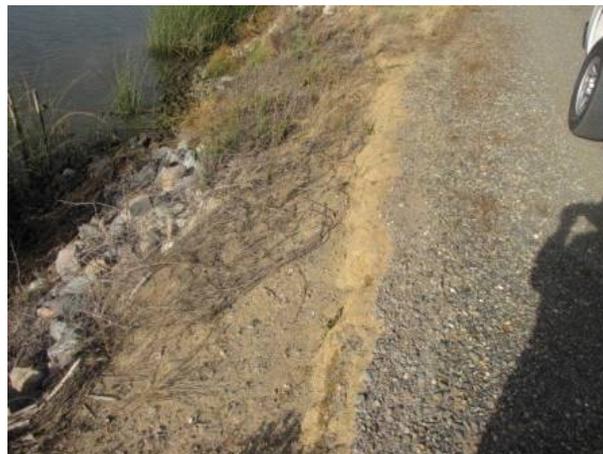
Levee Mile Report Line	82
Start Levee Mile	10.44
End Levee Mile	10.44
Location	Water Side
Category	Earthen Levee
Item	Erosion / Bank Caving

Looking northwest at updated picture of erosion site on waterside slope and shoulder as of October 2010.

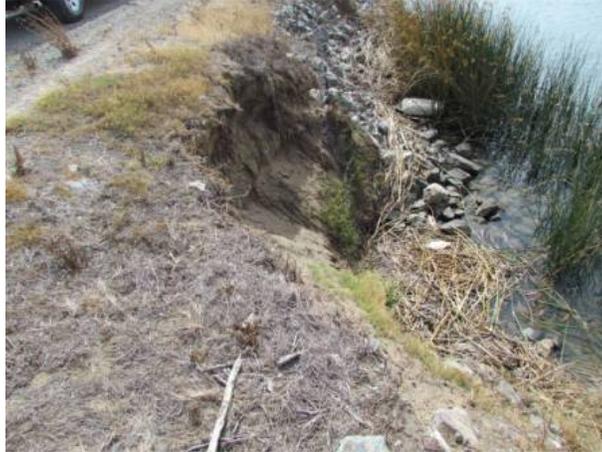
Levee Mile Report Line	82
Start Levee Mile	10.44
End Levee Mile	10.44
Location	Water Side
Category	Earthen Levee
Item	Erosion / Bank Caving

Looking southwest at erosion on waterside slope and toe.

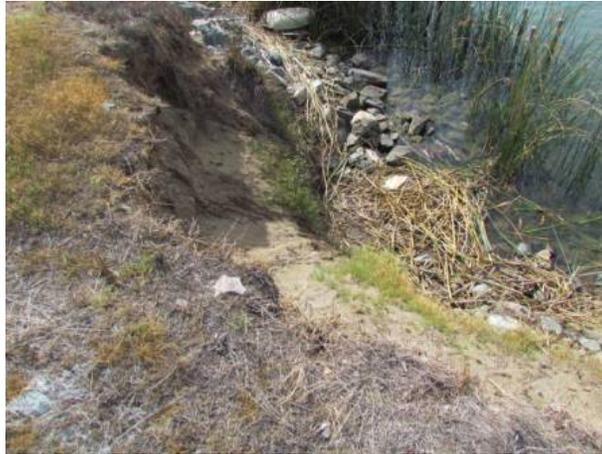
Levee Mile Report Line	82
Start Levee Mile	10.44
End Levee Mile	10.44
Location	Water Side
Category	Earthen Levee
Item	Erosion / Bank Caving

Looking west at erosion on waterside slope and toe.

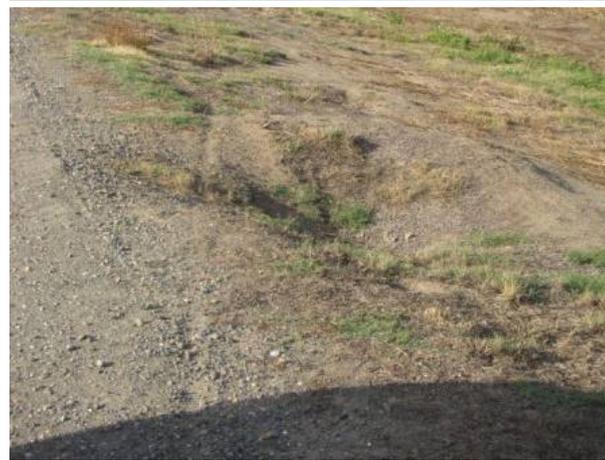
Levee Mile Report Line	84
Start Levee Mile	10.77
End Levee Mile	10.77
Location	Land Side
Category	Earthen Levee
Item	Slope Stability

84	10.77	10.77	Earthen Levee	Slope Stability	LS	U	Repair slope instability. Inspector Comments: Deep depression on landside shoulder and slope possible pipe collapse	38.141940 ° -121.598033 °	38.141940 ° -121.598033 °	76 Y
85	10.82	10.82	Earthen Levee	Animal Control	LS	M	No rodents visible, but rodent burrows visible; need to backfill and compact or grout burrows.	38.141362 ° -121.597598 °	38.141362 ° -121.597598 °	77
86	10.90	10.90	Earthen Levee	Slope Stability	WS	M	Repair slope instability. Inspector Comments: Site is not completely repaired	38.140307 ° -121.596957 °	38.140307 ° -121.596957 °	79 Y
87	11.49	11.59	Earthen Levee	Encroachments	WS	M	Prunings	38.133556 ° -121.590641 °	38.132462 ° -121.589452 °	952

Looking northeast a depression on landside shoulder and slope above 10" irrigation pipe four feet below crown.
