**Flood Control Project Maintenance  
Levee Inspections**

**Fall 2011 Levee Maintenance Deficiency Summary Report**

**Reclamation District No. 0563 Tyler Island**

Waterway	Bank	Unit Miles
Unit No. 01 Georgiana Slough (Tyler Island)	Left	12.38

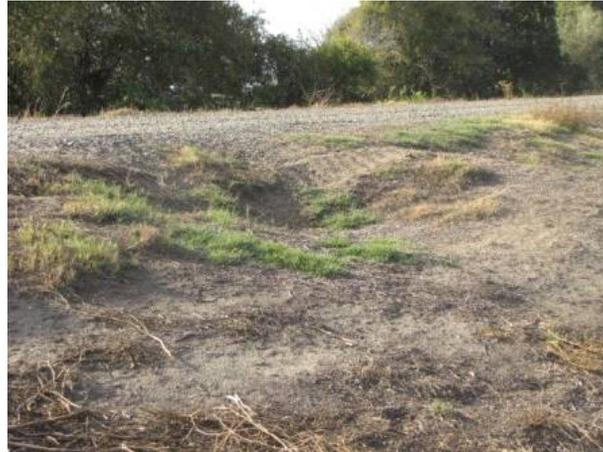
Levee Mile Report Line	84
Start Levee Mile	10.77
End Levee Mile	10.77
Location	Land Side
Category	Earthen Levee
Item	Slope Stability

84	10.77	10.77	Earthen Levee	Slope Stability	LS	U	Repair slope instability. Inspector Comments: Deep depression on landside shoulder and slope possible pipe collapse	38.141940 ° -121.598033 °	38.141940 ° -121.598033 °	76 Y
85	10.82	10.82	Earthen Levee	Animal Control	LS	M	No rodents visible, but rodent burrows visible; need to backfill and compact or grout burrows.	38.141362 ° -121.597598 °	38.141362 ° -121.597598 °	77
86	10.90	10.90	Earthen Levee	Slope Stability	WS	M	Repair slope instability. Inspector Comments: Site is not completely repaired	38.140307 ° -121.596957 °	38.140307 ° -121.596957 °	79 Y
87	11.49	11.59	Earthen Levee	Encroachments	WS	M	Prunings	38.133556 ° -121.590641 °	38.132462 ° -121.589452 °	952

Looking west at depression on landside shoulder and slope.

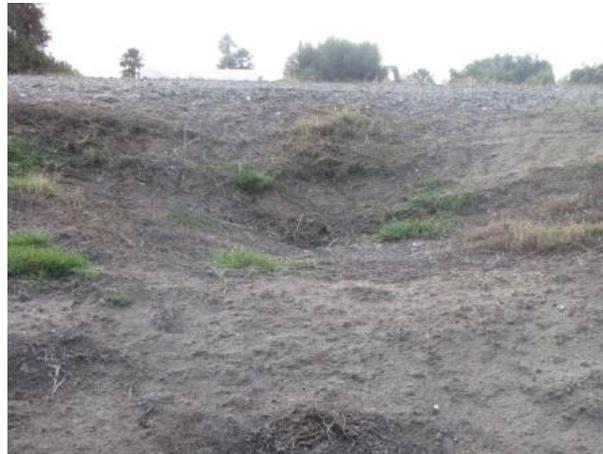
Levee Mile Report Line	84
Start Levee Mile	10.77
End Levee Mile	10.77
Location	Land Side
Category	Earthen Levee
Item	Slope Stability

Looking west at depression on landside shoulder and slope from landside toe.

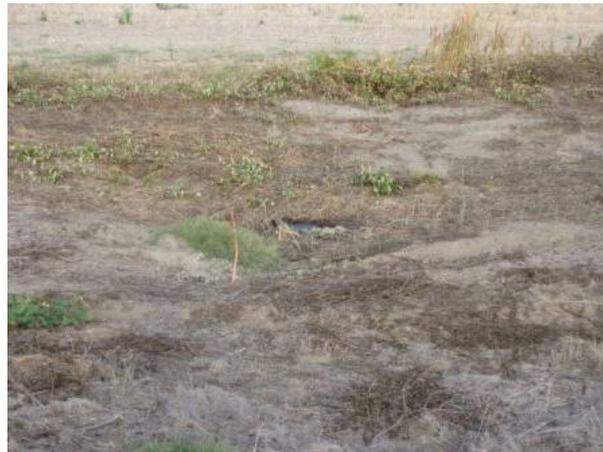
Levee Mile Report Line	84
Start Levee Mile	10.77
End Levee Mile	10.77
Location	Land Side
Category	Earthen Levee
Item	Slope Stability

Looking east at water ponding at landside toe just above 10" irrigation pipe.

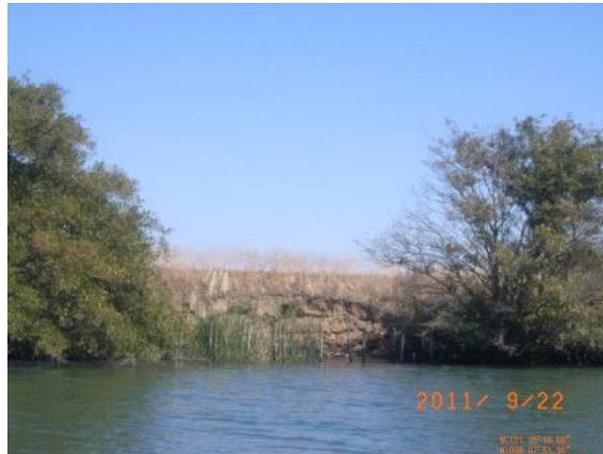
LMIR No.	Levee Mile		Category	Item	* Location	** Rating	Action/Comment	GPS Latitude/Longitude		Issue No. Photo
	Start	End						Start	End	
88	11.61	12.04	Supplemental	USACE Erosion Survey	WS	U	Inspector Comments: 1997 - Erosion pockets into the levee toe. 1999 - Some small pockets fixed with rock riprap. 2002 - New "brush boxes" along the bank toe. 2005 - Brush boxes are empty. Some pockets are filled with new stone. 2006 - Some new rock at the downstream end (~100 ft long). Several small pockets of new rock in scallops. Brush boxes in poor to fair condition. 2010 - Site looks a little worse, some toe rock but still has erosion scars at lower to mid slope. 2011: Site upgraded to CRITICAL. Significant new erosion. Erosion scallops are vertical and almost the height of the levee. [2011 Site ID: GEO_0-3_L]	38.131126 ° -121.588337 °	38.130368 ° -121.582266 °	55 Y
89	11.63	11.63	Earthen Levee	Animal Control	LS	U	No rodents visible, but rodent burrows visible; need to backfill and compact or grout burrows.	38.131943 ° -121.588912 °	38.131943 ° -121.588912 °	91 Y

Levee Mile Report Line	88
Start Levee Mile	11.61
End Levee Mile	12.04
Location	Water Side
Category	Supplemental
Item	USACE Erosion Survey
USACE 2011 Photo #1	
USACE2011_GEO_0-3_L_1.jpg

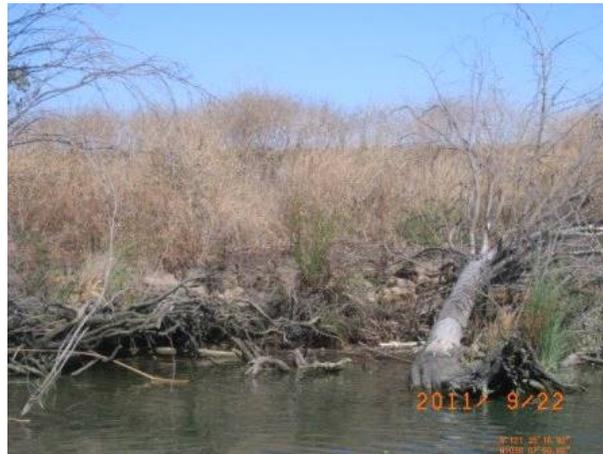
Levee Mile Report Line	88
Start Levee Mile	11.61
End Levee Mile	12.04
Location	Water Side
Category	Supplemental
Item	USACE Erosion Survey
USACE 2011 Photo #2	
USACE2011_GEO_0-3_L_2.jpg

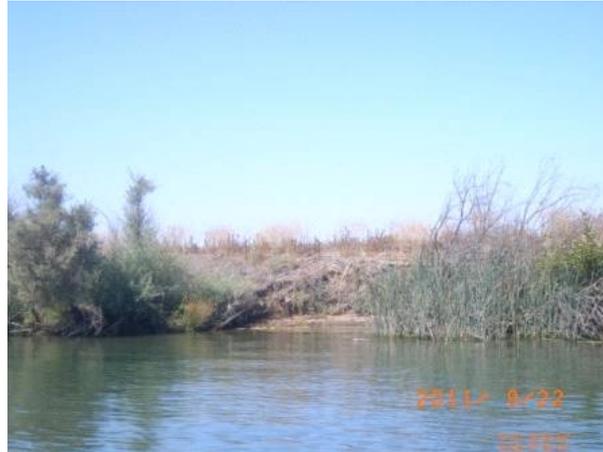
Levee Mile Report Line	88
Start Levee Mile	11.61
End Levee Mile	12.04
Location	Water Side
Category	Supplemental
Item	USACE Erosion Survey
USACE 2011 Photo #3	
USACE2011_GEO_0-3_L_3.jpg

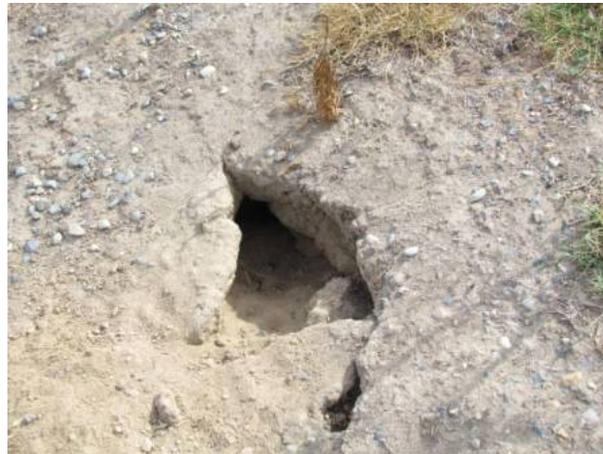
Levee Mile Report Line	89
Start Levee Mile	11.63
End Levee Mile	11.63
Location	Land Side
Category	Earthen Levee
Item	Animal Control
Looking east at rodent hole on landside slope.	
richard_f_20111006_594.jpg

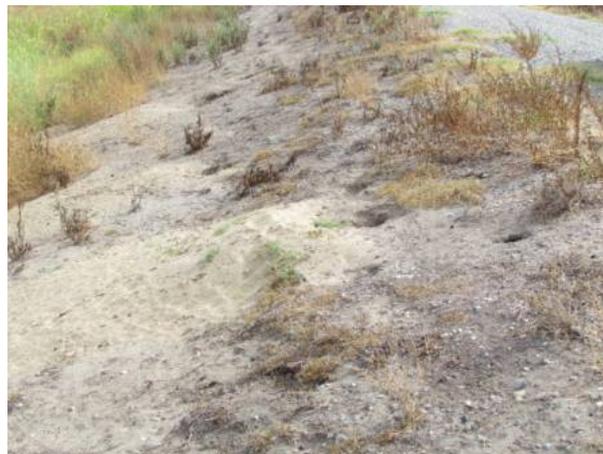
Levee Mile Report Line	89
Start Levee Mile	11.63
End Levee Mile	11.63
Location	Land Side
Category	Earthen Levee
Item	Animal Control
Looking south at rodent holes on landside slope.	
richard_f_20111006_595.jpg

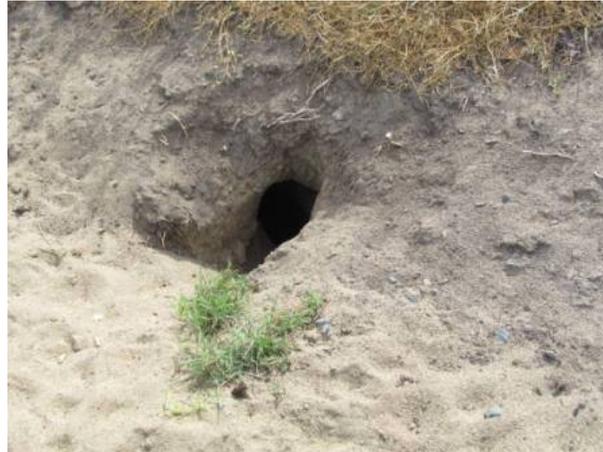
Levee Mile Report Line	89
Start Levee Mile	11.63
End Levee Mile	11.63
Location	Land Side
Category	Earthen Levee
Item	Animal Control
Looking west at rodent hole on landside slope.	
richard_f_20111006_596.jpg
