**Flood Control Project Maintenance
Levee Inspections**

Fall 2014 Levee Maintenance Deficiency Summary Report

Reclamation District No. 0563 Tyler Island

Waterway		Bank	Unit Miles	
Unit No. 01 Georgiana Slough (Tyler Island)		Left	12.11	
	Spring (March - May)	Summer (June - August)	(September - November) Fall	Winter (December - February)
Unit Maintenance Rating (Fall Only)			U	
Date of Inspection	03/25/2014 - 03/26/2014		10/09/2014 - 10/09/2014	
DWR Inspector	Richard Willoughby		Richard Willoughby	
Accompanied By	Steve Mello RD 563		Steve Mello RD 563

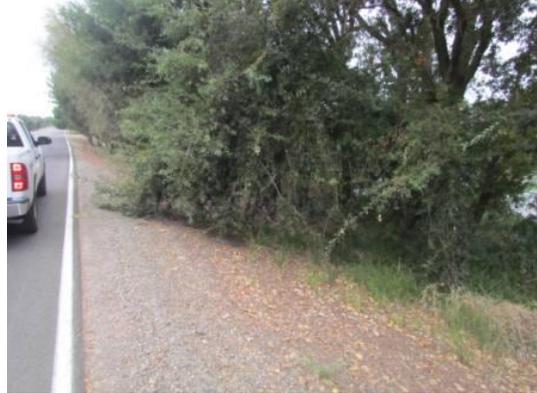
Photo 1 of 1 : FA_2014_RD0563_210_4_20141006_00003.jpg

LM Start	0.13	Rating **	A/W	Issue No.	4
LM End	0.13	Issue Type +	Ma	Location *	WS
Category	Earthen Levee		GPS Latitude/Longitude		
			Start	End	
Item	Trim / Thin Trees		38.234018 °	38.234018 °	
			-121.518547 °	-121.518547 °	
DWR ID	DWR_RD0563_01_s_2012_4				
Action/Comments					
Trim trees to at least five feet above ground level.

Looking southwest at overgrown tree on waterside slope.

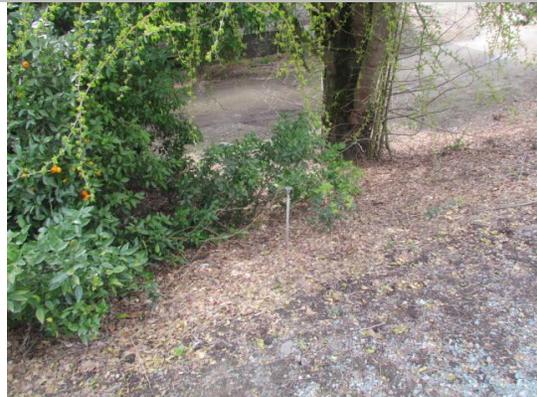
Photo 1 of 2 : FA_2014_RD0563_210_28_20141006_00032.jpg

LM Start	0.14	Rating **	M	Issue No.	28
LM End	0.16	Issue Type +	Ma	Location *	LS
Category	Earthen Levee		GPS Latitude/Longitude		
			Start	End	
Item	Trim / Thin Trees		38.233910 °	38.233655 °	
			-121.518722 °	-121.519000 °	
DWR ID	DWR_RD0563_01_s_2012_28				
Action/Comments					
Trim trees to at least five feet above ground level.

Looking east at sprinklers on landside slope.

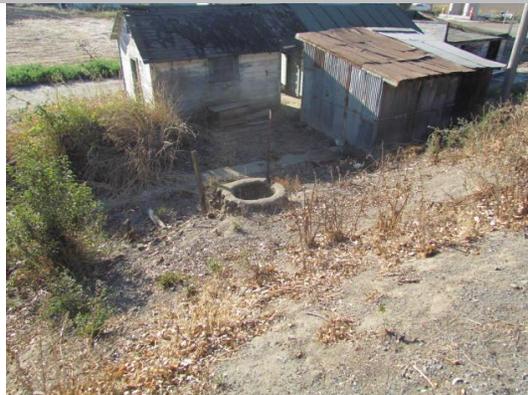
Photo 1 of 3 : FA_2014_RD0563_210_10_20141006_00012.jpg

LM Start	0.17	Rating **	M	Issue No.	10
LM End	0.17	Issue Type +	En	Location *	LS
Category	Earthen Levee		GPS Latitude/Longitude		
			Start	End	
Item	Encroachments		38.233572 °	38.233572 °	
			-121.519083 °	-121.519083 °	
DWR ID	DWR_RD0563_01_f_2013_10				
Action/Comments					
Building Inspector Comments: Tool shed and fire pit on landward slope and toe.

Looking east at fire pit on landward slope.

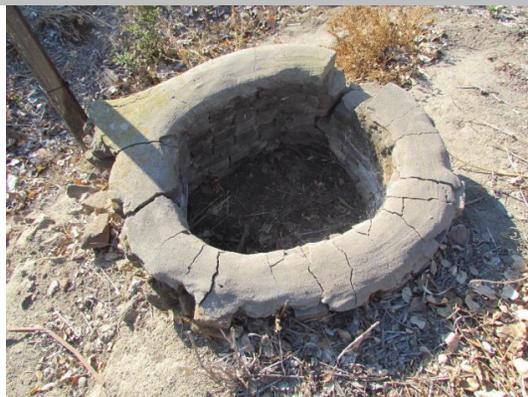
Photo 2 of 3 : FA_2014_RD0563_210_10_20141006_00013.jpg

Looking southeast at fire pit on landward slope.

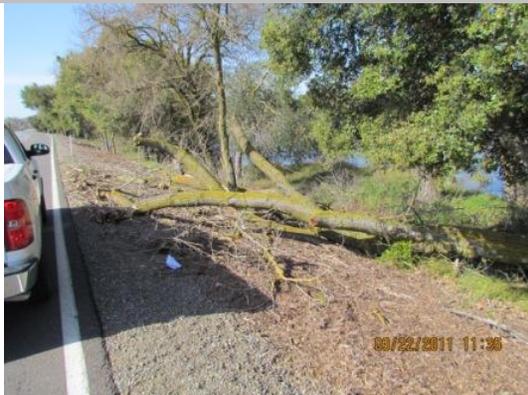
Photo 1 of 1 : FA_2014_RD0563_210_32_20141006_00034.jpg

LM Start	0.19	Rating **	M	Issue No.	32
LM End	0.19	Issue Type +	Ma	Location *	WS
Category	Earthen Levee		GPS Latitude/Longitude		
			Start	End	
Item	Encroachments		38.233315 °	38.233315 °	
			-121.519360 °	-121.519360 °	
DWR ID	DWR_RD0563_01_s_2012_32				
Action/Comments					
Tree or limb Inspector Comments: Tree fallen across waterward slope.

Looking south (downstream) at fallen tree limb on waterside slope.

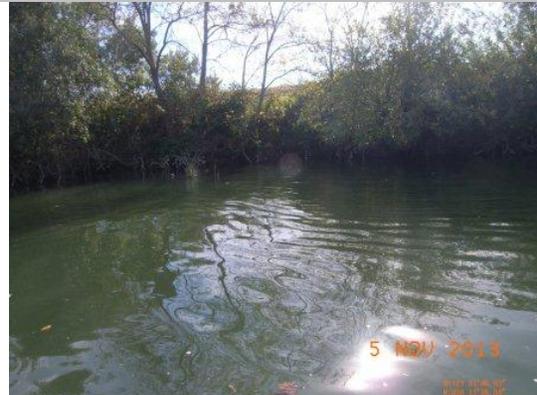
Photo 1 of 1 : FA_2014_RD0563_210_55_20141006_00053.jpg

LM Start	0.35	Rating **	M	Issue No.	55
LM End	0.42	Issue Type +	Ma	Location *	WS
Category	Supplemental		GPS Latitude/Longitude		
			Start	End	
Item	USACE Erosion Survey		38.226522 °	38.227157 °	
			-121.529094 °	-121.530432 °	
DWR ID	DWR_RD0563_01_f_2014_55				
Action/Comments					
Inspector Comments: 2011 - Short sections of eroding bank at the waterline and holes in toe of levee. 2012 - Site extended upstream. 2013: Erosion pockets filled with an insufficient amounts of revetment. [2013 Site ID: GEO_11-0_L]

USACE 2013 Photo #1

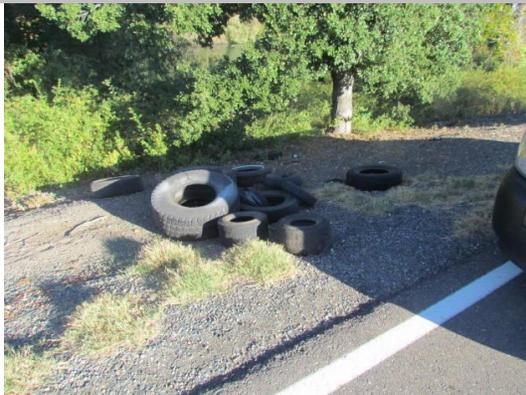
Photo 2 of 2 : FA_2014_RD0563_210_139_20141010_00167.jpg

LM Start	0.36	Rating **	M	Issue No.	139 (cont)
LM End	0.36	Issue Type +	Ma	Location *	WS
Category	Earthen Levee		GPS Latitude/Longitude		
			Start	End	
Item	Encroachments		38.231452 °	38.231452 °	
			-121.521262 °	-121.521262 °	
DWR ID	DWR_RD0563_01_f_2014_139				
Action/Comments					
Garbage Inspector Comments: Tires discarded on waterward slope.

Looking north at tires dumped on waterward slope.

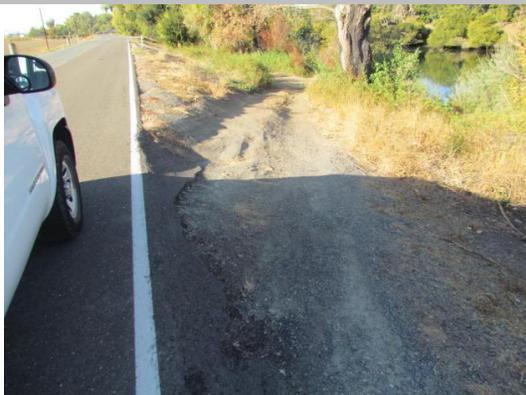
Photo 1 of 1 : FA_2014_RD0563_210_16_20141006_00020.jpg

LM Start	0.41	Rating **	M	Issue No.	16
LM End	0.41	Issue Type +	Ma	Location *	WS
Category	Earthen Levee		GPS Latitude/Longitude		
			Start	End	
Item	Slope Stability		38.230841 °	38.230841 °	
			-121.521898 °	-121.521898 °	
DWR ID	DWR_RD0563_01_f_2013_16				
Action/Comments					
Repair the levee slope damaged by vehicle traffic and prevent access where possible. Inspector Comments: Slope damage is due to fishermen vehicle traffic.

Looking southwest at slope damage caused by vehicle traffic.

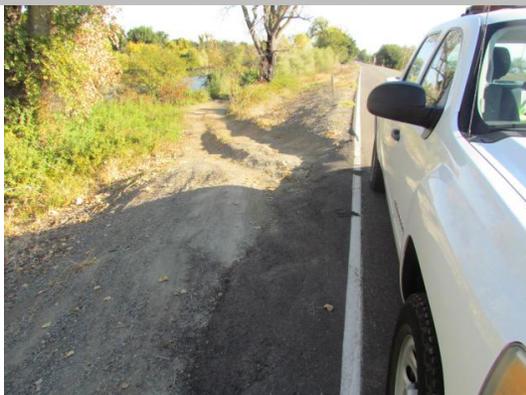
Photo 1 of 1 : FA_2014_RD0563_210_26_20141006_00029.jpg

LM Start	0.45	Rating **	M	Issue No.	26
LM End	0.45	Issue Type +	Ma	Location *	WS
Category	Earthen Levee		GPS Latitude/Longitude		
			Start	End	
Item	Slope Stability		38.230460 °	38.230460 °	
			-121.522324 °	-121.522324 °	
DWR ID	DWR_RD0563_01_f_2013_26				
Action/Comments					
Repair the levee slope damaged by vehicle traffic and prevent access where possible. Inspector Comments: Slope damage due to fishermen vehicle traffic.

Looking northwest at slope damage caused by vehicle traffic.

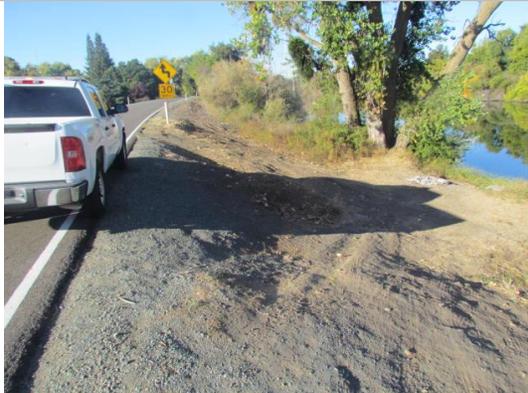
Photo 1 of 2 : FA_2014_RD0563_210_143_20141010_00168.jpg

LM Start	0.63	Rating **	M	Issue No.	143
LM End	0.63	Issue Type +	Ma	Location *	WS
Category	Earthen Levee		GPS Latitude/Longitude		
			Start	End	
Item	Slope Stability		38.228507 °	38.228507 °	
			-121.524543 °	-121.524543 °	
DWR ID	DWR_RD0563_01_f_2014_143				
Action/Comments					
Repair the levee slope damaged by vehicle traffic and prevent access where possible. Inspector Comments: Slope damage due to vehicle traffic.

Looking southeast at slope damage on waterward slope.

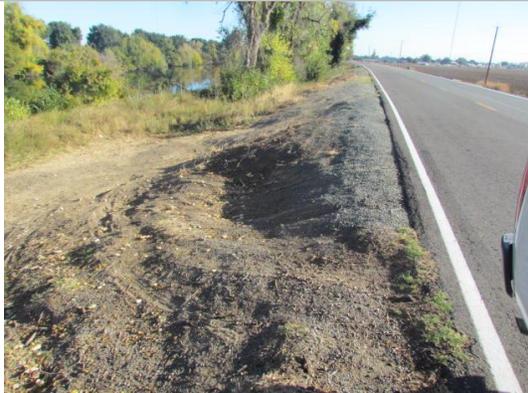
Photo 2 of 2 : FA_2014_RD0563_210_143_20141010_00169.jpg

Looking northwest at slope damage on waterward slope.

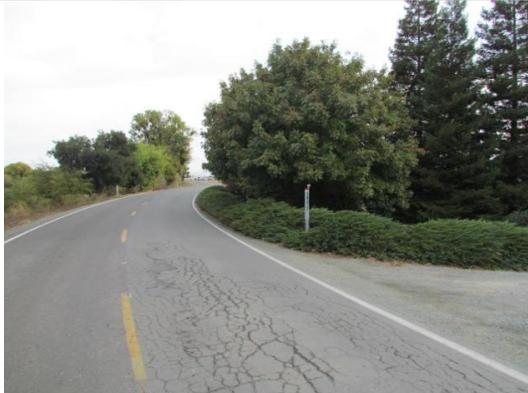
Photo 1 of 2 : FA_2014_RD0563_210_50_20141006_00048.jpg

LM Start	0.68	Rating **	U	Issue No.	50
LM End	0.71	Issue Type +	En	Location *	LS
Category	Earthen Levee		GPS Latitude/Longitude		
			Start	End	
Item	Vegetation		38.228033 °	38.227777 °	
			-121.525268 °	-121.525627 °	
DWR ID	DWR_RD0563_01_s_2012_50				
Action/Comments					
Landscaping

Looking northwest at dense landscaping on landside slope.

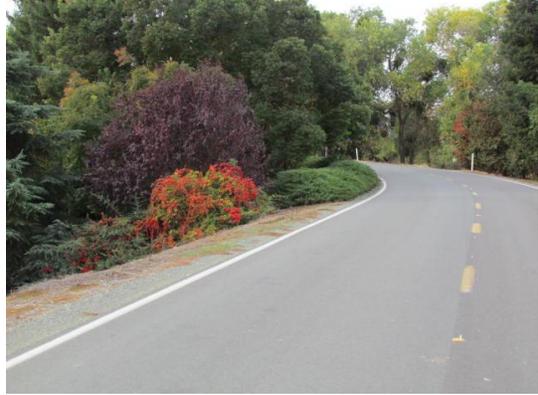
Photo 2 of 2 : FA_2014_RD0563_210_50_20141006_00049.jpg

LM Start	0.68	Rating **	U	Issue No.	50 (cont)
LM End	0.71	Issue Type +	En	Location *	LS
Category	Earthen Levee		GPS Latitude/Longitude		
			Start	End	
Item	Vegetation		38.228033 °	38.227777 °	
			-121.525268 °	-121.525627 °	
DWR ID	DWR_RD0563_01_s_2012_50				
Action/Comments					
Landscaping

Looking southeast at dense landscaping on landside slope.

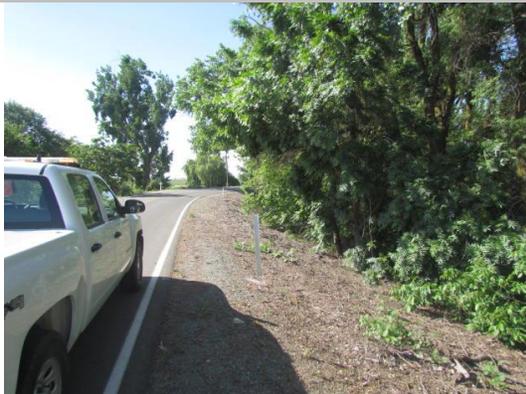
Photo 1 of 2 : FA_2014_RD0563_210_3_20141006_00001.jpg

LM Start	0.80	Rating **	A/W	Issue No.	3
LM End	0.80	Issue Type +	Ma	Location *	WS
Category	Earthen Levee		GPS Latitude/Longitude		
			Start	End	
Item	Trim / Thin Trees		38.226370 °	38.226370 °	
			-121.525912 °	-121.525912 °	
DWR ID	DWR_RD0563_01_s_2012_3				
Action/Comments					
Trim trees to at least five feet above ground level.

Looking south at trimmed trees on waterward slope. (Spring 2013)

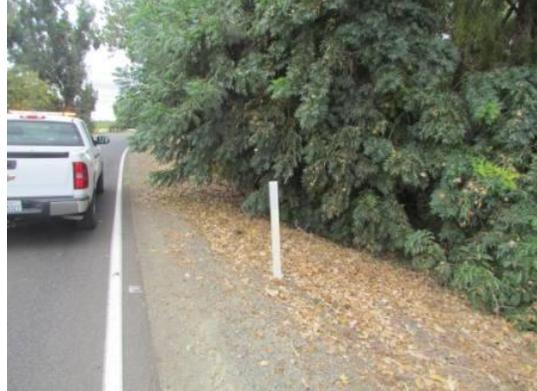
Photo 2 of 2 : FA_2014_RD0563_210_3_20141006_00002.jpg

LM Start	0.80	Rating **	A/W	Issue No.	3 (cont)
LM End	0.80	Issue Type +	Ma	Location *	WS
Category	Earthen Levee		GPS Latitude/Longitude		
			Start	End	
Item	Trim / Thin Trees		38.226370 °	38.226370 °	
			-121.525912 °	-121.525912 °	
DWR ID	DWR_RD0563_01_s_2012_3				
Action/Comments					
Trim trees to at least five feet above ground level.

Looking southwest at overgrown trees on waterside slope.

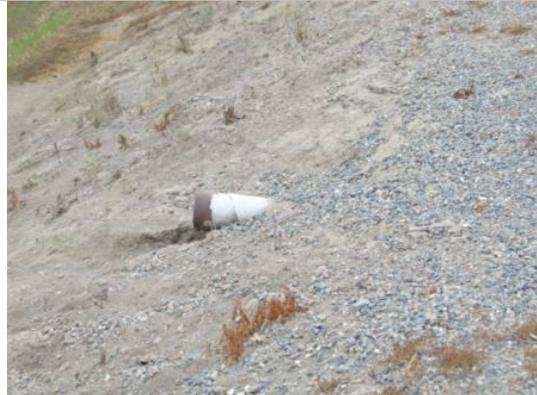
Photo 1 of 2 : FA_2014_RD0563_210_937_20141006_00135.jpg

LM Start	0.98	Rating **	M	Issue No.	937
LM End	0.98	Issue Type +	Ma	Location *	CR
Category	Earthen Levee			GPS Latitude/Longitude	
				Start	End
Item	Encroachments			38.225813 °	38.225813 °
				-121.528198 °	-121.528198 °
DWR ID	DWR_RD0563_01_s_2012_937				
Action/Comments					
Pipe Inspector Comments: Abandoned pipe should be removed.

Looking southwest at abandoned pipe on landside slope.

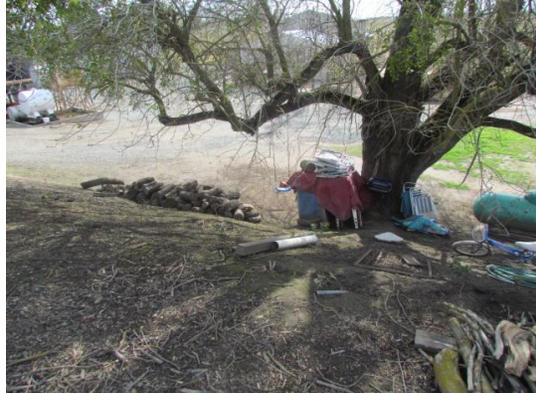
Photo 1 of 2 : FA_2014_RD0563_210_57_20141006_00054.jpg

LM Start	1.25	Rating **	M	Issue No.	57
LM End	1.25	Issue Type +	En	Location *	LS
Category	Earthen Levee		GPS Latitude/Longitude		
			Start	End	
Item	Encroachments		38.226345 °	38.226345 °	
			-121.532332 °	-121.532332 °	
DWR ID	DWR_RD0563_01_s_2012_57				
Action/Comments					
Building Inspector Comments: Landowner is stacking firewood and other items on landside slope and toe.

Looking east at firewood and other materials stored on landside slope and toe.

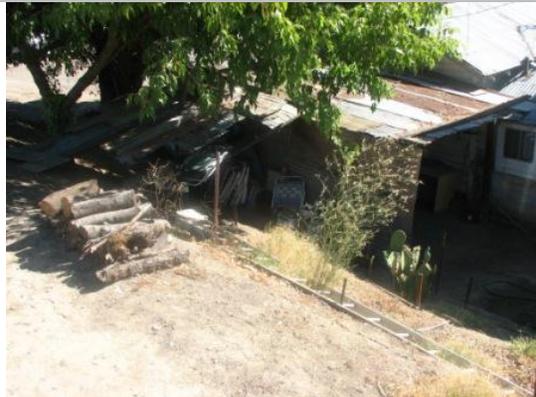
Photo 2 of 2 : FA_2014_RD0563_210_57_20141006_00055.jpg

Looking at a shed at landside toe.

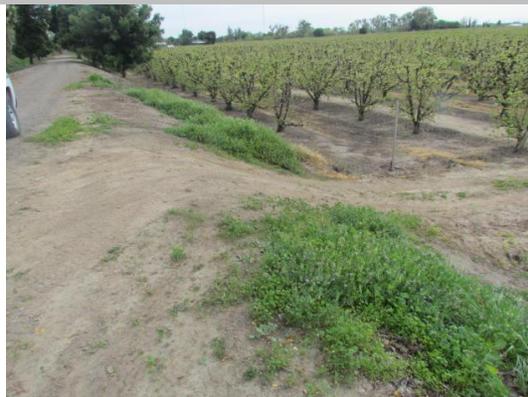
Photo 1 of 2 : FA_2014_RD0563_210_141_20141006_00128.jpg

LM Start	1.37	Rating **	M	Issue No.	141
LM End	1.37	Issue Type +	En	Location *	LS
Category	Earthen Levee		GPS Latitude/Longitude		
			Start	End	
Item	Encroachments				
DWR ID	DWR_RD0563_01_s_2014_141				
Action/Comments					
Ramp Inspector Comments: Landowner installed ramp without Board permit.

Looking northeast at ramp on landward slope.

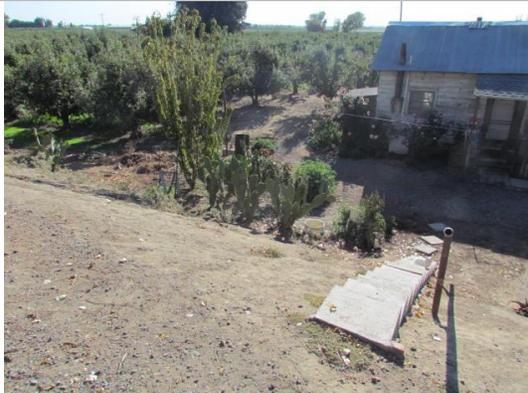
Photo 2 of 2 : FA_2014_RD0563_210_86_20141006_00103.jpg

LM Start	1.43	Rating **	M	Issue No.	86 (cont)
LM End	1.43	Issue Type +	En	Location *	LS
Category	Earthen Levee		GPS Latitude/Longitude		
			Start	End	
Item	Vegetation		38.224351 °	38.224351 °	
			-121.534209 °	-121.534209 °	
DWR ID	DWR_RD0563_01_f_2013_86				
Action/Comments					
Landscaping

Looking east at cactus at the landward toe.

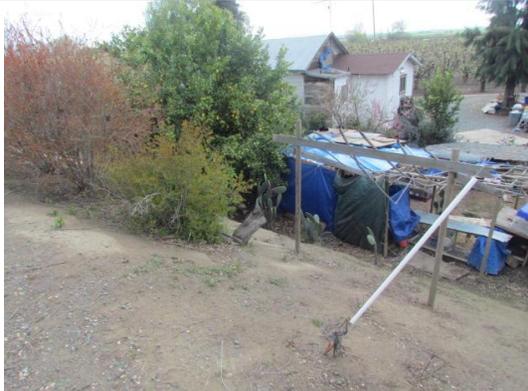
Photo 1 of 3 : FA_2014_RD0563_210_8_20141006_00007.jpg

LM Start	1.43	Rating **	U	Issue No.	8
LM End	1.43	Issue Type +	En	Location *	LS
Category	Earthen Levee		GPS Latitude/Longitude		
			Start	End	
Item	Encroachments		38.224315 °	38.224315 °	
			-121.534288 °	-121.534288 °	
DWR ID	DWR_RD0563_01_s_2012_8				
Action/Comments					
Building Inspector Comments: Tool shed, animal storage container, and landscaping on waterside slope and toe.

Looking east at landscaping and animal containers on the landside slope and toe.

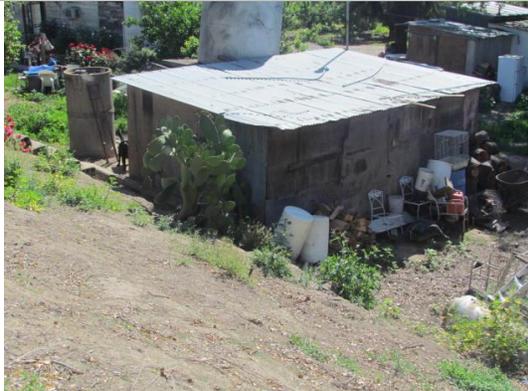
Photo 2 of 3 : FA_2014_RD0563_210_8_20141006_00008.jpg

Looking northeast at a tool shed on the landward toe.

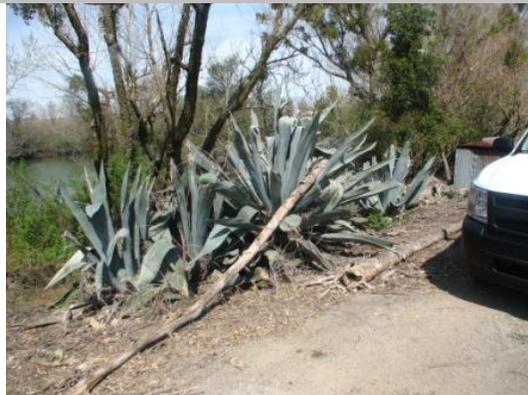
Photo 2 of 2 : FA_2014_RD0563_210_6_20141006_00006.jpg

LM Start	1.44	Rating **	M	Issue No.	6 (cont)
LM End	1.48	Issue Type +	Ma	Location *	WS
Category	Earthen Levee		GPS Latitude/Longitude		
			Start	End	
Item	Vegetation		38.224280 °	38.224000 °	
			-121.534377 °	-121.535038 °	
DWR ID	DWR_RD0563_01_s_2012_6				
Action/Comments					
Remove the wild growth other than native grasses from the levee slopes. Inspector Comments: Remove century plant from waterward shoulder.

Century plant on waterward shoulder at LM 1.42

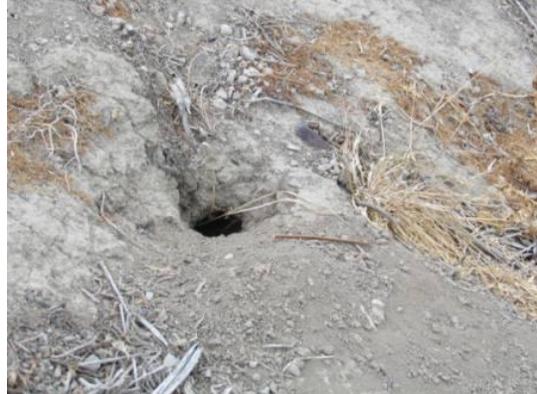
Photo 1 of 1 : FA_2014_RD0563_210_83_20141006_00095.jpg

LM Start	1.68	Rating **	M	Issue No.	83
LM End	1.77	Issue Type +	Ma	Location *	LS
Category	Earthen Levee		GPS Latitude/Longitude		
			Start	End	
Item	Animal Control		38.222967 °	38.222967 °	
			-121.540055 °	-121.540055 °	
DWR ID	DWR_RD0563_01_s_2012_83				
Action/Comments					
Exterminate rodents and backfill and compact or grout burrows.

Looking west at rodent hole on landside slope.

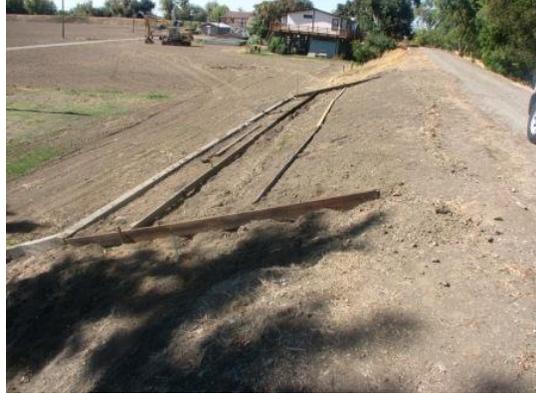
Photo 2 of 12 : FA_2014_RD0563_210_60_20141006_00057.jpg

LM Start	1.86	Rating **	M	Issue No.	60 (cont)
LM End	1.86	Issue Type +	En	Location *	LS
Category	Earthen Levee		GPS Latitude/Longitude		
			Start	End	
Item	Encroachments		38.222702 °	38.222702 °	
			-121.541678 °	-121.541678 °	
DWR ID	DWR_RD0563_01_s_2012_60				
Action/Comments					
Stairway Inspector Comments: Landowner has built a pad on the landside shoulder, 60' x 15', for a metal walkway leading from the house to a pad with a concrete deadman. Landowner also installed a temporary stairway on landside slope and stairway on waterside slope. Electrical conduit on landside toe.

Looking southeast at top of retaining wall.

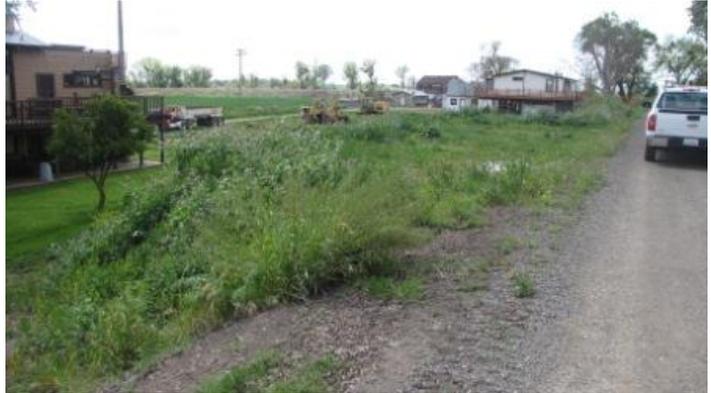
Photo 3 of 12 : FA_2014_RD0563_210_60_20141006_00058.jpg

Looking southeast at earthen pad on landside shoulder covering retaining wall.

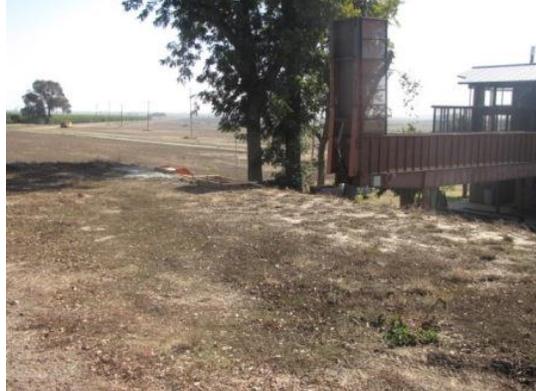
Photo 5 of 12 : FA_2014_RD0563_210_60_20141006_00060.jpg

LM Start	1.86	Rating **	M	Issue No.	60 (cont)
LM End	1.86	Issue Type +	En	Location *	LS
Category	Earthen Levee		GPS Latitude/Longitude		
			Start	End	
Item	Encroachments		38.222702 °	38.222702 °	
			-121.541678 °	-121.541678 °	
DWR ID	DWR_RD0563_01_s_2012_60				
Action/Comments					
Stairway Inspector Comments: Landowner has built a pad on the landside shoulder, 60' x 15', for a metal walkway leading from the house to a pad with a concrete deadman. Landowner also installed a temporary stairway on landside slope and stairway on waterside slope. Electrical conduit on landside toe.

Looking northeast metal walkway on landside of levee.

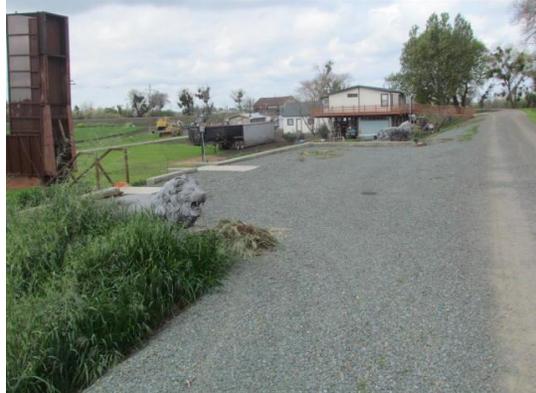
Photo 6 of 12 : FA_2014_RD0563_210_60_20141006_00061.jpg

Looking south at retaining wall on landside shoulder. (Updated Spring 2012)

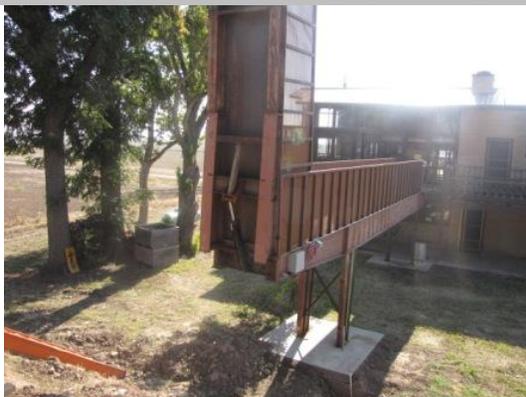
Photo 8 of 12 : FA_2014_RD0563_210_60_20141006_00063.jpg

LM Start	1.86	Rating **	M	Issue No.	60 (cont)
LM End	1.86	Issue Type +	En	Location *	LS
Category	Earthen Levee		GPS Latitude/Longitude		
			Start	End	
Item	Encroachments		38.222702 °	38.222702 °	
			-121.541678 °	-121.541678 °	
DWR ID	DWR_RD0563_01_s_2012_60				
Action/Comments					
Stairway Inspector Comments: Landowner has built a pad on the landside shoulder, 60' x 15', for a metal walkway leading from the house to a pad with a concrete deadman. Landowner also installed a temporary stairway on landside slope and stairway on waterside slope. Electrical conduit on landside toe.

Looking east at metal walkway on landside.

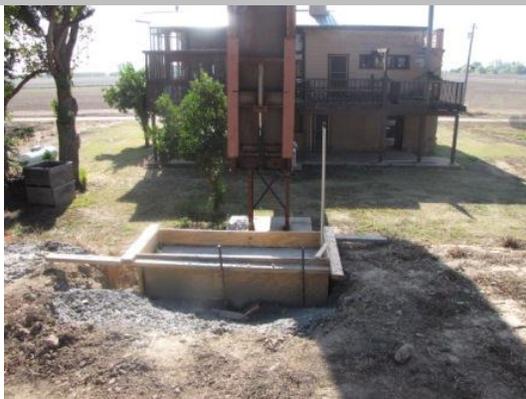
Photo 9 of 12 : FA_2014_RD0563_210_60_20141006_00064.jpg

Looking east at deadman on landside shoulder.

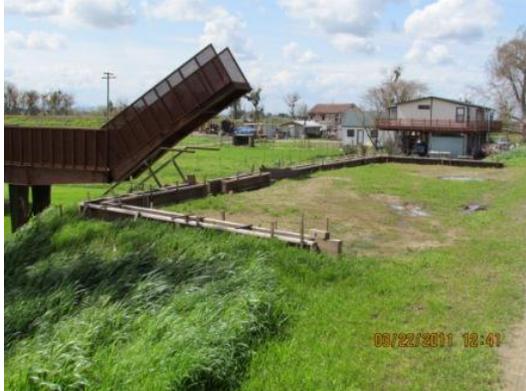
Photo 11 of 12 : FA_2014_RD0563_210_60_20141006_00066.jpg

LM Start	1.86	Rating **	M	Issue No.	60 (cont)
LM End	1.86	Issue Type +	En	Location *	LS
Category	Earthen Levee		GPS Latitude/Longitude		
			Start	End	
Item	Encroachments		38.222702 °	38.222702 °	
			-121.541678 °	-121.541678 °	
DWR ID	DWR_RD0563_01_s_2012_60				
Action/Comments					
Stairway Inspector Comments: Landowner has built a pad on the landside shoulder, 60' x 15', for a metal walkway leading from the house to a pad with a concrete deadman. Landowner also installed a temporary stairway on landside slope and stairway on waterside slope. Electrical conduit on landside toe.

Looking southeast at framing for footings on landside shoulder.

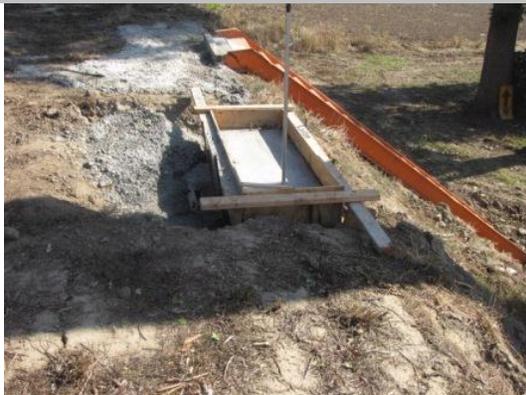
Photo 12 of 12 : FA_2014_RD0563_210_60_20141006_00067.jpg

Looking north at deadman for metal walkway on earthen pad on landside shoulder.

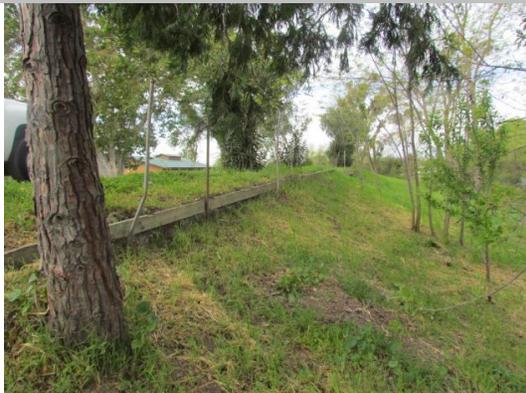
Photo 1 of 2 : FA_2014_RD0563_210_142_20141006_00130.jpg

LM Start	1.90	Rating **	M	Issue No.	142
LM End	1.92	Issue Type +	En	Location *	WS
Category	Earthen Levee		GPS Latitude/Longitude		
			Start	End	
Item	Vegetation				
DWR ID	DWR_RD0563_01_s_2014_142				
Action/Comments					
Landscaping Inspector Comments: Landowner has planted oleander, trees and planting box on waterward slope.

Looking southeast at planting box on waterward shoulder.

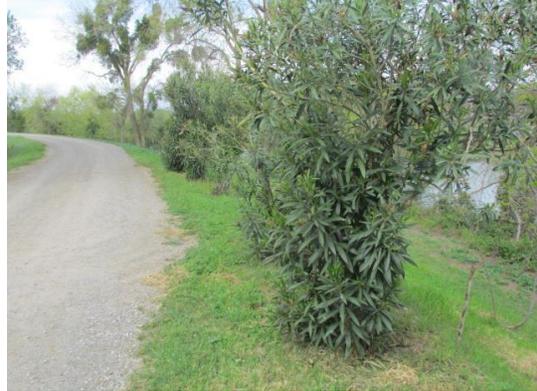
Photo 2 of 2 : FA_2014_RD0563_210_142_20141006_00131.jpg

LM Start	1.90	Rating **	M	Issue No.	142 (cont)
LM End	1.92	Issue Type +	En	Location *	WS
Category	Earthen Levee		GPS Latitude/Longitude		
			Start	End	
Item	Vegetation				
DWR ID	DWR_RD0563_01_s_2014_142				
Action/Comments					
Landscaping Inspector Comments: Landowner has planted oleander, trees and planting box on waterward slope.

Looking southwest at oleanders on waterward shoulder.

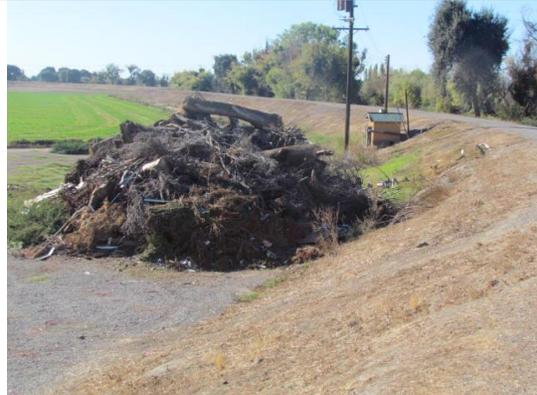
Photo 1 of 1 : FA_2014_RD0563_210_96_20141010_00170.jpg

LM Start	1.98	Rating **	M	Issue No.	96
LM End	1.98	Issue Type +	Ma	Location *	LS
Category	Earthen Levee		GPS Latitude/Longitude		
			Start	End	
Item	Encroachments		38.222094 °	38.222094 °	
			-121.543435 °	-121.543435 °	
DWR ID	DWR_RD0563_01_f_2013_96				
Action/Comments					
Prunings Inspector Comments: Large pruning pile at landward toe.

Looking south at large pruning pile at landward toe.

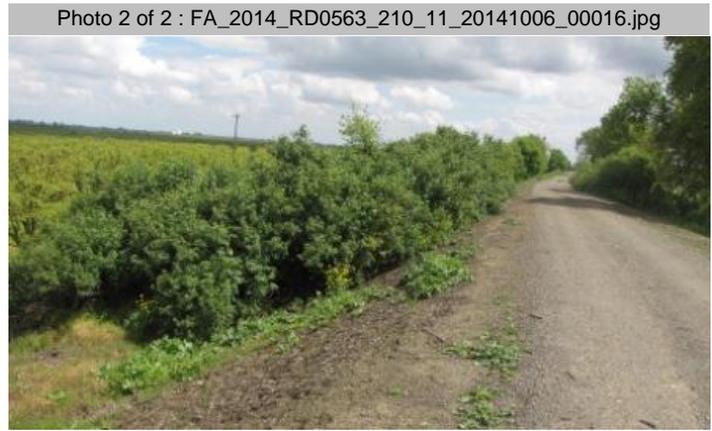
LM Start	2.44	Rating **	M	Issue No.	11 (cont)
LM End	2.45	Issue Type +	Ma	Location *	LS
Category	Earthen Levee		GPS Latitude/Longitude		
			Start	End	
Item	Vegetation		38.216242 °	38.216147 °	
			-121.540835 °	-121.540612 °	
DWR ID	DWR_RD0563_01_s_2012_11				
Action/Comments					
Elderberries are blocking visibility and flood fight capability. Inspector Comments: District is controlling the elderberry.

Looking southeast at elderberry on the landside slope and toe.

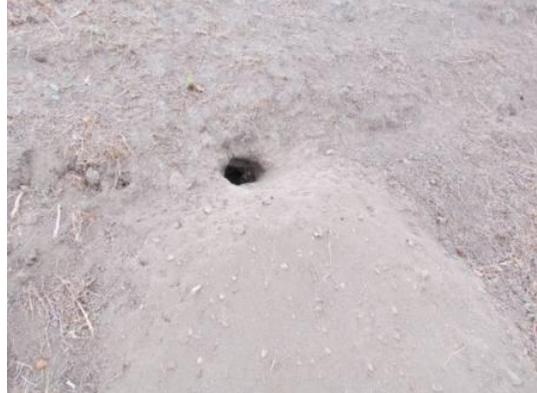
Photo 1 of 4 : FA_2014_RD0563_210_85_20141006_00098.jpg

LM Start	2.58	Rating **	M	Issue No.	85
LM End	2.61	Issue Type +	Ma	Location *	LS
Category	Earthen Levee		GPS Latitude/Longitude		
			Start	End	
Item	Animal Control		38.215082 °	38.214852 °	
			-121.538652 °	-121.538305 °	
DWR ID	DWR_RD0563_01_s_2012_85				
Action/Comments					
No rodents visible, but rodent burrows visible; need to backfill and compact or grout burrows.

Looking west at rodent hole on landside slope.

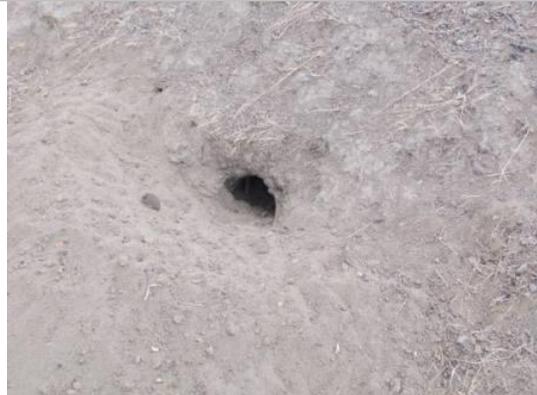
Photo 2 of 4 : FA_2014_RD0563_210_85_20141006_00099.jpg

Looking east at rodent hole on landside slope.

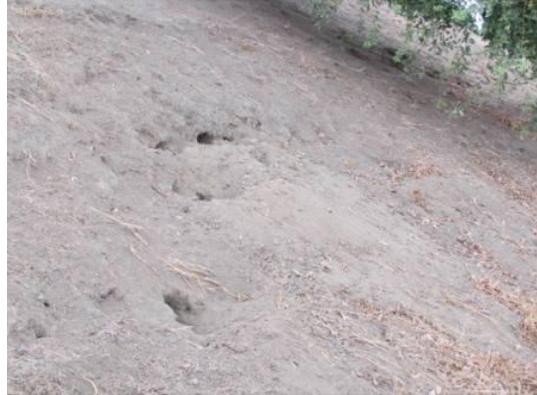
Photo 4 of 4 : FA_2014_RD0563_210_85_20141006_00101.jpg

LM Start	2.58	Rating **	M	Issue No.	85 (cont)
LM End	2.61	Issue Type +	Ma	Location *	LS
Category	Earthen Levee		GPS Latitude/Longitude		
			Start	End	
Item	Animal Control		38.215082 °	38.214852 °	
			-121.538652 °	-121.538305 °	
DWR ID	DWR_RD0563_01_s_2012_85				
Action/Comments					
No rodents visible, but rodent burrows visible; need to backfill and compact or grout burrows.

Looking northeast at rodent holes on landside slope.

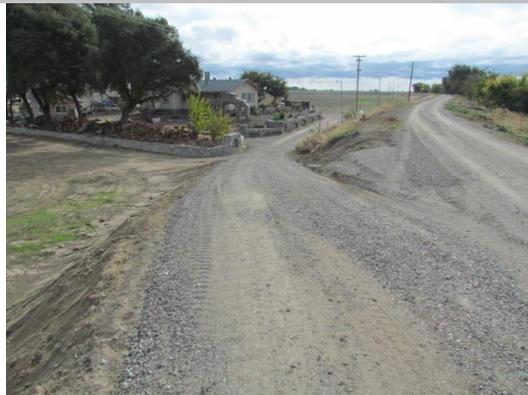
Photo 2 of 2 : FA_2014_RD0563_210_80_20141006_00093.jpg

LM Start	2.62	Rating **	M	Issue No.	80 (cont)
LM End	2.62	Issue Type +	En	Location *	LS
Category	Earthen Levee		GPS Latitude/Longitude		
			Start	End	
Item	Encroachments			°	°
DWR ID	DWR_RD0563_01_f_2012_80				
Action/Comments					
Ramp Inspector Comments: Landowner installed unauthorized ramp on landside slope.

Looking southeast at unauthorized ramp on landside slope.

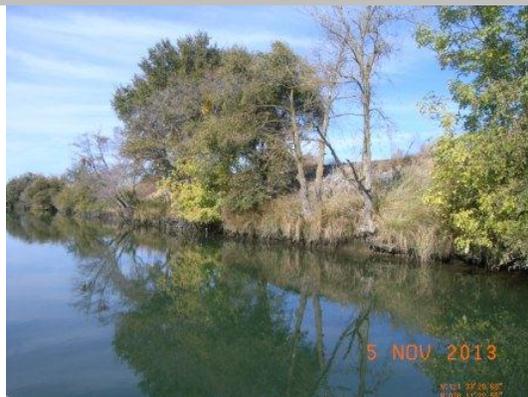
Photo 1 of 1 : FA_2014_RD0563_210_53_20141006_00051.jpg

LM Start	2.67	Rating **	M	Issue No.	53
LM End	2.87	Issue Type +	Ma	Location *	WS
Category	Supplemental		GPS Latitude/Longitude		
			Start	End	
Item	USACE Erosion Survey		38.214133 °	38.211737 °	°
			-121.537778 °	-121.535436 °	°
DWR ID	DWR_RD0563_01_f_2014_53				
Action/Comments					
Inspector Comments: 1997 - Loss of rock at toe; pockets of upper berm erosion; very narrow berm width; toe rock problem; erosion pockets in rock. 2002 - New brush boxes at toe of the worst spots. 2005 - Upstream 200 ft removed because of the wide berm. 2006 - Some rock repair pockets behind the brush boxes at the upstream end. 2010 - Some new erosion. 2013: New rock placed on the levee slope. [2013 Site ID: GEO_9-3_L]

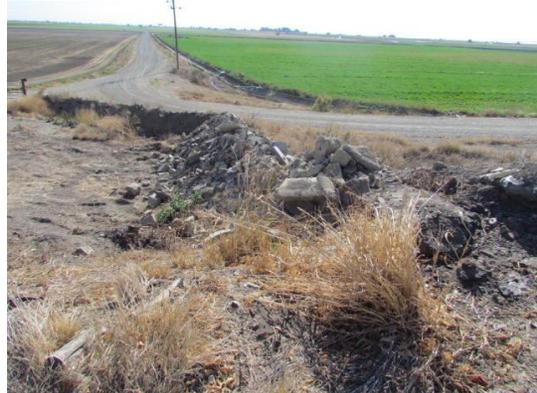
Photo 2 of 2 : FA_2014_RD0563_210_104_20141006_00126.jpg

LM Start	2.95	Rating **	M	Issue No.	104
LM End	2.95	Issue Type +	Ma	Location *	LS
Category	Earthen Levee		GPS Latitude/Longitude		
			Start	End	
Item	Encroachments		38.210966 °	38.210966 °	
			-121.534813 °	-121.534813 °	
DWR ID	DWR_RD0563_01_f_2013_104				
Action/Comments					
Material Inspector Comments: Landowner stockpiled concrete rubble on landward and waterward slope to stop trespassers. Landowner should replace the stockpile with a proper fence.

Looking east at concrete rubble on landward slope.

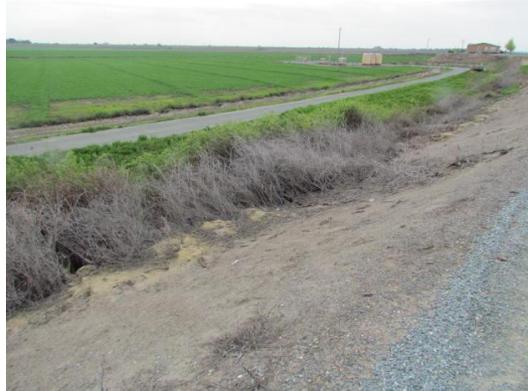
Photo 1 of 2 : FA_2014_RD0563_210_84_20141006_00096.jpg

LM Start	3.50	Rating **	M	Issue No.	84
LM End	3.50	Issue Type +	Ma	Location *	LS
Category	Earthen Levee		GPS Latitude/Longitude		
			Start	End	
Item	Vegetation		°	°	
DWR ID	DWR_RD0563_01_f_2012_84				
Action/Comments					
Remove the wild growth other than native grasses from the levee slopes. Inspector Comments: Vegetation at landward toe.

Looking southeast at dead berryvines on landward toe.

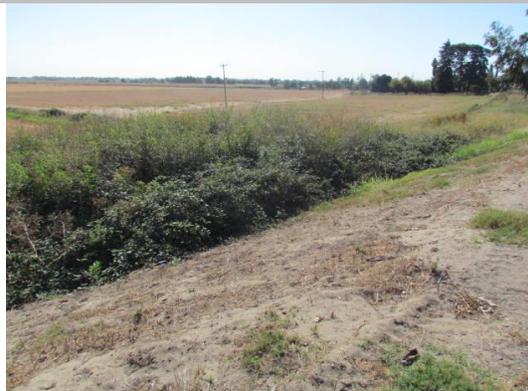
Photo 2 of 2 : FA_2014_RD0563_210_84_20141006_00097.jpg

Looking southeast at dense berryvines on landward toe.

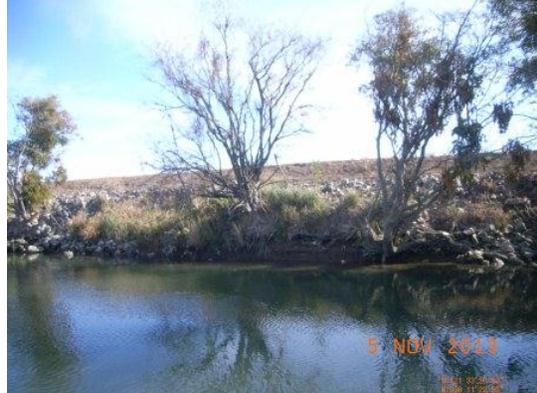
Photo 1 of 1 : FA_2014_RD0563_210_51_20141006_00050.jpg

LM Start	4.00	Rating **	M	Issue No.	51
LM End	4.10	Issue Type +	Ma	Location *	WS
Category	Supplemental		GPS Latitude/Longitude		
			Start	End	
Item	USACE Erosion Survey		38.200733 °	38.199925 °	
			-121.542571 °	-121.544249 °	
DWR ID	DWR_RD0563_01_f_2014_51				
Action/Comments					
Inspector Comments: 1997 - Narrow eroding berm upstream of existing rock. 2001 - Staked, low fascine walls at bankline. 2011 - Minor new erosion. Site extended downstream. 2012 - Rock repair failing in one erosion pocket. 2013: No observed changes. [2013 Site ID: GEO_8-3_L]

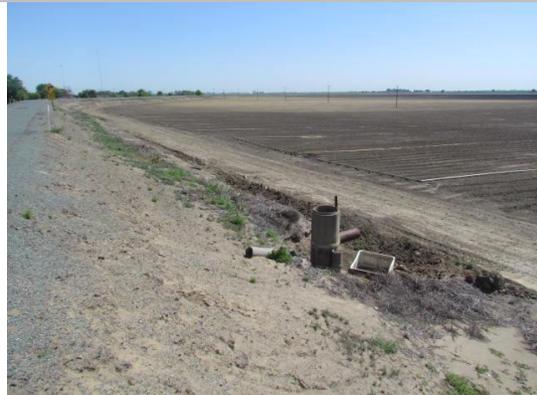
Photo 1 of 2 : FA_2014_RD0563_210_17_20141006_00021.jpg

LM Start	4.05	Rating **	M	Issue No.	17
LM End	4.19	Issue Type +	En	Location *	LS
Category	Earthen Levee		GPS Latitude/Longitude		
			Start	End	
Item	Encroachments		38.200238 °	38.198830 °	
			-121.543308 °	-121.544913 °	
DWR ID	DWR_RD0563_01_s_2013_17				
Action/Comments					
Ditch

Looking northeast at irrigation ditch on landward toe.

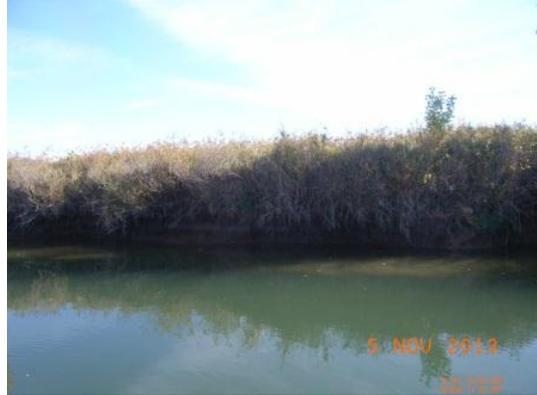
Photo 1 of 1 : FA_2014_RD0563_210_49_20141006_00047.jpg

LM Start	5.04	Rating **	M	Issue No.	49
LM End	5.14	Issue Type +	Ma	Location *	WS
Category	Supplemental			GPS Latitude/Longitude	
				Start	End
Item	USACE Erosion Survey			38.190073 °	38.189524 °
				-121.556307 °	-121.557227 °
DWR ID	DWR_RD0563_01_f_2014_49				
Action/Comments					
Inspector Comments: 2009 - Small scallops of erosion into the levee toe behind brush boxes. 2011 - Minor new erosion. 2012 - Site extended upstream to account for addition erosion pockets. 2013: No observed changes. [2013 Site ID: GEO_7-2_L]

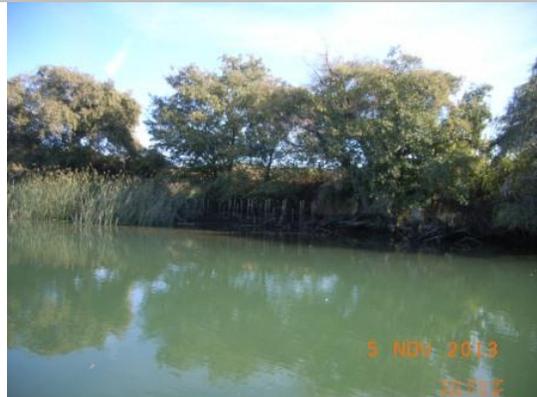
Photo 1 of 1 : FA_2014_RD0563_210_48_20141006_00046.jpg

LM Start	5.26	Rating **	U	Issue No.	48
LM End	5.44	Issue Type +	Ma	Location *	WS
Category	Supplemental			GPS Latitude/Longitude	
				Start	End
Item	USACE Erosion Survey			38.188216 °	38.185968 °
				-121.558442 °	-121.561667 °
DWR ID	DWR_RD0563_01_f_2014_48				
Action/Comments					
Inspector Comments: 1997 - Deep pockets of erosion into a narrow berm just downstream of the rock. 2000 - Scallops in banks with small colored flags, some new biotech rolls in with older rolls in the scallops. 2001 - Staked , low fascine walls at the bankline. 2011 - Site upgraded to CRITICAL. Site extended upstream due to new erosion pocket. New tree popouts and new erosion. 2013: Pipe observed at upstream end of site. [2013 Site ID: GEO_6-8_L]

USACE 2013 Photo #1

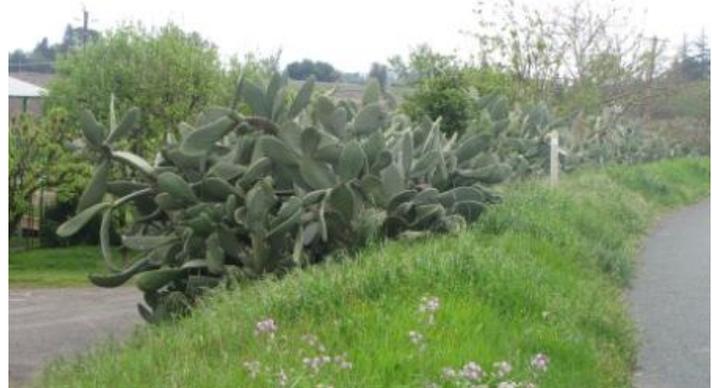
Photo 1 of 2 : FA_2014_RD0563_210_22_20141006_00025.jpg

LM Start	6.04	Rating **	U	Issue No.	22
LM End	6.08	Issue Type +	Ma	Location *	LS
Category	Earthen Levee			GPS Latitude/Longitude	
				Start	End
Item	Vegetation			38.181965 °	38.181763 °
				-121.569913 °	-121.570447 °
DWR ID	DWR_RD0563_01_s_2012_22				
Action/Comments					
Remove the wild growth other than native grasses from the levee slopes. Inspector Comments: Large cactus on landward slope.

Looking at north end of cactus on the landside slope.

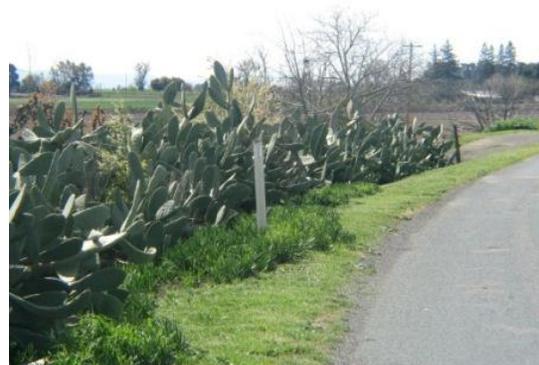
Photo 2 of 2 : FA_2014_RD0563_210_22_20141006_00026.jpg

Large cactus plant on landward slope from LM 6.04 to 6.08

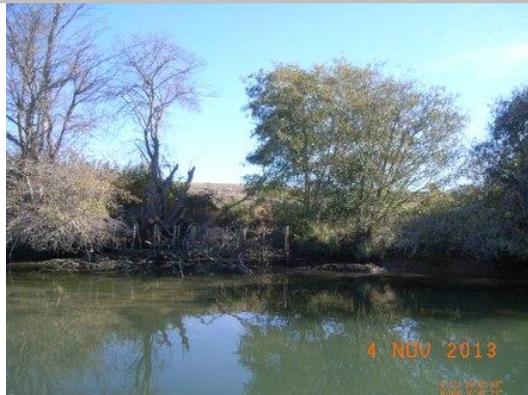
Photo 1 of 1 : FA_2014_RD0563_210_45_20141006_00044.jpg

LM Start	6.39	Rating **	M	Issue No.	45
LM End	6.60	Issue Type +	Ma	Location *	WS
Category	Supplemental		GPS Latitude/Longitude		
			Start	End	
Item	USACE Erosion Survey		38.180462 °	38.179319 °	
			-121.577895 °	-121.578566 °	
DWR ID	DWR_RD0563_01_f_2014_45				
Action/Comments					
Inspector Comments: 2013: Erosion pockets into the levee prism. Erosion pockets primarily located behind unmaintained brush boxes. [2013 Site ID: GEO_5-8_L]

USACE 2013 Photo #1

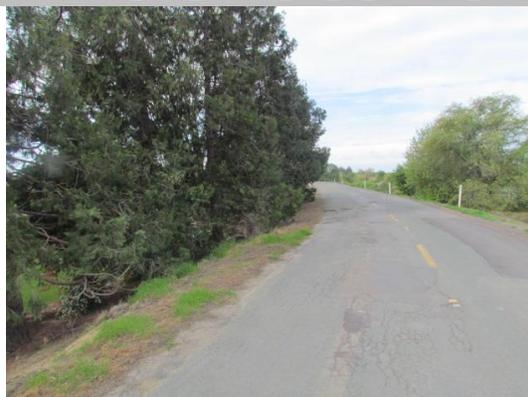
Photo 1 of 1 : FA_2014_RD0563_210_23_20141006_00027.jpg

Looking south at trees on landward shoulder.

LM Start	6.39	Rating **	M	Issue No.	23
LM End	6.41	Issue Type +	Ma	Location *	LS
Category	Earthen Levee		GPS Latitude/Longitude		
			Start	End	
Item	Trim / Thin Trees		38.181273 °	38.181165 °	
			-121.575873 °	-121.576217 °	
DWR ID	DWR_RD0563_01_s_2012_23				
Action/Comments					
Trim trees to at least five feet above ground level.

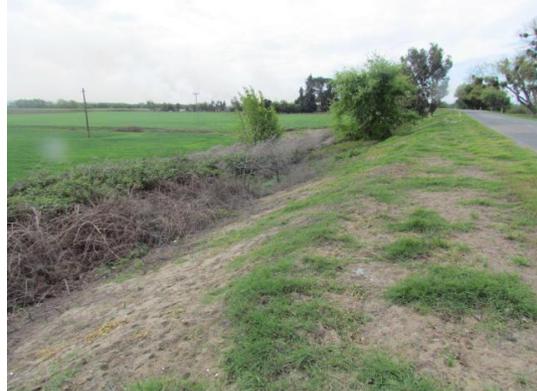
Photo 1 of 2 : FA_2014_RD0563_210_145_20141006_00132.jpg

LM Start	6.72	Rating **	U	Issue No.	145
LM End	6.80	Issue Type +	Ma	Location *	LS
Category	Earthen Levee		GPS Latitude/Longitude		
			Start	End	
Item	Vegetation		°	°	
			°	°	
DWR ID	DWR_RD0563_01_s_2014_145				
Action/Comments					
Remove the wild growth other than native grasses from the levee slopes. Inspector Comments: Dense vegetation blocking view of landward toe.

Looking south at dense dead berryvines at landward toe.

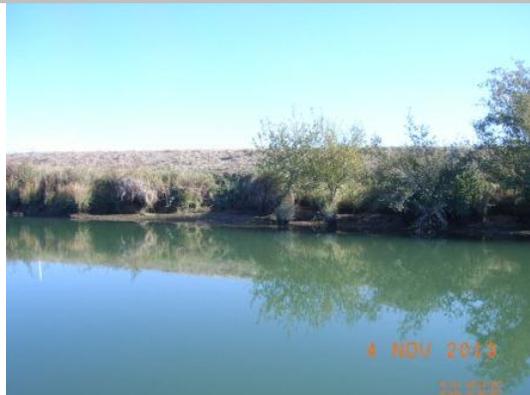
Photo 1 of 1 : FA_2014_RD0563_210_44_20141006_00043.jpg

LM Start	6.78	Rating **	M	Issue No.	44
LM End	7.44	Issue Type +	Ma	Location *	WS
Category	Supplemental		GPS Latitude/Longitude		
			Start	End	
Item	USACE Erosion Survey		38.176861 °	38.167959 °	
			-121.579747 °	-121.581616 °	
DWR ID	DWR_RD0563_01_f_2014_44				
Action/Comments					
Inspector Comments: 1997 - Pocket erosion into the toe of the levee. 2000 - Scallops in banks with small colored flags, biotech rolls present. 2001 - Staked, low fascine walls at bankline. 2003 - Still have visibly bad spots, especially at the upstream end. 2005 - Some new brush bundles in the brush boxes; some with missing bundles. Some boxes too low relative to high tide. 2010 - Site extended upstream. 2011 -

USACE 2013 Photo #1

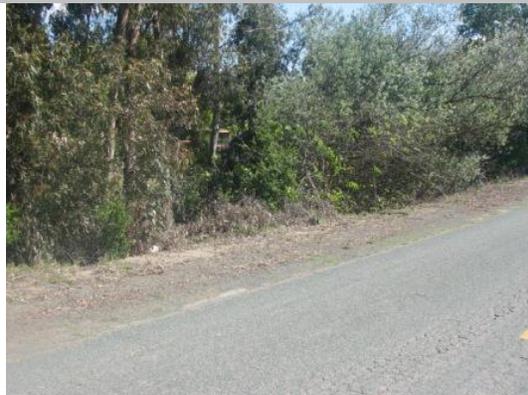
Photo 1 of 2 : FA_2014_RD0563_210_27_20141006_00030.jpg

Front view of dense trees along landside shoulder and slope.

LM Start	6.90	Rating **	U	Issue No.	27
LM End	6.94	Issue Type +	Ma	Location *	LS
Category	Earthen Levee		GPS Latitude/Longitude		
			Start	End	
Item	Trim / Thin Trees		38.175190 °	38.174610 °	
			-121.580035 °	-121.579948 °	
DWR ID	DWR_RD0563_01_s_2012_27				
Action/Comments					
Trim trees to at least five feet above ground level.

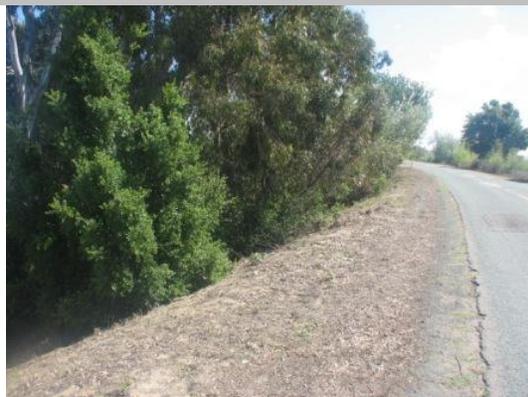
Photo 2 of 2 : FA_2014_RD0563_210_27_20141006_00031.jpg

Side view of dense trees along landside slope and shoulder.

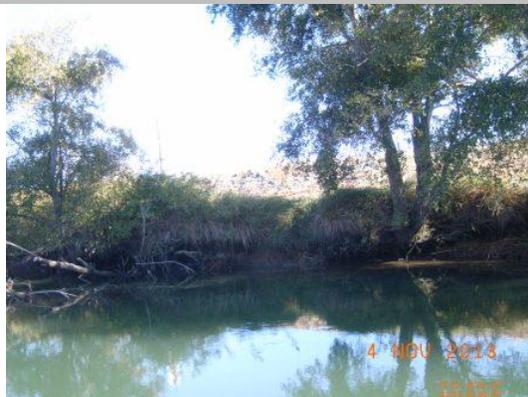
Photo 1 of 1 : FA_2014_RD0563_210_43_20141006_00042.jpg

LM Start	7.64	Rating **	U	Issue No.	43
LM End	7.97	Issue Type +	Ma	Location *	WS
Category	Supplemental		GPS Latitude/Longitude		
			Start	End	
Item	USACE Erosion Survey		38.164462 °	38.160888 °	
			-121.583092 °	-121.584807 °	
DWR ID	DWR_RD0563_01_f_2014_43				
Action/Comments					
Inspector Comments: 1997 - Pocket erosion at upstream end and into the levee toe under the Alder trees. 2003 - New brush boxes with wattles on bank. 2004 - No brush boxes. 2005 - Site extended from the downstream side of the bridge. Whole bank is vertical. 2010 - Some minor new erosion. 2011 - Site upgraded to CRITICAL. New erosion pockets throughout the site. Sites 4.5, and 4.6 were combined. 2013: No observed changes. [2013 Site ID: GEO_4-5_L]

USACE 2013 Photo #1

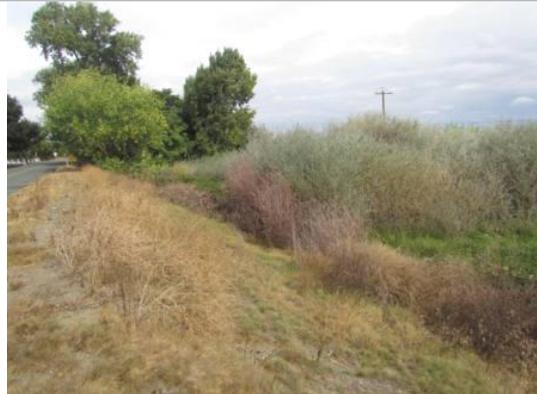
Photo 1 of 4 : FA_2014_RD0563_210_90_20141006_00106.jpg

LM Start	7.97	Rating **	M	Issue No.	90
LM End	8.10	Issue Type +	Ma	Location *	LS
Category	Earthen Levee		GPS Latitude/Longitude		
			Start	End	
Item	Vegetation		38.160800 °	38.160487 °	
			-121.584598 °	-121.584717 °	
DWR ID	DWR_RD0563_01_s_2012_90				
Action/Comments					
Remove the wild growth other than native grasses from the levee slopes. Inspector Comments: Berryvines and willows on landside toe.

Looking northeast at dense vegetation on landside toe.

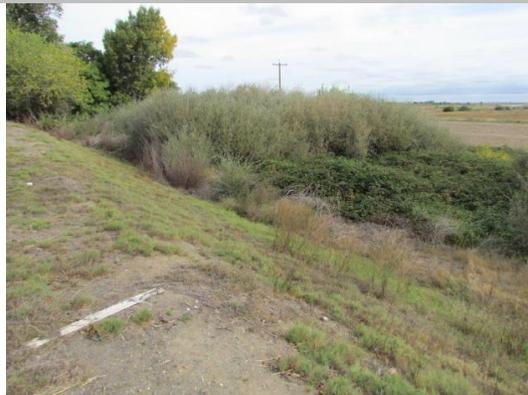
Photo 3 of 4 : FA_2014_RD0563_210_90_20141006_00108.jpg

LM Start	7.97	Rating **	M	Issue No.	90 (cont)
LM End	8.10	Issue Type +	Ma	Location *	LS
Category	Earthen Levee		GPS Latitude/Longitude		
			Start	End	
Item	Vegetation		38.160800 °	38.160487 °	
			-121.584598 °	-121.584717 °	
DWR ID	DWR_RD0563_01_s_2012_90				
Action/Comments					
Remove the wild growth other than native grasses from the levee slopes. Inspector Comments: Berryvines and willows on landside toe.

Looking northeast at dense vegetation on landside toe. (2012 Fall Inspection)

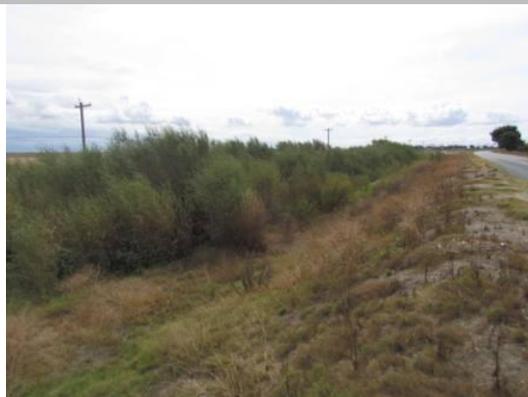
Photo 4 of 4 : FA_2014_RD0563_210_90_20141006_00109.jpg

Looking southwest at dense vegetation on landside toe.

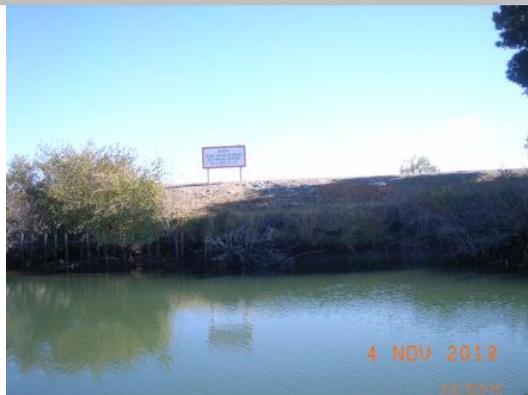
Photo 1 of 1 : FA_2014_RD0563_210_42_20141006_00041.jpg

LM Start	8.05	Rating **	M	Issue No.	42
LM End	8.19	Issue Type +	Ma	Location *	WS
Category	Supplemental		GPS Latitude/Longitude		
			Start	End	
Item	USACE Erosion Survey		38.160261 °	38.157625 °	
			-121.585056 °	-121.586543 °	
DWR ID	DWR_RD0563_01_f_2014_42				
Action/Comments					
Inspector Comments: 1997 - Pockets of erosion into the levee toe. 1999 - Minor rock riprap and willow bundles place in a couple of spots. 2001 - Staked, low fascine walls at bankline. 2003 - Small unprotected pockets still eroding. 2004 - Numerous brush boxes, some falling apart, some with new bundles. 2005 - Some new brush boxes installed; some boxes are empty. Levee slope and banks still look bad

USACE 2013 Photo #1

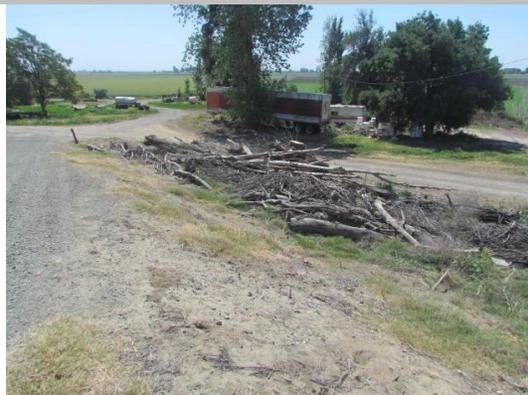
Photo 1 of 2 : FA_2014_RD0563_210_73_20141006_00079.jpg

LM Start	9.50	Rating **	U	Issue No.	73
LM End	9.50	Issue Type +	Ma	Location *	LS
Category	Earthen Levee		GPS Latitude/Longitude		
			Start	End	
Item	Encroachments		38.145957 °	38.145957 °	
			-121.589653 °	-121.589653 °	
DWR ID	DWR_RD0563_01_s_2012_73				
Action/Comments					
Prunings Inspector Comments: Large pruning pile on landward toe.

Looking east at prunings on landward slope. (Spring 2013)

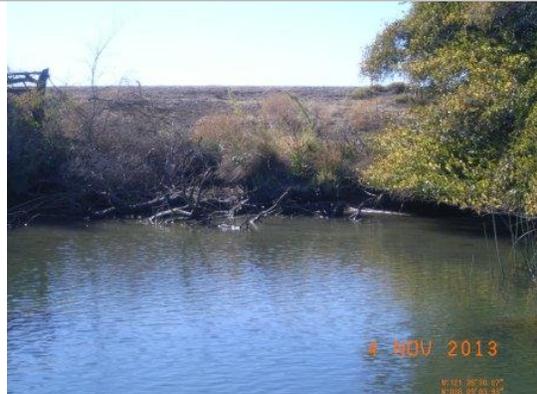
Photo 1 of 1 : FA_2014_RD0563_210_40_20141006_00039.jpg

LM Start	9.74	Rating **	M	Issue No.	40
LM End	9.92	Issue Type +	Ma	Location *	WS
Category	Supplemental		GPS Latitude/Longitude		
			Start	End	
Item	USACE Erosion Survey		38.150820 °	38.150647 °	
			-121.593650 °	-121.596858 °	
DWR ID	DWR_RD0563_01_f_2014_40				
Action/Comments					
Inspector Comments: 1997 - Erosion pockets into the toe of the levee. 2001 - Staked low fascine walls at the bankline. 2004 - Numerous "Brush Boxes." 2005 - Some new bundles in the brush boxes. 2012 - Site extended downstream to account for new bank sloughing. 2013: Some rock added to the upstream end by the local RD. [2013 Site ID: GEO_2-5_L]

USACE 2013 Photo #1

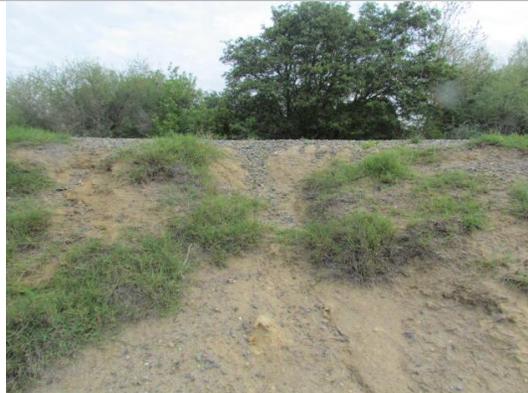
Photo 1 of 2 : FA_2014_RD0563_210_99_20141006_00120.jpg

Looking west at minor erosion on landward shoulder and slope.

LM Start	9.83	Rating **	M	Issue No.	99
LM End	9.83	Issue Type +	Ma	Location *	LS
Category	Earthen Levee		GPS Latitude/Longitude		
			Start	End	
Item	Erosion / Bank Caving		38.149905 °	38.149905 °	
			-121.592910 °	-121.592910 °	
DWR ID	DWR_RD0563_01_s_2013_99				
Action/Comments					
Note and monitor erosion site.

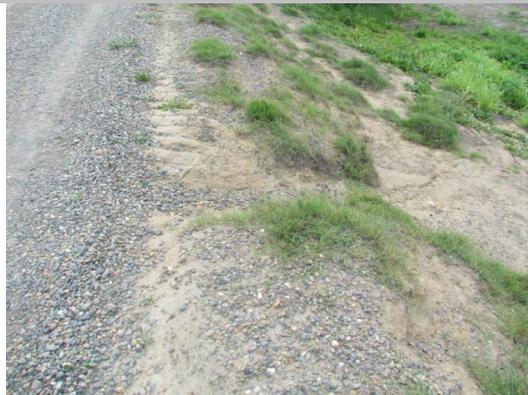
Photo 2 of 2 : FA_2014_RD0563_210_99_20141006_00121.jpg

Looking north at minor erosion on landward shoulder and slope.

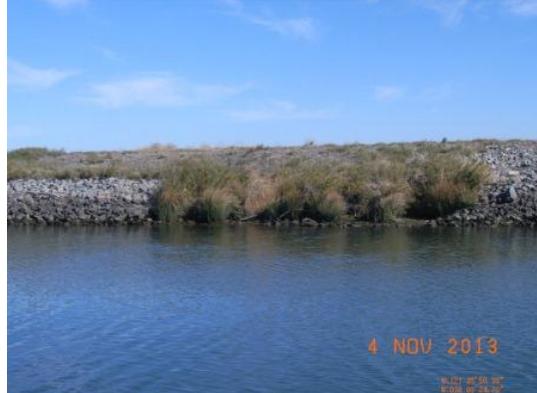
Photo 1 of 1 : FA_2014_RD0563_210_39_20141006_00038.jpg

LM Start	10.46	Rating **	M	Issue No.	39
LM End	10.76	Issue Type +	Ma	Location *	WS
Category	Supplemental		GPS Latitude/Longitude		
			Start	End	
Item	USACE Erosion Survey		38.143519 °	38.139918 °	
			-121.599677 °	-121.596986 °	
DWR ID	DWR_RD0563_01_f_2014_39				
Action/Comments					
Inspector Comments: 1997 - Old damaged rock riprap along the toe. 1999 - Downstream end (400 ft) repaired with rock. 2002 - New rock/concrete rubble section on the downstream end. 2004 - Small pocket repairs at the downstream end. 2005 - Some new bundles in the brush boxes. 2012 - Some rock has been placed in last year. 2013: No observed changes. [2013 Site ID: GEO_1-7_L]

USACE 2013 Photo #1
