**Flood Control Project Maintenance
Levee Inspections**

Fall 2014 Levee Maintenance Deficiency Summary Report

Reclamation District No. 0563 Tyler Island

Waterway		Bank	Unit Miles	
Unit No. 01 Georgiana Slough (Tyler Island)		Left	12.11	
	Spring (March - May)	Summer (June - August)	(September - November) Fall	Winter (December - February)
Unit Maintenance Rating (Fall Only)			U	
Date of Inspection	03/25/2014 - 03/26/2014		10/09/2014 - 10/09/2014	
DWR Inspector	Richard Willoughby		Richard Willoughby	
Accompanied By	Steve Mello RD 563		Steve Mello RD 563

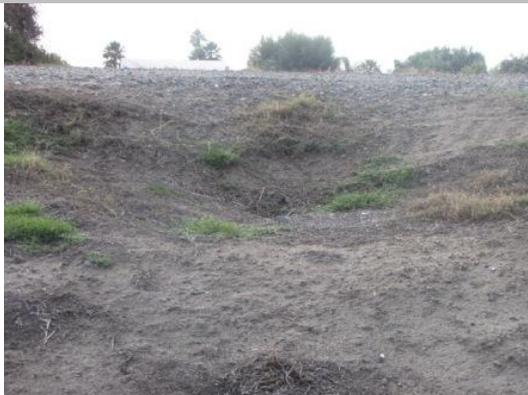
Photo 3 of 4 : FA_2014_RD0563_210_76_20141006_00085.jpg

LM Start	10.77	Rating **	U	Issue No.	76 (cont)
LM End	10.77	Issue Type +	Ma	Location *	LS
Category	Earthen Levee			GPS Latitude/Longitude	
				Start	End
Item	Slope Stability			38.141940 °	38.141940 °
				-121.598033 °	-121.598033 °
DWR ID	DWR_RD0563_01_s_2012_76				
Action/Comments					
Repair slope instability. Inspector Comments: Deep depression on landside shoulder and slope; possible pipe collapse.

Looking west at depression on landside shoulder and slope from landside toe.

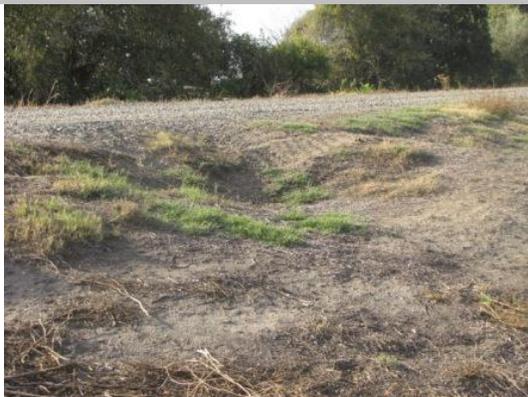
Photo 4 of 4 : FA_2014_RD0563_210_76_20141006_00086.jpg

Looking west at depression on landside shoulder and slope.

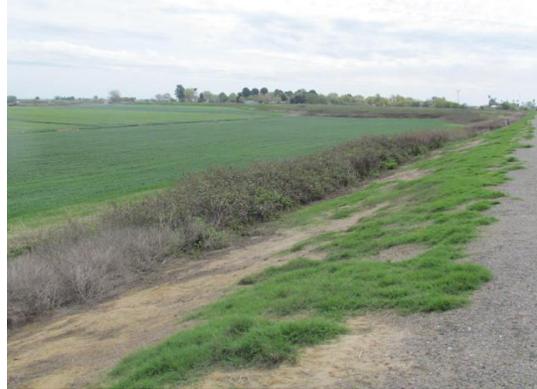
Photo 2 of 2 : FA_2014_RD0563_210_100_20141006_00123.jpg

LM Start	11.49	Rating **	U	Issue No.	100 (cont)
LM End	12.04	Issue Type +	Ma	Location *	LS
Category	Earthen Levee		GPS Latitude/Longitude		
			Start	End	
Item	Vegetation		38.134880 °	38.130448 °	
			-121.592180 °	-121.587087 °	
DWR ID	DWR_RD0563_01_s_2013_100				
Action/Comments					
Remove the wild growth other than native grasses from the levee slopes. Inspector Comments: Wild rose or grape vines on landward slope and toe.

Looking south at dense vegetation at landward toe.

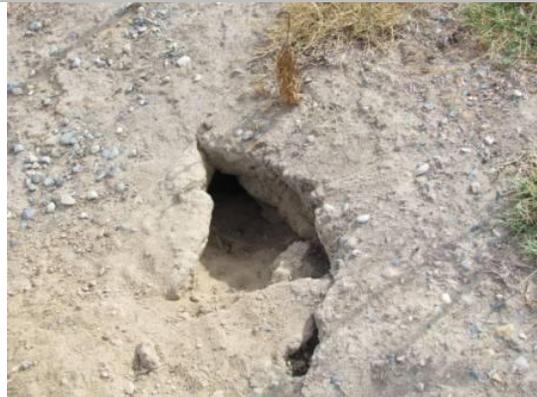
Photo 1 of 3 : FA_2014_RD0563_210_91_20141006_00110.jpg

LM Start	11.63	Rating **	M	Issue No.	91
LM End	11.63	Issue Type +	Ma	Location *	LS
Category	Earthen Levee		GPS Latitude/Longitude		
			Start	End	
Item	Animal Control		38.131943 °	38.131943 °	
			-121.588912 °	-121.588912 °	
DWR ID	DWR_RD0563_01_s_2012_91				
Action/Comments					
No rodents visible, but rodent burrows visible; need to backfill and compact or grout burrows.

Looking east at rodent hole on landside slope.

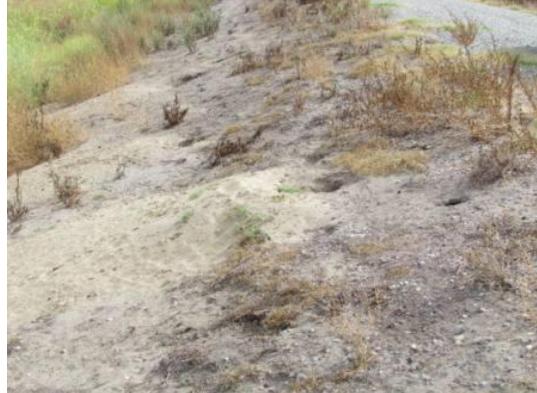
Photo 3 of 3 : FA_2014_RD0563_210_91_20141006_00112.jpg

LM Start	11.63	Rating **	M	Issue No.	91 (cont)
LM End	11.63	Issue Type +	Ma	Location *	LS
Category	Earthen Levee			GPS Latitude/Longitude	
				Start	End
Item	Animal Control			38.131943 °	38.131943 °
				-121.588912 °	-121.588912 °
DWR ID	DWR_RD0563_01_s_2012_91				
Action/Comments					
No rodents visible, but rodent burrows visible; need to backfill and compact or grout burrows.

Looking south at rodent holes on landside slope.

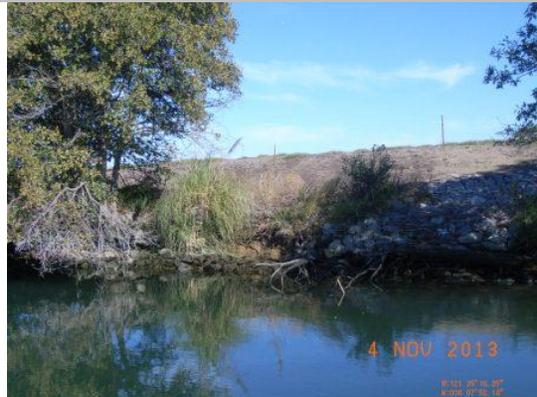
Photo 1 of 1 : FA_2014_RD0563_210_38_20141006_00037.jpg

LM Start	11.69	Rating **	M	Issue No.	38
LM End	11.79	Issue Type +	Ma	Location *	WS
Category	Supplemental			GPS Latitude/Longitude	
				Start	End
Item	USACE Erosion Survey			38.131126 °	38.129948 °
				-121.588337 °	-121.585026 °
DWR ID	DWR_RD0563_01_f_2014_38				
Action/Comments					
Inspector Comments: 1997 - Erosion pockets into the levee toe. 1999 - Some small pockets fixed with rock riprap. 2002 - New "brush boxes" along the bank toe. 2005 - Brush boxes are empty. Some pockets are filled with new stone. 2006 - Some new rock at the downstream end (~100 ft long). Several small pockets of new rock in scallops. Brush boxes in poor to fair condition. 2010 - Site looks a little worse, some toe rock but still has erosion scars at lower to mid slope. 2011 - Site upgraded to CRITICAL. Significant new erosion. Erosion scallops are vertical and almost the height of the levee. 2012 - Rock has been placed in some of the erosion scallops and therefore the site is no longer critical. 2013: Site shortened site. The downstream half of site was repaired by RD. Pipe no longer in site limits [2013 Site ID: GEO_0-3_L]

USACE 2013 Photo #1

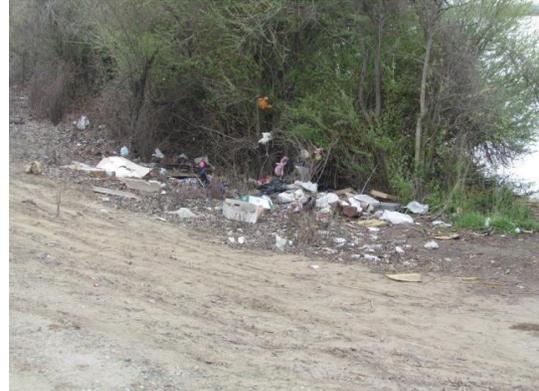
Photo 1 of 1 : FA_2014_RD0563_210_107_20141006_00127.jpg

LM Start	12.21	Rating **	A/W	Issue No.	107
LM End	12.21	Issue Type +	Ma	Location *	WS
Category	Earthen Levee			GPS Latitude/Longitude	
				Start	End
Item	Encroachments			38.130776 °	38.130776 °
				-121.579063 °	-121.579063 °
DWR ID	DWR_RD0563_01_f_2013_107				
Action/Comments					
Garbage

Looking southwest at garbage at waterward slope and toe.
