**Flood Control Project Maintenance
Levee Inspections**
LMA District Cover Sheet
Spring 2011 Levee Inspection Results

Reclamation District No. 0563 Tyler Island

Levee Inspection Report By Mile - Spring 2011

Waterway	Bank	Unit Miles	Inspection Start/End	Inspector
Unit No. 01 Georgiana Slough (Tyler Island)	Left	12.38	03/22/2011 03/28/2011	Richard Willoughby

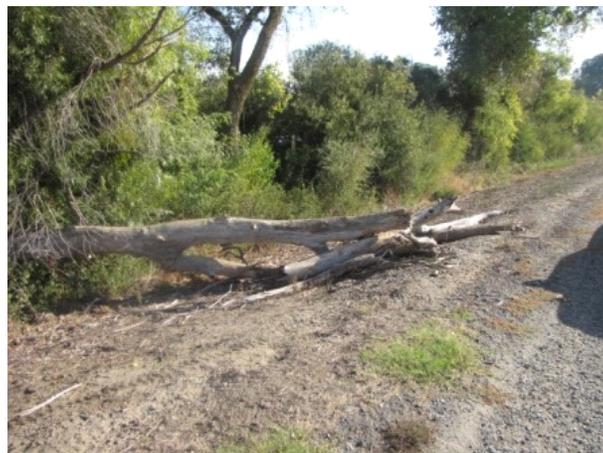
Levee Mile Report Line	11
Start Levee Mile	1.06
End Levee Mile	1.06
Location	Water Side
Category	Earthen Levee
Item	Encroachments
Looking north at downed tree on waterside slope.	
richard_s_20110215_292.jpg

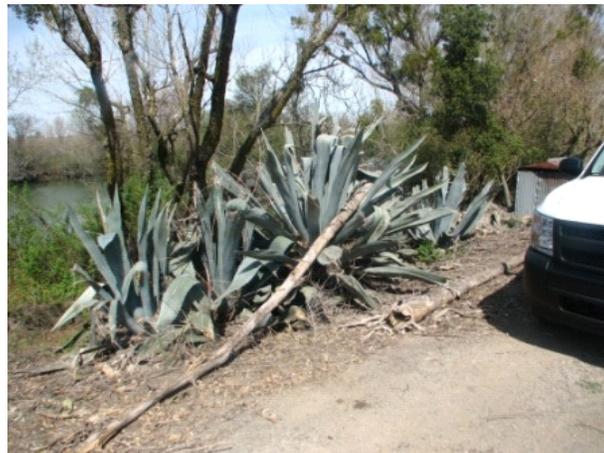
Levee Mile Report Line	18
Start Levee Mile	1.44
End Levee Mile	1.48
Location	Water Side
Category	Earthen Levee
Item	Vegetation

Century plant on waterward shoulder at LM 1.42

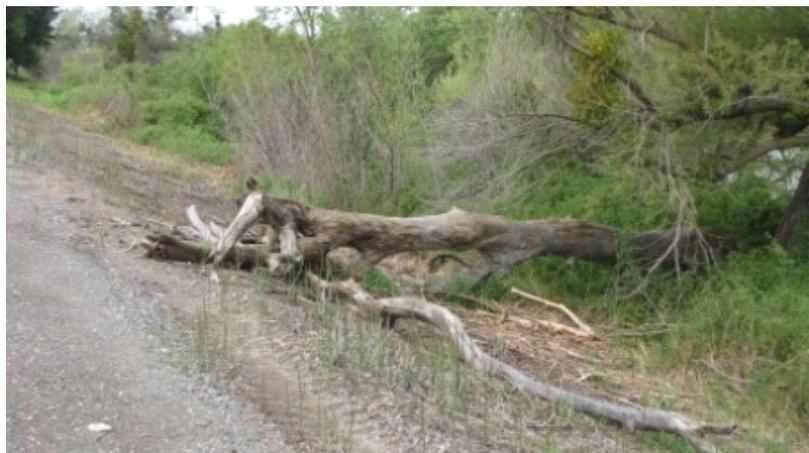
Levee Mile Report Line	20
Start Levee Mile	1.46
End Levee Mile	1.46
Location	Water Side
Category	Earthen Levee
Item	Encroachments
Looking at tree limb on waterside slope.	
richard_s_20110215_236.jpg

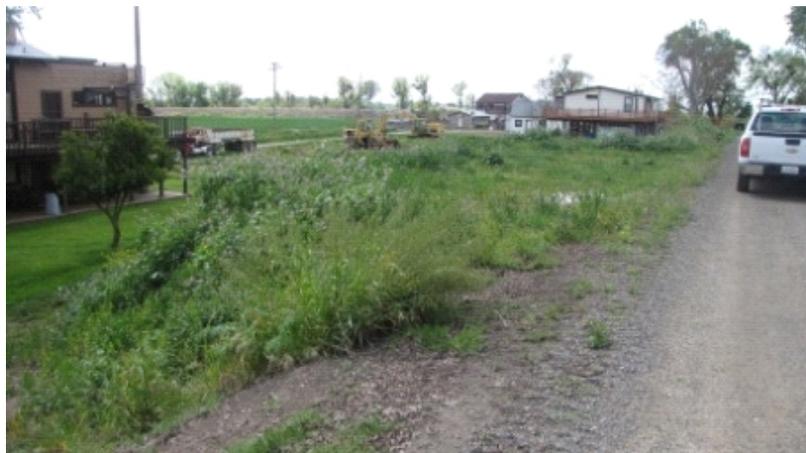
Levee Mile Report Line	24
Start Levee Mile	1.86
End Levee Mile	1.86
Location	Land Side
Category	Earthen Levee
Item	Encroachments
Looking southeast at earthen pad on landside shoulder covering retaining wall.	
richard_s_20110215_268.jpg

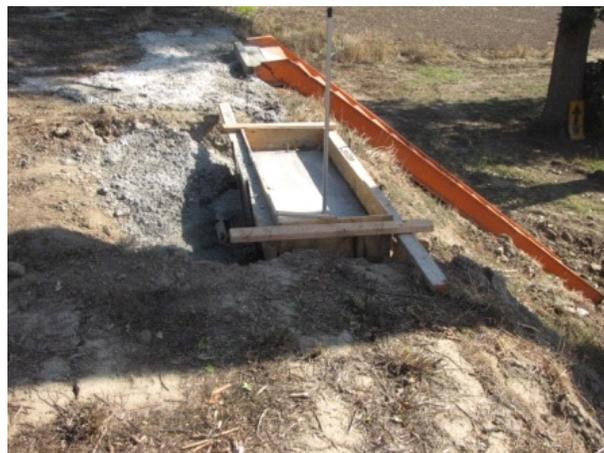
Levee Mile Report Line	24
Start Levee Mile	1.86
End Levee Mile	1.86
Location	Land Side
Category	Earthen Levee
Item	Encroachments
Looking north at deadman for metal walkway on earthen pad on landside shoulder.	
richard_s_20110215_271.jpg

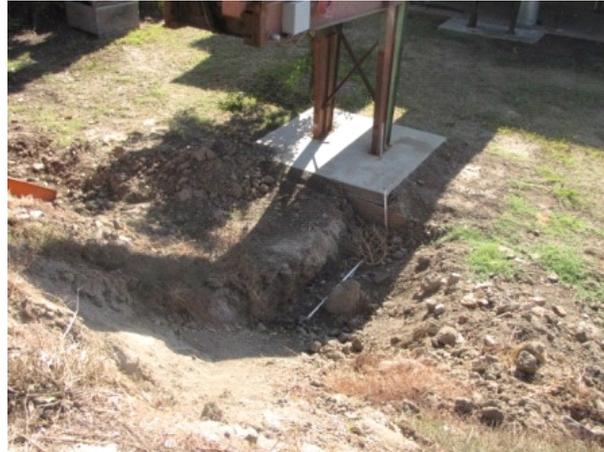
Levee Mile Report Line	24
Start Levee Mile	1.86
End Levee Mile	1.86
Location	Land Side
Category	Earthen Levee
Item	Encroachments

Looking east at electrical conduit in trench on landside toe and concrete pad for walkway.

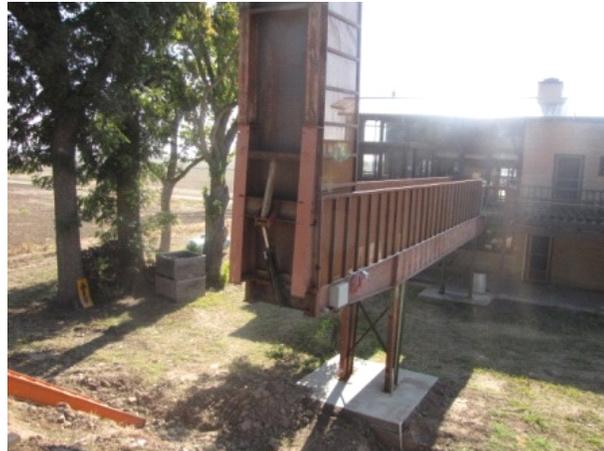
Levee Mile Report Line	24
Start Levee Mile	1.86
End Levee Mile	1.86
Location	Land Side
Category	Earthen Levee
Item	Encroachments

Looking east at metal walkway on landside.

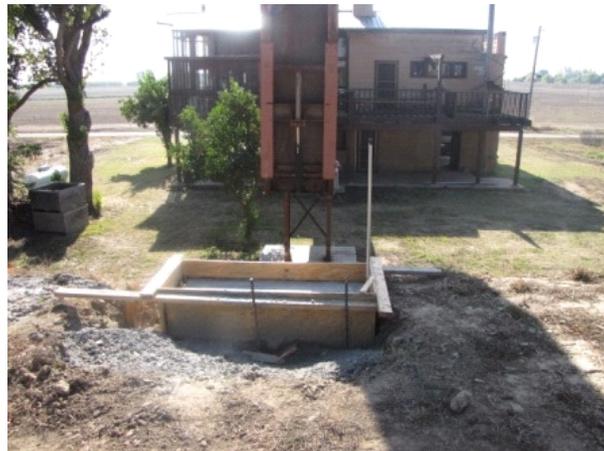
Levee Mile Report Line	24
Start Levee Mile	1.86
End Levee Mile	1.86
Location	Land Side
Category	Earthen Levee
Item	Encroachments

Looking east at deadman on landside shoulder.

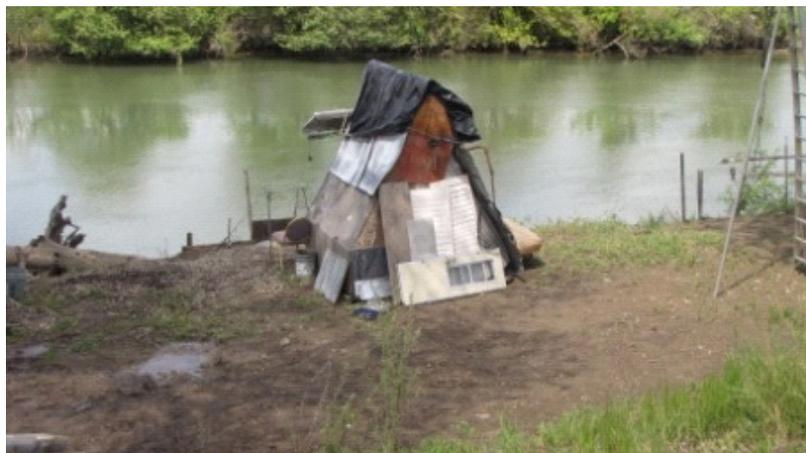
Levee Mile Report Line	25
Start Levee Mile	1.94
End Levee Mile	1.94
Location	Water Side
Category	Earthen Levee
Item	Encroachments
Looking west at shed on waterside berm.	
richard_s_20110215_239.jpg

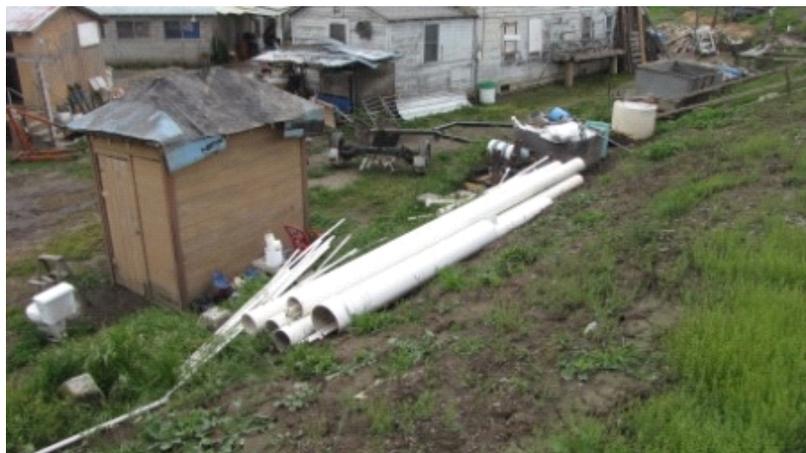
Levee Mile Report Line	26
Start Levee Mile	1.96
End Levee Mile	1.98
Location	Land Side
Category	Earthen Levee
Item	Encroachments
Looking southeast at material and equipment on landside slope and toe.	
richard_s_20110215_237.jpg

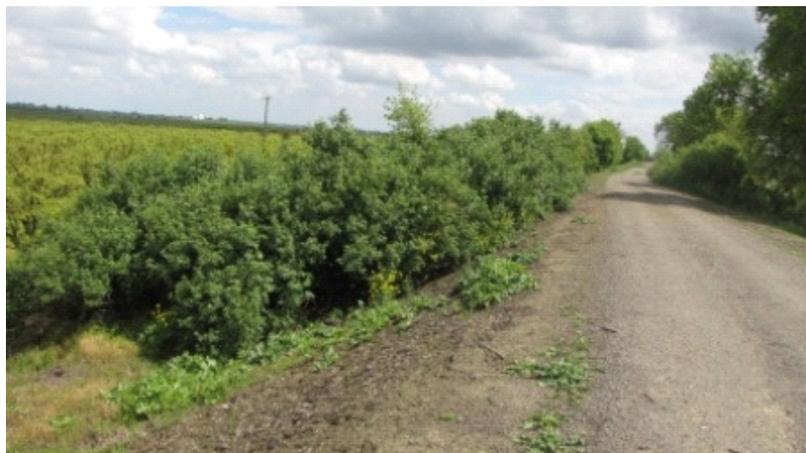
Levee Mile Report Line	31
Start Levee Mile	2.44
End Levee Mile	2.45
Location	Land Side
Category	Earthen Levee
Item	Vegetation
Looking southeast at elderberry on the landside slope and toe.	
richard_s_20110215_238.jpg

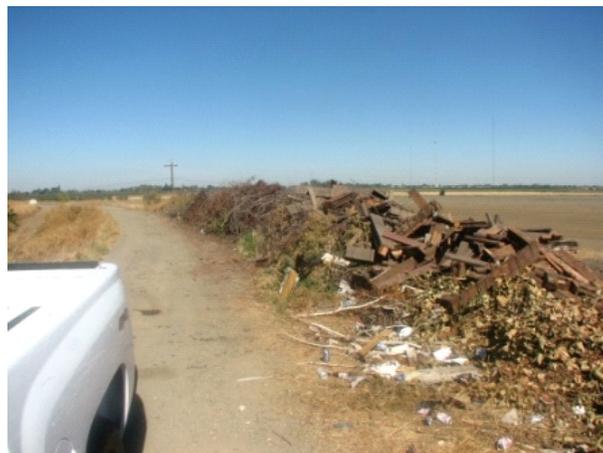
Levee Mile Report Line	38
Start Levee Mile	2.94
End Levee Mile	2.94
Location	Land Side
Category	Earthen Levee
Item	Encroachments
View looking upstream at pruning pile.	
richard_s_20110215_242.jpg

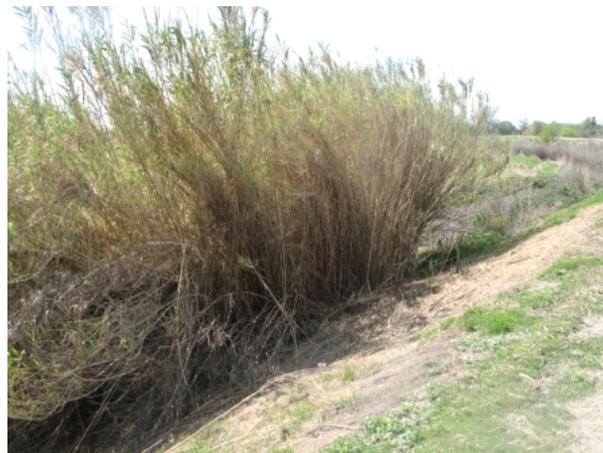
40	3.06	3.12	Earthen Levee	Vegetation	LS	W	Remove the wild growth other than native grasses from the levee slopes. Inspector Comments: Bamboo and vines (Berry or wildroses) along landside toe.	38.210230 ° -121.536342 °	38.210251 ° -121.537290 °	17 Y
41	3.09	3.13	Earthen Levee	Vegetation	LS	U	Remove the wild growth other than native grasses from the levee slopes. Inspector Comments: Berryvines at landside toe.	38.210212 ° -121.536728 °	38.210240 ° -121.537517 °	74 Y
42	3.13	3.13	Earthen Levee	Slope Stability	LS	M	Repair slope instability.	38.210240 ° -121.537517 °	38.210240 ° -121.537517 °	78 Y
43	3.28	3.28	Earthen Levee	Trim / Thin Trees	LS	M	Thin trees to allow visibility of the ground and room to flood fight.	38.209217 ° -121.539823 °	38.209217 ° -121.539823 °	68 Y
44	3.32	3.32	Earthen Levee	Encroachments	LS	M	Tree or limb	38.208813 ° -121.540213 °	38.208813 ° -121.540213 °	80 Y
45	4.00	4.02	Supplemental	USACE Erosion Survey	WS	M	Inspector Comments: 2009: 15 ft berm, 1.5:1 slope, no stability issues, clays and silts, 3.68 ft/s [2009 SiteID:GEO_8-3_L]	38.200769 ° -121.542569 °	38.200600 ° -121.542942 °	42 Y

Levee Mile Report Line	40
Start Levee Mile	3.06
End Levee Mile	3.12
Location	Land Side
Category	Earthen Levee
Item	Vegetation
Bamboo at landward toe at LM 3.05	
richard_s_20110215_244.jpg

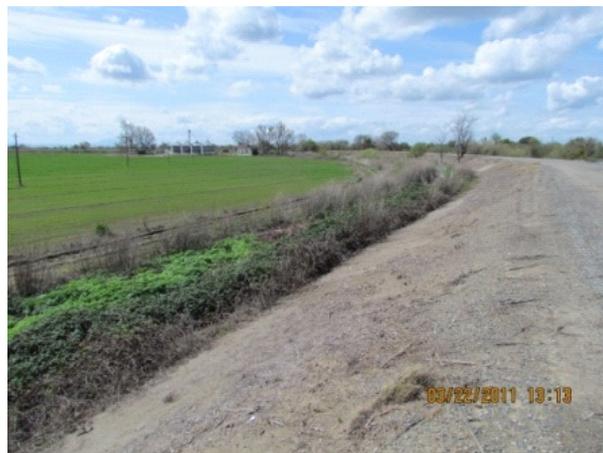
Levee Mile Report Line	41
Start Levee Mile	3.09
End Levee Mile	3.13
Location	Land Side
Category	Earthen Levee
Item	Vegetation
Looking southeast at berryvines on landside toe.	
richard_s_20110330_467.jpg

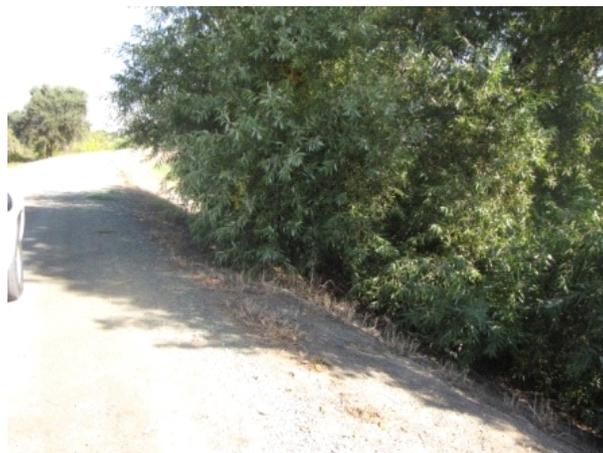
Levee Mile Report Line	43
Start Levee Mile	3.28
End Levee Mile	3.28
Location	Land Side
Category	Earthen Levee
Item	Trim / Thin Trees
Looking southeast at dense tree on landside slope and toe.	
richard_s_20110215_280.jpg

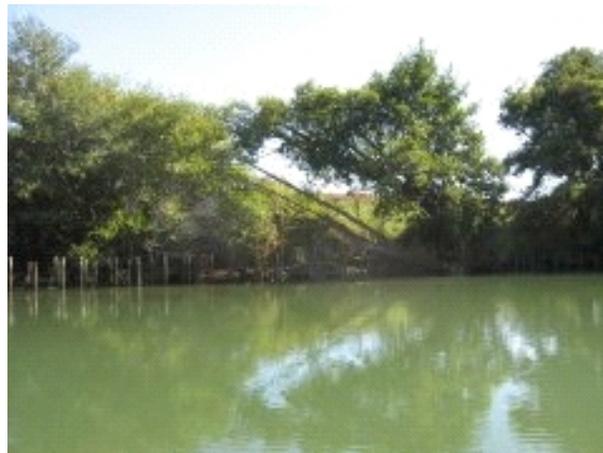
Levee Mile Report Line	47
Start Levee Mile	5.29
End Levee Mile	5.52
Location	Water Side
Category	Supplemental
Item	USACE Erosion Survey
2009: 10 ft berm, 1.5:1 slope, tree hazards and holes, clays and silts, 3.78 ft/s [2009 SiteID:GEO_6-8_L]	
richard_s_20110215_255.JPG

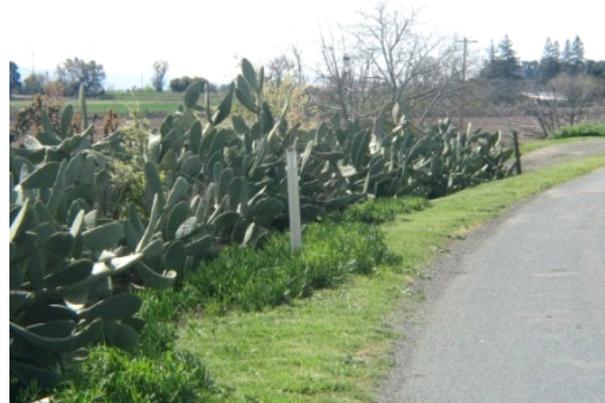
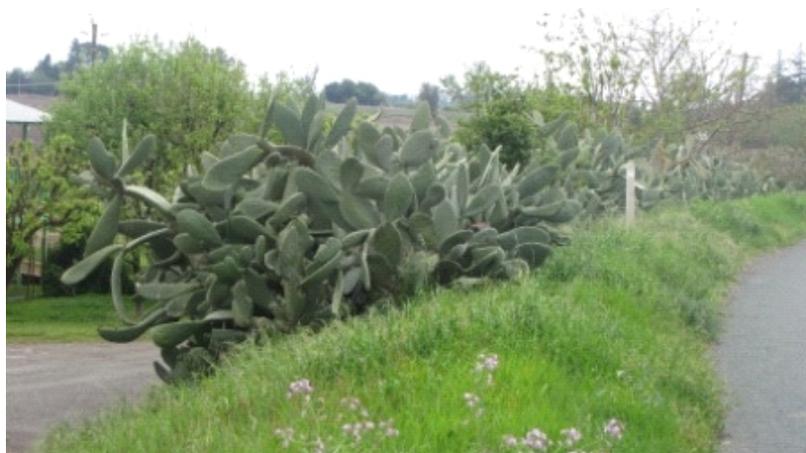
LMR No.	Levee Mile		Category	Item	Location	Rating	Action/Comment	GPS Latitude/Longitude		Issue No. Photo
	Start	End						Start	End	
49	6.04	6.08	Earthen Levee	Vegetation	LS	U	Remove the wild growth other than native grasses from the levee slopes. Inspector Comments: Large Cactus on landward slope.	38.181965 ° -121.569913 °	38.181763 ° -121.570447 °	22 Y
50	6.07	6.41	Supplemental	USACE Erosion Survey	WS	M	Inspector Comments: 2009: 10 ft berm, 1.5:1 slope, tree hazards, clays and silts, 3.95 ft/s [2009 SiteID:GEO_6-1_L]	38.182086 ° -121.570261 °	38.181406 ° -121.576303 °	45 Y
51	6.09	6.09	Earthen Levee	Trim / Thin Trees	LS	M	Trim trees to at least five feet above ground level.	38.181732 ° -121.570524 °	38.181732 ° -121.570524 °	35
52	6.13	6.13	Earthen Levee	Trim / Thin Trees	LS	M	Trim trees to at least five feet above ground level.	38.181503 ° -121.571263 °	38.181503 ° -121.571263 °	70
53	6.38	6.39	Earthen Levee	Trim / Thin Trees	LS	M	Trim trees to at least five feet above ground level.	38.181273 ° -121.575873 °	38.181217 ° -121.576070 °	23

Levee Mile Report Line	49
Start Levee Mile	6.04
End Levee Mile	6.08
Location	Land Side
Category	Earthen Levee
Item	Vegetation
Large Cactus plant on landward slope from LM 6.04 to 6.08	
richard_s_20110215_247.jpg

Levee Mile Report Line	49
Start Levee Mile	6.04
End Levee Mile	6.08
Location	Land Side
Category	Earthen Levee
Item	Vegetation
Looking at north end of cactus on the landside slope.	
richard_s_20110215_248.jpg

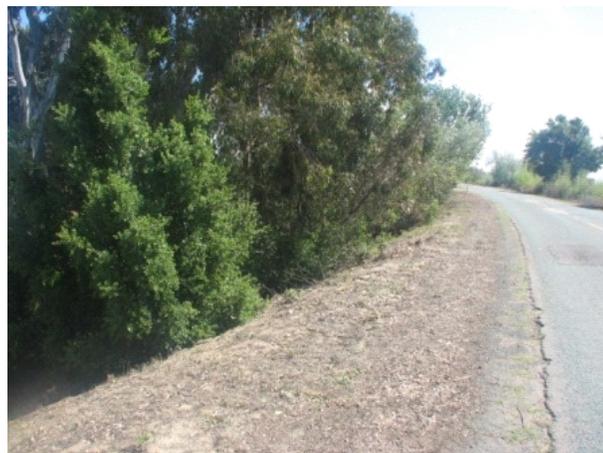
Levee Mile Report Line	57
Start Levee Mile	6.90
End Levee Mile	6.94
Location	Land Side
Category	Earthen Levee
Item	Trim / Thin Trees
Side view of dense trees along landside slope and shoulder.	
richard_s_20110215_250.jpg

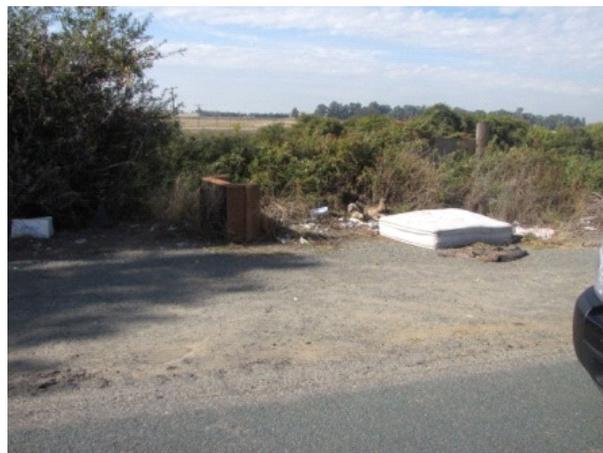
Levee Mile Report Line	60
Start Levee Mile	7.54
End Levee Mile	7.54
Location	Water Side
Category	Earthen Levee
Item	Encroachments
Looking west at garbage on waterside shoulder.	
richard_s_20110215_281.jpg

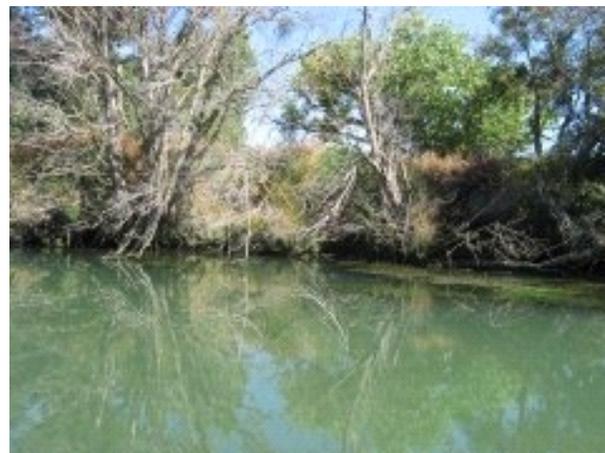
Levee Mile Report Line	63
Start Levee Mile	7.93
End Levee Mile	7.97
Location	Water Side
Category	Supplemental
Item	USACE Erosion Survey
2009: 5 ft berm, 1.5:1 slope, tree hazards, clays and silts, 4.01 ft/s [2009 SiteID:GEO_4-5_L]	
richard_s_20110215_259.JPG

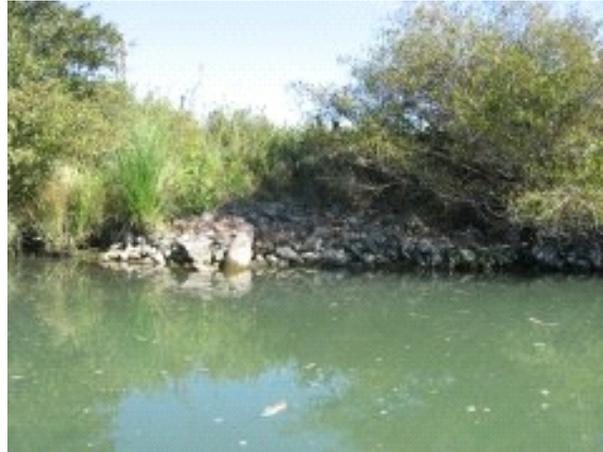
Levee Mile Report Line	64
Start Levee Mile	8.04
End Levee Mile	8.23
Location	Water Side
Category	Supplemental
Item	USACE Erosion Survey
2009: 5 ft berm, 1.5:1 slope, no stability issues, clays and silts, 4.02 ft/s [2009 SiteID:GEO_4-3_L]	
richard_s_20110215_260.JPG

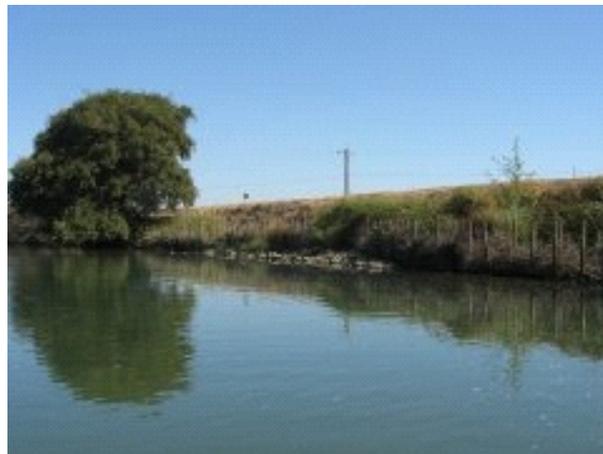
Levee Mile Report Line	65
Start Levee Mile	8.29
End Levee Mile	8.39
Location	Water Side
Category	Supplemental
Item	USACE Erosion Survey
2009: 5 ft berm, 1:1 slope, no stability issues, clays and silts, 3.76 ft/s [2009 SiteID:GEO_4-0_L]	
richard_s_20110215_261.JPG

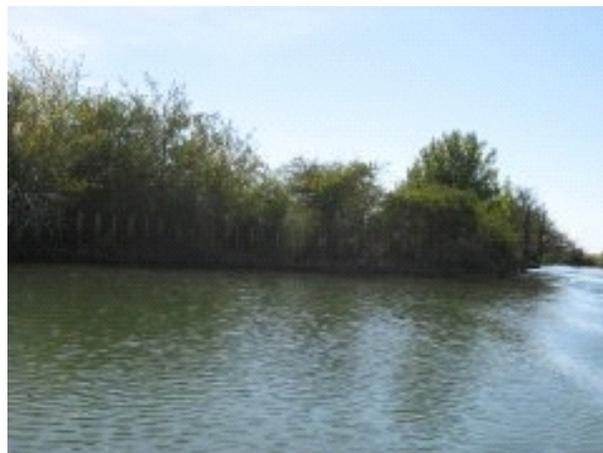
Levee Mile Report Line	66
Start Levee Mile	8.40
End Levee Mile	8.48
Location	Water Side
Category	Supplemental
Item	USACE Erosion Survey
2009: 5 ft berm, 2:1 slope, holes, sands and silts, 4.04 ft/s [2009 SiteID:GEO_3-71_L]	
richard_s_20110215_262.JPG

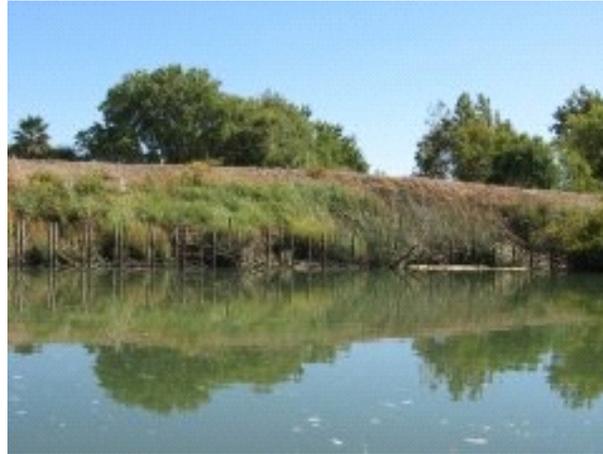
Levee Mile Report Line	67
Start Levee Mile	8.50
End Levee Mile	8.53
Location	Water Side
Category	Supplemental
Item	USACE Erosion Survey
2009: 5 ft berm, 2:1 slope, holes, sands and silts, 4.64 ft/s [2009 SiteID:GEO_3-7_L]	
richard_s_20110215_264.JPG

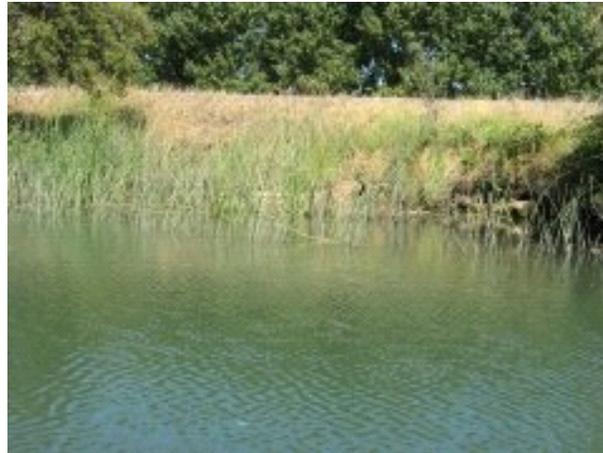
Levee Mile Report Line	68
Start Levee Mile	8.55
End Levee Mile	8.75
Location	Water Side
Category	Supplemental
Item	USACE Erosion Survey
2009: 5 ft berm, 2:1 slope, holes, clays and silts, 4.04 ft/s [2009 SiteID:GEO_3-6_L]	
richard_s_20110215_265.JPG

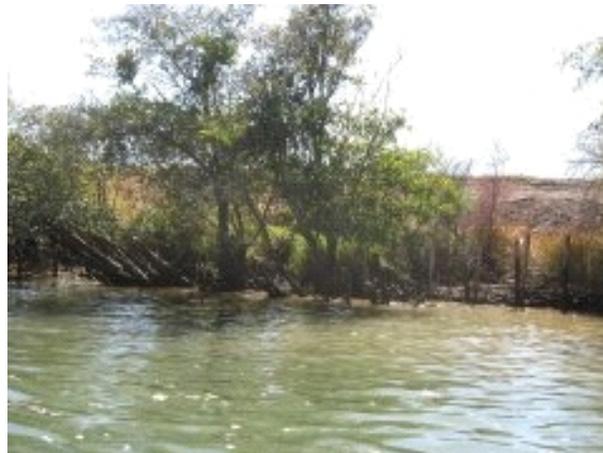
Levee Mile Report Line	73
Start Levee Mile	9.90
End Levee Mile	9.96
Location	Water Side
Category	Supplemental
Item	USACE Erosion Survey
2009: 5 ft berm, 2.5:1 slope, no stability issues, clays and silts, 3.99 ft/s [2009 SiteID:GEO_2-5_L]	
richard_s_20110215_276.JPG

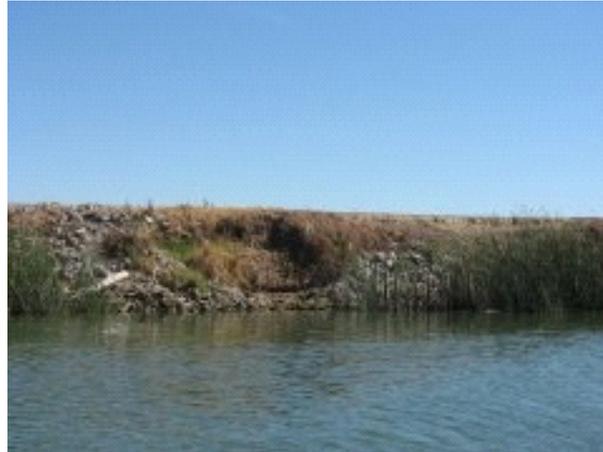
Levee Mile Report Line	76
Start Levee Mile	10.33
End Levee Mile	10.44
Location	Water Side
Category	Supplemental
Item	USACE Erosion Survey
2009: no berm, 2:1 slope, no stability issues, clays and silts, 4.01 ft/s [2009 SiteID:GEO_2-0_L]	
richard_s_20110215_277.JPG

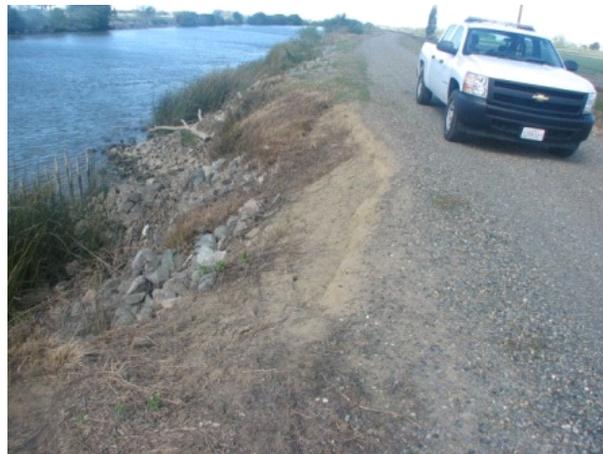
Levee Mile Report Line	77
Start Levee Mile	10.44
End Levee Mile	10.44
Location	Water Side
Category	Earthen Levee
Item	Erosion / Bank Caving
Looking downstream at erosion site on waterside slope and shoulder.	
richard_s_20110215_293.jpg

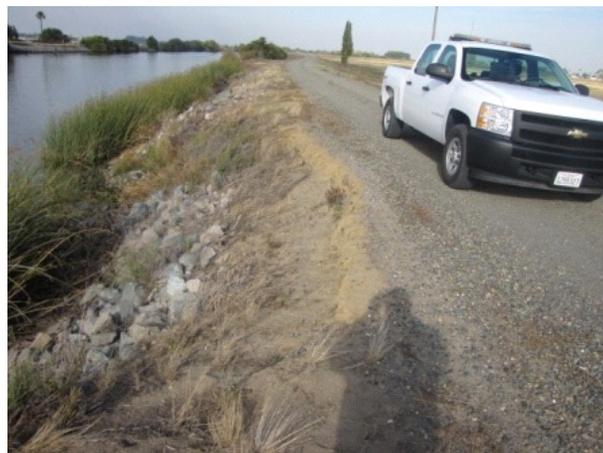
Levee Mile Report Line	77
Start Levee Mile	10.44
End Levee Mile	10.44
Location	Water Side
Category	Earthen Levee
Item	Erosion / Bank Caving
Looking north at updated picture of erosion site as of October 2010	
richard_s_20110215_294.jpg

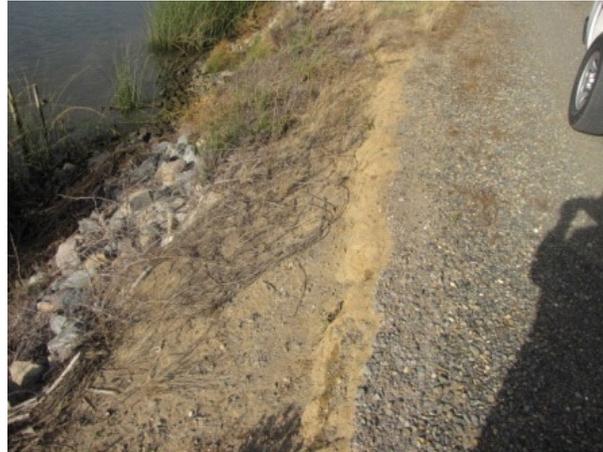
richard_s_20110215_295.jpg

Looking northwest at updated picture of erosion site on waterside slope and shoulder as of October 2010.

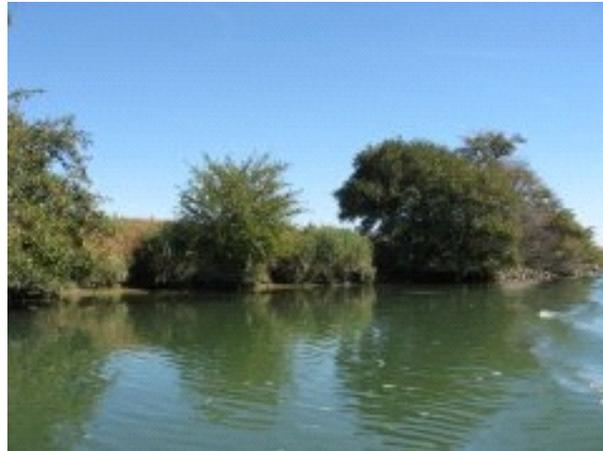
richard_s_20110215_278.JPG

Levee Mile Report Line	78
Start Levee Mile	10.63
End Levee Mile	10.89
Location	Water Side
Category	Supplemental
Item	USACE Erosion Survey

2009: 5 ft berm, 2:1 slope, holes, clays and silts, 4.05 ft/s [2009 SiteID:GEO_1-7_L]

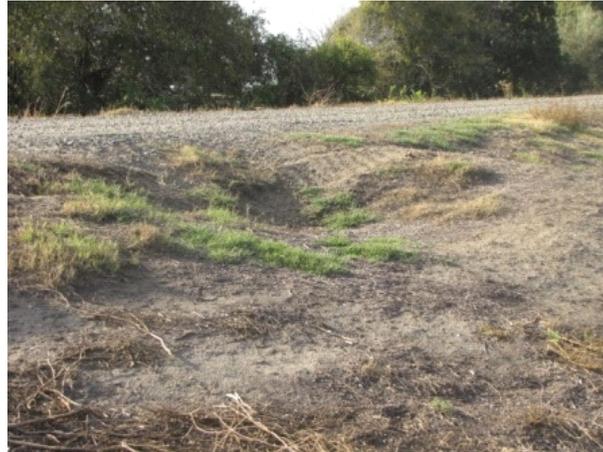
richard_s_20110215_288.jpg

Looking west at depression on landside shoulder and slope.

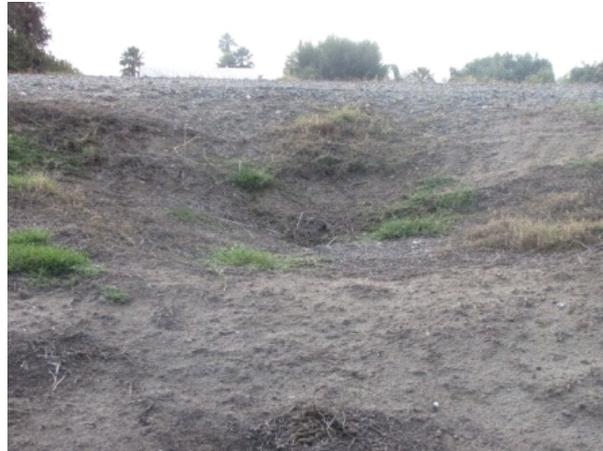
richard_s_20110215_289.jpg

Levee Mile Report Line	79
Start Levee Mile	10.77
End Levee Mile	10.77
Location	Land Side
Category	Earthen Levee
Item	Slope Stability

Looking west at depression on landside shoulder and slope from landside toe.

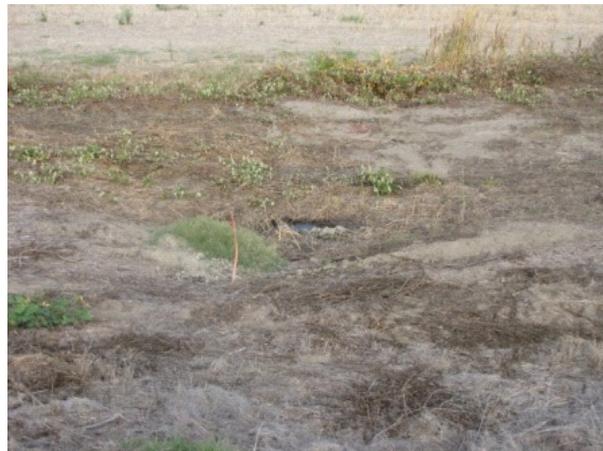
richard_s_20110215_290.jpg

Levee Mile Report Line	79
Start Levee Mile	10.77
End Levee Mile	10.77
Location	Land Side
Category	Earthen Levee
Item	Slope Stability

Looking east at water ponding at landside toe just above 10" irrigation pipe.

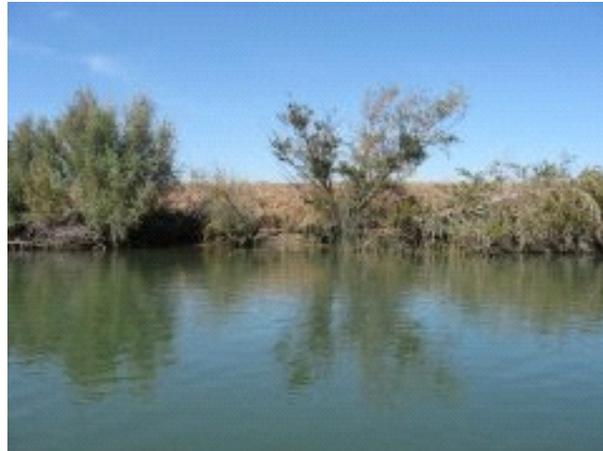
Levee Mile Report Line	83
Start Levee Mile	11.69
End Levee Mile	12.04
Location	Water Side
Category	Supplemental
Item	USACE Erosion Survey
2009: 5 ft berm, 1.5:1 slope, tree hazards and slumping, clays and silts, 4.63 ft/s [2009 SiteID:GEO_0-3_L]	
richard_s_20110215_279.JPG
