**Flood Control Project Maintenance
Levee Inspections**
LMA District Cover Sheet
Spring 2015 Levee Inspection Results

Reclamation District No. 0563 Tyler Island

Spring 2015 Levee Inspection Results

Waterway	Bank	Unit Miles
Unit No. 01 Georgiana Slough (Tyler Island)	Left	12.11

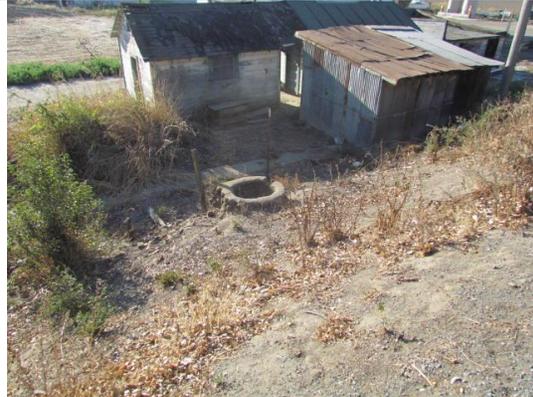
Photo 1 of 3 : SP_2015_RD0563_210_10_20150309_00012.jpg

LM Start	0.15	Rating **	M	Issue No.	10 (cont)
LM End	0.15	Issue Type +	En	Location *	LS

Looking east at fire pit on landward slope.

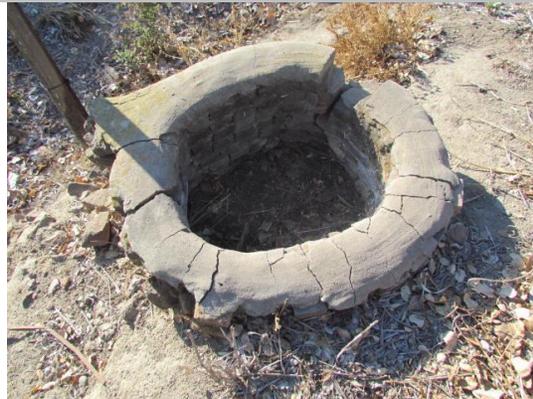
Photo 2 of 3 : SP_2015_RD0563_210_10_20150309_00013.jpg

Looking southeast at fire pit on landward slope.

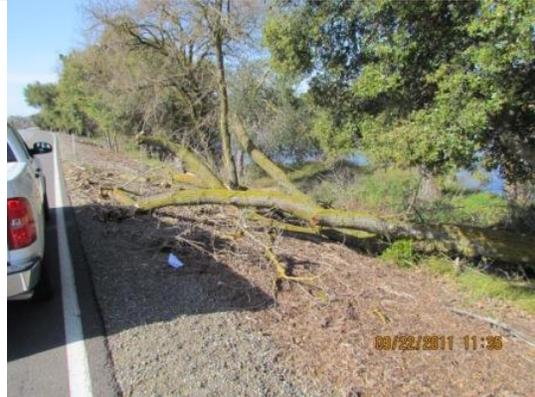
Photo 1 of 1 : SP_2015_RD0563_210_32_20150309_00034.jpg

LM Start	0.17	Rating **	M	Issue No.	32
LM End	0.17	Issue Type +	Ma	Location *	WS
Category	Earthen Levee		GPS Latitude/Longitude		
			Start	End	
Item	Encroachments		38.233315 °	38.233315 °	
			-121.519360 °	-121.519360 °	
DWR ID	DWR_RD0563_01_s_2012_32				
Action/Comments					
Tree or limb Inspector Comments: Tree fallen across waterward slope.

Looking south (downstream) at fallen tree limb on waterside slope.

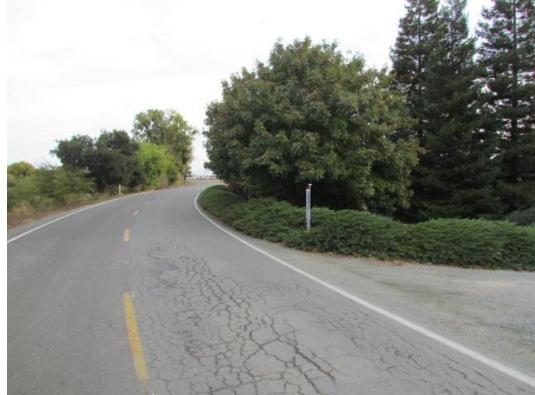
Photo 1 of 2 : SP_2015_RD0563_210_50_20150309_00048.jpg

LM Start	0.66	Rating **	U	Issue No.	50
LM End	0.69	Issue Type +	En	Location *	LS
Category	Earthen Levee		GPS Latitude/Longitude		
			Start	End	
Item	Vegetation		38.228033 °	38.227777 °	
			-121.525268 °	-121.525627 °	
DWR ID	DWR_RD0563_01_s_2012_50				
Action/Comments					
Landscaping

Looking northwest at dense landscaping on landside slope.

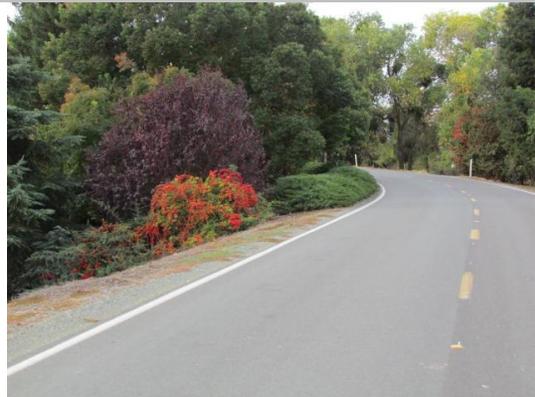
Photo 2 of 2 : SP_2015_RD0563_210_50_20150309_00049.jpg

Looking southeast at dense landscaping on landside slope.

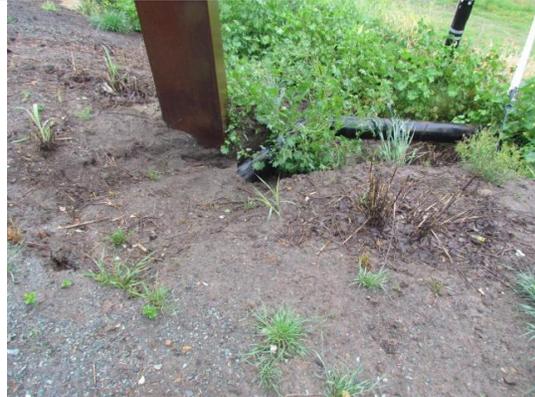
Photo 2 of 2 : SP_2015_RD0563_210_62_20150409_00967.jpg

LM Start	0.72	Rating **	M	Issue No.	62 (cont)
LM End	0.72	Issue Type +	En	Location *	WS
Category	Earthen Levee			GPS Latitude/Longitude	
				Start	End
Item	Encroachments			38.227328 °	38.227328 °
				-121.525872 °	-121.525872 °
DWR ID	DWR_RD0563_01_s_2013_62				
Action/Comments					
Pipe Inspector Comments: Landowner installed a new black steel pipe. Two to four inch depression above pipe on landward slope.

Looking northeast at depression above newly installed black steel pipe.

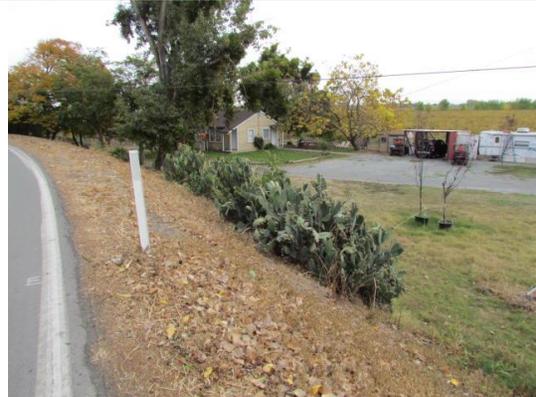
Photo 1 of 1 : SP_2015_RD0563_210_61_20150309_00069.jpg

LM Start	0.86	Rating **	M	Issue No.	61
LM End	0.86	Issue Type +	En	Location *	LS
Category	Earthen Levee		GPS Latitude/Longitude		
			Start	End	
Item	Vegetation		°	°	
			°	°	
DWR ID	DWR_RD0563_01_f_2012_61				
Action/Comments					
Landscaping Inspector Comments: Cactus on landside toe.

Looking northwest at cactus along landside toe.

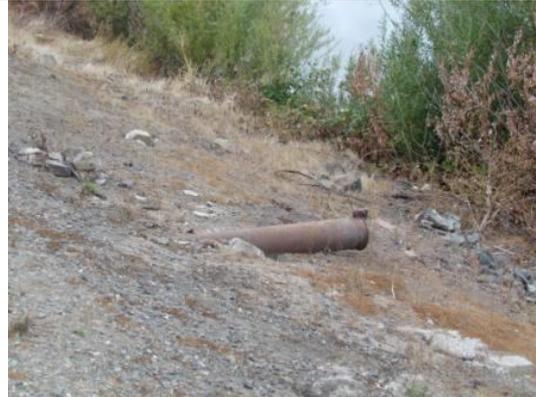
Photo 2 of 2 : SP_2015_RD0563_210_937_20150309_00136.jpg

LM Start	0.95	Rating **	M	Issue No.	937 (cont)
LM End	0.95	Issue Type +	Ma	Location *	CR
Category	Earthen Levee			GPS Latitude/Longitude	
				Start	End
Item	Encroachments			38.225813 °	38.225813 °
				-121.528198 °	-121.528198 °
DWR ID	DWR_RD0563_01_s_2012_937				
Action/Comments					
Pipe Inspector Comments: Abandoned pipe should be removed.

Looking southwest at pipe on waterside slope.

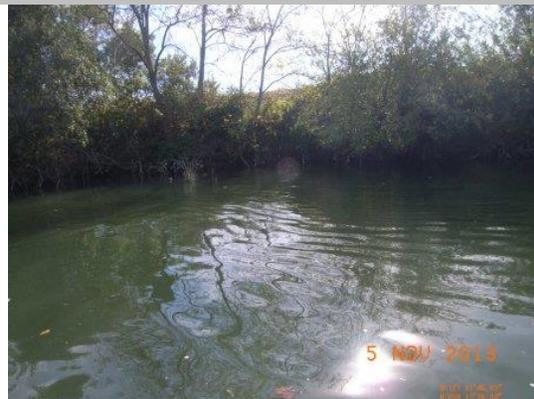
Photo 1 of 1 : SP_2015_RD0563_210_55_20150309_00053.jpg

LM Start	1.02	Rating **	M	Issue No.	55
LM End	1.11	Issue Type +	Ma	Location *	WS
Category	Supplemental		GPS Latitude/Longitude		
			Start	End	
Item	USACE Erosion Survey		38.226522 °	38.227157 °	
			-121.529094 °	-121.530432 °	
DWR ID	DWR_RD0563_01_f_2014_55				
Action/Comments					
Inspector Comments: 2011 - Short sections of eroding bank at the waterline and holes in toe of levee. 2012 - Site extended upstream. 2013: Erosion pockets filled with an insufficient amounts of revetment. [2013 Site ID: GEO_11-0_L]

USACE 2013 Photo #1

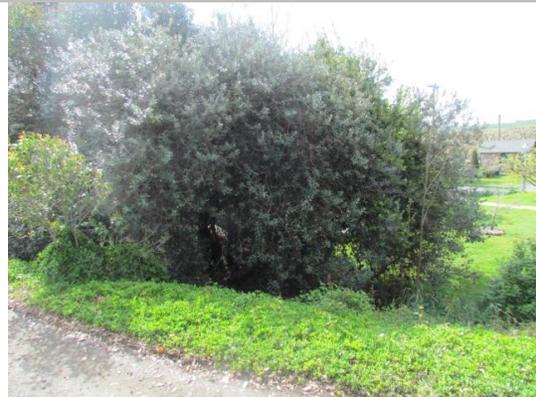
Photo 1 of 1 : SP_2015_RD0563_210_54_20150309_00052.jpg

LM Start	1.09	Rating **	M	Issue No.	54
LM End	1.12	Issue Type +	En	Location *	LS
Category	Earthen Levee			GPS Latitude/Longitude	
				Start	End
Item	Vegetation			38.226933 °	38.227037 °
				-121.530307 °	-121.530850 °
DWR ID	DWR_RD0563_01_s_2012_54				
Action/Comments					
Landscaping

Looking east at landscaping on landside slope.

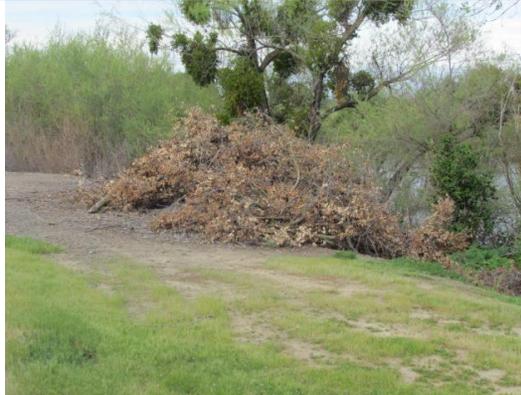
Photo 1 of 1 : SP_2015_RD0563_210_69_20150309_00073.jpg

LM Start	1.18	Rating **	M	Issue No.	69
LM End	1.18	Issue Type +	En	Location *	WS
Category	Earthen Levee		GPS Latitude/Longitude		
			Start	End	
Item	Encroachments		38.226748 °	38.226748 °	
			-121.531756 °	-121.531756 °	
DWR ID	DWR_RD0563_01_f_2013_69				
Action/Comments					
Prunings Inspector Comments: Pruning pile should be burned or removed from waterward slope.

Looking west at pruning pile on waterward slope.

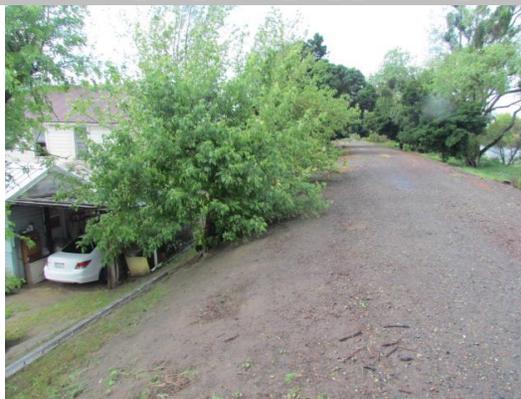
Photo 1 of 1 : SP_2015_RD0563_210_5_20150409_00969.jpg

LM Start	1.22	Rating **	M	Issue No.	5
LM End	1.22	Issue Type +	Ma	Location *	LS
Category	Earthen Levee		GPS Latitude/Longitude		
			Start	End	
Item	Trim / Thin Trees		38.226326 °	38.226326 °	
			-121.532298 °	-121.532298 °	
DWR ID	DWR_RD0563_01_s_2012_5				
Action/Comments					
Trim trees to at least five feet above ground level.

Looking south at untrimmed trees on landward slope.

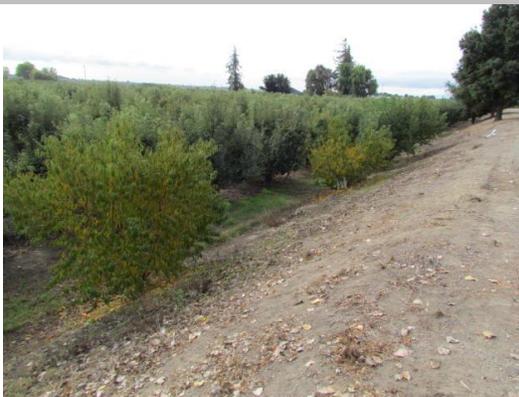
Photo 1 of 1 : SP_2015_RD0563_210_64_20150309_00070.jpg

LM Start	1.27	Rating **	M	Issue No.	64
LM End	1.27	Issue Type +	Ma	Location *	LS
Category	Earthen Levee			GPS Latitude/Longitude	
				Start	End
Item	Trim / Thin Trees			38.225730 °	38.225730 °
				-121.532824 °	-121.532824 °
DWR ID	DWR_RD0563_01_f_2012_64				
Action/Comments					
Trim trees to at least five feet above ground level. Inspector Comments: Trees located at landside toe.

Looking southeast at fruit trees on landside toe.

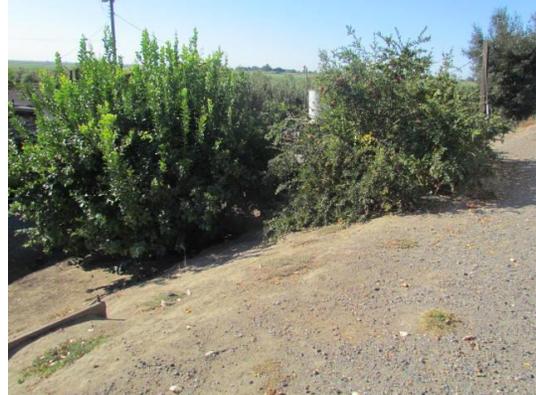
Photo 1 of 2 : SP_2015_RD0563_210_86_20150309_00099.jpg

LM Start	1.39	Rating **	M	Issue No.	86
LM End	1.39	Issue Type +	En	Location *	LS
Category	Earthen Levee		GPS Latitude/Longitude		
			Start	End	
Item	Vegetation		38.224351 °	38.224351 °	
			-121.534209 °	-121.534209 °	
DWR ID	DWR_RD0563_01_f_2013_86				
Action/Comments					
Landscaping

Looking southeast at dense landscaping on the landward slope.

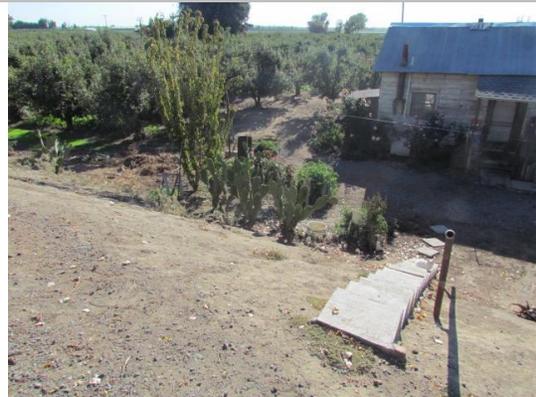
Photo 2 of 2 : SP_2015_RD0563_210_86_20150309_00100.jpg

Looking east at cactus at the landward toe.

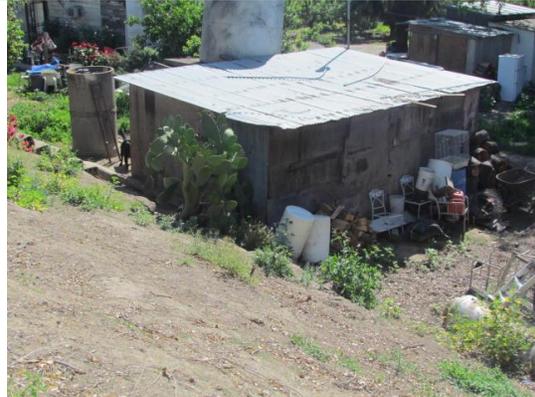
Photo 2 of 3 : SP_2015_RD0563_210_8_20150309_00008.jpg

LM Start	1.40	Rating **	U	Issue No.	8 (cont)
LM End	1.40	Issue Type +	En	Location *	LS
Category	Earthen Levee		GPS Latitude/Longitude		
			Start	End	
Item	Encroachments		38.224315 °	38.224315 °	
			-121.534288 °	-121.534288 °	
DWR ID	DWR_RD0563_01_s_2012_8				
Action/Comments					
Building Inspector Comments: Tool shed, animal storage container, and landscaping on waterside slope and toe.

Looking northeast at a tool shed on the landward toe.

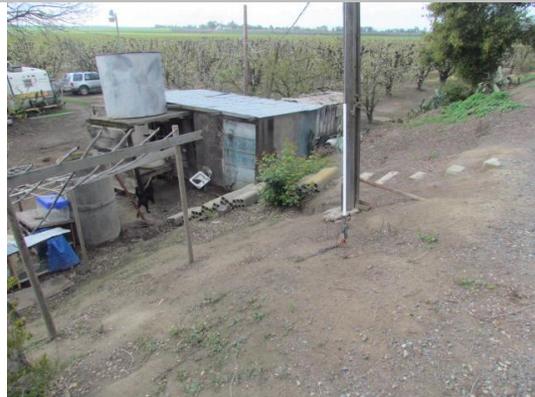
Photo 3 of 3 : SP_2015_RD0563_210_8_20150309_00009.jpg

Looking southeast at a tool shed at the landside toe.

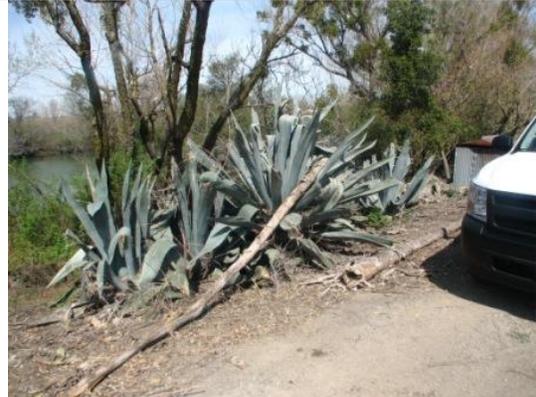
Photo 2 of 2 : SP_2015_RD0563_210_6_20150309_00006.jpg

LM Start	1.40	Rating **	M	Issue No.	6 (cont)
LM End	1.44	Issue Type +	Ma	Location *	WS
Category	Earthen Levee			GPS Latitude/Longitude	
				Start	End
Item	Vegetation			38.224280 °	38.224000 °
				-121.534377 °	-121.535038 °
DWR ID	DWR_RD0563_01_s_2012_6				
Action/Comments					
Remove the wild growth other than native grasses from the levee slopes. Inspector Comments: Remove the century plant from waterward shoulder.

Century plant on waterward shoulder at LM 1.42

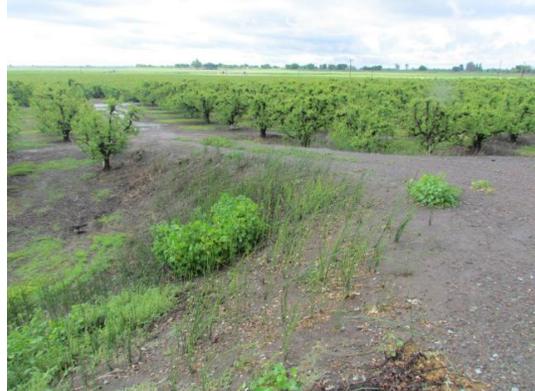
Photo 1 of 2 : SP_2015_RD0563_210_141_20150409_00970.jpg

LM Start	1.53	Rating **	M	Issue No.	141
LM End	1.53	Issue Type +	En	Location *	LS
Category	Earthen Levee		GPS Latitude/Longitude		
			Start	End	
Item	Encroachments		38.223575 °	38.223575 °	
			-121.536580 °	-121.536580 °	
DWR ID	DWR_RD0563_01_s_2014_141				
Action/Comments					
Ramp Inspector Comments: Landowner installed ramp without Board permit.

Looking southeast at ramp on landward slope.

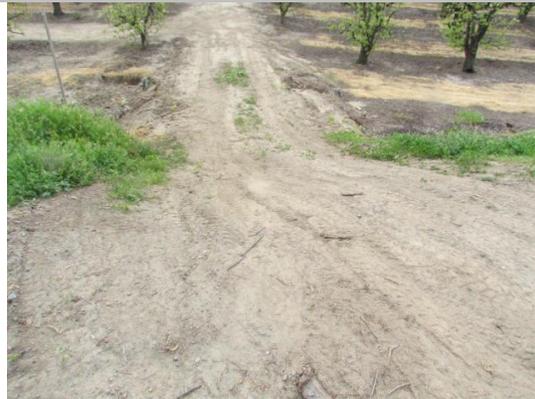
Photo 2 of 2 : SP_2015_RD0563_210_141_20150309_00125.jpg

Looking east at ramp on landward slope.

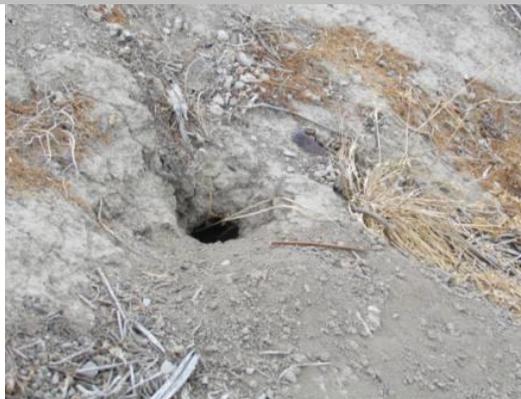
Photo 1 of 1 : SP_2015_RD0563_210_83_20150309_00092.jpg

Looking west at rodent hole on landside slope.

LM Start	1.73	Rating **	A/W	Issue No.	83
LM End	1.73	Issue Type +	Ma	Location *	LS
Category	Earthen Levee			GPS Latitude/Longitude	
				Start	End
Item	Animal Control			38.222967 °	38.222967 °
				-121.540055 °	-121.540055 °
DWR ID	DWR_RD0563_01_s_2012_83				
Action/Comments					
Exterminate rodents and backfill and compact or grout burrows.

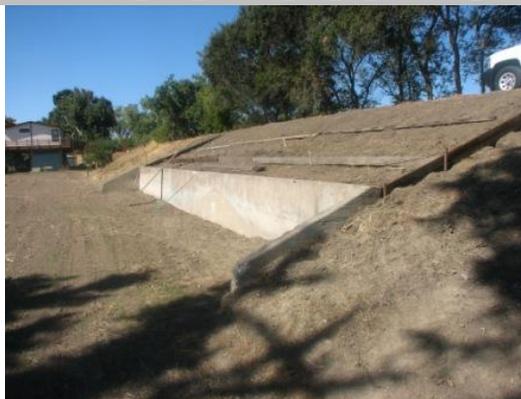
Photo 1 of 12 : SP_2015_RD0563_210_60_20150309_00057.jpg

LM Start	1.82	Rating **	M	Issue No.	60
LM End	1.82	Issue Type +	En	Location *	LS
Category	Earthen Levee			GPS Latitude/Longitude	
				Start	End
Item	Encroachments			38.222702 °	38.222702 °
				-121.541678 °	-121.541678 °
DWR ID	DWR_RD0563_01_s_2012_60				
Action/Comments					
Stairway Inspector Comments: Landowner has built a pad on the landside shoulder, 60' x 15', for a metal walkway leading from the house to a pad with a concrete deadman. Landowner also installed a temporary stairway on landside slope and stairway on waterside slope. Electrical conduit on landside toe.

Unauthorized retaining wall on landside toe.

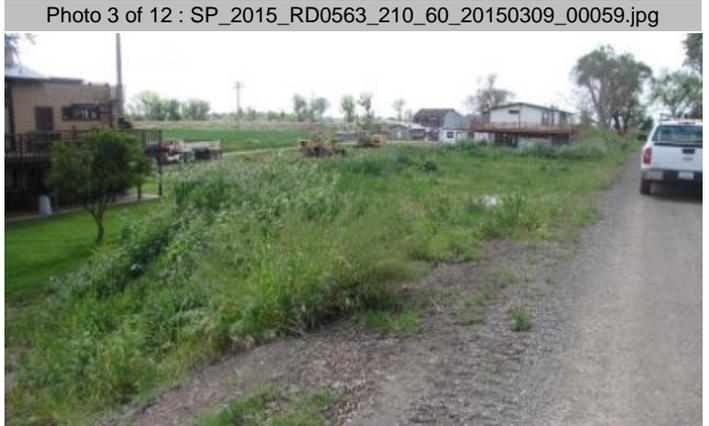
LM Start	1.82	Rating **	M	Issue No.	60 (cont)
LM End	1.82	Issue Type +	En	Location *	LS
Category	Earthen Levee			GPS Latitude/Longitude	
				Start	End
Item	Encroachments			38.222702 °	38.222702 °
				-121.541678 °	-121.541678 °
DWR ID	DWR_RD0563_01_s_2012_60				
Action/Comments					
Stairway Inspector Comments: Landowner has built a pad on the landside shoulder, 60' x 15', for a metal walkway leading from the house to a pad with a concrete deadman. Landowner also installed a temporary stairway on landside slope and stairway on waterside slope. Electrical conduit on landside toe.

Looking southeast at earthen pad on landside shoulder covering retaining wall.

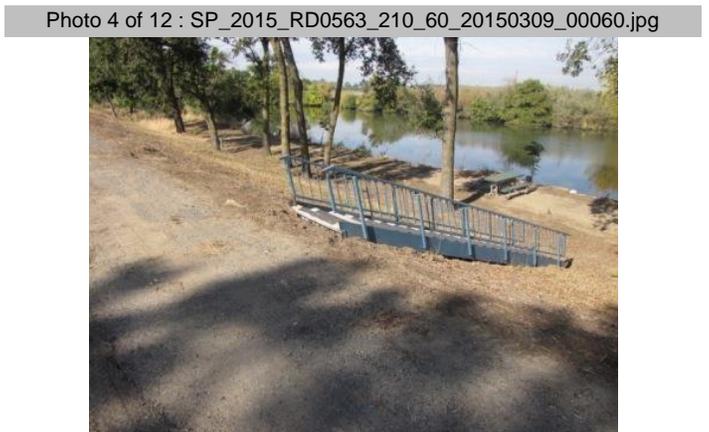
Looking west at metal stairs on waterside slope.

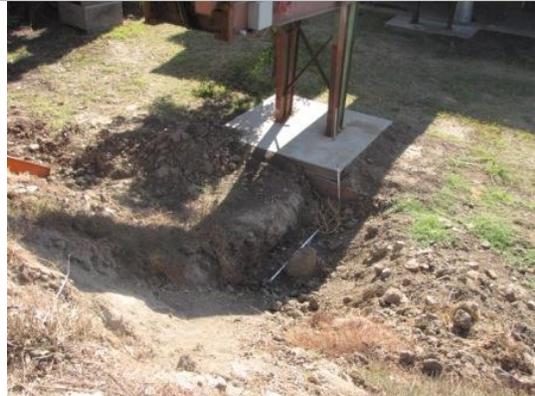
Photo 7 of 12 : SP_2015_RD0563_210_60_20150309_00063.jpg

Looking east at electrical conduit in trench on landside toe and concrete pad for walkway.

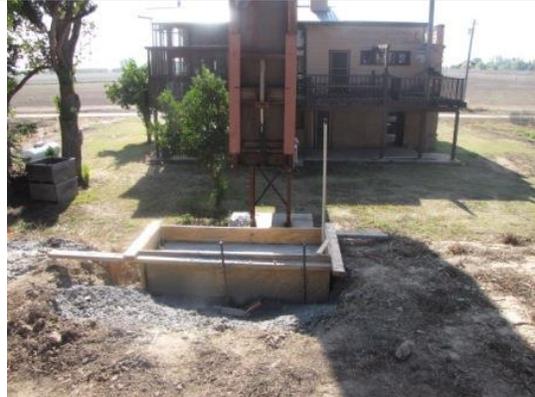
Photo 9 of 12 : SP_2015_RD0563_210_60_20150309_00065.jpg

LM Start	1.82	Rating **	M	Issue No.	60 (cont)
LM End	1.82	Issue Type +	En	Location *	LS
Category	Earthen Levee			GPS Latitude/Longitude	
				Start	End
Item	Encroachments			38.222702 °	38.222702 °
				-121.541678 °	-121.541678 °
DWR ID	DWR_RD0563_01_s_2012_60				
Action/Comments					
Stairway Inspector Comments: Landowner has built a pad on the landside shoulder, 60' x 15', for a metal walkway leading from the house to a pad with a concrete deadman. Landowner also installed a temporary stairway on landside slope and stairway on waterside slope. Electrical conduit on landside toe.

Looking east at deadman on landside shoulder.

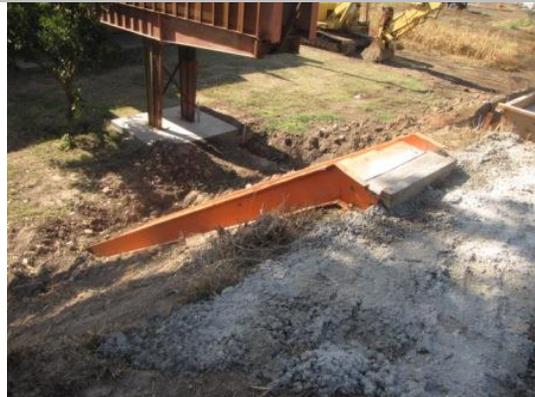
Photo 10 of 12 : SP_2015_RD0563_210_60_20150309_00066.jpg

Looking southeast at temporary metal stairs on landside slope.

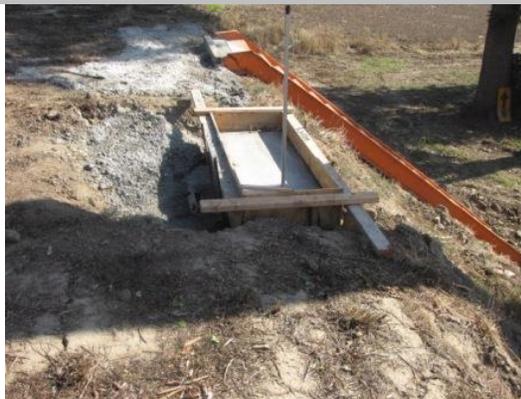
Photo 12 of 12 : SP_2015_RD0563_210_60_20150309_00068.jpg

LM Start	1.82	Rating **	M	Issue No.	60 (cont)
LM End	1.82	Issue Type +	En	Location *	LS
Category	Earthen Levee		GPS Latitude/Longitude		
			Start	End	
Item	Encroachments		38.222702 °	38.222702 °	
			-121.541678 °	-121.541678 °	
DWR ID	DWR_RD0563_01_s_2012_60				
Action/Comments					
Stairway Inspector Comments: Landowner has built a pad on the landside shoulder, 60' x 15', for a metal walkway leading from the house to a pad with a concrete deadman. Landowner also installed a temporary stairway on landside slope and stairway on waterside slope. Electrical conduit on landside toe.

Looking north at deadman for metal walkway on earthen pad on landside shoulder.

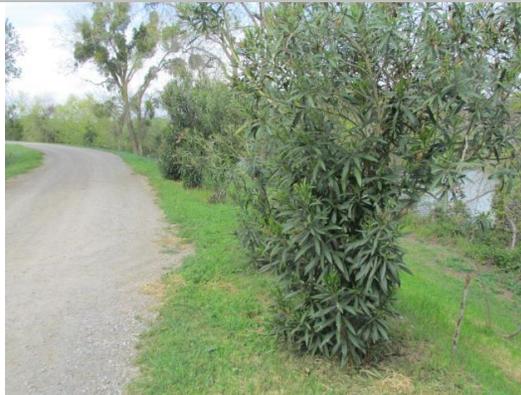
Photo 2 of 2 : SP_2015_RD0563_210_142_20150309_00127.jpg

LM Start	1.90	Rating **	M	Issue No.	142 (cont)
LM End	1.92	Issue Type +	En	Location *	WS
Category	Earthen Levee		GPS Latitude/Longitude		
			Start	End	
Item	Vegetation		°	°	
			°	°	
DWR ID	DWR_RD0563_01_s_2014_142				
Action/Comments					
Landscaping Inspector Comments: Landowner has planted oleander, trees and planting box on waterward slope.

Looking southwest at oleanders on waterward shoulder.

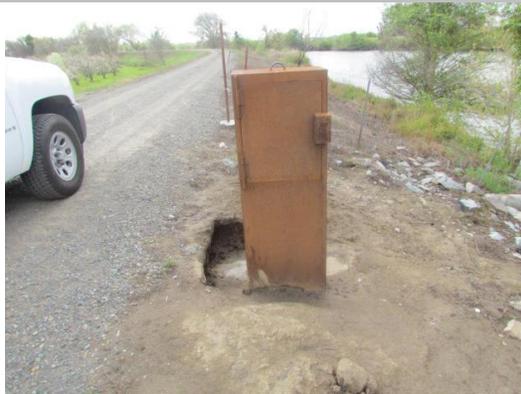
Photo 1 of 1 : SP_2015_RD0563_210_15_20150309_00019.jpg

LM Start	2.18	Rating **	M	Issue No.	15
LM End	2.18	Issue Type +	En	Location *	WS
Category	Earthen Levee		GPS Latitude/Longitude		
			Start	End	
Item	Encroachments		38.218575 °	38.218575 °	
			-121.542668 °	-121.542668 °	
DWR ID	DWR_RD0563_01_s_2012_15				
Action/Comments					
Equipment Inspector Comments: Landowner installed metal box around siphon breaker.

Looking south at siphon box installed on waterside shoulder.

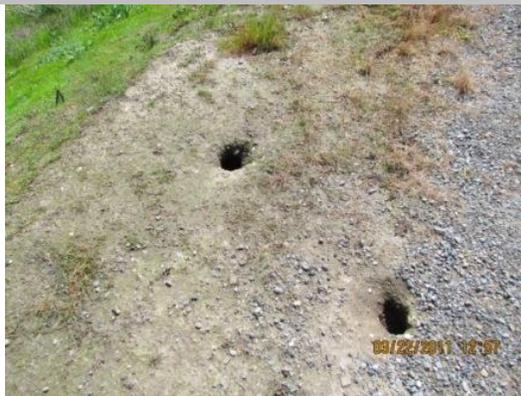
Photo 1 of 1 : SP_2015_RD0563_210_33_20150309_00035.jpg

LM Start	2.19	Rating **	M	Issue No.	33
LM End	2.19	Issue Type +	Ma	Location *	LS
Category	Earthen Levee		GPS Latitude/Longitude		
			Start	End	
Item	Animal Control		38.218463 °	38.218463 °	
			-121.542650 °	-121.542650 °	
DWR ID	DWR_RD0563_01_s_2012_33				
Action/Comments					
Exterminate rodents and backfill and compact or grout burrows. Inspector Comments: Rodent holes on landside shoulder.

Looking southeast at squirrel holes on landside shoulder.

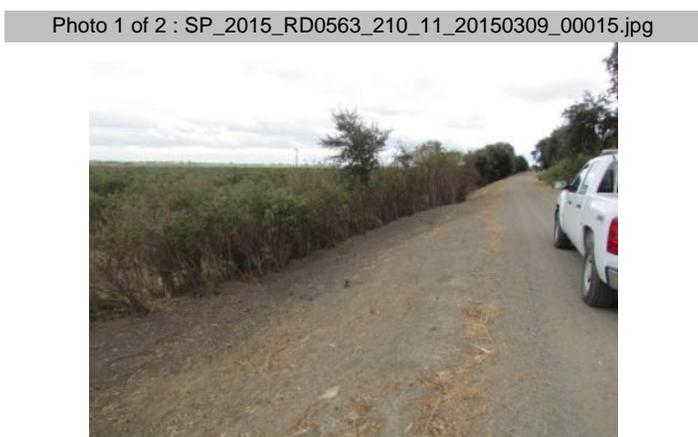
LM Start	2.39	Rating **	A/W	Issue No.	11
LM End	2.40	Issue Type +	Ma	Location *	LS
Category	Earthen Levee		GPS Latitude/Longitude		
			Start	End	
Item	Vegetation		38.216242 °	38.216147 °	
			-121.540835 °	-121.540612 °	
DWR ID	DWR_RD0563_01_s_2012_11				
Action/Comments					
Elderberries are blocking visibility and flood fight capability. Inspector Comments: District is controlling the elderberry.

Look southeast at updated (10/11) view of elderberries on landside slope.

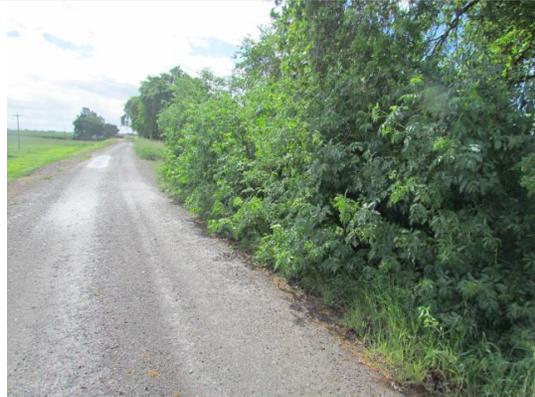
Photo 1 of 2 : SP_2015_RD0563_210_12_20150409_00972.jpg

LM Start	2.40	Rating **	U	Issue No.	12
LM End	2.41	Issue Type +	Ma	Location *	WS
Category	Earthen Levee		GPS Latitude/Longitude		
			Start	End	
Item	Vegetation		38.216122 °	38.216047 °	
			-121.540555 °	-121.540415 °	
DWR ID	DWR_RD0563_01_s_2012_12				
Action/Comments					
Elderberries are blocking visibility and flood fight capability.

Looking south at dense elderberry on waterward shoulder and slope. (Spring 2015)

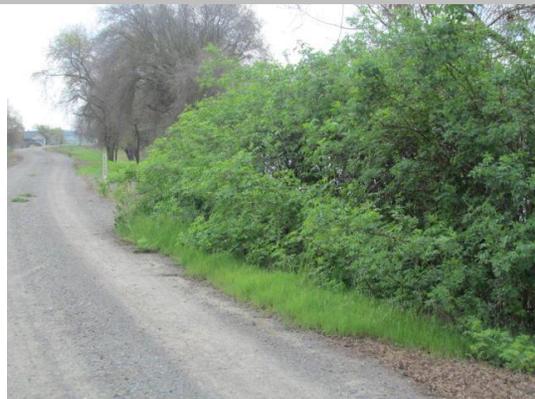
Photo 2 of 2 : SP_2015_RD0563_210_12_20150309_00017.jpg

Looking southwest at dense elderberry on waterside shoulder and slope. (Fall 2014)

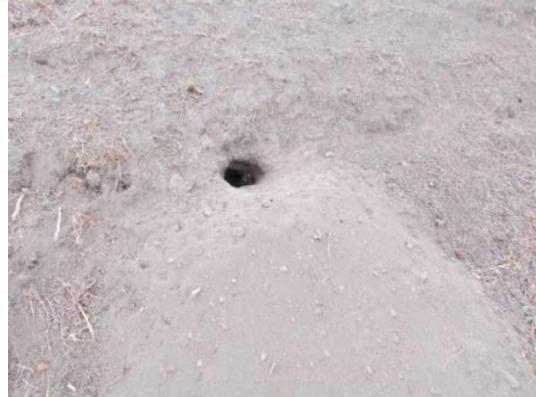
Photo 1 of 4 : SP_2015_RD0563_210_85_20150309_00095.jpg

LM Start	2.53	Rating **	M	Issue No.	85
LM End	2.55	Issue Type +	Ma	Location *	LS
Category	Earthen Levee		GPS Latitude/Longitude		
			Start	End	
Item	Animal Control		38.215082 °	38.214852 °	
			-121.538652 °	-121.538305 °	
DWR ID	DWR_RD0563_01_s_2012_85				
Action/Comments					
No rodents visible, but rodent burrows visible; need to backfill and compact or grout burrows.

Looking west at rodent hole on landside slope.

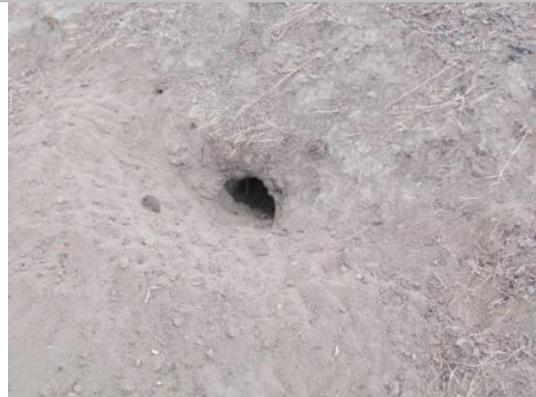
Photo 2 of 4 : SP_2015_RD0563_210_85_20150309_00096.jpg

Looking east at rodent hole on landside slope.

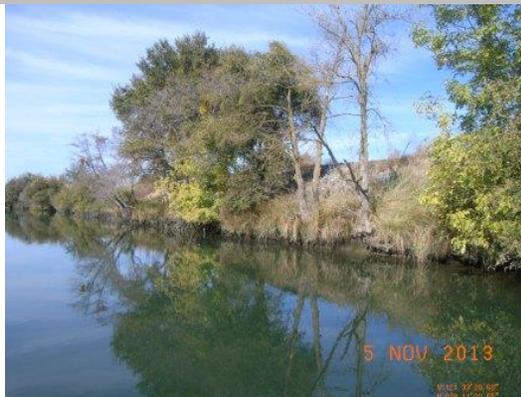
Photo 1 of 1 : SP_2015_RD0563_210_53_20150309_00051.jpg

LM Start	2.61	Rating **	M	Issue No.	53
LM End	2.82	Issue Type +	Ma	Location *	WS
Category	Supplemental			GPS Latitude/Longitude	
				Start	End
Item	USACE Erosion Survey			38.214133 °	38.211737 °
				-121.537778 °	-121.535436 °
DWR ID	DWR_RD0563_01_f_2014_53				
Action/Comments					
Inspector Comments: 1997 - Loss of rock at toe; pockets of upper berm erosion; very narrow berm width; toe rock problem; erosion pockets in rock. 2002 - New brush boxes at toe of the worst spots. 2005 - Upstream 200 ft removed because of the wide berm. 2006 - Some rock repair pockets behind the brush boxes at the upstream end. 2010 - Some new erosion. 2013: New rock placed on the levee slope. [2013 Site ID: GEO_9-3_L]

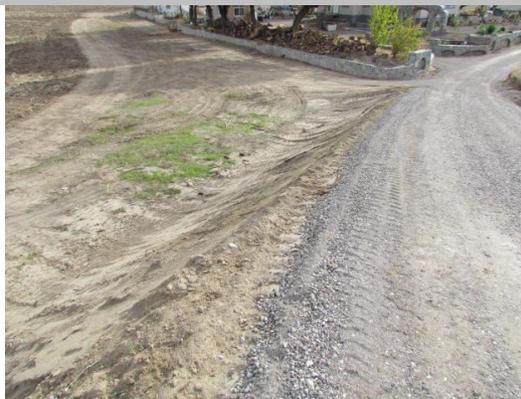
Photo 1 of 2 : SP_2015_RD0563_210_80_20150309_00089.jpg

LM Start	2.62	Rating **	M	Issue No.	80
LM End	2.62	Issue Type +	En	Location *	LS
Category	Earthen Levee			GPS Latitude/Longitude	
				Start	End
Item	Encroachments				
DWR ID	DWR_RD0563_01_f_2012_80				
Action/Comments					
Ramp Inspector Comments: Landowner installed unauthorized ramp on landside slope.

Looking east at unauthorized ramp on landside slope.

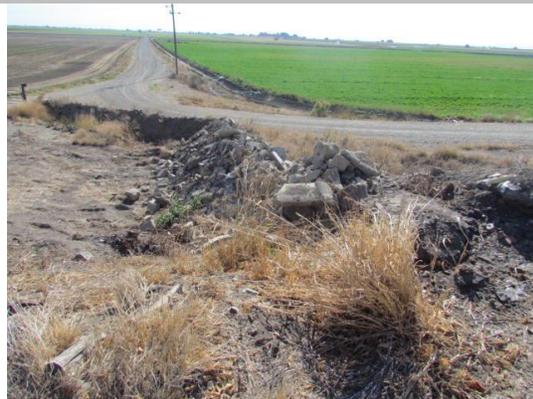
Photo 2 of 2 : SP_2015_RD0563_210_104_20150309_00120.jpg

LM Start	2.89	Rating **	M	Issue No.	104
LM End	2.89	Issue Type +	Ma	Location *	LS
Category	Earthen Levee			GPS Latitude/Longitude	
				Start	End
Item	Encroachments			38.210966 °	38.210966 °
				-121.534813 °	-121.534813 °
DWR ID	DWR_RD0563_01_f_2013_104				
Action/Comments					
Material Inspector Comments: Landowner stockpiled concrete rubble on landward and waterward slope to stop trespassers. Landowner should replace the stockpile with a proper fence.

Looking east at concrete rubble on landward slope.

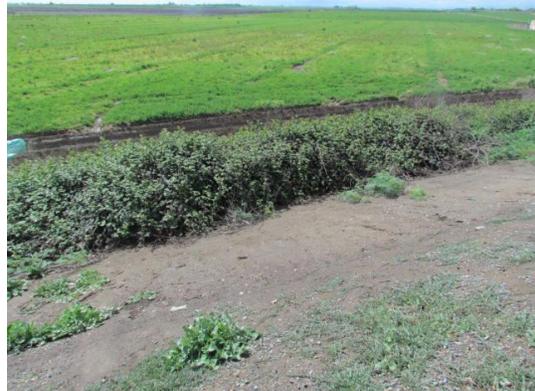
Photo 1 of 1 : SP_2015_RD0563_210_67_20150409_00973.jpg

LM Start	2.94	Rating **	M	Issue No.	67
LM End	2.94	Issue Type +	Ma	Location *	LS
Category	Earthen Levee		GPS Latitude/Longitude		
			Start	End	
Item	Vegetation		38.210402 °	38.210402 °	
			-121.535268 °	-121.535268 °	
DWR ID	DWR_RD0563_01_s_2012_67				
Action/Comments					
Remove the wild growth other than native grasses from the levee slopes. Inspector Comments: Vines (Berry or wildroses) on landside toe.

Looking east at dense vegetation at landward toe.

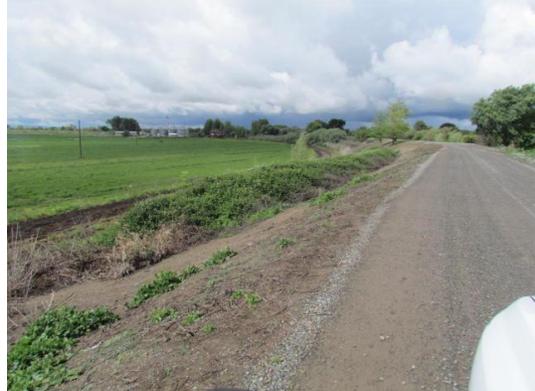
Photo 1 of 3 : SP_2015_RD0563_210_74_20150409_00974.jpg

LM Start	3.02	Rating **	U	Issue No.	74
LM End	3.21	Issue Type +	Ma	Location *	LS
Category	Earthen Levee		GPS Latitude/Longitude		
			Start	End	
Item	Vegetation		38.210212 °	38.209165 °	
			-121.536728 °	-121.539920 °	
DWR ID	DWR_RD0563_01_s_2012_74				
Action/Comments					
Remove the wild growth other than native grasses from the levee slopes. Inspector Comments: Dead berryvines at landside toe blocking view of toe.

Looking southeast at dense berryvines at landward toe. (Spring 2015)

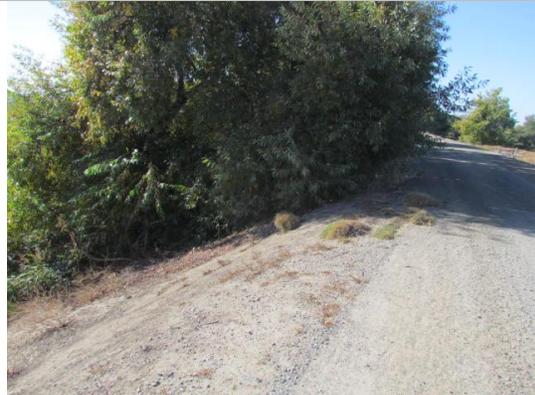
Photo 1 of 2 : SP_2015_RD0563_210_68_20150309_00071.jpg

LM Start	3.21	Rating **	U	Issue No.	68
LM End	3.21	Issue Type +	Ma	Location *	LS
Category	Earthen Levee			GPS Latitude/Longitude	
				Start	End
Item	Trim / Thin Trees			38.209217 °	38.209217 °
				-121.539823 °	-121.539823 °
DWR ID	DWR_RD0563_01_s_2012_68				
Action/Comments					
Thin trees to allow visibility of the ground and room to flood fight.

Looking south at dense trees on landward slope.

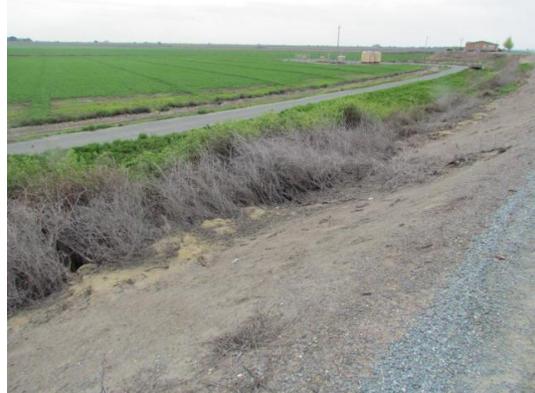
Photo 1 of 2 : SP_2015_RD0563_210_84_20150309_00093.jpg

LM Start	3.50	Rating **	A/W	Issue No.	84
LM End	3.50	Issue Type +	Ma	Location *	LS
Category	Earthen Levee			GPS Latitude/Longitude	
				Start	End
Item	Vegetation			38.205130 °	38.205130 °
				-121.540397 °	-121.540397 °
DWR ID	DWR_RD0563_01_f_2012_84				
Action/Comments					
Remove the wild growth other than native grasses from the levee slopes. Inspector Comments: Vegetation at landward toe.

Looking southeast at dead berryvines on landward toe.

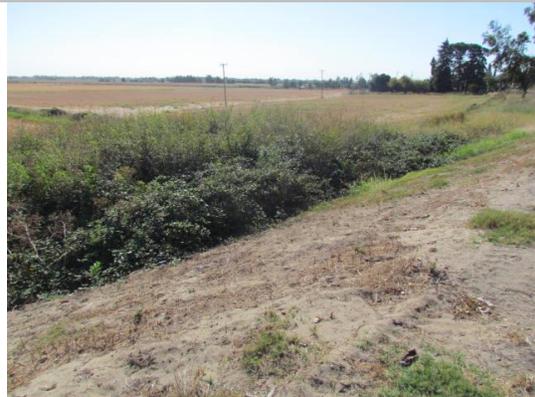
Photo 2 of 2 : SP_2015_RD0563_210_84_20150309_00094.jpg

Looking southeast at dense berryvines on landward toe.

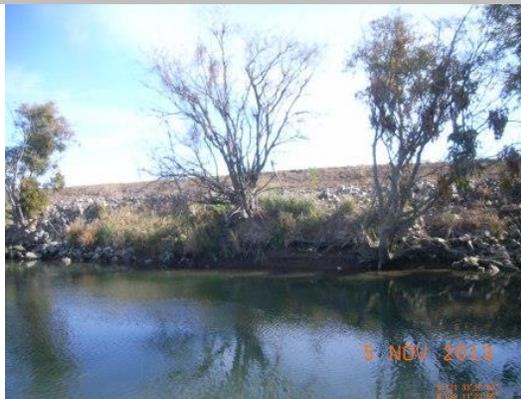
Photo 1 of 1 : SP_2015_RD0563_210_51_20150309_00050.jpg

LM Start	3.91	Rating **	M	Issue No.	51
LM End	4.01	Issue Type +	Ma	Location *	WS
Category	Supplemental			GPS Latitude/Longitude	
				Start	End
Item	USACE Erosion Survey			38.200733 °	38.199925 °
				-121.542571 °	-121.544249 °
DWR ID	DWR_RD0563_01_f_2014_51				
Action/Comments					
Inspector Comments: 1997 - Narrow eroding berm upstream of existing rock. 2001 - Staked, low fascine walls at bankline. 2011 - Minor new erosion. Site extended downstream. 2012 - Rock repair failing in one erosion pocket. 2013: No observed changes. [2013 Site ID: GEO_8-3_L]

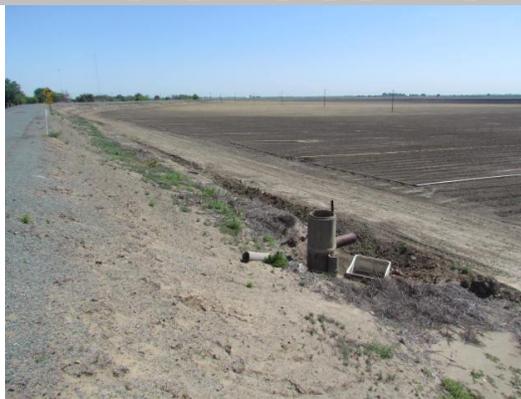
Photo 1 of 2 : SP_2015_RD0563_210_17_20150309_00021.jpg

LM Start	3.96	Rating **	M	Issue No.	17
LM End	4.10	Issue Type +	En	Location *	LS
Category	Earthen Levee			GPS Latitude/Longitude	
				Start	End
Item	Encroachments			38.200238 °	38.198830 °
				-121.543308 °	-121.544913 °
DWR ID	DWR_RD0563_01_s_2013_17				
Action/Comments					
Ditch

Looking northeast at irrigation ditch on landward toe.

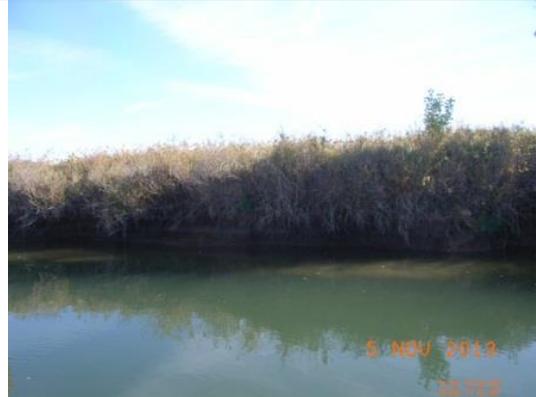
Photo 1 of 1 : SP_2015_RD0563_210_49_20150309_00047.jpg

LM Start	4.98	Rating **	M	Issue No.	49
LM End	5.04	Issue Type +	Ma	Location *	WS
Category	Supplemental			GPS Latitude/Longitude	
				Start	End
Item	USACE Erosion Survey			38.190073 °	38.189524 °
				-121.556307 °	-121.557227 °
DWR ID	DWR_RD0563_01_f_2014_49				
Action/Comments					
Inspector Comments: 2009 - Small scallops of erosion into the levee toe behind brush boxes. 2011 - Minor new erosion. 2012 - Site extended upstream to account for addition erosion pockets. 2013: No observed changes. [2013 Site ID: GEO_7-2_L]

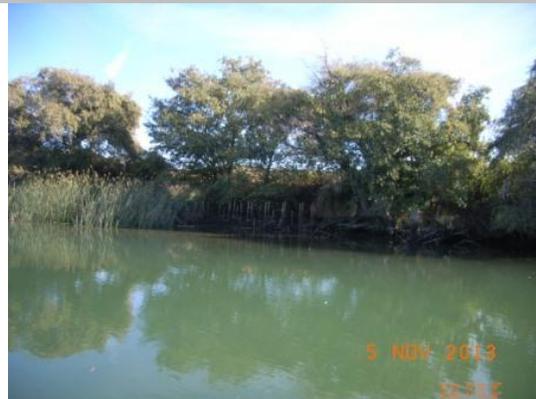
Photo 1 of 1 : SP_2015_RD0563_210_48_20150309_00046.jpg

LM Start	5.15	Rating **	U	Issue No.	48
LM End	5.39	Issue Type +	Ma	Location *	WS
Category	Supplemental			GPS Latitude/Longitude	
				Start	End
Item	USACE Erosion Survey			38.188216 °	38.185968 °
				-121.558442 °	-121.561667 °
DWR ID	DWR_RD0563_01_f_2014_48				
Action/Comments					
Inspector Comments: 1997 - Deep pockets of erosion into a narrow berm just downstream of the rock. 2000 - Scallops in banks with small colored flags, some new biotech rolls in with older rolls in the scallops. 2001 - Staked, low fascine walls at the bankline. 2011 - Site upgraded to CRITICAL. Site extended upstream due to new erosion pocket. New tree popouts and new erosion. 2013: Pipe observed at upstream end of site. [2013 Site ID: GEO_6-8_L]

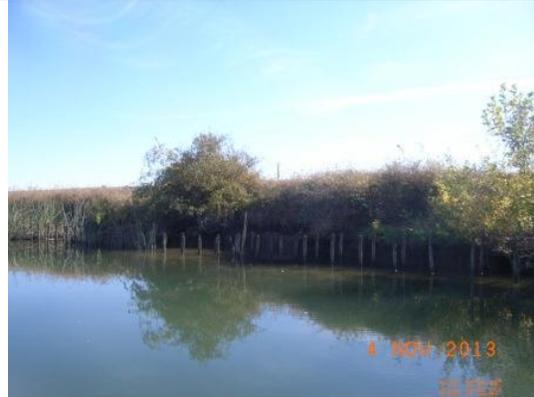
Photo 1 of 1 : SP_2015_RD0563_210_46_20150309_00045.jpg

LM Start	5.49	Rating **	M	Issue No.	46
LM End	6.27	Issue Type +	Ma	Location *	WS
Category	Supplemental		GPS Latitude/Longitude		
			Start	End	
Item	USACE Erosion Survey		38.185479 °	38.181359 °	
			-121.563296 °	-121.576292 °	
DWR ID	DWR_RD0563_01_f_2014_46				
Action/Comments					
Inspector Comments: 1997 - Deep pockets of erosion and narrow berm. Reach is characterized by lots of pockets into the existing berm and/or levee slope. 1999 - Some pockets filled with rock riprap. 2000 - Exposed fabric. 2001 - Staked, low fascine walls at bankline. 2002 - New spot of rock at upstream end. Some new brush boxes. 2005 - Some stone sliding off the underlying geotextile fabric. Some new brush bundles in the brush boxes; some with missing bundles. Some boxes too low relative to high tide. 2009 - Minimal new erosion, site length extended. 2010 - New erosion on downstream end, site extended downstream. 2011 - Sites 6.1. 6.4 and 6.6 were combined. New erosion pockets, site extended to include the erosion in between the old sites. 2012 - Rock has been placed in portions of the bank since last year. 2013: No observed changes. [2013 Site ID: GEO_6-3_L]

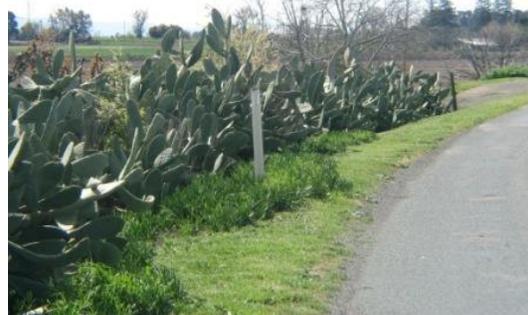
Photo 2 of 2 : SP_2015_RD0563_210_22_20150309_00026.jpg

LM Start	5.92	Rating **	U	Issue No.	22 (cont)
LM End	5.96	Issue Type +	Ma	Location *	LS
Category	Earthen Levee		GPS Latitude/Longitude		
			Start	End	
Item	Vegetation		38.181965 °	38.181763 °	
			-121.569913 °	-121.570447 °	
DWR ID	DWR_RD0563_01_s_2012_22				
Action/Comments					
Remove the wild growth other than native grasses from the levee slopes. Inspector Comments: Large cactus on landward slope.

Large cactus plant on landward slope from LM 6.04 to 6.08

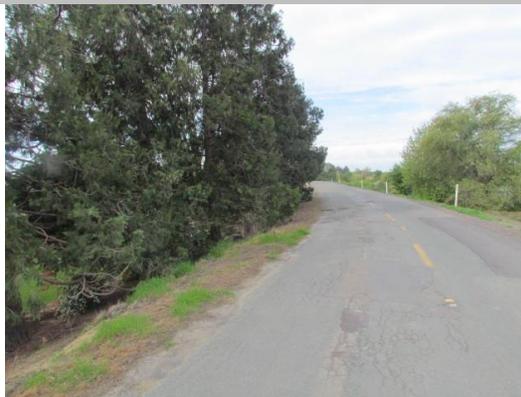
Photo 1 of 1 : SP_2015_RD0563_210_23_20150309_00027.jpg

LM Start	6.26	Rating **	A/W	Issue No.	23
LM End	6.28	Issue Type +	Ma	Location *	LS
Category	Earthen Levee			GPS Latitude/Longitude	
				Start	End
Item	Trim / Thin Trees			38.181273 °	38.181165 °
				-121.575873 °	-121.576217 °
DWR ID	DWR_RD0563_01_s_2012_23				
Action/Comments					
Trim trees to at least five feet above ground level.

Looking south at trees on landward shoulder.

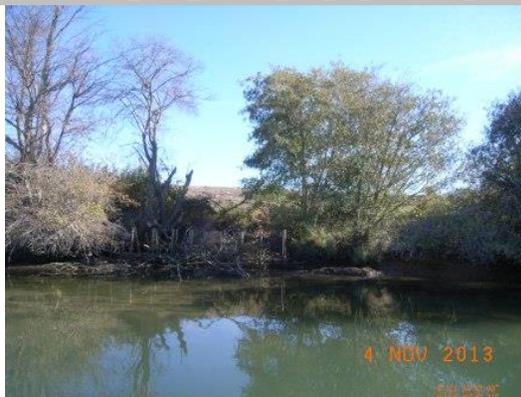
Photo 1 of 1 : SP_2015_RD0563_210_45_20150309_00044.jpg

LM Start	6.37	Rating **	M	Issue No.	45
LM End	6.46	Issue Type +	Ma	Location *	WS
Category	Supplemental			GPS Latitude/Longitude	
				Start	End
Item	USACE Erosion Survey			38.180462 °	38.179319 °
				-121.577895 °	-121.578566 °
DWR ID	DWR_RD0563_01_f_2014_45				
Action/Comments					
Inspector Comments: 2013: Erosion pockets into the levee prism. Erosion pockets primarily located behind unmaintained brush boxes. [2013 Site ID: GEO_5-8_L]

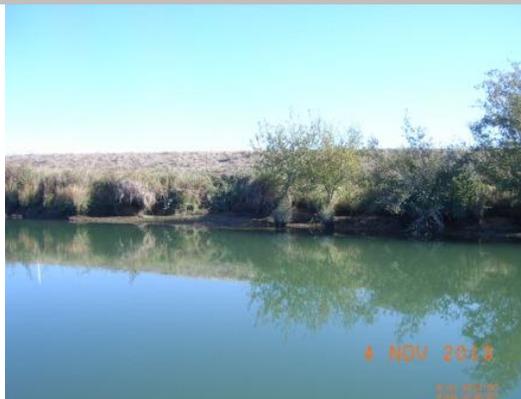
Photo 1 of 1 : SP_2015_RD0563_210_44_20150309_00043.jpg

LM Start	6.64	Rating **	M	Issue No.	44
LM End	7.28	Issue Type +	Ma	Location *	WS
Category	Supplemental			GPS Latitude/Longitude	
				Start	End
Item	USACE Erosion Survey			38.176861 °	38.167959 °
				-121.579747 °	-121.581616 °
DWR ID	DWR_RD0563_01_f_2014_44				
Action/Comments					
Inspector Comments: 1997 - Pocket erosion into the toe of the levee. 2000 - Scallops in banks with small colored flags, biotech rolls present. 2001 - Staked, low fascine walls at bankline. 2003 - Still have visibly bad spots, especially at the upstream end. 2005 - Some new brush bundles in the brush boxes; some with missing bundles. Some boxes too low relative to high tide. 2010 - Site extended upstream. 2011 - Minor new erosion. 2013: No observed changes. [2013 Site ID: GEO_5-3_L]

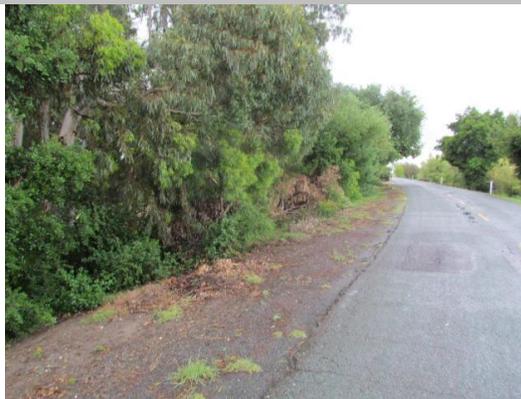
Photo 1 of 1 : SP_2015_RD0563_210_145_20150409_00977.jpg

LM Start	6.75	Rating **	U	Issue No.	145
LM End	6.79	Issue Type +	Ma	Location *	LS
Category	Earthen Levee		GPS Latitude/Longitude		
			Start	End	
Item	Trim / Thin Trees		38.175219 °	38.174743 °	
			-121.580053 °	-121.580016 °	
DWR ID	DWR_RD0563_01_s_2014_145				
Action/Comments					
Thin trees to allow visibility of the ground and room to flood fight. Inspector Comments: Untrimmed trees blocking view of landward toe.

Looking southeast at dense vegetation on landward slope and toe.

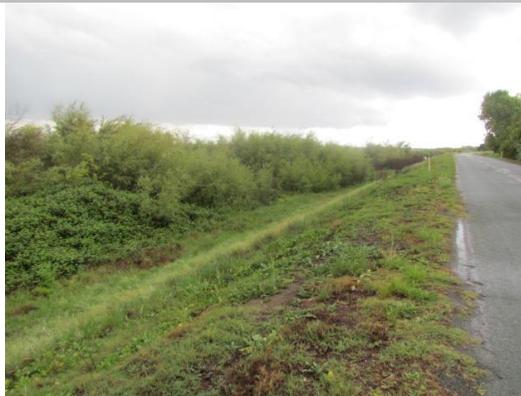
Photo 1 of 1 : SP_2015_RD0563_210_27_20150409_00978.jpg

LM Start	7.42	Rating **	U	Issue No.	27
LM End	7.47	Issue Type +	Ma	Location *	LS
Category	Earthen Levee			GPS Latitude/Longitude	
				Start	End
Item	Vegetation			38.165981 °	38.165273 °
				-121.582394 °	-121.582593 °
DWR ID	DWR_RD0563_01_s_2015_27				
Action/Comments					
Remove the wild growth other than native grasses from the levee slopes. Inspector Comments: Dense vegetation at landward toe.

Looking southeast at dense vegetation within landward right away.

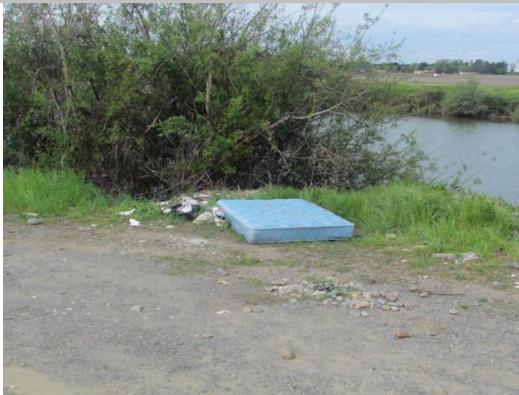
Photo 1 of 1 : SP_2015_RD0563_210_146_20150309_00132.jpg

LM Start	7.53	Rating **	A/W	Issue No.	146
LM End	7.53	Issue Type +	En	Location *	WS
Category	Earthen Levee			GPS Latitude/Longitude	
				Start	End
Item	Encroachments			38.164509 °	38.164509 °
				-121.582807 °	-121.582807 °
DWR ID	DWR_RD0563_01_s_2014_146				
Action/Comments					
Garbage

Looking west at garbage on waterward slope and toe.

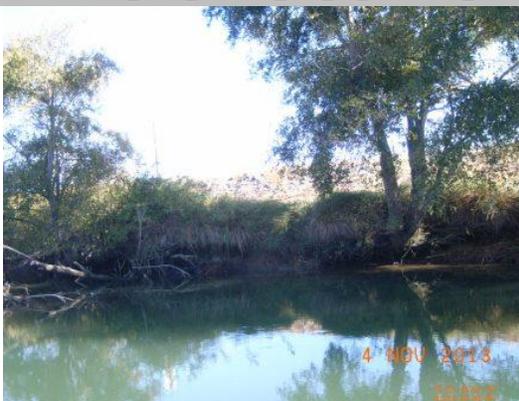
Photo 1 of 1 : SP_2015_RD0563_210_43_20150309_00042.jpg

LM Start	7.53	Rating **	U	Issue No.	43
LM End	7.80	Issue Type +	Ma	Location *	WS
Category	Supplemental			GPS Latitude/Longitude	
				Start	End
Item	USACE Erosion Survey			38.164462 °	38.160888 °
				-121.583092 °	-121.584807 °
DWR ID	DWR_RD0563_01_f_2014_43				
Action/Comments					
Inspector Comments: 1997 - Pocket erosion at upstream end and into the levee toe under the Alder trees. 2003 - New brush boxes with wattles on bank. 2004 - No brush boxes. 2005 - Site extended from the downstream side of the bridge. Whole bank is vertical. 2010 - Some minor new erosion. 2011 - Site upgraded to CRITICAL. New erosion pockets throughout the site. Sites 4.5, and 4.6 were combined. 2013: No observed changes. [2013 Site ID: GEO_4-5_L]

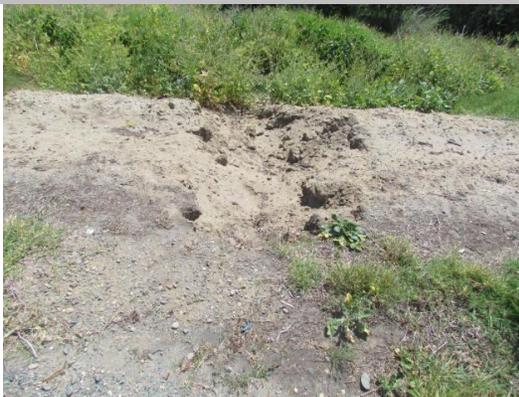
Photo 1 of 1 : SP_2015_RD0563_210_97_20150309_00113.jpg

LM Start	7.62	Rating **	M	Issue No.	97
LM End	7.62	Issue Type +	Ma	Location *	LS
Category	Earthen Levee			GPS Latitude/Longitude	
				Start	End
Item	Slope Stability			38.163240 °	38.163240 °
				-121.583328 °	-121.583328 °
DWR ID	DWR_RD0563_01_s_2013_97				
Action/Comments					
Repair slope instability. Inspector Comments: Minor erosion on landside shoulder and slope.

Looking east at slope erosion on landward shoulder and slope.

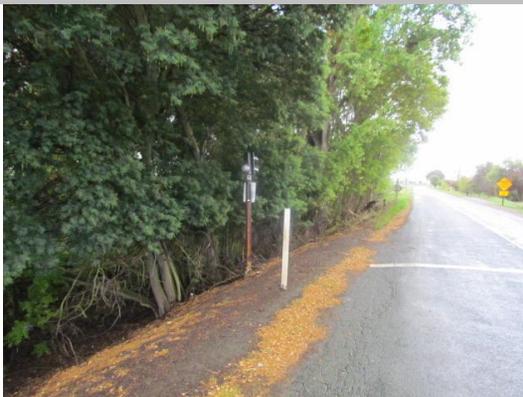
Photo 1 of 1 : SP_2015_RD0563_210_29_20150409_00979.jpg

LM Start	7.74	Rating **	M	Issue No.	29
LM End	7.78	Issue Type +	Ma	Location *	LS
Category	Earthen Levee		GPS Latitude/Longitude		
			Start	End	
Item	Trim / Thin Trees		38.161607 °	38.161092 °	
			-121.584258 °	-121.584470 °	
DWR ID	DWR_RD0563_01_s_2012_29				
Action/Comments					
Trim trees to at least five feet above ground level. Inspector Comments: Dense (untrimmed) trees on landward slope.

Looking southeast at dense trees on landward slope and toe.

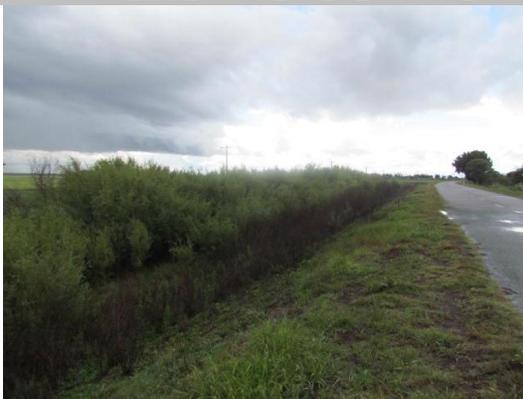
Photo 1 of 5 : SP_2015_RD0563_210_90_20150409_00980.jpg

LM Start	7.80	Rating **	M	Issue No.	90
LM End	7.82	Issue Type +	Ma	Location *	LS
Category	Earthen Levee		GPS Latitude/Longitude		
			Start	End	
Item	Vegetation		38.160800 °	38.160487 °	
			-121.584598 °	-121.584717 °	
DWR ID	DWR_RD0563_01_s_2012_90				
Action/Comments					
Remove the wild growth other than native grasses from the levee slopes. Inspector Comments: Berryvines and willows on landside toe.

Looking southeast at dense vegetation at landward toe. (Spring 2015)

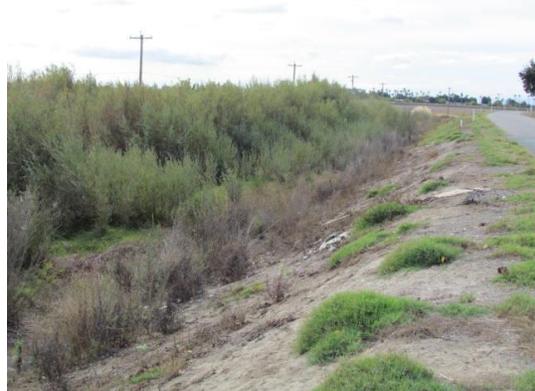
Photo 3 of 5 : SP_2015_RD0563_210_90_20150309_00104.jpg

Looking south at dense vegetation on landside toe. (2012 Fall

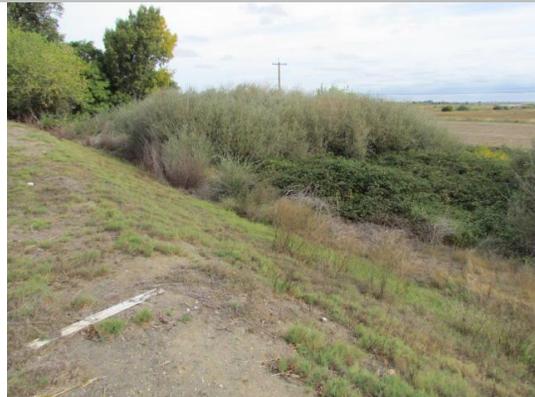
Photo 4 of 5 : SP_2015_RD0563_210_90_20150309_00105.jpg

Looking northeast at dense vegetation on landside toe. (2012 Fall Inspection)

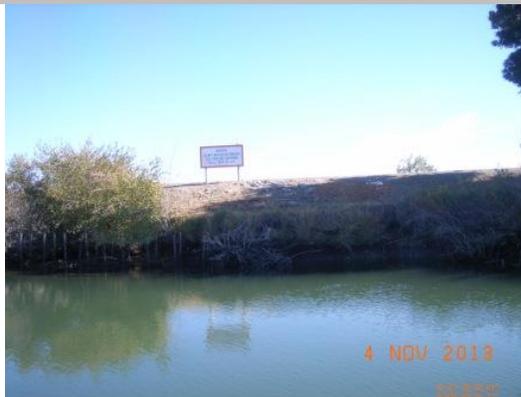
Photo 1 of 1 : SP_2015_RD0563_210_42_20150309_00041.jpg

LM Start	7.85	Rating **	M	Issue No.	42
LM End	8.05	Issue Type +	Ma	Location *	WS
Category	Supplemental			GPS Latitude/Longitude	
				Start	End
Item	USACE Erosion Survey			38.160261 °	38.157625 °
				-121.585056 °	-121.586543 °
DWR ID	DWR_RD0563_01_f_2014_42				
Action/Comments					
Inspector Comments: 1997 - Pockets of erosion into the levee toe. 1999 - Minor rock riprap and willow bundles place in a couple of spots. 2001 - Staked, low fascine walls at bankline. 2003 - Small unprotected pockets still eroding. 2004 - Numerous brush boxes, some falling apart, some with new bundles. 2005 - Some new brush boxes installed; some boxes are empty. Levee slope and banks still look bad

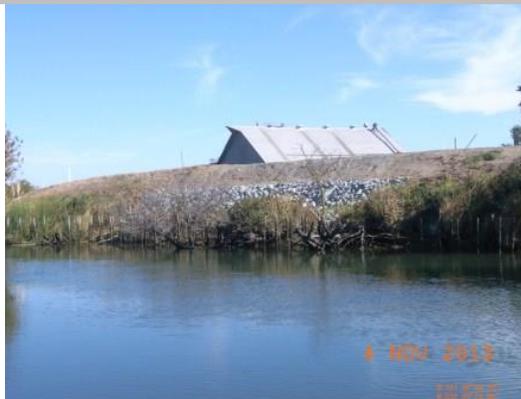
Photo 1 of 1 : SP_2015_RD0563_210_41_20150309_00040.jpg

LM Start	8.12	Rating **	M	Issue No.	41
LM End	8.59	Issue Type +	Ma	Location *	WS
Category	Supplemental			GPS Latitude/Longitude	
				Start	End
Item	USACE Erosion Survey			38.156987 °	38.152919 °
				-121.587427 °	-121.591129 °
DWR ID	DWR_RD0563_01_f_2014_41				
Action/Comments					
Inspector Comments: 1997 - Pockets of erosion into the levee at the water line. Alders are being undercut and rotating out into the channel. Damaged rock at upstream end. 2000 - New minor erosion. 2001 - Staked low fascine walls at bankline. 2002 - New "Brush Boxes" along the bank toe. 2003 - New erosion pockets in the middle of the site. 2005 - Some new bundles in the brush boxes. 2011 - Site upgraded to CRITICAL. Significant new erosion. Sites 3.6, 3.7, 3.71, and 4.0 were combined. 2012 - Rock has been placed in some of the erosion pockets since last year, however site remains critical. 2013: Site no longer critical. The worst pockets were filled with rock by the local RD. [2013 Site ID: GEO_3-8_L]

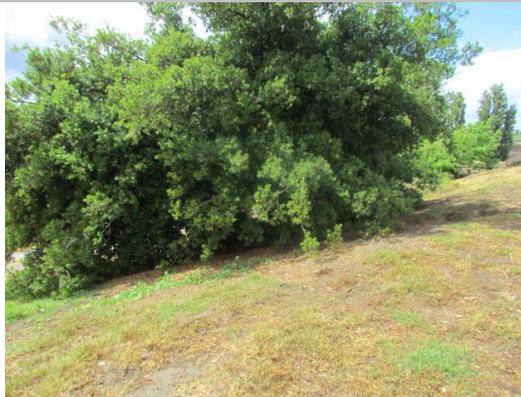
Photo 1 of 1 : SP_2015_RD0563_210_98_20150409_00983.jpg

LM Start	9.28	Rating **	U	Issue No.	98
LM End	9.28	Issue Type +	Ma	Location *	LS
Category	Earthen Levee			GPS Latitude/Longitude	
				Start	End
Item	Trim / Thin Trees			38.145825 °	38.145825 °
				-121.588807 °	-121.588807 °
DWR ID	DWR_RD0563_01_s_2013_98				
Action/Comments					
Trim trees to at least five feet above ground level.

Looking southeast at untrimmed trees on landward slope.
