**Flood Control Project Maintenance
Levee Inspections**
LMA District Cover Sheet
Spring 2015 Levee Inspection Results

Reclamation District No. 0563 Tyler Island

Spring 2015 Levee Inspection Results

Waterway	Bank	Unit Miles
Unit No. 01 Georgiana Slough (Tyler Island)	Left	12.11

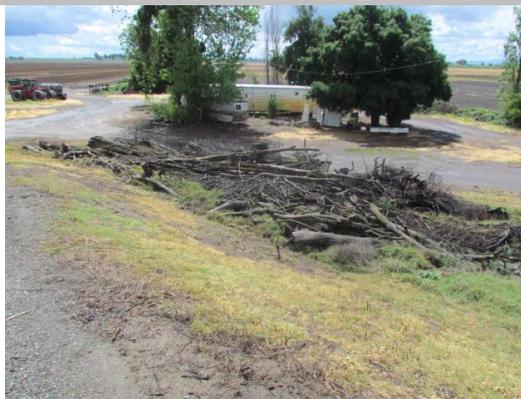
Photo 1 of 2 : SP_2015_RD0563_210_73_20150409_00984.jpg

LM Start	9.33	Rating **	U	Issue No.	73
LM End	9.33	Issue Type +	Ma	Location *	LS
Category	Earthen Levee			GPS Latitude/Longitude	
				Start	End
Item	Encroachments			38.145957 °	38.145957 °
				-121.589653 °	-121.589653 °
DWR ID	DWR_RD0563_01_s_2012_73				
Action/Comments					
Prunings Inspector Comments: Large pruning pile on landward toe.

Looking east at prunings at landward toe. (Spring 2015)

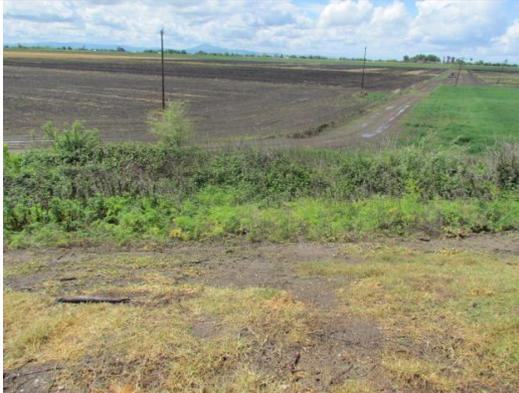
Photo 1 of 1 : SP_2015_RD0563_210_769_20150409_00985.jpg

LM Start	9.36	Rating **	U	Issue No.	769
LM End	9.43	Issue Type +	Ma	Location *	LS
Category	Earthen Levee		GPS Latitude/Longitude		
			Start	End	
Item	Vegetation		38.146276 °	38.147034 °	
			-121.590189 °	-121.590907 °	
DWR ID	DWR_RD0563_01_s_2015_769				
Action/Comments					
Remove the wild growth other than native grasses from the levee slopes.

Looking east at dense vegetation at landward toe. (Spring 2015)

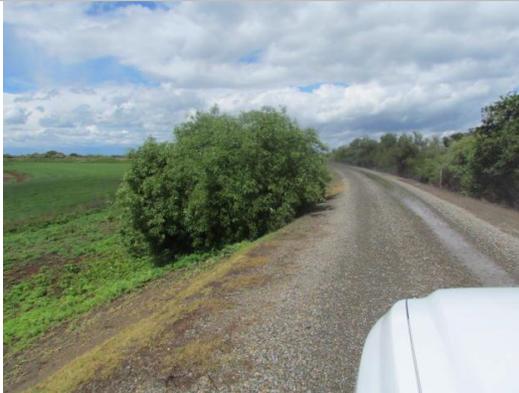
Photo 1 of 1 : SP_2015_RD0563_210_36_20150409_00986.jpg

LM Start	9.64	Rating **	M	Issue No.	36
LM End	9.64	Issue Type +	Ma	Location *	LS
Category	Earthen Levee		GPS Latitude/Longitude		
			Start	End	
Item	Vegetation		38.149790 °	38.149790 °	
			-121.592788 °	-121.592788 °	
DWR ID	DWR_RD0563_01_s_2012_36				
Action/Comments					
Elderberries are blocking visibility and flood fight capability. Inspector Comments: Vegetation blocking view of levee slope.

Looking south at elderberry on landward slope.

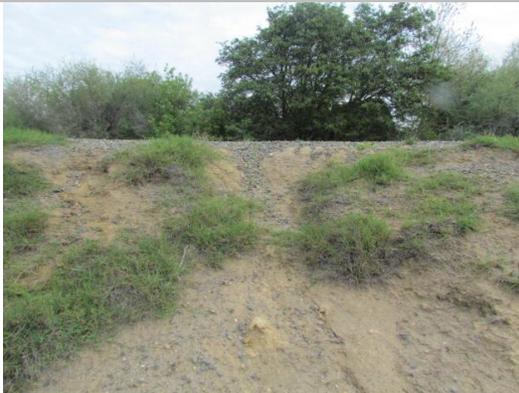
Photo 1 of 2 : SP_2015_RD0563_210_99_20150309_00114.jpg

LM Start	9.65	Rating **	M	Issue No.	99
LM End	9.65	Issue Type +	Ma	Location *	LS
Category	Earthen Levee		GPS Latitude/Longitude		
			Start	End	
Item	Erosion / Bank Caving		38.149905 °	38.149905 °	
			-121.592910 °	-121.592910 °	
DWR ID	DWR_RD0563_01_s_2013_99				
Action/Comments					
Note and monitor erosion site.

Looking west at minor erosion on landward shoulder and slope.

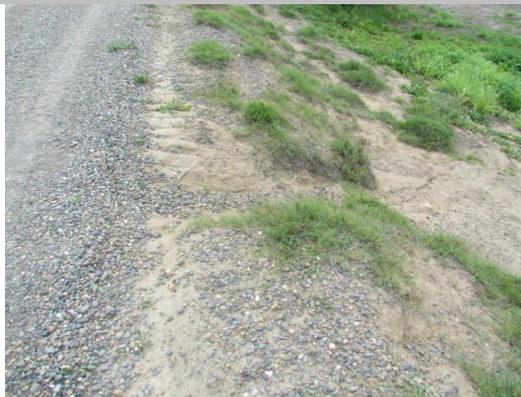
Photo 2 of 2 : SP_2015_RD0563_210_99_20150309_00115.jpg

LM Start	9.65	Rating **	M	Issue No.	99 (cont)
LM End	9.65	Issue Type +	Ma	Location *	LS
Category	Earthen Levee			GPS Latitude/Longitude	
				Start	End
Item	Erosion / Bank Caving			38.149905 °	38.149905 °
				-121.592910 °	-121.592910 °
DWR ID	DWR_RD0563_01_s_2013_99				
Action/Comments					
Note and monitor erosion site.

Looking north at minor erosion on landward shoulder and slope.

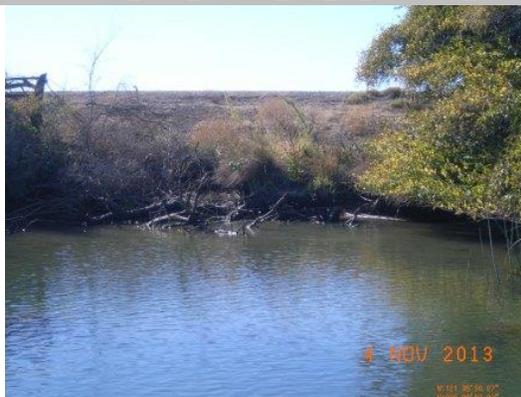
Photo 1 of 1 : SP_2015_RD0563_210_40_20150309_00039.jpg

LM Start	9.73	Rating **	M	Issue No.	40
LM End	9.90	Issue Type +	Ma	Location *	WS
Category	Supplemental			GPS Latitude/Longitude	
				Start	End
Item	USACE Erosion Survey			38.150820 °	38.150647 °
				-121.593650 °	-121.596858 °
DWR ID	DWR_RD0563_01_f_2014_40				
Action/Comments					
Inspector Comments: 1997 - Erosion pockets into the toe of the levee. 2001 - Staked low fascine walls at the bankline. 2004 - Numerous "Brush Boxes." 2005 - Some new bundles in the brush boxes. 2012 - Site extended downstream to account for new bank sloughing. 2013: Some rock added to the upstream end by the local RD. [2013 Site ID: GEO_2-5_L]

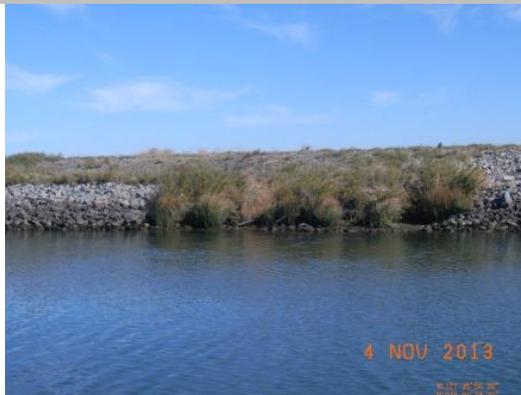
Photo 1 of 1 : SP_2015_RD0563_210_39_20150309_00038.jpg

LM Start	10.45	Rating **	M	Issue No.	39
LM End	10.74	Issue Type +	Ma	Location *	WS
Category	Supplemental			GPS Latitude/Longitude	
				Start	End
Item	USACE Erosion Survey			38.143519 °	38.139918 °
				-121.599677 °	-121.596986 °
DWR ID	DWR_RD0563_01_f_2014_39				
Action/Comments					
Inspector Comments: 1997 - Old damaged rock riprap along the toe. 1999 - Downstream end (400 ft) repaired with rock. 2002 - New rock/concrete rubble section on the downstream end. 2004 - Small pocket repairs at the downstream end. 2005 - Some new bundles in the brush boxes. 2012 - Some rock has been placed in last year. 2013: No observed changes. [2013 Site ID: GEO_1-7_L]

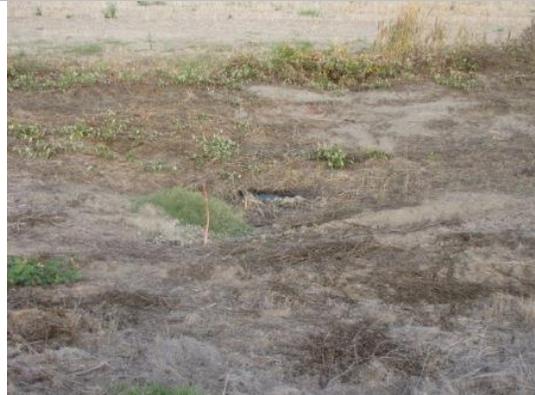
Photo 2 of 4 : SP_2015_RD0563_210_76_20150309_00081.jpg

LM Start	10.59	Rating **	U	Issue No.	76
LM End	10.59	Issue Type +	Ma	Location *	LS
Category	Earthen Levee			GPS Latitude/Longitude	
				Start	End
Item	Slope Stability			38.141940 °	38.141940 °
				-121.598033 °	-121.598033 °
DWR ID	DWR_RD0563_01_s_2012_76				
Action/Comments					
Repair slope instability. Inspector Comments: Deep depression on landside shoulder and slope; possible pipe collapse.

LM Start	10.59	Rating **	U	Issue No.	76 (cont)
LM End	10.59	Issue Type +	Ma	Location *	LS

Looking east at water ponding at landside toe just above 10" irrigation pipe.

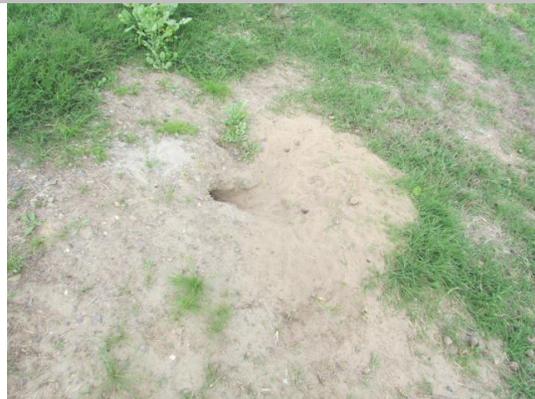
Photo 1 of 1 : SP_2015_RD0563_210_77_20150309_00084.jpg

LM Start	10.64	Rating **	A/W	Issue No.	77
LM End	10.64	Issue Type +	Ma	Location *	LS
Category	Earthen Levee			GPS Latitude/Longitude	
				Start	End
Item	Animal Control			38.141362 °	38.141362 °
				-121.597598 °	-121.597598 °
DWR ID	DWR_RD0563_01_s_2012_77				
Action/Comments					
No rodents visible, but rodent burrows visible; need to backfill and compact or grout burrows.

Looking at typical rodent holes on landward slope.

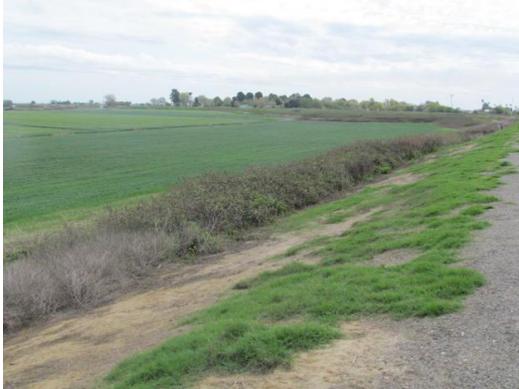
Photo 2 of 3 : SP_2015_RD0563_210_100_20150309_00117.jpg

LM Start	10.72	Rating **	U	Issue No.	100 (cont)
LM End	10.81	Issue Type +	Ma	Location *	LS
Category	Earthen Levee		GPS Latitude/Longitude		
			Start	End	
Item	Vegetation		38.140307 °	38.139079 °	
			-121.596900 °	-121.596214 °	
DWR ID	DWR_RD0563_01_s_2013_100				
Action/Comments					
Remove the wild growth other than native grasses from the levee slopes. Inspector Comments: Wild rose or grape vines on landward slope and toe.

Looking south at dense vegetation at landward toe. (Fall 2014)

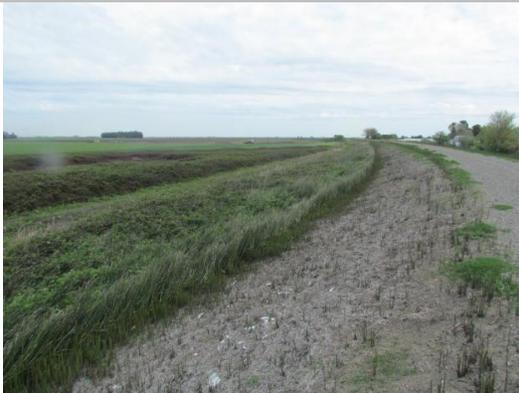
Photo 3 of 3 : SP_2015_RD0563_210_100_20150309_00116.jpg

LM Start	10.72	Rating **	U	Issue No.	100 (cont)
LM End	10.81	Issue Type +	Ma	Location *	LS

Looking south at additional dense vegetation at landward toe.

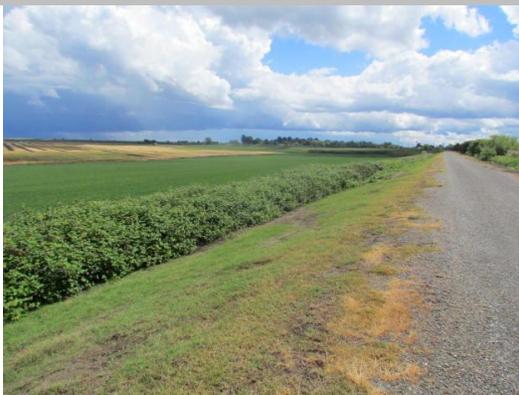
Photo 1 of 1 : SP_2015_RD0563_210_770_20150409_00988.jpg

LM Start	11.12	Rating **	U	Issue No.	770
LM End	12.00	Issue Type +	Ma	Location *	LS
Category	Earthen Levee		GPS Latitude/Longitude		
			Start	End	
Item	Vegetation		38.135468 °	38.130739 °	
			-121.592898 °	-121.579678 °	
DWR ID	DWR_RD0563_01_s_2015_770				
Action/Comments					
Remove the wild growth other than native grasses from the levee slopes.

Looking southeast at dense vegetation at landward toe. (Spring 2015)

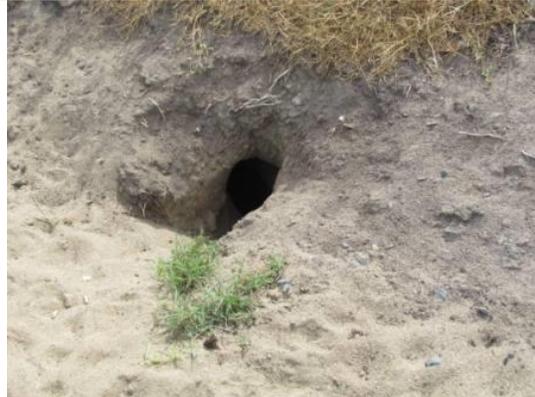
Photo 2 of 3 : SP_2015_RD0563_210_91_20150309_00108.jpg

LM Start	11.45	Rating **	A/W	Issue No.	91 (cont)
LM End	11.45	Issue Type +	Ma	Location *	LS
Category	Earthen Levee			GPS Latitude/Longitude	
				Start	End
Item	Animal Control			38.131943 °	38.131943 °
				-121.588912 °	-121.588912 °
DWR ID	DWR_RD0563_01_s_2012_91				
Action/Comments					
No rodents visible, but rodent burrows visible; need to backfill and compact or grout burrows.

Looking west at rodent hole on landside slope.

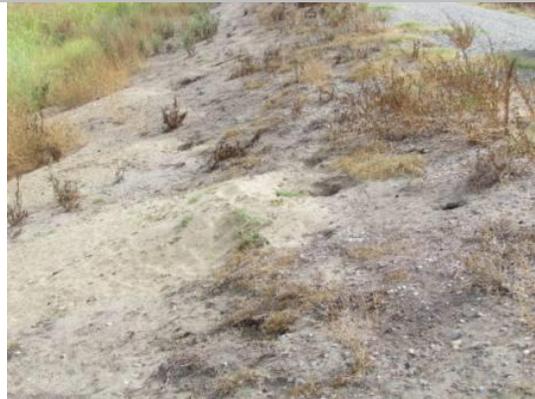
Photo 3 of 3 : SP_2015_RD0563_210_91_20150309_00109.jpg

LM Start	11.45	Rating **	A/W	Issue No.	91 (cont)
LM End	11.45	Issue Type +	Ma	Location *	LS

Looking south at rodent holes on landside slope.

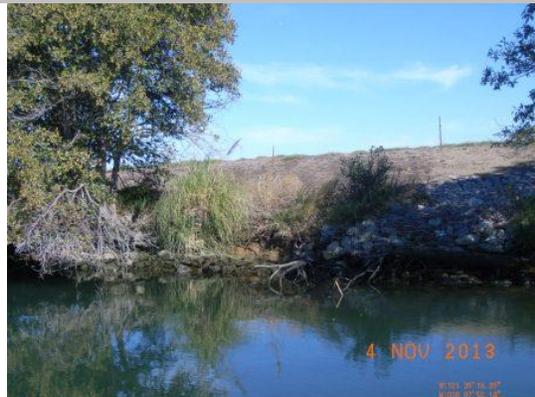
Photo 1 of 1 : SP_2015_RD0563_210_38_20150309_00037.jpg

LM Start	11.51	Rating **	M	Issue No.	38
LM End	11.70	Issue Type +	Ma	Location *	WS
Category	Supplemental			GPS Latitude/Longitude	
				Start	End
Item	USACE Erosion Survey			38.131126 °	38.129948 °
				-121.588337 °	-121.585026 °
DWR ID	DWR_RD0563_01_f_2014_38				
Action/Comments					
Inspector Comments: 1997 - Erosion pockets into the levee toe. 1999 - Some small pockets fixed with rock riprap. 2002 - New "brush boxes" along the bank toe. 2005 - Brush boxes are empty. Some pockets are filled with new stone. 2006 - Some new rock at the downstream end (~100 ft long). Several small pockets of new rock in scallops. Brush boxes in poor to fair condition. 2010 - Site looks a little worse, some

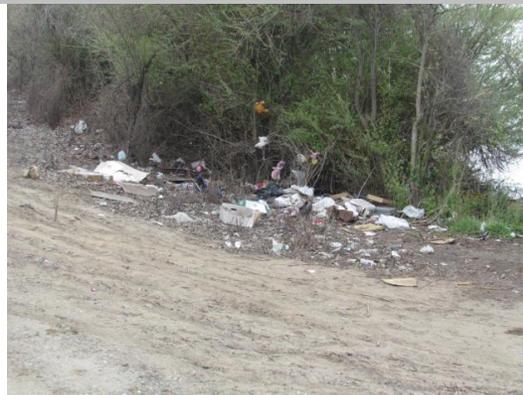
Photo 1 of 1 : SP_2015_RD0563_210_107_20150309_00121.jpg

LM Start	12.03	Rating **	A/W	Issue No.	107
LM End	12.03	Issue Type +	Ma	Location *	WS
Category	Earthen Levee		GPS Latitude/Longitude		
			Start	End	
Item	Encroachments		38.130776 °	38.130776 °	
			-121.579063 °	-121.579063 °	
DWR ID	DWR_RD0563_01_f_2013_107				
Action/Comments					
Garbage

Looking southwest at garbage at waterward slope and toe.
