**Flood Control Project Maintenance
Levee Inspections**
LMA District Cover Sheet
Spring 2016 Levee Inspection Results

Reclamation District No. 0563 Tyler Island

Spring 2016 Levee Inspection Results

Waterway	Bank	Unit Miles
Unit No. 01 Georgiana Slough (Tyler Island)	Left	12.11

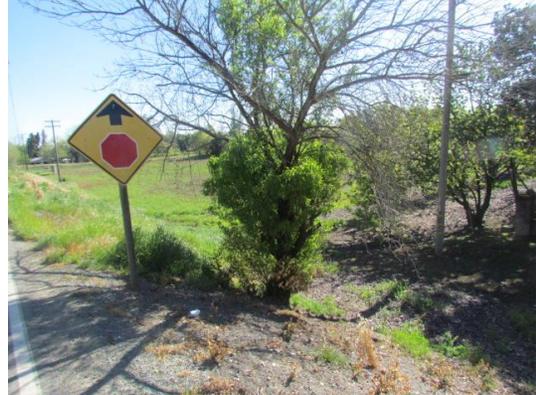
Photo 1 of 1 : SP_2016_RD0563_210_59_20160330_00227.jpg

LM Start	0.10	Rating **	M	Issue No.	59
LM End	0.10	Issue Type +	Ma	Location *	LS
Category	Earthen Levee			GPS Latitude/Longitude	
				Start	End
Item	Trim / Thin Trees			38.234113 °	38.234113 °
				-121.518467 °	-121.518467 °
DWR ID	DWR_RD0563_01_s_2013_59				
Comment Code					
T1 : Trim trees to at least five feet above ground level.					
Inspector Comment					
Dead tree should be removed.

Looking northeast at dead tree on landward slope.

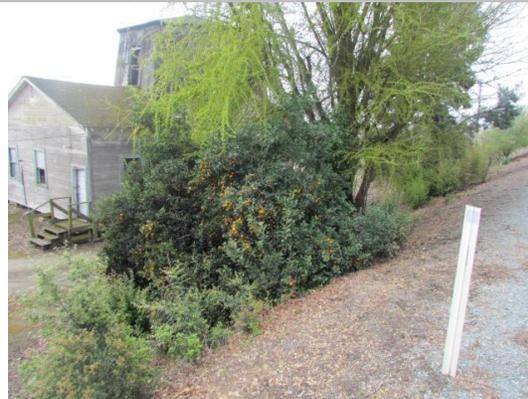
Photo 2 of 2 : SP_2016_RD0563_210_28_20160308_00030.jpg

LM Start	0.12	Rating **	A/W	Issue No.	28 (cont)
LM End	0.14	Issue Type +	Ma	Location *	LS
Category	Earthen Levee			GPS Latitude/Longitude	
				Start	End
Item	Trim / Thin Trees			38.233910 °	38.233655 °
				-121.518722 °	-121.519000 °
DWR ID	DWR_RD0563_01_s_2012_28				
Comment Code					
T1 : Trim trees to at least five feet above ground level.					
Inspector Comment

Looking southeast at landscaping on landside slope and toe.

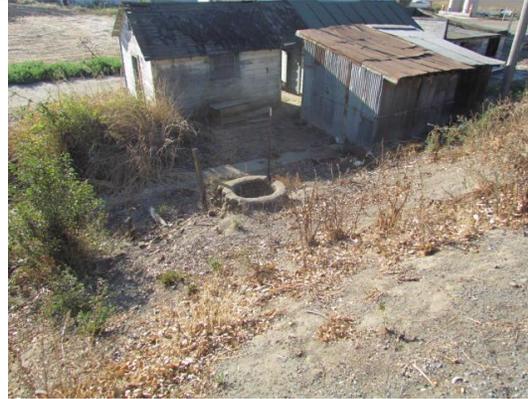
Photo 1 of 3 : SP_2016_RD0563_210_10_20160308_00011.jpg

LM Start	0.15	Rating **	M	Issue No.	10
LM End	0.15	Issue Type +	En	Location *	LS
Category	Earthen Levee			GPS Latitude/Longitude	
				Start	End
Item	Encroachments			38.233572 °	38.233572 °
				-121.519083 °	-121.519083 °
DWR ID	DWR_RD0563_01_f_2013_10				
Comment Code					
BU : Building					
Inspector Comment					
Tool shed and fire pit on landward slope and toe.

Looking east at fire pit on landward slope.

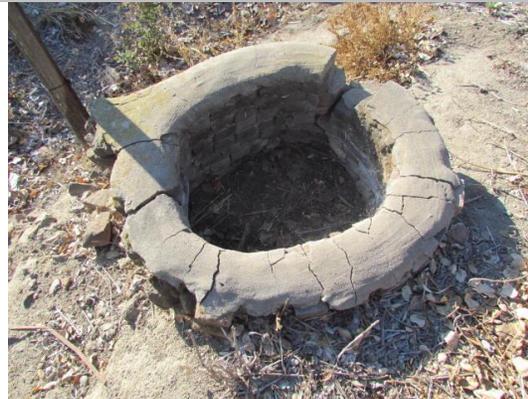
Photo 2 of 3 : SP_2016_RD0563_210_10_20160308_00012.jpg

LM Start	0.15	Rating **	M	Issue No.	10 (cont)
LM End	0.15	Issue Type +	En	Location *	LS

Looking southeast at fire pit on landward slope.

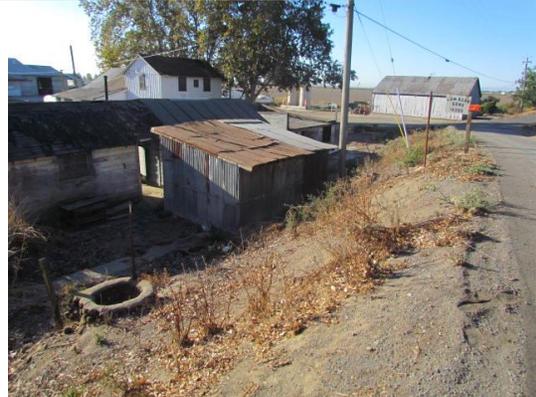
Photo 3 of 3 : SP_2016_RD0563_210_10_20160308_00013.jpg

LM Start	0.15	Rating **	M	Issue No.	10 (cont)
LM End	0.15	Issue Type +	En	Location *	LS
Category	Earthen Levee		GPS Latitude/Longitude		
			Start	End	
Item	Encroachments		38.233572 °	38.233572 °	
			-121.519083 °	-121.519083 °	
DWR ID	DWR_RD0563_01_f_2013_10				
Comment Code					
BU : Building					
Inspector Comment					
Tool shed and fire pit on landward slope and toe.

Looking southeast at storage shed at landward toe.

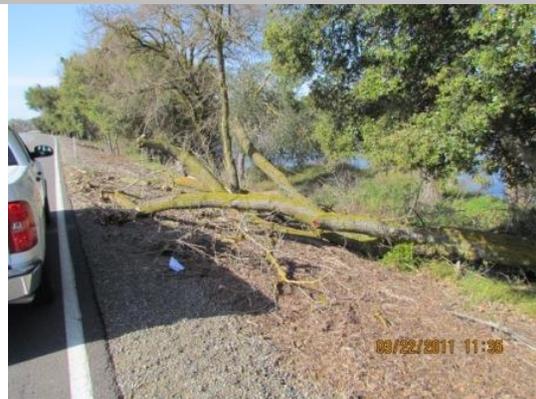
Photo 1 of 1 : SP_2016_RD0563_210_32_20160308_00033.jpg

LM Start	0.17	Rating **	M	Issue No.	32
LM End	0.17	Issue Type +	Ma	Location *	WS
Category	Earthen Levee		GPS Latitude/Longitude		
			Start	End	
Item	Encroachments		38.233315 °	38.233315 °	
			-121.519360 °	-121.519360 °	
DWR ID	DWR_RD0563_01_s_2012_32				
Comment Code					
TR : Tree or limb					
Inspector Comment					
Tree fallen across waterward slope.

Looking south (downstream) at fallen tree limb on waterside slope.

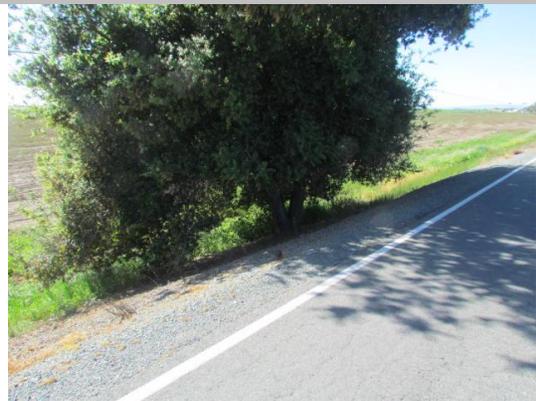
Photo 1 of 1 : SP_2016_RD0563_210_135_20160330_00228.jpg

LM Start	0.33	Rating **	U	Issue No.	135
LM End	0.33	Issue Type +	Ma	Location *	LS
Category	Earthen Levee		GPS Latitude/Longitude		
			Start	End	
Item	Trim / Thin Trees		38.231548 °	38.231548 °	
			-121.521140 °	-121.521140 °	
DWR ID	DWR_RD0563_01_f_2015_135				
Comment Code					
T1 : Trim trees to at least five feet above ground level.					
Inspector Comment					
Untrimmed tree on landward slope.

Looking southeast at untrimmed tree on landward slope.

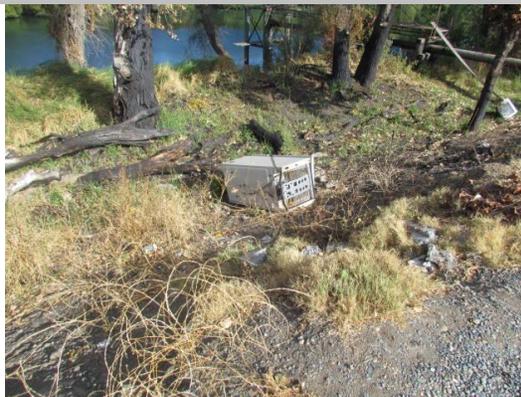
Photo 1 of 1 : SP_2016_RD0563_210_137_20160308_00119.jpg

LM Start	0.46	Rating **	A/W	Issue No.	137
LM End	0.46	Issue Type +	En	Location *	LS
Category	Earthen Levee		GPS Latitude/Longitude		
			Start	End	
Item	Encroachments		38.230145 °	38.230145 °	
			-121.522673 °	-121.522673 °	
DWR ID	DWR_RD0563_01_f_2015_137				
Comment Code					
GA : Garbage					
Inspector Comment					
Discarded appliance on waterward slope.

Looking at garbage at waterward toe and berm.

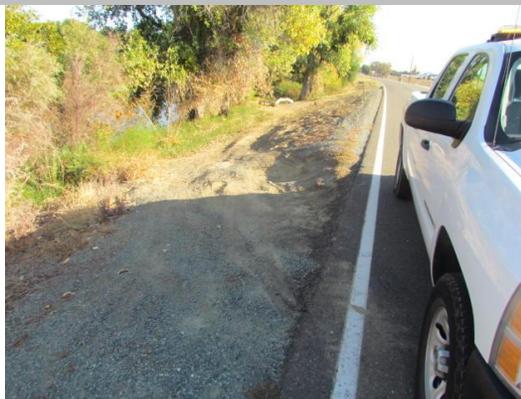
Photo 1 of 1 : SP_2016_RD0563_210_34_20160308_00035.jpg

LM Start	0.56	Rating **	M	Issue No.	34
LM End	0.56	Issue Type +	Ma	Location *	WS
Category	Earthen Levee		GPS Latitude/Longitude		
			Start	End	
Item	Slope Stability		38.228948 °	38.228948 °	
			-121.523904 °	-121.523904 °	
DWR ID	DWR_RD0563_01_f_2013_34				
Comment Code					
S3 : Repair the levee slope damaged by vehicle traffic and prevent access where possible.					
Inspector Comment					
Slope damage is due to fishermen vehicle traffic.

Looking northwest at slope damage caused by vehicle traffic.

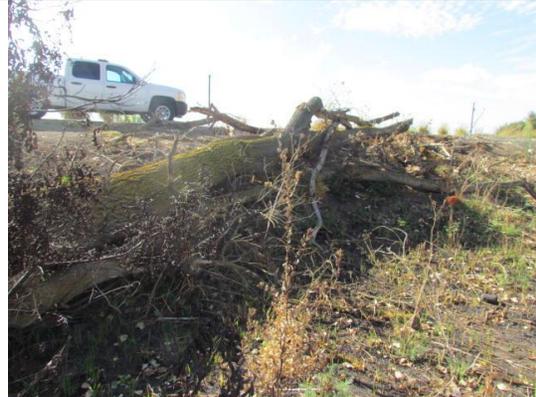
Photo 1 of 5 : SP_2016_RD0563_210_139_20160308_00120.jpg

Looking southeast at fallen tree on waterward slope.

LM Start	0.60	Rating **	U	Issue No.	139 (cont)
LM End	0.60	Issue Type +	Ma	Location *	WS
Category	Earthen Levee			GPS Latitude/Longitude	
				Start	End
Item	Encroachments			38.228605 °	38.228605 °
				-121.524364 °	-121.524364 °
DWR ID	DWR_RD0563_01_f_2015_139				
Comment Code					
TR : Tree or limb					
Inspector Comment					
Large fallen tree on waterward slope. Fallen tree left large hole on waterward berm.

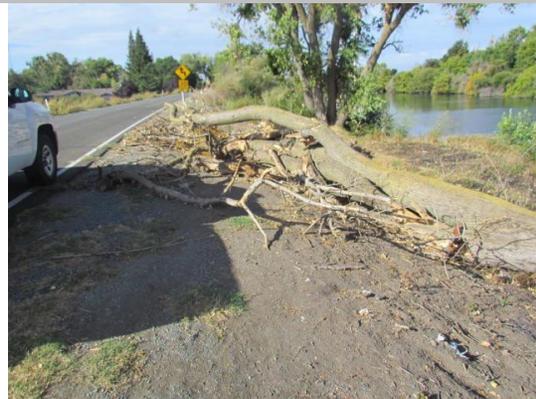
Photo 2 of 5 : SP_2016_RD0563_210_139_20160308_00121.jpg

Looking south at fallen tree on waterward slope.

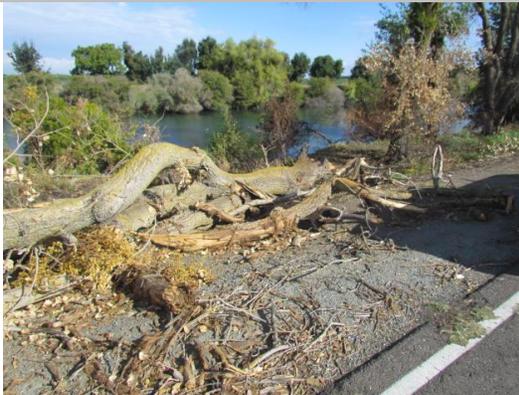
Photo 4 of 5 : SP_2016_RD0563_210_139_20160308_00123.jpg

Looking northwest at fallen tree on waterward slope.

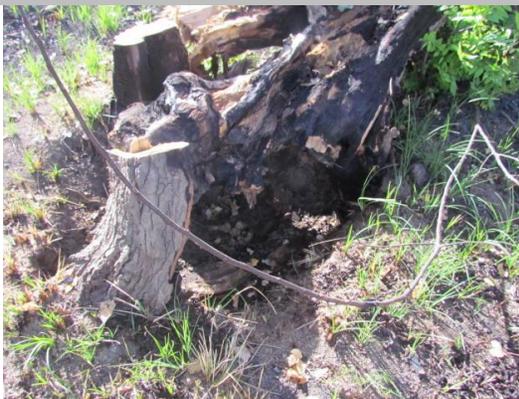
Photo 5 of 5 : SP_2016_RD0563_210_139_20160308_00124.jpg

Looking at large hole left by fallen tree on waterward berm.

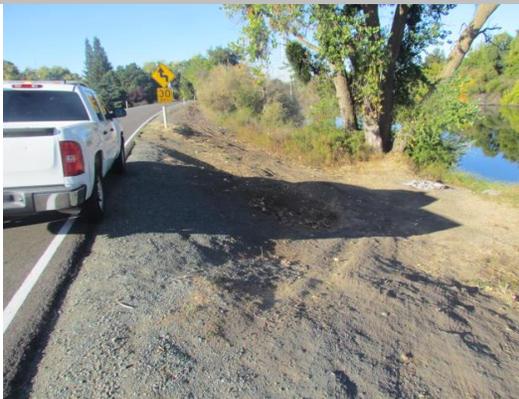
Photo 1 of 2 : SP_2016_RD0563_210_143_20160308_00129.jpg

LM Start	0.61	Rating **	M	Issue No.	143
LM End	0.61	Issue Type +	Ma	Location *	WS
Category	Earthen Levee			GPS Latitude/Longitude	
				Start	End
Item	Slope Stability			38.228507 °	38.228507 °
				-121.524543 °	-121.524543 °
DWR ID	DWR_RD0563_01_f_2014_143				
Comment Code					
S3 : Repair the levee slope damaged by vehicle traffic and prevent access where possible.					
Inspector Comment					
Slope damage due to vehicle traffic.

Looking southeast at slope damage on waterward slope.

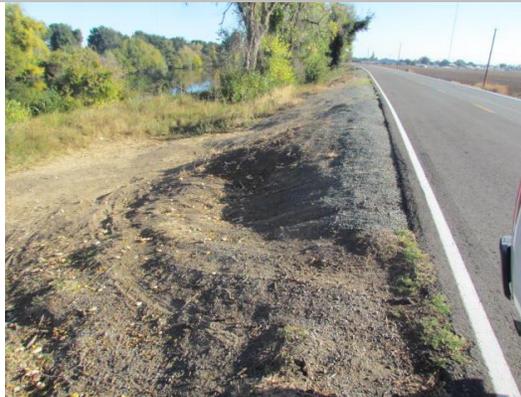
Photo 2 of 2 : SP_2016_RD0563_210_143_20160308_00130.jpg

LM Start	0.61	Rating **	M	Issue No.	143 (cont)
LM End	0.61	Issue Type +	Ma	Location *	WS
Category	Earthen Levee			GPS Latitude/Longitude	
				Start	End
Item	Slope Stability			38.228507 °	38.228507 °
				-121.524543 °	-121.524543 °
DWR ID	DWR_RD0563_01_f_2014_143				
Comment Code					
S3 : Repair the levee slope damaged by vehicle traffic and prevent access where possible.					
Inspector Comment					
Slope damage due to vehicle traffic.

Looking northwest at slope damage on waterward slope.

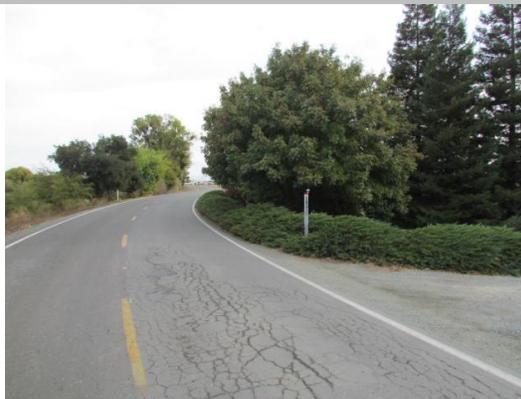
Photo 1 of 2 : SP_2016_RD0563_210_50_20160308_00048.jpg

LM Start	0.66	Rating **	U	Issue No.	50
LM End	0.69	Issue Type +	En	Location *	LS
Category	Earthen Levee			GPS Latitude/Longitude	
				Start	End
Item	Vegetation			38.228033 °	38.227777 °
				-121.525268 °	-121.525627 °
DWR ID	DWR_RD0563_01_s_2012_50				
Comment Code					
V6 : Landscaping					
Inspector Comment

Looking northwest at dense landscaping on landside slope.

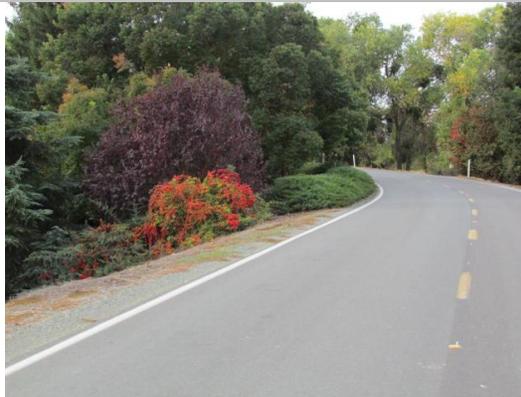
Photo 2 of 2 : SP_2016_RD0563_210_50_20160308_00049.jpg

LM Start	0.66	Rating **	U	Issue No.	50 (cont)
LM End	0.69	Issue Type +	En	Location *	LS

Looking southeast at dense landscaping on landside slope.

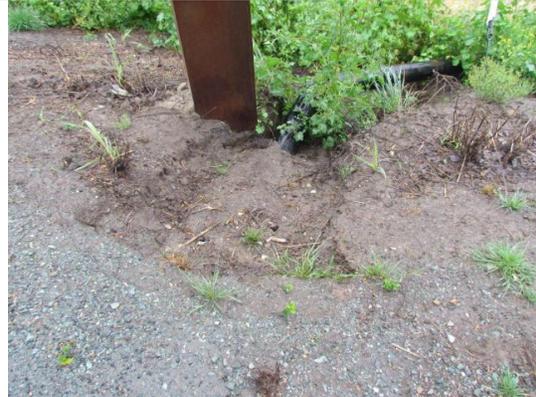
Photo 1 of 2 : SP_2016_RD0563_210_62_20160308_00057.jpg

LM Start	0.72	Rating **	M	Issue No.	62
LM End	0.72	Issue Type +	En	Location *	WS
Category	Earthen Levee		GPS Latitude/Longitude		
			Start	End	
Item	Encroachments		38.227328 °	38.227328 °	
			-121.525872 °	-121.525872 °	
DWR ID	DWR_RD0563_01_s_2013_62				
Comment Code					
PI : Pipe					
Inspector Comment					
Landowner installed a new black steel pipe. Two to four inch depression above pipe on landward slope.

Looking east at depression above newly installed black steel pipe.

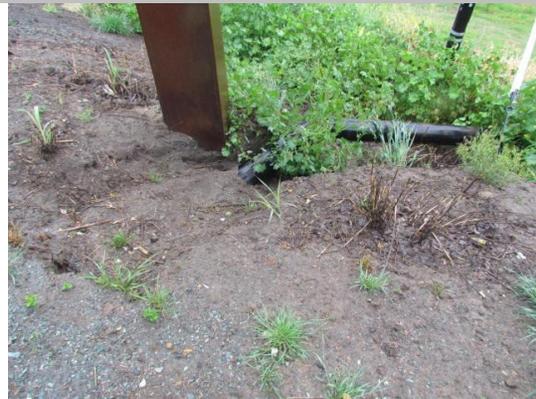
Photo 2 of 2 : SP_2016_RD0563_210_62_20160308_00058.jpg

LM Start	0.72	Rating **	M	Issue No.	62 (cont)
LM End	0.72	Issue Type +	En	Location *	WS

Looking northeast at depression above newly installed black steel pipe.

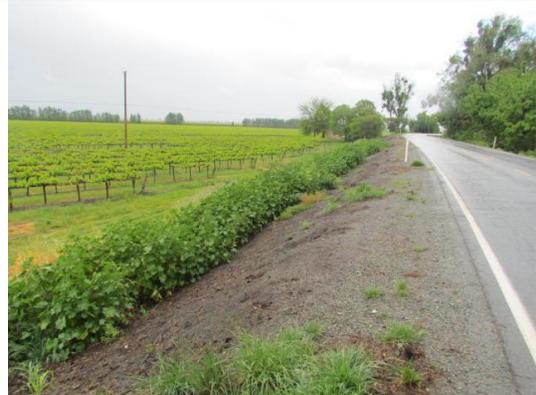
Photo 1 of 1 : SP_2016_RD0563_210_754_20160308_00139.jpg

LM Start	0.72	Rating **	A/W	Issue No.	754
LM End	0.79	Issue Type +	Ma	Location *	LS
Category	Earthen Levee		GPS Latitude/Longitude		
			Start	End	
Item	Vegetation		38.227287 °	38.226376 °	
			-121.525832 °	-121.525908 °	
DWR ID	DWR_RD0563_01_s_2015_754				
Comment Code					
V2 : Remove the wild growth other than native grasses from the levee slopes.					
Inspector Comment

Looking southeast at dense vegetation at landward toe.

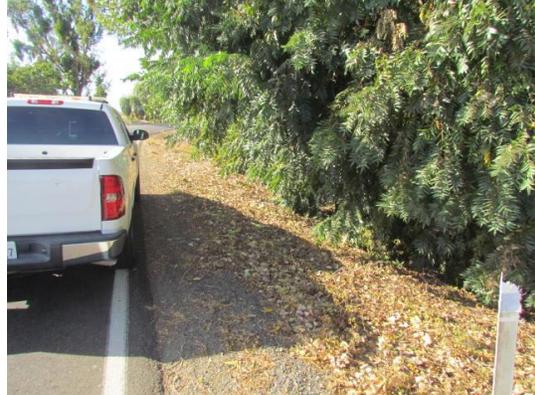
Photo 1 of 1 : SP_2016_RD0563_210_3_20160308_00001.jpg

LM Start	0.79	Rating **	M	Issue No.	3
LM End	0.79	Issue Type +	Ma	Location *	WS
Category	Earthen Levee		GPS Latitude/Longitude		
			Start	End	
Item	Trim / Thin Trees		38.226370 °	38.226370 °	
			-121.525912 °	-121.525912 °	
DWR ID	DWR_RD0563_01_s_2012_3				
Comment Code					
T1 : Trim trees to at least five feet above ground level.					
Inspector Comment

Looking south at untrimmed trees on waterward slope and toe.

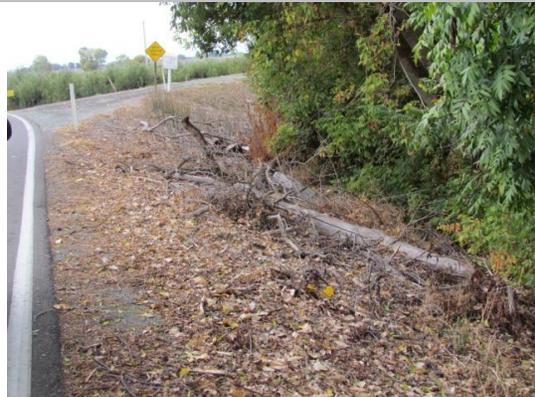
Photo 2 of 2 : SP_2016_RD0563_210_9_20160308_00010.jpg

LM Start	0.84	Rating **	A/W	Issue No.	9
LM End	0.84	Issue Type +	Ma	Location *	WS
Category	Earthen Levee		GPS Latitude/Longitude		
			Start	End	
Item	Encroachments		38.225685 °	38.225685 °	
			-121.526288 °	-121.526288 °	
DWR ID	DWR_RD0563_01_s_2012_9				
Comment Code					
PR : Prunings					
Inspector Comment					
Prunings on waterside slope should be burned or removed.

Looking southwest at tree limbs on waterside slope.

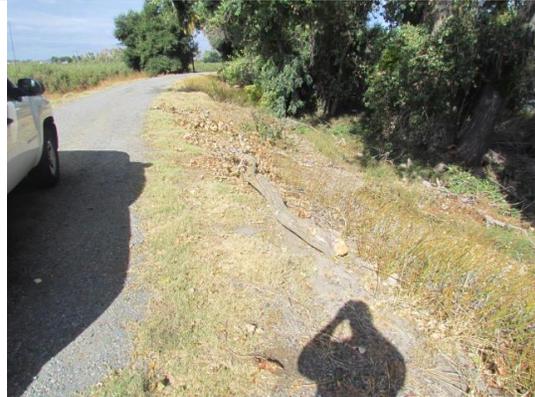
Photo 1 of 1 : SP_2016_RD0563_210_144_20160308_00131.jpg

LM Start	0.89	Rating **	M	Issue No.	144
LM End	0.89	Issue Type +	Ma	Location *	WS
Category	Earthen Levee		GPS Latitude/Longitude		
			Start	End	
Item	Encroachments		38.225477 °	38.225477 °	
			-121.527047 °	-121.527047 °	
DWR ID	DWR_RD0563_01_f_2014_144				
Comment Code					
PR : Prunings					
Inspector Comment					
Tree limbs on waterward slope.

Looking at tree limbs on waterward shoulder and slope.

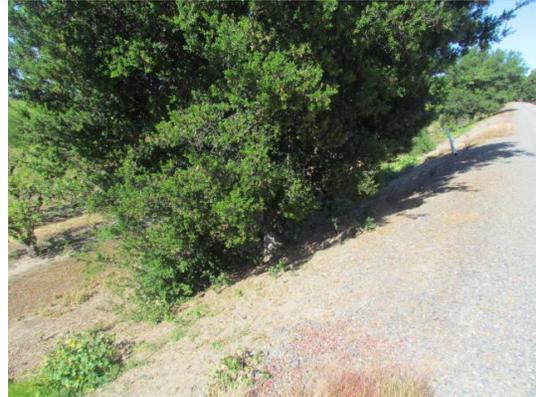
Photo 1 of 1 : SP_2016_RD0563_210_756_20160330_00230.jpg

LM Start	0.98	Rating **	U	Issue No.	756
LM End	0.98	Issue Type +	Ma	Location *	LS
Category	Earthen Levee			GPS Latitude/Longitude	
				Start	End
Item	Trim / Thin Trees			38.226011 °	38.226011 °
				-121.528524 °	-121.528524 °
DWR ID	DWR_RD0563_01_s_2015_756				
Comment Code					
T1 : Trim trees to at least five feet above ground level.					
Inspector Comment

Looking southeast at untrimmed tree on landward slope.

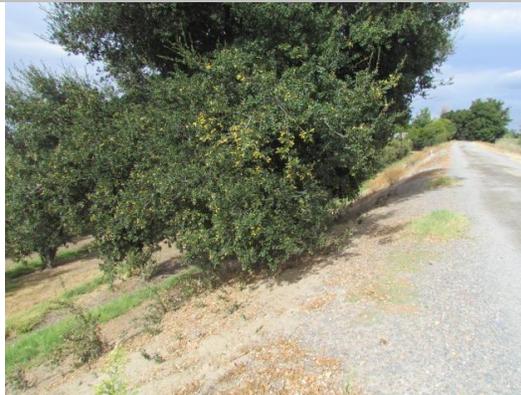
Photo 1 of 1 : SP_2016_RD0563_210_757_20160308_00140.jpg

LM Start	1.01	Rating **	M	Issue No.	757
LM End	1.01	Issue Type +	Ma	Location *	LS
Category	Earthen Levee		GPS Latitude/Longitude		
			Start	End	
Item	Trim / Thin Trees		38.226294 °	38.226294 °	
			-121.529055 °	-121.529055 °	
DWR ID	DWR_RD0563_01_s_2015_757				
Comment Code					
T1 : Trim trees to at least five feet above ground level.					
Inspector Comment

Looking at untrimmed trees on landward slope.

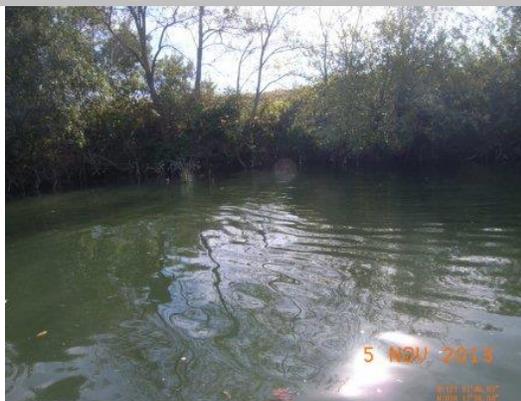
Photo 1 of 1 : SP_2016_RD0563_210_48_20160308_00047.jpg

LM Start	1.02	Rating **	M	Issue No.	48
LM End	1.11	Issue Type +	Ma	Location *	WS
Category	Supplemental		GPS Latitude/Longitude		
			Start	End	
Item	2015 USACE Erosion Survey, DRAFT		38.226522 °	38.227157 °	
			-121.529094 °	-121.530432 °	
DWR ID	DWR_RD0563_01_s_2016_48				
Comment Code					
Inspector Comment					
2011 - Short sections of eroding bank at the waterline and holes in toe of levee. 2012 - Site extended upstream. 2013 - Erosion pockets filled with an insufficient amounts of revetment. 2015: Last observed in 2013. [2015 Site ID: GEO_11-0_L]

USACE 2013 Photo #1

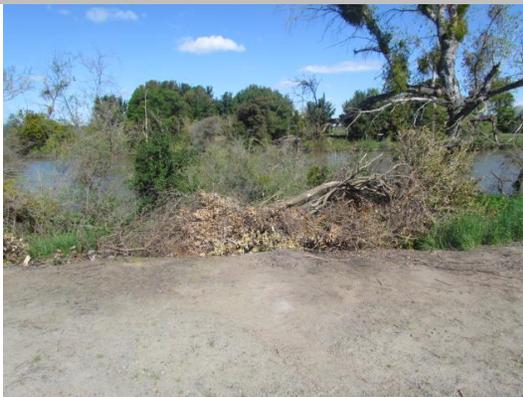
Photo 1 of 1 : SP_2016_RD0563_210_133_20160330_00233.jpg

LM Start	1.18	Rating **	M	Issue No.	133
LM End	1.18	Issue Type +	En	Location *	WS
Category	Earthen Levee		GPS Latitude/Longitude		
			Start	End	
Item	Encroachments		38.226752 °	38.226752 °	
			-121.531752 °	-121.531752 °	
DWR ID	DWR_RD0563_01_s_2016_133				
Comment Code					
PR : Prunings					
Inspector Comment					
Discarded tree limbs and branches on waterward slope.

Looking west at tree limbs and branches on waterward slope.

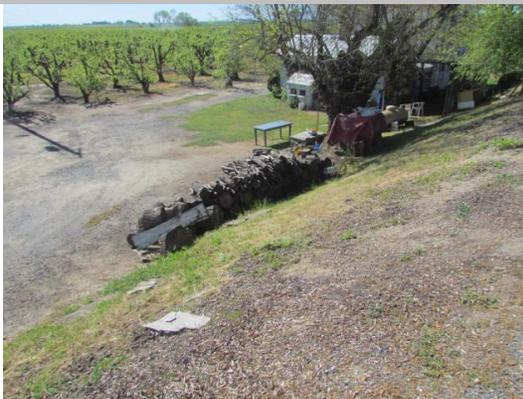
Photo 1 of 1 : SP_2016_RD0563_210_134_20160330_00234.jpg

LM Start	1.21	Rating **	M	Issue No.	134
LM End	1.21	Issue Type +	En	Location *	LS
Category	Earthen Levee		GPS Latitude/Longitude		
			Start	End	
Item	Encroachments		38.226462 °	38.226462 °	
			-121.532172 °	-121.532172 °	
DWR ID	DWR_RD0563_01_s_2016_134				
Comment Code					
FW : Firewood					
Inspector Comment					
Landowner stock piling firewood at landward toe.

Looking southeast at firewood at landward toe.,

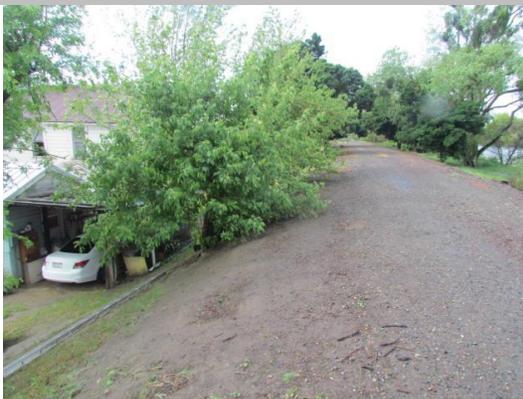
Photo 1 of 1 : SP_2016_RD0563_210_5_20160308_00003.jpg

LM Start	1.22	Rating **	M	Issue No.	5
LM End	1.22	Issue Type +	Ma	Location *	LS
Category	Earthen Levee		GPS Latitude/Longitude		
			Start	End	
Item	Trim / Thin Trees		38.226326 °	38.226326 °	
			-121.532298 °	-121.532298 °	
DWR ID	DWR_RD0563_01_s_2012_5				
Comment Code					
T1 : Trim trees to at least five feet above ground level.					
Inspector Comment

Looking south at untrimmed trees on landward slope.

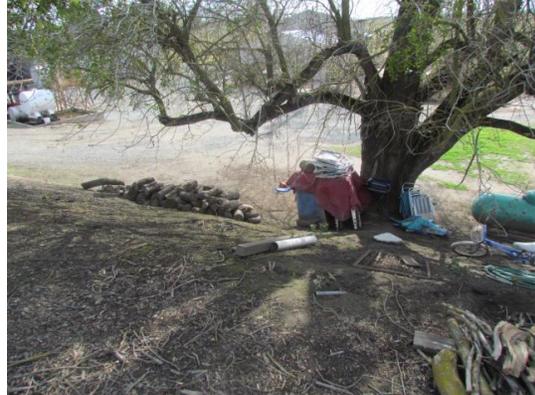
Photo 1 of 2 : SP_2016_RD0563_210_57_20160308_00054.jpg

LM Start	1.22	Rating **	M	Issue No.	57
LM End	1.22	Issue Type +	En	Location *	LS
Category	Earthen Levee		GPS Latitude/Longitude		
			Start	End	
Item	Encroachments		38.226345 °	38.226345 °	
			-121.532332 °	-121.532332 °	
DWR ID	DWR_RD0563_01_s_2012_57				
Comment Code					
BU : Building					
Inspector Comment					
Landowner is stacking firewood and other items on landside slope and toe.

Looking east at firewood and other materials stored on landside slope and toe.

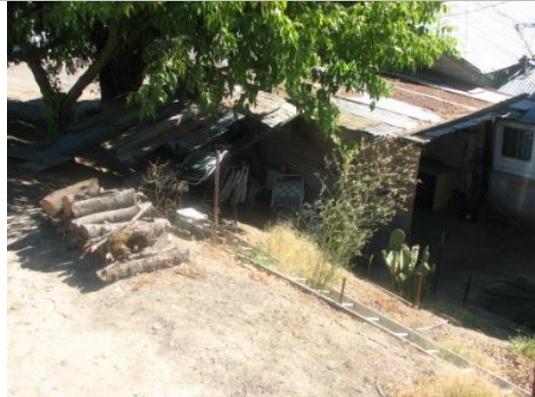
Photo 2 of 2 : SP_2016_RD0563_210_57_20160308_00055.jpg

LM Start	1.22	Rating **	M	Issue No.	57 (cont)
LM End	1.22	Issue Type +	En	Location *	LS

Looking at a shed at landside toe.

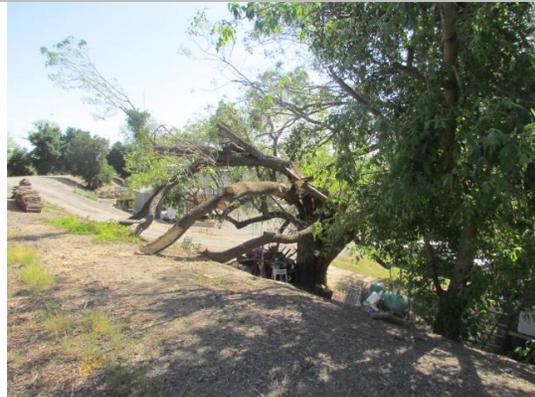
Photo 1 of 1 : SP_2016_RD0563_210_103_20160308_00114.jpg

LM Start	1.25	Rating **	A/W	Issue No.	103
LM End	1.25	Issue Type +	Ma	Location *	LS
Category	Earthen Levee		GPS Latitude/Longitude		
			Start	End	
Item	Encroachments		38.225960 °	38.225960 °	
			-121.532616 °	-121.532616 °	
DWR ID	DWR_RD0563_01_s_2013_103				
Comment Code					
TR : Tree or limb					
Inspector Comment					
Broken tree branches on landward slope.

Looking northeast at broken tree branch on landward slope.

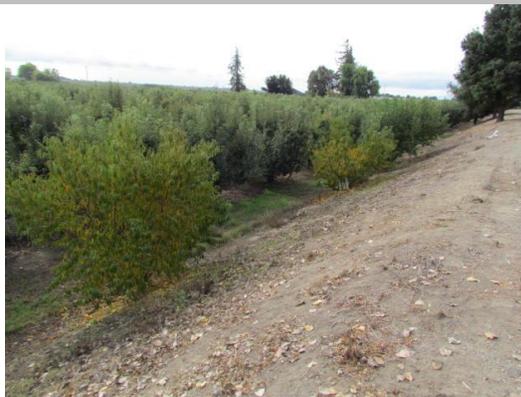
Photo 1 of 1 : SP_2016_RD0563_210_64_20160308_00059.jpg

LM Start	1.27	Rating **	M	Issue No.	64
LM End	1.27	Issue Type +	Ma	Location *	LS
Category	Earthen Levee		GPS Latitude/Longitude		
			Start	End	
Item	Trim / Thin Trees		38.225730 °	38.225730 °	
			-121.532824 °	-121.532824 °	
DWR ID	DWR_RD0563_01_f_2012_64				
Comment Code					
T1 : Trim trees to at least five feet above ground level.					
Inspector Comment					
Trees located at landside toe.

Looking southeast at fruit trees on landside toe.

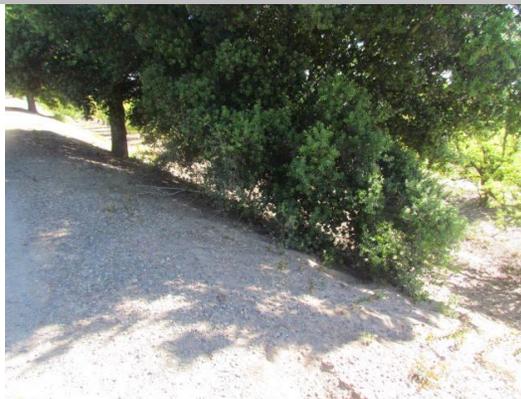
Photo 1 of 1 : SP_2016_RD0563_210_79_20160330_00235.jpg

LM Start	1.32	Rating **	U	Issue No.	79
LM End	1.32	Issue Type +	Ma	Location *	LS
Category	Earthen Levee		GPS Latitude/Longitude		
			Start	End	
Item	Trim / Thin Trees		38.225177 °	38.225177 °	
			-121.533285 °	-121.533285 °	
DWR ID	DWR_RD0563_01_f_2013_79				
Comment Code					
T1 : Trim trees to at least five feet above ground level.					
Inspector Comment

Looking northeast at untrimmed trees on landward slope and toe.

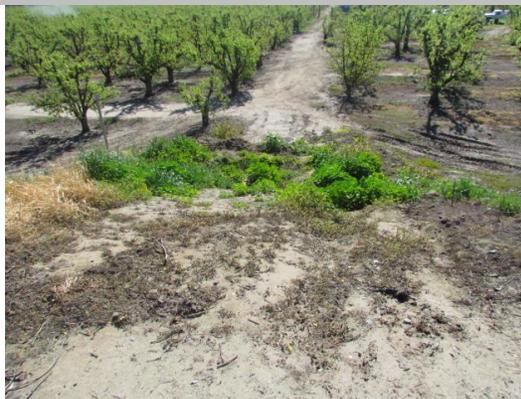
Photo 1 of 3 : SP_2016_RD0563_210_150_20160330_00236.jpg

LM Start	1.35	Rating **	M	Issue No.	150
LM End	1.35	Issue Type +	En	Location *	LS
Category	Earthen Levee		GPS Latitude/Longitude		
			Start	End	
Item	Encroachments		38.224817 °	38.224817 °	
			-121.533602 °	-121.533602 °	
DWR ID	DWR_RD0563_01_s_2016_150				
Comment Code					
RA : Ramp					
Inspector Comment					
Unauthorized ramp on landward slope.

Looking southeast at ramp on landward slope.

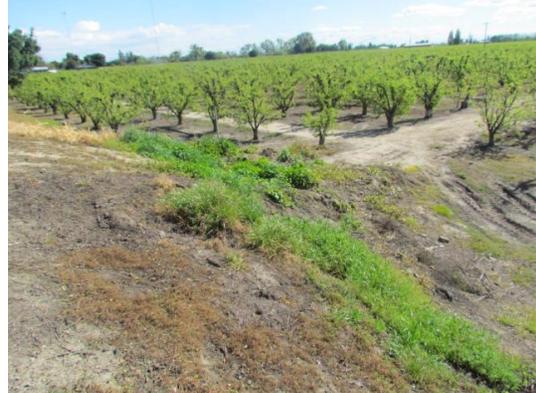
Photo 2 of 3 : SP_2016_RD0563_210_150_20160330_00237.jpg

LM Start	1.35	Rating **	M	Issue No.	150 (cont)
LM End	1.35	Issue Type +	En	Location *	LS
Category	Earthen Levee			GPS Latitude/Longitude	
				Start	End
Item	Encroachments			38.224817 °	38.224817 °
				-121.533602 °	-121.533602 °
DWR ID	DWR_RD0563_01_s_2016_150				
Comment Code					
RA : Ramp					
Inspector Comment					
Unauthorized ramp on landward slope.

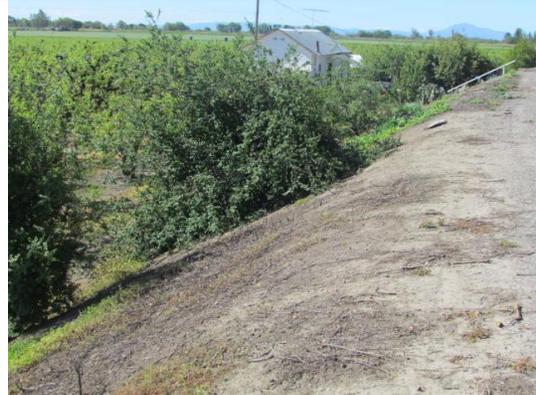
Photo 1 of 1 : SP_2016_RD0563_210_7_20160330_00239.jpg

LM Start	1.36	Rating **	M	Issue No.	7
LM End	1.36	Issue Type +	Ma	Location *	LS
Category	Earthen Levee			GPS Latitude/Longitude	
				Start	End
Item	Trim / Thin Trees			38.224690 °	38.224690 °
				-121.533731 °	-121.533731 °
DWR ID	DWR_RD0563_01_s_2012_7				
Comment Code					
T1 : Trim trees to at least five feet above ground level.					
Inspector Comment

Looking southeast at untrimmed tree at landward toe.

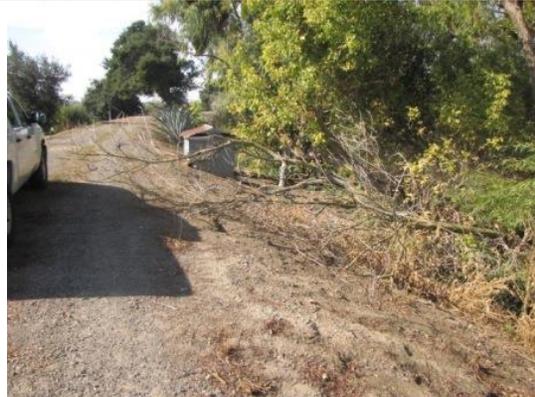
Photo 1 of 1 : SP_2016_RD0563_210_19_20160308_00022.jpg

LM Start	1.39	Rating **	M	Issue No.	19
LM End	1.39	Issue Type +	Ma	Location *	WS
Category	Earthen Levee		GPS Latitude/Longitude		
			Start	End	
Item	Encroachments		38.224367 °	38.224367 °	
			-121.534165 °	-121.534165 °	
DWR ID	DWR_RD0563_01_s_2012_19				
Comment Code					
TR : Tree or limb					
Inspector Comment					
Broken tree along waterside slope.

Looking south at a downed tree on waterside slope.

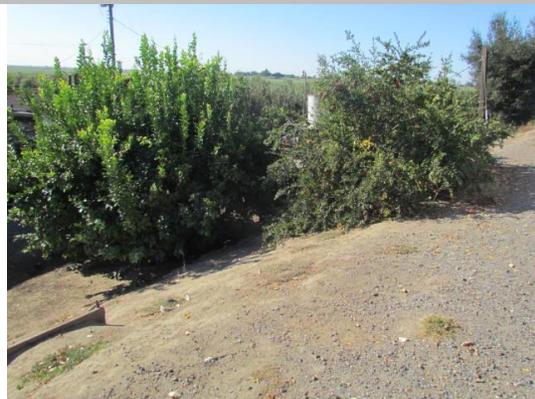
Photo 1 of 2 : SP_2016_RD0563_210_86_20160308_00091.jpg

LM Start	1.39	Rating **	M	Issue No.	86
LM End	1.39	Issue Type +	En	Location *	LS
Category	Earthen Levee		GPS Latitude/Longitude		
			Start	End	
Item	Vegetation		38.224351 °	38.224351 °	
			-121.534209 °	-121.534209 °	
DWR ID	DWR_RD0563_01_f_2013_86				
Comment Code					
V6 : Landscaping					
Inspector Comment

Looking southeast at dense landscaping on the landward slope.

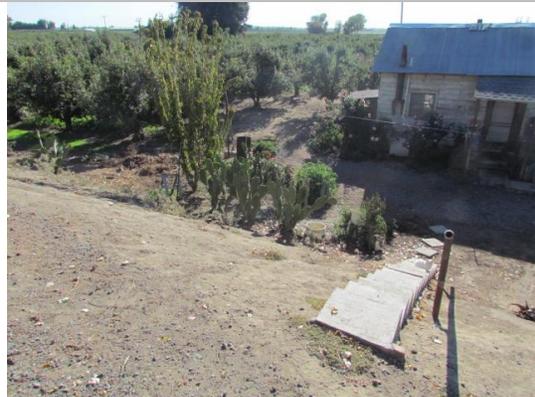
Photo 2 of 2 : SP_2016_RD0563_210_86_20160308_00092.jpg

LM Start	1.39	Rating **	M	Issue No.	86 (cont)
LM End	1.39	Issue Type +	En	Location *	LS

Looking east at cactus at the landward toe.

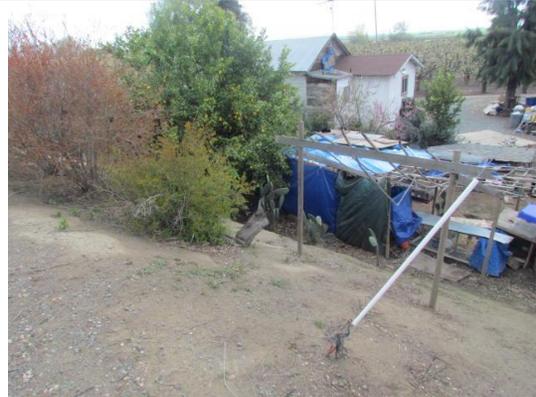
Photo 1 of 3 : SP_2016_RD0563_210_8_20160308_00006.jpg

LM Start	1.40	Rating **	U	Issue No.	8
LM End	1.40	Issue Type +	En	Location *	LS
Category	Earthen Levee		GPS Latitude/Longitude		
			Start	End	
Item	Encroachments		38.224315 °	38.224315 °	
			-121.534288 °	-121.534288 °	
DWR ID	DWR_RD0563_01_s_2012_8				
Comment Code					
BU : Building					
Inspector Comment					
Tool shed, animal storage container, and landscaping on waterside slope and toe.

Looking east at landscaping and animal containers on the landside slope and toe.

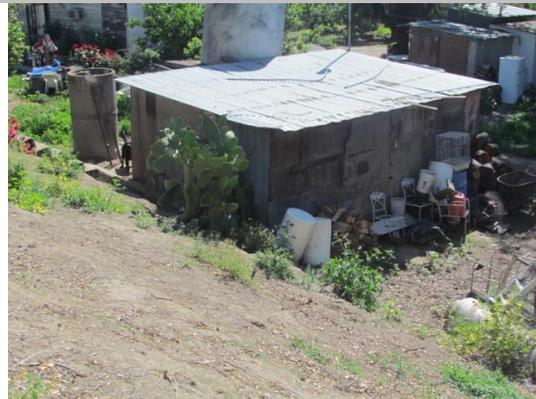
Photo 2 of 3 : SP_2016_RD0563_210_8_20160308_00007.jpg

LM Start	1.40	Rating **	U	Issue No.	8 (cont)
LM End	1.40	Issue Type +	En	Location *	LS

Looking northeast at a tool shed on the landward toe.

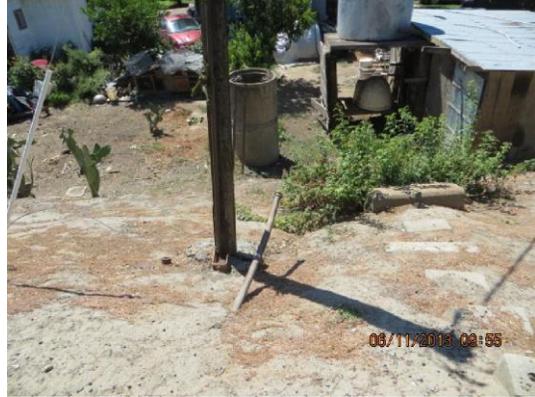
Photo 1 of 2 : UCIP_SP_2016_14873_24527.jpg

LM Start	1.40	Rating **	M	Issue No.	965
LM End	1.40	Issue Type +	En	Location *	LS
Category	Supplemental			GPS Latitude/Longitude	
				Start	End
Item	DWR UCIP Field Study			38.224302 °	38.224302 °
				-121.534287 °	-121.534287 °
DWR ID					
Comment Code					
Inspector Comment					
FS_ID:14873 DS_ID:20134 EP_NO: N/A Repair Type: Non-Urgent Crossing Status: Found UCIP Comments: Pipe open on LS and should be removed. FIELD_STRUCT_DESC: *Abandoned* 2-inch pipe through levee 2.0 feet below the crown. FS Date: 6/11/2013

Pipe visible on LS slope at JP.

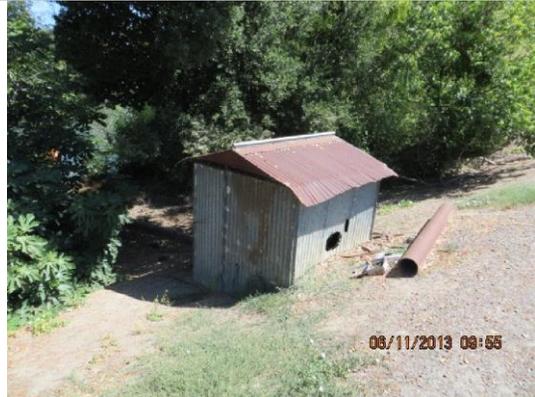
Photo 2 of 2 : UCIP_SP_2016_14873_24526.jpg

LM Start	1.40	Rating **	M	Issue No.	965 (cont)
LM End	1.40	Issue Type +	En	Location *	LS

Pipe goes to pumphouse on WS slope.

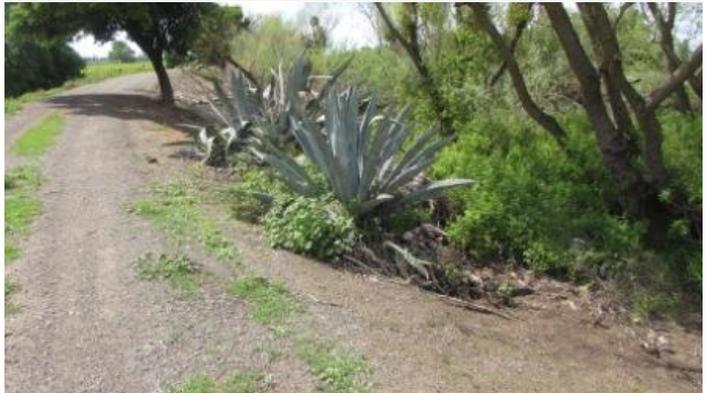
Photo 1 of 2 : SP_2016_RD0563_210_6_20160308_00004.jpg

LM Start	1.40	Rating **	M	Issue No.	6
LM End	1.44	Issue Type +	Ma	Location *	WS
Category	Earthen Levee			GPS Latitude/Longitude	
				Start	End
Item	Vegetation			38.224280 °	38.224000 °
				-121.534377 °	-121.535038 °
DWR ID	DWR_RD0563_01_s_2012_6				
Comment Code					
V2 : Remove the wild growth other than native grasses from the levee slopes.					
Inspector Comment					
Remove the century plant from waterward shoulder.

Updated view looking upstream at a century plant on waterside shoulder slope.

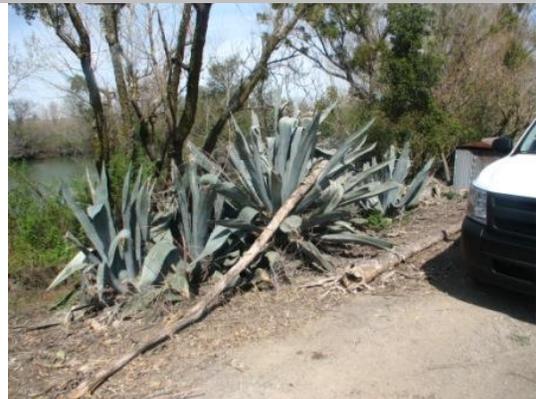
Photo 2 of 2 : SP_2016_RD0563_210_6_20160308_00005.jpg

LM Start	1.40	Rating **	M	Issue No.	6 (cont)
LM End	1.44	Issue Type +	Ma	Location *	WS

Century plant on waterward shoulder at LM 1.42

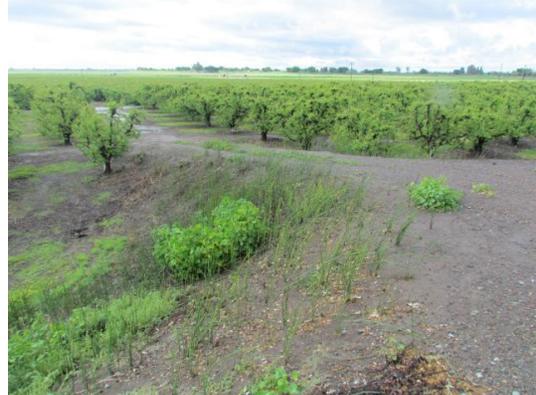
Photo 1 of 2 : SP_2016_RD0563_210_141_20160308_00125.jpg

LM Start	1.53	Rating **	M	Issue No.	141
LM End	1.53	Issue Type +	En	Location *	LS
Category	Earthen Levee		GPS Latitude/Longitude		
			Start	End	
Item	Encroachments		38.223575 °	38.223575 °	
			-121.536580 °	-121.536580 °	
DWR ID	DWR_RD0563_01_s_2014_141				
Comment Code					
RA : Ramp					
Inspector Comment					
Landowner installed ramp without Board permit.

Looking southeast at ramp on landward slope.

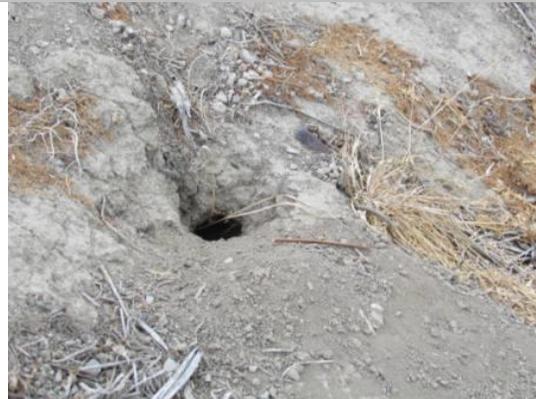
Photo 1 of 1 : SP_2016_RD0563_210_83_20160308_00084.jpg

Looking west at rodent hole on landside slope.

LM Start	1.73	Rating **	A/W	Issue No.	83
LM End	1.73	Issue Type +	Ma	Location *	LS
Category	Earthen Levee		GPS Latitude/Longitude		
			Start	End	
Item	Animal Control		38.222967 °	38.222967 °	
			-121.540055 °	-121.540055 °	
DWR ID	DWR_RD0563_01_s_2012_83				
Comment Code					
A1 : Exterminate rodents and backfill and compact or grout burrows.					
Inspector Comment

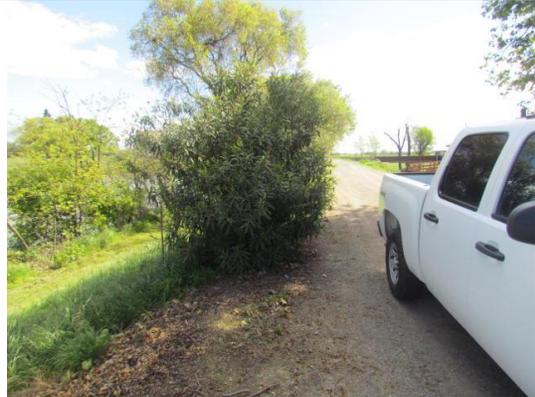
Photo 1 of 4 : SP_2016_RD0563_210_142_20160330_00242.jpg

Looking south at oleanders on landward shoulder. (Spring 2016)

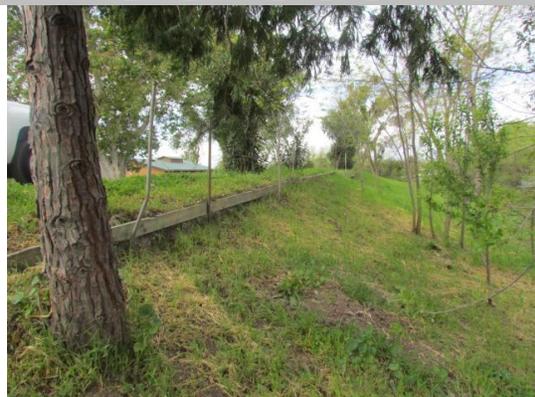
Photo 3 of 4 : SP_2016_RD0563_210_142_20160308_00127.jpg

Looking southeast at planting box on waterward shoulder.

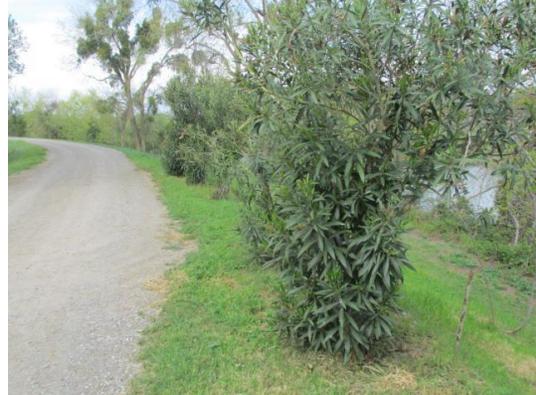
Photo 4 of 4 : SP_2016_RD0563_210_142_20160308_00128.jpg

LM Start	1.86	Rating **	M	Issue No.	142 (cont)
LM End	1.87	Issue Type +	En	Location *	WS
Category	Earthen Levee			GPS Latitude/Longitude	
				Start	End
Item	Vegetation			38.222743 °	38.222720 °
				-121.542523 °	-121.542741 °
DWR ID	DWR_RD0563_01_s_2014_142				
Comment Code					
V6 : Landscaping					
Inspector Comment					
Landowner has planted oleander on waterward shoulder.

Looking southwest at oleanders on waterward shoulder.

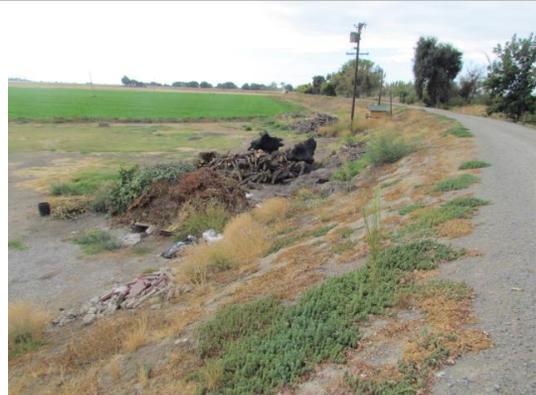
Photo 1 of 2 : SP_2016_RD0563_210_96_20160308_00105.jpg

LM Start	1.92	Rating **	A/W	Issue No.	96
LM End	1.92	Issue Type +	Ma	Location *	LS
Category	Earthen Levee			GPS Latitude/Longitude	
				Start	End
Item	Encroachments			38.222299 °	38.222299 °
				-121.543366 °	-121.543366 °
DWR ID	DWR_RD0563_01_f_2013_96				
Comment Code					
PR : Prunings					
Inspector Comment					
Large pruning pile at landward toe. Landowner has burned pile, but pile is still within right away.

Looking south at pruning piles at landward toe. (Fall 2015)

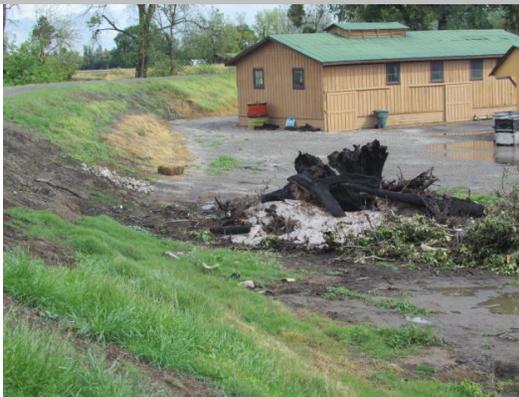
Photo 2 of 2 : SP_2016_RD0563_210_96_20160308_00106.jpg

Looking north at partially burned pruning pile at landward toe. (Spring 2015)

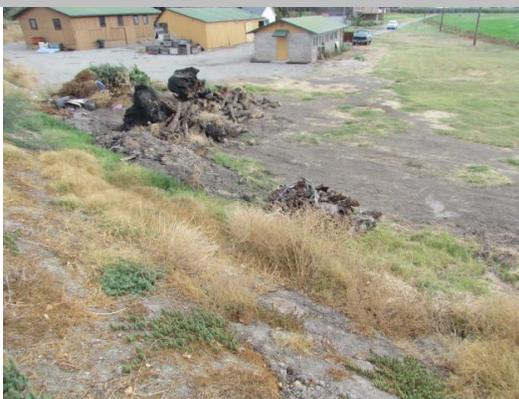
Photo 1 of 1 : SP_2016_RD0563_210_157_20160308_00136.jpg

LM Start	1.94	Rating **	A/W	Issue No.	157
LM End	1.94	Issue Type +	Ma	Location *	LS
Category	Earthen Levee			GPS Latitude/Longitude	
				Start	End
Item	Encroachments			38.222080 °	38.222080 °
				-121.543445 °	-121.543445 °
DWR ID	DWR_RD0563_01_f_2015_157				
Comment Code					
GA : Garbage					
Inspector Comment					
Landowner stockpiling garbage at landward toe.

Looking at garbage stockpile at landward toe.

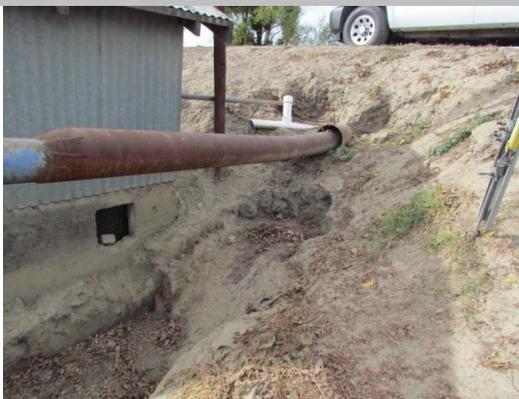
Photo 1 of 2 : SP_2016_RD0563_210_71_20160308_00063.jpg

LM Start	1.95	Rating **	M	Issue No.	71
LM End	1.95	Issue Type +	Ma	Location *	LS
Category	Earthen Levee			GPS Latitude/Longitude	
				Start	End
Item	Erosion / Bank Caving			38.221826 °	38.221826 °
				-121.543467 °	-121.543467 °
DWR ID	DWR_RD0563_01_f_2012_71				
Comment Code					
E1 : Note and monitor erosion site.					
Inspector Comment					
Erosion around irrigation pump house and pipe on landside slope.

Looking west at erosion at landside toe and slope next to pump house.

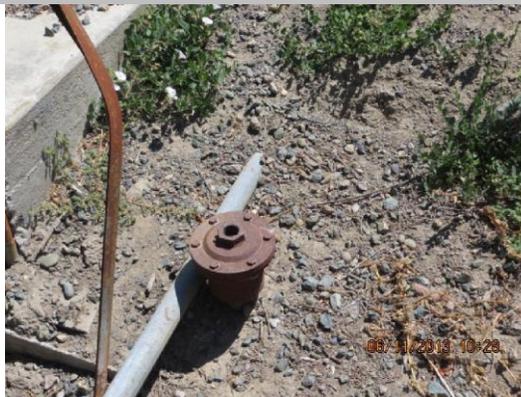
Photo 2 of 2 : UCIP_SP_2016_14878_24536.jpg

LM Start	1.96	Rating **	U	Issue No.	966 (cont)
LM End	1.96	Issue Type +	En	Location *	LS
Category	Supplemental			GPS Latitude/Longitude	
				Start	End
Item	DWR UCIP Field Study			38.221785 °	38.221785 °
				-121.543474 °	-121.543474 °
DWR ID					
Comment Code					
Inspector Comment					
FS_ID:14878 DS_ID:20136 EP_NO: 11204 Repair Type: Urgent Crossing Status: Found UCIP Comments: Annular space not grouted between 8-inch and 10-inch pipe and the metal walkway is structurally failing. FIELD_STRUCT_DESC: 8-inch steel pipe sleeved through a 10-inch pipe through the levee 4.0 feet below the crown. Pump on pile structure. Timber walkway to pump. Service pole on landward slope. Siphon breaker on waterward slope (ABO No.11204, 1971). 1.5-inch electrical conduit through levee at same location. Originally included in 1954 O&M manual. FS Date: 6/11/2013

Siphon breaker and 1.5-inch galvanized iron electrical conduit.

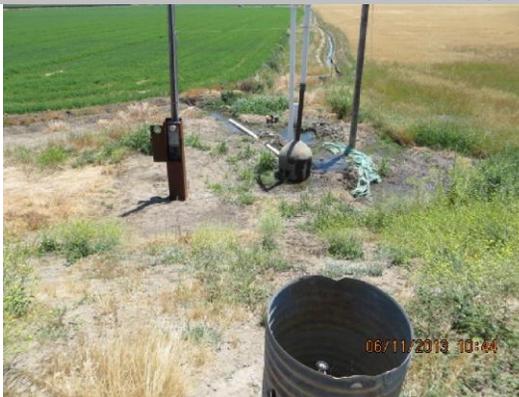
Photo 2 of 2 : UCIP_SP_2016_14882_24540.jpg

LM Start	2.19	Rating **	U	Issue No.	967 (cont)
LM End	2.19	Issue Type +	En	Location *	WS
Category	Supplemental			GPS Latitude/Longitude	
				Start	End
Item	DWR UCIP Field Study			38.218534 °	38.218534 °
				-121.542656 °	-121.542656 °
DWR ID					
Comment Code					
Inspector Comment					
FS_ID:14882 DS_ID:20176 EP_NO: 13311 Repair Type: Urgent Crossing Status: Found UCIP Comments: Concrete standpipe on LS toe is not functioning properly. Leaks springing up in the ground around the standpipe. This may erode the soil at base of levee. FIELD_STRUCT_DESC: 1 of 2: 12-inch pipe through levee 3.0 feet below crown (Permit No. 13311, 1982). Slant pump on WS toe. 36-inch concrete standpipe and pipe works on LS toe. Siphon breaker in 24-inch CMP riser on LS shoulder. Pipe replaced 12-inch pipe from O&M manual/Permit No. 11207. FS Date: 6/11/2013

Concrete standpipe, and 24-inch CMP riser on LS of levee.

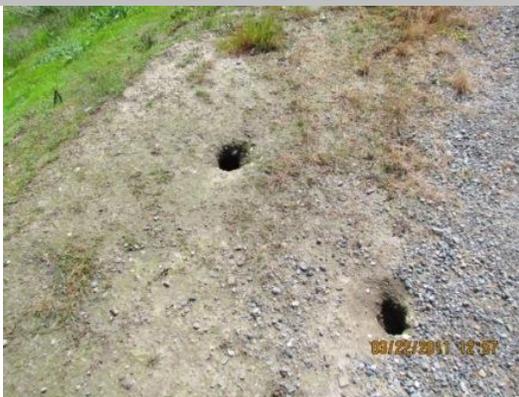
Photo 1 of 1 : SP_2016_RD0563_210_33_20160308_00034.jpg

LM Start	2.19	Rating **	M	Issue No.	33
LM End	2.19	Issue Type +	Ma	Location *	LS
Category	Earthen Levee			GPS Latitude/Longitude	
				Start	End
Item	Animal Control			38.218463 °	38.218463 °
				-121.542650 °	-121.542650 °
DWR ID	DWR_RD0563_01_s_2012_33				
Comment Code					
A1 : Exterminate rodents and backfill and compact or grout burrows.					
Inspector Comment					
Rodent holes on landside shoulder.

Looking southeast at squirrel holes on landside shoulder.

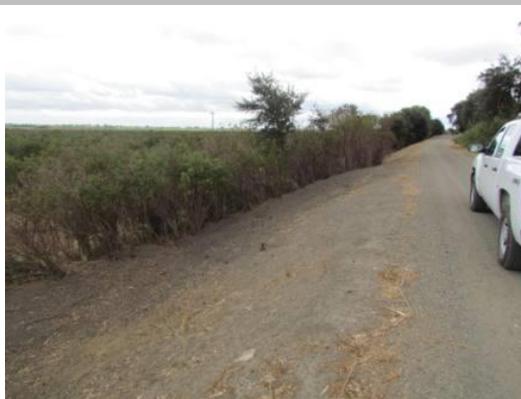
Photo 1 of 2 : SP_2016_RD0563_210_11_20160308_00014.jpg

LM Start	2.39	Rating **	A/W	Issue No.	11
LM End	2.40	Issue Type +	Ma	Location *	LS
Category	Earthen Levee		GPS Latitude/Longitude		
			Start	End	
Item	Vegetation		38.216242 °	38.216147 °	
			-121.540835 °	-121.540612 °	
DWR ID	DWR_RD0563_01_s_2012_11				
Comment Code					
V4 : Elderberries are blocking visibility and flood fight capability.					
Inspector Comment					
District is controlling the elderberry.

Look southeast at updated (10/11) view of elderberries on landside slope.

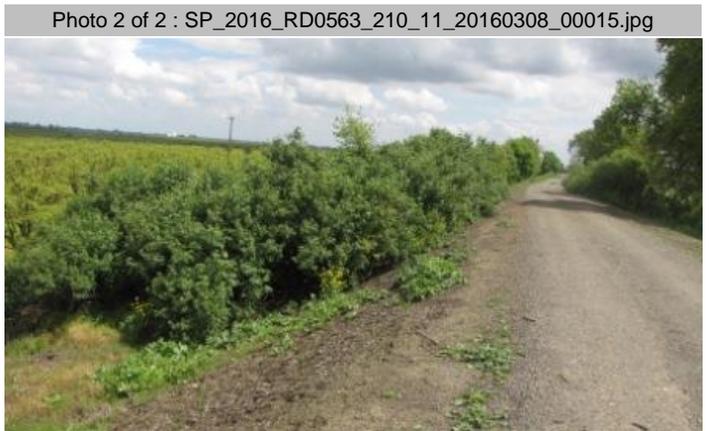
LM Start	2.39	Rating **	A/W	Issue No.	11 (cont)
LM End	2.40	Issue Type +	Ma	Location *	LS
Category	Earthen Levee			GPS Latitude/Longitude	
				Start	End
Item	Vegetation			38.216242 °	38.216147 °
				-121.540835 °	-121.540612 °
DWR ID	DWR_RD0563_01_s_2012_11				
Comment Code					
V4 : Elderberries are blocking visibility and flood fight capability.					
Inspector Comment					
District is controlling the elderberry.

Looking southeast at elderberry on the landside slope and toe.

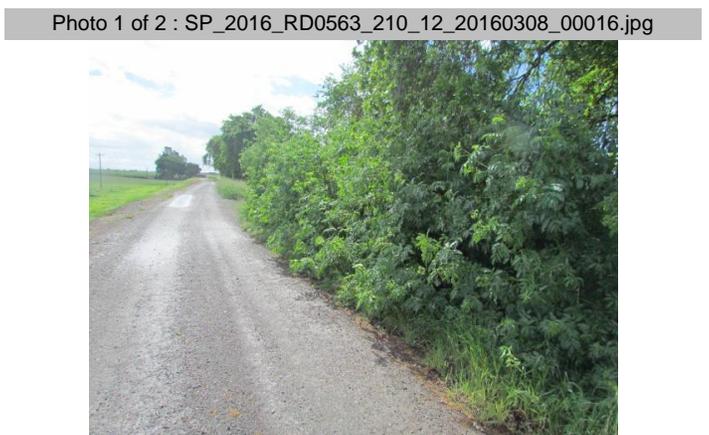
LM Start	2.40	Rating **	U	Issue No.	12
LM End	2.41	Issue Type +	Ma	Location *	WS
Category	Earthen Levee			GPS Latitude/Longitude	
				Start	End
Item	Vegetation			38.216122 °	38.216047 °
				-121.540555 °	-121.540415 °
DWR ID	DWR_RD0563_01_s_2012_12				
Comment Code					
V4 : Elderberries are blocking visibility and flood fight capability.					
Inspector Comment

Looking south at dense elderberry on waterward shoulder and slope. (Spring 2015)

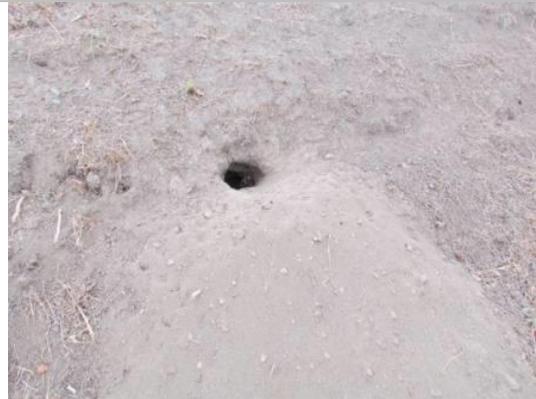
Photo 1 of 4 : SP_2016_RD0563_210_85_20160308_00087.jpg

Looking west at rodent hole on landside slope.

LM Start	2.53	Rating **	M	Issue No.	85
LM End	2.55	Issue Type +	Ma	Location *	LS
Category	Earthen Levee			GPS Latitude/Longitude	
				Start	End
Item	Animal Control			38.215082 °	38.214852 °
				-121.538652 °	-121.538305 °
DWR ID	DWR_RD0563_01_s_2012_85				
Comment Code					
A3 : No rodents visible, but rodent burrows visible; need to backfill and compact or grout burrows.					
Inspector Comment

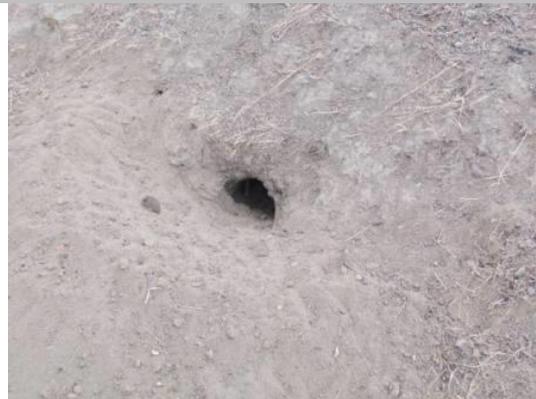
Photo 2 of 4 : SP_2016_RD0563_210_85_20160308_00088.jpg

Looking east at rodent hole on landside slope.

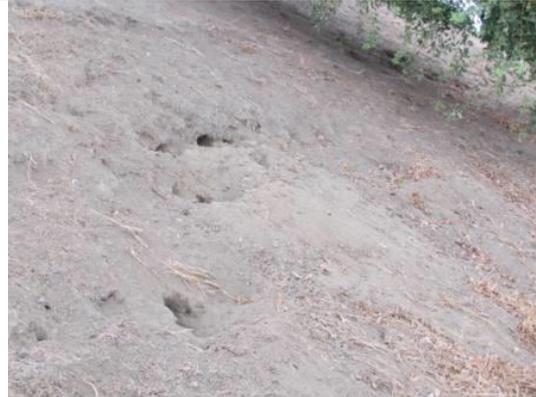
Photo 4 of 4 : SP_2016_RD0563_210_85_20160308_00090.jpg

Looking northeast at rodent holes on landside slope.

LM Start	2.53	Rating **	M	Issue No.	85 (cont)
LM End	2.55	Issue Type +	Ma	Location *	LS
Category	Earthen Levee			GPS Latitude/Longitude	
				Start	End
Item	Animal Control			38.215082 °	38.214852 °
				-121.538652 °	-121.538305 °
DWR ID	DWR_RD0563_01_s_2012_85				
Comment Code					
A3 : No rodents visible, but rodent burrows visible; need to backfill and compact or grout burrows.					
Inspector Comment

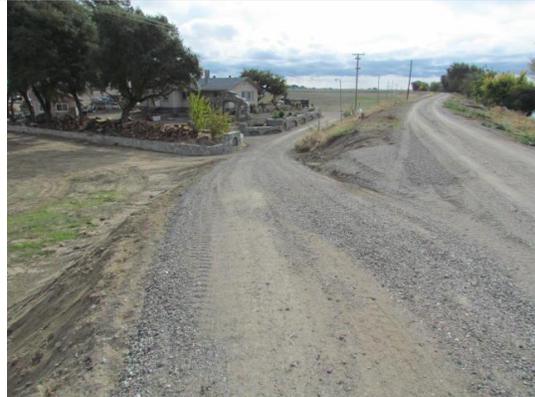
Photo 2 of 2 : SP_2016_RD0563_210_80_20160308_00082.jpg

LM Start	2.57	Rating **	M	Issue No.	80 (cont)
LM End	2.57	Issue Type +	En	Location *	LS
Category	Earthen Levee			GPS Latitude/Longitude	
				Start	End
Item	Encroachments			38.214707 °	38.214707 °
				-121.538061 °	-121.538061 °
DWR ID	DWR_RD0563_01_f_2012_80				
Comment Code					
RA : Ramp					
Inspector Comment					
Landowner installed unauthorized ramp on landside slope. This ramp is not part of permit # 9146.

Looking southeast at unauthorized ramp on landside slope.

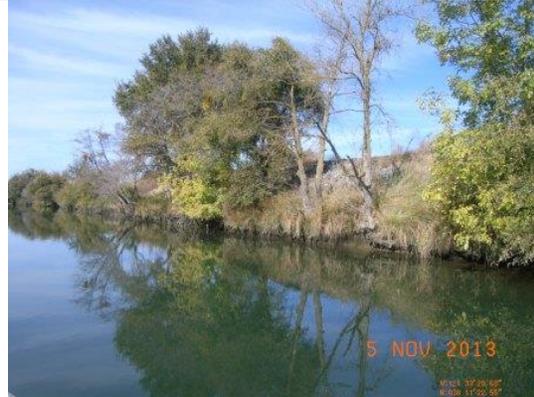
Photo 1 of 1 : SP_2016_RD0563_210_39_20160308_00038.jpg

LM Start	2.61	Rating **	M	Issue No.	39
LM End	2.82	Issue Type +	Ma	Location *	WS
Category	Supplemental			GPS Latitude/Longitude	
				Start	End
Item	2015 USACE Erosion Survey, DRAFT			38.214133 °	38.211737 °
				-121.537778 °	-121.535436 °
DWR ID	DWR_RD0563_01_s_2016_39				
Comment Code					
Inspector Comment					
1997 - Loss of rock at toe; pockets of upper berm erosion; very narrow berm width; toe rock problem; erosion pockets in rock. 2002 - New brush boxes at toe of the worst spots. 2005 - Upstream 200 ft removed because of the wide berm. 2006 - Some rock repair pockets behind the brush boxes at the upstream end. 2010 - Some new erosion. 2013 - New rock placed on the levee slope. 2015: Last observed in 2013. [2015 Site ID: GEO_9-3_L]
