**Flood Control Project Maintenance
Levee Inspections**
LMA District Cover Sheet
Spring 2016 Levee Inspection Results

Reclamation District No. 0563 Tyler Island

Spring 2016 Levee Inspection Results

Waterway	Bank	Unit Miles
Unit No. 01 Georgiana Slough (Tyler Island)	Left	12.11

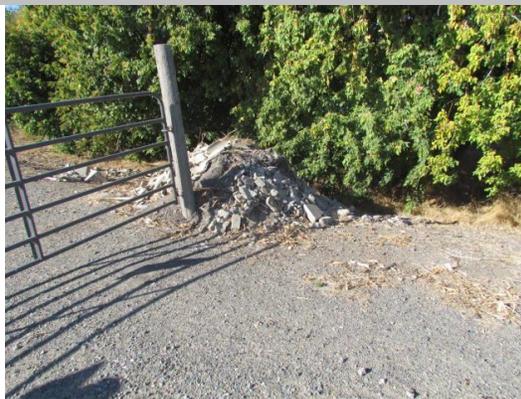
Photo 1 of 2 : SP_2016_RD0563_210_104_20160308_00115.jpg

LM Start	2.89	Rating **	M	Issue No.	104
LM End	2.89	Issue Type +	Ma	Location *	LS
Category	Earthen Levee		GPS Latitude/Longitude		
			Start	End	
Item	Encroachments		38.210966°	38.210966°	
			-121.534813°	-121.534813°	
DWR ID	DWR_RD0563_01_f_2013_104				
Comment Code					
MA : Material					
Inspector Comment					
Landowner stockpiled concrete rubble on landward and waterward slope to stop trespassers. Landowner should replace the stockpile with a proper fence.

Looking west at concrete rubble on waterward shoulder and slope.

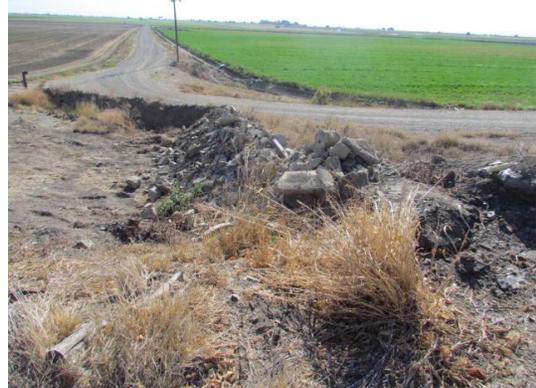
Photo 2 of 2 : SP_2016_RD0563_210_104_20160308_00116.jpg

LM Start	2.89	Rating **	M	Issue No.	104 (cont)
LM End	2.89	Issue Type +	Ma	Location *	LS
Category	Earthen Levee			GPS Latitude/Longitude	
				Start	End
Item	Encroachments			38.210966 °	38.210966 °
				-121.534813 °	-121.534813 °
DWR ID	DWR_RD0563_01_f_2013_104				
Comment Code					
MA : Material					
Inspector Comment					
Landowner stockpiled concrete rubble on landward and waterward slope to stop trespassers. Landowner should replace the stockpile with a proper fence.

Looking east at concrete rubble on landward slope.

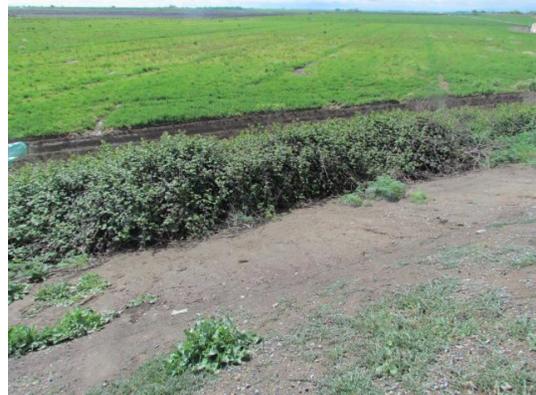
Photo 1 of 1 : SP_2016_RD0563_210_67_20160308_00060.jpg

LM Start	2.94	Rating **	M	Issue No.	67
LM End	2.94	Issue Type +	Ma	Location *	LS
Category	Earthen Levee			GPS Latitude/Longitude	
				Start	End
Item	Vegetation			38.210402 °	38.210402 °
				-121.535268 °	-121.535268 °
DWR ID	DWR_RD0563_01_s_2012_67				
Comment Code					
V2 : Remove the wild growth other than native grasses from the levee slopes.					
Inspector Comment					
Vines (Berry or wildroses) on landside toe.

Looking east at dense vegetation at landward toe.

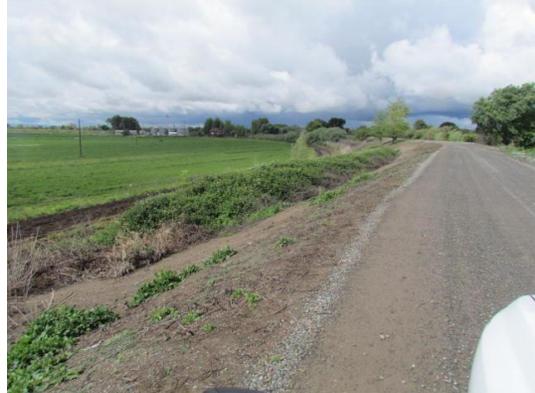
Photo 2 of 4 : SP_2016_RD0563_210_74_20160308_00067.jpg

Looking southeast at dense berryvines at landward toe. (Spring 2015)

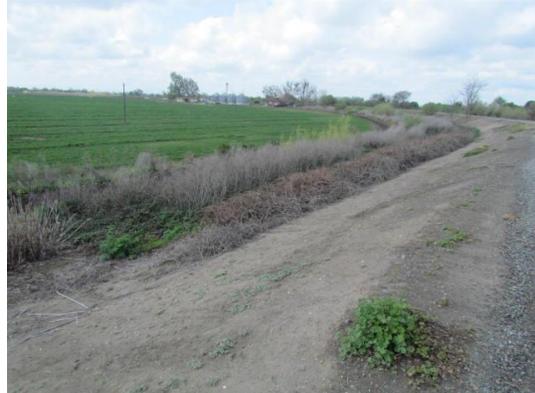
Photo 3 of 4 : SP_2016_RD0563_210_74_20160308_00068.jpg

Looking southeast at dead berryvine on landside toe. (Fall 2014)

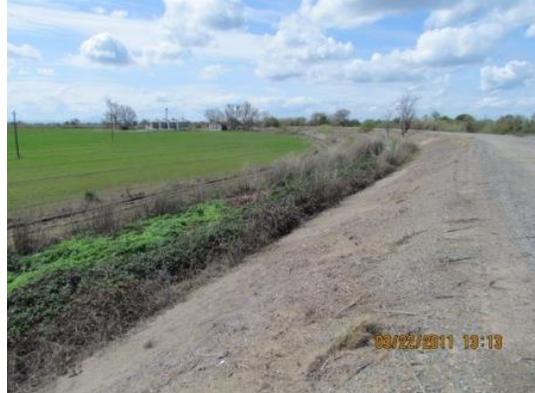
Photo 4 of 4 : SP_2016_RD0563_210_74_20160308_00069.jpg

Looking southeast at berryvines on landside toe. (Fall 2014)

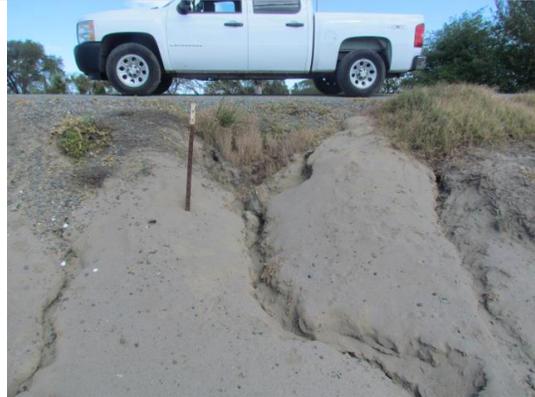
Photo 1 of 5 : SP_2016_RD0563_210_78_20160330_00247.jpg

LM Start	3.06	Rating **	U	Issue No.	78
LM End	3.06	Issue Type +	Ma	Location *	LS
Category	Earthen Levee			GPS Latitude/Longitude	
				Start	End
Item	Slope Stability			38.210240 °	38.210240 °
				-121.537517 °	-121.537517 °
DWR ID	DWR_RD0563_01_s_2012_78				
Comment Code					
S1 : Repair slope instability.					
Inspector Comment					
Slope damage on landward shoulder and slope.

Looking west at finger erosion on landward slope. (Spring 2016)

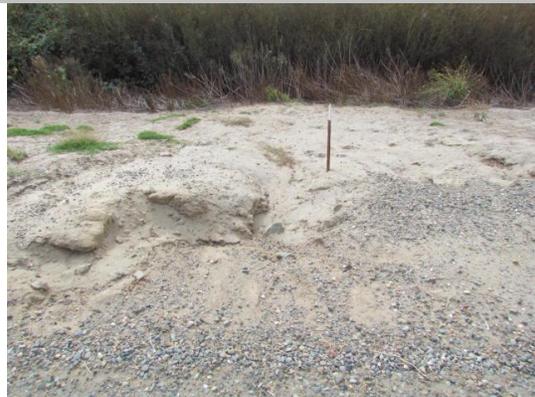
Photo 3 of 5 : SP_2016_RD0563_210_78_20160308_00078.jpg

Looking east at slope damage on 10/31/2012, no change in status.

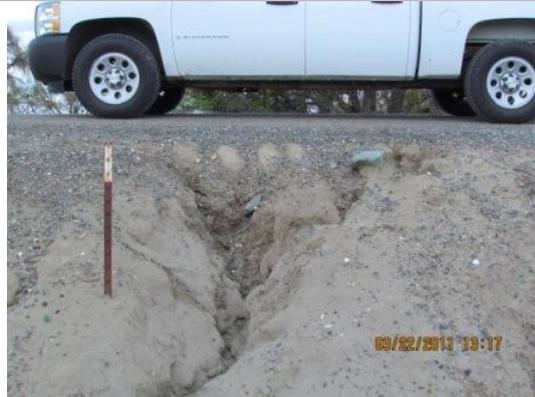
Photo 5 of 5 : SP_2016_RD0563_210_78_20160308_00080.jpg

Looking west at slope erosion cause by runoff on landside slope.

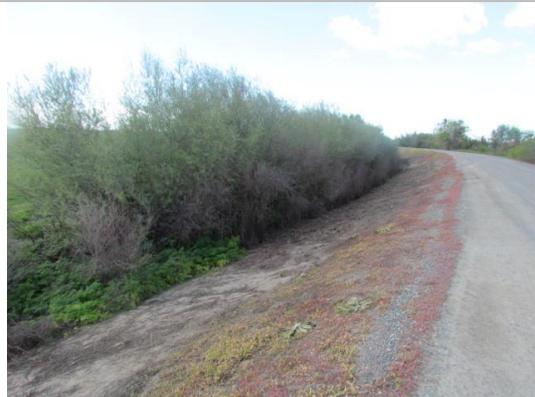
Photo 1 of 2 : SP_2016_RD0563_210_763_20160330_00248.jpg

LM Start	3.11	Rating **	U	Issue No.	763
LM End	3.21	Issue Type +	Ma	Location *	LS
Category	Earthen Levee			GPS Latitude/Longitude	
				Start	End
Item	Vegetation			38.210005 °	38.209229 °
				-121.538452 °	-121.539855 °
DWR ID	DWR_RD0563_01_s_2015_763				
Comment Code					
V2 : Remove the wild growth other than native grasses from the levee slopes.					
Inspector Comment					
Dense vegetation (willows) at landward toe.

Looking south at dense vegetation (willows) at landward toe. (Spring 2016)

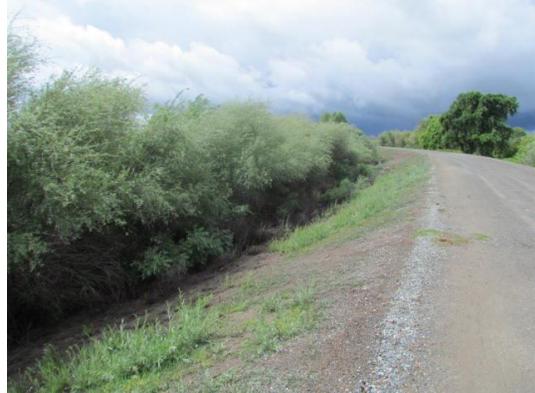
Photo 2 of 2 : SP_2016_RD0563_210_763_20160308_00141.jpg

Looking south at dense vegetation at landward slope and toe. (Spring 2015)

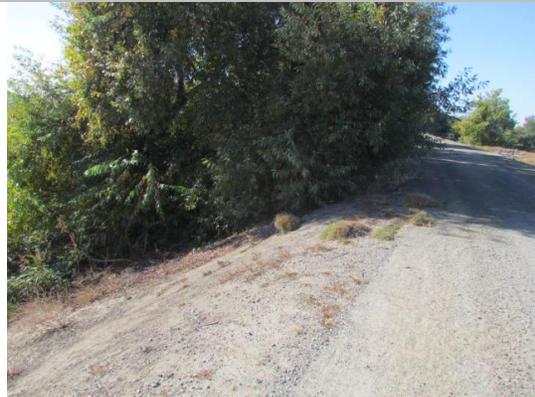
Photo 1 of 2 : SP_2016_RD0563_210_68_20160308_00061.jpg

LM Start	3.21	Rating **	U	Issue No.	68
LM End	3.21	Issue Type +	Ma	Location *	LS
Category	Earthen Levee			GPS Latitude/Longitude	
				Start	End
Item	Trim / Thin Trees			38.209217 °	38.209217 °
				-121.539823 °	-121.539823 °
DWR ID	DWR_RD0563_01_s_2012_68				
Comment Code					
T2 : Thin trees to allow visibility of the ground and room to flood fight.					
Inspector Comment

Looking south at dense trees on landward slope.

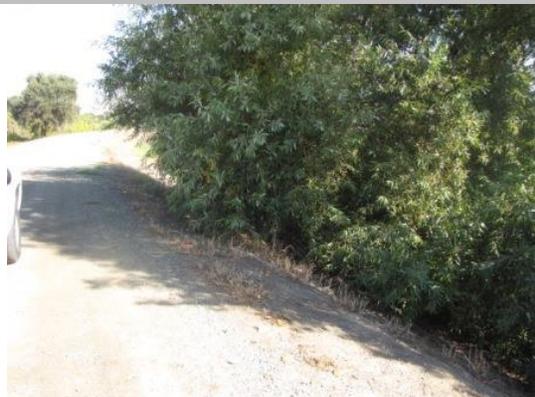
Photo 2 of 2 : SP_2016_RD0563_210_68_20160308_00062.jpg

Looking southeast at dense trees on landside slope and toe.

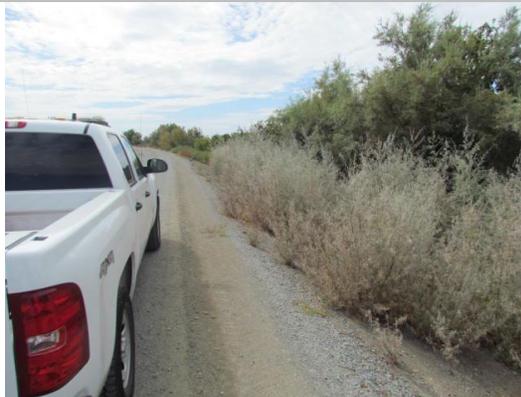
Photo 1 of 1 : SP_2016_RD0563_210_159_20160308_00137.jpg

LM Start	3.39	Rating **	A/W	Issue No.	159
LM End	3.39	Issue Type +	Ma	Location *	WS
Category	Earthen Levee		GPS Latitude/Longitude		
			Start	End	
Item	Vegetation		38.206727 °	38.206727 °	
			-121.540666 °	-121.540666 °	
DWR ID	DWR_RD0563_01_f_2015_159				
Comment Code					
V2 : Remove the wild growth other than native grasses from the levee slopes.					
Inspector Comment					
Dense willows on waterward slope within the twenty foot zone.

Looking south at dense willows on waterward slope.

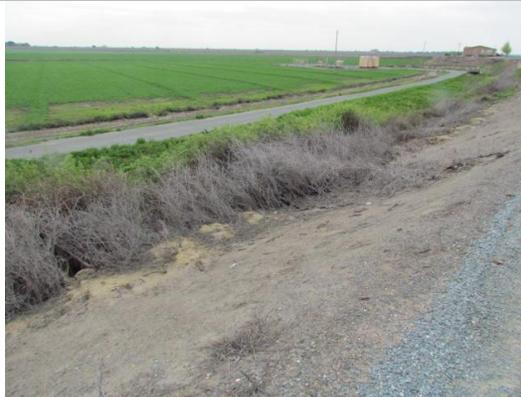
Photo 1 of 2 : SP_2016_RD0563_210_84_20160308_00085.jpg

LM Start	3.50	Rating **	A/W	Issue No.	84
LM End	3.50	Issue Type +	Ma	Location *	LS
Category	Earthen Levee		GPS Latitude/Longitude		
			Start	End	
Item	Vegetation		38.205130 °	38.205130 °	
			-121.540397 °	-121.540397 °	
DWR ID	DWR_RD0563_01_f_2012_84				
Comment Code					
V2 : Remove the wild growth other than native grasses from the levee slopes.					
Inspector Comment					
Vegetation at landward toe.

Looking southeast at dead berryvines on landward toe.

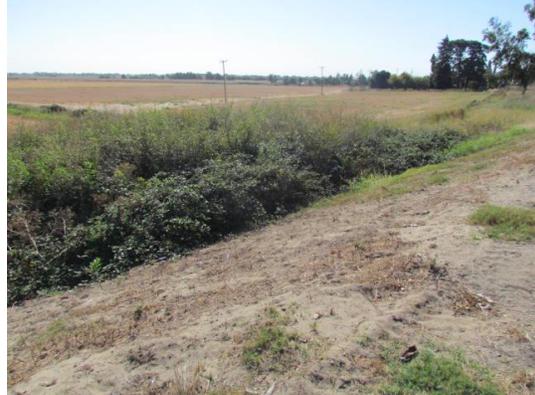
Photo 2 of 2 : SP_2016_RD0563_210_84_20160308_00086.jpg

Looking southeast at dense berryvines on landward toe.

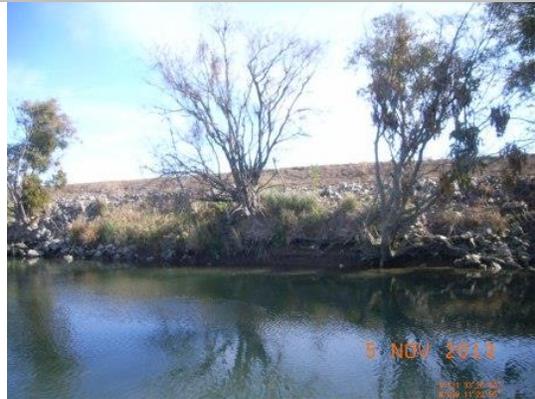
Photo 1 of 1 : SP_2016_RD0563_210_38_20160308_00037.jpg

LM Start	3.91	Rating **	M	Issue No.	38
LM End	4.01	Issue Type +	Ma	Location *	WS
Category	Supplemental			GPS Latitude/Longitude	
				Start	End
Item	2015 USACE Erosion Survey, DRAFT			38.200733 °	38.199925 °
				-121.542571 °	-121.544249 °
DWR ID	DWR_RD0563_01_s_2016_38				
Comment Code					
Inspector Comment					
1997 - Narrow eroding berm upstream of existing rock. 2001 - Staked, low fascine walls at bankline. 2011 - Minor new erosion. Site extended downstream. 2012 - Rock repair failing in one erosion pocket. 2015: Last observed in 2013. [2015 Site ID: GEO_8-3_L]

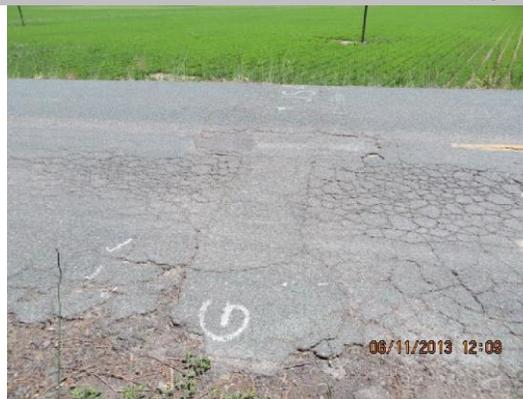
Photo 1 of 2 : UCIP_SP_2016_16244_27390.jpg

LM Start	4.26	Rating **	M	Issue No.	971
LM End	4.26	Issue Type +	En	Location *	WS
Category	Supplemental			GPS Latitude/Longitude	
				Start	End
Item	DWR UCIP Field Study			38.196725 °	38.196725 °
				-121.546310 °	-121.546310 °
DWR ID					
Comment Code					
Inspector Comment					
FS_ID:16244 DS_ID:23971 EP_NO: N/A Repair Type: Non-Urgent Crossing Status: Found UCIP Comments: Need to determine disposition of pipe. Likely that this pipe was removed from levee section as evidenced by the cut in pavement on crown. FIELD_STRUCT_DESC: 4.5-inch gas line through the levee at an unknown depth below the crown. Cut in pavement and Pipe visible on WS toe. (Permit No. 15539) FS Date: 6/11/2013

Cut in pavement with USAA markings for gasoline.

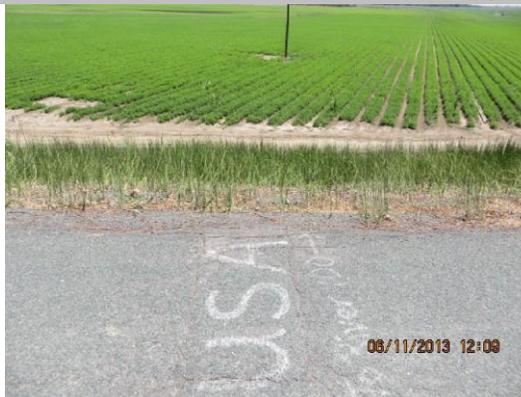
Photo 2 of 2 : UCIP_SP_2016_16244_27389.jpg

Cut in pavement with USAA markings for gasoline.

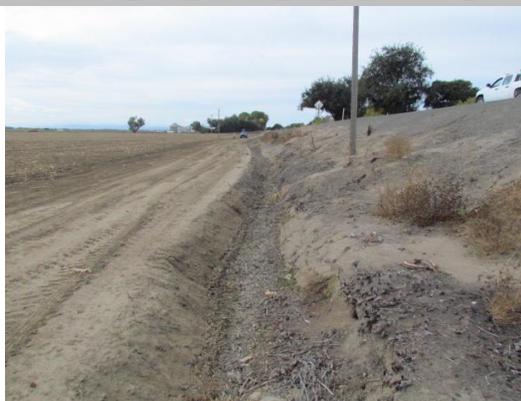
Photo 1 of 1 : SP_2016_RD0563_210_93_20160308_00103.jpg

LM Start	4.48	Rating **	M	Issue No.	93
LM End	4.59	Issue Type +	Ob	Location *	LS
Category	Earthen Levee			GPS Latitude/Longitude	
				Start	End
Item	Encroachments			38.194424 °	38.193415 °
				-121.548952 °	-121.550632 °
DWR ID	DWR_RD0563_01_f_2012_93				
Comment Code					
DT : Ditch					
Inspector Comment					
Ditch at landside toe should be removed.

Looking south at irrigation ditch at landside toe.

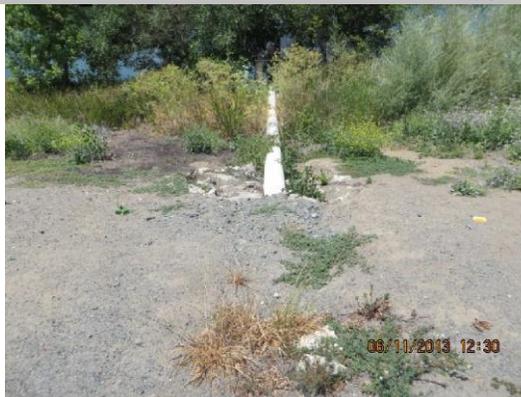
Photo 2 of 2 : UCIP_SP_2016_14927_24589.jpg

LM Start	4.75	Rating **	M	Issue No.	977 (cont)
LM End	4.75	Issue Type +	En	Location *	LS
Category	Supplemental			GPS Latitude/Longitude	
				Start	End
Item	DWR UCIP Field Study			38.191864 °	38.191864 °
				-121.552606 °	-121.552606 °
DWR ID					
Comment Code					
Inspector Comment					
FS_ID:14927 DS_ID:20145 EP_NO: 11205 Repair Type: Non-Urgent Crossing Status: Found UCIP Comments: Some settlement over pipe on WS shoulder and there is some animal burrow tunnels over the pipe on the LS shoulder. FIELD_STRUCT_DESC: 4 of 5: 10-inch pipe through levee 3.8 feet below crown. Siphon breaker on landward shoulder. Slant pump off WS toe. Booster and filter station off LS toe. Abandoned concrete distribution box at LS toe. 1-inch galvanized iron electrical conduit at same location (ABO No.11205, 1971). Originally included in the 1954 O&M manual. FS Date: 6/11/2013

Pipe on WS slope.

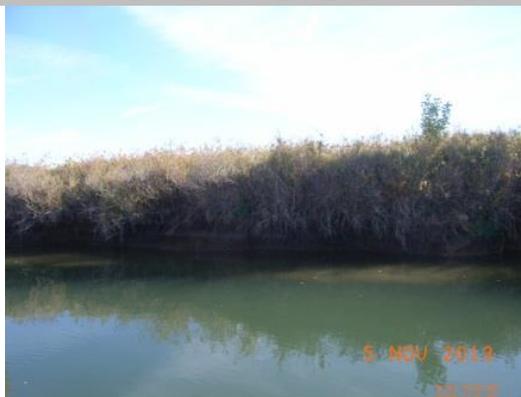
Photo 1 of 1 : SP_2016_RD0563_210_45_20160308_00044.jpg

LM Start	4.98	Rating **	M	Issue No.	45
LM End	5.04	Issue Type +	Ma	Location *	WS
Category	Supplemental			GPS Latitude/Longitude	
				Start	End
Item	2015 USACE Erosion Survey, DRAFT			38.190073 °	38.189524 °
				-121.556307 °	-121.557227 °
DWR ID	DWR_RD0563_01_s_2016_45				
Comment Code					
Inspector Comment					
2009 - Small scallops of erosion into the levee toe behind brush boxes. 2011 - Minor new erosion. 2012 - Site extended upstream to account for addition erosion pockets. 2015: Last observed in 2013. [2015 Site ID: GEO_7-2_L]

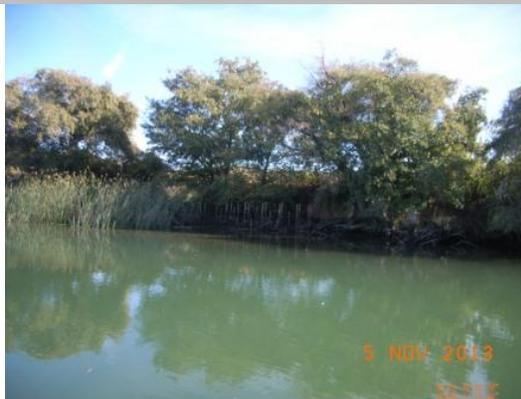
Photo 1 of 1 : SP_2016_RD0563_210_46_20160308_00045.jpg

LM Start	5.15	Rating **	U	Issue No.	46
LM End	5.39	Issue Type +	Ma	Location *	WS
Category	Supplemental			GPS Latitude/Longitude	
				Start	End
Item	2015 USACE Erosion Survey, DRAFT			38.188216°	38.185968°
				-121.558442°	-121.561667°
DWR ID	DWR_RD0563_01_s_2016_46				
Comment Code					
Inspector Comment					
1997 - Deep pockets of erosion into a narrow berm just downstream of the rock. 2000 - Scallops in banks with small colored flags, some new biotech rolls in with older rolls in the scallops. 2001 - Staked, low fascine walls at the bankline. 2011 - Site upgraded to CRITICAL. Site extended upstream due to new erosion pocket. New tree popouts and new erosion. 2013 - Pipe observed at upstream end of site. 2015: Last observed in 2013. [2015 Site ID: GEO_6-8_L]

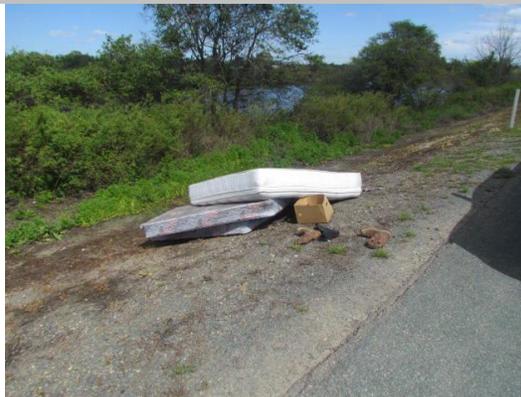
Photo 1 of 1 : SP_2016_RD0563_210_163_20160330_00249.jpg

LM Start	5.15	Rating **	M	Issue No.	163
LM End	5.15	Issue Type +	En	Location *	WS
Category	Earthen Levee			GPS Latitude/Longitude	
				Start	End
Item	Encroachments			38.188121°	38.188121°
				-121.558359°	-121.558359°
DWR ID	DWR_RD0563_01_s_2016_163				
Comment Code					
GA : Garbage					
Inspector Comment					
Garbage on waterward slope.

Looking west at garbage on waterward slope.

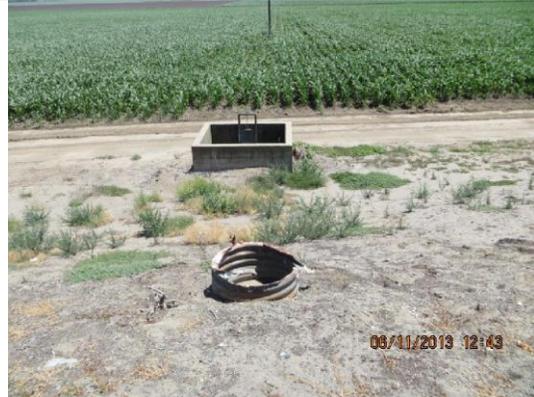
Photo 1 of 2 : UCIP_SP_2016_14943_24595.jpg

LM Start	5.17	Rating **	M	Issue No.	978
LM End	5.17	Issue Type +	En	Location *	WS
Category	Supplemental			GPS Latitude/Longitude	
				Start	End
Item	DWR UCIP Field Study			38.187938 °	38.187938 °
				-121.558495 °	-121.558495 °
DWR ID					
Comment Code					
Inspector Comment					
FS_ID:14943 DS_ID:20146 EP_NO: 11205 Repair Type: Non-Urgent Crossing Status: Found UCIP Comments: Need to verify wether or not pipe has been abandoned. FIELD_STRUCT_DESC: 5 of 5: 8-inch pipe through levee 3.7 feet below crown. Pump and gate valve on waterward end. Siphon breaker on landward shoulder. (ABO No. 11205, 1971). Originally included in 1954 O&M manual with the description 1" air valve, brass cock and cover, reinforced concrete spillbox. FS Date: 6/11/2013

Distribution box and 24-inch CMP riser on LS slope.

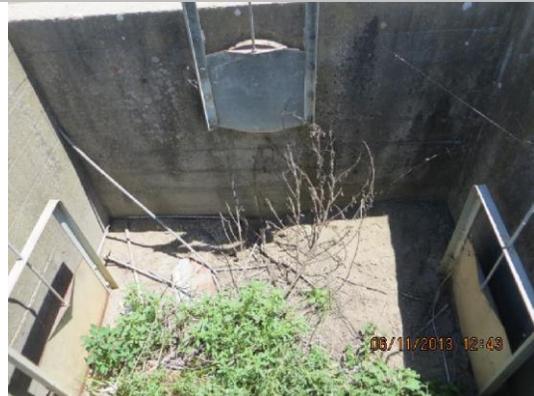
Photo 2 of 2 : UCIP_SP_2016_14943_24594.jpg

Inside distribution box at LS toe.

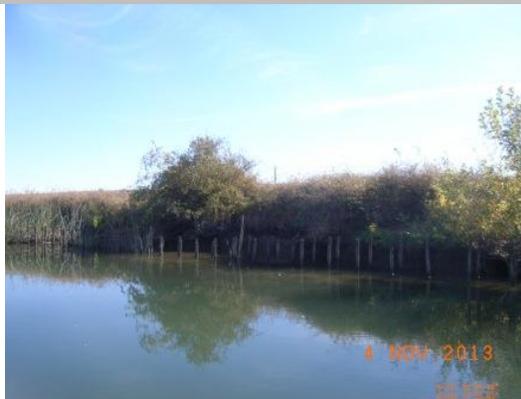
Photo 1 of 1 : SP_2016_RD0563_210_55_20160308_00053.jpg

Comment Code					
Inspector Comment					
<p>1997 - Deep pockets of erosion and narrow berm. Reach is characterized by lots of pockets into the existing berm and/or levee slope. 1999 - Some pockets filled with rock riprap. 2000 - Exposed fabric. 2001 - Staked, low fascine walls at bankline. 2002 - New spot of rock at upstream end. Some new brush boxes. 2005 - Some stone sliding off the underlying geotextile fabric. Some new brush bundles in the brush boxes; some with missing bundles. Some boxes too low relative to high tide. 2009 - Minimal new erosion, site length extended. 2010 - New erosion on downstream end, site extended downstream. 2011 - Sites 6.1, 6.4 and 6.6 were combined. New erosion pockets, site extended to include the erosion in between the old sites. 2012 - Rock has been placed in portions of the bank since last year. 2015: Last observed in 2013. [2015 Site ID: GEO_6-3_L]</p>

USACE 2013 Photo #1

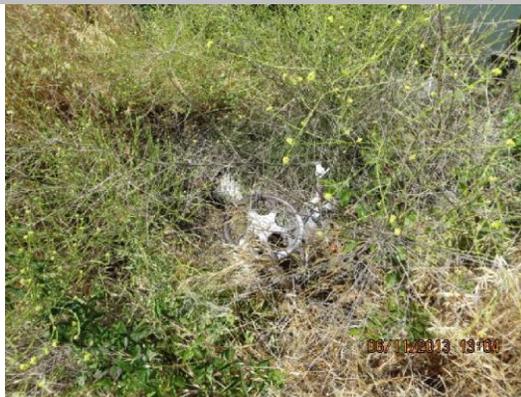
Photo 1 of 2 : UCIP_SP_2016_14949_24603.jpg

LM Start	5.88	Rating **	M	Issue No.	979
LM End	5.88	Issue Type +	En	Location *	WS
Category	Supplemental			GPS Latitude/Longitude	
				Start	End
Item	DWR UCIP Field Study			38.182334 °	38.182334 °
				-121.569193 °	-121.569193 °
DWR ID					
Comment Code					
Inspector Comment					
FS_ID:14949 DS_ID:20175 EP_NO: 11206 Repair Type: Non-Urgent Crossing Status: Found UCIP Comments: Pipe appears abandoned and should be done so properly. FIELD_STRUCT_DESC: 1 of 2: 8-inch pipe through levee 3.7 feet below crown. Pump and gate valve on waterward side. Siphon breaker on landward shoulder. 7'X9' concrete distribution box at LS toe (ABO No. 11206, 1971). Originally included in 1954 O&M. FS Date: 6/11/2013

Slide gate at pump on WS slope

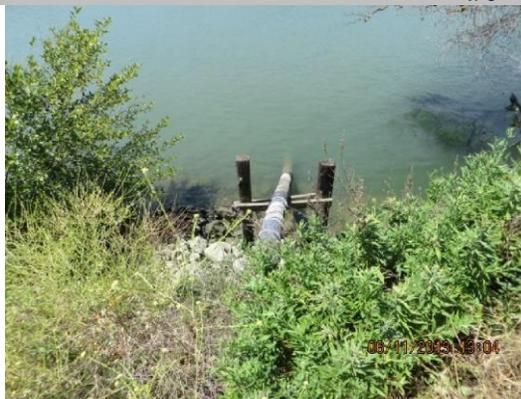
Photo 2 of 2 : UCIP_SP_2016_14949_24602.jpg

Pipe at WS toe.

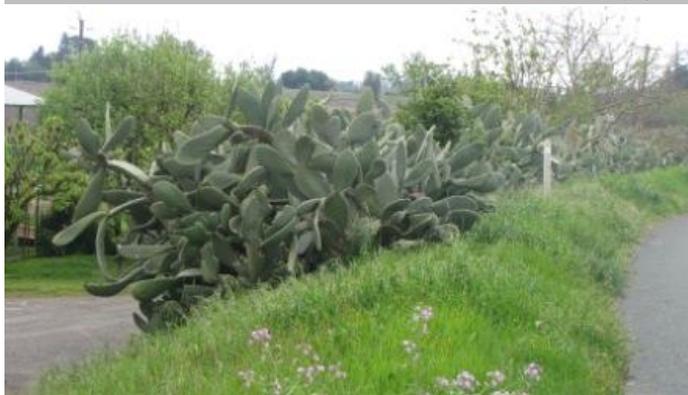
Photo 1 of 2 : SP_2016_RD0563_210_22_20160308_00023.jpg

LM Start	5.92	Rating **	U	Issue No.	22
LM End	5.96	Issue Type +	Ma	Location *	LS
Category	Earthen Levee		GPS Latitude/Longitude		
			Start	End	
Item	Vegetation		38.181965 °	38.181763 °	
			-121.569913 °	-121.570447 °	
DWR ID	DWR_RD0563_01_s_2012_22				
Comment Code					
V2 : Remove the wild growth other than native grasses from the levee slopes.					
Inspector Comment					
Large cactus on landward slope.

Looking at north end of cactus on the landside slope.

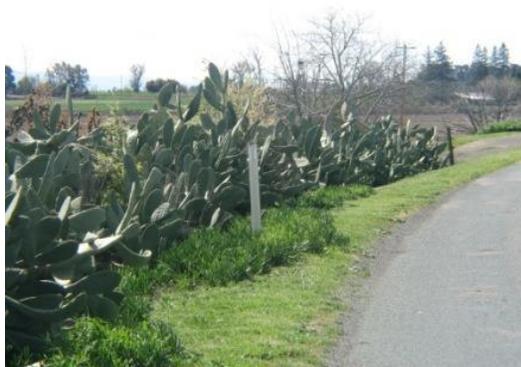
Photo 2 of 2 : SP_2016_RD0563_210_22_20160308_00024.jpg

Large cactus plant on landward slope from LM 6.04 to 6.08

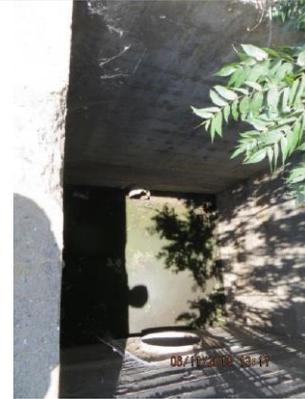
Photo 2 of 2 : UCIP_SP_2016_14950_24606.jpg

LM Start	6.01	Rating **	M	Issue No.	980 (cont)
LM End	6.01	Issue Type +	En	Location *	LS
Category	Supplemental			GPS Latitude/Longitude	
				Start	End
Item	DWR UCIP Field Study			38.181477 °	38.181477 °
				-121.571417 °	-121.571417 °
DWR ID					
Comment Code					
Inspector Comment					
FS_ID:14950 DS_ID:20149 EP_NO: 11206 Repair Type: Non-Urgent Crossing Status: Found UCIP Comments: Need to install a CMP riser on LS shoulder to protect the vent/filler pipe. FIELD_STRUCT_DESC: 2 of 2: 10-inch steel irrigation siphon through the levee 4.8 feet below the crown. Vent/filler pipe on LS shoulder. 7'X9' concrete distribution box on LS toe (ABO No. 11206, 1971). Originally included in 1954 O&M manual with the description 2" air and primer valve, reinforced concrete spillbox. FS Date: 6/11/2013

Outlet pipe in distribution box on LS toe.

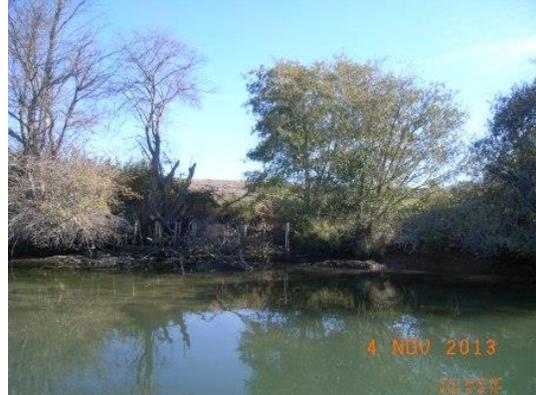
Photo 1 of 1 : SP_2016_RD0563_210_44_20160308_00043.jpg

LM Start	6.38	Rating **	M	Issue No.	44
LM End	6.46	Issue Type +	Ma	Location *	WS
Category	Supplemental			GPS Latitude/Longitude	
				Start	End
Item	2015 USACE Erosion Survey, DRAFT			38.180462°	38.179319°
				-121.577895°	-121.578566°
DWR ID	DWR_RD0563_01_s_2016_44				
Comment Code					
Inspector Comment					
2013 - Erosion pockets into the levee prism. Erosion pockets primarily located behind unmaintained brush boxes. 2015: Last observed in 2013. [2015 Site ID: GEO_5-8_L]

USACE 2013 Photo #1

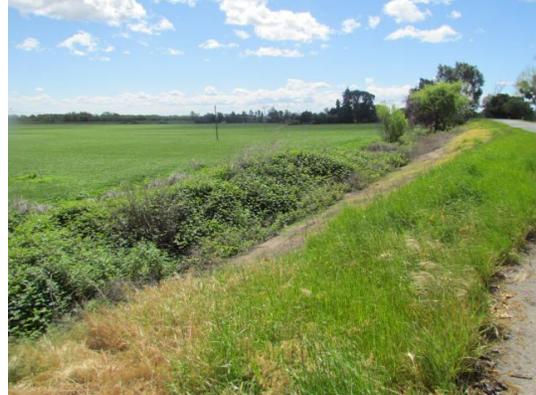
Photo 1 of 1 : SP_2016_RD0563_210_164_20160330_00250.jpg

LM Start	6.59	Rating **	U	Issue No.	164
LM End	6.62	Issue Type +	Ma	Location *	LS
Category	Earthen Levee		GPS Latitude/Longitude		
			Start	End	
Item	Vegetation		38.177438 °	38.177033 °	
			-121.579151 °	-121.579344 °	
DWR ID	DWR_RD0563_01_s_2016_164				
Comment Code					
V2 : Remove the wild growth other than native grasses from the levee slopes.					
Inspector Comment					
Dense vegetation (vines) at landward toe.

Looking east at dense vegetation (vines) at landward toe.

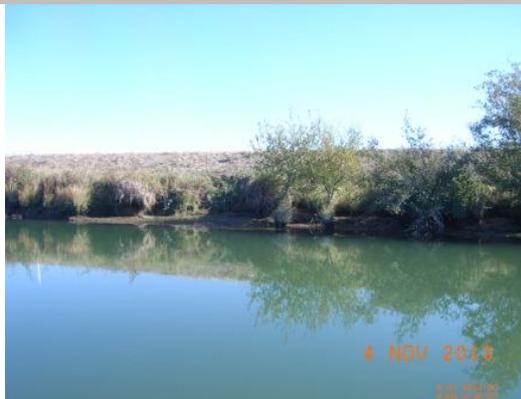
Photo 1 of 1 : SP_2016_RD0563_210_51_20160308_00050.jpg

LM Start	6.64	Rating **	M	Issue No.	51
LM End	7.28	Issue Type +	Ma	Location *	WS
Category	Supplemental			GPS Latitude/Longitude	
				Start	End
Item	2015 USACE Erosion Survey, DRAFT			38.176861 °	38.167959 °
				-121.579747 °	-121.581616 °
DWR ID	DWR_RD0563_01_s_2016_51				
Comment Code					
Inspector Comment					
1997 - Pocket erosion into the toe of the levee. 2000 - Scallops in banks with small colored flags, biotech rolls present. 2001 - Staked, low fascine walls at bankline. 2003 - Still have visibly bad spots, especially at the upstream end. 2005 - Some new brush bundles in the brush boxes; some with missing bundles. Some boxes too low relative to high tide. 2010 - Site extended upstream. 2011 - Minor new erosion. 2015: Last observed in 2013. [2015 Site ID: GEO_5-3_L]

USACE 2013 Photo #1

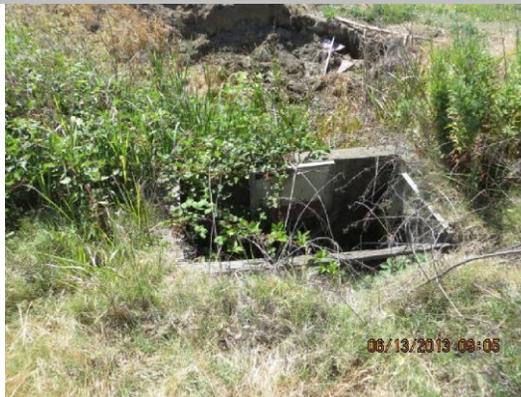
Photo 1 of 2 : UCIP_SP_2016_40790_24633.jpg

LM Start	6.66	Rating **	M	Issue No.	987
LM End	6.66	Issue Type +	En	Location *	WS
Category	Supplemental			GPS Latitude/Longitude	
				Start	End
Item	DWR UCIP Field Study			38.176465 °	38.176465 °
				-121.579615 °	-121.579615 °
DWR ID					
Comment Code					
Inspector Comment					
FS_ID:40790 DS_ID:20153 EP_NO: 11202 Repair Type: Non-Urgent Crossing Status: Found UCIP Comments: Pipe appears abandoned and if so should be done so properly. FIELD_STRUCT_DESC: 12-inch pipe through the levee 4.5 feet below crown. Vent/filler pipe in 24-inch CMP riser on landward shoulder and a 7'X9' concrete distribution box on LS toe (ABO No. 11202, 1971). Originally included in the 1954 O&M manual. FS Date: 6/11/2013

7'X9' concrete distribution box on LS toe.

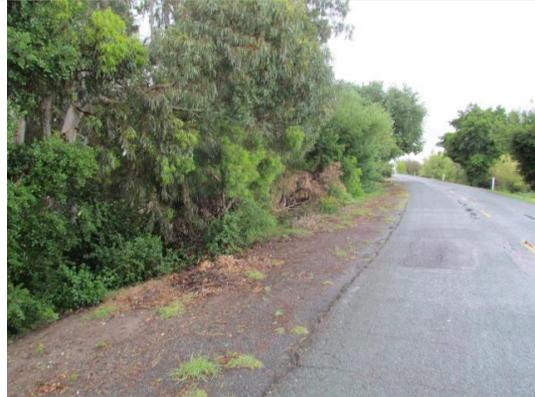
Photo 1 of 1 : SP_2016_RD0563_210_145_20160308_00132.jpg

LM Start	6.75	Rating **	U	Issue No.	145
LM End	6.79	Issue Type +	Ma	Location *	LS
Category	Earthen Levee			GPS Latitude/Longitude	
				Start	End
Item	Trim / Thin Trees			38.175219 °	38.174743 °
				-121.580053 °	-121.580016 °
DWR ID	DWR_RD0563_01_s_2014_145				
Comment Code					
T2 : Thin trees to allow visibility of the ground and room to flood fight.					
Inspector Comment					
Untrimmed trees blocking view of landward toe.

Looking southeast at dense vegetation on landward slope and toe.

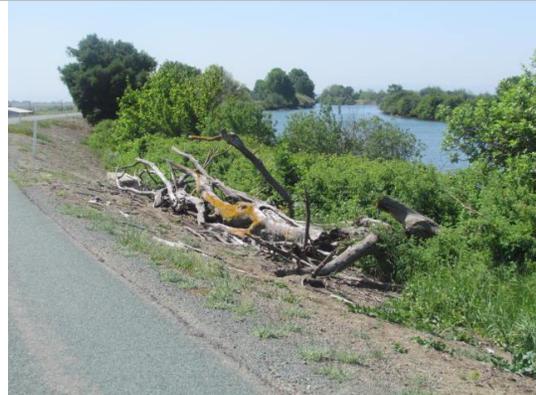
Photo 1 of 1 : SP_2016_RD0563_210_95_20160308_00104.jpg

LM Start	6.95	Rating **	M	Issue No.	95
LM End	6.95	Issue Type +	Ma	Location *	WS
Category	Earthen Levee		GPS Latitude/Longitude		
			Start	End	
Item	Encroachments		38.172351 °	38.172351 °	
			-121.579520 °	-121.579520 °	
DWR ID	DWR_RD0563_01_f_2012_95				
Comment Code					
PR : Prunings					
Inspector Comment					
Prunings should be burned or removed from waterward slope.

Looking southwest at prunings on waterward slope.

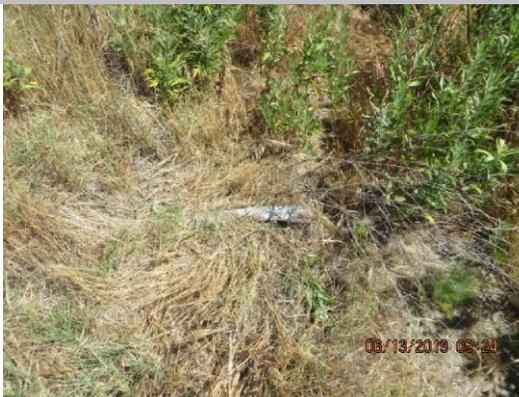
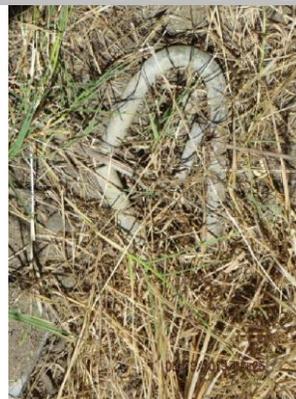
LM Start	7.04	Rating **	M	Issue No.	983
LM End	7.04	Issue Type +	En	Location *	WS
Category	Supplemental			GPS Latitude/Longitude	
				Start	End
Item	DWR UCIP Field Study			38.171156°	38.171156°
				-121.579756°	-121.579756°
DWR ID					
Comment Code					
Inspector Comment					
FS_ID:14968 DS_ID:20154 EP_NO: 11214 Repair Type: Non-Urgent Crossing Status: Indicator Found UCIP Comments: Verify type of abandonment. Wide berm on LS toe with some evidence of steel slide gate in soil at berm. FIELD_STRUCT_DESC: 1 of 2: 8-inch pipe through levee 3.7 feet below crown. Siphon breaker on waterward slope (ABO No. 11214, 1971). Originally included in the 1954 O&M manual with the description 1" air and primer valve, reinforced concrete spillbox. FS Date: 6/13/2013

Steel parts on LS toe may indicate location of distribution box.

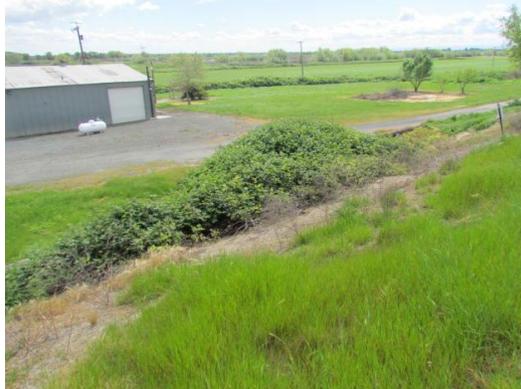
Photo 1 of 1 : SP_2016_RD0563_210_151_20160330_00252.jpg

LM Start	7.14	Rating **	U	Issue No.	151
LM End	7.14	Issue Type +	Ma	Location *	LS
Category	Earthen Levee			GPS Latitude/Longitude	
				Start	End
Item	Vegetation			38.169705 °	38.169705 °
				-121.580355 °	-121.580355 °
DWR ID	DWR_RD0563_01_f_2014_151				
Comment Code					
V2 : Remove the wild growth other than native grasses from the levee slopes.					
Inspector Comment					
Dense berryvines at landward toe.

Looking southeast at dense vegetation at landward toe.

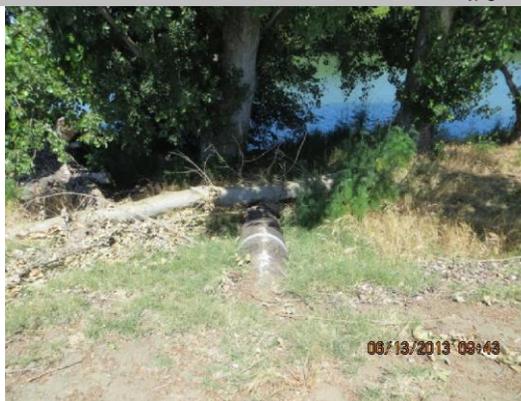
Photo 1 of 2 : UCIP_SP_2016_42743_24641.jpg

LM Start	7.36	Rating **	M	Issue No.	986
LM End	7.36	Issue Type +	En	Location *	LS
Category	Supplemental			GPS Latitude/Longitude	
				Start	End
Item	DWR UCIP Field Study			38.166832 °	38.166832 °
				-121.582112 °	-121.582112 °
DWR ID					
Comment Code					
Inspector Comment					
FS_ID:42743 DS_ID:20155 EP_NO: 11214 Repair Type: Non-Urgent Crossing Status: Found UCIP Comments: Good candidate for video inspection. FIELD_STRUCT_DESC: 2 of 2: 24-inch steel irrigation siphon through the levee 0.5-feet below the crown. Vent and filler pipe on landward slope (ABO No. 11214, 1971). Originally included in the 1954 O&M manual. FS Date: 6/13/2013

Pipe visible on WS slope.

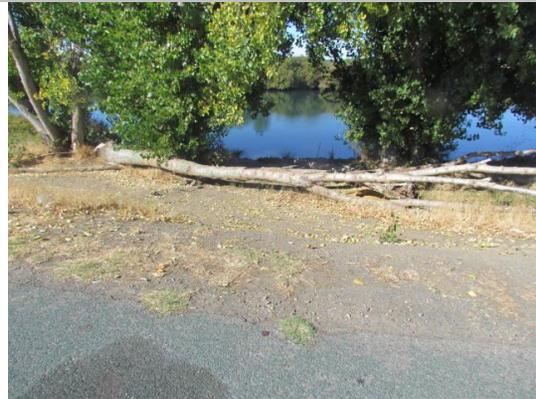
Photo 1 of 1 : SP_2016_RD0563_210_152_20160308_00134.jpg

LM Start	7.52	Rating **	A/W	Issue No.	152
LM End	7.52	Issue Type +	En	Location *	WS
Category	Earthen Levee		GPS Latitude/Longitude		
			Start	End	
Item	Encroachments		38.164648 °	38.164648 °	
			-121.582793 °	-121.582793 °	
DWR ID	DWR_RD0563_01_f_2014_152				
Comment Code					
TR : Tree or limb					
Inspector Comment					
Downed tree branch on waterward slope.

Looking west at tree branch on waterward slope.

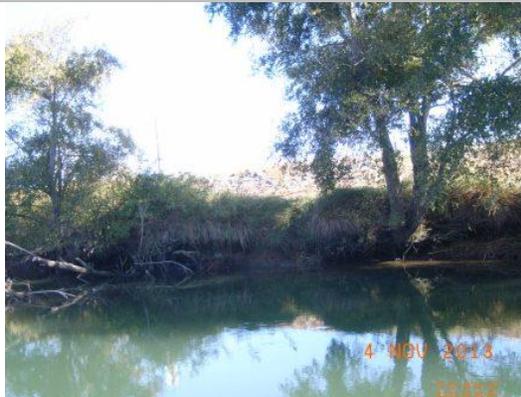
Photo 1 of 1 : SP_2016_RD0563_210_53_20160308_00051.jpg

LM Start	7.53	Rating **	U	Issue No.	53
LM End	7.80	Issue Type +	Ma	Location *	WS
Category	Supplemental			GPS Latitude/Longitude	
				Start	End
Item	2015 USACE Erosion Survey, DRAFT			38.164462 °	38.160888 °
				-121.583092 °	-121.584807 °
DWR ID	DWR_RD0563_01_s_2016_53				
Comment Code					
Inspector Comment					
1997 - Pocket erosion at upstream end and into the levee toe under the Alder trees. 2003 - New brush boxes with wattles on bank. 2004 - No brush boxes. 2005 - Site extended from the downstream side of the bridge. Whole bank is vertical. 2010 - Some minor new erosion. 2011 - Site upgraded to CRITICAL. New erosion pockets throughout the site. Sites 4.5, and 4.6 were combined. 2015: Last observed in 2013. [2015 Site ID: GEO_4-5_L]

USACE 2013 Photo #1

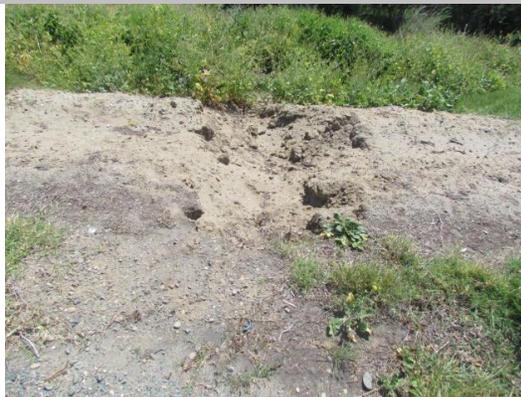
Photo 1 of 1 : SP_2016_RD0563_210_97_20160308_00107.jpg

LM Start	7.62	Rating **	M	Issue No.	97
LM End	7.62	Issue Type +	Ma	Location *	LS
Category	Earthen Levee			GPS Latitude/Longitude	
				Start	End
Item	Slope Stability			38.163240 °	38.163240 °
				-121.583328 °	-121.583328 °
DWR ID	DWR_RD0563_01_s_2013_97				
Comment Code					
S1 : Repair slope instability.					
Inspector Comment					
Minor erosion on landside shoulder and slope.

Looking east at slope erosion on landward shoulder and slope.

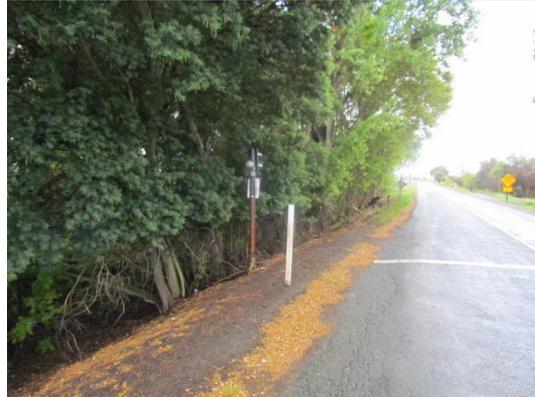
Photo 1 of 1 : SP_2016_RD0563_210_29_20160308_00031.jpg

LM Start	7.74	Rating **	M	Issue No.	29
LM End	7.78	Issue Type +	Ma	Location *	LS
Category	Earthen Levee		GPS Latitude/Longitude		
			Start	End	
Item	Trim / Thin Trees		38.161607 °	38.161092 °	
			-121.584258 °	-121.584470 °	
DWR ID	DWR_RD0563_01_s_2012_29				
Comment Code					
T1 : Trim trees to at least five feet above ground level.					
Inspector Comment					
Dense (untrimmed) trees on landward slope.

Looking southeast at dense trees on landward slope and toe.

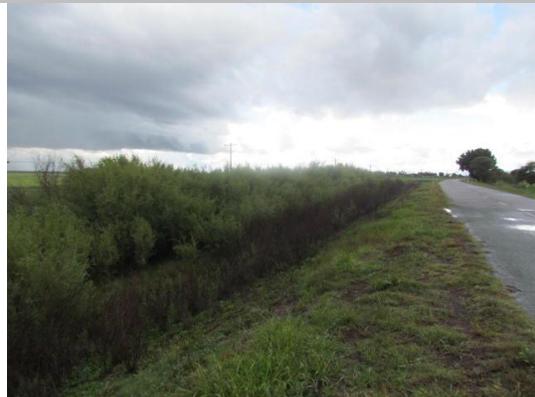
Photo 1 of 5 : SP_2016_RD0563_210_90_20160308_00095.jpg

LM Start	7.80	Rating **	U	Issue No.	90
LM End	7.82	Issue Type +	Ma	Location *	LS
Category	Earthen Levee		GPS Latitude/Longitude		
			Start	End	
Item	Vegetation		38.160800 °	38.160487 °	
			-121.584598 °	-121.584717 °	
DWR ID	DWR_RD0563_01_s_2012_90				
Comment Code					
V2 : Remove the wild growth other than native grasses from the levee slopes.					
Inspector Comment					
Berryvines and willows on landside toe.

Looking southeast at dense vegetation at landward toe. (Spring 2015)

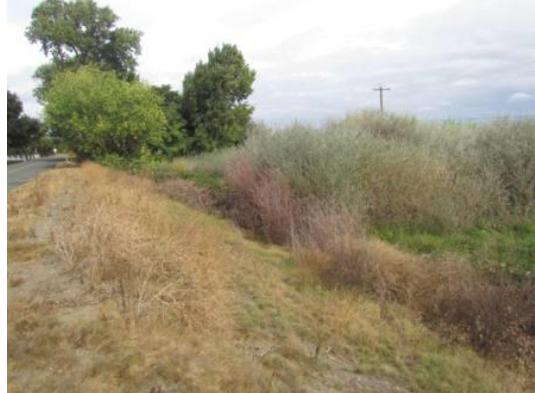
Photo 2 of 5 : SP_2016_RD0563_210_90_20160308_00096.jpg

Looking northeast at dense vegetation on landside toe.

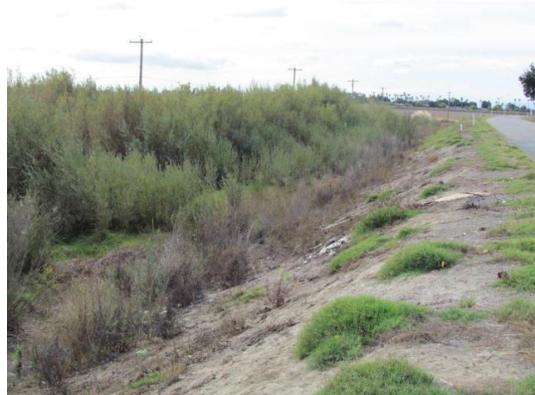
Photo 3 of 5 : SP_2016_RD0563_210_90_20160308_00097.jpg

Looking south at dense vegetation on landside toe. (2012 Fall Inspection)

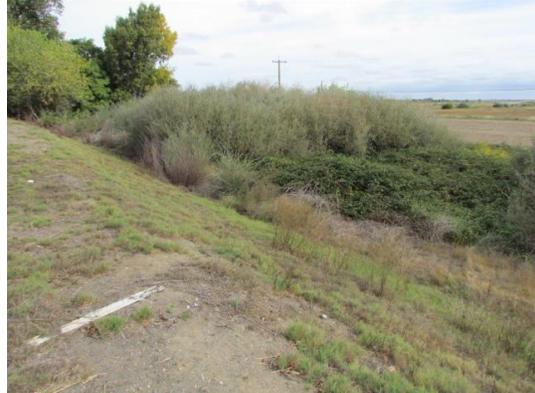
Photo 4 of 5 : SP_2016_RD0563_210_90_20160308_00098.jpg

Looking northeast at dense vegetation on landside toe. (2012 Fall Inspection)

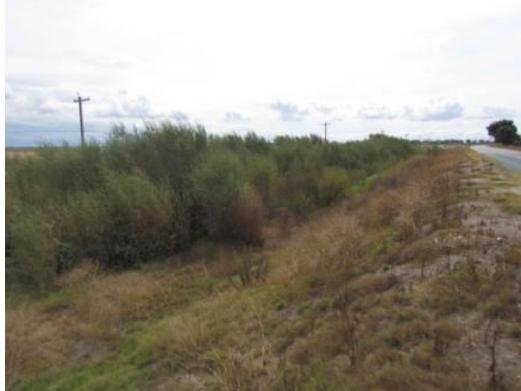
Photo 5 of 5 : SP_2016_RD0563_210_90_20160308_00099.jpg

LM Start	7.80	Rating **	U	Issue No.	90 (cont)
LM End	7.82	Issue Type +	Ma	Location *	LS
Category	Earthen Levee		GPS Latitude/Longitude		
			Start	End	
Item	Vegetation		38.160800 °	38.160487 °	
			-121.584598 °	-121.584717 °	
DWR ID	DWR_RD0563_01_s_2012_90				
Comment Code					
V2 : Remove the wild growth other than native grasses from the levee slopes.					
Inspector Comment					
Berryvines and willows on landside toe.

Looking southwest at dense vegetation on landside toe.

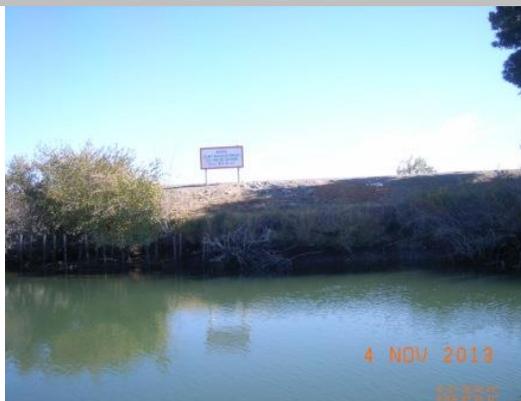
Photo 1 of 1 : SP_2016_RD0563_210_13_20160308_00018.jpg

LM Start	7.85	Rating **	M	Issue No.	13
LM End	8.05	Issue Type +	Ma	Location *	WS
Category	Supplemental		GPS Latitude/Longitude		
			Start	End	
Item	2015 USACE Erosion Survey, DRAFT		38.160261 °	38.157625 °	
			-121.585056 °	-121.586543 °	
DWR ID	DWR_RD0563_01_s_2016_13

Comment Code					
Inspector Comment					
1997 - Pockets of erosion into the levee toe. 1999 - Minor rock riprap and willow bundles place in a couple of spots. 2001 - Staked, low fascine walls at bankline. 2003 - Small unprotected pockets still eroding. 2004 - Numerous brush boxes, some falling apart, some with new bundles. 2005 - Some new brush boxes installed; some boxes are empty. Levee slope and banks still look bad with pocket scallops into the levee slopes. 2011 - Erosion continues and the number of pockets is increasing. 2013 - Some of the downstream end was repaired by the RD. 2015: Last observed in 2013. [2015 Site ID: GEO_4-3_L]

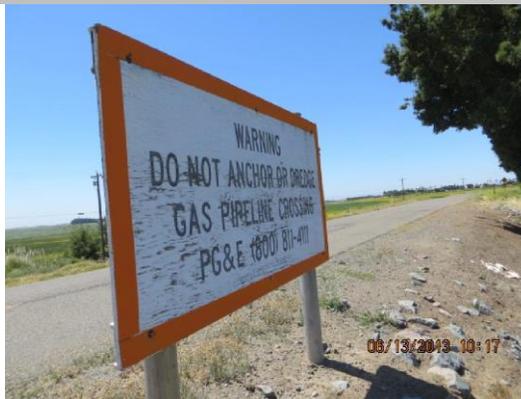
Photo 1 of 2 : UCIP_SP_2016_16263_27401.jpg

LM Start	7.92	Rating **	M	Issue No.	972
LM End	7.92	Issue Type +	En	Location *	WS
Category	Supplemental			GPS Latitude/Longitude	
				Start	End
Item	DWR UCIP Field Study			38.159207 °	38.159207 °
				-121.585304 °	-121.585304 °
DWR ID					
Comment Code					
Inspector Comment					
FS_ID:16263 DS_ID:23973 EP_NO: N/A Repair Type: Non-Urgent Crossing Status: Indicator Found UCIP Comments: Need to determine disposition of all gas lines in this immediate area. FIELD_STRUCT_DESC: Gas line marker on WS shoulder. Pipe through the levee at unknown depth below the crown. FS Date: 6/13/2013

Sign on WS shoulder.

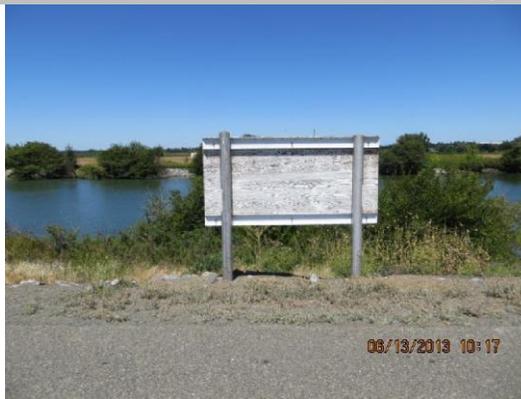
Photo 2 of 2 : UCIP_SP_2016_16263_27400.jpg

Sign on WS shoulder.

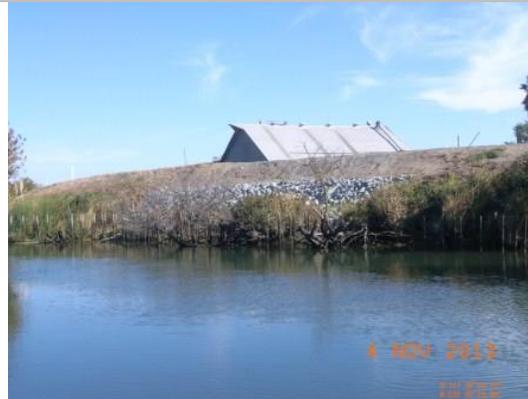
Photo 1 of 1 : SP_2016_RD0563_210_40_20160308_00039.jpg

Comment Code					
Inspector Comment					
1997 - Pockets of erosion into the levee at the water line. Alders are being undercut and rotating out into the channel. Damaged rock at upstream end. 2000 - New minor erosion. 2001 - Staked low fascine walls at bankline. 2002 - New "Brush Boxes" along the bank toe. 2003 - New erosion pockets in the middle of the site. 2005 - Some new bundles in the brush boxes. 2011 - Site upgraded to CRITICAL. Significant new erosion. Sites 3.6, 3.7, 3.71, and 4.0 were combined. 2012 - Rock has been placed in some of the erosion pockets since last year, however site remains critical. 2013 - Site no longer critical. The worst pockets were filled with rock by the local RD. 2015: Last observed in 2013. [2015 Site ID: GEO_3-8_L]

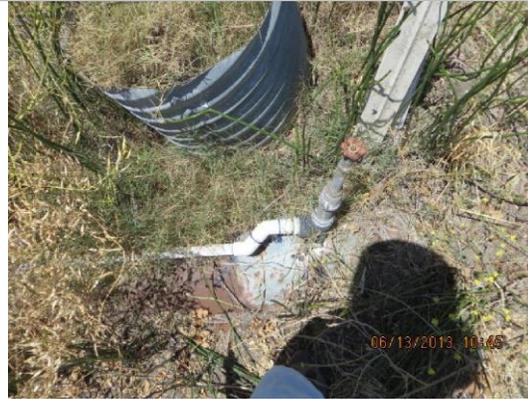
Photo 1 of 2 : UCIP_SP_2016_14988_24670.jpg

LM Start	8.13	Rating **	M	Issue No.	963
LM End	8.13	Issue Type +	En	Location *	WS
Category	Supplemental			GPS Latitude/Longitude	
				Start	End
Item	DWR UCIP Field Study			38.156884 °	38.156884 °
				-121.587464 °	-121.587464 °
DWR ID					
Comment Code					
Inspector Comment					
FS_ID:14988 DS_ID:20160 EP_NO: 9145 Repair Type: Non-Urgent Crossing Status: Found UCIP Comments: Good candidate for video inspection. Erosion in levee adjacent to pipe. FIELD_STRUCT_DESC: 2 of 2: 16-inch pipe through levee 3.0 feet below crown. 14-inch steel irrigation siphon sleeved through the 16-inch pipe with annular space grouted. Air vent/filler pipe on LS shoulder with and a slide gate in a 48-inch steel standpipe on the LS toe (ABO No. 9145, 1973). Originally included in the 1954 O&M manual. FS Date: 6/13/2013

air vent/filler pipe on LS shoulder.

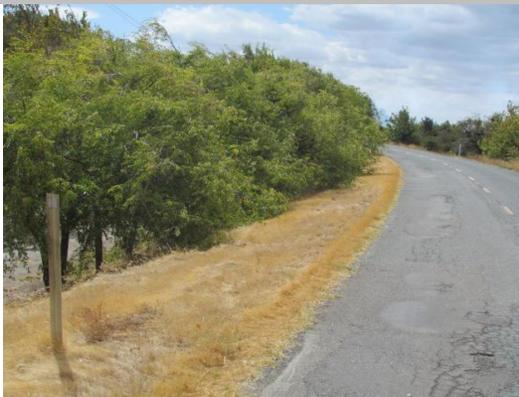
Photo 1 of 1 : SP_2016_RD0563_210_31_20160308_00032.jpg

LM Start	8.38	Rating **	U	Issue No.	31
LM End	8.41	Issue Type +	Ma	Location *	LS
Category	Earthen Levee		GPS Latitude/Longitude		
			Start	End	
Item	Trim / Thin Trees		38.155974 °	38.155543 °	
			-121.591452 °	-121.591595 °	
DWR ID	DWR_RD0563_01_s_2012_31				
Comment Code					
T1 : Trim trees to at least five feet above ground level.					
Inspector Comment

Looking southeast at untrimmed trees on landward slope and toe.

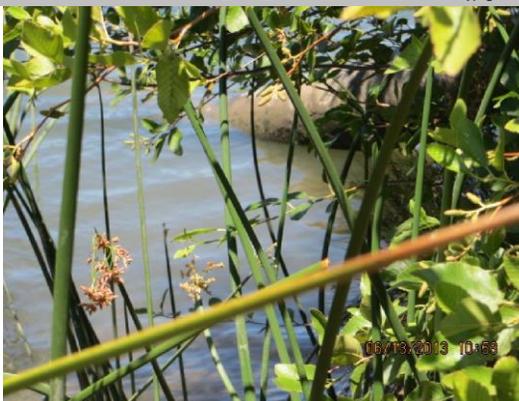
Photo 1 of 2 : UCIP_SP_2016_14990_24677.jpg

LM Start	8.47	Rating **	M	Issue No.	964
LM End	8.47	Issue Type +	En	Location *	LS
Category	Supplemental		GPS Latitude/Longitude		
			Start	End	
Item	DWR UCIP Field Study		38.154648 °	38.154648 °	
			-121.591609 °	-121.591609 °	
DWR ID					
Comment Code					
Inspector Comment					
FS_ID:14990 DS_ID:20161 EP_NO: 11217 Repair Type: Non-Urgent Crossing Status: Found UCIP Comments: Pipe appears abandoned and should be done so properly. FIELD_STRUCT_DESC: 1 of 11: 12-inch steel irrigation siphon pipe through the levee 3.6 feet below the crown. Vent/filler pipe on the landward shoulder and a slide gate in a 7'X9' concrete distribution box on LS toe (ABO No. 11217, 1971). Originally included in 1954 O&M manual. FS Date: 6/13/2013

Pipe visibel behind trees on WS toe.

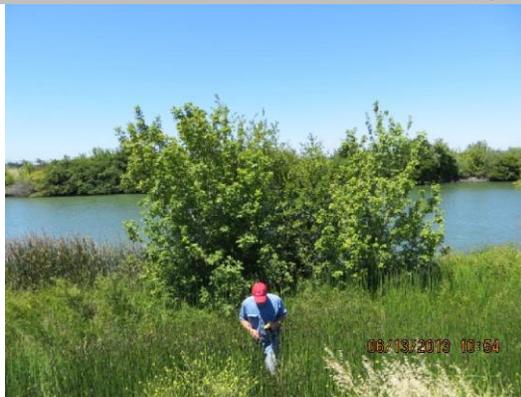
Photo 2 of 2 : UCIP_SP_2016_14990_24676.jpg

Pipe visibel behind trees on WS toe.

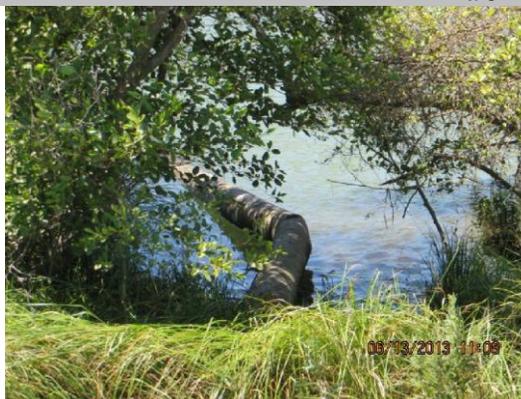
Photo 1 of 2 : UCIP_SP_2016_16292_27453.jpg

LM Start	8.88	Rating **	M	Issue No.	956
LM End	8.88	Issue Type +	En	Location *	LS
Category	Supplemental			GPS Latitude/Longitude	
				Start	End
Item	DWR UCIP Field Study			38.150420 °	38.150420 °
				-121.586840 °	-121.586840 °
DWR ID					
Comment Code					
Inspector Comment					
FS_ID:16292 DS_ID:20163 EP_NO: 11217 Repair Type: Non-Urgent Crossing Status: Found UCIP Comments: Appears abandoned and should be done so properly. Slide gate broken. FIELD_STRUCT_DESC: 3 of 11: 14-inch pipe through the levee 4.2 feet below the crown. Vent/filler pipe on landward shoulder. Slide gate in 7'X9' concrete distribution box on LS toe (ABO No.11217, 1971). Originally included in the 1954 O&M manual. FS Date: 6/13/2013

Pipe visible on WS toe. See damage to pipe at bend.

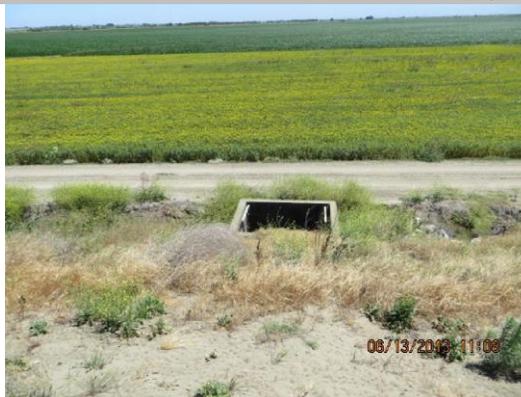
Photo 2 of 2 : UCIP_SP_2016_16292_27452.jpg

Concrete distribution box at LS toe.

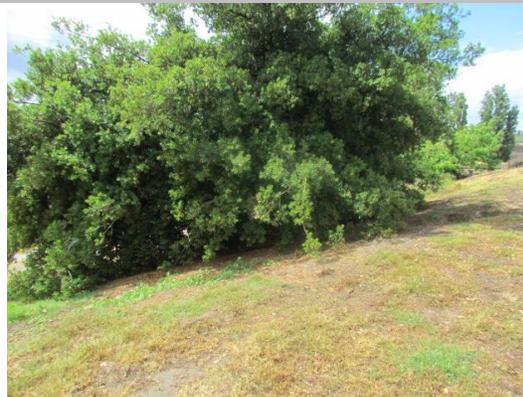
Photo 1 of 1 : SP_2016_RD0563_210_98_20160308_00108.jpg

LM Start	9.28	Rating **	U	Issue No.	98
LM End	9.28	Issue Type +	Ma	Location *	LS
Category	Earthen Levee		GPS Latitude/Longitude		
			Start	End	
Item	Trim / Thin Trees		38.145825 °	38.145825 °	
			-121.588807 °	-121.588807 °	
DWR ID	DWR_RD0563_01_s_2013_98				
Comment Code					
T1 : Trim trees to at least five feet above ground level.					
Inspector Comment

Looking southeast at untrimmed trees on landward slope.

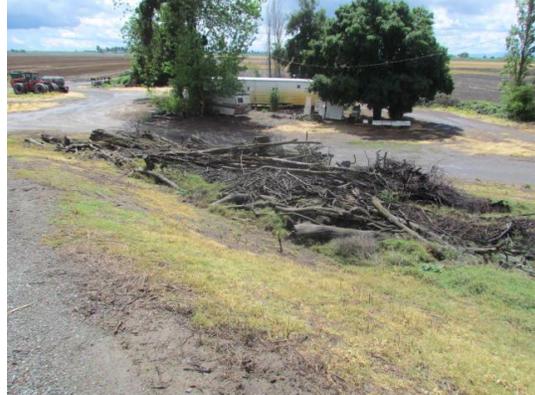
Photo 1 of 2 : SP_2016_RD0563_210_73_20160308_00065.jpg

LM Start	9.33	Rating **	U	Issue No.	73
LM End	9.33	Issue Type +	Ma	Location *	LS
Category	Earthen Levee		GPS Latitude/Longitude		
			Start	End	
Item	Encroachments		38.145957 °	38.145957 °	
			-121.589653 °	-121.589653 °	
DWR ID	DWR_RD0563_01_s_2012_73				
Comment Code					
PR : Prunings					
Inspector Comment					
Large pruning pile on landward toe.

Looking east at prunings at landward toe. (Spring 2015)

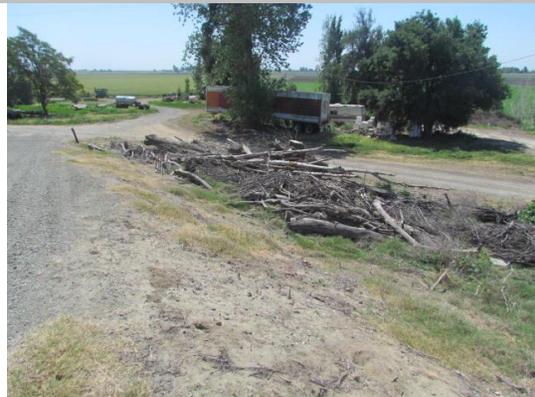
Photo 2 of 2 : SP_2016_RD0563_210_73_20160308_00066.jpg

Looking east at prunings on landward slope. (Spring 2013)

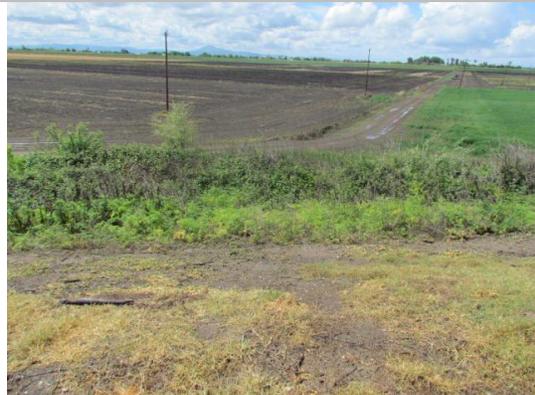
Photo 1 of 1 : SP_2016_RD0563_210_769_20160308_00143.jpg

LM Start	9.36	Rating **	U	Issue No.	769
LM End	9.43	Issue Type +	Ma	Location *	LS
Category	Earthen Levee		GPS Latitude/Longitude		
			Start	End	
Item	Vegetation		38.146276 °	38.147034 °	
			-121.590189 °	-121.590907 °	
DWR ID	DWR_RD0563_01_s_2015_769				
Comment Code					
V2 : Remove the wild growth other than native grasses from the levee slopes.					
Inspector Comment

Looking east at dense vegetation at landward toe. (Spring 2015)
