**Flood Control Project Maintenance
Levee Inspections**
LMA District Cover Sheet
Spring 2016 Levee Inspection Results

Reclamation District No. 0563 Tyler Island

Spring 2016 Levee Inspection Results

Waterway	Bank	Unit Miles
Unit No. 01 Georgiana Slough (Tyler Island)	Left	12.11

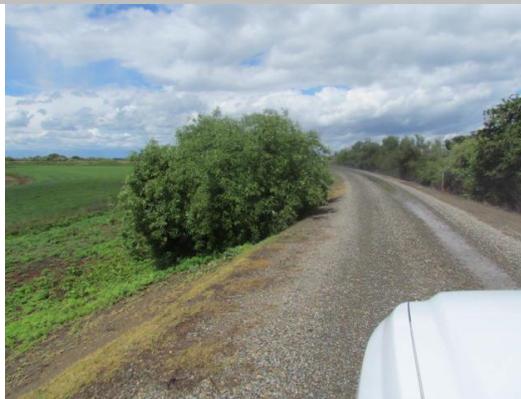
Photo 1 of 1 : SP_2016_RD0563_210_36_20160308_00036.jpg

LM Start	9.64	Rating **	U	Issue No.	36
LM End	9.64	Issue Type +	Ma	Location *	LS
Category	Earthen Levee			GPS Latitude/Longitude	
				Start	End
Item	Vegetation			38.149790 °	38.149790 °
				-121.592788 °	-121.592788 °
DWR ID	DWR_RD0563_01_s_2012_36				
Comment Code					
V4 : Elderberries are blocking visibility and flood fight capability.					
Inspector Comment					
Vegetation blocking view of levee slope.

Looking south at elderberry on landward slope.

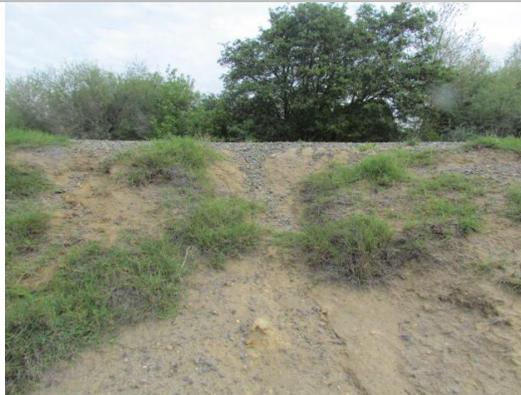
Photo 1 of 2 : SP_2016_RD0563_210_99_20160308_00109.jpg

LM Start	9.65	Rating **	M	Issue No.	99
LM End	9.65	Issue Type +	Ma	Location *	LS
Category	Earthen Levee		GPS Latitude/Longitude		
			Start	End	
Item	Erosion / Bank Caving		38.149905 °	38.149905 °	
			-121.592910 °	-121.592910 °	
DWR ID	DWR_RD0563_01_s_2013_99				
Comment Code					
E1 : Note and monitor erosion site.					
Inspector Comment					
Finger erosion on landward shoulder and slope.

Looking west at minor erosion on landward shoulder and slope.

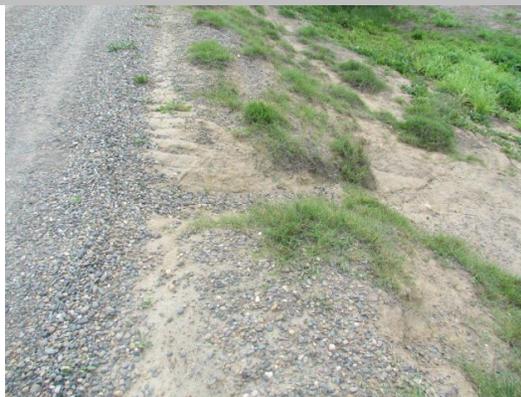
Photo 2 of 2 : SP_2016_RD0563_210_99_20160308_00110.jpg

Looking north at minor erosion on landward shoulder and slope.

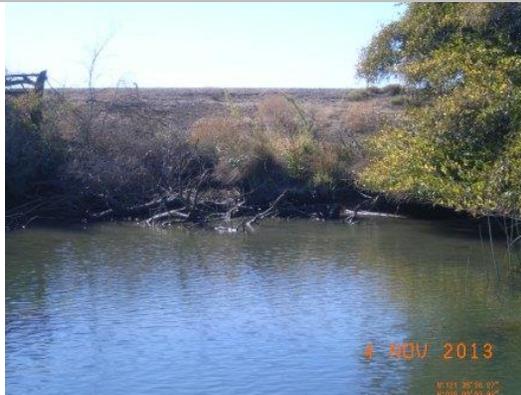
Photo 1 of 1 : SP_2016_RD0563_210_41_20160308_00040.jpg

LM Start	9.73	Rating **	M	Issue No.	41
LM End	9.90	Issue Type +	Ma	Location *	WS
Category	Supplemental		GPS Latitude/Longitude		
			Start	End	
Item	2015 USACE Erosion Survey, DRAFT		38.150820 °	38.150647 °	
			-121.593650 °	-121.596858 °	
DWR ID	DWR_RD0563_01_s_2016_41				
Comment Code					
Inspector Comment					
1997 - Erosion pockets into the toe of the levee. 2001 - Staked low fascine walls at the bankline. 2004 - Numerous "Brush Boxes." 2005 - Some new bundles in the brush boxes. 2012 - Site extended downstream to account for new bank sloughing. 2013 - Some rock added to the upstream end by the local RD. 2015: Last observed in 2013. [2015 Site ID: GEO_2-5_L]

USACE 2013 Photo #1

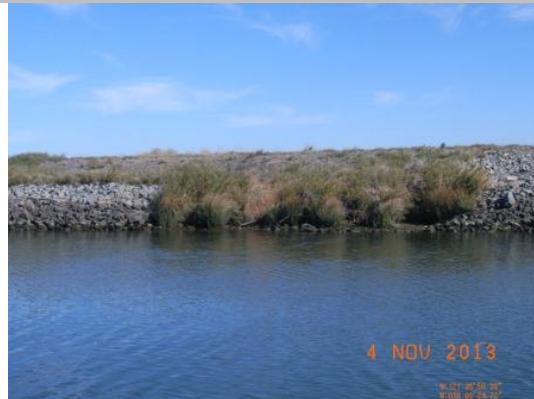
Photo 1 of 1 : SP_2016_RD0563_210_43_20160308_00042.jpg

LM Start	10.45	Rating **	M	Issue No.	43
LM End	10.74	Issue Type +	Ma	Location *	WS
Category	Supplemental		GPS Latitude/Longitude		
			Start	End	
Item	2015 USACE Erosion Survey, DRAFT		38.143519 °	38.139918 °	
			-121.599677 °	-121.596986 °	
DWR ID	DWR_RD0563_01_s_2016_43				
Comment Code					
Inspector Comment					
1997 - Old damaged rock riprap along the toe. 1999 - Downstream end (400 ft) repaired with rock. 2002 - New rock/concrete rubble section on the downstream end. 2004 - Small pocket repairs at the downstream end. 2005 - Some new bundles in the brush boxes. 2012 - Some rock has been placed in last year. 2015: Last observed in 2013. [2015 Site ID: GEO_1-7_L]

USACE 2013 Photo #1

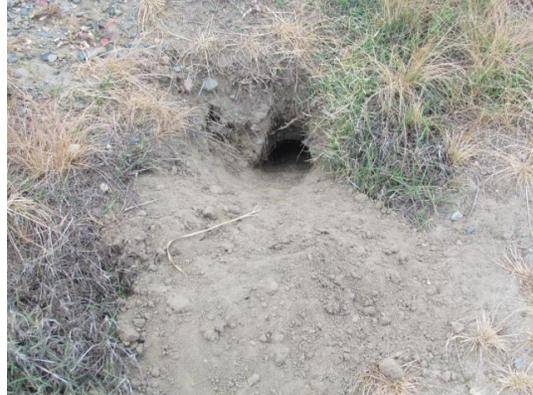
Photo 1 of 4 : SP_2016_RD0563_210_77_20160330_00253.jpg

LM Start	10.59	Rating **	U	Issue No.	77
LM End	10.64	Issue Type +	Ma	Location *	LS
Category	Earthen Levee			GPS Latitude/Longitude	
				Start	End
Item	Animal Control			38.141957 °	38.141362 °
				-121.598058 °	-121.597598 °
DWR ID	DWR_RD0563_01_s_2012_77				
Comment Code					
A1 : Exterminate rodents and backfill and compact or grout burrows.					
Inspector Comment					
Several rodent holes and rodents noted at this site.

Looking at typical rodent hole on landward slope. (Spring 2016)

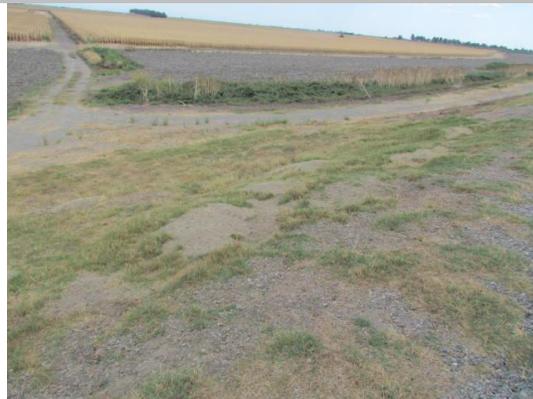
Photo 2 of 4 : SP_2016_RD0563_210_77_20160308_00074.jpg

Looking southeast at several rodent holes on landward slope.

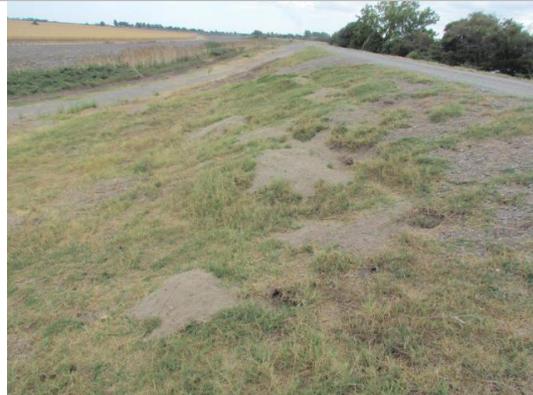
Photo 3 of 4 : SP_2016_RD0563_210_77_20160308_00075.jpg

Looking south at several rodent holes on landward slope.

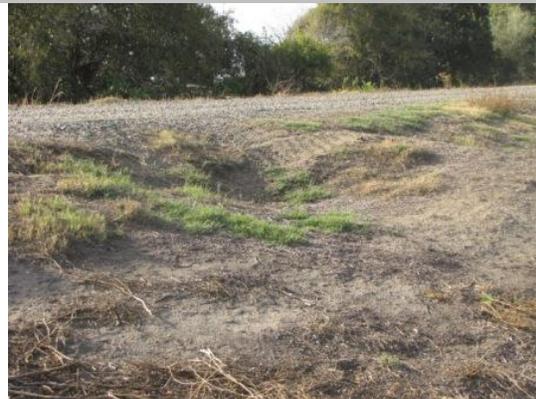
Photo 4 of 4 : SP_2016_RD0563_210_76_20160308_00073.jpg

LM Start	10.59	Rating **	M	Issue No.	76
LM End	10.59	Issue Type +	Ma	Location *	LS
Category	Earthen Levee		GPS Latitude/Longitude		
			Start	End	
Item	Slope Stability		38.141940 °	38.141940 °	
			-121.598033 °	-121.598033 °	
DWR ID	DWR_RD0563_01_s_2012_76				
Comment Code					
S1 : Repair slope instability.					
Inspector Comment					
Deep depression on landside shoulder and slope; possible pipe collapse.

Looking west at depression on landside shoulder and slope.

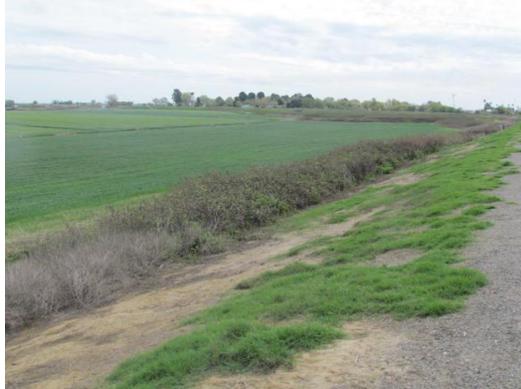
Photo 2 of 3 : SP_2016_RD0563_210_100_20160308_00112.jpg

LM Start	10.67	Rating **	U	Issue No.	100
LM End	10.81	Issue Type +	Ma	Location *	LS
Category	Earthen Levee			GPS Latitude/Longitude	
				Start	End
Item	Vegetation			38.140886 °	38.139079 °
				-121.597280 °	-121.596214 °
DWR ID	DWR_RD0563_01_s_2013_100				
Comment Code					
V2 : Remove the wild growth other than native grasses from the levee slopes.					
Inspector Comment					
Wild rose or grape vines on landward slope and toe.

Looking south at dense vegetation at landward toe. (Fall 2014)

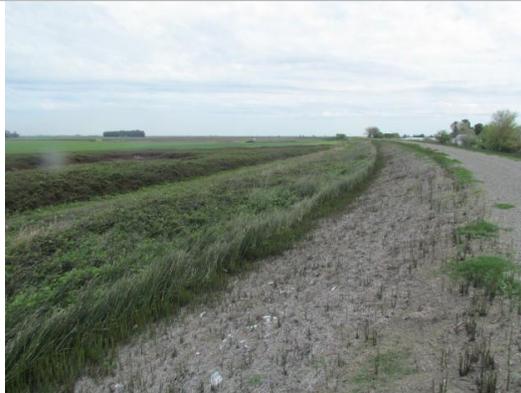
Photo 3 of 3 : SP_2016_RD0563_210_100_20160308_00113.jpg

Looking south at additional dense vegetation at landward toe.

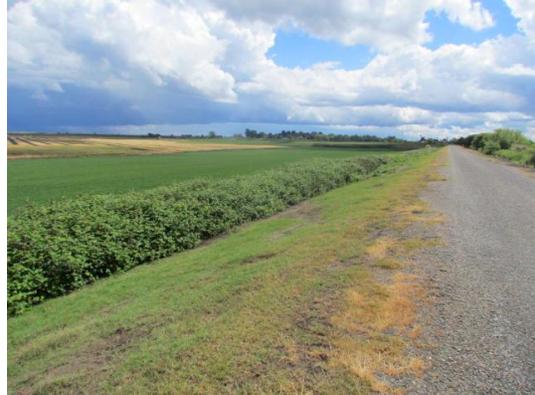
Photo 1 of 1 : SP_2016_RD0563_210_770_20160308_00144.jpg

LM Start	11.01	Rating **	U	Issue No.	770
LM End	12.00	Issue Type +	Ma	Location *	LS
Category	Earthen Levee		GPS Latitude/Longitude		
			Start	End	
Item	Vegetation		38.136623 °	38.130739 °	
			-121.594216 °	-121.579678 °	
DWR ID	DWR_RD0563_01_s_2015_770				
Comment Code					
V2 : Remove the wild growth other than native grasses from the levee slopes.					
Inspector Comment

Looking southeast at dense vegetation at landward toe. (Spring 2015)

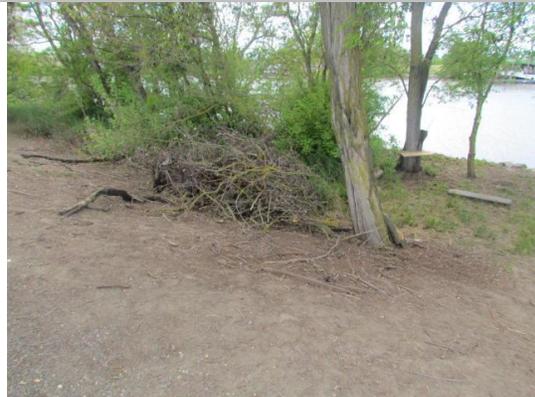
Photo 1 of 1 : SP_2016_RD0563_210_167_20160330_00254.jpg

LM Start	11.24	Rating **	M	Issue No.	167
LM End	11.24	Issue Type +	Ma	Location *	WS
Category	Earthen Levee		GPS Latitude/Longitude		
			Start	End	
Item	Encroachments		38.134224 °	38.134224 °	
			-121.591406 °	-121.591406 °	
DWR ID	DWR_RD0563_01_s_2016_167				
Comment Code					
PR : Prunings					
Inspector Comment					
Prunings on waterward slope.

Looking west at prunings on waterward slope.

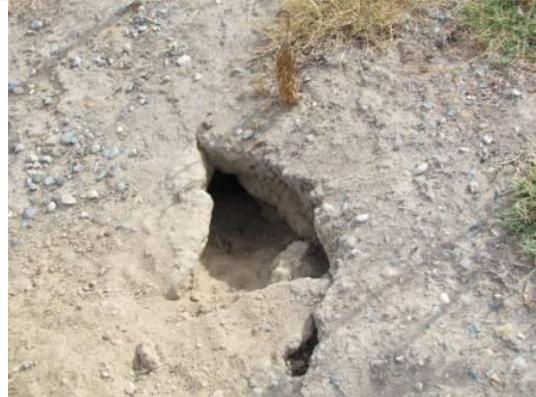
Photo 1 of 3 : SP_2016_RD0563_210_91_20160308_00100.jpg

LM Start	11.45	Rating **	M	Issue No.	91
LM End	11.45	Issue Type +	Ma	Location *	LS
Category	Earthen Levee		GPS Latitude/Longitude		
			Start	End	
Item	Animal Control		38.131943 °	38.131943 °	
			-121.588912 °	-121.588912 °	
DWR ID	DWR_RD0563_01_s_2012_91				
Comment Code					
A3 : No rodents visible, but rodent burrows visible; need to backfill and compact or grout burrows.					
Inspector Comment

Looking east at rodent hole on landside slope.

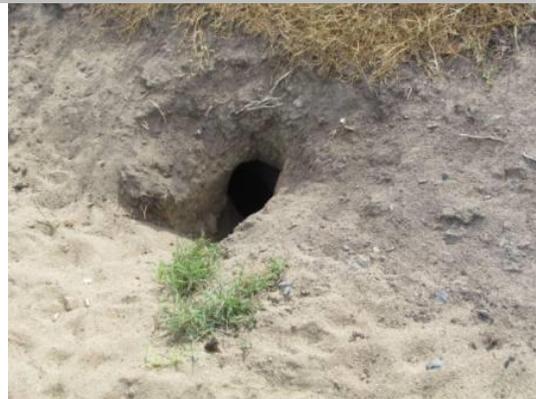
Photo 2 of 3 : SP_2016_RD0563_210_91_20160308_00101.jpg

Looking west at rodent hole on landside slope.

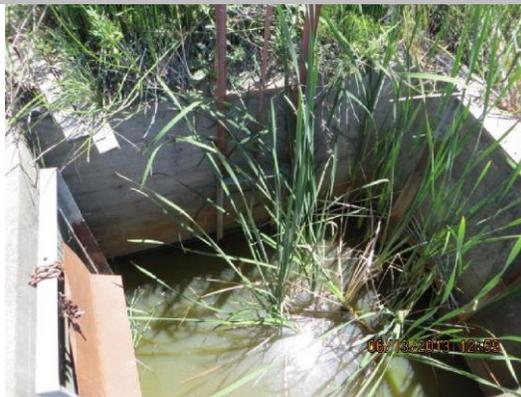
Photo 2 of 2 : UCIP_SP_2016_15004_24704.jpg

LM Start	11.76	Rating **	M	Issue No.	984 (cont)
LM End	11.76	Issue Type +	En	Location *	WS
Category	Supplemental			GPS Latitude/Longitude	
				Start	End
Item	DWR UCIP Field Study			38.130291 °	38.130291 °
				-121.583981 °	-121.583981 °
DWR ID					
Comment Code					
Inspector Comment					
FS_ID:15004 DS_ID:20174 EP_NO: 11217 Repair Type: Non-Urgent Crossing Status: Found UCIP Comments: Pipe appears abandoned and should be done so properly. FIELD_STRUCT_DESC: 11 of 11: 12-inch steel irrigation siphon pipe through the levee 4.5 feet below the crown. Air vent on landward shoulder and slide gate in 7'X9' concrete distribution box at LS toe (ABO No. 11217, 1971). Originally included in the 1954 O&M manual. FS Date: 6/13/2013

Distribution box and slide gate visible on LS toe.

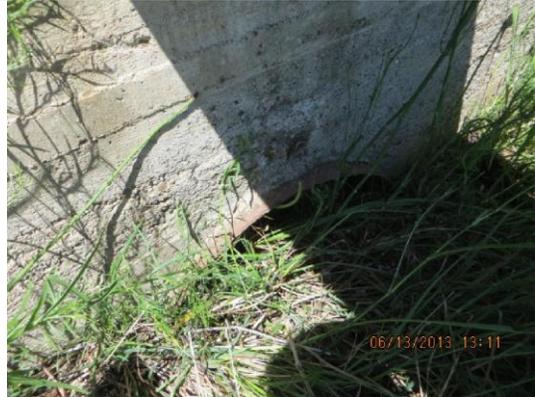
Photo 1 of 2 : UCIP_SP_2016_15028_24736.jpg

LM Start	12.00	Rating **	M	Issue No.	957
LM End	12.00	Issue Type +	En	Location *	LS
Category	Supplemental			GPS Latitude/Longitude	
				Start	End
Item	DWR UCIP Field Study			38.130730 °	38.130730 °
				-121.579616 °	-121.579616 °
DWR ID					
Comment Code					
Inspector Comment					
FS_ID:15028 DS_ID:20182 EP_NO: N/A Repair Type: Non-Urgent Crossing Status: Found UCIP Comments: Verify pipe is properly abandoned. FIELD_STRUCT_DESC: 1 of 2: 36-inch pipe through the levee 4-feet below the crown. Shut-off valve at pump. Pipe visible on WS at headwall. Originally included in the 1954 O&M manual. Replaced by a 30-inch pipe under Permit No. 2635. FS Date: 6/13/2013

Pipe at concrete headwall on WS slope.

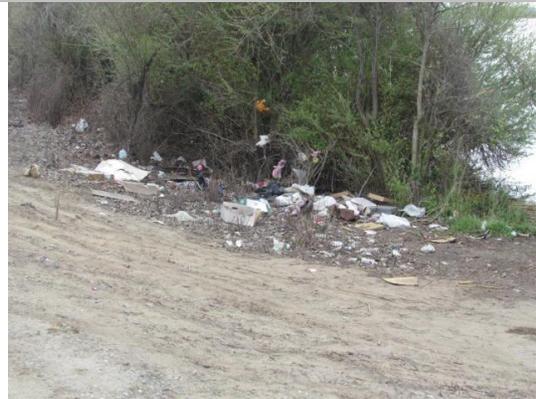
Photo 1 of 1 : SP_2016_RD0563_210_107_20160308_00117.jpg

LM Start	12.03	Rating **	A/W	Issue No.	107
LM End	12.03	Issue Type +	Ma	Location *	WS
Category	Earthen Levee			GPS Latitude/Longitude	
				Start	End
Item	Encroachments			38.130776 °	38.130776 °
				-121.579063 °	-121.579063 °
DWR ID	DWR_RD0563_01_f_2013_107				
Comment Code					
GA : Garbage					
Inspector Comment

Looking southwest at garbage at waterward slope and toe.
