**Flood Control Project Maintenance
Levee Inspections**

Maintenance Issue Types Only, Levee Inspection Report By Mile - Fall 2015

Reclamation District No. 0563 Tyler Island

Waterway	Bank	Unit Miles	Inspection Start/End	Inspector
Unit No. 01 Georgiana Slough (Tyler Island)	Left	12.11	09/16/2015 09/16/2015	Richard Willoughby

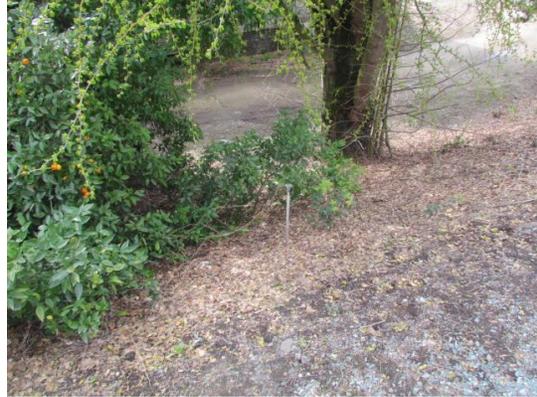
Photo 1 of 2 : FA_2015_RD0563_210_28_20150914_00031.jpg

Looking east at sprinklers on landside slope.

LM Start	0.12	Rating **	A/W	Issue No.	28
LM End	0.14	Issue Type +	Ma	Location *	LS
Category	Earthen Levee		GPS Latitude/Longitude		
			Start	End	
Item	Trim / Thin Trees		38.233910 °	38.233655 °	
			-121.518722 °	-121.519000 °	
DWR ID	DWR_RD0563_01_s_2012_28				
Action/Comments					
Trim trees to at least five feet above ground level.

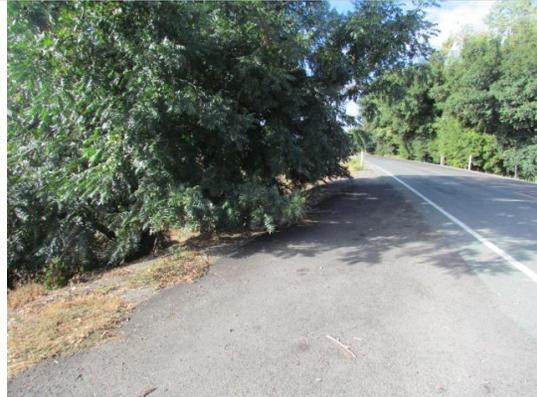
Photo 1 of 1 : FA_2015_RD0563_210_18_20150917_00179.jpg

Looking at untrimmed tree on landward slope.

LM Start	0.20	Rating **	M	Issue No.	18
LM End	0.20	Issue Type +	Ma	Location *	LS
Category	Earthen Levee		GPS Latitude/Longitude		
			Start	End	
Item	Trim / Thin Trees		38.232967 °	38.232967 °	
			-121.519727 °	-121.519727 °	
DWR ID	DWR_RD0563_01_f_2014_18				
Action/Comments					
Trim trees to at least five feet above ground level.

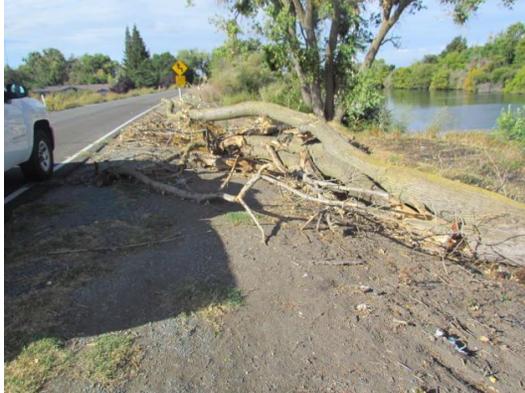
Photo 2 of 5 : FA_2015_RD0563_210_139_20150917_00184.jpg

LM Start	0.60	Rating **	U	Issue No.	139 (cont)
LM End	0.60	Issue Type +	Ma	Location *	WS
Category	Earthen Levee			GPS Latitude/Longitude	
				Start	End
Item	Encroachments			38.228605 °	38.228605 °
				-121.524364 °	-121.524364 °
DWR ID	DWR_RD0563_01_f_2015_139				
Action/Comments					
Tree or limb Inspector Comments: Large fallen tree on waterward slope. Fallen tree left large hole on waterward berm.

Looking south at fallen tree on waterward slope.

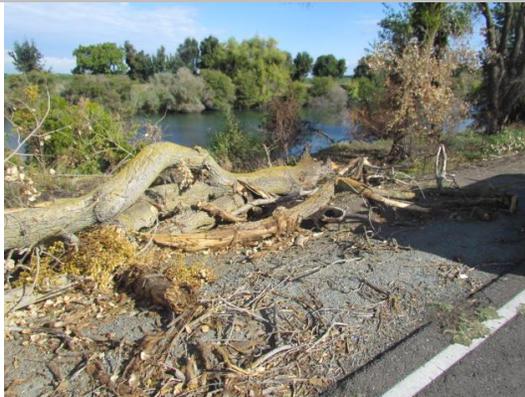
Photo 3 of 5 : FA_2015_RD0563_210_139_20150917_00183.jpg

Looking northwest at fallen tree on waterward slope.

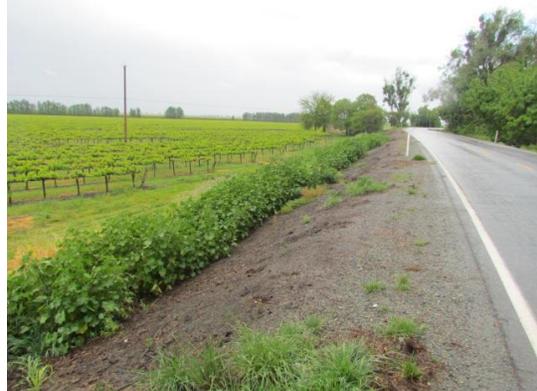
Photo 1 of 1 : FA_2015_RD0563_210_754_20150914_00142.jpg

Looking southeast at dense vegetation at landward toe.

LM Start	0.72	Rating **	A/W	Issue No.	754
LM End	0.79	Issue Type +	Ma	Location *	LS
Category	Earthen Levee		GPS Latitude/Longitude		
			Start	End	
Item	Vegetation		38.227287 °	38.226376 °	
			-121.525832 °	-121.525908 °	
DWR ID	DWR_RD0563_01_s_2015_754				
Action/Comments					
Remove the wild growth other than native grasses from the levee slopes.

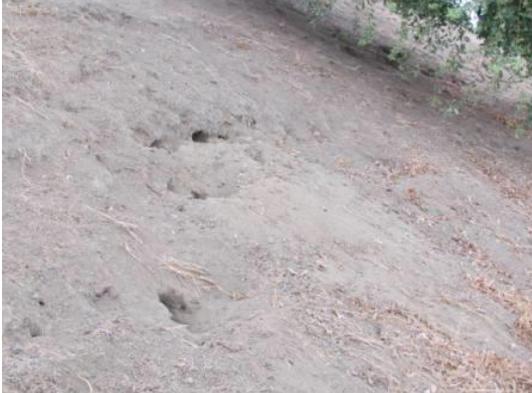
Photo 4 of 4 : FA_2015_RD0563_210_85_20150914_00105.jpg

Looking northeast at rodent holes on landside slope.

LM Start	2.53	Rating **	M	Issue No.	85 (cont)
LM End	2.55	Issue Type +	Ma	Location *	LS
Category	Earthen Levee			GPS Latitude/Longitude	
				Start	End
Item	Animal Control			38.215082 °	38.214852 °
				-121.538652 °	-121.538305 °
DWR ID	DWR_RD0563_01_s_2012_85				
Action/Comments					
No rodents visible, but rodent burrows visible; need to backfill and compact or grout burrows.

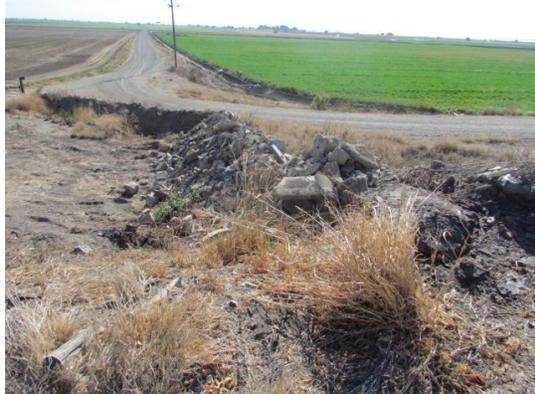
Photo 2 of 2 : FA_2015_RD0563_210_104_20150914_00130.jpg

Looking east at concrete rubble on landward slope.

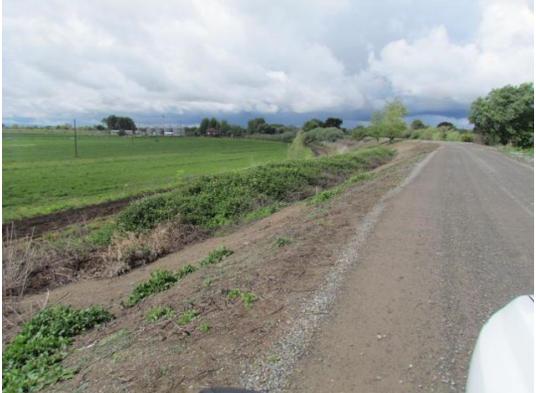
Photo 1 of 3 : FA_2015_RD0563_210_74_20150914_00084.jpg

LM Start	3.02	Rating **	U	Issue No.	74
LM End	3.21	Issue Type +	Ma	Location *	LS
Category	Earthen Levee		GPS Latitude/Longitude		
			Start	End	
Item	Vegetation		38.210212 °	38.209165 °	
			-121.536728 °	-121.539920 °	
DWR ID	DWR_RD0563_01_s_2012_74				
Action/Comments					
Remove the wild growth other than native grasses from the levee slopes. Inspector Comments: Dead berryvines at landside toe blocking view of toe.

Looking southeast at dense berryvines at landward toe. (Spring 2015)

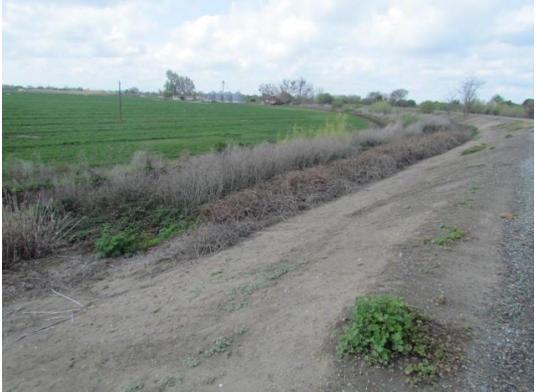
Photo 2 of 3 : FA_2015_RD0563_210_74_20150914_00085.jpg

Looking southeast at dead berryvine on landside toe. (Fall 2014)

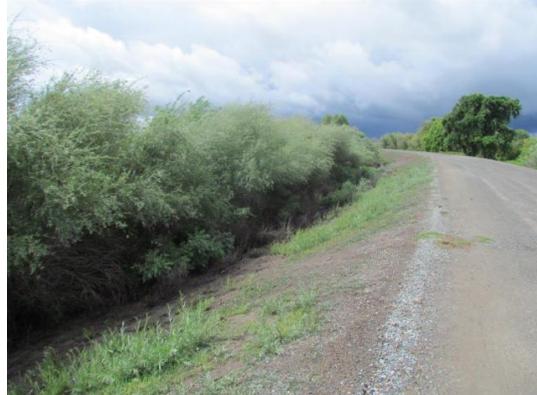
Photo 1 of 1 : FA_2015_RD0563_210_763_20150914_00143.jpg

Looking south at dense vegetation at landward slope and toe. (Spring 2015)

LM Start	3.11	Rating **	U	Issue No.	763
LM End	3.21	Issue Type +	Ma	Location *	LS
Category	Earthen Levee		GPS Latitude/Longitude		
			Start	End	
Item	Trim / Thin Trees		38.210005 °	38.209229 °	
			-121.538452 °	-121.539855 °	
DWR ID	DWR_RD0563_01_s_2015_763				
Action/Comments					
Thin trees to allow visibility of the ground and room to flood fight.

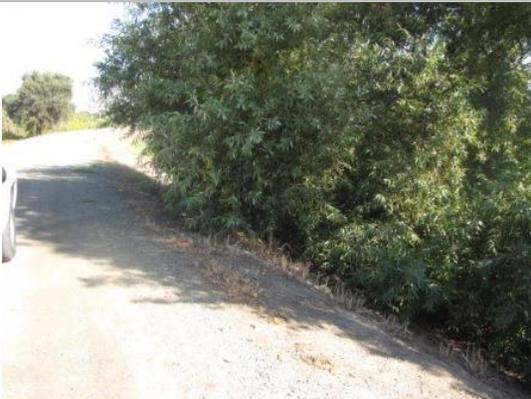
Photo 2 of 2 : FA_2015_RD0563_210_68_20150914_00078.jpg

Looking southeast at dense trees on landside slope and toe.

LM Start	3.21	Rating **	U	Issue No.	68 (cont)
LM End	3.21	Issue Type +	Ma	Location *	LS
Category	Earthen Levee		GPS Latitude/Longitude		
			Start	End	
Item	Trim / Thin Trees		38.209217 °	38.209217 °	
			-121.539823 °	-121.539823 °	
DWR ID	DWR_RD0563_01_s_2012_68				
Action/Comments					
Thin trees to allow visibility of the ground and room to flood fight.

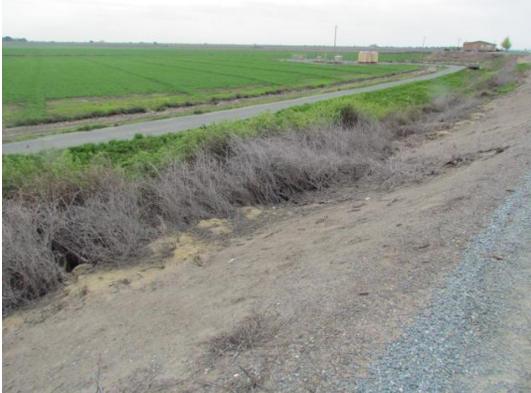
Photo 1 of 2 : FA_2015_RD0563_210_84_20150914_00100.jpg

LM Start	3.50	Rating **	A/W	Issue No.	84
LM End	3.50	Issue Type +	Ma	Location *	LS
Category	Earthen Levee			GPS Latitude/Longitude	
				Start	End
Item	Vegetation			38.205130 °	38.205130 °
				-121.540397 °	-121.540397 °
DWR ID	DWR_RD0563_01_f_2012_84				
Action/Comments					
Remove the wild growth other than native grasses from the levee slopes. Inspector Comments: Vegetation at landward toe.

Looking southeast at dead berryvines on landward toe.

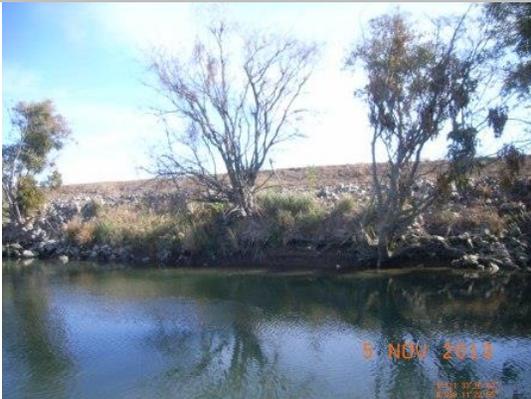
Photo 1 of 1 : USACE2013A_GEO_8-3_L_6.jpg

LM Start	3.91	Rating **	M	Issue No.	38
LM End	4.01	Issue Type +	Ma	Location *	WS
Category	Supplemental			GPS Latitude/Longitude	
				Start	End
Item	2015 USACE Erosion Survey, DRAFT			38.200733 °	38.199925 °
				-121.542571 °	-121.544249 °
DWR ID					
Action/Comments					
Inspector Comments: 1997 - Narrow eroding berm upstream of existing rock. 2001 - Staked, low fascine walls at bankline. 2011 - Minor new erosion. Site extended downstream. 2012 - Rock repair failing in one erosion pocket. 2015: Last observed in 2013. [2015 Site ID: GEO_8-3_L]

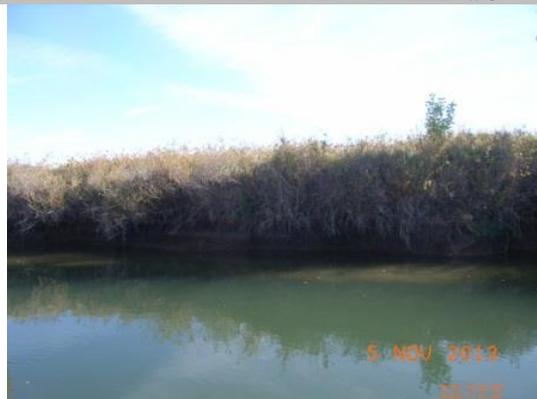
Photo 1 of 1 : USACE2013A_GEO_7-2_L_6.jpg

LM Start	4.98	Rating **	M	Issue No.	45
LM End	5.04	Issue Type +	Ma	Location *	WS
Category	Supplemental		GPS Latitude/Longitude		
			Start	End	
Item	2015 USACE Erosion Survey, DRAFT		38.190073 °	38.189524 °	
			-121.556307 °	-121.557227 °	
DWR ID					
Action/Comments					
Inspector Comments: 2009 - Small scallops of erosion into the levee toe behind brush boxes. 2011 - Minor new erosion. 2012 - Site extended upstream to account for addition erosion pockets. 2015: Last observed in 2013. [2015 Site ID: GEO_7-2_L]

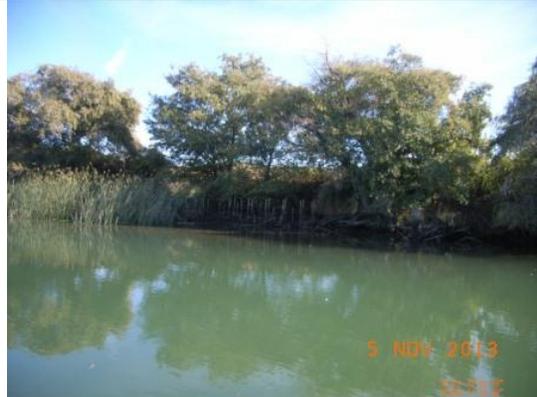
Photo 1 of 1 : USACE2013A_GEO_6-8_L_8.jpg

LM Start	5.15	Rating **	U	Issue No.	46
LM End	5.39	Issue Type +	Ma	Location *	WS
Category	Supplemental			GPS Latitude/Longitude	
				Start	End
Item	2015 USACE Erosion Survey, DRAFT			38.188216 °	38.185968 °
				-121.558442 °	-121.561667 °
DWR ID					
Action/Comments					
Inspector Comments: 1997 - Deep pockets of erosion into a narrow berm just downstream of the rock. 2000 - Scallops in banks with small colored flags, some new biotech rolls in with older rolls in the scallops. 2001 - Staked , low fascine walls at the bankline. 2011 - Site upgraded to CRITICAL. Site extended upstream due to new erosion pocket. New tree popouts and new erosion. 2013 - Pipe observed at upstream end of site. 2015: Last observed in 2013. [2015 Site ID: GEO_6-8_L]

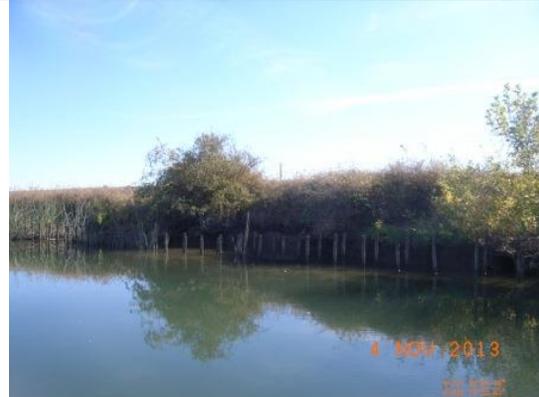
Photo 1 of 1 : USACE2013A_GEO_6-3_L_13.jpg

LM Start	5.49	Rating **	M	Issue No.	55
LM End	6.27	Issue Type +	Ma	Location *	WS
Category	Supplemental			GPS Latitude/Longitude	
				Start	End
Item	2015 USACE Erosion Survey, DRAFT			38.185479 °	38.181359 °
				-121.563296 °	-121.576292 °
DWR ID					
Action/Comments					
Inspector Comments: 1997 - Deep pockets of erosion and narrow berm. Reach is characterized by lots of pockets into the existing berm and/or levee slope. 1999 - Some pockets filled with rock riprap. 2000 - Exposed fabric. 2001 - Staked, low fascine walls at bankline. 2002 - New spot of rock at upstream end. Some new brush boxes. 2005 - Some stone sliding off the underlying geotextile fabric. Some new brush bundles in the brush boxes; some with missing bundles. Some boxes too low relative to high tide. 2009 - Minimal new erosion, site length extended. 2010 - New erosion on downstream end, site extended downstream. 2011 - Sites 6.1, 6.4 and 6.6 were combined. New erosion pockets, site extended to include the erosion in between the old sites. 2012 - Rock has been placed in portions of the bank since last year. 2015: Last observed in 2013. [2015 Site ID: GEO_6-3_L]

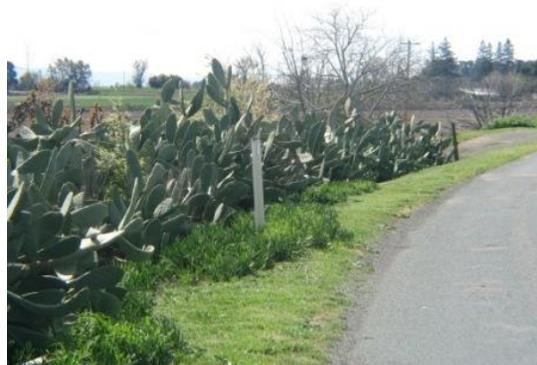
Photo 2 of 2 : FA_2015_RD0563_210_22_20150914_00026.jpg

LM Start	5.92	Rating **	U	Issue No.	22 (cont)
LM End	5.96	Issue Type +	Ma	Location *	LS
Category	Earthen Levee		GPS Latitude/Longitude		
			Start	End	
Item	Vegetation		38.181965 °	38.181763 °	
			-121.569913 °	-121.570447 °	
DWR ID	DWR_RD0563_01_s_2012_22				
Action/Comments					
Remove the wild growth other than native grasses from the levee slopes. Inspector Comments: Large cactus on landward slope.

Large cactus plant on landward slope from LM 6.04 to 6.08

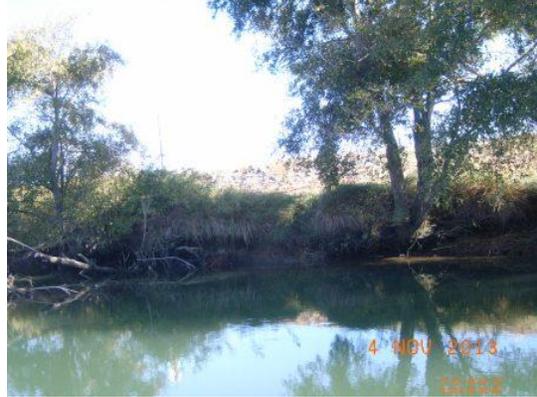
Photo 1 of 1 : USACE2013A_GEO_4-5_L_11.jpg

LM Start	7.53	Rating **	U	Issue No.	53
LM End	7.80	Issue Type +	Ma	Location *	WS
Category	Supplemental			GPS Latitude/Longitude	
				Start	End
Item	2015 USACE Erosion Survey, DRAFT			38.164462 °	38.160888 °
				-121.583092 °	-121.584807 °
DWR ID					
Action/Comments					
Inspector Comments: 1997 - Pocket erosion at upstream end and into the levee toe under the Alder trees. 2003 - New brush boxes with wattles on bank. 2004 - No brush boxes. 2005 - Site extended from the downstream side of the bridge. Whole bank is vertical. 2010 - Some minor new erosion. 2011 - Site upgraded to CRITICAL. New erosion pockets throughout the site. Sites 4.5, and 4.6 were combined. 2015: Last observed in 2013. [2015 Site ID: GEO_4-5_L]

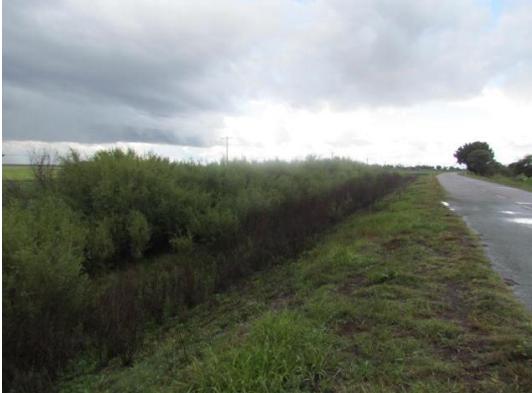
Photo 1 of 5 : FA_2015_RD0563_210_90_20150914_00110.jpg

LM Start	7.80	Rating **	U	Issue No.	90
LM End	7.82	Issue Type +	Ma	Location *	LS
Category	Earthen Levee			GPS Latitude/Longitude	
				Start	End
Item	Vegetation			38.160800 °	38.160487 °
				-121.584598 °	-121.584717 °
DWR ID	DWR_RD0563_01_s_2012_90				
Action/Comments					
Remove the wild growth other than native grasses from the levee slopes. Inspector Comments: Berryvines and willows on landside toe.

Looking southeast at dense vegetation at landward toe. (Spring 2015)

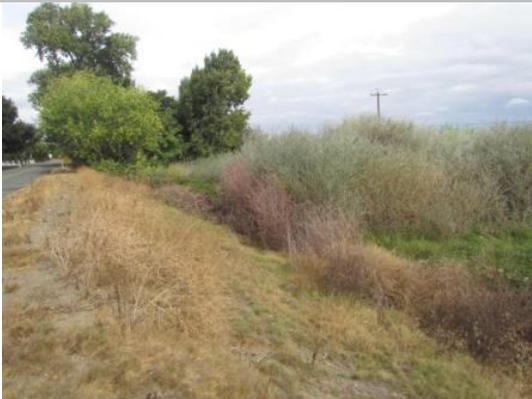
Photo 2 of 5 : FA_2015_RD0563_210_90_20150914_00111.jpg

Looking northeast at dense vegetation on landside toe.

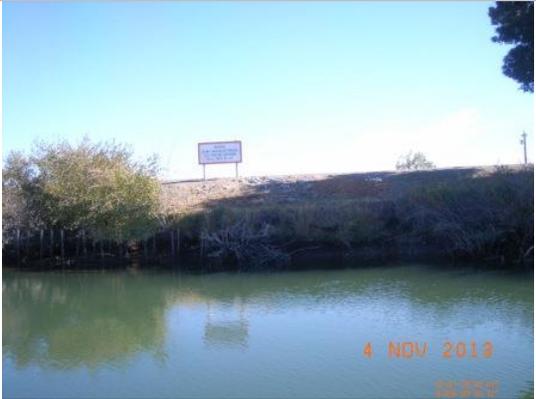
Photo 1 of 1 : USACE2013A_GEO_4-3_L_10.jpg

LM Start	7.85	Rating **	M	Issue No.	13
LM End	8.05	Issue Type +	Ma	Location *	WS
Category	Supplemental			GPS Latitude/Longitude	
				Start	End
Item	2015 USACE Erosion Survey, DRAFT			38.160261 °	38.157625 °
				-121.585056 °	-121.586543 °
DWR ID					
Action/Comments					
Inspector Comments: 1997 - Pockets of erosion into the levee toe. 1999 - Minor rock riprap and willow bundles place in a couple of spots. 2001 - Staked, low fascine walls at bankline. 2003 - Small unprotected pockets still eroding. 2004 - Numerous brush boxes, some falling apart, some with new bundles. 2005 - Some new brush boxes installed; some boxes are empty. Levee slope and banks still look bad

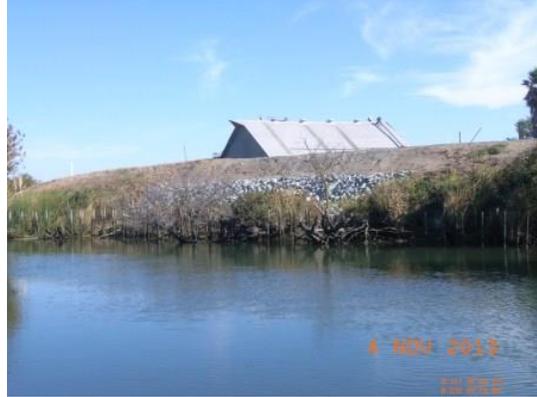
Photo 1 of 1 : USACE2013A_GEO_3-8_L_16.jpg

LM Start	8.12	Rating **	M	Issue No.	40
LM End	8.59	Issue Type +	Ma	Location *	WS
Category	Supplemental			GPS Latitude/Longitude	
				Start	End
Item	2015 USACE Erosion Survey, DRAFT			38.156987 °	38.152919 °
				-121.587427 °	-121.591129 °
DWR ID					
Action/Comments					
Inspector Comments: 1997 - Pockets of erosion into the levee at the water line. Alders are being undercut and rotating out into the channel. Damaged rock at upstream end. 2000 - New minor erosion. 2001 - Staked low fascine walls at bankline. 2002 - New "Brush Boxes" along the bank toe. 2003 - New erosion pockets in the middle of the site. 2005 - Some new bundles in the brush boxes. 2011 - Site upgraded to CRITICAL. Significant new erosion. Sites 3.6, 3.7, 3.71, and 4.0 were combined. 2012 - Rock has been placed in some of the erosion pockets since last year, however site remains critical. 2013 - Site no longer critical. The worst pockets were filled with rock by the local RD. 2015: Last observed in 2013. [2015 Site ID: GEO_3-8_L]

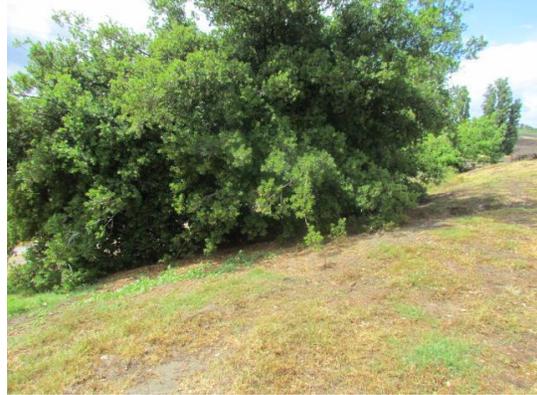
Photo 1 of 1 : FA_2015_RD0563_210_98_20150914_00122.jpg

Looking southeast at untrimmed trees on landward slope.

LM Start	9.28	Rating **	U	Issue No.	98
LM End	9.28	Issue Type +	Ma	Location *	LS
Category	Earthen Levee		GPS Latitude/Longitude		
			Start	End	
Item	Trim / Thin Trees		38.145825 °	38.145825 °	
			-121.588807 °	-121.588807 °	
DWR ID	DWR_RD0563_01_s_2013_98				
Action/Comments					
Trim trees to at least five feet above ground level.

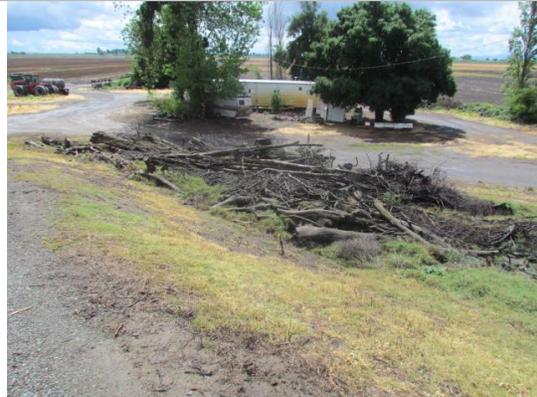
Photo 1 of 2 : FA_2015_RD0563_210_73_20150914_00082.jpg

LM Start	9.33	Rating **	U	Issue No.	73
LM End	9.33	Issue Type +	Ma	Location *	LS
Category	Earthen Levee		GPS Latitude/Longitude		
			Start	End	
Item	Encroachments		38.145957 °	38.145957 °	
			-121.589653 °	-121.589653 °	
DWR ID	DWR_RD0563_01_s_2012_73				
Action/Comments					
Prunings Inspector Comments: Large pruning pile on landward toe.

Looking east at prunings at landward toe. (Spring 2015)

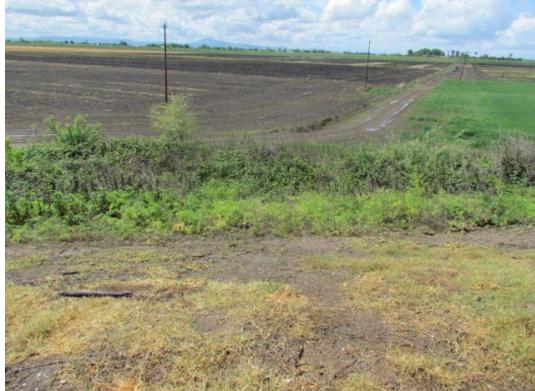
Photo 1 of 1 : FA_2015_RD0563_210_769_20150914_00146.jpg

Looking east at dense vegetation at landward toe. (Spring 2015)

LM Start	9.36	Rating **	U	Issue No.	769
LM End	9.43	Issue Type +	Ma	Location *	LS
Category	Earthen Levee		GPS Latitude/Longitude		
			Start	End	
Item	Vegetation		38.146276 °	38.147034 °	
			-121.590189 °	-121.590907 °	
DWR ID	DWR_RD0563_01_s_2015_769				
Action/Comments					
Remove the wild growth other than native grasses from the levee slopes.

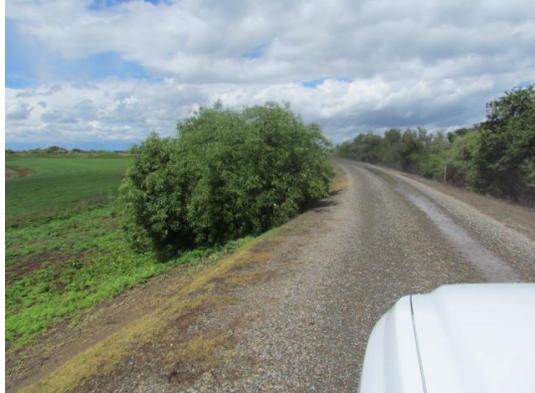
Photo 1 of 1 : FA_2015_RD0563_210_36_20150914_00038.jpg

LM Start	9.64	Rating **	M	Issue No.	36
LM End	9.64	Issue Type +	Ma	Location *	LS
Category	Earthen Levee		GPS Latitude/Longitude		
			Start	End	
Item	Vegetation		38.149790 °	38.149790 °	
			-121.592788 °	-121.592788 °	
DWR ID	DWR_RD0563_01_s_2012_36				
Action/Comments					
Elderberries are blocking visibility and flood fight capability. Inspector Comments: Vegetation blocking view of levee slope.

Looking south at elderberry on landward slope.

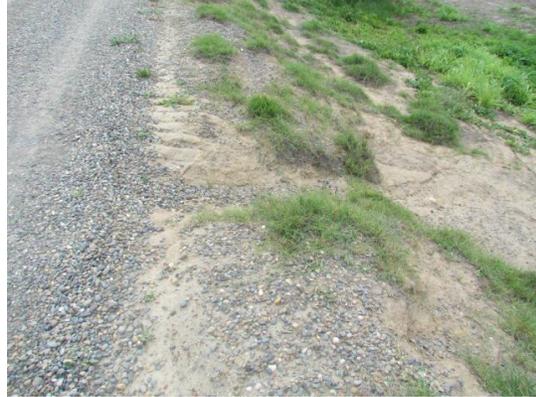
Photo 2 of 2 : FA_2015_RD0563_210_99_20150914_00124.jpg

Looking north at minor erosion on landward shoulder and slope.

LM Start	9.65	Rating **	M	Issue No.	99 (cont)
LM End	9.65	Issue Type +	Ma	Location *	LS
Category	Earthen Levee		GPS Latitude/Longitude		
			Start	End	
Item	Erosion / Bank Caving		38.149905 °	38.149905 °	
			-121.592910 °	-121.592910 °	
DWR ID	DWR_RD0563_01_s_2013_99				
Action/Comments					
Note and monitor erosion site.

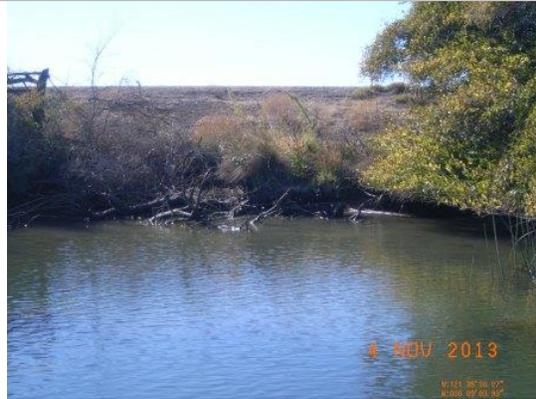
Photo 1 of 1 : USACE2013A_GEO_2-5_L_10.jpg

LM Start	9.73	Rating **	M	Issue No.	41
LM End	9.90	Issue Type +	Ma	Location *	WS
Category	Supplemental		GPS Latitude/Longitude		
			Start	End	
Item	2015 USACE Erosion Survey, DRAFT		38.150820 °	38.150647 °	
			-121.593650 °	-121.596858 °	
DWR ID					
Action/Comments					
Inspector Comments: 1997 - Erosion pockets into the toe of the levee. 2001 - Staked low fascine walls at the bankline. 2004 - Numerous "Brush Boxes." 2005 - Some new bundles in the brush boxes. 2012 - Site extended downstream to account for new bank sloughing. 2013 - Some rock added to the upstream end by the local RD. 2015: Last observed in 2013. [2015 Site ID: GEO_2-5_L]

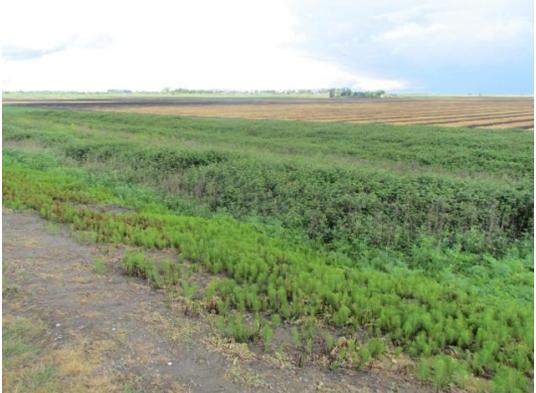
Photo 1 of 3 : FA_2015_RD0563_210_100_20150914_00125.jpg

LM Start	10.72	Rating **	U	Issue No.	100
LM End	10.81	Issue Type +	Ma	Location *	LS
Category	Earthen Levee			GPS Latitude/Longitude	
				Start	End
Item	Vegetation			38.140307 °	38.139079 °
				-121.596900 °	-121.596214 °
DWR ID	DWR_RD0563_01_s_2013_100				
Action/Comments					
Remove the wild growth other than native grasses from the levee slopes. Inspector Comments: Wild rose or grape vines on landward slope and toe.

Looking northeast at dense vegetation at landward toe. (Spring 2015)

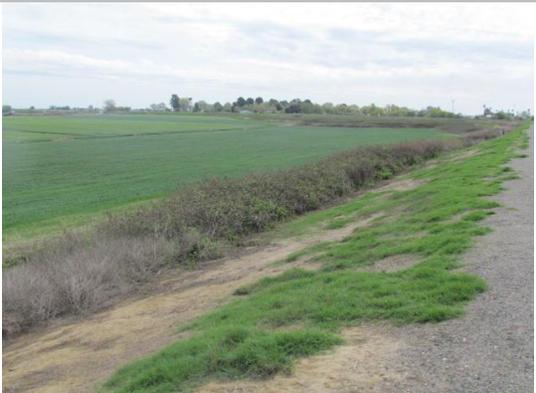
Photo 2 of 3 : FA_2015_RD0563_210_100_20150914_00126.jpg

Looking south at dense vegetation at landward toe. (Fall 2014)

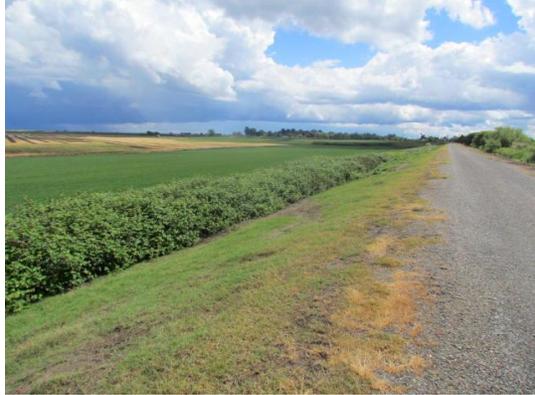
Photo 1 of 1 : FA_2015_RD0563_210_770_20150914_00147.jpg

Looking southeast at dense vegetation at landward toe. (Spring 2015)

LM Start	11.01	Rating **	U	Issue No.	770
LM End	12.00	Issue Type +	Ma	Location *	LS
Category	Earthen Levee		GPS Latitude/Longitude		
			Start	End	
Item	Vegetation		38.136623 °	38.130739 °	
			-121.594216 °	-121.579678 °	
DWR ID	DWR_RD0563_01_s_2015_770				
Action/Comments					
Remove the wild growth other than native grasses from the levee slopes.

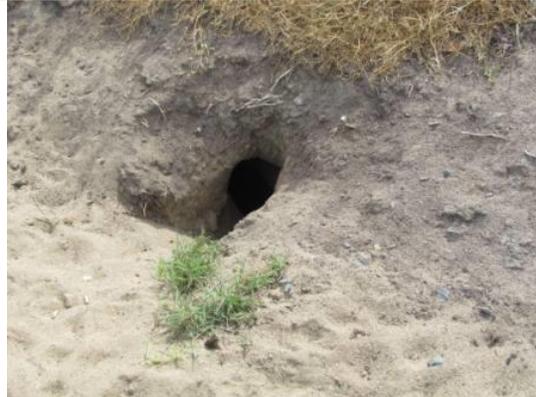
Photo 2 of 3 : FA_2015_RD0563_210_91_20150914_00116.jpg

Looking west at rodent hole on landside slope.

LM Start	11.45	Rating **	A/W	Issue No.	91 (cont)
LM End	11.45	Issue Type +	Ma	Location *	LS
Category	Earthen Levee			GPS Latitude/Longitude	
				Start	End
Item	Animal Control			38.131943 °	38.131943 °
				-121.588912 °	-121.588912 °
DWR ID	DWR_RD0563_01_s_2012_91				
Action/Comments					
No rodents visible, but rodent burrows visible; need to backfill and compact or grout burrows.

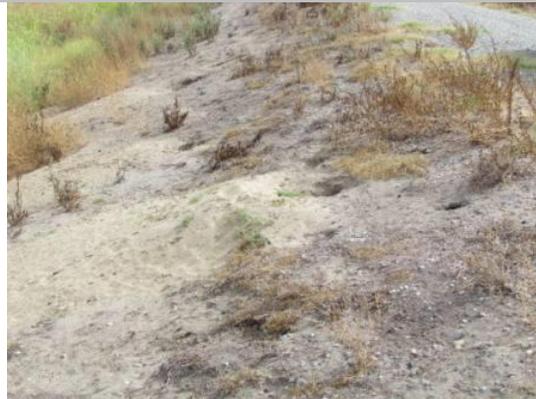
Photo 3 of 3 : FA_2015_RD0563_210_91_20150914_00117.jpg

Looking south at rodent holes on landside slope.

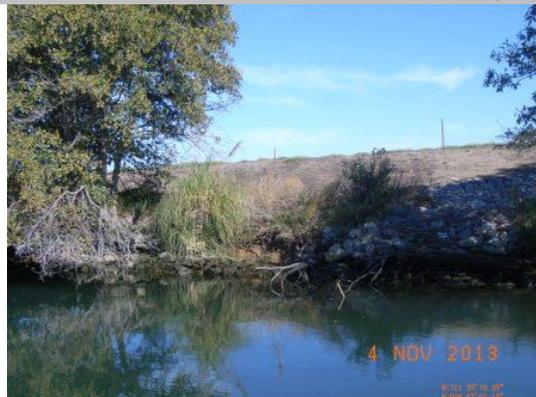
Photo 1 of 1 : USACE2013A_GEO_0-3_L_16.jpg

LM Start	11.51	Rating **	M	Issue No.	42
LM End	11.86	Issue Type +	Ma	Location *	WS
Category	Supplemental			GPS Latitude/Longitude	
				Start	End
Item	2015 USACE Erosion Survey, DRAFT			38.131126 °	38.130368 °
				-121.588337 °	-121.582266 °
DWR ID					
Action/Comments					
Inspector Comments: 1997 - Erosion pockets into the levee toe. 1999 - Some small pockets fixed with rock riprap. 2002 - New "brush boxes" along the bank toe. 2005 - Brush boxes are empty. Some pockets are filled with new stone. 2006 - Some new rock at the downstream end (~100 ft long). Several small pockets of new rock in scallops. Brush boxes in poor to fair condition. 2010 - Site looks a little worse, some
