**Flood Control Project Maintenance  
Levee Inspections  
LMA District Cover Sheet**

**Reclamation District No. 0755 Randall**

**Levee Inspection Report By Mile - Spring 2021**

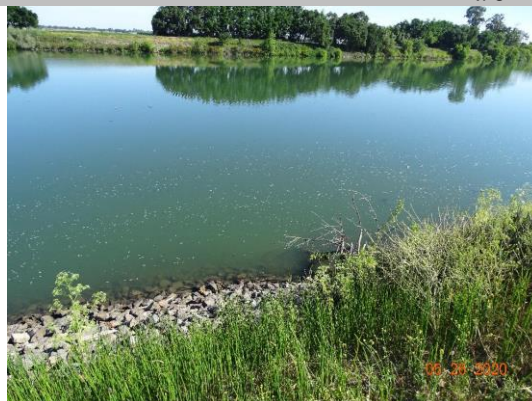
Photo 3 of 3 : UCIP\_SP\_2021\_57009\_84332.jpg

Water-Side: View of levee slope looking from crown

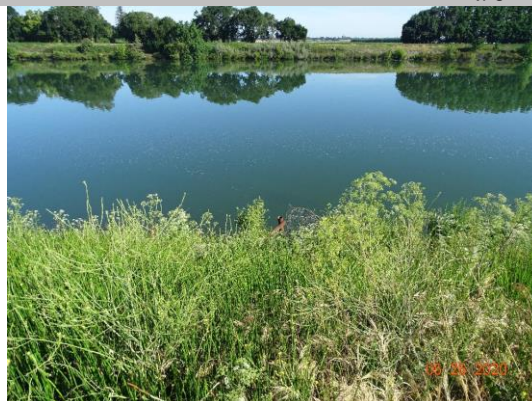
Photo 2 of 3 : UCIP\_SP\_2021\_57010\_84336.jpg

FS\_ID:57010  
DS\_ID:18848  
EP\_NO: 11221  
Repair Type: Urgent  
Crossing Status: Found  
UCIP Comments: 05/26/2020 Record updated to Urgent. Through holes in pipe on LS slope. Open end of electrical conduit without wires at LS toe next to abandoned service pole. These two could pose flood risk to landside. 14-inch to 12-inch pipe welded connection on LS shoulder. Ruined pile structure at riverbank, missing pump. Abandoned service pole at LS toe. Crossing appears abandoned. Need to have CVFPB review ABO and determine current owner. Coordinates of crossing have been updated. (O.Yakimov - DWR UCIP)  
FIELD\_STRUCT\_DESC: 14-inch irrigation discharge pipe of an unknown material through the levee, invert elevation 4.2 feet below the crown, 2-inch steel electrical conduit at same location. Pump on a pile structure in the river. Wooden stairs and walkway to the pump. 42-inch concrete standpipe and service pole at landside toe. (14-inch pipe [HLM 0.18] authorized under Automatic Board Order (ABO) issued as Permit No. 11221, 1975 - Greene and Hemly, Inc). [Additional Reference(s): DWR Levee Log, 2005 (HLM 0.18). USACE As-Built Drawing No. 50-04-2983, Sheet 14, RM 36.5, March 1954, listed as 12-inch pipe].

Water-Side: View of levee slope looking from crown

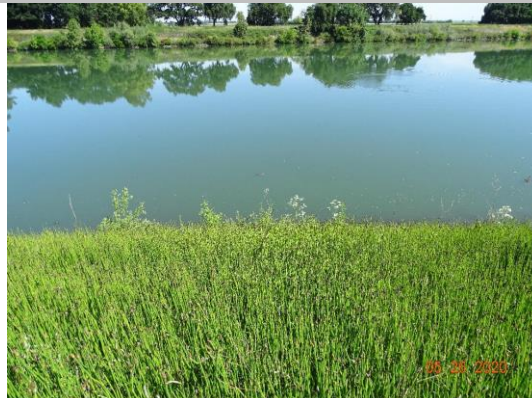
Photo 2 of 3 : UCIP\_SP\_2021\_57011\_84346.jpg

Comment Code						
Inspector Comment						
FS_ID:57011						
DS_ID:18866						
EP_NO: N/A						
Repair Type: Non-Urgent						
Crossing Status: Not Found						
UCIP Comments: 05/26/2020 Record updated to Non-Urgent. Crossing not found. No permit has been identified authorizing pipe. (O.Yakimov - DWR UCIP)						
FIELD_STRUCT_DESC: 12-inch irrigation discharge pipe of an unknown material through the levee, invert elevation 4.2 feet below the crown. Pump on the waterside (WS). [Additional Reference(s): USACE Sacramento O&M Manual, Unit 111, May 1959, Revised 29 December 2016, (RM 36.42), listed as 12-inch pipe].						
FS Date: 5/26/2020 10:12:22 AM

Water-Side: View of levee slope looking from crown

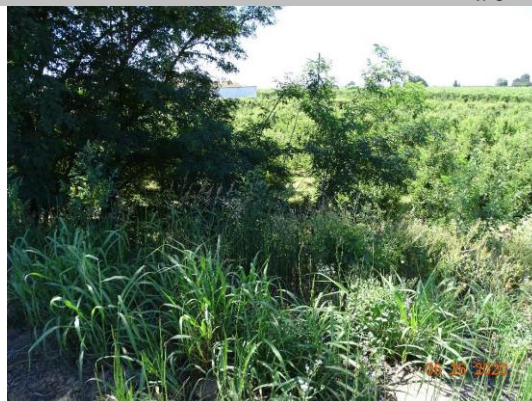
Photo 3 of 3 : UCIP\_SP\_2021\_57011\_84347.jpg

Land-Side: View of levee slope looking from crown

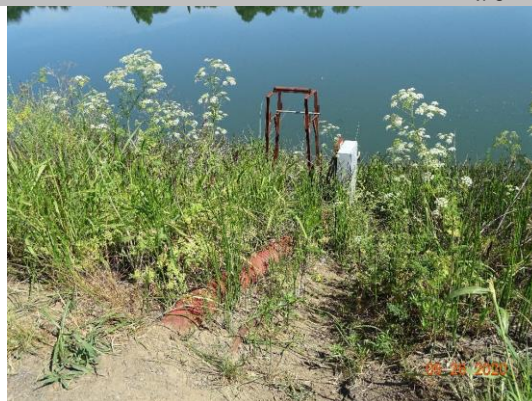
Photo 2 of 3 : UCIP\_SP\_2021\_57013\_84357.jpg

Comment Code						
Inspector Comment						
FS_ID:57013 DS_ID:18849 EP_NO: 4302 Repair Type: Non-Urgent Crossing Status: Found UCIP Comments: 05/26/2020 Record remains Non-Urgent. Pump is running, minor leak through pump sealing on WS slope observed. (O.Yakimov - DWR UCIP) 08/06/2013 FBC about 2 feet.Power conduit also through the levee.Wet ground on pump site/location. May need investigation about wet ground. FIELD_STRUCT_DESC: 8-inch coated steel irrigation discharge pipe through the levee, 2 feet below the crown. 2-inch electrical conduit through the levee at same location. Pump, electrical box, and control valve on the waterside (WS) slope. Siphon breaker on the landside (LS) shoulder. Pipe connected to two screen filters on LS. Service pole at the LS toe. (8-inch pipe [HLM 0.43] authorized under Permit No. 4302, 1963 - E. C. Hemly). [Additional Reference(s): DWR Levee Log, 2005 (HLM 0.44)]. FS Date: 5/26/2020 10:33:38 AM

Water-Side: View of levee slope looking from crown

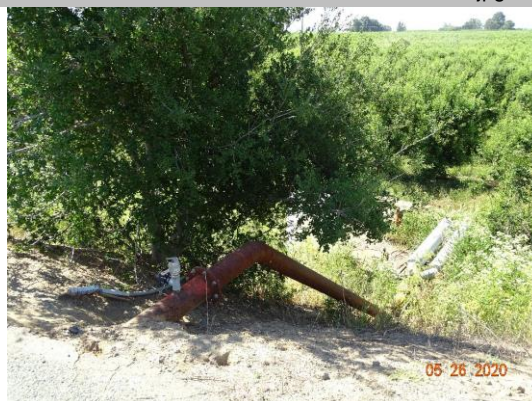
Photo 3 of 3 : UCIP\_SP\_2021\_57013\_84358.jpg

Land-Side: View of levee slope looking from crown

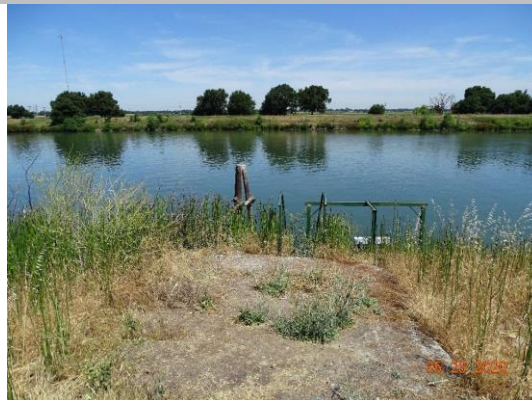
Photo 2 of 3 : UCIP\_SP\_2021\_57018\_84385.jpg

Comment Code						
Inspector Comment						
FS_ID:57018 DS_ID:18861 EP_NO: N/A Repair Type: Non-Urgent Crossing Status: Not Found UCIP Comments: 05/26/2020 Record updated from No Action Needed to Non-Urgent. Crossing not found. 12-inch pipe debris on LS slope, buried headwall at LS toe. No permit has been identified authorizing pipe. (O.Yakimov - DWR UCIP) 08/06/2013 Not found. FIELD_STRUCT_DESC: 12-inch irrigation discharge pipe of unknown material, at unknown depth. Pump and gate on landside. [Additional Reference(s): USACE Sacramento O&M Manual, Unit 111, May 1959, Revised 29 December 2016, (RM 36.01), listed as 12-inch pipe]. FS Date: 5/26/2020 12:43:14 PM

Water-Side: View of waterside looking from crown

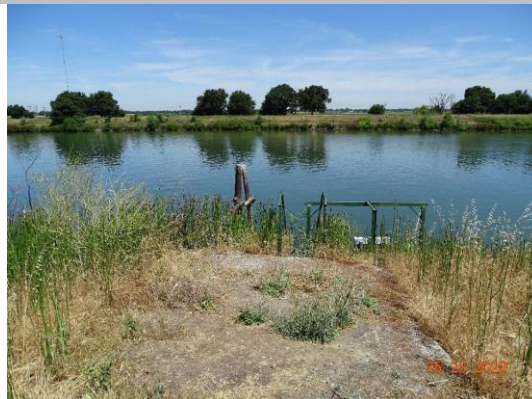
Photo 2 of 3 : UCIP\_SP\_2021\_57022\_84387.jpg

Water-Side: View of levee slope looking from crown

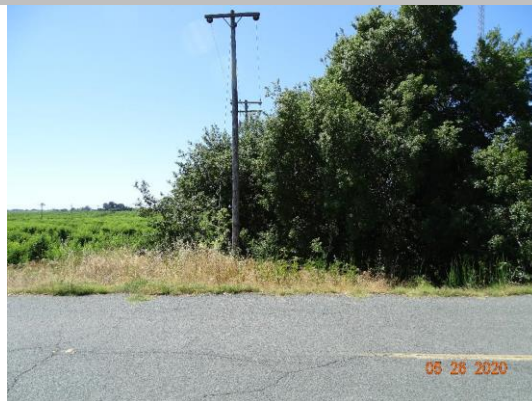
Photo 3 of 3 : UCIP\_SP\_2021\_57022\_84388.jpg

Land-Side: View of landside looking from crown

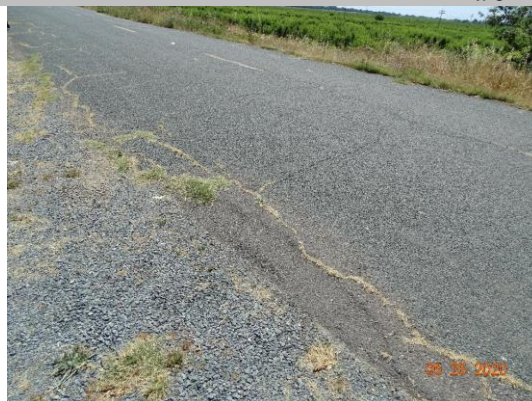
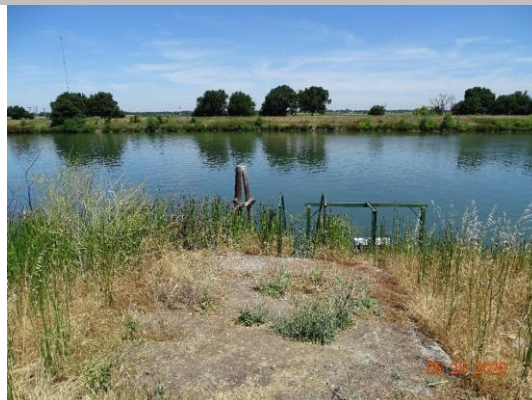
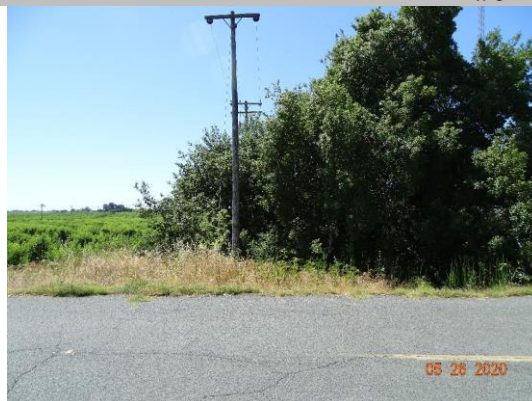
LM Start	0.68	Rating **	M	Issue No.	9	
LM End	0.68	Issue Type +	En	Location *		
Category	Supplemental			GPS Latitude/Longitude		
				Start		End
Item	DWR UCIP Field Study			38.345123 °		38.345123 °
				-121.547777 °		-121.547777 °
DWR ID	18862					
Comment Code						
Inspector Comment						
FS_ID:57037 DS_ID:18862 EP_NO: N/A Repair Type: Non-Urgent Crossing Status: Not Found UCIP Comments: 05/26/2020 Record remains Non-Urgent. Crossing not found. No permit has been identified authorizing pipe. (O.Yakimov - DWR UCIP) FIELD_STRUCT_DESC: 12-inch irrigation discharge pipe of an unknown material through the levee, unknown depth below the crown. [Additional Reference(s): USACE Sacramento O&M Manual, Unit 111, May 1959, Revised 29 December 2016, (RM 36.01), listed as 12-inch pipe]. FS Date: 5/26/2020 11:07:22 AM

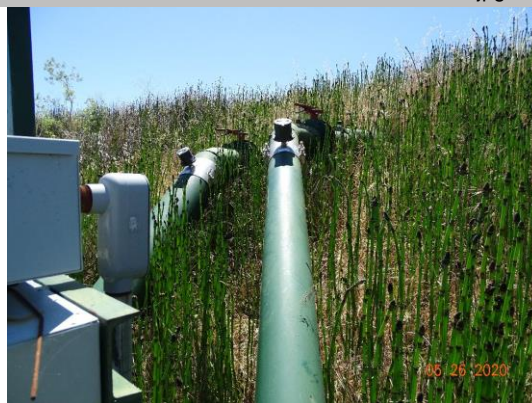
Photo 3 of 3 : UCIP\_SP\_2021\_57034\_84425.jpg

FS\_ID:57034  
DS\_ID:18850  
EP\_NO: 4637  
Repair Type: Non-Urgent  
Crossing Status: Found  
UCIP Comments: 05/26/2020 Record updated from No Action Needed to Non-Urgent. Pumping platform on pile structure in the river has been removed. Unable to find permit authorizing modifications to this crossing to sleeve 12-inch pipe through 16-inch pipe. (O.Yakimov - DWR UCIP)  
08/06/2013 12-inch steel pipe sleeved through 16 in steel pipe. Pump was running during field survey.  
FIELD\_STRUCT\_DESC: 12-inch pipe sleeved through a 16-inch coated steel irrigation discharge pipe through the levee, 5 feet below the crown. Pump on pumping platform of WS slope with stairs to the pump. Flow meter installed on 12-inch pipe. This crossing replaces 16-inch pipe (see DSID 25613). (Replacement of a portion of 16-inch pipe through the levee section authorized under Permit No. 4637, 1964 - Green and McKeown Farms, Inc). [Additional Reference(s): DWR Levee Log, 2005 (HLM 0.70). USACE Sacramento O&M Manual, Unit 111, May 1959, Revised 29 December 2016, (RM 35.90), listed as 14-inch pipe].

Water-Side: View of levee slope looking towards crown

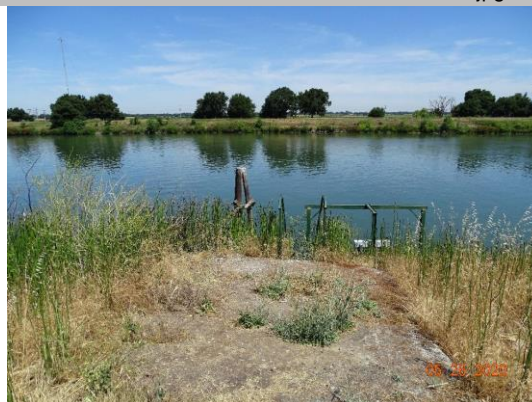
Photo 2 of 3 : UCIP\_SP\_2021\_57035\_84407.jpg

FS\_ID:57035  
DS\_ID:18851  
EP\_NO: 7357  
Repair Type: Non-Urgent  
Crossing Status: Found  
UCIP Comments: 05/26/2020 Record remains Non-Urgent. Pumping platform on pile structure in the river has been removed. No permit has been identified authorizing original 16-inch pipe. Annular space between 8-inch pipe and 16-inch pipe has been grouted. (O.Yakimov - DWR UCIP)  
08/06/2013 An abandoned 12-in steel pipe lying on LS levee slope should be removed. A buried concrete headwall found on LS levee slope should be checked for any pipe or connection.  
FIELD\_STRUCT\_DESC: 8-inch pipe and 2-inch electrical conduit sleeved through a 16-inch steel irrigation discharge pipe through the levee, 4.2 feet below the crown. Pump on pumping platform on WS slope with stairs to pump. (Additional pump installation on WS and sleeving 8-inch pipe through an existing 14-inch pipe authorized under Permit 7357, 1971 - Green and Keown Farms, Inc). [Additional Reference(s): DWR Levee Log, 2005, (HLM 0.70), 14-inch outer pipe referenced. USACE Sacramento O&M Manual, Unit 111, May 1959, Revised 29 December 2016, (RM 35.90), listed as 14-inch pipe].

Water-Side: View of waterside looking from crown

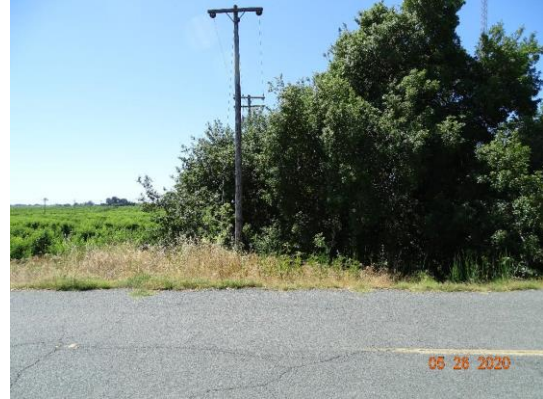
Photo 3 of 3 : UCIP\_SP\_2021\_57035\_84439.jpg

Land-Side: View of landside looking from crown

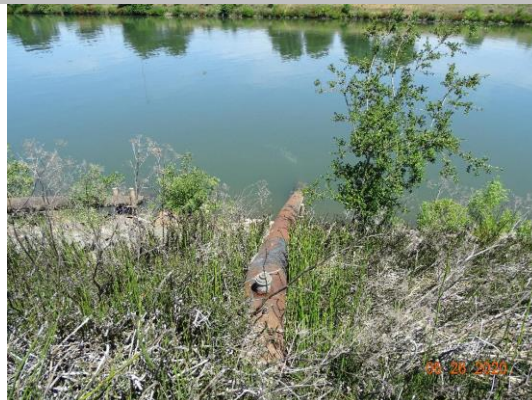
Photo 2 of 3 : UCIP\_SP\_2021\_57038\_84442.jpg

Comment Code						
Inspector Comment						
FS_ID:57038 DS_ID:18852 EP_NO: 11222 Repair Type: Non-Urgent Crossing Status: Found UCIP Comments: 05/26/2020 Record updated from No Action Needed to Non-Urgent. No permit has been identified authorizing pipe. Pipe was running during site visit pumping water to the waterside. (O.Yakimov - DWR UCIP) 08/06/2013 It was working during field survey. A pump found 150 ft from the levee. Not sure whether the pump belong to this drainage system. FIELD_STRUCT_DESC: 16-inch steel drainage pipe sleeved through a 24-inch steel drainage pipe through the levee, invert elevation 8 feet below the crown. Air vent installed on the pipe on WS slope. Concrete headwall on LS. (12-inch pipe sleeved through 24-inch pipe-inch pipe [HLM 0.71] authorized under Automatic Board Order (ABO) issued as Permit No. 11222, 1975 - Green McKeown, Inc). [Additional Reference(s): DWR Levee Log, 2005 (HLM 0.71), referenced as 12-inch pipe through 24-inch pipe. USACE Sacramento O&M Manual, Unit 111, May 1959, Revised 29 December 2016, (RM 35.89), listed as 24-inch pipe]. FS Date: 5/26/2020 3:00:07 PM

Water-Side: View of levee slope looking from crown

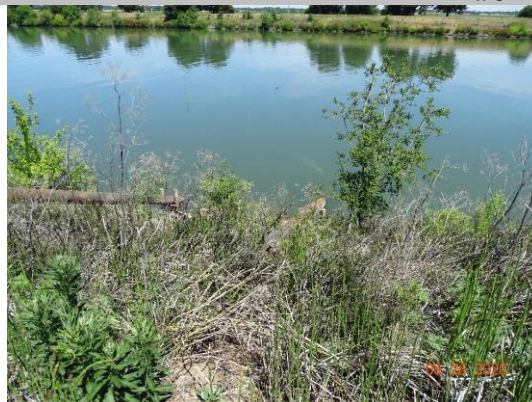
Photo 2 of 3 : UCIP\_SP\_2021\_57042\_84450.jpg

Comment Code						
Inspector Comment						
FS_ID:57042 DS_ID:18853 EP_NO: N/A Repair Type: Non-Urgent Crossing Status: Found UCIP Comments: 05/26/2020 Record updated from No Action Needed to Non-Urgent. Crossing appears abandoned: landside end filled with concrete and capped with a steel plate. Unauthorized encroachment recorded in Levee Log prior to 2011. (O.Yakimov - DWR UCIP)  FIELD_STRUCT_DESC: 30-inch pipe of an unknown material or purpose through the levee, 10.5 feet below the crown. Landside (LS) end filled with concrete and capped with a steel plate. Concrete headwall on the LS end. [Additional Reference(s): DWR Levee Log, 2005 (HLM 0.71)]. FS Date: 5/26/2020 3:47:43 PM

Water-Side: View of levee slope looking from crown

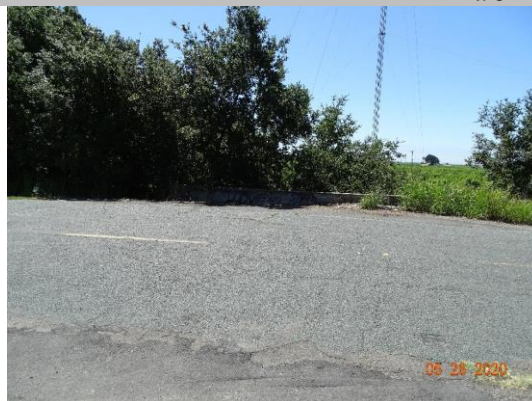
Photo 2 of 3 : UCIP\_SP\_2021\_57043\_84453.jpg

Top of Levee: View of levee crown and landside looking from crown

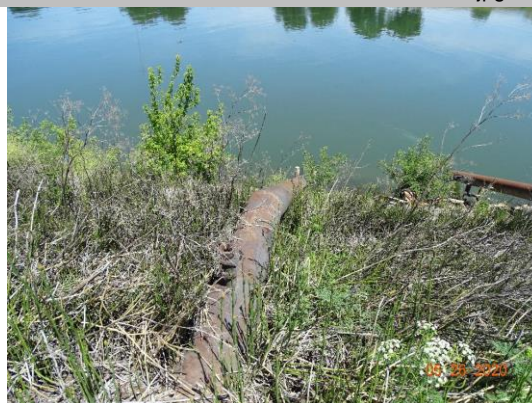
Photo 3 of 3 : UCIP\_SP\_2021\_57043\_84454.jpg

Water-Side: View of levee slope looking from crown

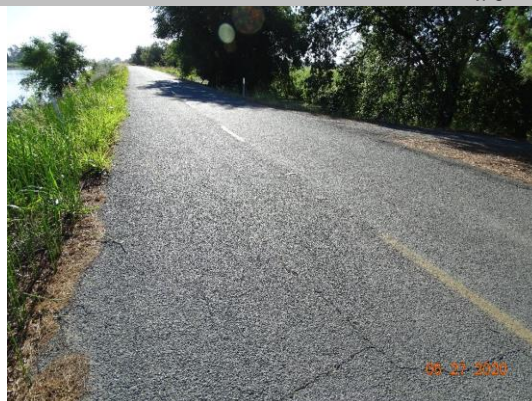
Photo 1 of 3 : UCIP\_SP\_2021\_57044\_84456.jpg

LM Start	0.93	Rating **	M	Issue No.	34
LM End	0.93	Issue Type +	En	Location *	
Category	Supplemental			GPS Latitude/Longitude	
				Start	End
Item	DWR UCIP Field Study			38.344097 °	38.344097 °
				-121.552110 °	-121.552110 °
DWR ID	18863				
Comment Code					
Inspector Comment					
FS_ID:57044					
DS_ID:18863					
EP_NO: N/A					
Repair Type: Non-Urgent					
Crossing Status: Not Found					
UCIP Comments: 05/27/2020 Record updated to Non-Urgent. Crossing not found. No permit has been identified authorizing pipe. (O.Yakimov - DWR UCIP)					
FIELD_STRUCT_DESC: 10-inch irrigation discharge pipe of an unknown material through the levee, at an unknown depth. Pump and gate valve on the landside (LS). [Additional Reference(s): USACE Sacramento O&M Manual, Unit 111, May 1959, Revised 29 December 2016, (RM 35.76), listed as 10-inch pipe].					
FS Date: 5/27/2020 4:18:21 PM

Top of Levee: View of levee crown looking upstream

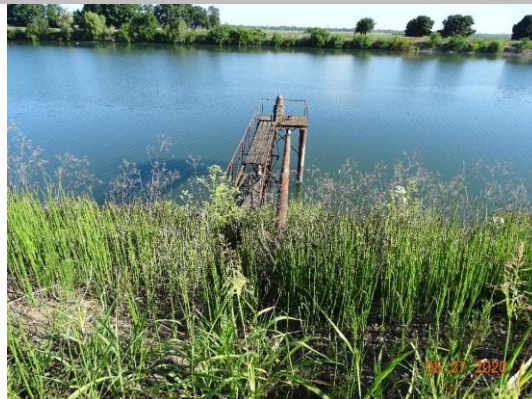
Photo 2 of 3 : UCIP\_SP\_2021\_57044\_84457.jpg

Water-Side: View of levee slope looking from crown

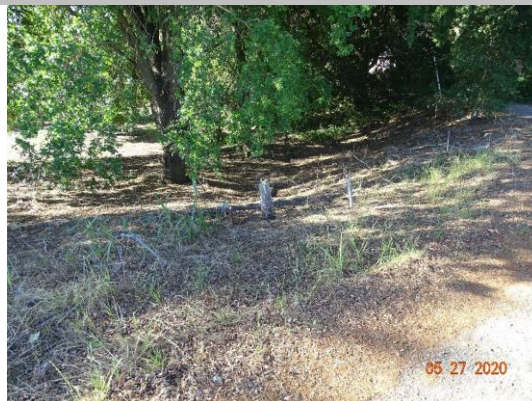
Photo 3 of 3 : UCIP\_SP\_2021\_57044\_84458.jpg

Land-Side: View of levee slope looking from crown

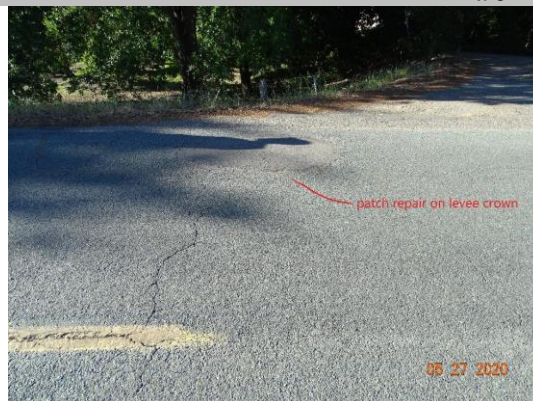
Photo 1 of 3 : UCIP\_SP\_2021\_57080\_84498.jpg

FS\_ID:57080  
DS\_ID:18855  
EP\_NO: 11225  
Repair Type: Urgent  
Crossing Status: Found  
UCIP Comments: 05/27/2020 Record updated from Non-Urgent to Urgent. Through holes in pipe on waterside slope, sinkhole on WS shoulder measures 3'x3'x1'. Erosion continues to levee crown - road pavement. Asphalt patch repair on the crown. Knocked down service pole with electric box on LS slope. Crossing appears abandoned. Need to have CVFPB review ABO and determine current owner. (O.Yakimov - DWR UCIP)  
08/06/2013 Abandoned pipe and pump. Service pole, power box lying on LS slope.  
FIELD\_STRUCT\_DESC: 10-inch irrigation discharge pipe of an unknown material and a 1-inch electrical conduit through the levee, invert elevation 5.6 feet below the crown. Pump on a pile structure with a walkway to the pump. Abandoned service pole on the landside (LS) slope. (10-inch pipe [HLM 0.94] authorized under Automatic Board Order (ABO) issued as Permit No. 11225, 1975 - Helen D. Wilson). [Additional Reference(s): DWR Levee Log, 2005 (HLM 0.94). USACE Sacramento O&M Manual, Unit 111, May 1959, Revised 29 December 2016, (RM 35.66), listed as 10-inch pipe. USACE As-Built Drawing No. 50-04-2983, Sheet 13, downstream of Station 515+00, March 1954].

Top of Levee: View of levee crown looking across the road

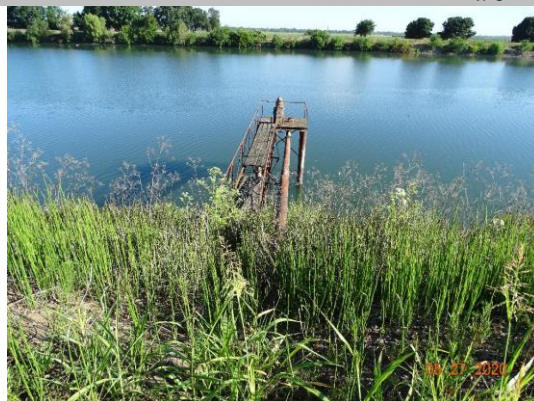
Photo 3 of 3 : UCIP\_SP\_2021\_57080\_84495.jpg

Water-Side: View of levee slope looking from crown

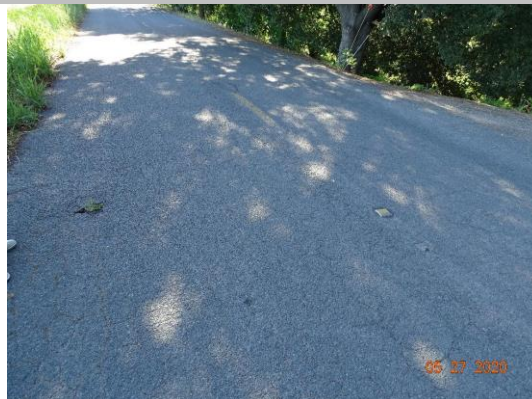
Photo 1 of 3 : UCIP\_SP\_2021\_57081\_84506.jpg

FS\_ID:57081  
DS\_ID:18856  
EP\_NO: N/A  
Repair Type: Non-Urgent  
Crossing Status: Found  
UCIP Comments: 05/27/2020 Record remains Non-Urgent. A sinkhole is developing on levee crown closer to waterside hinge. The sinkhole is currently measuring 12"x18" in size. Was unable to locate pipe on landside slope. Crossing appears abandoned. No permit has been identified authorizing pipe. (O.Yakimov - DWR UCIP)  
08/06/2013 Needs to be properly abandoned.  
FIELD\_STRUCT\_DESC: 12-inch pipe of an unknown material or purpose through the levee, invert elevation 5 feet below the crown. Siphon breaker on the waterside (WS). Pipe not found on the landside (LS). [Additional Reference(s): DWR Levee Log, 2005 (HLM 1.05). USACE Sacramento O&M Manual, Unit 111, May 1959, Revised 29 December 2016, (RM 35.55), listed as 12-inch pipe].  
FS Date: 5/27/2020 7:33:53 AM

Top of Levee: View of levee crown looking upstream

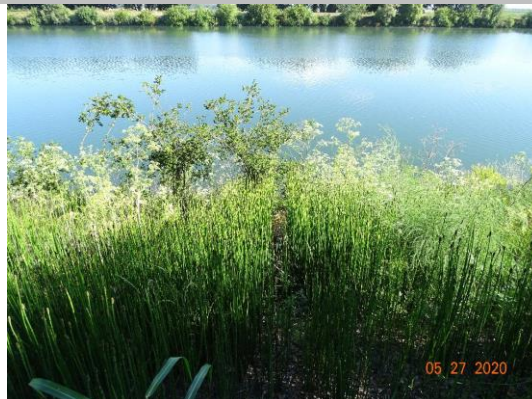
Photo 2 of 3 : UCIP\_SP\_2021\_57081\_84507.jpg

Water-Side: View of levee slope looking from crown

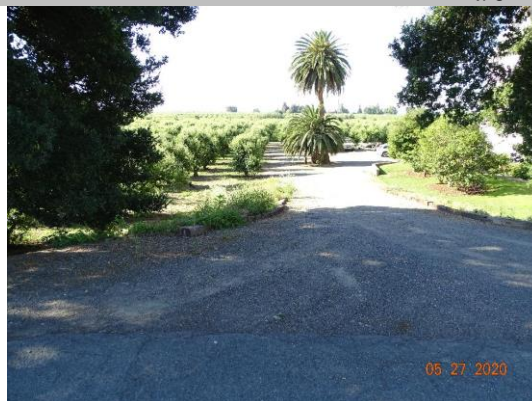
Photo 3 of 3 : UCIP\_SP\_2021\_57081\_84508.jpg

Land-Side: View of levee slope looking from crown

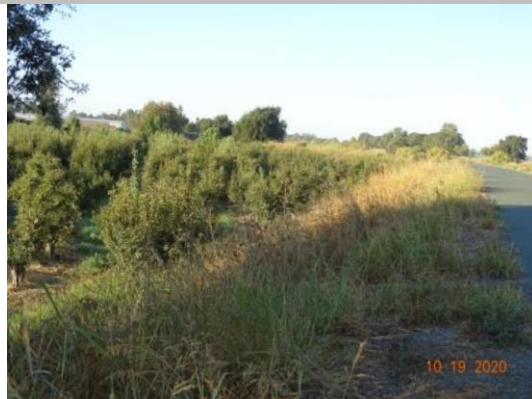
Photo 1 of 1 : SP\_2021\_RD0755\_177\_54\_20210301\_00024.jpg

LM Start	1.11	Rating **	M	Issue No.	54
LM End	1.76	Issue Type +	Ma	Location *	LS
Category	Earthen Levee			GPS Latitude/Longitude	
				Start	End
Item	Vegetation			38.343345 °	38.337423 °
				-121.555430 °	-121.564028 °
DWR ID	DWR_RD0755_01_f _ 2020_54				
Comment Code					
V1 : Control annual grass and weeds on the levee slopes and easements.					
Inspector Comment

View looking downstream at annual vegetation on the landside slope (Fall 2020).

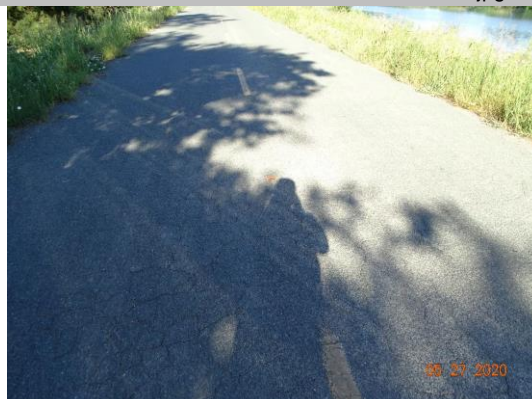
Photo 1 of 3 : UCIP\_SP\_2021\_57083\_84522.jpg

LM Start	1.12	Rating **	U	Issue No.	39
LM End	1.12	Issue Type +	En	Location *	
Category	Supplemental			GPS Latitude/Longitude	
				Start	End
Item	DWR UCIP Field Study			38.343305 °	38.343305 °
				-121.555538 °	-121.555538 °
DWR ID	18857

Comment Code					
Inspector Comment					
FS_ID:57083 DS_ID:18857 EP_NO: 11219 Repair Type: Urgent Crossing Status: Found UCIP Comments: 05/27/2020 Record updated from Non-Urgent to Urgent. Unauthorized 8'x3'x3' excavation between pump house and WS levee slope was observed. Excavation exposes 8-inch pipe cut-off that was welded to a 6-inch pipe going towards pump house. Pump is running, minor water leaks from pump in pump house observed. CMP riser on LS shoulder is filled with soil and debris. No permit has been identified authorizing pipe. (O.Yakimov - DWR UCIP) 08/06/2013 requires cleaning of siphon breaker box. FIELD_STRUCT_DESC: 8-inch irrigation discharge pipe of an unknown material through the levee, invert elevation 5.7 feet below the crown. Siphon breaker in a 26-inch corrugated metal pipe (CMP) riser on the landside (LS) shoulder. Power pole on the LS. Pump and power box in a pump house on the waterside (WS) slope. Electrical conduit through the levee at the same location. (8-inch pipe [HLM 1.13] authorized under Automatic Board Order (ABO) issued as Permit No. 11219, 1975 - David J. Jr and Bonnie Elliott). [Additional Reference(s): DWR Levee Log, 2005 (HLM 1.13). USACE Sacramento O&M Manual, Unit 111, May 1959, Revised 29 December 2016, (RM 35.47), listed as 8-inch pipe]. FS Date: 5/27/2020 9:09:23 AM

Top of Levee: View of levee crown looking downstream

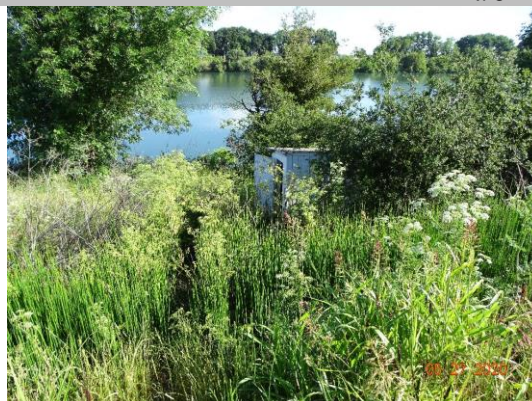
Photo 2 of 3 : UCIP\_SP\_2021\_57083\_84523.jpg

LM Start	<b>1.12</b>	Rating **	U	Issue No.	<b>39 (cont)</b>
LM End	<b>1.12</b>	Issue Type +	En	Location *	
Category	Supplemental		GPS Latitude/Longitude		
			Start	End	
Item	DWR UCIP Field Study		38.343305 °	38.343305 °	
			-121.555538 °	-121.555538 °	
DWR ID	18857

Water-Side: View of levee slope looking from crown

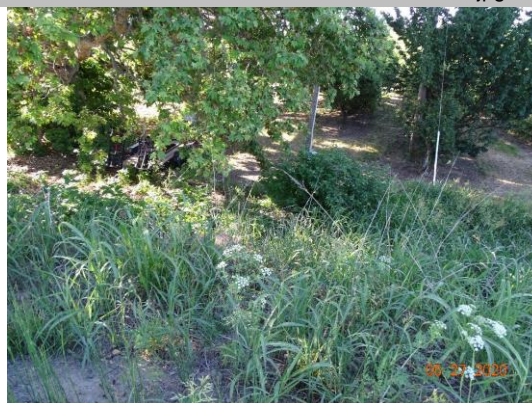
Photo 3 of 3 : UCIP\_SP\_2021\_57083\_84524.jpg

LM Start	<b>1.12</b>	Rating **	U	Issue No.	<b>39 (cont)</b>
LM End	<b>1.12</b>	Issue Type +	En	Location *

Land-Side: View of levee slope looking from crown

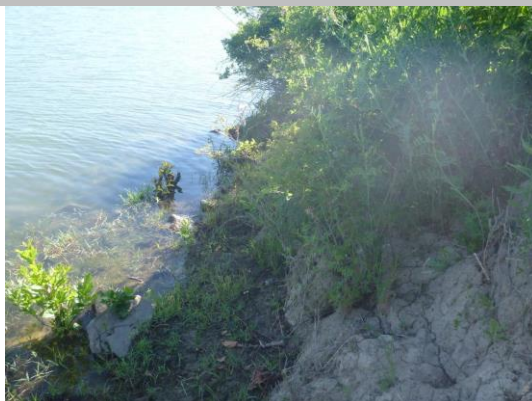
Photo 1 of 1 : SP\_2021\_RD0755\_177\_22\_20210301\_00009.jpg

LM Start	1.23	Rating **	A/W	Issue No.	22
LM End	1.29	Issue Type +	Ma	Location *	WS
Category	Earthen Levee			GPS Latitude/Longitude	
				Start	End
Item	Erosion / Bank Caving			38.342992 °	38.342633 °
				-121.557572 °	-121.558622 °
DWR ID	LMA-155				
Comment Code					
E1 : Note and monitor erosion site.					
Inspector Comment					
This was a 2017 Storm Damage site. Damage consists of erosion of the lower waterside levee slope and bank approximately 322 feet in length. Site ID No:328 Site Designation:LMA-155 6/18/2020 Field Notes: Erosion is into berm and not prism.

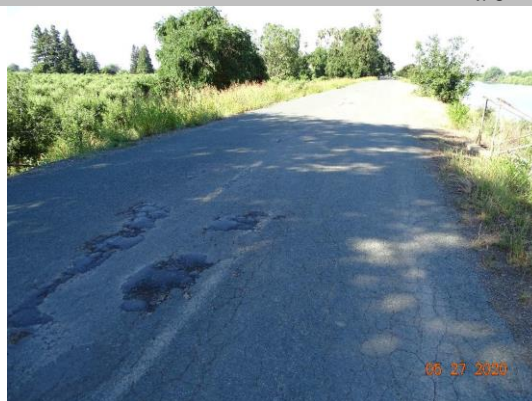
Photo 1 of 3 : UCIP\_SP\_2021\_57084\_84533.jpg

FS\_ID:57084  
DS\_ID:18858  
EP\_NO: 11219  
Repair Type: Non-Urgent  
Crossing Status: Found  
UCIP Comments: 05/27/2020 Record remains Non-Urgent. 14-inch supply pipe segment on waterside cut off between closure device and levee shoulder and replaced with 12-inch pipe from WS shoulder to riverbank. Pump house with a pump at LS toe was built. 8-inch pipe daylights in this pump house. Pump on pile structure in the river and walkway to the pump have been abandoned. 2-inch electrical conduit through the levee has open end with no wires on LS shoulder - should be abandoned properly. Need to have CVFPB review ABO and determine current owner. (O.Yakimov - DWR UCIP)  
08/06/2013 Pump and walkway seem abandoned.- Power line is not connected with pump.- A pump house like structure found on LS levee toe.  
FIELD\_STRUCT\_DESC: 14-inch irrigation discharge pipe of an unknown material through the levee, invert elevation 8.5 feet below the crown. Pump house at landside levee toe. Siphon breaker and power pole on the landside (LS) slope. 2-inch electrical conduit through the levee at the same location. Pump on pile structure in the river and walkway to the pump have been abandoned. (14-inch pipe [HLM 1.65] authorized under Automatic Board Order (ABO) issued as Permit No. 11219, 1975 - David J. Jr and Bonnie Elliott). [Additional Reference(s): DWR Levee Log, 2005 (HLM 1.65). USACE Sacramento O&M Manual, Unit 111, May 1959, Revised 29 December 2016, (RM35.02), 14-inch pipe referenced in RD0551. USACE As-Built Drawing No. 50-4-2983, Sheet 11, page 15, March 1954. USACE As-Built Drawing No. 06-13-1100, Sheet 12, near 'L' 1283+75, January 1933].

Top of Levee: View of levee crown looking downstream

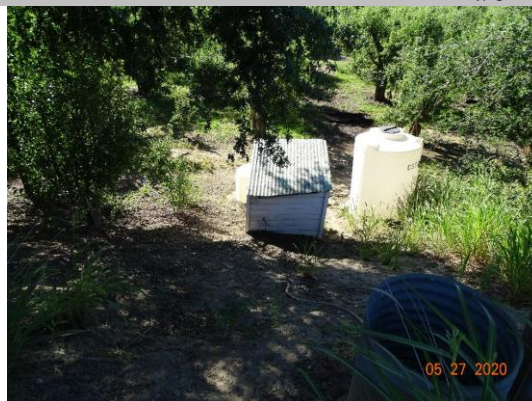
Photo 2 of 3 : UCIP\_SP\_2021\_57084\_84532.jpg

LM Start	<b>1.64</b>	Rating **	M	Issue No.	<b>40 (cont)</b>
LM End	<b>1.64</b>	Issue Type +	En	Location *	
Category	Supplemental		GPS Latitude/Longitude		
			Start	End	
Item	DWR UCIP Field Study		38.338715 °	38.338715 °	
			-121.562560 °	-121.562560 °	
DWR ID	18858

Land-Side: View of levee slope looking from crown

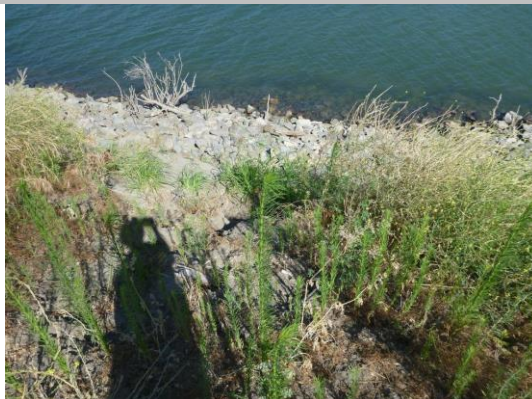
Photo 1 of 3 : SP\_2021\_RD0755\_177\_24\_20210301\_00011.jpg

LM Start	1.73	Rating **	A/W	Issue No.	24
LM End	1.81	Issue Type +	Ma	Location *	WS
Category	Supplemental			GPS Latitude/Longitude	
				Start	End
Item	2017 Storm Damage			38.337758 °	38.336789 °
				-121.563856 °	-121.564739 °
DWR ID	LMA-156

Planned For Repair.  
Levee Evaluation Comments  
Description: The damage consists of erosion of the lower waterside levee slope and bank approximately 424 feet in length along the east (left) bank of the Sacramento River. See attached pages for photos.  
Site location T06N R04E Section 29.  
Site ID No: 329  
Site Designation: LMA-156  
Repair Type: Erosion  
Rating: Serious  
Field Date: 7/13/2017  
Notes: Crown is a paved road. Large LS berm on part. Good visibility here. Serious because erosion cut into prism significantly for a long distance and soils are very sandy here and WS slope is very steep.
