**Flood Control Project Maintenance
Levee Inspections
LMA District Cover Sheet**

Reclamation District No. 0755 Randall

**Flood Control Project Maintenance
Levee Inspections**

Levee Inspection Report By Mile - Spring 2022

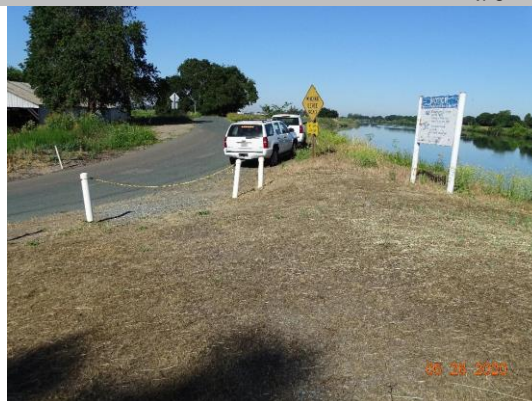
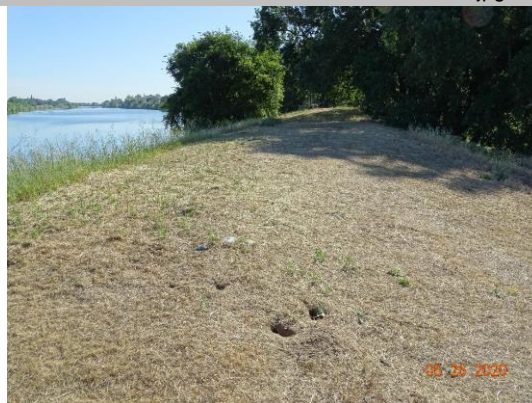
Photo 1 of 3 : UCIP_SP_2022_57009_84330.jpg

LM Start	0.16	Rating **	M	Issue No.	2	
LM End	0.16	Issue Type +	En	Location *		
Category	Supplemental			GPS Latitude/Longitude		
				Start		End
Item	DWR UCIP Field Study			38.346815 °		38.346815 °
				-121.538491 °		-121.538491 °
DWR ID	18860					
Comment Code						
Inspector Comment						
FS_ID:57009 DS_ID:18860 EP_NO: N/A Repair Type: Non-Urgent Crossing Status: Not Found UCIP Comments: 05/26/2020 Record updated to Non-Urgent. Crossing not found. No permit has been identified authorizing pipe. (O.Yakimov - DWR UCIP) FIELD_STRUCT_DESC: 6-inch pipe of an unknown material or purpose through the levee, at unknown depth. [Additional Reference(s): USACE Sacramento O&M Manual, Unit 111, May 1959, Revised 29 December 2016, (RM 36.51), listed as 6-inch pipe]. FS Date: 5/26/2020 9:06:25 AM

Top of Levee: View of levee crown at potential crossing looking downstream

Top of Levee: View of levee crown at potential crossing looking upstream

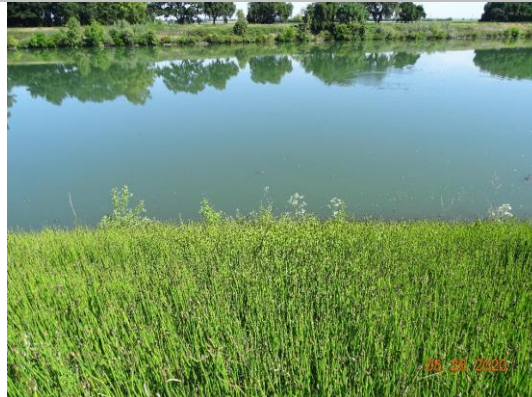
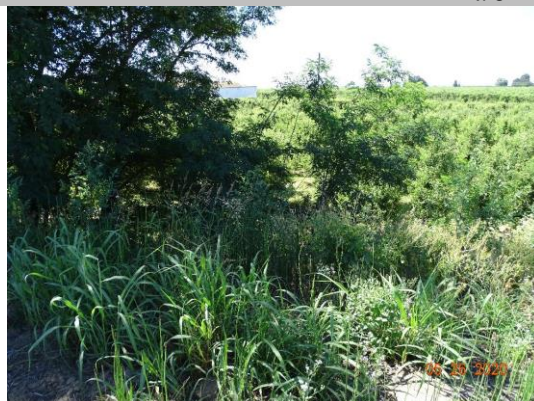
Photo 2 of 3 : UCIP_SP_2022_57011_84346.jpg

Comment Code						
Inspector Comment						
FS_ID:57011						
DS_ID:18866						
EP_NO: N/A						
Repair Type: Non-Urgent						
Crossing Status: Not Found						
UCIP Comments: 05/26/2020 Record updated to Non-Urgent. Crossing not found. No permit has been identified authorizing pipe. (O.Yakimov - DWR UCIP)						
FIELD_STRUCT_DESC: 12-inch irrigation discharge pipe of an unknown material through the levee, invert elevation 4.2 feet below the crown. Pump on the waterside (WS). [Additional Reference(s): USACE Sacramento O&M Manual, Unit 111, May 1959, Revised 29 December 2016, (RM 36.42), listed as 12-inch pipe].						
FS Date: 5/26/2020 10:12:22 AM

Water-Side: View of levee slope looking from crown

Land-Side: View of levee slope looking from crown

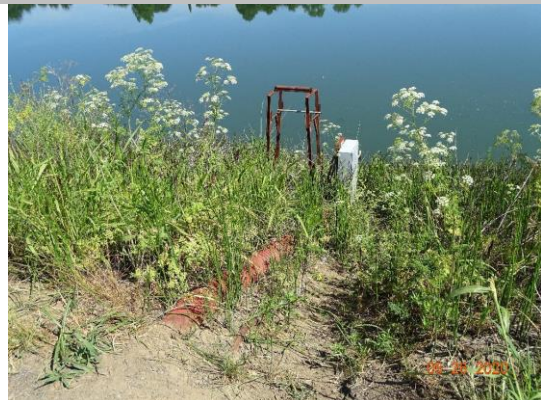
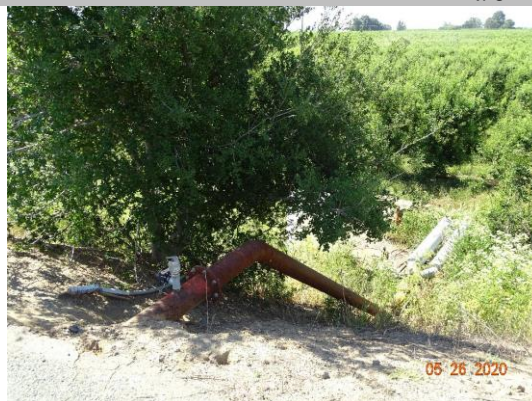
Photo 1 of 3 : UCIP_SP_2022_57013_84356.jpg

Comment Code						
Inspector Comment						
FS_ID:57013 DS_ID:18849 EP_NO: 4302 Repair Type: Non-Urgent Crossing Status: Found UCIP Comments: 05/26/2020 Record remains Non-Urgent. Pump is running, minor leak through pump sealing on WS slope observed. (O.Yakimov - DWR UCIP) 08/06/2013 FBC about 2 feet.Power conduit also through the leeve.Wet ground on pump site/location. May need investigation about wet ground. FIELD_STRUCT_DESC: 8-inch coated steel irrigation discharge pipe through the levee, 2 feet below the crown. 2-inch electrical conduit through the levee at same location. Pump, electrical box, and control valve on the waterside (WS) slope. Siphon breaker on the landside (LS) shoulder. Pipe connected to two screen filters on LS. Service pole at the LS toe. (8-inch pipe [HLM 0.43] authorized under Permit No. 4302, 1963 - E. C. Hemly). [Additional Reference(s): DWR Levee Log, 2005 (HLM 0.44)]. FS Date: 5/26/2020 10:33:38 AM

Top of Levee: View on levee crown at the crossing looking downstream

Water-Side: View of levee slope looking from crown

Land-Side: View of levee slope looking from crown

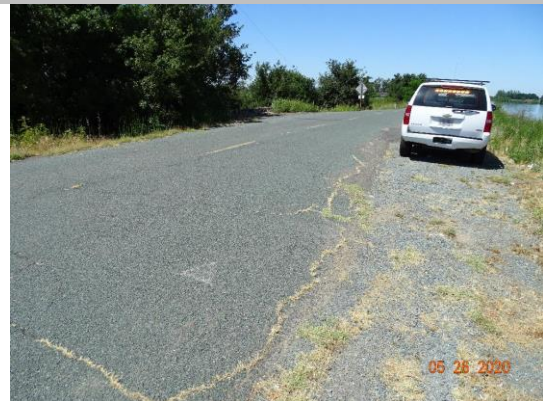
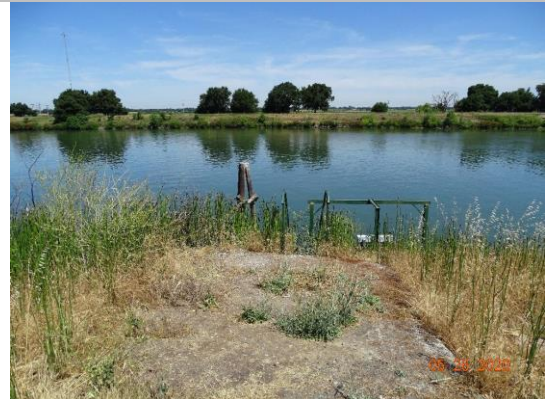
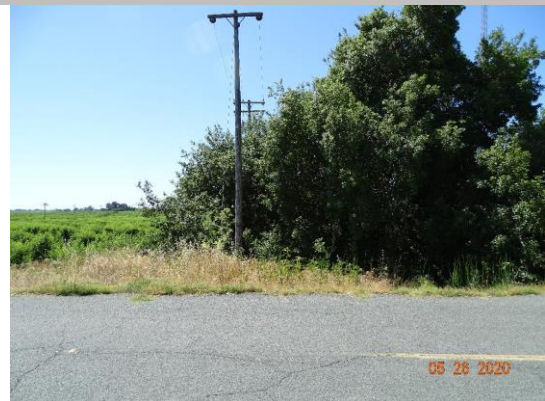
Photo 1 of 3 : UCIP_SP_2022_57018_84377.jpg

Comment Code					
Inspector Comment					
FS_ID:57018 DS_ID:18861 EP_NO: N/A Repair Type: Non-Urgent Crossing Status: Not Found UCIP Comments: 05/26/2020 Record updated from No Action Needed to Non-Urgent. Crossing not found. 12-inch pipe debris on LS slope, burried headwall at LS toe. No permit has been identified authorizing pipe. (O.Yakimov - DWR UCIP) 08/06/2013 Not found. FIELD_STRUCT_DESC: 12-inch irrigation discharge pipe of unknown material, at unknown depth. Pump and gate on landside. [Additional Reference(s): USACE Sacramento O&M Manual, Unit 111, May 1959, Revised 29 December 2016, (RM 36.01), listed as 12-inch pipe]. FS Date: 5/26/2020 12:43:14 PM

Top of Levee: View of levee crown at potential crossing looking downstream

Water-Side: View of waterside looking from crown

Land-Side: View of landside looking from the crown

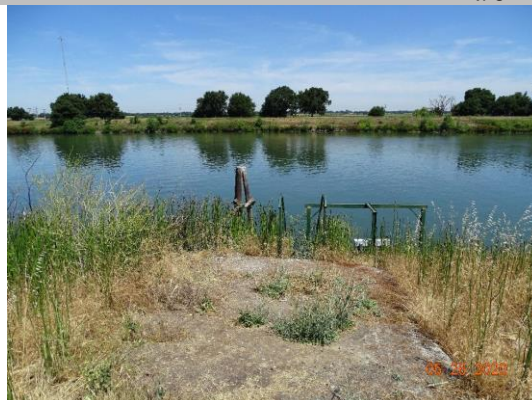
Photo 2 of 3 : UCIP_SP_2022_57022_84387.jpg

Comment Code						
Inspector Comment						
FS_ID:57022 DS_ID:18867 EP_NO: N/A Repair Type: Non-Urgent Crossing Status: Not Found UCIP Comments: 05/26/2020 Record updated from No Action Needed to Non-Urgent. Crossing not found. No permit has been identified authorizing pipe. (O.Yakimov - DWR UCIP) 08/06/2013 12-inch steel pipe lying on the LS slope.Not found- Pump LS, Gate LS. FIELD_STRUCT_DESC: 4-inch irrigation discharge pipe of unknown material through the levee, at unknown depth. Pump and gate valve on the landside (LS). [Additional Reference(s): USACE Sacramento O&M Manual, Unit 111, May 1959, Revised 29 December 2016, (RM 36.01), listed as 4-inch pipe]. FS Date: 5/26/2020 1:37:16 PM

Water-Side: View of levee slope looking from crown

Land-Side: View of landside looking from crown

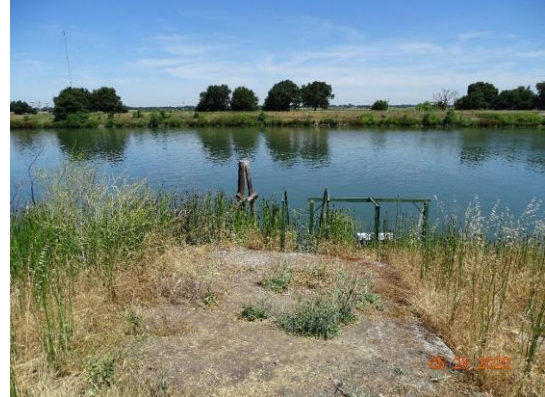
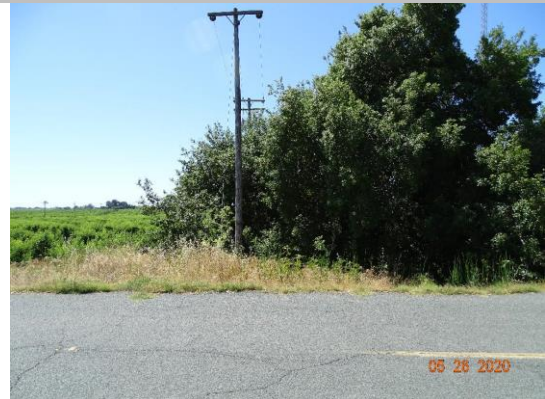
Photo 1 of 3 : UCIP_SP_2022_57037_84427.jpg

FS_ID:57037
 DS_ID:18862
 EP_NO: N/A
 Repair Type: Non-Urgent
 Crossing Status: Not Found
 UCIP Comments: 05/26/2020 Record remains Non-Urgent. Crossing not found. No permit has been identified authorizing pipe. (O.Yakimov - DWR UCIP)
 FIELD_STRUCT_DESC: 12-inch irrigation discharge pipe of an unknown material through the levee, unknown depth below the crown.
 [Additional Reference(s): USACE Sacramento O&M Manual, Unit 111, May 1959, Revised 29 December 2016, (RM 36.01), listed as 12-inch pipe].
 FS Date: 5/26/2020 11:07:22 AM

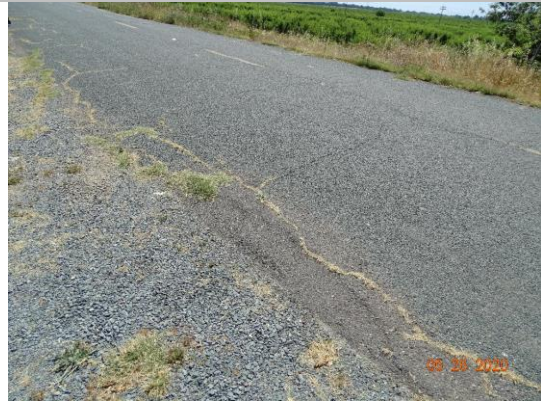
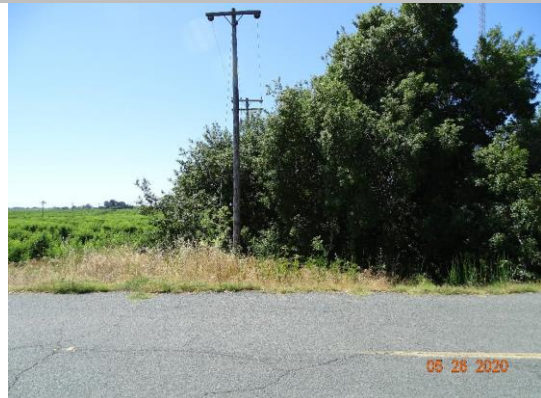
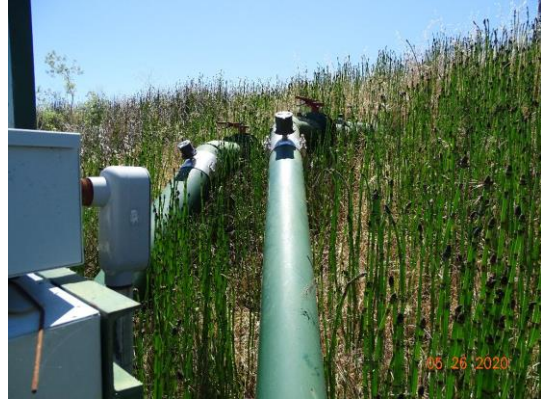
Photo 1 of 3 : UCIP_SP_2022_57034_84419.jpg

Comment Code					
Inspector Comment					
FS_ID:57034 DS_ID:18850 EP_NO: 4637 Repair Type: Non-Urgent Crossing Status: Found UCIP Comments: 05/26/2020 Record updated from No Action Needed to Non-Urgent. Pumping platform on pile structure in the river has been removed. Unable to find permit authorizing modifications to this crossing to sleeve 12-inch pipe through 16-inch pipe. (O.Yakimov - DWR UCIP) 08/06/2013 12-inch steel pipe sleeved through 16 in steel pipe. Pump was running during field survey. FIELD_STRUCT_DESC: 12-inch pipe sleeved through a 16-inch coated steel irrigation discharge pipe through the levee, 5 feet below the crown. Pump on pumping platform of WS slope with stairs to the pump. Flow meter installed on 12-inch pipe. This crossing replaces 16-inch pipe (see DSID 25613). (Replacement of a portion of 16-inch pipe through the levee section authorized under Permit No. 4637, 1964 - Green and McKeown Farms, Inc). [Additional Reference(s): DWR Levee Log, 2005 (HLM 0.70). USACE Sacramento O&M Manual, Unit 111, May 1959, Revised 29 December 2016, (RM 35.90), listed as 14-inch pipe]. FS Date: 5/26/2020 8:27:31 AM

Top of Levee: View of levee crown at the crossing looking upstream

Land-Side: View of landside looking from crown

Water-Side: View of levee slope looking towards crown

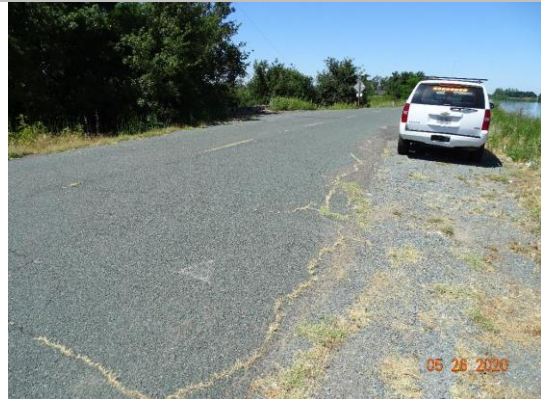
Photo 1 of 3 : UCIP_SP_2022_57035_84433.jpg

FS_ID:57035
DS_ID:18851
EP_NO: 7357
Repair Type: Non-Urgent
Crossing Status: Found
UCIP Comments: 05/26/2020 Record remains Non-Urgent. Pumping platform on pile structure in the river has been removed. No permit has been identified authorizing original 16-inch pipe. Annular space between 8-inch pipe and 16-inch pipe has been grouted. (O.Yakimov - DWR UCIP)
08/06/2013 An abandoned 12-in steel pipe lying on LS levee slope should be removed. A buried concrete headwall found on LS levee slope should be checked for any pipe or connection.
FIELD_STRUCT_DESC: 8-inch pipe and 2-inch electrical conduit sleeved through a 16-inch steel irrigation discharge pipe through the levee, 4.2 feet below the crown. Pump on pumping platform on WS slope with stairs to pump. (Additional pump installation on WS and sleeving 8-inch pipe through an existing 14-inch pipe authorized under Permit 7357, 1971 - Green and Keown Farms, Inc). [Additional Reference(s): DWR Levee Log, 2005, (HLM 0.70), 14-inch outer pipe referenced. USACE Sacramento O&M Manual, Unit 111, May 1959, Revised 29 December 2016, (RM 35.90), listed as 14-inch pipe].

Top of levee: View of levee crown looking downstream

Water-Side: View of waterside looking from crown

Land-Side: View of landside looking from crown

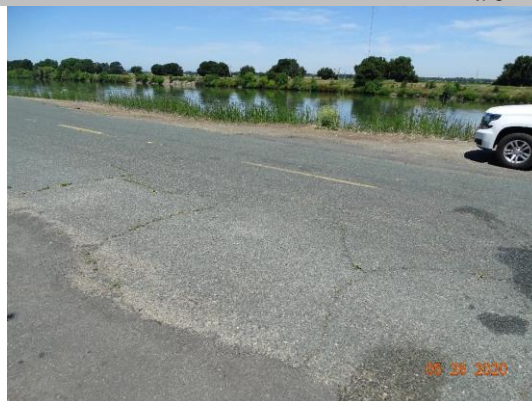
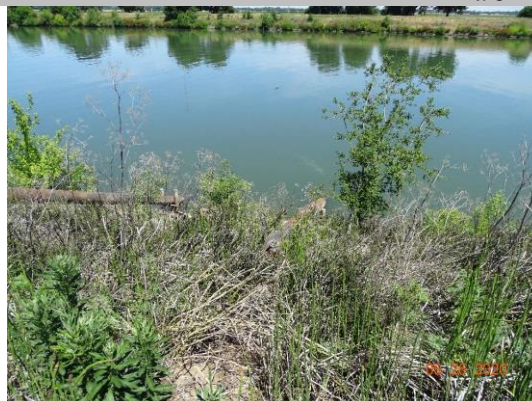
Photo 1 of 3 : UCIP_SP_2022_57042_84449.jpg

FS_ID:57042
DS_ID:18853
EP_NO: N/A
Repair Type: Non-Urgent
Crossing Status: Found
UCIP Comments: 05/26/2020 Record updated from No Action Needed to Non-Urgent. Crossing appears abandoned: landside end filled with concrete and capped with a steel plate. Unauthorized encroachment recorded in Levee Log prior to 2011. (O.Yakimov - DWR UCIP)

FIELD_STRUCT_DESC: 30-inch pipe of an unknown material or purpose through the levee, 10.5 feet below the crown. Landside (LS) end filled with concrete and capped with a steel plate. Concrete headwall on the LS end. [Additional Reference(s): DWR Levee Log, 2005 (HLM 0.71)].
FS Date: 5/26/2020 3:47:43 PM

Top of Levee: View of levee crown looking downstream

Water-Side: View of levee slope looking from crown

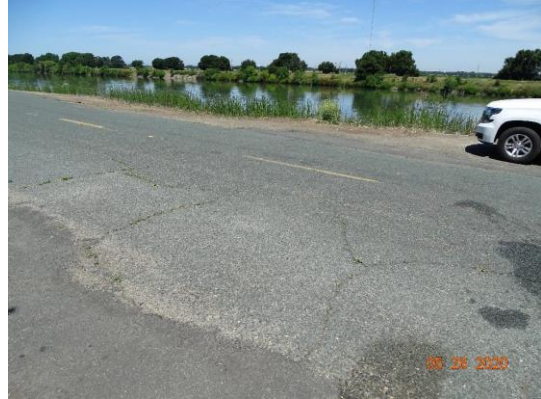
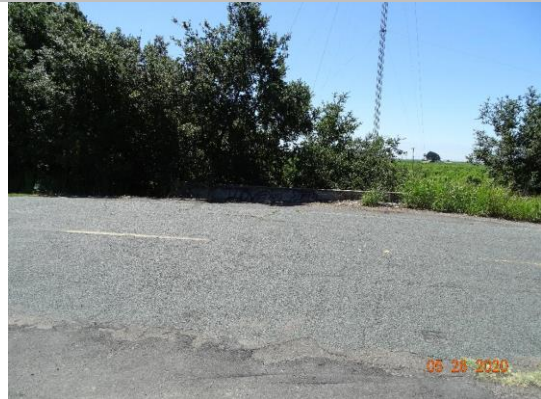
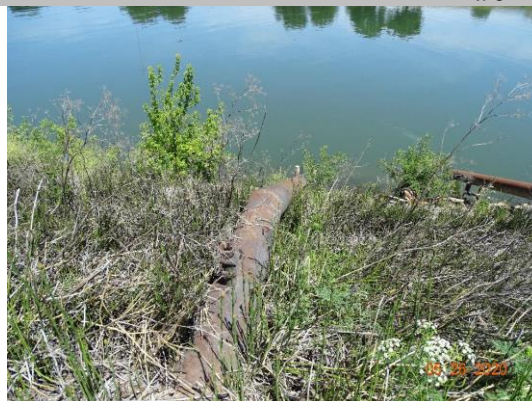
Photo 1 of 3 : UCIP_SP_2022_57043_84452.jpg

Comment Code					
Inspector Comment					
FS_ID:57043 DS_ID:18854 EP_NO: 1716 Repair Type: Non-Urgent Crossing Status: Found UCIP Comments: 05/26/2020 Record remains Non-Urgent. Crossing appears abandoned. Unable to find pipe on landside during field visit due to excessive vegetation. (O.Yakimov - DWR UCIP) 08/06/2013 Not found- a 4-inch pipe on waterward shoulder but a 2-inch GI pipe found on landside slope. FIELD_STRUCT_DESC: 18-inch drainage pipe of an unknown material through the levee, invert elevation 4.5 feet below the crown. Concrete headwall on LS. (18-inch pipe authorized under Permit No. 1716, 1952 - Reclamation District No. 755). [Additional Reference(s): DWR Levee Log, 2005 (HLM 0.72). USACE Sacramento O&M Manual, Unit 111, May 1959, Revised 29 December 2016, (RM 35.88), listed as 18-inch pipe]. FS Date: 5/26/2020 4:05:57 PM

Top of Levee: View of levee crown looking downstream

Top of Levee: View of levee crown and landside looking from crown

Water-Side: View of levee slope looking from crown

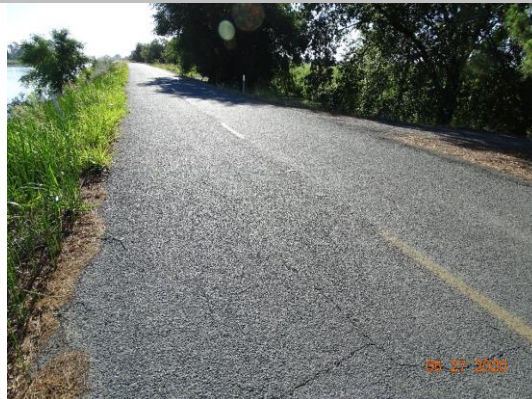
Photo 1 of 3 : UCIP_SP_2022_57044_84456.jpg

LM Start	0.93	Rating **	M	Issue No.	29
LM End	0.93	Issue Type +	En	Location *	
Category	Supplemental			GPS Latitude/Longitude	
				Start	End
Item	DWR UCIP Field Study			38.344097 °	38.344097 °
				-121.552110 °	-121.552110 °
DWR ID	18863				
Comment Code					
Inspector Comment					
FS_ID:57044 DS_ID:18863 EP_NO: N/A Repair Type: Non-Urgent Crossing Status: Not Found UCIP Comments: 05/27/2020 Record updated to Non-Urgent. Crossing not found. No permit has been identified authorizing pipe. (O.Yakimov - DWR UCIP) FIELD_STRUCT_DESC: 10-inch irrigation discharge pipe of an unknown material through the levee, at an unknown depth. Pump and gate valve on the landside (LS). [Additional Reference(s): USACE Sacramento O&M Manual, Unit 111, May 1959, Revised 29 December 2016, (RM 35.76), listed as 10-inch pipe]. FS Date: 5/27/2020 4:18:21 PM

Top of Levee: View of levee crown looking upstream

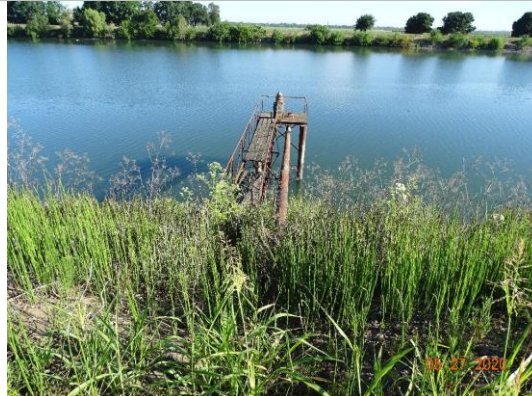
Photo 2 of 3 : UCIP_SP_2022_57044_84457.jpg

Water-Side: View of levee slope looking from crown

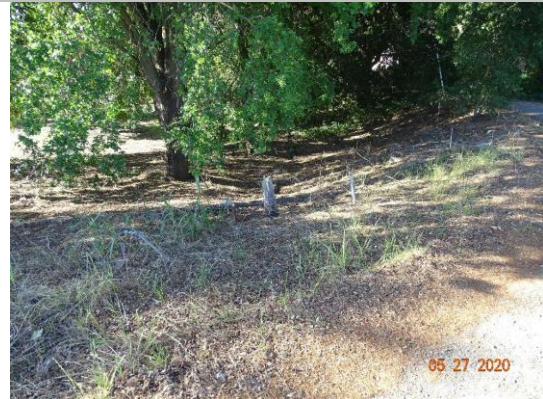
Photo 3 of 3 : UCIP_SP_2022_57044_84458.jpg

LM Start	0.93	Rating **	M	Issue No.	29 (cont)
LM End	0.93	Issue Type +	En	Location *	
Category	Supplemental		GPS Latitude/Longitude		
			Start	End	
Item	DWR UCIP Field Study		38.344097 °	38.344097 °	
			-121.552110 °	-121.552110 °	
DWR ID	18863

Land-Side: View of levee slope looking from crown

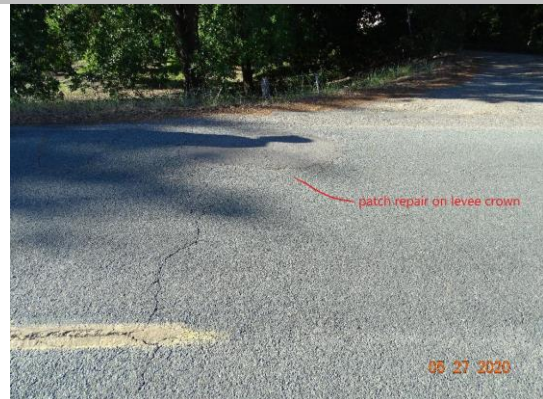
Photo 1 of 3 : UCIP_SP_2022_57080_84498.jpg

LM Start	0.93	Rating **	U	Issue No.	30
LM End	0.93	Issue Type +	En	Location *	
Category	Supplemental		GPS Latitude/Longitude		
			Start	End	
Item	DWR UCIP Field Study		38.344103 °	38.344103 °	
			-121.552119 °	-121.552119 °	
DWR ID	18855

FS_ID:57080
DS_ID:18855
EP_NO: 11225
Repair Type: Urgent
Crossing Status: Found
UCIP Comments: 05/27/2020 Record updated from Non-Urgent to Urgent. Through holes in pipe on waterside slope, sinkhole on WS shoulder measures 3'x3'x1'. Erosion continues to levee crown - road pavement. Asphalt patch repair on the crown. Knocked down service pole with electric box on LS slope. Crossing appears abandoned. Need to have CVFPB review ABO and determine current owner. (O.Yakimov - DWR UCIP)
08/06/2013 Abandoned pipe and pump. Service pole, power box lying on LS slope.
FIELD_STRUCT_DESC: 10-inch irrigation discharge pipe of an unknown material and a 1-inch electrical conduit through the levee, invert elevation 5.6 feet below the crown. Pump on a pile structure with a walkway to the pump. Abandoned service pole on the landside (LS) slope. (10-inch pipe [HLM 0.94] authorized under Automatic Board Order (ABO) issued as Permit No. 11225, 1975 - Helen D. Wilson). [Additional Reference(s): DWR Levee Log, 2005 (HLM 0.94). USACE Sacramento O&M Manual, Unit 111, May 1959, Revised 29 December 2016, (RM 35.66), listed as 10-inch pipe. USACE As-Built Drawing No. 50-04-2983, Sheet 13, downstream of Station 515+00, March 1954].

Top of Levee: View of levee crown looking across the road

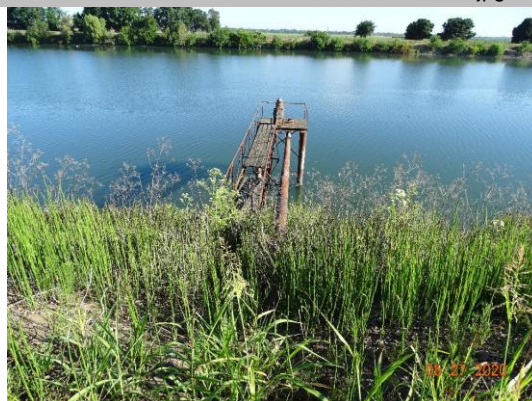
Photo 3 of 3 : UCIP_SP_2022_57080_84495.jpg

LM Start	0.93	Rating **	U	Issue No.	30 (cont)
LM End	0.93	Issue Type +	En	Location *

Water-Side: View of levee slope looking from crown

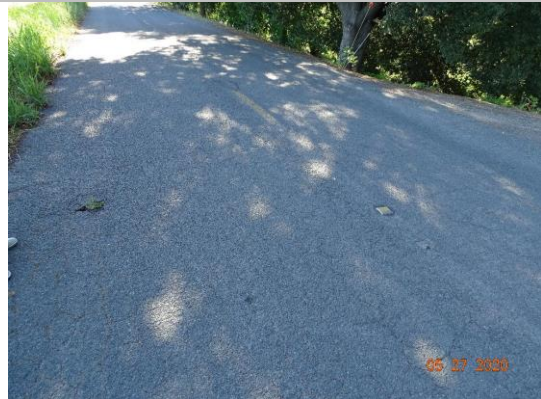
Photo 1 of 3 : UCIP_SP_2022_57081_84506.jpg

Comment Code						
Inspector Comment						
FS_ID:57081 DS_ID:18856 EP_NO: N/A Repair Type: Non-Urgent Crossing Status: Found UCIP Comments: 05/27/2020 Record remains Non-Urgent. A sinkhole is developing on levee crown closer to waterside hinge. The sinkhole is currently measuring 12"x18" in size. Was unable to locate pipe on landside slope. Crossing appears abandoned. No permit has been identified authorizing pipe. (O.Yakimov - DWR UCIP) 08/06/2013 Needs to be properly abandoned. FIELD_STRUCT_DESC: 12-inch pipe of an unknown material or purpose through the levee, invert elevation 5 feet below the crown. Siphon breaker on the waterside (WS). Pipe not found on the landside (LS). [Additional Reference(s): DWR Levee Log, 2005 (HLM 1.05). USACE Sacramento O&M Manual, Unit 111, May 1959, Revised 29 December 2016, (RM 35.55), listed as 12-inch pipe]. FS Date: 5/27/2020 7:33:53 AM

Top of Levee: View of levee crown looking upstream

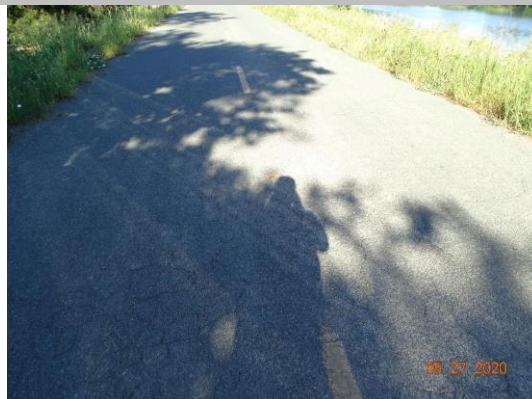
Photo 1 of 3 : UCIP_SP_2022_57083_84522.jpg

FS_ID:57083
DS_ID:18857
EP_NO: 11219
Repair Type: Urgent
Crossing Status: Found
UCIP Comments: 05/27/2020 Record updated from Non-Urgent to Urgent. Unauthorized 8'x3'x3' excavation between pump house and WS levee slope was observed. Excavation exposes 8-inch pipe cut-off that was welded to a 6-inch pipe going towards pump house. Pump is running, minor water leaks from pump in pump house observed. CMP riser on LS shoulder is filled with soil and debris. No permit has been identified authorizing pipe. (O.Yakimov - DWR UCIP)
08/06/2013 requires cleaning of siphon breaker box.
FIELD_STRUCT_DESC: 8-inch irrigation discharge pipe of an unknown material through the levee, invert elevation 5.7 feet below the crown. Siphon breaker in a 26-inch corrugated metal pipe (CMP) riser on the landside (LS) shoulder. Power pole on the LS. Pump and power box in a pump house on the waterside (WS) slope. Electrical conduit through the levee at the same location. (8-inch pipe [HLM 1.13] authorized under Automatic Board Order (ABO) issued as Permit No. 11219, 1975 - David J. Jr and Bonnie Elliott). [Additional Reference(s): DWR Levee Log, 2005 (HLM 1.13). USACE Sacramento O&M Manual, Unit 111, May 1959, Revised 29 December 2016, (RM 35.47), listed as 8-inch pipe].

Top of Levee: View of levee crown looking downstream

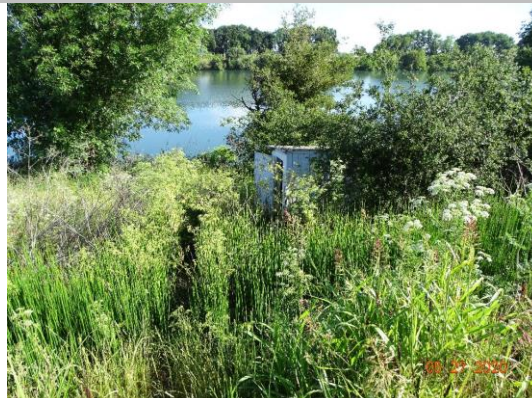
Photo 2 of 3 : UCIP_SP_2022_57083_84523.jpg

Water-Side: View of levee slope looking from crown

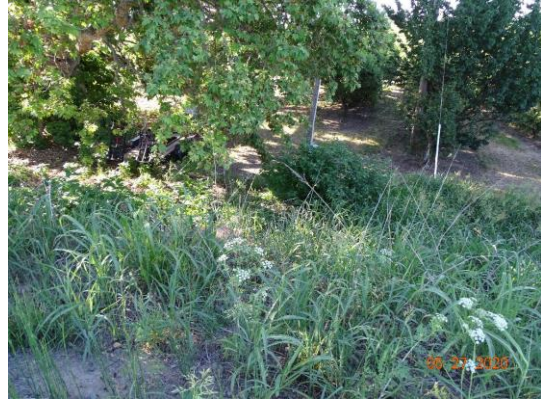
Photo 3 of 3 : UCIP_SP_2022_57083_84524.jpg

LM Start	1.12	Rating **	U	Issue No.	35 (cont)
LM End	1.12	Issue Type +	En	Location *	
Category	Supplemental		GPS Latitude/Longitude		
			Start	End	
Item	DWR UCIP Field Study		38.343305 °	38.343305 °	
			-121.555538 °	-121.555538 °	
DWR ID	18857

Land-Side: View of levee slope looking from crown

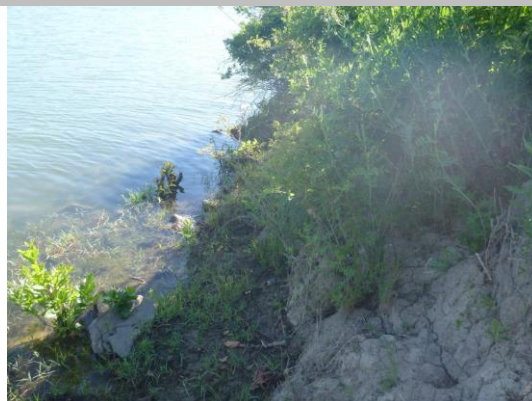
Photo 1 of 1 : SP_2022_RD0755_177_22_20220307_00007.jpg

LM Start	1.23	Rating **	A/W	Issue No.	22	
LM End	1.29	Issue Type +	Ma	Location *	WS	
Category	Earthen Levee			GPS Latitude/Longitude		
				Start	End	
Item	Erosion / Bank Caving			38.342992 °	38.342633 °	
				-121.557572 °	-121.558622 °	
DWR ID	LMA-155					
Comment Code						
E1 : Note and monitor erosion site.						
Inspector Comment						
This was a 2017 Storm Damage site. Damage consists of erosion of the lower waterside levee slope and bank approximately 322 feet in length. Site ID No:328 Site Designation:LMA-155 6/18/2020 Field Notes: Erosion is into berm and not prism.

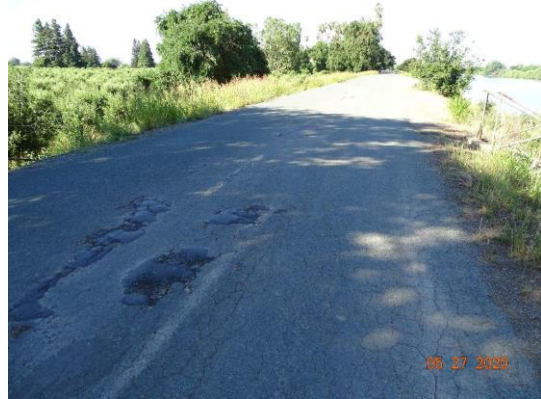
Photo 1 of 3 : UCIP_SP_2022_57084_84533.jpg

FS_ID:57084
DS_ID:18858
EP_NO: 11219
Repair Type: Non-Urgent
Crossing Status: Found
UCIP Comments: 05/27/2020 Record remains Non-Urgent. 14-inch supply pipe segment on waterside cut off between closure device and levee shoulder and replaced with 12-inch pipe from WS shoulder to riverbank. Pump house with a pump at LS toe was built. 8-inch pipe daylights in this pump house. Pump on pile structure in the river and walkway to the pump have been abandoned. 2-inch electrical conduit through the levee has open end with no wires on LS shoulder - should be abandoned properly. Need to have CVFPB review ABO and determine current owner. (O.Yakimov - DWR UCIP)
08/06/2013 Pump and walkway seem abandoned.- Power line is not connected with pump.- A pump house like structure found on LS levee toe.
FIELD_STRUCT_DESC: 14-inch irrigation discharge pipe of an unknown material through the levee, invert elevation 8.5 feet below the crown. Pump house at landside levee toe. Siphon breaker and power pole on the landside (LS) slope. 2-inch electrical conduit through the levee at the same location. Pump on pile structure in the river and walkway to the pump have been abandoned. (14-inch pipe [HLM 1.65] authorized under Automatic Board Order (ABO) issued as Permit No. 11219, 1975 - David J. Jr and Bonnie Elliott). [Additional Reference(s): DWR Levee Log, 2005 (HLM 1.65). USACE Sacramento O&M Manual, Unit 111, May 1959, Revised 29 December 2016, (RM35.02), 14-inch pipe referenced in RD0551. USACE As-Built Drawing No. 50-4-2983, Sheet 11, page 15, March 1954. USACE As-Built Drawing No. 06-13-1100, Sheet 12, near 'L' 1283+75, January 1933].

Top of Levee: View of levee crown looking downstream

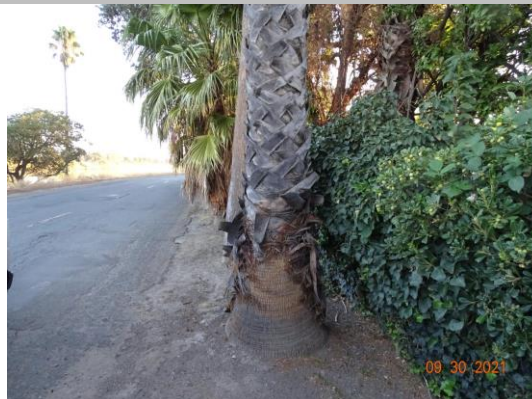
Photo 1 of 1 : SP_2022_RD0755_177_25_20220307_00009.jpg

LM Start	1.73	Rating **	U	Issue No.	25
LM End	1.84	Issue Type +	En	Location *	LS
Category	Earthen Levee			GPS Latitude/Longitude	
				Start	End
Item	Vegetation			38.337688 °	38.336437 °
				-121.563738 °	-121.564800 °
DWR ID	DWR_RD0755_01_f_2017_25				
Comment Code					
V6 : Landscaping					
Inspector Comment					
Landscaping on landside should be maintained to allow inspection and access to levee slope and toe.

View looking upstream at landscaping on the landside slope (Fall 2021).
