**Flood Control Project Maintenance  
Levee Inspections**

**Fall 2017 Levee Maintenance Deficiency Summary Report**

**Reclamation District No. 0765 Glide**

Waterway			Bank	Unit Miles
Unit No. 01 Sacramento River			Right	1.72
	Spring (March - May)	Summer (June - August)	(September - November) Fall	Winter (December - February)
Unit Maintenance Rating (Fall Only)			<b>U</b>	
Date of Inspection	3/13/2017 - 3/13/2017		9/5/2017 - 9/5/2017	
DWR Inspector	Richard Willoughby		Dave Torres	
Accompanied By	Everett Lovejoy RD 765		David Dickson RD765

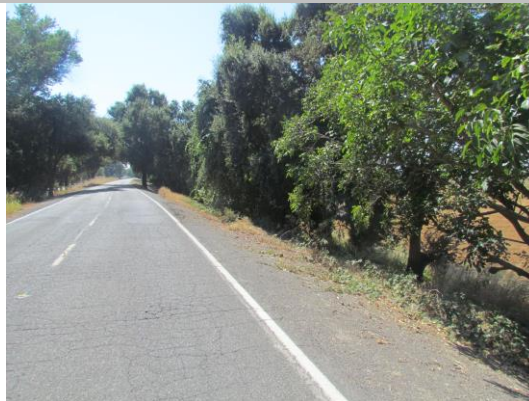
Photo 1 of 1 : FA\_2017\_RD0765\_211\_38\_20170901\_00039.jpg

LM Start	1.09	Rating **	M	Issue No.	38
LM End	1.15	Issue Type +	Ma	Location *	LS
Category	Earthen Levee			GPS Latitude/Longitude	
				Start	End
Item	Trim / Thin Trees			38.488279 °	38.487465 °
				-121.554615 °	-121.554117 °
DWR ID	DWR_RD0765_01_s_2012_38				
Comment Code					
T1 : Trim trees to at least five feet above ground level.					
Inspector Comment

Looking southwest at untrimmed trees on landward slope.

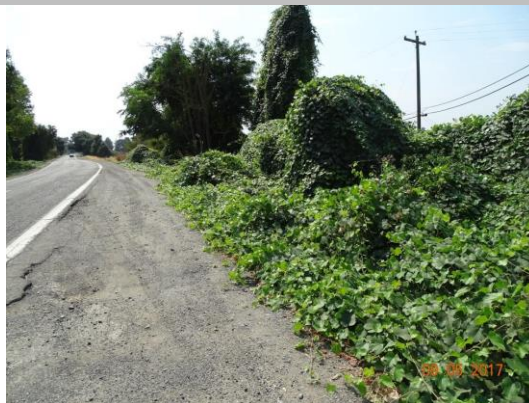
Photo 1 of 3 : FA\_2017\_RD0765\_211\_33\_20170919\_00079.jpg

LM Start	1.28	Rating **	U	Issue No.	33
LM End	1.32	Issue Type +	Ma	Location *	LS
Category	Earthen Levee			GPS Latitude/Longitude	
				Start	End
Item	Vegetation			38.485699 °	38.485161 °
				-121.553107 °	-121.552806 °
DWR ID	DWR_RD0765_01_f_2015_33				
Comment Code					
V2 : Remove the wild growth other than native grasses from the levee slopes.					
Inspector Comment					
Dense vines on landward slope and toe.

Looking south at the landside slope.

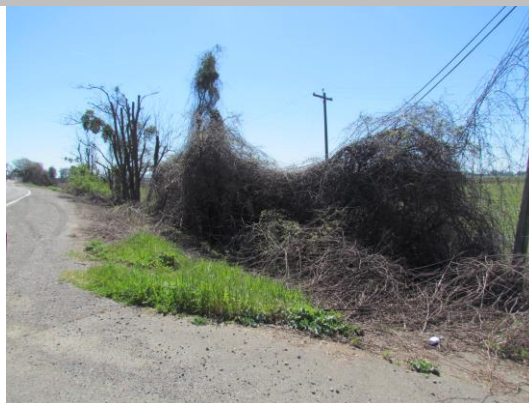
Photo 2 of 3 : FA\_2017\_RD0765\_211\_33\_20170901\_00036.jpg

Looking west at dead vines on landward slope. (Spring 2017)

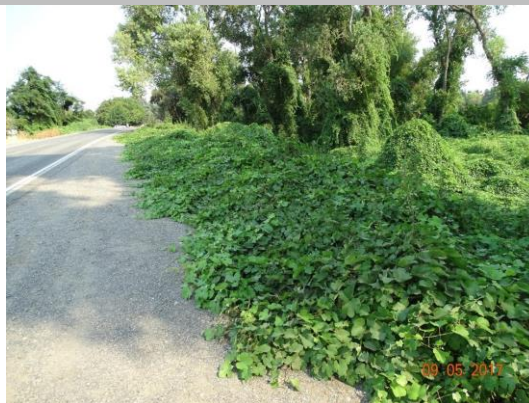
Photo 1 of 1 : FA\_2017\_RD0765\_211\_56\_20170919\_00077.jpg

LM Start	1.29	Rating **	M	Issue No.	56
LM End	1.37	Issue Type +	Ma	Location *	WS
Category	Earthen Levee			GPS Latitude/Longitude	
				Start	End
Item	Vegetation			38.485662 °	38.484617 °
				-121.553001 °	-121.552327 °
DWR ID	DWR_RD0765_01_f_2016_56				
Comment Code					
V2 : Remove the wild growth other than native grasses from the levee slopes.					
Inspector Comment					
Wild gape vines on waterward slope

Looking northwest at waterside slope.

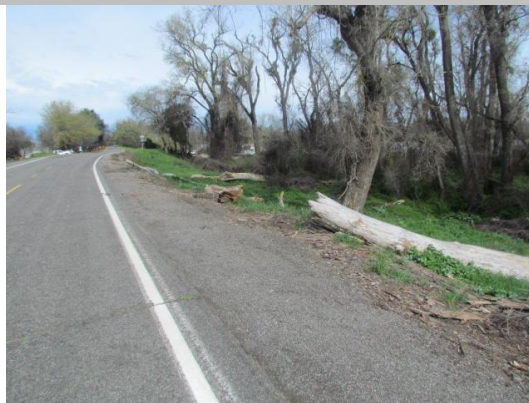
Photo 2 of 4 : FA\_2017\_RD0765\_211\_7\_20170901\_00009.jpg

LM Start	<b>1.32</b>	Rating **	M	Issue No.	<b>7 (cont)</b>
LM End	<b>1.34</b>	Issue Type +	Ma	Location *	WS

Looking northeast at tree limbs on waterward slope.

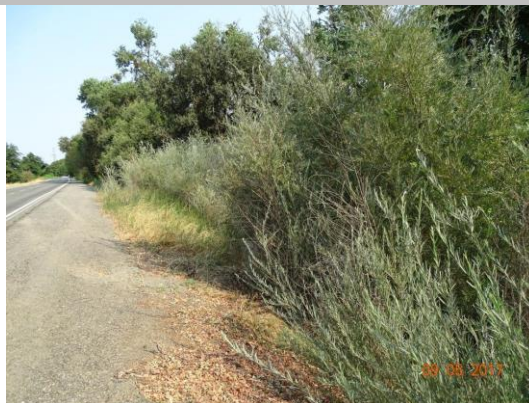
Photo 1 of 1 : FA\_2017\_RD0765\_211\_5\_20170919\_00072.jpg

LM Start	1.42	Rating **	U	Issue No.	5
LM End	1.45	Issue Type +	Ma	Location *	WS
Category	Earthen Levee			GPS Latitude/Longitude	
				Start	End
Item	Trim / Thin Trees			38.483925 °	38.483530 °
				-121.551845 °	-121.551587 °
DWR ID	DWR_RD0765_01_s_2012_5				
Comment Code					
T2 : Thin trees to allow visibility of the ground and room to flood fight.					
Inspector Comment					
Control willow trees on waterward slope.

Looking northwest at the waterside slope.

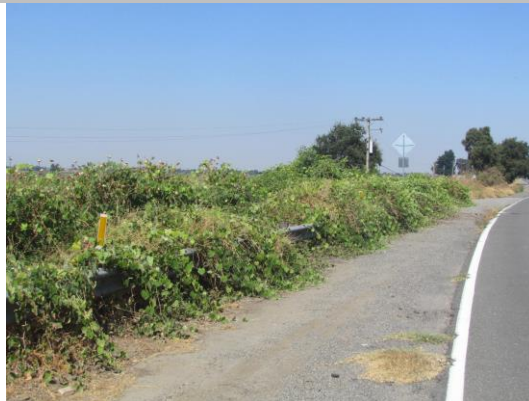
Photo 3 of 5 : FA\_2017\_RD0765\_211\_29\_20170901\_00031.jpg

Looking northwest at berryvines on landward slope and toe. (Fall 2016)

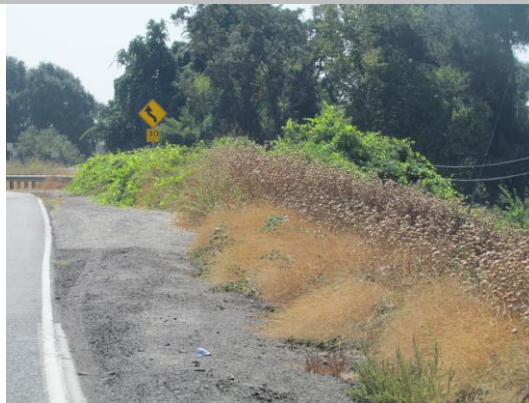
Photo 4 of 5 : FA\_2017\_RD0765\_211\_29\_20170901\_00032.jpg

Looking southwest at dense berry vines and other vegetation on landward slope. (Fall 2016)

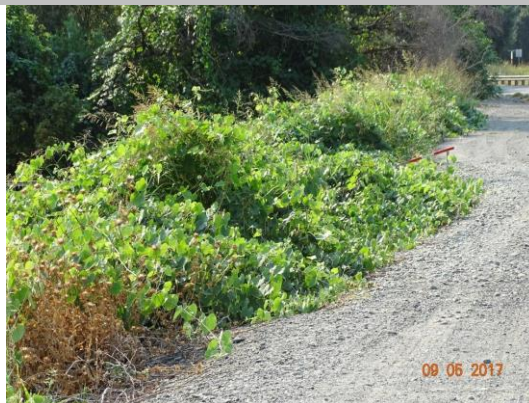
Photo 1 of 3 : FA\_2017\_RD0765\_211\_48\_20170919\_00075.jpg

LM Start	1.53	Rating **	U	Issue No.	48
LM End	1.56	Issue Type +	Ma	Location *	WS
Category	Earthen Levee			GPS Latitude/Longitude	
				Start	End
Item	Vegetation			38.482539 °	38.482144 °
				-121.550887 °	-121.550657 °
DWR ID	DWR_RD0765_01_f_2016_48				
Comment Code					
V2 : Remove the wild growth other than native grasses from the levee slopes.					
Inspector Comment					
Wildgrape vines on waterward slope should be removed from waterward slope.

Looking southeast at the waterside slope.

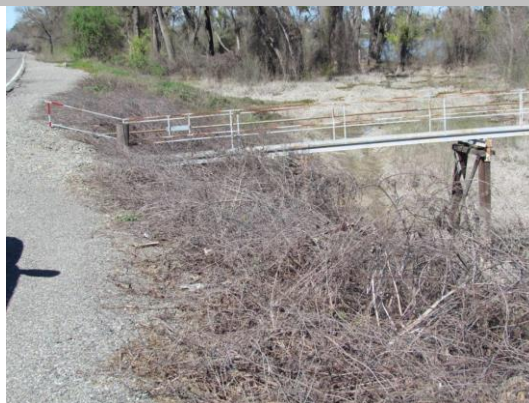
Photo 2 of 3 : FA\_2017\_RD0765\_211\_48\_20170901\_00047.jpg

Looking north at dead vines on waterward slope. (Spring 2017)

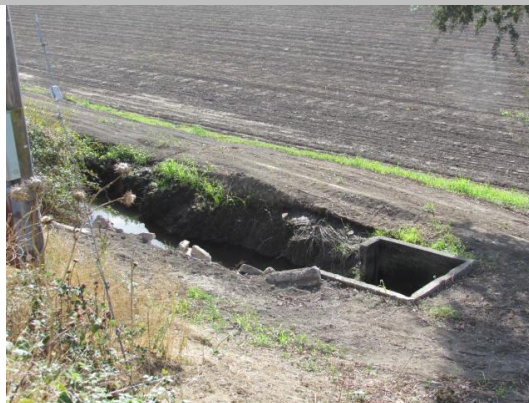
Photo 1 of 2 : FA\_2017\_RD0765\_211\_60\_20170901\_00060.jpg

LM Start	1.55	Rating **	U	Issue No.	60
LM End	1.61	Issue Type +	En	Location *	LS
Category	Earthen Levee			GPS Latitude/Longitude	
				Start	End
Item	Encroachments			38.482300 °	38.481482 °
				-121.550808 °	-121.550283 °
DWR ID	DWR_RD0765_01_f_2013_60				
Comment Code					
DT : Ditch					
Inspector Comment					
Old irrigation ditch at landward toe.

Looking southwest at irrigation ditch at landward toe. (Fall 2014)

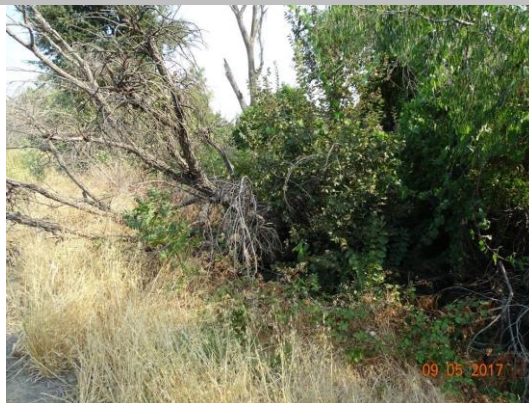
Photo 1 of 1 : FA\_2017\_RD0765\_211\_39\_20170919\_00074.jpg

LM Start	1.59	Rating **	U	Issue No.	39
LM End	1.59	Issue Type +	Ma	Location *	WS
Category	Earthen Levee			GPS Latitude/Longitude	
				Start	End
Item	Encroachments			38.481798 °	38.481798 °
				-121.550449 °	-121.550449 °
DWR ID	DWR_RD0765_01_f_2016_39				
Comment Code					
TR : Tree or limb					
Inspector Comment					
Downed tree on waterward slope.

Looking north at the waterside slope.
