**Flood Control Project Maintenance
Levee Inspections**

Maintenance Issue Types Only, Levee Inspection Report By Mile - Fall 2017

Reclamation District No. 0765 Glide

Waterway	Bank	Unit Miles	Inspection Start/End	Inspector
Unit No. 01 Sacramento River	Right	1.72	09/05/2017 09/05/2017	Dave Torres

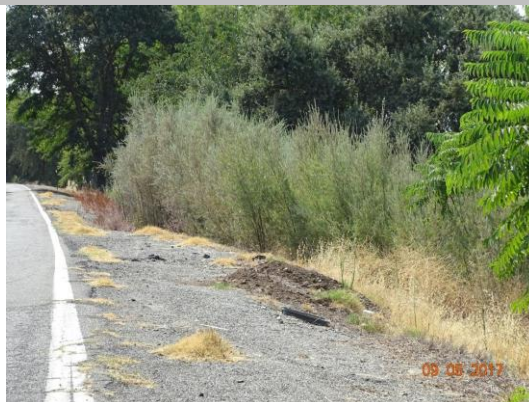
Photo 1 of 2 : FA_2017_RD0765_211_59_20170919_00083.jpg

LM Start	0.48	Rating **	U	Issue No.	59
LM End	0.48	Issue Type +	Ma	Location *	LS
Category	Earthen Levee			GPS Latitude/Longitude	
				Start	End
Item	Vegetation			38.496053 °	38.496053 °
				-121.559690 °	-121.559690 °
DWR ID	DWR_RD0765_01_s_2016_59				
Comment Code					
V2 : Remove the wild growth other than native grasses from the levee slopes.					
Inspector Comment					
Dense vegetation on landward slope.

Looking south at the landside slope.

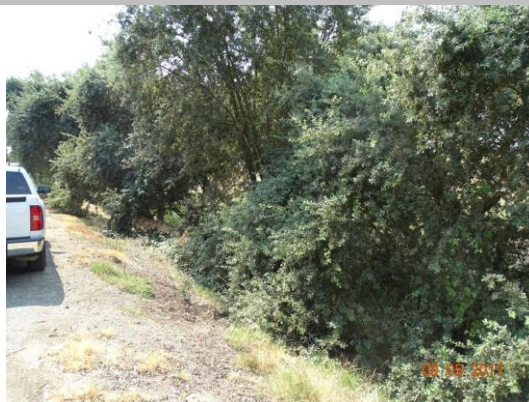
Photo 1 of 1 : FA_2017_RD0765_211_34_20170919_00080.jpg

LM Start	0.54	Rating **	M	Issue No.	34
LM End	0.63	Issue Type +	Ma	Location *	LS
Category	Earthen Levee			GPS Latitude/Longitude	
				Start	End
Item	Trim / Thin Trees			38.495347 °	38.494204 °
				-121.559291 °	-121.558313 °
DWR ID	DWR_RD0765_01_s_2012_34				
Comment Code					
T1 : Trim trees to at least five feet above ground level.					
Inspector Comment

Looking south at landside slope.

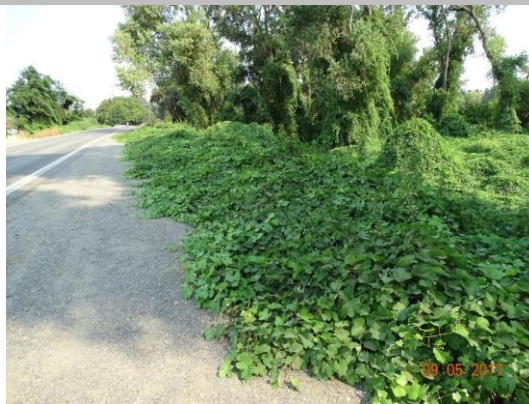
Photo 1 of 1 : FA_2017_RD0765_211_56_20170919_00077.jpg

LM Start	1.29	Rating **	M	Issue No.	56
LM End	1.37	Issue Type +	Ma	Location *	WS
Category	Earthen Levee			GPS Latitude/Longitude	
				Start	End
Item	Vegetation			38.485662 °	38.484617 °
				-121.553001 °	-121.552327 °
DWR ID	DWR_RD0765_01_f_2016_56				
Comment Code					
V2 : Remove the wild growth other than native grasses from the levee slopes.					
Inspector Comment					
Wild gape vines on waterward slope

Looking northwest at waterside slope.

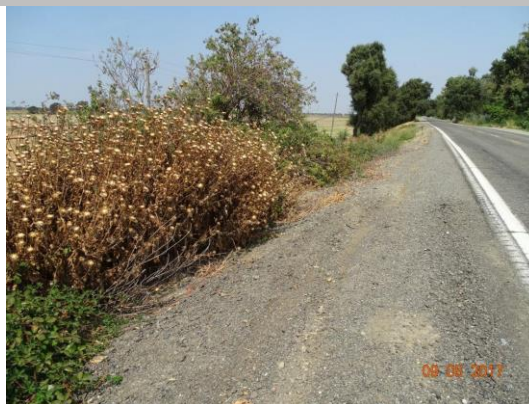
Photo 1 of 5 : FA_2017_RD0765_211_29_20170919_00078.jpg

LM Start	1.52	Rating **	U	Issue No.	29
LM End	1.62	Issue Type +	Ma	Location *	LS
Category	Earthen Levee			GPS Latitude/Longitude	
				Start	End
Item	Vegetation			38.482665 °	38.481421 °
				-121.551036 °	-121.550207 °
DWR ID	DWR_RD0765_01_s_2012_29				
Comment Code					
V2 : Remove the wild growth other than native grasses from the levee slopes.					
Inspector Comment					
Dense berryvines and dense trees on landward slope has been in place for multiple inspection cycles.

Looking northwest at the landside slope.

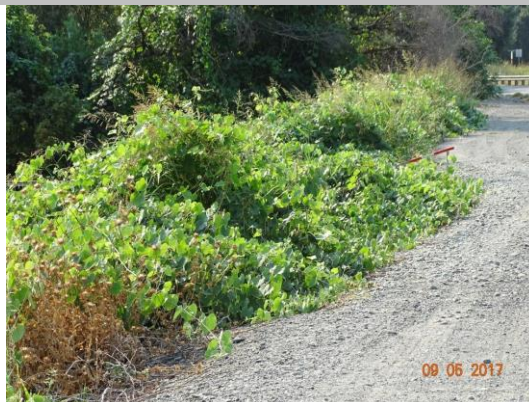
Photo 1 of 3 : FA_2017_RD0765_211_48_20170919_00075.jpg

LM Start	1.53	Rating **	U	Issue No.	48
LM End	1.56	Issue Type +	Ma	Location *	WS
Category	Earthen Levee			GPS Latitude/Longitude	
				Start	End
Item	Vegetation			38.482539 °	38.482144 °
				-121.550887 °	-121.550657 °
DWR ID	DWR_RD0765_01_f_2016_48				
Comment Code					
V2 : Remove the wild growth other than native grasses from the levee slopes.					
Inspector Comment					
Wildgrape vines on waterward slope should be removed from waterward slope.

Looking southeast at the waterside slope.

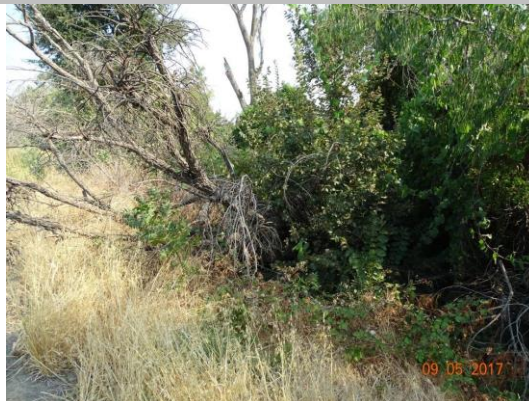
Photo 1 of 1 : FA_2017_RD0765_211_39_20170919_00074.jpg

LM Start	1.59	Rating **	U	Issue No.	39
LM End	1.59	Issue Type +	Ma	Location *	WS
Category	Earthen Levee			GPS Latitude/Longitude	
				Start	End
Item	Encroachments			38.481798 °	38.481798 °
				-121.550449 °	-121.550449 °
DWR ID	DWR_RD0765_01_f_2016_39				
Comment Code					
TR : Tree or limb					
Inspector Comment					
Downed tree on waterward slope.

Looking north at the waterside slope.

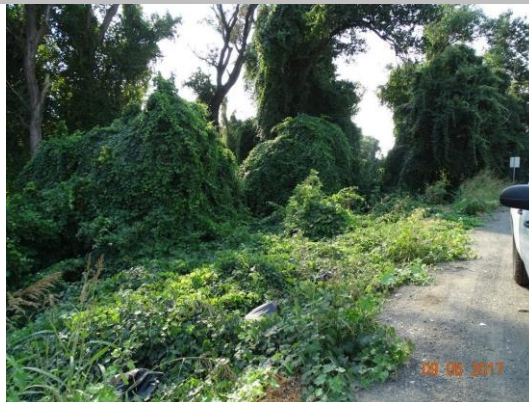
Photo 1 of 2 : FA_2017_RD0765_211_25_20170919_00085.jpg

LM Start	1.59	Rating **	U	Issue No.	25
LM End	1.72	Issue Type +	Ma	Location *	WS
Category	Earthen Levee			GPS Latitude/Longitude	
				Start	End
Item	Vegetation			38.481782 °	38.480140 °
				-121.550426 °	-121.549426 °
DWR ID	DWR_RD0765_01_f_2016_25				
Comment Code					
V2 : Remove the wild growth other than native grasses from the levee slopes.					
Inspector Comment					
Dense vegetation on waterward slope.

Looking southeast at waterside slope.
