**Flood Control Project Maintenance
Levee Inspections**

Maintenance Issue Types Only, Levee Inspection Report By Mile - Spring 2017

Reclamation District No. 0765 Glide

Waterway	Bank	Unit Miles	Inspection Start/End	Inspector
Unit No. 01 Sacramento River	Right	1.72	03/13/2017 03/13/2017	Richard Willoughby

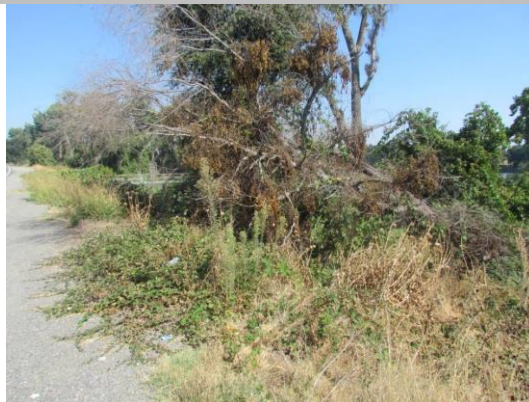
Photo 1 of 2 : SP_2017_RD0765_211_39_20170313_00035.jpg

LM Start	1.59	Rating **	U	Issue No.	39
LM End	1.59	Issue Type +	Ma	Location *	WS
Category	Earthen Levee			GPS Latitude/Longitude	
				Start	End
Item	Encroachments			38.481798 °	38.481798 °
				-121.550449 °	-121.550449 °
DWR ID	DWR_RD0765_01_f_2016_39				
Comment Code					
TR : Tree or limb					
Inspector Comment					
Downed tree on waterward slope.
