**Flood Control Project Maintenance  
Levee Inspections**

**Fall 2012 Levee Maintenance Deficiency Summary Report**

**Sacramento River Basin**

**Reclamation District No. 0784 Plumas Lake**

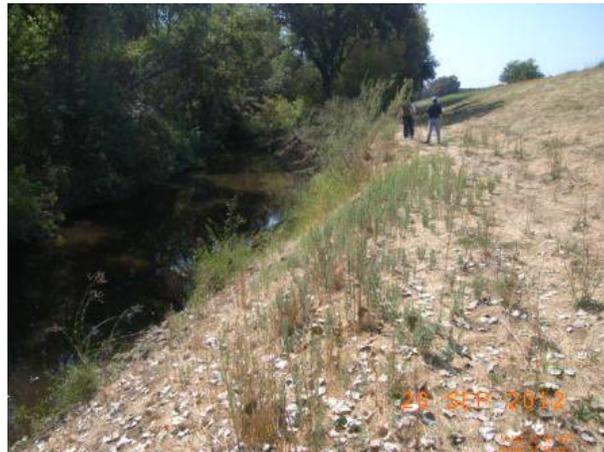
Levee Mile Report Line	4
Start Levee Mile	4.30
End Levee Mile	4.31
Location	Water Side
Category	Supplemental
Item	USACE Erosion Survey
USACE 2012 Photo #1	
USACE2012_BER_4-9_R_1.jpg

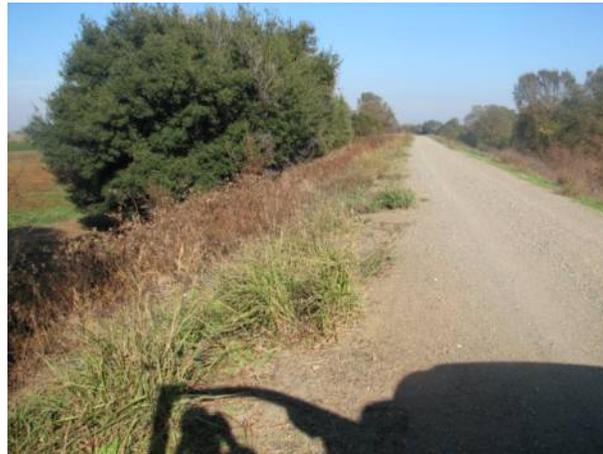
Levee Mile Report Line	6
Start Levee Mile	0.54
End Levee Mile	0.79
Location	Land Side
Category	Earthen Levee
Item	Vegetation
Levee mile 0.54, the landside slope.	
cathom_f_20121119_272.JPG

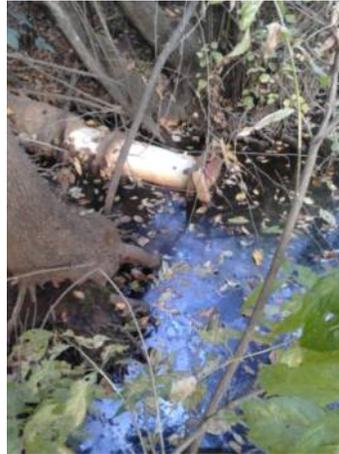
cathom\_f\_20121119\_276.jpg

Levee mile 1.33 waterside of the levee, this pipe appears to be sleeved into a larger pipe, access to both ends is limited.

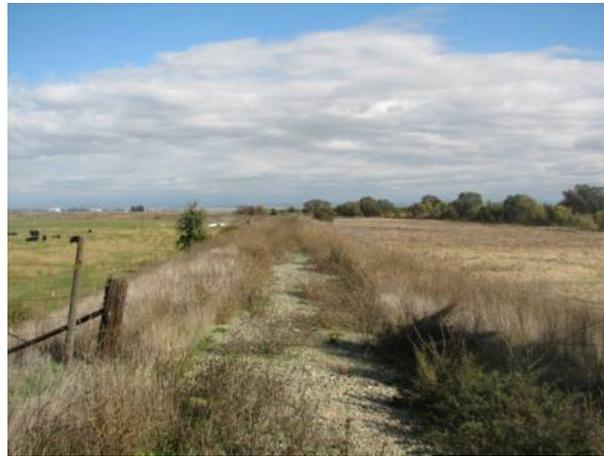
cathom\_f\_20121119\_275.JPG

Levee Mile Report Line	14
Start Levee Mile	1.27
End Levee Mile	1.50
Location	Crown
Category	Earthen Levee
Item	Vegetation

Levee mile 1.27 looking upstream, typical of the levee from 1.27 to 1.50.

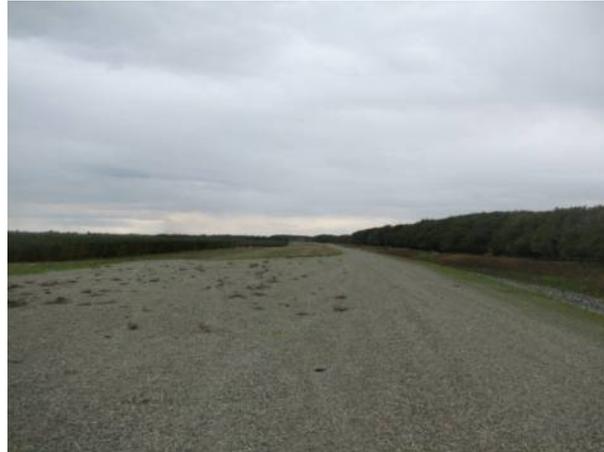
Levee Mile Report Line	1
Start Levee Mile	0.00
End Levee Mile	3.89
Location	Land Side
Category	Earthen Levee
Item	Vegetation
Levee mile 3.89, looking downstream at the landside slope.	
cathom_f_20121119_277.JPG

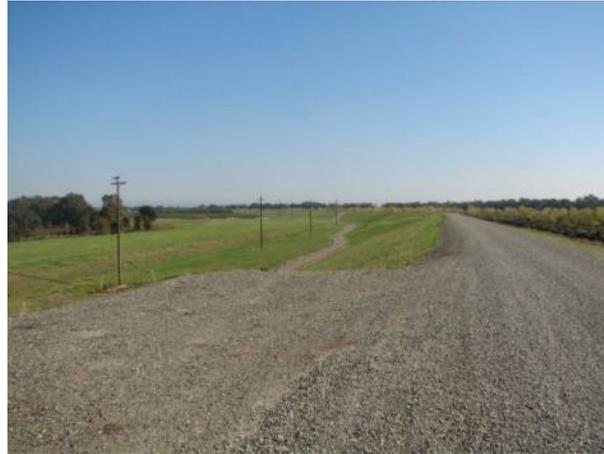
Levee Mile Report Line	1
Start Levee Mile	0.00
End Levee Mile	1.88
Location	Land Side
Category	Earthen Levee
Item	Vegetation
Levee mile 0.00, the landside slope of the levee.	
cathom_f_20121119_279.JPG

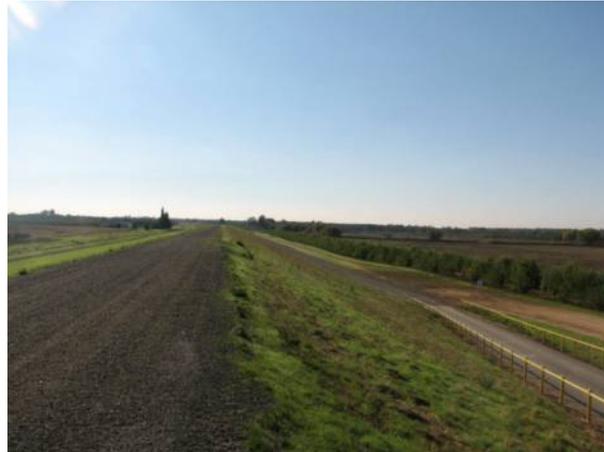
Levee Mile Report Line	1
Start Levee Mile	3.08
End Levee Mile	5.68
Location	Water Side
Category	Earthen Levee
Item	Vegetation
Levee mile 3.08, the waterside slope of the levee.	
cathom_f_20121119_282.JPG
