**Flood Control Project Maintenance
Levee Inspections**

Fall 2013 Levee Maintenance Deficiency Summary Report

Sacramento River Basin

RD0784		Overall LMA Rating	Total LMA Miles						
Reclamation District No. 0784 Plumas Lake		M	34.79						
Rated Item	Maintenance Deficiency				Enforcement		Design & System Obsolescence		
	M Miles	U Miles	M + 4U Miles	Threshold %	M Miles	U Miles	M Miles	U Miles	
<i>Earthen Levee</i>									
Vegetation	0.27	0.96	4.11	11.81%					
Encroachments					2.01	1.54			
Erosion / Bank Caving	0.01		0.01	0.03%					
<i>Interior Drainage & Piping Systems</i>									
Culverts: Inlets / Outlets	0.07		0.07	0.20%					
Culverts: Breaks / Holes / Cracks		0.02	0.08	0.23%					
<i>Supplemental</i>									
USACE Erosion Survey	0.41		0.41	1.18%					
DWR UCIP Field Study					0.15	0.08			
<i>LMA Totals:</i>	0.76	0.98	4.68	13.45%	2.16	1.62	0.00	0.00

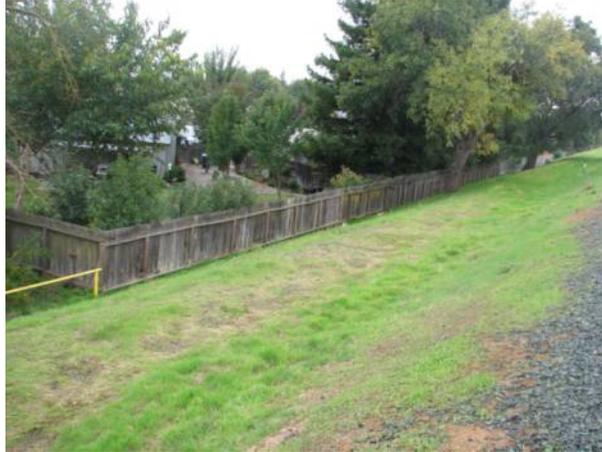
Levee Mile Report Line	4
Start Levee Mile	0.52
End Levee Mile	1.00
Location	Land Side
Category	Earthen Levee
Item	Encroachments
<p>Levee mile 0.53-1.00, this photo shows the fences and other obstruction near the toe of the levee on the landside.</p>	
<p>mhoffman_f_20130917_062.JPG</p>

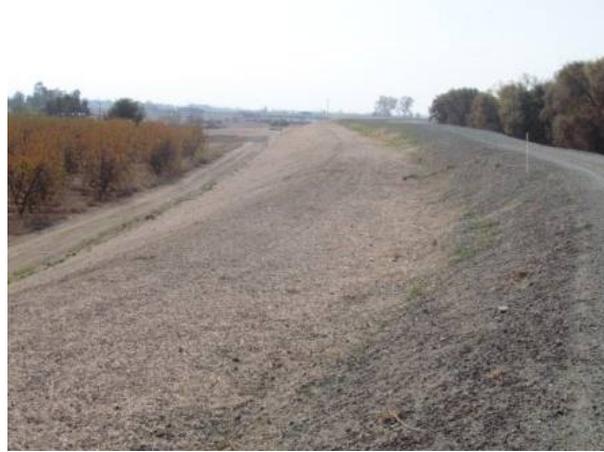
This photo was taken from the levee crown facing south looking down the landward slope at acceptable vegetation control. Fall 2013.

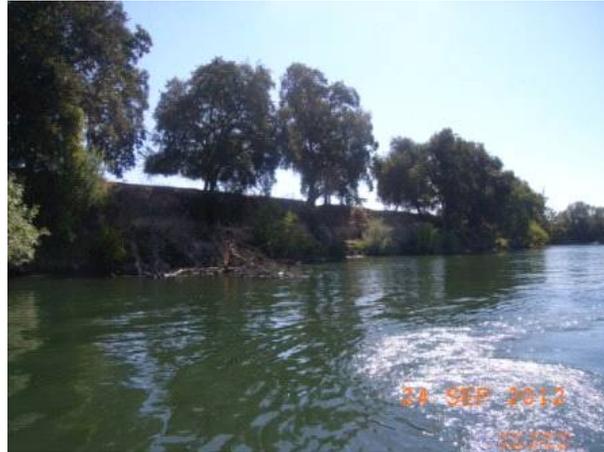
Levee Mile Report Line	1
Start Levee Mile	8.96
End Levee Mile	9.36
Location	Water Side
Category	Supplemental
Item	USACE Erosion Survey
USACE 2012 Photo #1	
USACE2013_FHR_17-8_L_1.jpg

1	8.96	9.36	Supplemental	USACE Erosion Survey	WS	M Ma	Inspector Comments: 2003 - Bank is near vertical. Identified as a Potentially Critical site. 2004 - Eddy flow off downstream end of Modesto formation eroding the fluvial sediments. 2005 - Some new slumping. Actively eroding but berm width is greater than 50 ft. 2006 - Downgraded to regular erosion site. Still actively eroding. Large old rotational failures in high bank on the downstream end. 2008 - Removed from inventory due to wide berm width does not meet criteria for an erosion site. 2010 - Added back to the inventory after 10 ft of bank erosion in the winter 2009 storm. Steep vertical face. 2011 - Bank has retreated an additional 2.5 ft from last year. New tree popouts and erosion throughout the site. 2012: Site continues to worsen with new tree popouts and many areas of new erosion. [2012 Site ID: FHR_17-8_L]	39.009366 ° -121.579766 °	39.004549 ° -121.579143 °	2 Y

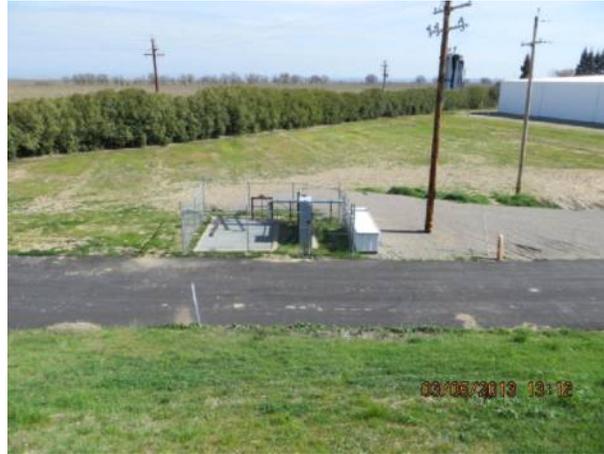
4	9.25	9.25	Supplemental	DWR UCIP Field Study	LS	M En	Inspector Comments: FS_ID:11589 EP_NO: 18227 Repair Type: Non-Urgent Crossing Status: Indicator Found UCIP Comments: Gate on enclosure at LS toe is not locked. Vaults on WS toe are open and need to be secured. FIELD_STRUCT_DESC: 1 of 3: 30-inch HDPE irrigation pipe through the levee 3-feet below the crown. Siphon breaker and air relief valve in vault on waterside shoulder. Pumps in pump house on the bank. Gate valves in concrete distribution box. Chain link enclosure at the landside toe. Discharges into concrete box on the landward side. (Permit No. 18227, 2007) FS Date: 3/5/2013	39.005970 ° 39.005970 °	-121.578008 ° -121.578008 °	5 Y
---	------	------	--------------	----------------------	----	---------	------------------------------------------------------------------------------------------------------------------------------------------------------------------------------------------------------------------------------------------------------------------------------------------------------------------------------------------------------------------------------------------------------------------------------------------------------------------------------------------------------------------------------------------------------------------------------------------------------------------------------	----------------------------	--------------------------------	--------

Levee Mile Report Line	4
Start Levee Mile	9.25
End Levee Mile	9.25
Location	Water Side
Category	Supplemental
Item	DWR UCIP Field Study
Concrete distribution box with chain link enclosure on LS toe.	
UCIP_8992.jpg

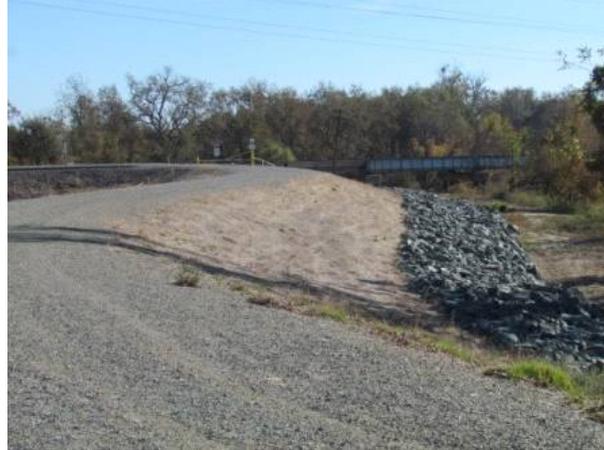
This photo was taken from the levee crown facing east looking down the waterward slope at acceptable vegetation control. Fall 2013.

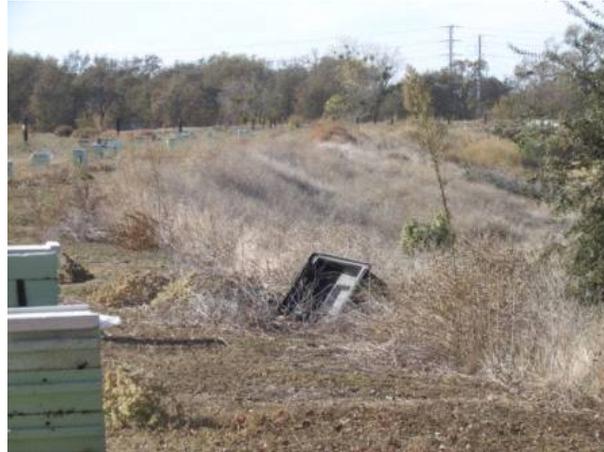
This photo was taken from the levee crown facing west looking at vegetation covering the landward slope. Fall 2013.

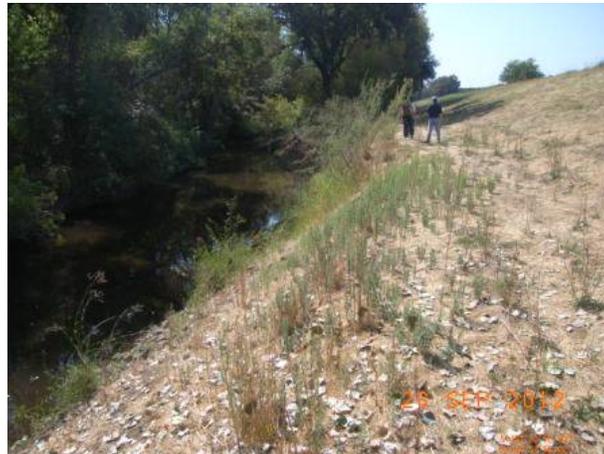
USACE 2012 Photo #1

Levee Mile Report Line	2
Start Levee Mile	4.30
End Levee Mile	4.31
Location	Water Side
Category	Supplemental
Item	USACE Erosion Survey

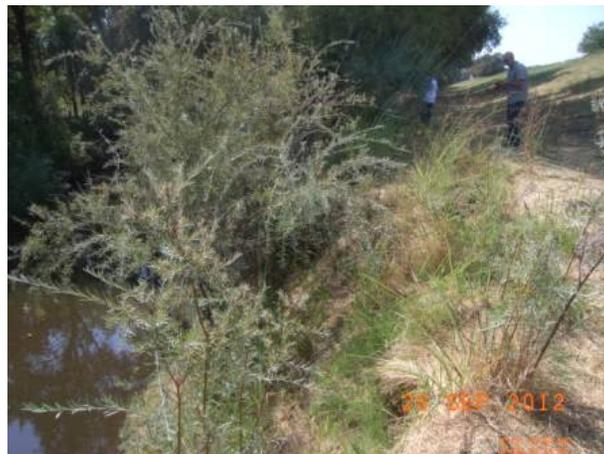
USACE 2012 Photo #2

Levee Mile Report Line	2
Start Levee Mile	4.30
End Levee Mile	4.31
Location	Water Side
Category	Supplemental
Item	USACE Erosion Survey

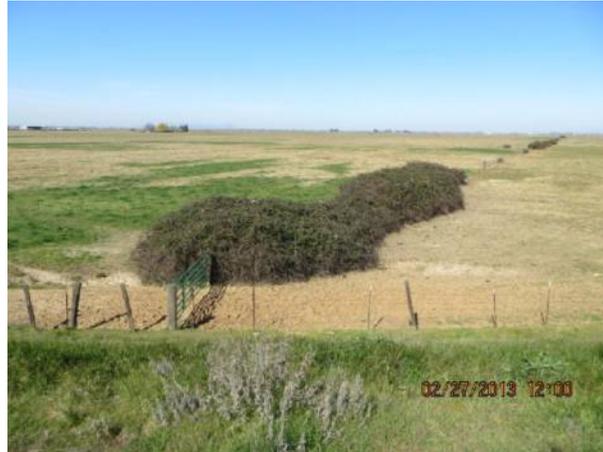
Levee Mile Report Line	3
Start Levee Mile	4.69
End Levee Mile	4.69
Location	Water Side
Category	Supplemental
Item	DWR UCIP Field Study
Unable to locate inlet due to blackberry overgrowth on LS toe.	
UCIP_6346.jpg

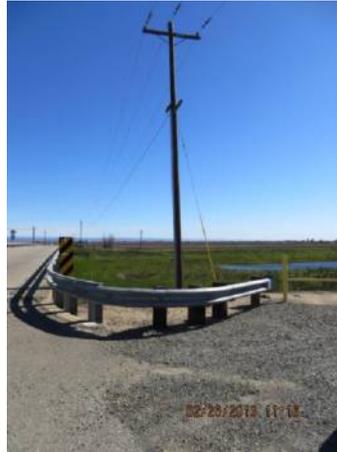
LMR No.	Levee Mile		Category	Item	* Location	** Rating	Action/Comment	GPS Latitude/Longitude		Issue No. Photo
	Start	End						Start	End	
1	3.60	3.60	Supplemental	DWR UCIP Field Study	CR	M En	Inspector Comments: FS_ID:11563 EP_NO: N/A Repair Type: Non-Urgent Crossing Status: Found UCIP Comments: No permit identified for crossing. FIELD_STRUCT_DESC: Communication line through the levee at unknown depth on downstream side of bridge. FS Date: 2/26/2013	39.026347 ° 39.026347 °	-121.542343 ° -121.542343 °	1 Y
DWR ID: DWR_RD0784_04_f_2013_1										
2	3.84	3.84	Earthen Levee	Vegetation	LS	A Ma	V1 : Control annual grass and weeds on the levee slopes and easements.	39.029771 ° -121.542350 °	39.029771 ° -121.542350 °	3 Y
DWR ID: DWR_RD0784_04_f_2013_3										
3	4.31	4.43	Earthen Levee	Erosion / Bank Caving	CR	A Ma	E1 : Note and monitor erosion site.	39.036594 ° -121.542377 °	39.038493 ° -121.542380 °	4 Y

Levee Mile Report Line	1
Start Levee Mile	3.60
End Levee Mile	3.60
Location	Crown
Category	Supplemental
Item	DWR UCIP Field Study
Communication line at base of JP on WS slope.	
UCIP_6329.jpg

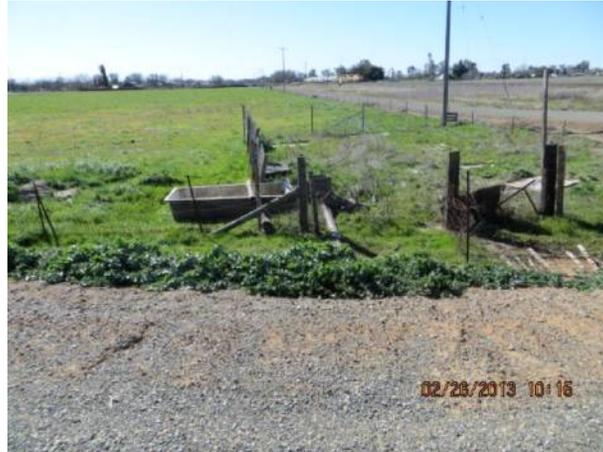
DWR ID: DWR_RD0784_04_s_2012_4										
4	6.26	6.26	Supplemental	DWR UCIP Field Study	CR	U En	Inspector Comments: FS_ID:9528 EP_NO: 5384 Repair Type: Urgent Crossing Status: Found UCIP Comments: Large animal burrough along pipe alignment on WS has undermined pipe for an unknown length. Pipe is corroded through on WS. Pipe should be properly abandoned. FIELD_STRUCT_DESC: 8-inch pipe through the levee 2.6 feet below the crown. Vertical pump unit and service pole on the waterward side. Discharge into concrete riser on the landward side. (Permit No. 5284) 1966. FS Date: 2/26/2013	39.058533 ° 39.058533 °	-121.550485 ° -121.550485 °	2 Y
DWR ID: DWR_RD0784_04_f_2013_2

Levee Mile Report Line	4
Start Levee Mile	6.26
End Levee Mile	6.26
Location	Crown
Category	Supplemental
Item	DWR UCIP Field Study
Concrete riser and pipe on LS toe.	
UCIP_5691.jpg

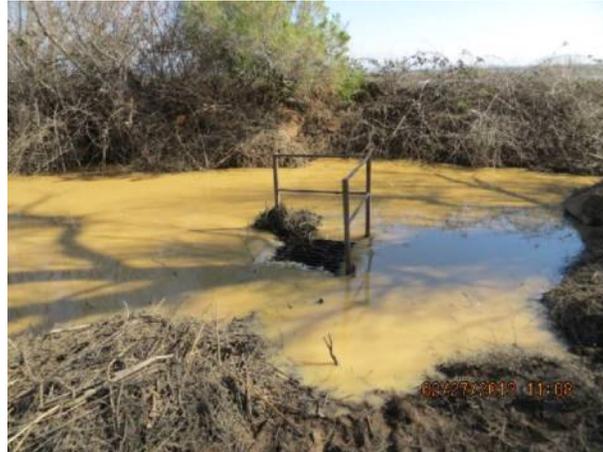
Concrete drop-inlet at LS toe.

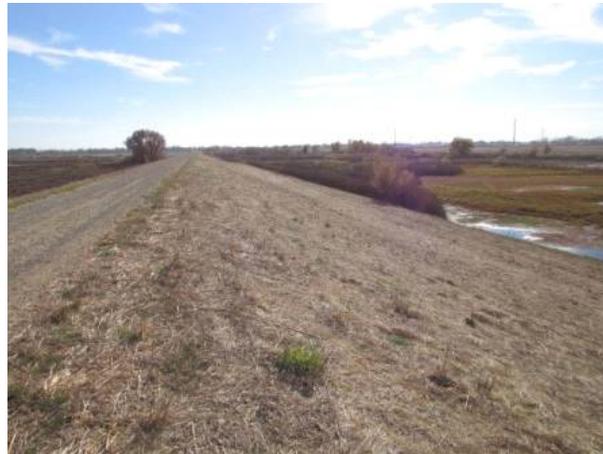
Levee Mile Report Line	2
Start Levee Mile	1.02
End Levee Mile	1.02
Location	Water Side
Category	Earthen Levee
Item	Vegetation

This photo was taken from the levee crown facing west looking down the waterward slope at acceptable vegetation control. Fall 2013.

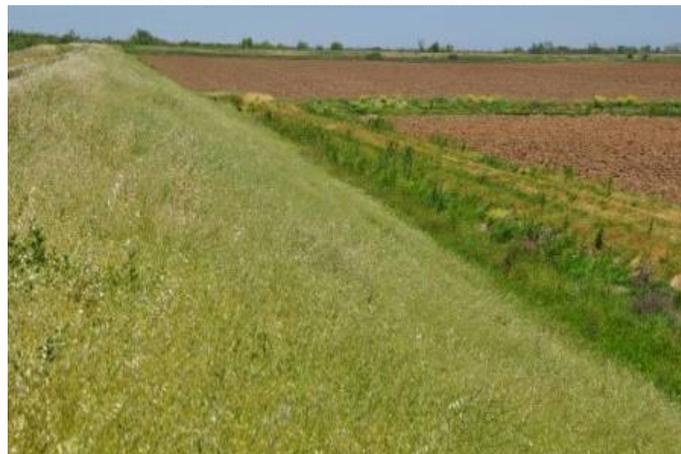
Levee Mile Report Line	3
Start Levee Mile	1.08
End Levee Mile	1.72
Location	Land Side
Category	Earthen Levee
Item	Encroachments

Ditch at L/S toe.

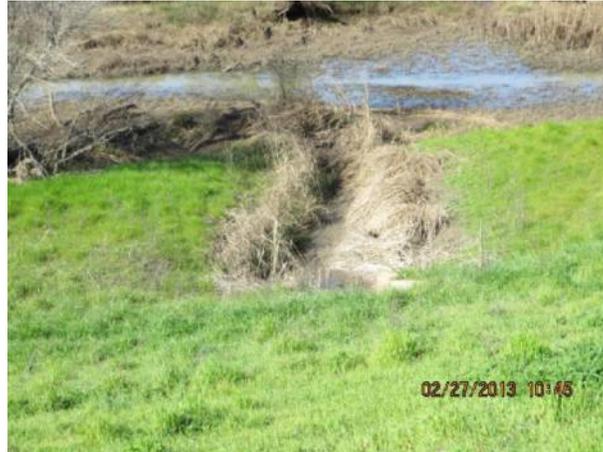
Levee Mile Report Line	4
Start Levee Mile	1.85
End Levee Mile	1.85
Location	Land Side
Category	Supplemental
Item	DWR UCIP Field Study
Drainage outlet on WS toe.	
UCIP_5698.jpg

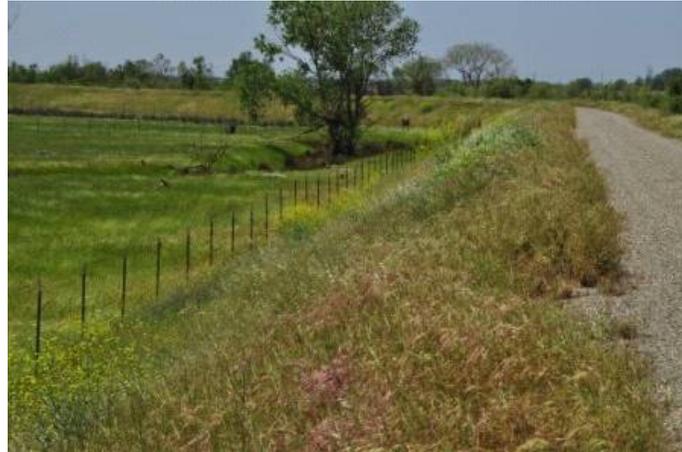
Levee Mile Report Line	9
Start Levee Mile	2.51
End Levee Mile	3.36
Location	Water Side
Category	Earthen Levee
Item	Encroachments
Fence at L/S levee toe.	
mhoffman_f_20130917_078.JPG

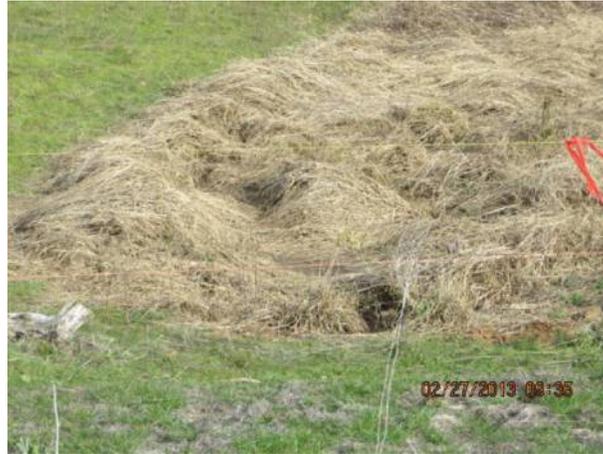
Levee Mile Report Line	16
Start Levee Mile	3.96
End Levee Mile	3.96
Location	Water Side
Category	Supplemental
Item	DWR UCIP Field Study
Outlet on WS toe .	
UCIP_5717.jpg

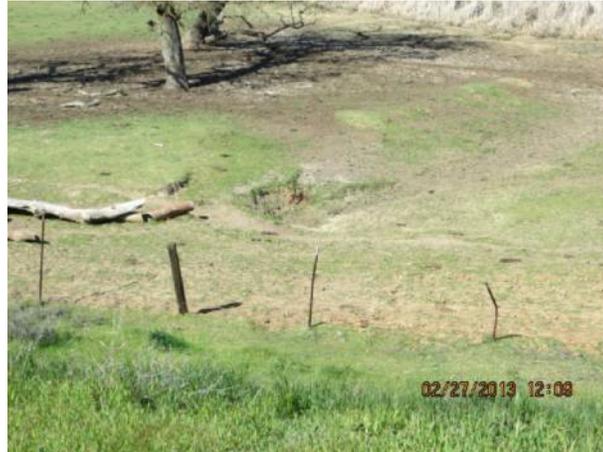
Levee Mile Report Line	1
Start Levee Mile	0.06
End Levee Mile	0.06
Location	Land Side
Category	Supplemental
Item	DWR UCIP Field Study
INlet at LS toe.	
UCIP_5720.jpg

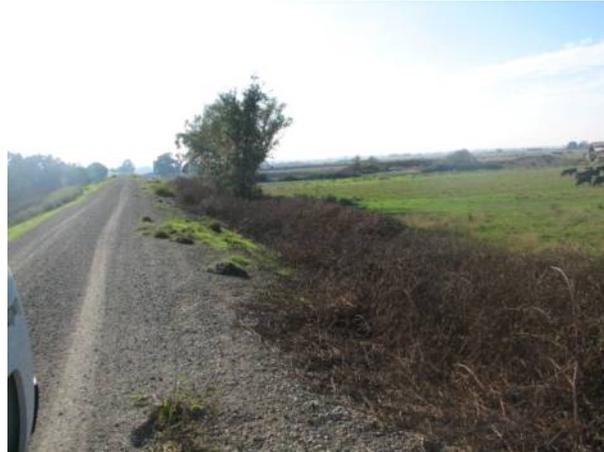
Levee Mile Report Line	6
Start Levee Mile	0.32
End Levee Mile	0.39
Location	Land Side
Category	Earthen Levee
Item	Vegetation
Levee mile 0.39 looking downstream at the vegetation on the slope. The slope is maintained by RD 817 in unit 3.	
mhoffman_f_20130917_082.JPG

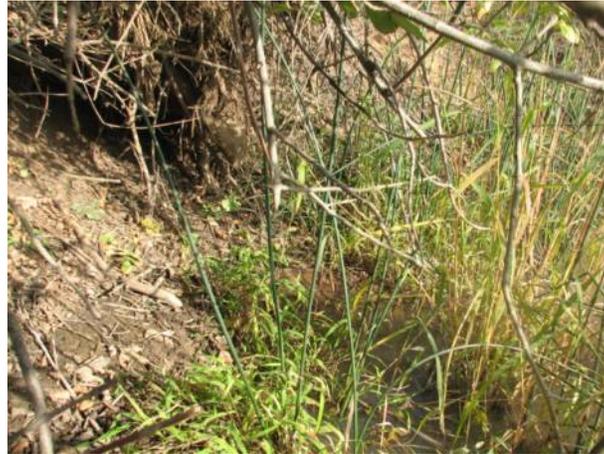
Levee mile 0.68, this is located near the low flow channel, the flap gate is lying on the ground, the end of the pipe was not located.

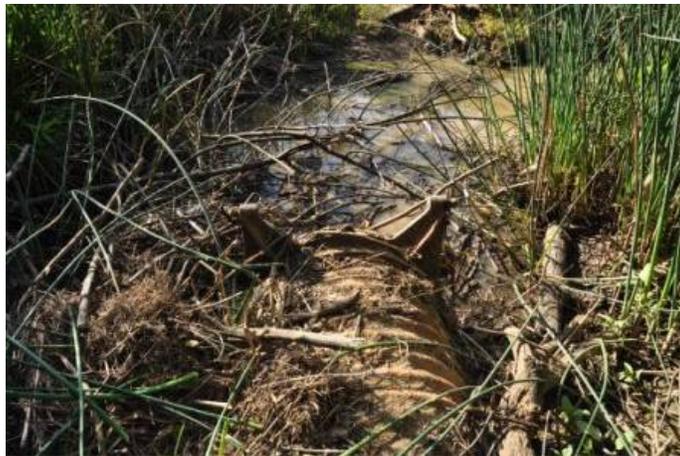
Levee Mile Report Line	10
Start Levee Mile	0.68
End Levee Mile	0.68
Location	Water Side
Category	Interior Drainage & Piping Systems
Item	Culverts: Breaks / Holes / Cracks

CMP is rusting and has numerous holes but flap gate is in place. 4/25/13 - Burnett

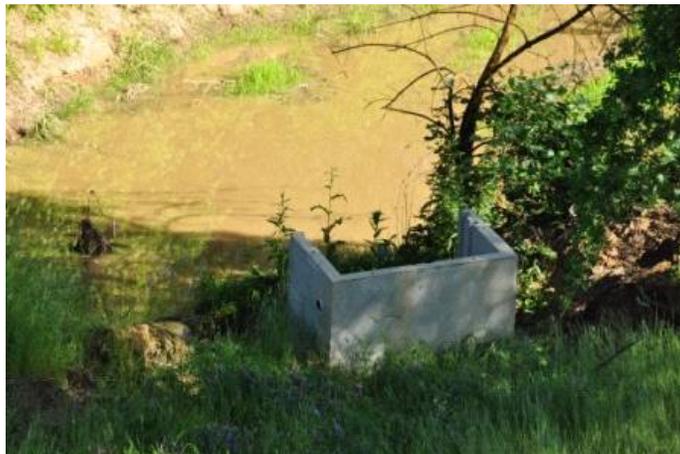
L/S Intake at LM 0.68

Levee Mile Report Line	10
Start Levee Mile	0.68
End Levee Mile	0.68
Location	Water Side
Category	Interior Drainage & Piping Systems
Item	Culverts: Breaks / Holes / Cracks

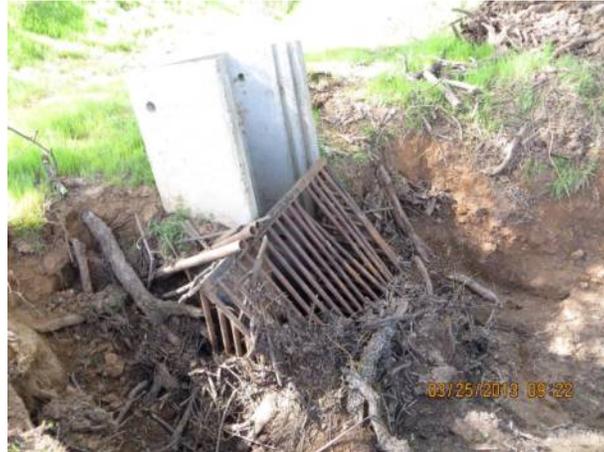
Levee Mile Report Line	11
Start Levee Mile	0.69
End Levee Mile	0.69
Location	Water Side
Category	Supplemental
Item	DWR UCIP Field Study
debris partially blocking inlet on LS toe.	
UCIP_6336.jpg

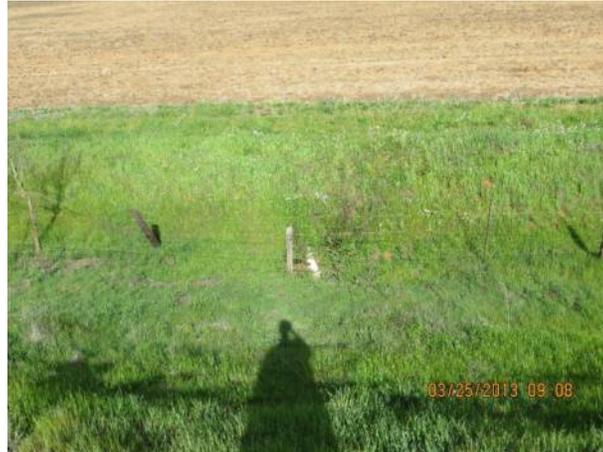
Pipe on LS toe with 8-inch PVC pipe sticking out.

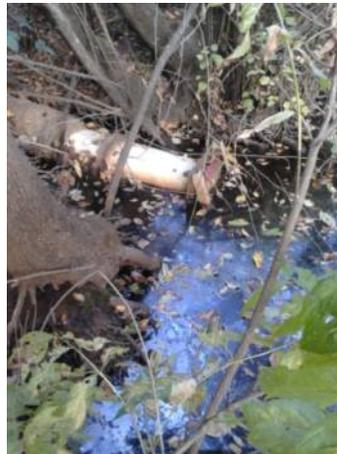
mhoffman_f_20130917_090.jpg

Levee mile 1.33 waterside of the levee, this pipe appears to be sleeved into a larger pipe, access to both ends is limited.

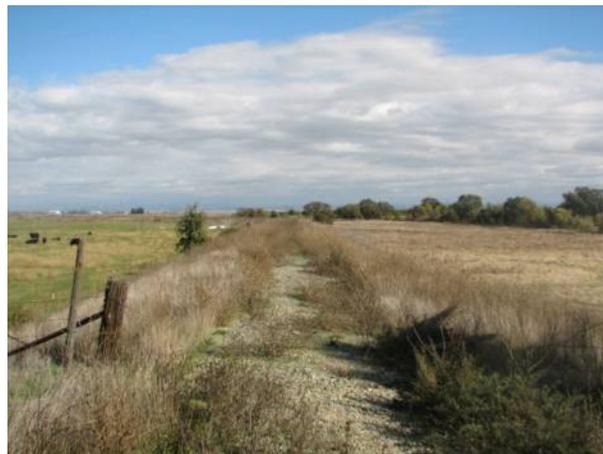
mhoffman_f_20130917_088.JPG

Levee Mile Report Line	21
Start Levee Mile	1.27
End Levee Mile	1.50
Location	Crown
Category	Earthen Levee
Item	Vegetation

Levee mile 1.27 looking upstream, typical of the levee from 1.27 to 1.50.

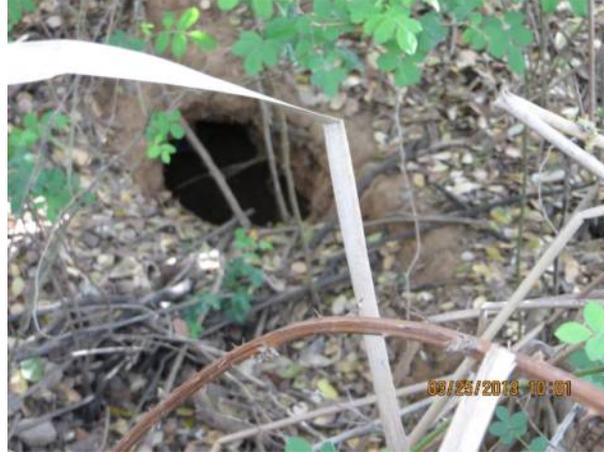
Levee Mile Report Line	22
Start Levee Mile	1.29
End Levee Mile	1.29
Location	Crown
Category	Supplemental
Item	DWR UCIP Field Study
Sinkhole or animal burrow over pipe on LS toe.	
UCIP_6341.jpg

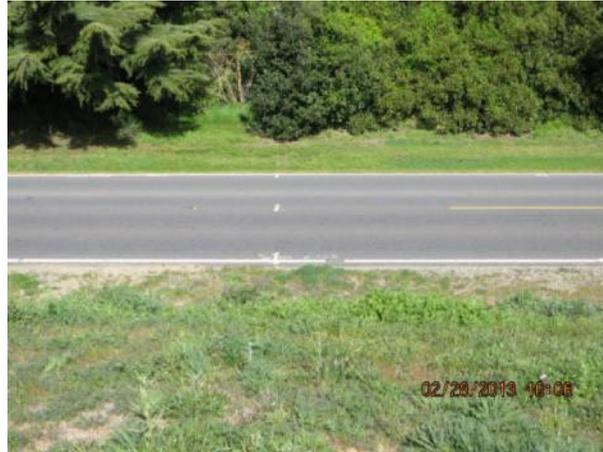
Levee Mile Report Line	1
Start Levee Mile	0.69
End Levee Mile	0.69
Location	Land Side
Category	Supplemental
Item	DWR UCIP Field Study
Paint alignment marks on pavement, LS toe.	
UCIP_5725.jpg

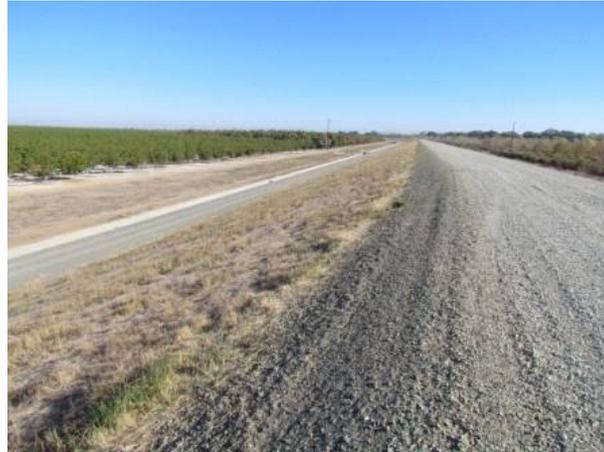
mhoffman_f_20131115_703.JPG

This photo was taken from the levee crown facing east looking down the landward slope at acceptable vegetation control. Fall 2013.

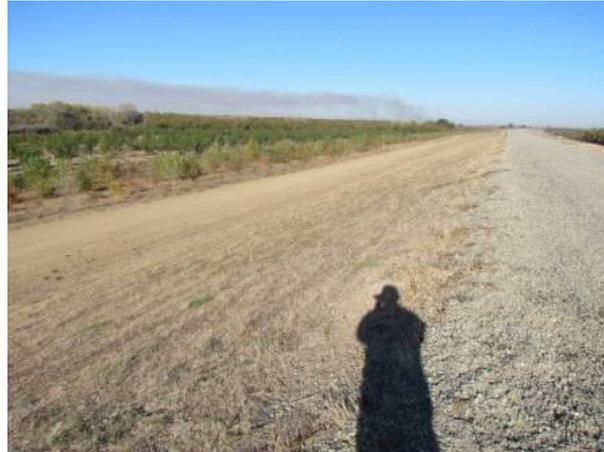
mhoffman_f_20131115_701.JPG

This photo was taken from the levee crown facing north looking down the waterward slope at acceptable vegetation control. Fall 2013.
