**Flood Control Project Maintenance
Levee Inspections**

Fall 2015 Levee Maintenance Deficiency Summary Report

Sacramento River Basin

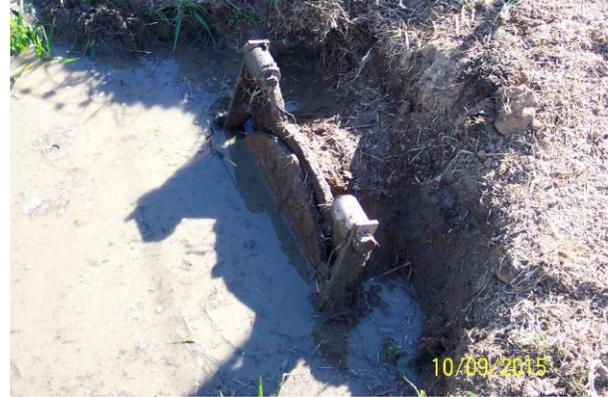
Photo 3 of 3 : UCIP_FA_2015_6089.jpg

LM Start	Rating **	M	Issue No.	12 (cont)	
LM End	Issue Type +	En	Location *	WS	
Category	Supplemental		GPS Latitude/Longitude		
			Start	End	
Item	DWR UCIP Field Study		39.019787 °	39.019787 °	
			-121.513386 °	-121.513386 °	
DWR ID					
Action/Comments					
Inspector Comments: FS_ID:46781 DS_ID:18593 EP_NO: N/A FS_HLM: 3.96 Repair Type: Non-Urgent Crossing Status: Found
