**Flood Control Project Maintenance
Levee Inspections**
LMA District Cover Sheet
Spring 2013 Levee Inspection Results

Reclamation District No. 0784 Plumas Lake

Spring 2013 Levee Inspection Results

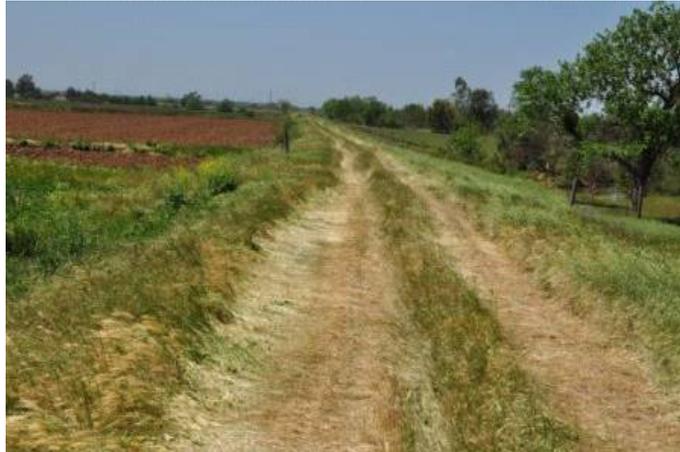
Levee Mile Report Line	1
Start Levee Mile	0.00
End Levee Mile	4.19
Location	Water Side
Category	
Item	Vegetation
W/S vegetation.	
rburnett_s_20130424_274.JPG

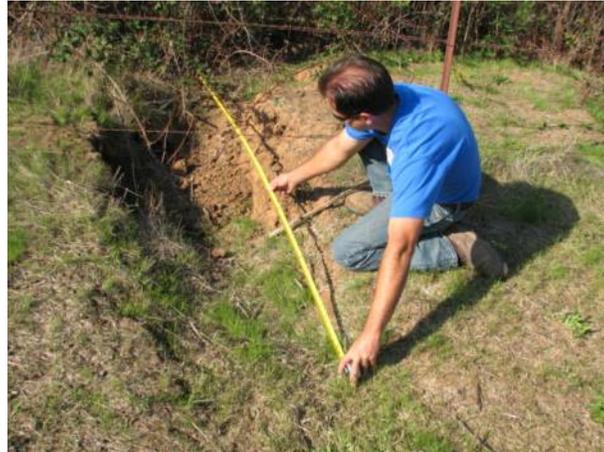
Levee Mile Report Line	7
Start Levee Mile	2.98
End Levee Mile	2.98
Location	Water Side
Category	
Item	Erosion / Bank Caving
Levee mile 2.98, erosion near the waterside levee toe.	
jhirabay_s_20130314_054.JPG

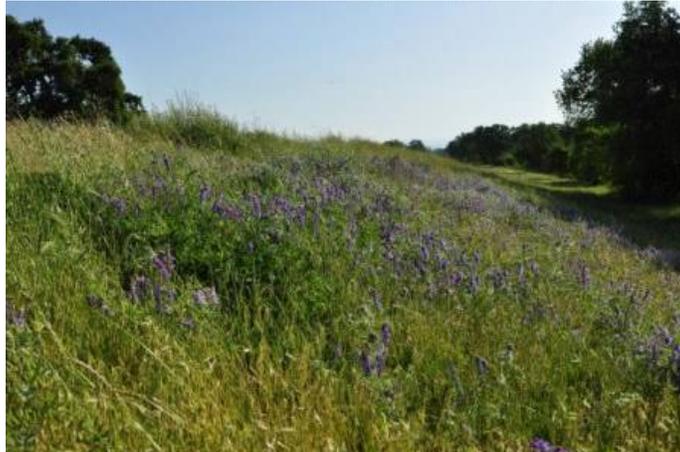
Levee Mile Report Line	1
Start Levee Mile	0.00
End Levee Mile	1.26
Location	Water Side
Category	
Item	Vegetation
Typical W/S vegetation.	
rburnett_s_20130425_280.JPG

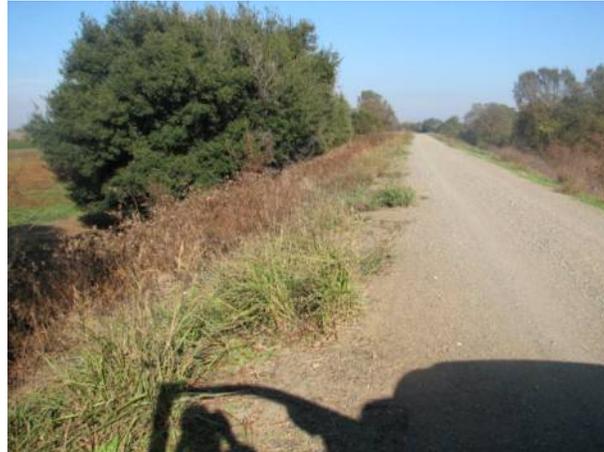
Levee Mile Report Line	6
Start Levee Mile	0.54
End Levee Mile	0.79
Location	Land Side
Category	
Item	Vegetation
Levee mile 0.54, the landside slope.	
jhirabay_s_20130314_058.JPG

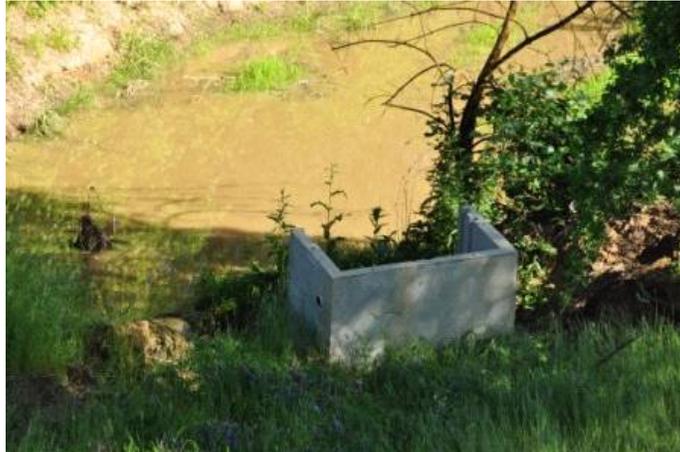
Levee Mile Report Line	8
Start Levee Mile	0.68
End Levee Mile	0.68
Location	Water Side
Category	Interior Drainage & Piping Systems
Item	Culverts: Breaks / Holes / Cracks
L/S Intake at LM 0.68	
rburnett_s_20130425_283.JPG

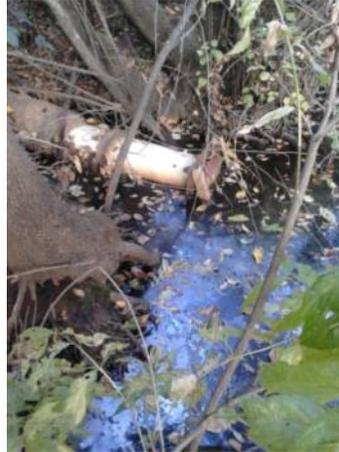
jhirabay_s_20130314_062.jpg

Levee mile 1.33 waterside of the levee, this pipe appears to be sleeved into a larger pipe, access to both ends is limited.

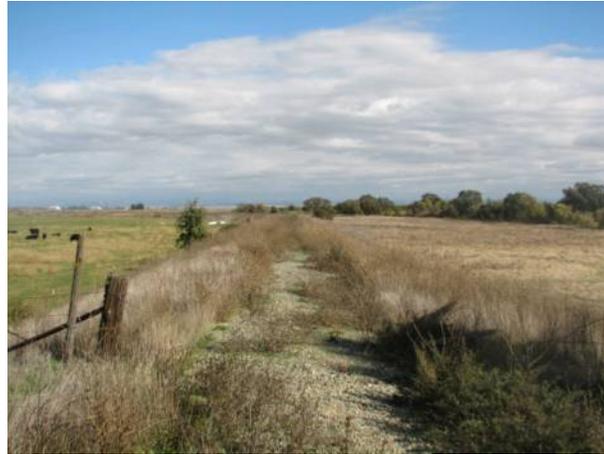
jhirabay_s_20130314_061.JPG

Levee Mile Report Line	15
Start Levee Mile	1.27
End Levee Mile	1.50
Location	Crown
Category	
Item	Vegetation

Levee mile 1.27 looking upstream, typical of the levee from 1.27 to 1.50.

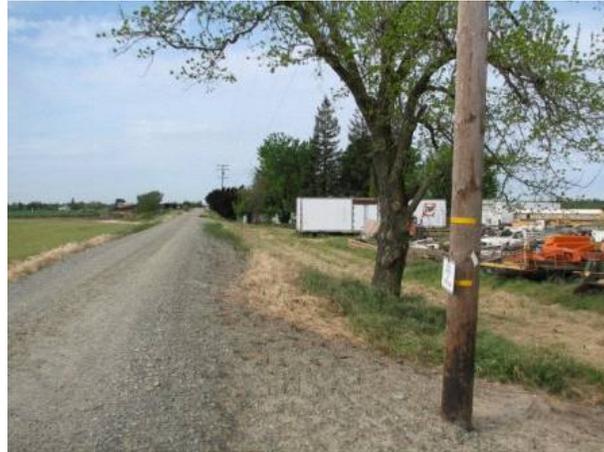
Levee Mile Report Line	1
Start Levee Mile	2.18
End Levee Mile	2.18
Location	Water Side
Category	
Item	Encroachments
Water side buildings and equipment levee mile 2.18.	
jhirabay_s_20130314_063.jpg

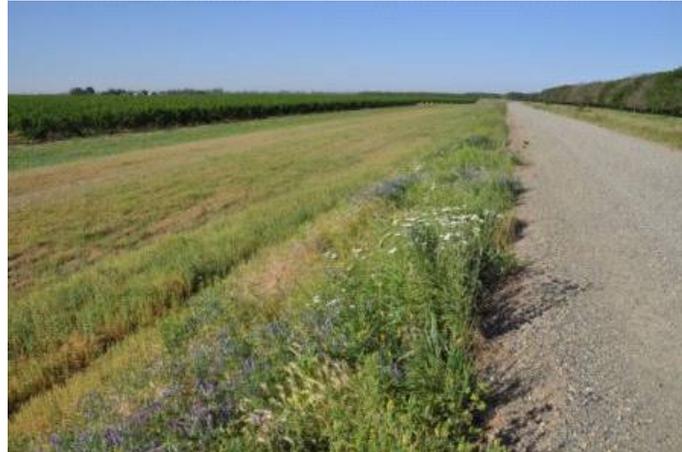
Levee Mile Report Line	3
Start Levee Mile	3.88
End Levee Mile	3.88
Location	Land Side
Category	
Item	Vegetation
Typical L/S seasonal vegetation.	
rburnett_s_20130424_260.JPG

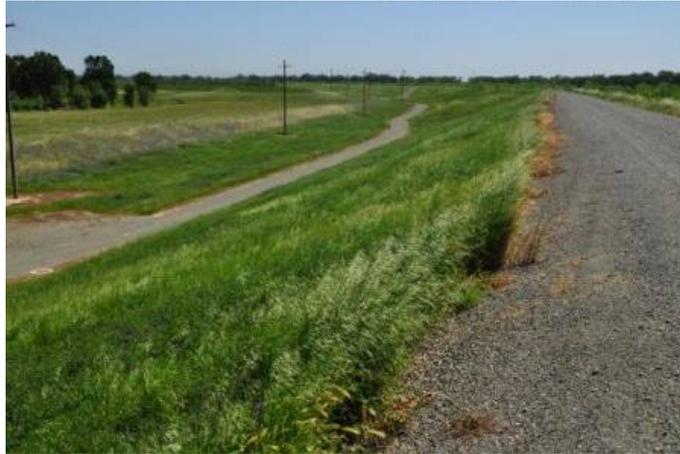
Levee Mile Report Line	1
Start Levee Mile	0.01
End Levee Mile	1.87
Location	Land Side
Category	
Item	Vegetation
Typical L/S vegetation.	
rburnett_s_20130424_270.JPG

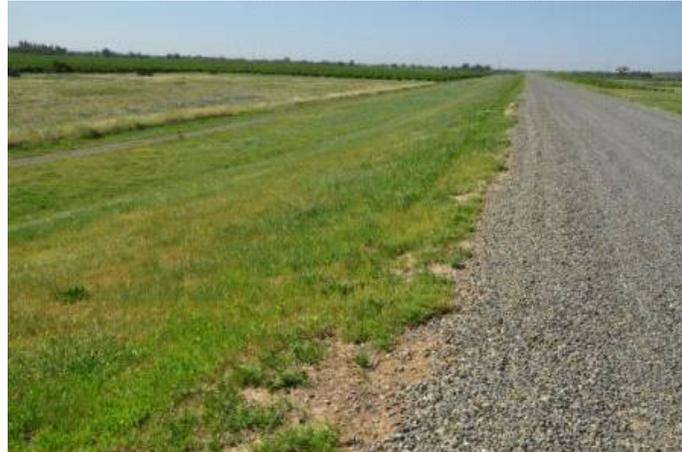
Levee Mile Report Line	1
Start Levee Mile	0.03
End Levee Mile	0.03
Location	Land Side
Category	
Item	Vegetation
Typical L/S vegetation.	
rburnett_s_20130424_267.JPG
