**Flood Control Project Maintenance
Levee Inspections**

Maintenance Issue Types Only, Levee Inspection Report By Mile - Fall 2017

Reclamation District No. 0784 Plumas Lake

Waterway	Bank	Unit Miles	Inspection Start/End	Inspector
Unit No. 01 Yuba River	Left	2.21	10/31/2017 10/31/2017	Sterling York

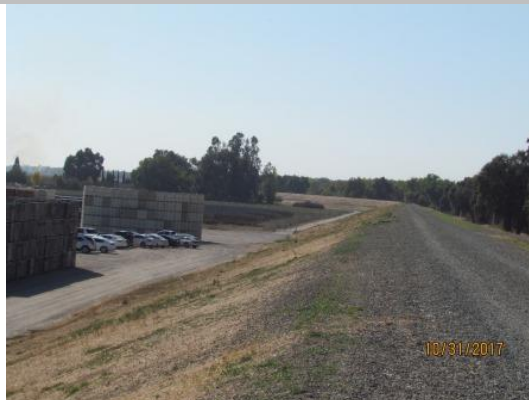
Photo 1 of 2 : FA_2017_RD0784_532_2_20171102_00005.jpg

LM Start	8.96	Rating **	A	Issue No.	2
LM End	12.90	Issue Type +	Ma	Location *	LS
Category	Earthen Levee			GPS Latitude/Longitude	
				Start	End
Item	Vegetation			39.009969 °	38.954106 °
				-121.579282 °	-121.574571 °
DWR ID	DWR_RD0784_02B_f_2017_2				
Comment Code					
V1 : Control annual grass and weeds on the levee slopes and easements.					
Inspector Comment					
Annual vegetation is well maintained, Fall 2017.

View looking downstream landside of well maintained annual vegetation, Fall 2017.

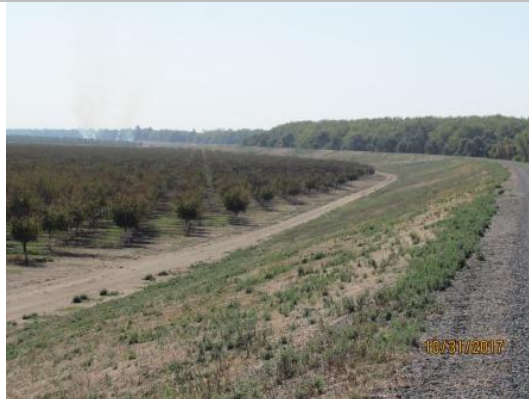
Photo 2 of 2 : FA_2017_RD0784_532_2_20171102_00006.jpg

Another view looking downstream landside of the well maintained annual vegetation, Fall 2017.

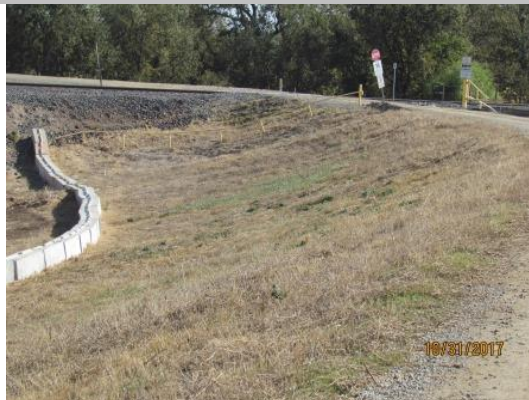
Photo 2 of 2 : FA_2017_RD0784_533_1_20171102_00003.jpg

Second view looking upstream landside of the well maintained annual vegetation, Fall 2017.

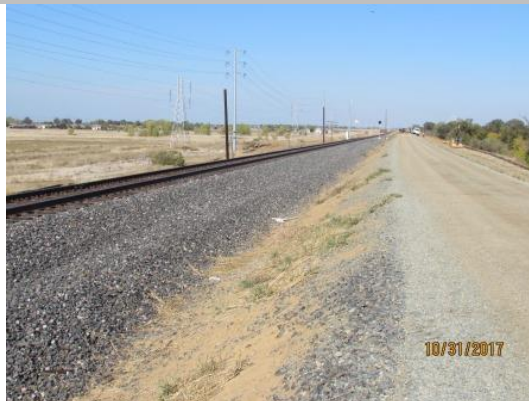
Photo 1 of 1 : FA_2017_RD0784_181_2_20171102_00004.jpg

LM Start	0.00	Rating **	A	Issue No.	2
LM End	0.27	Issue Type +	Ma	Location *	LS
Category	Earthen Levee			GPS Latitude/Longitude	
				Start	End
Item	Vegetation			38.974795 °	38.978537 °
				-121.535077 °	-121.535763 °
DWR ID	DWR_RD0784_04_f_2017_2				
Comment Code					
V1 : Control annual grass and weeds on the levee slopes and easements.					
Inspector Comment					
Annual vegetation is well maintained, Fall 2017.

View looking upstream landside of the well maintained annual vegetation, Fall 2017.

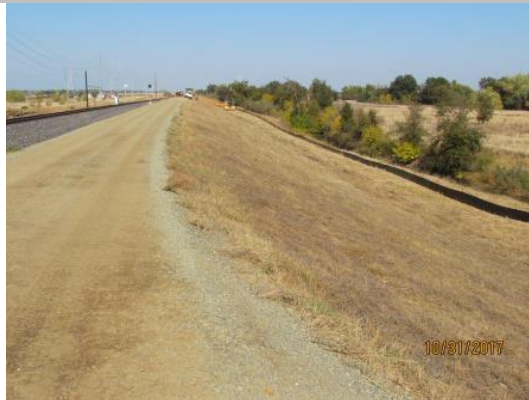
Photo 1 of 1 : FA_2017_RD0784_181_3_20171102_00005.jpg

LM Start	0.00	Rating **	A	Issue No.	3
LM End	0.27	Issue Type +	Ma	Location *	WS
Category	Earthen Levee			GPS Latitude/Longitude	
				Start	End
Item	Vegetation			38.974795 °	38.978537 °
				-121.535077 °	-121.535763 °
DWR ID	DWR_RD0784_04_f_2017_3				
Comment Code					
V1 : Control annual grass and weeds on the levee slopes and easements.					
Inspector Comment					
Annual vegetation is well maintained, Fall 2017.

View looking upstream waterside of the well maintained annual vegetation, Fall 2017.

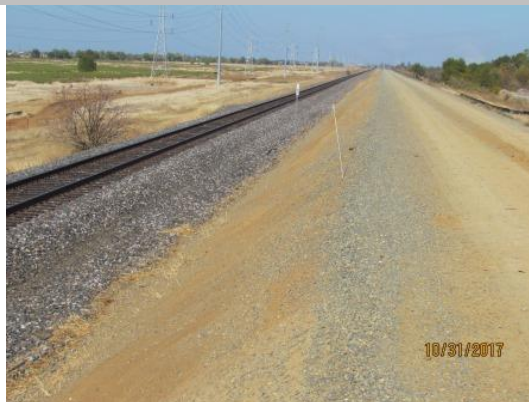
Photo 1 of 1 : FA_2017_RD0784_181_5_20171106_00009.jpg

LM Start	0.53	Rating **	A	Issue No.	5
LM End	2.54	Issue Type +	Ma	Location *	LS
Category	Earthen Levee			GPS Latitude/Longitude	
				Start	End
Item	Vegetation			38.982343 °	39.011175 °
				-121.536502 °	-121.541715 °
DWR ID	DWR_RD0784_04_f_2017_5				
Comment Code					
V1 : Control annual grass and weeds on the levee slopes and easements.					
Inspector Comment					
Annual vegetation is well maintained, Fall 2017.

View looking upstream landside of the well maintained annual vegetation, Fall 2017.

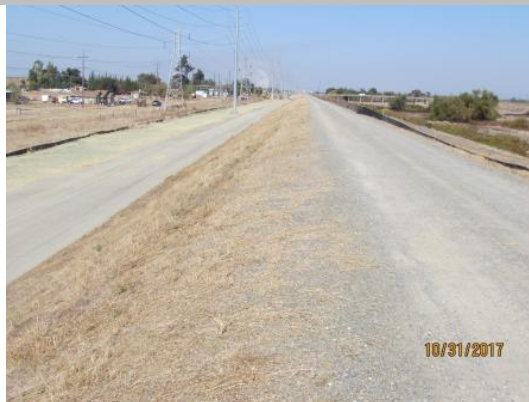
Photo 1 of 1 : FA_2017_RD0784_181_8_20171106_00014.jpg

LM Start	3.29	Rating **	A	Issue No.	8
LM End	4.48	Issue Type +	Ma	Location *	LS
Category	Earthen Levee			GPS Latitude/Longitude	
				Start	End
Item	Vegetation			39.021946 °	39.039299 °
				-121.542273 °	-121.542399 °
DWR ID	DWR_RD0784_04_f_2017_8				
Comment Code					
V1 : Control annual grass and weeds on the levee slopes and easements.					
Inspector Comment					
Annual vegetation is well maintained, Fall 2017.

View looking upstream landside of the well maintained annual vegetation, Fall 2017.

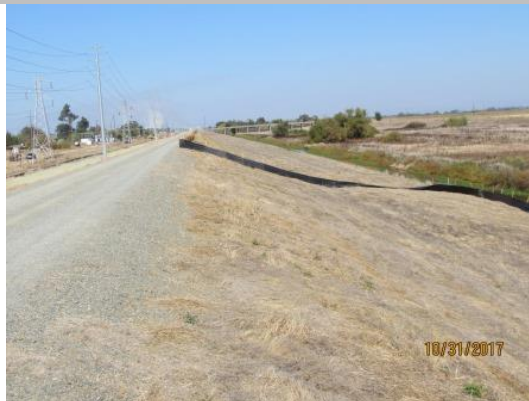
Photo 1 of 1 : FA_2017_RD0784_181_9_20171106_00013.jpg

LM Start	3.29	Rating **	A	Issue No.	9
LM End	4.48	Issue Type +	Ma	Location *	WS
Category	Earthen Levee			GPS Latitude/Longitude	
				Start	End
Item	Vegetation			39.021946 °	39.039299 °
				-121.542273 °	-121.542399 °
DWR ID	DWR_RD0784_04_f_2017_9				
Comment Code					
V1 : Control annual grass and weeds on the levee slopes and easements.					
Inspector Comment					
Annual vegetation is well maintained, Fall 2017.

View looking upstream waterside of the well maintained annual vegetation, Fall 2017.

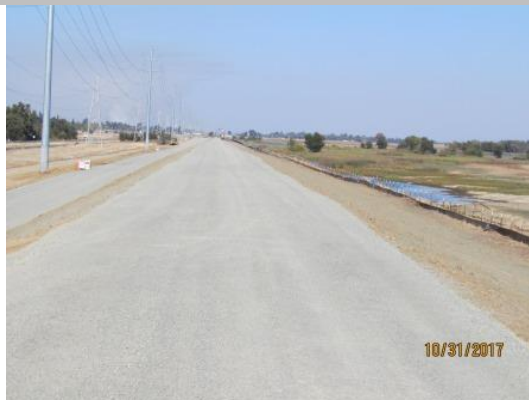
Photo 1 of 2 : FA_2017_RD0784_181_10_20171106_00015.jpg

LM Start	4.48	Rating **	A	Issue No.	10
LM End	5.88	Issue Type +	Ma	Location *	CR
Category	Earthen Levee			GPS Latitude/Longitude	
				Start	End
Item	Crown Surface / Depressions / Rutting			39.039299 °	39.058603 °
				-121.542399 °	-121.543825 °
DWR ID	DWR_RD0784_04_f_2017_10				
Comment Code					
C1 : Add appropriate material and re-grade the levee to bring the crown above the design elevation.					
Inspector Comment					
Under construction, Fall 2017

View looking upstream where the levee is under construction, Fall 2017.

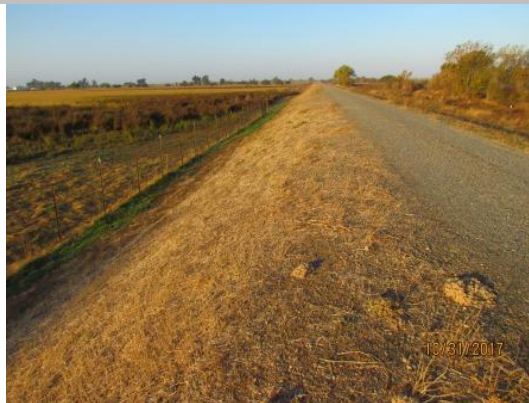
Photo 1 of 1 : FA_2017_RD0784_182_14_20171106_00061.jpg

LM Start	0.01	Rating **	A	Issue No.	14
LM End	4.18	Issue Type +	Ma	Location *	LS
Category	Earthen Levee			GPS Latitude/Longitude	
				Start	End
Item	Vegetation			38.974522 °	39.020521 °
				-121.532507 °	-121.509274 °
DWR ID	DWR_RD0784_05_f_2017_14				
Comment Code					
V1 : Control annual grass and weeds on the levee slopes and easements.					
Inspector Comment					
Annual vegetation is well maintained, Fall 2017.

View looking downstream landside of well maintained vegetation, Fall 2017.

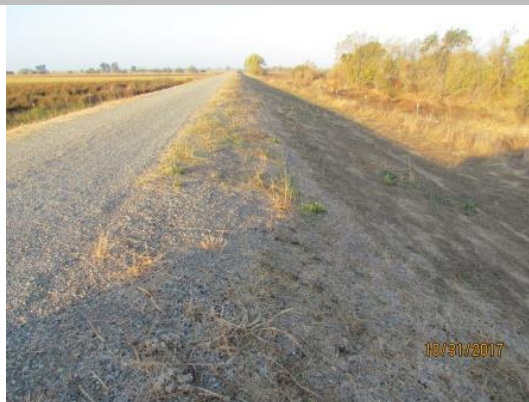
Photo 1 of 1 : FA_2017_RD0784_182_15_20171106_00060.jpg

LM Start	0.01	Rating **	A	Issue No.	15
LM End	4.18	Issue Type +	Ma	Location *	WS
Category	Earthen Levee			GPS Latitude/Longitude	
				Start	End
Item	Vegetation			38.974522 °	39.020521 °
				-121.532507 °	-121.509274 °
DWR ID	DWR_RD0784_05_f_2017_15				
Comment Code					
V1 : Control annual grass and weeds on the levee slopes and easements.					
Inspector Comment					
Annual vegetation is well maintained, Fall 2017.

View looking downstream waterside of well maintained vegetation, Fall 2017.

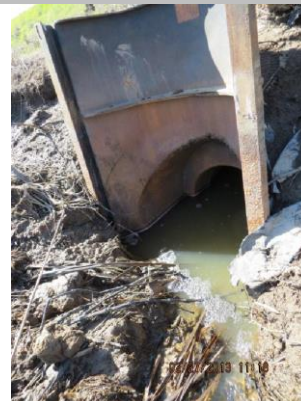
Photo 1 of 3 : UCIP_FA_2017_51711_16552.jpg

LM Start	0.12	Rating **	A/W	Issue No.	16
LM End	0.12	Issue Type +	Ma	Location *	
Category	Supplemental			GPS Latitude/Longitude	
				Start	End
Item	DWR UCIP LMA Responsibility			38.976147 °	38.976147 °
				-121.533019 °	-121.533019 °
DWR ID					
Comment Code					
Inspector Comment					
FS_ID:51711					
DS_ID:18592					
EP_NO: N/A					
Repair Type: No Action Needed					
Crossing Status: Found					
UCIP Comments: Good candidate for video inspection.					
FIELD_STRUCT_DESC: 18-inch corrugated metal drainage pipe through the levee, 18 feet below the crown. Flap gate on the waterside (WS) end. Concrete U-shaped headwall on the WS end. Polyvinyl chloride weir inlet on landside (LS) toe. [Additional Reference(s): DWR Levee Log, 2005. USACE Sacramento O&M Manual 145, August 1955 (Station 25+28)].					
FS Date: 2/26/2013

inlet control structure on LS toe.

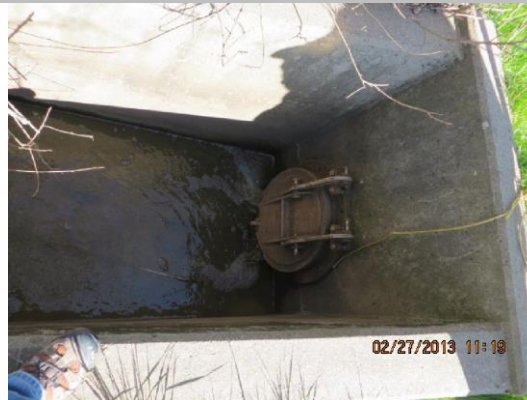
Photo 2 of 3 : UCIP_FA_2017_51711_16555.jpg

Concrete U-shaped outlet with flap gate on WS toe.

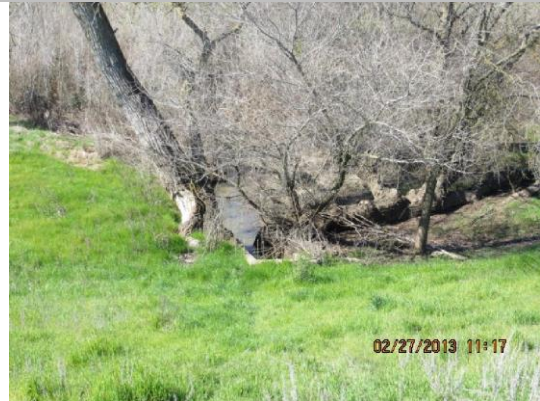
Photo 3 of 3 : UCIP_FA_2017_51711_16554.jpg

Concrete U-shaped outlet on WS toe.

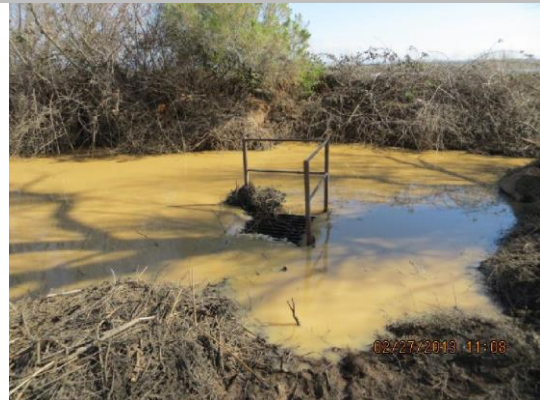
Photo 1 of 2 : UCIP_FA_2017_51710_54246.jpg

LM Start	0.84	Rating **	M	Issue No.	17	
LM End	0.84	Issue Type +	Ma	Location *		
Category	Supplemental			GPS Latitude/Longitude		
				Start	End	
Item	DWR UCIP LMA Responsibility			38.986432 °	38.986432 °	
				-121.534983 °	-121.534983 °	
DWR ID						
Comment Code						
Inspector Comment						
FS_ID:51710						
DS_ID:18591						
EP_NO: N/A						
Repair Type: Non-Urgent						
Crossing Status: Found						
UCIP Comments: No handle or access to slide gate on LS toe.						
FIELD_STRUCT_DESC: 30-inch corrugated metal drainage pipe						
through the levee, 23.7 feet below the crown. Flap gate on the						
waterside (WS) end. Slide gate inside a concrete drop inlet on the						
landside (LS). [Additional Reference(s): DWR Levee Log, 2005. USACE						
Sacramento O&M Manual 145, August 1955 (Station 63+00)].						
FS Date: 9/11/2015 9:05:00 AM

Concrete drop-inlet at LS toe.

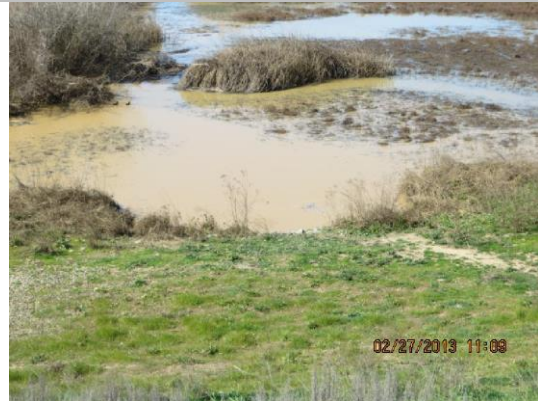
Photo 2 of 2 : UCIP_FA_2017_51710_54245.jpg

Outlet with riprap on WS toe.

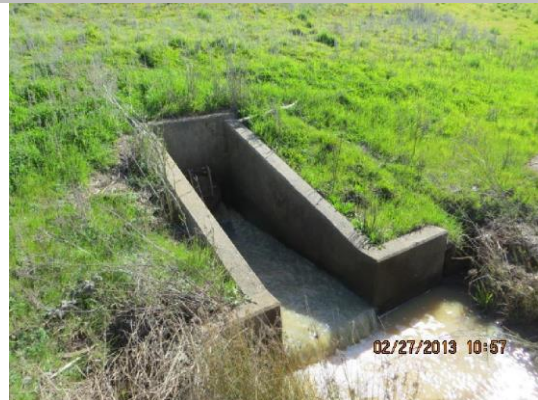
Photo 1 of 3 : UCIP_FA_2017_51709_16565.jpg

LM Start	1.60	Rating **	A/W	Issue No.	18
LM End	1.60	Issue Type +	Ma	Location *	
Category	Supplemental			GPS Latitude/Longitude	
				Start	End
Item	DWR UCIP LMA Responsibility			38.997305 °	38.997305 °
				-121.537081 °	-121.537081 °
DWR ID					
Comment Code					
Inspector Comment					
FS_ID:51709 DS_ID:18590 EP_NO: N/A Repair Type: No Action Needed Crossing Status: Found UCIP Comments: Good candidate for video inspection. FIELD_STRUCT_DESC: 18-inch corrugated metal drainage pipe through the levee, 14.5 feet below the crown. Flap gate on the waterside (WS) end. Concrete U-shaped headwall on the WS. Polyvinyl chloride weir on inlet. (See Drawing No. 2-4-106, Sheet 5). [Additional Reference(s): DWR Levee Log, 2005. USACE Sacramento O&M Manual 145, August 1955 (Station 103+23)]. FS Date: 2/26/2013

Concrete U-shaped headwall and flap gate on WS toe.

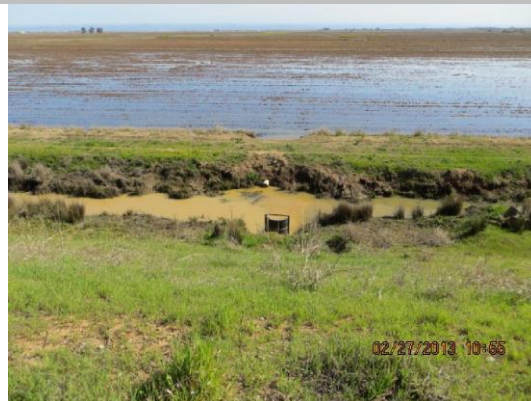
Photo 2 of 3 : UCIP_FA_2017_51709_16563.jpg

Pvc weir on inlet at LS toe.

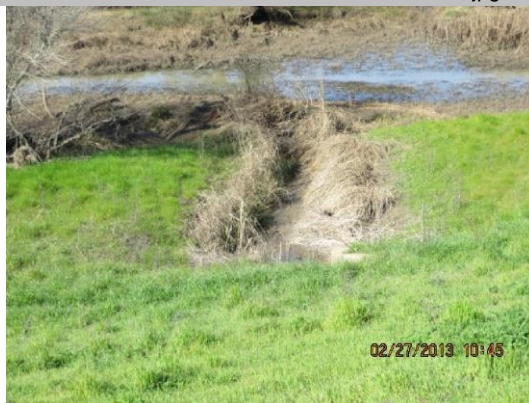
Photo 3 of 3 : UCIP_FA_2017_51719_54249.jpg

FS_ID:51719
DS_ID:18588
EP_NO: N/A
Repair Type: Non-Urgent
Crossing Status: Found
UCIP Comments: 09/11/2015 Inlet buried. Good candidate for video inspection as pipe is corroded. (G. Wylie - FPIIB)
FIELD_STRUCT_DESC: 18-inch corrugated metal drainage pipe through the levee, 14.5 feet below the crown. Flap gate on the waterside (WS) end. Concrete U-shaped headwall on the WS.
[Additional Reference(s): DWR Levee Log, 2005. USACE Sacramento O&M Manual 145, August 1955 (Station 116+78)].
FS Date: 9/11/2015 9:36:00 AM

Drainage outlet on WS toe.

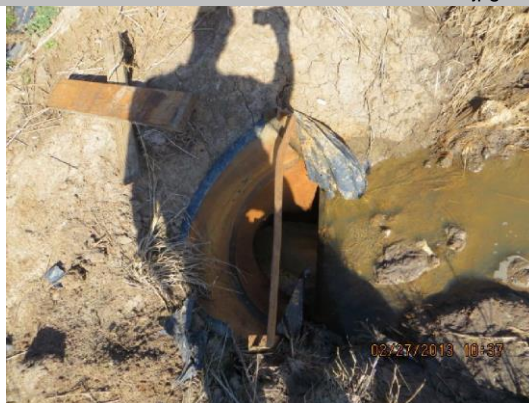
Photo 1 of 3 : UCIP_FA_2017_51707_54250.jpg

FS_ID:51707
DS_ID:18587
EP_NO: N/A
Repair Type: Non-Urgent
Crossing Status: Found
UCIP Comments: On 1/31/2017 The waterside excess pipe end was discovered to be floating to the surface due to landside water runoff through the pipe. Because of the floating pipe, the water was not draining all the way through the pipe. Instead, the water was overtopping the levee shelf area. In order to resolve this issue, the excess portion of the pipe was cut off. After doing so, the water immediately started draining properly again. (P. Meagher, RD784 2/3/2017). Erosion at outlet may or may not be an issue.
FIELD_STRUCT_DESC: 18-inch corrugated metal drainage pipe through the levee, 14.5 feet below the crown. Flap gate on the waterside (WS) end. Concrete U-shaped headwall on the WS. Polyvinyl chloride weir on inlet. [Additional Reference(s): DWR Levee Log, 2005. USACE Sacramento O&M Manual 145, August 1955 (Station 126+53)].

Inlet with PVC weir on LS toe.

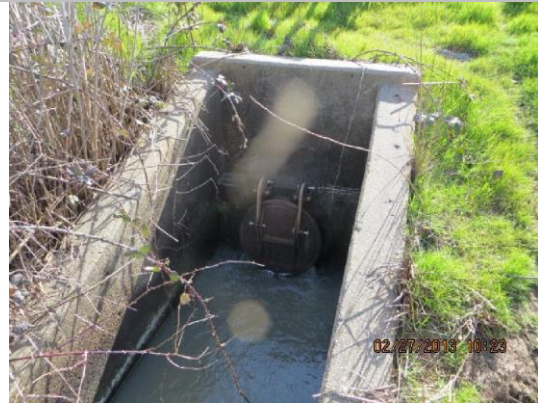
Photo 1 of 3 : UCIP_FA_2017_52570_54258.jpg

FS_ID:52570
DS_ID:18597
EP_NO: N/A
Repair Type: Urgent
Crossing Status: Found
UCIP Comments: 11/30/2017 - same as previous inspection - crossing remains Urgent. Received updated photos from DWR levee inspector, S. York, showing current condition of levee LS and WS. (O. Magana - DWR UCIP) 12/15/2016 - Coordination email was received from RD0784 this afternoon. Patrick Meagher with Reclamation District is closely monitoring the eroded pipe area at the Horseshoe Levee due to periodic rainstorms and unpredictable water flow elevations. To avoid further damage at this location, Mr. Meagher has coordinated with LMA Consultant Sean Minard at MHM Engineering and DWR Levee Inspector Sterling York to address further deterioration at site. As a proactive measure by RD784, sandbags were used to fill in the sink hole on the WS. A "V" shape diversion dam was also built of sandbags above the sinkhole area to help divert running rainwater coming down the slope around the fill area. RD0784 used approximately 100 sandbags at the site to fill in sink hole and create the "V" shaped diversion dam. (O. Magana - DWR UCIP)07/29/2016 - Erosion scarp on LS cut into levee shoulder starting at inlet headwall. Cavity failure on WS shoulder approximately 2-feet in diameter and several feet in depth. (T. Hatch/UCIP)11/01/2015 - The concrete box weir structure on the landside inlet has slumped off the end of the pipe. DWR Chief inspector George Wilie inspected the site on 8/13/2015 with Steve Fordice, General Manager of RD784. (P. Meagher - RD784)

2/27/2013 - Heavy erosion around inlet headwall due to beaver activity. (W. Wylie/UCIP)
FIELD_STRUCT_DESC: 18-inch corrugated metal drainage pipe through the levee, 15.5 feet below the crown. Flap gate on the waterside (WS) toe. Concrete U-shaped headwall on the WS toe. (Removable standpipe and bulkheads approved under Permit No. 9230, 1974 - Frach, Inc.). [Additional Reference(s): DWR Levee Log, 2005. USACE Sacramento O&M Manual 145, August 1955 (Station 13+72). USACE As-Built Drawing No. 2-4-106, Sheet 6, July 1944 (Station 13+72)].
FS Date: 12/15/2016 3:36:00 PM

Concrete U-shaped headwall and flap gate on WS toe.

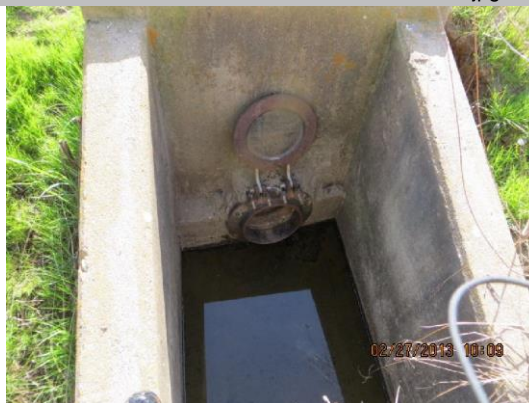
Photo 1 of 3 : UCIP_FA_2017_51714_54259.jpg

FS_ID:51714
DS_ID:18596
EP_NO: N/A
Repair Type: Non-Urgent
Crossing Status: Found
UCIP Comments: Pipe has been sliplied with PVC, but the liner appears to be eroding at outlet and may be disjointed internal to the levee. See pic. Good candidate for video inspection.
FIELD_STRUCT_DESC: 12-inch corrugated metal drainage pipe through the levee, 12 feet below the crown. Flap gate and concrete U-shaped headwall on the waterside (WS). Polyvinyl chloride weir on inlet at the landside (LS) toe. [Additional Reference(s): DWR Levee Log, 2005. USACE Sacramento O&M Manual 145, August 1955 (Station 44+96)].
FS Date: 9/11/2015 9:26:00 AM

Concrete U-shaped headwall and flap gate on WS toe.

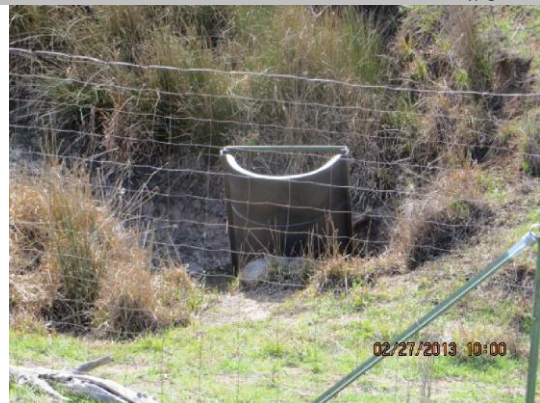
Photo 1 of 2 : UCIP_FA_2017_9566_16594.jpg

LM Start	3.23	Rating **	A/W	Issue No.	23
LM End	3.23	Issue Type +	Ma	Location *	
Category	Supplemental			GPS Latitude/Longitude	
				Start	End
Item	DWR UCIP LMA Responsibility			39.017336 °	39.017336 °
				-121.526530 °	-121.526530 °
DWR ID					
Comment Code					
Inspector Comment					
FS_ID:9566 DS_ID:18595 EP_NO: N/A Repair Type: No Action Needed Crossing Status: Found UCIP Comments: Good candidate for video inspection. FIELD_STRUCT_DESC: 18-inch corrugated metal drainage pipe through the levee, 15.8 feet below the crown. Flap gate on the waterside (WS) end. Polyvinyl chloride weir on inlet at the landside (LS) toe. [Additional Reference(s): DWR Levee Log, 2005. USACE Sacramento O&M Manual 145, August 1955, Drawing No. 2-4-106, Sheet 6 (Station 53+86)]. FS Date: 2/27/2013

PVC weir inlet on LS toe.

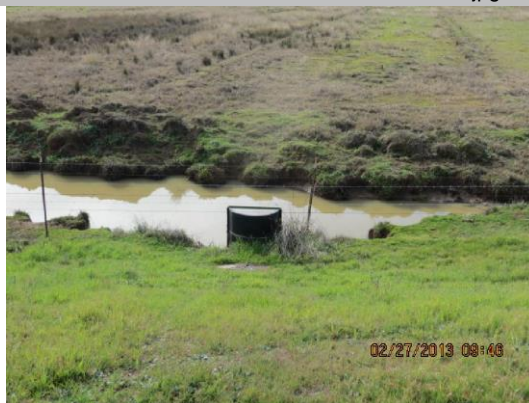
Photo 2 of 3 : UCIP_FA_2017_51713_16591.jpg

LM Start	3.79	Rating **	A/W	Issue No.	24 (cont)	
LM End	3.79	Issue Type +	Ma	Location *		
Category	Supplemental			GPS Latitude/Longitude		
				Start	End	
Item	DWR UCIP LMA Responsibility			39.019222 °	39.019222 °	
				-121.516414 °	-121.516414 °	
DWR ID						
Comment Code						
Inspector Comment						
FS_ID:51713						
DS_ID:18594						
EP_NO: N/A						
Repair Type: No Action Needed						
Crossing Status: Found						
UCIP Comments:						
FIELD_STRUCT_DESC: 18-inch corrugated metal drainage pipe						
through the levee, 8.8 feet below the crown. Flap gate and headwall on						
the waterside (WS) end. [Additional Reference(s): DWR Levee Log,						
2005. USACE Sacramento O&M Manual 145, August 1955 (Station						
83+39)].						
FS Date: 2/27/2013

PVC weir at inlet on LS toe.

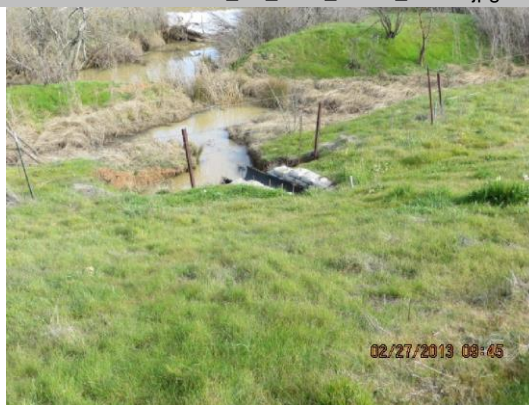
Photo 3 of 3 : UCIP_FA_2017_51713_16592.jpg

Concrete outlet on WS toe.

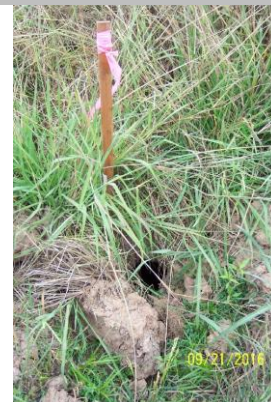
Photo 2 of 3 : UCIP_FA_2017_51712_76148.jpg

FS_ID:51712
DS_ID:18593
EP_NO: N/A
Repair Type: Non-Urgent
Crossing Status: Found
UCIP Comments: 11/14/2016 - Photos added of exposed flap gate on WS and possible inlet location on LS. Condition remains as Non-Urgent because of inlet not being fully operable. Unknown if pipe will operate as designed during high water or if it is full of sediment. 11/01/2015 - Waterside Flap Gate Uncovered. Photo sent to DWR Matt Hoffman on 3/3/2014. Fresh photo sent to DWR Pavel Kazi on 9/9/2015. Landside toe has never been able to be located. Requesting DWR inspector to change the status of this issue to "No Action Needed". (P.Meagher - RD784). Pipe buried on LS toe and flap gate is blocked by soil on WS toe. (W. Wylie - UCIP Inspector).
FIELD_STRUCT_DESC: 18-inch corrugated metal drainage pipe through the levee, 10 feet below the crown. Flap gate on the waterside (WS) end. [Additional Reference(s): DWR Levee Log, 2005. USACE Sacramento O&M Manual 145, August 1955 (Station 91+50)].

Possible location of the inlet on the LS toe

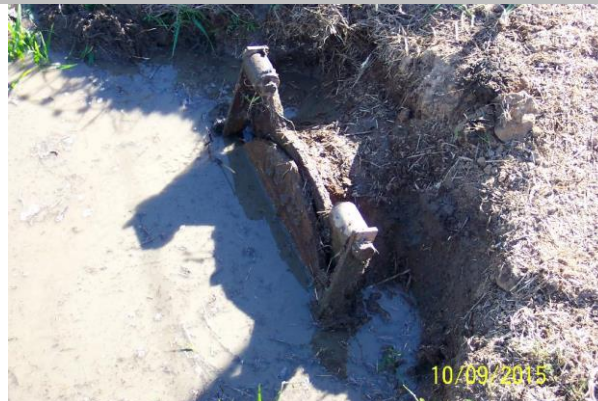
Photo 3 of 3 : UCIP_FA_2017_51712_74710.jpg

FS_ID:51712
DS_ID:18593
EP_NO: N/A
Repair Type: Non-Urgent
Crossing Status: Found
UCIP Comments: 11/14/2016 - Photos added of exposed flap gate on WS and possible inlet location on LS. Condition remains as Non-Urgent because of inlet not being fully operable. Unknown if pipe will operate as designed during high water or if it is full of sediment. 11/01/2015 - Waterside Flap Gate Uncovered. Photo sent to DWR Matt Hoffman on 3/3/2014. Fresh photo sent to DWR Pavel Kazi on 9/9/2015. Landside toe has never been able to be located. Requesting DWR inspector to change the status of this issue to "No Action Needed". (P.Meagher - RD784). Pipe buried on LS toe and flap gate is blocked by soil on WS toe. (W. Wylie - UCIP Inspector).
FIELD_STRUCT_DESC: 18-inch corrugated metal drainage pipe through the levee, 10 feet below the crown. Flap gate on the waterside (WS) end. [Additional Reference(s): DWR Levee Log, 2005. USACE Sacramento O&M Manual 145, August 1955 (Station 91+50)].

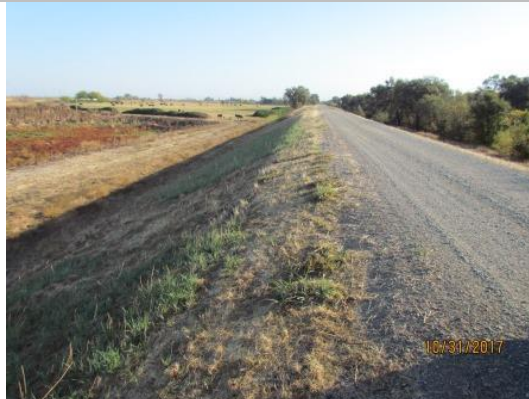
Photo 1 of 1 : FA_2017_RD0784_183_2_20171106_00007.jpg

LM Start	0.00	Rating **	A	Issue No.	2
LM End	0.25	Issue Type +	Ma	Location *	LS
Category	Earthen Levee			GPS Latitude/Longitude	
				Start	End
Item	Vegetation			38.985576 °	38.987567 °
				-121.510446 °	-121.506637 °
DWR ID	DWR_RD0784_06_f_2017_2				
Comment Code					
V1 : Control annual grass and weeds on the levee slopes and easements.					
Inspector Comment					
Annual vegetation is well maintained, Fall 2017.

View looking upstream landside of well maintained vegetation, Fall 2017.

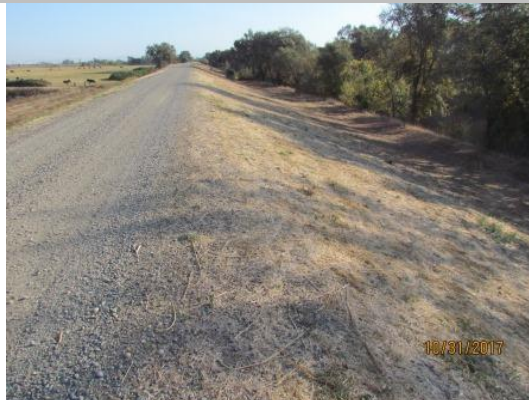
Photo 1 of 1 : FA_2017_RD0784_183_3_20171106_00008.jpg

LM Start	0.00	Rating **	A	Issue No.	3
LM End	0.25	Issue Type +	Ma	Location *	WS
Category	Earthen Levee			GPS Latitude/Longitude	
				Start	End
Item	Vegetation			38.985576 °	38.987567 °
				-121.510446 °	-121.506637 °
DWR ID	DWR_RD0784_06_f_2017_3				
Comment Code					
V1 : Control annual grass and weeds on the levee slopes and easements.					
Inspector Comment					
Annual vegetation is well maintained, Fall 2017.

View looking upstream waterside of well maintained vegetation, Fall 2017.

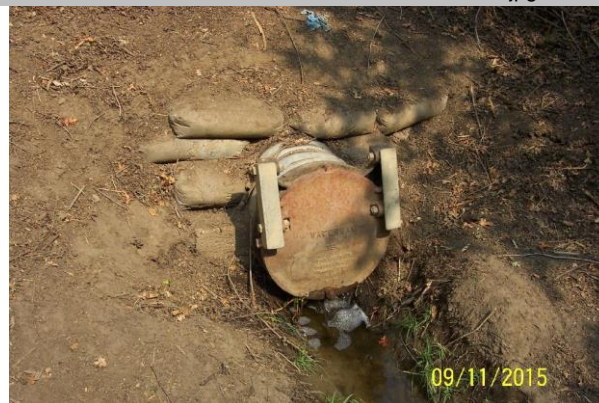
Photo 1 of 3 : UCIP_FA_2017_51716_74682.jpg

FS_ID:51716
DS_ID:18626
EP_NO: N/A
Repair Type: Non-Urgent
Crossing Status: Found
UCIP Comments: 10-30-2015 - Waterside flap gate was cleared in December 2014 and again in September 2015 No LMA access available on Landside (P. Meagher). Pipe partially blocked on LS and flap gate blocked on WS (W. Wylie-UCIP Inspector)
FIELD_STRUCT_DESC: 18-inch corrugated metal storm drainage pipe through the levee, 19 feet below the crown. Gate valve on the waterside (WS). [Additional Reference(s): USACE Drawing No. 2-4-106, Sheet 2].
FS Date: 9/11/2015

Flap Gate is clear as of 9/11/15.

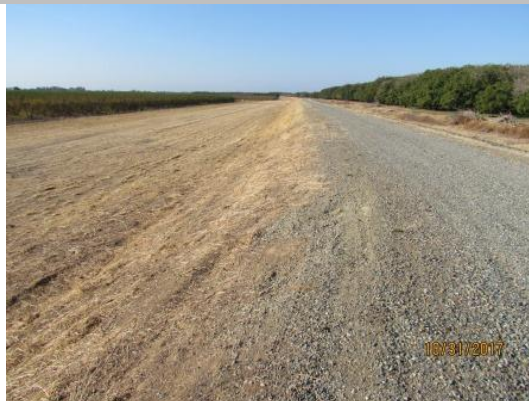
Photo 1 of 2 : FA_2017_RD0784_184_1_20171106_00001.jpg

LM Start	0.00	Rating **	A	Issue No.	1
LM End	3.80	Issue Type +	Ma	Location *	LS
Category	Earthen Levee			GPS Latitude/Longitude	
				Start	End
Item	Vegetation			39.134861 °	39.165463 °
				-121.552194 °	-121.495653 °
DWR ID	DWR_RD0784_07_f_2017_1				
Comment Code					
V1 : Control annual grass and weeds on the levee slopes and easements.					
Inspector Comment					
Annual vegetation is well maintained, Fall 2017.

View looking downstream landside of well maintained vegetation, Fall 2017.

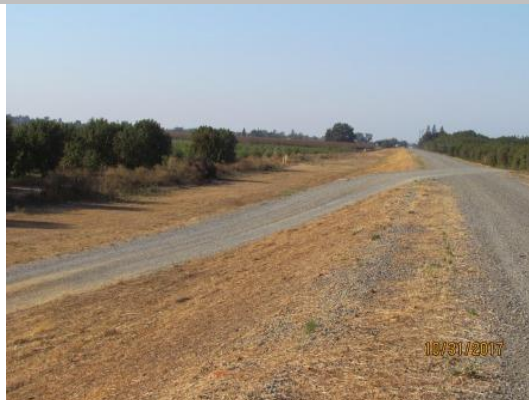
Photo 2 of 2 : FA_2017_RD0784_184_1_20171106_00002.jpg

Second view looking downstream landside of well maintained vegetation, Fall 2017.

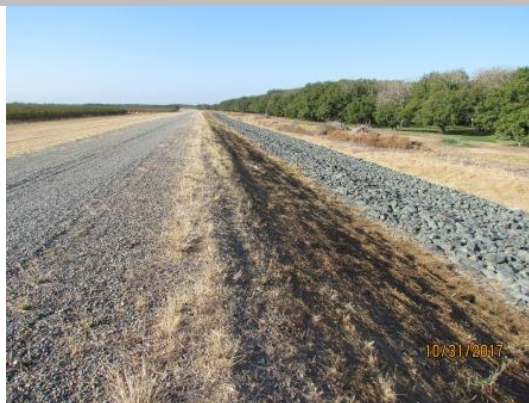
Photo 1 of 2 : FA_2017_RD0784_184_2_20171106_00003.jpg

LM Start	0.00	Rating **	A	Issue No.	2
LM End	3.80	Issue Type +	Ma	Location *	WS
Category	Earthen Levee			GPS Latitude/Longitude	
				Start	End
Item	Vegetation			39.134861 °	39.165463 °
				-121.552194 °	-121.495653 °
DWR ID	DWR_RD0784_07_f_2017_2				
Comment Code					
V1 : Control annual grass and weeds on the levee slopes and easements.					
Inspector Comment					
Annual vegetation is well maintained, Fall 2017.

View looking downstream waterside of well maintained vegetation, Fall 2017.

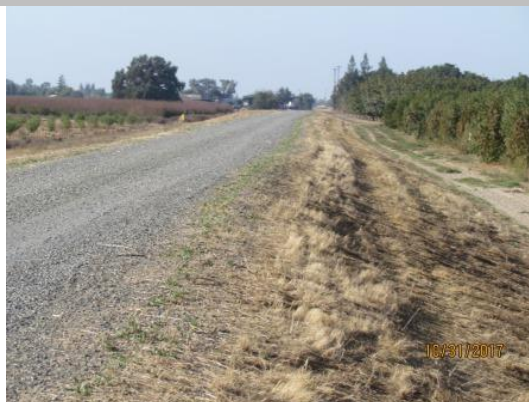
Photo 2 of 2 : FA_2017_RD0784_184_2_20171106_00004.jpg

Second view looking downstream waterside of well maintained vegetation, Fall 2017.

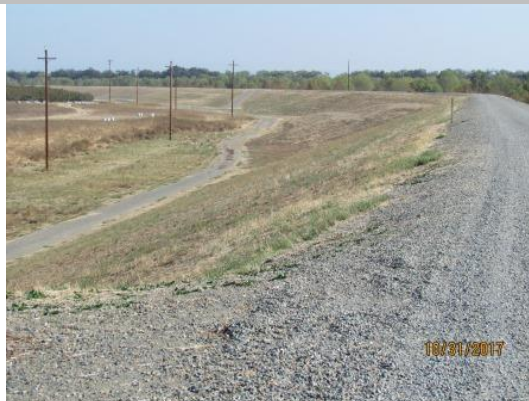
Photo 1 of 2 : FA_2017_RD0784_437_1_20171106_00001.jpg

View looking upstream landside of well maintained vegetation, Fall 2017.

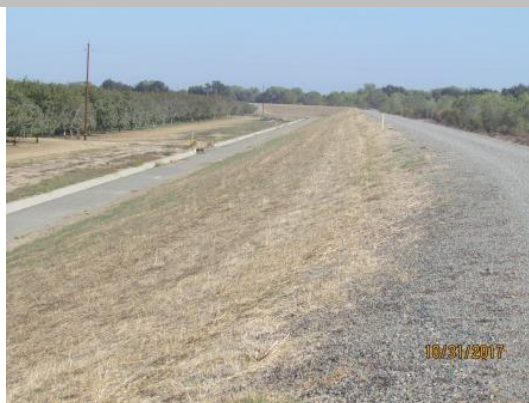
Photo 2 of 2 : FA_2017_RD0784_437_1_20171106_00002.jpg

Second view looking upstream landside of well maintained vegetation, Fall 2017.

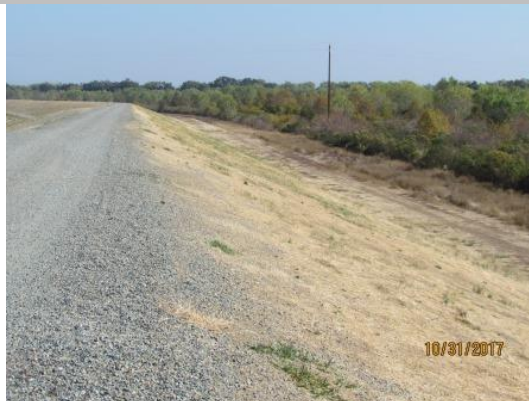
Photo 1 of 2 : FA_2017_RD0784_437_2_20171106_00003.jpg

LM Start	0.01	Rating **	A	Issue No.	2
LM End	1.92	Issue Type +	Ma	Location *	WS
Category	Earthen Levee			GPS Latitude/Longitude	
				Start	End
Item	Vegetation			38.955474 °	38.970388 °
				-121.574783 °	-121.547640 °
DWR ID	DWR_RD0784_08_f_2017_2				
Comment Code					
V1 : Control annual grass and weeds on the levee slopes and easements.					
Inspector Comment					
Annual vegetation is well maintained, Fall 2017.

View looking upstream waterside of well maintained vegetation, Fall 2017.

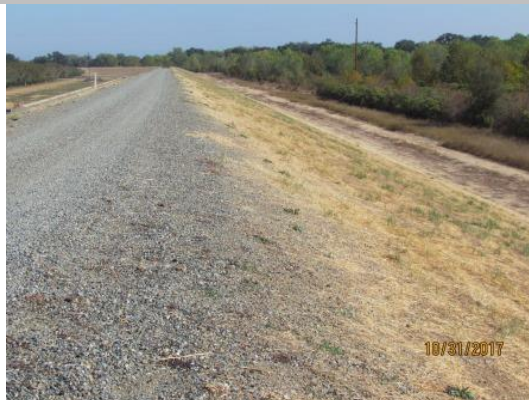
Photo 2 of 2 : FA_2017_RD0784_437_2_20171106_00004.jpg

Second view looking upstream waterside of well maintained vegetation, Fall 2017.

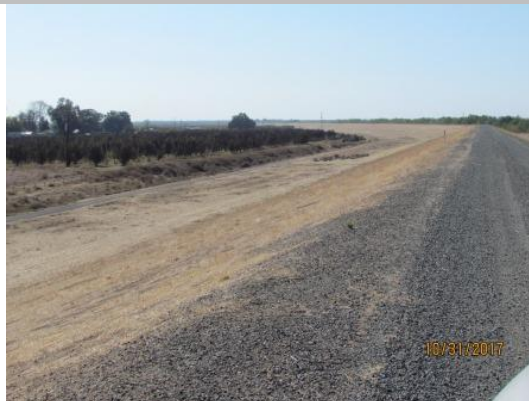
Photo 1 of 3 : FA_2017_RD0784_530_1_20171106_00002.jpg

LM Start	0.01	Rating **	A	Issue No.	1
LM End	5.71	Issue Type +	Ma	Location *	LS
Category	Earthen Levee			GPS Latitude/Longitude	
				Start	End
Item	Vegetation			39.090180 °	39.010176 °
				-121.584781 °	-121.579448 °
DWR ID	DWR_RD0784_09_f_2017_1				
Comment Code					
V1 : Control annual grass and weeds on the levee slopes and easements.					
Inspector Comment					
Annual vegetation is well maintained, Fall 2017.

View at the start of Unit 9 looking downstream landside of well maintained vegetation, Fall 2017.

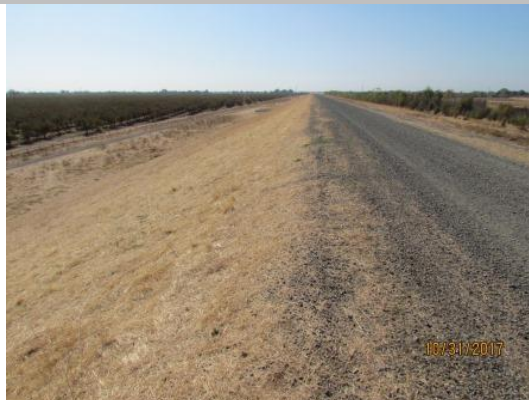
Photo 2 of 3 : FA_2017_RD0784_530_1_20171106_00001.jpg

View around midpoint of Unit 9 looking downstream landside of well maintained vegetation, Fall 2017.

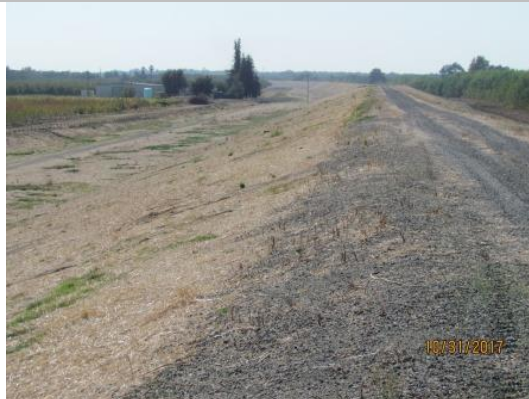
Photo 3 of 3 : FA_2017_RD0784_530_1_20171106_00003.jpg

LM Start	0.01	Rating **	A	Issue No.	1 (cont)	
LM End	5.71	Issue Type +	Ma	Location *	LS	
Category	Earthen Levee			GPS Latitude/Longitude		
				Start	End	
Item	Vegetation			39.090180 °	39.010176 °	
				-121.584781 °	-121.579448 °	
DWR ID	DWR_RD0784_09_f_2017_1					
Comment Code						
V1 : Control annual grass and weeds on the levee slopes and easements.						
Inspector Comment						
Annual vegetation is well maintained, Fall 2017.

View towards the end point of Unit 9 looking downstream landside of well maintained vegetation, Fall 2017.

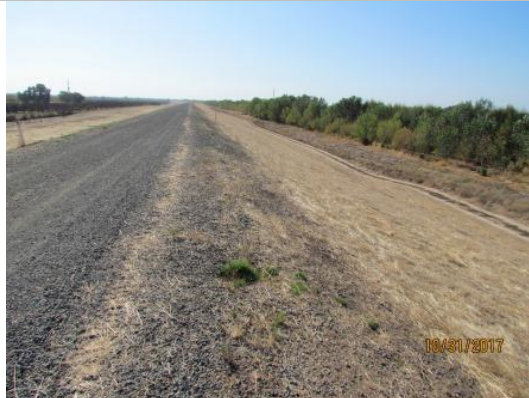
Photo 1 of 3 : FA_2017_RD0784_530_2_20171106_00005.jpg

LM Start	0.01	Rating **	A	Issue No.	2
LM End	5.71	Issue Type +	Ma	Location *	WS
Category	Earthen Levee			GPS Latitude/Longitude	
				Start	End
Item	Vegetation			39.090180 °	39.010176 °
				-121.584781 °	-121.579448 °
DWR ID	DWR_RD0784_09_f_2017_2				
Comment Code					
V1 : Control annual grass and weeds on the levee slopes and easements.					
Inspector Comment					
Annual vegetation is well maintained, Fall 2017.

View at the start of Unit 9 looking downstream waterside of well maintained vegetation, Fall 2017.

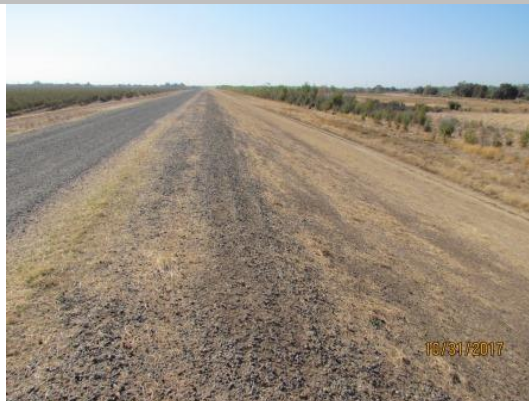
Photo 2 of 3 : FA_2017_RD0784_530_2_20171106_00004.jpg

View around midpoint of Unit 9 looking downstream waterside of well maintained vegetation, Fall 2017.

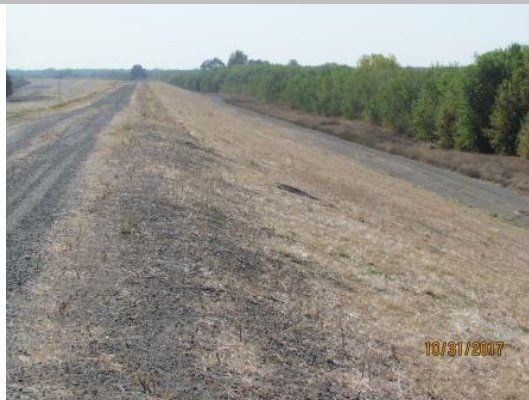
Photo 3 of 3 : FA_2017_RD0784_530_2_20171106_00006.jpg

View towards the end point of Unit 9 looking downstream waterside of well maintained vegetation, Fall 2017.
