**Flood Control Project Maintenance  
Levee Inspections**

**Maintenance Issue Types Only, Levee Inspection Report By Mile - Fall 2018**

**Reclamation District No. 0784 Plumas Lake**

Waterway	Bank	Unit Miles	Inspection Start/End	Inspector
Unit No. 01 Yuba River	Left	2.21	10/25/2018 10/25/2018	Sterling York

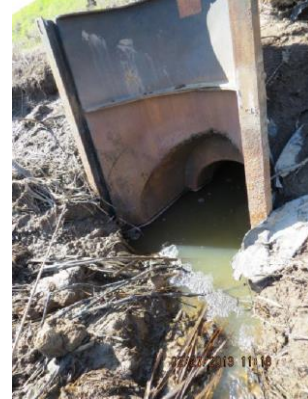
Photo 1 of 3 : UCIP\_FA\_2018\_51711\_16552.jpg

inlet control structure on LS toe.

LM Start	0.12	Rating **	A/W	Issue No.	17 (cont)	
LM End	0.12	Issue Type +	Ma	Location *		
Category	Supplemental			GPS Latitude/Longitude		
				Start	End	
Item	DWR UCIP LMA Responsibility			38.976147 °	38.976147 °	
				-121.533019 °	-121.533019 °	
DWR ID	18592					
Comment Code						
Inspector Comment						
FS_ID:51711						
DS_ID:18592						
EP_NO: N/A						
Repair Type: No Action Needed						
Crossing Status: Found						
UCIP Comments: 02/26/2013 Good candidate for video inspection. (W. Wylie - DWR UCIP)						
FIELD_STRUCT_DESC: 18-inch corrugated metal drainage pipe through the levee, 18 feet below the crown. Flap gate on the waterside (WS) end. Concrete U-shaped headwall on the WS end. Polyvinyl chloride weir inlet on landside (LS) toe. [Additional Reference(s): DWR Levee Log, 2005. USACE Sacramento O&M Manual 145, August 1955 (Station 25+28)].						
FS Date: 2/26/2013

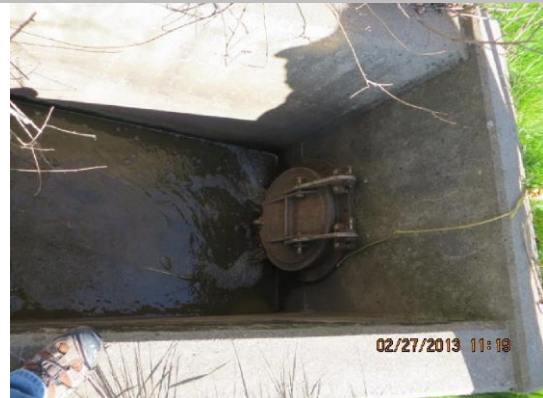
Photo 2 of 3 : UCIP\_FA\_2018\_51711\_16555.jpg

Concrete U-shaped outlet with flap gate on WS toe.

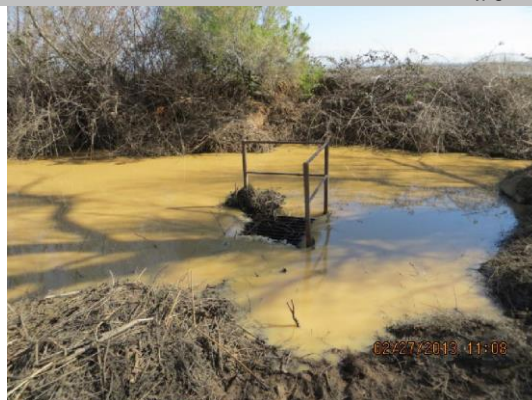
Photo 1 of 2 : UCIP\_FA\_2018\_51710\_54246.jpg

LM Start	0.84	Rating **	M	Issue No.	18	
LM End	0.84	Issue Type +	Ma	Location *		
Category	Supplemental			GPS Latitude/Longitude		
				Start		End
Item	DWR UCIP LMA Responsibility			38.986432 °		38.986432 °
				-121.534983 °		-121.534983 °
DWR ID	18591					
Comment Code						
Inspector Comment						
FS_ID:51710 DS_ID:18591 EP_NO: N/A Repair Type: Non-Urgent Crossing Status: Found UCIP Comments: 02/26/2013 No handle or access to slide gate on LS toe. (W. Wylie - DWR UCIP) FIELD_STRUCT_DESC: 30-inch corrugated metal drainage pipe through the levee, 23.7 feet below the crown. Flap gate on the waterside (WS) end. Slide gate inside a concrete drop inlet on the landside (LS). [Additional Reference(s): DWR Levee Log, 2005. USACE Sacramento O&M Manual 145, August 1955 (Station 63+00)]. FS Date: 9/11/2015 9:05:00 AM

Concrete drop-inlet at LS toe.

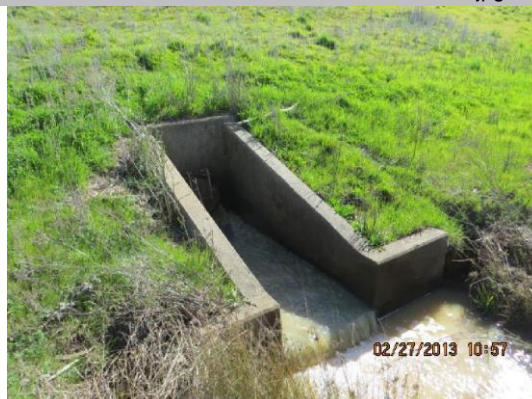
Photo 1 of 3 : UCIP\_FA\_2018\_51709\_16565.jpg

LM Start	1.60	Rating **	A/W	Issue No.	19	
LM End	1.60	Issue Type +	Ma	Location *		
Category	Supplemental			GPS Latitude/Longitude		
				Start		End
Item	DWR UCIP LMA Responsibility			38.997305 °		38.997305 °
				-121.537081 °		-121.537081 °
DWR ID	18590					
Comment Code						
Inspector Comment						
FS_ID:51709 DS_ID:18590 EP_NO: N/A Repair Type: No Action Needed Crossing Status: Found UCIP Comments: 02/26/2013 Good candidate for video inspection. (W. Wylie - DWR UCIP) FIELD_STRUCT_DESC: 18-inch corrugated metal drainage pipe through the levee, 14.5 feet below the crown. Flap gate on the waterside (WS) end. Concrete U-shaped headwall on the WS. Polyvinyl chloride weir on inlet. (See Drawing No. 2-4-106, Sheet 5). [Additional Reference(s): DWR Levee Log, 2005. USACE Sacramento O&M Manual 145, August 1955 (Station 103+23)]. FS Date: 2/26/2013

Concrete U-shaped headwall and flap gate on WS toe.

Comment Code						
Inspector Comment						
FS_ID:51709						
DS_ID:18590						
EP_NO: N/A						
Repair Type: No Action Needed						
Crossing Status: Found						
UCIP Comments: 02/26/2013 Good candidate for video inspection.

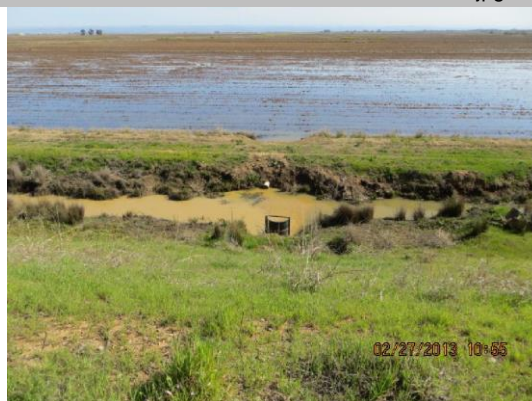
Photo 2 of 3 : UCIP\_FA\_2018\_51709\_16563.jpg

Pvc weir on inlet at LS toe.

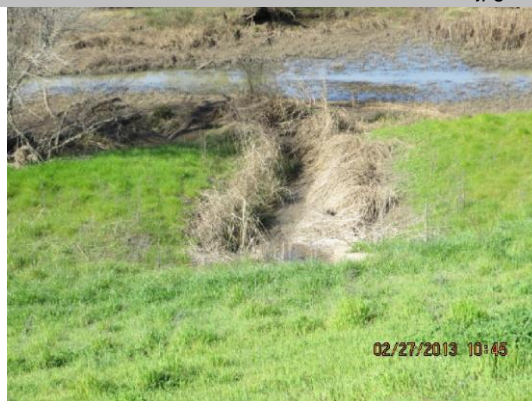
Photo 3 of 3 : UCIP\_FA\_2018\_51719\_54249.jpg

LM Start	1.86	Rating **	M	Issue No.	20 (cont)	
LM End	1.86	Issue Type +	Ma	Location *		
Category	Supplemental			GPS Latitude/Longitude		
				Start	End	
Item	DWR UCIP LMA Responsibility			39.000975 °	39.000975 °	
				-121.537779 °	-121.537779 °	
DWR ID	18588					
Comment Code						
Inspector Comment						
FS_ID:51719 DS_ID:18588 EP_NO: N/A Repair Type: Non-Urgent Crossing Status: Found UCIP Comments: 09/11/2015 Inlet burried. Good candidate for video inspection as pipe is corroded. (G. Wylie - FPIIB) FIELD_STRUCT_DESC: 18-inch corrugated metal drainage pipe through the levee, 14.5 feet below the crown. Flap gate on the waterside (WS) end. Concrete U-shaped headwall on the WS. [Additional Reference(s): DWR Levee Log, 2005. USACE Sacramento O&M Manual 145, August 1955 (Station 116+78)]. FS Date: 9/11/2015 9:36:00 AM

Drainage outlet on WS toe.

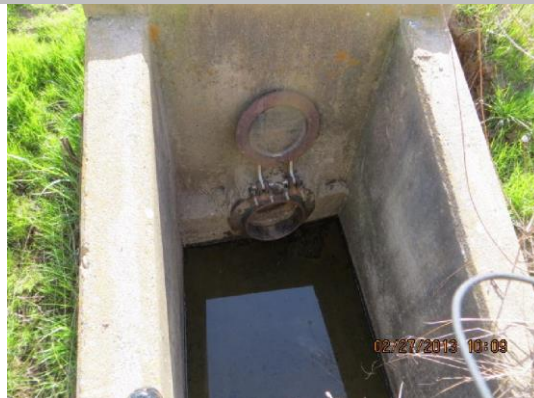
Photo 1 of 3 : UCIP\_FA\_2018\_51714\_54259.jpg

Comment Code						
Inspector Comment						
FS_ID:51714						
DS_ID:18596						
EP_NO: N/A						
Repair Type: Non-Urgent						
Crossing Status: Found						
UCIP Comments: 02/27/2013 Pipe has been sliplined with PVC, but the liner appears to be eroding at outlet and may be disjointed internal to the levee. See pic. Good candidate for video inspection. (W. Wylie - DWR UCIP)						
FIELD_STRUCT_DESC: 12-inch corrugated metal drainage pipe through the levee, 12 feet below the crown. Flap gate and concrete U-shaped headwall on the waterside (WS). Polyvinyl chloride weir on inlet at the landside (LS) toe. [Additional Reference(s): DWR Levee Log, 2005. USACE Sacramento O&M Manual 145, August 1955 (Station 44+96)].						
FS Date: 9/11/2015 9:26:00 AM

Concrete U-shaped headwall and flap gate on WS toe.

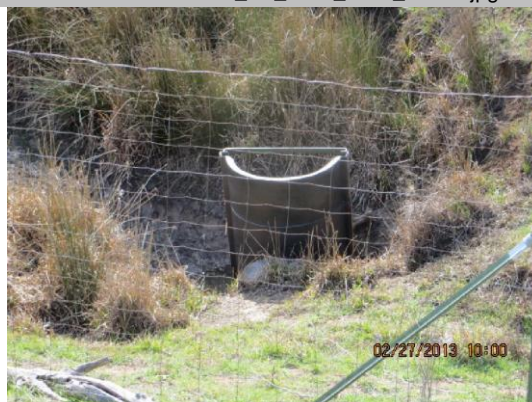
Photo 1 of 2 : UCIP\_FA\_2018\_9566\_16594.jpg

LM Start	3.23	Rating **	A/W	Issue No.	24
LM End	3.23	Issue Type +	Ma	Location *	
Category	Supplemental			GPS Latitude/Longitude	
				Start	End
Item	DWR UCIP LMA Responsibility			39.017336 °	39.017336 °
				-121.526530 °	-121.526530 °
DWR ID	18595				
Comment Code					
Inspector Comment					
FS_ID:9566 DS_ID:18595 EP_NO: N/A Repair Type: No Action Needed Crossing Status: Found UCIP Comments: 02/27/2013 Good candidate for video inspection. (W. Wylie - DWR UCIP) FIELD_STRUCT_DESC: 18-inch corrugated metal drainage pipe through the levee, 15.8 feet below the crown. Flap gate on the waterside (WS) end. Polyvinyl chloride weir on inlet at the landside (LS) toe. [Additional Reference(s): DWR Levee Log, 2005. USACE Sacramento O&M Manual 145, August 1955, Drawing No. 2-4-106, Sheet 6 (Station 53+86)]. FS Date: 2/27/2013

PVC weir inlet on LS toe.

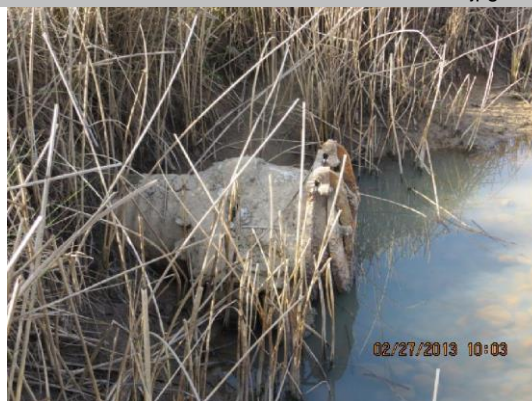
Photo 2 of 2 : UCIP\_FA\_2018\_9566\_16593.jpg

LM Start	3.23	Rating **	A/W	Issue No.	24 (cont)	
LM End	3.23	Issue Type +	Ma	Location *		
Category	Supplemental			GPS Latitude/Longitude		
				Start		End
Item	DWR UCIP LMA Responsibility			39.017336 °		39.017336 °
				-121.526530 °		-121.526530 °
DWR ID	18595					
Comment Code						
Inspector Comment						
FS_ID:9566						
DS_ID:18595						
EP_NO: N/A						
Repair Type: No Action Needed						
Crossing Status: Found						
UCIP Comments: 02/27/2013 Good candidate for video inspection. (W. Wylie - DWR UCIP)						
FIELD_STRUCT_DESC: 18-inch corrugated metal drainage pipe through the levee, 15.8 feet below the crown. Flap gate on the waterside (WS) end. Polyvinyl chloride weir on inlet at the landside (LS) toe. [Additional Reference(s): DWR Levee Log, 2005. USACE Sacramento O&M Manual 145, August 1955, Drawing No. 2-4-106, Sheet 6 (Station 53+86)].						
FS Date: 2/27/2013

Flap gate at WS toe.

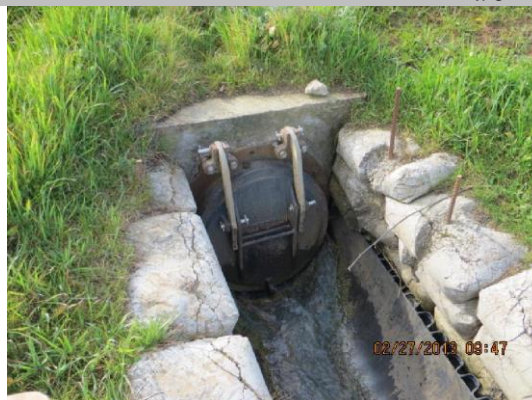
Photo 1 of 3 : UCIP\_FA\_2018\_51713\_16590.jpg

LM Start	3.79	Rating **	A/W	Issue No.	25
LM End	3.79	Issue Type +	Ma	Location *	
Category	Supplemental			GPS Latitude/Longitude	
				Start	End
Item	DWR UCIP LMA Responsibility			39.019222 °	39.019222 °
				-121.516414 °	-121.516414 °
DWR ID	18594				
Comment Code					
Inspector Comment					
FS_ID:51713					
DS_ID:18594					
EP_NO: N/A					
Repair Type: No Action Needed					
Crossing Status: Found					
UCIP Comments:					
FIELD_STRUCT_DESC: 18-inch corrugated metal drainage pipe through the levee, 8.8 feet below the crown. Flap gate and headwall on the waterside (WS) end. [Additional Reference(s): DWR Levee Log, 2005. USACE Sacramento O&M Manual 145, August 1955 (Station 83+39)].					
FS Date: 2/27/2013

Concrete outlet and flap gate on WS toe.

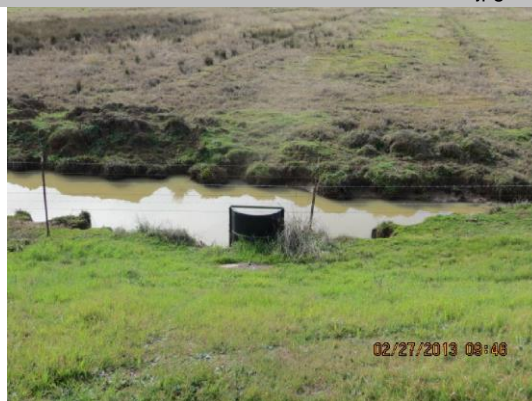
Photo 2 of 3 : UCIP\_FA\_2018\_51713\_16591.jpg

LM Start	3.79	Rating **	A/W	Issue No.	25 (cont)	
LM End	3.79	Issue Type +	Ma	Location *		
Category	Supplemental			GPS Latitude/Longitude		
				Start	End	
Item	DWR UCIP LMA Responsibility			39.019222°	39.019222°	
				-121.516414°	-121.516414°	
DWR ID	18594					
Comment Code						
Inspector Comment						
FS_ID:51713						
DS_ID:18594						
EP_NO: N/A						
Repair Type: No Action Needed						
Crossing Status: Found						
UCIP Comments:						
FIELD_STRUCT_DESC: 18-inch corrugated metal drainage pipe through the levee, 8.8 feet below the crown. Flap gate and headwall on the waterside (WS) end. [Additional Reference(s): DWR Levee Log, 2005. USACE Sacramento O&M Manual 145, August 1955 (Station 83+39)].						
FS Date: 2/27/2013

PVC weir at inlet on LS toe.

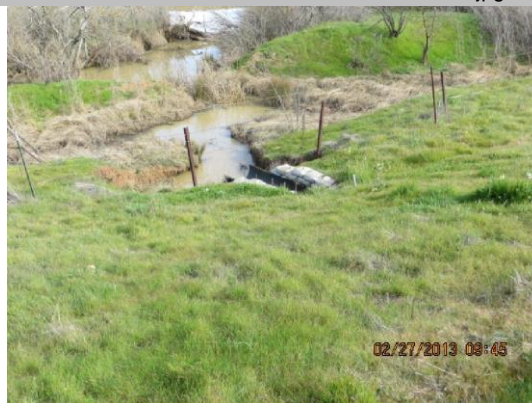
Photo 3 of 3 : UCIP\_FA\_2018\_51713\_16592.jpg

Concrete outlet on WS toe.
