**Flood Control Project Maintenance
Levee Inspections**

Maintenance Issue Types Only, Levee Inspection Report By Mile - Fall 2019

Reclamation District No. 0784 Plumas Lake

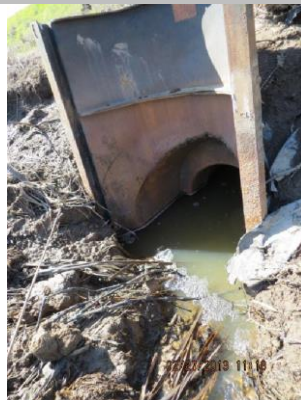
Photo 1 of 3 : UCIP_FA_2019_53544_16552.jpg

inlet control structure on LS toe.

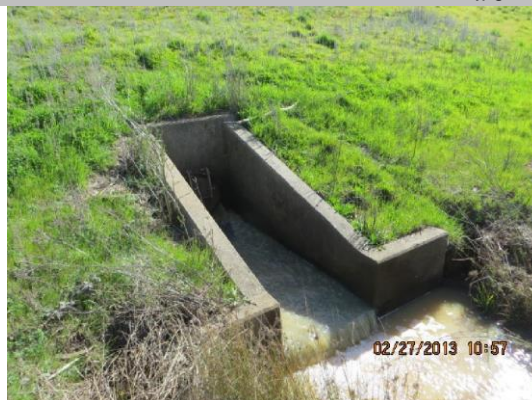
Photo 1 of 3 : UCIP_FA_2019_53547_16565.jpg

Comment Code						
Inspector Comment						
DS_ID:18590						
FS_ID:53547						
EP_NO: N/A						
Repair Type: No Action Needed						
Crossing Status: Found						
UCIP Comments: 2-1-2019 - Pipe crossing was video inspected on						
8/14/2018. (P. Meagher)02/26/2013 Good candidate for video						
inspection. (W. Wylie - DWR UCIP)						
FIELD_STRUCT_DESC: 18-inch corrugated metal drainage pipe						
through the levee, 14.5 feet below the crown. Flap gate on the						
waterside (WS) end. Concrete U-shaped headwall on the WS. Polyvinyl						
chloride weir on inlet. (See Drawing No. 2-4-106, Sheet 5). [Additional						
Reference(s): DWR Levee Log, 2005. USACE Sacramento O&M						
Manual 145, August 1955 (Station 103+23)].						
FS Date: 2/26/2013

Concrete U-shaped headwall and flap gate on WS toe.

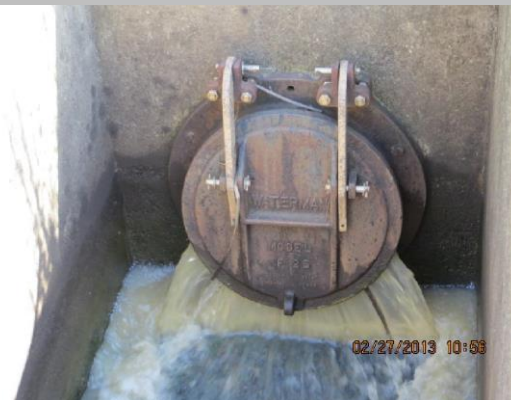
Photo 3 of 3 : UCIP_FA_2019_53547_16562.jpg

Concrete U-shaped headwall and flap gate on WS toe.

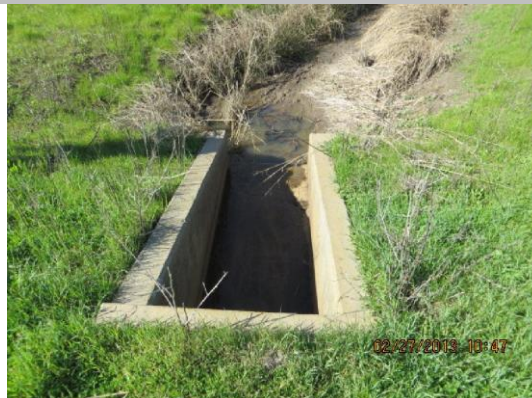
Photo 1 of 3 : UCIP_FA_2019_53548_54247.jpg

LM Start	1.86	Rating **	M	Issue No.	19	
LM End	1.86	Issue Type +	Ma	Location *		
Category	Supplemental			GPS Latitude/Longitude		
				Start		End
Item	DRAFT DWR UCIP LMA Responsibility			39.000975 °		39.000975 °
				-121.537779 °		-121.537779 °
DWR ID	18588					
Comment Code						
Inspector Comment						
DS_ID:18588 FS_ID:53548 EP_NO: N/A Repair Type: Non-Urgent Crossing Status: Found UCIP Comments: 2-1-2019 - Pipe crossing was video inspected on 8/14/2018. (P. Meagher)09/11/2015 Inlet burried. Good candidate for video inspection as pipe is corroded. (G. Wylie - FPIIB) FIELD_STRUCT_DESC: 18-inch corrugated metal drainage pipe through the levee, 14.5 feet below the crown. Flap gate on the waterside (WS) end. Concrete U-shaped headwall on the WS. [Additional Reference(s): DWR Levee Log, 2005. USACE Sacramento O&M Manual 145, August 1955 (Station 116+78)]. FS Date: 9/11/2015 9:36:00 AM

Concrete U-shaped outlet and flap-gate on WS toe.

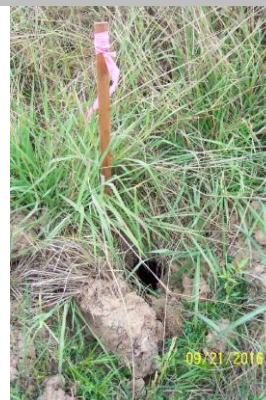
Photo 2 of 3 : UCIP_FA_2019_53550_76148.jpg

Possible location of the inlet on the LS toe

Comment Code						
Inspector Comment						
DS_ID:18593 FS_ID:53550 EP_NO: N/A Repair Type: Non-Urgent Crossing Status: Found UCIP Comments: 2/1/2019 - An attempt was made to video inspect this pipe crossing on 8/15/2018 but conditions were too muddy inside the pipe. (P. Meagher)11/14/2016 - Photos added of exposed flap gate on WS and possible inlet location on LS. Condition remains as Non-Urgent because of inlet not being fully operable. Unknown if pipe will operate as designed during high water or if it is full of sediment.11/01/2015 - Waterside Flap Gate Uncovered. Photo sent to DWR Matt Hoffman on 3/3/2014. Fresh photo sent to DWR Pavel Kazi on 9/9/2015. Landside toe has never been able to be located. Requesting DWR inspector to change the status of this issue to "No Action Needed". (P.Meagher - RD784).Pipe burried on LS toe and flap gate is blocked by soil on WS toe. (W. Wylie - UCIP Inspector). FIELD_STRUCT_DESC: 18-inch corrugated metal drainage pipe through the levee, 10 feet below the crown. Flap gate on the waterside (WS) end. [Additional Reference(s): DWR Levee Log, 2005. USACE Sacramento O&M Manual 145, August 1955 (Station 91+50)]. FS Date: 10/9/2015
